ODOT District 8
2024 In-Depth & NSTM Inspection Report

INSPECTION July/Aug 2024
REPORT Sept 2024

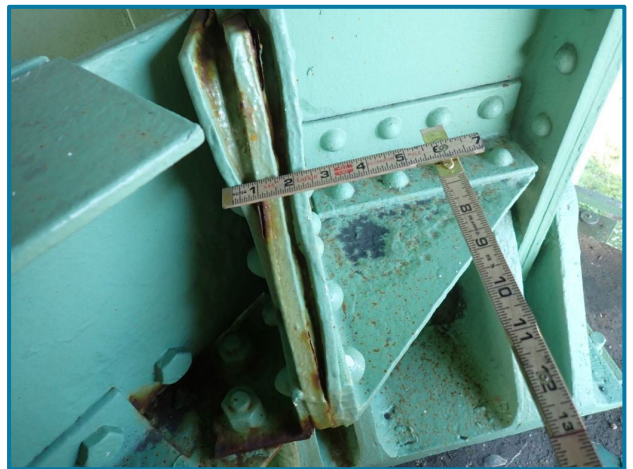
Photo 85 – Up to 1" pack rust at the connection to the truss (L20, North Truss, Span 11, looking northwest).

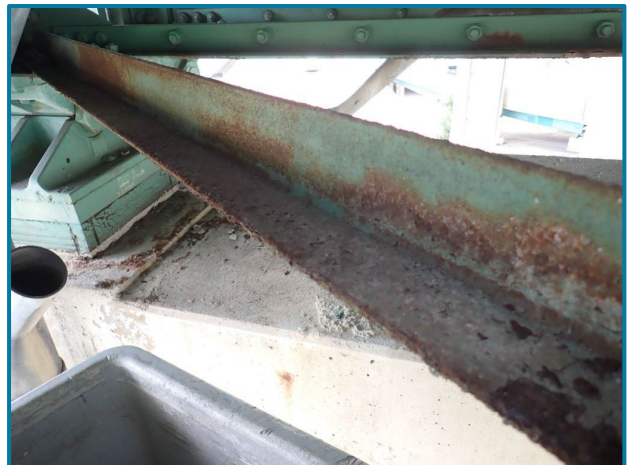
Photo 86 – Paint failure at the lower lateral bracing (Floorbeam 0, South Girder, Span 14, looking west).

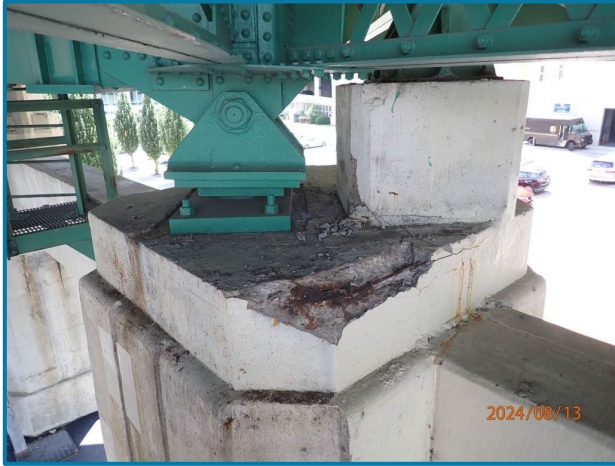
Photo 87 – 4' L x 8" W x 6" D spall with exposed rebar (Pier 5, Center Column, North Face, looking southwest).

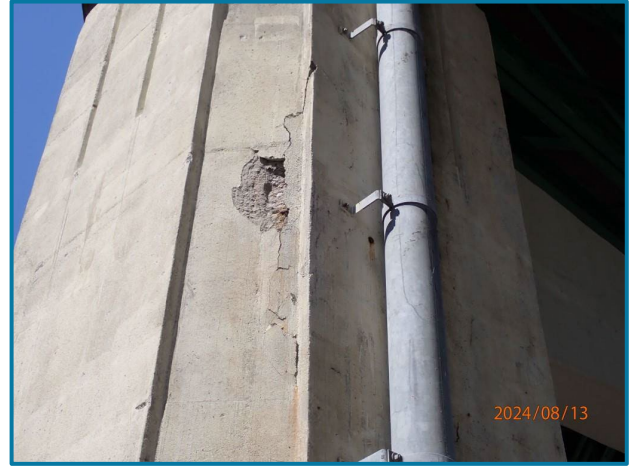
Photo 88 – 2' L x 5' H delamination with 1 SF x 1" spall (Pier 7, South Column, SE Corner, looking northwest).

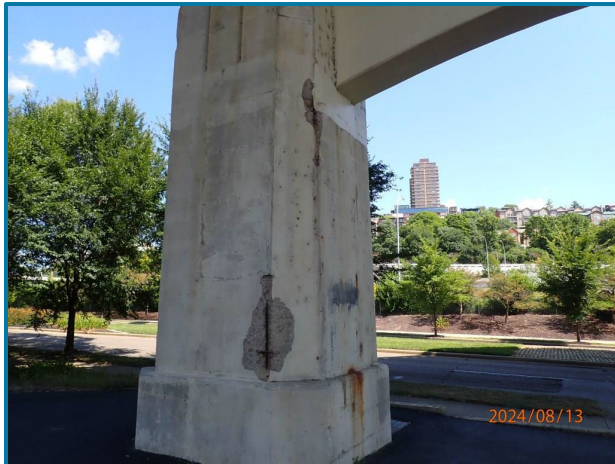
Photo 89 – Two spalls with exposed rebar (Pier 7, North Column, South and West Faces, looking northeast).

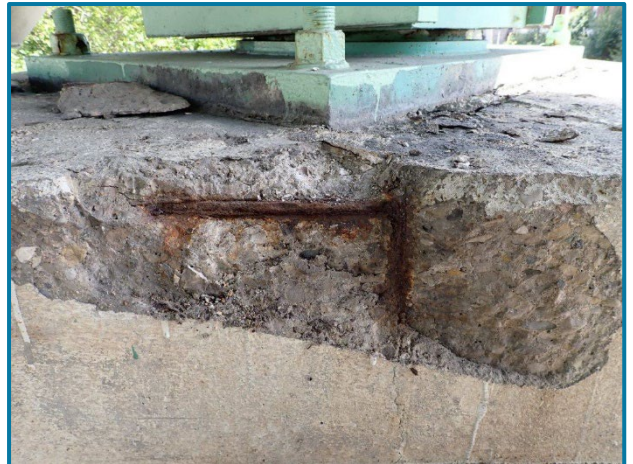
Photo 90 – 1'-9" L x 8" H x 2" D spall with exposed rebar (Pier 8, South Column, North Face, looking south).

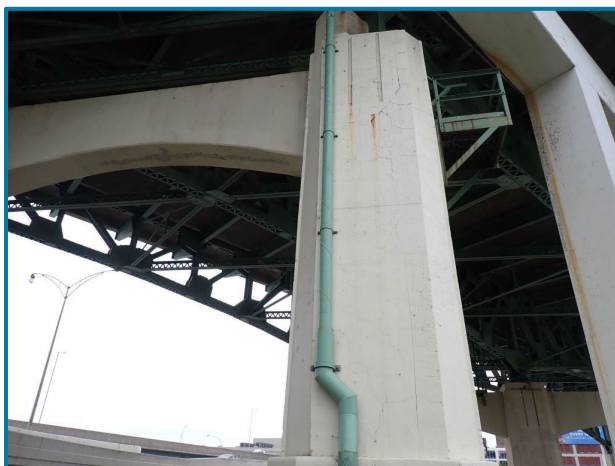
Photo 91 – Hairline cracking with rust staining (Pier 12, North Column, East Face, looking west).

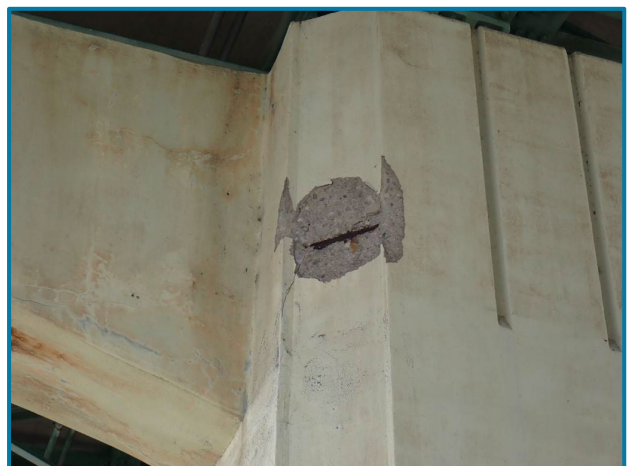
Photo 92 – 2' L x 2' H x 2" D spall with exposed rebar (Pier 13, Center Column, SE Corner, looking northwest).

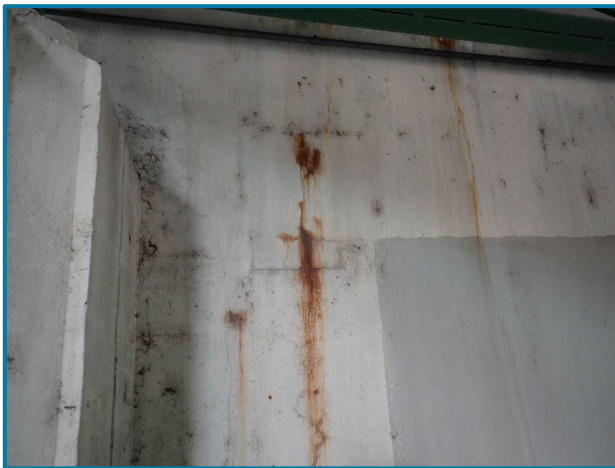
Photo 93 – Hairline cracking with rust staining (Abutment 1, East Face, looking west).

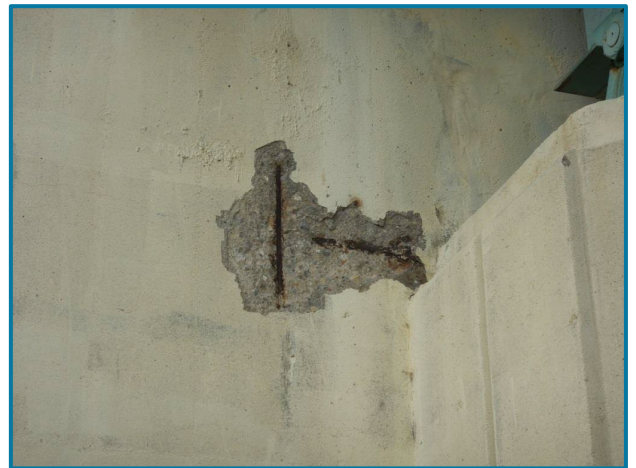
Photo 94 – 3' L x 2' H x 1" D spall with exposed rebar (Abutment 18, West Face, looking east).

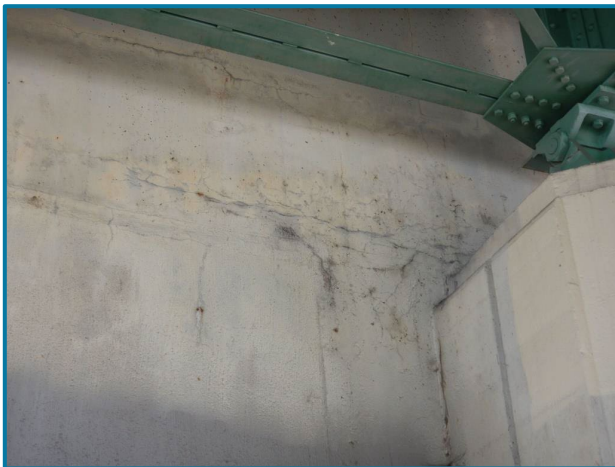
Photo 95 – Hairline map cracking over an area of 5' L x 2' H (Abutment 18, West Face, looking east).

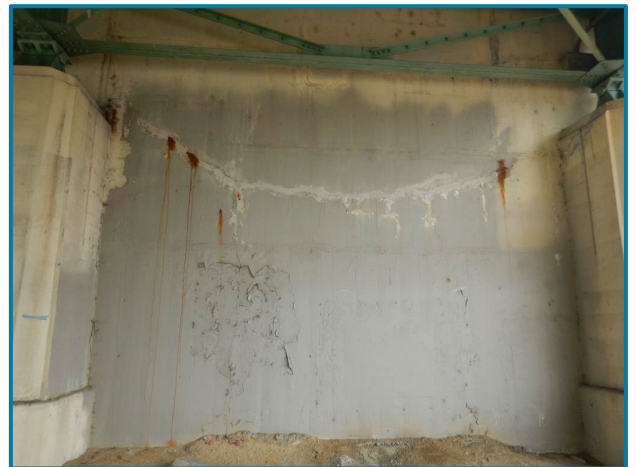
Photo 96 – 18' L horizontal sealed crack with rust staining and efflorescence (Abutment 18, West Face, looking east).

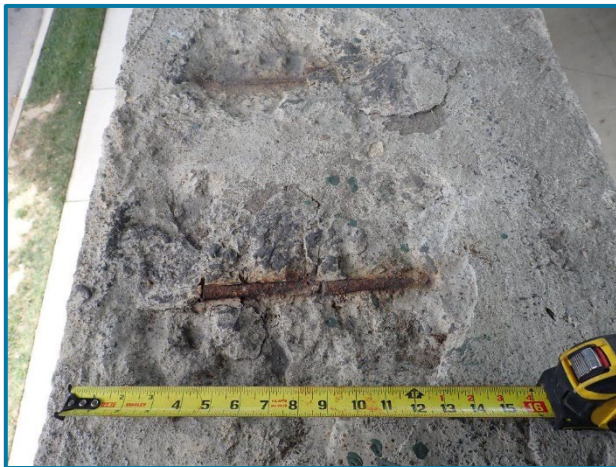
Photo 97 – (2) 1'-4" diameter x 1-1/2" D spall with exposed rebar (Pier 8, Top Face, looking down and north).

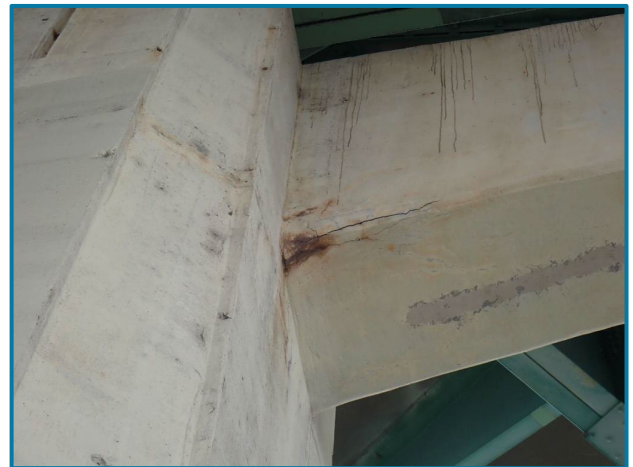
Photo 98 – 4' L wide crack with rust staining (Pier 12, West/Bottom Face, looking east).

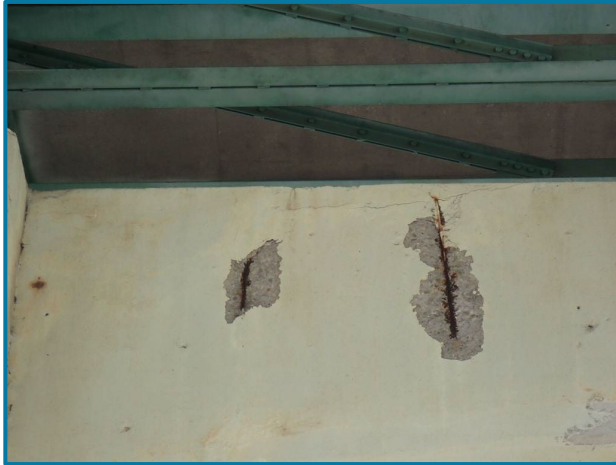
Photo 99 – 1' L x 3' H x 1" D and 1' L x 1' H x 1" D spalls with exposed rebar (Pier 13, East Face, looking west).

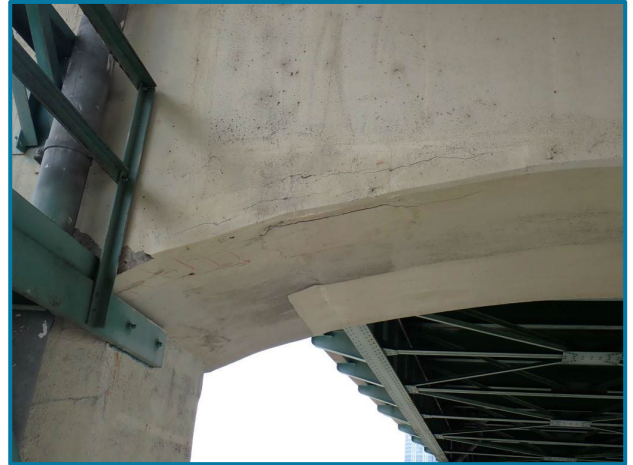
Photo 100 – 10' L section of cracked repair patch that extends 1' underneath (Pier 15, East Face, looking west).

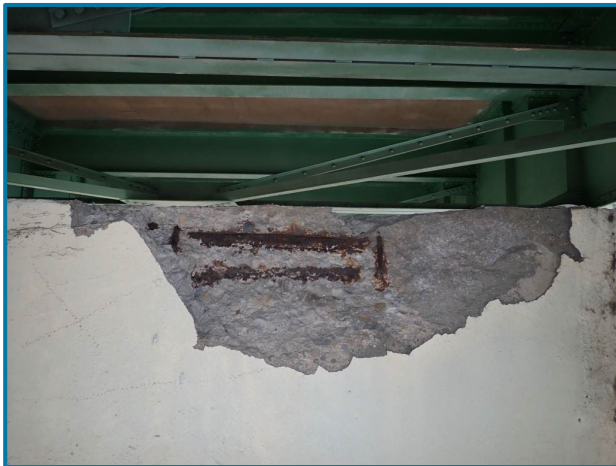
Photo 101 – 3'-8" L x 1'-1" H x 3" D spall with exposed rebar (Pier 16, East Face, looking west).

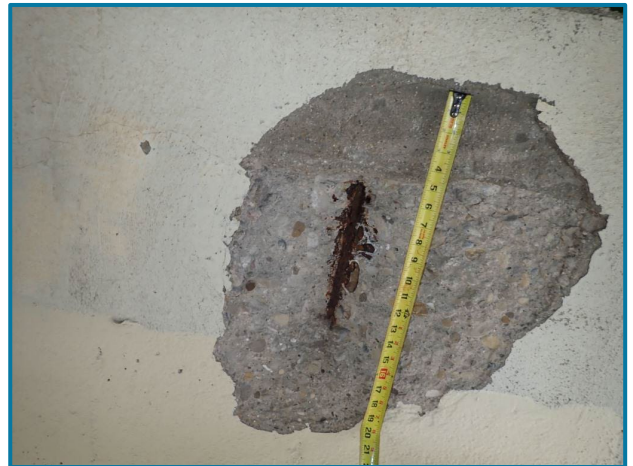
Photo 102 – 1'-8" diameter x 2" D spall with exposed rebar (Pier 16, West Face, looking east).

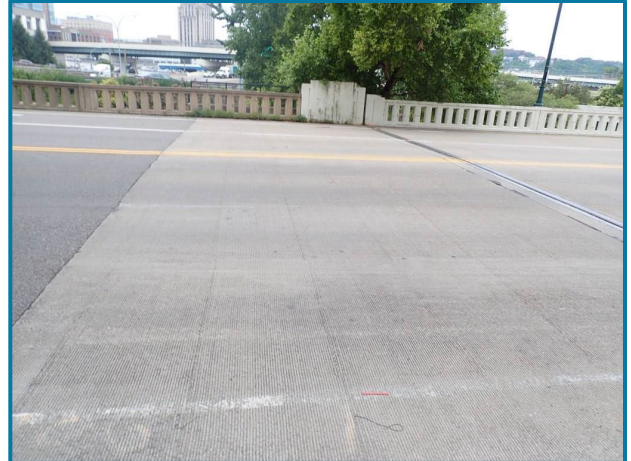
Photo 103 – Wear in the wheel lines of the approach slab (West Approach Slab, looking north).

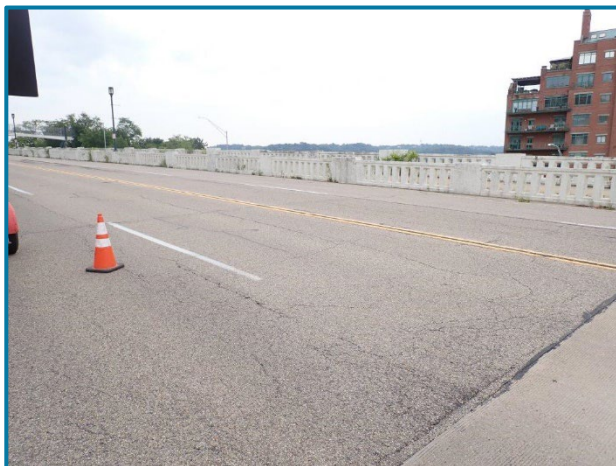
Photo 104 – Wide map and random cracking in the approach pavement (East Approach, looking southeast).

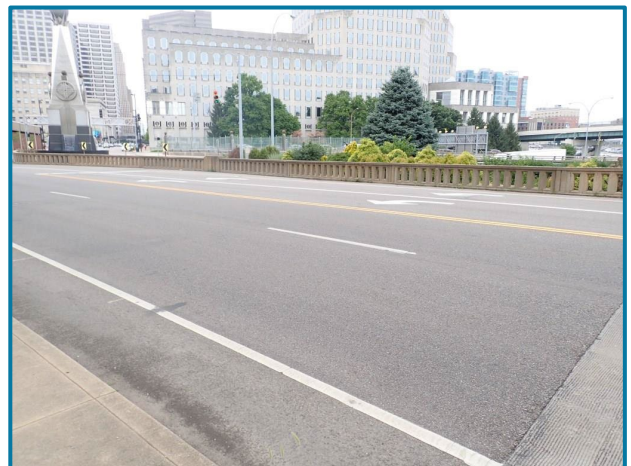
Photo 105 – Approach pavement at the west end of the bridge (West Approach, looking northwest).
