FRACTURE CRITICAL INSPECTION REPORT

SFN4400038 (LAW-07-0240)
SR-7 OVER SYMMES CREEK
LAWRENCE COUNTY, OH
DISTRICT 9

September 2024

Project: Symmes Creek Truss NSTM Inspection (PID No. 105476)

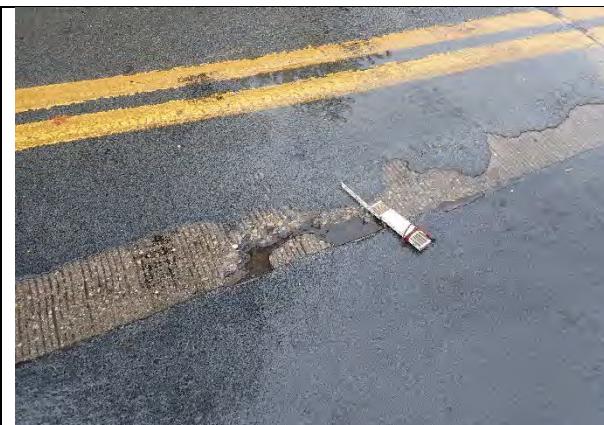
The reinforced concrete deck top surface is covered with an epoxy overlay and exhibits minor local cracks (Photo 6); however, in some locations, the wearing surface has completely worn away exposing the deck top surface (Photo 3). In these locations the deck top surface exhibited hairline to 1/32" wide map cracking and generally spaced at 2' to 3'. A few small and localized spalls are present on top of the deck at exposed locations; these generally are less than 1 square foot in size and of shallow depth. This overall has not substantially changed since the prior inspection. In Span 2, there is a 14" long by 4" wide by 2 1/2" high corner spall in the south edge of deck between Floor beams 2 and 3; no change for this inspection.

Photograph 3: General example of the deck top condition. Note worn away overlay and a small isolated spall on the top. No change this inspection.

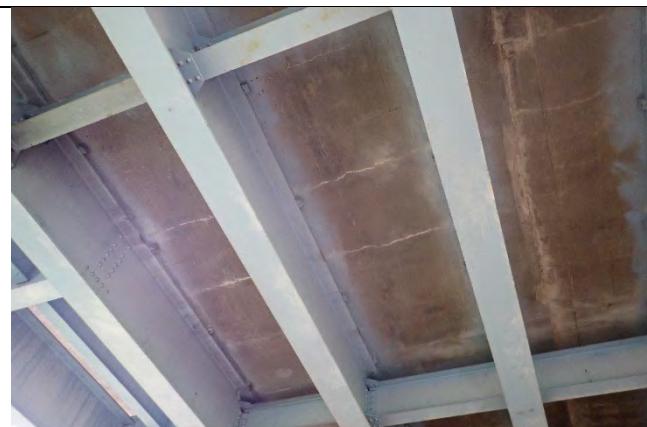
The deck soffit for the beam spans typically exhibited random transverse hairline to 1/32" cracks with efflorescence present; on average these cracks are spaced at 2' and occur along the full bridge length (Photos 4 and 5). There are isolated longitudinal cracks with efflorescence that are present along the bridge, generally these are a couple feet in length. The deck soffit in Span 2 exhibits hairline to 1/32" wide map cracks spaced as close as 12", transverse hairline cracks with minor to moderate efflorescence and isolated leakage, and isolated longitudinal hairline cracks with minor to moderate efflorescence (See Photo 3). Overall there were no substantial changes observed on the soffit.

Photograph 4: General example of transverse and map cracks with efflorescence on the soffit. Span 1 between Girders 4 and 5 shown.

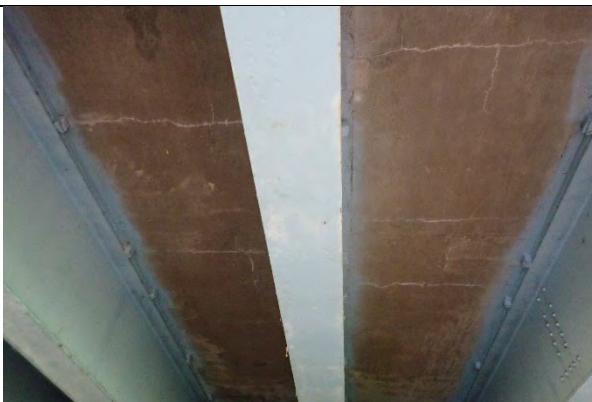
Photograph 5: General example of transverse and map cracks with efflorescence on the soffit. Span 1 shown.

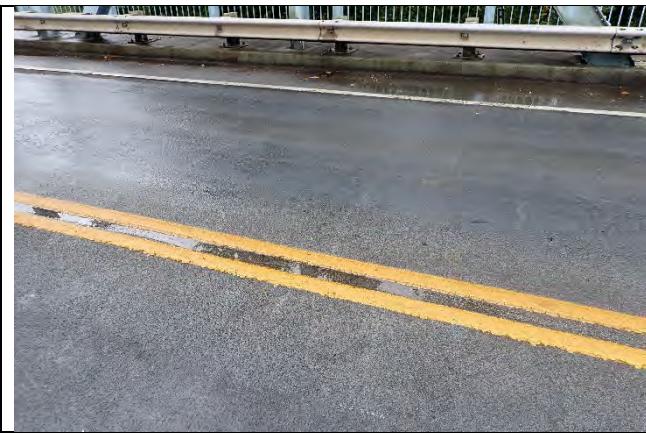
Photograph 6: Typical example of transverse and longitudinal cracks on the wearing surface. Span 2 eastbound near Pier 1 shown.

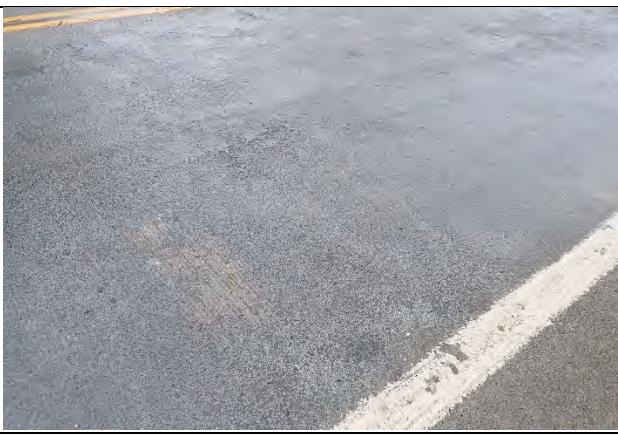
The 1/4" thick deck epoxy overlay exhibits moderate wear in the wheel lines (Photo 7). There are small, isolated locations throughout the bridge where the overlay is completely worn away and exposes the concrete surface. The largest is on the eastbound lane of Span 4 and currently a 6.5ft long x 2ft wide section is worn away (Photo 8); this location has slightly grown since the prior inspection.

Photograph 7: General example of wear on the overlay, Span 1 near Pier 1 shown.

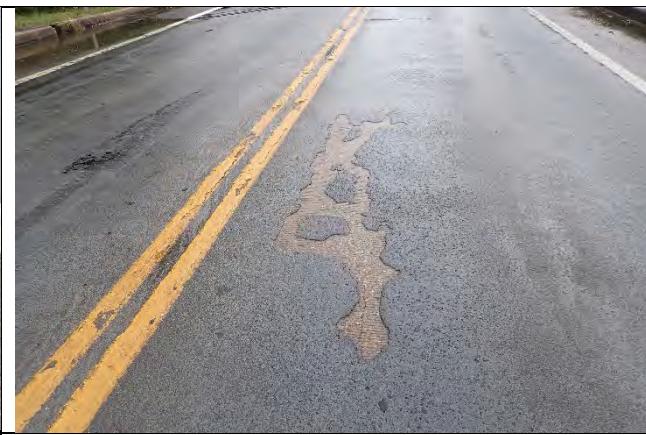
Photograph 8: Larger than normal example of wear occurring on top of the wearing surface in Span 4 eastbound.

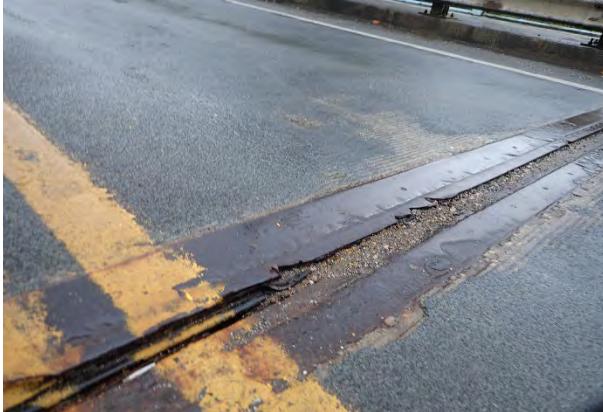
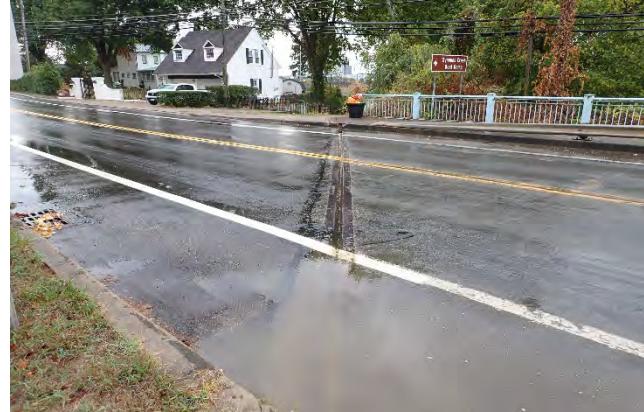
The middle 2ft of the joint seal is missing at Pier 2 at the centerline/yellow stripe (Photo 15). Additionally the end 4' of the joint on the south end is depressed down but has not fallen (Photo 16). At the Forward Abutment there is a total of 6" bulging/debonded joint seal over the eastbound lane (Photos 9 and 10).

<p>Photograph 9: Close up view of Far Abutment joint. Note typical snow plow damage and debris in the joint. Looking south.</p>	<p>Photograph 10: Overall view of the Far Abutment joint, looking south.</p>

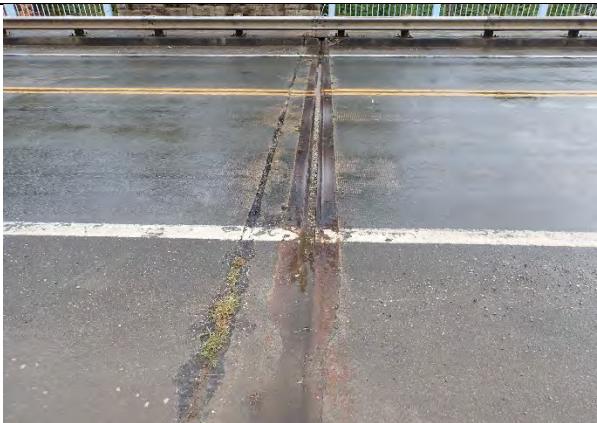
Photograph 11: Overall view of the Pier 3 joint. Note misalignment, debris in the joint, and armor damage. Looking south.

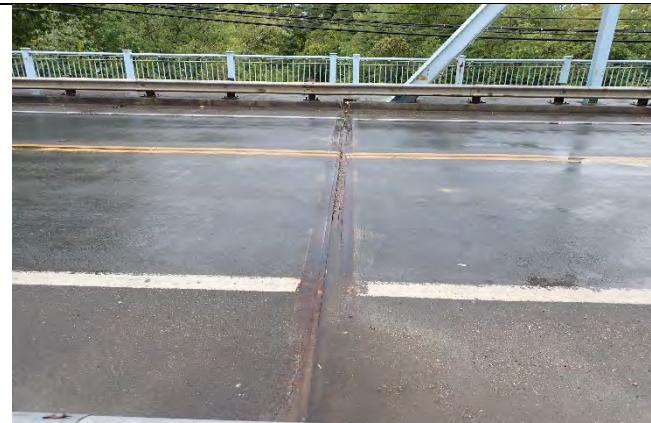
Photograph 12: Overall view of the Pier 2 joint. Note misalignment, debris in the joint, and armor damage. Looking south.

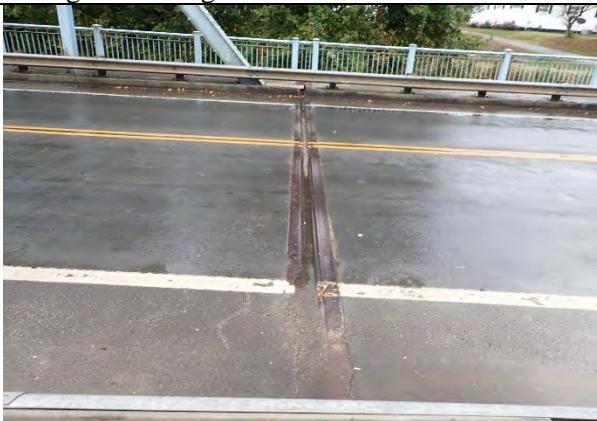
Photograph 13: Overall view of Pier 1 joint, looking south. Note debris in the joint.

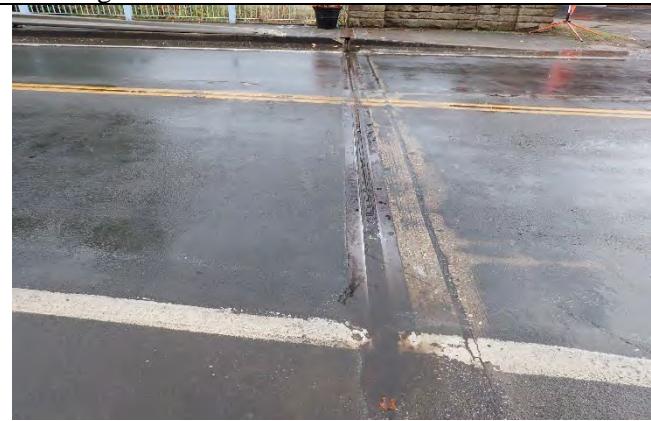
Photograph 14: Overall Rear Abutment joint, looking south. Note debris in the joint.

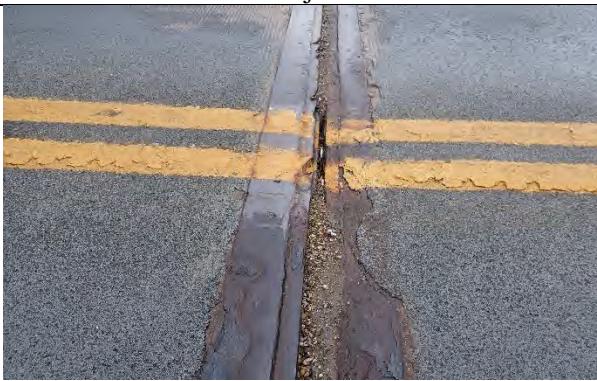
Photograph 15: Close up view of the Pier 2 joint near the centerline. Note the hole in the joint seal.

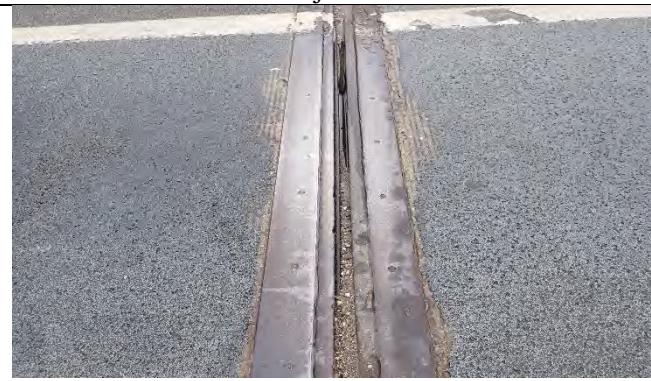
Photograph 16: View of the sunken joint seal over Pier 2 on the south end.

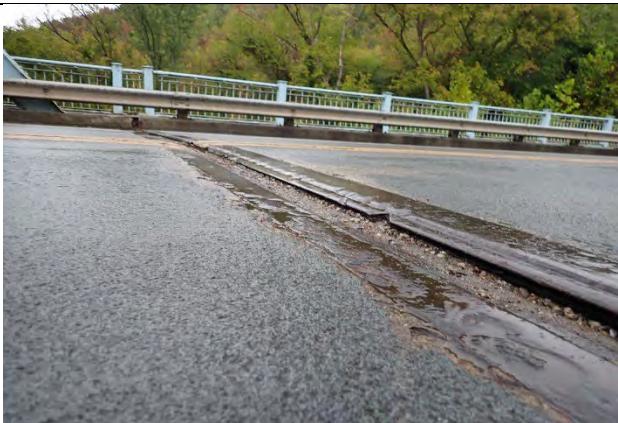
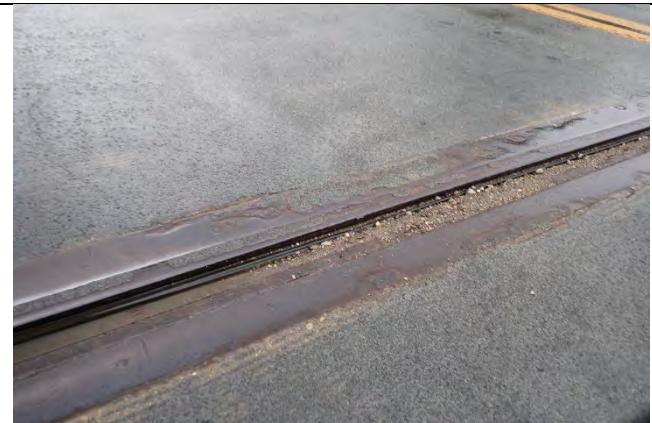
Vertical misalignments have previously been observed and recorded, and are still present at the joints. The largest vertical offset was at Pier 2 and currently measures 1-1/4" difference (Photos 17 and 18) with the Span 3 side higher. These measurements have not substantially changed from the prior inspection and there were no major condition differences noted from the prior inspection. The table below lists current and prior measurements of this situation for all the piers.

Photograph 17: View of the Pier 2 vertical offset and snowplow damage. Looking northeast.

Photograph 18: View of the Pier 2 vertical offset and snowplow damage. Looking southeast.

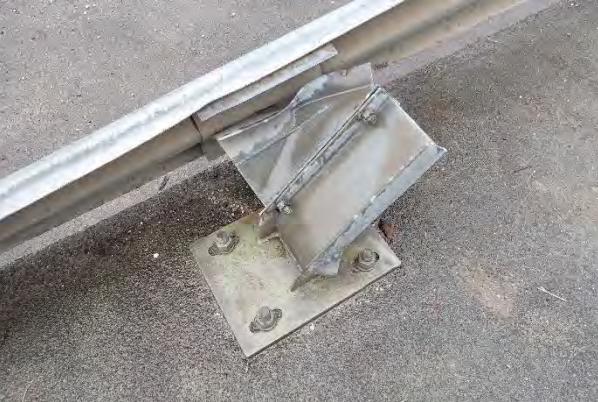
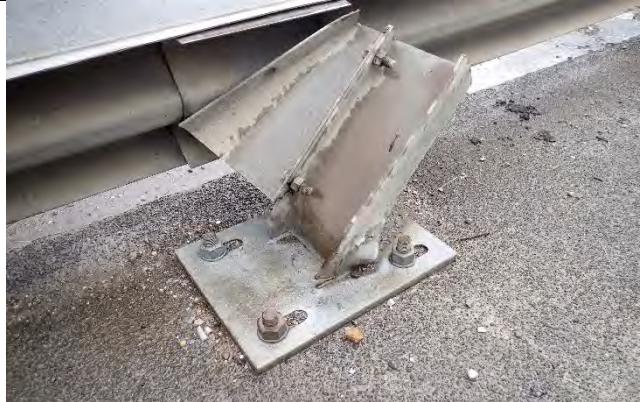
Photograph 19: Impact damage to the first post for the left forward rail, Span 4, looking southwest.	Photograph 20: Impact damage to the first post for right rear rail, Span 1, looking northeast. No change.

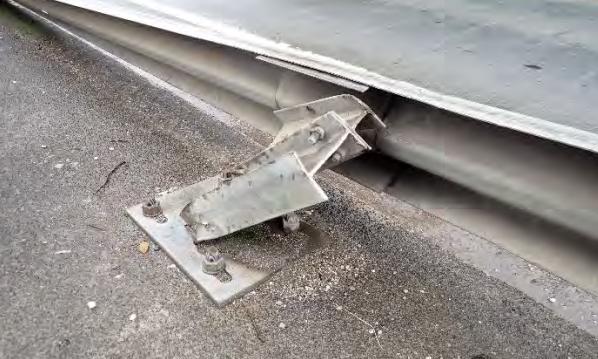
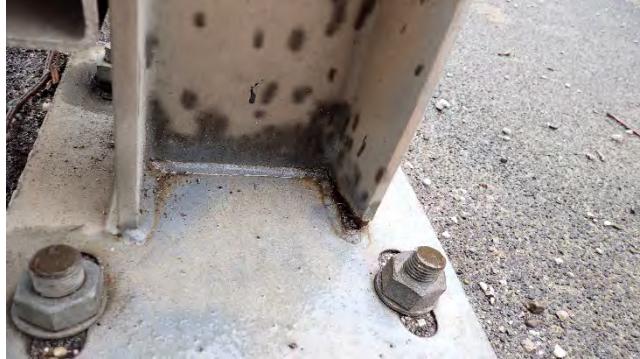
Photograph 21: Impact damage to first post for the right rear rail, Span 1, looking northwest.	Photograph 22: Impact damage to second post for the right rear rail, Span 1, looking east. No change.

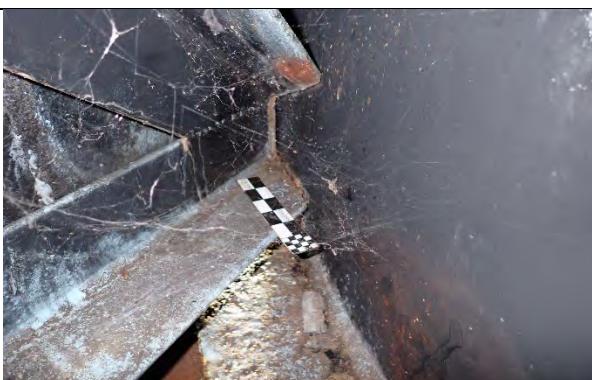
Photograph 23: Beam 4 at the Forward Abutment, north face. Note no change to broken cross frame weld.

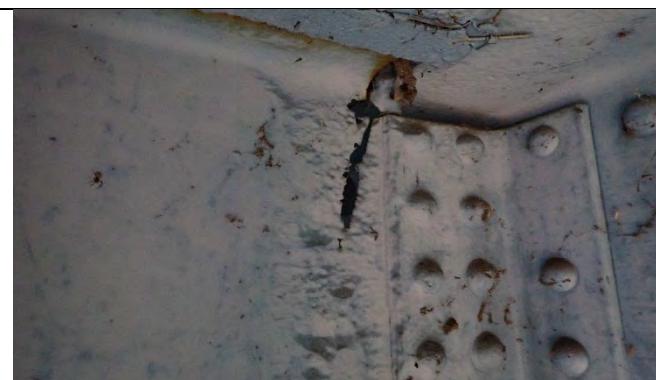
The end 2 feet of the beams in Span 4 at Pier 3 exhibit widespread laminating corrosion with negligible section loss. This has not changed since the prior inspection. The previously noted cracked weld between the north face of the Span 4 Beam 4 web and the cross frame bottom strut at the Forward Abutment is still present with no change. This is more of a broken weld than a true weld crack (Photo 23). A corrosion hole is present in Span 3 Pier 3 between Beams 1 and 2 (towards Beam 2), in the cope of the diaphragm (Photo 24).

Photograph 24: View of corrosion hole on diaphragm between Beams 1 and 2 at Pier 3 Span 3. Looking west.

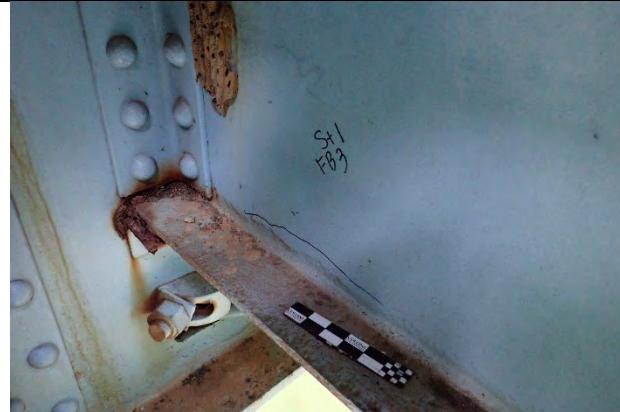
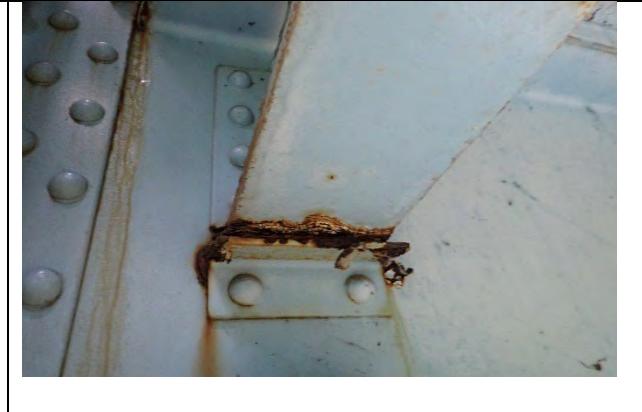
Photograph 25: View of the typical painted over pitting on the top of the bottom flange at the exterior face of the exterior stringer near floor beam connections. Floor Beam 3 Stringer 1 shown.	Photograph 26: Typical example of pack rust up to 1" thick between stringer bottom flanges and seat angles with up to 1/16" deep pitting to the stringer bottom flange underside.

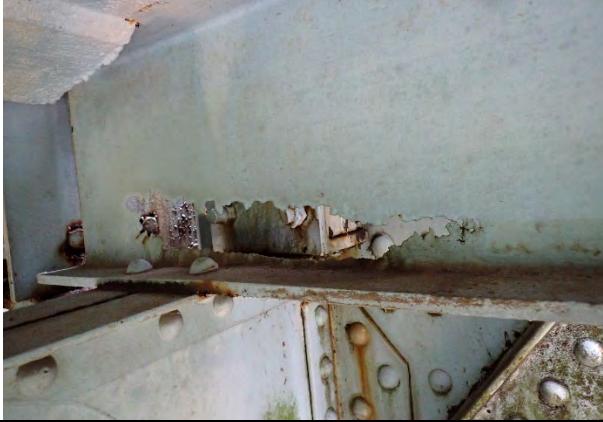
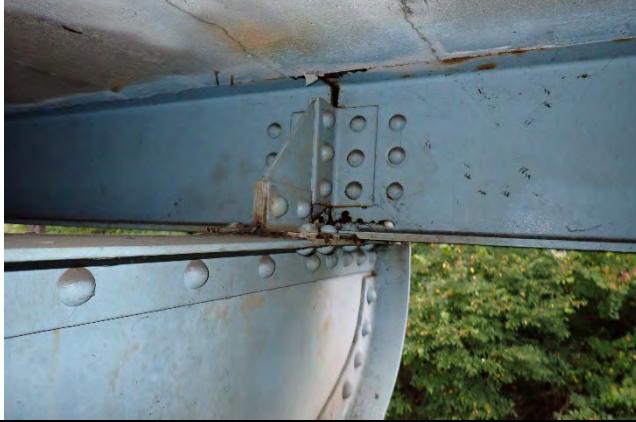
Sidewalk Stringers 2 and 3 have corrosion holes in the webs up to 24" long by 4 1/2" high and knife edging of the bottom flange isolated to the beam ends at the connections to the end floor beams (Photos 27 and 29). Little to no active corrosion was observed at these corrosion holes. The rivets connecting the sidewalk stringer bottom flanges to the sidewalk bracket top flanges regularly have over 80% loss to the rivet heads. This has not changed since the prior inspection. The Sidewalk Stringer 2 and 3 stub beam cantilevers at Piers 1 and 2 have advanced section loss and corrosion holes throughout (See Photo 28).

Photograph 27: General example of corrosion hole on the bottom of the sidewalk stringer web, Span 2.	Photograph 28: typical configuration of sidewalk stringer and cantilever.

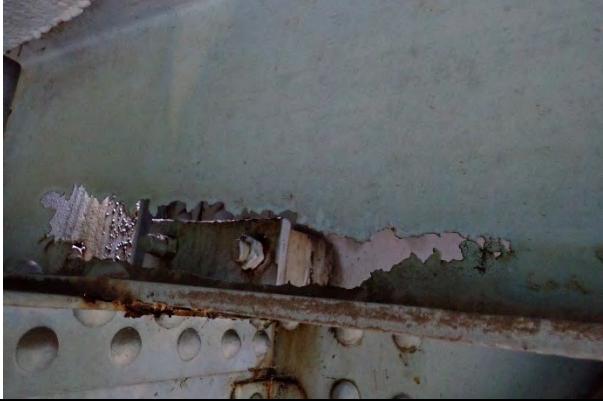
Photograph 29 (left): Sidewalk stringer 3 at L0 right truss Span 2. Note corrosion hole on web and flange. No change from prior inspection.

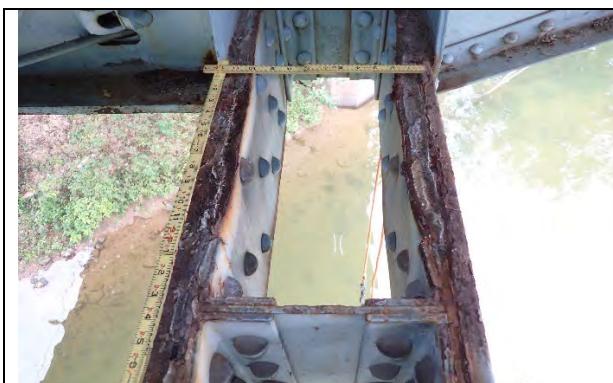
Lower chord members have 1" wide by up to 1/8" deep pitting (1/16" typical) along the full height of the exterior faces of the lower chords at the gusset plate interfaces and on the interior faces at diaphragm angle interfaces. This generally is similar to the prior inspection observations unless noted otherwise, though the active corrosion continues to slowly deteriorate the members. On L6L7 south truss near L7 there is up to 1 1/8" thick pack rust between the web plates that has bowed the top and bottom 4" of the interior plates (Photo 30). There is pack rust up to 5/8" thick between the lower chords and the internal diaphragm angles and pack rust up to 1/4" thick between lower chords and gusset plates.

Photograph 30: View of pack rust on L6L7 right truss. Looking east.

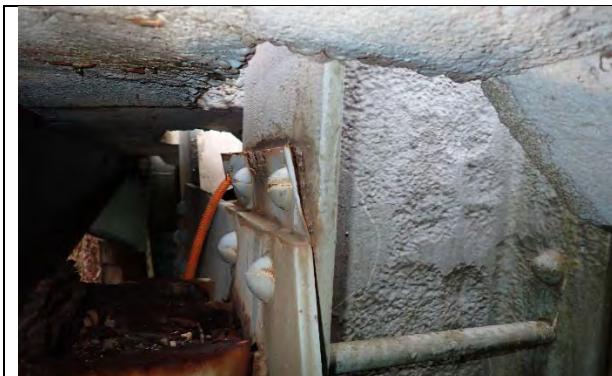
Up to 1/4" deep painted over pitting is present on truss vertical webs and flanges at the sidewalk level and on the exterior face of the inboard flange at previous guardrail connections (Photo 31). At these locations the load is still carried by the truss member. The truss verticals typically have section loss from painted over pitting up to 1/8" on most faces within the lower chord gusset plates. The worst case was noted at L2 south truss, where the L2U2 vertical has 1/4" deep pitting in the web with localized 5/8" deep pockets that extend to the flanges, with isolated corrosion holes. At these locations most of member load has been developed to the

Photograph 31: Typical example of painted over pitting on truss vertical webs at the sidewalk level above lower panel points, L2 right truss shown looking southeast.

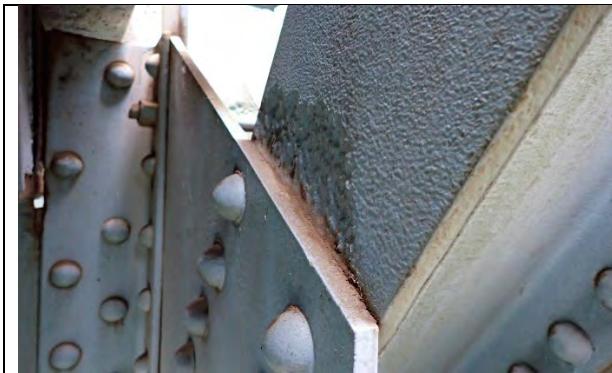
At deck level, the truss diagonals have up to 1/4" deep cleaned and painted pitting at the interface where the members go through the deck. There is up to 3" high by full width by 3/16" deep pitting to the exterior of the flanges of the truss diagonals along lower gusset plate interfaces (Photo 32). Pack rust up to 1/4" thick was noted between the diagonals and lower gusset plates.

Photograph 32: View of typical painted over pitting on truss diagonals at lower gusset plates. U2L3 right truss shown looking southeast.

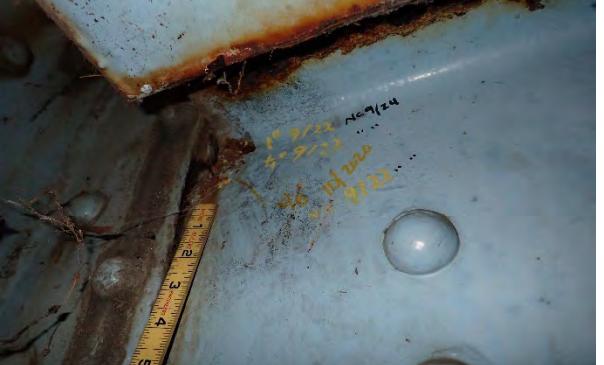
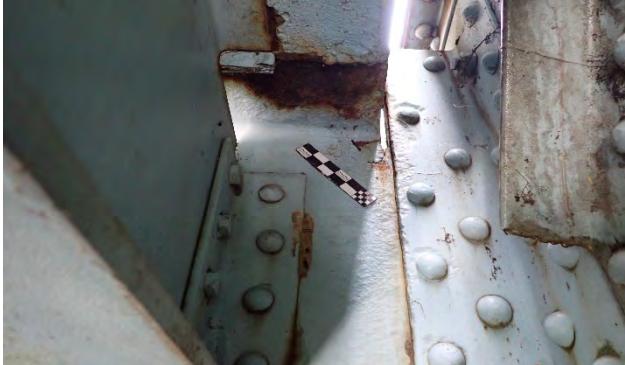
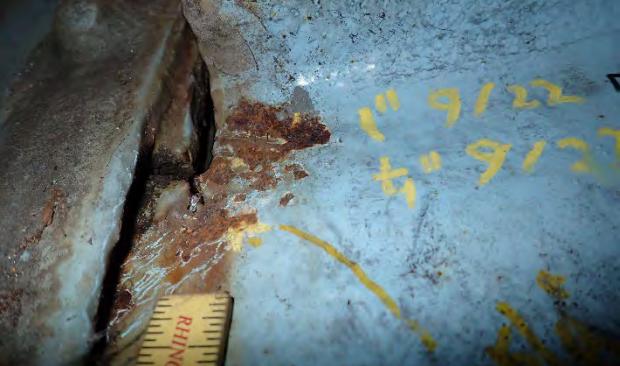
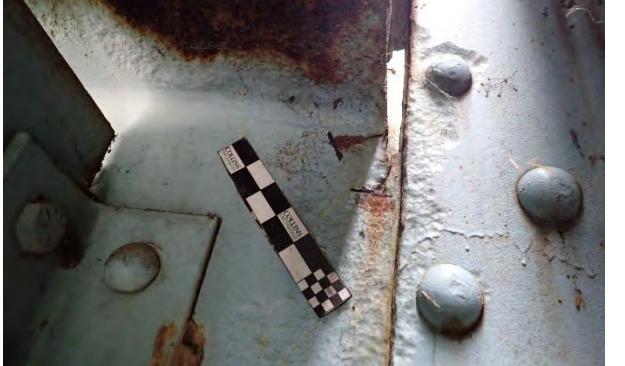
There are cracks emanating from the copes in the webs at both end floor beams. At these locations the floor beam rotates with the deck flexure with passing cars, and the stress riser at the cope is cracking as a result. These cracks are noted in prior inspection reports and changes from the prior inspection are documented below. At the Floor beam 0 connection to the left truss, there is a **1-1/2" long (was 1-3/8")** horizontal crack on the top of the web and a **1-7/8" long (was 1-3/4")** vertical crack below this (Photos 34 and

36). An overcut measuring 1/4" long is between them. Evidence from prior inspection reports shows that these cracks are slowly, but continually, growing.

At Floor Beam 9 there are cracks at both truss connections. At the Floor Beam 9 connection to the left (north) truss, there is a **1-1/16" long (was 1") horizontal crack** on the top of the web and a 1 3/8" long diagonal crack below this that has not changed (Photos 33 and 35). Between the cracks there is a 1/4" long overcut. The horizontal crack has a slight growth from the prior inspection. At the Floor Beam 9 connection to the right (south) truss there are three diagonal cracks present in the floor beam web at the cope. These cracks have not grown since the prior inspection. The top and middle diagonal cracks measure 1" and 1/4" long, respectively; the bottom crack, which emanates from a 1/2" overcut in the web, is 5/8" long (Photos 37 and 38). Prior inspection reports have called out as cracks locations that are actually overcuts (Floor beam 3 at the right (south) truss) or just paint cracks (Floor Beams 3 and 5). These locations have not changed for this inspection and no cracks were observed in the primary steel. The cope radius for Floor Beams 1 through 8 is not sufficient and overcuts are common in the floor beam webs.

Photograph 33: General view, Floor Beam 9 right (south) truss cracks	Photograph 34: View of cracks at Floor Beam 0 left cope. Overall view of detail.

Photograph 35: Close up view, Floor Beam 9 right (south) truss cracks	Photograph 36: Close up of Floor Beam 0 left truss cracks.

- Monitor the deck wear and concrete cracks for advancing deterioration during future inspections.
- Monitor the cracks present on the end floor beams during future inspections. These cracks currently exhibit slow but continual growth for inspection cycles.
- Reset the rocker bearing for Beam 1 at the Rear Abutment.
- Monitor the section loss, painted over pitting, and reactivating corrosion/pack rust on the lower chords and at the lower panel points in future inspections.
- Monitor the spalls and exposed reinforcing steel on substructure units.

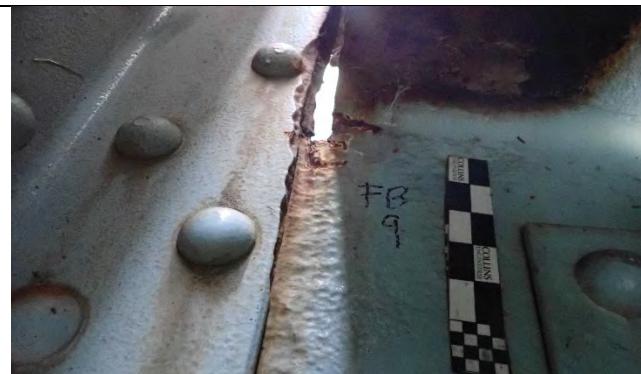
Photograph 37: View of cracks at Floor Beam 9 left (north) truss. Overall view looking east.

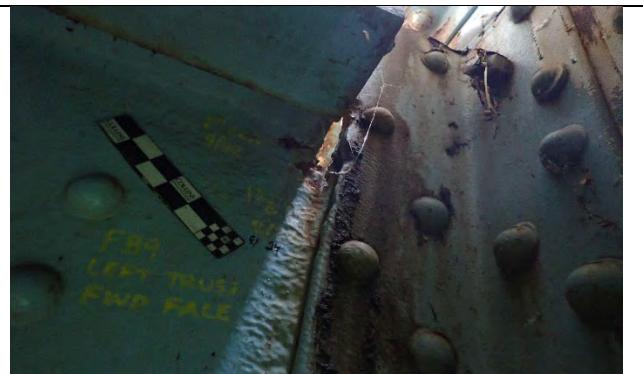
Photograph 38: View of cracks at Floor Beam 9 left (north) truss. Overall view looking east

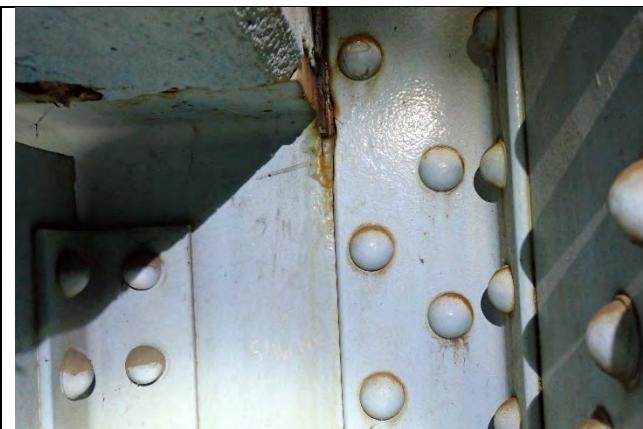
Generally, the floor beams exhibited up to 1/4" deep pitting (1/8" deep typical) on the webs adjacent to floor beam connection angles (Photos 40 to 43). This is a high shear zone where most the load is carried by the floor beam web. Typically, floor beam pitting is painted over but isolated areas are reactivating. Floor Beam 0 has a 12' long by 6" high area of 1/4" deep pitting on the rear web that starts 5' from the right truss. This section was caused by joint leakage at the Rear Abutment. A plug weld was observed on Floor Beam 8, forward (east) face just above Stringer 1 (Photo 44). No defects or cracks were observed. The bottom flange of Floor beam 9 has isolated 3/8" deep pitting on the forward bottom flange edge adjacent to the left truss and isolated 1/4" deep pitting to the forward bottom flange edge and underside at the right truss. Specific details of floor beam pitting and section loss are listed in Exhibit 3.

Photograph 40: Typical example of pitting on the floor beam web at truss floor beam connections.

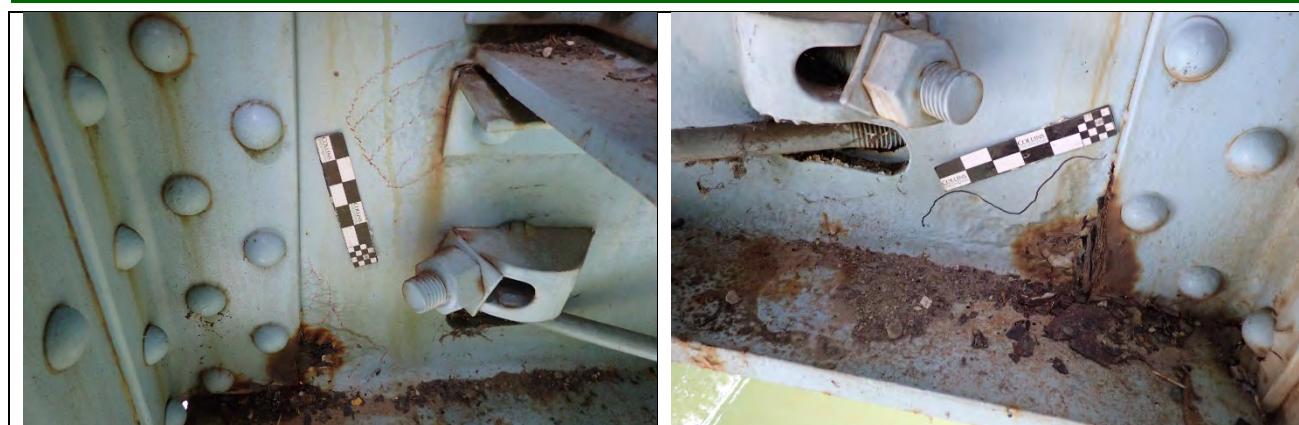
Photograph 44: Typical example of floor beam web pitting around the end stringer connection.

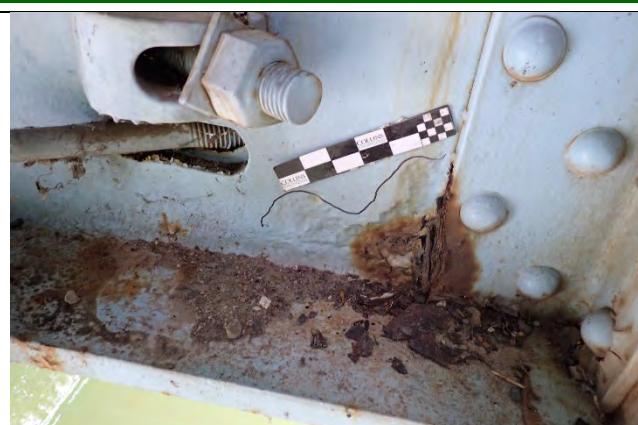
Photograph 42: Typical example of floor beam web pitting near the truss connection.

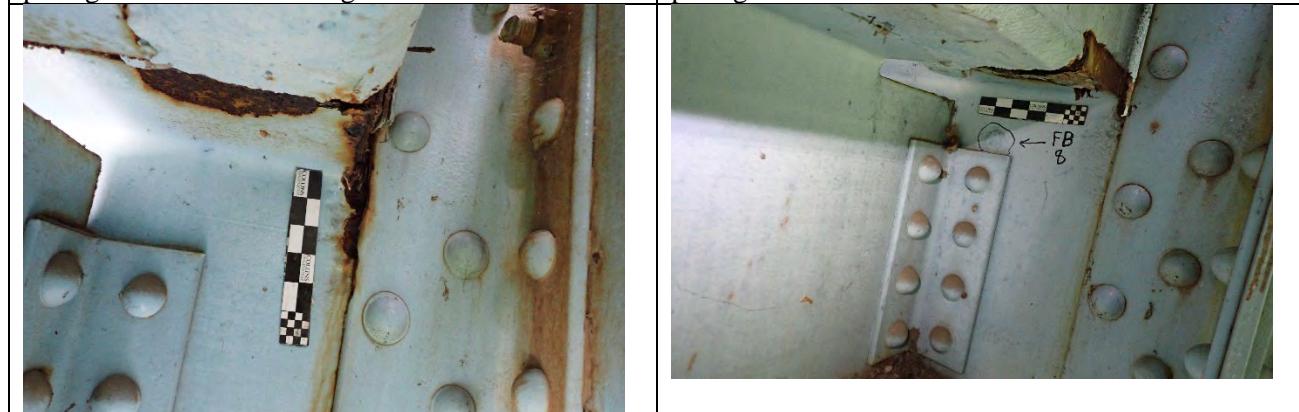
Photograph 43: Typical example of floor beam web pitting near the truss connection.

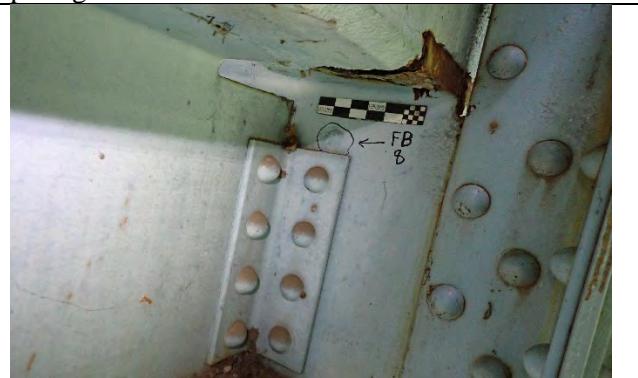
Photograph 44: Floor Beam 8, forward (east) face just above Stringer 1. Note plug weld present, no defects or cracks observed. Overall view looking west.

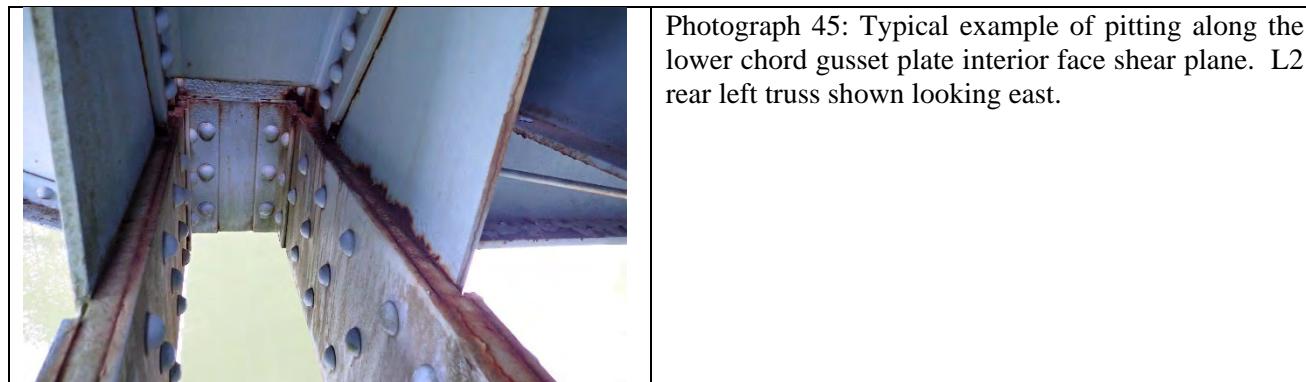
Photograph 45: Typical example of pitting along the lower chord gusset plate interior face shear plane. L2 rear left truss shown looking east.

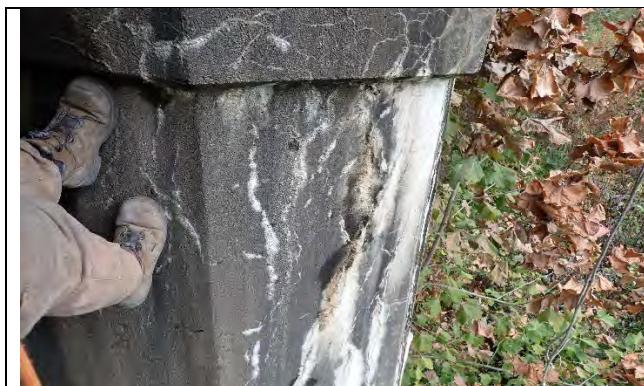
The reinforced concrete columns of Pier 2 exhibit spalls up to 12" wide by 6" high with exposed reinforcement at the top of both columns on the east face. Additionally, the top of the south column on Pier 2 has widespread hairline vertical and horizontal cracks with heavy efflorescence on the south face (See Photo 49). The north column on Pier 1 has heavy vegetation growth throughout the full height of the column. This vegetation continues along the north rail and in the north conduit along Span 2.

Photograph 49: View of the heavy efflorescence in the cracks for the south column at Pier 2. Looking northeast.

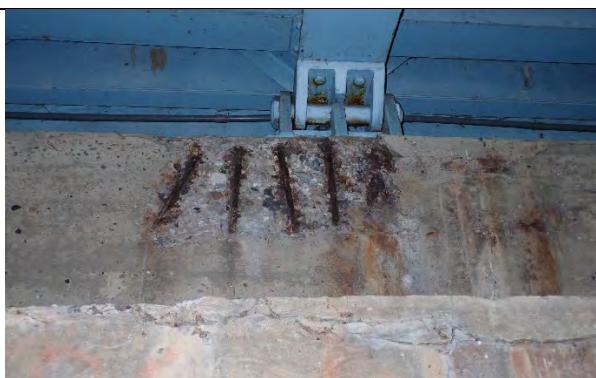
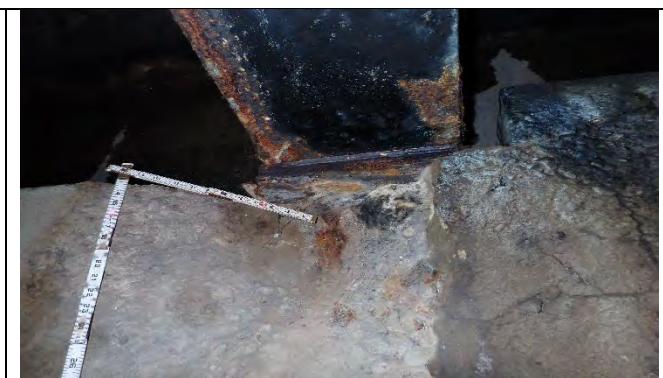
The bottom rear edge of the Pier 3 pile cap has exposed reinforcement due to shallow spalls and lack of cover over its full length with one broken reinforcing bar noted near the north end of the cap. The end of several secondary bars are exposed and bent. There is a 15" high by 24" wide by 5 1/2" deep spall with 1 exposed reinforcement on the forward side of Pier 3 below Beam 4 in Span 4 (Photo 51). This was previously noted to be undermining the bearing seat up to 5 1/2" and has not changed. On the rear face there are spalls on the cap exposing reinforcing under Beams 6 and 7 which has not changed for this inspection (Photo 50). Additionally, there are isolated full height by up to 3' wide by 1" deep spalls with exposed reinforcing in the vertical faces of the beam seats on the rear face of the Pier 3 pile cap.

Photograph 50: Rear face of Pier 3 under Beam 6. Note no change to spall under the beam.	Photograph 51: Forward face of Pier 3, under Beam 4. Note no major change to spall undermining the bearing up to 5-1/2".

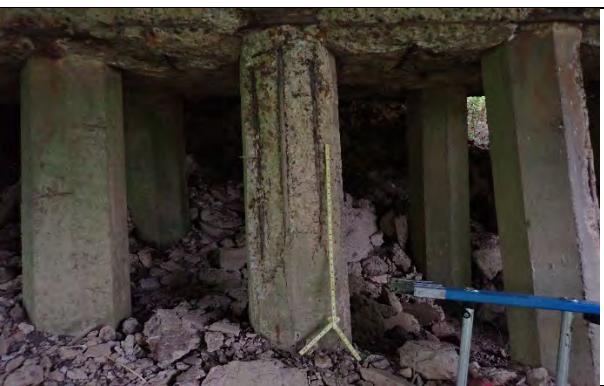
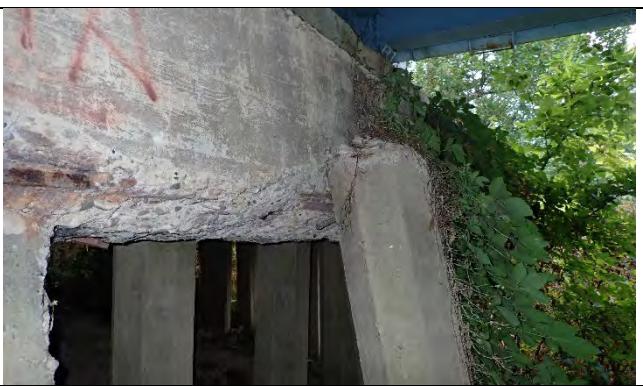
There are 34 exposed reinforced concrete piles at Pier 3 that are split into two rows. In the rear row, between Beams 4 and 6, one pile has a full height by full width by 2" deep spall with exposed reinforcing on the west face and two piles have full height by 12" wide by 2" deep spalls with exposed reinforcing on the west face (Photo 52). Additionally, the pile under Beam 7 on the rear face does not support the cap, as it was constructed incorrectly and sits in front of the cap (Photo 53).

Photograph 52: Pier 3, rear pile row, under Beams 4 to 6, note extensive spalls and exposed reinforcing steel for the pile. Looking east.	Photograph 53: Pier 3, the rear face pile under Beam 7 does not provide support for the cap. Looking southeast.

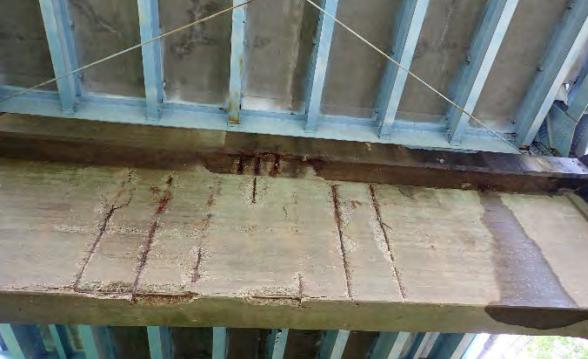
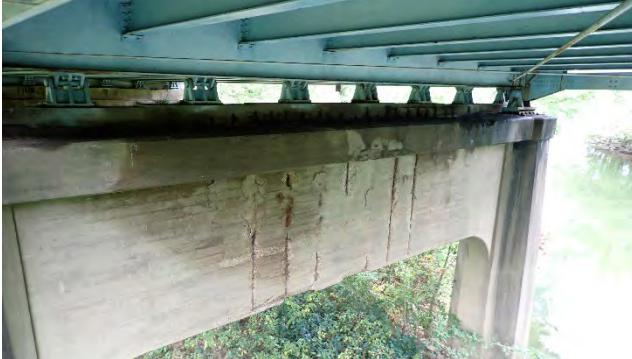
Photograph 54: Overall view of the rear face of Pier 2. Note extensive spalls and exposed reinforcing steel.	Photograph 55: Overall view of the rear face of Pier 2. Note extensive spalls and exposed reinforcing steel.

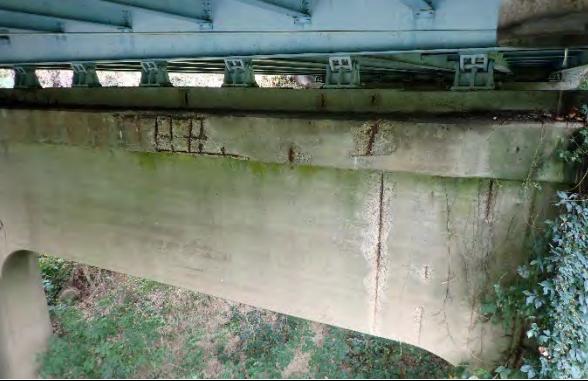
Photograph 56: Overall view of spalls with exposed rebar on the forward face of Pier 1.

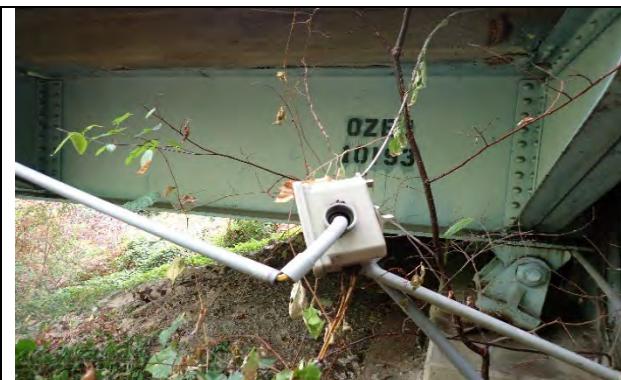
Photograph 57: No change to the broken conduit at the north side of the bridge near the Rear Abutment.

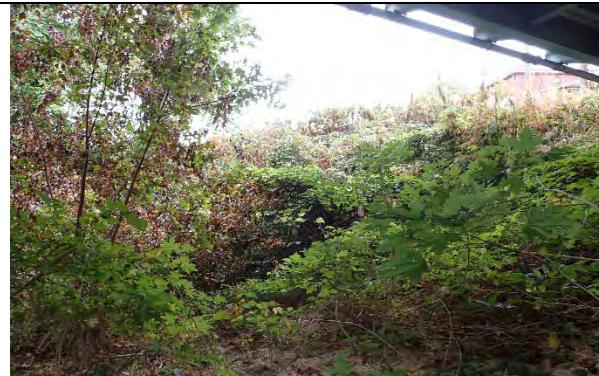
Photograph 62: View of sloughing on the right rear (southwest) embankment.

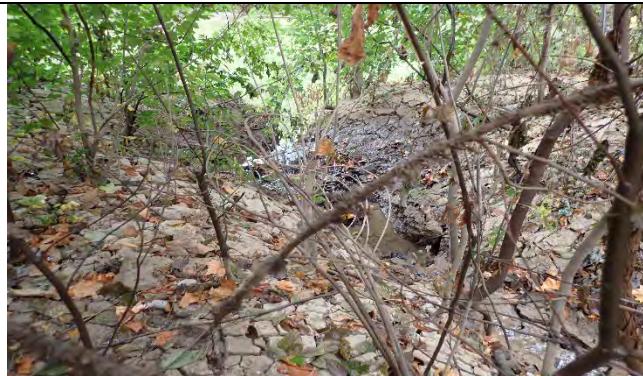
Photograph 63: View of the lower part of the erosion gully as it goes from scupper down to the channel.

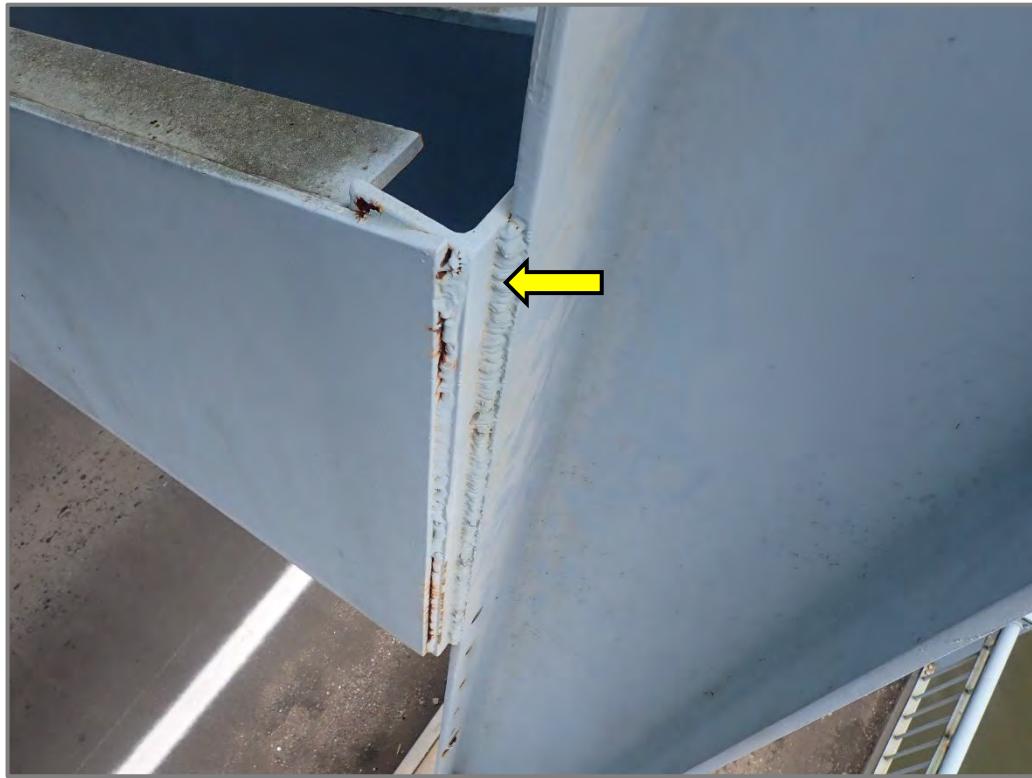
Photo 1 – Sway bracing connection angle attached by fillet welds with no transition radius (Category E). U6-L6 of the Right Truss is shown (looking northeast).

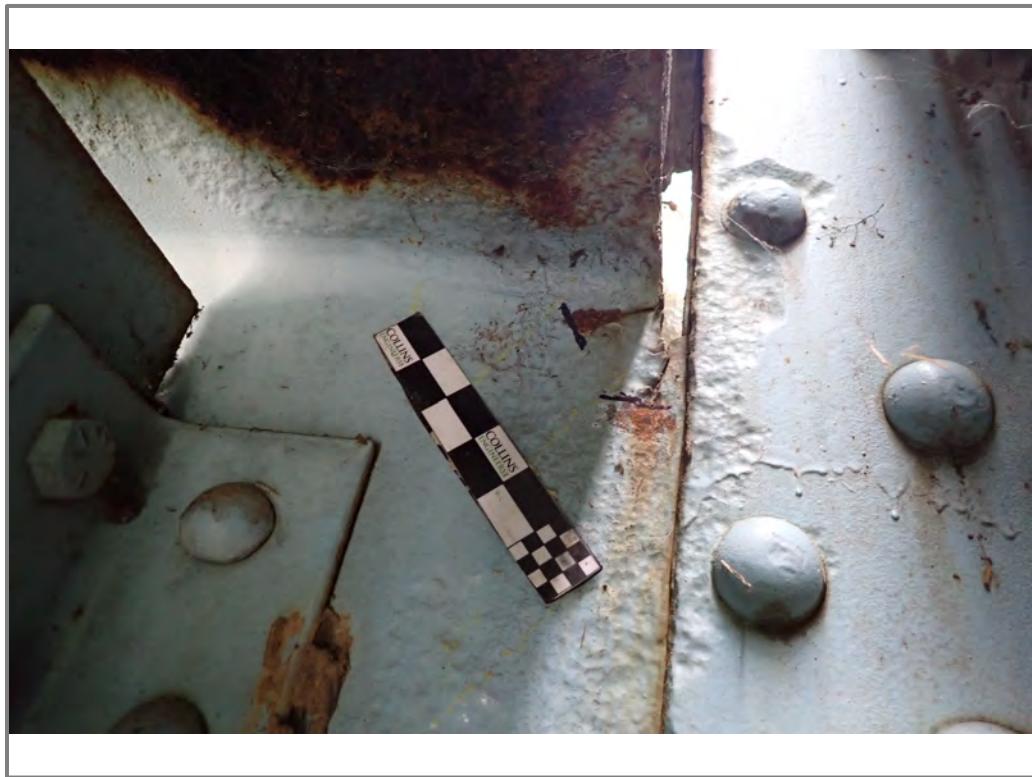
Photo 2 – Cracking in the web of a floorbeam at the upper cope (looking east at Floorbeam 0 in Span 2 adjacent to the Left Truss).

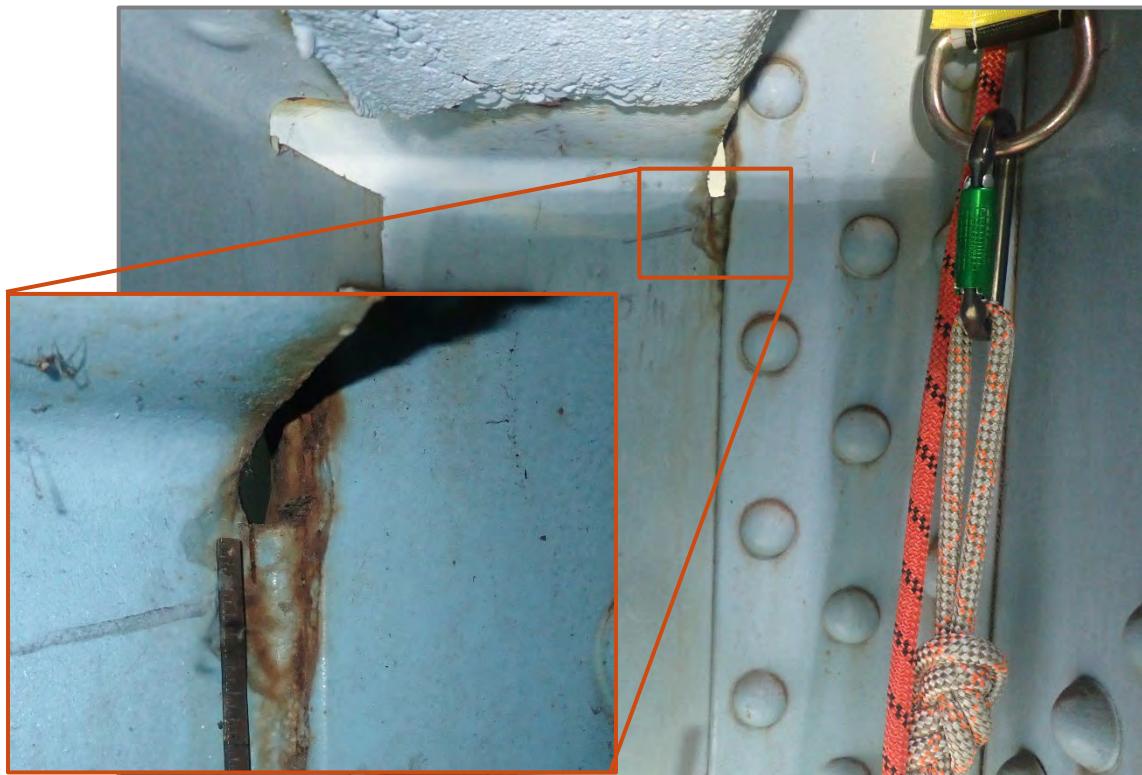
Photo 3 – Overcut in a floorbeam web at the upper cope at the connection to the truss
(looking east at Floorbeam 3 adjacent to the Right Truss).
