**PHYSICAL CONDITION REPORT  
FOR THE 2020 SPECIAL TOWER HEAD INSPECTION**

**SR 93 OVER THE OHIO RIVER**

BR#: LAW-93-0.00  
SFN: 4401263

**OHIO DEPARTMENT OF TRANSPORTATION  
DISTRICT 9  
PID #102917**

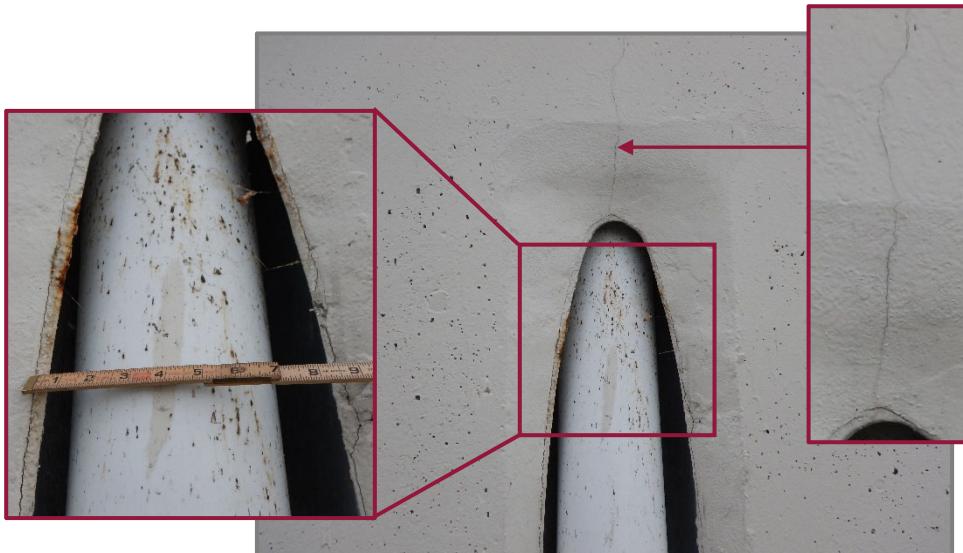
Overall the exterior faces of the towers are in good condition. Vertical and diagonal hairline cracking on the exterior faces of the towers at the cable anchorages is typical (see Photo 1). Cracking with rust staining from the guide tube on the exterior faces around the full circumference of the lowest anchorages in Segment 12 of the towers is also typical (see Photo 1). Poor construction/consolidation has resulted in minor to moderate voids up to 1" in diameter and up to 1/2" deep throughout the tower exterior vertical faces and roof with many of these voids not having the sealant penetrated inside (see Photo 3). Isolated areas with very minor rust staining were noted on the exterior faces (see Photo 2).

Photo 1 - Typical hairline crack above the anchor and cracking with rust staining around the guide tube (looking north at the south face of Tower 3 at Cable M16E in Segment 12).

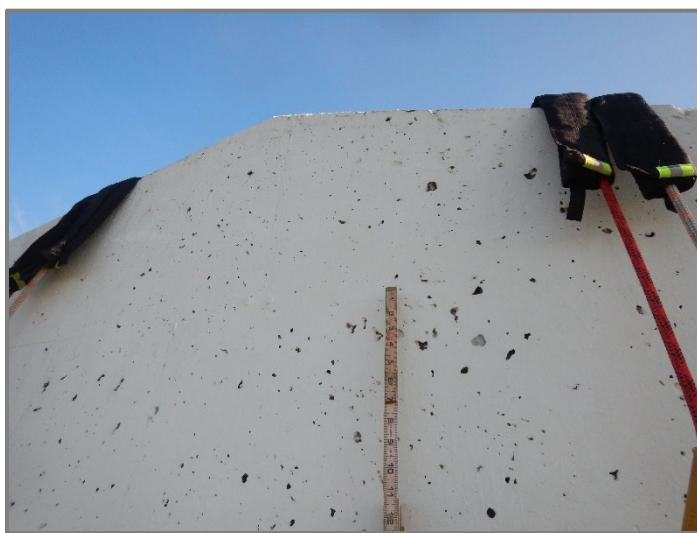
Photo 3 - Typical voids in the exterior faces of the towers (looking north at the south face of Tower 3 at the top).

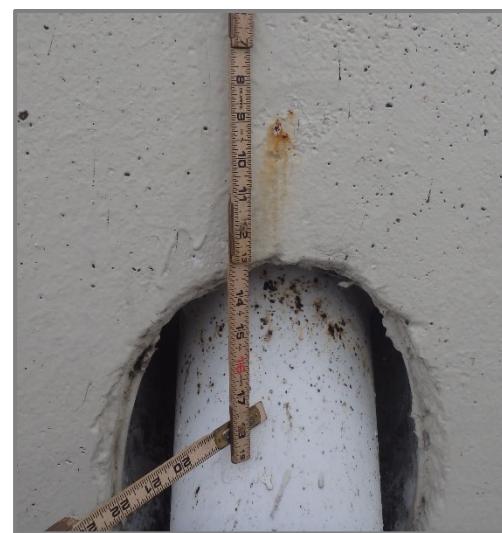
Photo 2 - Typical isolated area of minor rust staining (looking north at the south face of Tower 3 above Cable M19W).

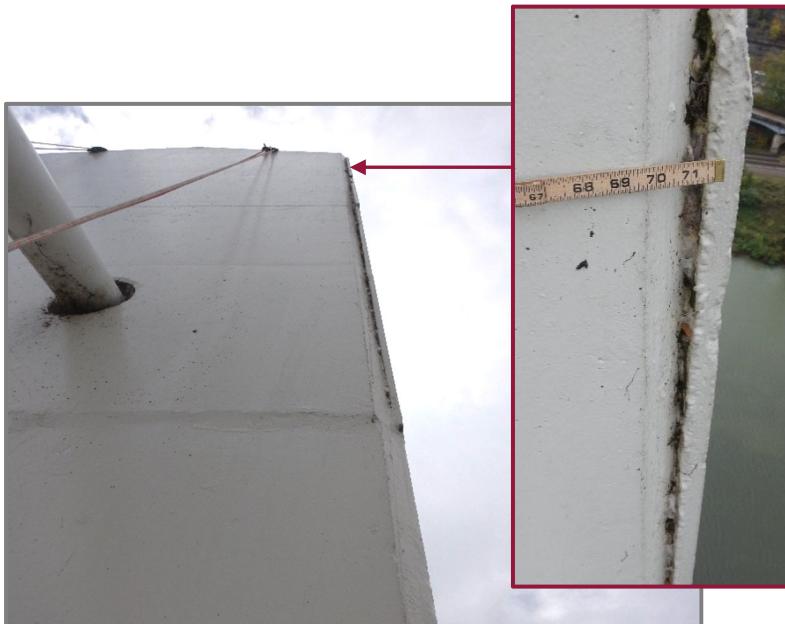
Besides the typical findings, there are uneven areas of forming most notably on the west face at the top of the tower in Segment 18 (see Photo 4), but no areas of delaminated, spalled or loose concrete were found. The rubber gaskets are extruded slightly from the steel guide tubes at the tops of Cables B14E and B13E on the south face of the tower (see Photo 5). Although the weather was calm at the time of inspection, it was noted that the top three cables had minor to moderate vibration.

Photo 4 – Uneven forming of the west face of Tower 3 at the top, but no loose concrete was found (looking south at the northwest corner).

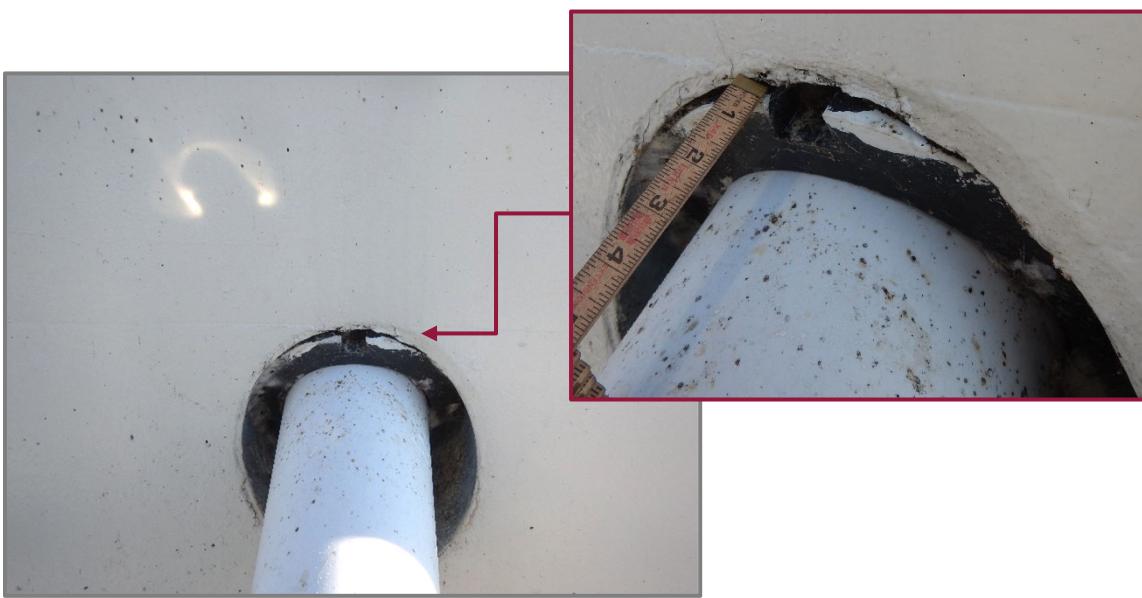
Photo 5 – Rubber gasket slightly extruded from steel guide tube (looking north at Cable B13E on the south face of Tower 3).

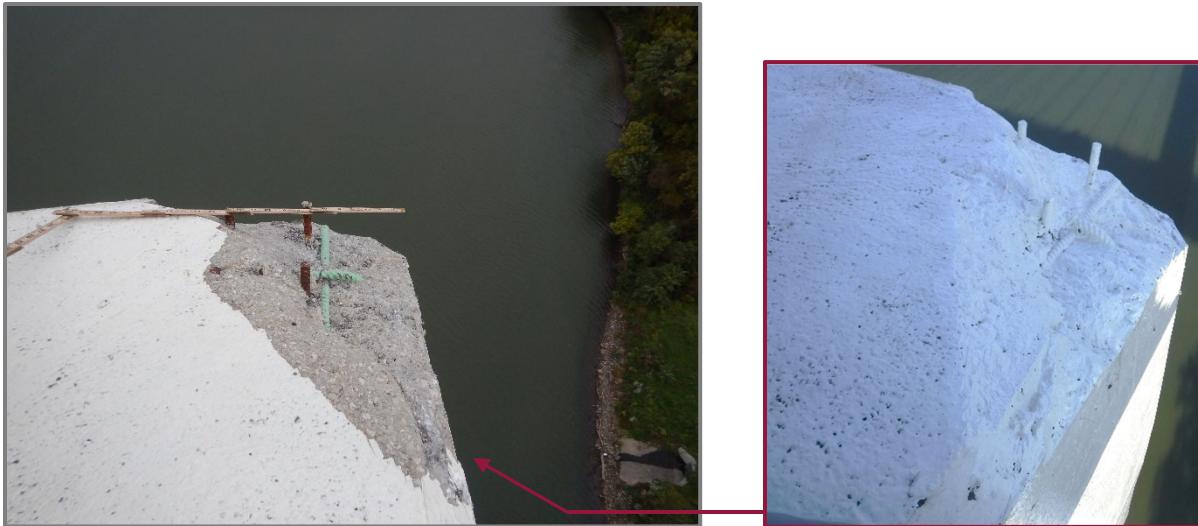
A spall at the top of the tower at the northwest corner was first documented by ODOT in a 2019 inspection. During this inspection, the spall was measured to be a maximum of 28" wide along the north face by 20" long along the west face by 8" high at the very corner and it was cleaned and sealed (see Photo 6Photo 5).

Photo 6 – Tower 4 northwest corner with existing spall (looking west) and after area was sealed (looking southwest).

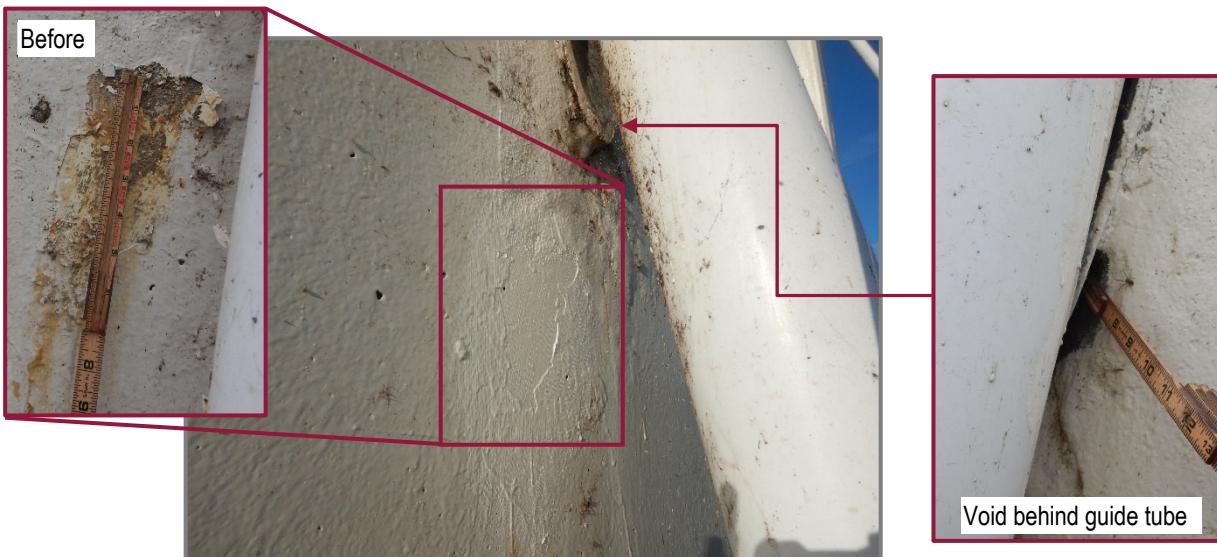
A 6" high by 3" wide area of failing sealant just east of the Cable B16E anchorage in Segment 12 on the north face of the tower was cleaned and sealed (see Photo 7). At this same cable, a 6" high by up to 8" deep void was found along the west side of the steel guide tube near the bottom due to poor consolidation around the bottom of the guide tube (see Photo 7).

Photo 7 – East leg of Tower 4 north face in Segment 12 near Cable B16E with area that was sealed (looking southwest). Also note the void along the bottom west side of the steel guide tube.

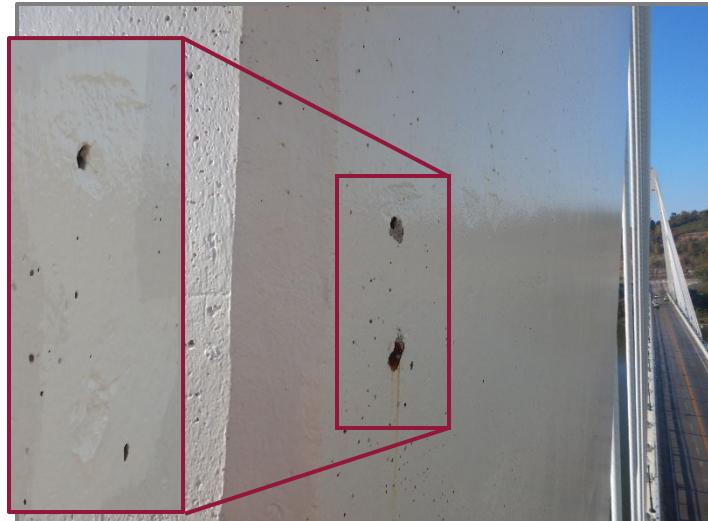
An existing void/spall from construction, approximately 1" wide by 1 1/2" high by 1 1/2" deep with partially exposed reinforcing was cleaned and sealed on the north face of the east leg in Segment 12. Two small areas of sealant failure, about 1 1/2" in diameter each were sealed on the west face of the east leg in Segment 11 (see Photo 8).

Photo 8 – Tower 4 west face with two small areas of sealant failure with the top one around a void (looking south) and after areas were sealed (inset).

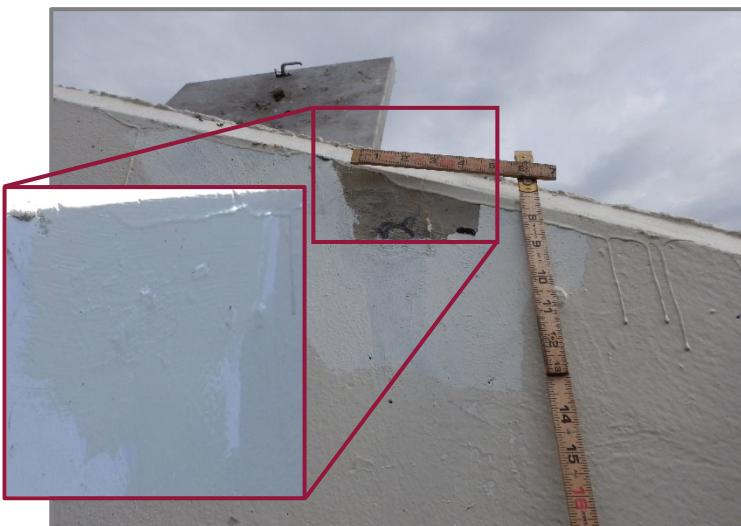
At the top of the south face above the east leg, an area up to 5" wide by 3" high was found to have a sealant that differed from the final coat so this area was cleaned and sealed (see Photo 9).

Photo 9 – Tower 4 south face at the top with an area that had a different color (looking north) and after areas were sealed (inset).

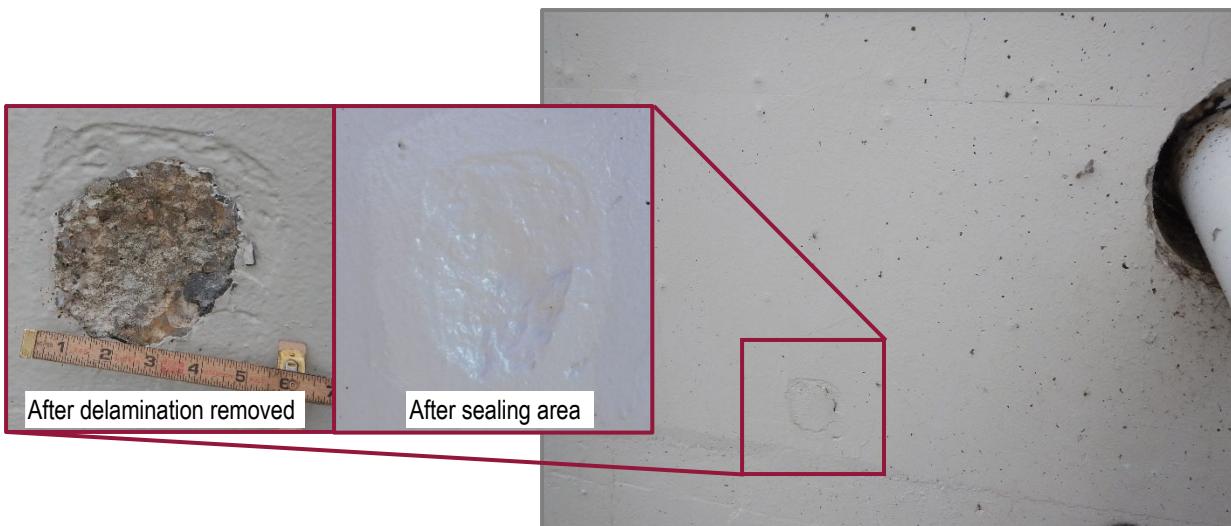
On the south face in Segment 17 below and about 24" west of Cable M30E, a 5" diameter delamination was found. The loose concrete was removed which resulted in a 1/4" deep spall that was then cleaned and sealed (see Photo 10).

Photo 10 – Tower 4 south face in Segment 17 near Cable M30E with a delamination that was removed and sealed (looking north).

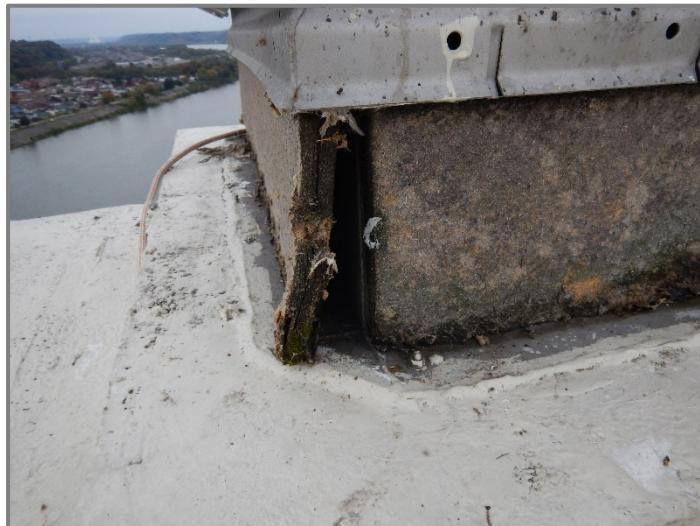
While not related to the concrete inspection, it was also noted that fiberboard around the hatch on the exterior is decaying and becoming debonded (**Photo 11**). However, it was not in danger of falling off at the time of inspection.

Photo 11 – Decayed boards around the exterior of the Tower 4 roof access hatch (looking east).

- Continue to monitor the exterior faces of the towers and perform sounding during in-depth inspections.
- Remove decaying boards around the tower roof access hatches.
- Although the existing anchors on the roof are adequate for rope access, future inspections may benefit from the installation of additional anchors.
