Ohio Bridge Inspection Summary Report

TUS-00800-0038 (7906374)

5A: Inventory Route 1 00800
 7: Facility On SR 800
 6: Feature Ints WEAVERS RUN
 9: Location 1.64 MI. S. OF JCT. SR258
 Lat, Lon 40.30615 , -81.290769

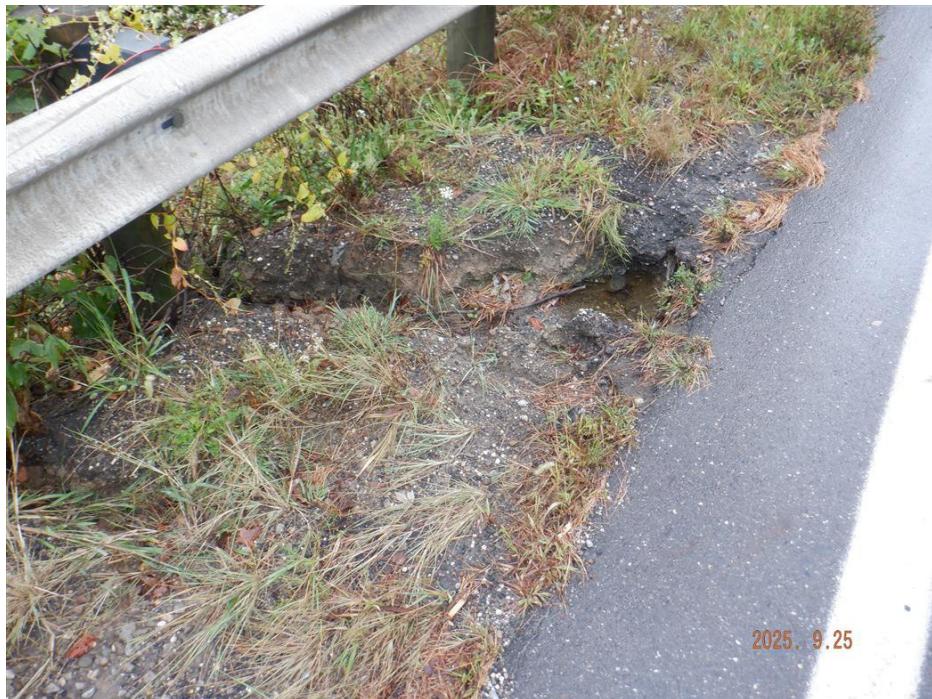
PHOTO 7

There is an erosion channel up to 3' wide by 1' deep in the right rear embankment ~ 50' from the bridge and 23" from the right edge line. There is minor erosion up to 9" deep at the bridge corners which exposes the concrete base of the first guardrail posts.

Description Erosion channel 23" from right edge line at right Rear approach, approximately 50' from bridge

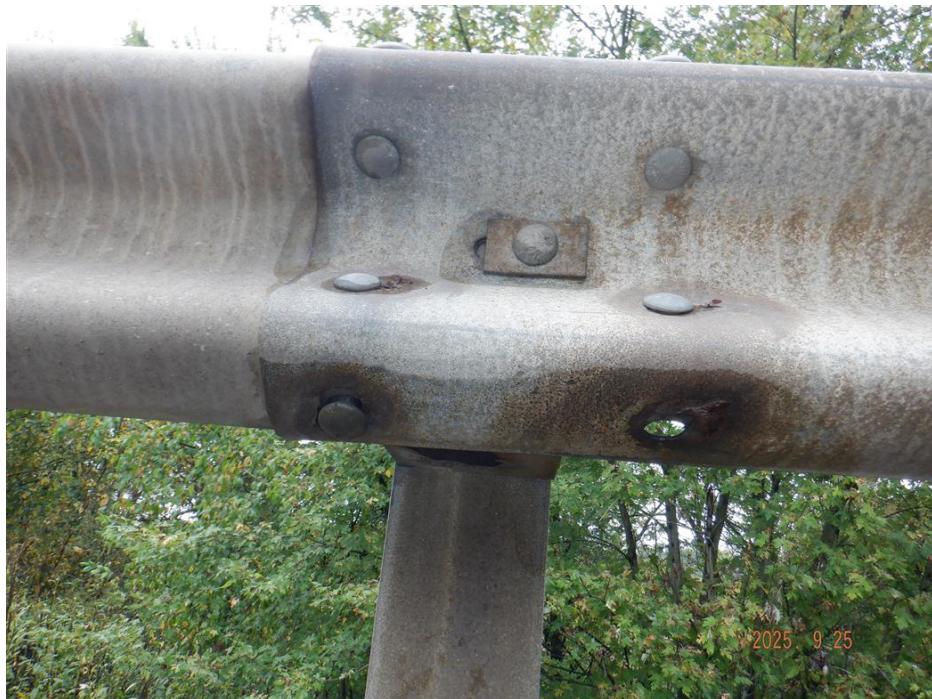
PHOTO 9

Description One missing and one loose connector at left rail W-beam splices, Span 1

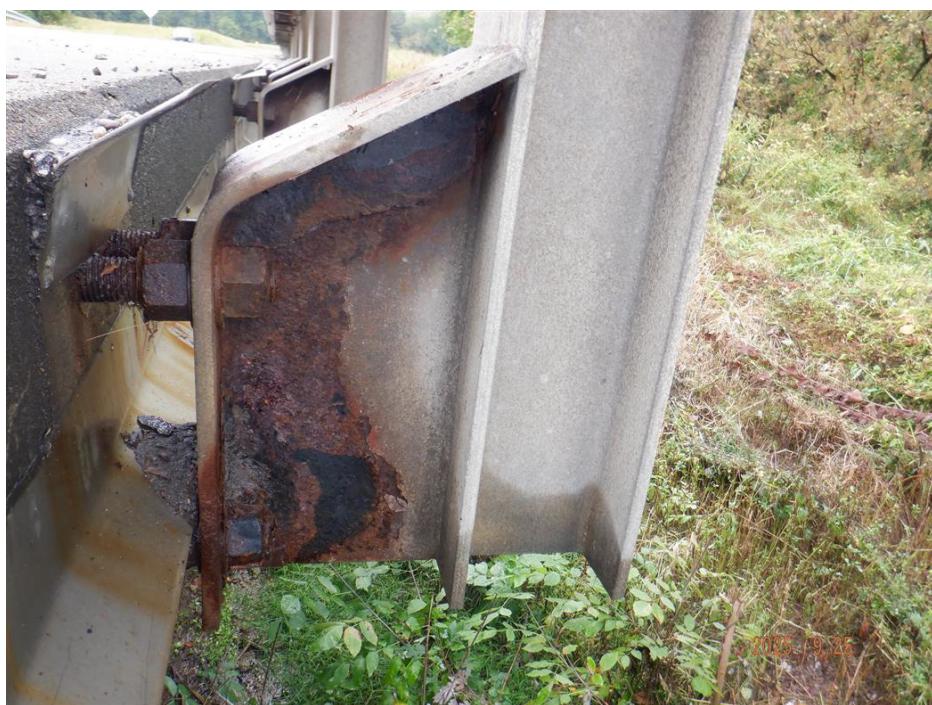
PHOTO 10

Description Typical rail post corrosion on traffic-facing side

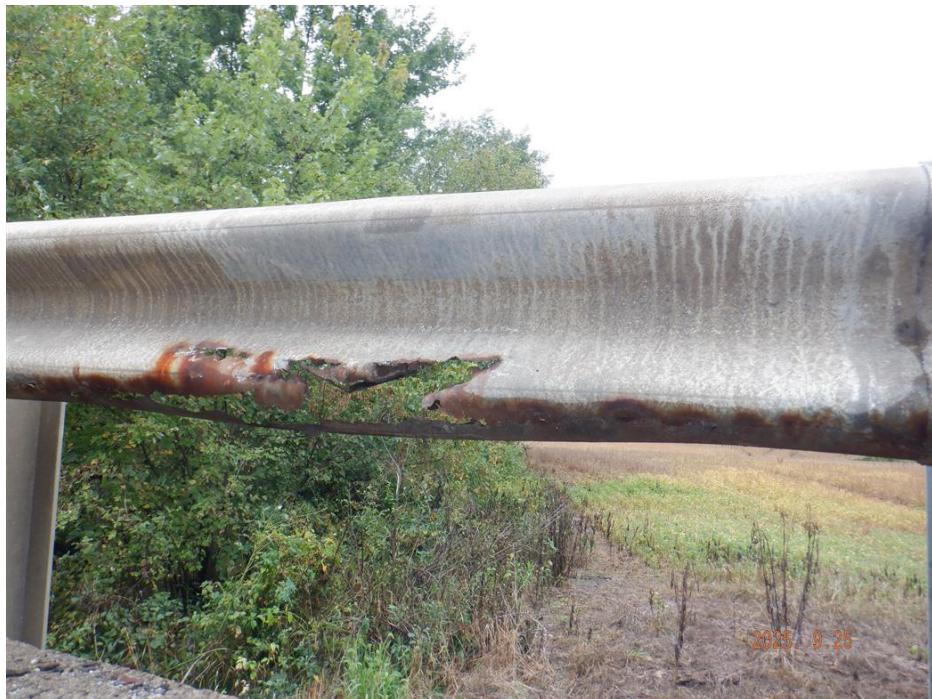
PHOTO 11

Description Surface corrosion holes at bottom of W-beam rail, Span 2

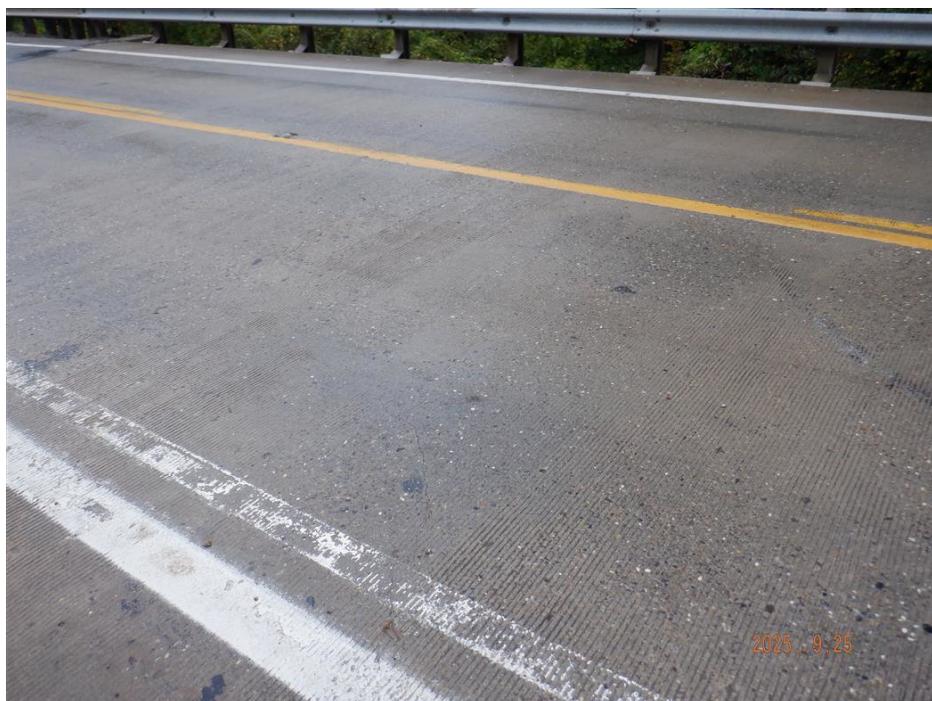
PHOTO 12

Description Transverse pavement cracks over Pier 2 looking northeast

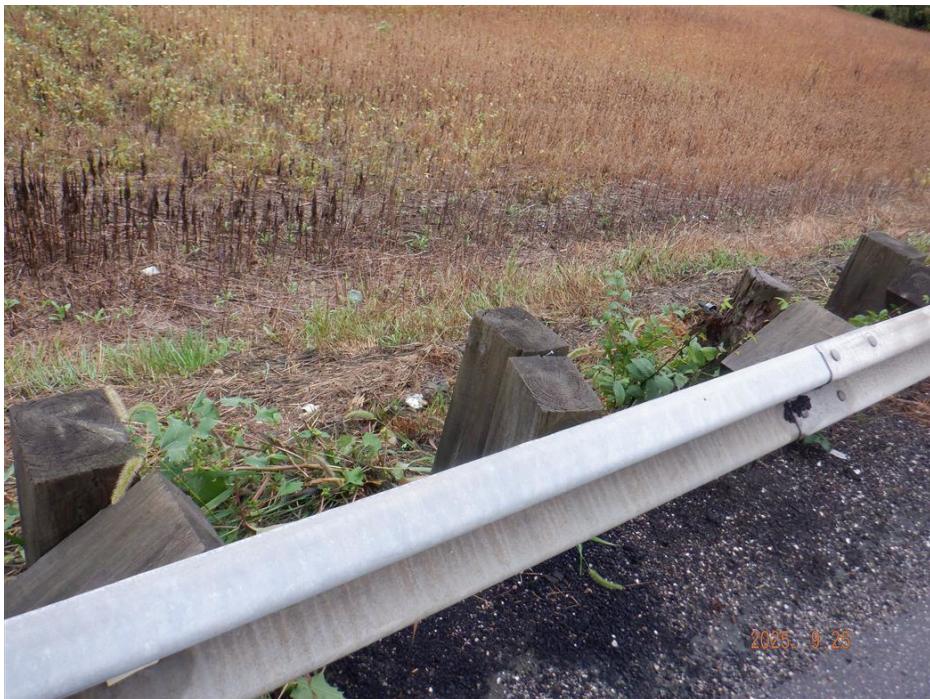
PHOTO 13

New turn panels at left and right forward, and left rear in 2021. The 6th timber post from the bridge at the Left Forward approach guardrail exhibits heavy decay in the top 12". Also at the Left Forward, 3 post block outs are rotated and/or loose. The approach rail concrete foundations are exposed at the 1st post off the bridge at Right Forward and Left Rear. Vegetation is encroaching on the Right Rear bridge terminal assembly.

Description Twisted knockouts and one rotten post at left Forward approach rail

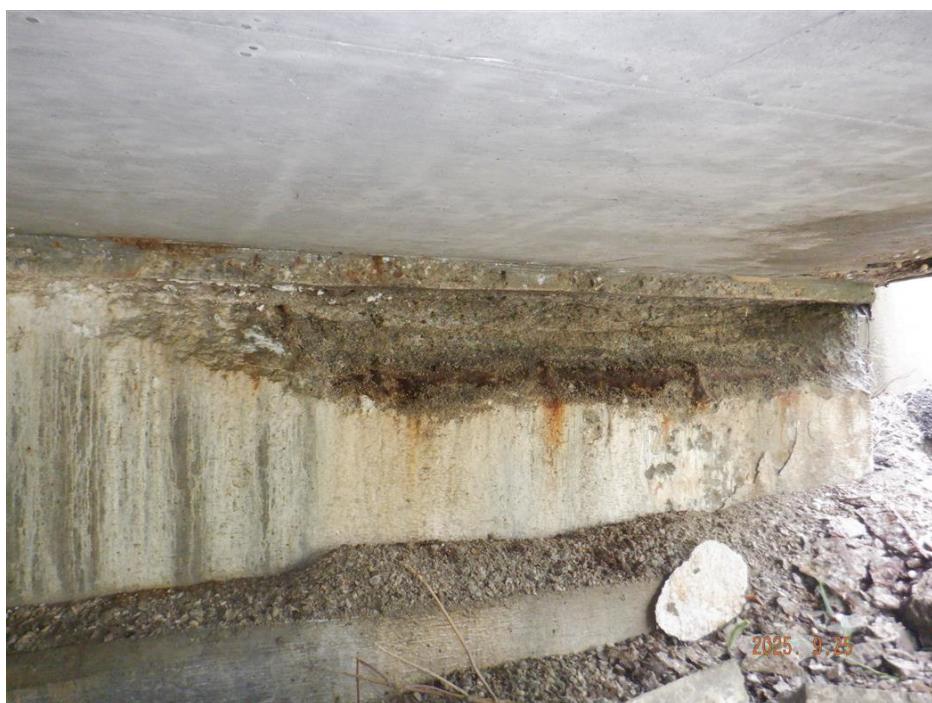
PHOTO 16

Description Left end of Rear Abutment spalled 7' long x up to 12" high x up to 9.5" (avg. 8") deep with exposed vertical and horizontal reinforcement

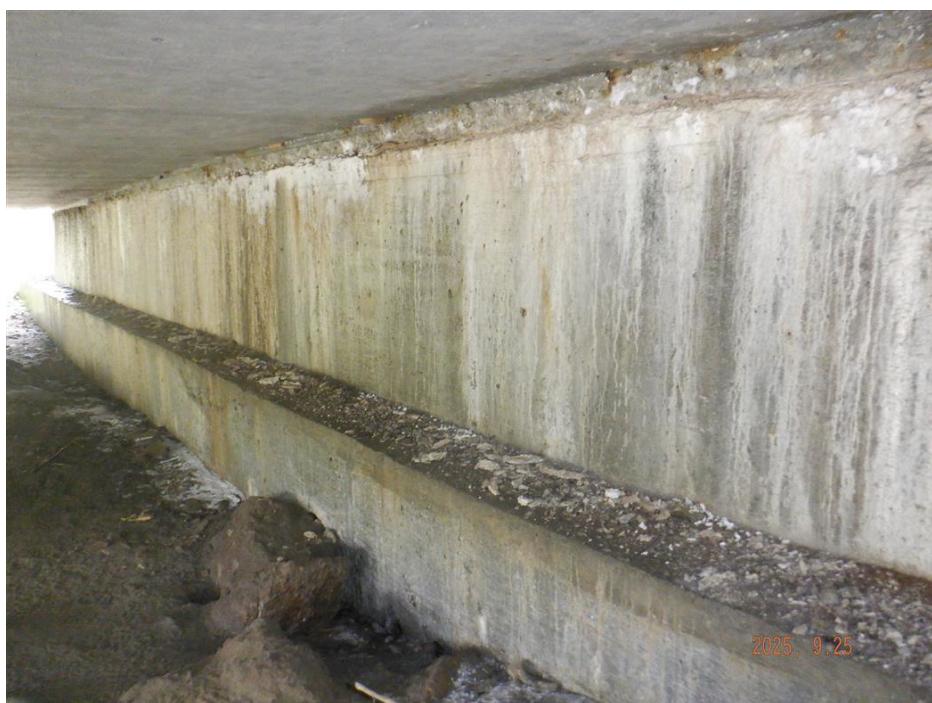
PHOTO 18

Both abutments have footing exposure along the full length; the top face and 18" of the vertical face is exposed but no undermining was found.

Description Top and up to 18" of vertical face of Rear Abutment footing exposed full length; no undermining

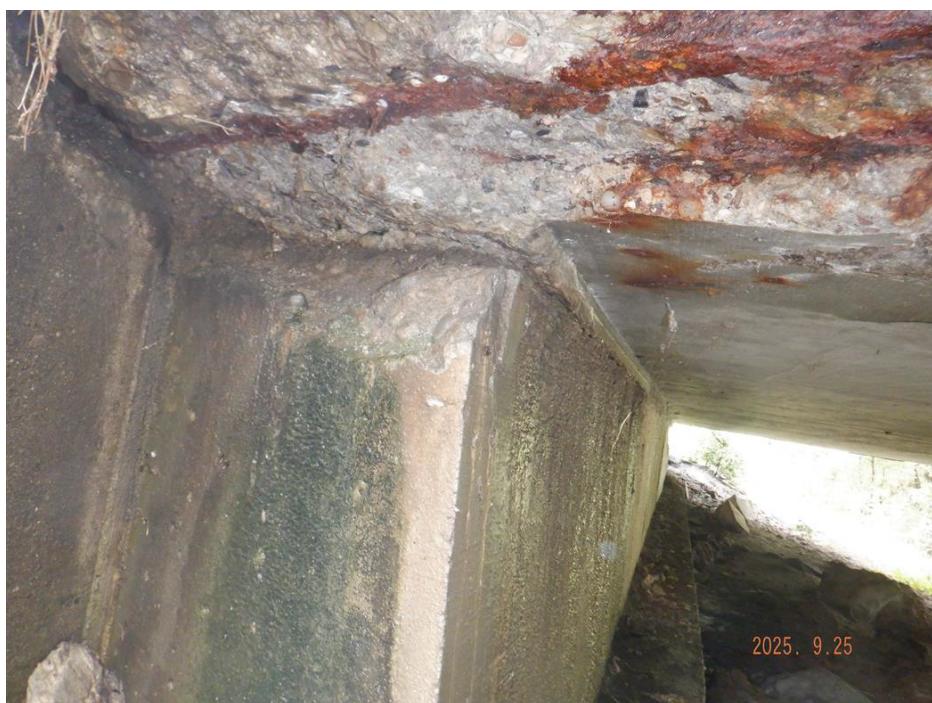
PHOTO 20

Description Right corner of Rear Abutment spall 4" long x 14" wide x 4" high

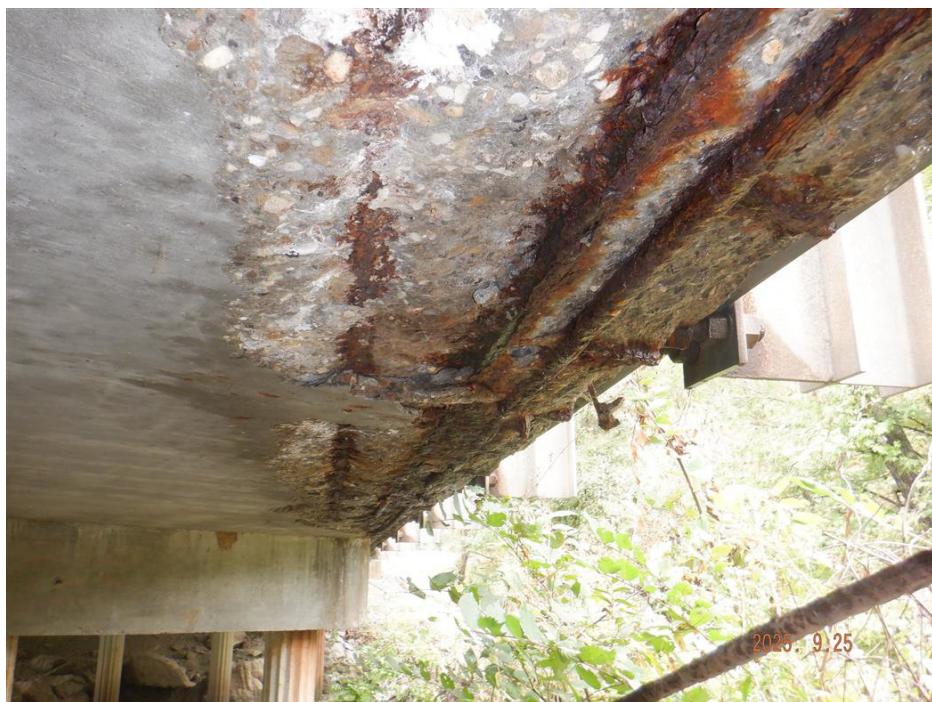
PHOTO 21

Environment	Total Quantity	Units	Condition State 1	Condition State 2	Condition State 3	Condition State 4
38-Reinforced Concrete Slab	3 - Mod.	2433	sq. ft.	2018	29	6	380
	Spans: 24'-0", 30'-0", 24'-0" Width: 30'-0" o/o Edge-of-deck spalls have exposed and corroded reinforcement. Bars noted with heavy section loss have approximately $\frac{3}{4}$ " diameter remaining (typical). CS2 Span 3: Minor longitudinal crack along the centerline of the span, full span length (24 SF) Delamination approximately 4.5' wide \times 1' long at the Forward Abutment, about 5' right of center (5 SF) CS3 Span 1: Spall with exposed reinforcement up to 12" wide \times 6' long \times 1" deep along the centerline (6 SF) CS4 Span 1: Right edge of slab spalled full length, approximately 6" high \times 31" wide; 5 longitudinal bars exposed, one hanging full length and two with heavy section loss and 360° exposure (62 SF) Left edge of slab spalled full length, approximately 7" high \times 24" wide; 3 longitudinal bars exposed, including one hanging and two with heavy section loss and 360° exposure (48 SF) Span 2: Left and right edges spalled full length, approximately 6" high \times up to 30" wide (150 SF) Left side: four longitudinal bars exposed, including three with 360° exposure Right side: one bar laying on the ground, two others with 360° exposure Span 3: Left and right edges spalled full length, approximately 6" high \times up to 30" wide (120 SF) Left side: four exposed bars, including one hanging bar and one with 360° exposure Right side: four exposed bars, including one hanging bar

Description Span 1 right deck edge spall; note ineffective reinforcing steel

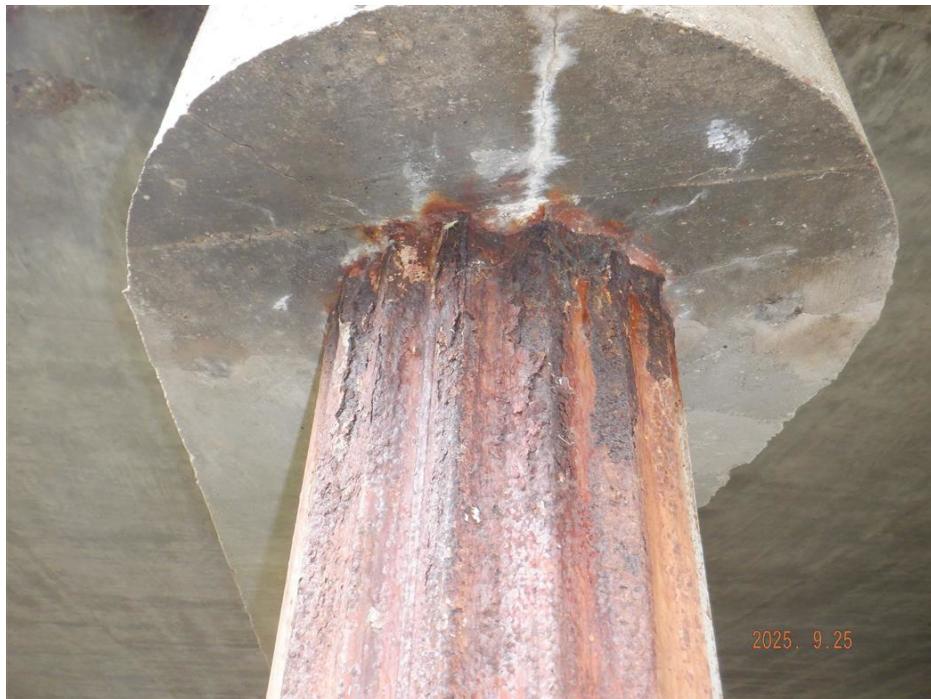
PHOTO 23

Description Pile 1 at Pier 1: moderate laminating corrosion up to 1/16" thick and up to 1/16" deep pitting at top 12", left side

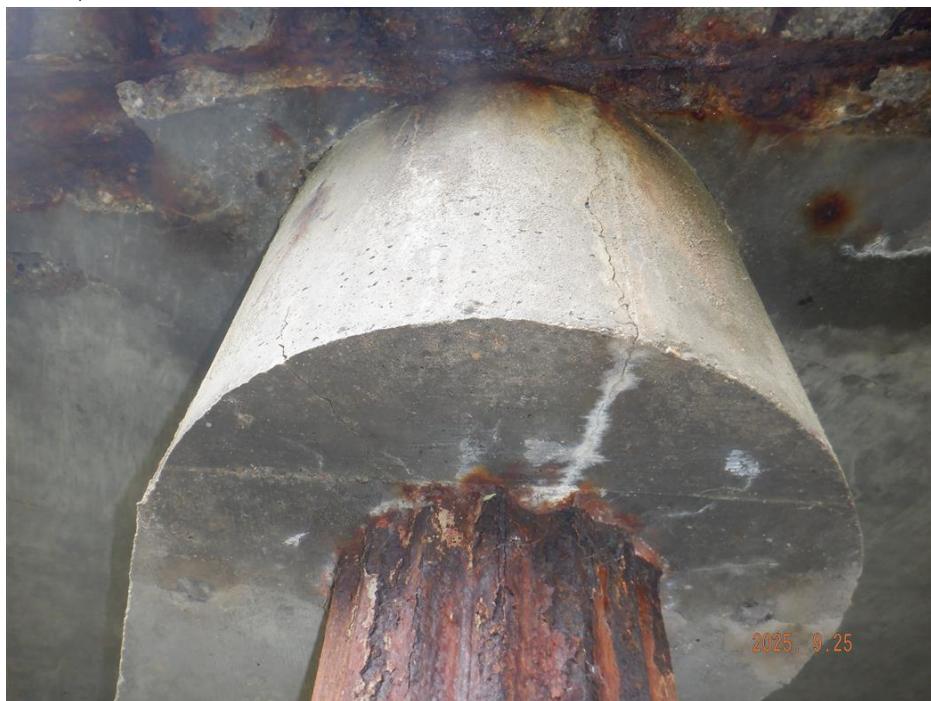
PHOTO 24

Description Pier 1 left/downstream nose: vertical delamination cracks with rust staining at left end of cap

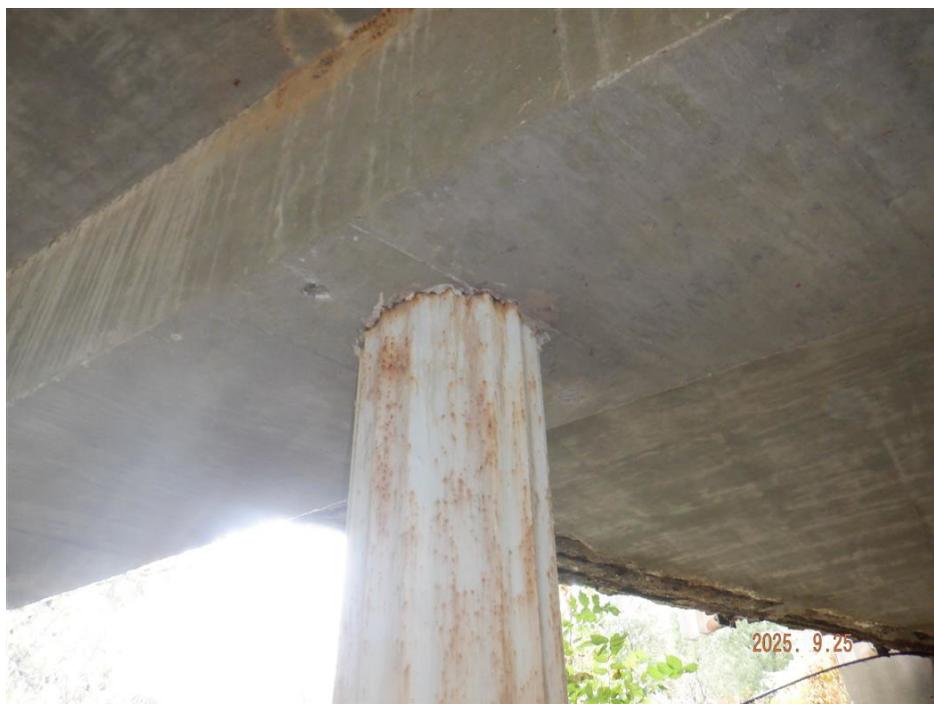
PHOTO 25

Description Typical pipe pile at pier cap; note surface corrosion (Pier 1, Pile 5 shown)

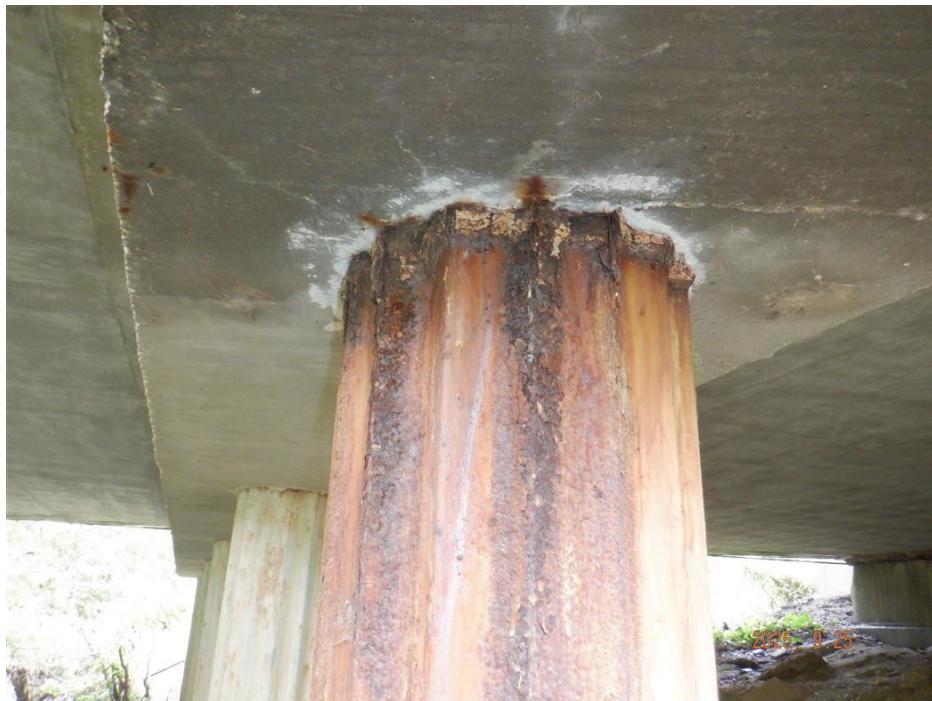
PHOTO 27

Description Pile 6 at Pier 2: moderate laminating corrosion up to 1/16" thick and up to 1/32" deep pitting at top 12", right side

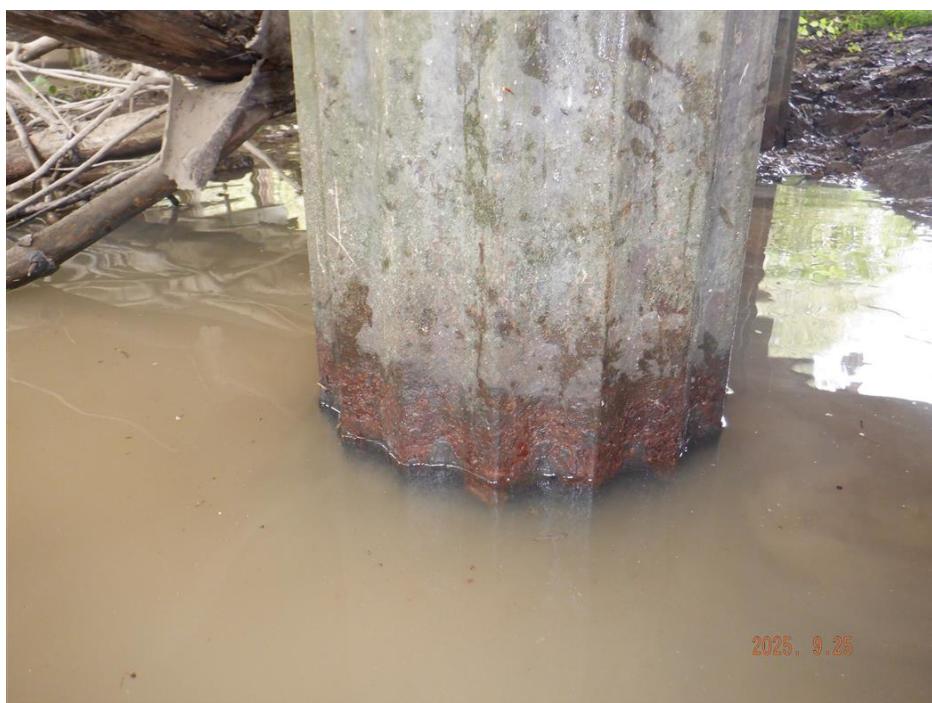
PHOTO 30

Description Typical surface corrosion at bottom of Pier 2 piling (Pile 5 shown)

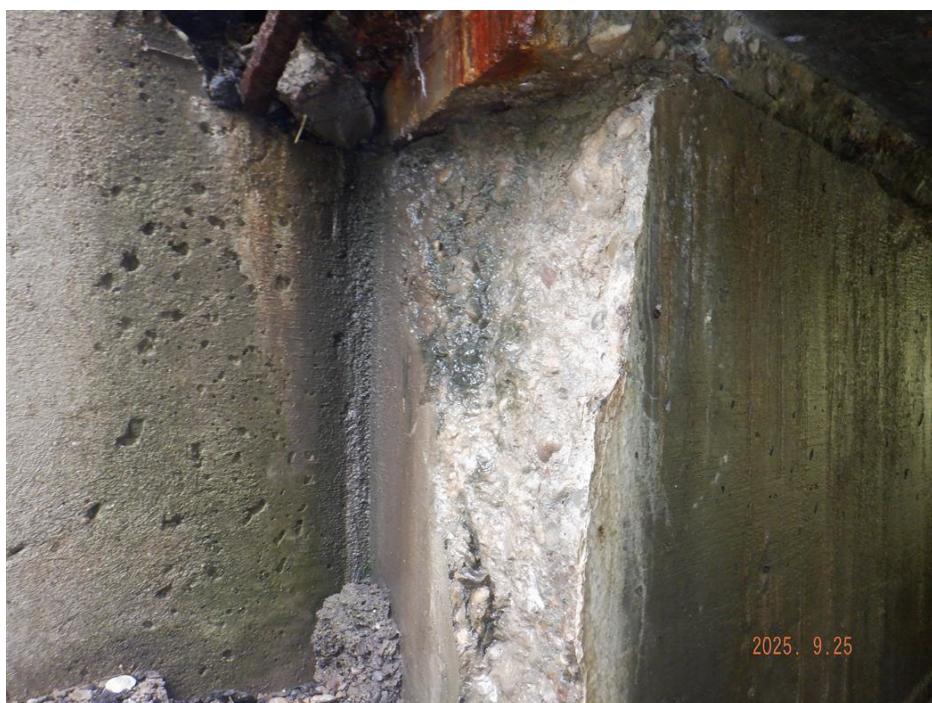
PHOTO 32

Description Forward Abutment left corner spall, 3" long x 14" wide x 2' high

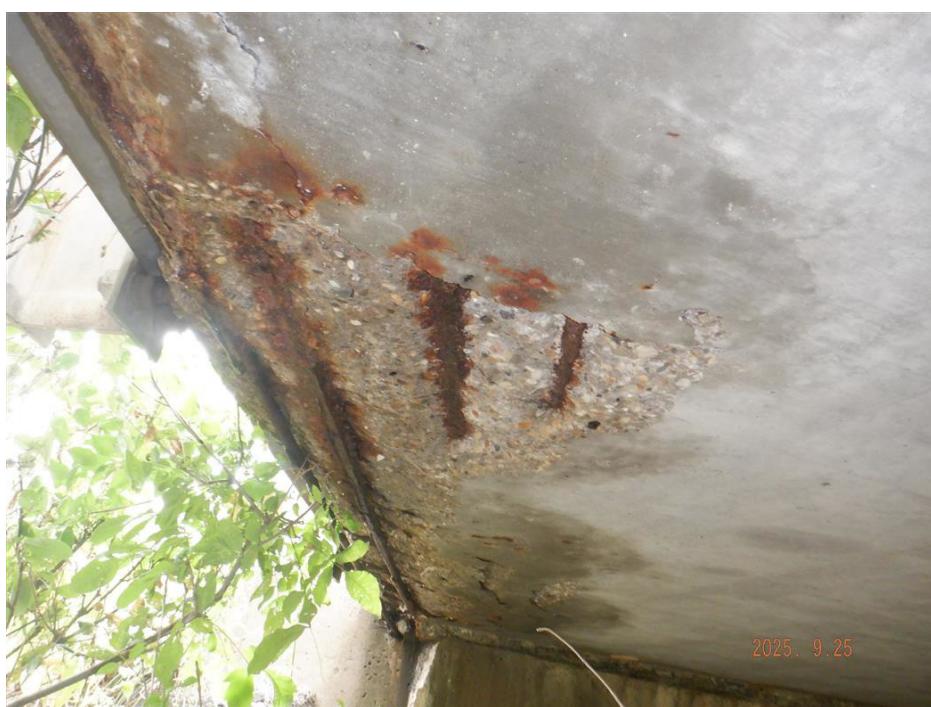
PHOTO 34

Description Span 3 left deck edge spalling

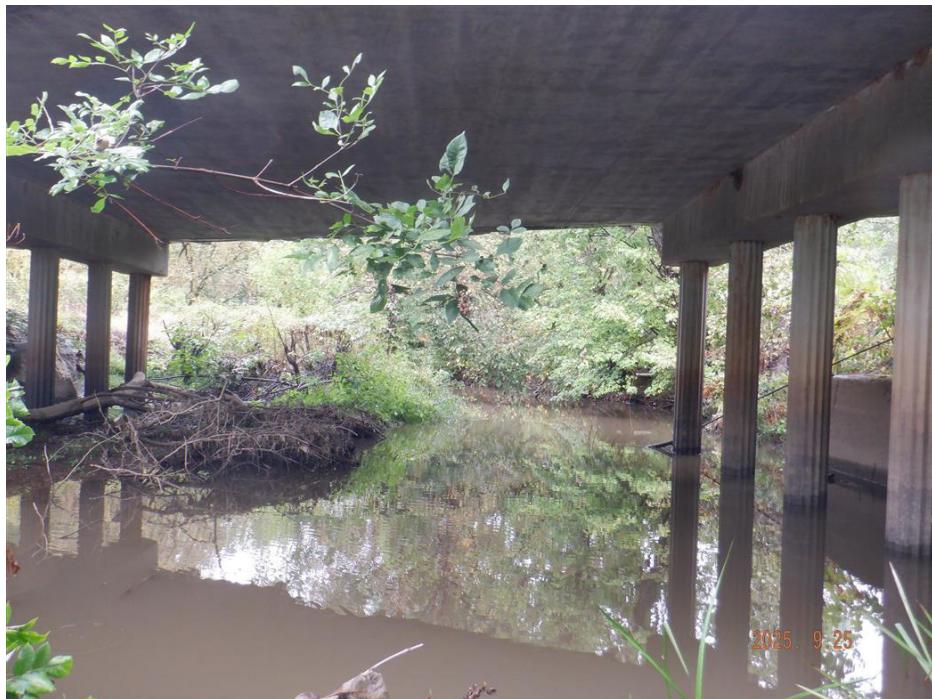
PHOTO 35

Channel flows from right to left. The stream is migrating south at the inlet with vegetation and flood debris in the channel at the upstream fascia pushing flow toward Pier 1 and along the rear face.

Description Sediment bar, vegetation, and flood debris in channel at upstream fascia directing flow toward Pier 1

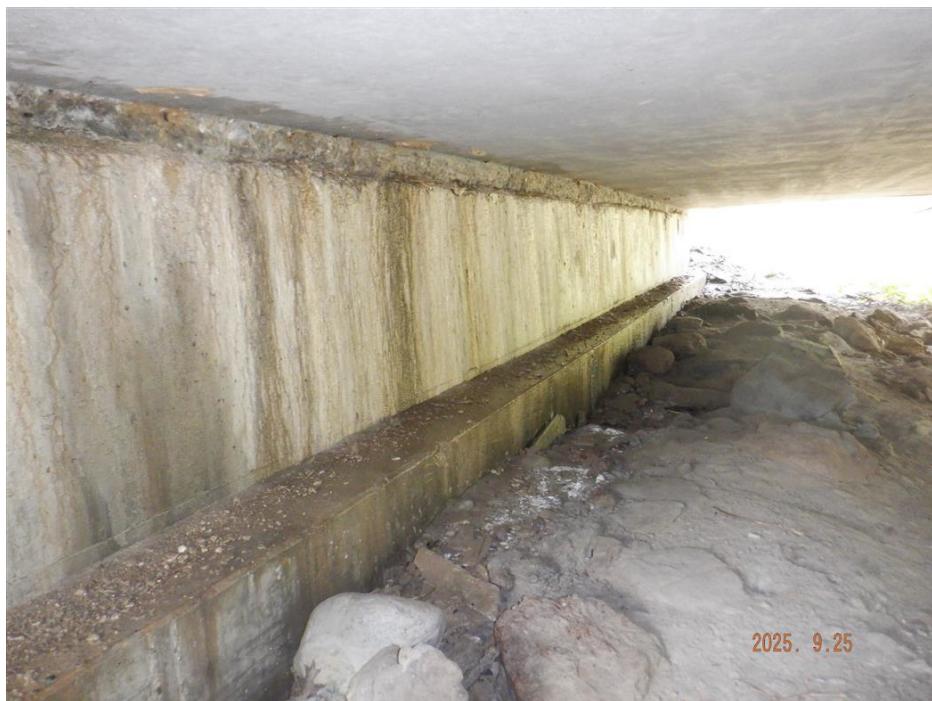
PHOTO 36

Description Forward Abutment looking northeast; north footing exposure
