STATE OF OHIO DEPARTMENT OF TRANSPORTATION
BRIDGE INSPECTION REPORT

Structure File Number: 1802046

Inventory Bridge Number: CUY 00017 02.830 N

SR17 over ROCKY RIVER

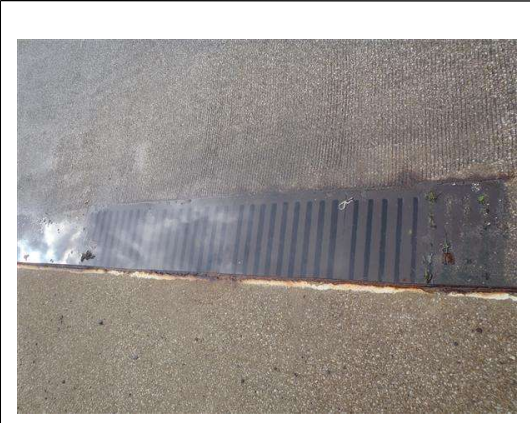
Drains along south curb are completely clogged in multiple spans. Ponding is occurring along the north curb in Spans A, F and G. All scuppers filled with dirt and vegetation, but some of them are still functioning. Large corrosion holes exist in downspouts at Tower B, north column, Tower F, south column and Tower G, south column.

Photo 1 | Ponding and clogged scupper along south curb, Span C (typical of multiple locations)

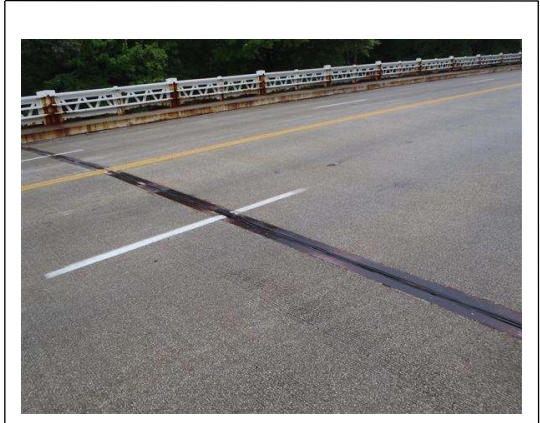
Seals have de-bonded from joints over Piers 6, 8, 9, 10, 11, 12 and the West Pylon. Sections of joint armor are missing at the East Abutment joint. Joint material at the West Abutment and West Vaults joints is still bonded to the joint armor, but torn in multiple locations. Edge spalls adjacent to West Abutment joint armor.

Photo 2 | Damaged seal 2

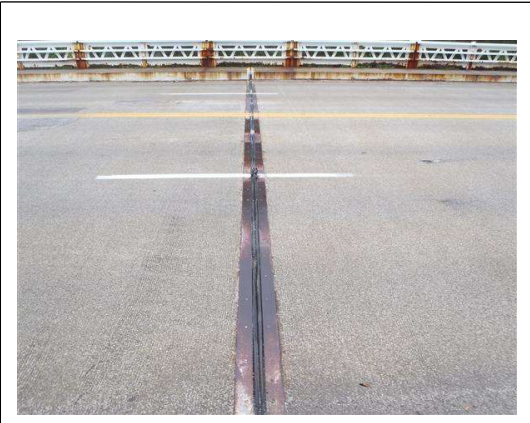
Photo 3 | Damaged seal

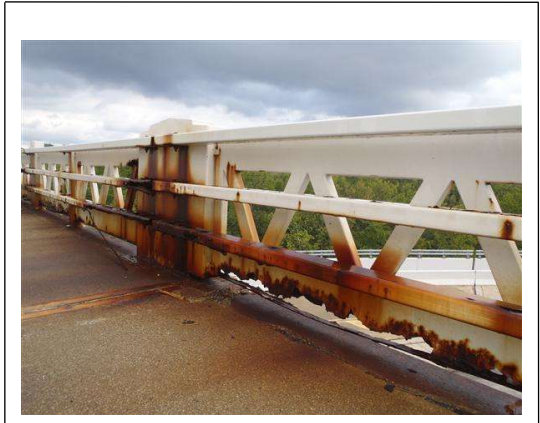
Photo 4 | Typical poor condition of railing.

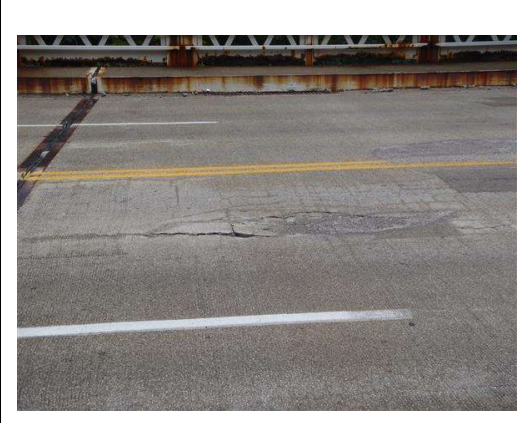
Photo 5 | Wearing surface deterioration

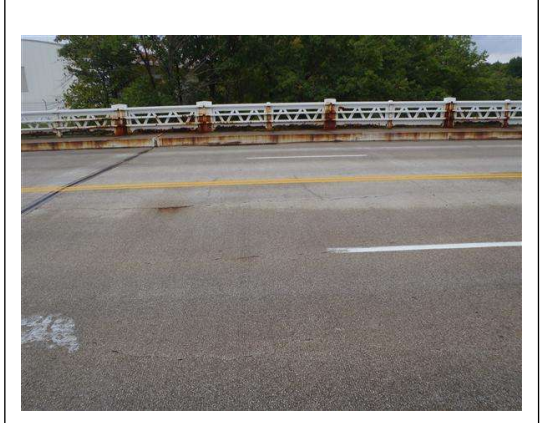
Photo 6 | Wearing surface cracking 2

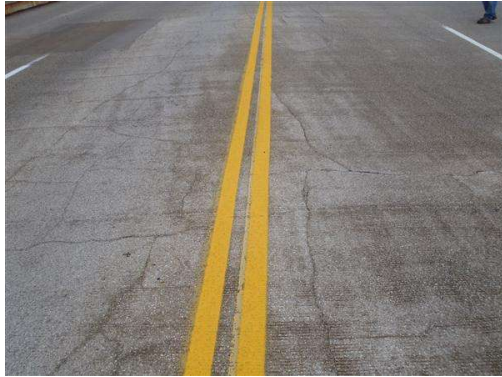
Photo 7 Wearing surface cracking

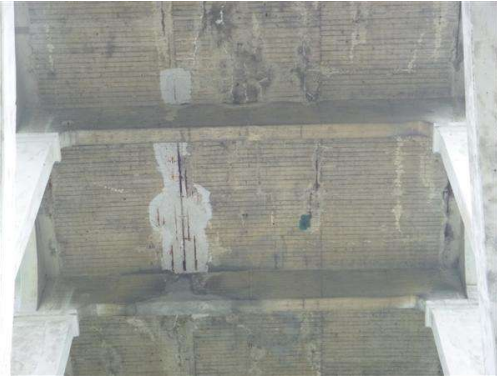
Photo 8 Typical spalls with exposed rebar in arch span deck soffit.

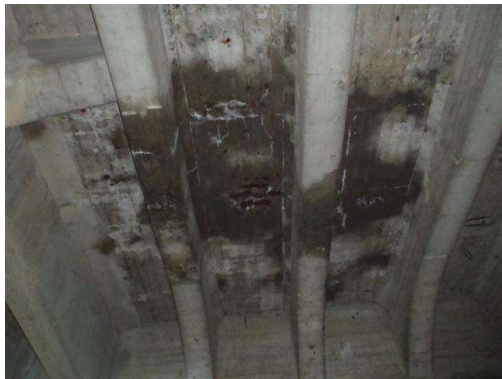
Photo 9 Typical cracking, leakage, efflorescence and spalls in approach span deck soffit.

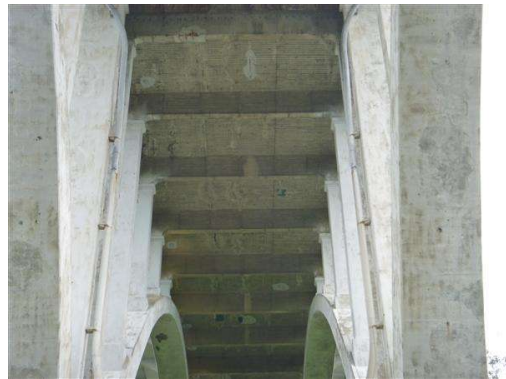
Random spalls with exposed reinforcing on the vertical faces of the floorbeams, sometimes connecting across the bottom face. Corrosion has resulted in minor section loss on some of the exposed reinforcing. Many spall areas have been sealed with white epoxy, but corrosion is beginning to re-activate in some of these bars. Floorbeams in approach spans also have some spalls and patches. Floorbeam A above the West Pylon has a 1-ft diameter spall.

Photo 10 Typical condition of floorbeams

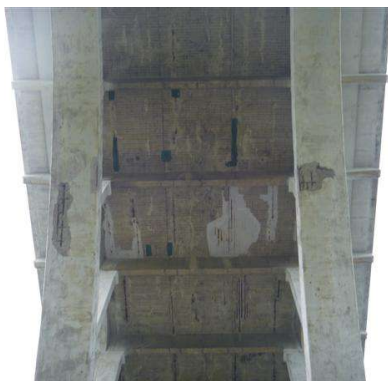
The arches have large patches, spalls and delamination on all faces, randomly throughout, but totaling less than 10% of the surface area of the arches.

Photo 11 Typical spalls on arches.

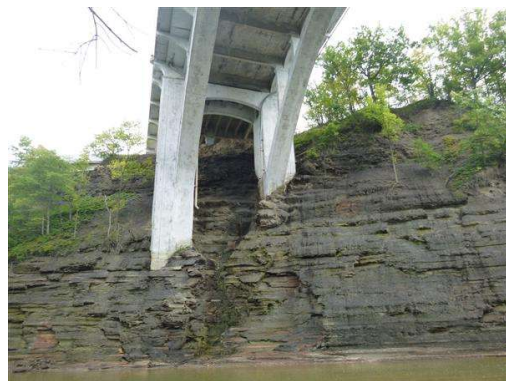
Stream appears to be gradually shifting or widening eastward at the bridge, in large part because of the runoff from east approach roadway.

Photo 12 Continued slow erosion of the east shale banks.
