Re: March 9 and 11, 2016 Bi-Weekly Readings
CUY-90-15.24 Slope Monitoring
PID 96504
SME Project No. 069032.00

Bi-weekly instrument readings for the I-90 west slope taken on March 9 and 11, 2016, are presented in this report. Bi Weekly readings currently include instruments at I/P-001-13, I/P-002-13, I/P-003-A-10, I/P-004-13, I/P-009-13, B-101, B-102, B-105, B-105A, B-05-03, B-05-04, B-05-A-11, P-1, P-9N, TGR I-2, and TGR I-4.

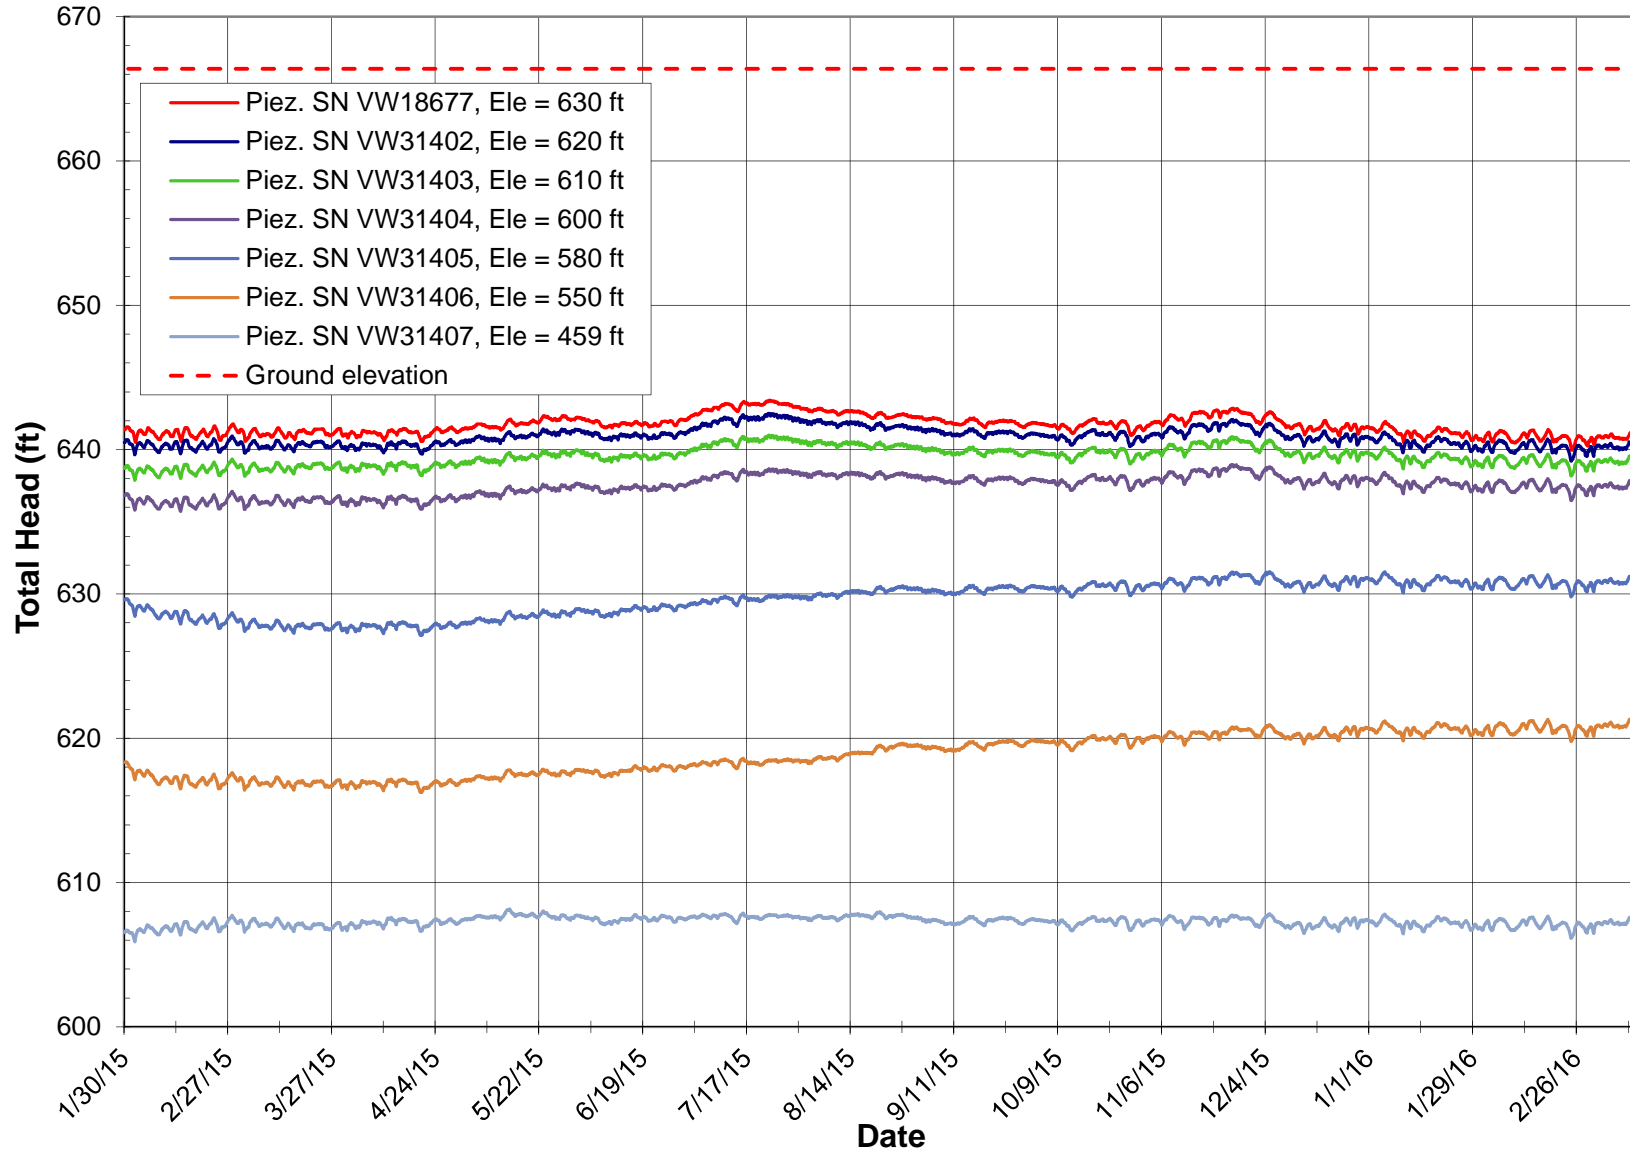
P-001-13 VW Piezometer Readings

P-001-13 – In every piezometer at this location, pore pressure readings indicate an increase in total head of about 0.5 feet over the past two weeks.

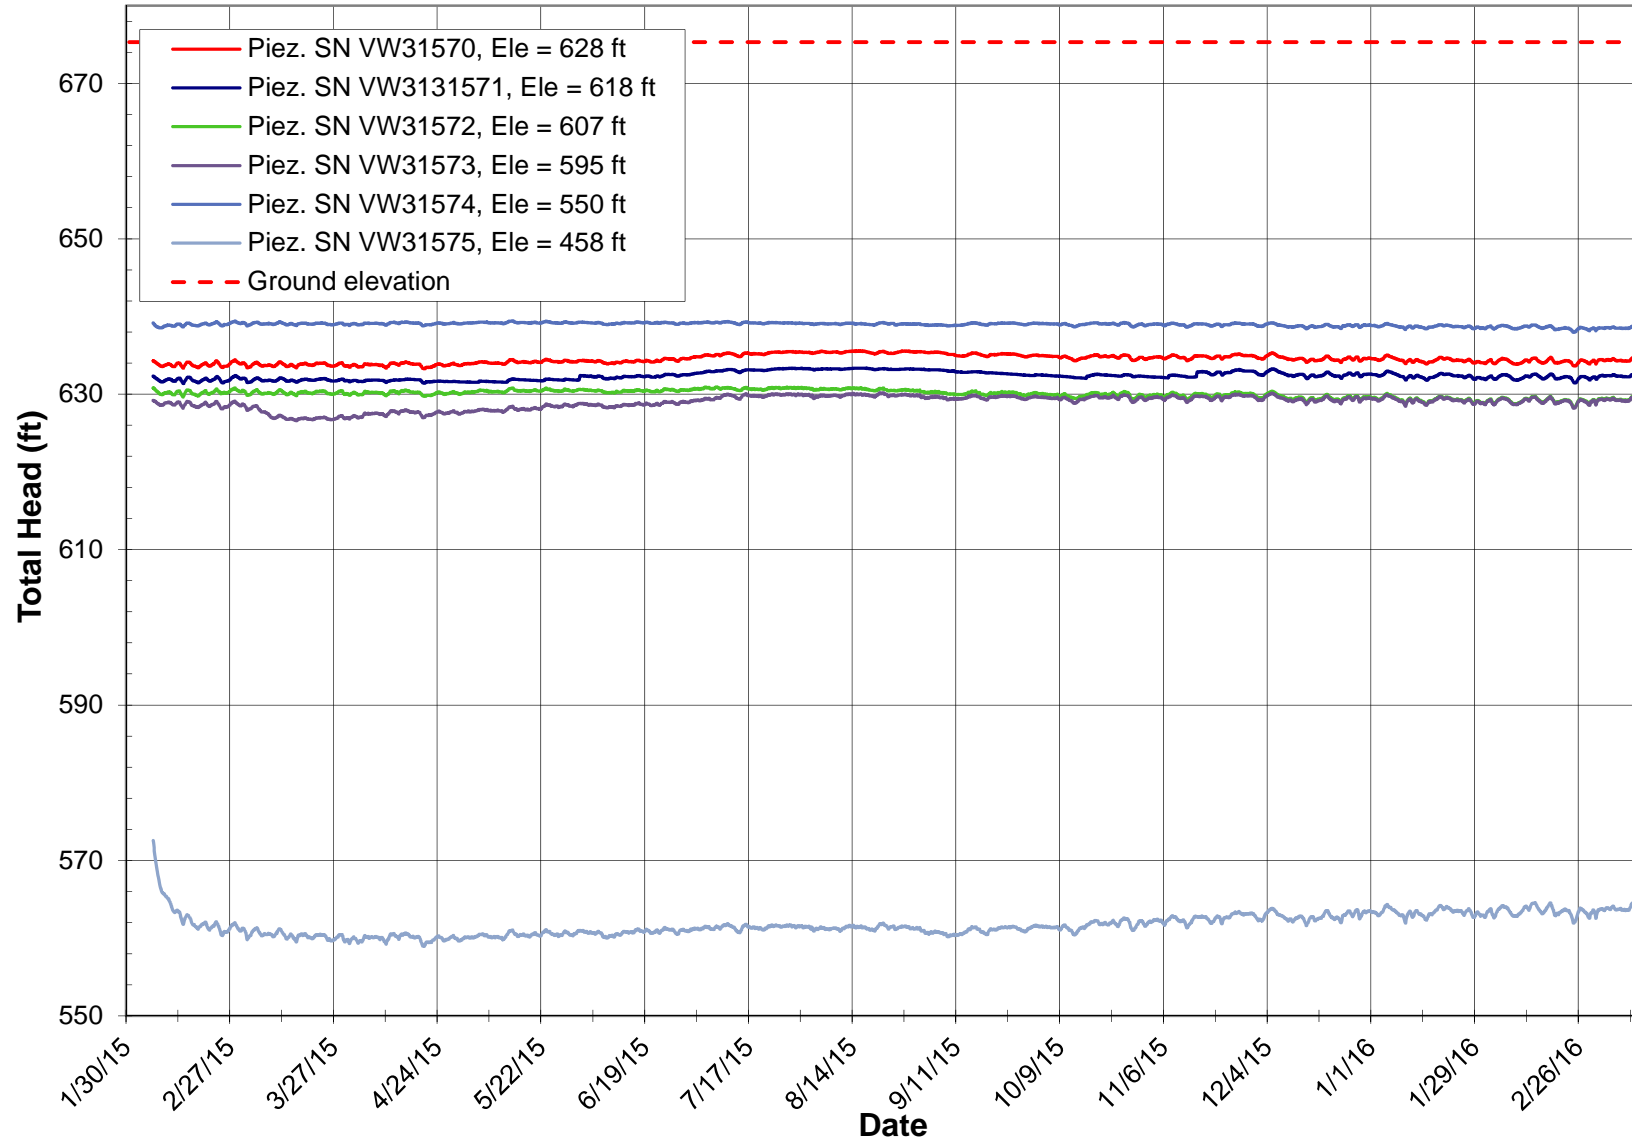
P-002-13 VW Piezometer Readings

P-002-13 – Pore pressure readings in all piezometers at this location indicate a slight increase in total head.

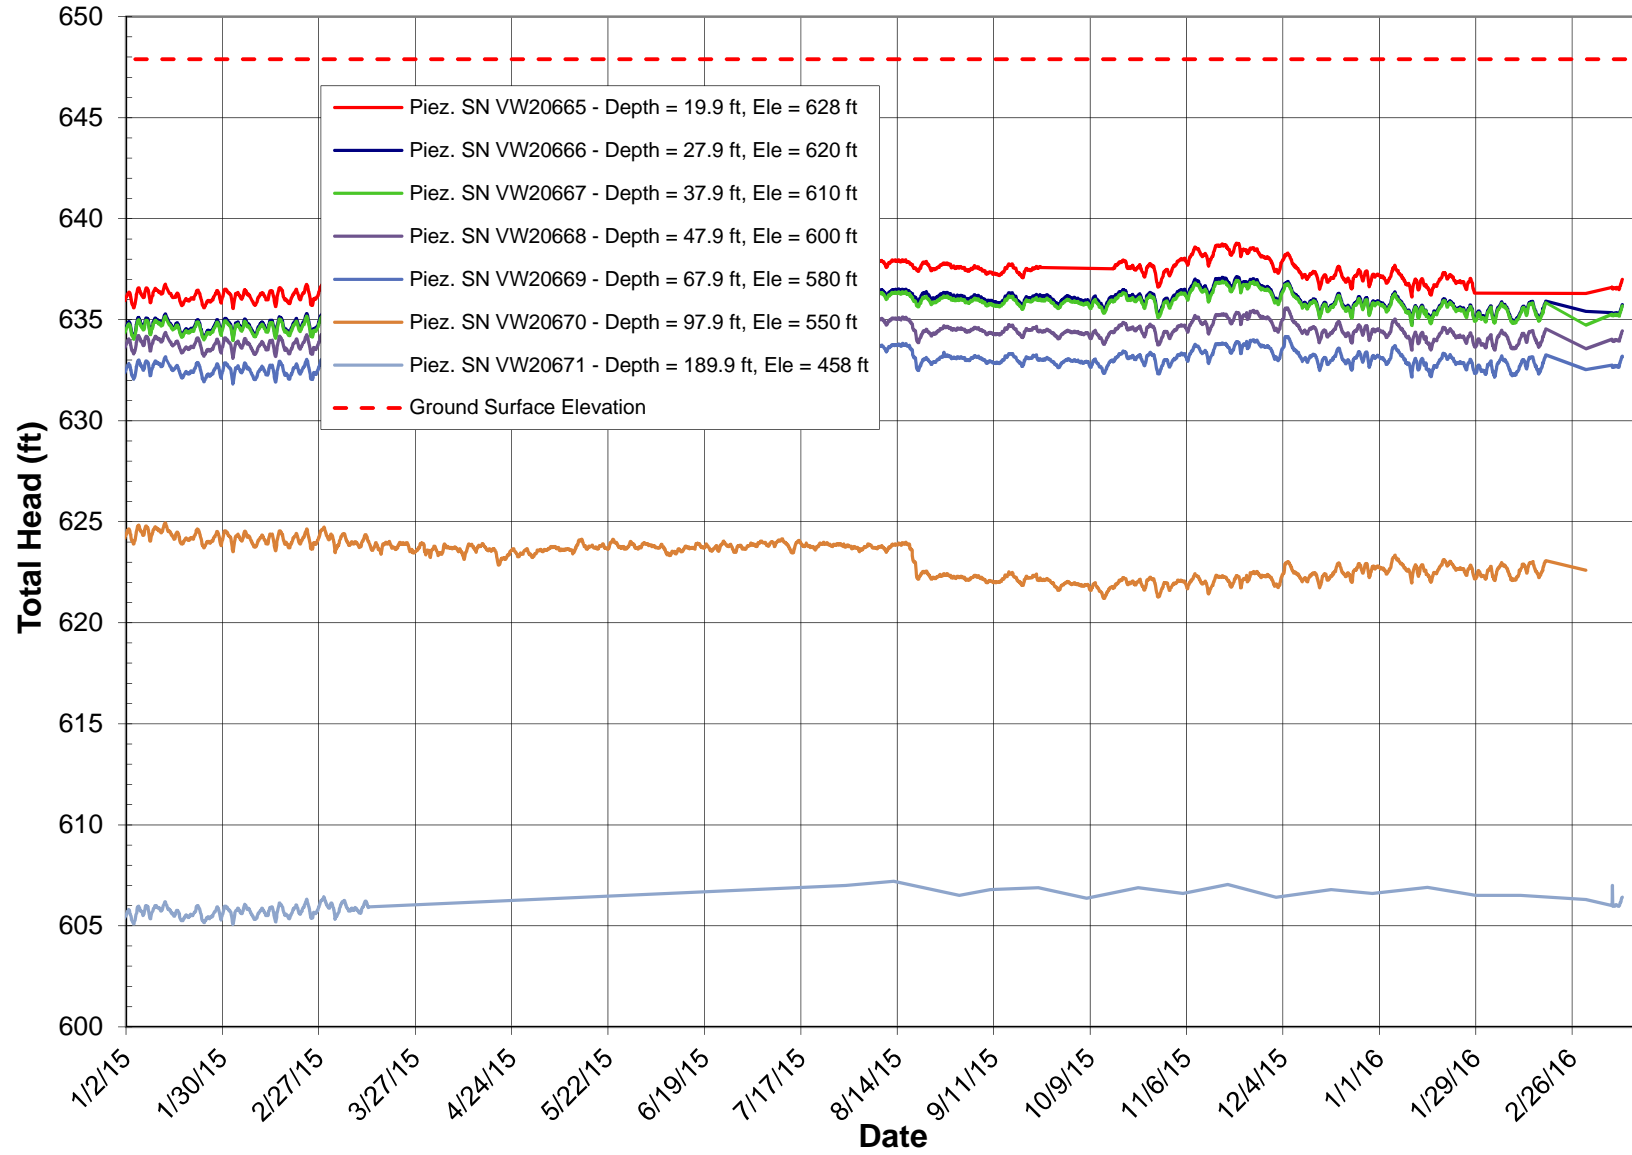
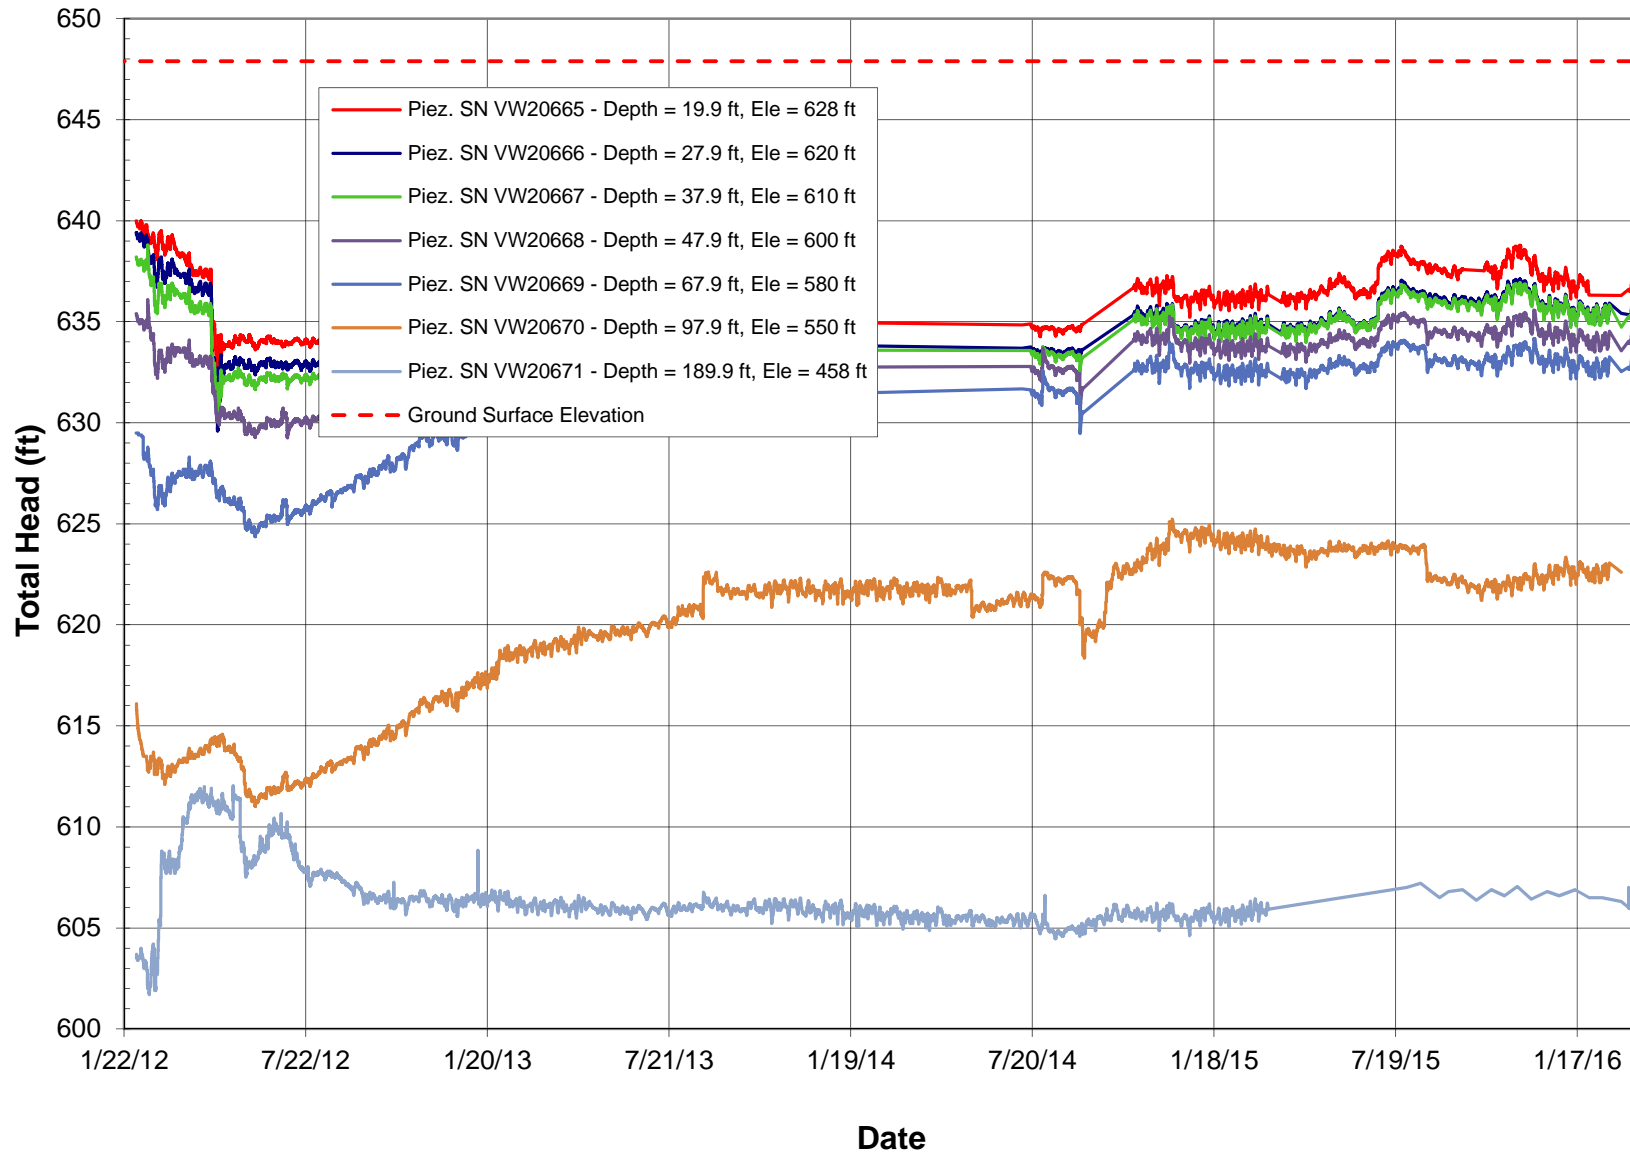
P-003-10 VW Piezometer Readings

P-003-10 – The gabion basket construction and backfill operation in the immediate area of these instruments was completed last week. We installed protective covers and reattached the dataloggers. When we returned later in the week for our biweekly readings we were unable to download data for the piezometer at 98 feet. We replaced the batteries in the datalogger and it seems to be functioning normally again. Pore pressure readings in the other piezometers indicate increases in total head ranging from 0.3 feet to 1 foot, with the largest increases occurring in the piezometers at 38, 48, and 68 feet. With these changes, the total heads are about the same as they were in early February.

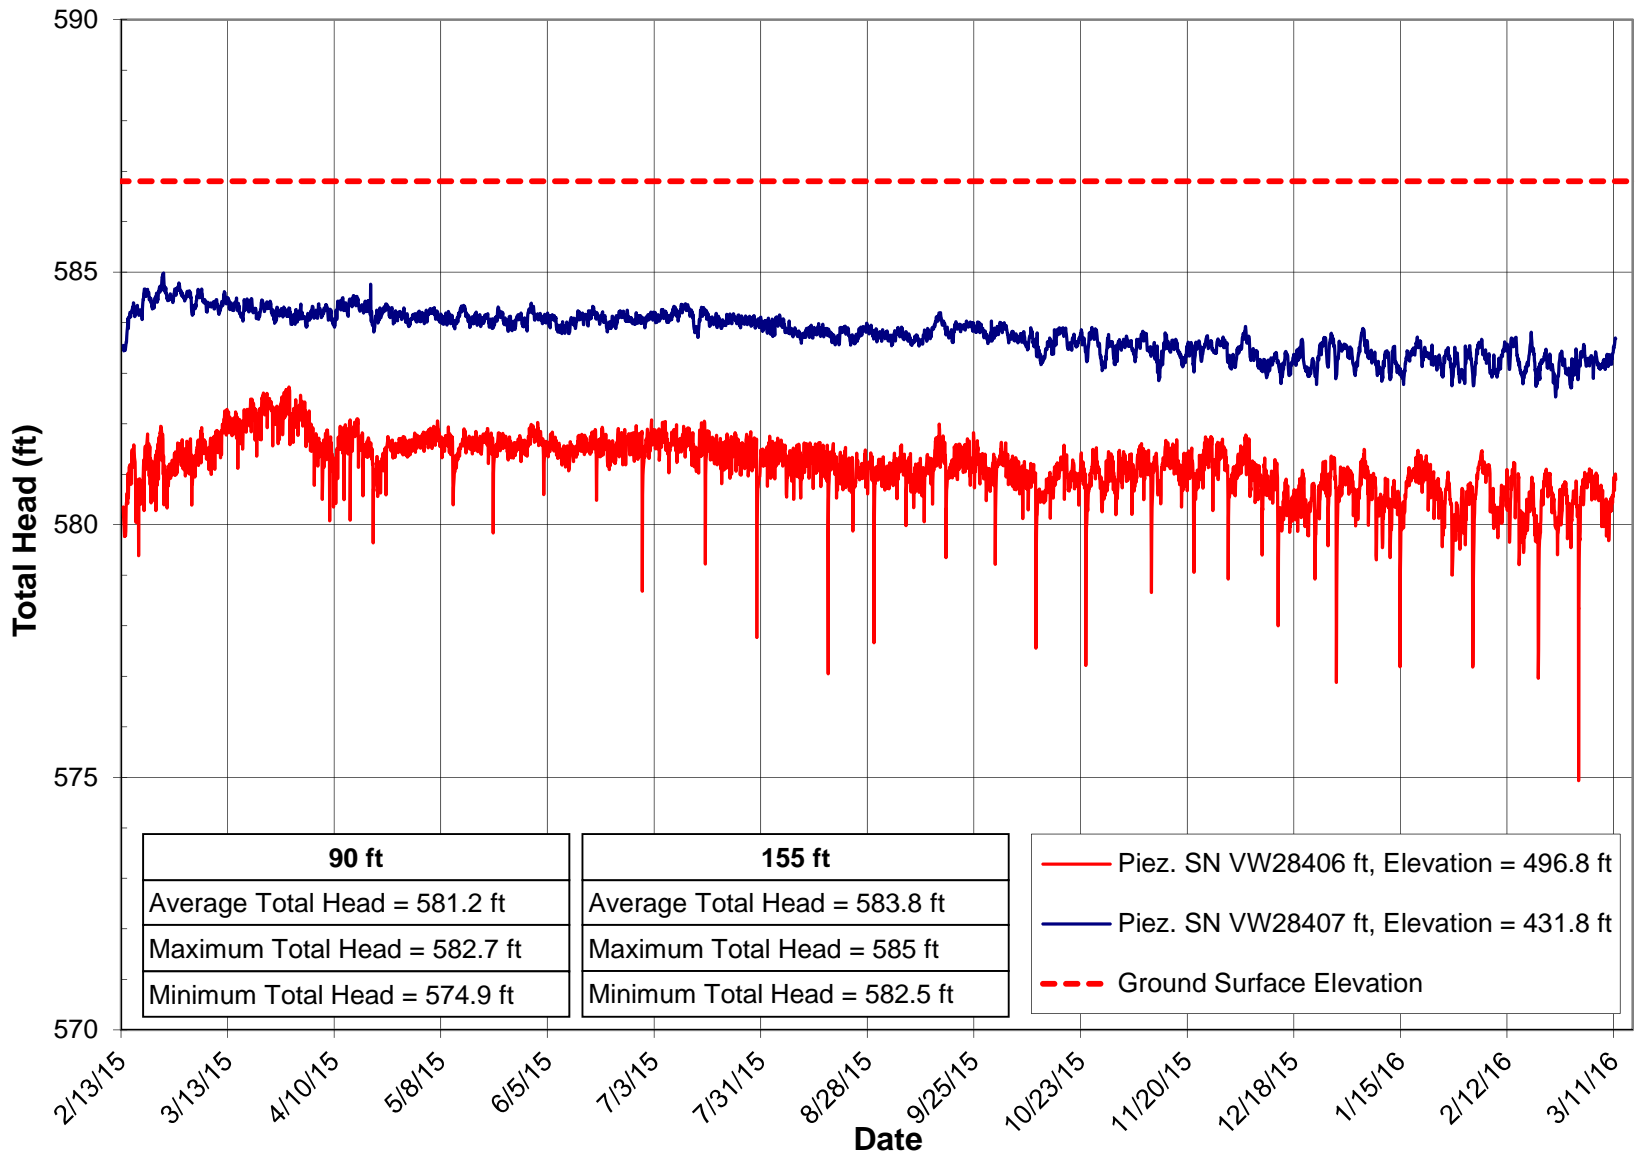
P-009-13 VW Piezometer Readings

P-009-13 – Pore pressure readings in the deep piezometer at this location increased by about 0.5 feet over the past two weeks. Pore pressures in the shallow piezometer fluctuated throughout the past two weeks, but show virtually no net change.

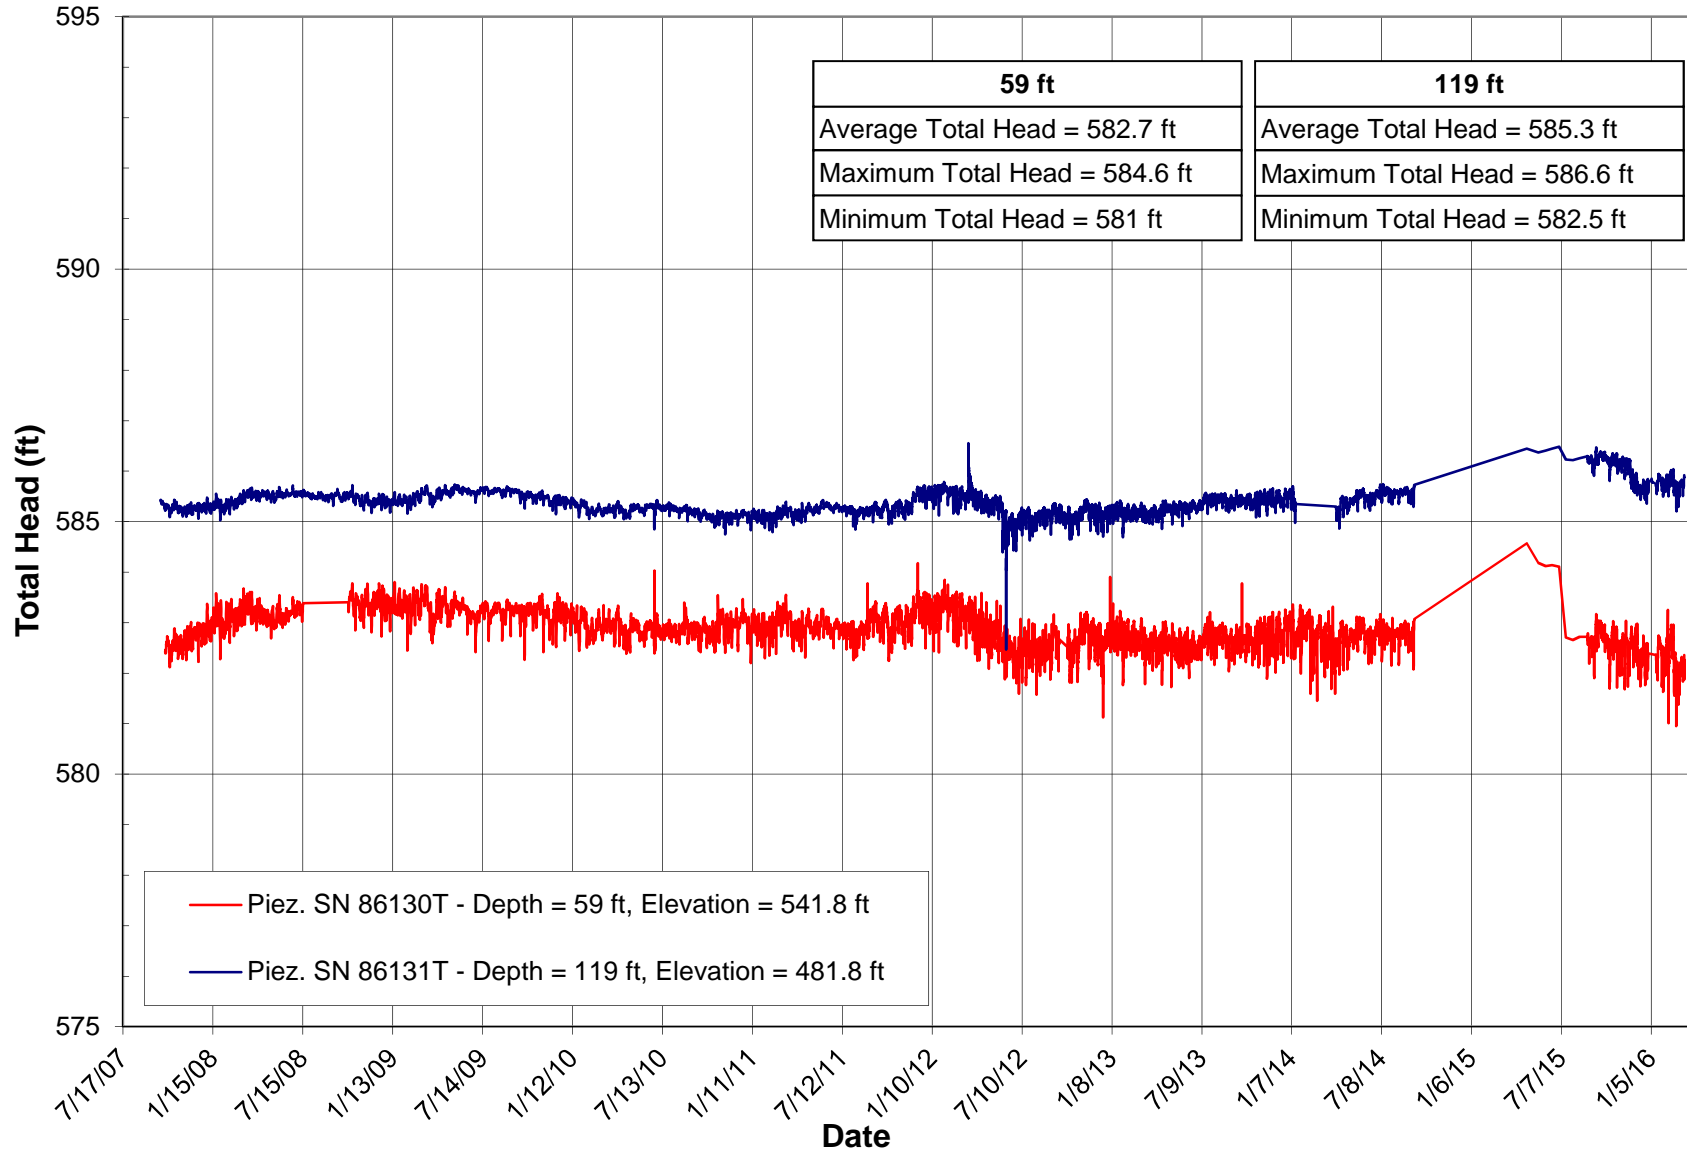
B-05-04 VW Piezometer Readings

B-05-04 – Bi-weekly readings at this location show increases in total head of about 0.5 feet in both piezometers. Average pore water pressures have remained nearly constant since mid-December 2015.

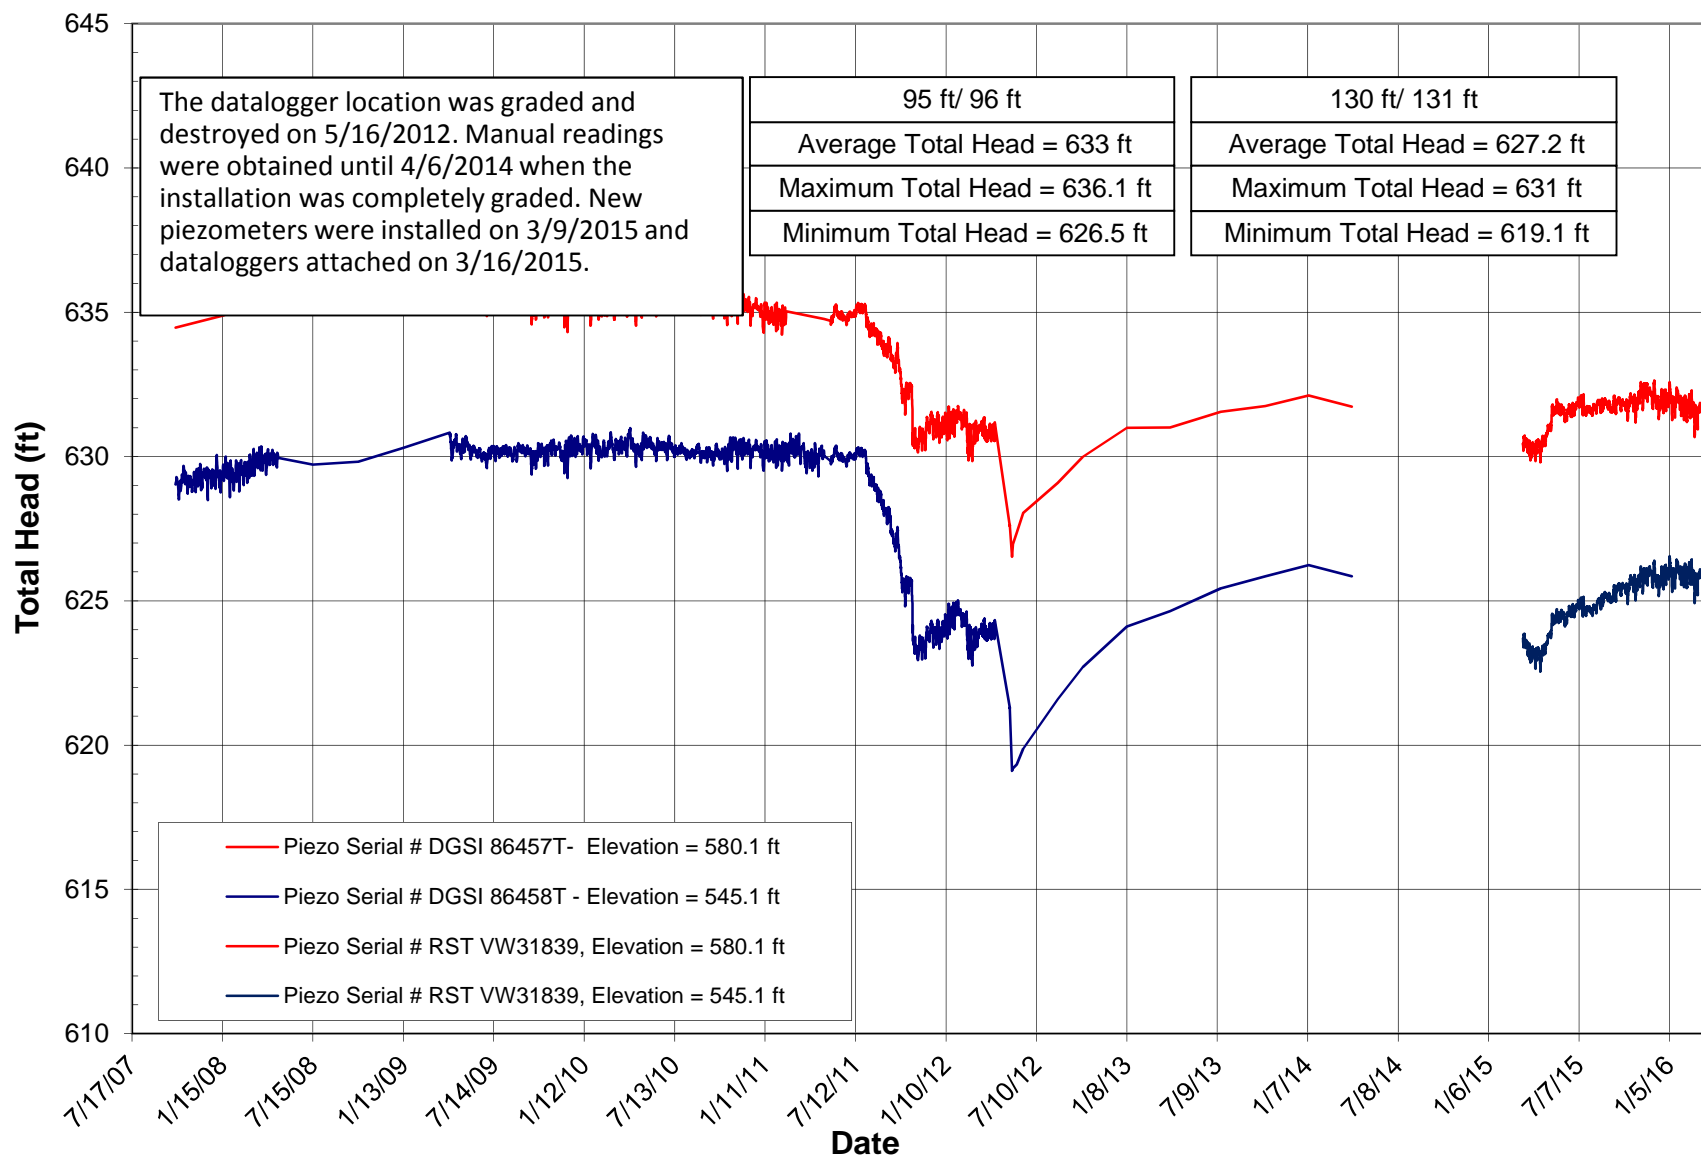
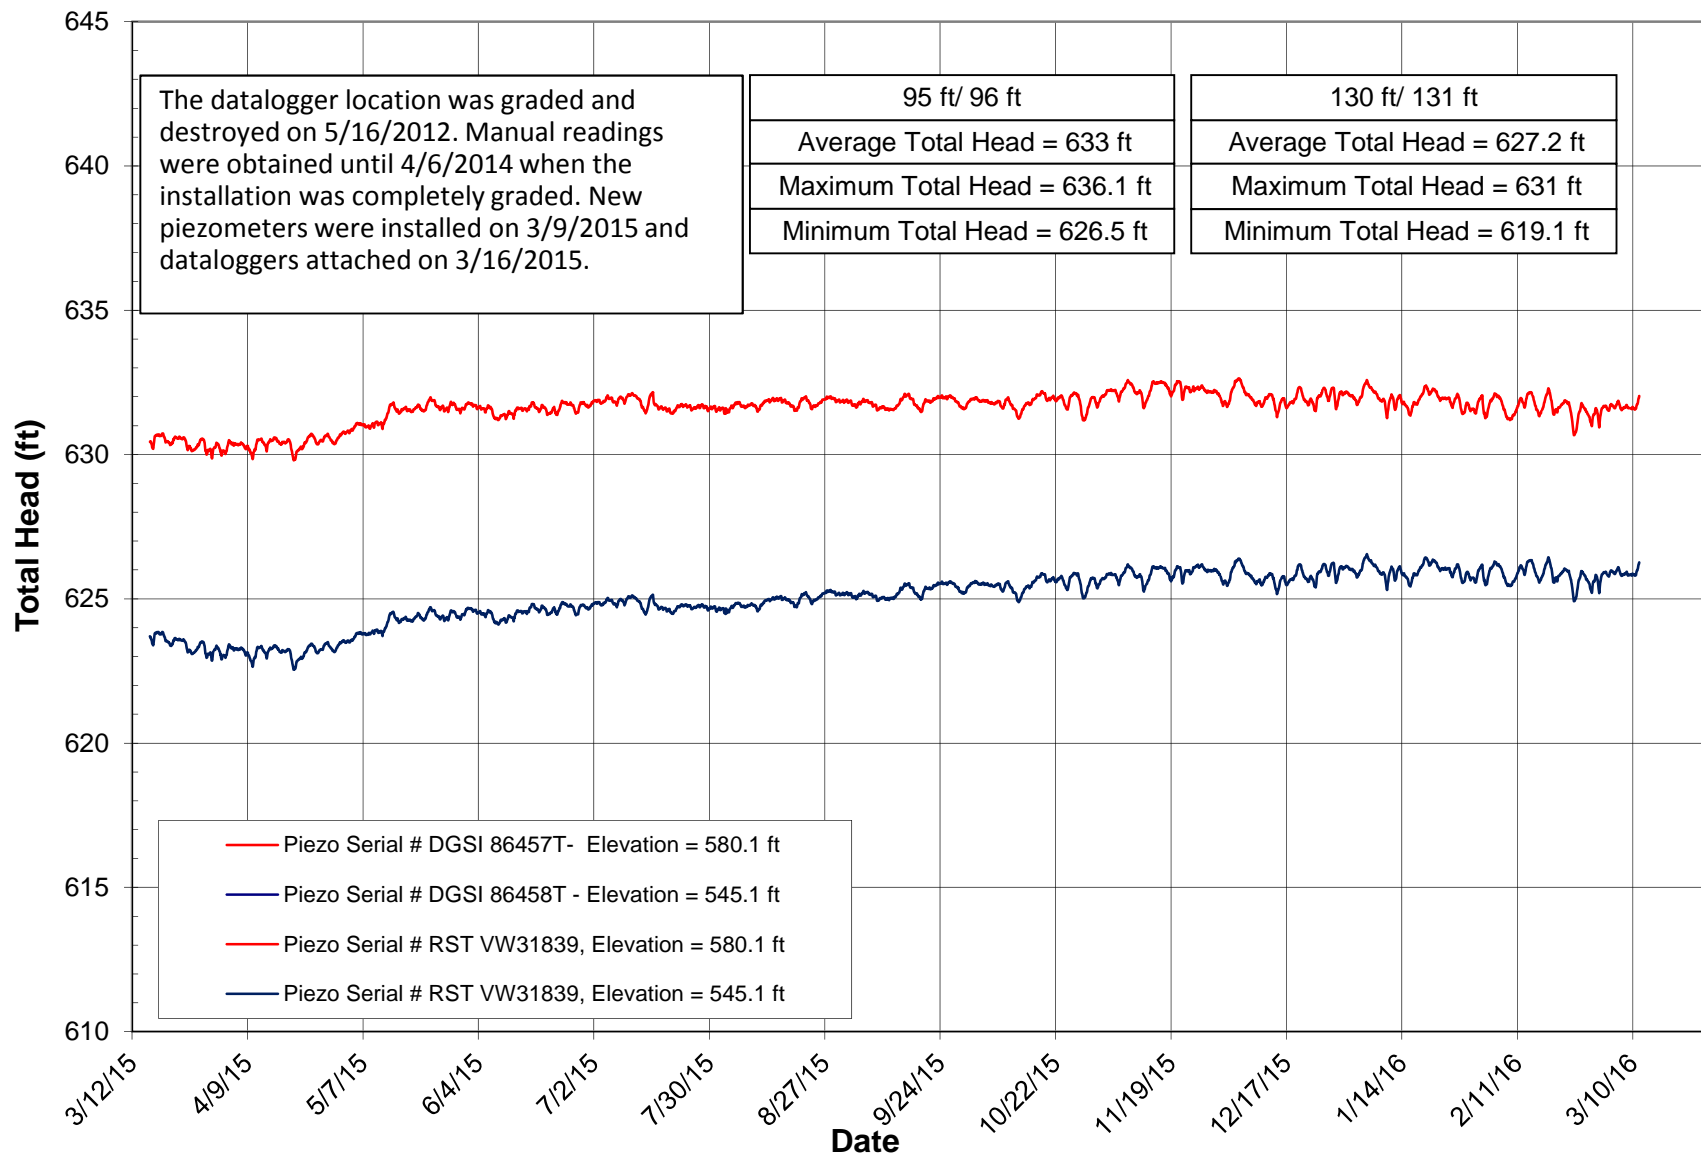
B-05-11/B-05-A-11 VW Piezometer Readings

B-05-A-11 – Pore pressure readings at this location indicate increases in total head of about 0.5 feet in both piezometers during the past two weeks. Average pore water pressures have remained nearly constant since mid-October 2015.

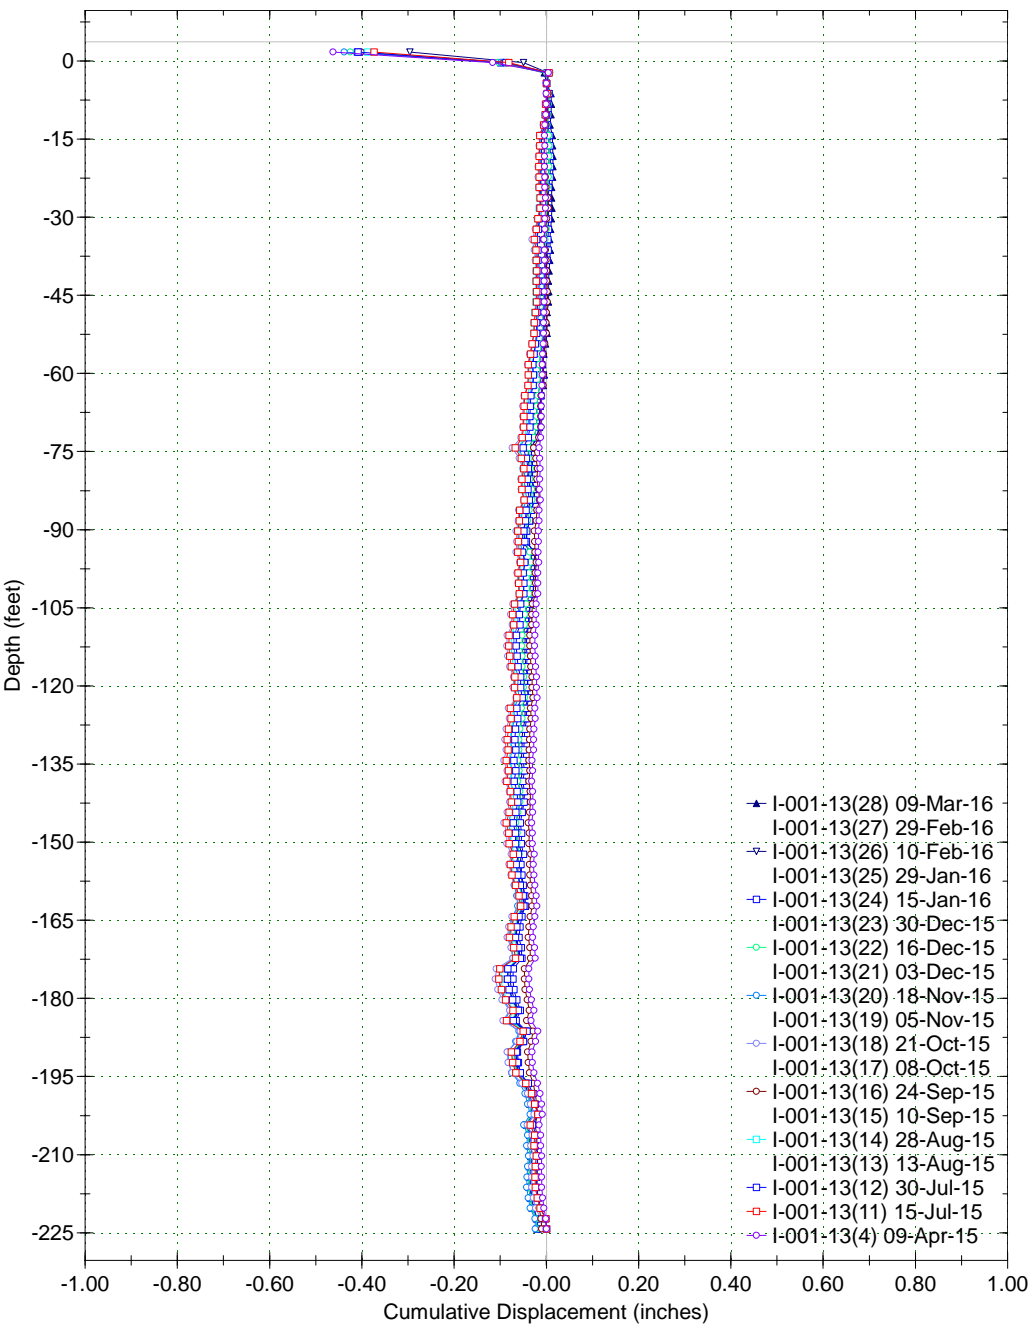
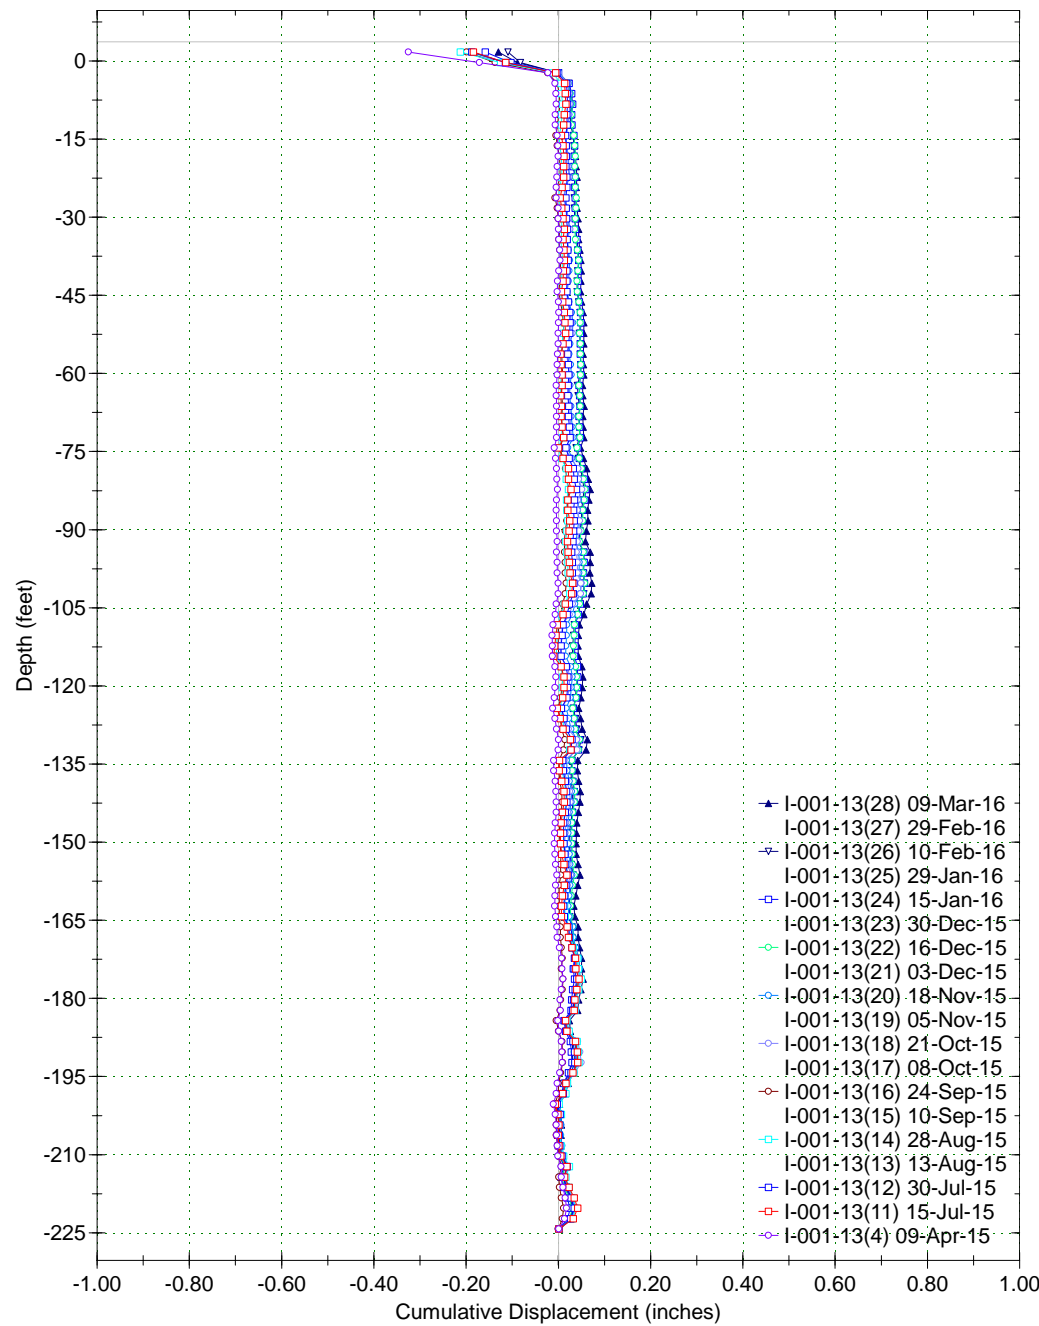
Borehole : I-001-13
Project : CUY-90-15-24
Location : Cleveland, Ohio
Northing :
Easting :
Collar :

Inclinometer readings at I-001-13, I-002-13, B-102, B-05-04, B-05-A-11, P-9N, and TGR I-4 showed virtually no movement this two-week period. Displacements at the top of some slope tubes is due to flexing of the tube when readings are taken because some of the protective covers are only temporarily set in place until earthwork near these installations is completed.

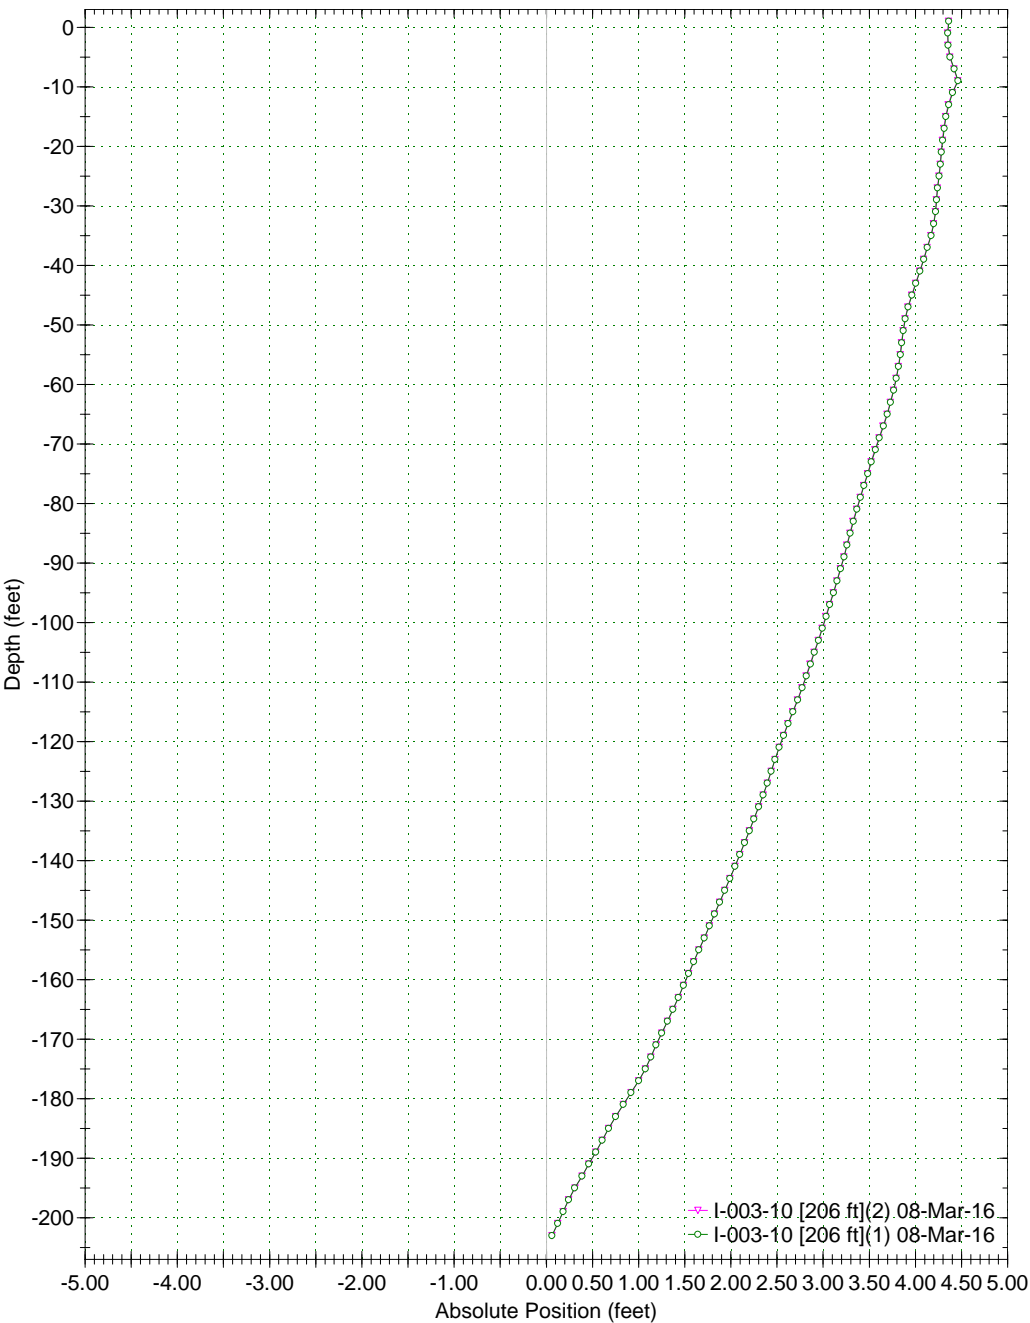
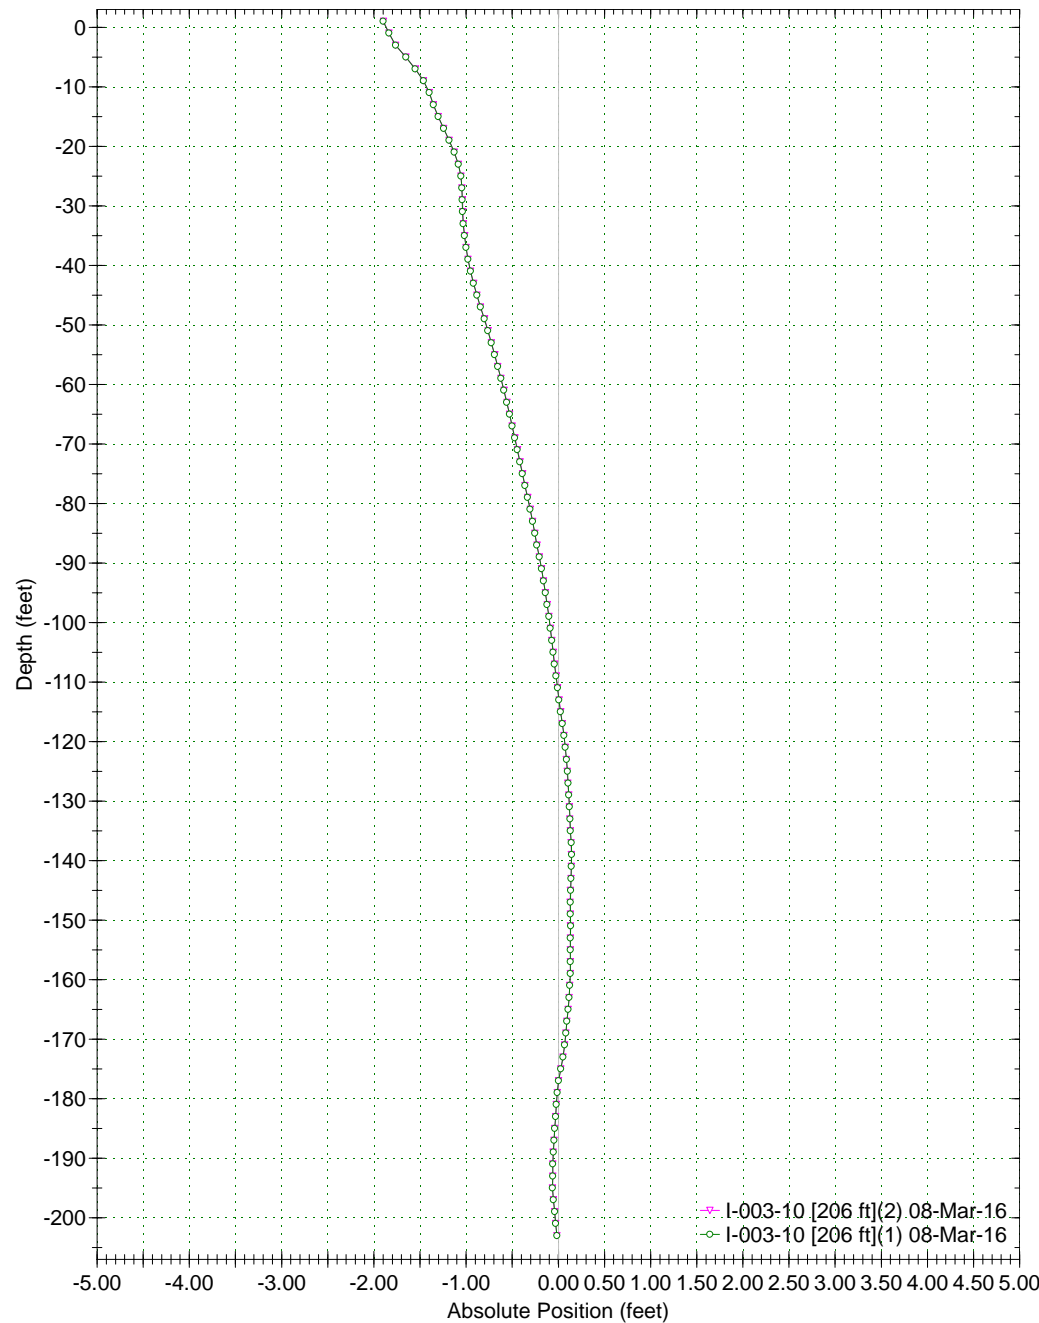
Borehole : I-003-10 [206 ft]
Project : CUY-90-15-24
Location :
Northing :
Easting :
Collar :

I-003-10 – We added a 4 foot section of casing to the inclinometer tube at this location because of the change in grade from the backfill operation in this area. We also installed a new protective cover. Absolute position plots for our new baseline reading as well as the plots from our previous readings are included in this report.
