Re: March 9 and 11, 2016 Bi-Weekly Readings
CUY-90-15.24 Slope Monitoring
PID 96504
SME Project No. 069032.00

Bi-weekly instrument readings for the I-90 west slope taken on March 9 and 11, 2016, are presented in this report. Bi Weekly readings currently include instruments at I/P-001-13, I/P-002-13, I/P-003-A-10, I/P-004-13, I/P-009-13, B-101, B-102, B-105, B-105A, B-05-03, B-05-04, B-05-A-11, P-1, P-9N, TGR I-2, and TGR I-4.

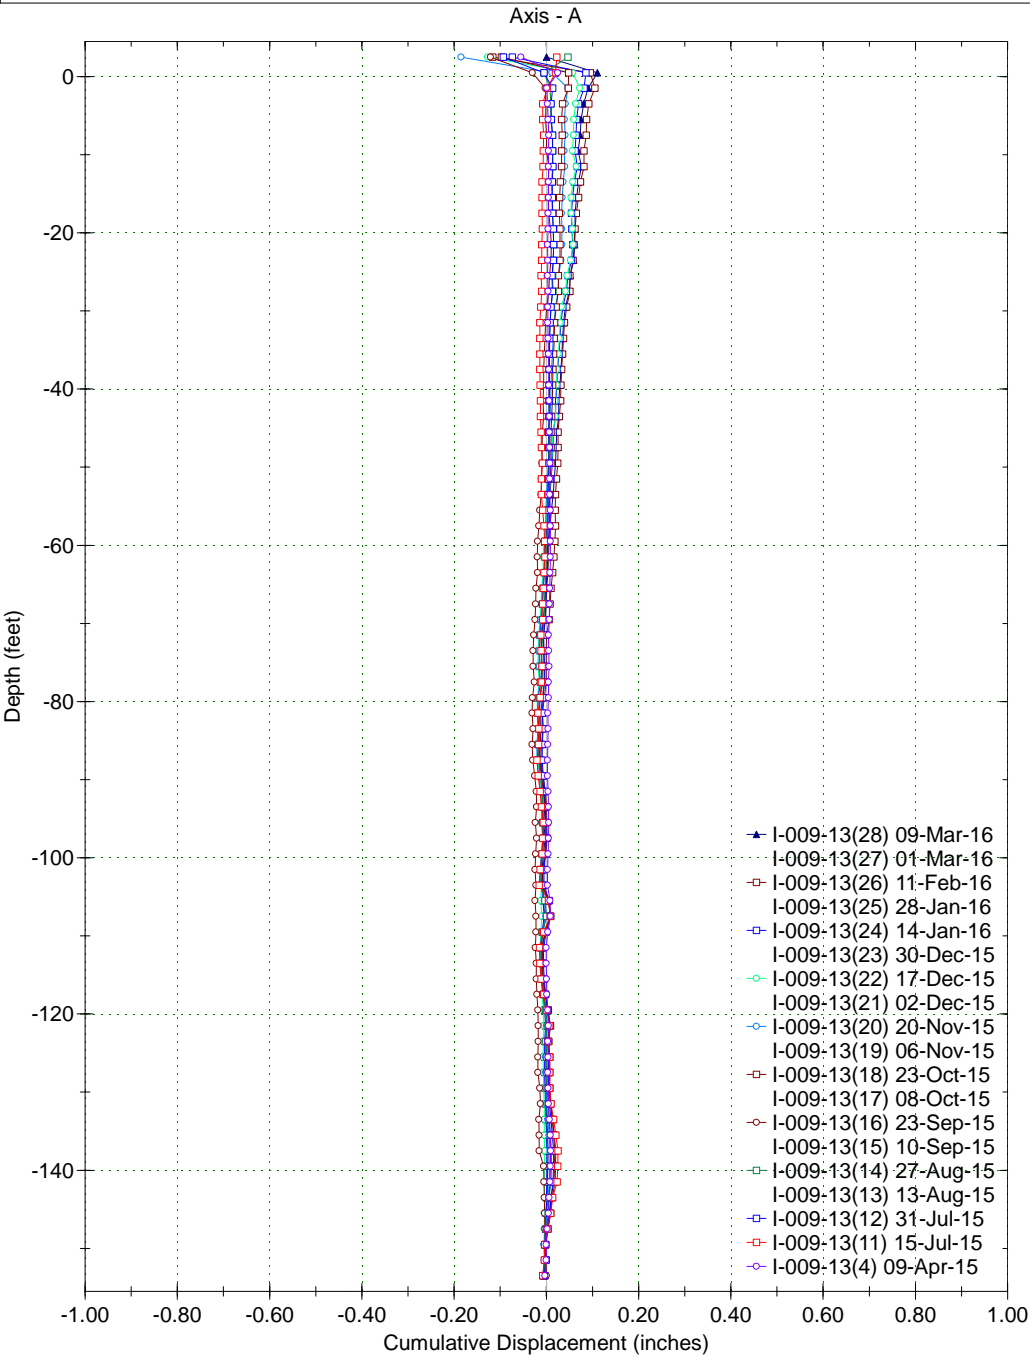
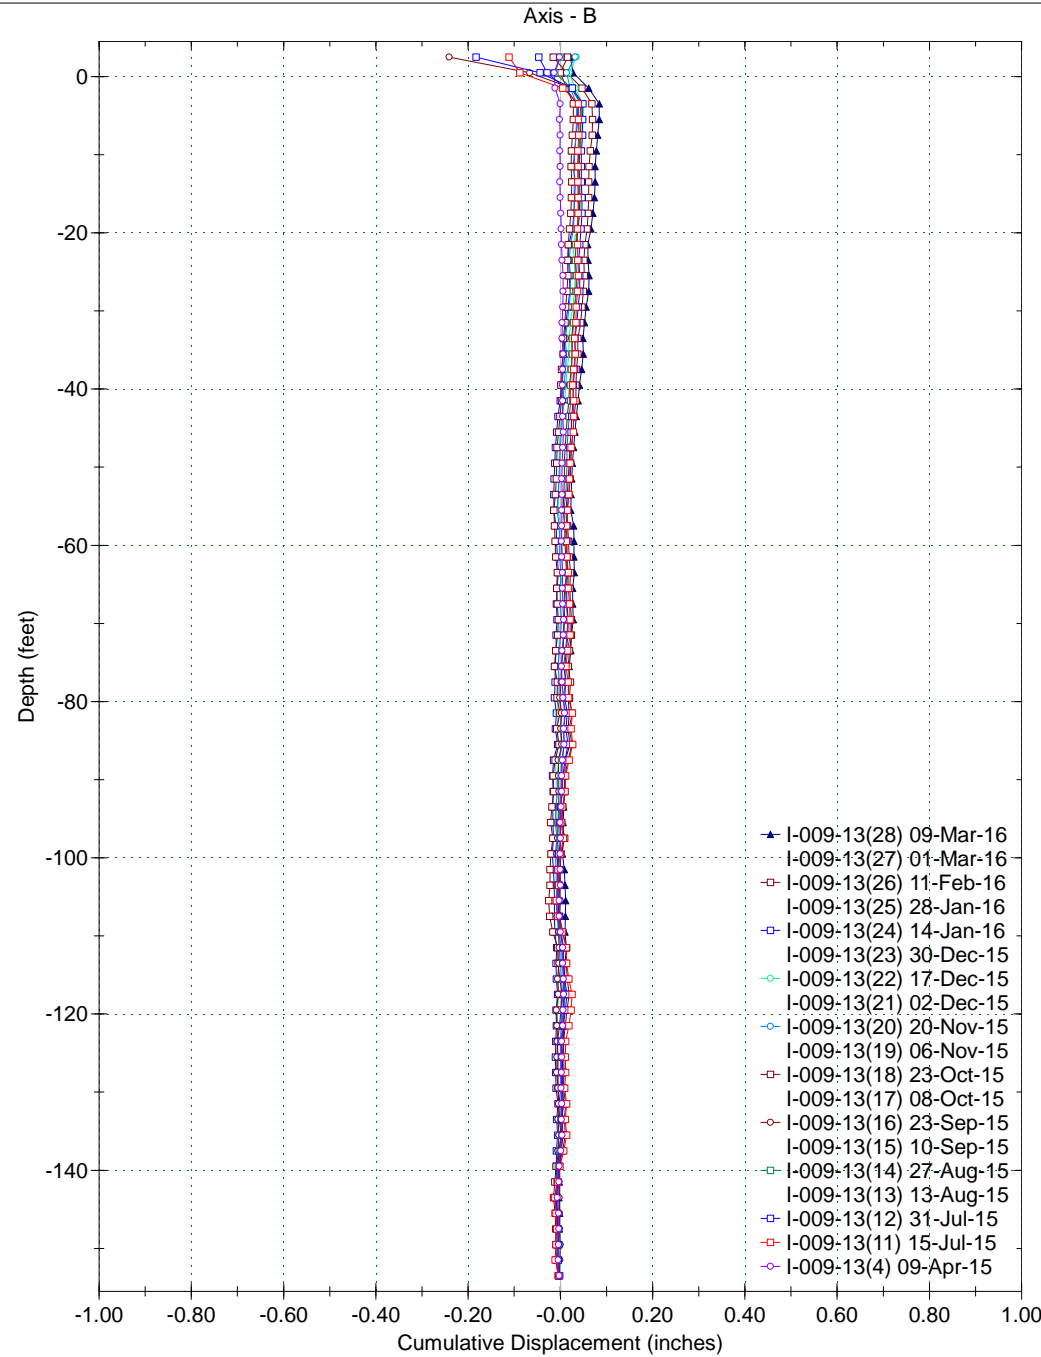
Borehole : I-009-13
Project : CUY-90-15-24
Location : Cleveland, Ohio
Northing :
Easting :
Collar :

I-009-13 – Inclinometer readings at this location indicate slight movement in the positive B-axis direction above 40 feet. No movement was indicated in the A-axis direction.

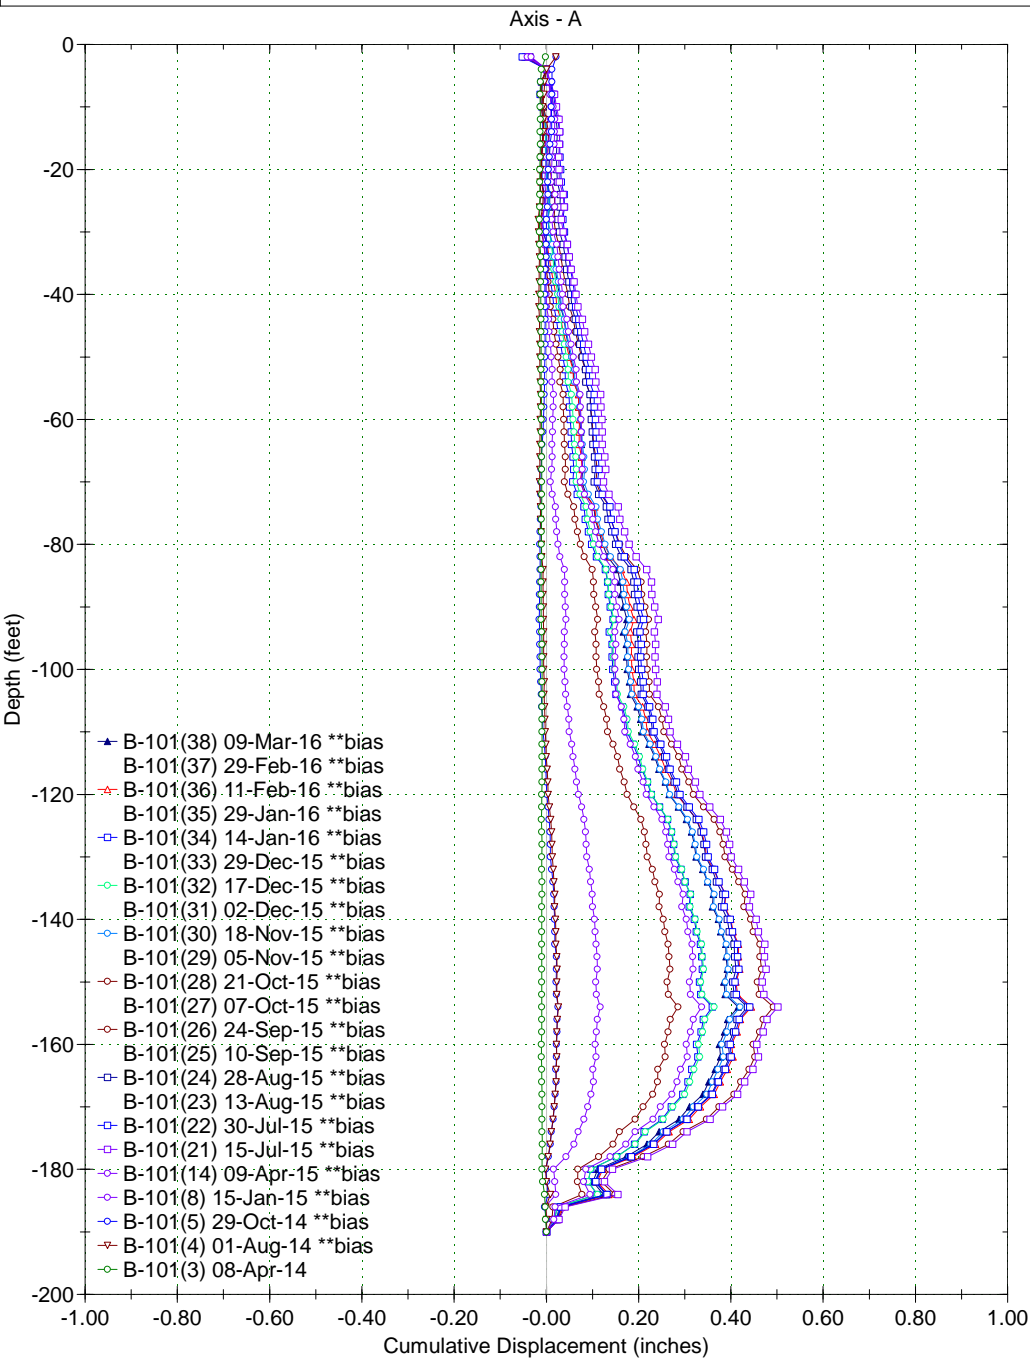
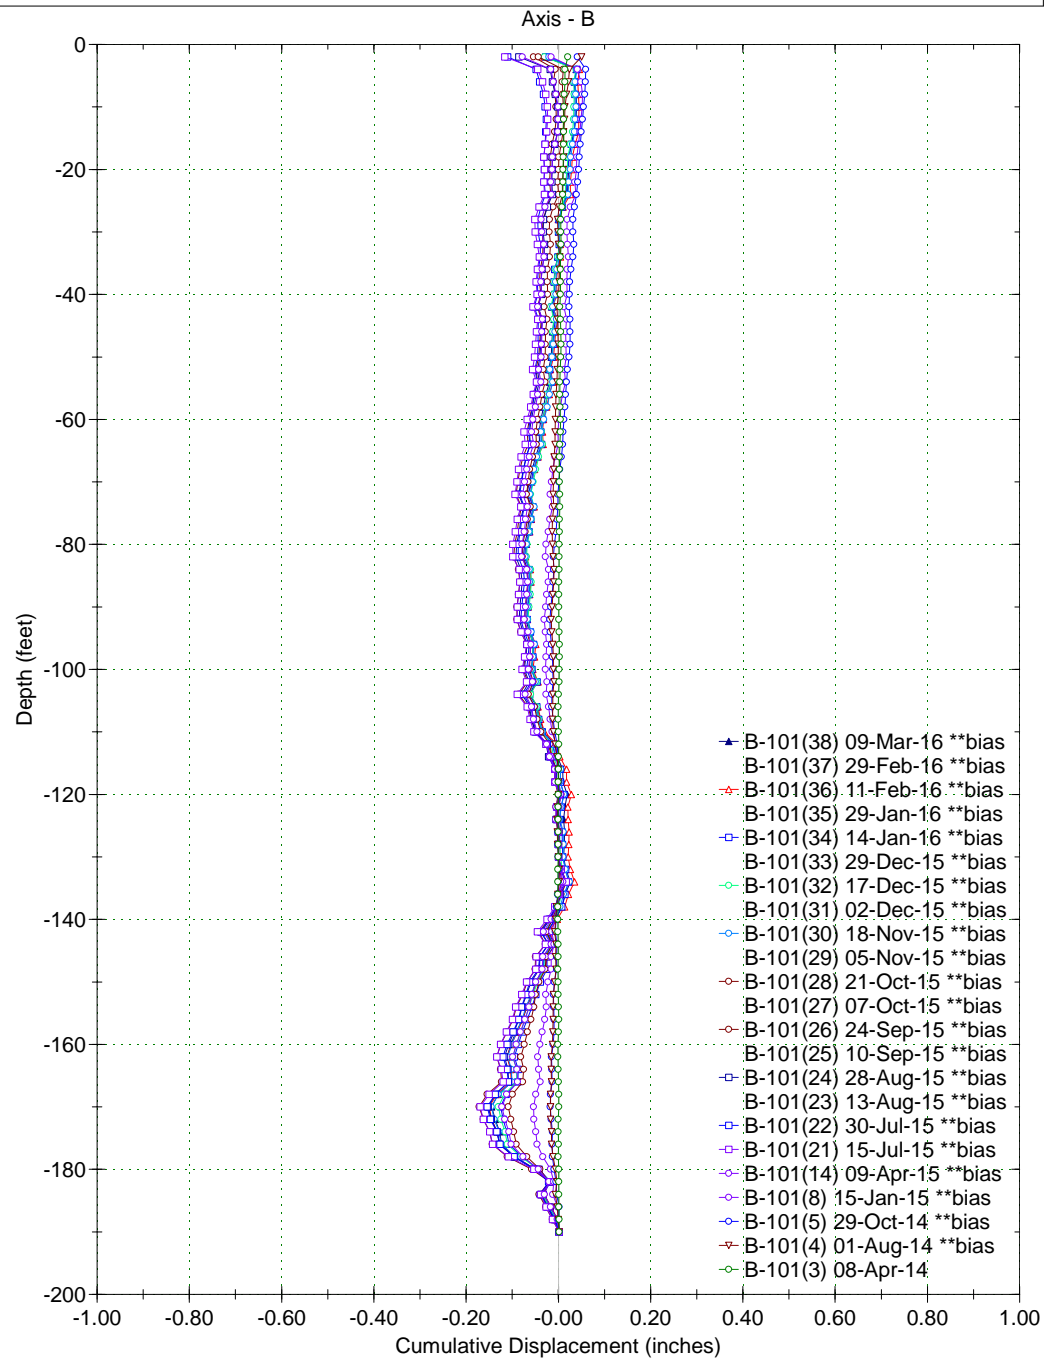
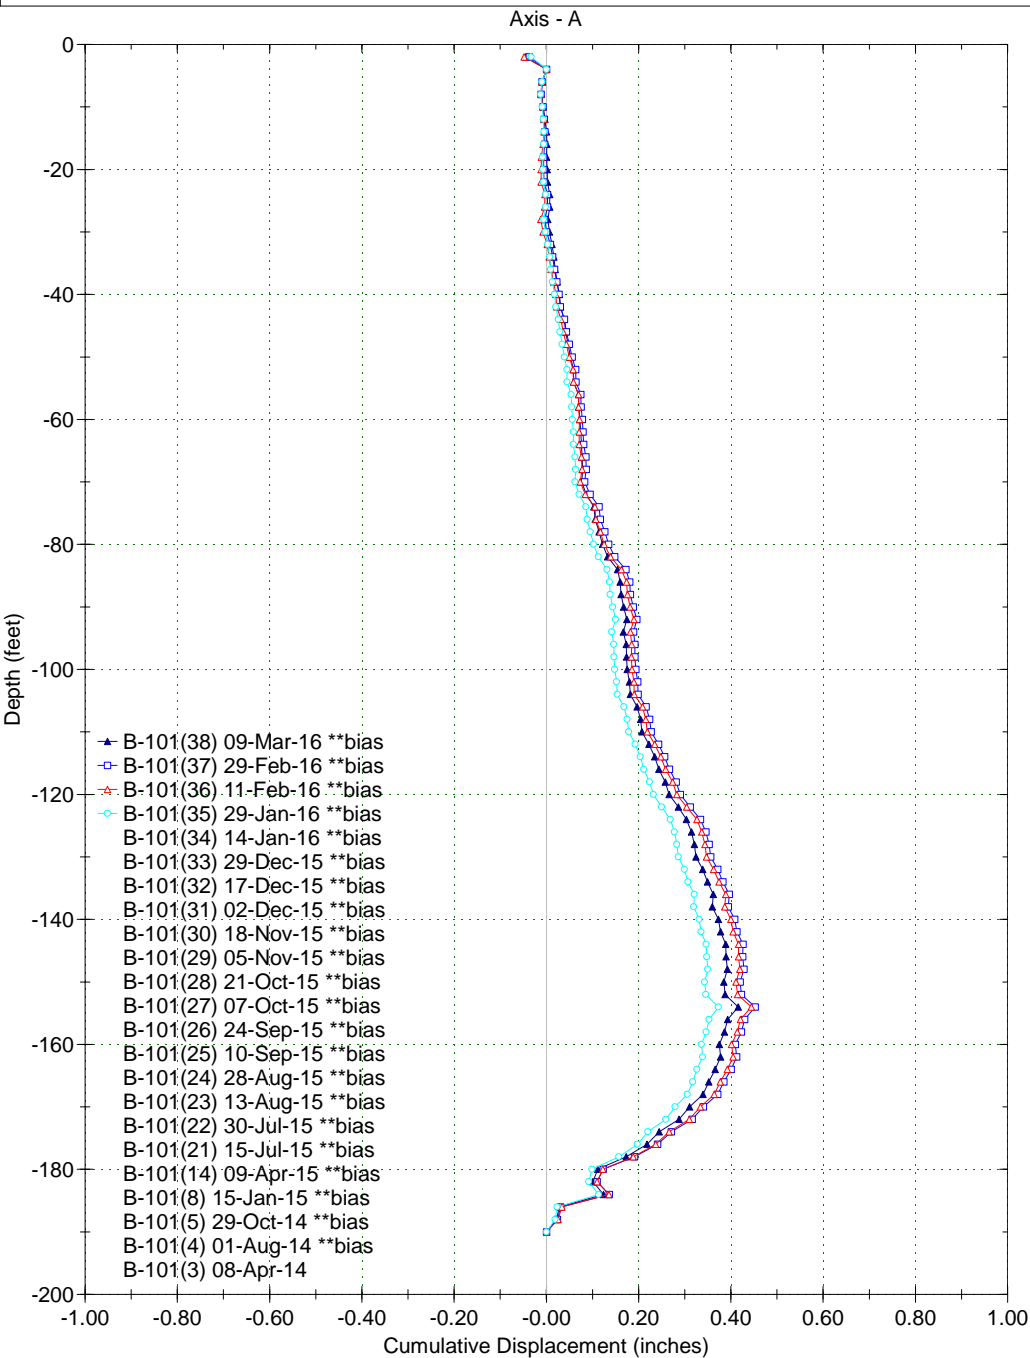
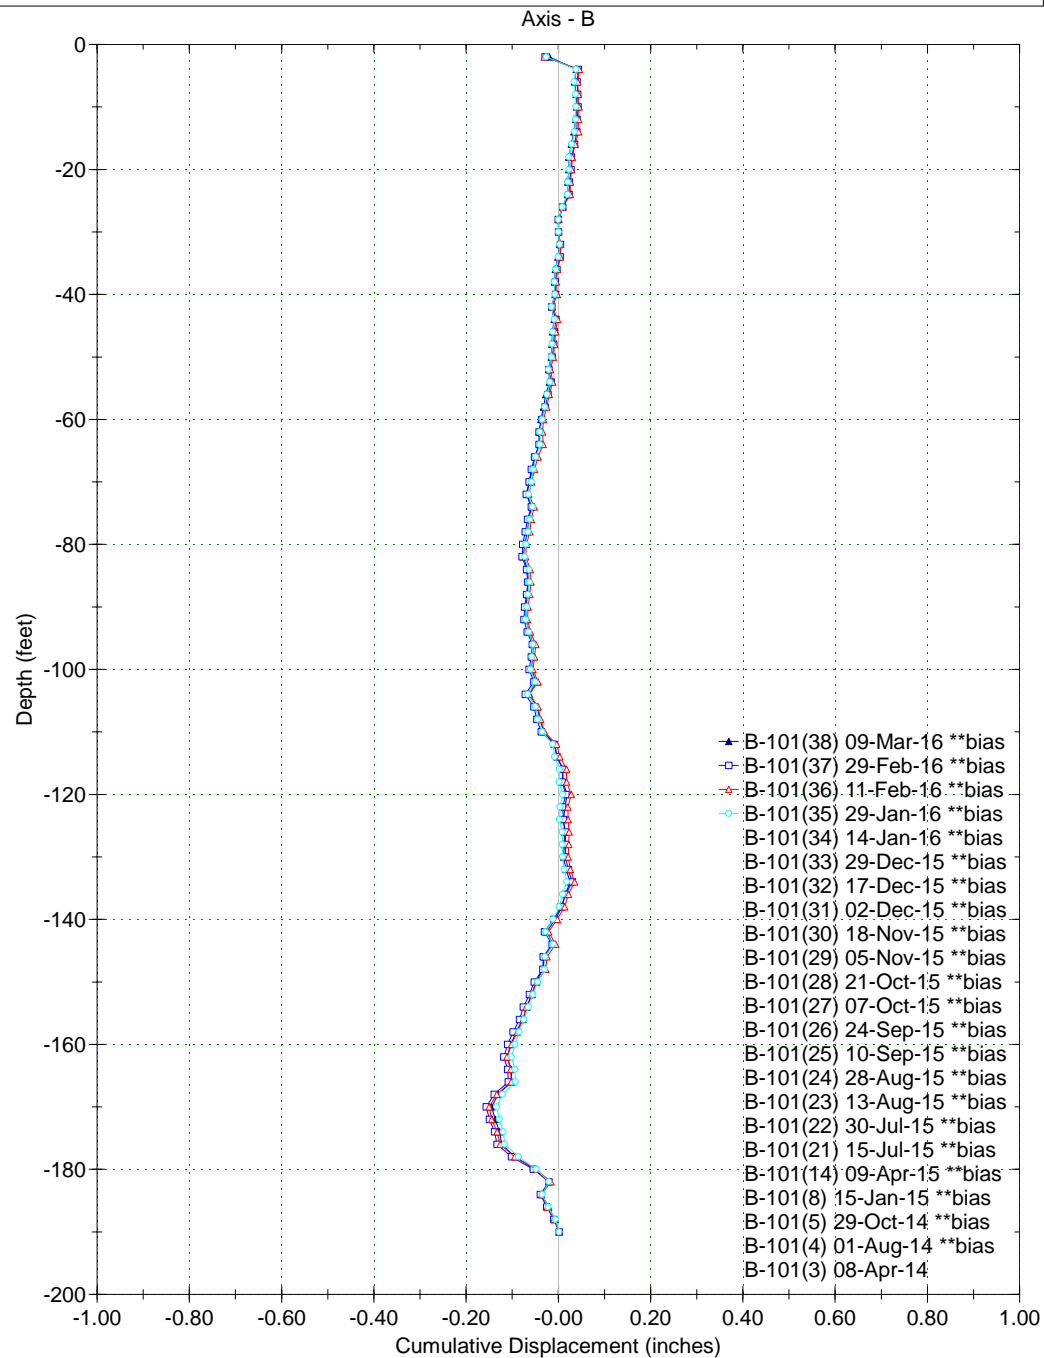
Borehole : B-101
 Project : CUY-90-15-24
 Location : Cleveland, Ohio
 Northing : Sta. 15+06.50
 Easting : 120.7' Rt of CL
 Collar :

B-101 – At this location, inclinometer readings indicate displacement in the negative A-axis direction between 80 and 180 feet. This is a reversal of the direction of movement seen over the past two months. No movement was indicated in the B-axis.

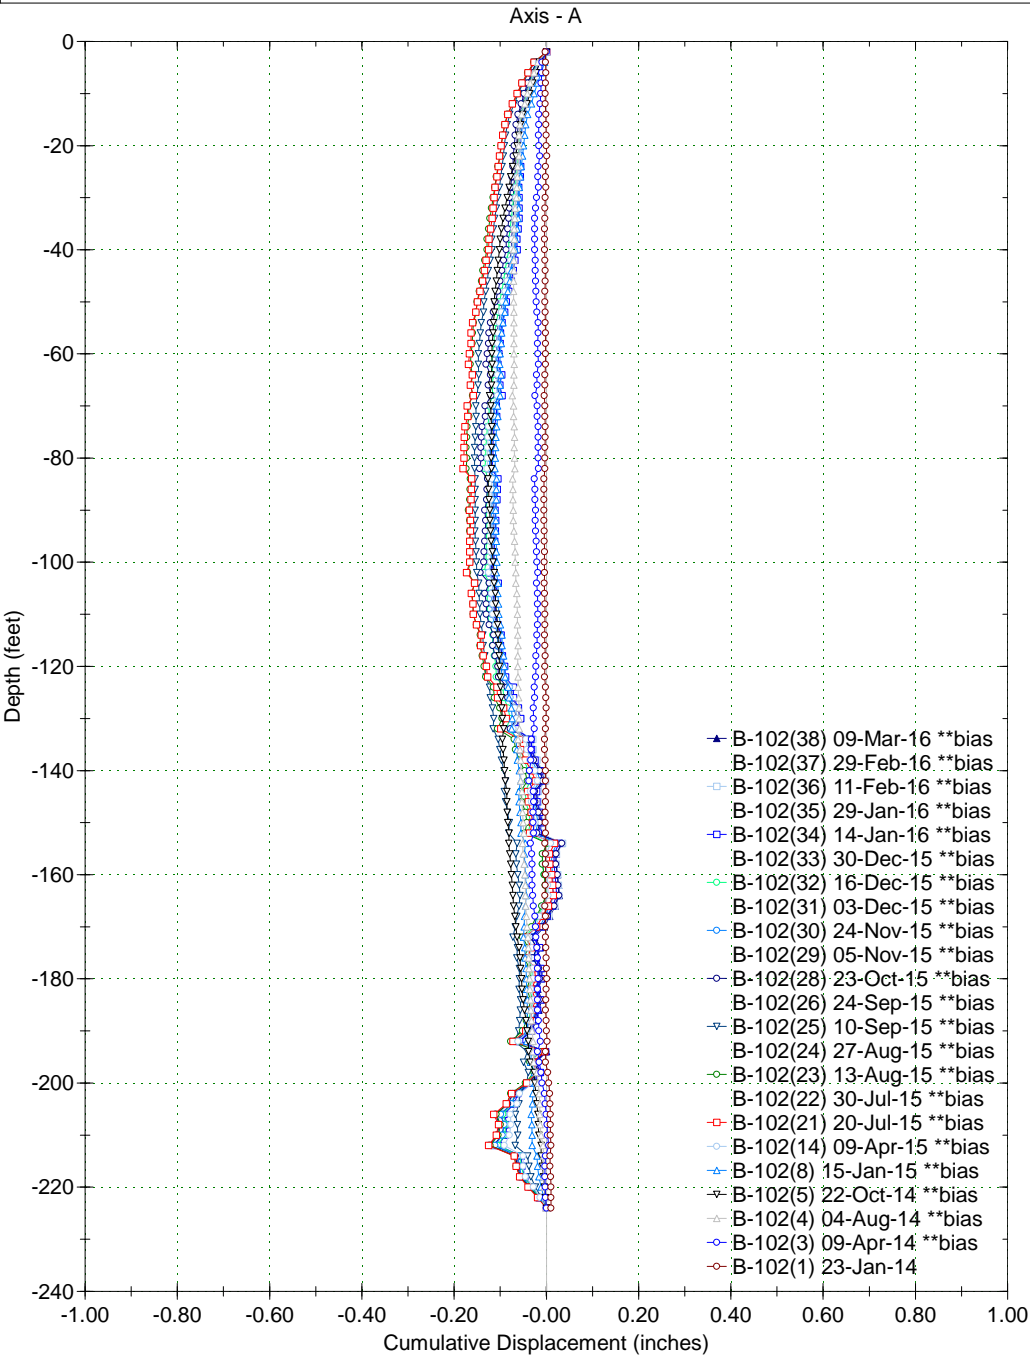
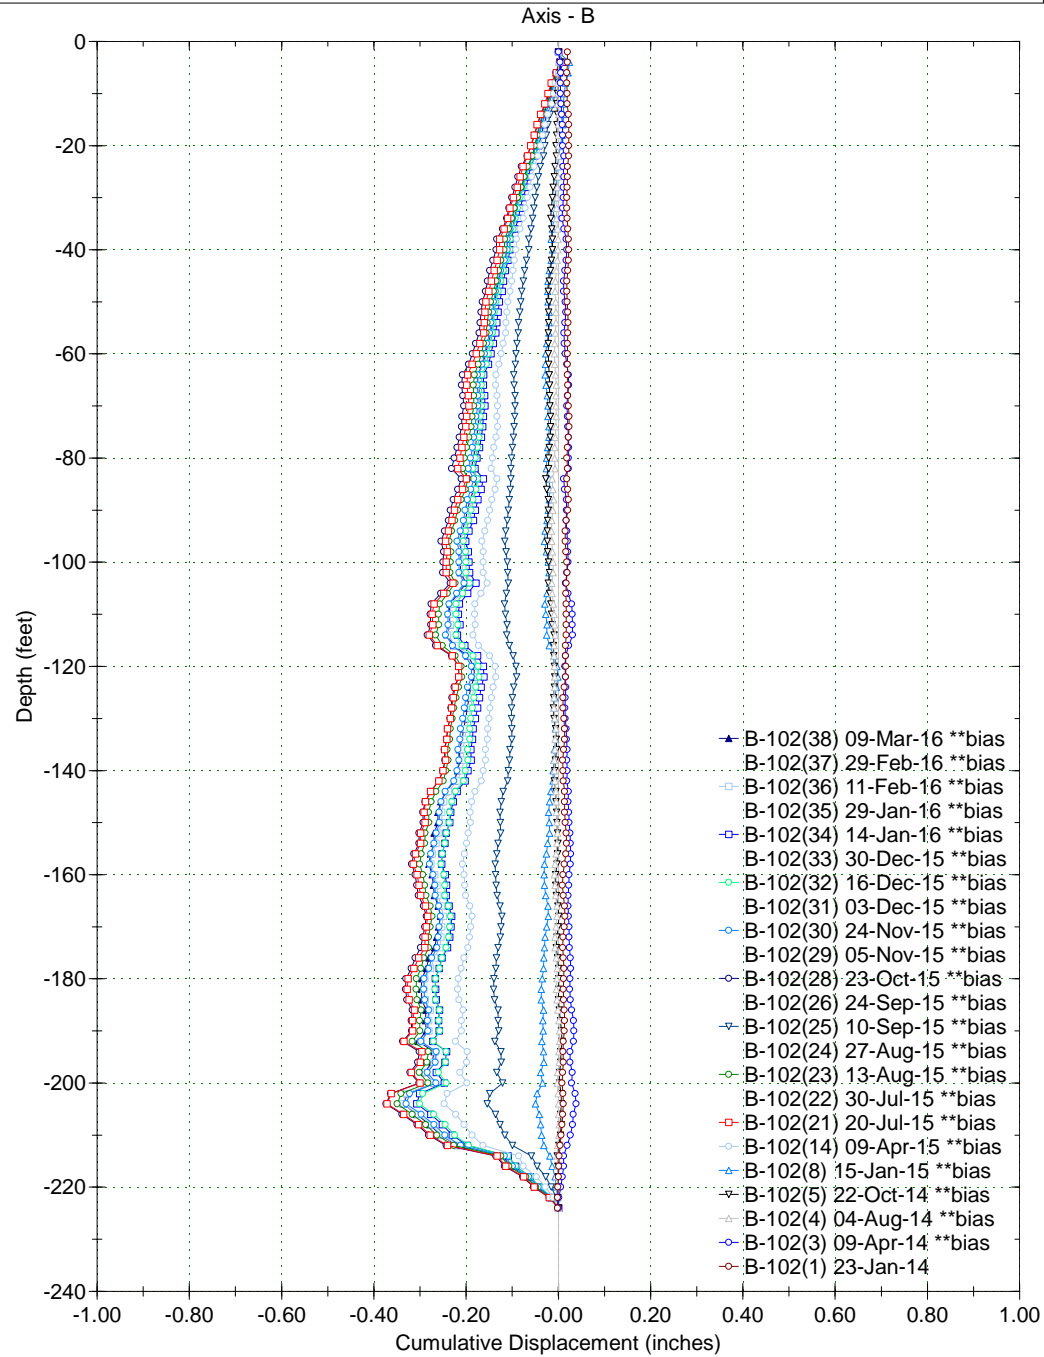
Borehole : B-102
 Project : CUY-90-15-24
 Location : Cleveland, Ohio
 Northing : Sta. 15+95.34
 Easting : 134.7' Rt of CL
 Collar :

Inclinometer readings at I-001-13, I-002-13, B-102, B-05-04, B-05-A-11, P-9N, and TGR I-4 showed virtually no movement this two-week period. Displacements at the top of some slope tubes is due to flexing of the tube when readings are taken because some of the protective covers are only temporarily set in place until earthwork near these installations is completed.

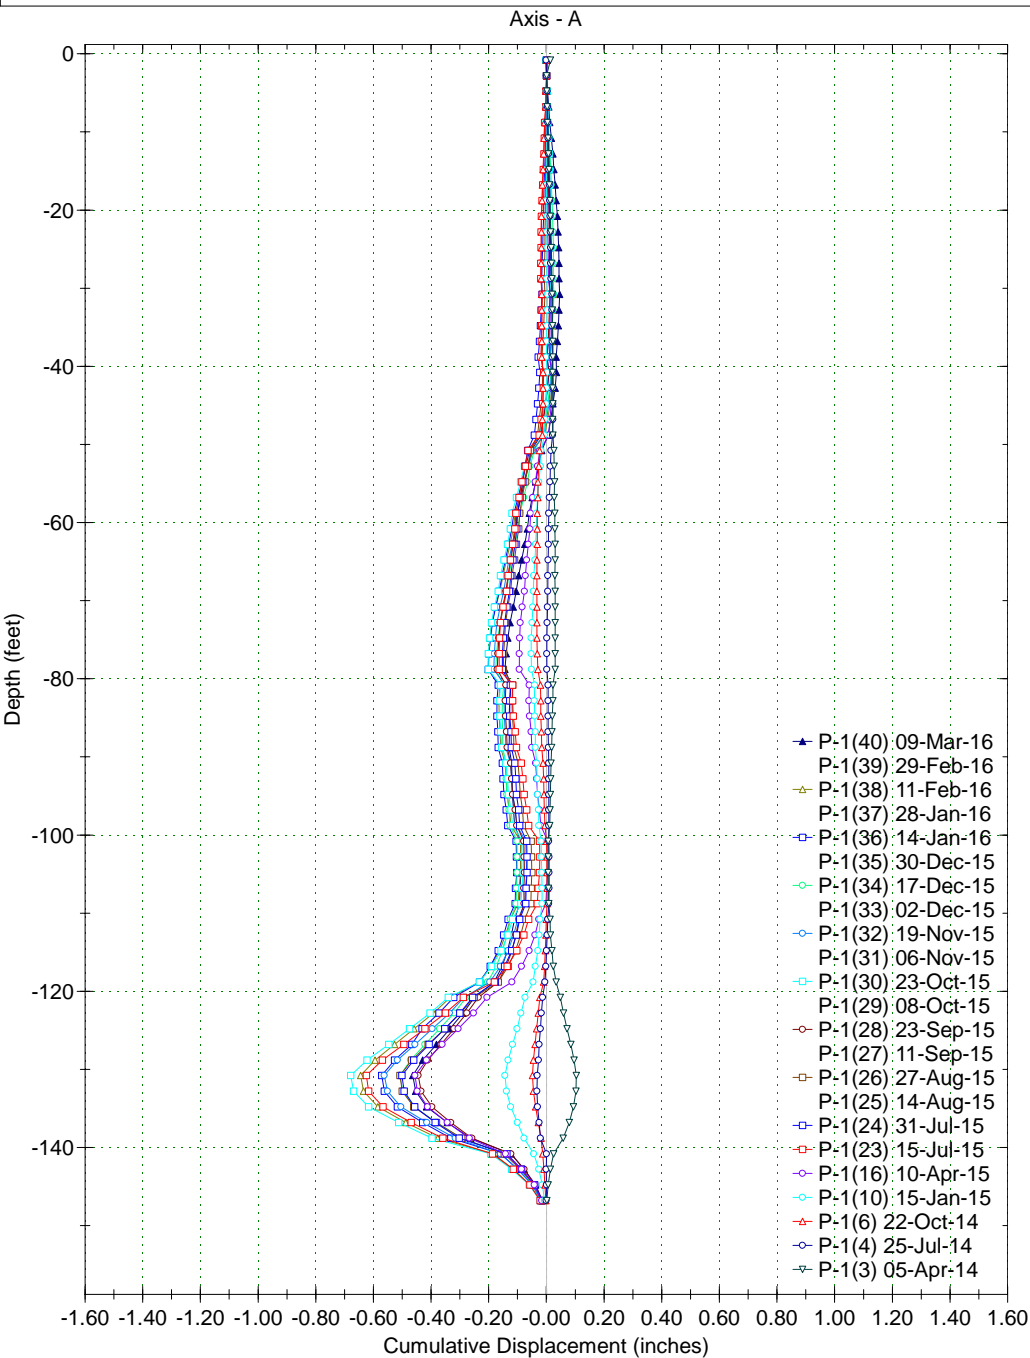
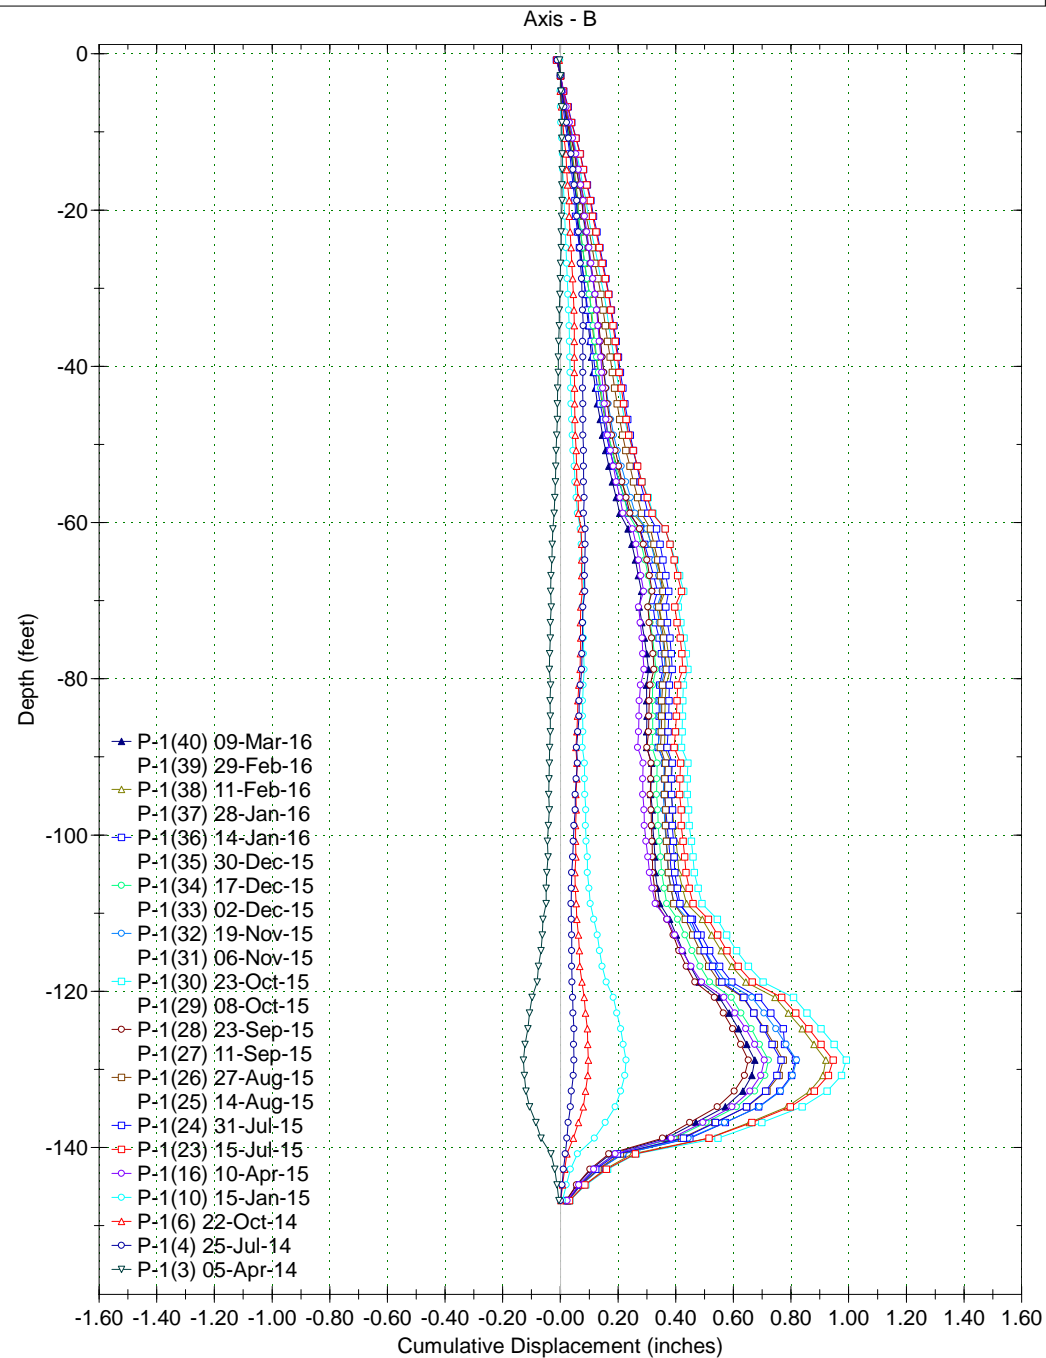
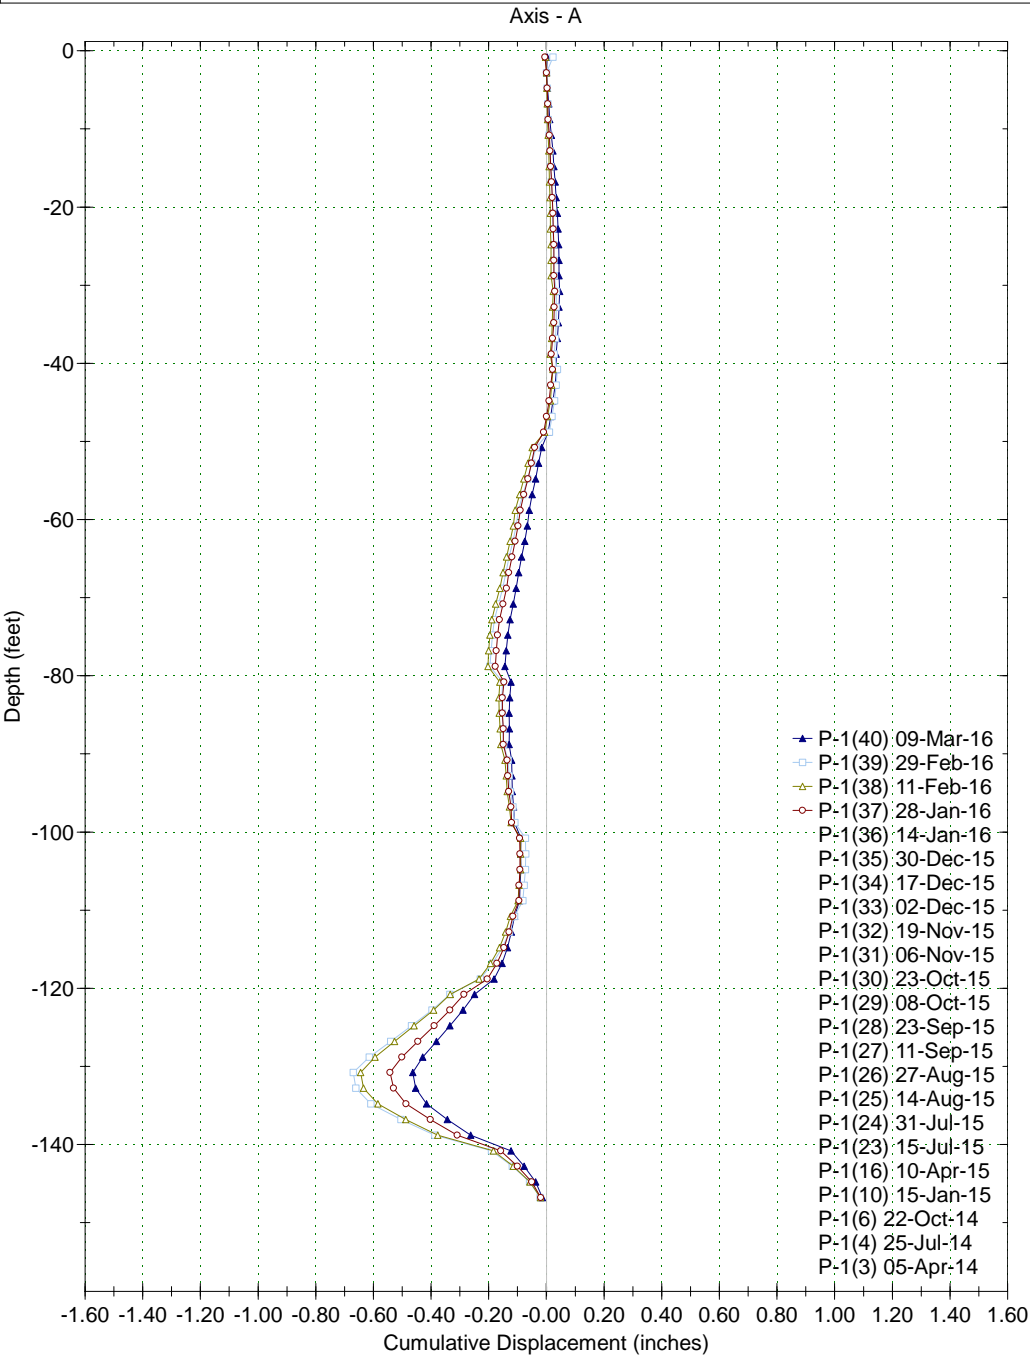
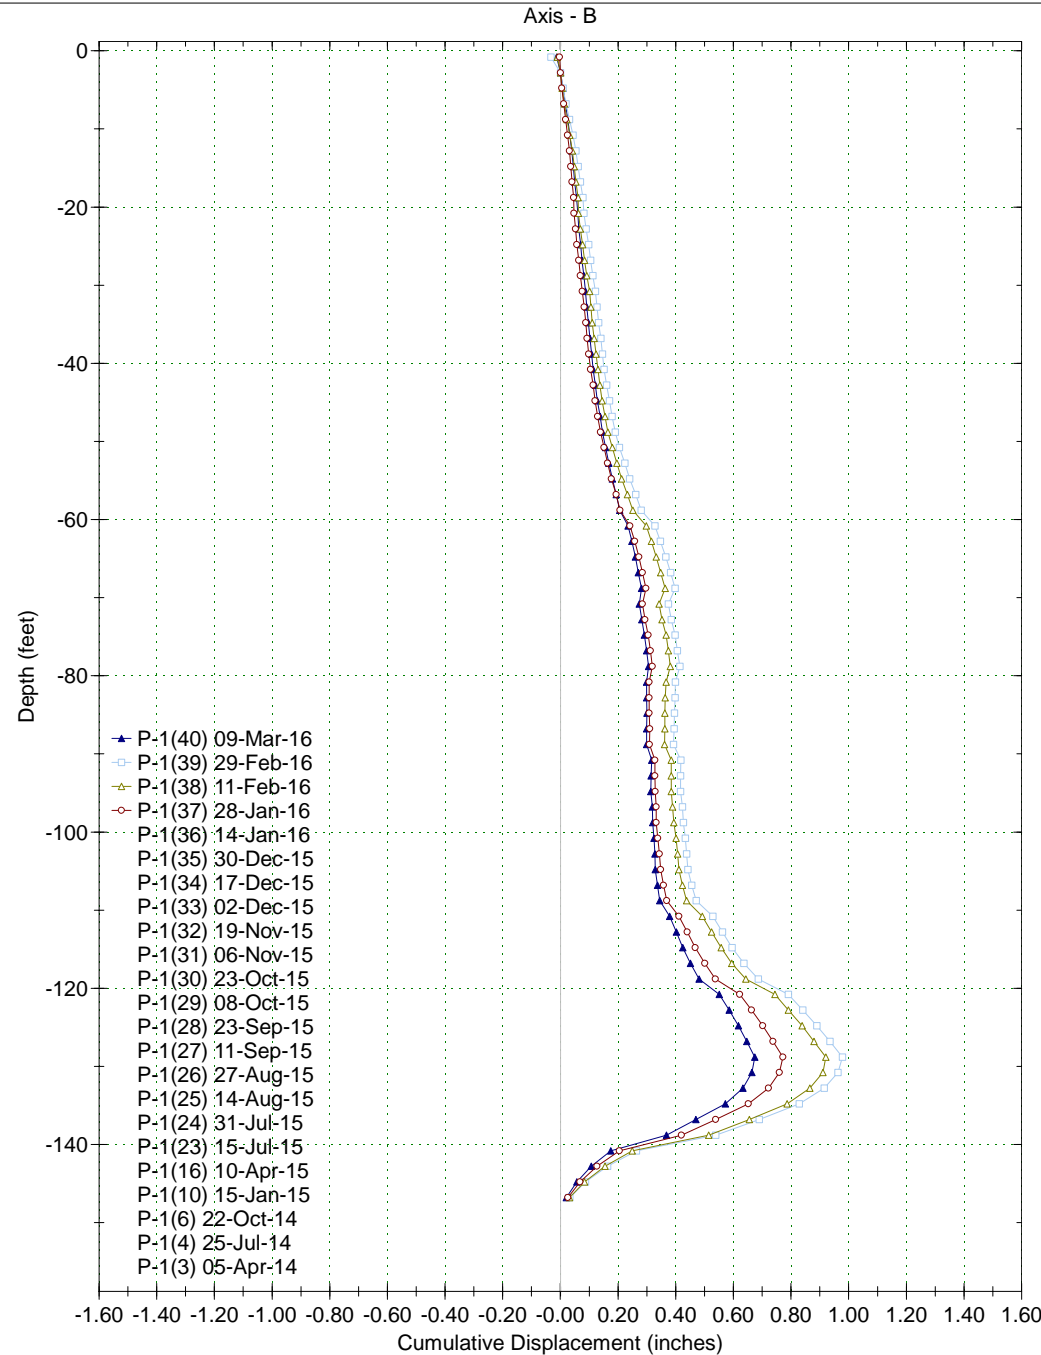
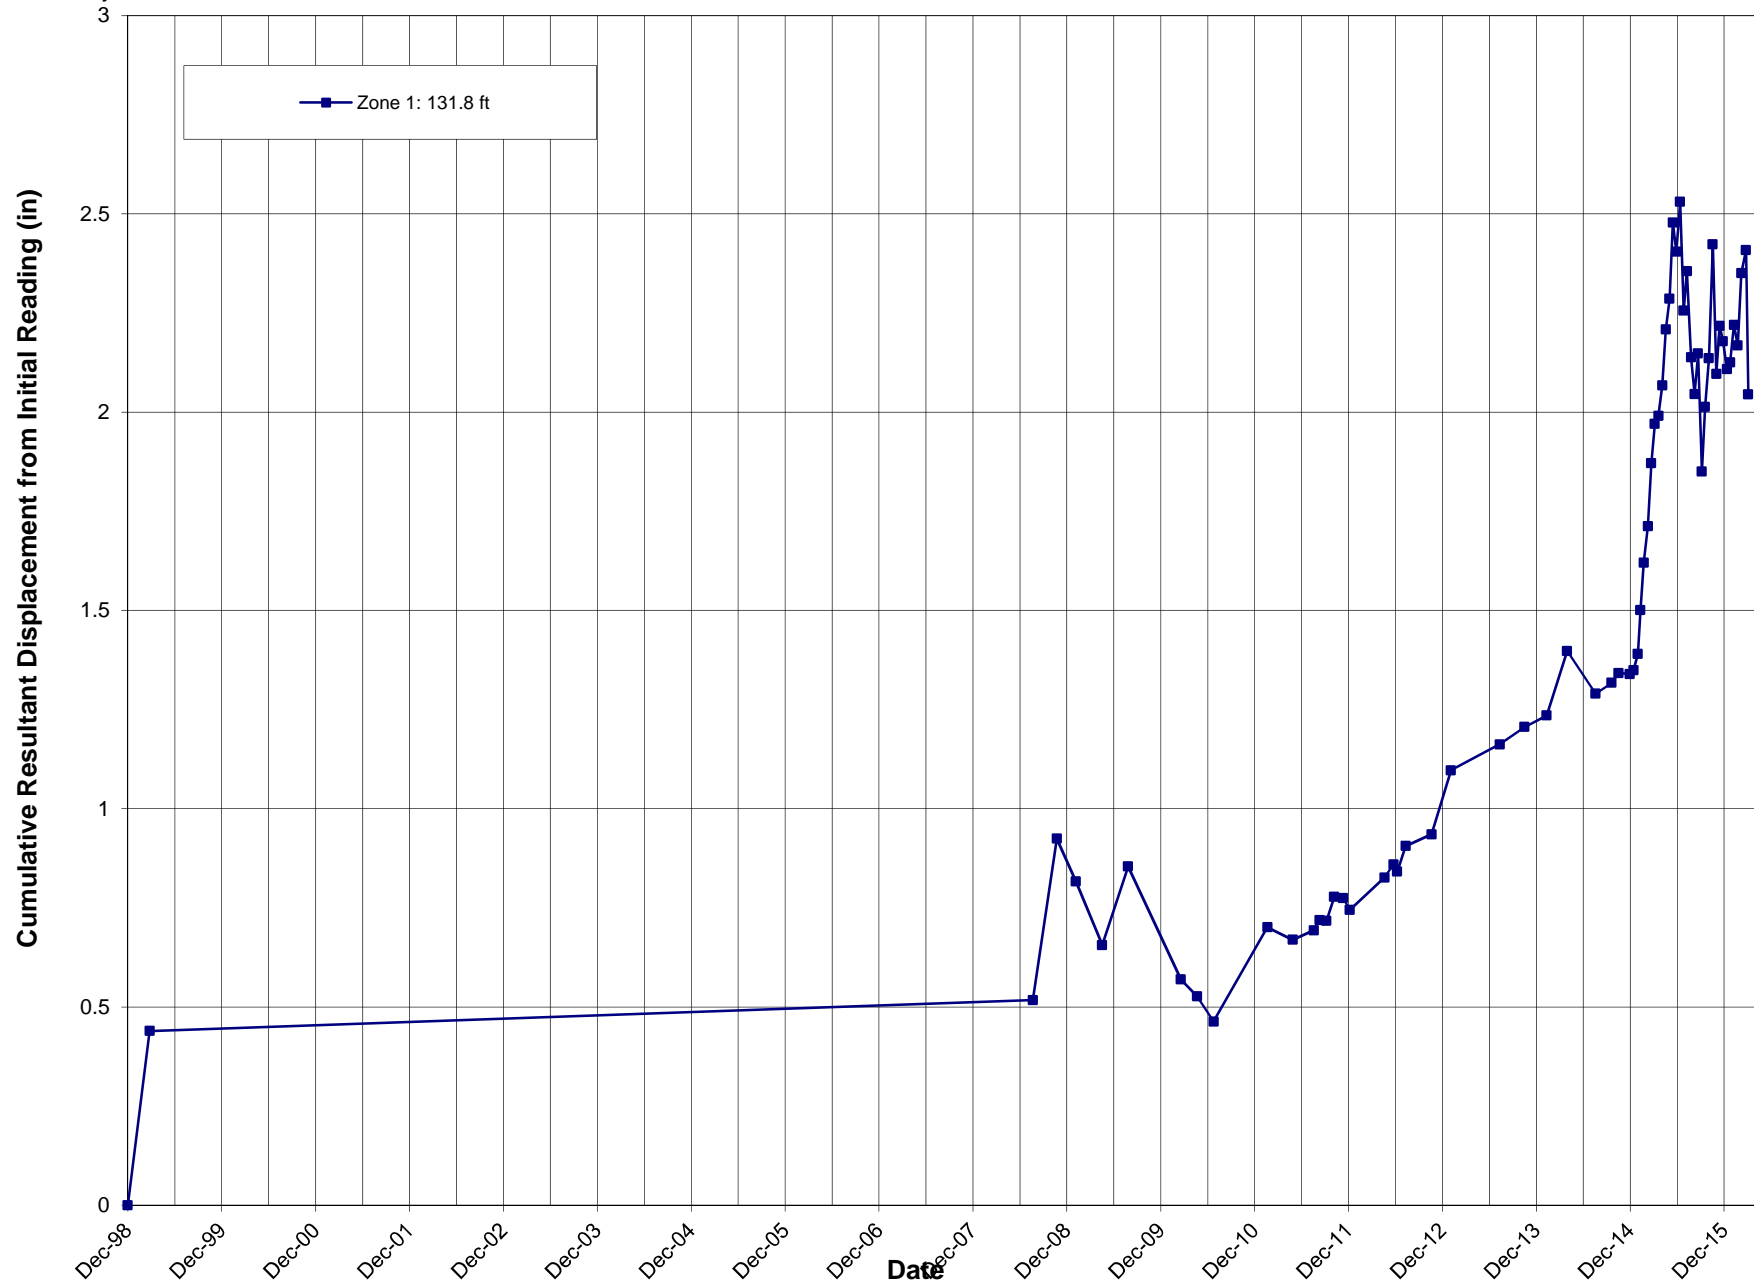
Borehole : P-1
 Project : CUY-90-15-24
 Location : Cleveland, Ohio
 Northing :
 Easting :
 Collar :

P-1 – Inclinometer readings for this location indicate movement in the positive A-axis direction and negative B-axis direction between about 120 and 140 feet. This is a reversal of the direction of movement observed over the past month. The cumulative resultant displacement zone plot at 132 feet indicates a decrease of about 0.4 inches.
