May 31, 2016

Re: May 19, 2016 Bi-Weekly Readings
CUY-90-15.24 Slope Monitoring
PID 96504
SME Project No. 069032.00

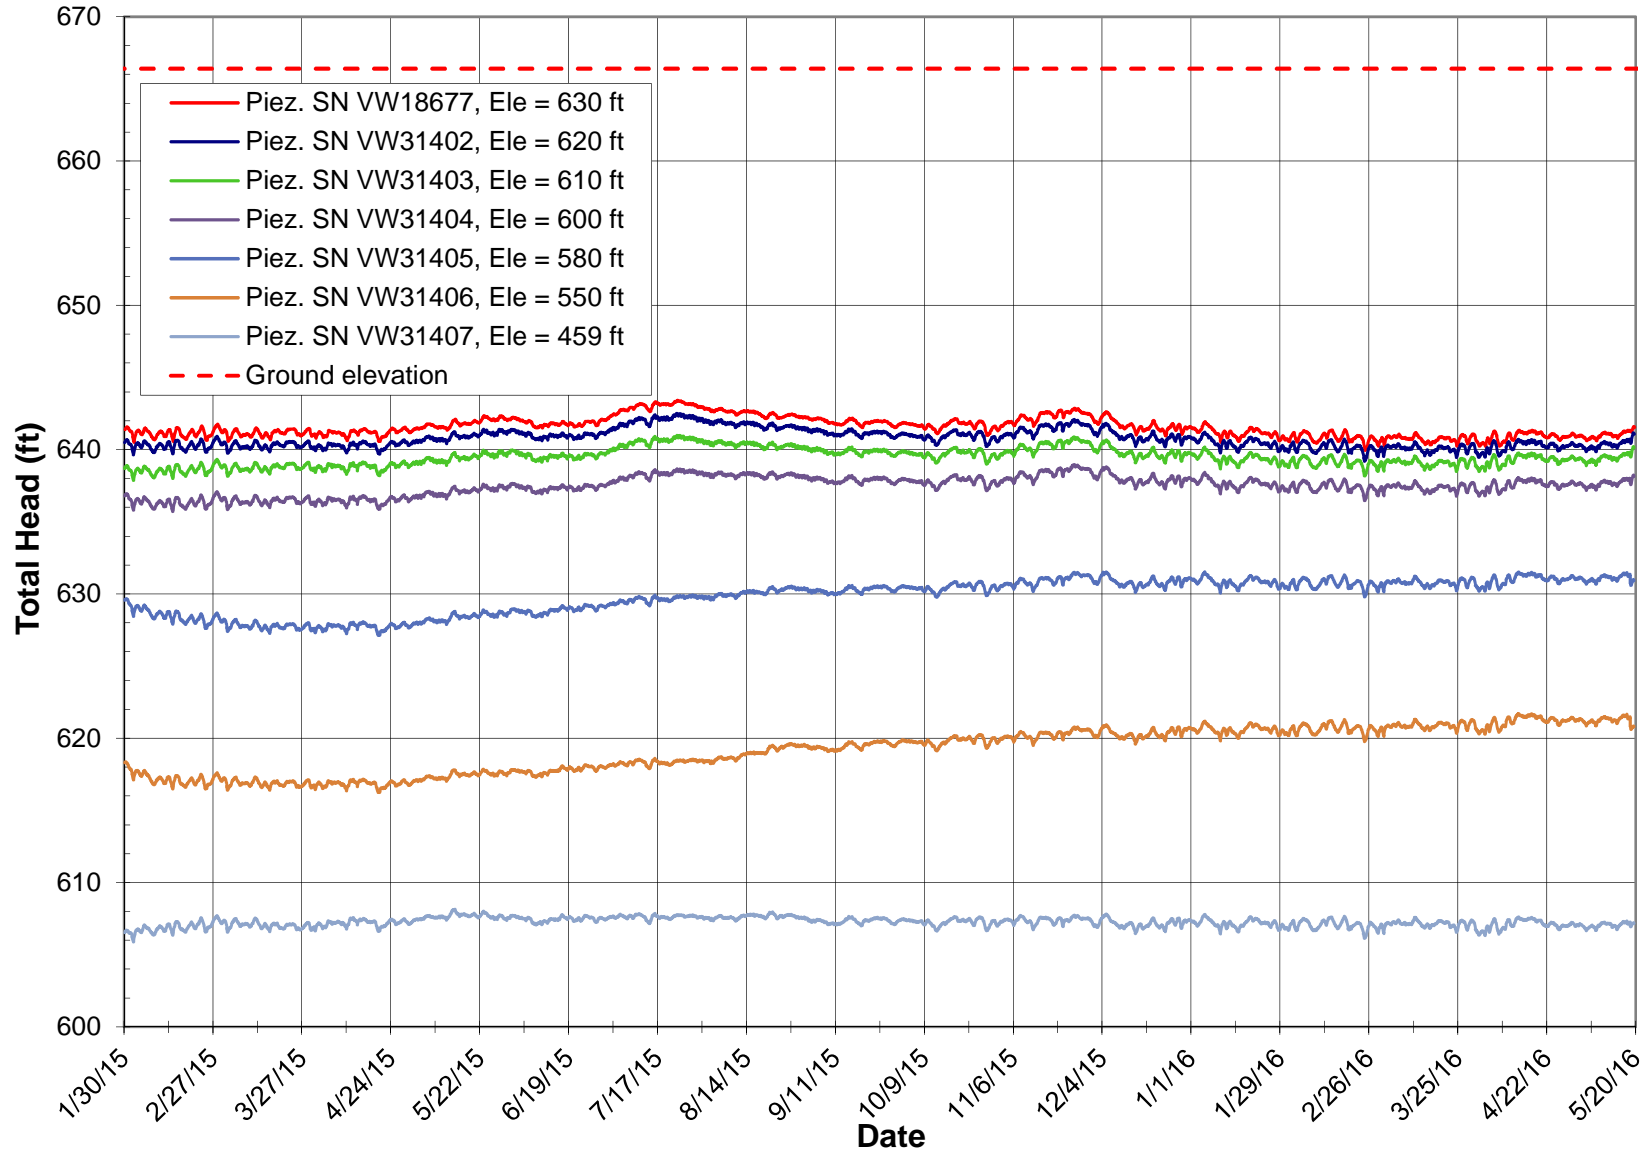
P-001-13 VW Piezometer Readings

P-001-13 – At this location, pore pressure readings indicate an increase in total head of about 1 foot in the four shallowest piezometers over the past two weeks. The three deep piezometers showed virtually no change.

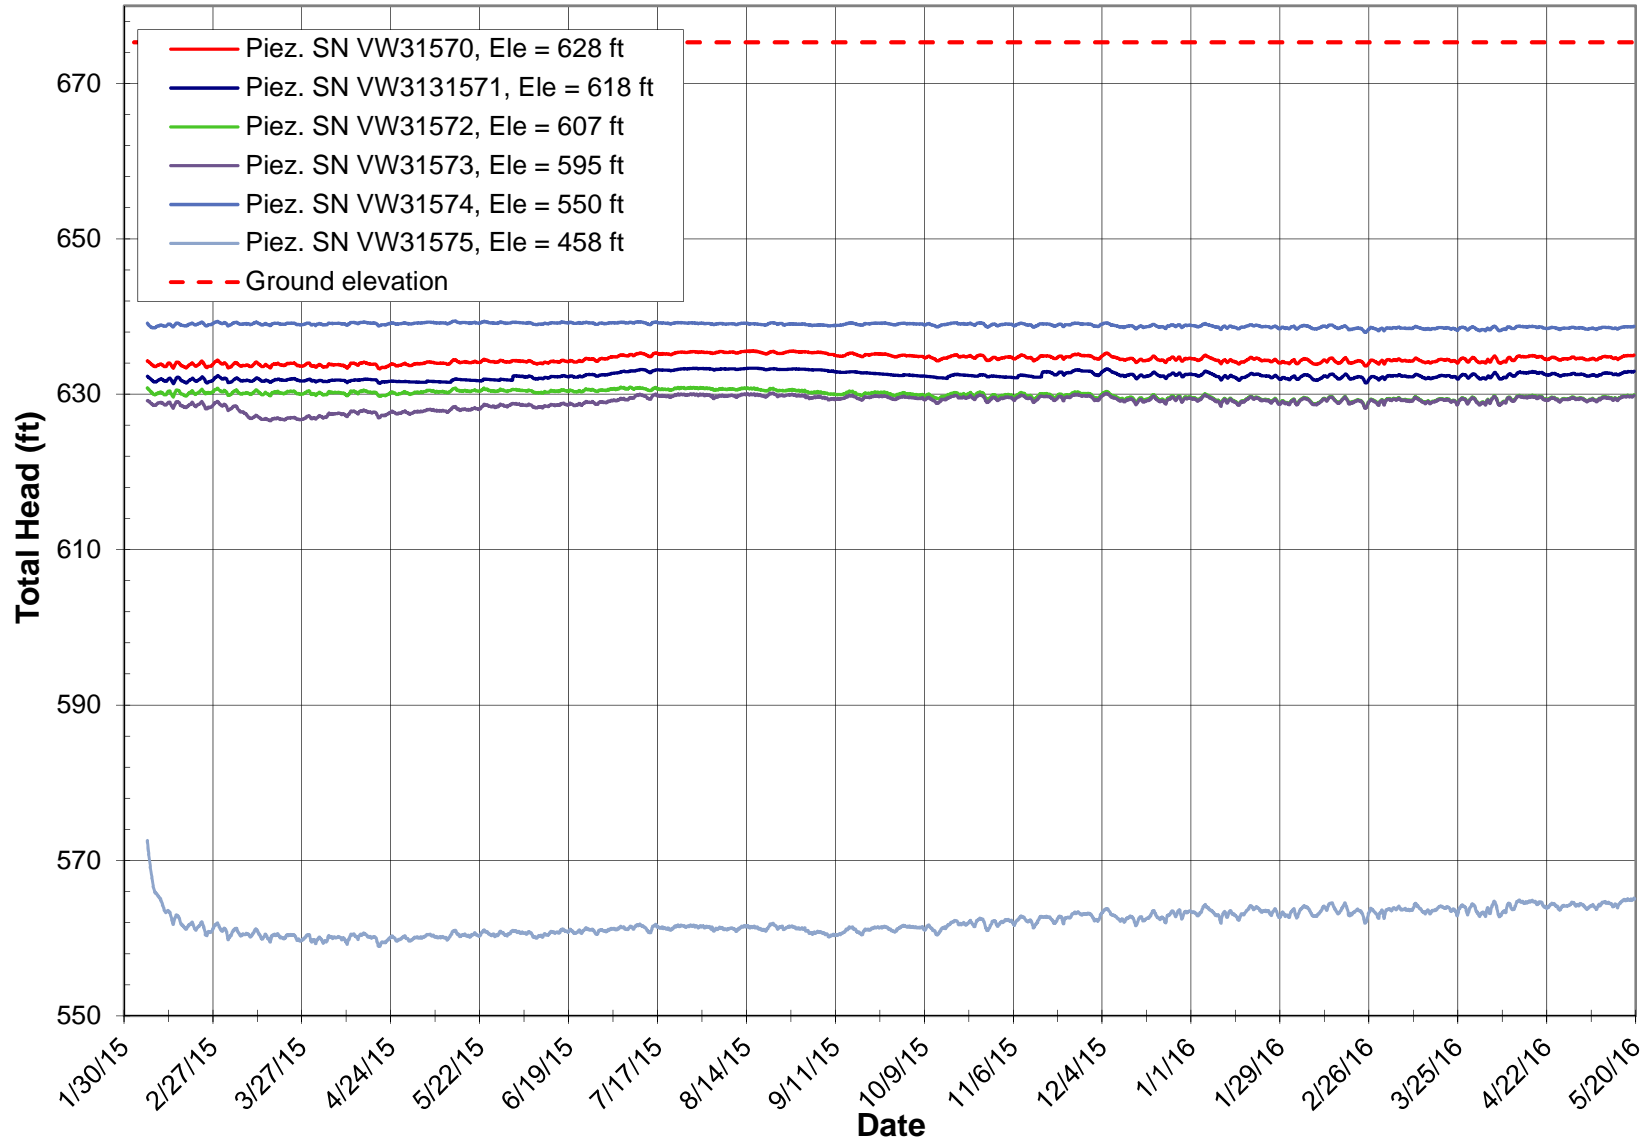
P-002-13 VW Piezometer Readings

P-002-13 – Data for this location shows no change this past two weeks.

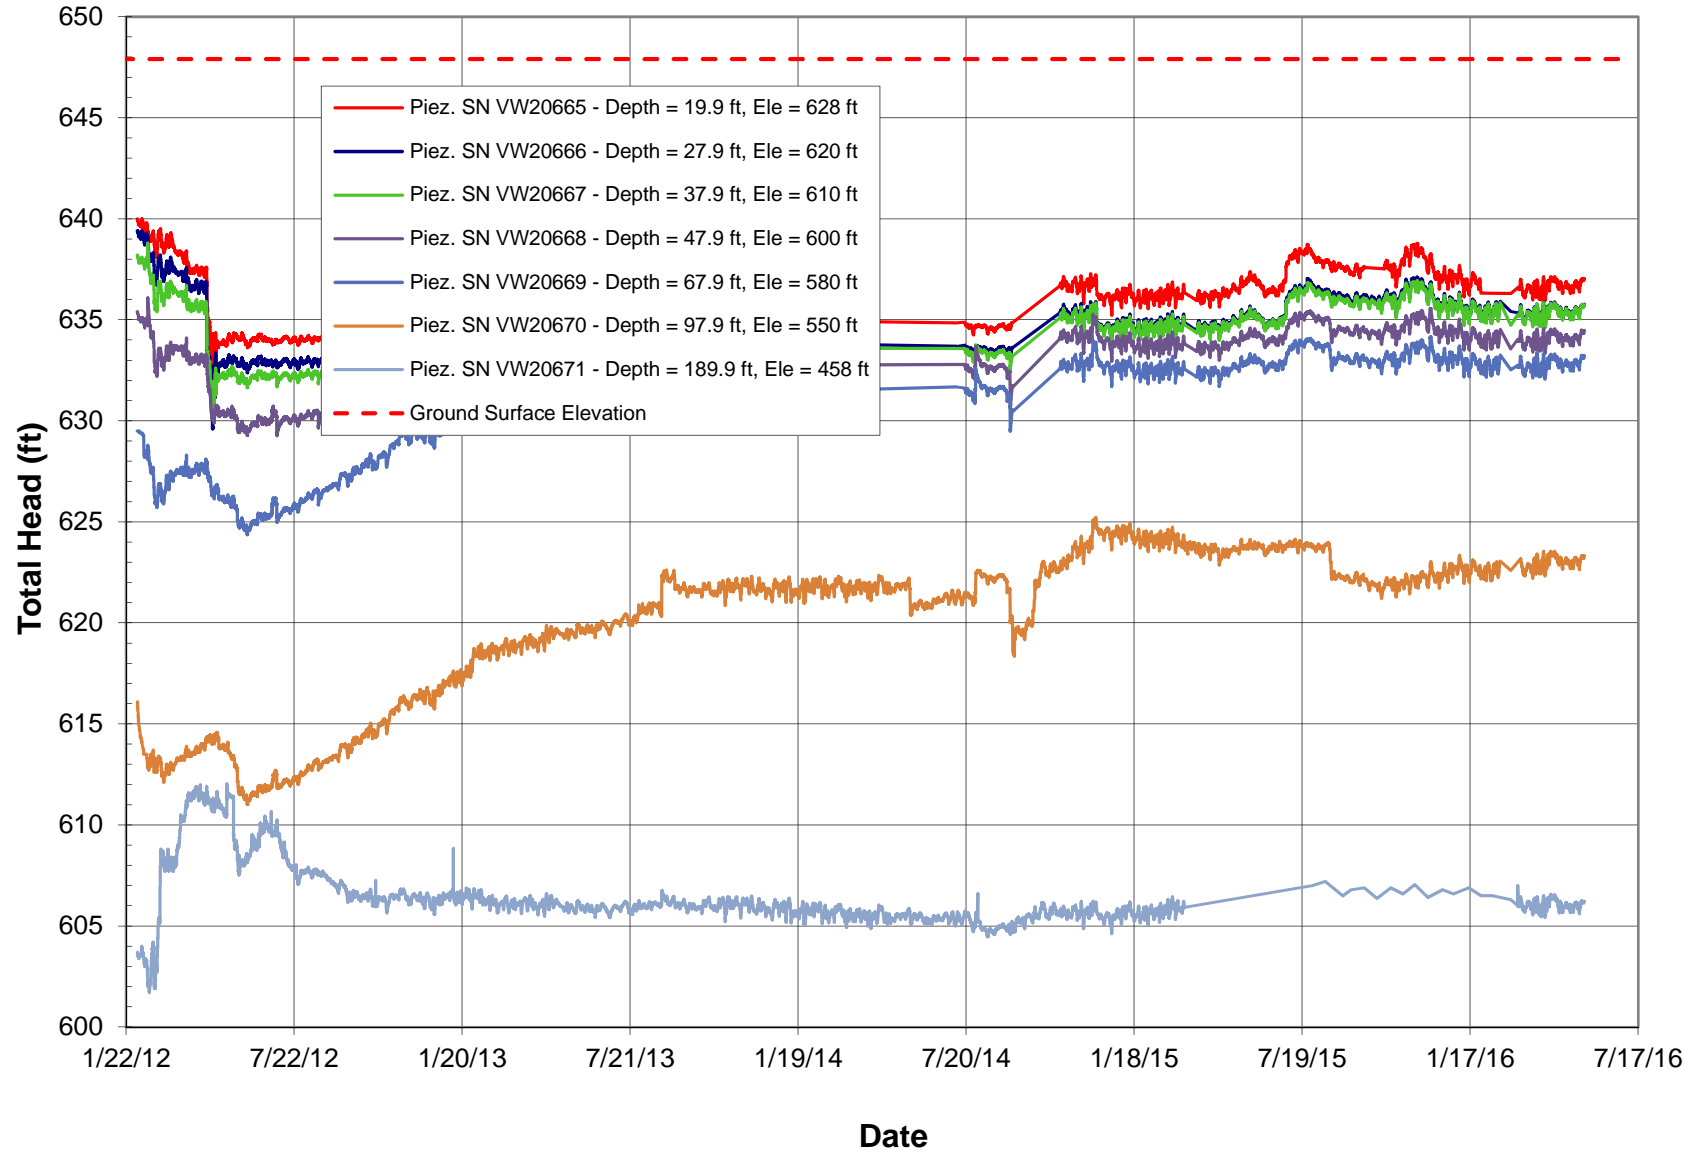
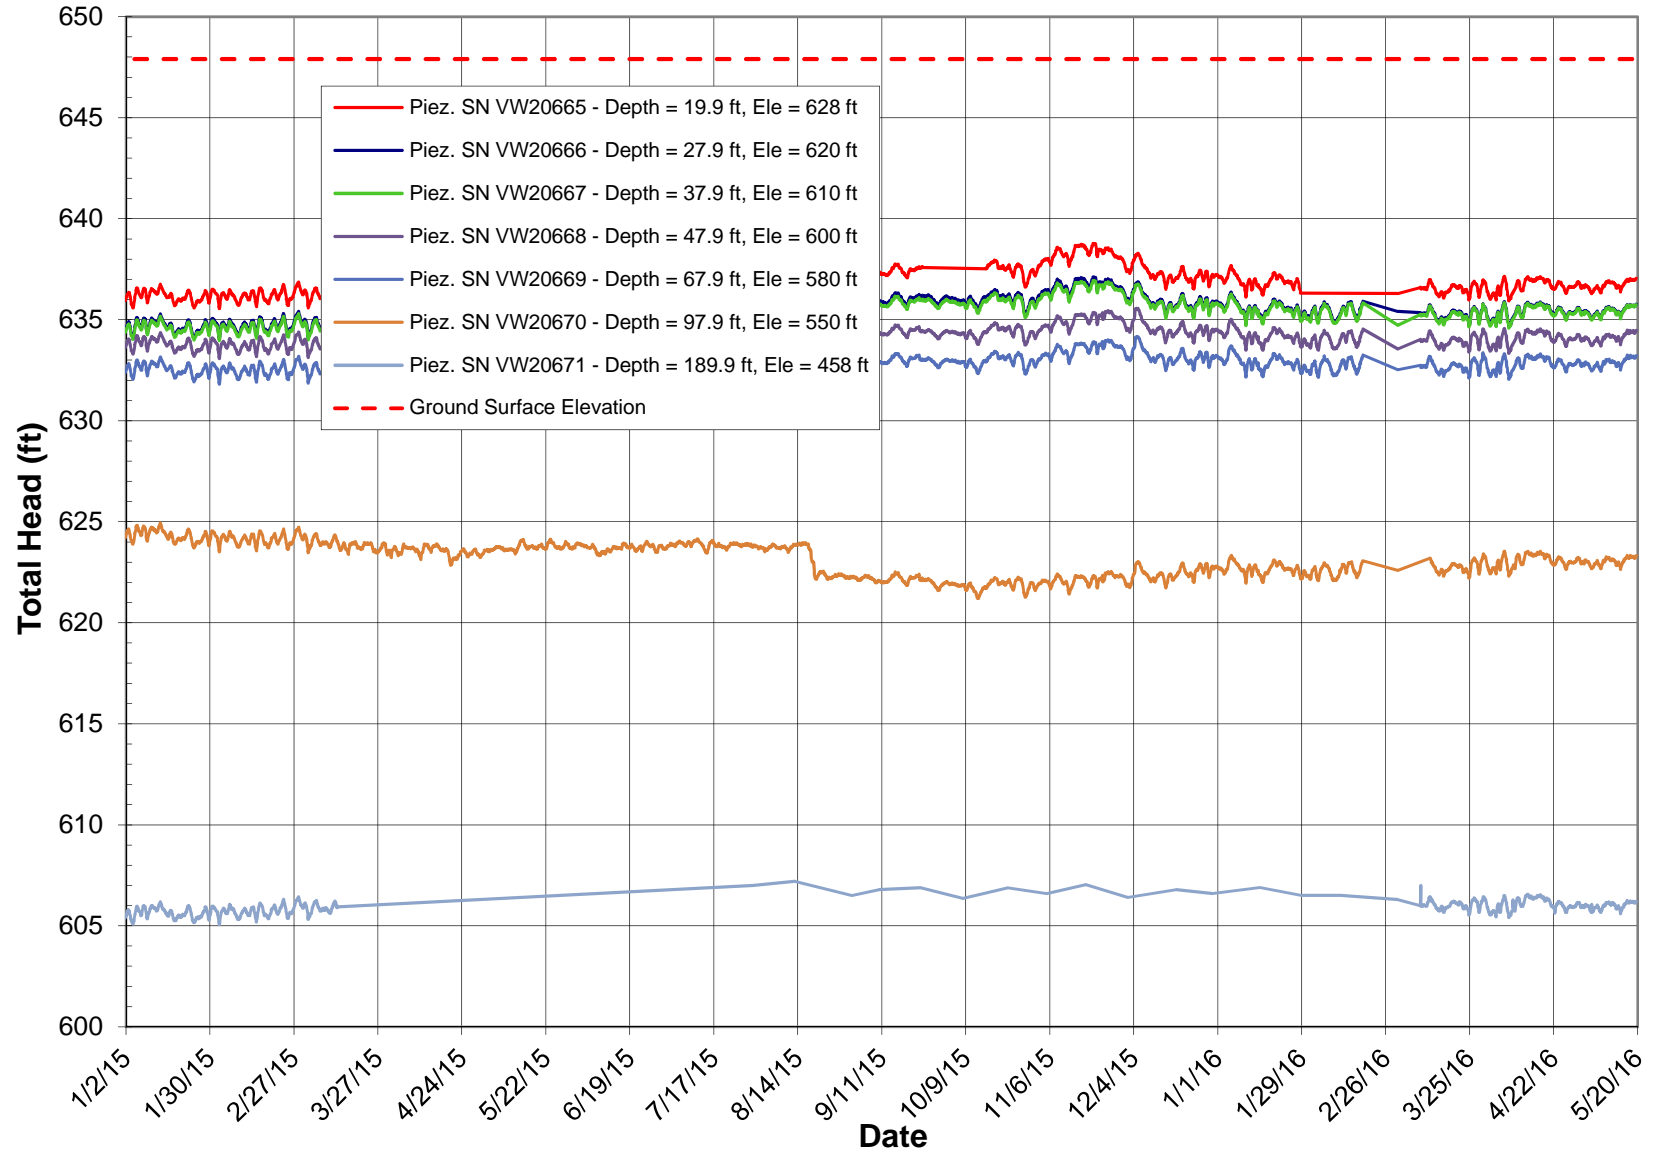
P-003-10 VW Piezometer Readings

P-003-10, P-009-13, B-105-A, B-05-A-03 – Pore pressure readings at these locations indicate total head increases of 0.5 feet or less in all piezometers this two-week period.

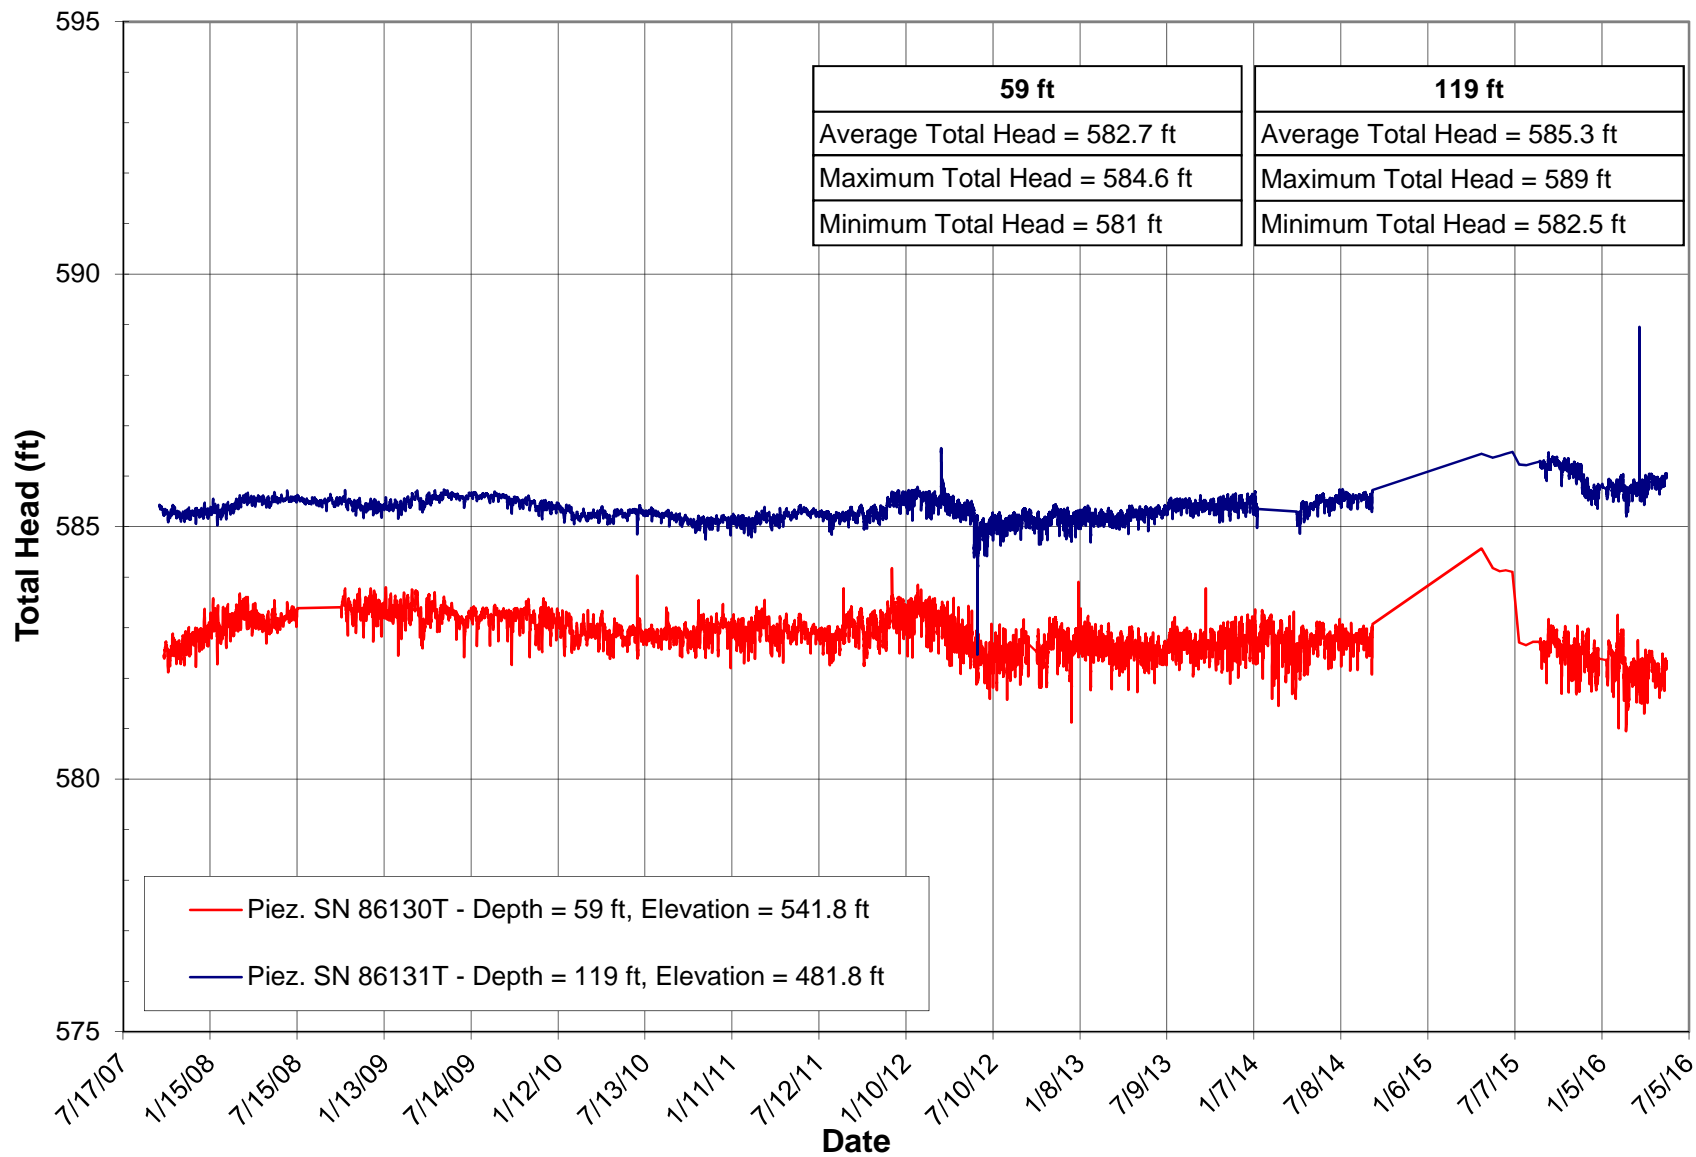
B-05-04 VW Piezometer Readings

B-05-04 – Pore pressure readings at this location indicate an increase of about 0.5 feet in the shallow piezometer and virtually no change in the deep piezometer.

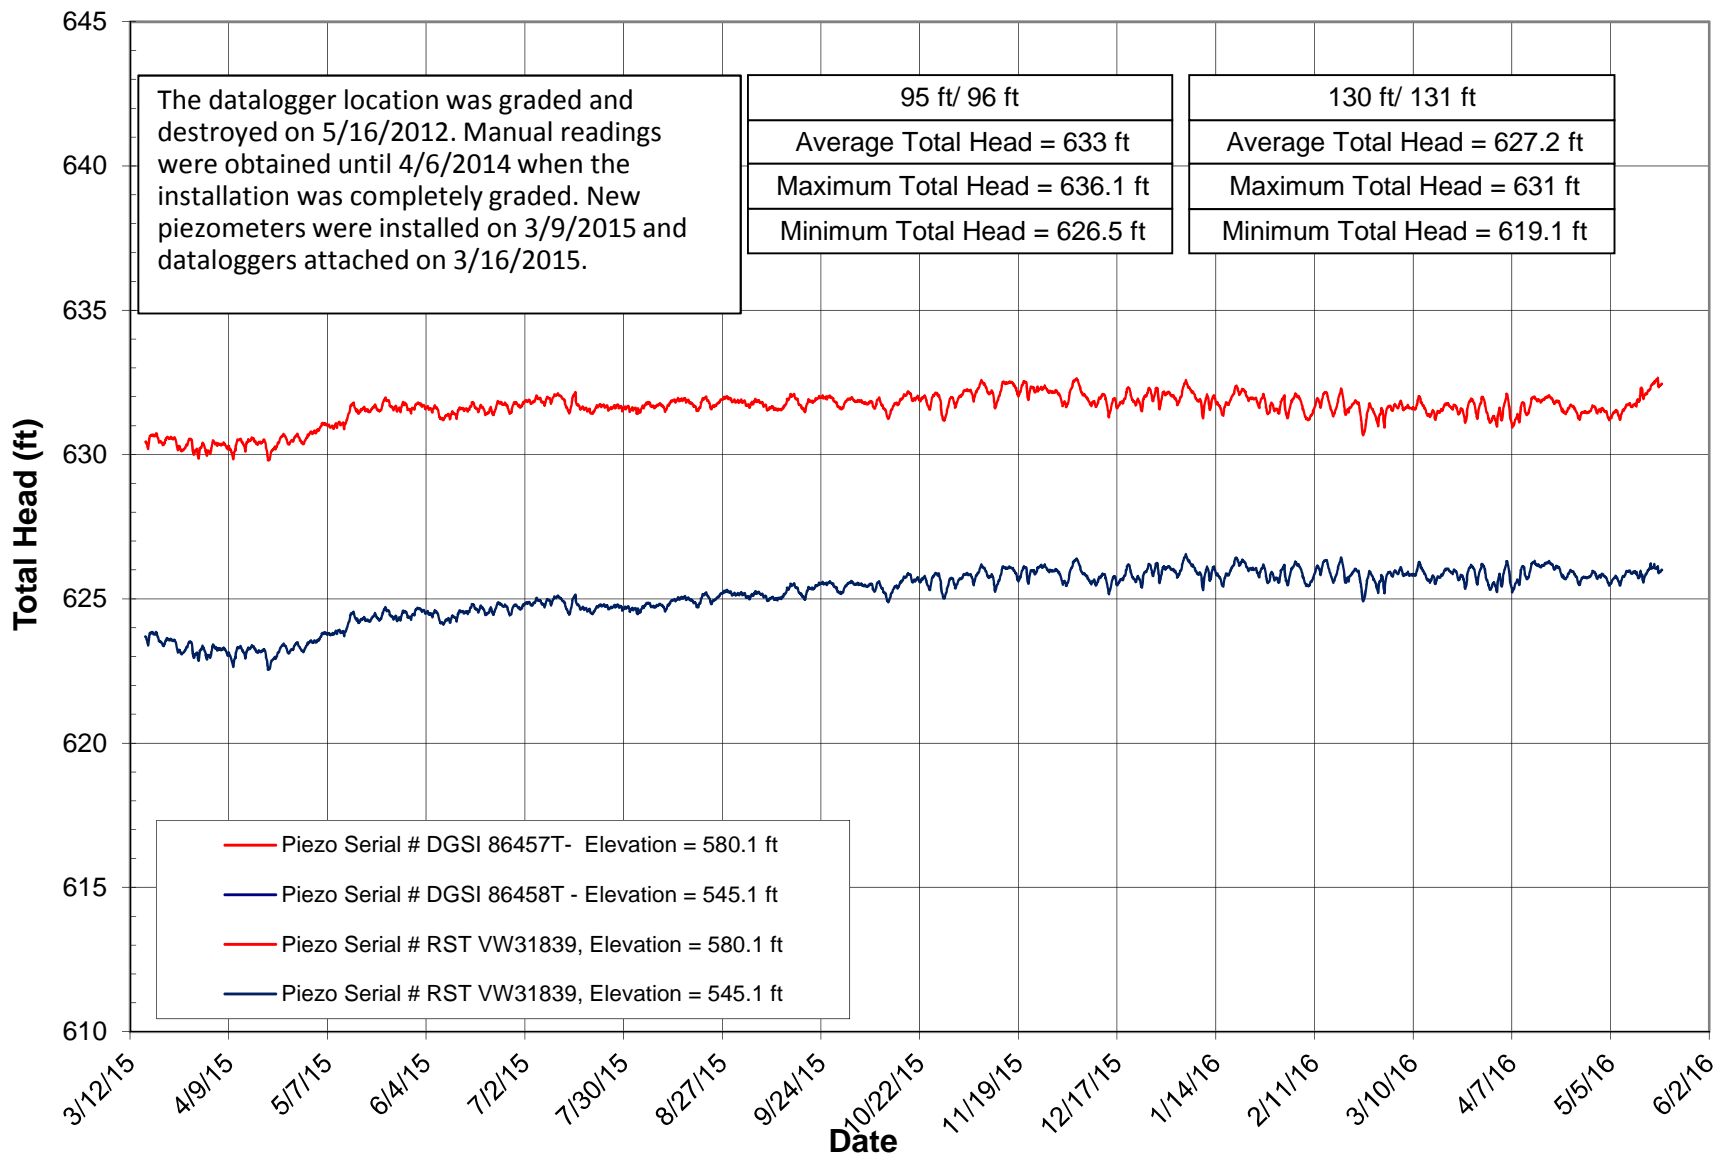
B-05-11/B-05-A-11 VW Piezometer Readings

B-05-A-11 – Data recorded for this location indicates an increase in total head of about 1.1 feet in the shallow piezometer and 0.5 feet in the deep piezometer for this two-week period.

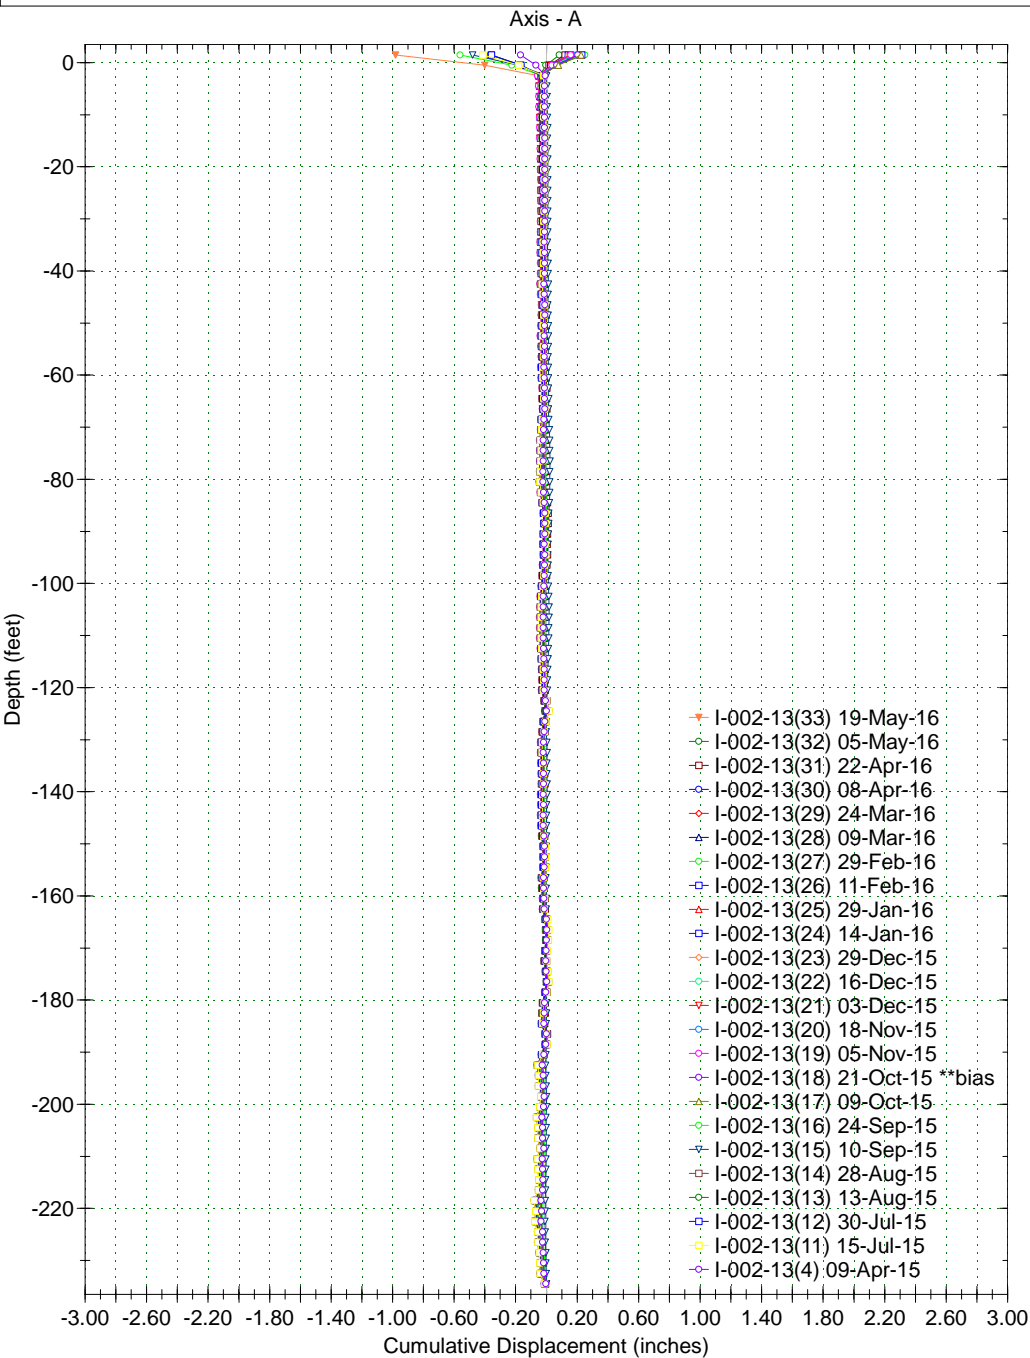
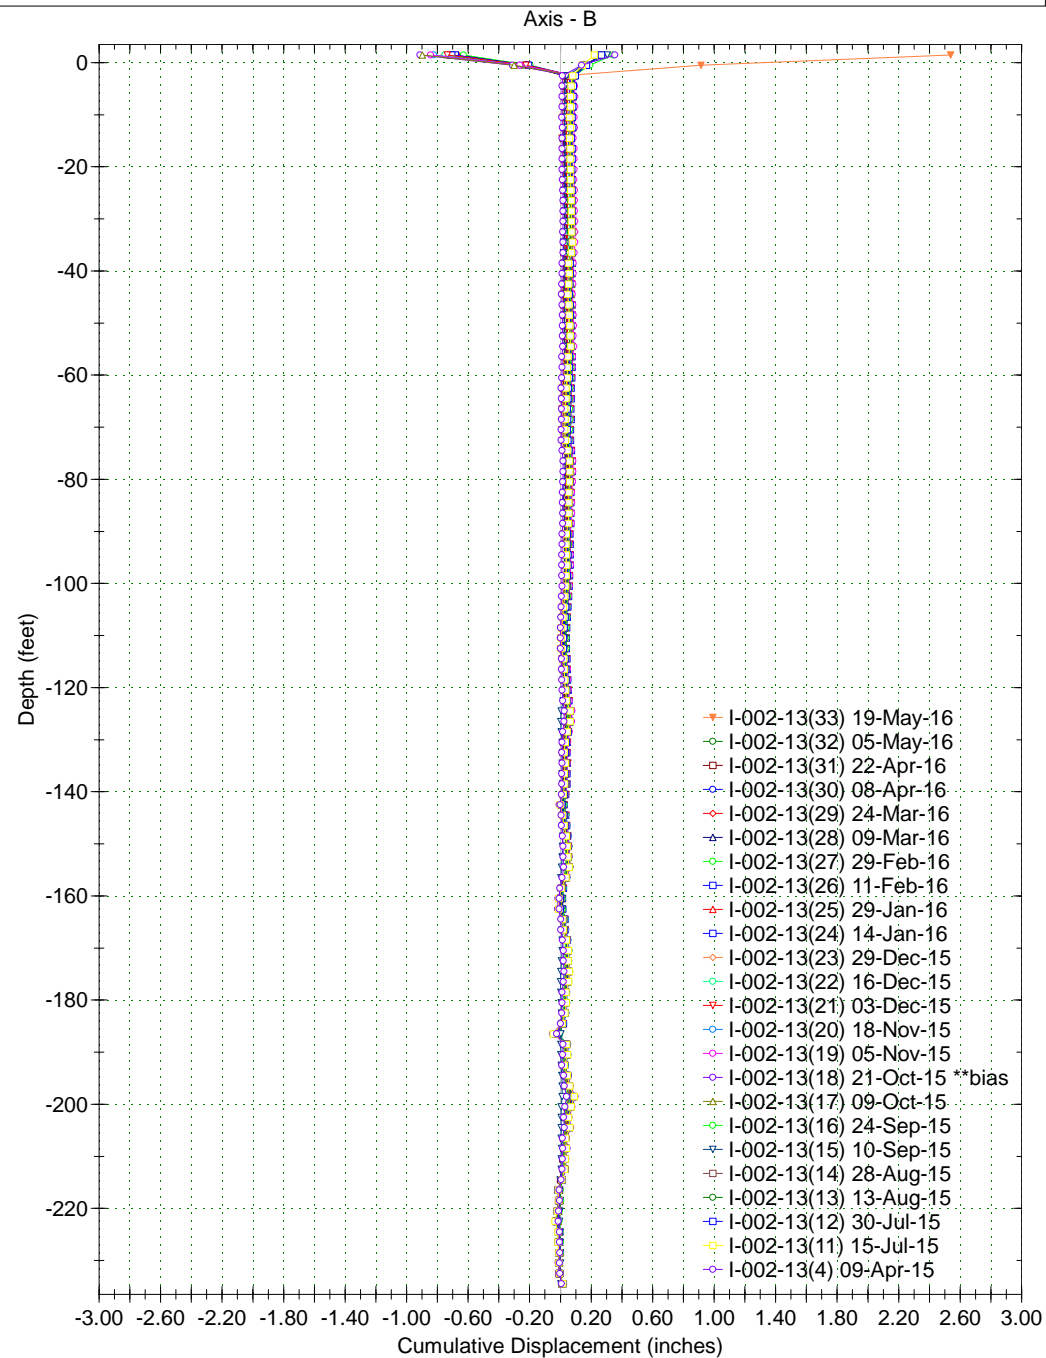
Borehole : I-002-13
Project : CUY-90-15-24
Location : Cleveland, Ohio
Northing :
Easting :
Collar :

I-002-13 – Inclinometer readings at this location show large displacements in the top 4 feet of the casing. This is due to the grading work in the surrounding area.

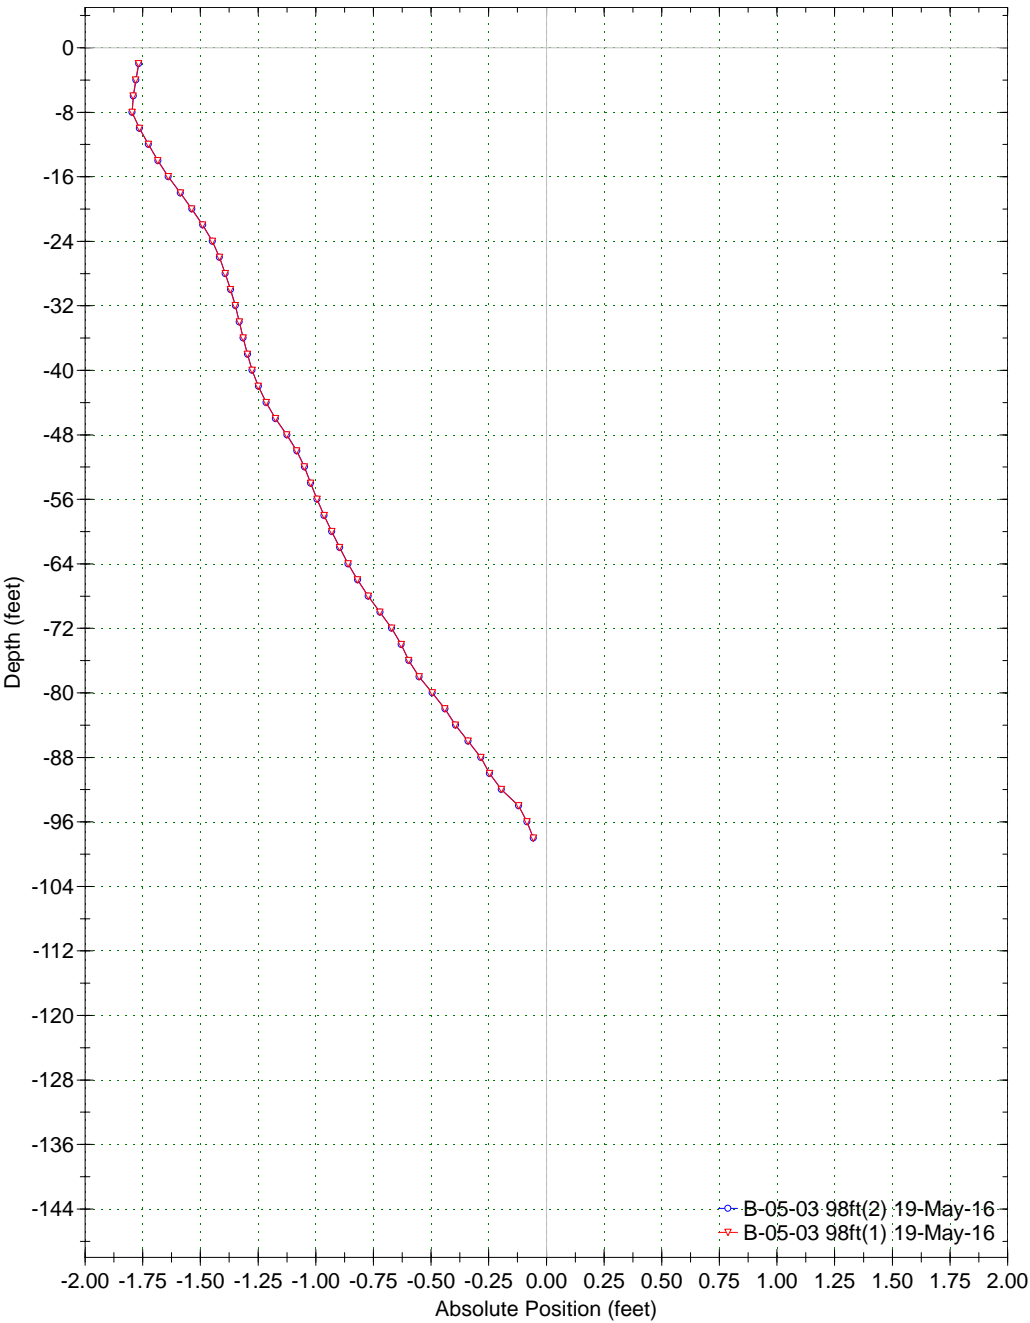
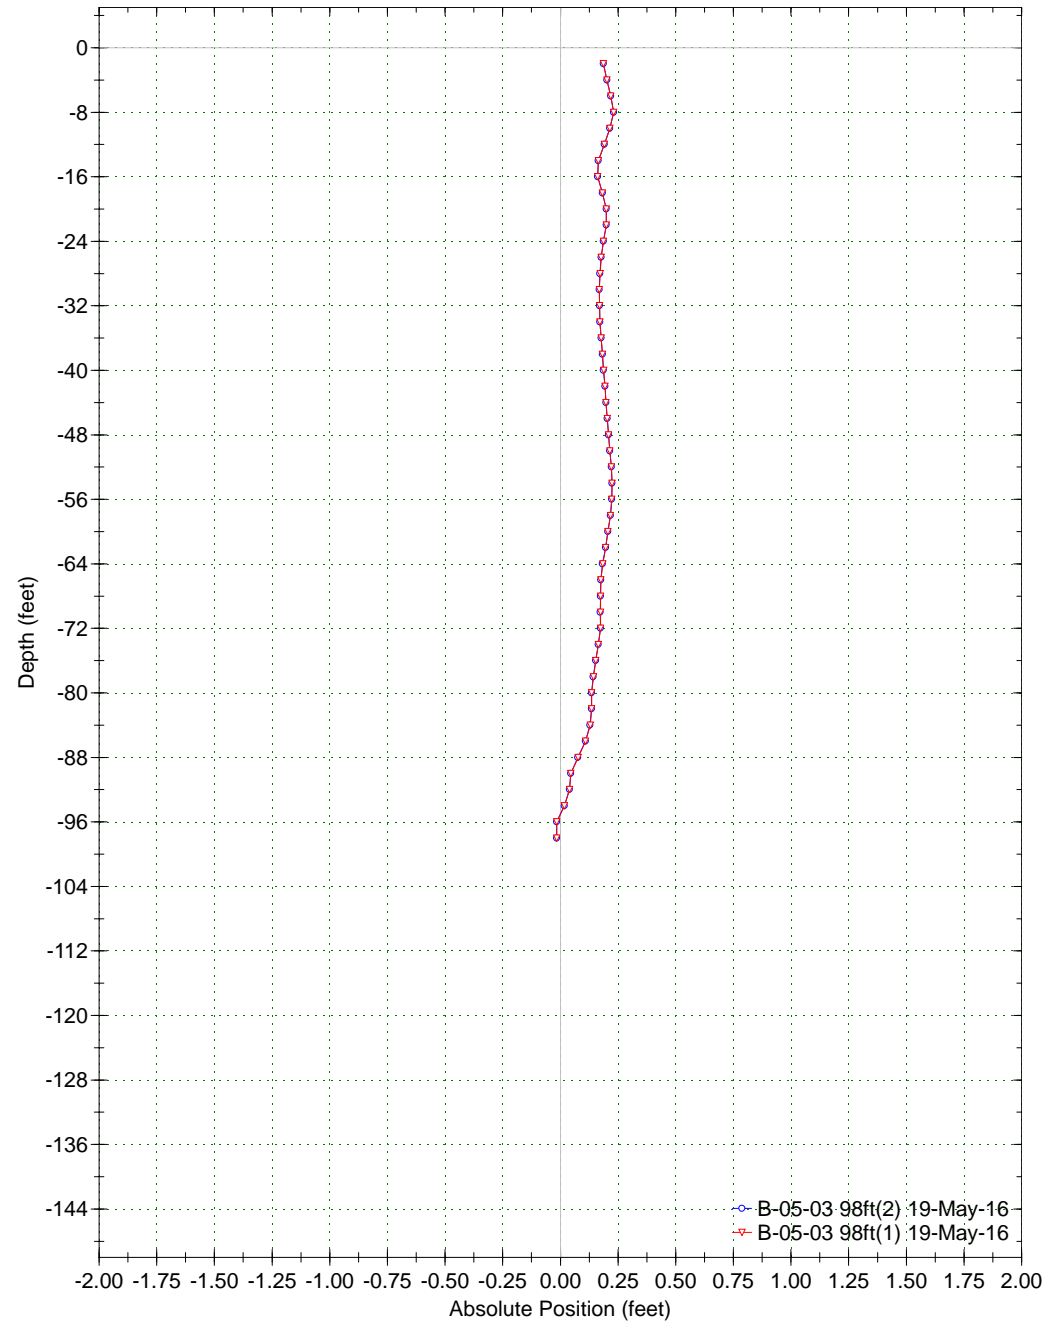
Borehole : B-05-A-03 [98 ft]
Project : CUY-90-15-24
Location :
Northing :
Easting :
Collar :

B-05-03A – Our drill crew purged water from the casing and we lowered a camera down the casing to investigate the large check sums obtained in our initial readings. We found a misalignment of the joint at 100 feet. The large check sums are due to the inclinometer wheels jumping out of the grooves at the misalignment. We checked with the manufacturer who stated that this could not have been a manufacturing defect. The misalignment cannot be corrected so this casing will be abandoned and replaced. The area around this instrument is currently being used to store catwalks for the bridge. This is preventing us from installing a new casing at this time. Until we can install a new casing, we will take readings on the top 98 feet of the current casing. The absolute position plots from the baseline readings are attached.

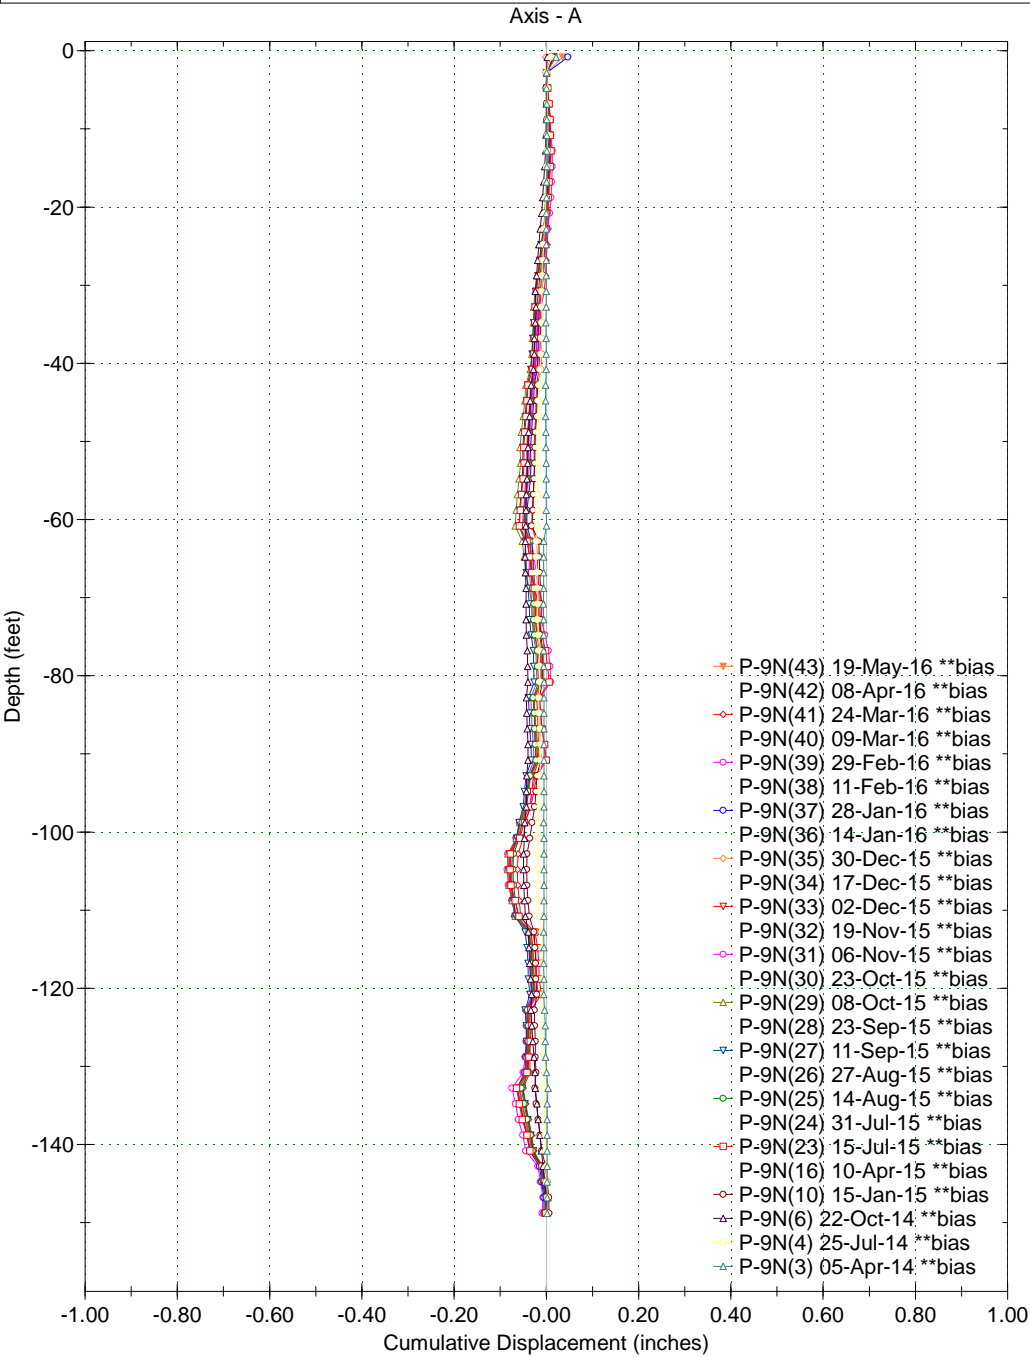
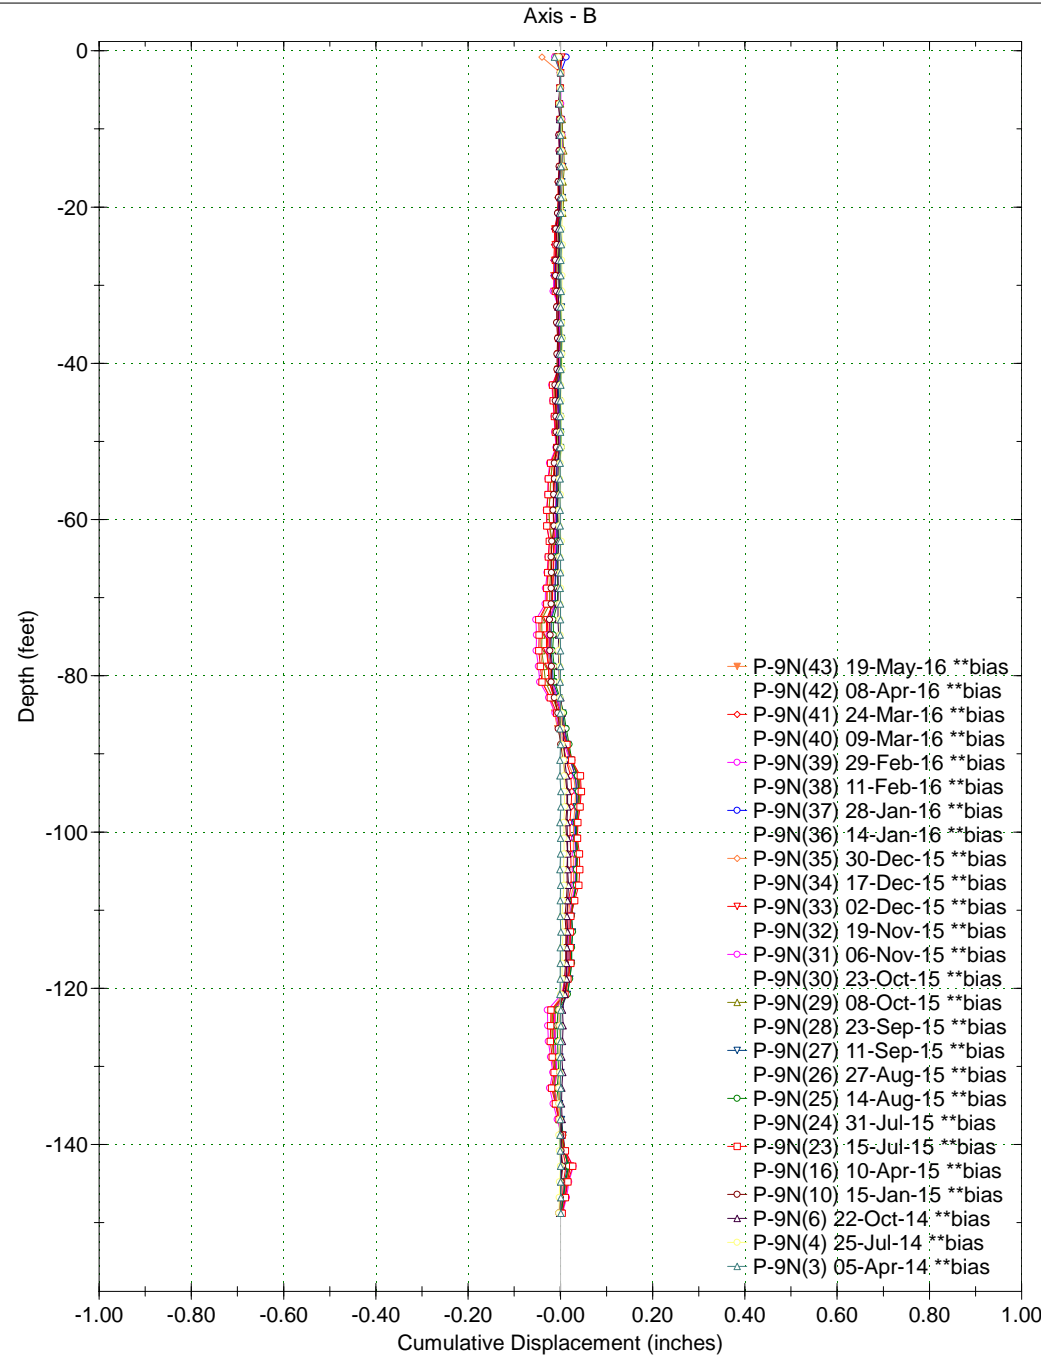
Borehole : P-9N
Project : CUY-90-15-24
Location : Cleveland, Ohio
Northing :
Easting :
Collar :

P-9N – The protective cover for this slope tube was bent and interfered with the inclinometer probe. We were able to bend the steel cover enough to take readings at this location again. Readings this week show virtually no movement.
