Re: April 2016 Quarterly Report
CUY-90-15.24 Slope Monitoring
PID 96504
EDP Project No. 069032.00

APRIL 2016 QUARTERLY REPORT

CUY-90-15.24 SLOPE MONITORING
PID 96504
CLEVELAND, OHIO
SME PROJECT NO. 069032.00

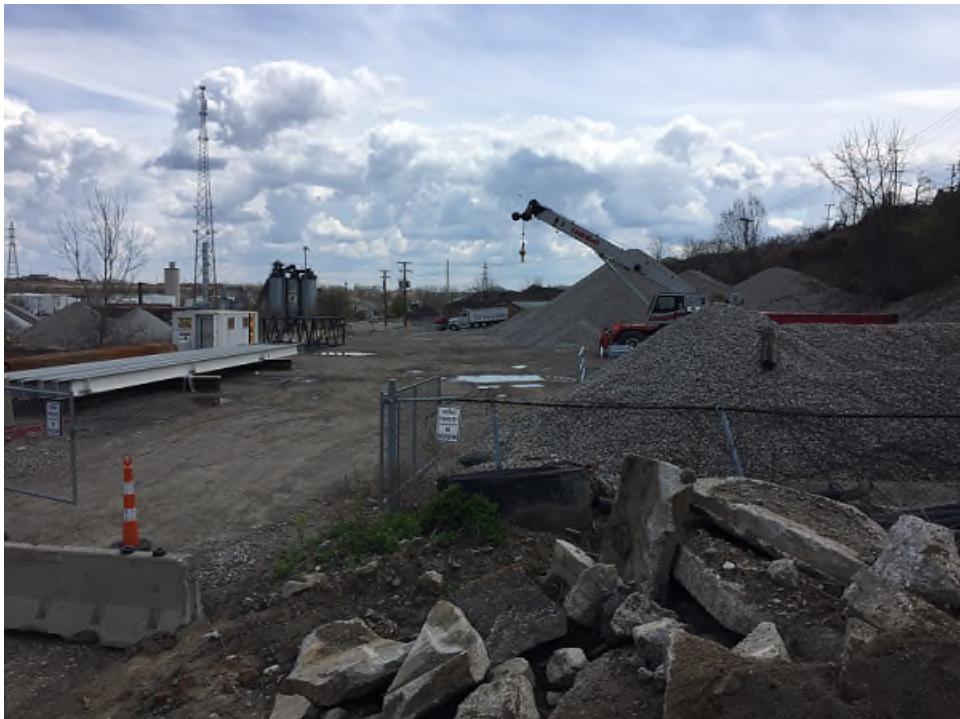
Figure 4. Aggregate stockpile east of the ODOT right-of-way (May 5, 2016)

We observed and photographed the aggregate stockpiles on May 5, 2016. The photos are Figures 4 and 5 which are included in Appendix A. Only a small pile of aggregate closest to the right-of-way fence remains. This pile has been virtually unchanged since January 2014. The pile is about 8 feet high and covers only a small area of the property.

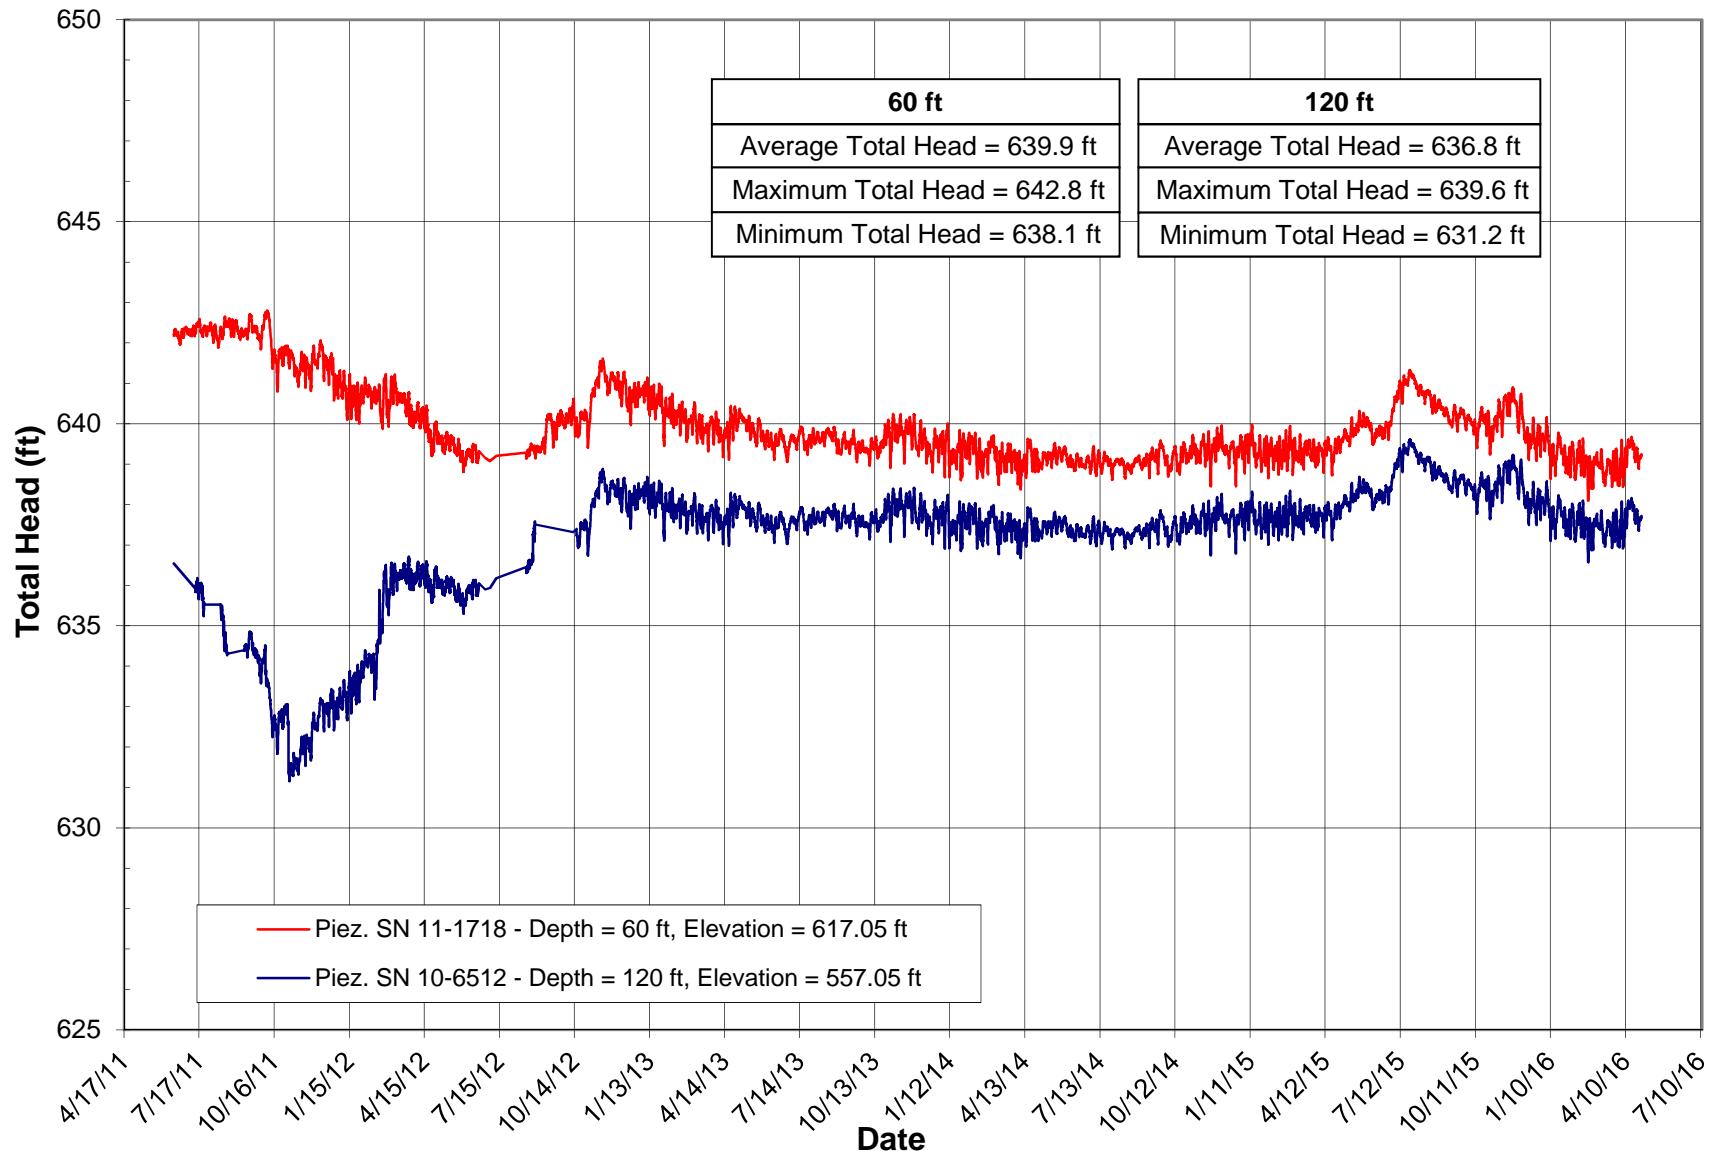
P-001-10 VW Piezometer Readings

P-001-10. Total head in both piezometers at P-001-10 decrease through most of this quarter continuing the trend that began in July 2015. Since July 2015, total head in both piezometers decreased about 2 feet. Average pore pressures this quarter were within the range that existed from April 2013 through April 2015.

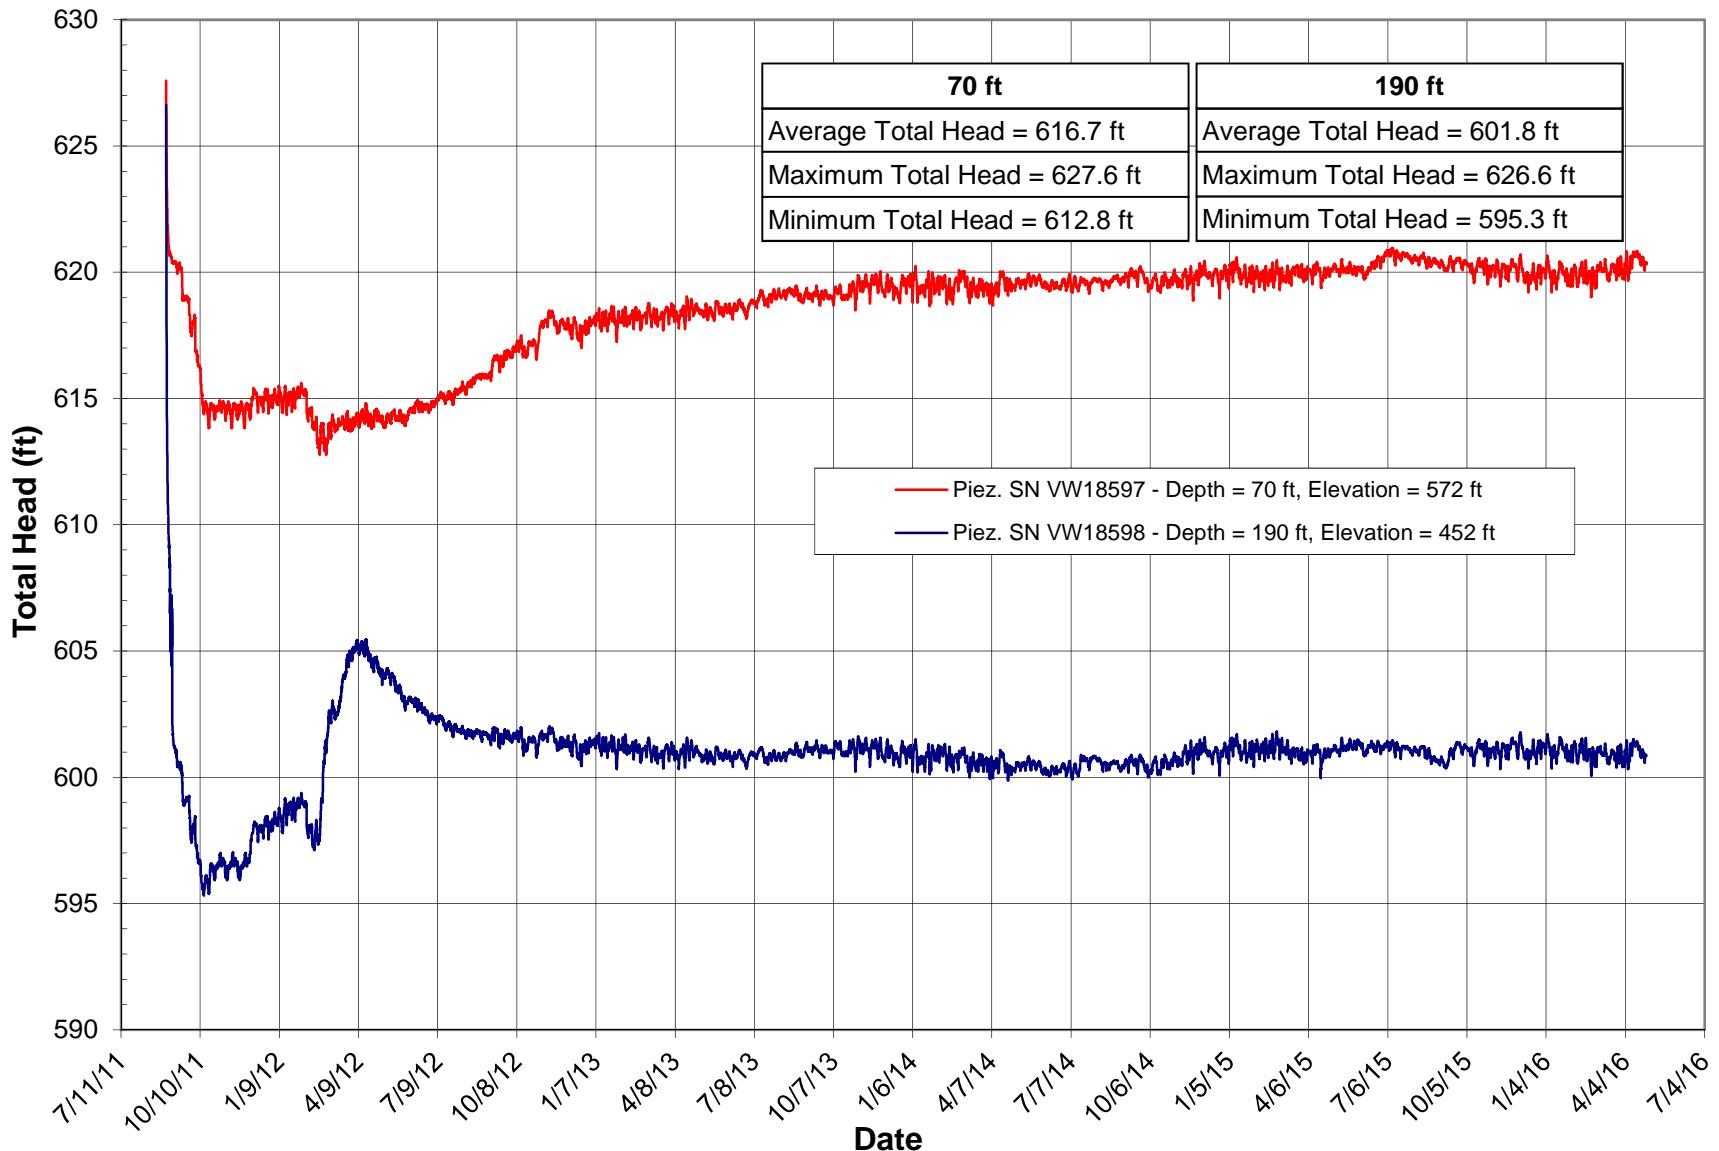
P-002-10 VW Piezometer Readings

P-002-10. Total head in both piezometers at P-002-10 fluctuated slightly over the past quarter, but show virtually no net change.

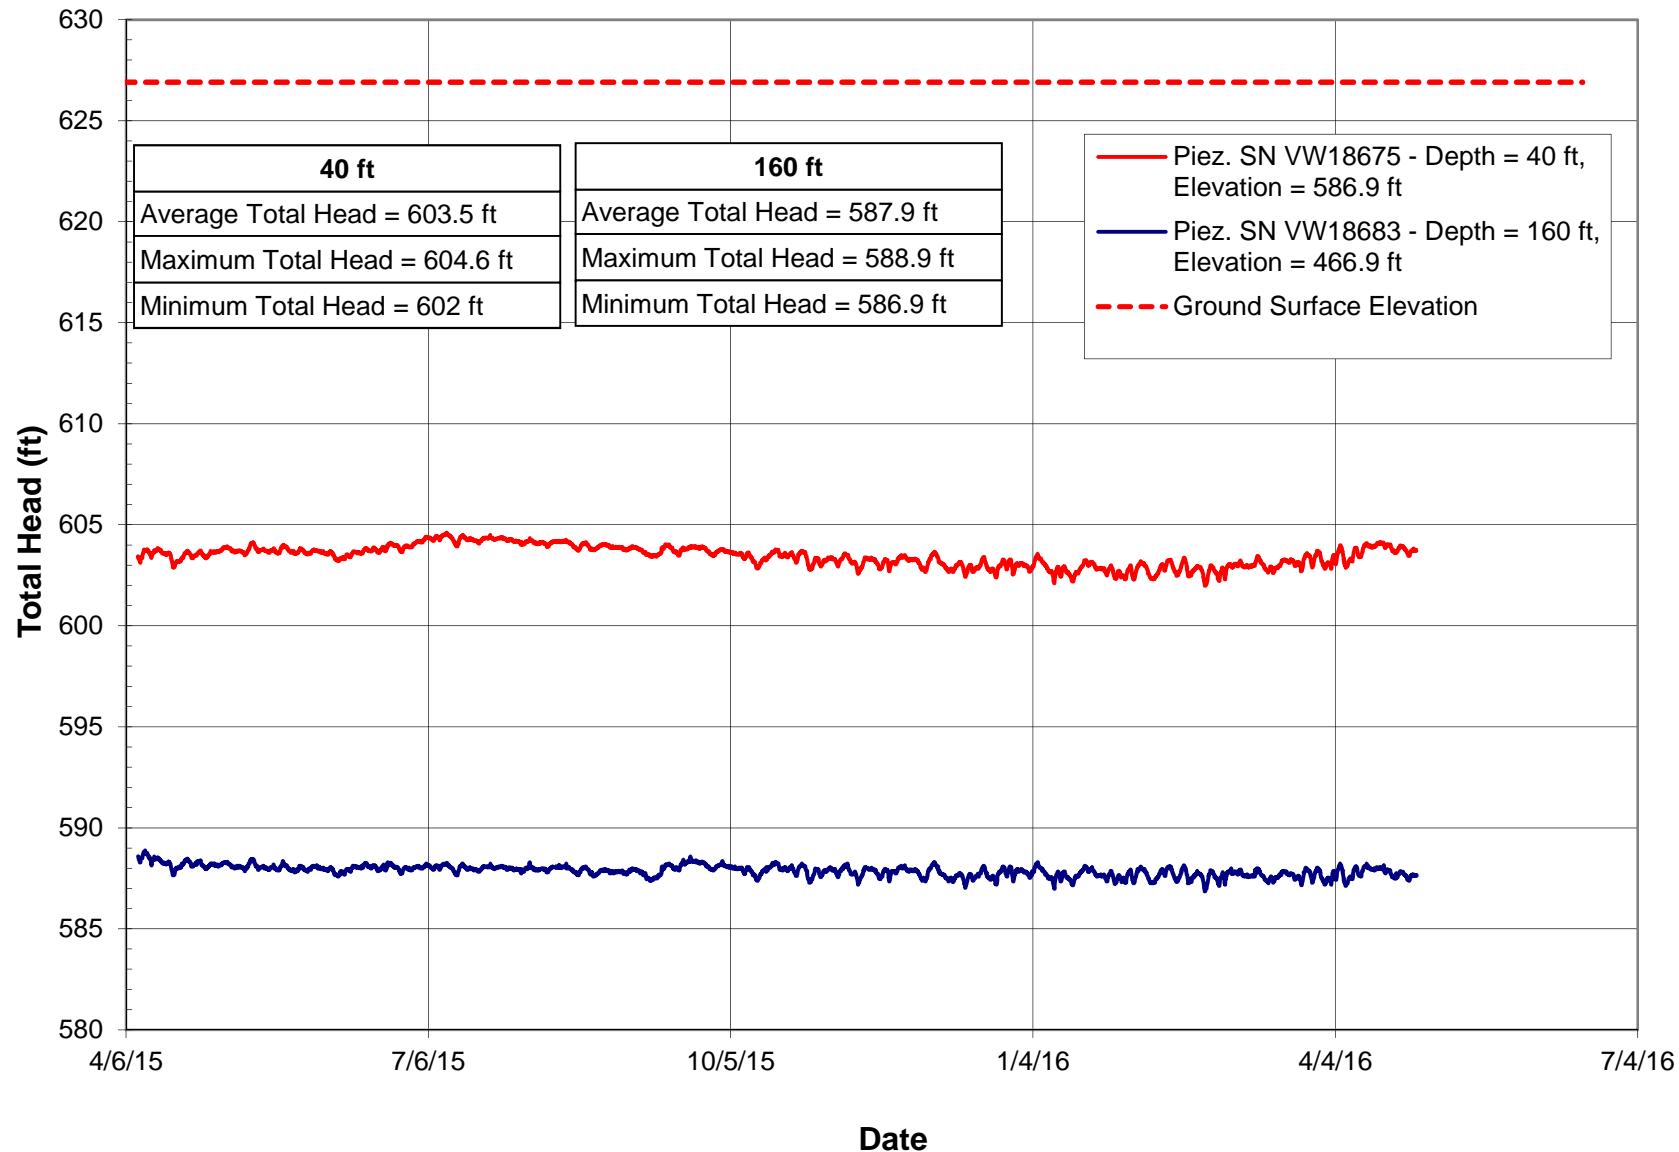
P-007-13 VW Piezometer Readings

P-007-13. In both piezometers at P-007-13, pore pressure readings indicate minor fluctuations in total head with no significant change during the quarter. In April 2016, total head increased by about 0.8 feet in the shallow piezometer.

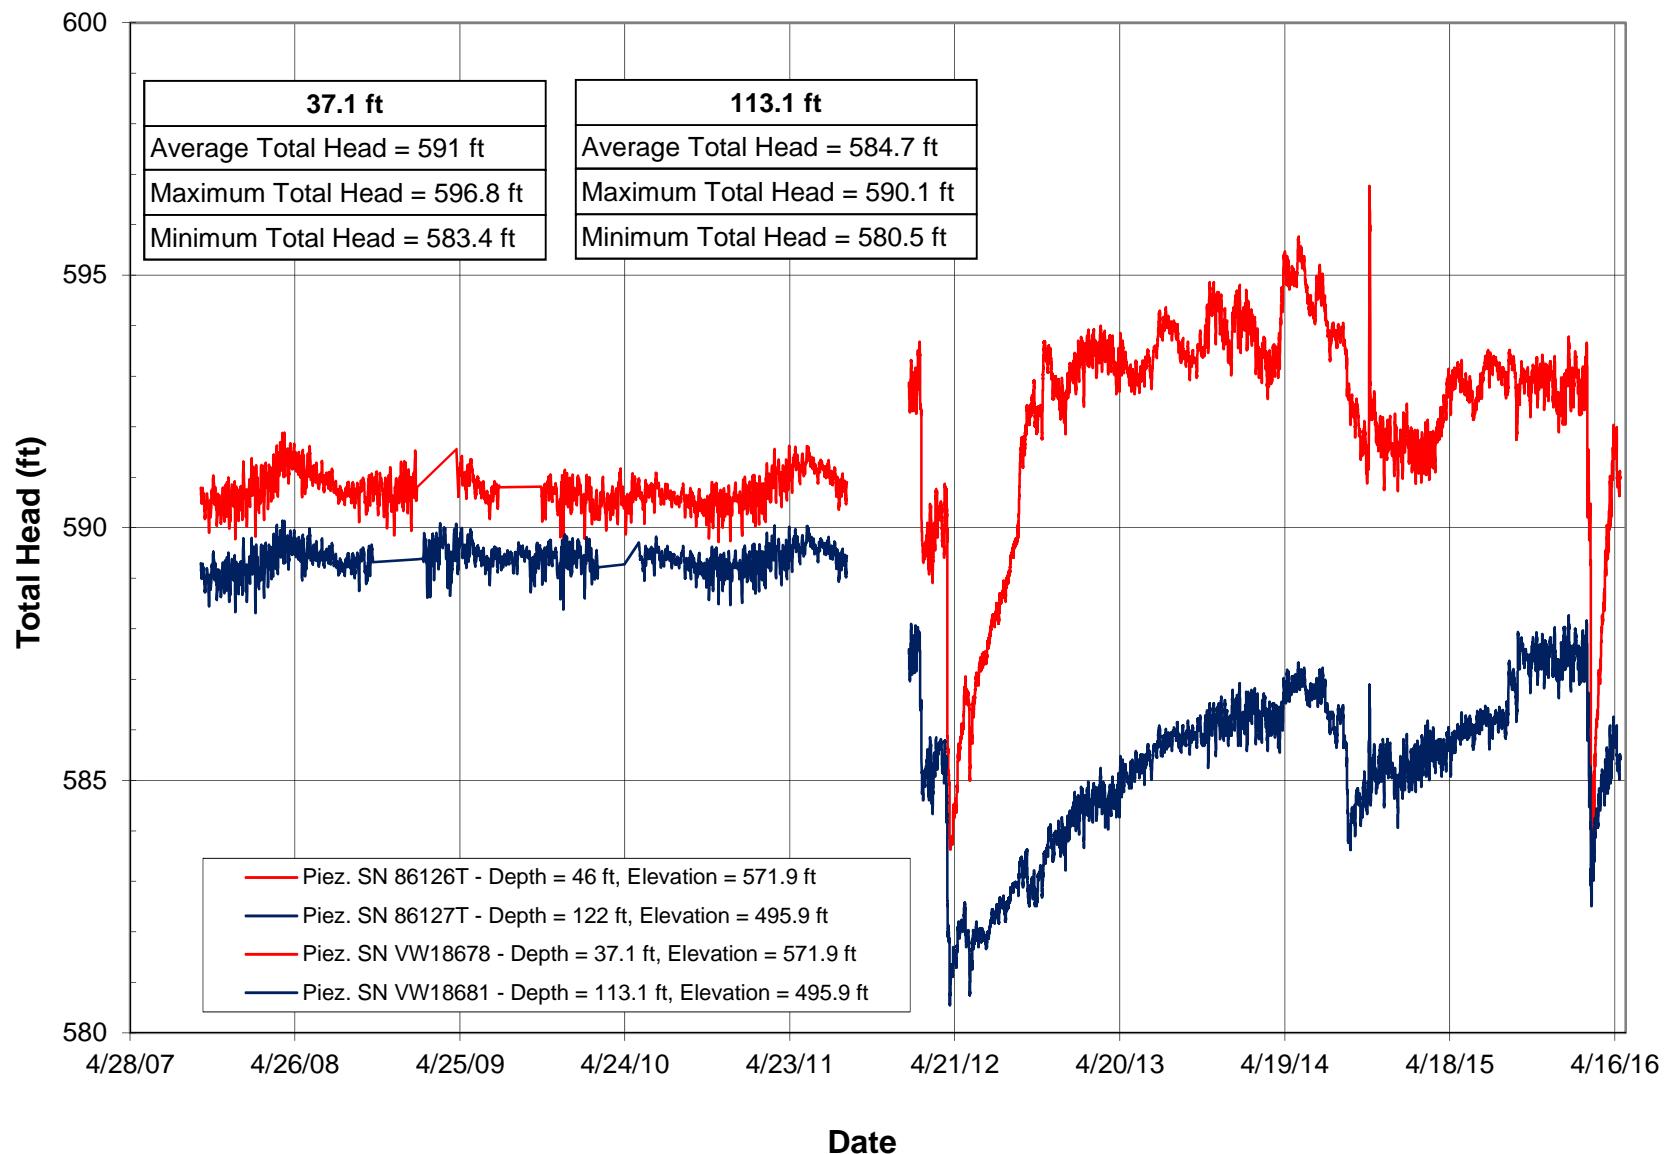
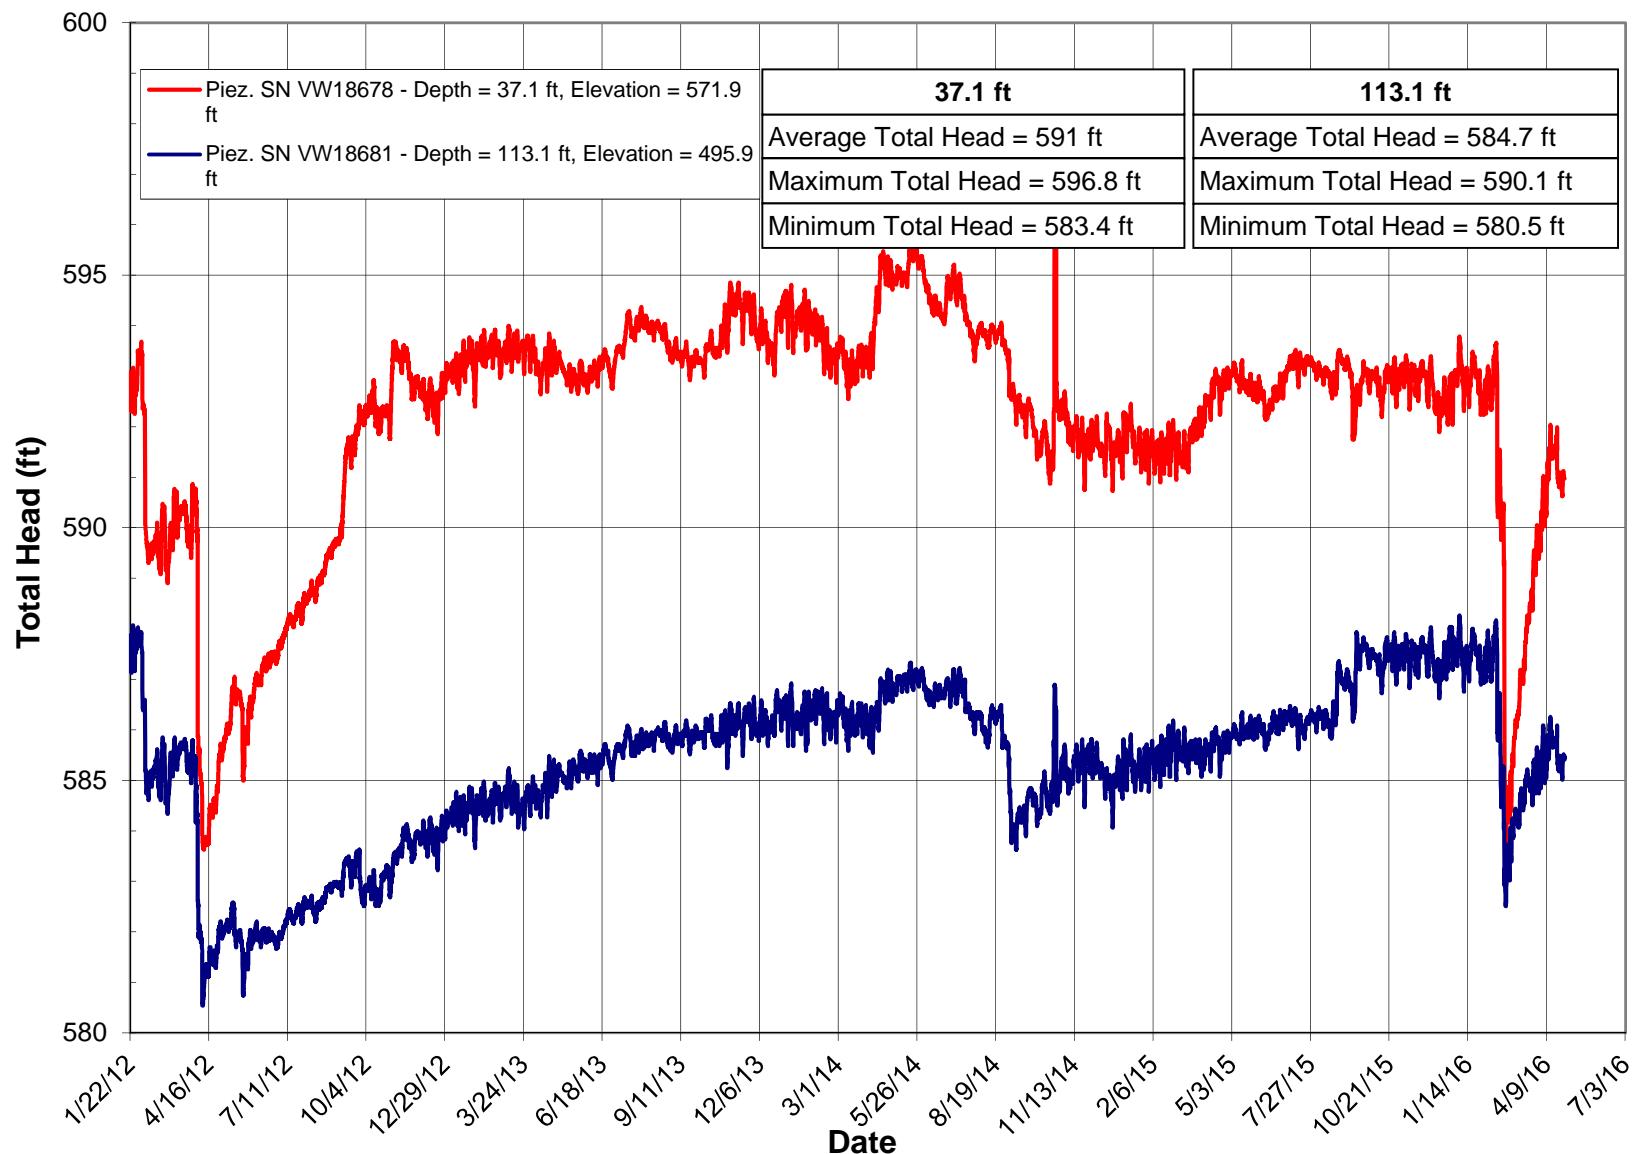
B-05-02 VW Piezometer Readings

B-05-02. The piezometers at this location were recently uncovered. The last data download at this location was on August 1, 2014. The dataloggers continued to record during the time the instruments were covered and inaccessible. Pore pressure data indicates a decrease in total head that occurred between April and October 2014 in the shallow piezometer, and between June and September 2014 in the deep piezometer. The total head in both piezometers then increased gradually reaching a new equilibrium in May 2015 in the shallow piezometer and September 2015 in the deep piezometer.

Beginning on February 14, 2016, the total head in both piezometers decreased again with a change of 10.3 feet in the shallow piezometer, and 5.7 feet in the deep piezometer. Then on February 24, 2016, the total head in both piezometers began to increase. By mid-April 2016, the total head increased by 8.6 feet in the shallow piezometer and 3.8 feet in the deep piezometer. Variations since then may indicate that pore pressures have reached equilibrium. The large decrease in pore pressure that occurred on February 14, was the result of excavation in the area.

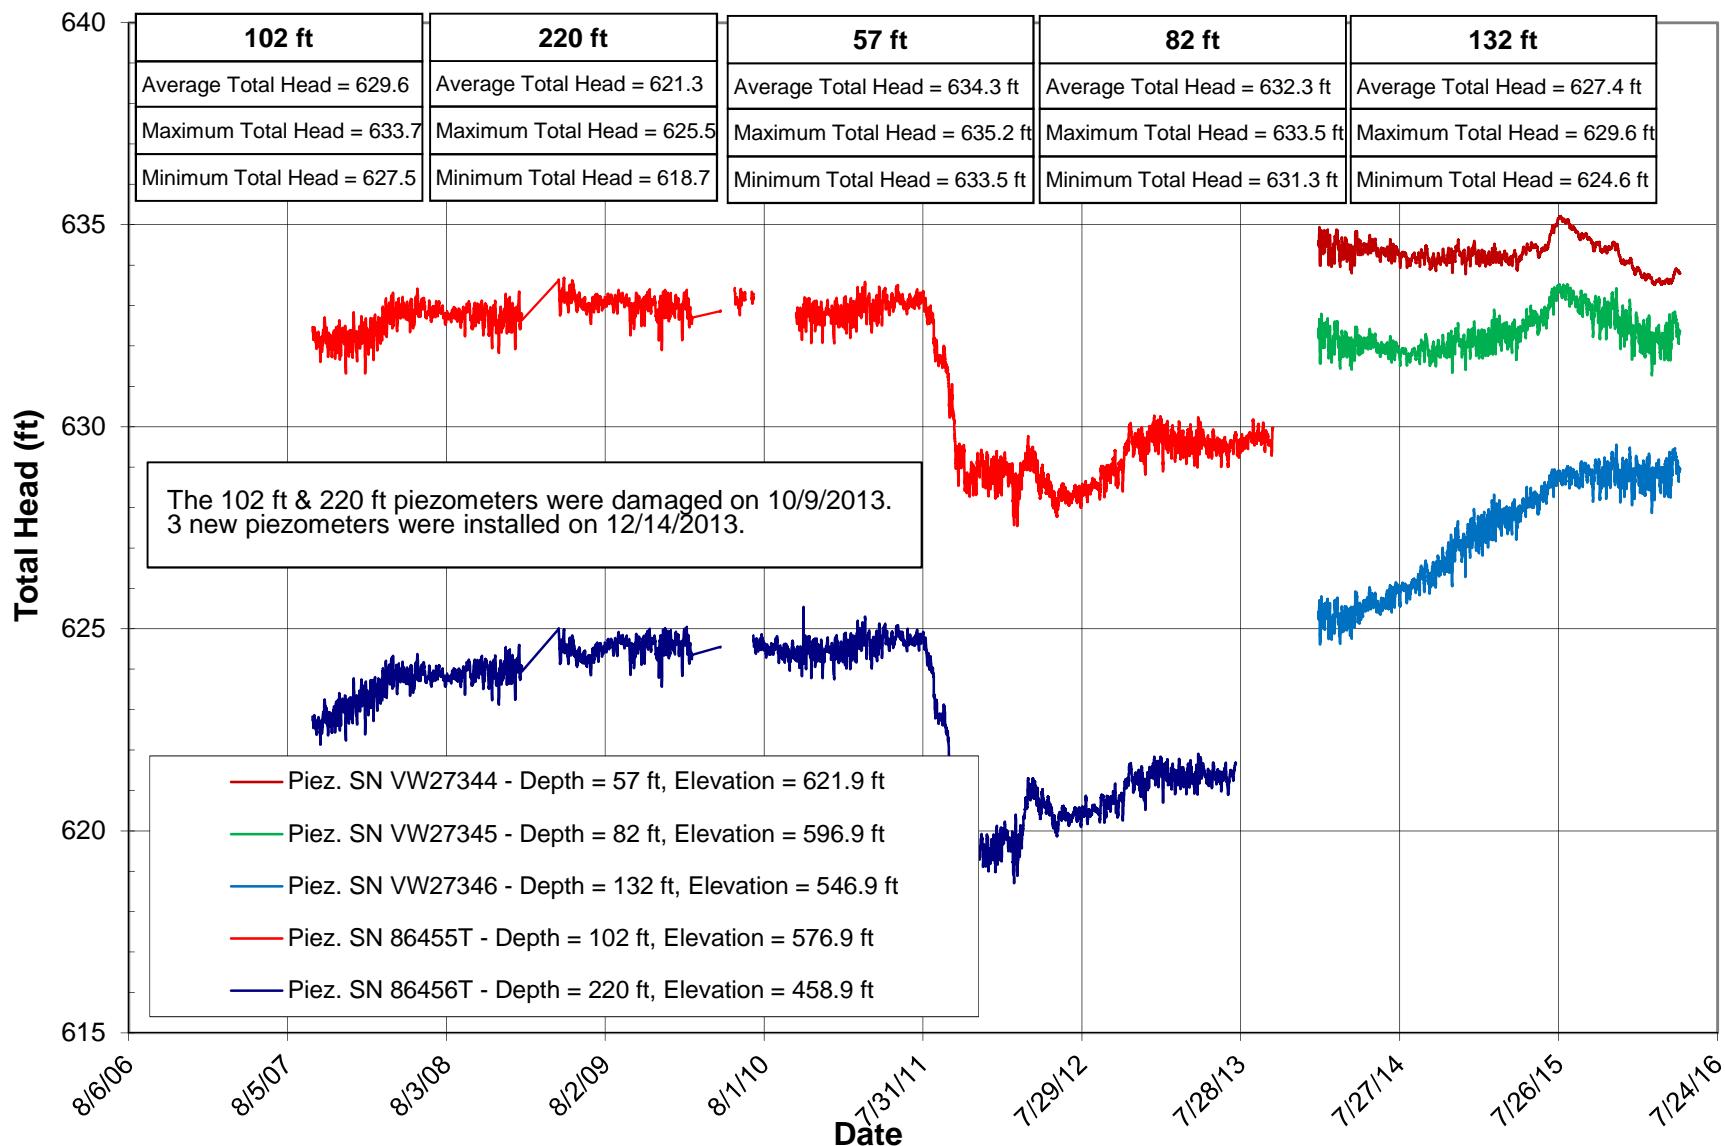
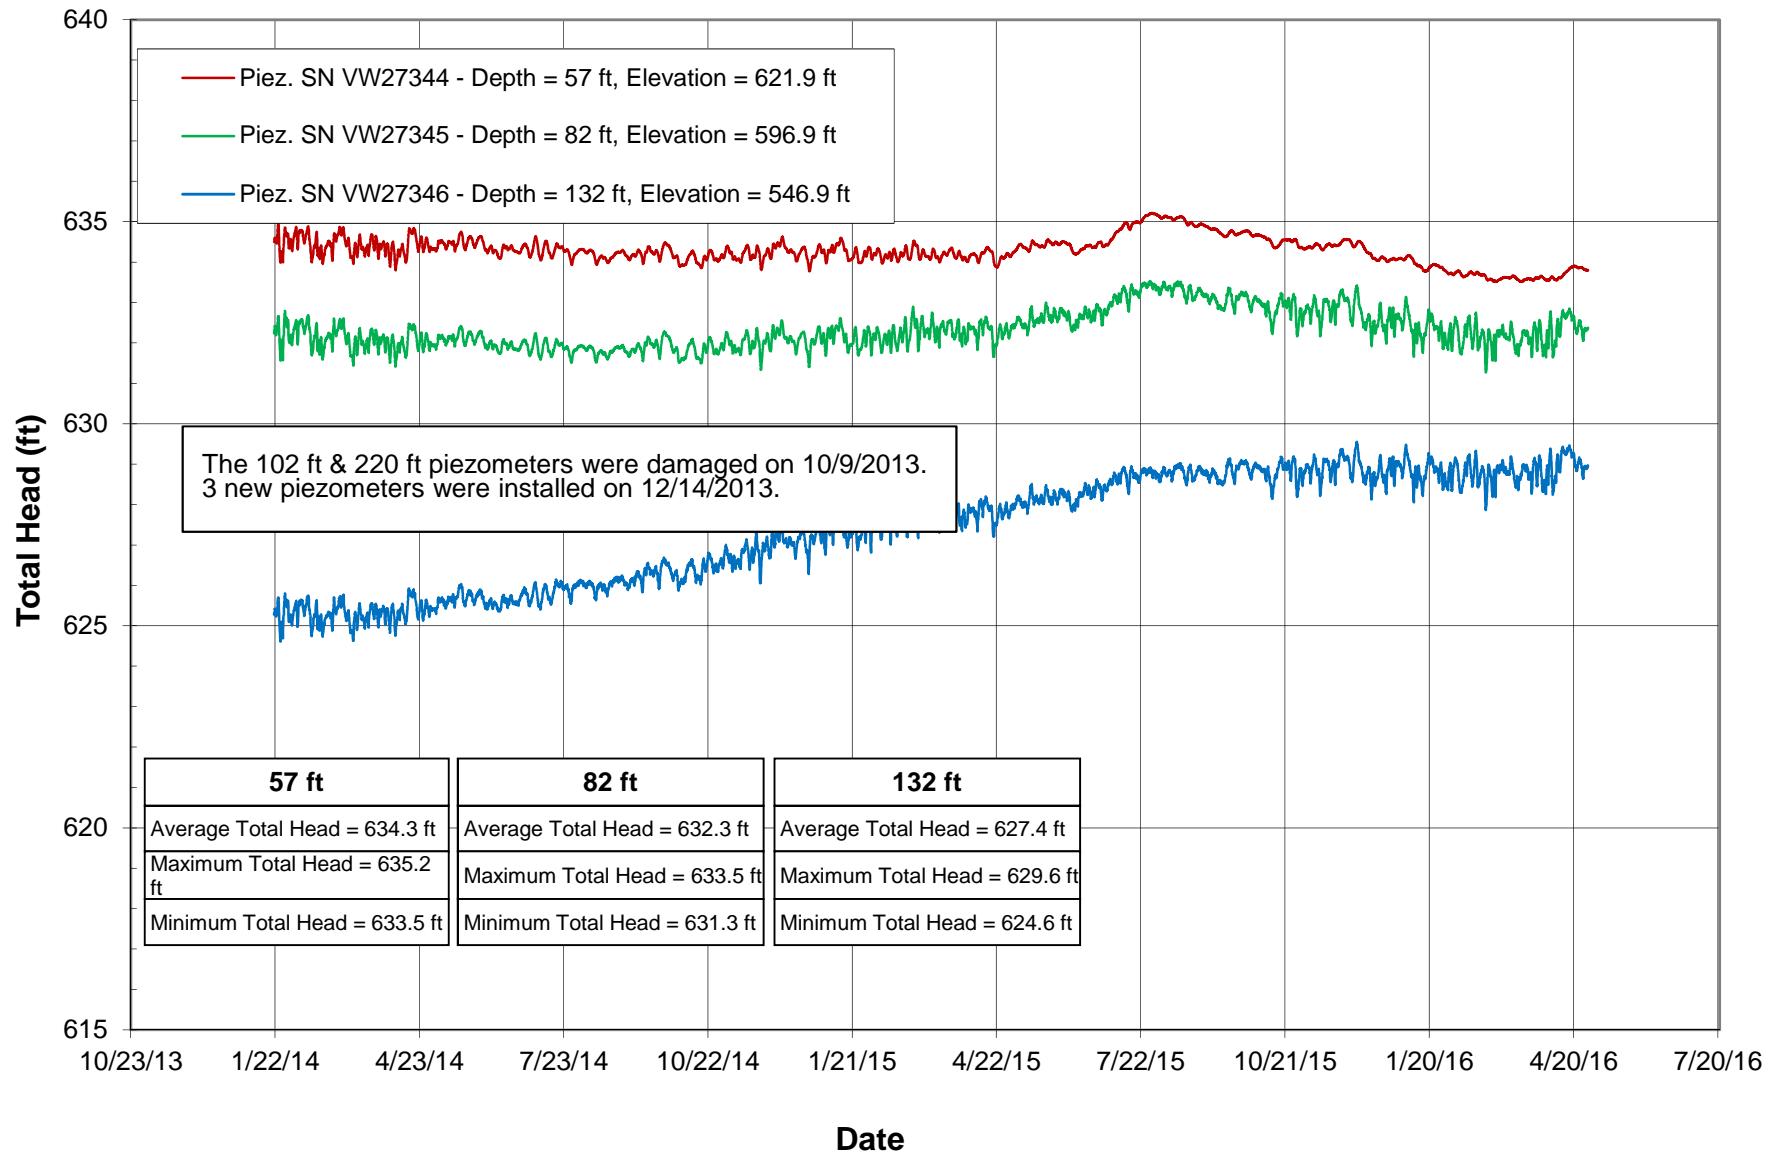
B-05-07 VW Piezometer Readings

B-05-07. Pore pressure readings in all three piezometers at B-05-07 indicate fluctuations in total head, but virtually no net change for the quarter.

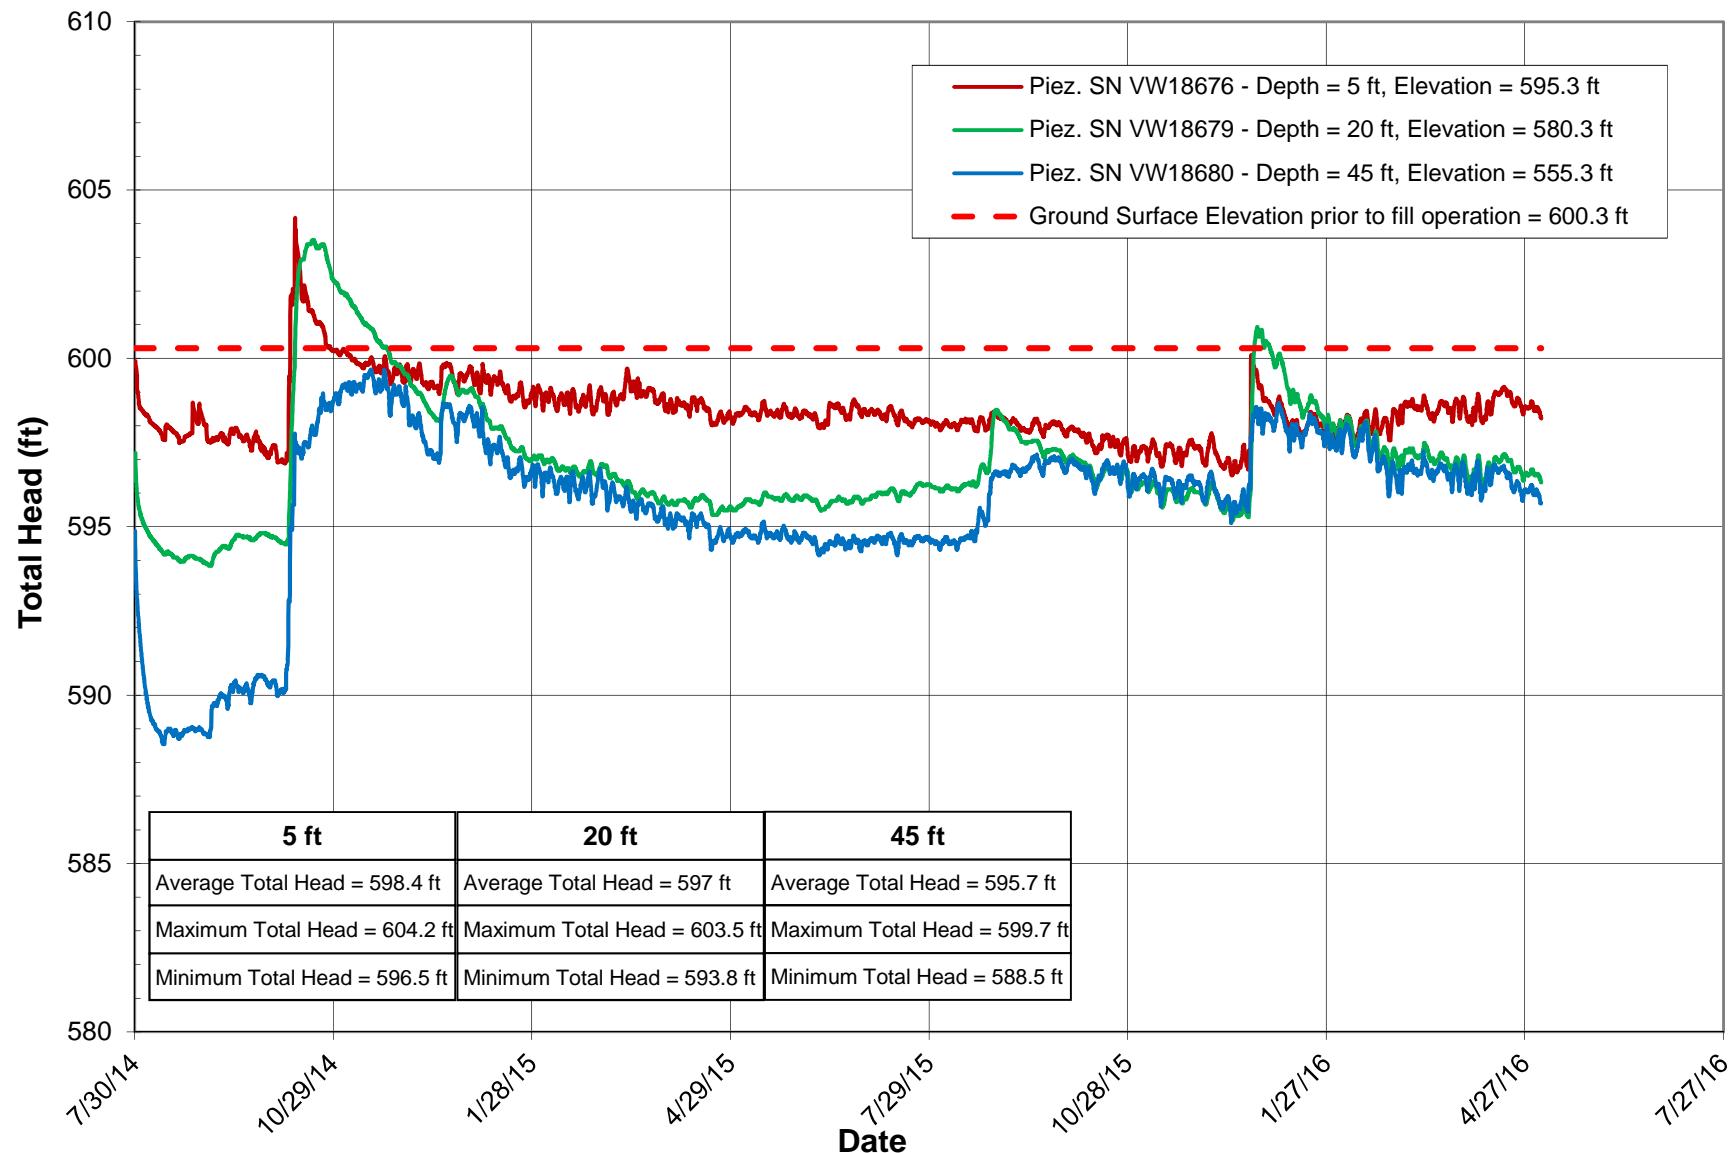
TGR P-3 VW Piezometer Readings

TGR P-3. On December 23, 2015, total head increases of 3 to 5 feet are shown in all three piezometers. This increase was caused by the placement of fill in the area which we observed during our biweekly visit. The pore pressures then began to decrease with the rate of decrease slowing with depth. Through most of this quarter, the total head in the two deep piezometers continued to decrease with a change of about 2 feet. Total head in the shallowest piezometer increased by about 1 foot.

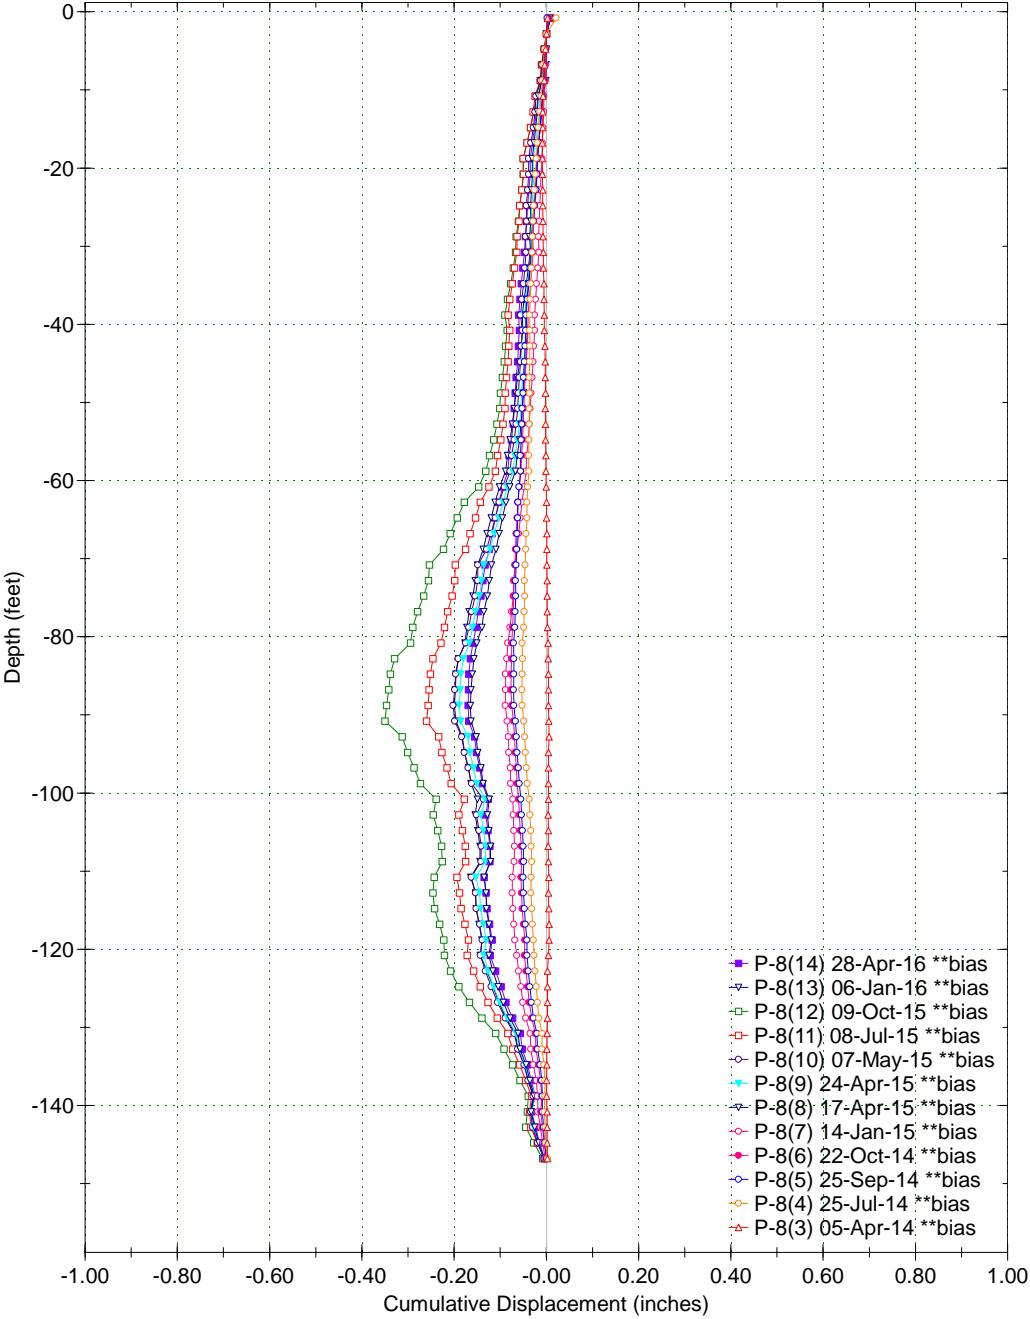
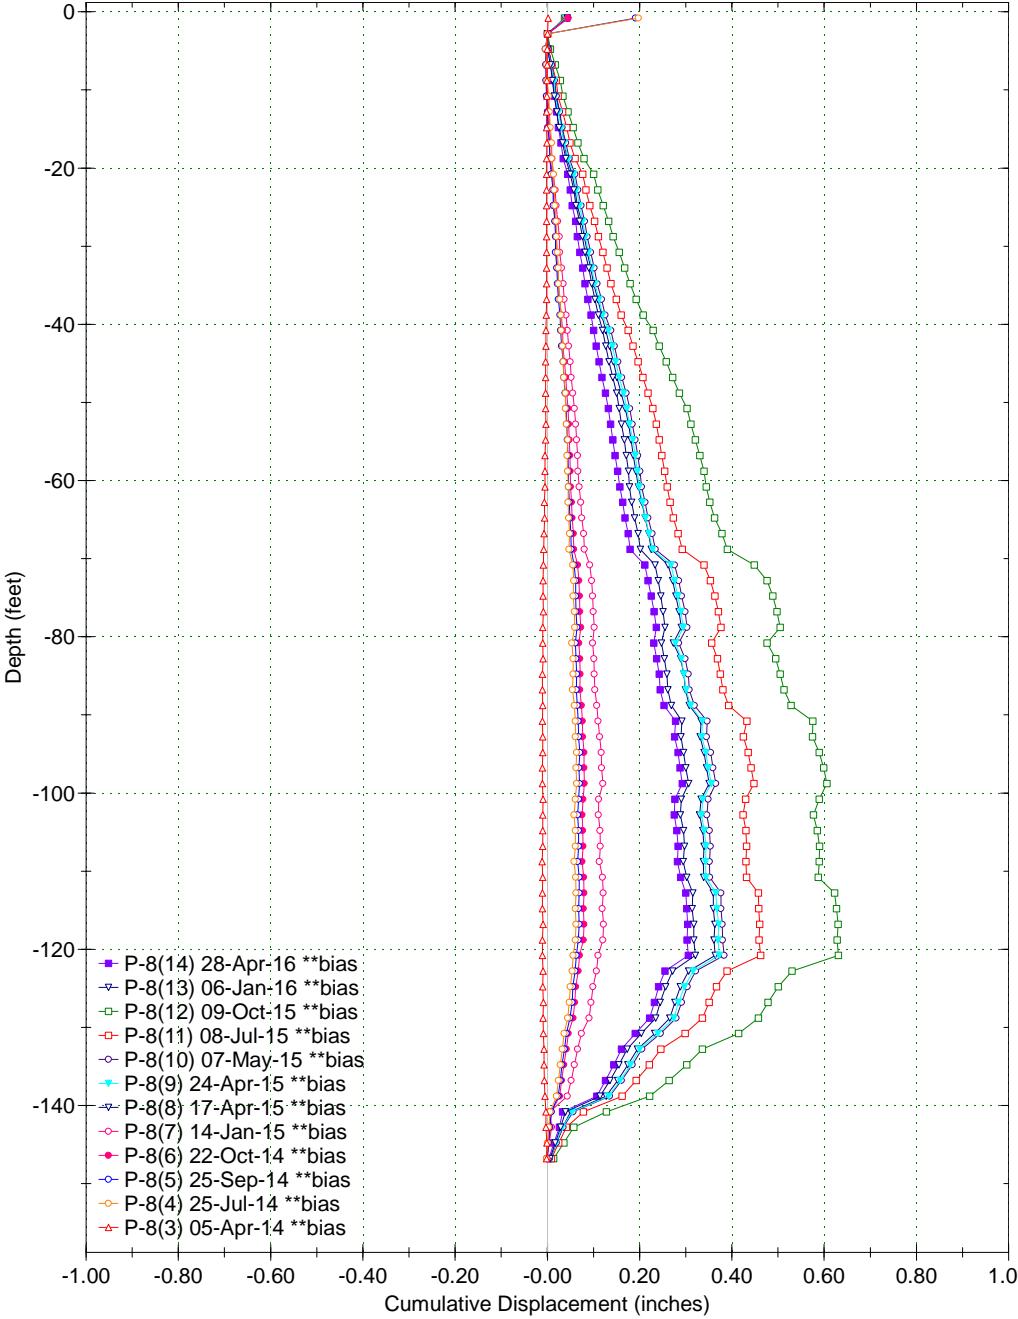
Borehole : P-8
 Project : CUY-90-15-24
 Location : Cleveland, Ohio
 Northing :
 Easting :
 Collar :

P-8. Inclinometer readings at this location indicate negative movement in the B-axis direction throughout the length of the tube.

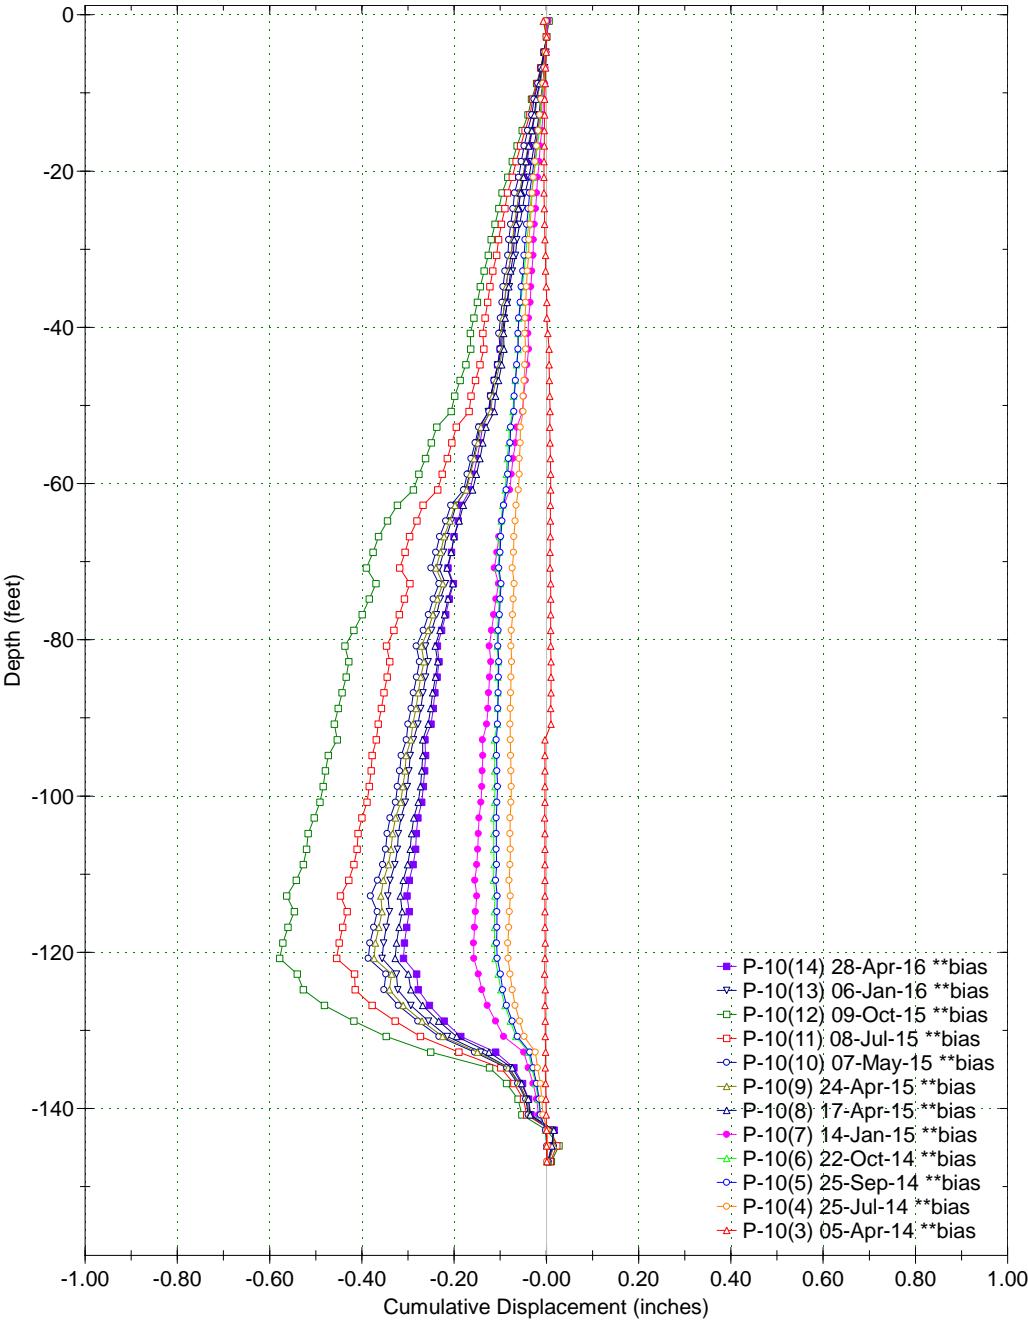
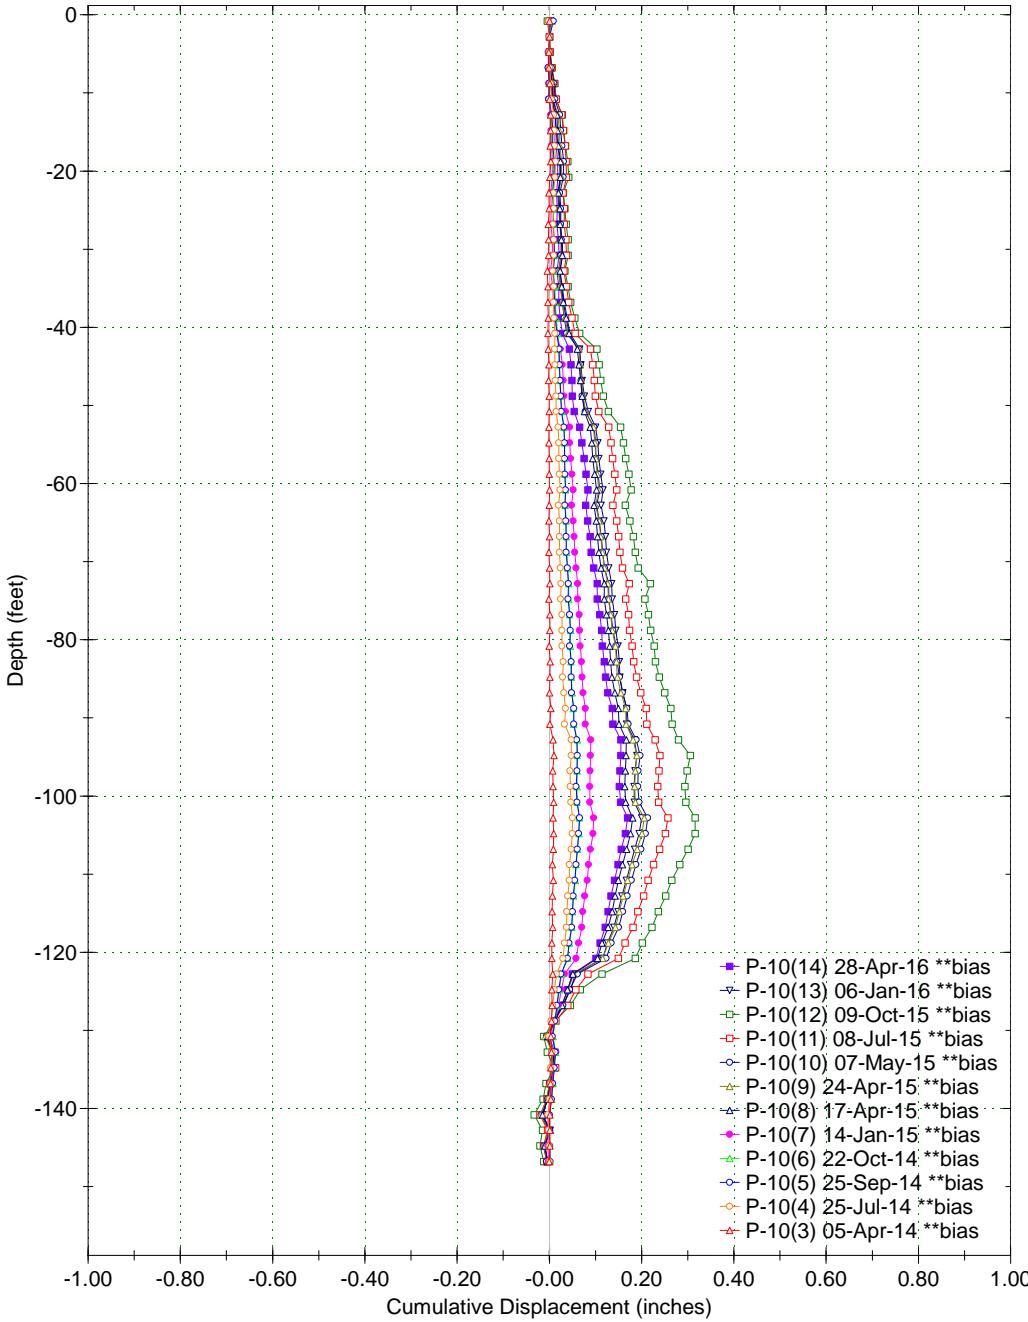
Borehole : P-10
 Project : CUY-90-15-24
 Location : Cleveland, Ohio
 Northing :
 Easting :
 Collar :

P-10. Inclinometer readings this quarter show less than 0.1 inches of displacement in the positive A-axis direction between 60 and 140 feet, and in the negative B-axis direction between 40 and 120 feet.
