Re: April 2016 Quarterly Report
CUY-90-15.24 Slope Monitoring
PID 96504
EDP Project No. 069032.00

APRIL 2016 QUARTERLY REPORT

CUY-90-15.24 SLOPE MONITORING
PID 96504
CLEVELAND, OHIO
SME PROJECT NO. 069032.00

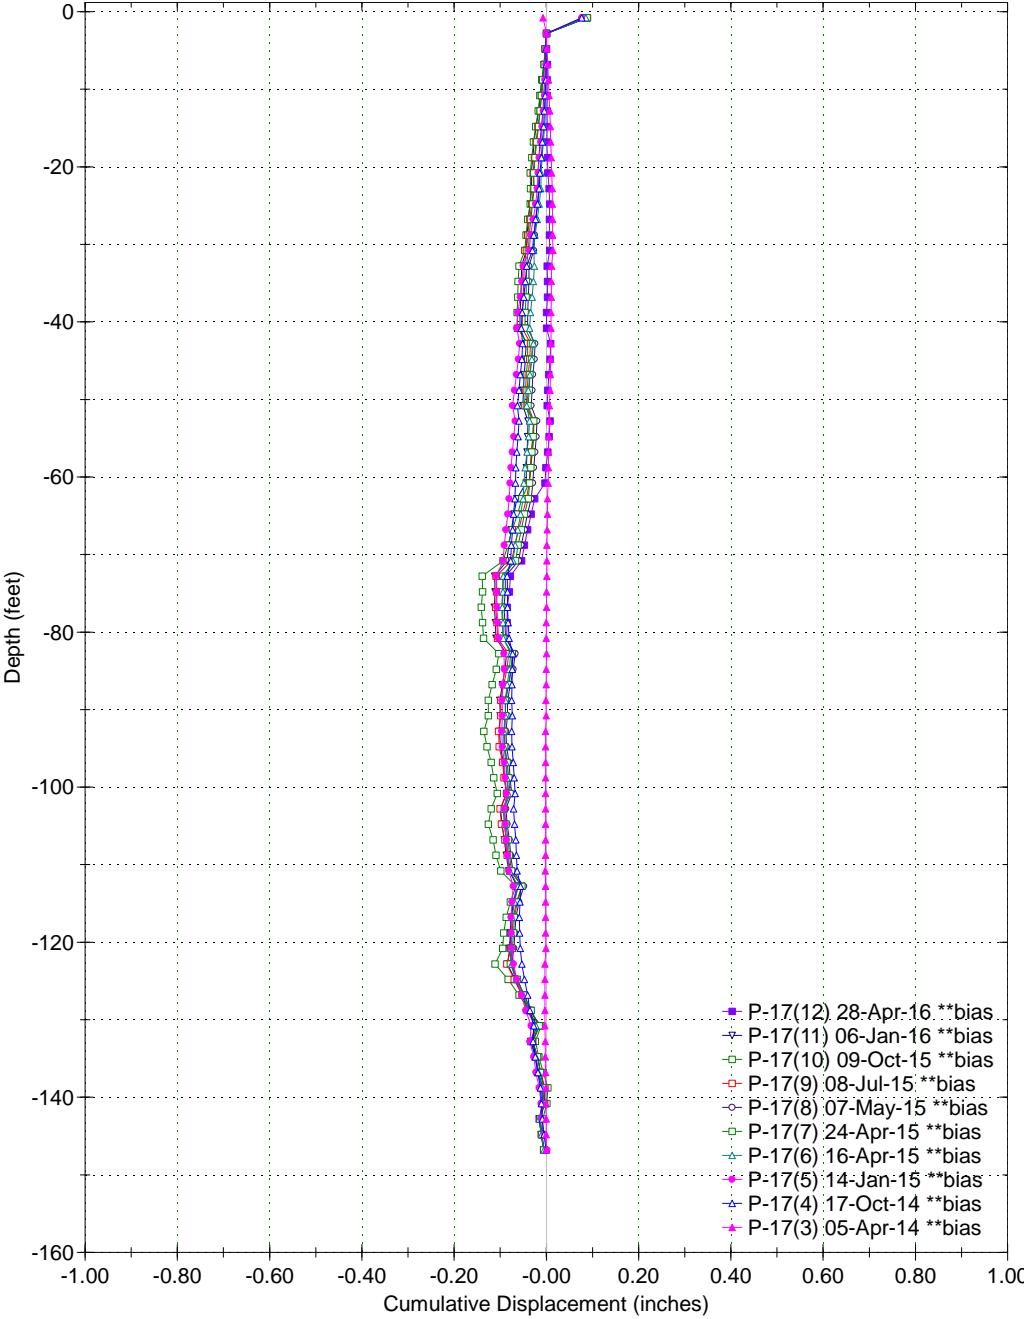
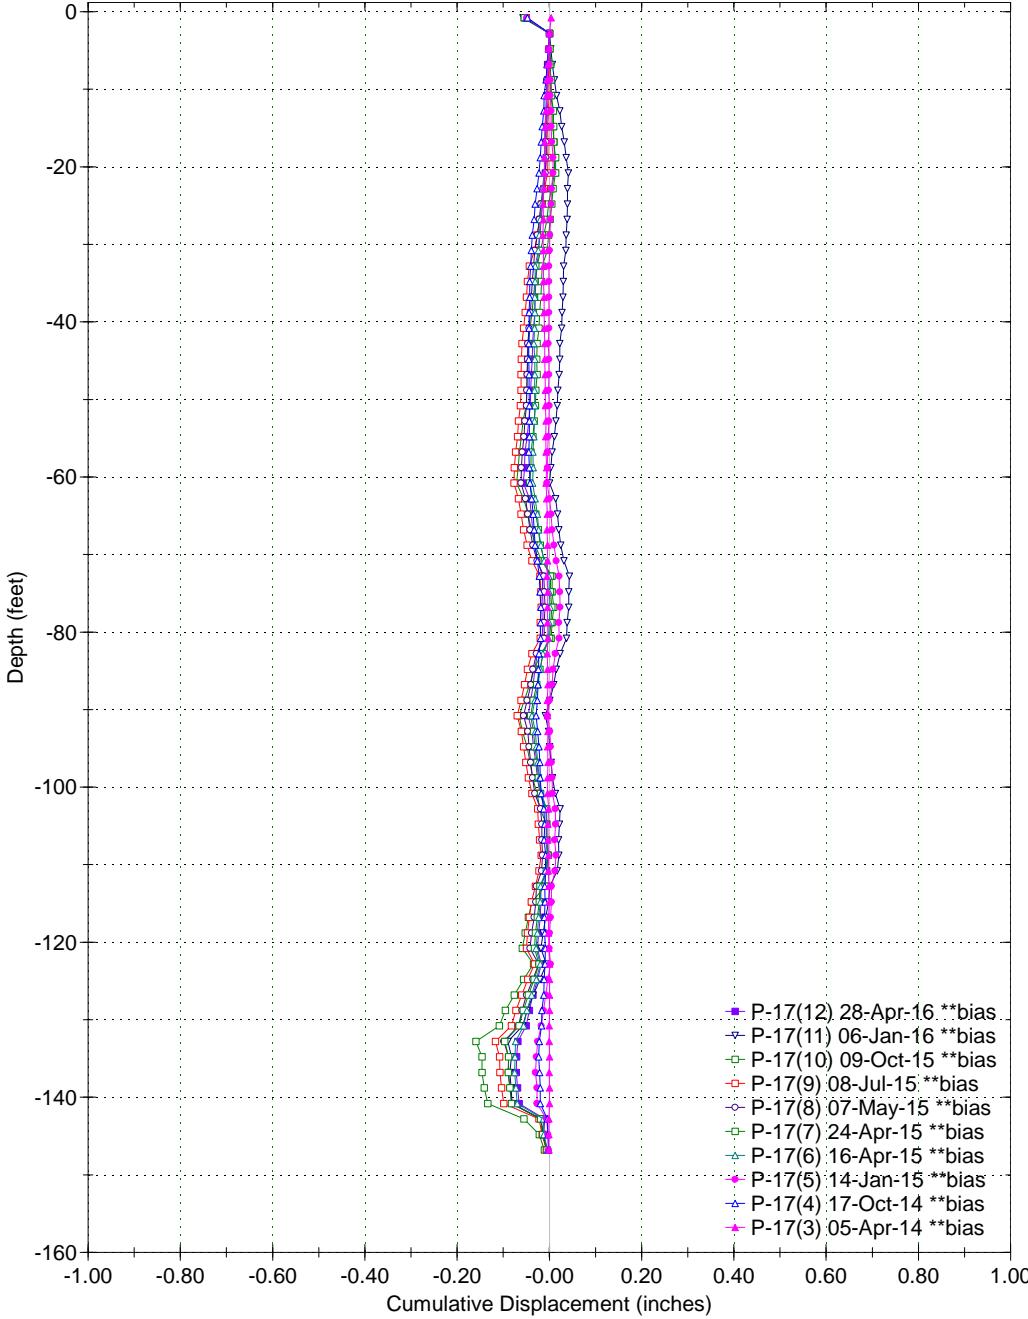
Borehole : P-17
 Project : CUY-90-15-24
 Location : Cleveland, Ohio
 Northing :
 Easting :
 Collar :

P-17. Inclinometer readings at this location indicate positive A-axis and negative B-axis displacement direction from the surface to 70 feet. Maximum displacement was less than 0.1 inches.

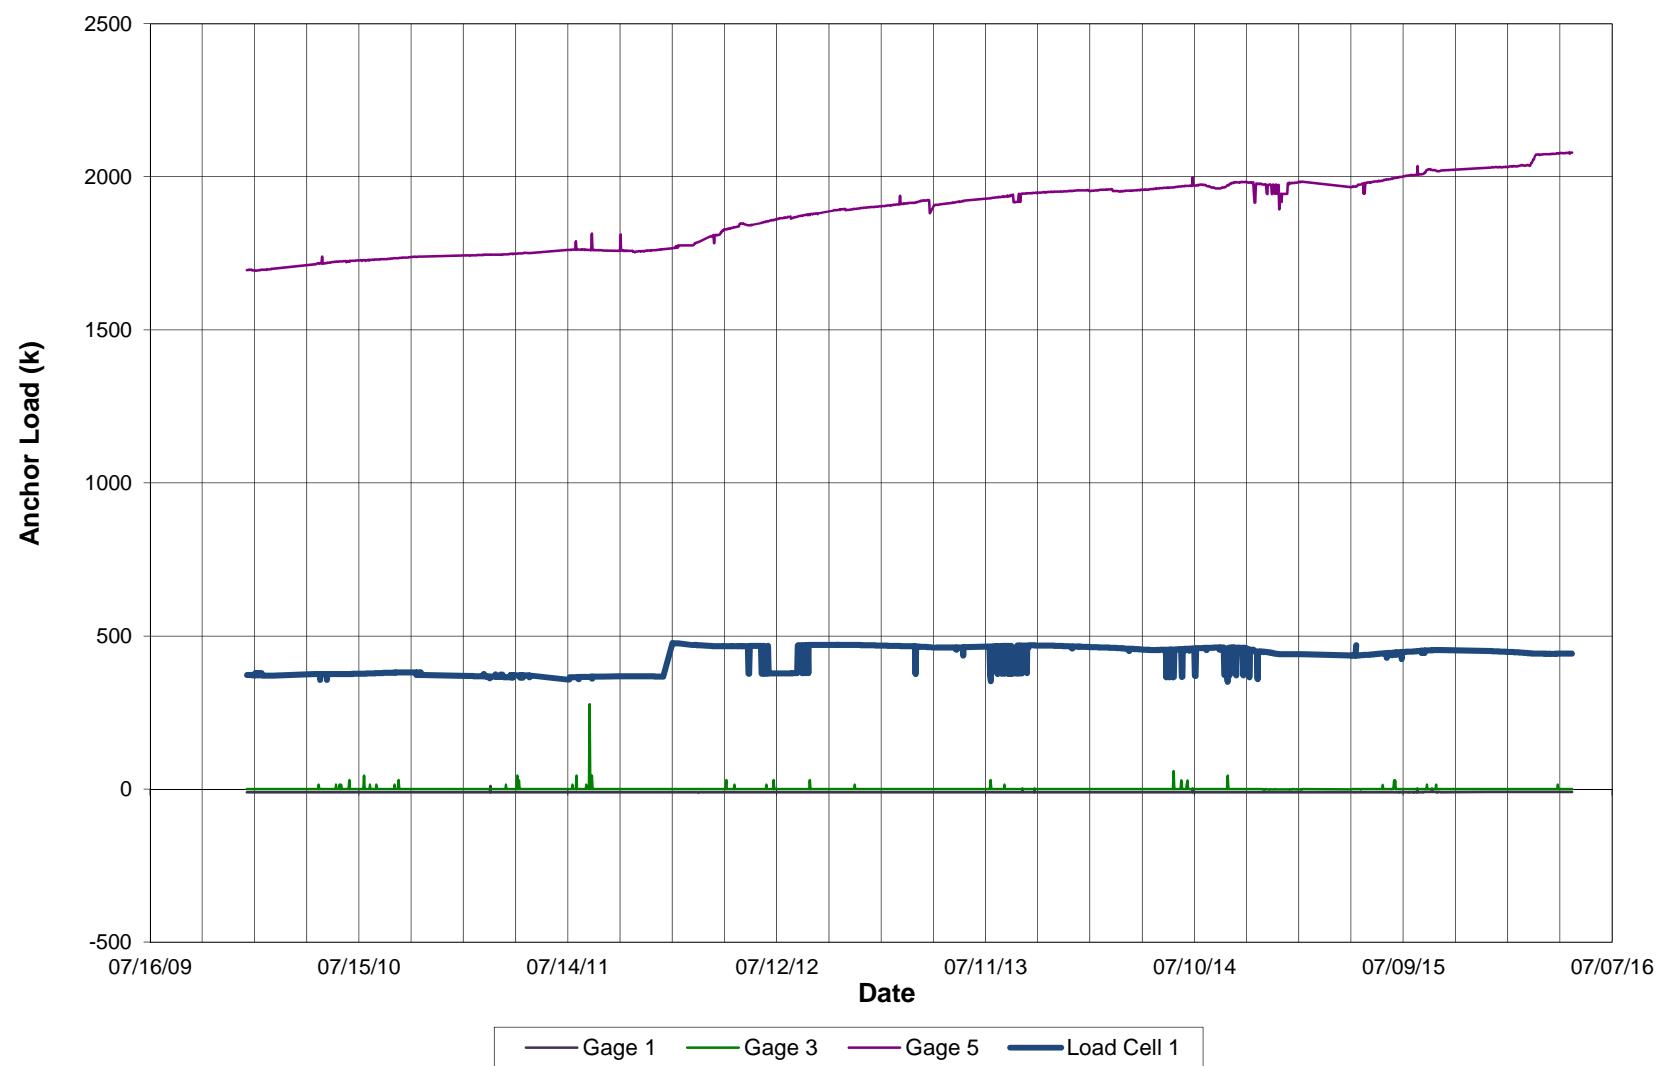
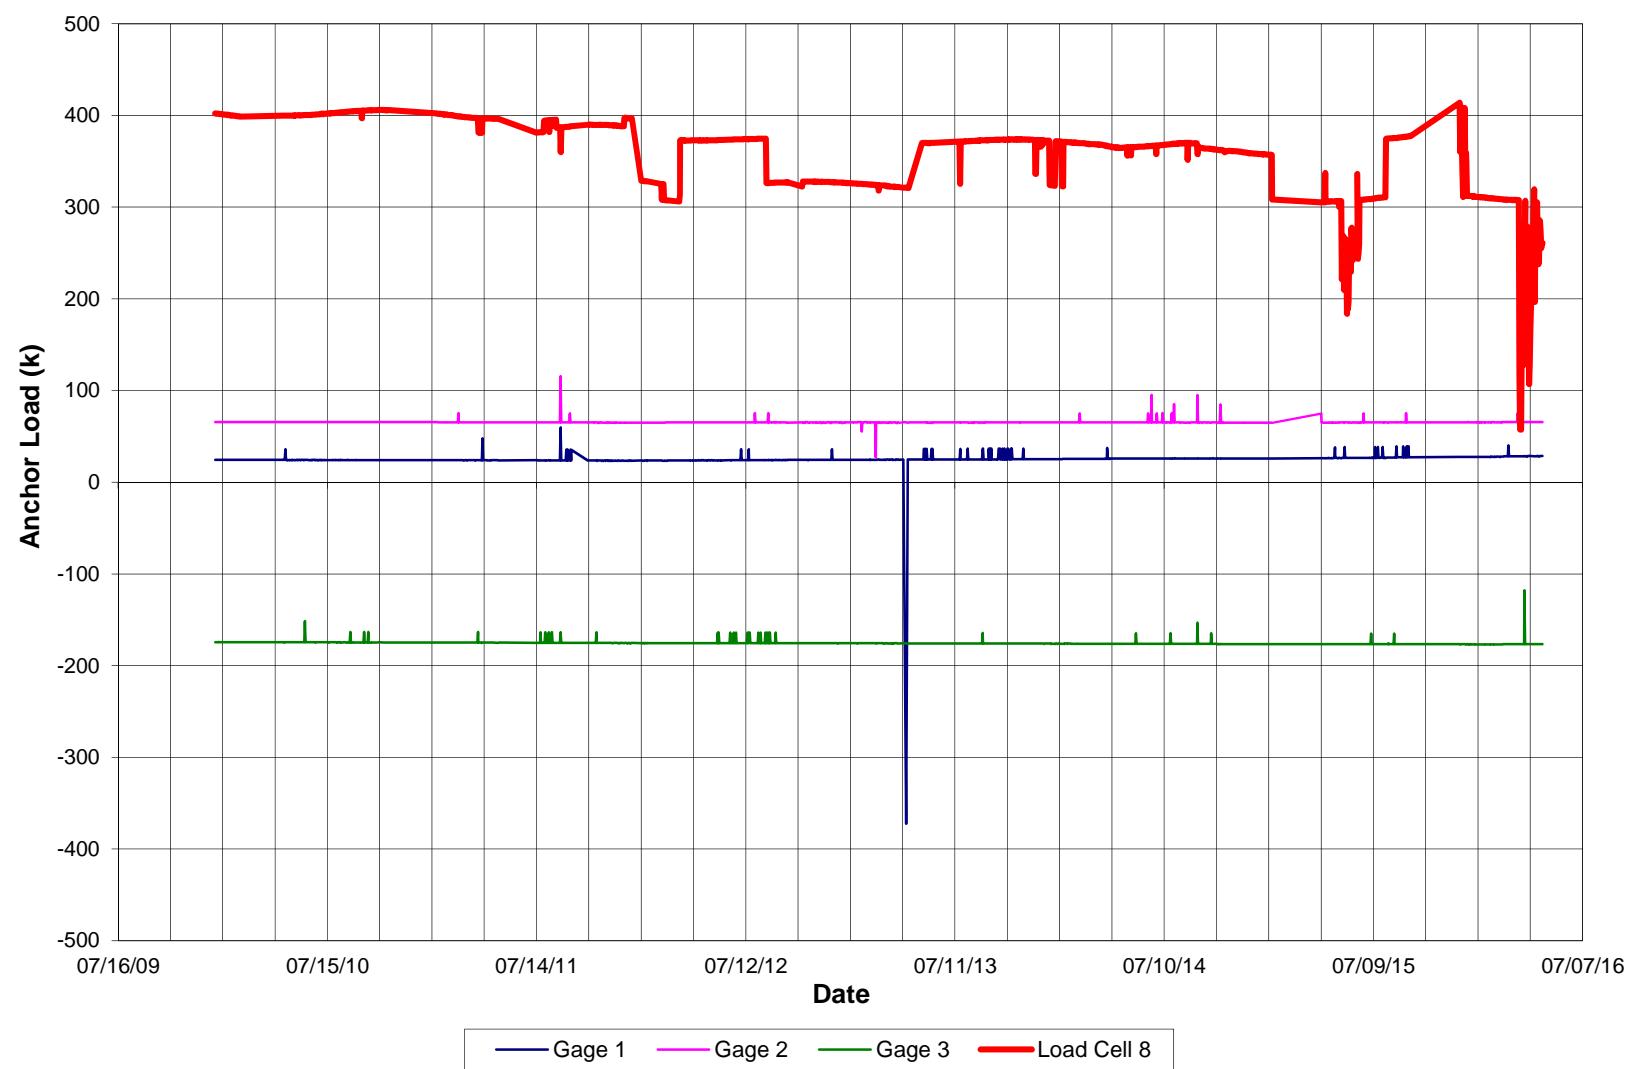
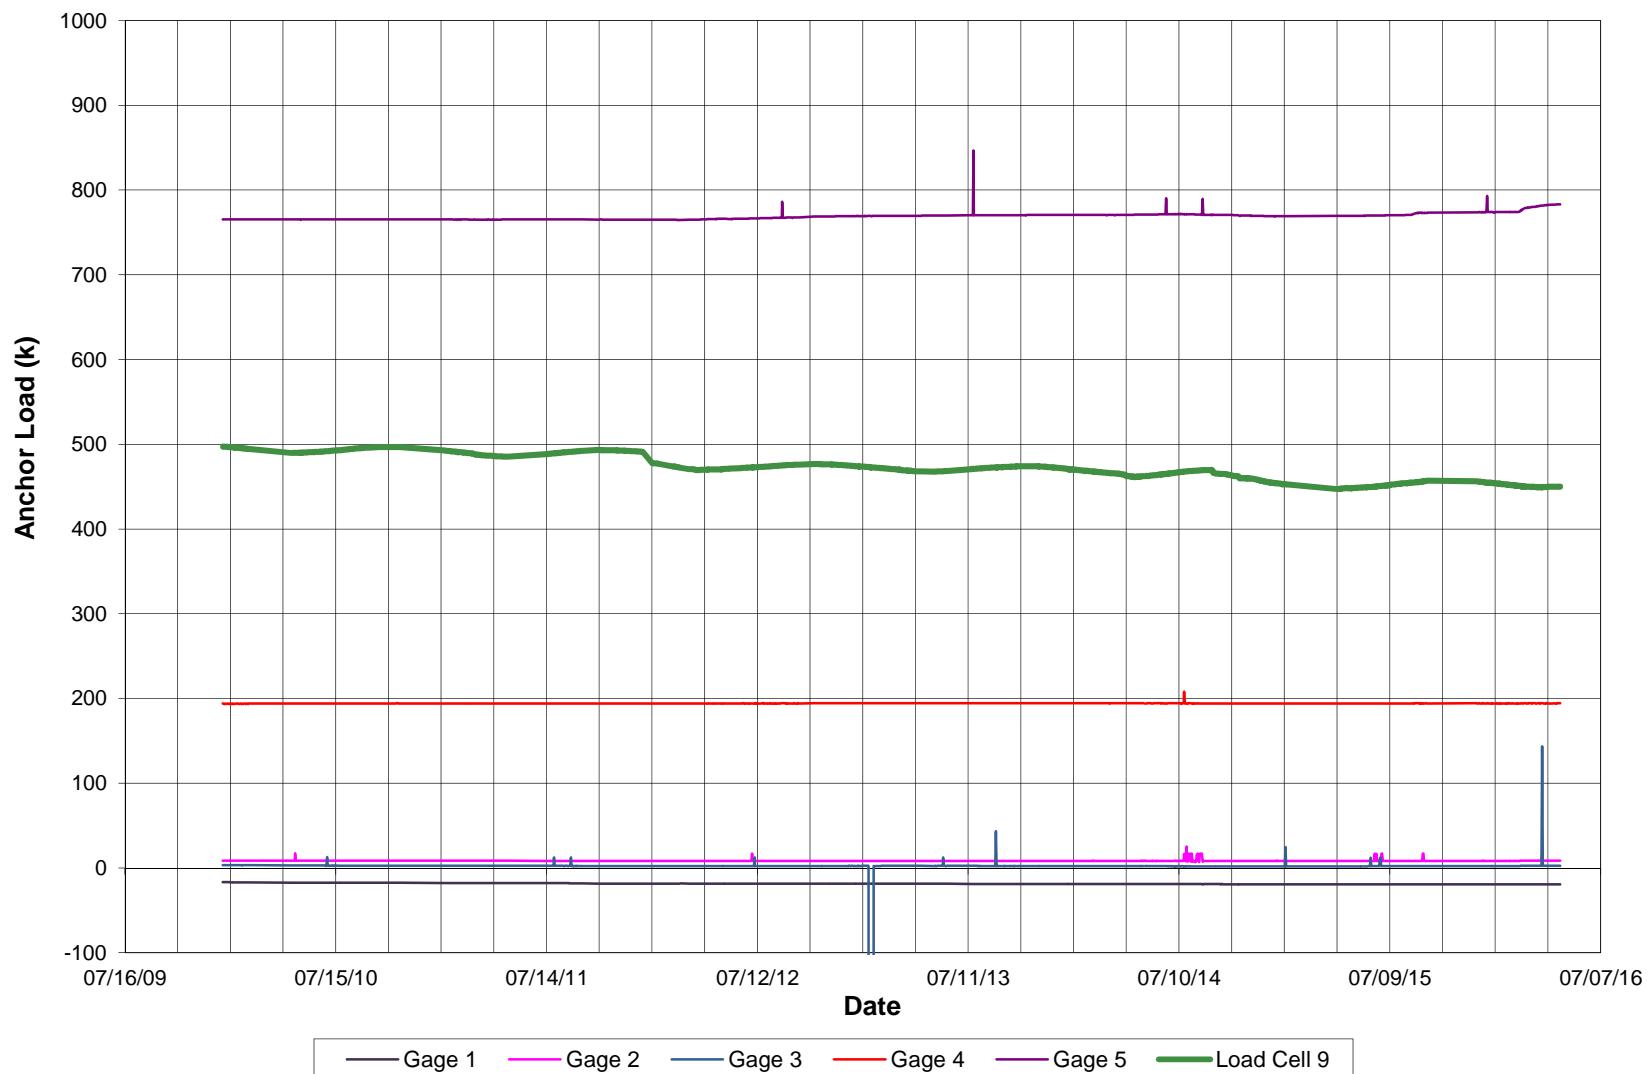
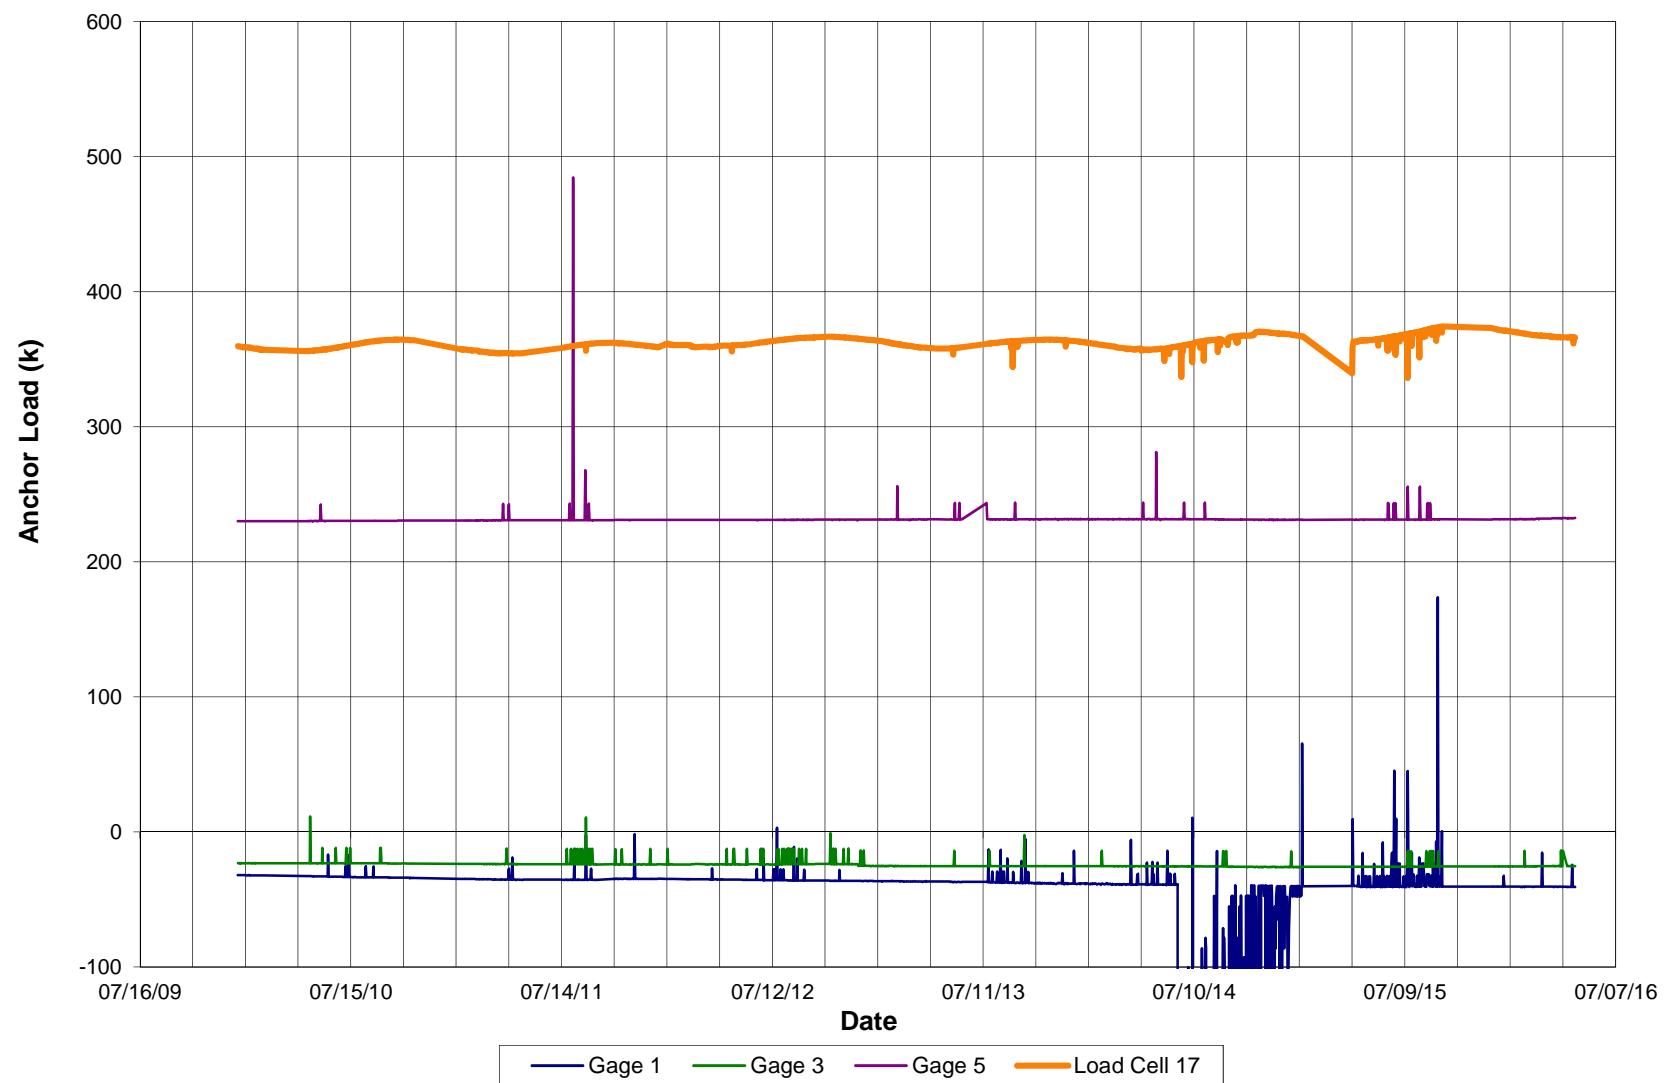
Seasonal variations are apparent in the plots for all of the load cells with the usual decrease in load seen during the winter months. Loads in Load Cells 1 and 9 have continued to trend downward and the load in Load Cell 17 has continued to trend upward. The many spikes shown in the Load Cell 8 plot this quarter occur when one or more of the gauges in the load cell fail to record. Table 2 shows which gages were active in each of the load cells this quarter. A plot of the load cell data is included in Appendix B.
