Re: June 16, 17, and 20, 2016 Bi-Weekly Readings
CUY-90-15.24 Slope Monitoring
PID 96504
SME Project No. 069032.00

Bi-weekly instrument readings for the I-90 west slope taken on June 16, 17, and 20, 2016, are presented in this report. Bi-weekly readings currently include instruments at I/P-001-13, I/P-002-13, I/P-003-10, I/P-004-13, I/P-009-13, B-101, B-102, B-105A, B-05-02, B-05-A-03, B-05-04, B-05-A-11, P-1, P-9N, TGR I-2, and TGR I-4. Changes reported for the individual instruments are for the previous two-week period unless noted otherwise.

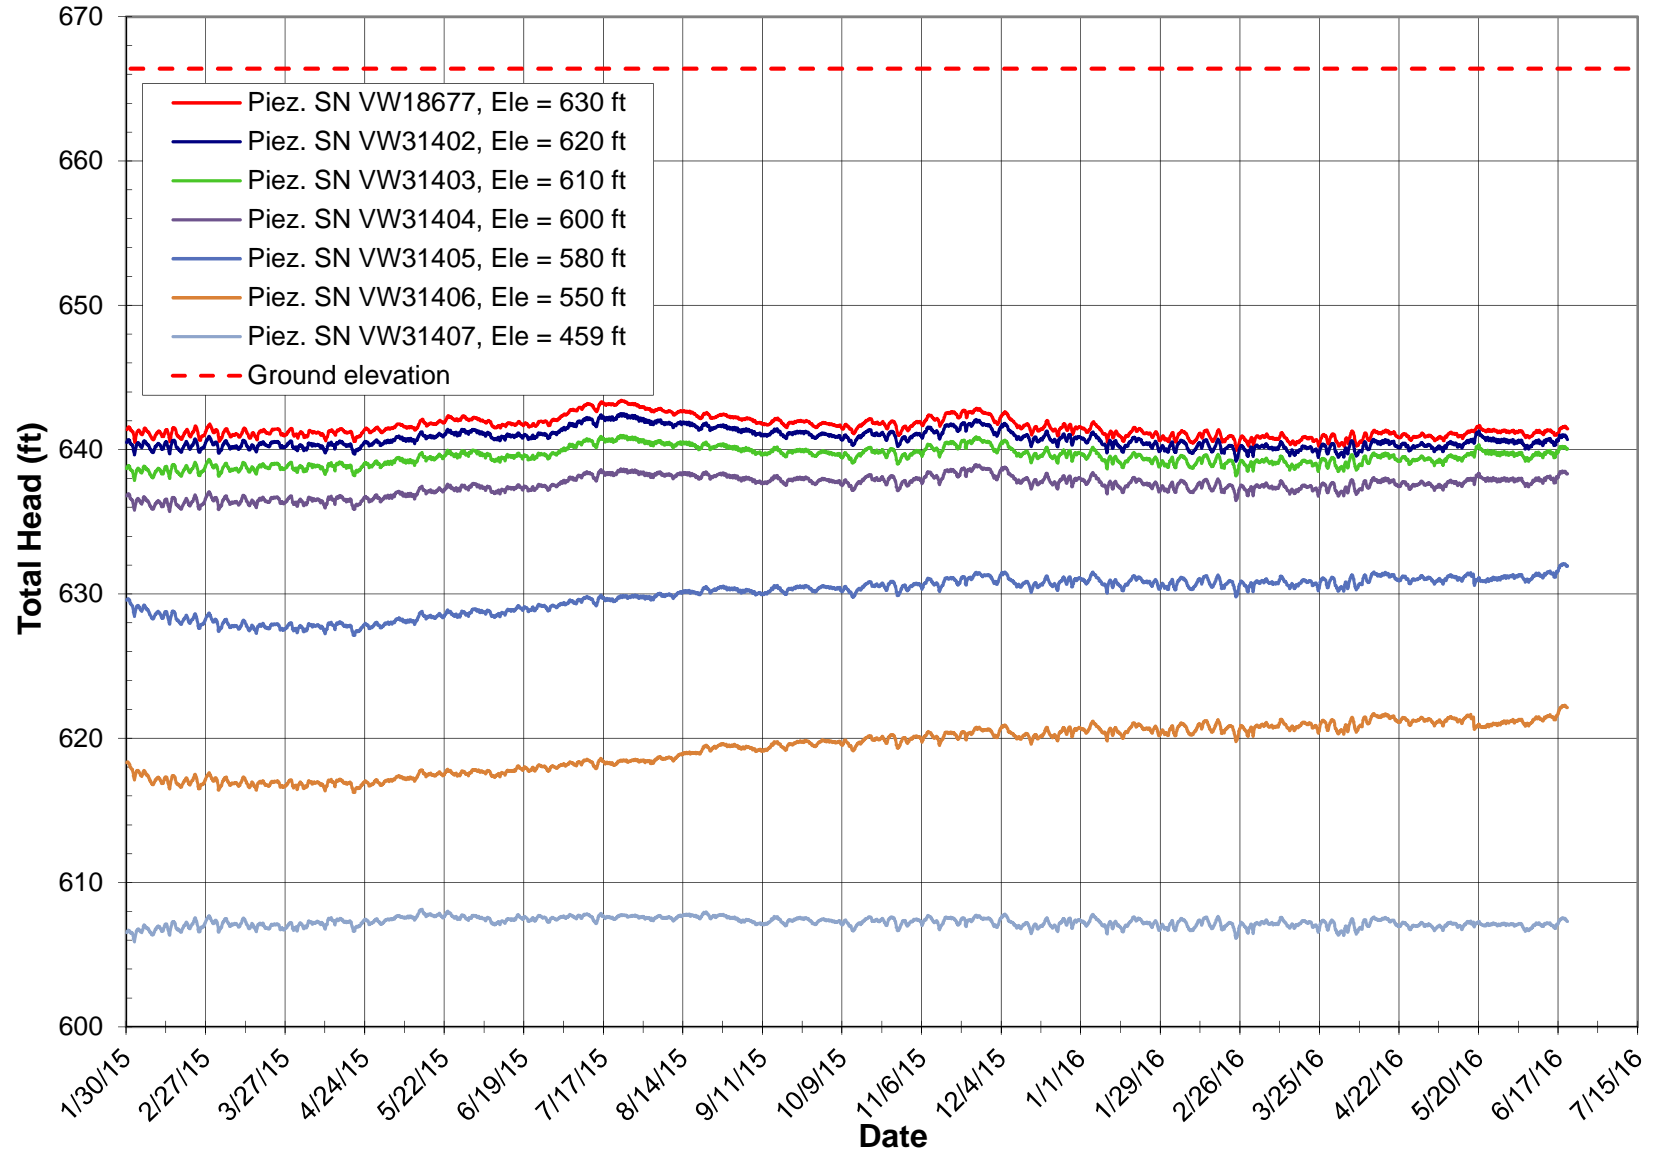
P-001-13 VW Piezometer Readings

P-001-13 – At this location, pore pressure readings indicate an increase in total head of about 1 foot in the piezometers at 86 feet and 116 feet. The remaining piezometers showed virtually no change.

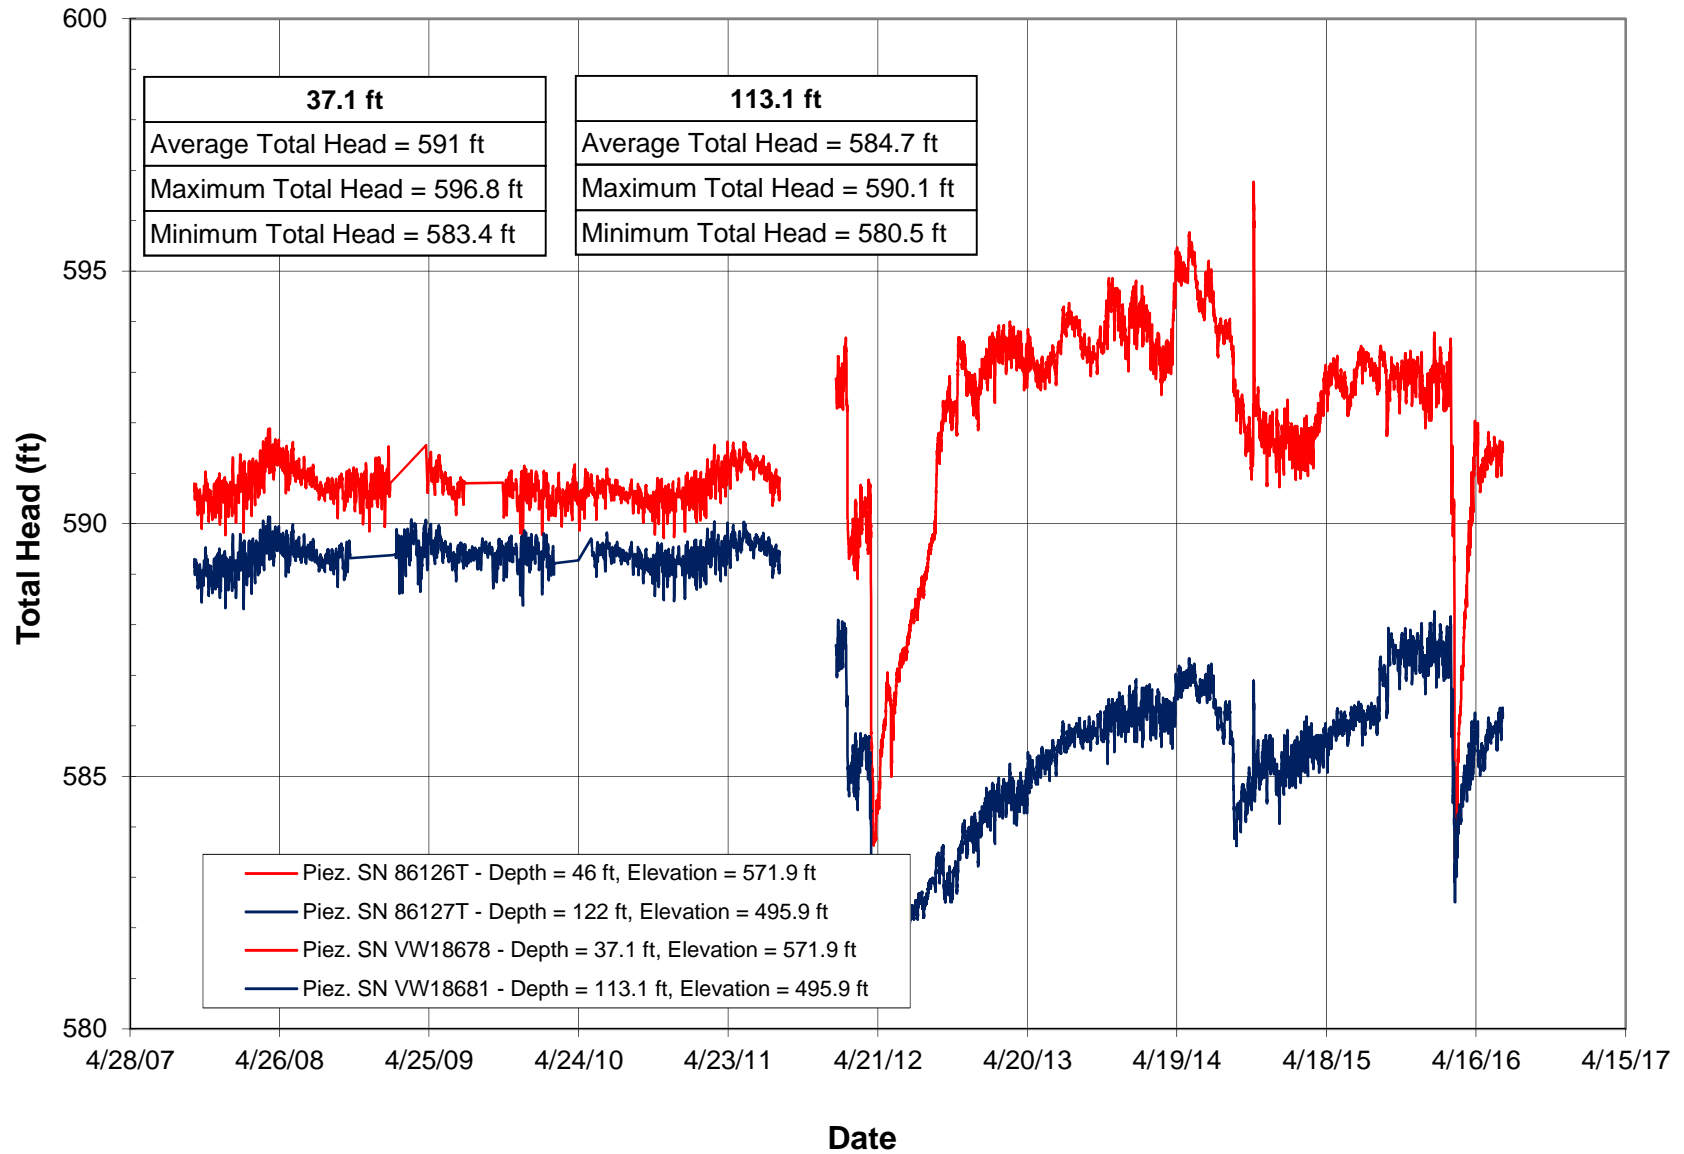
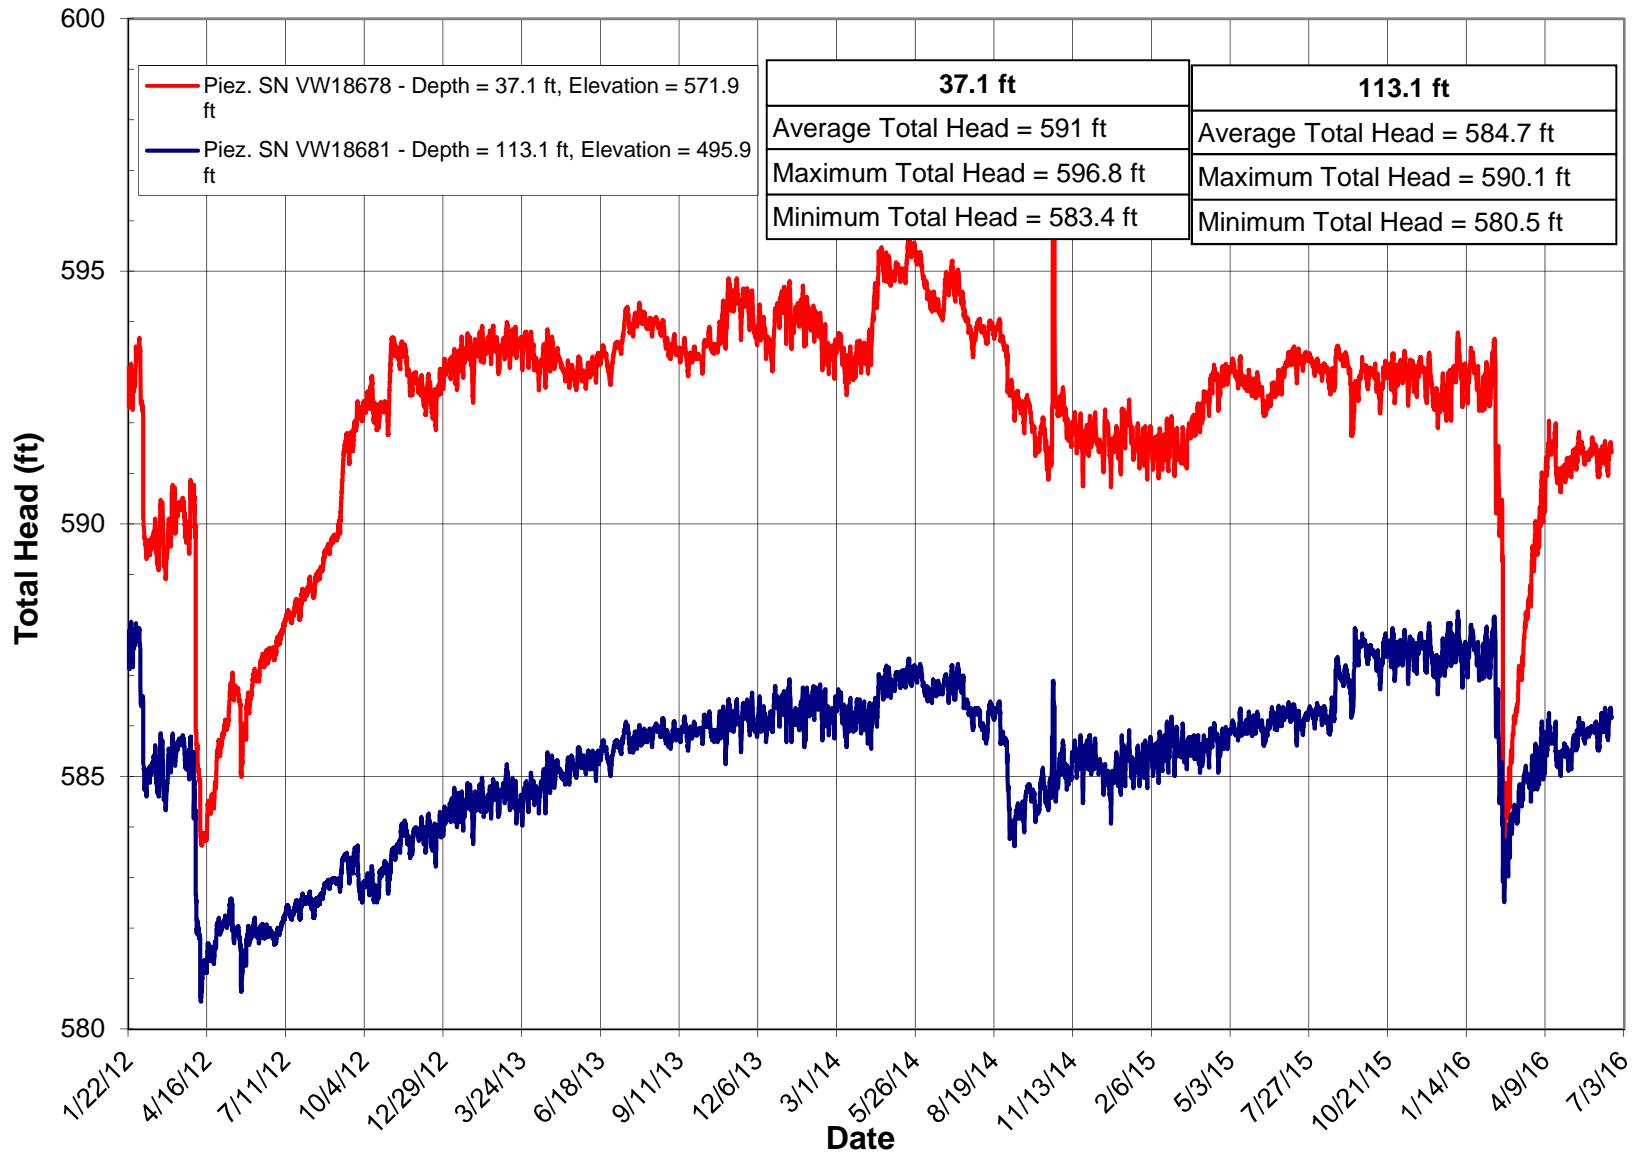
B-05-02 VW Piezometer Readings

B-05-02 – Pore pressure readings for the deep piezometer at this location show that total head increased by about 0.5 feet. Pore pressure readings in the shallow piezometer have remained virtually constant since mid-May 2016.

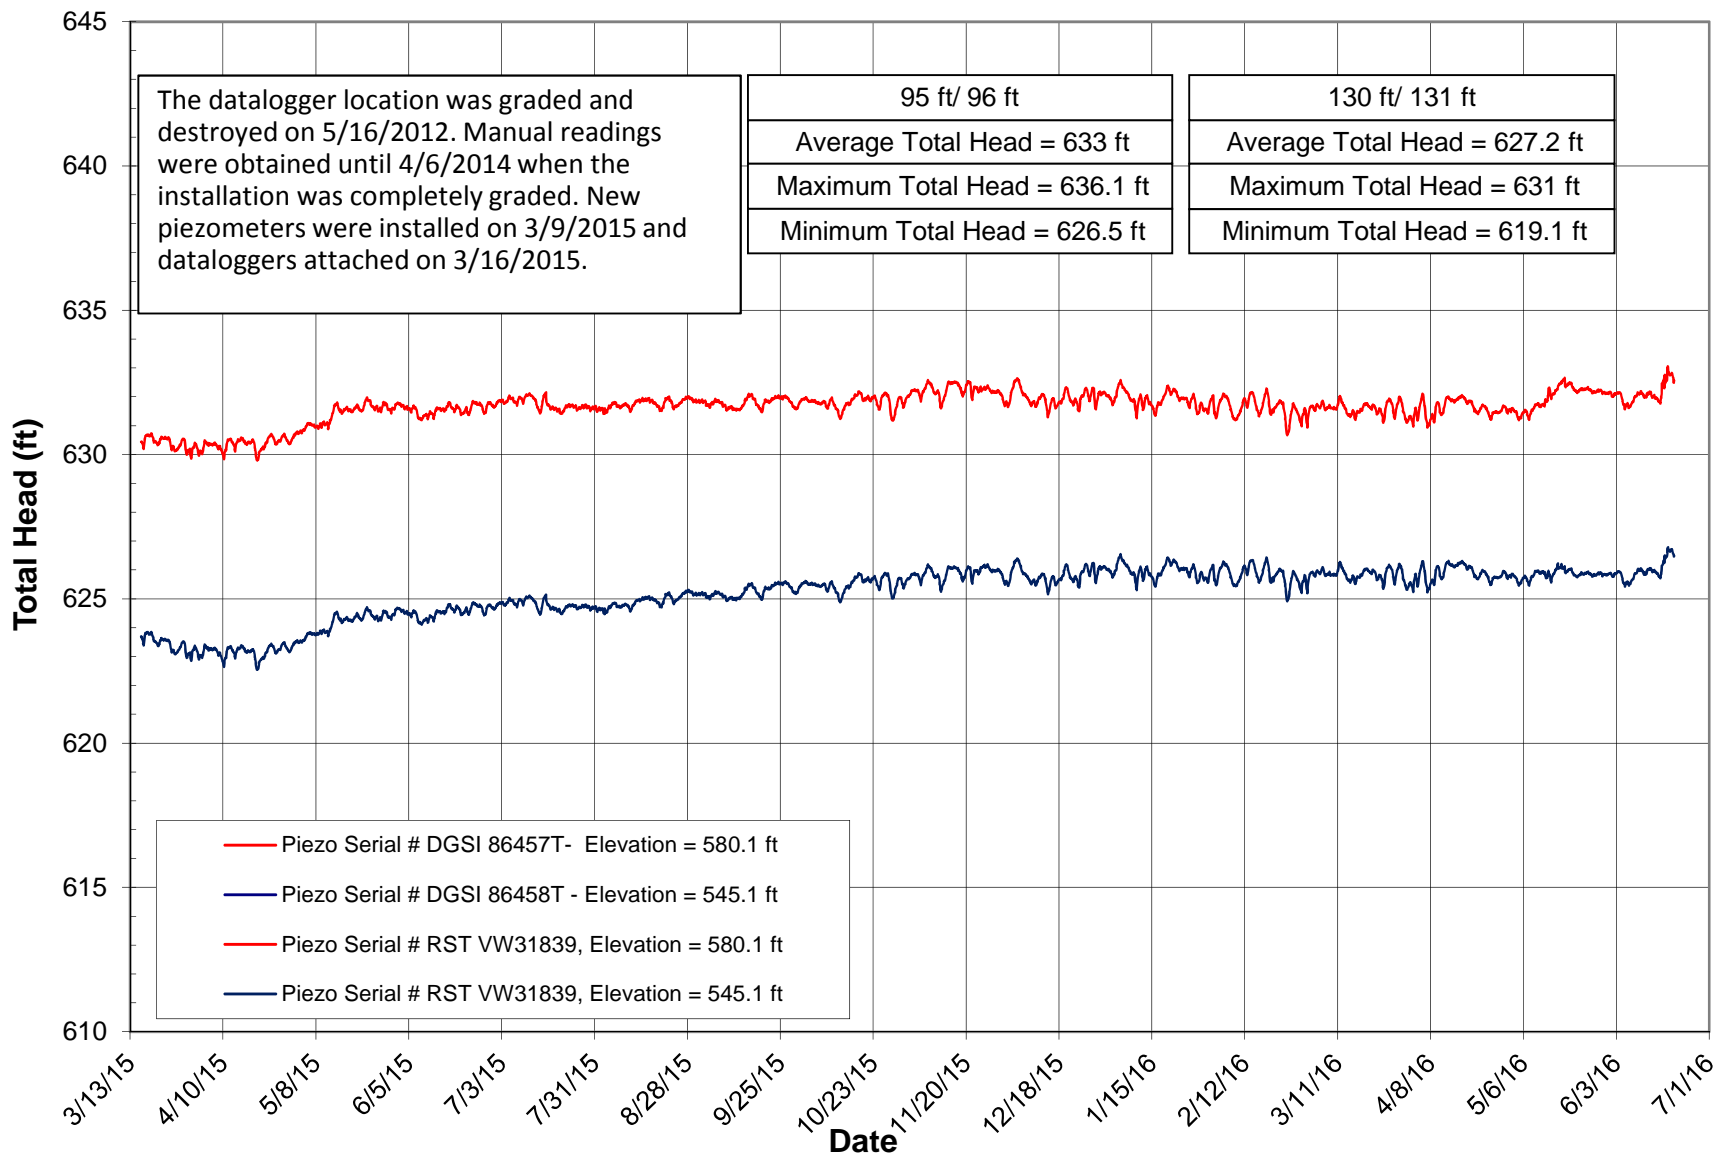
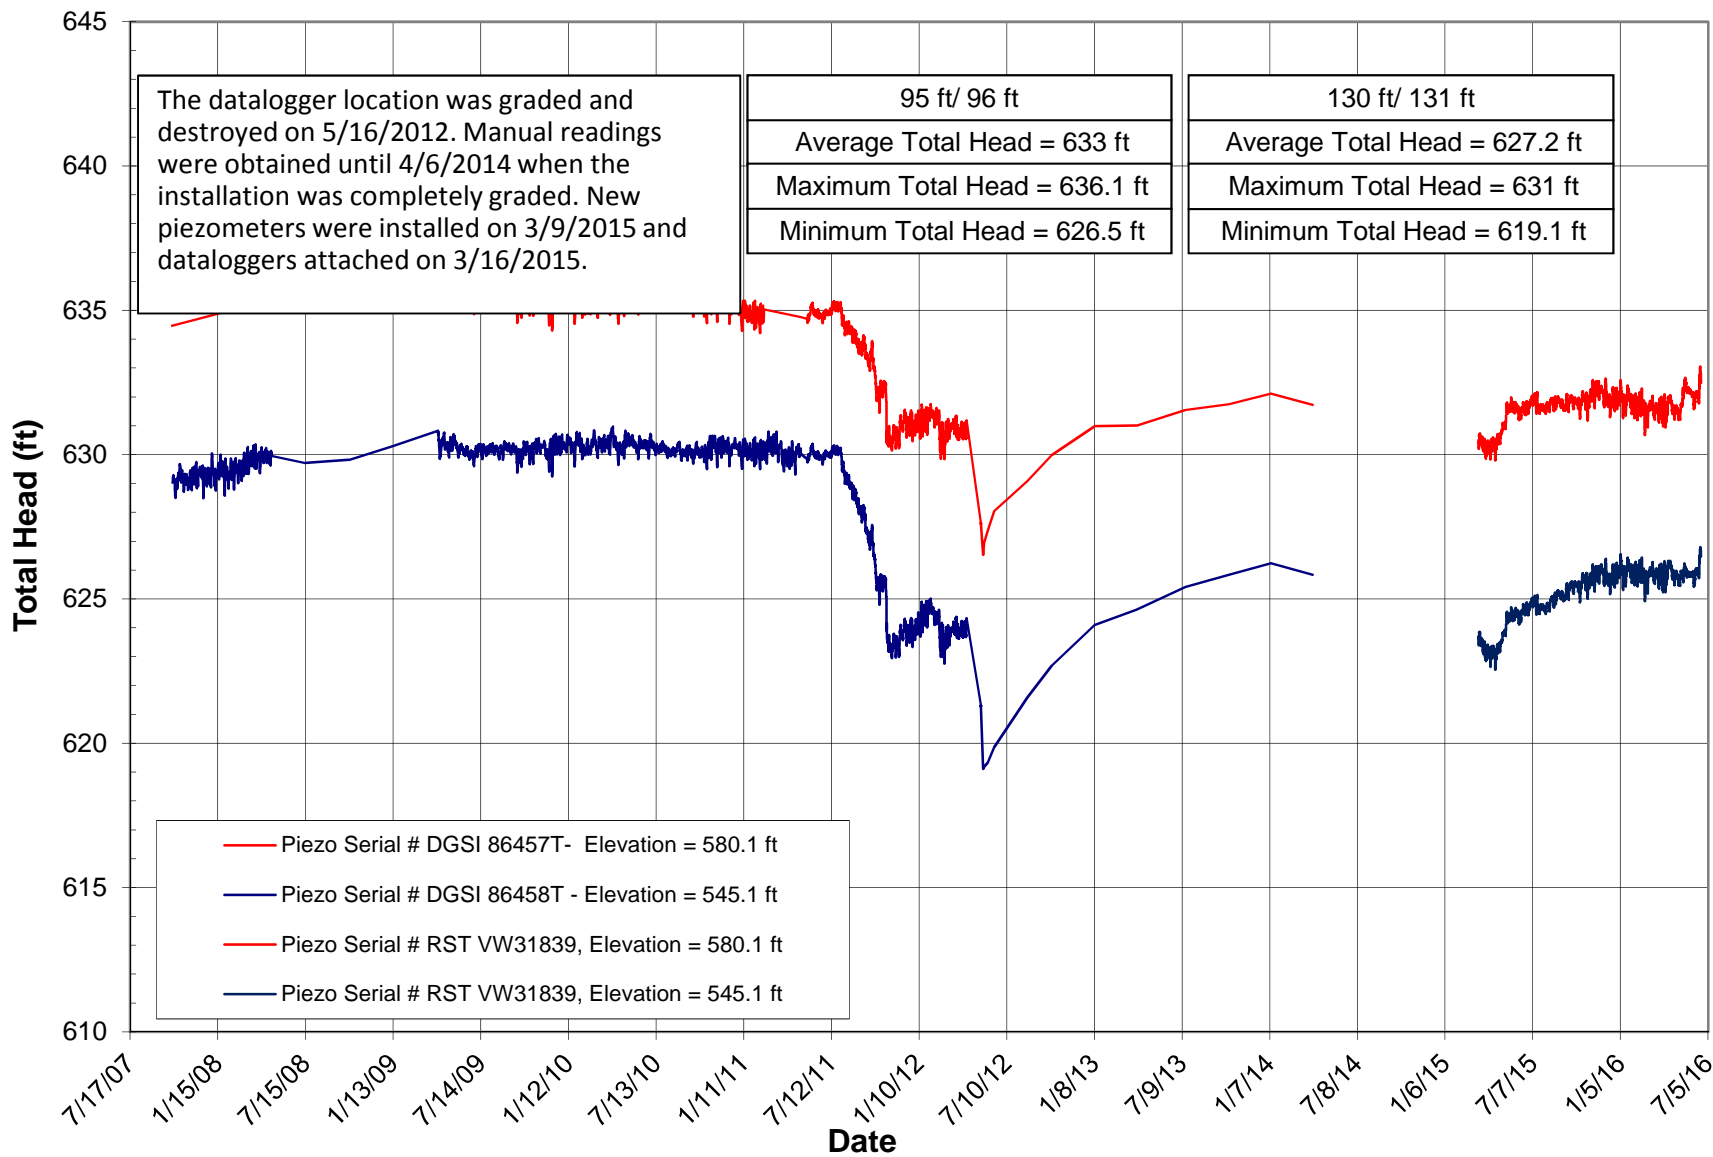
B-05-11/B-05-A-11 VW Piezometer Readings

B-05-A-11 – Pore pressure readings in both piezometers at this location indicate a 1 foot increase in total head just before the end of this two-week period. A temporary crane pad has been constructed on Abbey road near these instruments. This added load is likely the cause of the pore pressure increase.

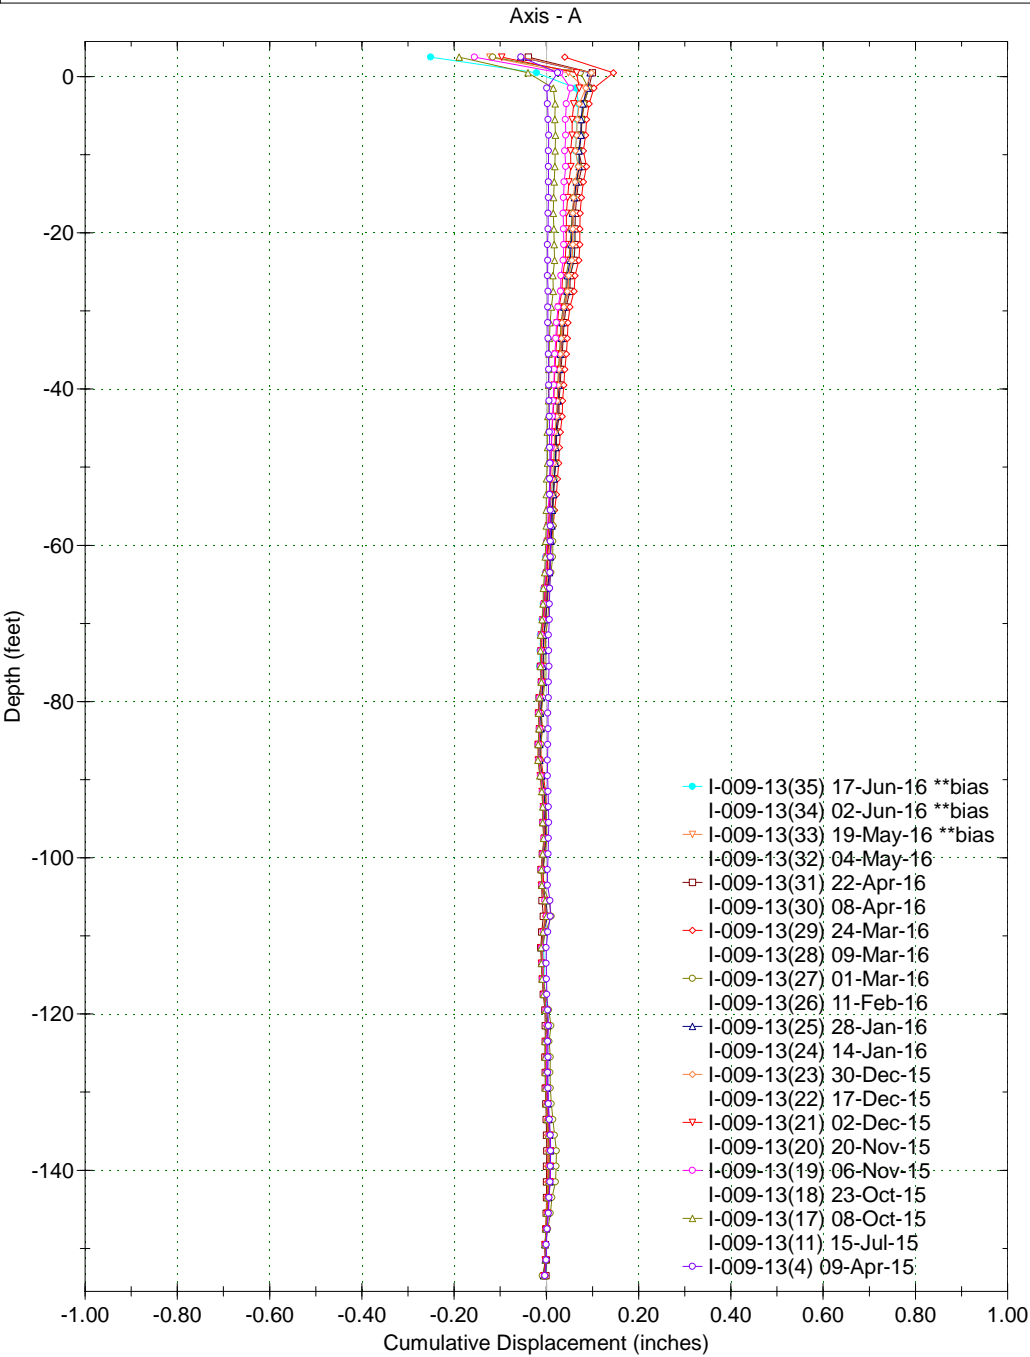
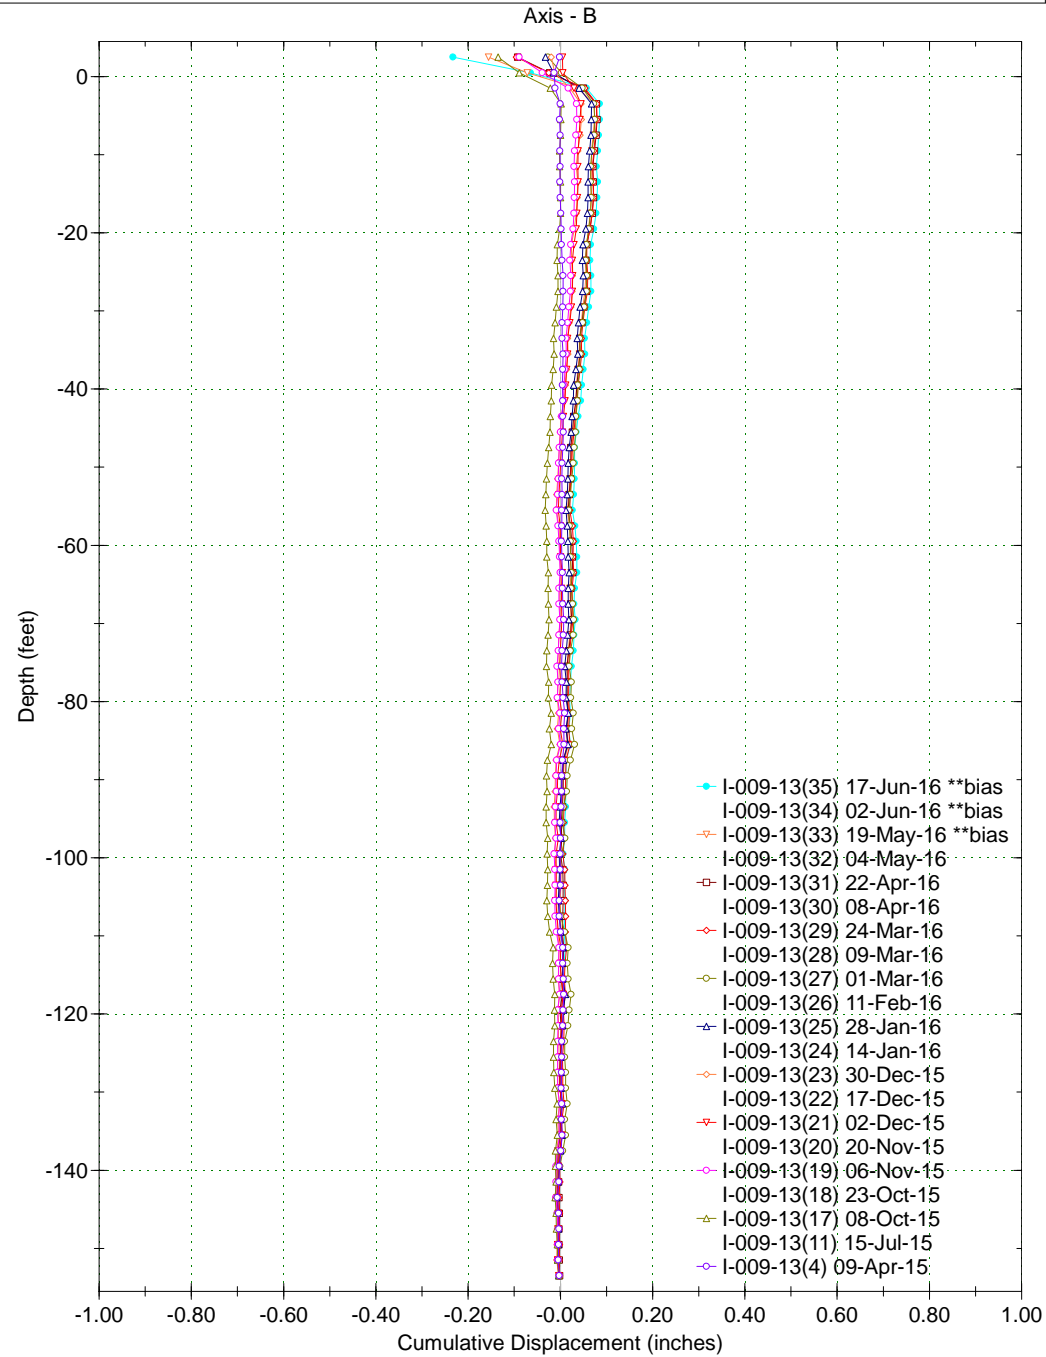
Borehole : I-009-13
 Project : CUY-90-15-24
 Location : Cleveland, Ohio
 Northing :
 Easting :
 Collar :

I-009-13 – Inclinometer readings at this location indicate slight negative A- and B-axis movement at the top of the casing.

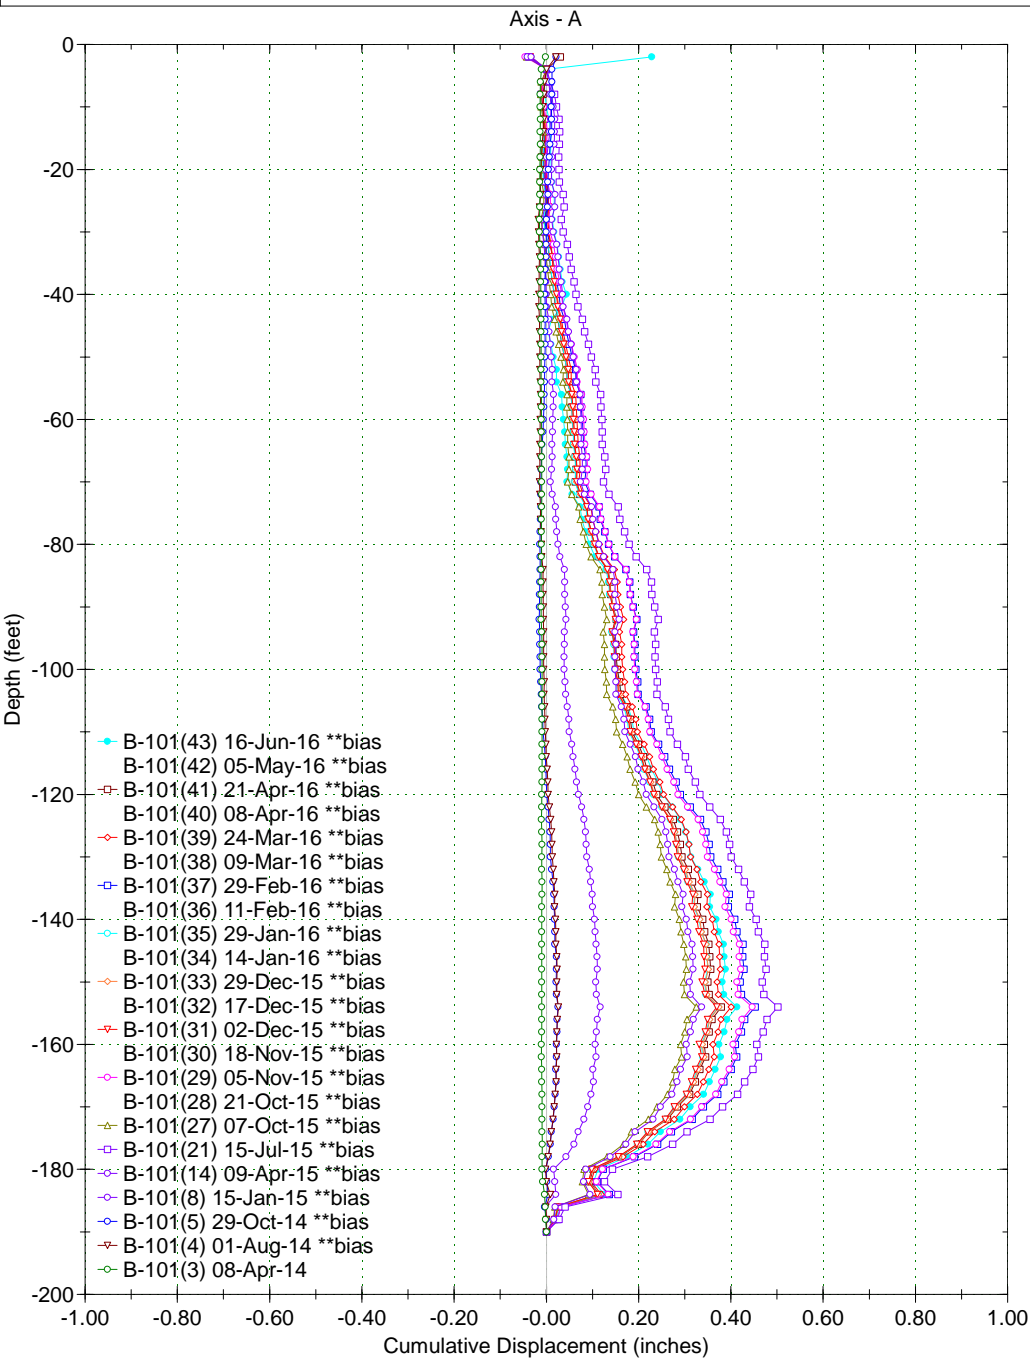
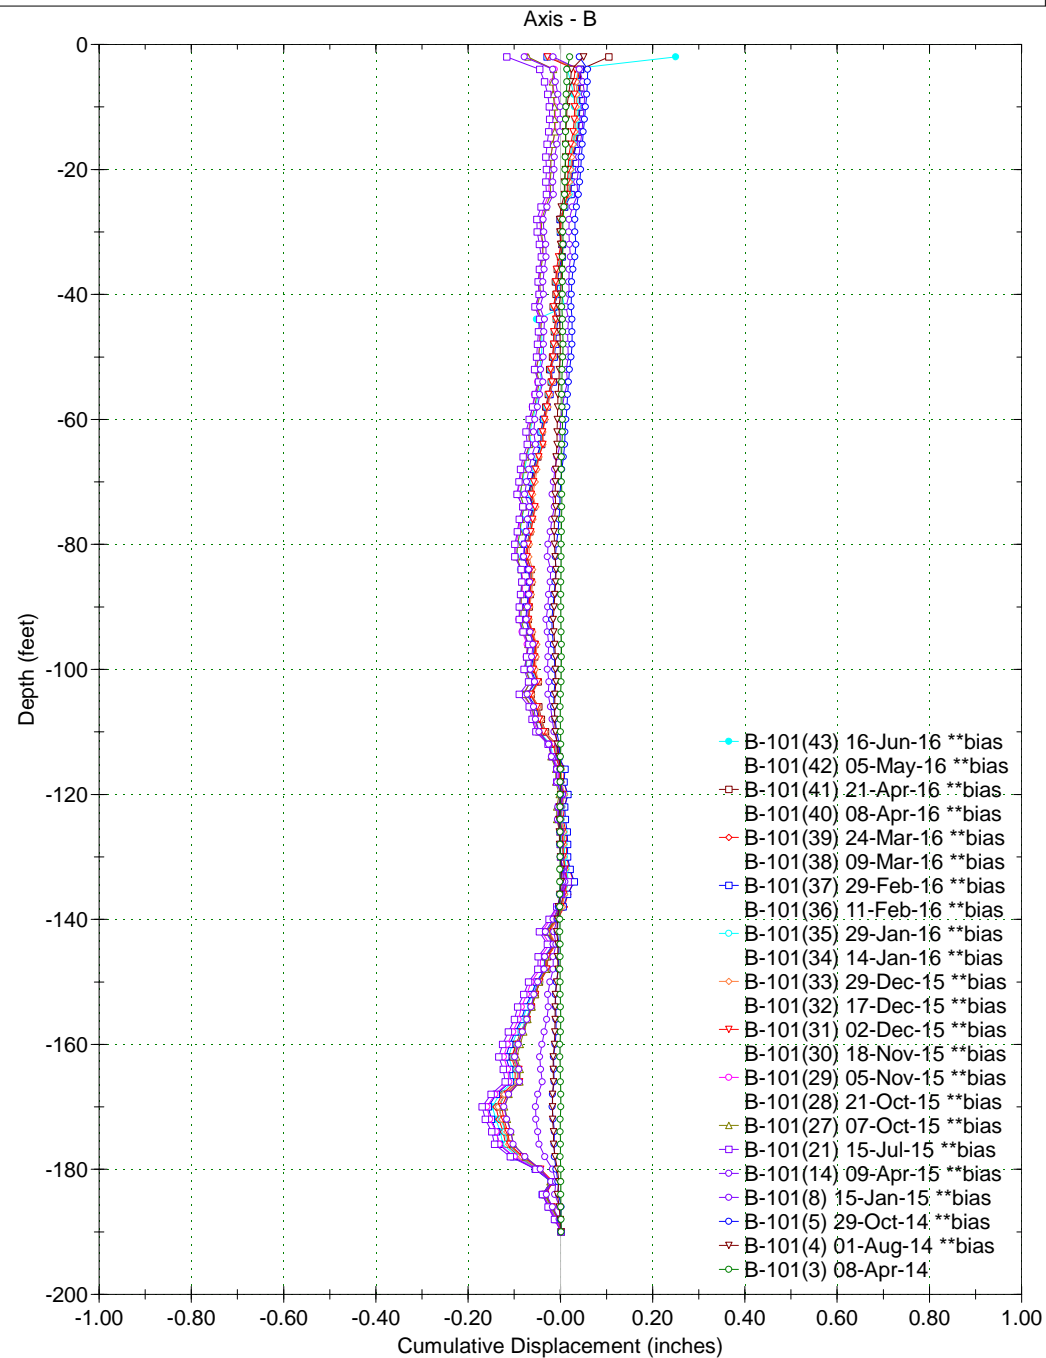
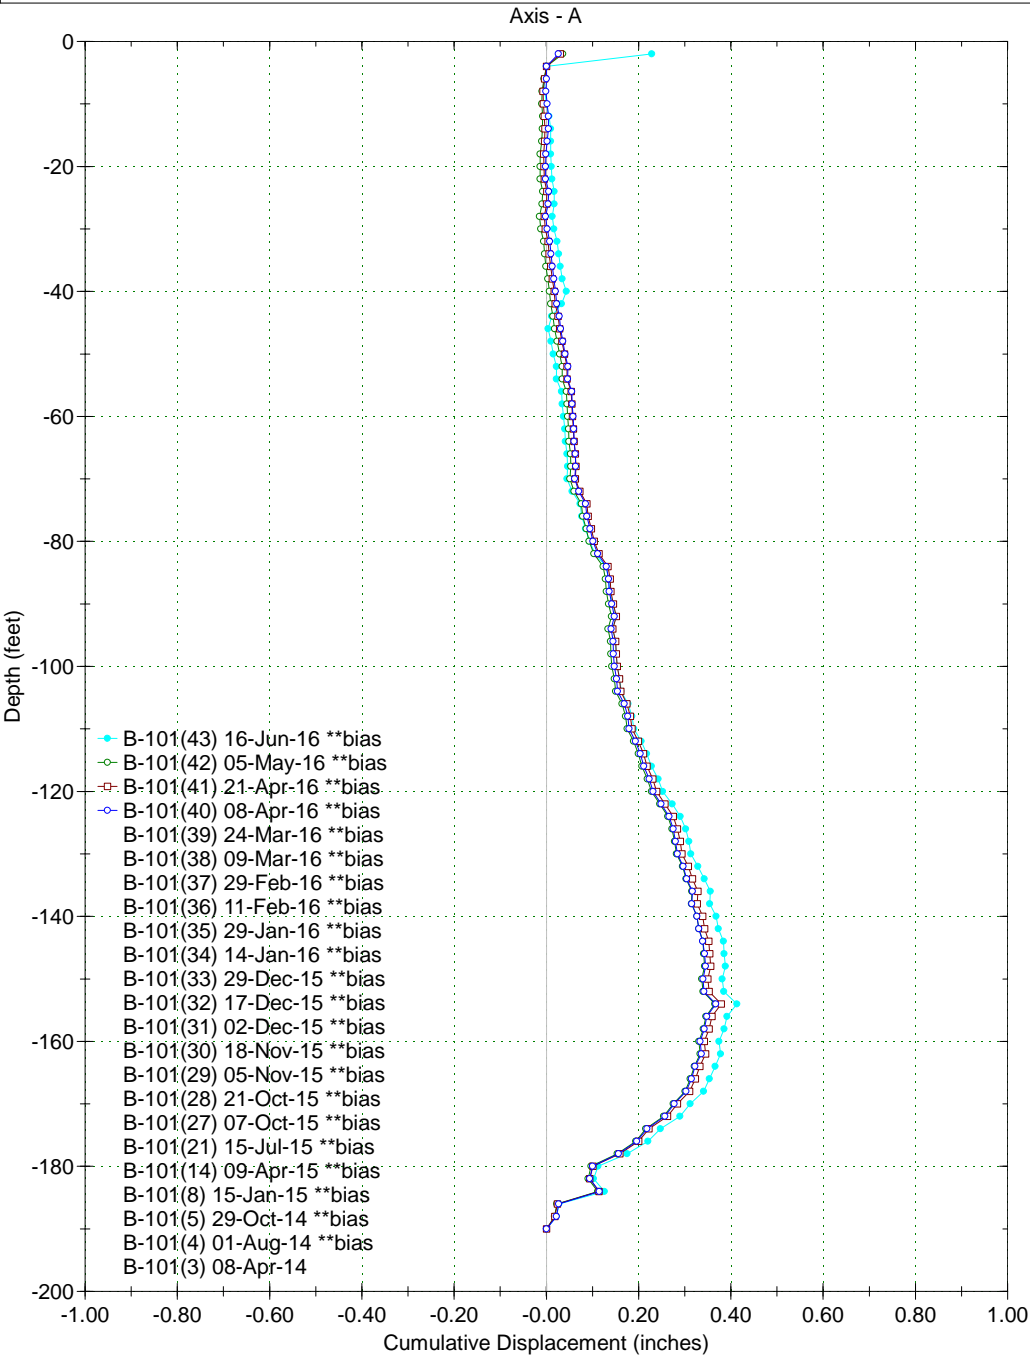
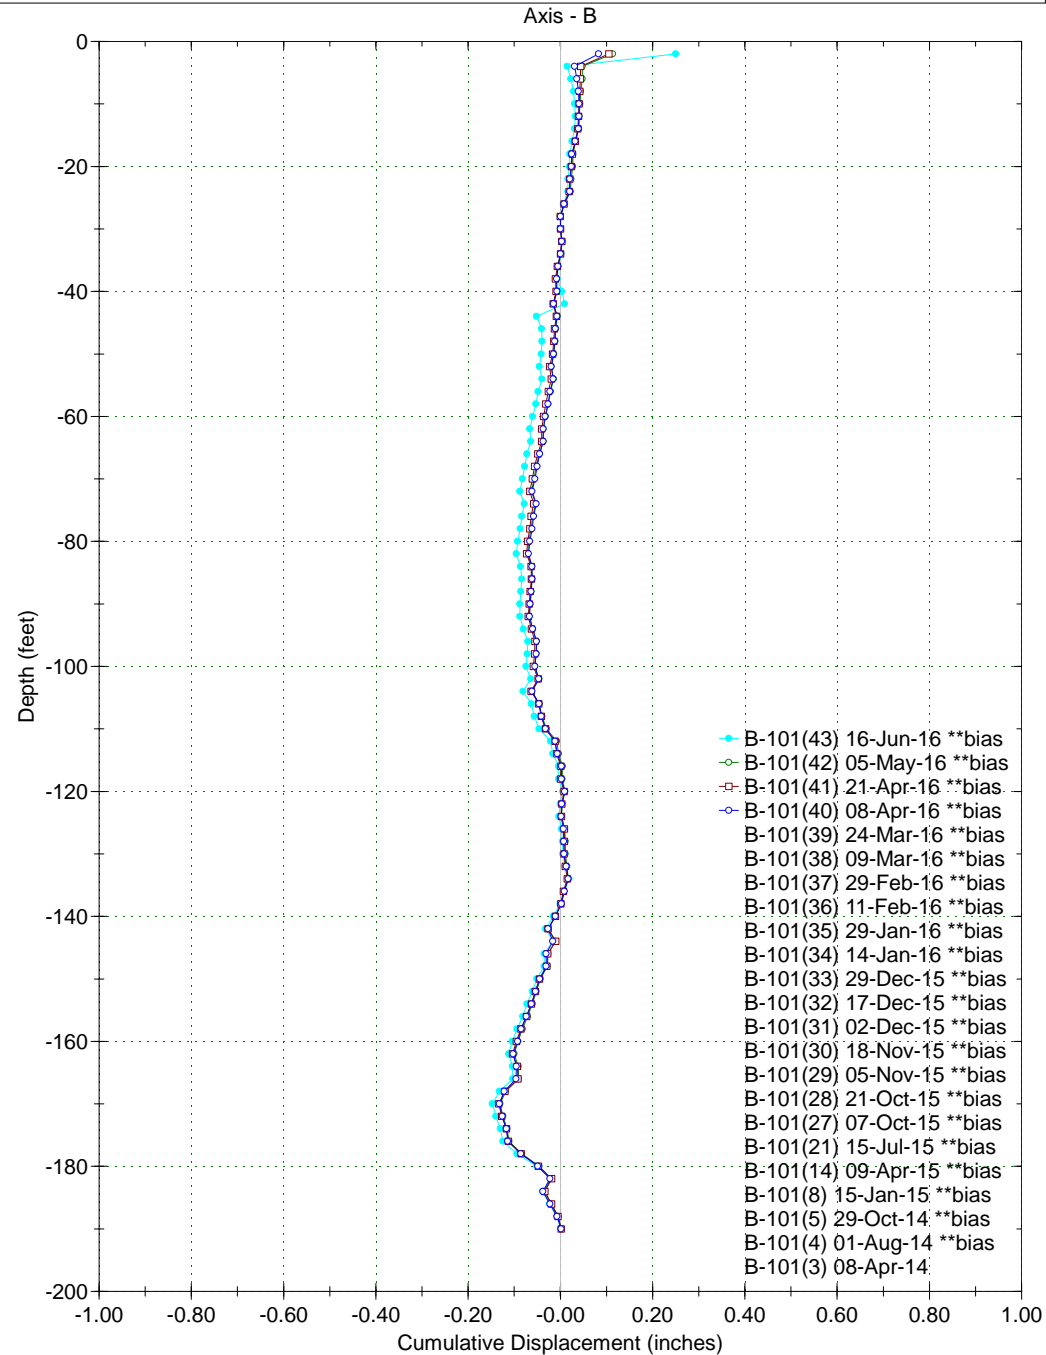
Borehole : B-101
 Project : CUY-90-15-24
 Location : Cleveland, Ohio
 Northing : Sta. 15+06.50
 Easting : 120.7' Rt of CL
 Collar :

B-101 – The inclinometer casing at this location has been uncovered and is now again readable. Readings this week indicate slight movement in the positive A-axis and positive B-axis directions at 42 to 44 feet.
