Re: June 16, 17, and 20, 2016 Bi-Weekly Readings
CUY-90-15.24 Slope Monitoring
PID 96504
SME Project No. 069032.00

Bi-weekly instrument readings for the I-90 west slope taken on June 16, 17, and 20, 2016, are presented in this report. Bi-weekly readings currently include instruments at I/P-001-13, I/P-002-13, I/P-003-10, I/P-004-13, I/P-009-13, B-101, B-102, B-105A, B-05-02, B-05-A-03, B-05-04, B-05-A-11, P-1, P-9N, TGR I-2, and TGR I-4. Changes reported for the individual instruments are for the previous two-week period unless noted otherwise.

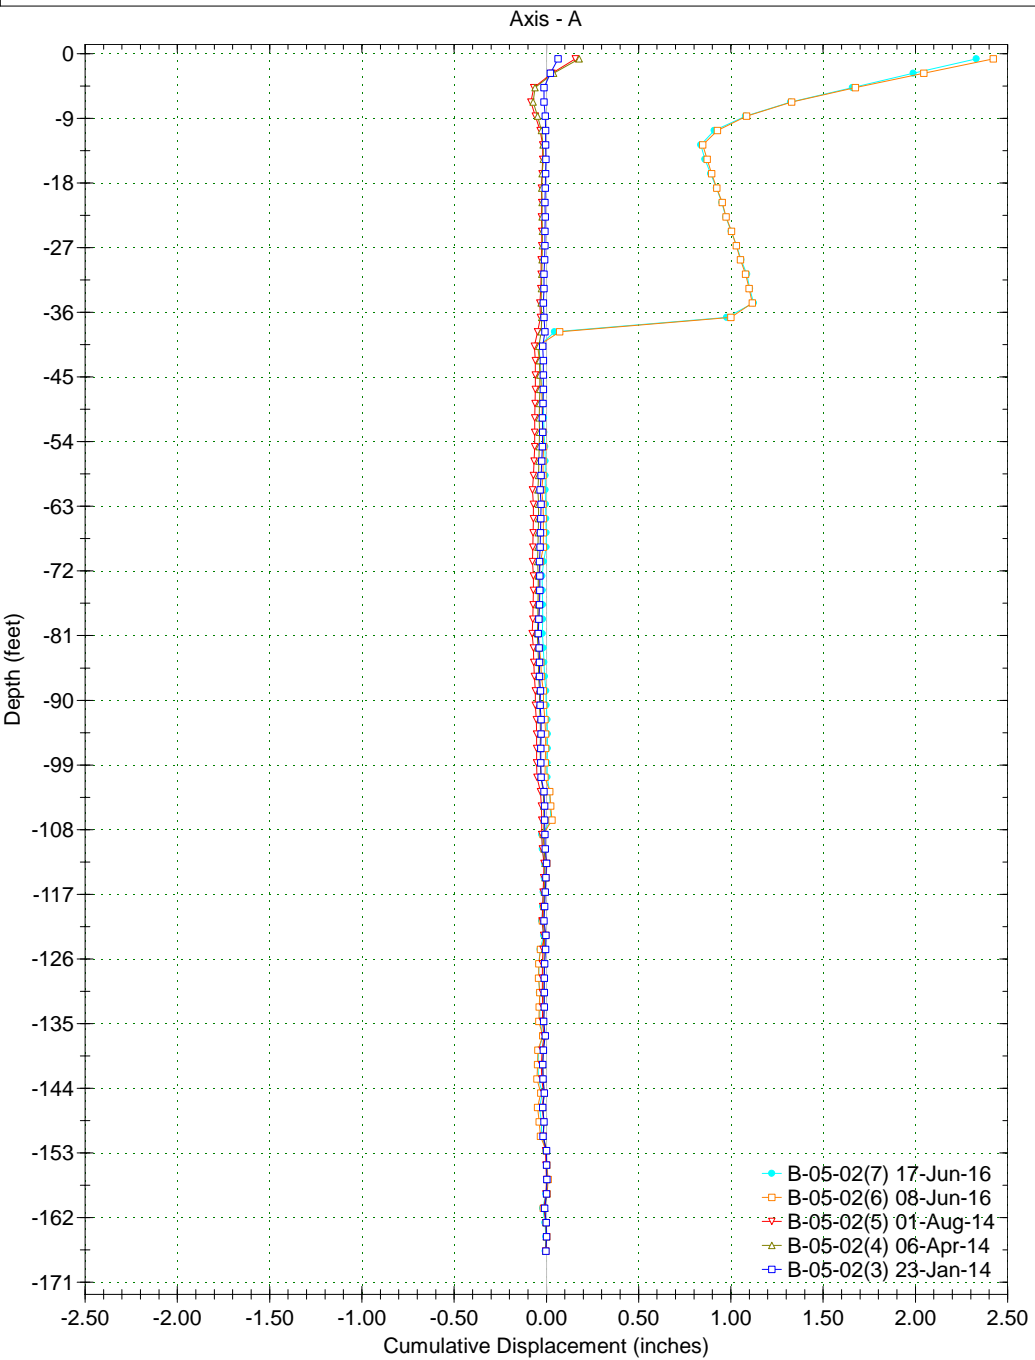
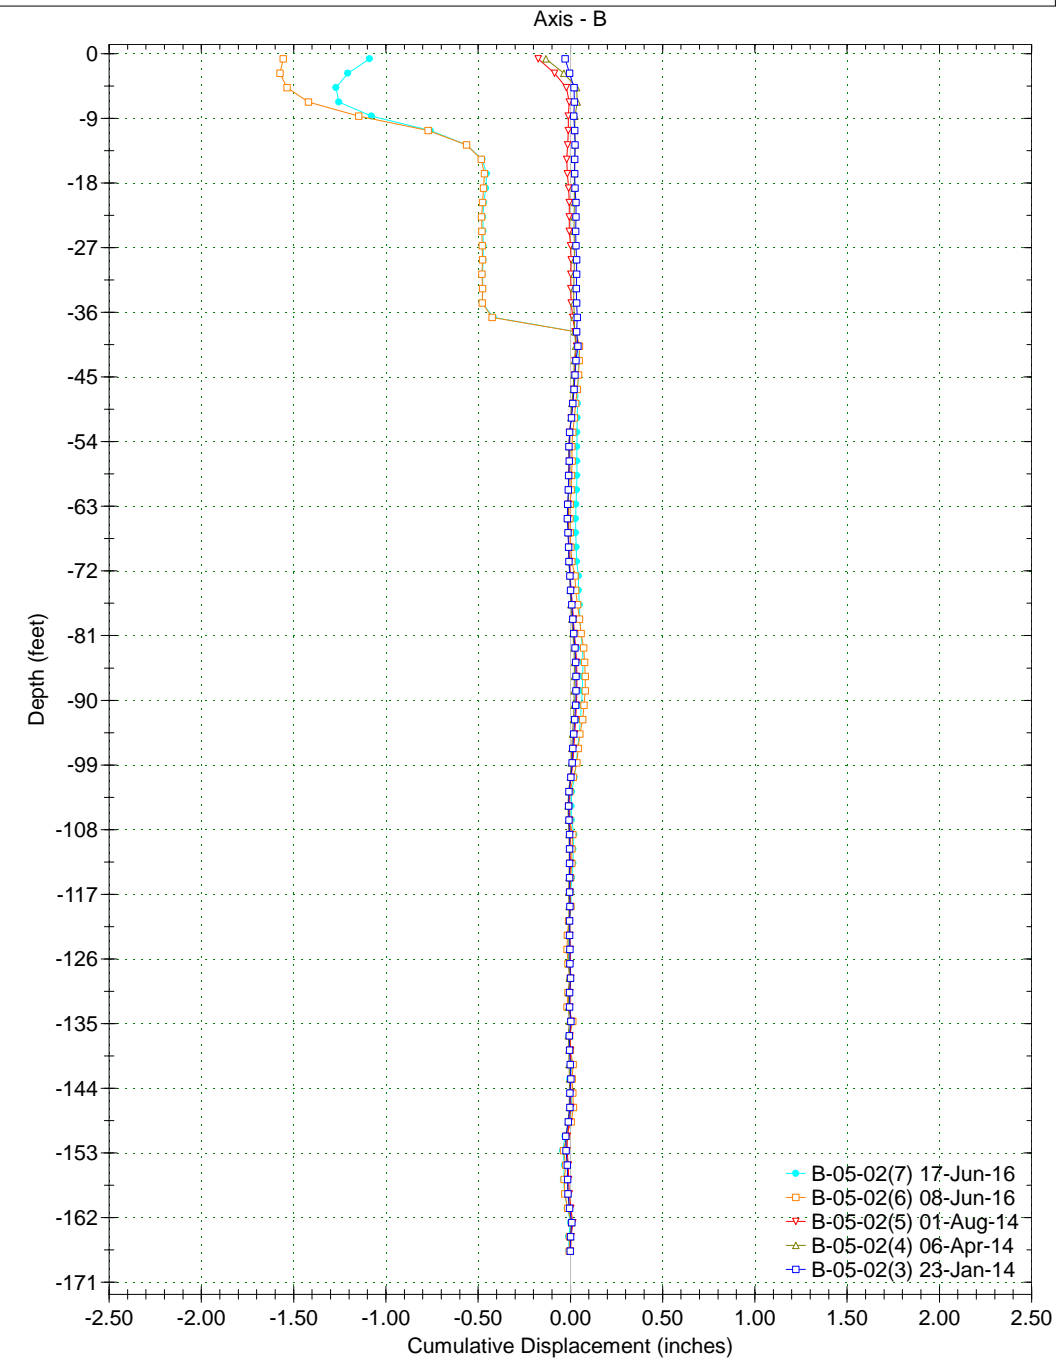
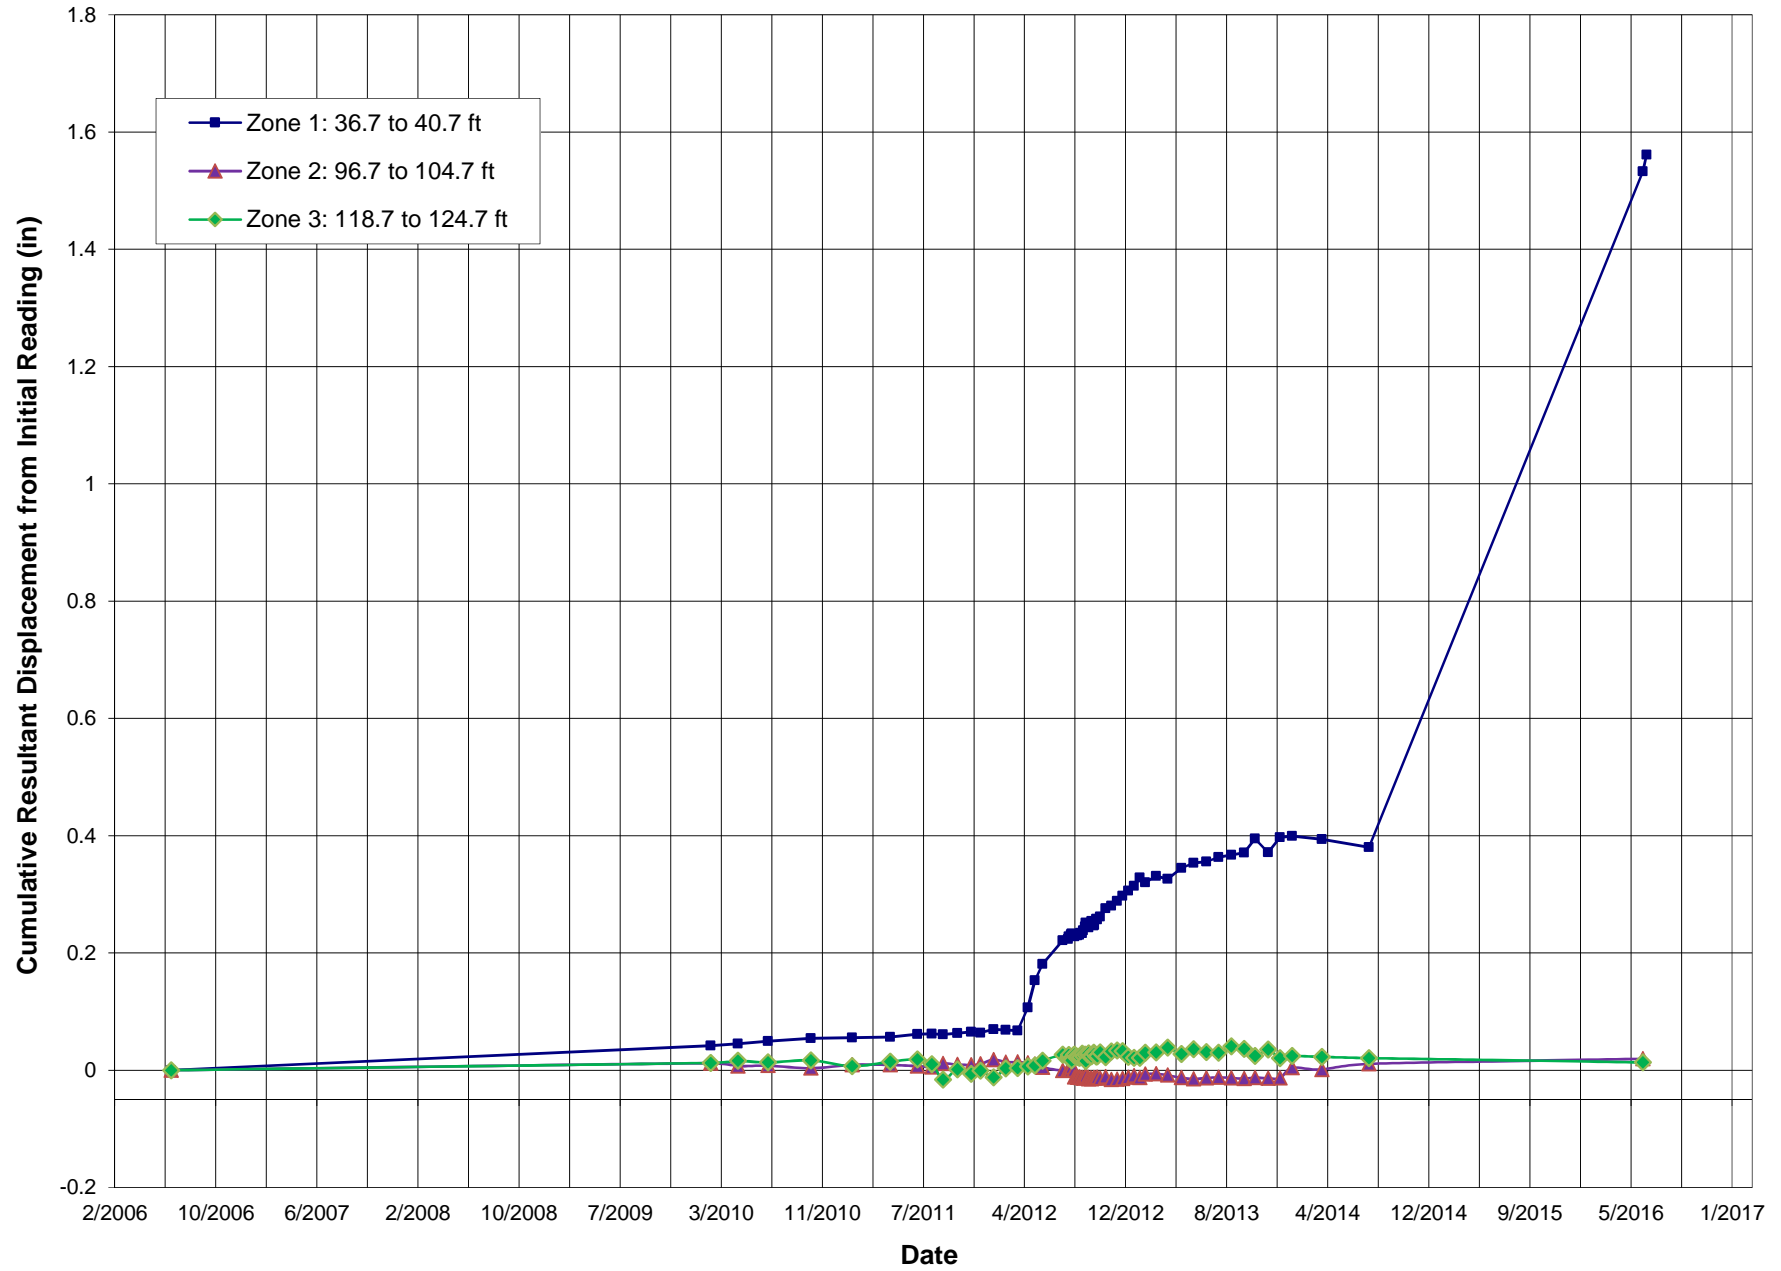
B-05-02 – The excavating contractor tore 10 feet off the casing at this location. We added 6 feet to the casing to bring the top of casing to an elevation that should be compatible with final grades. Because of the ongoing earthwork we have not installed a protective cover. The cumulative resultant zone plot for this location shows a slight increase in displacement between 37 and 41 feet. B-axis movement shown at the top 8 feet of the casing occurs as we are taking readings. We take three readings at the top of the casing which allows us to match the current readings with the historical readings.

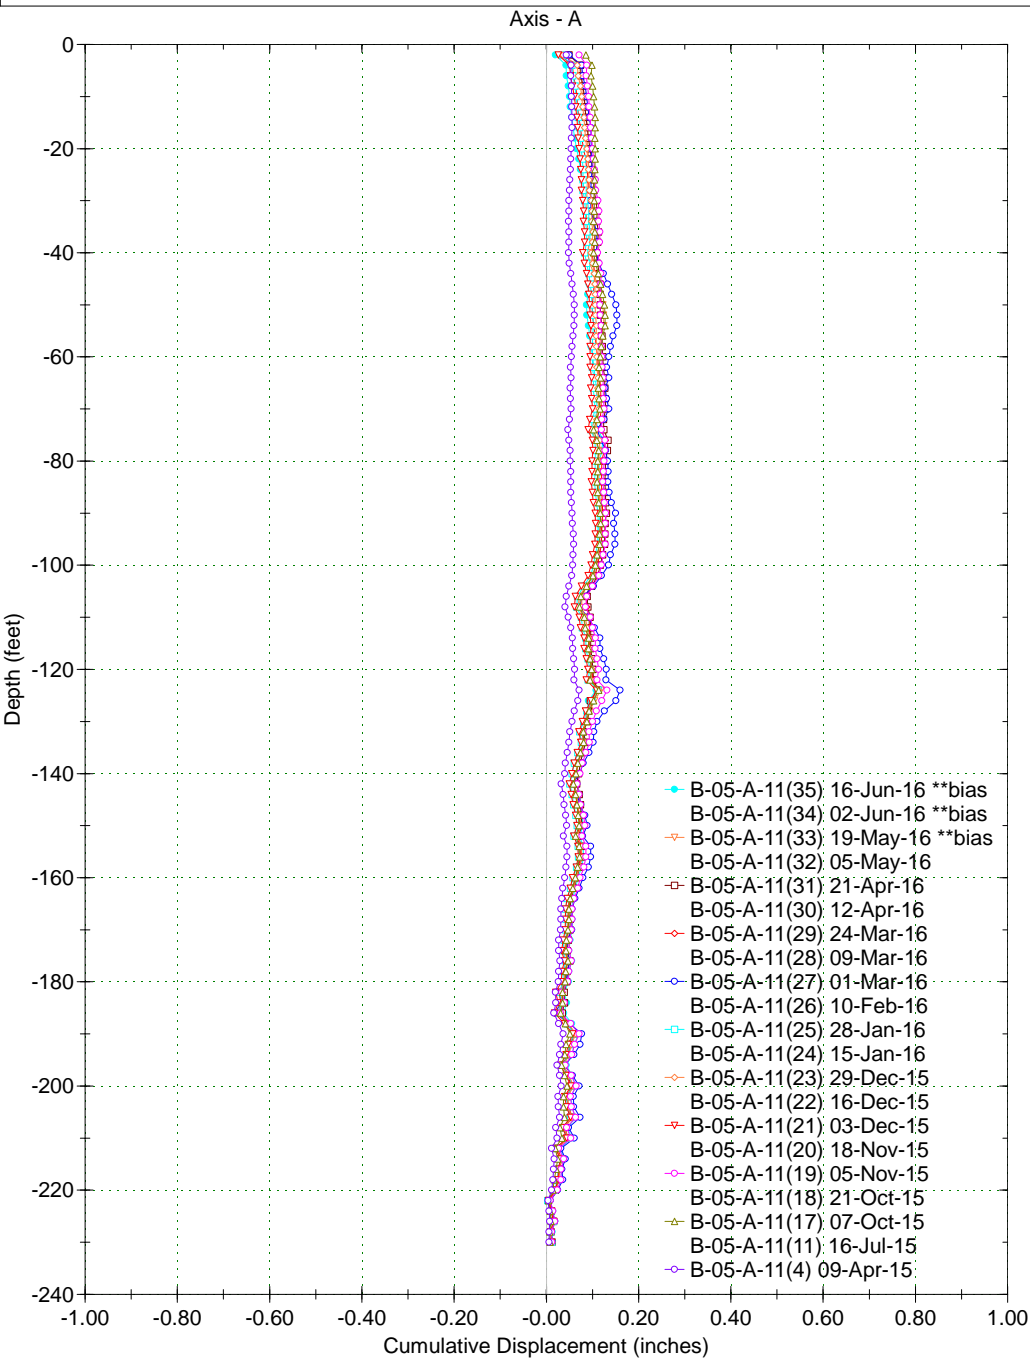
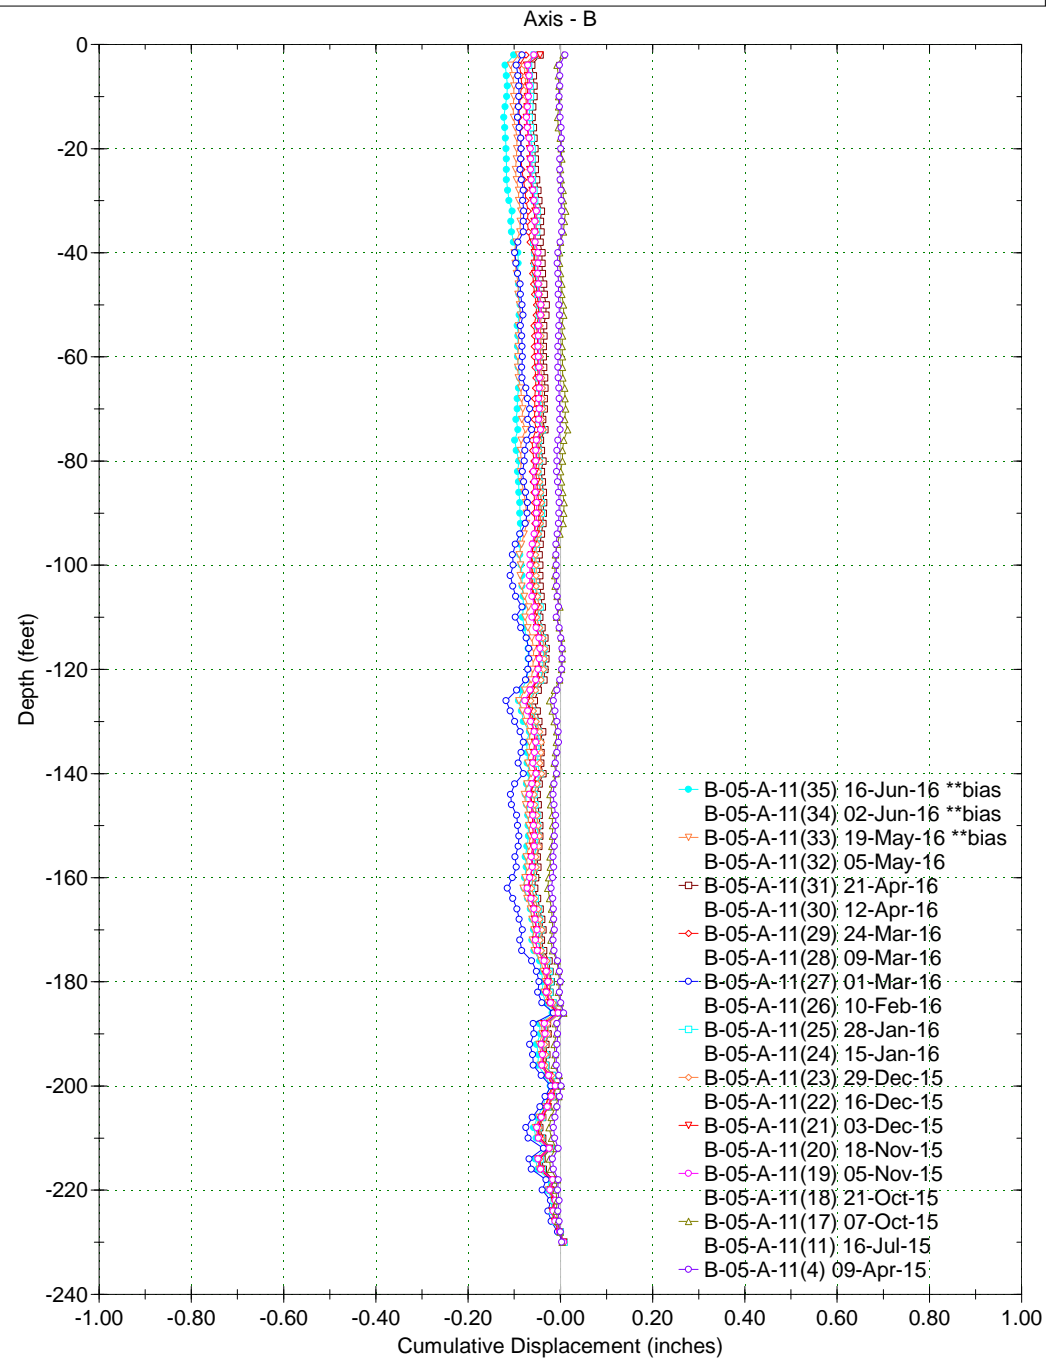
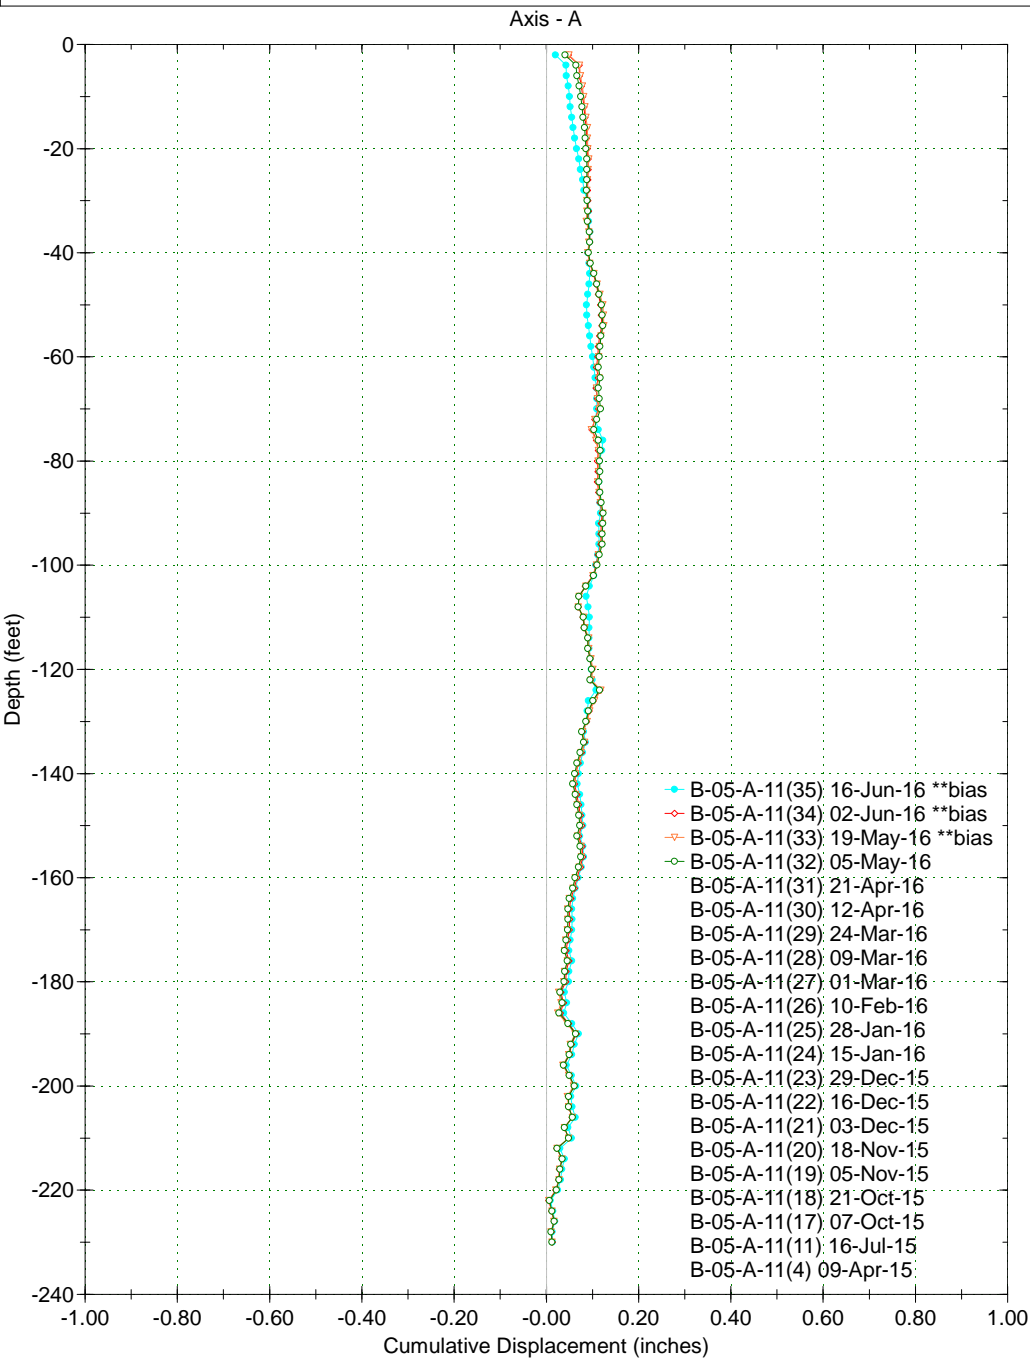
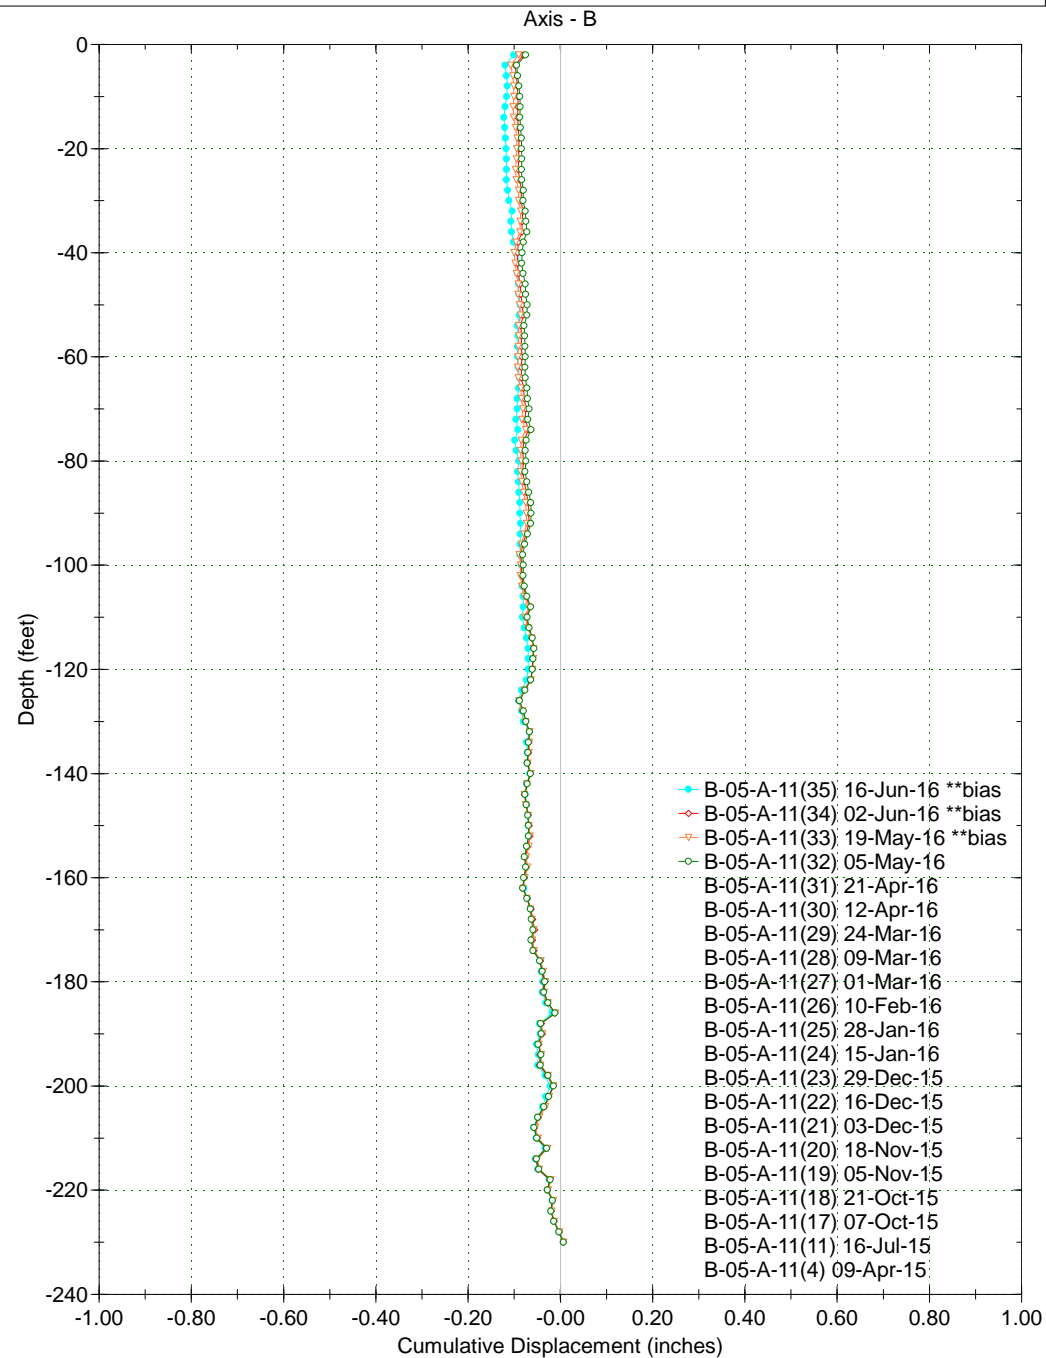
Borehole : B-05-A-11
Project : CUY-90-15-24
Location :
Northing :
Easting :
Collar :

B-05-A-11 – Inclinometer readings at this location indicate movement in the negative A- and negative B-axis direction from the surface to 40 feet.

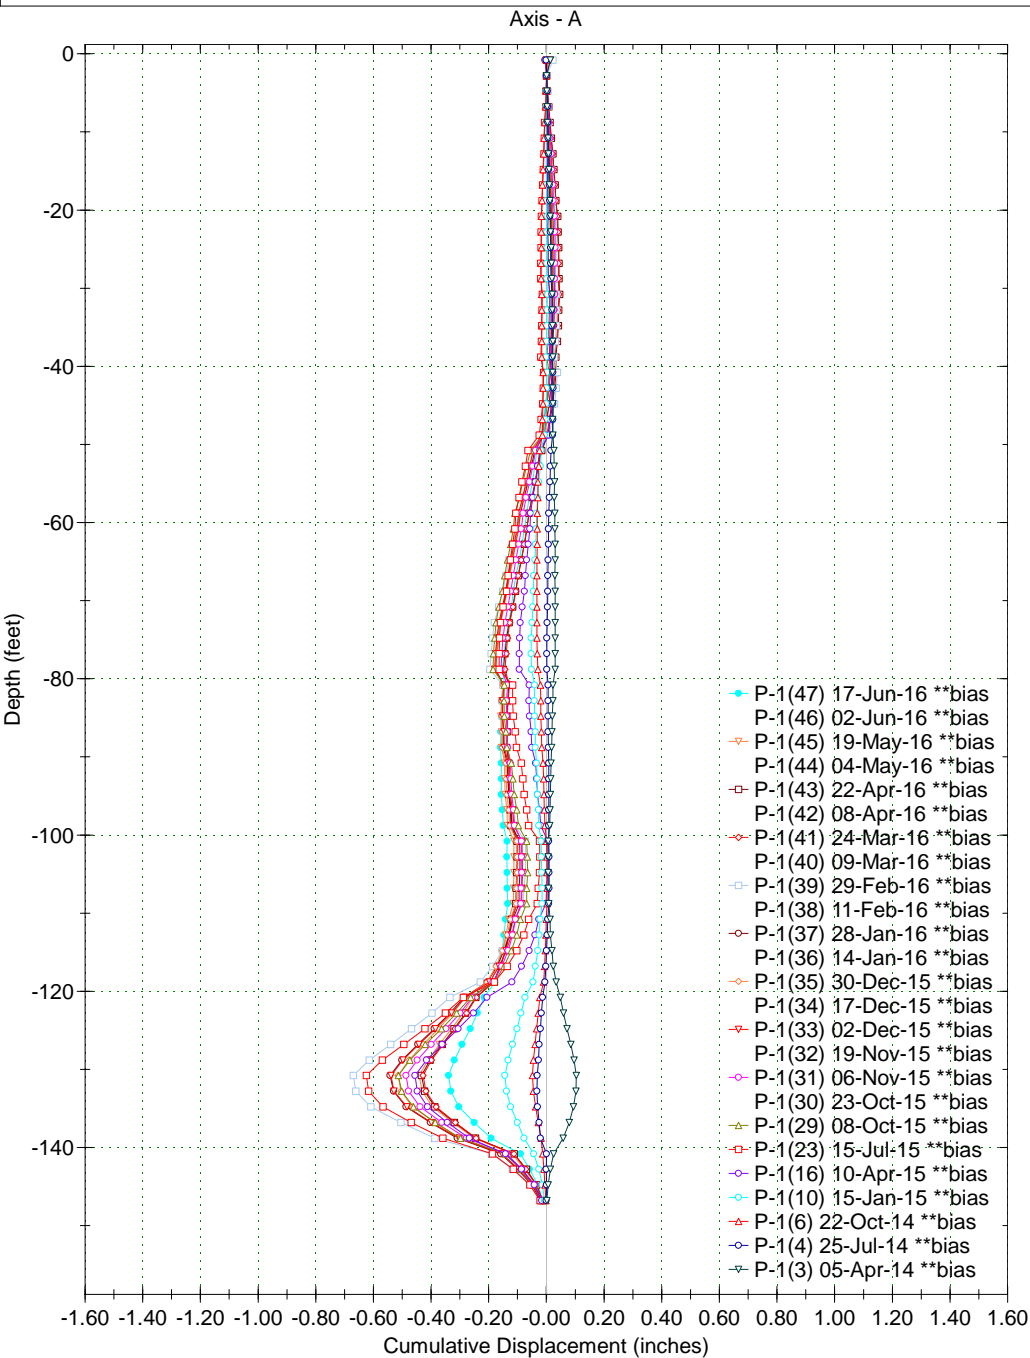
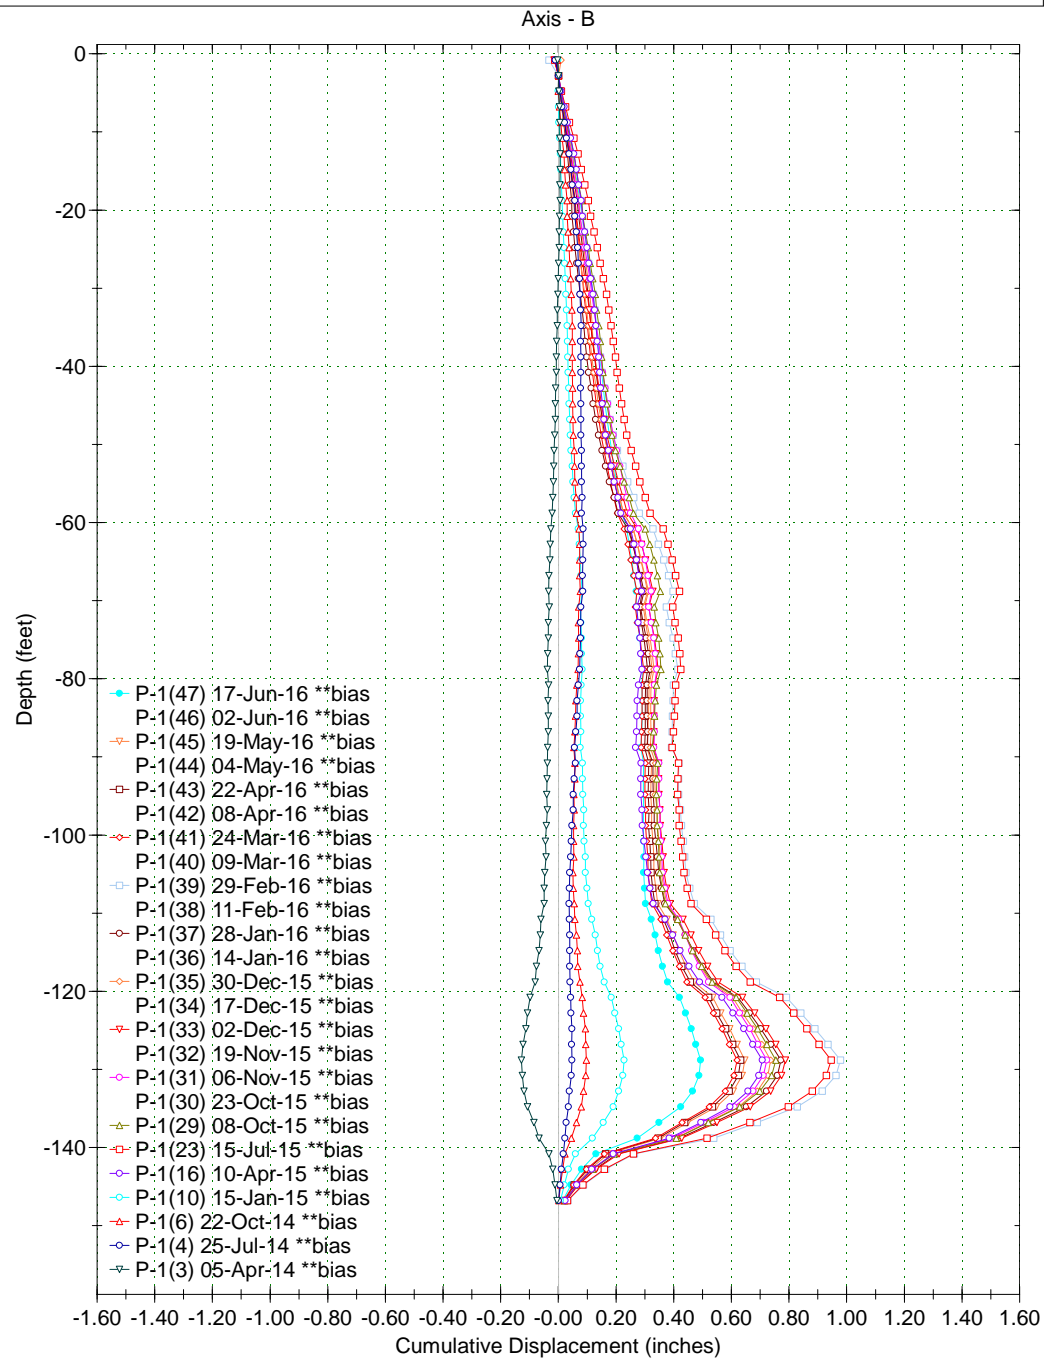
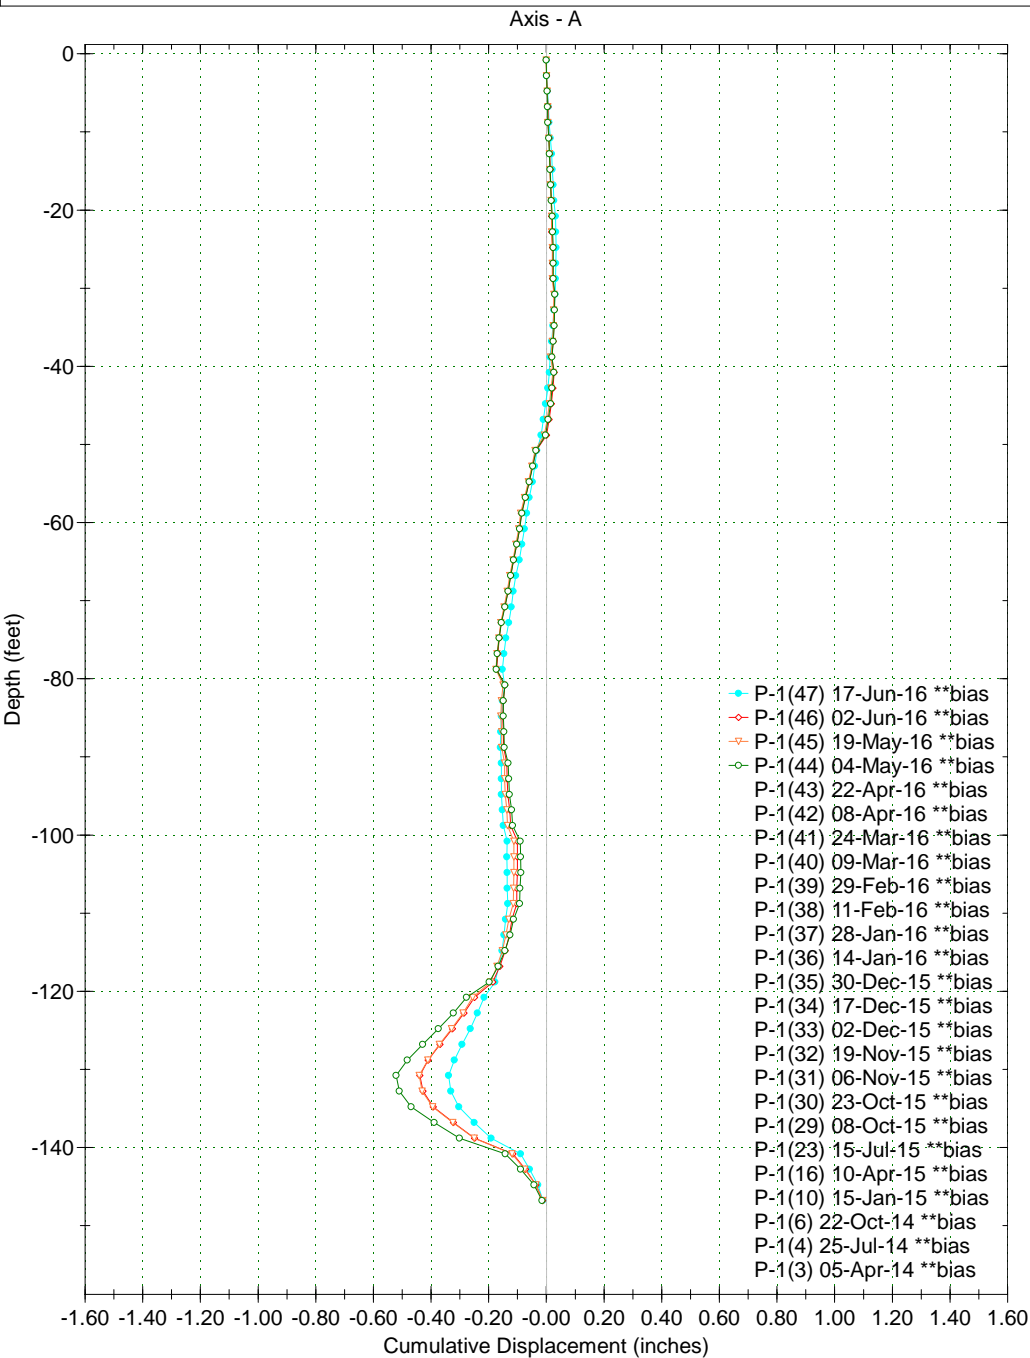
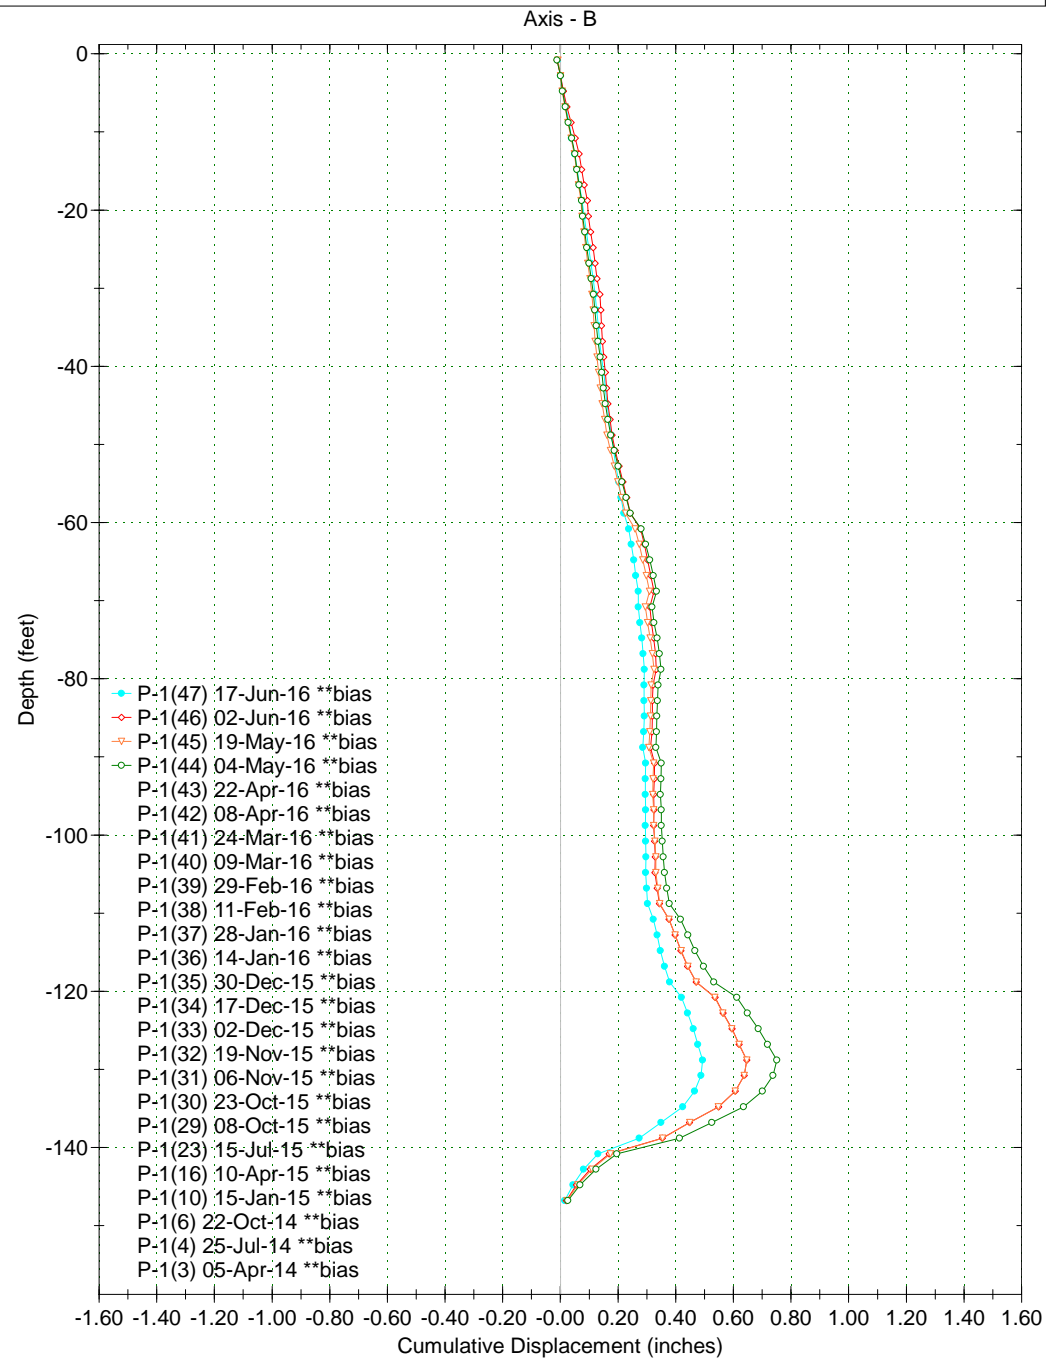
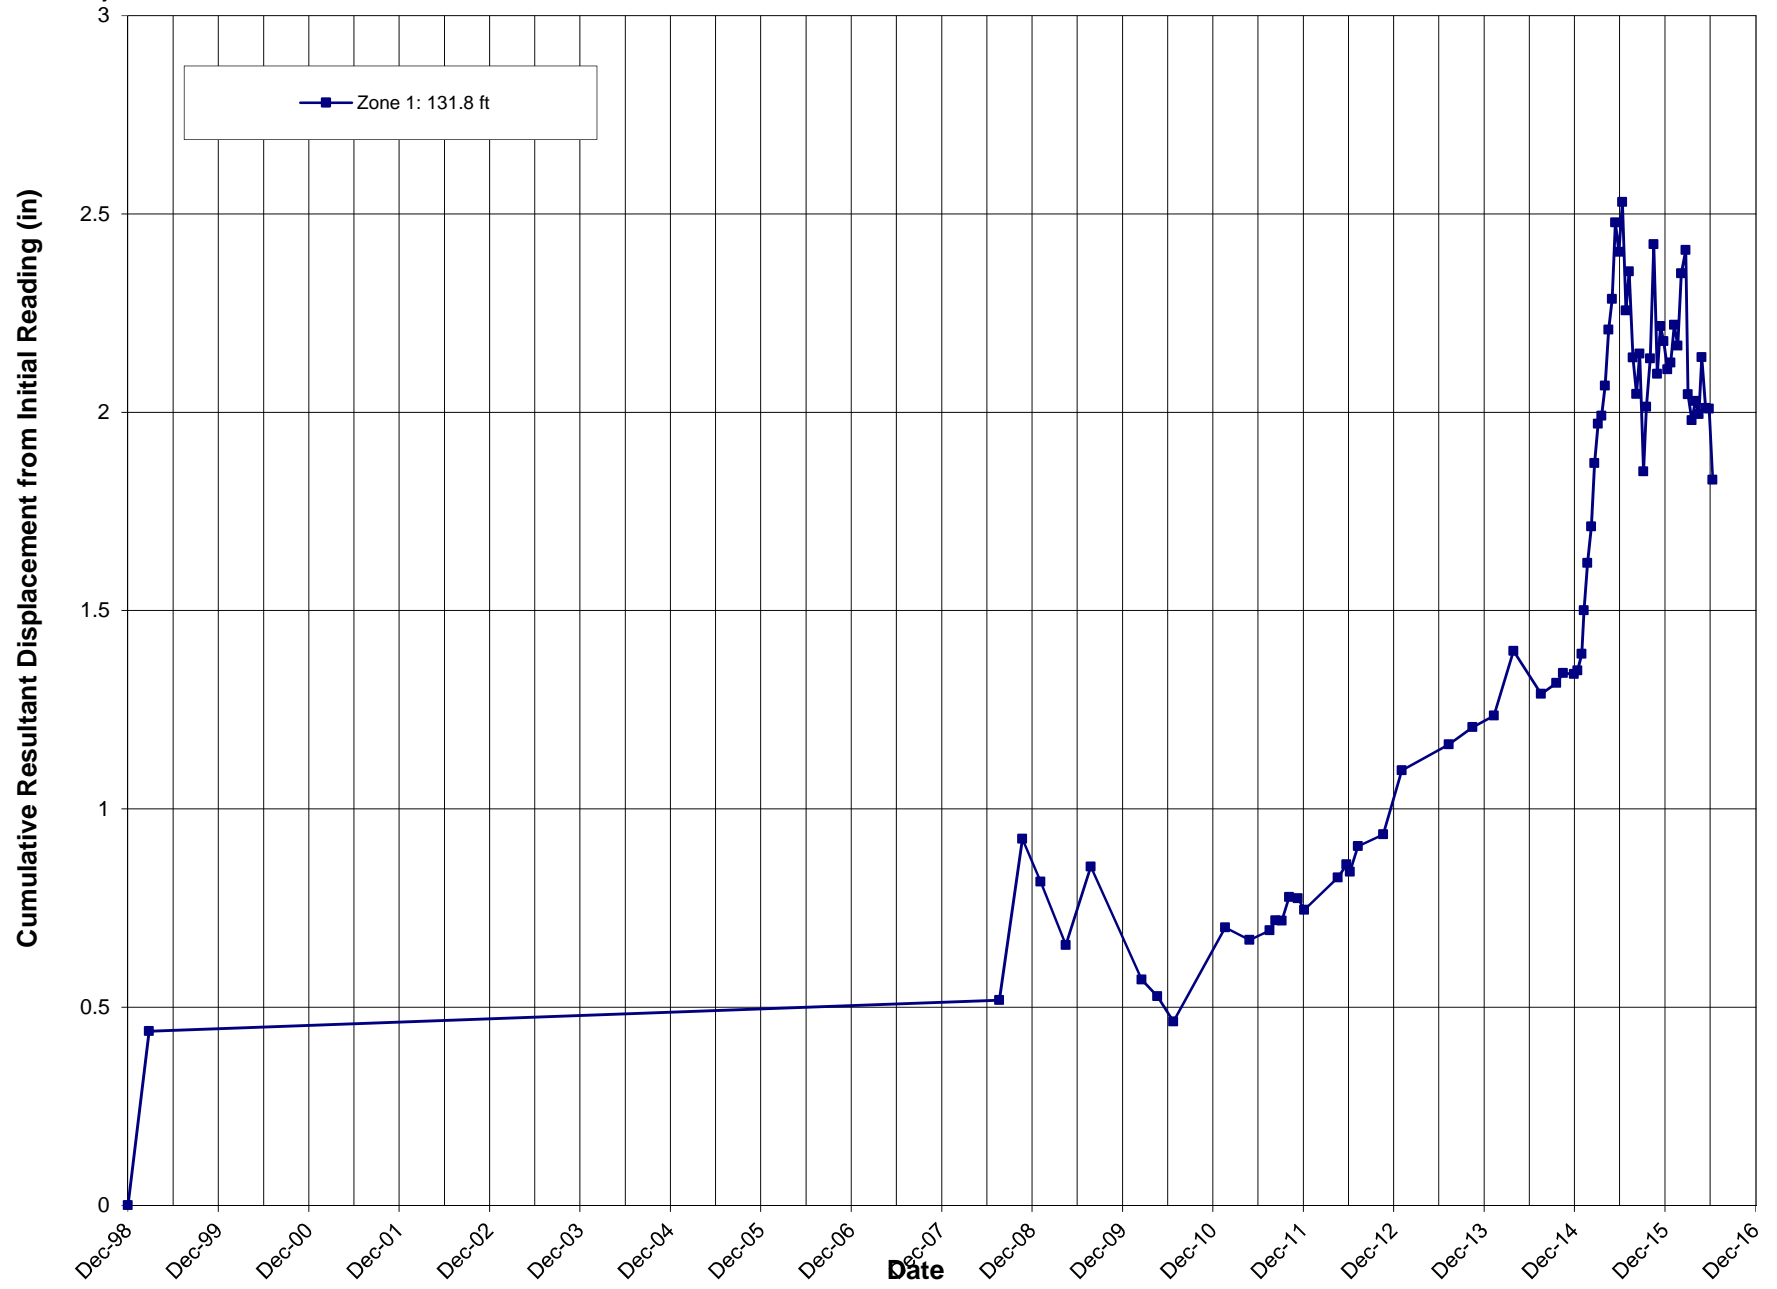
P-1 – Inclinometer readings at this location show another reversal in the direction of movement. At 132 feet, there has been about 0.2 inches and 0.3 inches of displacement in the positive A-axis and negative B-axis direction, respectively, since the May 4, 2016 reading.
