July 11, 2016

Re: June 30 and July 1, 2016 Bi-Weekly Readings
CUY-90-15.24 Slope Monitoring
PID 96504
SME Project No. 069032.00

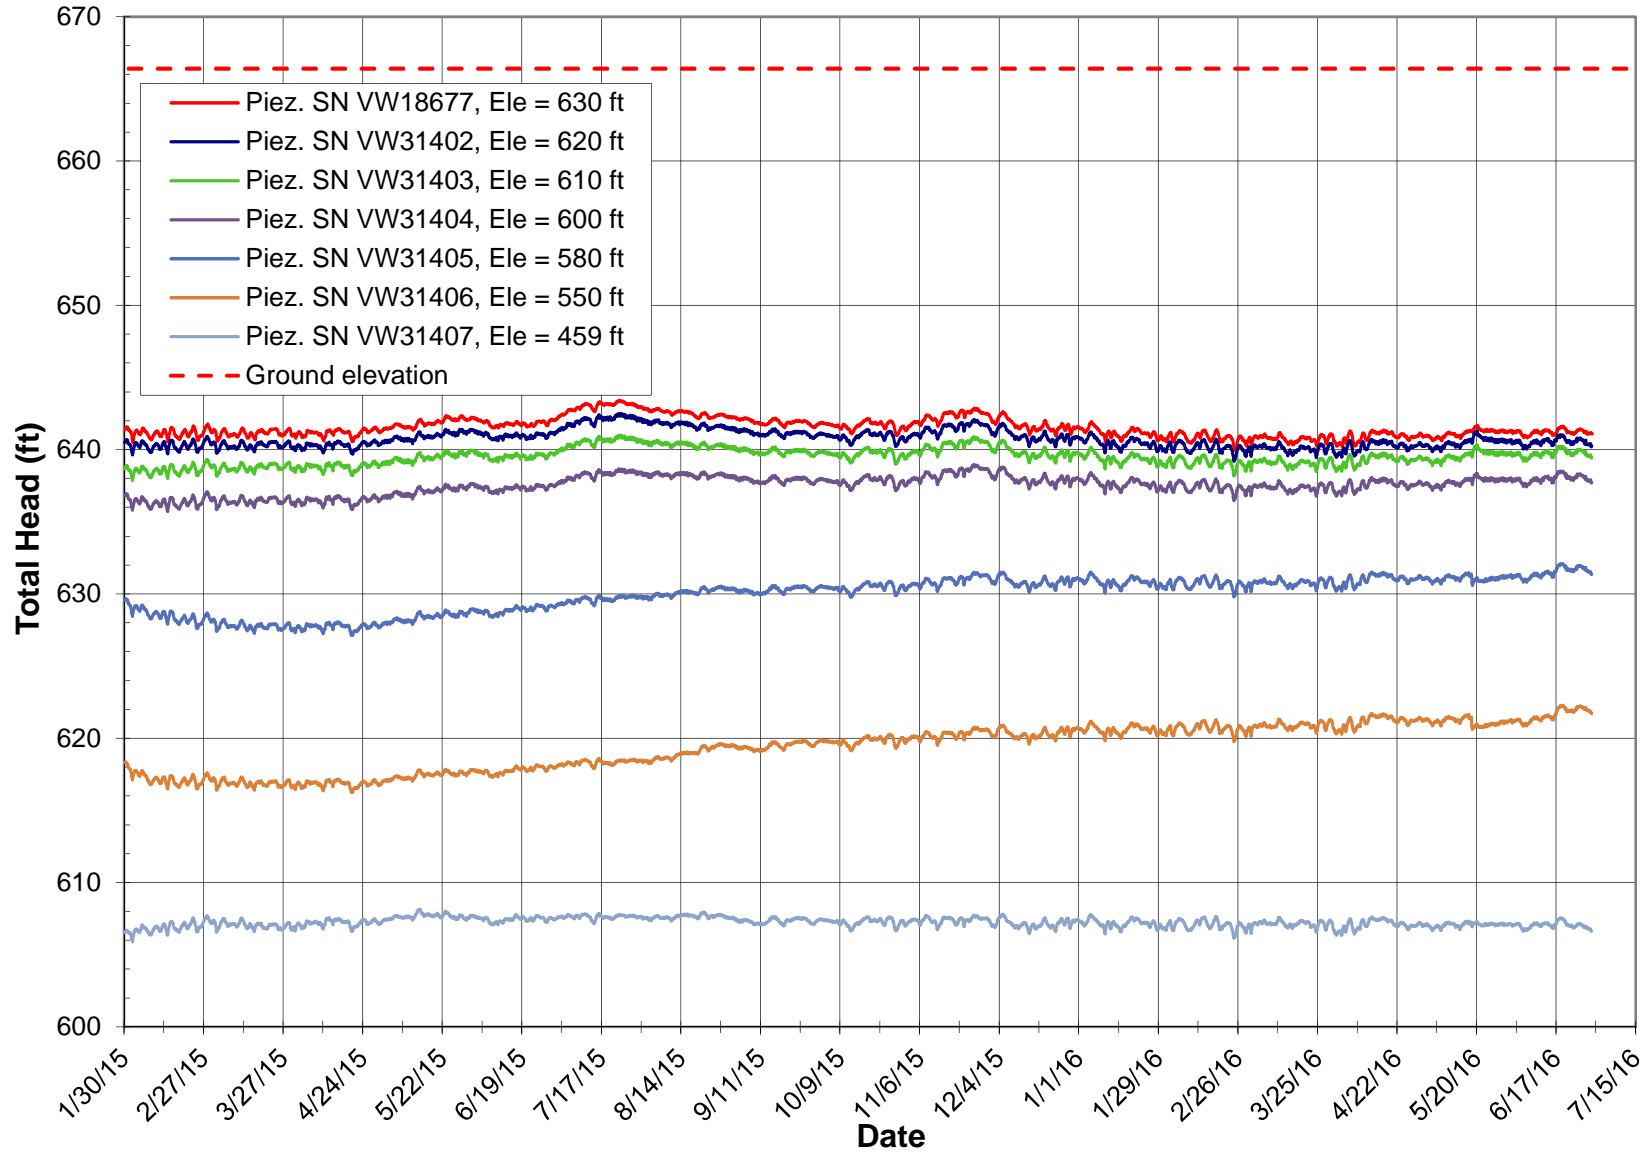
P-001-13 VW Piezometer Readings

P-001-13, P-002-13, P-009-13, B-05-02, B-05-A-03, B-05-04 – Pore pressure readings at these locations fluctuated by less than 0.5 feet, but show virtually no net change in total head.

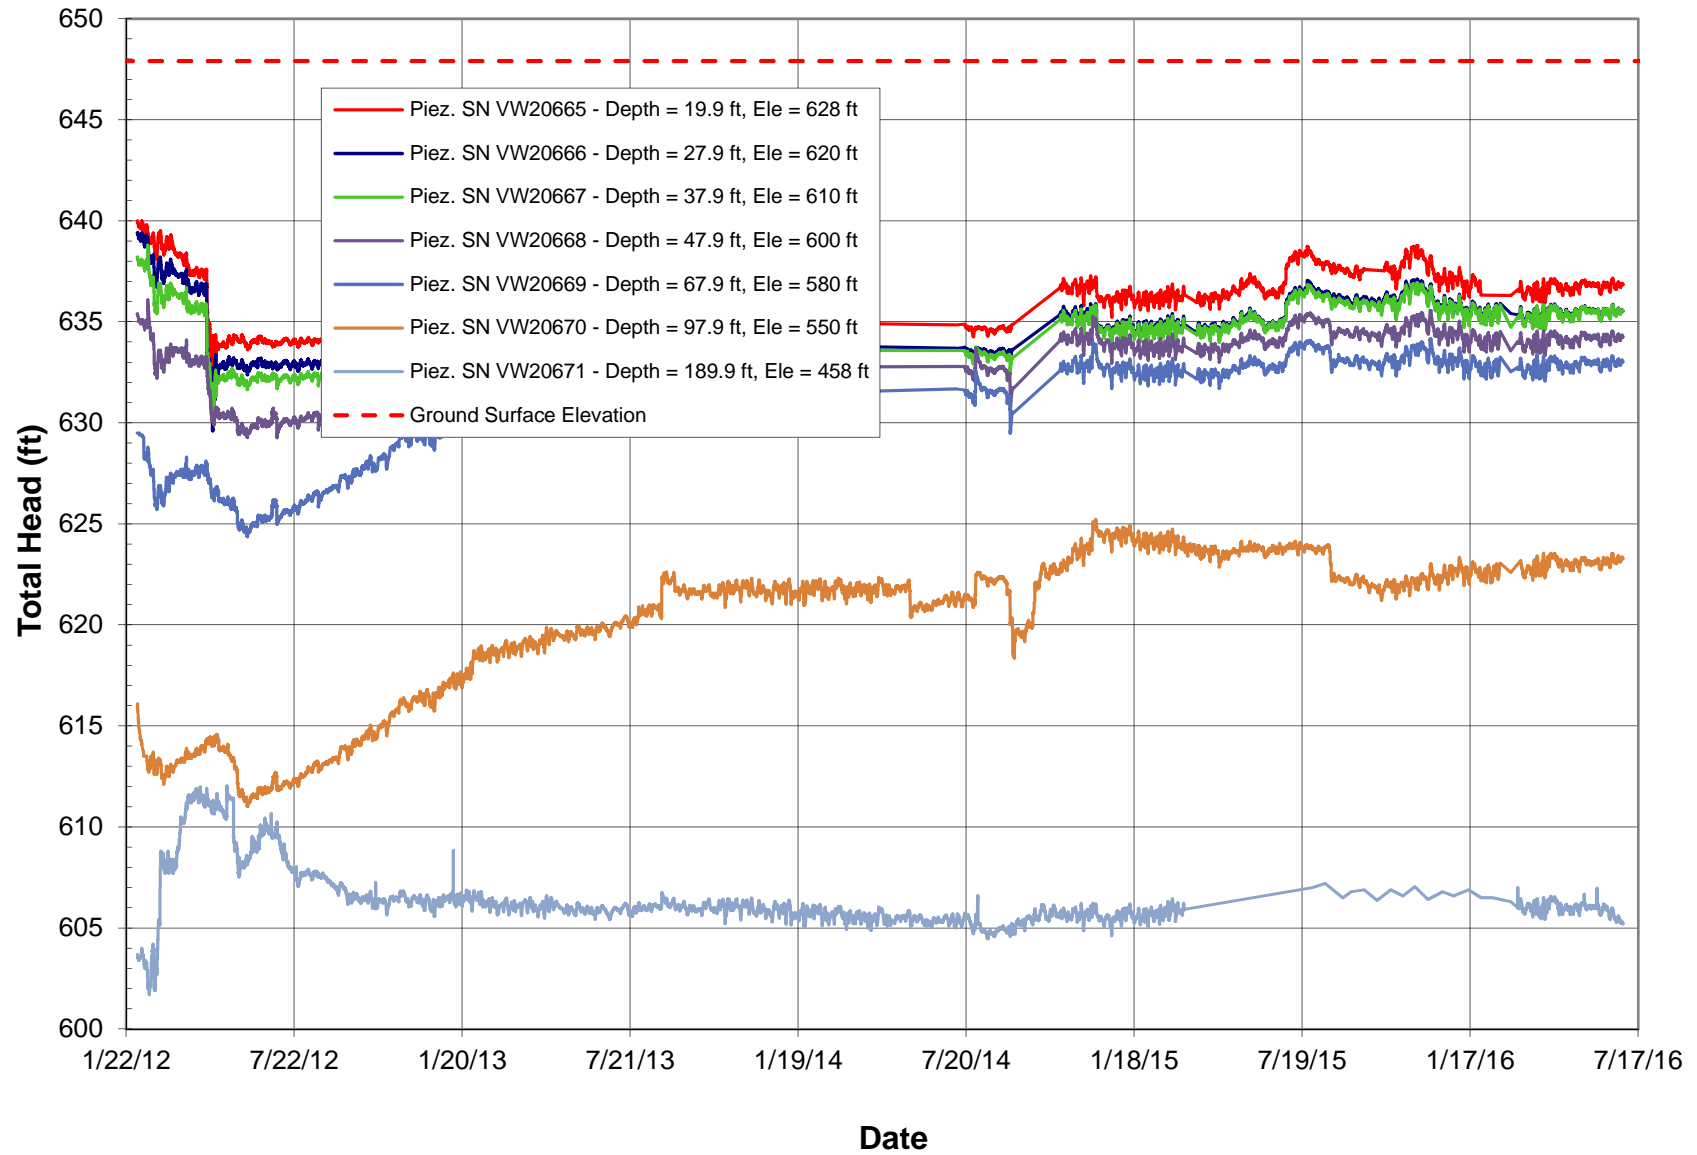
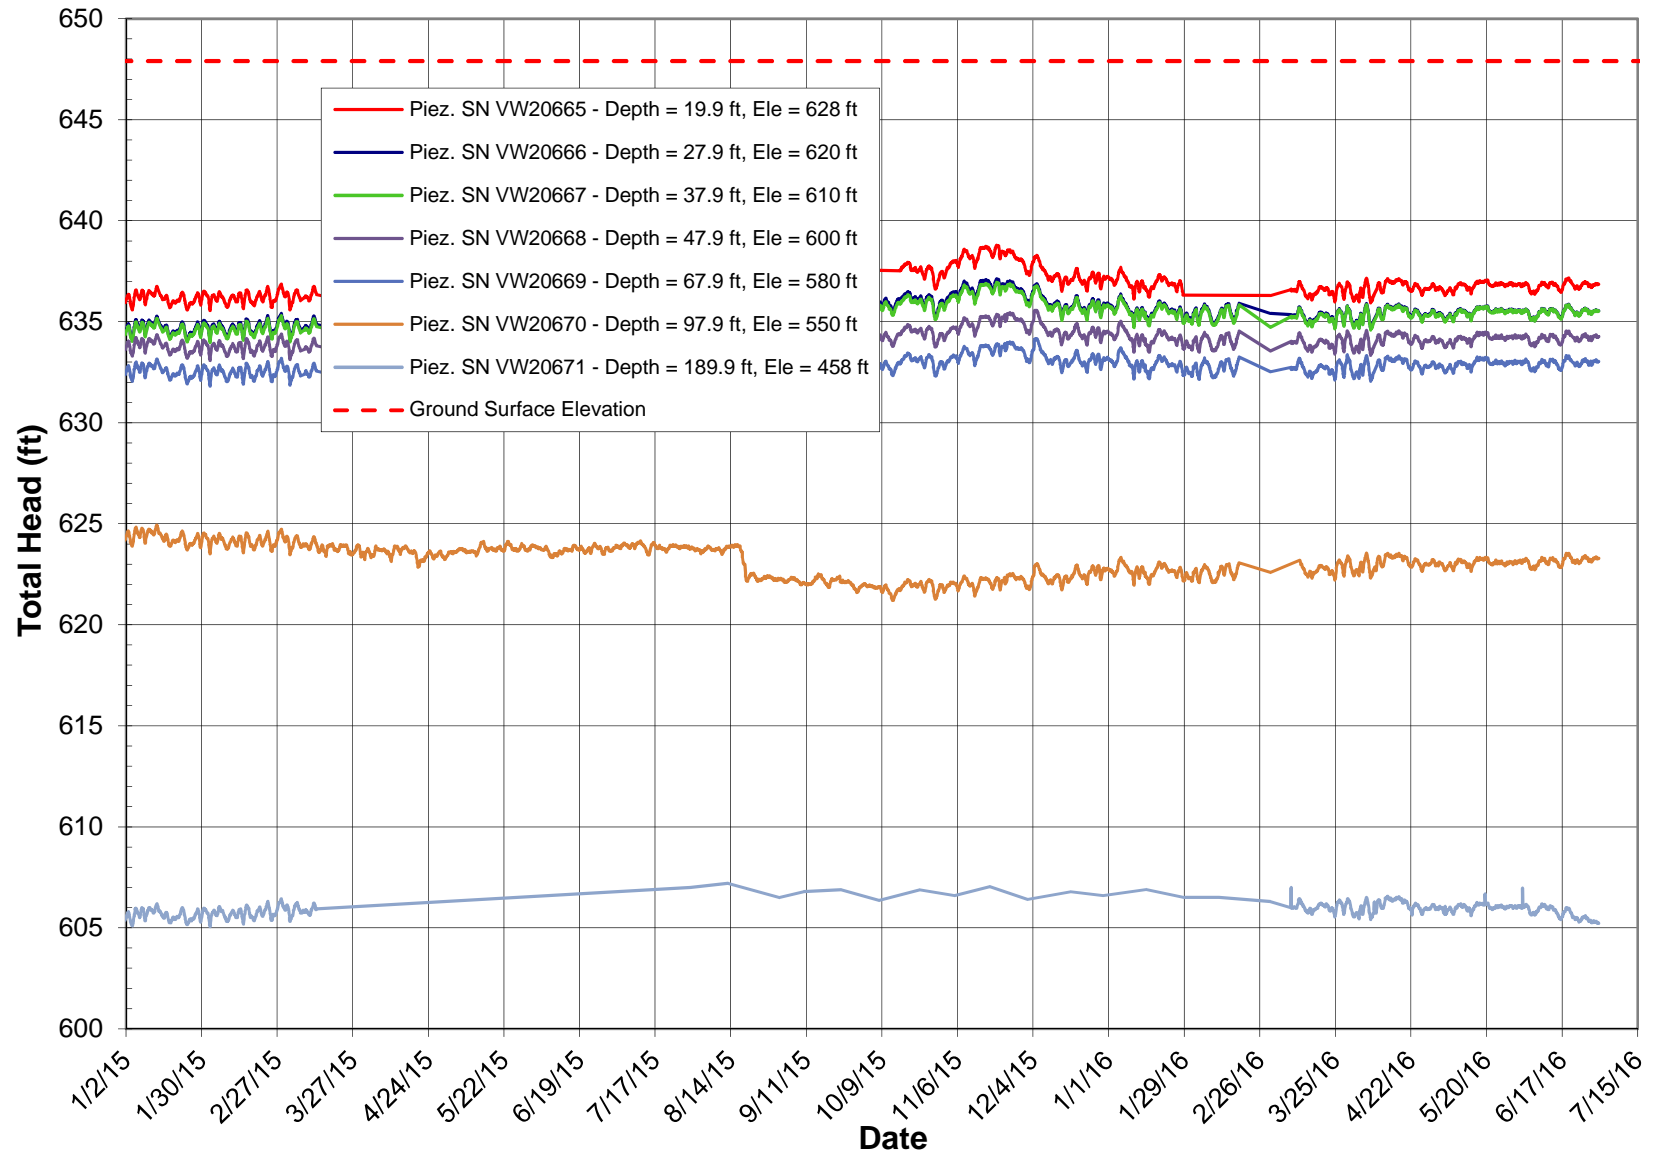
P-003-10 VW Piezometer Readings

P-003-10 – Pore pressure readings indicate a decrease in total head of about 0.5 feet in the piezometer at 190 feet. The remaining piezometers showed virtually no change.

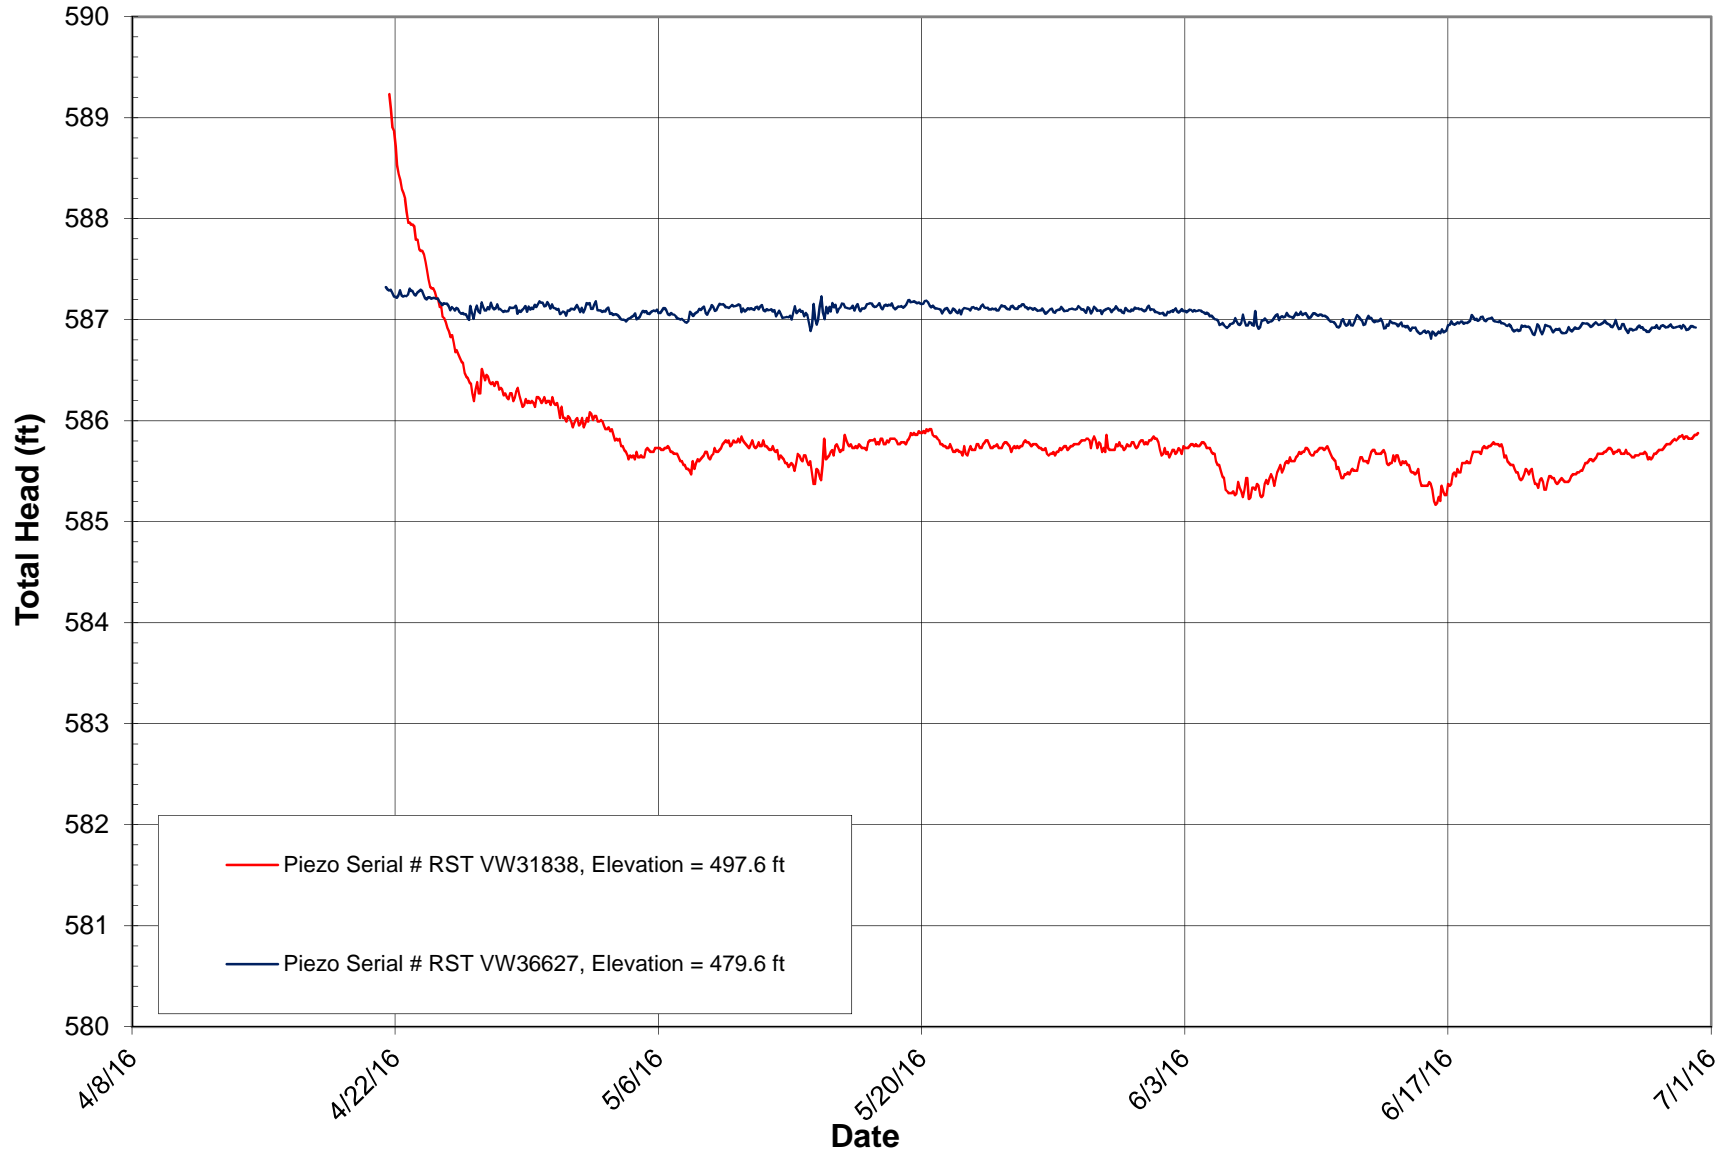
B-105A VW Piezometer Readings

B-105-A – Pore pressure readings indicate an increase in total head of about 0.5 feet in the shallow piezometer and no change in the deep piezometer.

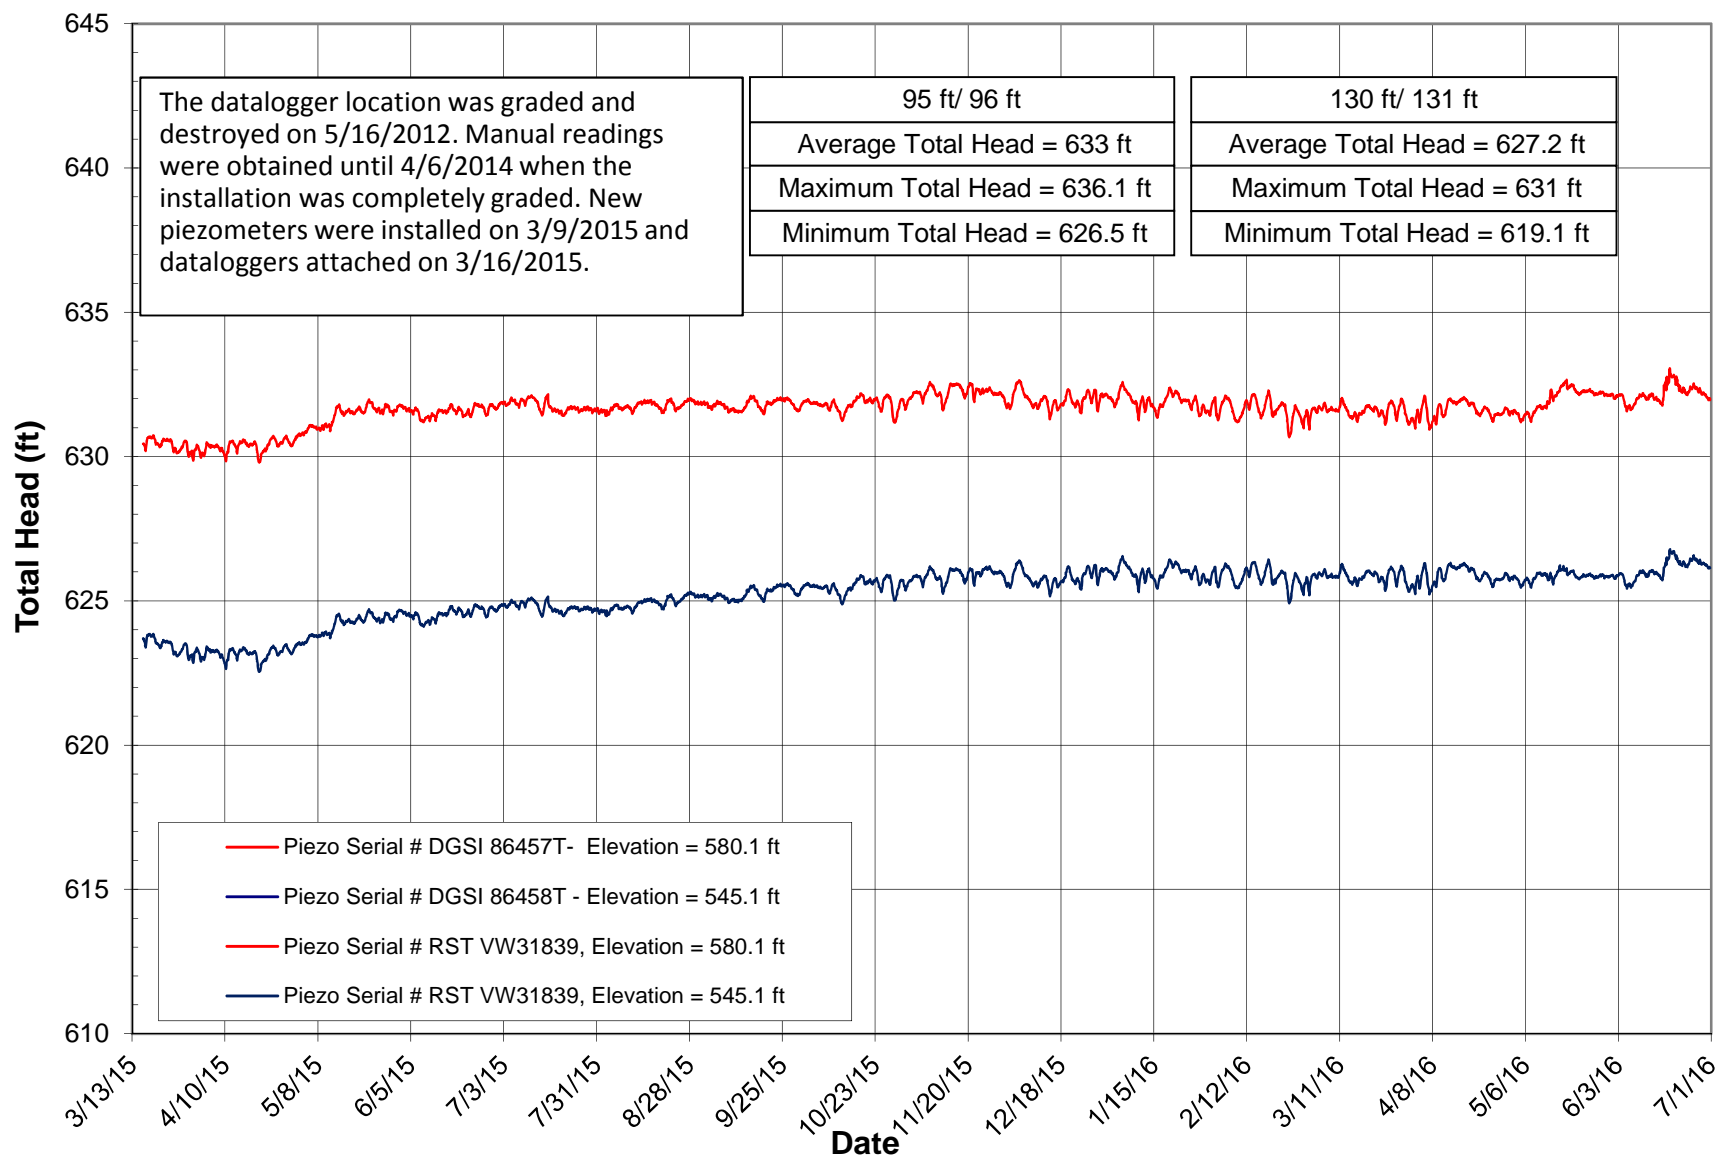
B-05-11/B-05-A-11 VW Piezometer Readings

B-05-A-11 – Pore pressure readings in both piezometers at this location indicate a decrease of about 0.5 feet in total head.

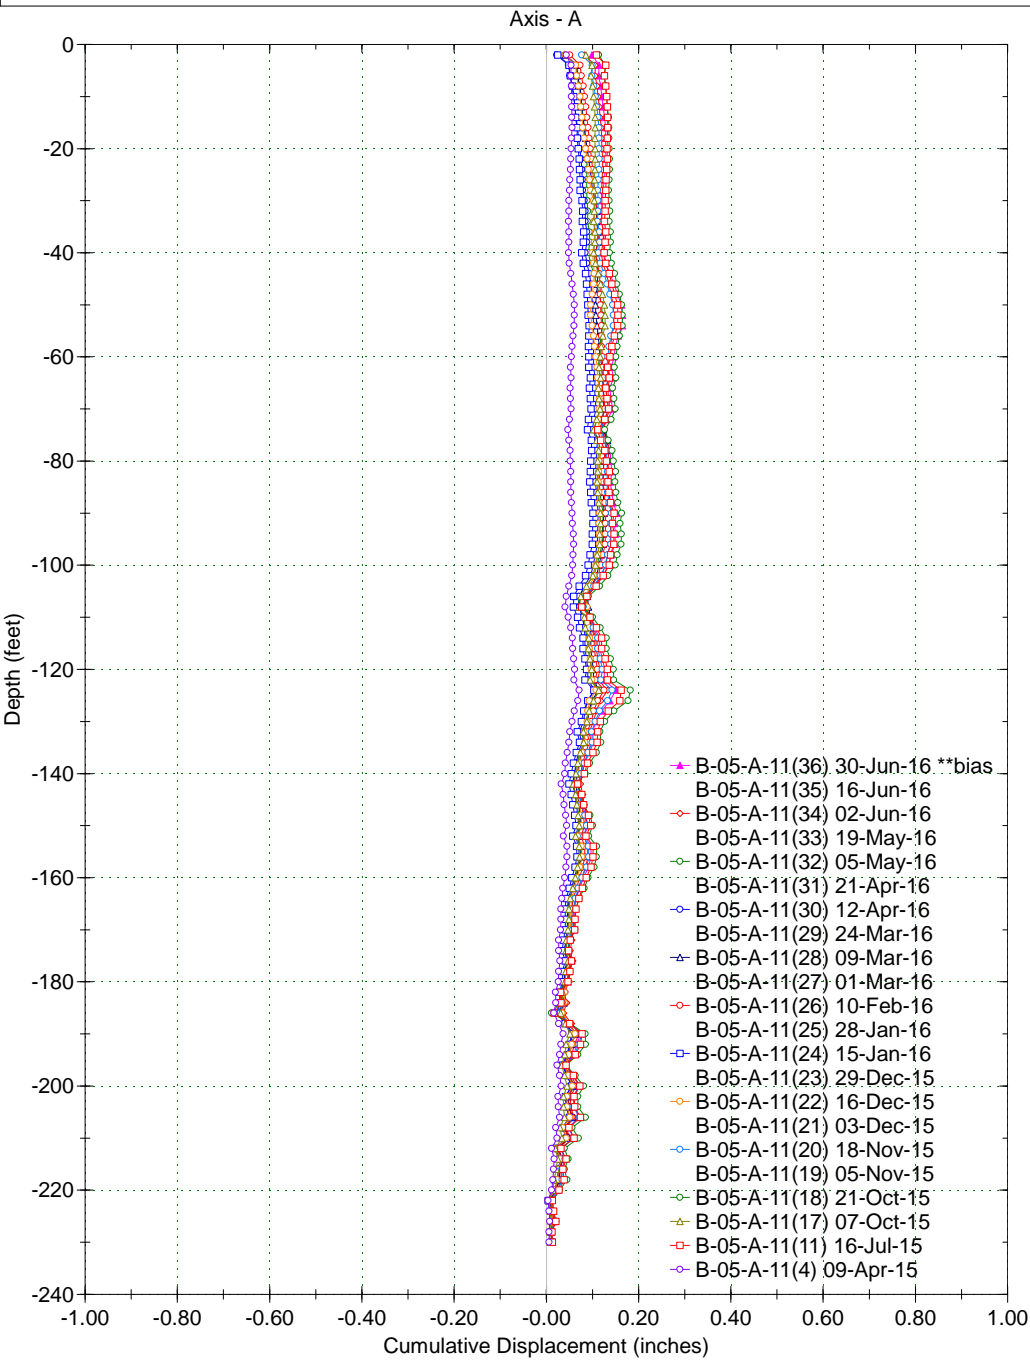
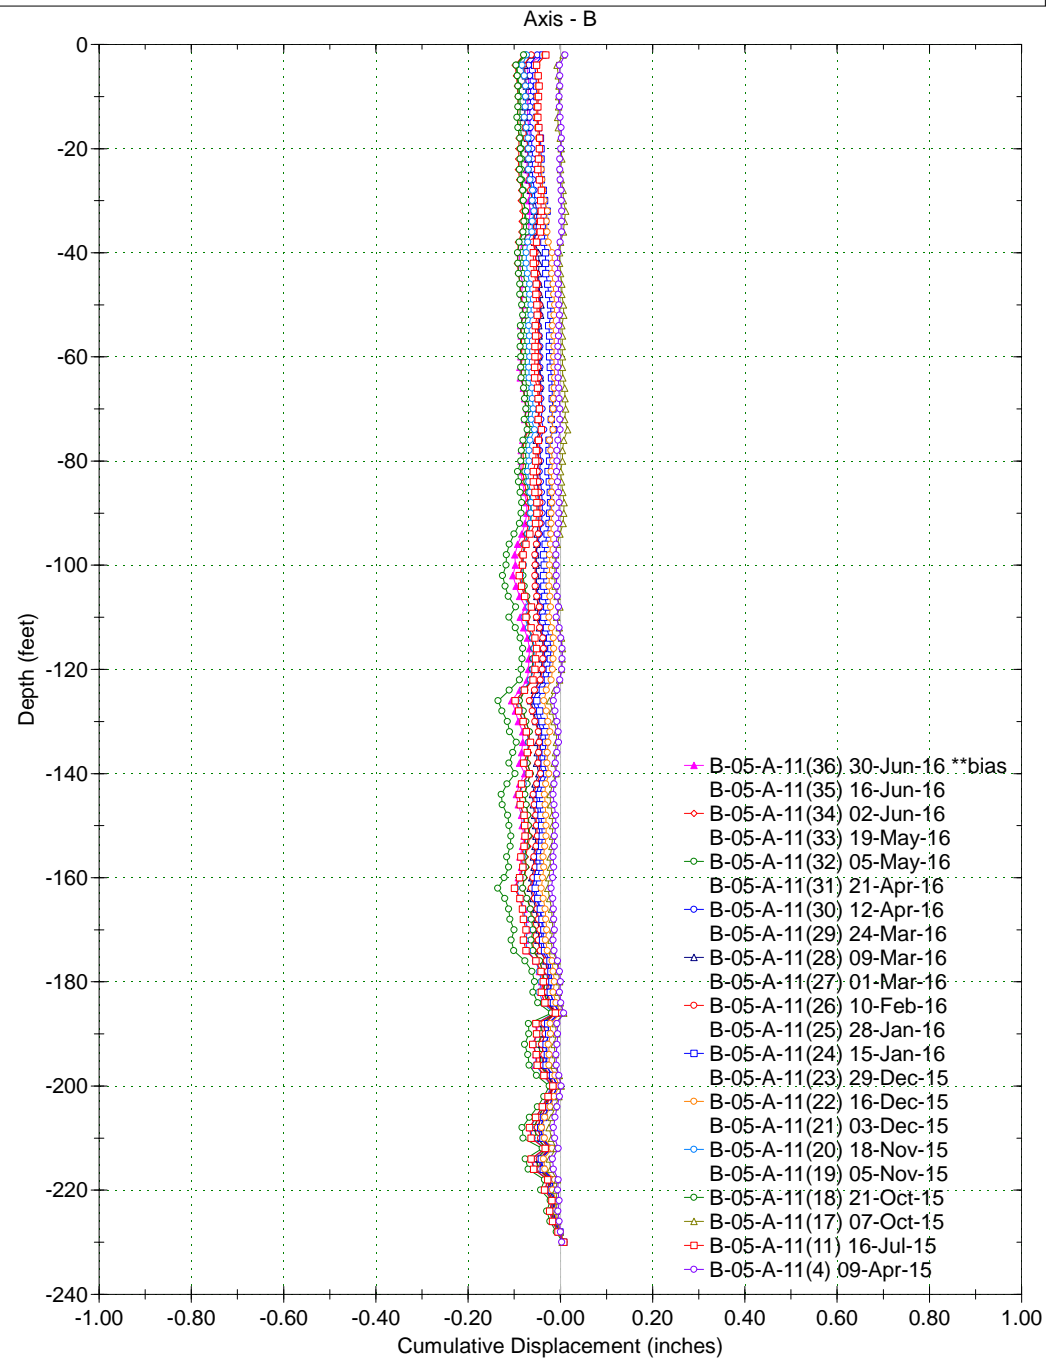
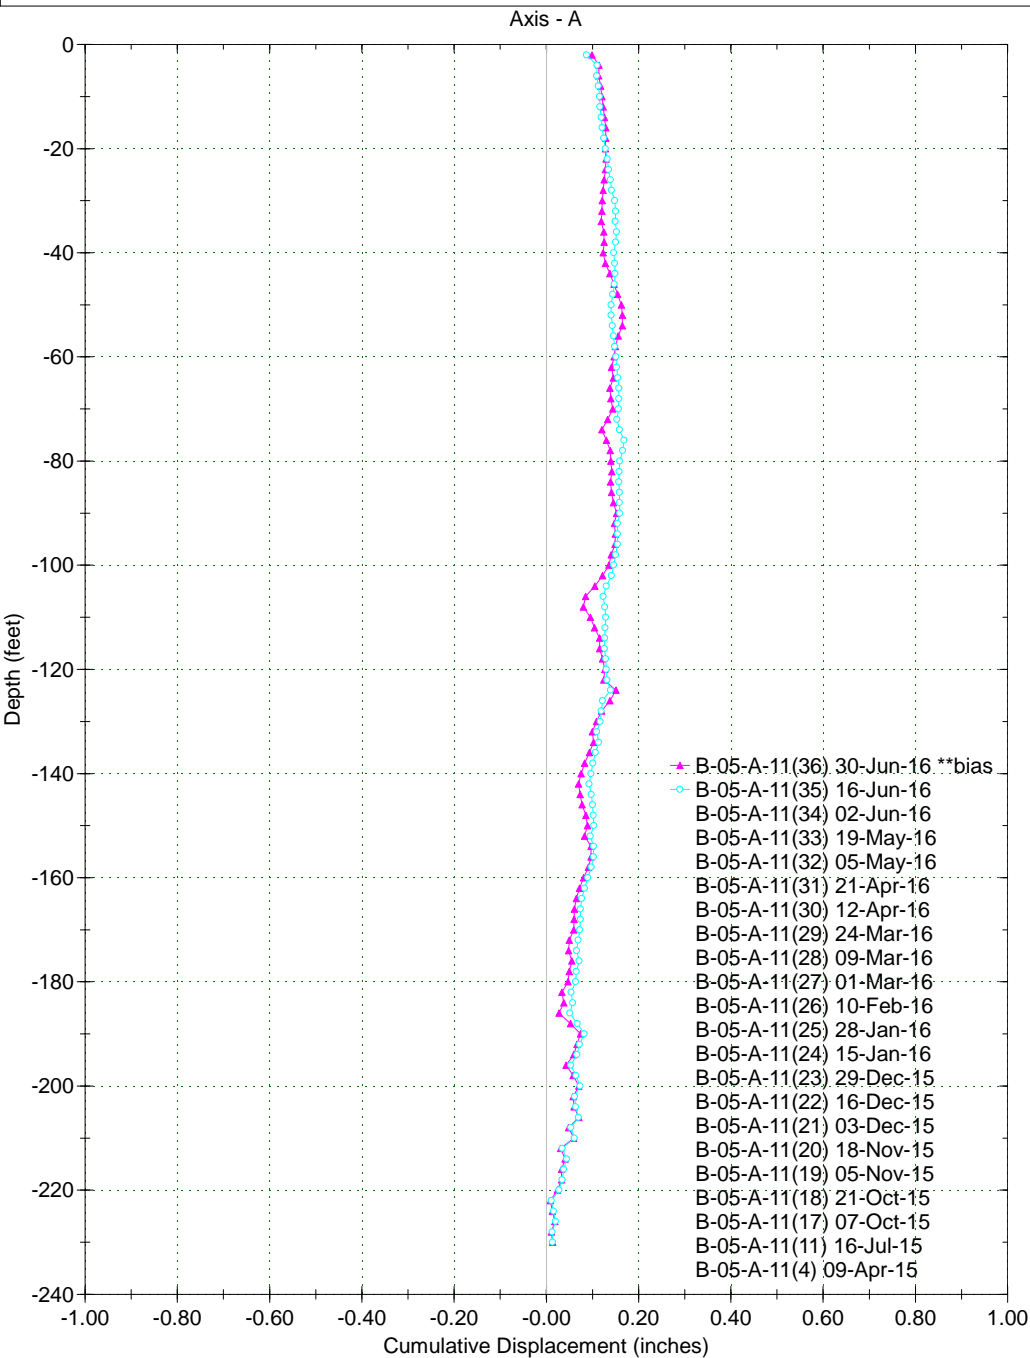
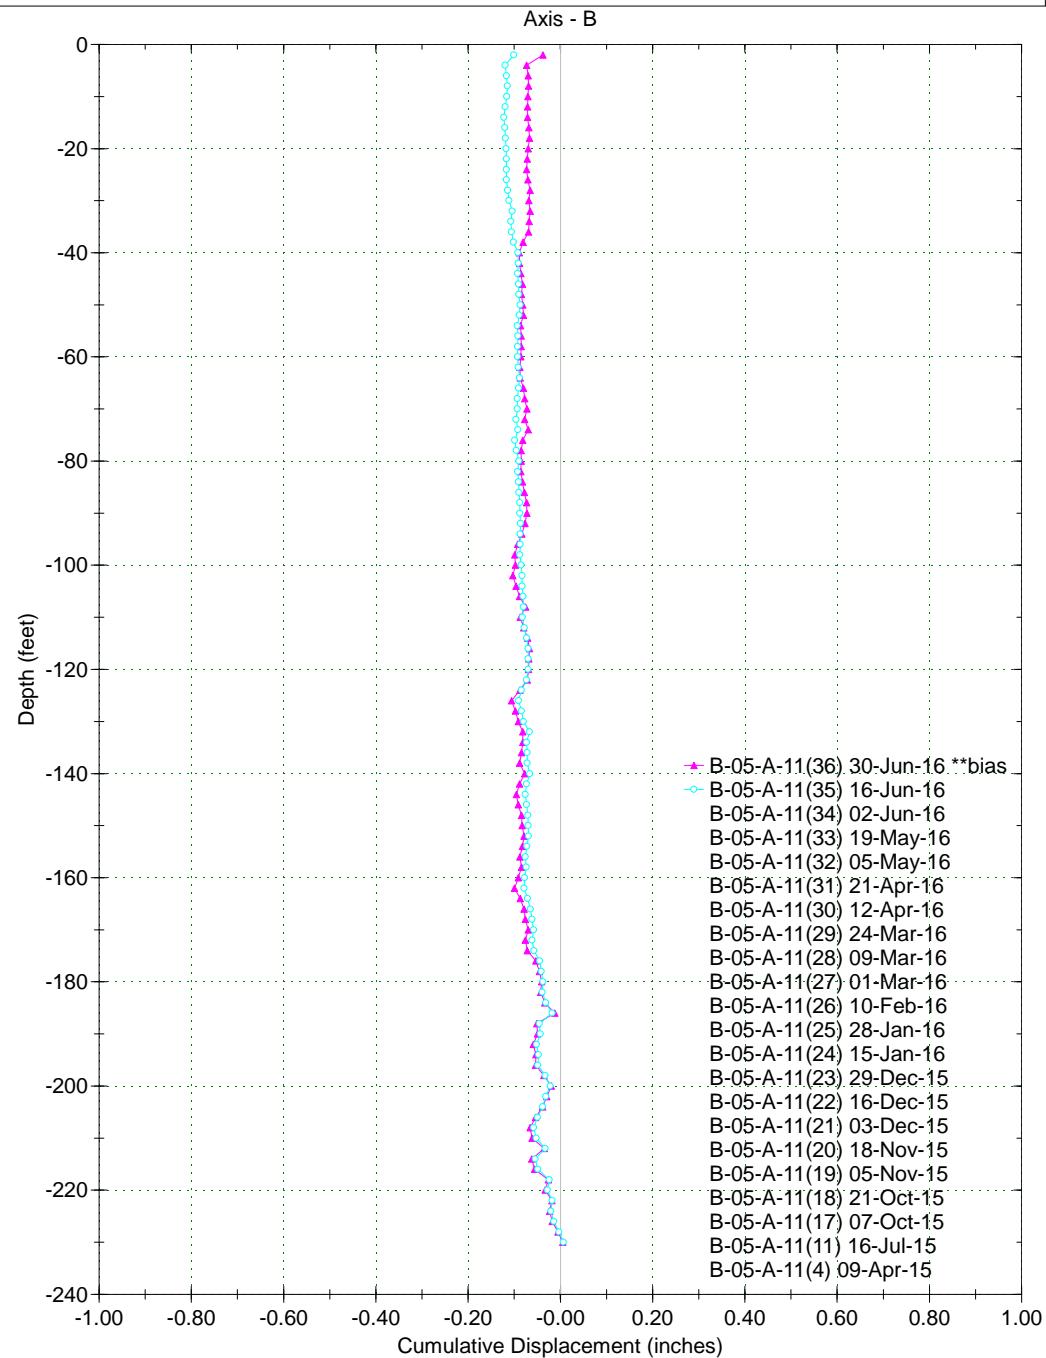
Borehole : B-05-A-11
Project : CUY-90-15-24
Location :
Northing :
Easting :
Collar :

B-05-A-11 – Inclinometer readings at this location indicate slight movement in the positive B-axis direction above 40 feet. Movement in the A-axis is negligible.

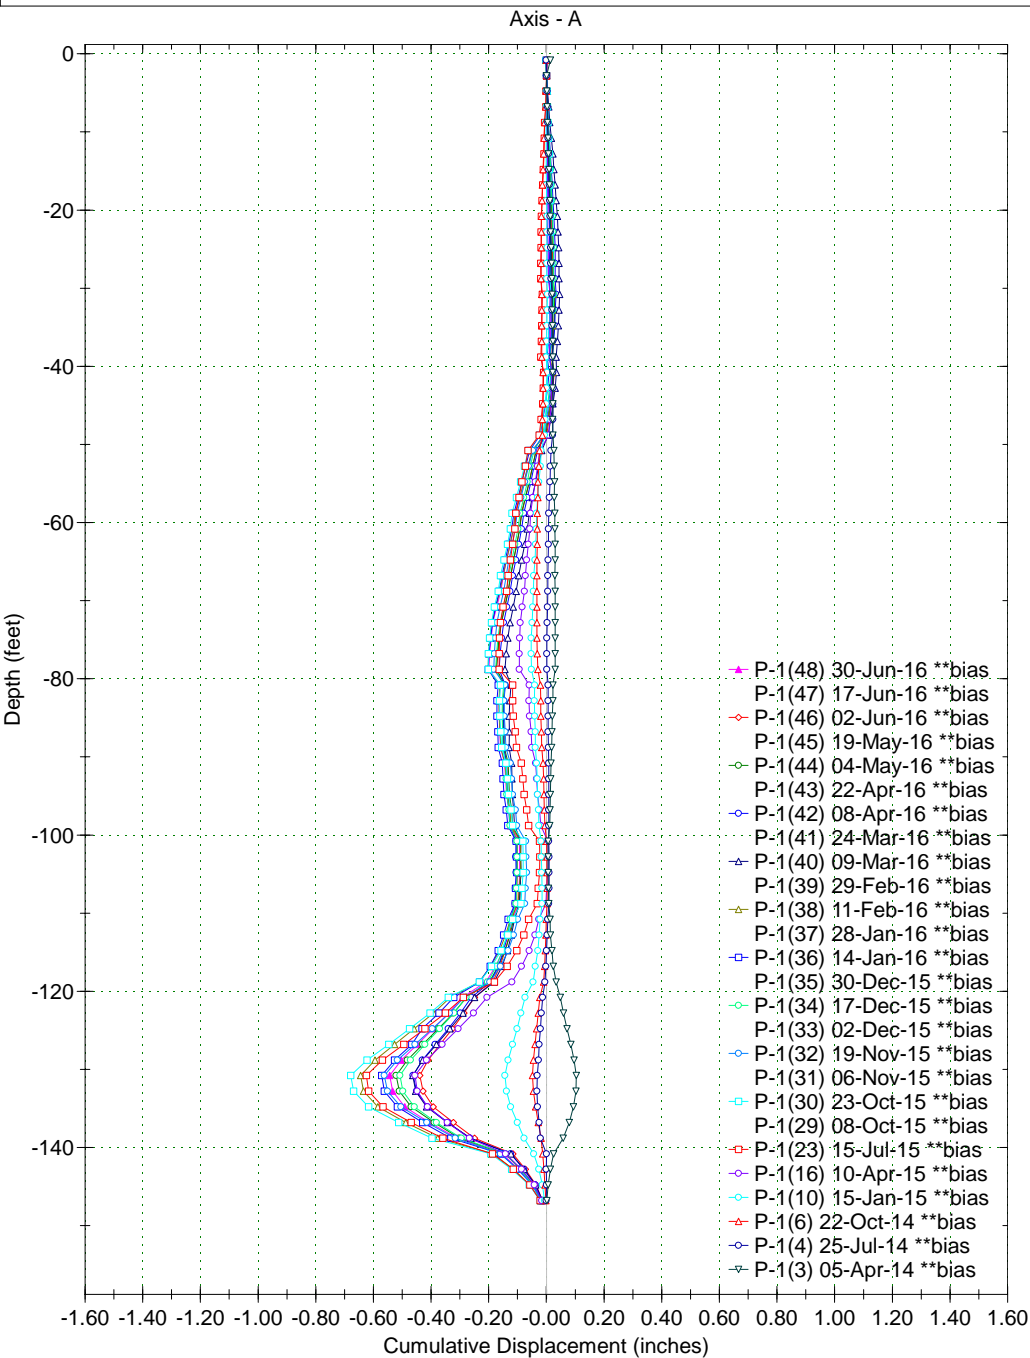
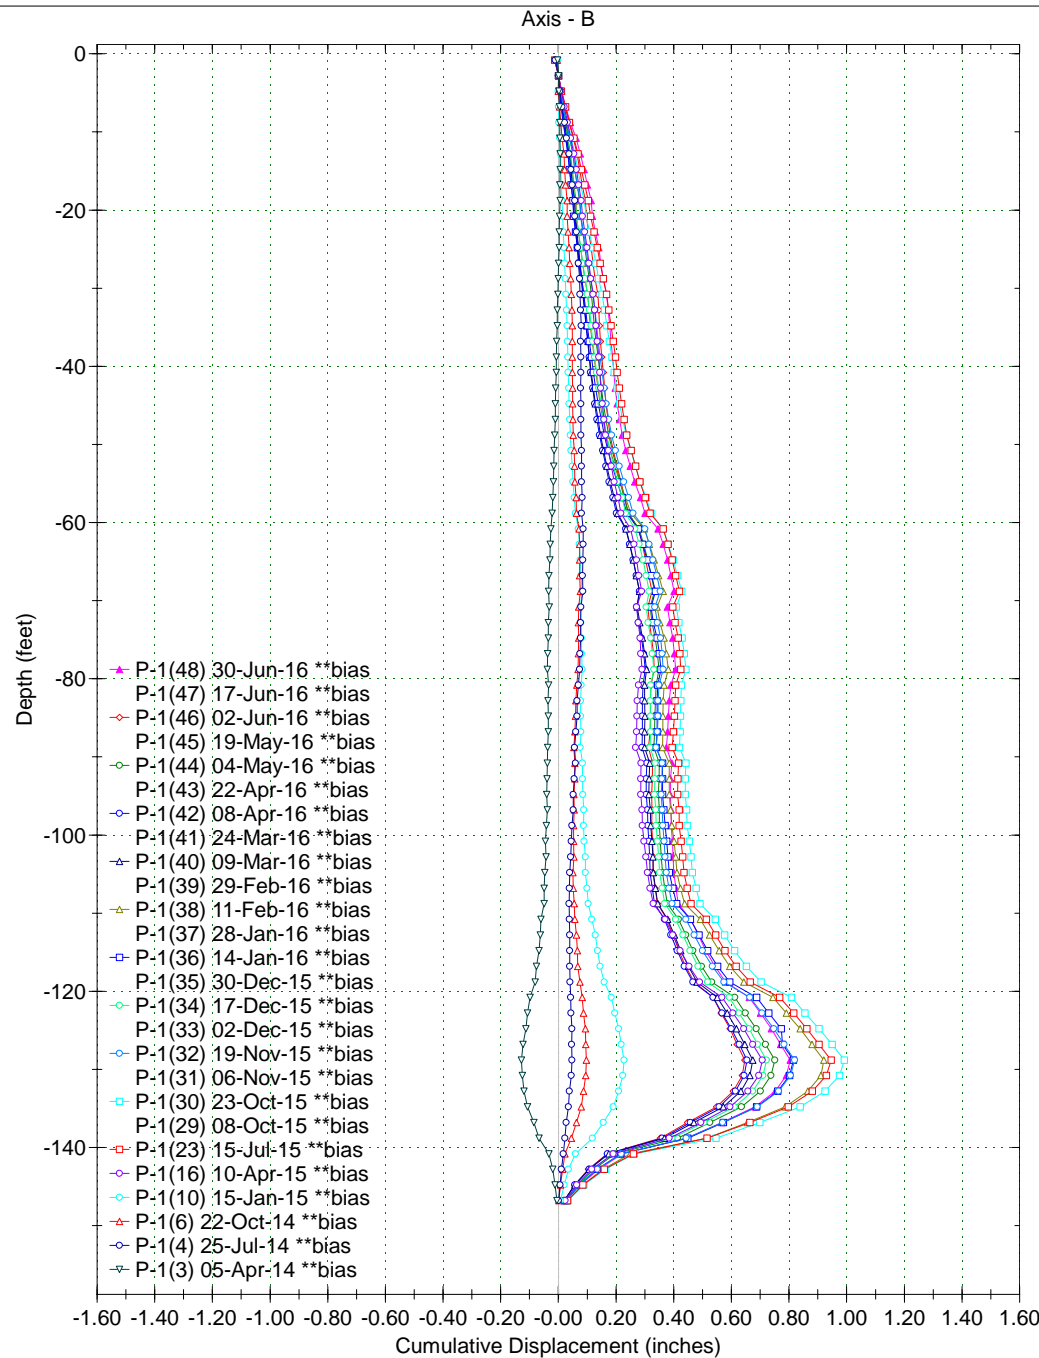
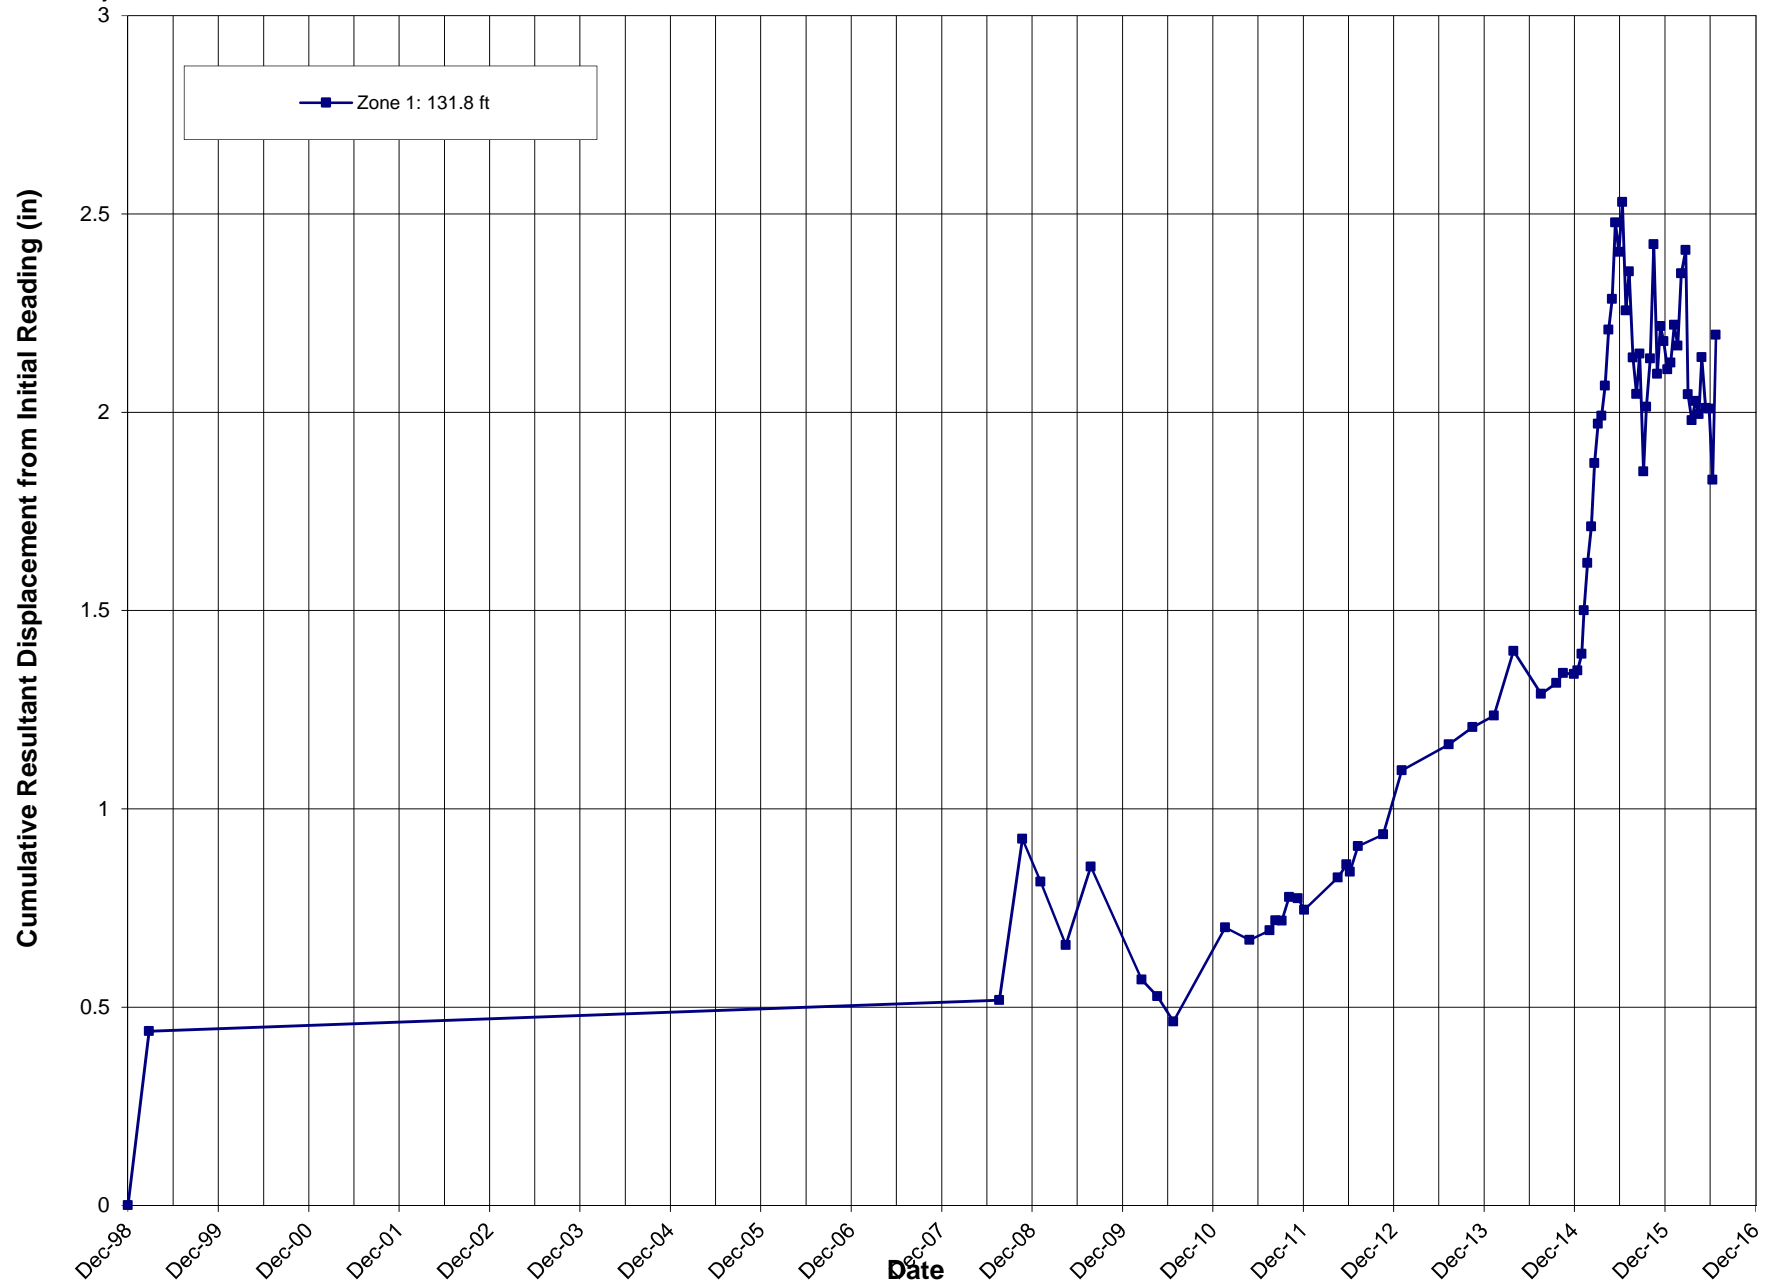
Borehole : P-1
Project : CUY-90-15-24
Location : Cleveland, Ohio
Northing :
Easting :
Collar :

P-1 – Inclinometer readings at this location show increase in displacement at 132 feet. The cumulative resultant displacement zone plot shows an increase of about 0.3 feet. This displacement is within the range of displacements seen since July 2015.
