Re: July 18, 19, and 20, 2016 Bi-Weekly Readings
CUY-90-15.24 Slope Monitoring
PID 96504
SME Project No. 069032.00

Bi-weekly instrument readings for the I-90 west slope taken on July 18, 19, and 20, 2016, are presented in this report. Bi-weekly readings currently include instruments at I/P-001-13, I/P-002-13, I/P-003-10, I/P-004-13, I/P-009-13, B-101, B-102, B-105A, B-05-02, B-05-A-03, B-05-04, B-05-A-11, P-1, P-9N, TGR I-2, and TGR I-4. Changes reported for the individual instruments are for the previous two-week period unless noted otherwise.

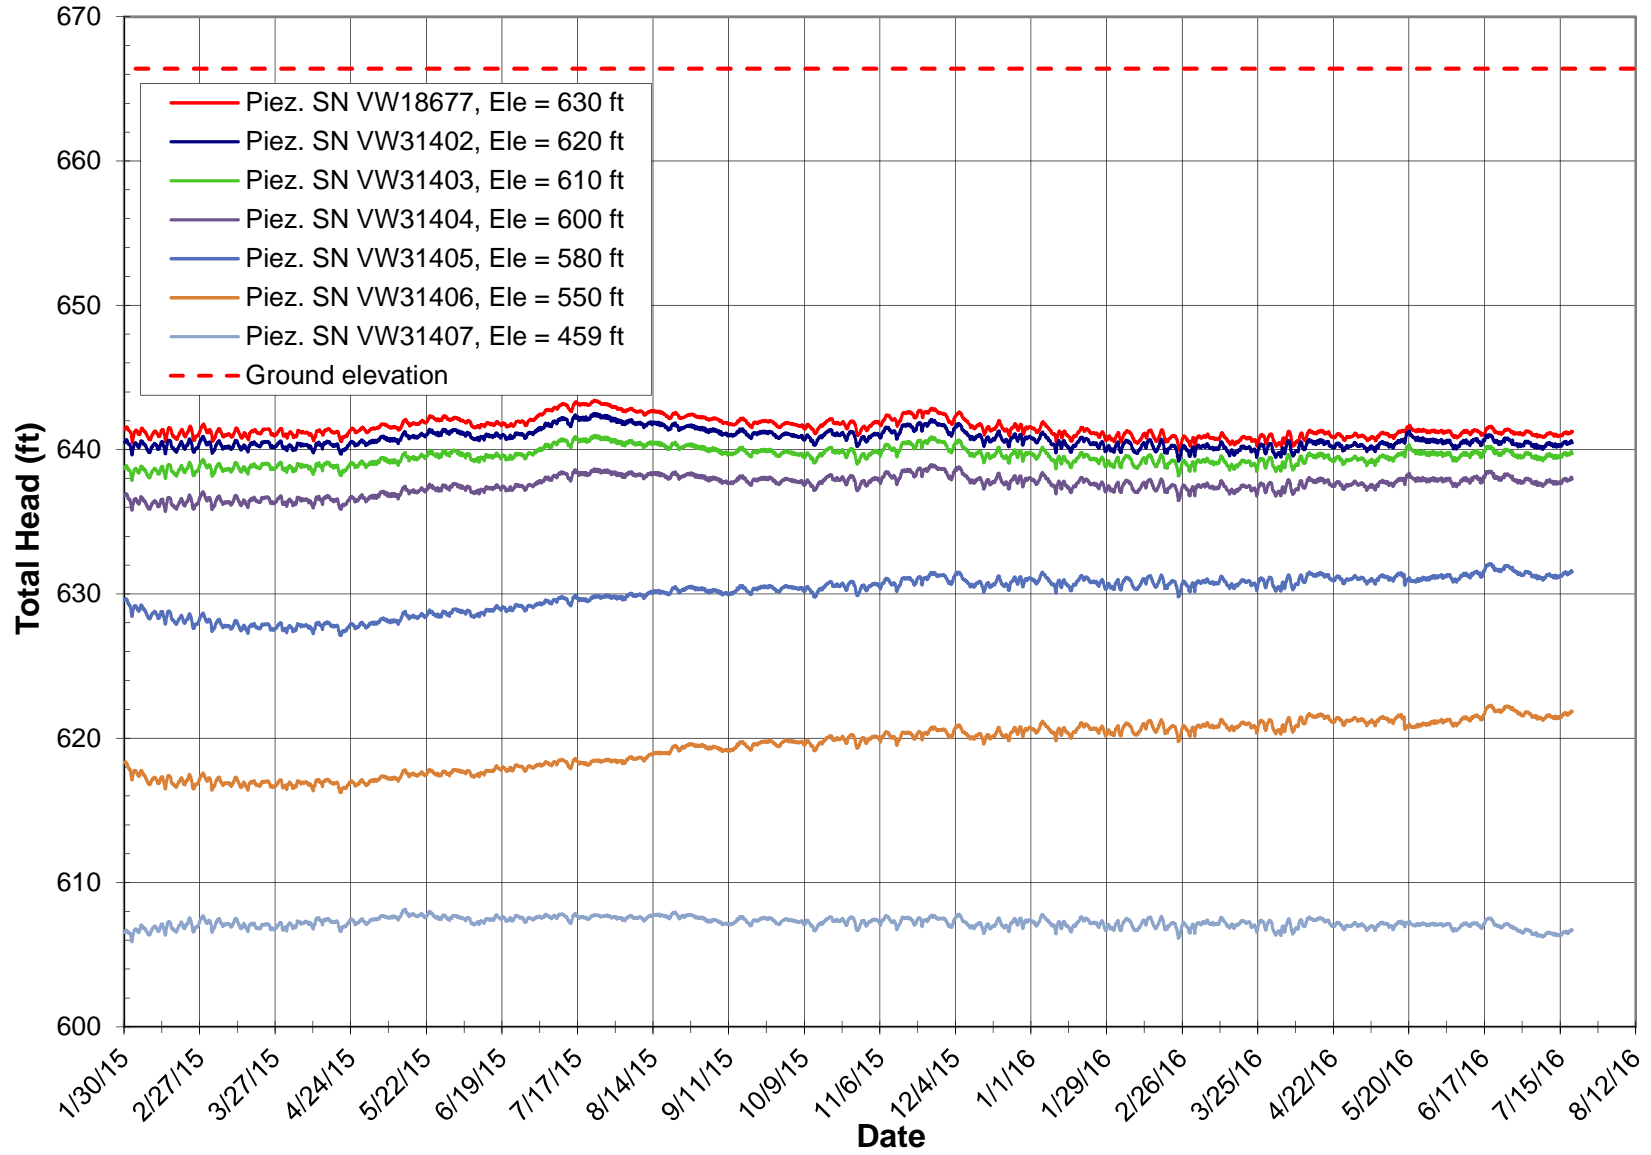
P-001-13 VW Piezometer Readings

P-001-13, P-002-13, P-003-10, P-009-13, B-05-A-03, B-05-04, B-05-A-11 – Pore pressure readings at these locations fluctuated by less than 0.5 feet, but show virtually no net change in total head.

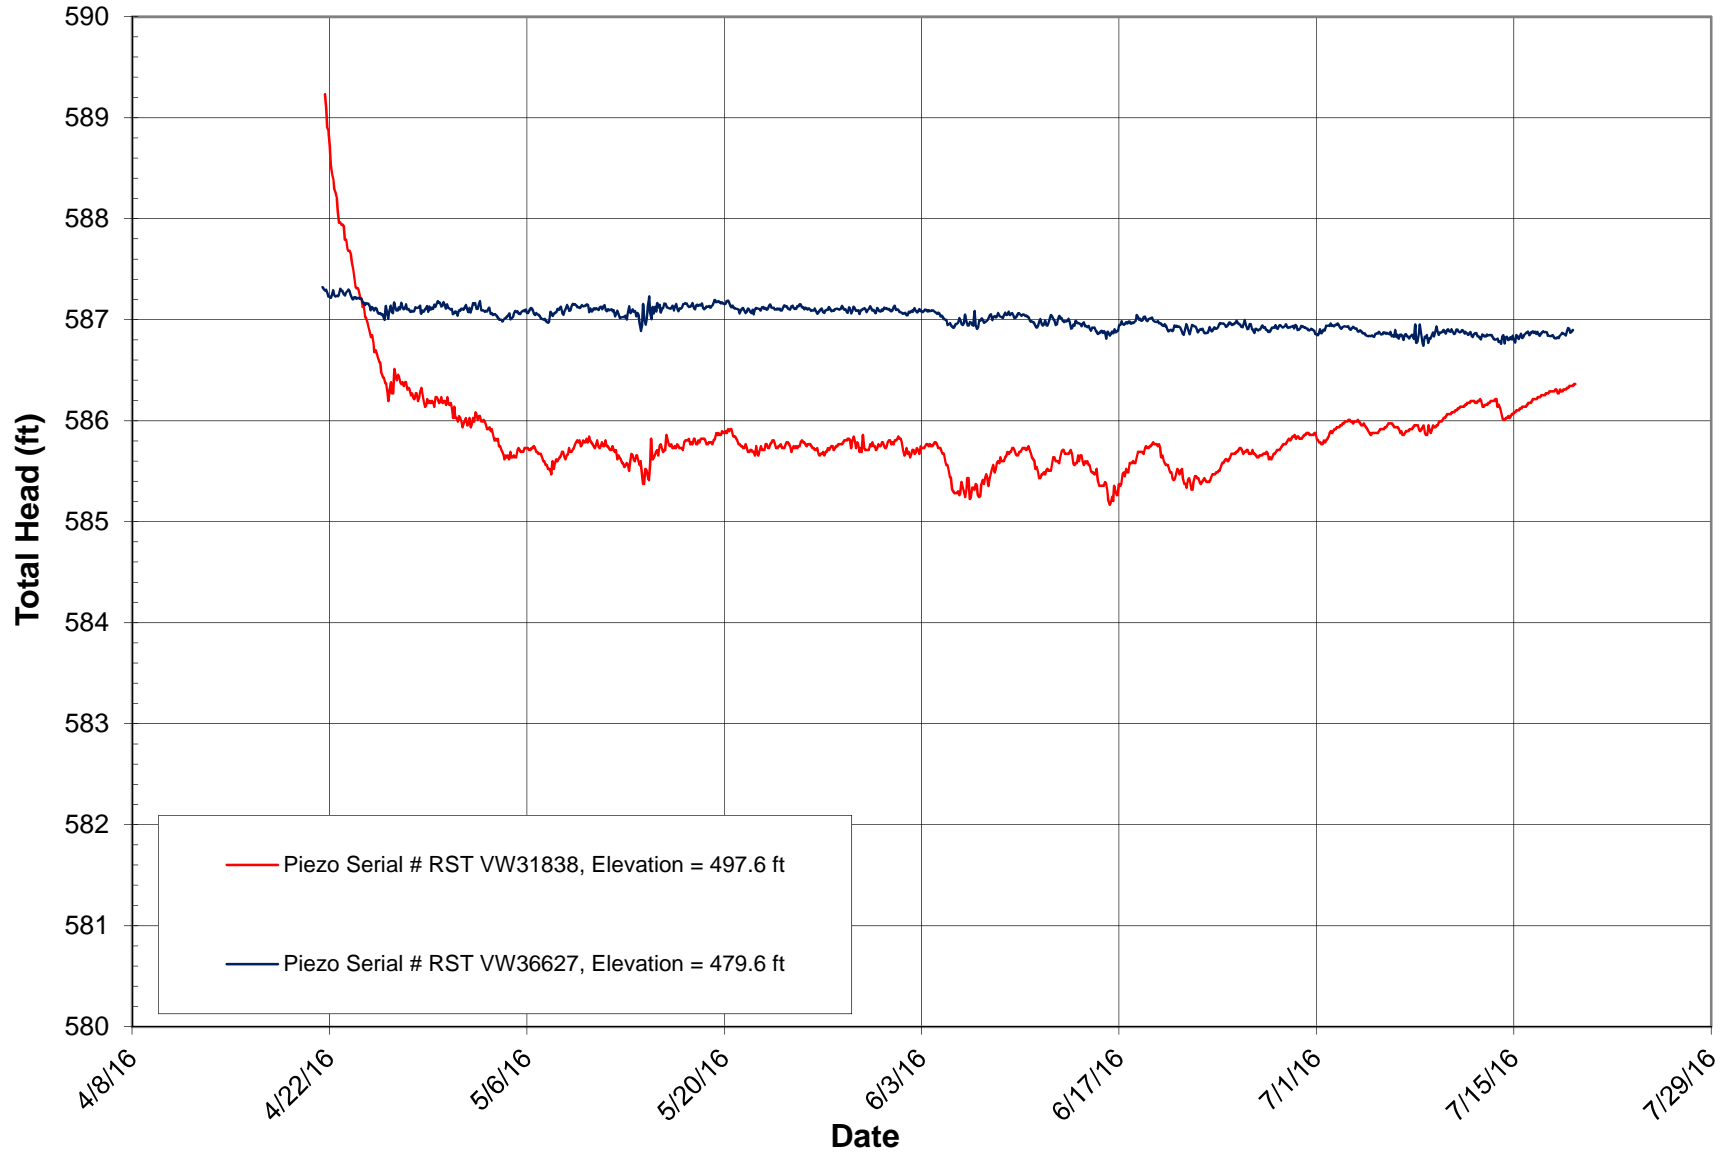
B-105A VW Piezometer Readings

B-105-A – Pore pressure readings indicate a continued increase in total head in the shallow piezometer at this location. Total head increased by about 1 foot since June 17, 2016. Virtually no change is indicated in the deep piezometer.

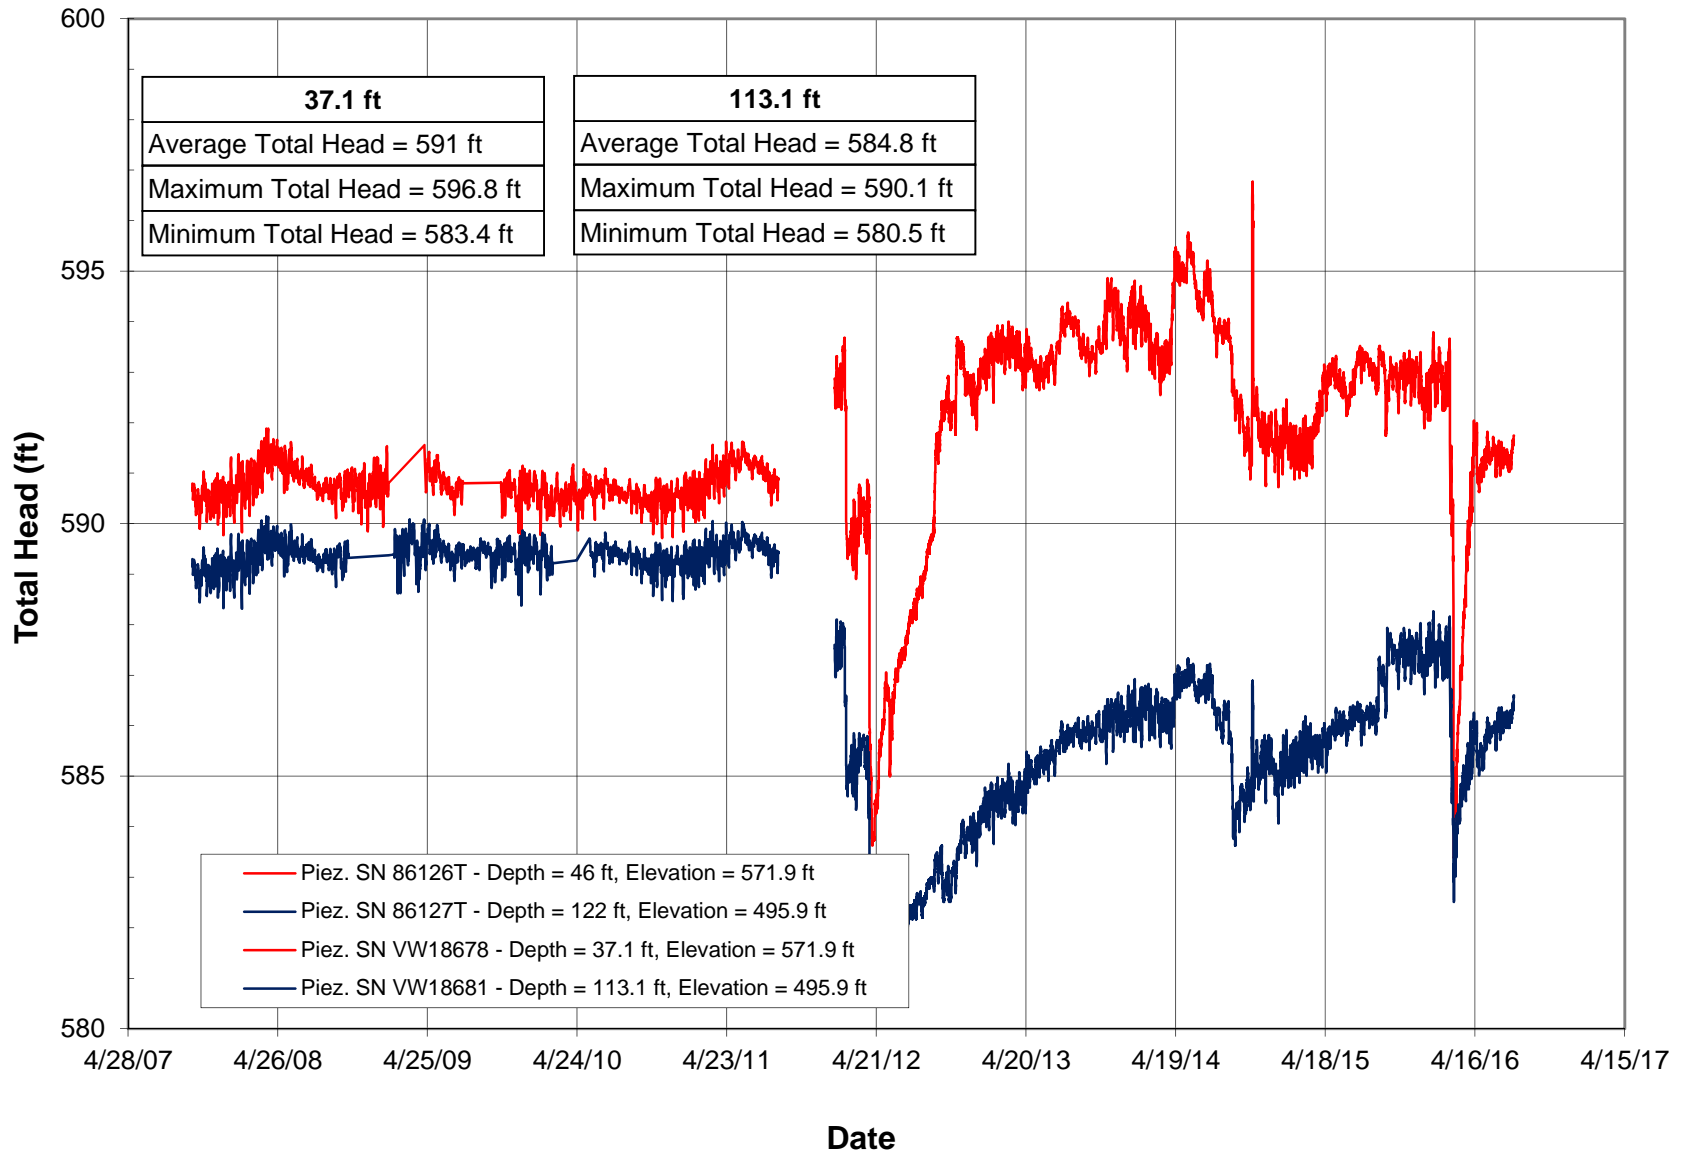
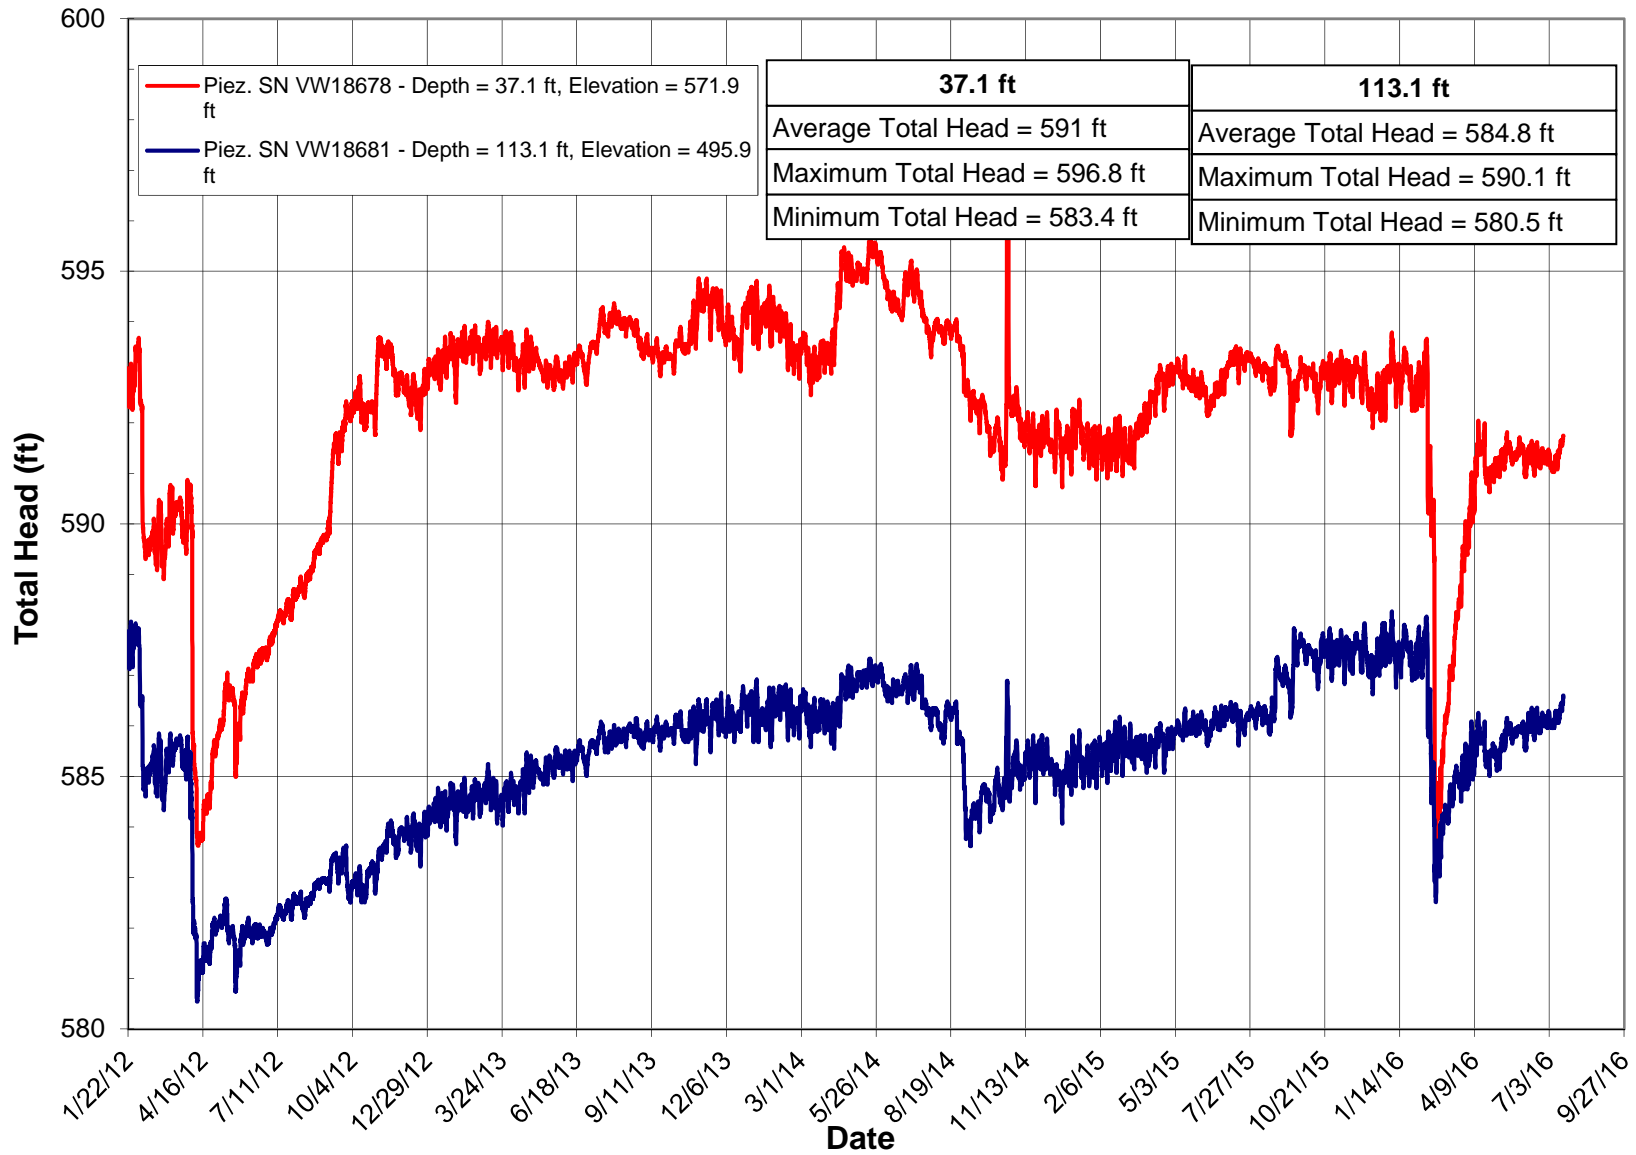
B-05-02 VW Piezometer Readings

B-05-02 – At this location, pore pressure readings indicate an increase in total head of about 0.5 feet in both piezometers.
