Re: July 18, 19, and 20, 2016 Bi-Weekly Readings
CUY-90-15.24 Slope Monitoring
PID 96504
SME Project No. 069032.00

Bi-weekly instrument readings for the I-90 west slope taken on July 18, 19, and 20, 2016, are presented in this report. Bi-weekly readings currently include instruments at I/P-001-13, I/P-002-13, I/P-003-10, I/P-004-13, I/P-009-13, B-101, B-102, B-105A, B-05-02, B-05-A-03, B-05-04, B-05-A-11, P-1, P-9N, TGR I-2, and TGR I-4. Changes reported for the individual instruments are for the previous two-week period unless noted otherwise.

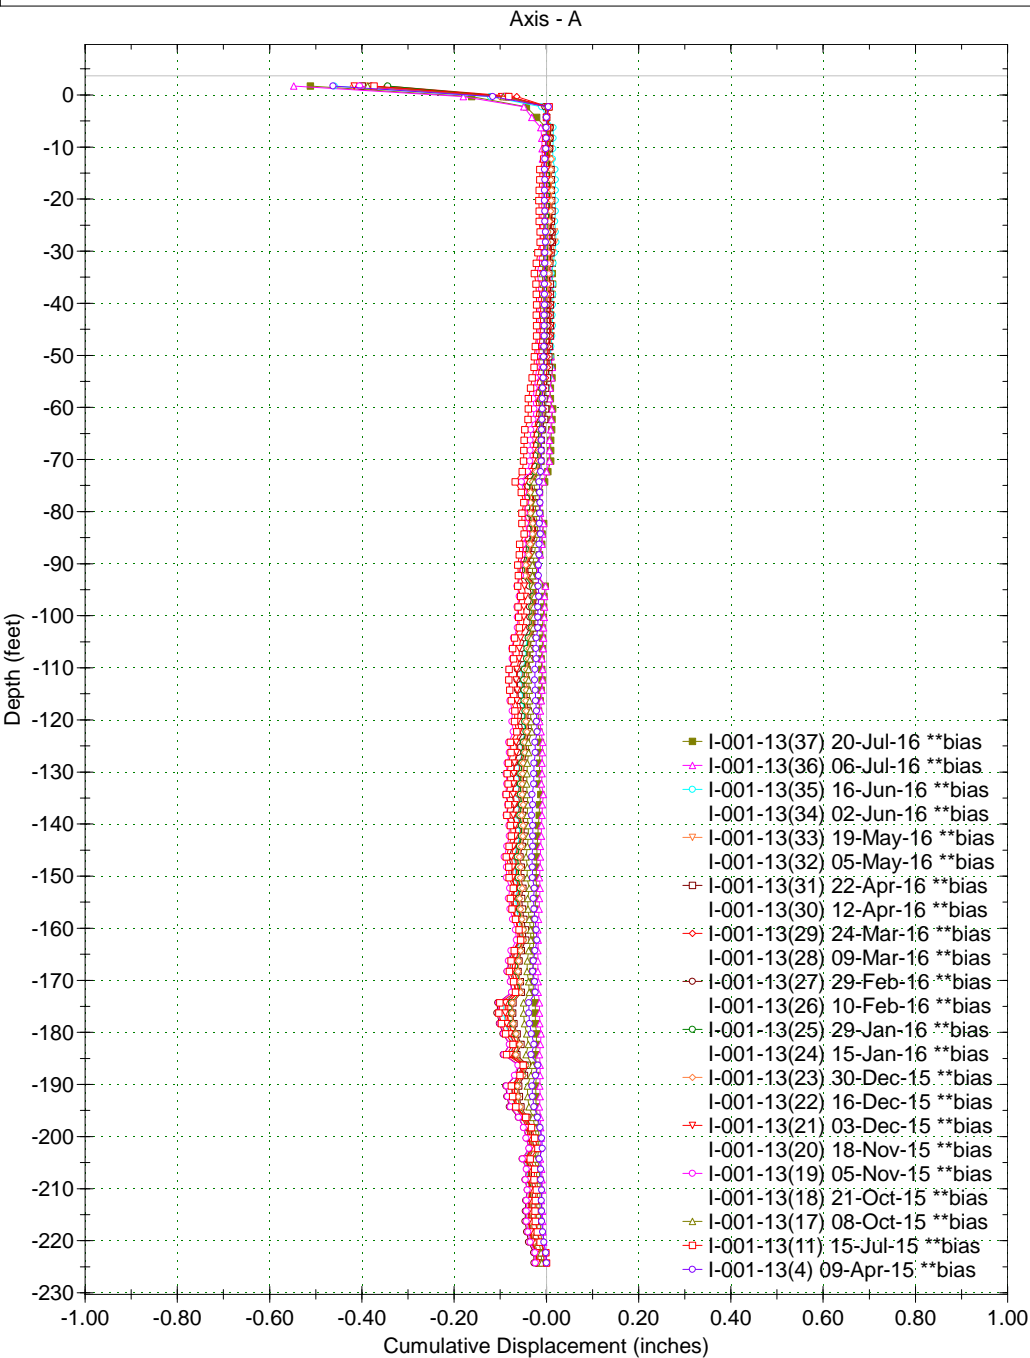
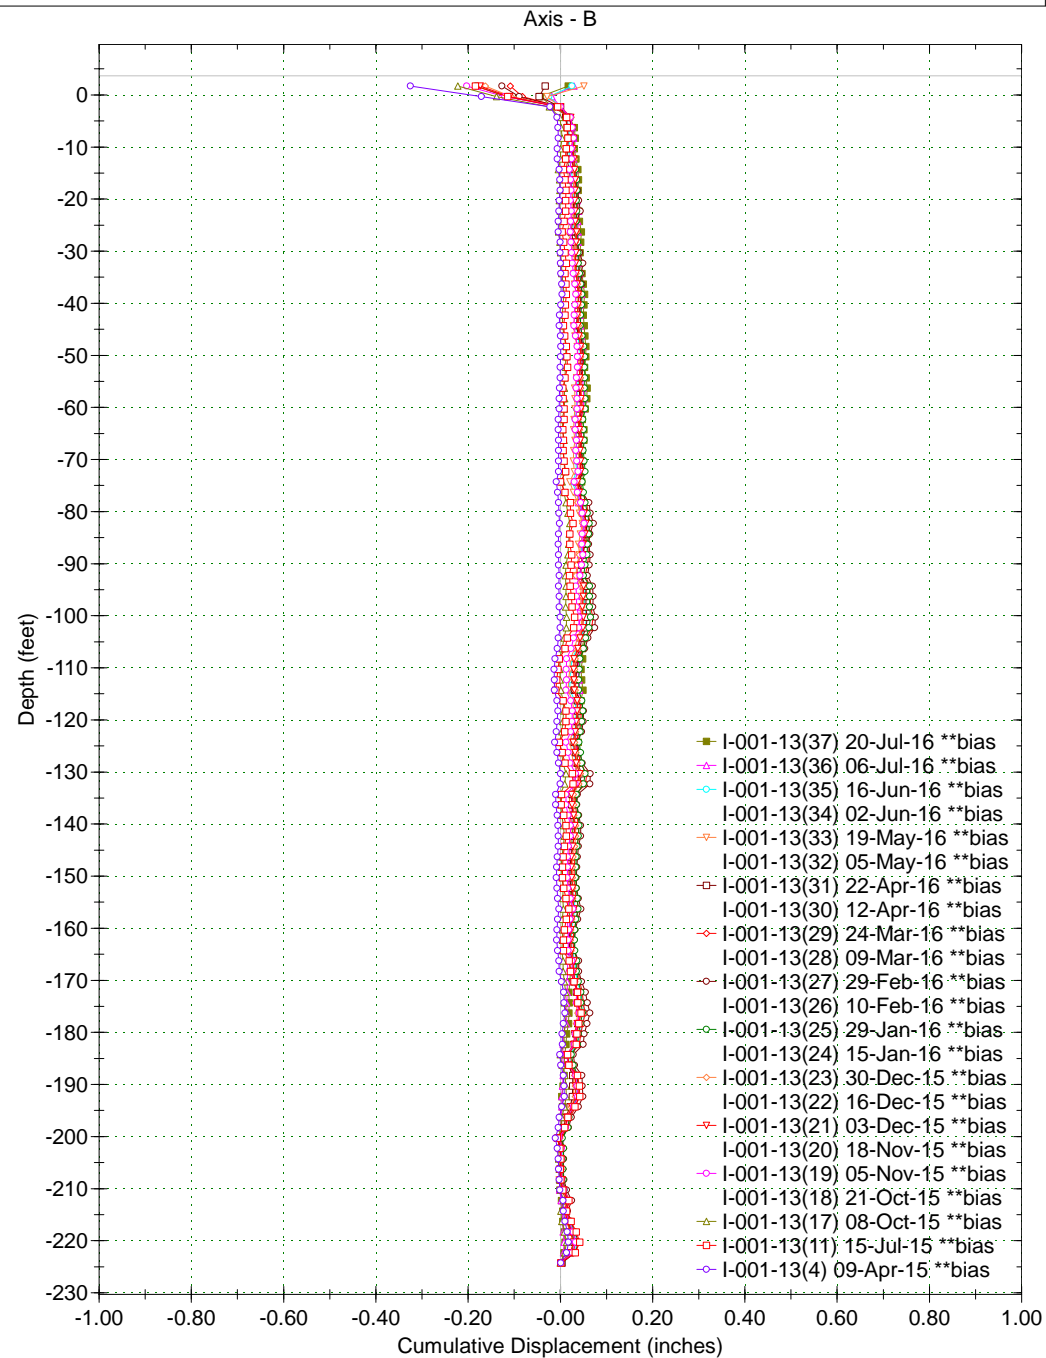
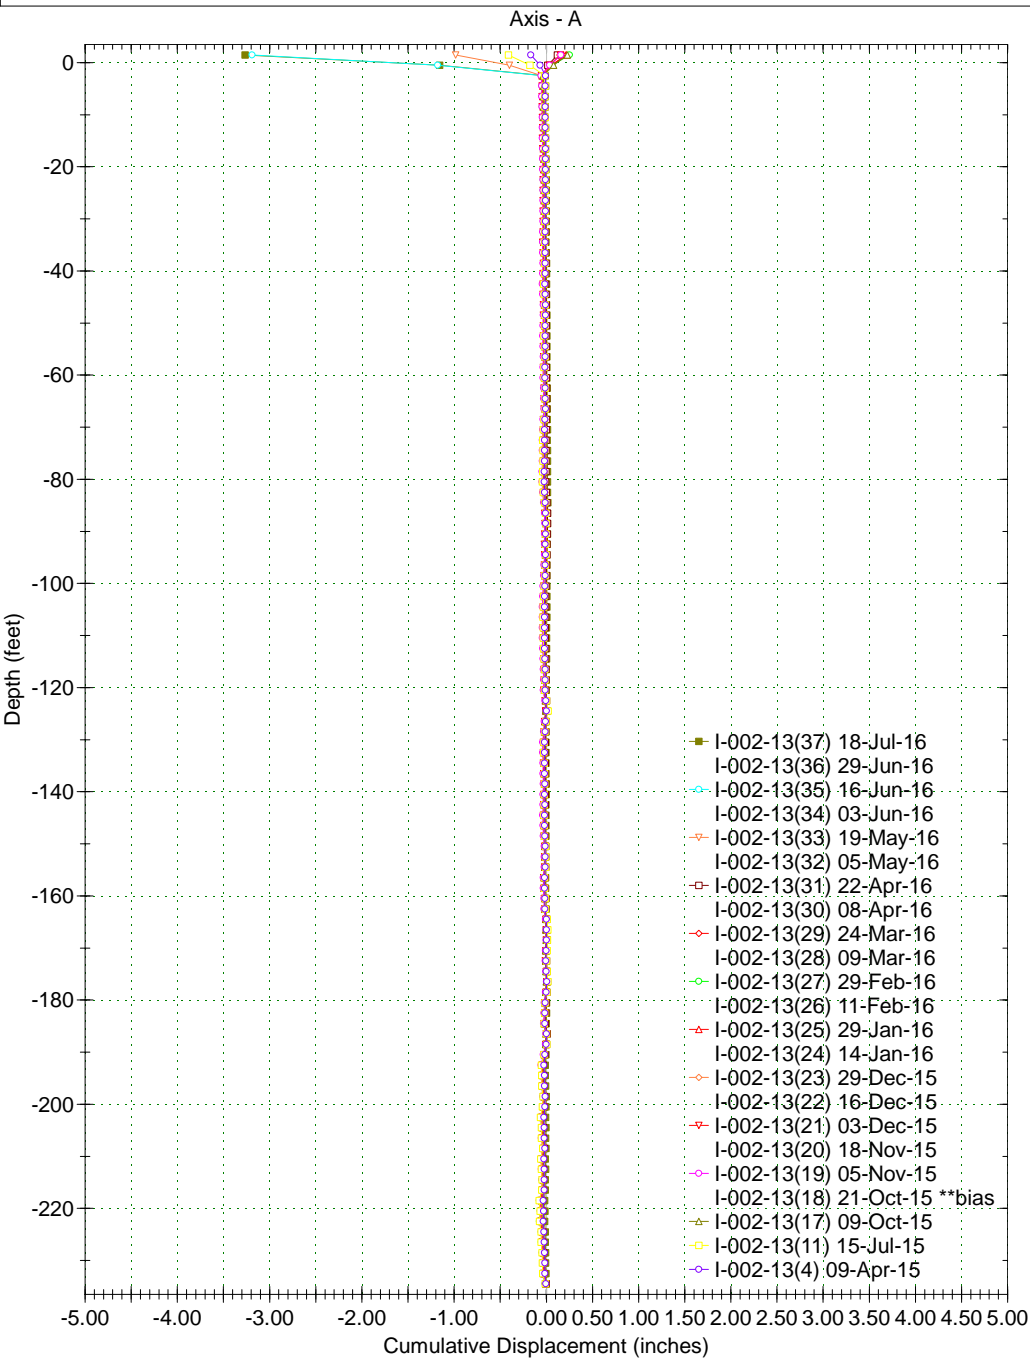
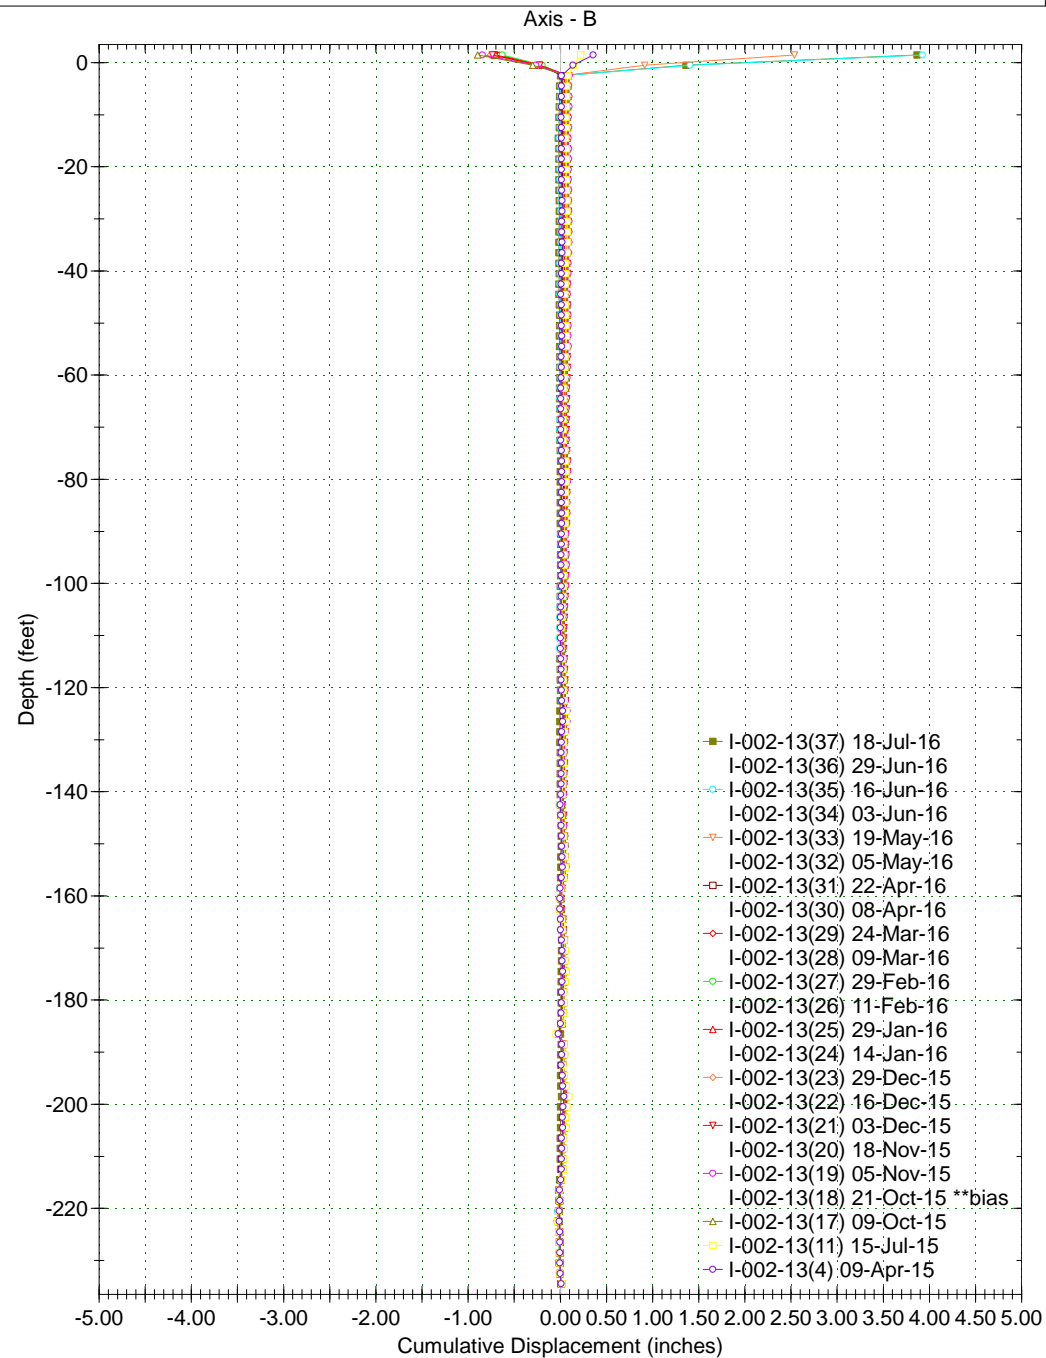
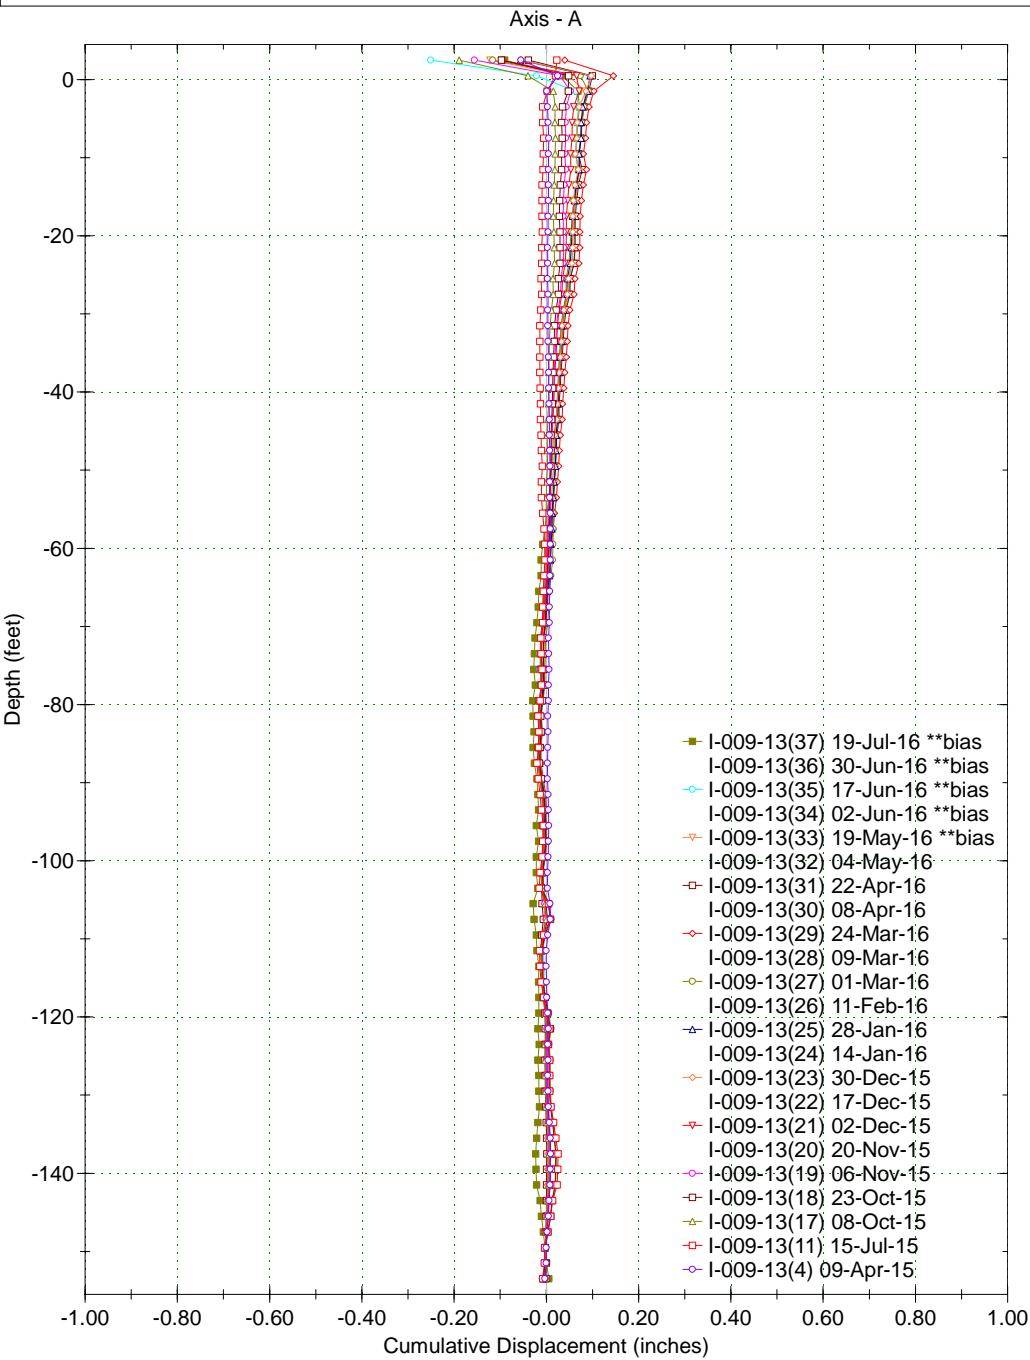
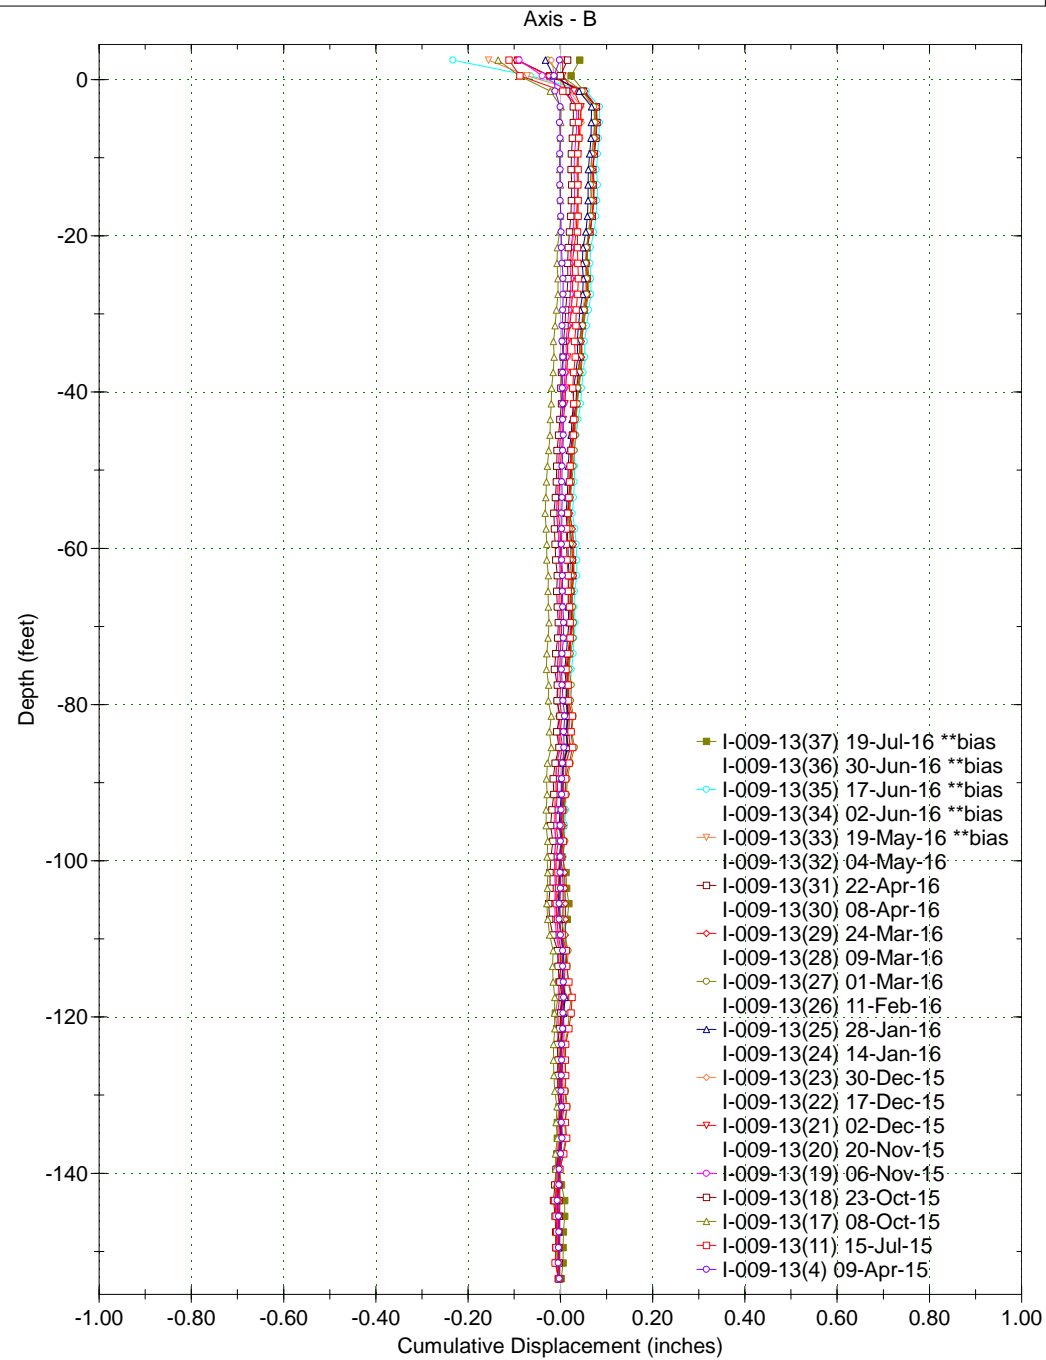
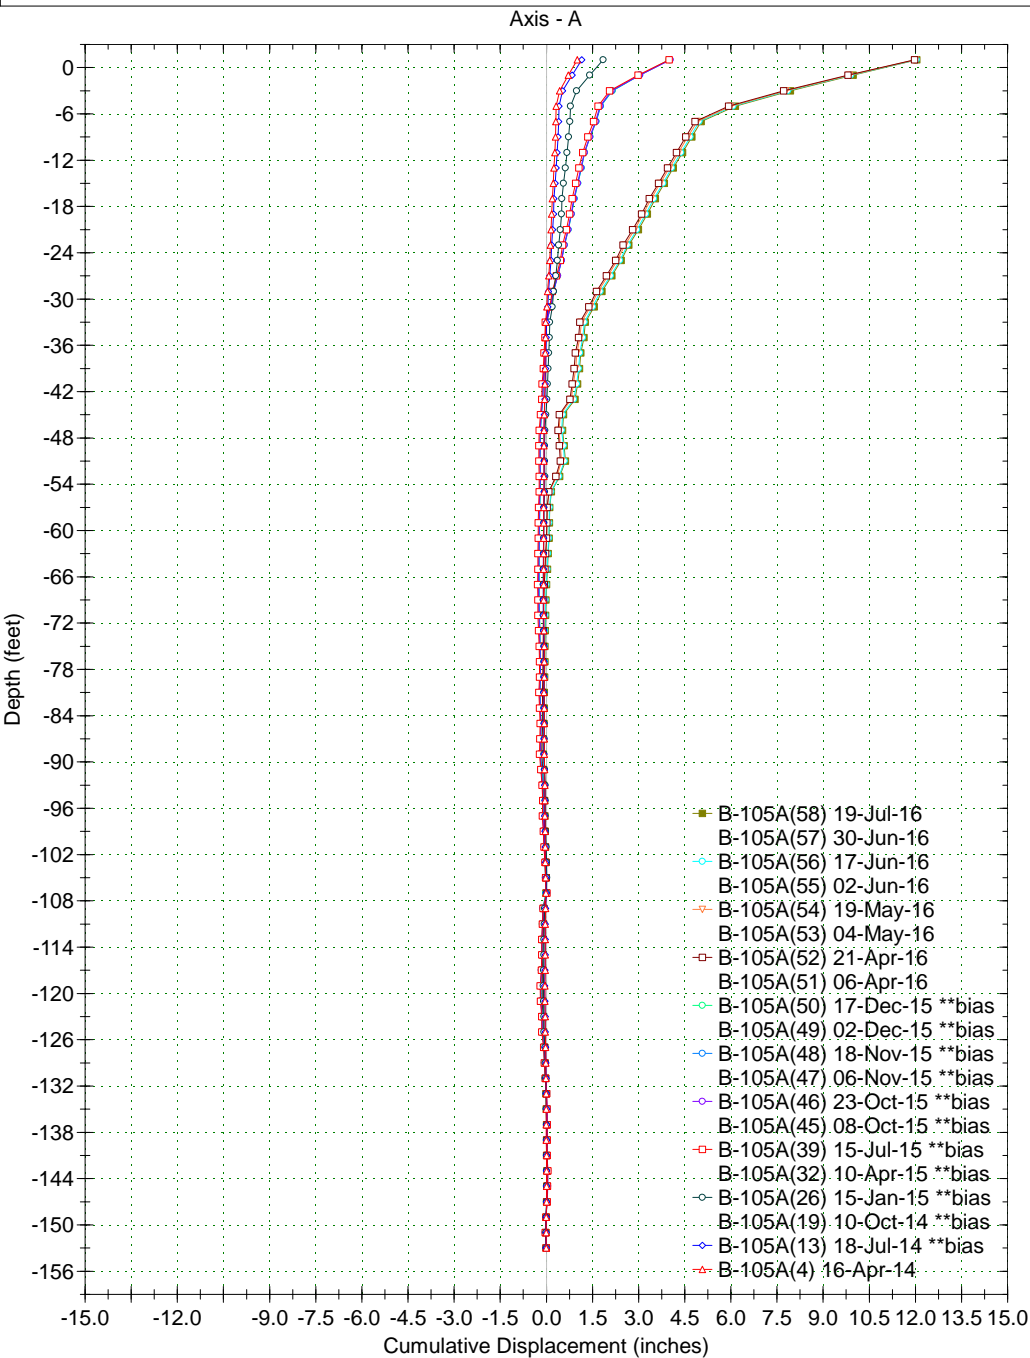
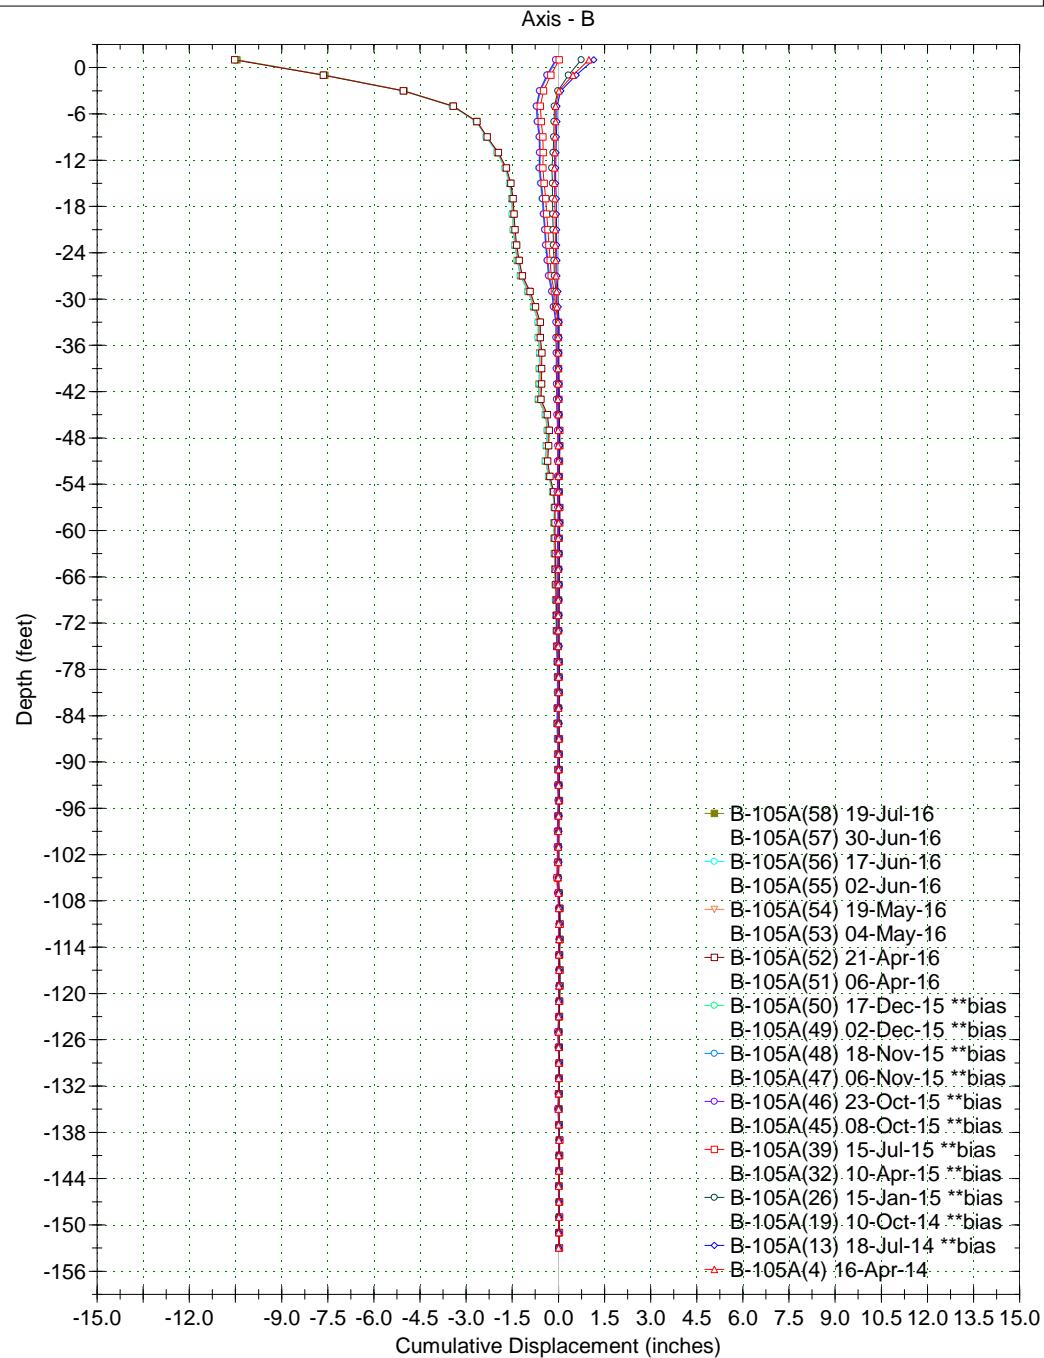
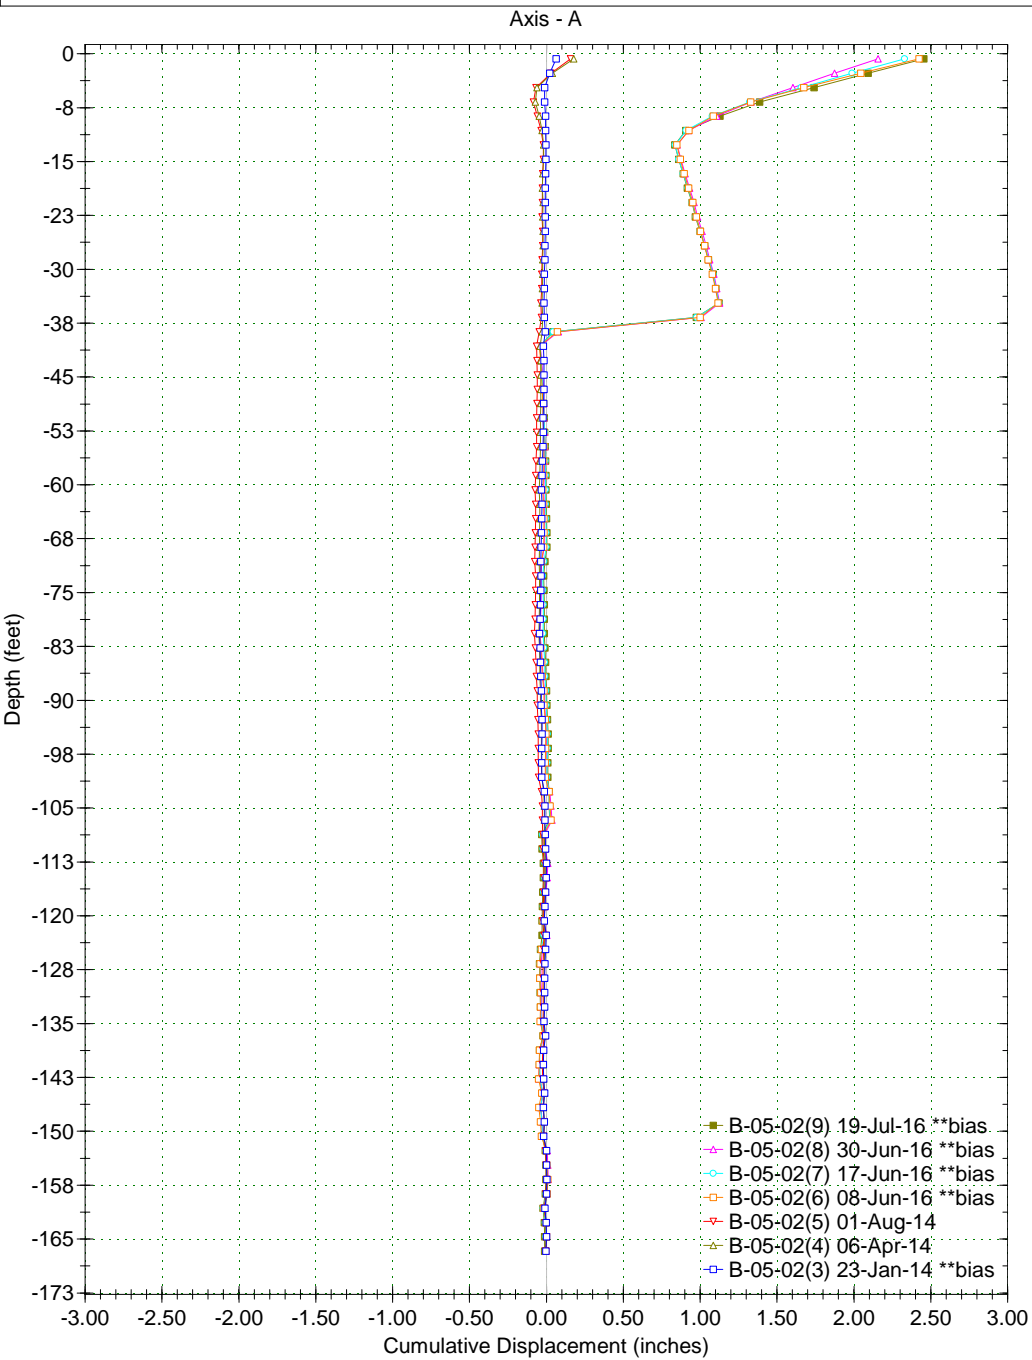
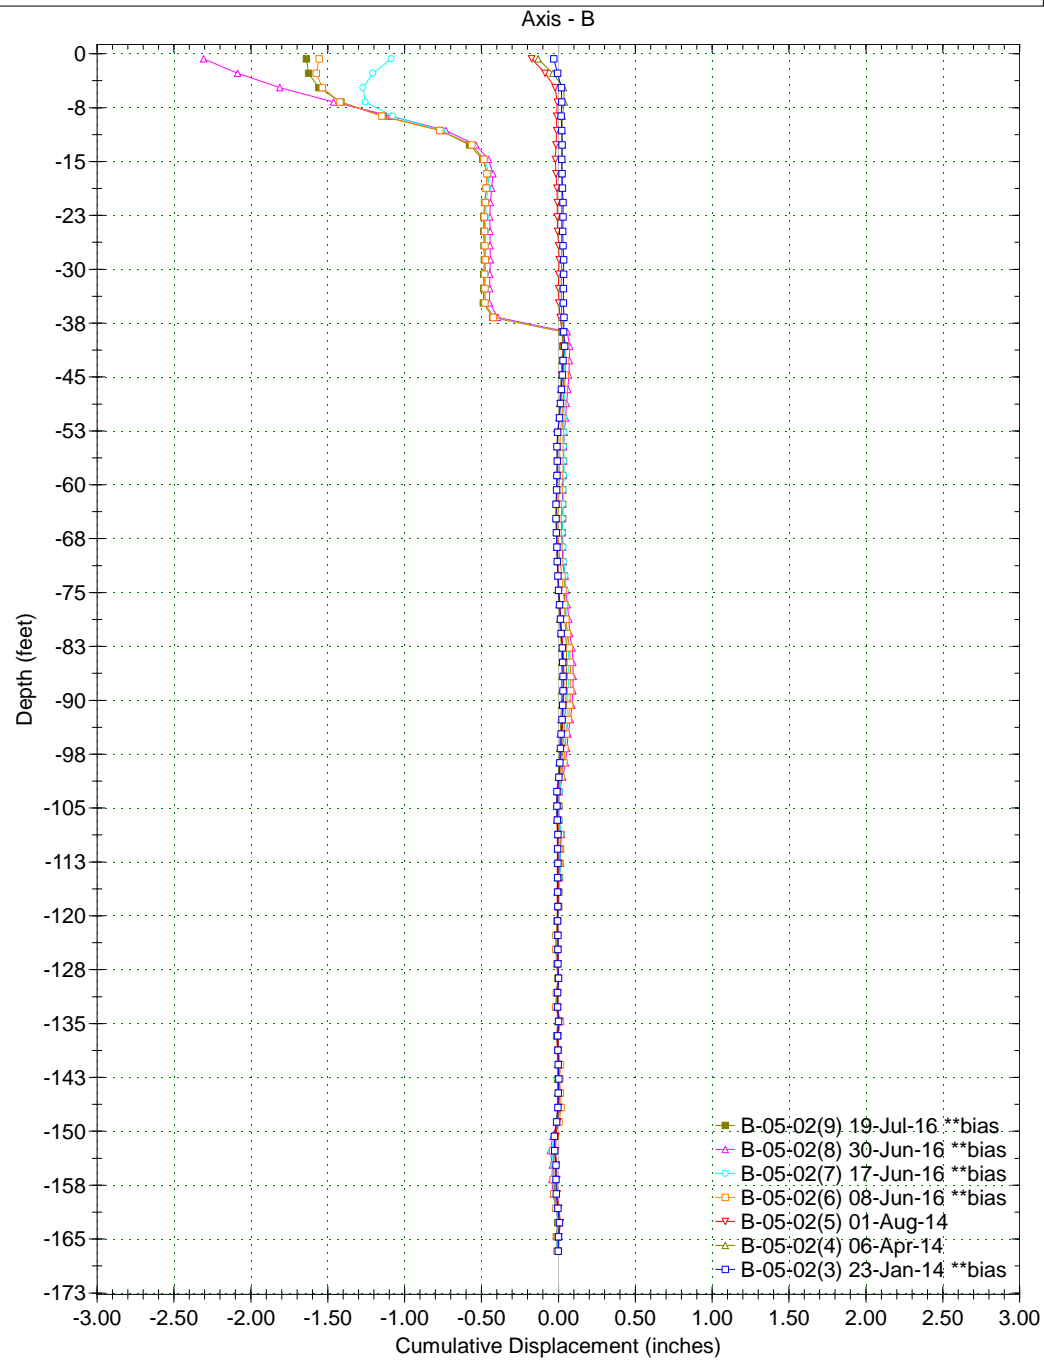
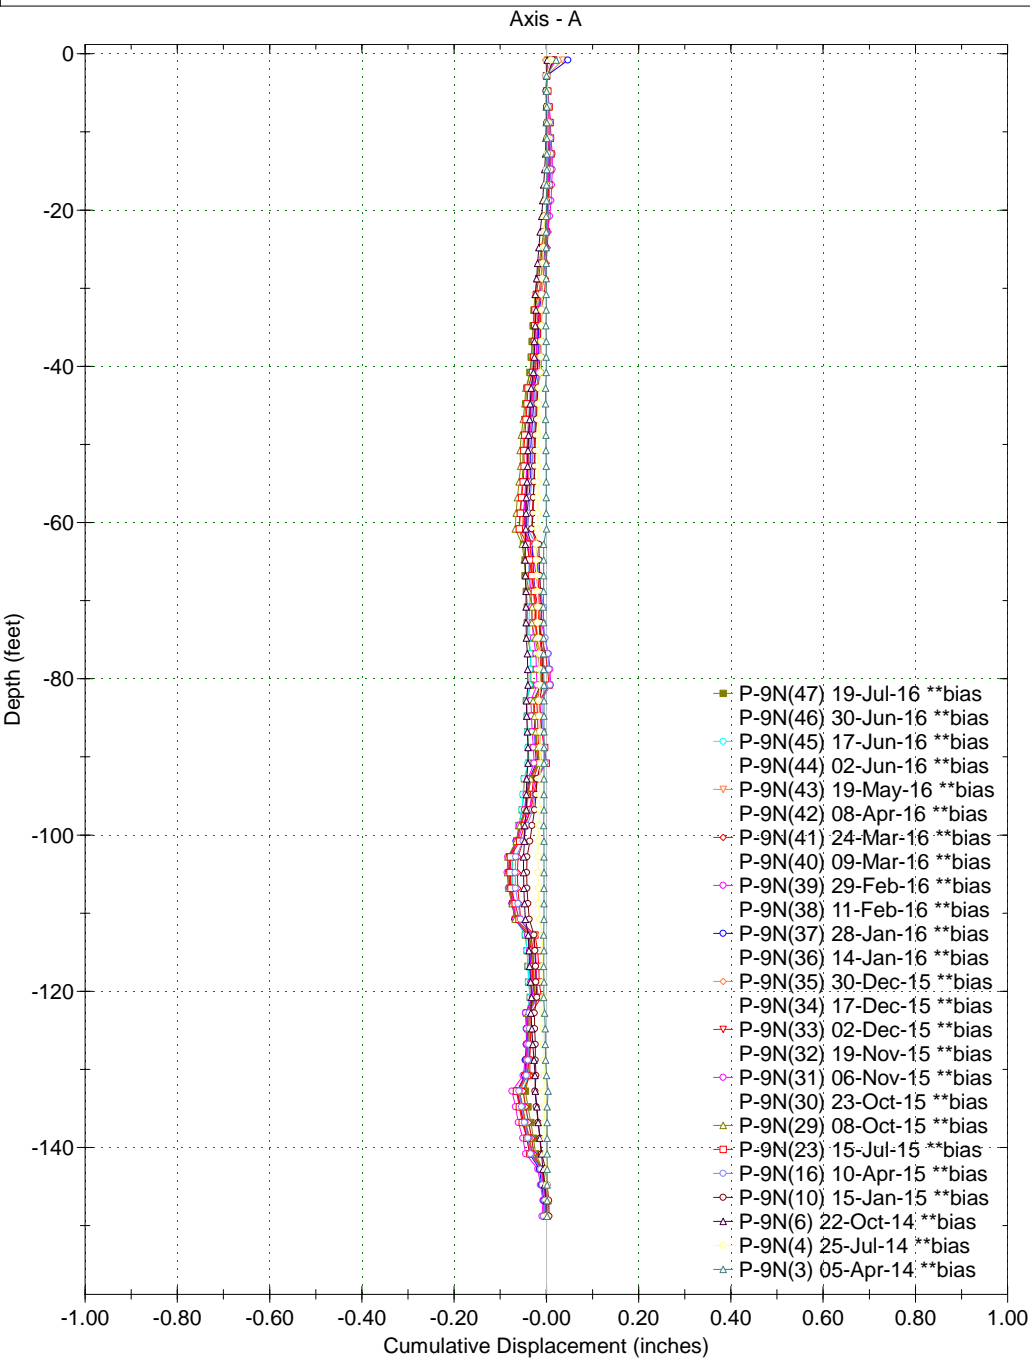
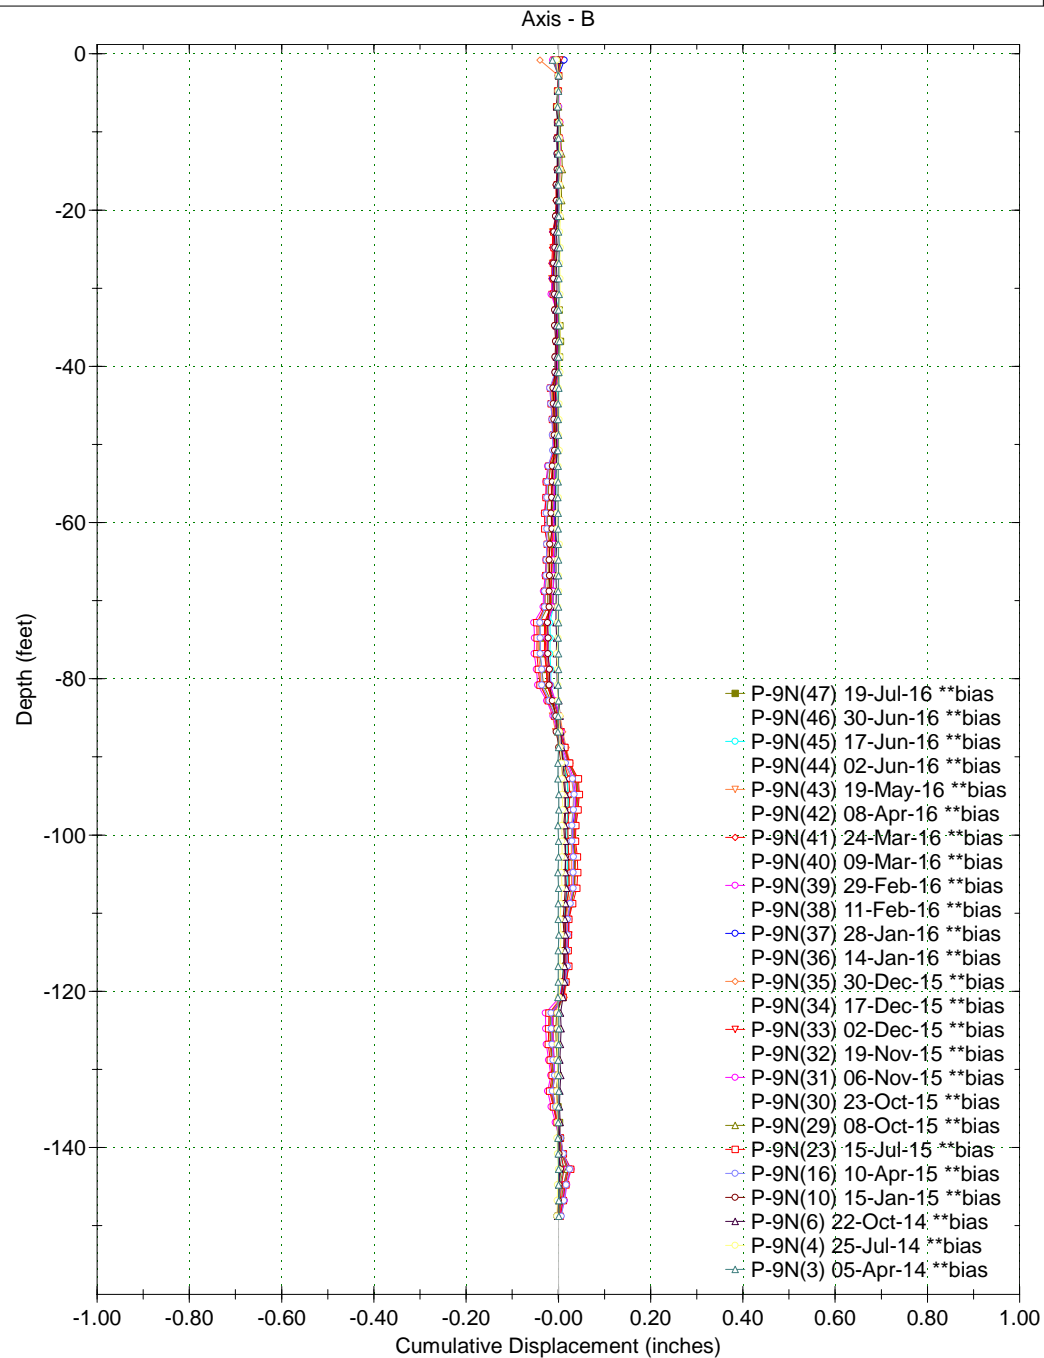
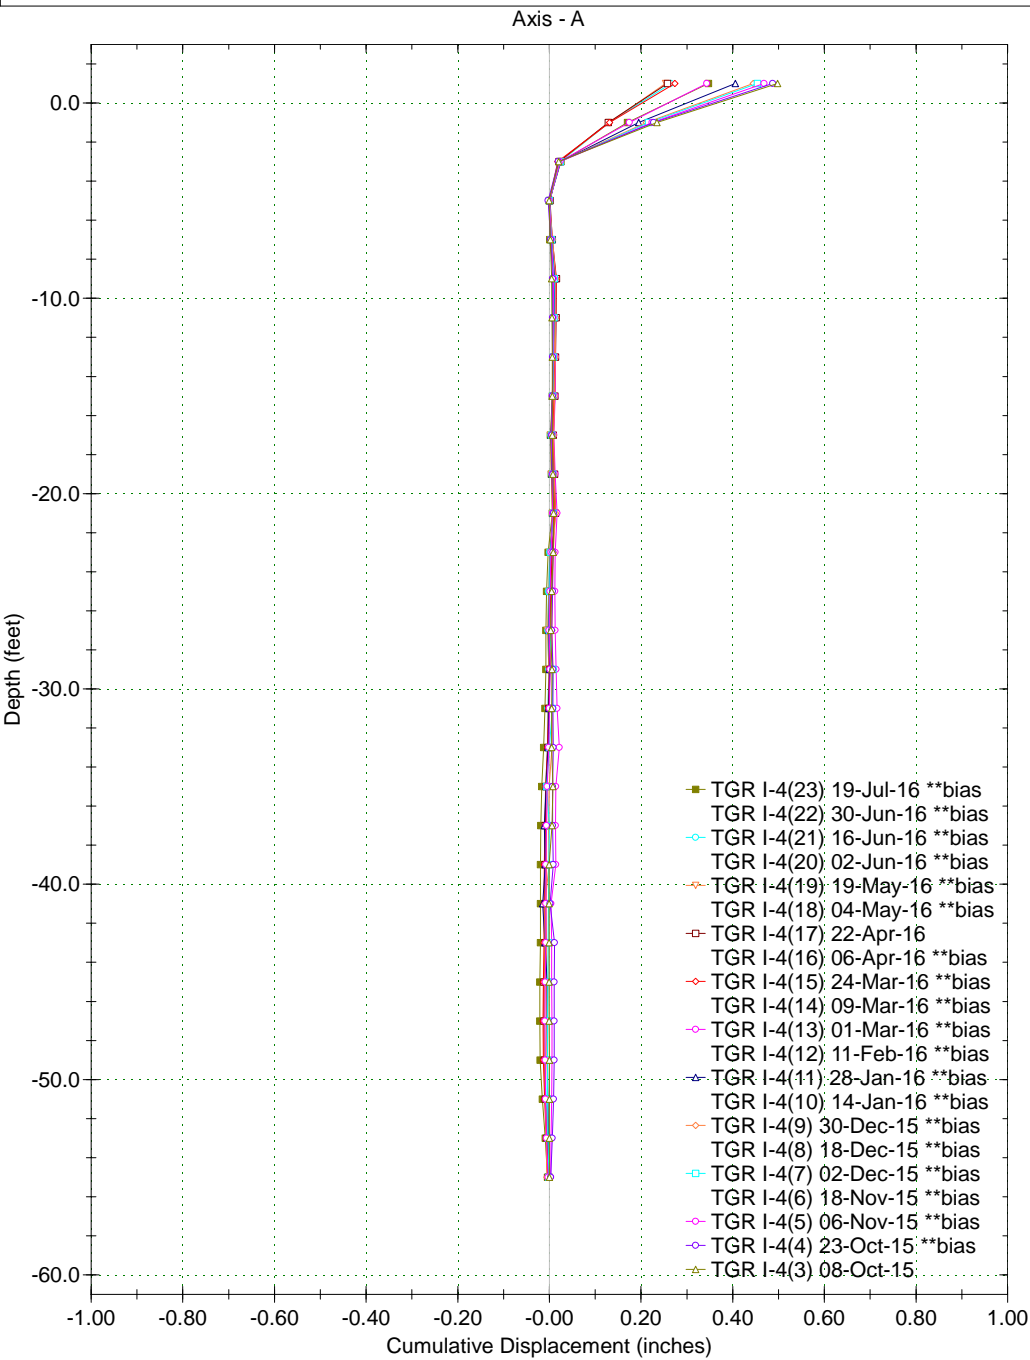
Inclinometer readings at I-001-13, I-002-13, I-009-13, B-105A, B-05-A-02, P-9N, and TGR I-4 showed virtually no movement. Displacement at the top of some slope tubes is due to construction disturbance or flexing of the inclinometer tube as readings were taken where the protective covers have not been concreted in place because of the ongoing construction activity.

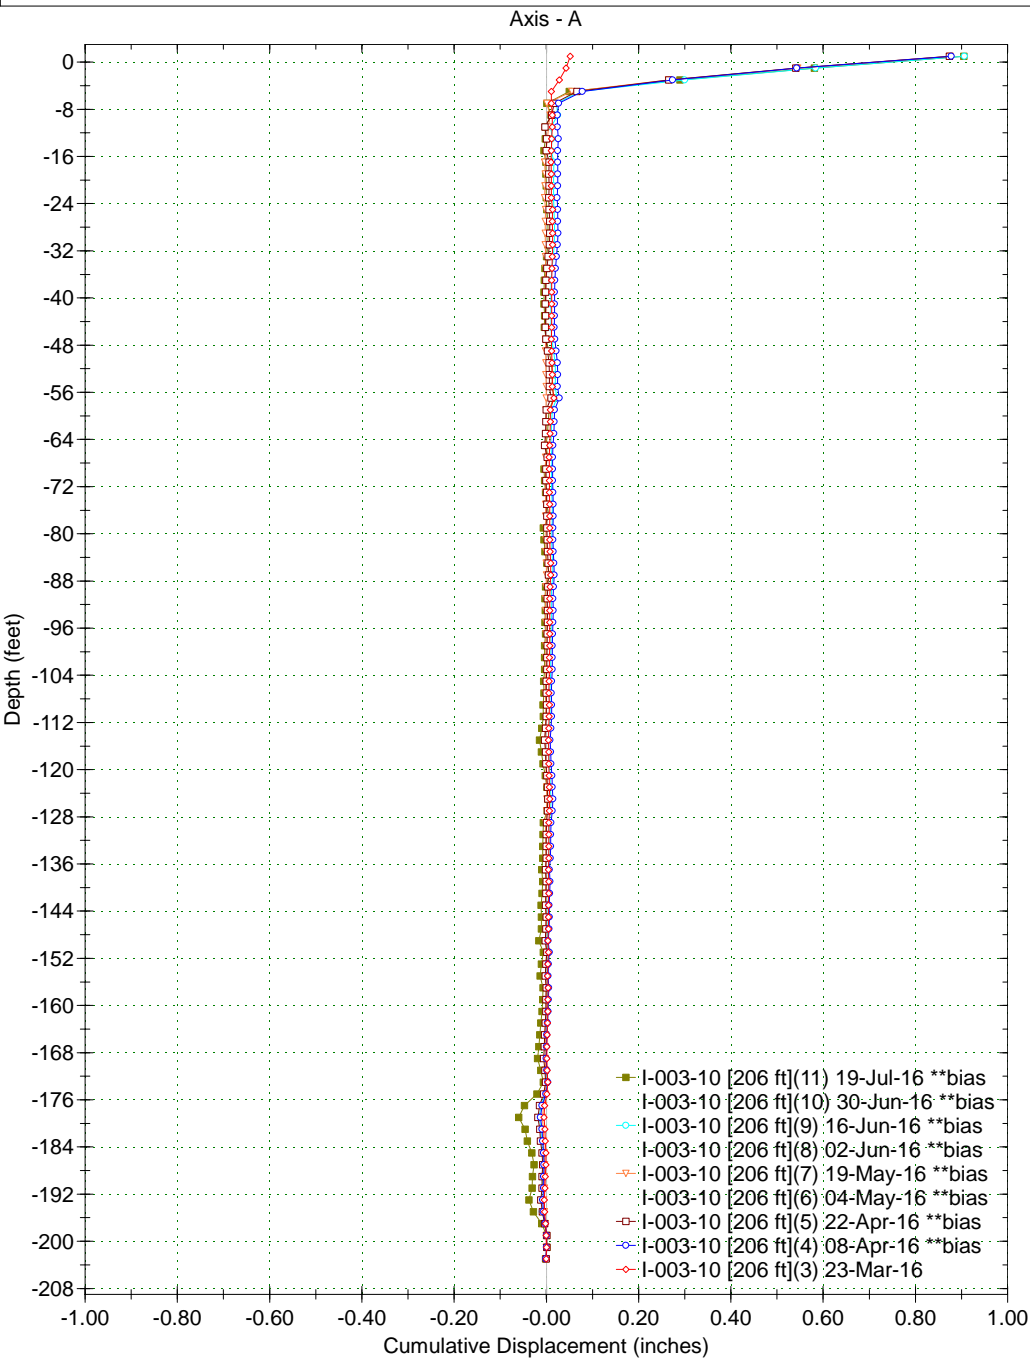
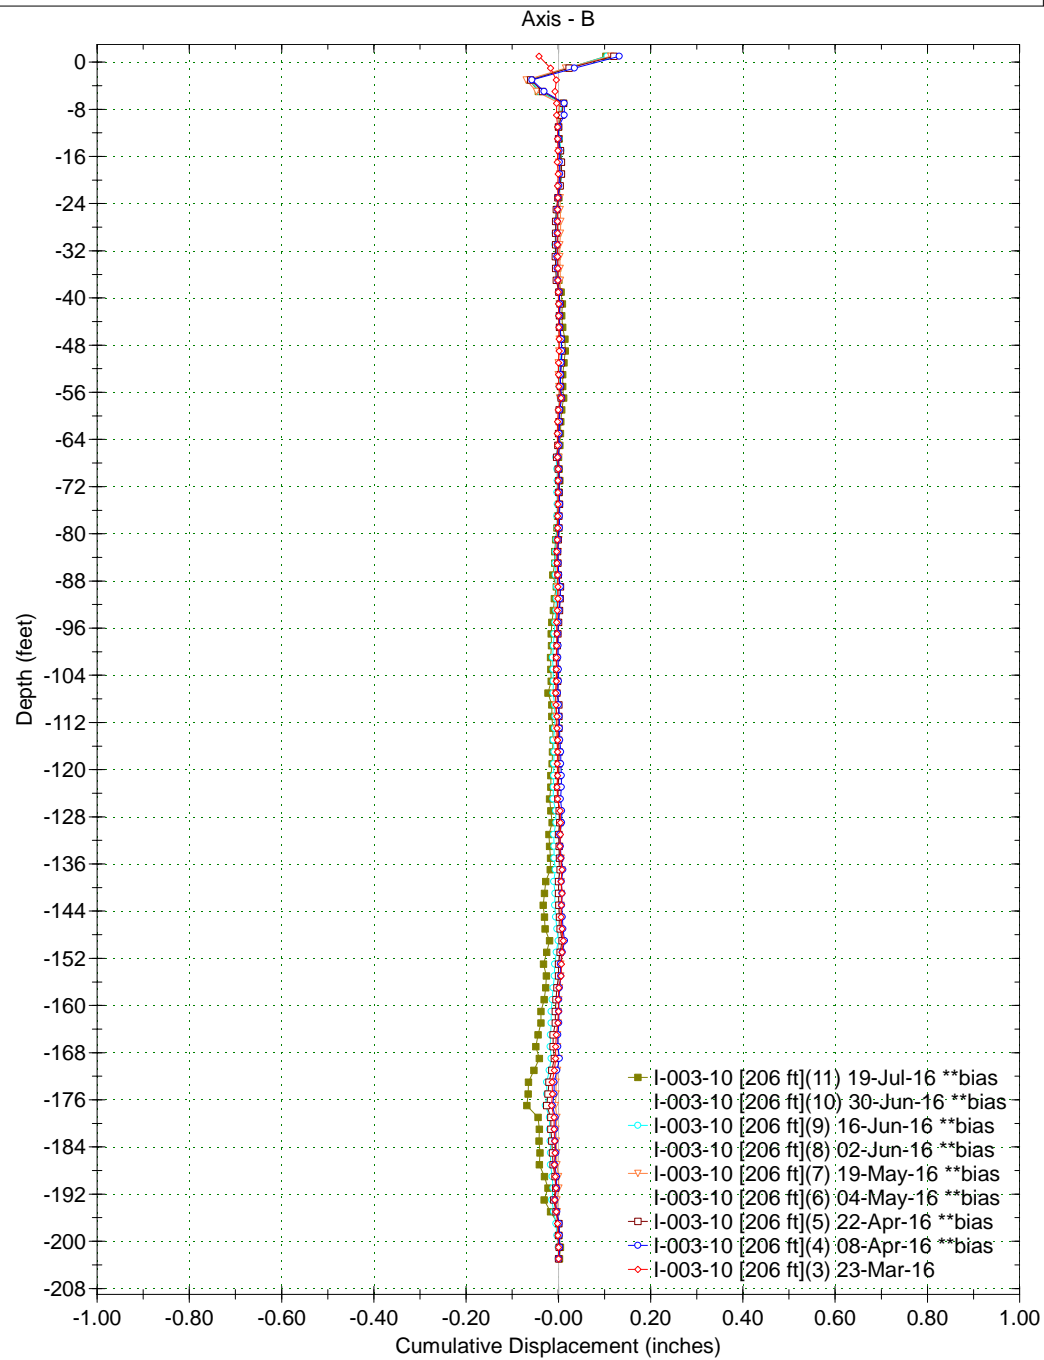
Borehole : I-003-10 [206 ft]
Project : CUY-90-15-24
Location :
Northing :
Easting :
Collar :

I-003-10 – The inclinometer readings at this location indicate a small amount of displacement in the negative A-axis direction from 176 to 200 feet and in the negative B-axis direction from 120 to 196 feet.
