Re: July 18, 19, and 20, 2016 Bi-Weekly Readings
CUY-90-15.24 Slope Monitoring
PID 96504
SME Project No. 069032.00

Bi-weekly instrument readings for the I-90 west slope taken on July 18, 19, and 20, 2016, are presented in this report. Bi-weekly readings currently include instruments at I/P-001-13, I/P-002-13, I/P-003-10, I/P-004-13, I/P-009-13, B-101, B-102, B-105A, B-05-02, B-05-A-03, B-05-04, B-05-A-11, P-1, P-9N, TGR I-2, and TGR I-4. Changes reported for the individual instruments are for the previous two-week period unless noted otherwise.

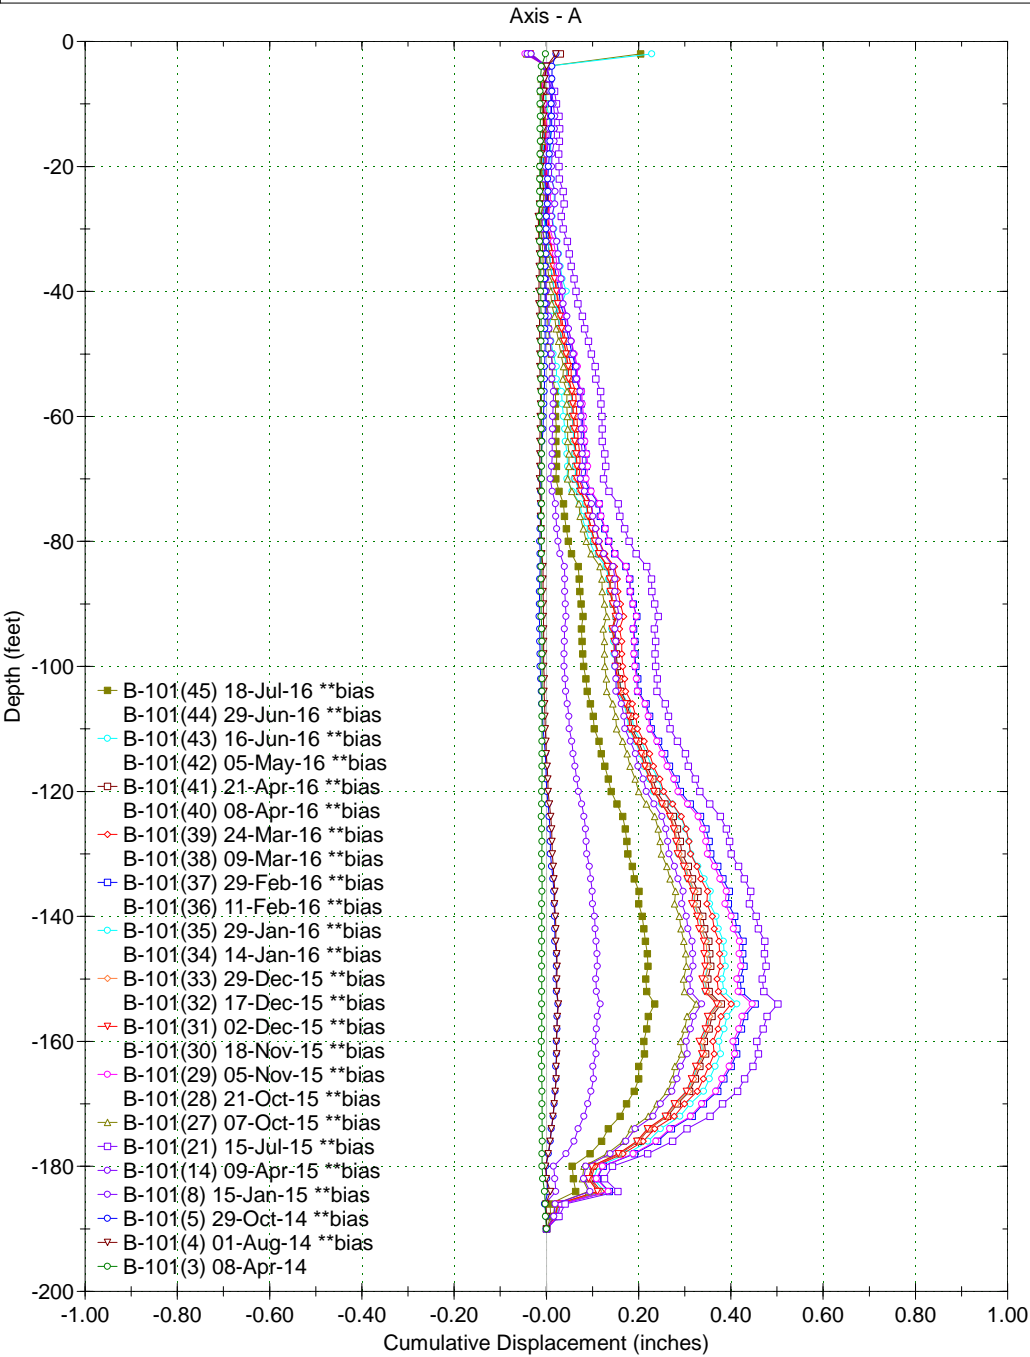
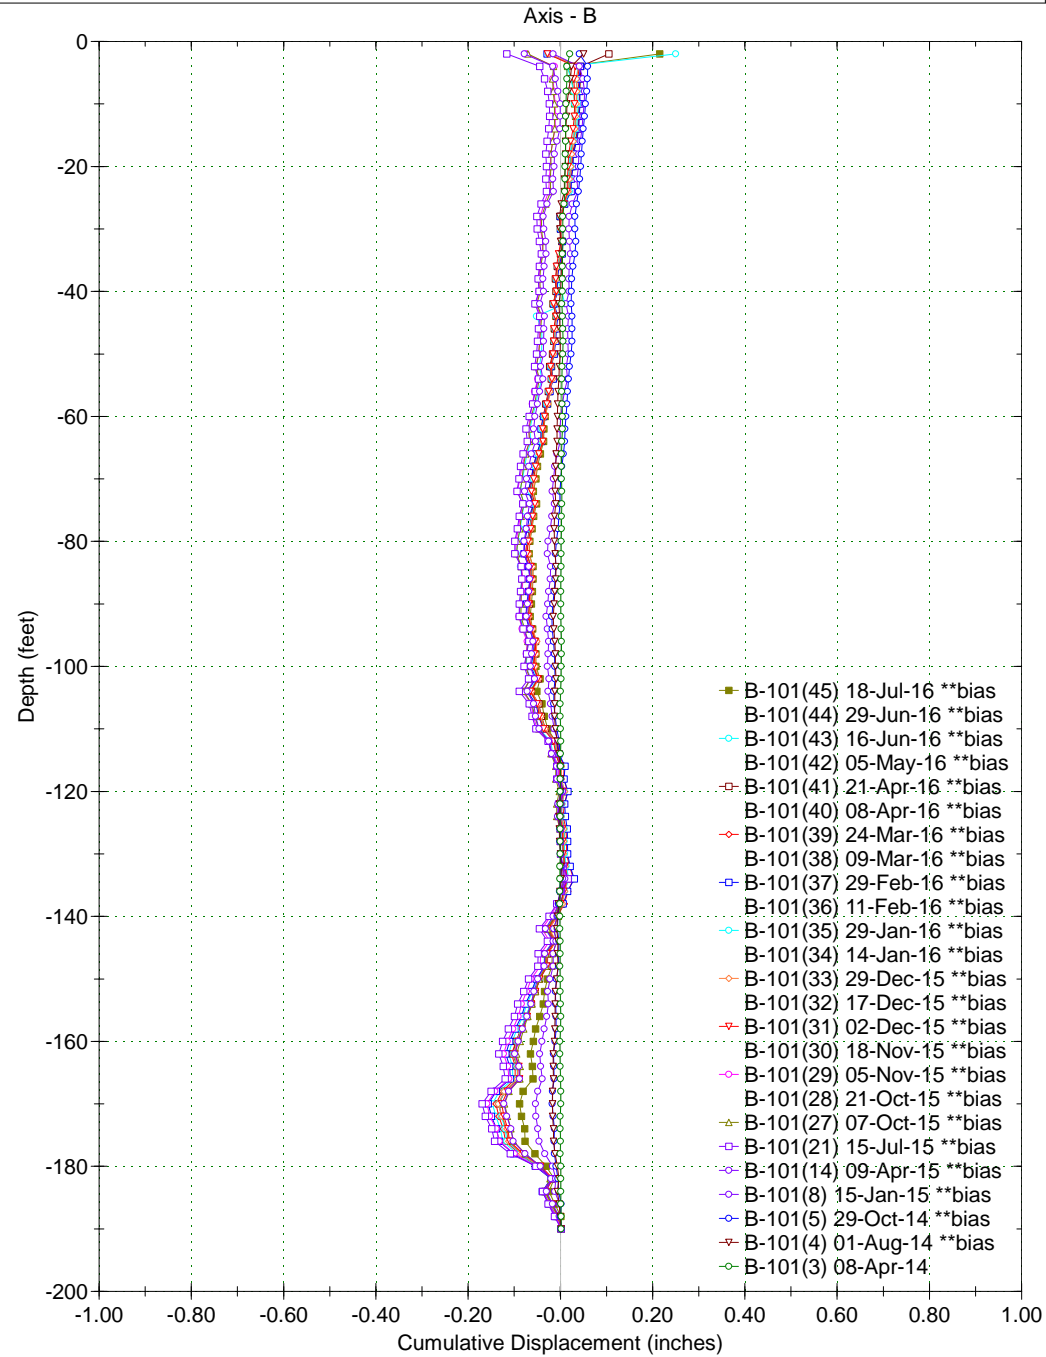
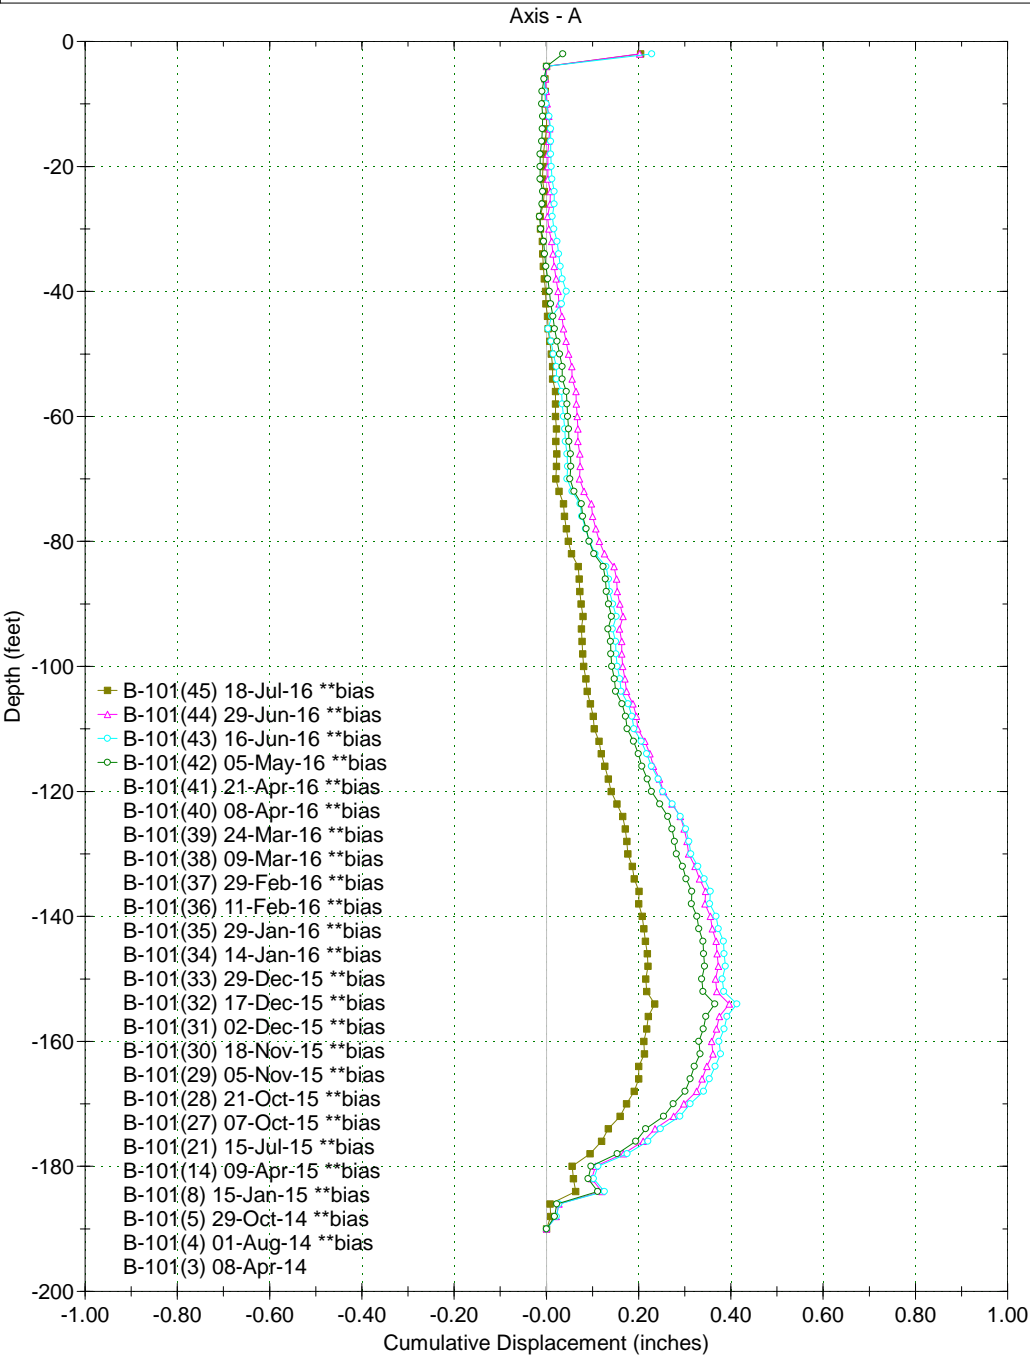
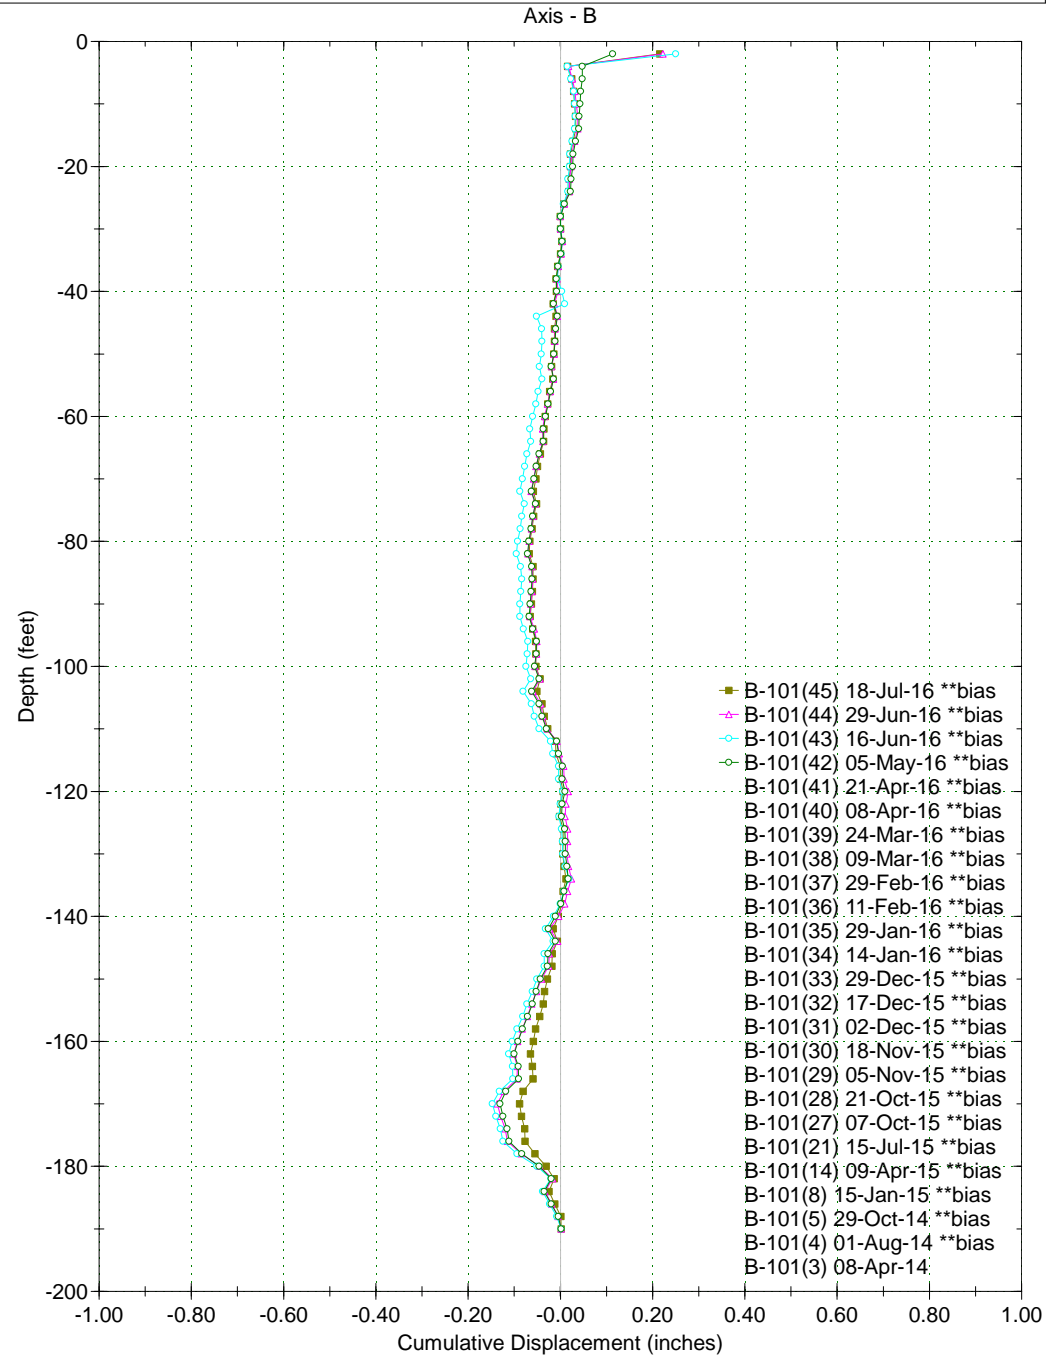
Borehole : B-101
 Project : CUY-90-15-24
 Location : Cleveland, Ohio
 Northing : Sta. 15+06.50
 Easting : 120.7' Rt of CL
 Collar :

B-101, B-102 – Inclinometer readings at these locations indicate a reversal in the direction of movement. At B-101, the maximum displacement of about 0.2 inches in the negative A-axis direction is shown at 152 feet. A slight reversal is also indicated in the positive B-axis direction from 144 to 182 feet. At B-102, the maximum displacement of about 0.2 inches in the reverse (positive) B-axis direction is shown at 202 feet.

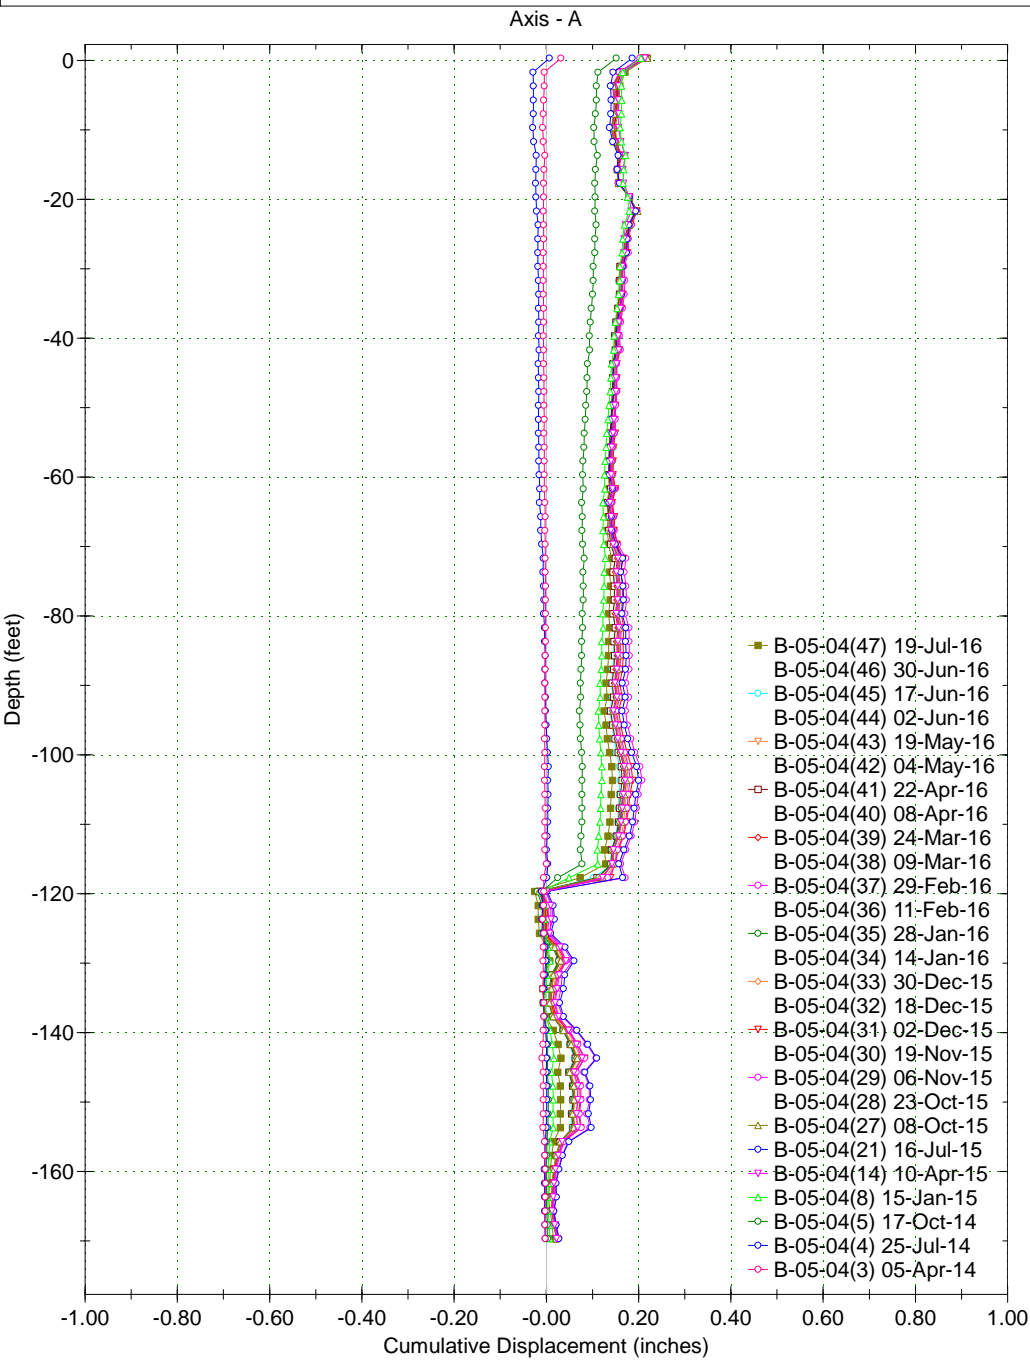
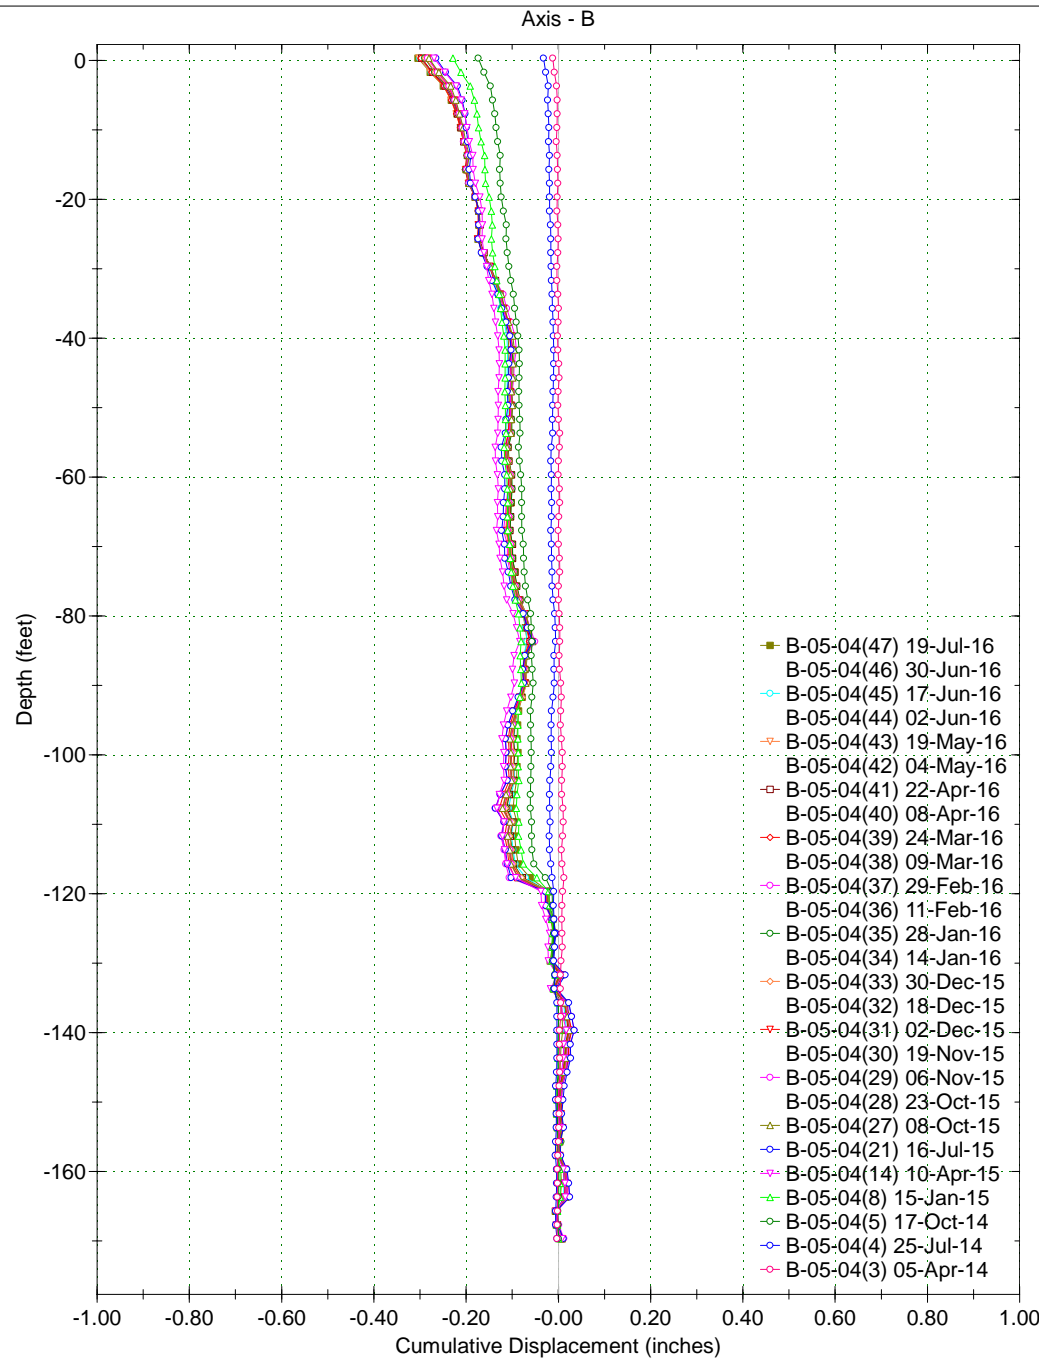
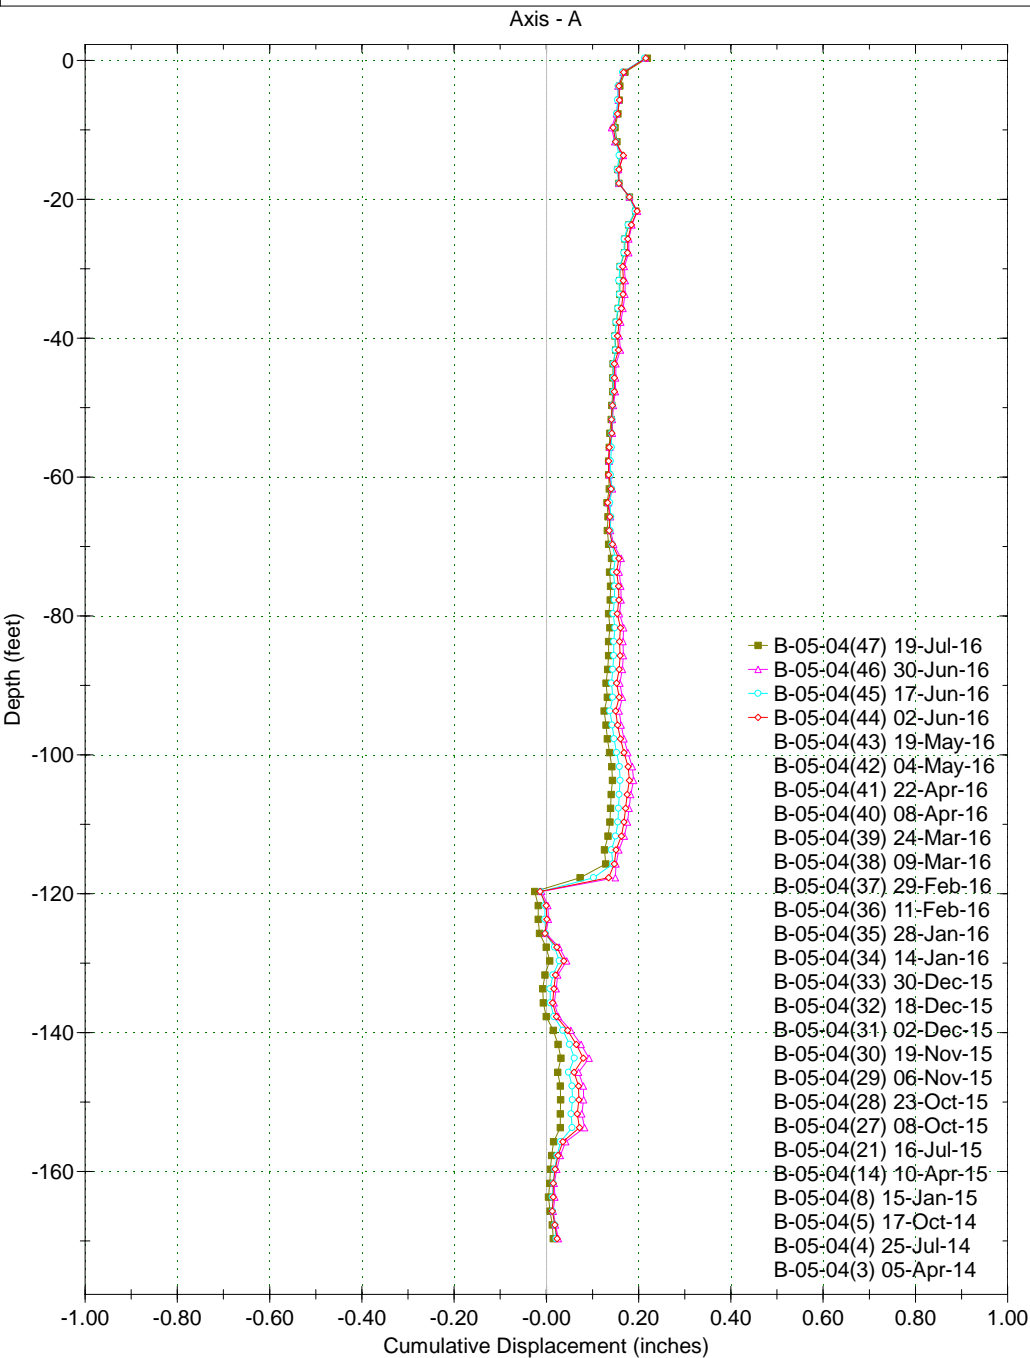
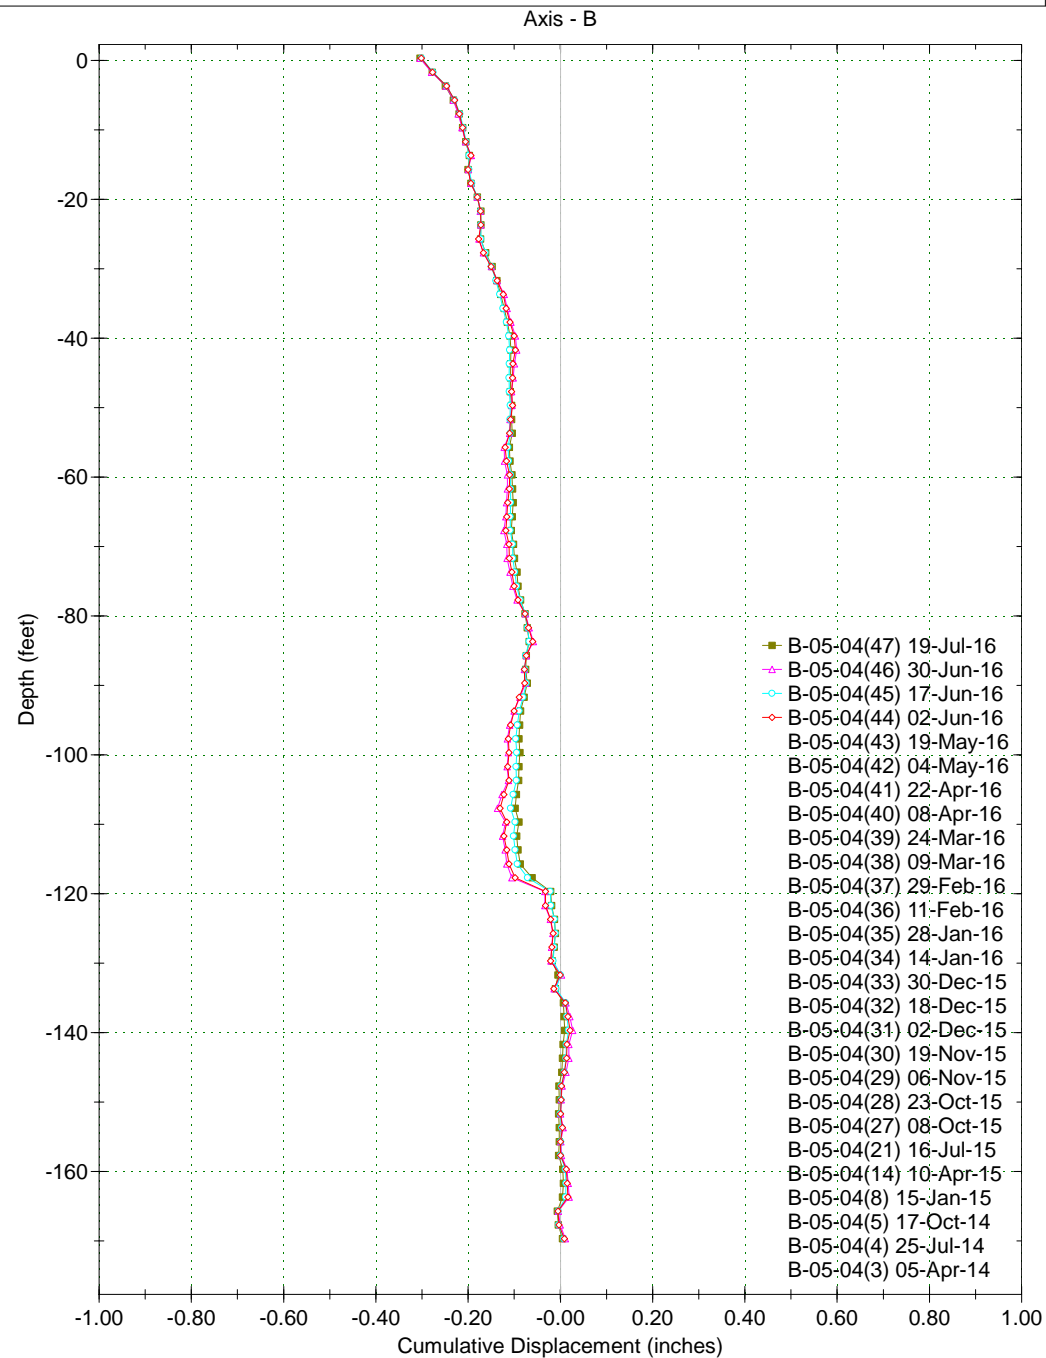
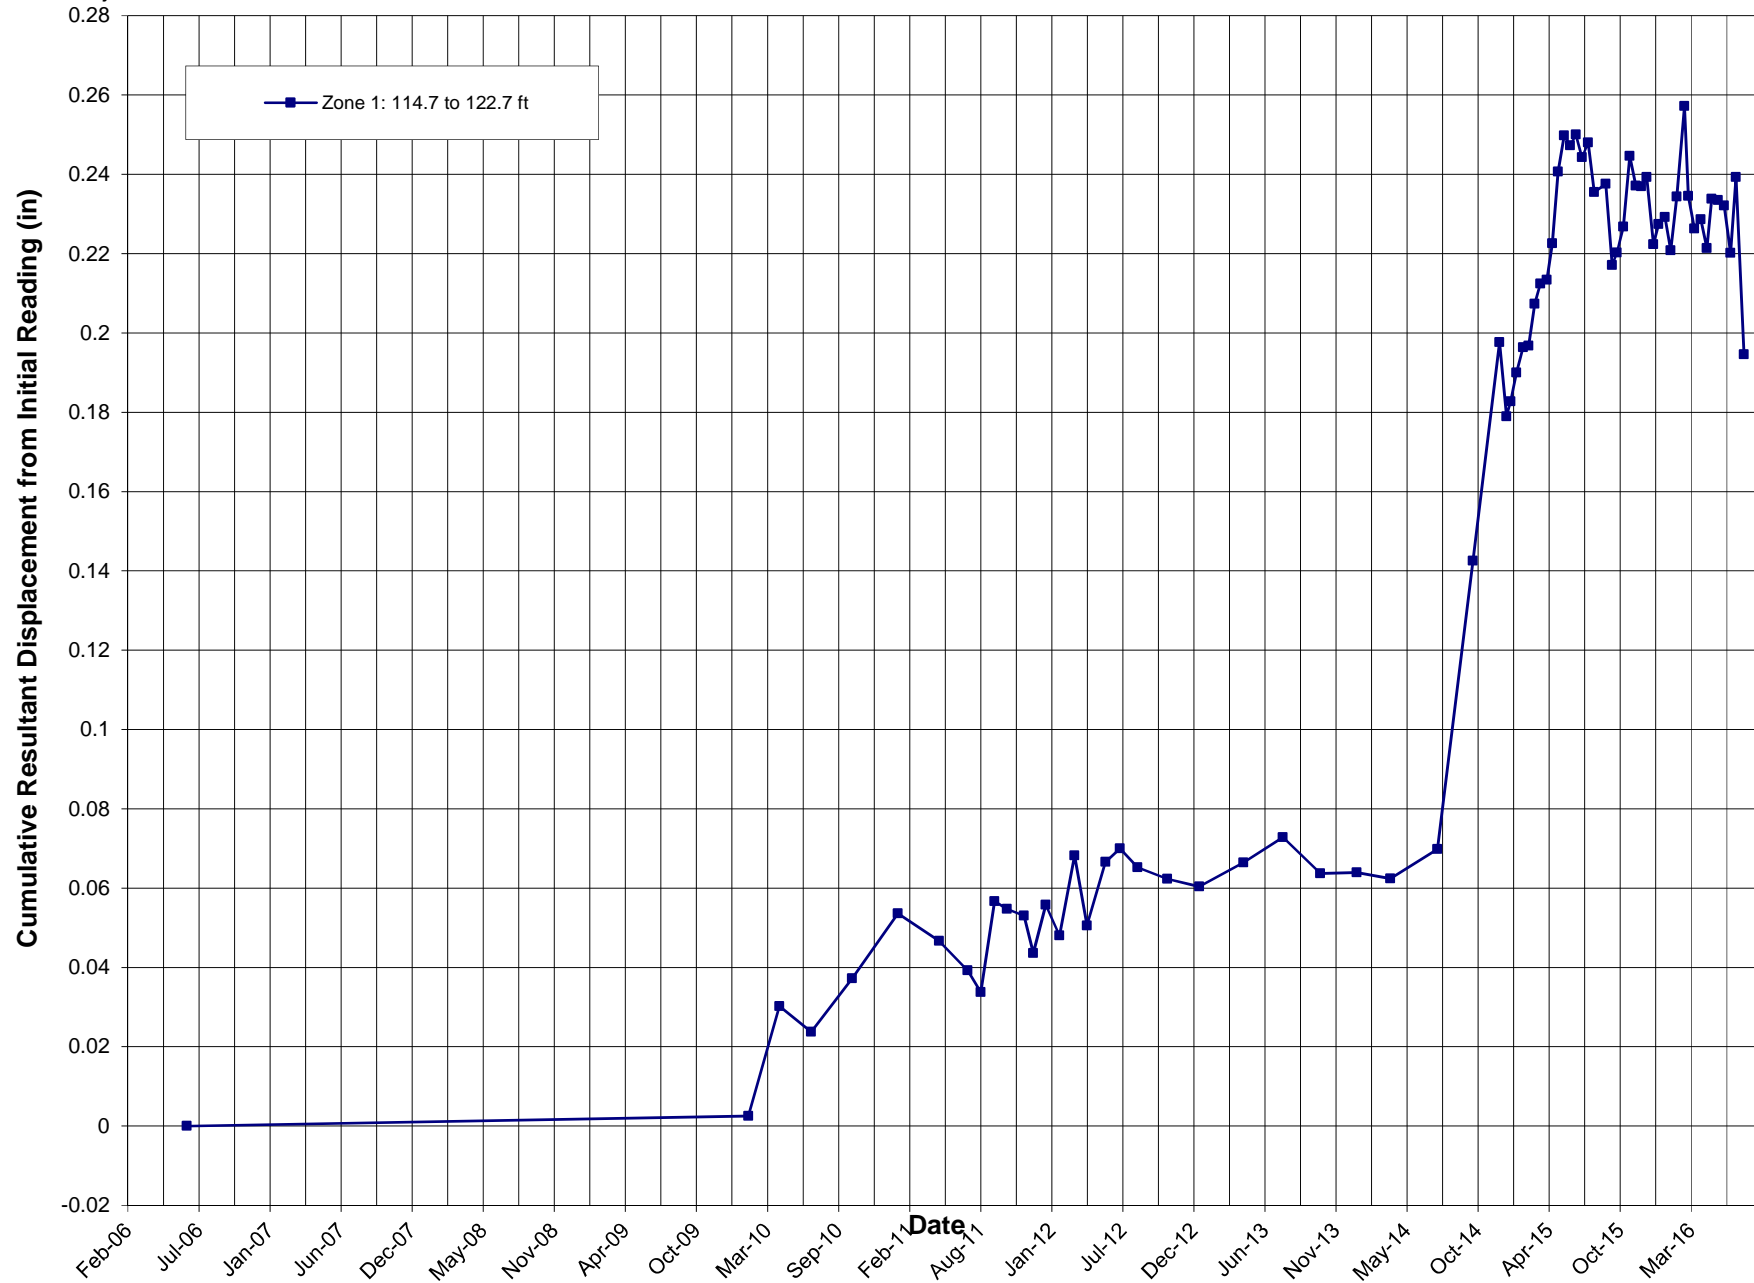
Borehole : B-05-04
Project : CUY-90-15-24
Location : Cleveland, Ohio
Northing : Sta. 133+51.67
Easting : 242.09' Rt of CL
Collar :

B-05-04 – Inclinometer readings at this location indicate slight movement in the negative A-axis direction from about 70 to 160 feet. This movement is shown to be in the reverse direction. Movement in the B-axis direction is negligible.

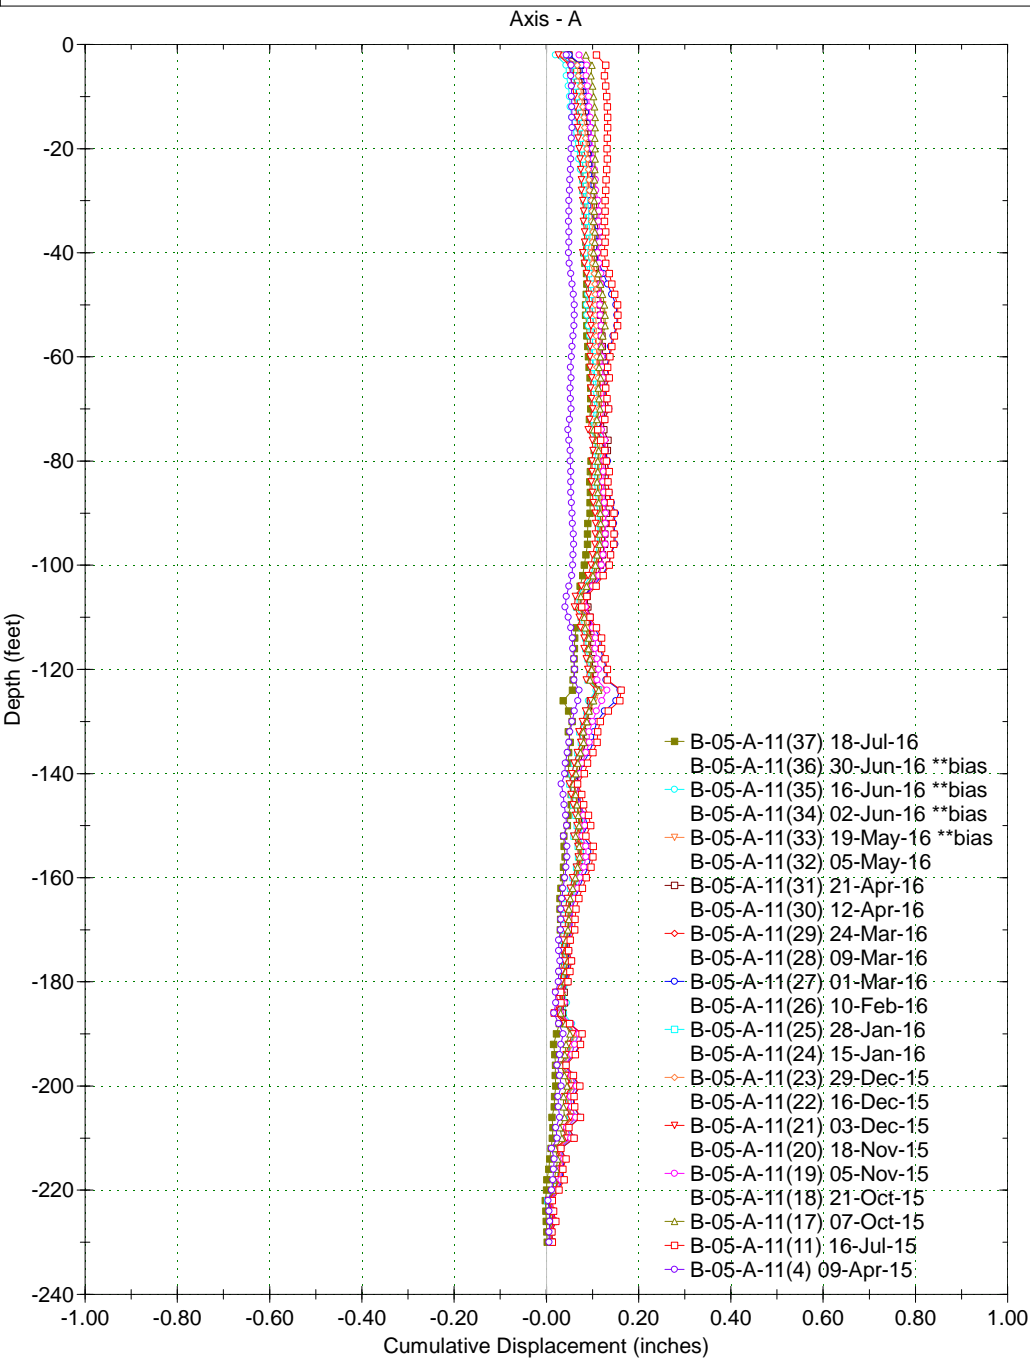
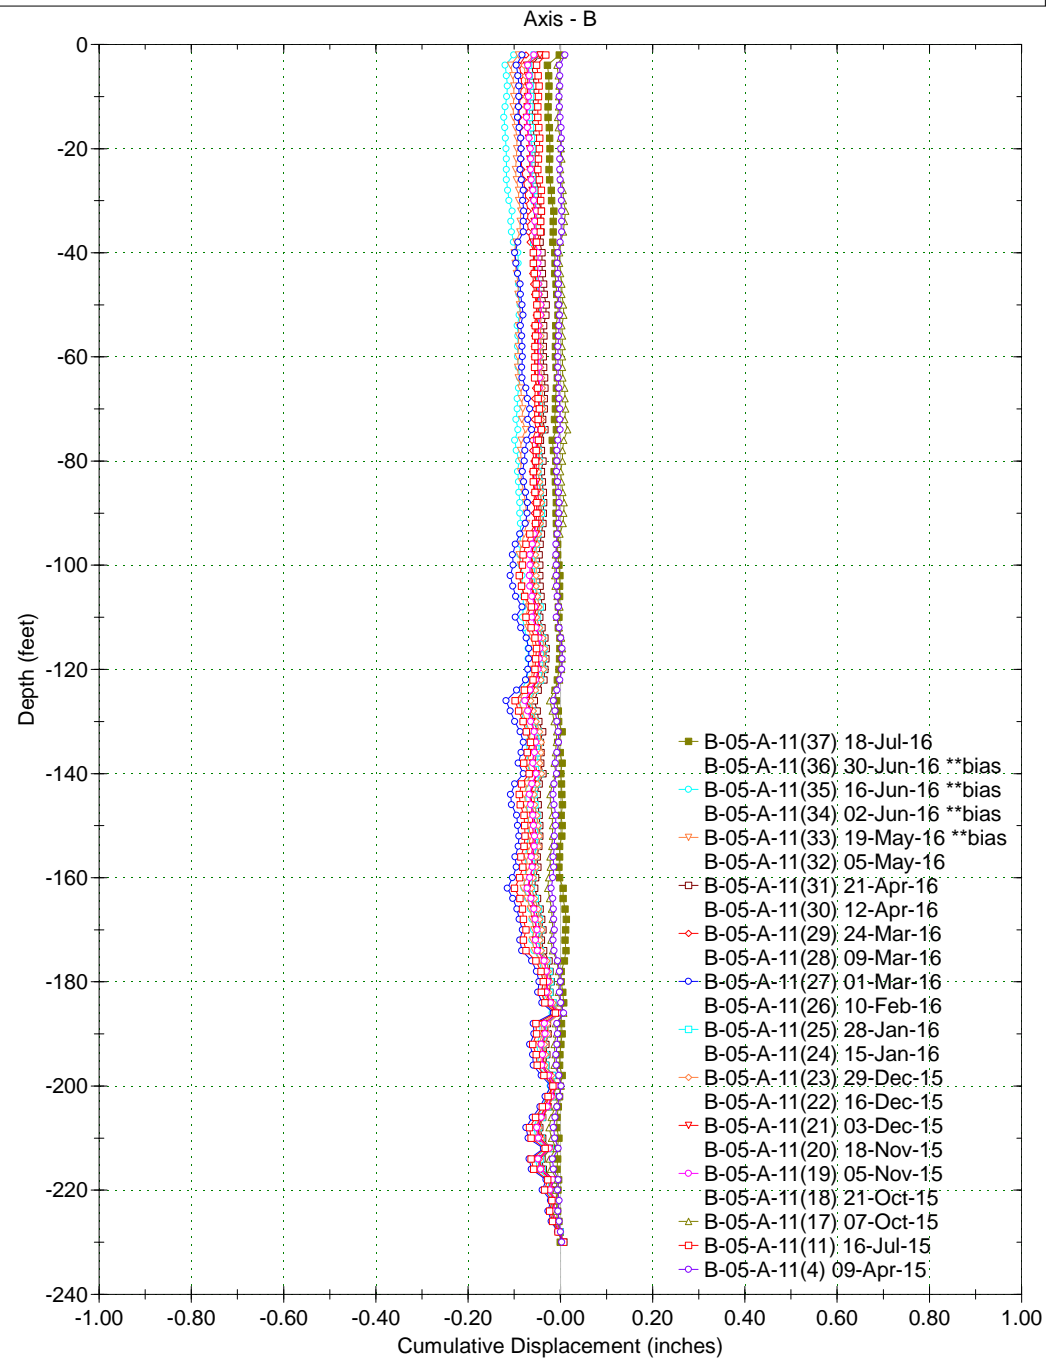
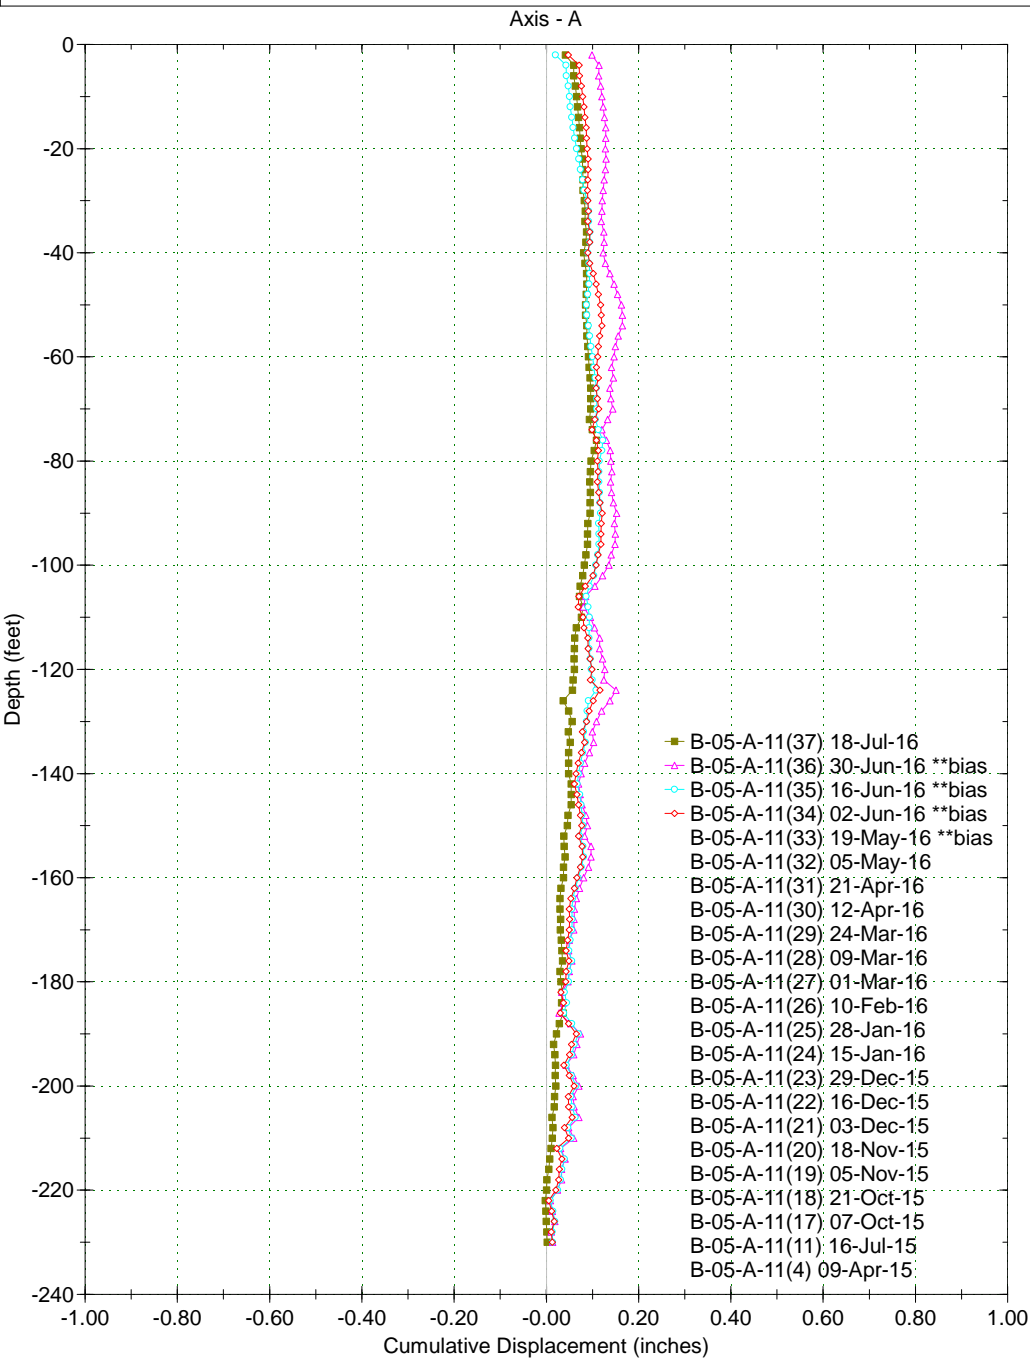
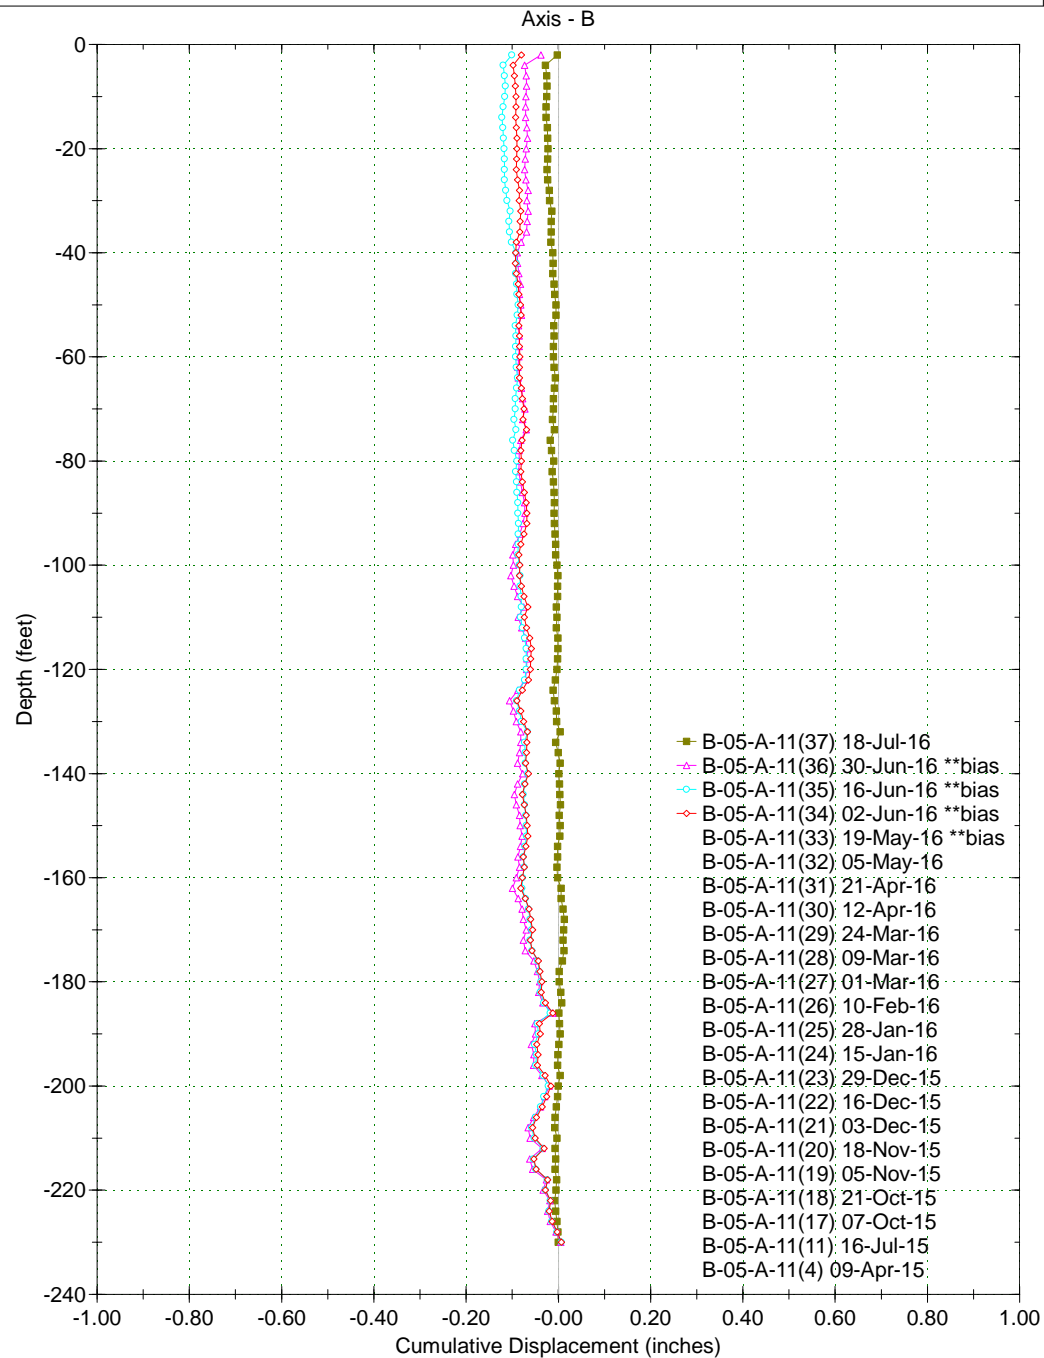
Borehole : B-05-A-11
Project : CUY-90-15-24
Location :
Northing :
Easting :
Collar :

B-05-A-11 – Inclinometer readings at this location indicate movement in both axis directions toward the baseline.
