Re: July 18, 19, and 20, 2016 Bi-Weekly Readings
CUY-90-15.24 Slope Monitoring
PID 96504
SME Project No. 069032.00

Bi-weekly instrument readings for the I-90 west slope taken on July 18, 19, and 20, 2016, are presented in this report. Bi-weekly readings currently include instruments at I/P-001-13, I/P-002-13, I/P-003-10, I/P-004-13, I/P-009-13, B-101, B-102, B-105A, B-05-02, B-05-A-03, B-05-04, B-05-A-11, P-1, P-9N, TGR I-2, and TGR I-4. Changes reported for the individual instruments are for the previous two-week period unless noted otherwise.

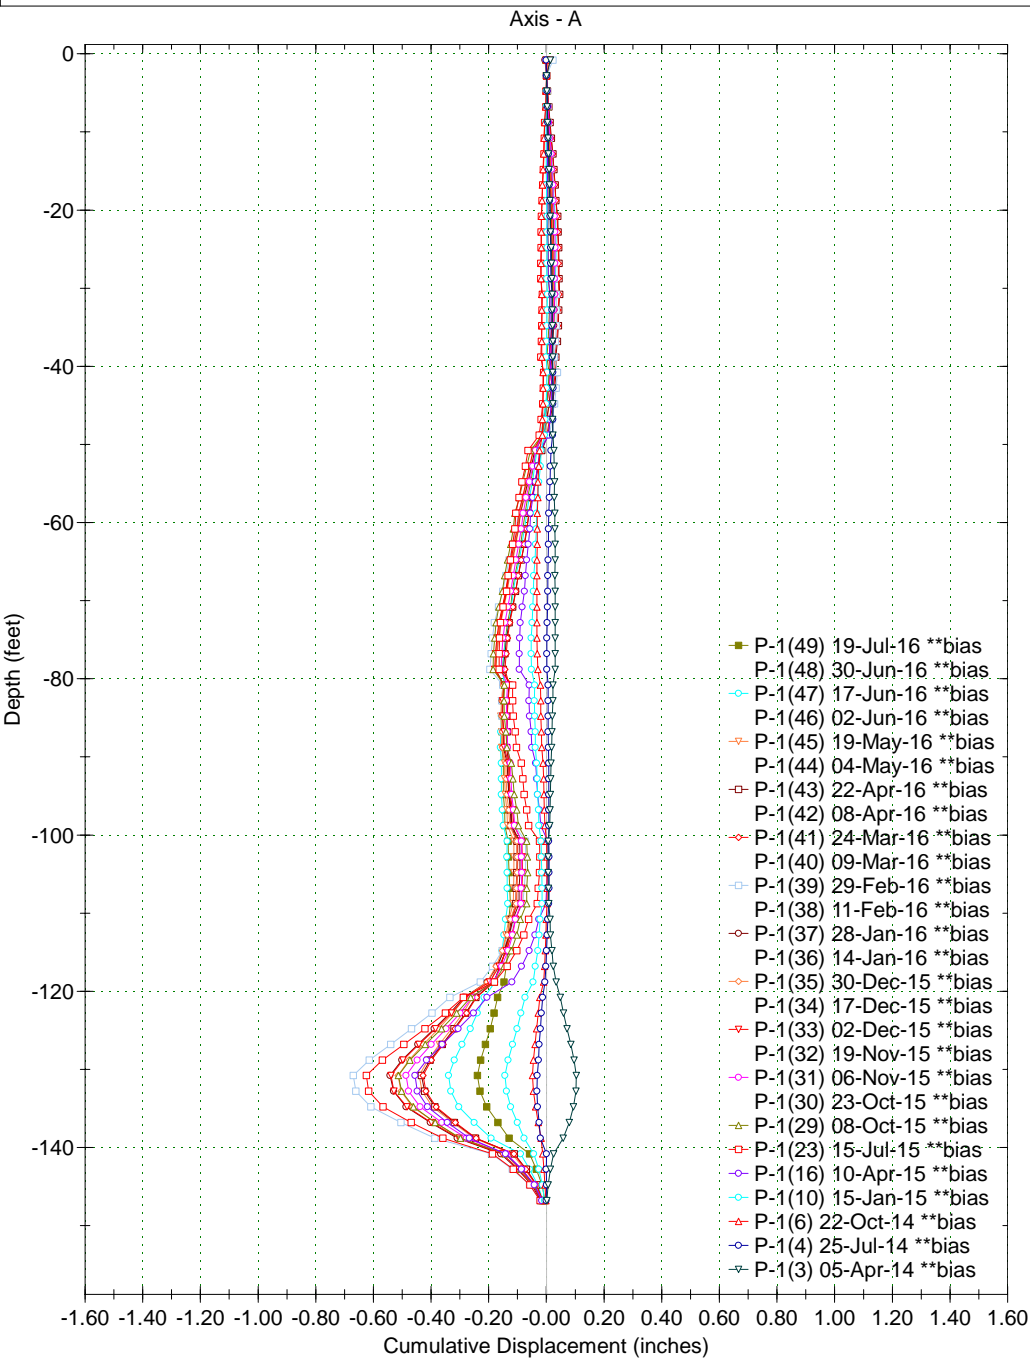
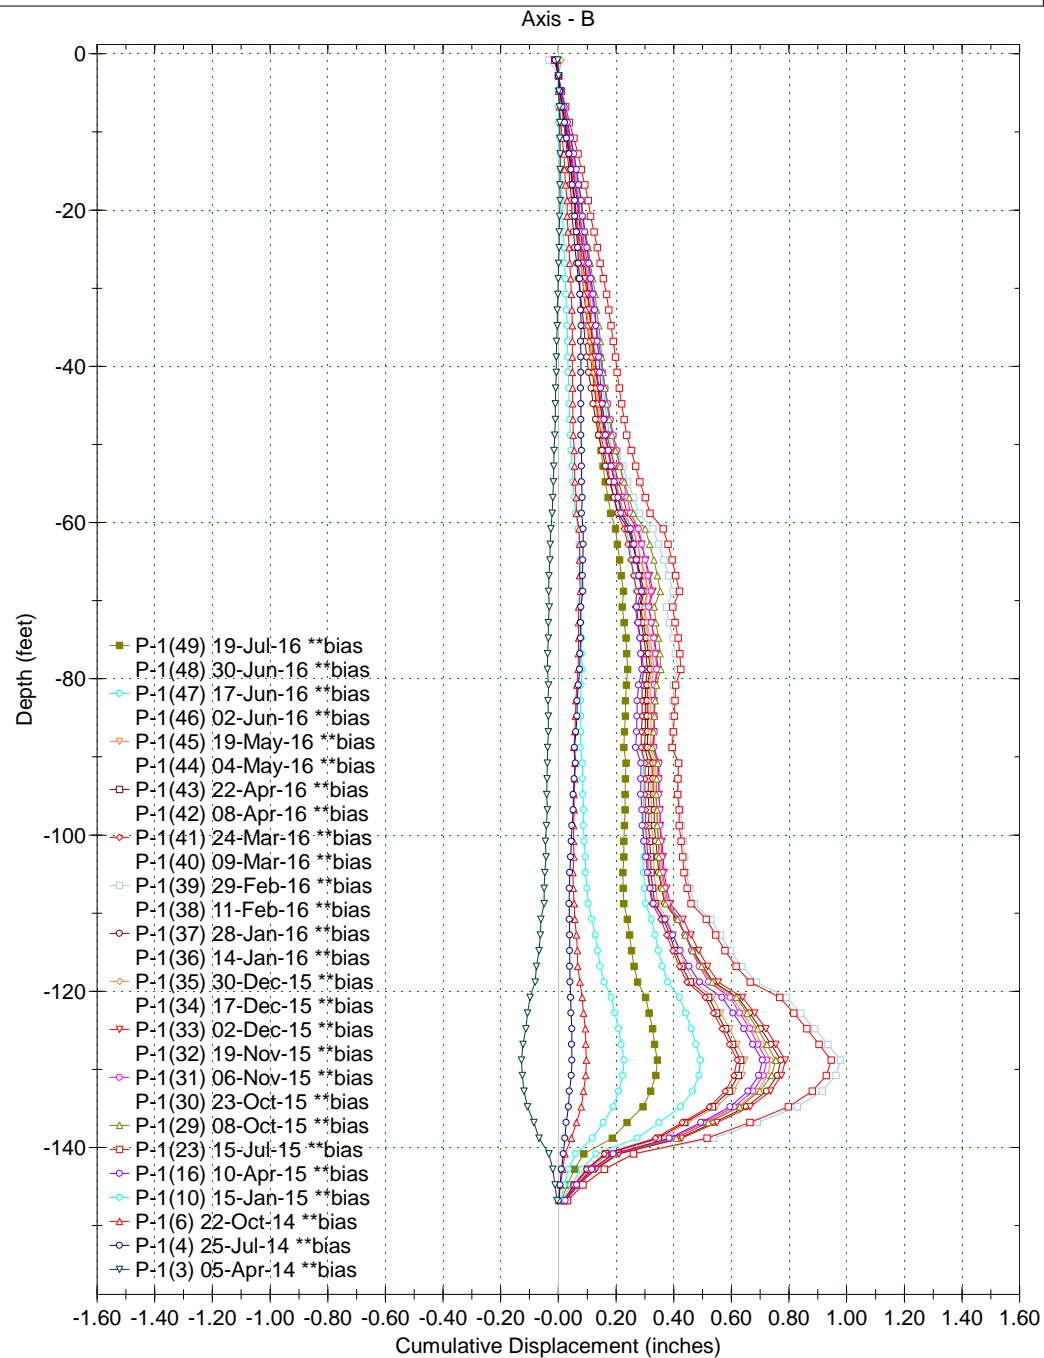
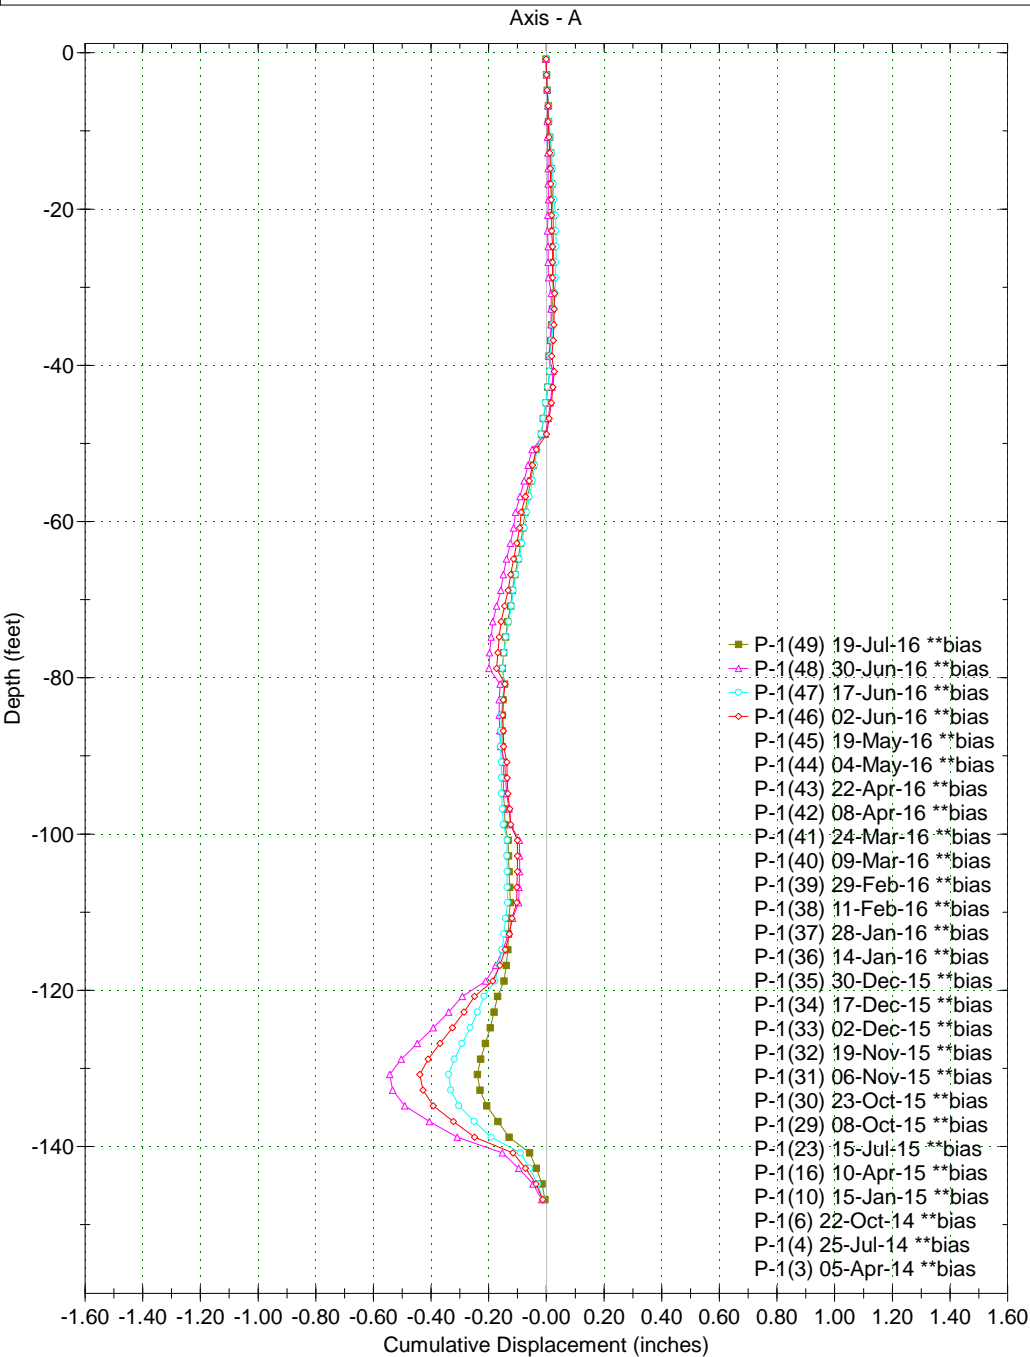
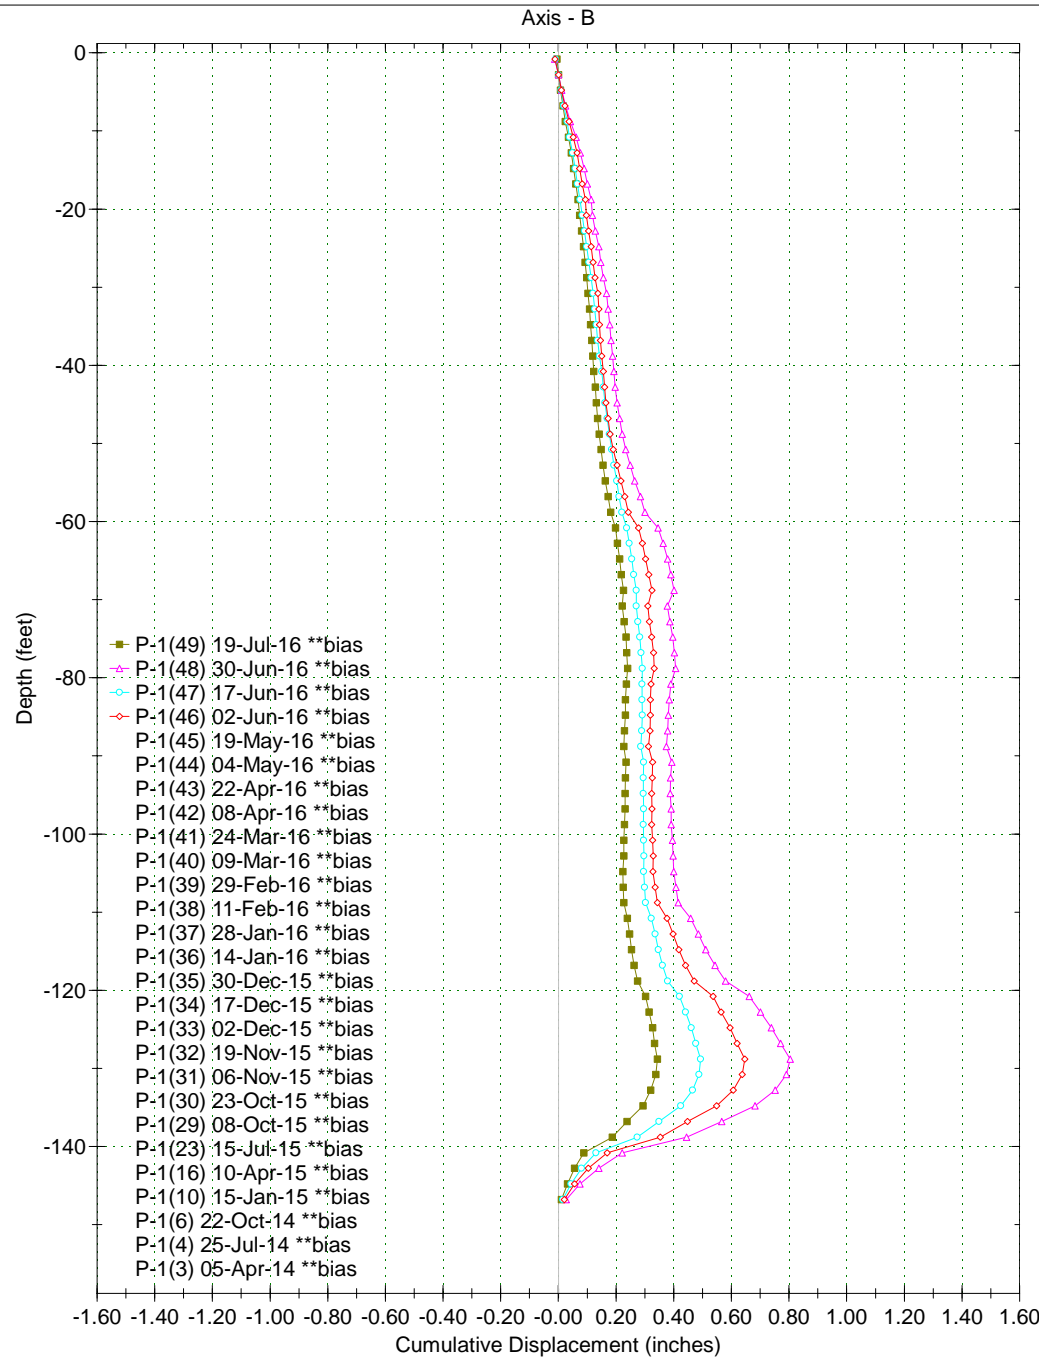
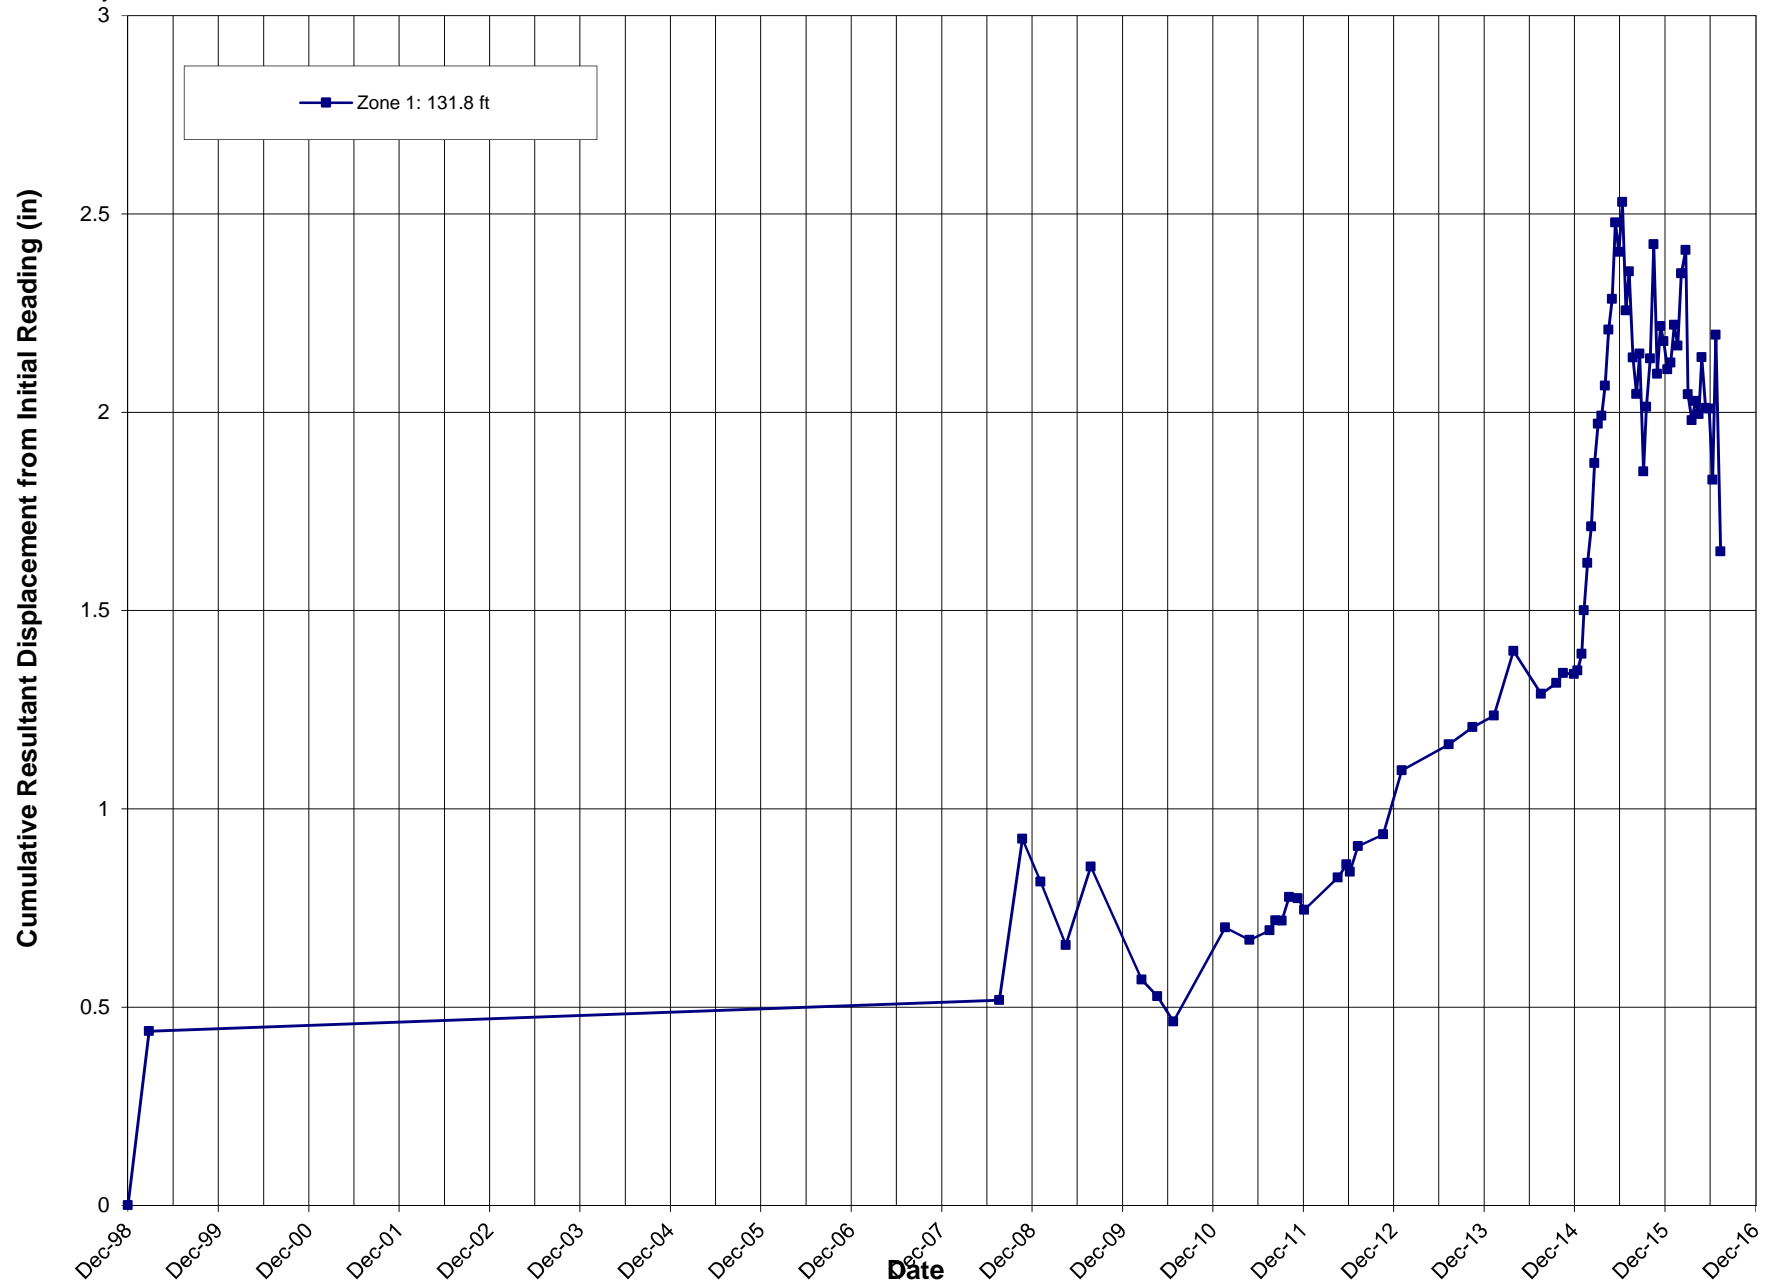
Borehole : P-1
Project : CUY-90-15-24
Location : Cleveland, Ohio
Northing :
Easting :
Collar :

P-1 – Inclinometer readings at this location show another reversal in the direction of displacement. The cumulative resultant displacement zone plot shows a decrease of about 0.5 inches.
