Re: August 2 and 3, 2016 Bi-Weekly Readings
CUY-90-15.24 Slope Monitoring
PID 96504
SME Project No. 069032.00

Bi-weekly instrument readings for the I-90 west slope taken on August 2 and 3, 2016, are presented in this report. Bi-weekly readings currently include instruments at I/P-001-13, I/P-002-13, I/P-003-10, I/P-004-13, I/P-009-13, B-101, B-102, B-105A, B-05-02, B-05-A-03, B-05-04, B-05-A-11, P-1, P-9N, TGR I-2, and TGR I-4. Changes reported for the individual instruments are for the previous two-week period unless noted otherwise.

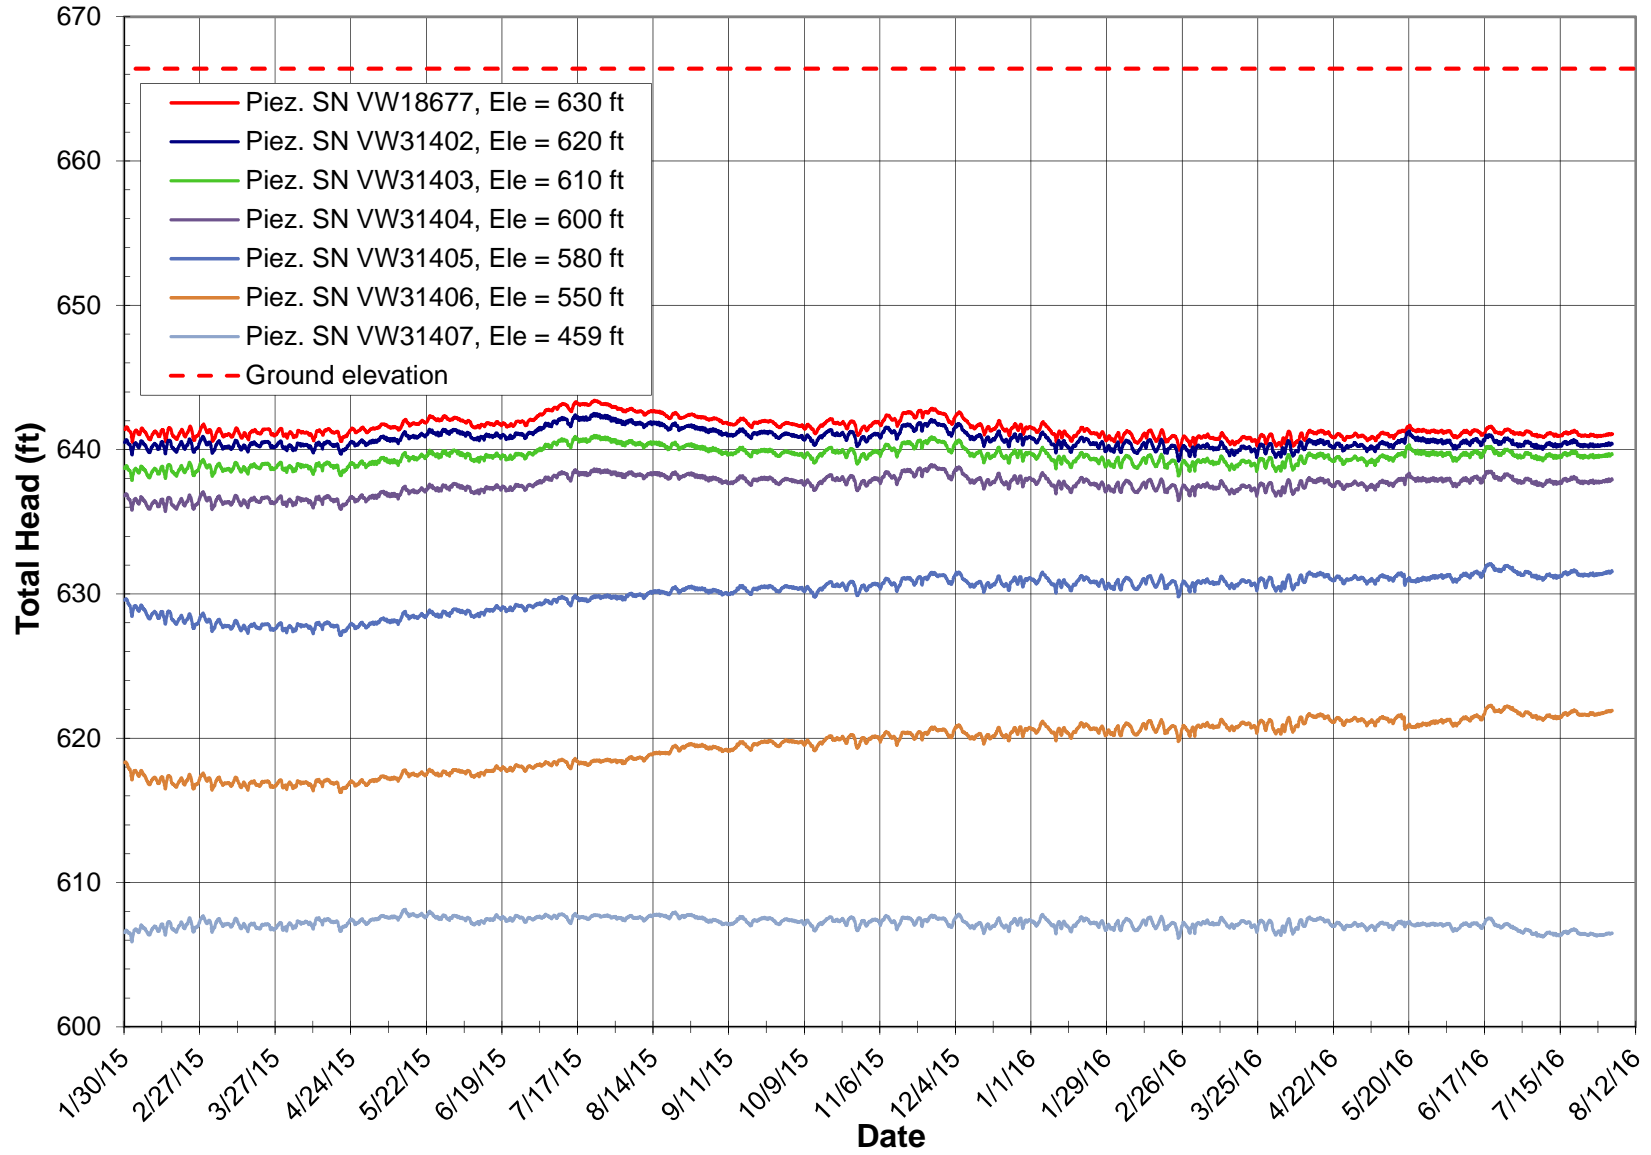
P-001-13 VW Piezometer Readings

P-001-13, P-002-13, P-003-10, P-009-13, B-05-02, B-05-A-03, B-05-04 – Pore pressure readings at these locations fluctuated by less than 0.5 feet, but show virtually no net change in total head.

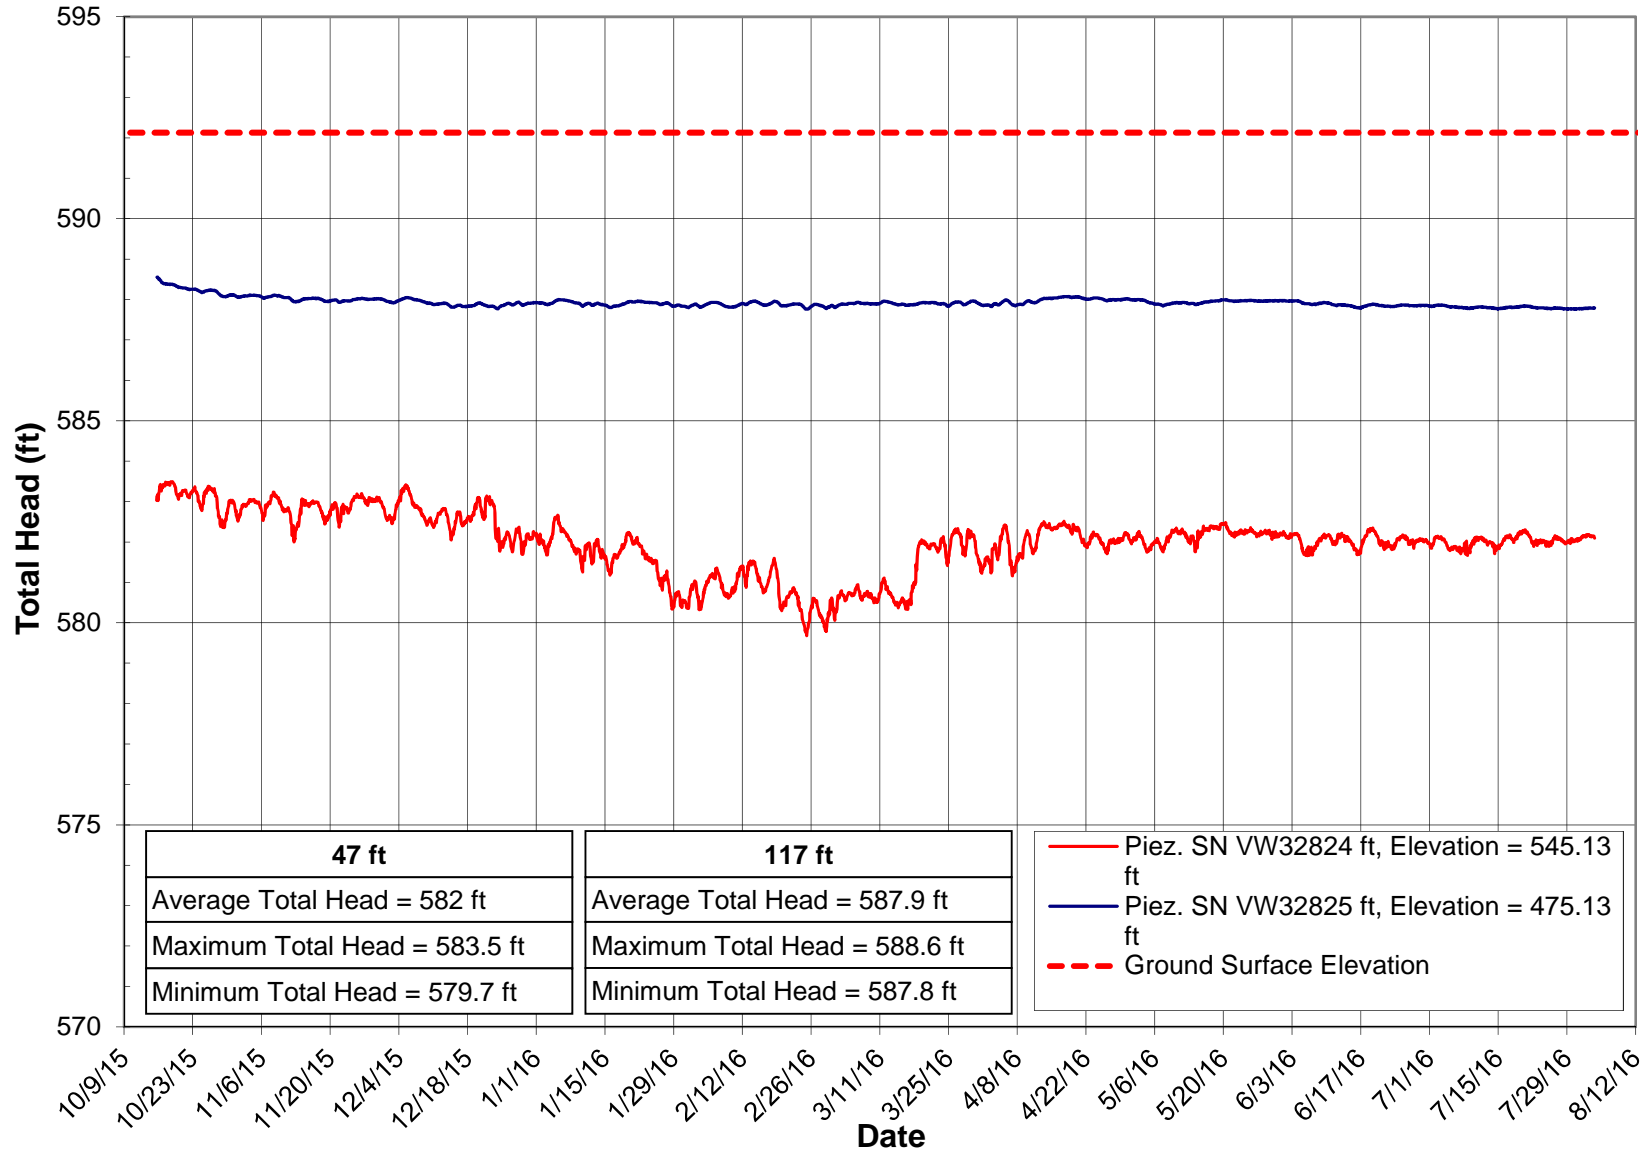
P-004-13 VW Piezometer Readings

P-004-13 – The dataloggers at this location were recently uncovered. The last set of readings were downloaded on February 11, 2016. Pore pressure readings indicate that the total head in the shallow piezometer decreased by about 1.5 feet during February 2016. On March 18, 2016, the total head in this piezometer increased by about 2 feet. During the following month, until about mid-April 2016, the total head fluctuated by less than 1 foot with a net increase of about 0.5 feet. Since mid-April 2016, there has been virtually no net change in total head in this piezometer. Total head in the deep piezometer has remained virtually constant since these piezometers were installed.

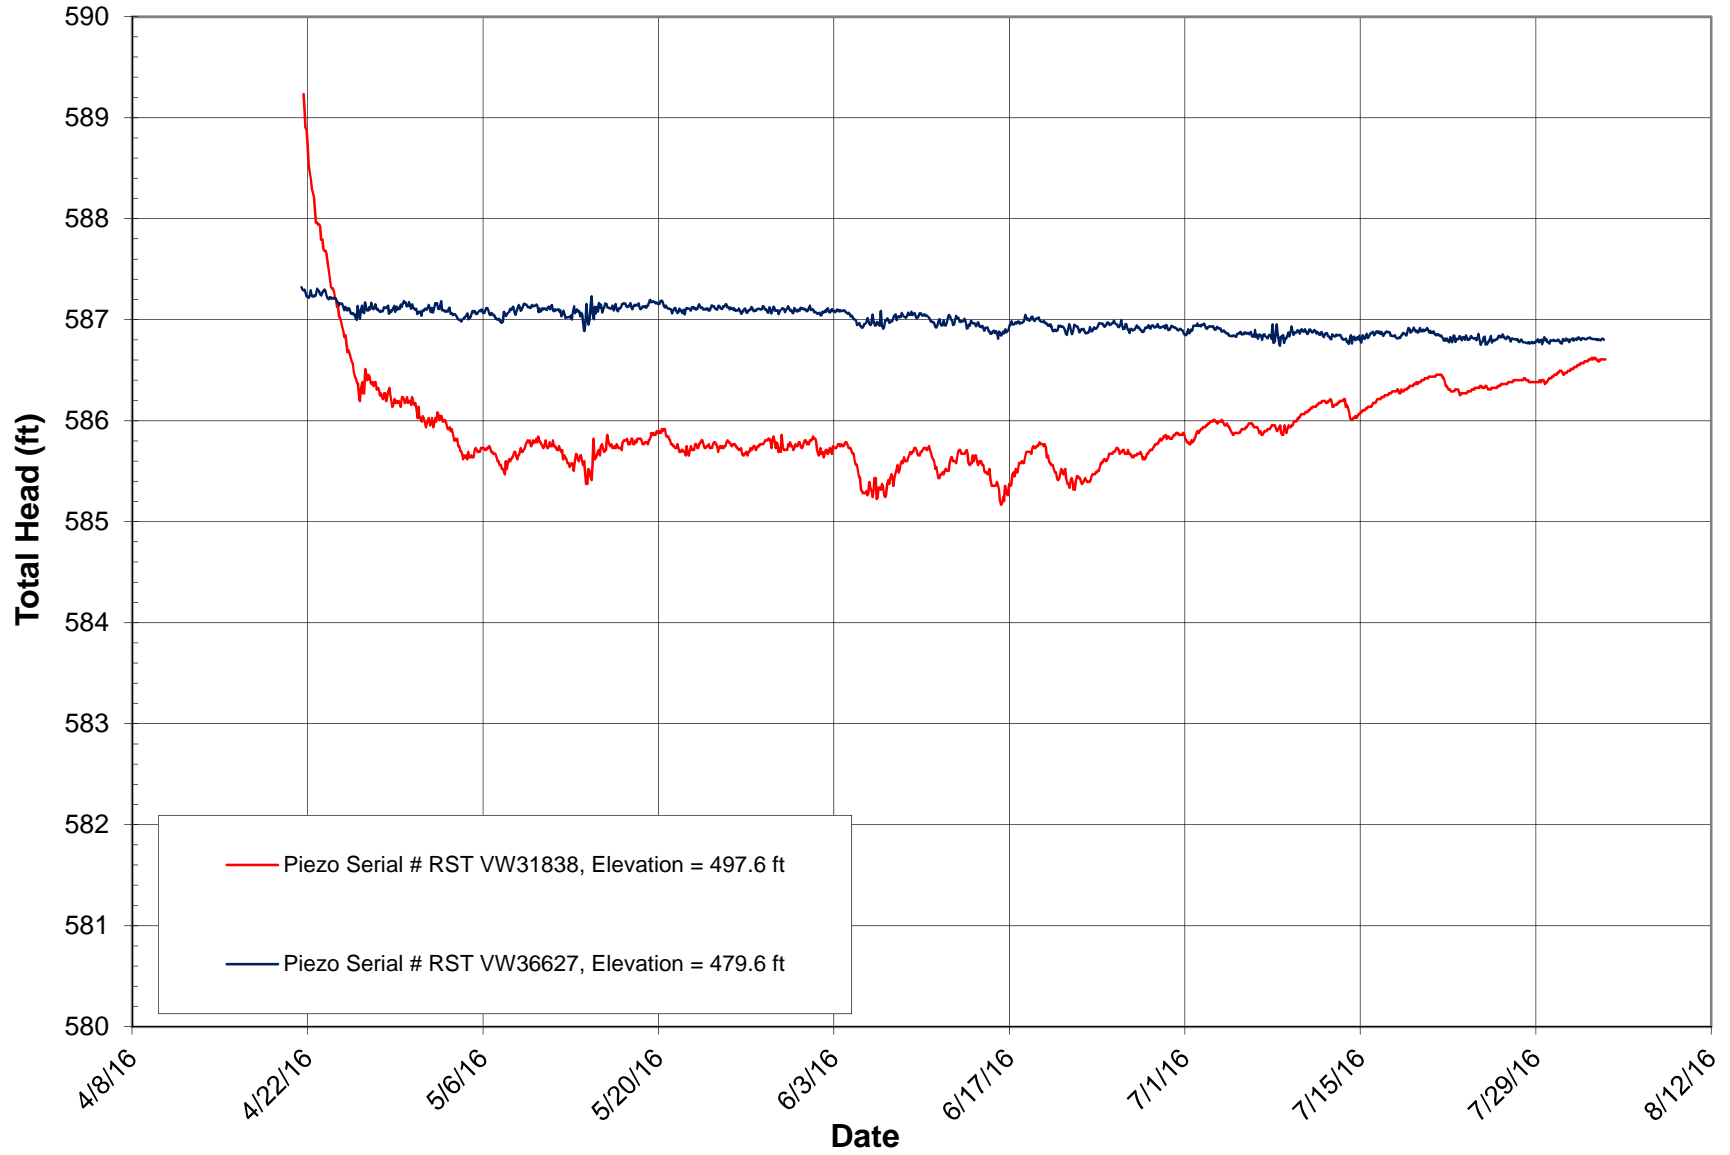
B-105A VW Piezometer Readings

B-105-A – The total head in the shallow piezometer at this location has increased by about 1.5 feet since June 17, 2016. Total head in the deep piezometer has decreased by about 0.3 feet since June 3, 2016.

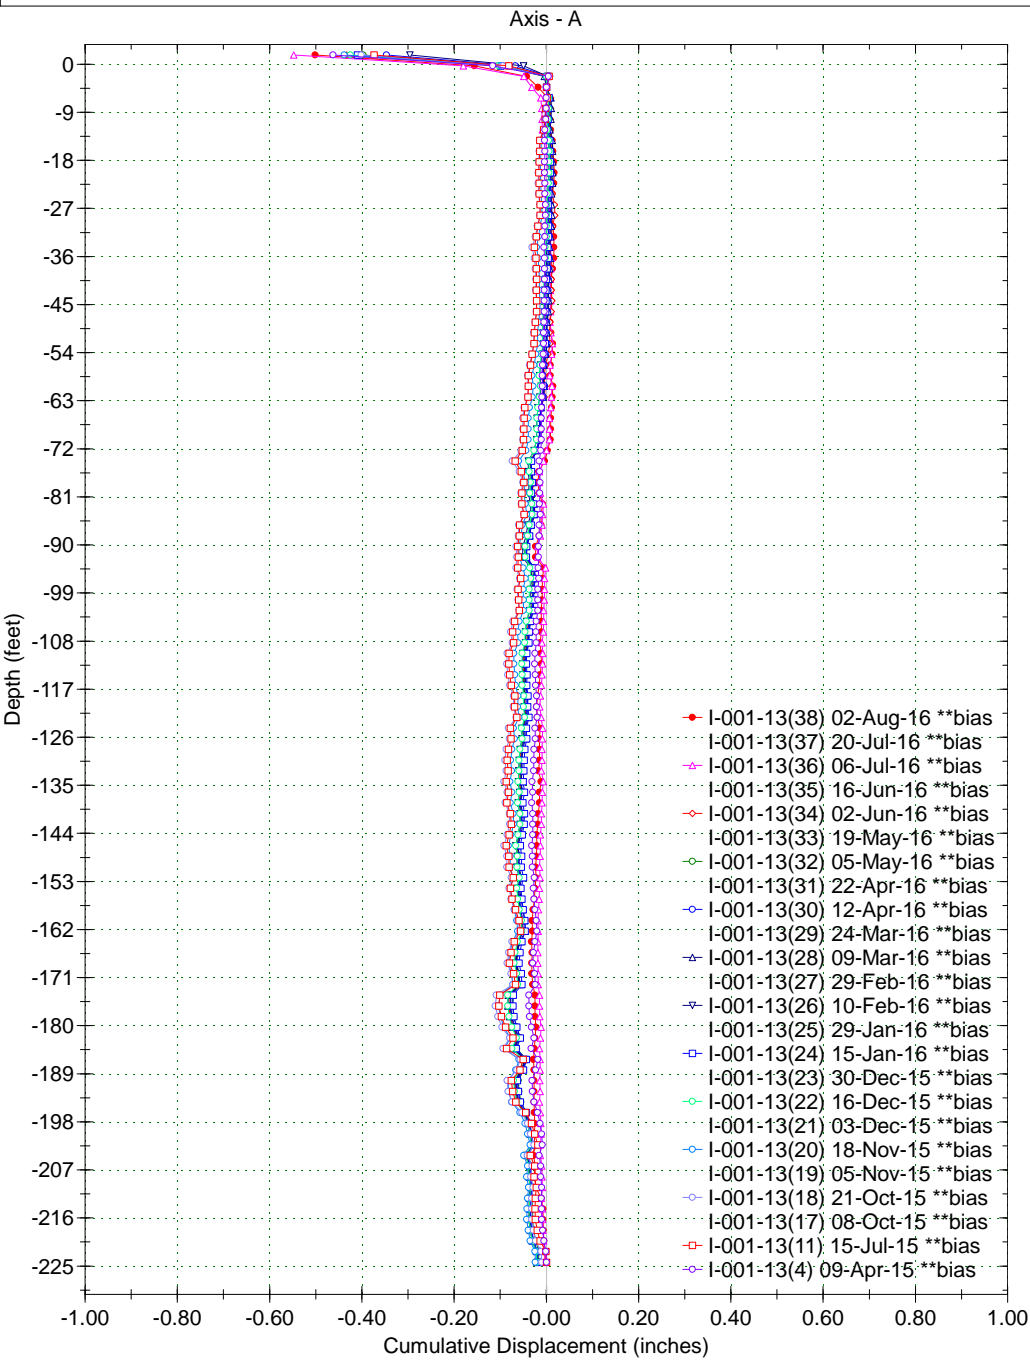
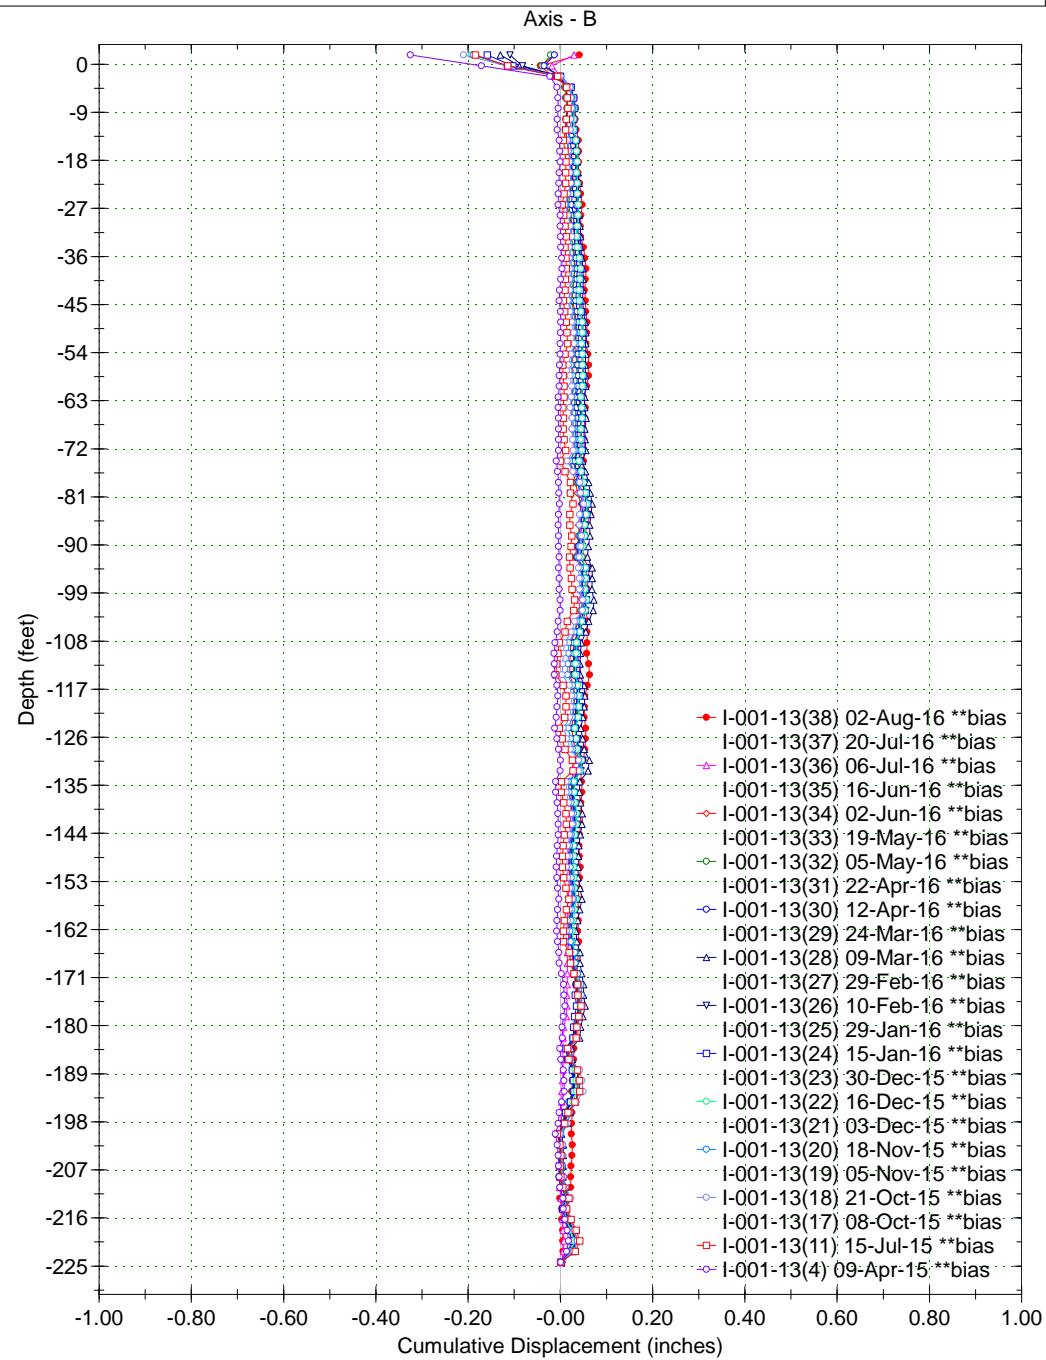
Borehole : I-001-13
Project : CUY-90-15-24
Location : Cleveland, Ohio
Northing :
Easting :
Collar :

Inclinometer readings at I-001-13, I-002-13, I-009-13, B-101, B-102, B-105A, B-05-02, B-05-A-03, B-05-04, P-1, P-9N, and TGR I-4 showed virtually no movement. Displacement at the top of some slope tubes is due to construction disturbance or flexing of the inclinometer tube as readings were taken where the protective covers have not been concreted in place because of the ongoing construction activity.

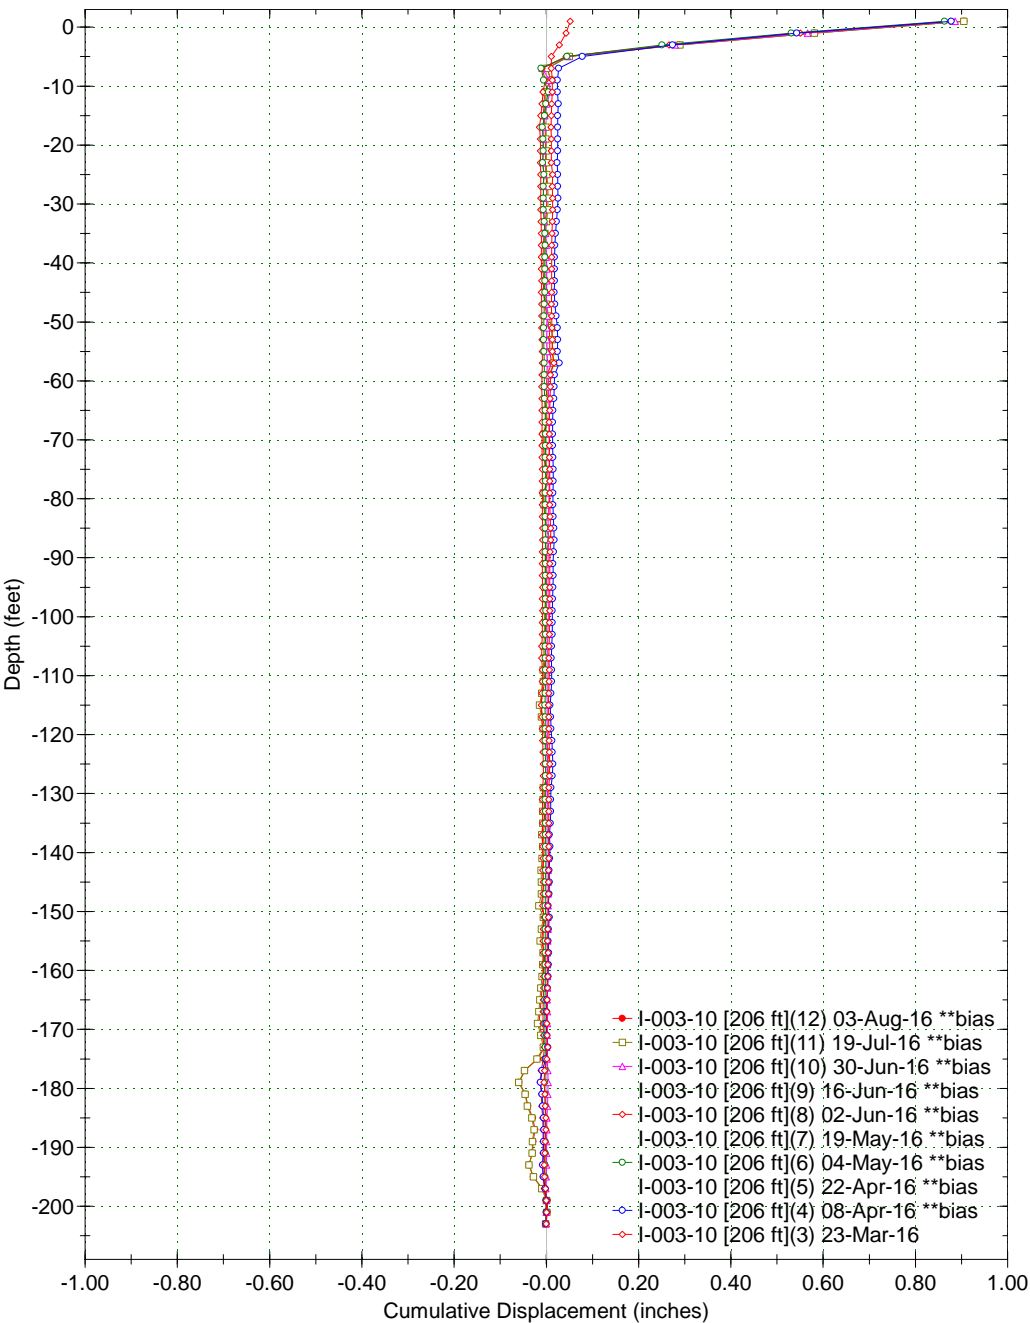
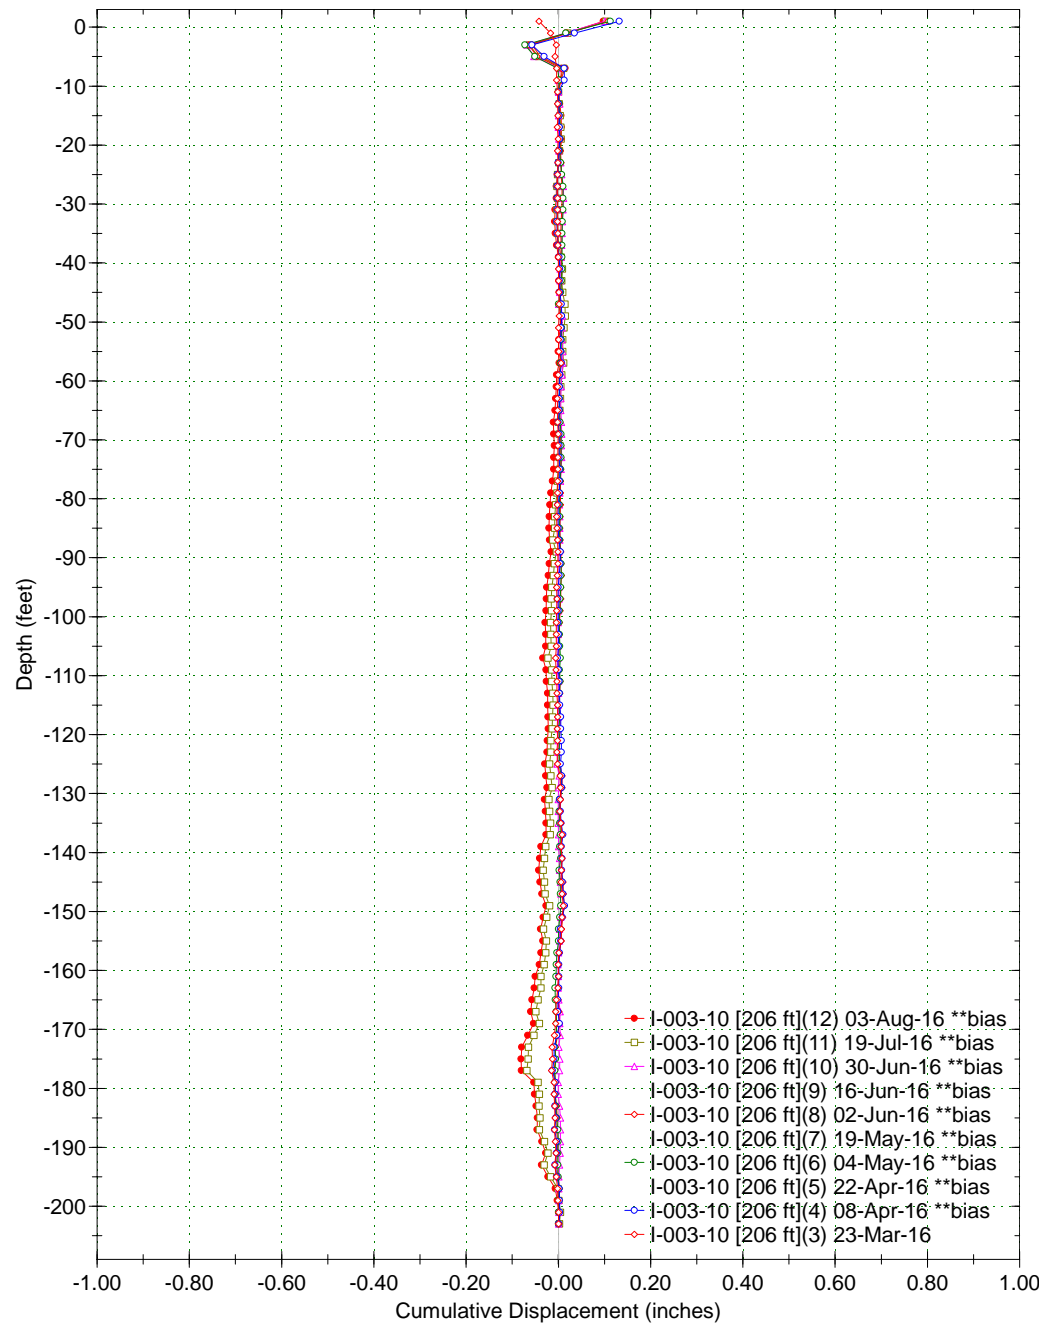
Borehole : I-003-10 [206 ft]
Project : CUY-90-15-24
Location :
Northing :
Easting :
Collar :

I-003-10 – The inclinometer readings at this location indicate an additional small amount of displacement in the negative B-axis direction from about 60 to 180 feet. Movement in the A-axis direction is negligible.
