Re: August 29 and 30, 2016 Bi-Weekly Readings  
CUY-90-15.24 Slope Monitoring  
PID 96504  
SME Project No. 069032.00

Bi-weekly instrument readings for the I-90 west slope taken on August 29 and 30, 2016, are presented in this report. Bi-weekly readings currently include instruments at I/P-001-13, I/P-002-13, I/P-003-10, I/P-004-13, I/P-009-13, B-101, B-102, B-105A, B-05-02, B-05-A-03, B-05-04, B-05-A-11, P-1, P-9N, TGR I-2, and TGR I-4. Changes reported for the individual instruments are for the previous two-week period unless noted otherwise.

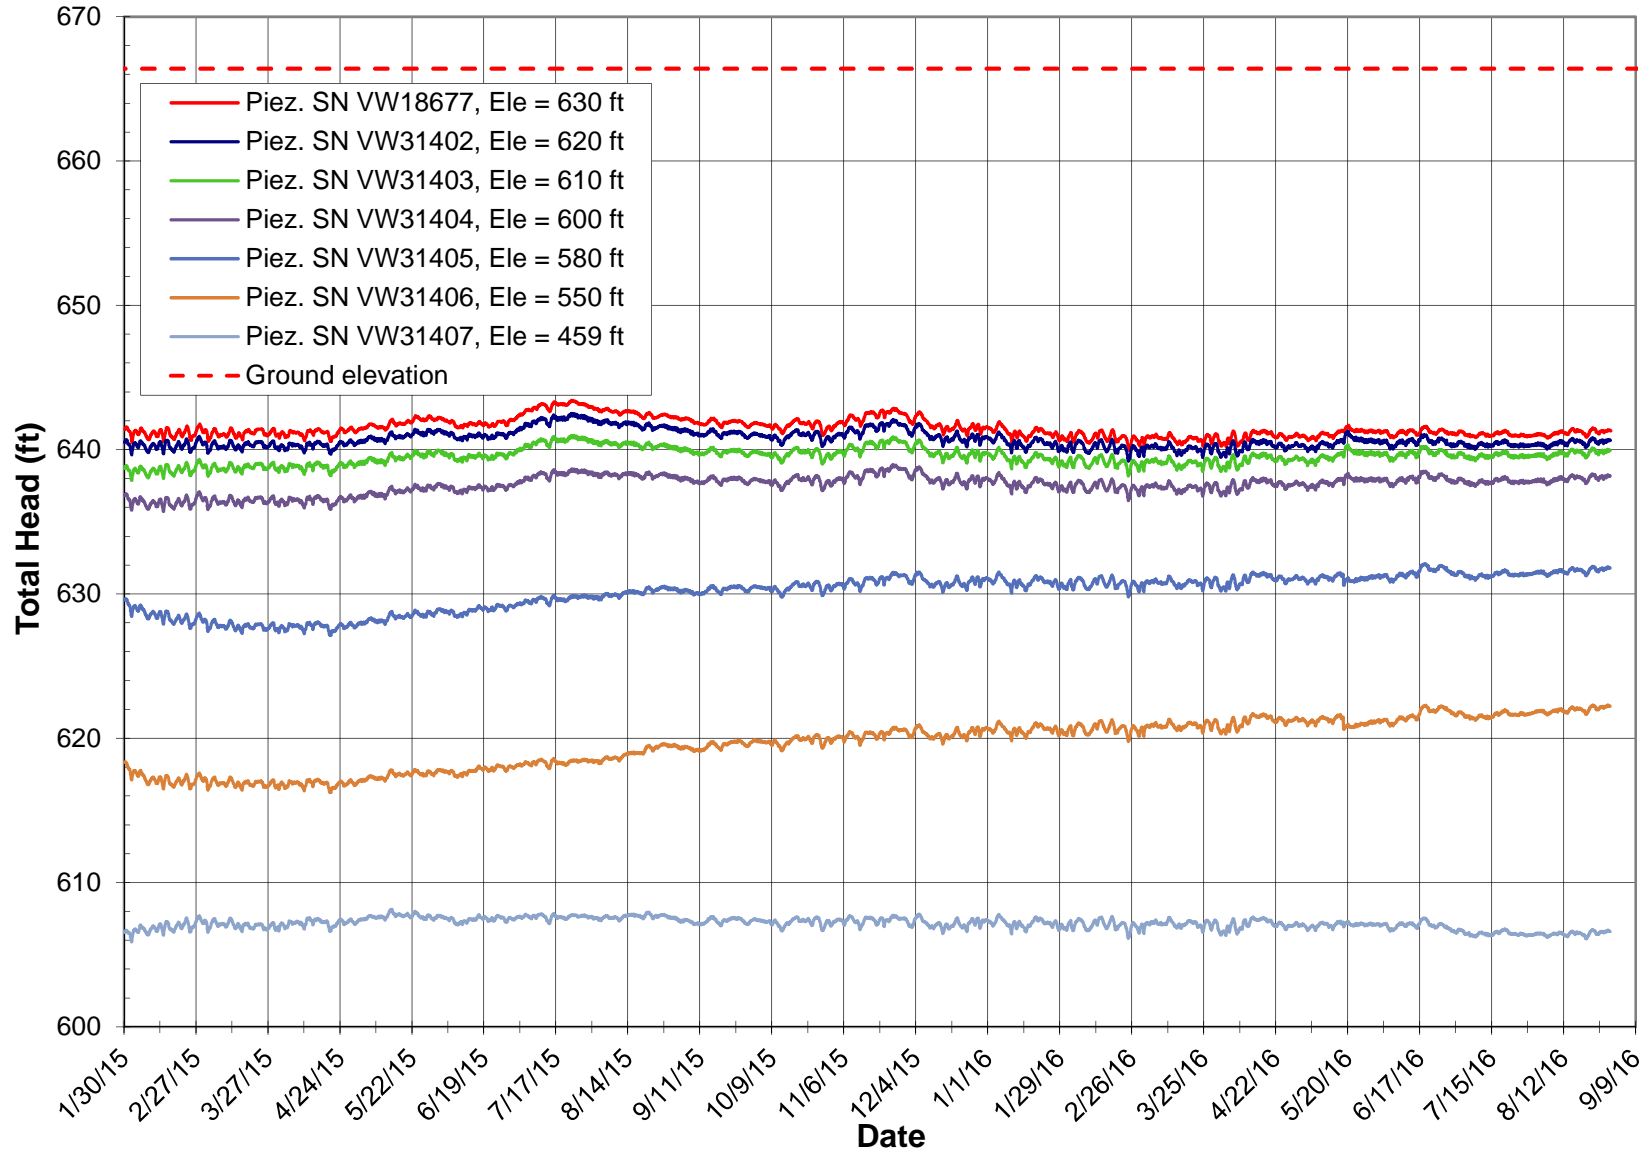
# P-001-13 VW Piezometer Readings

P-001-13, P-002-13, P-009-13, B-105A, B-05-02, B-05-04 – Pore pressure readings at these locations fluctuated by less than 0.5 feet, but show virtually no net change in total head.

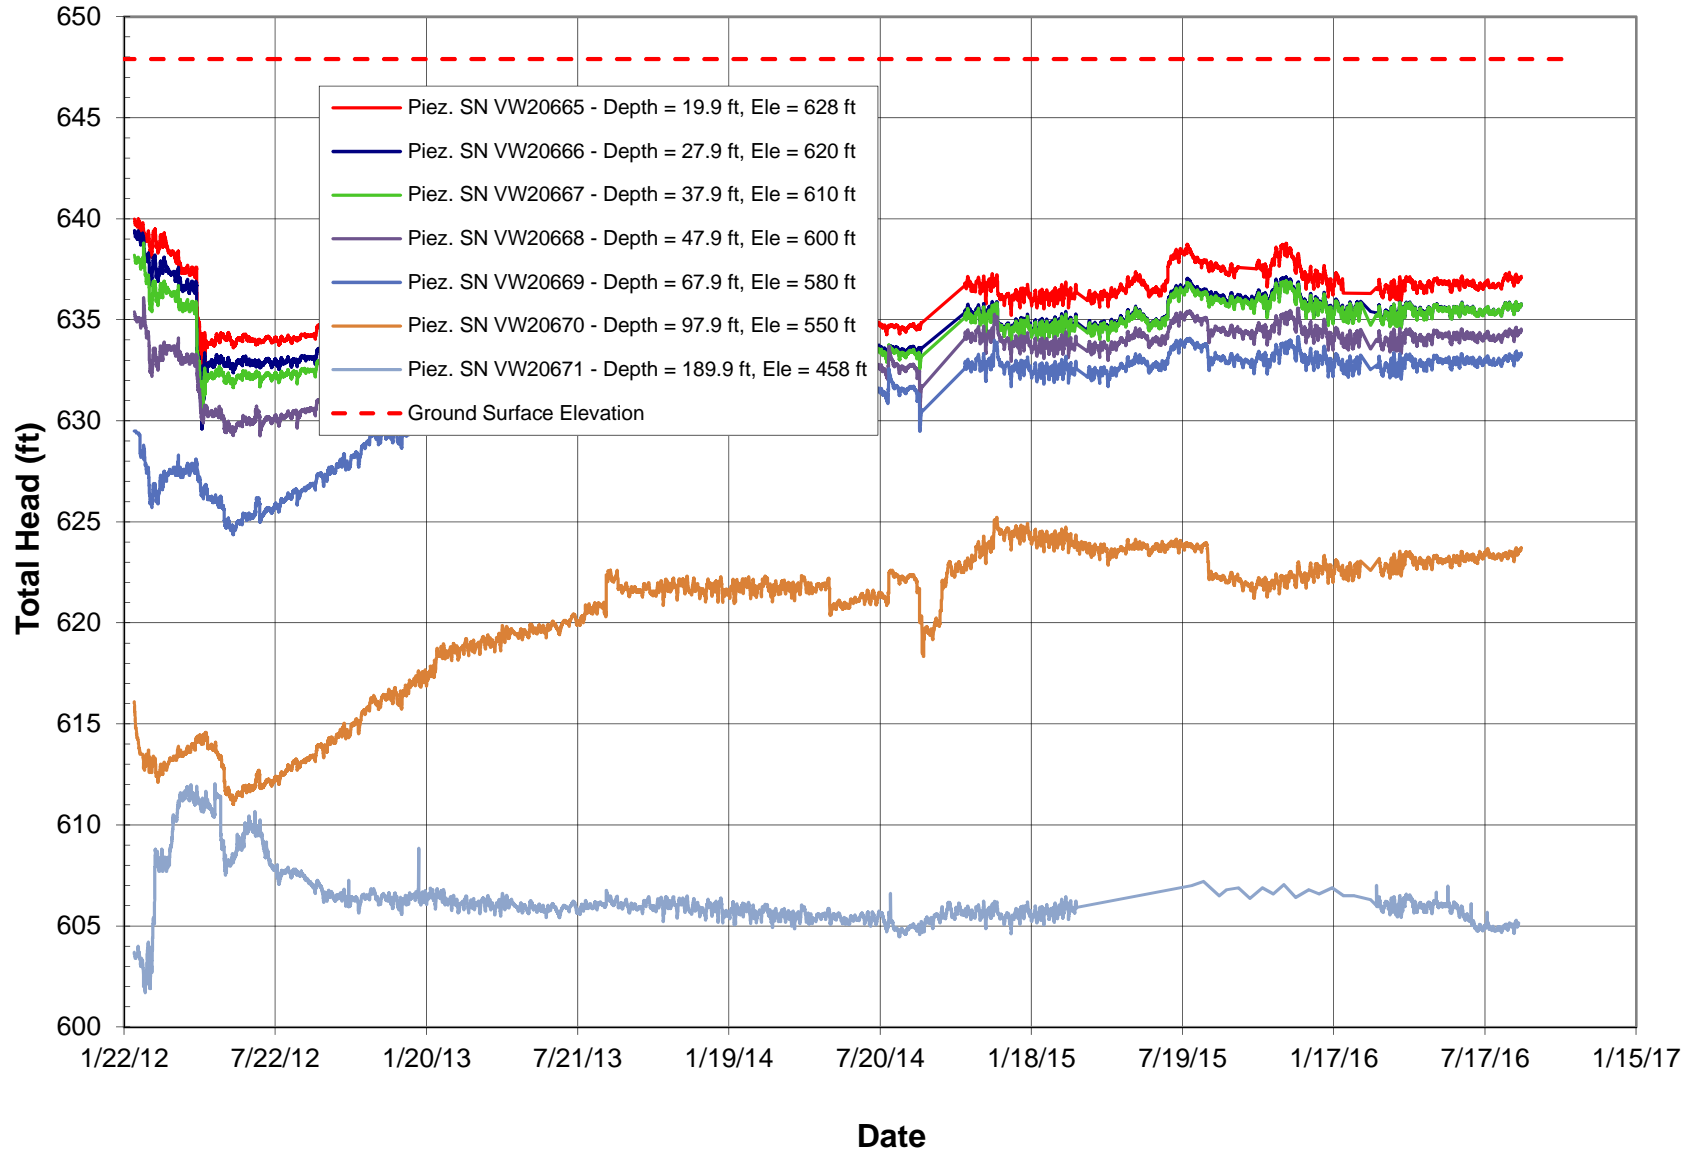
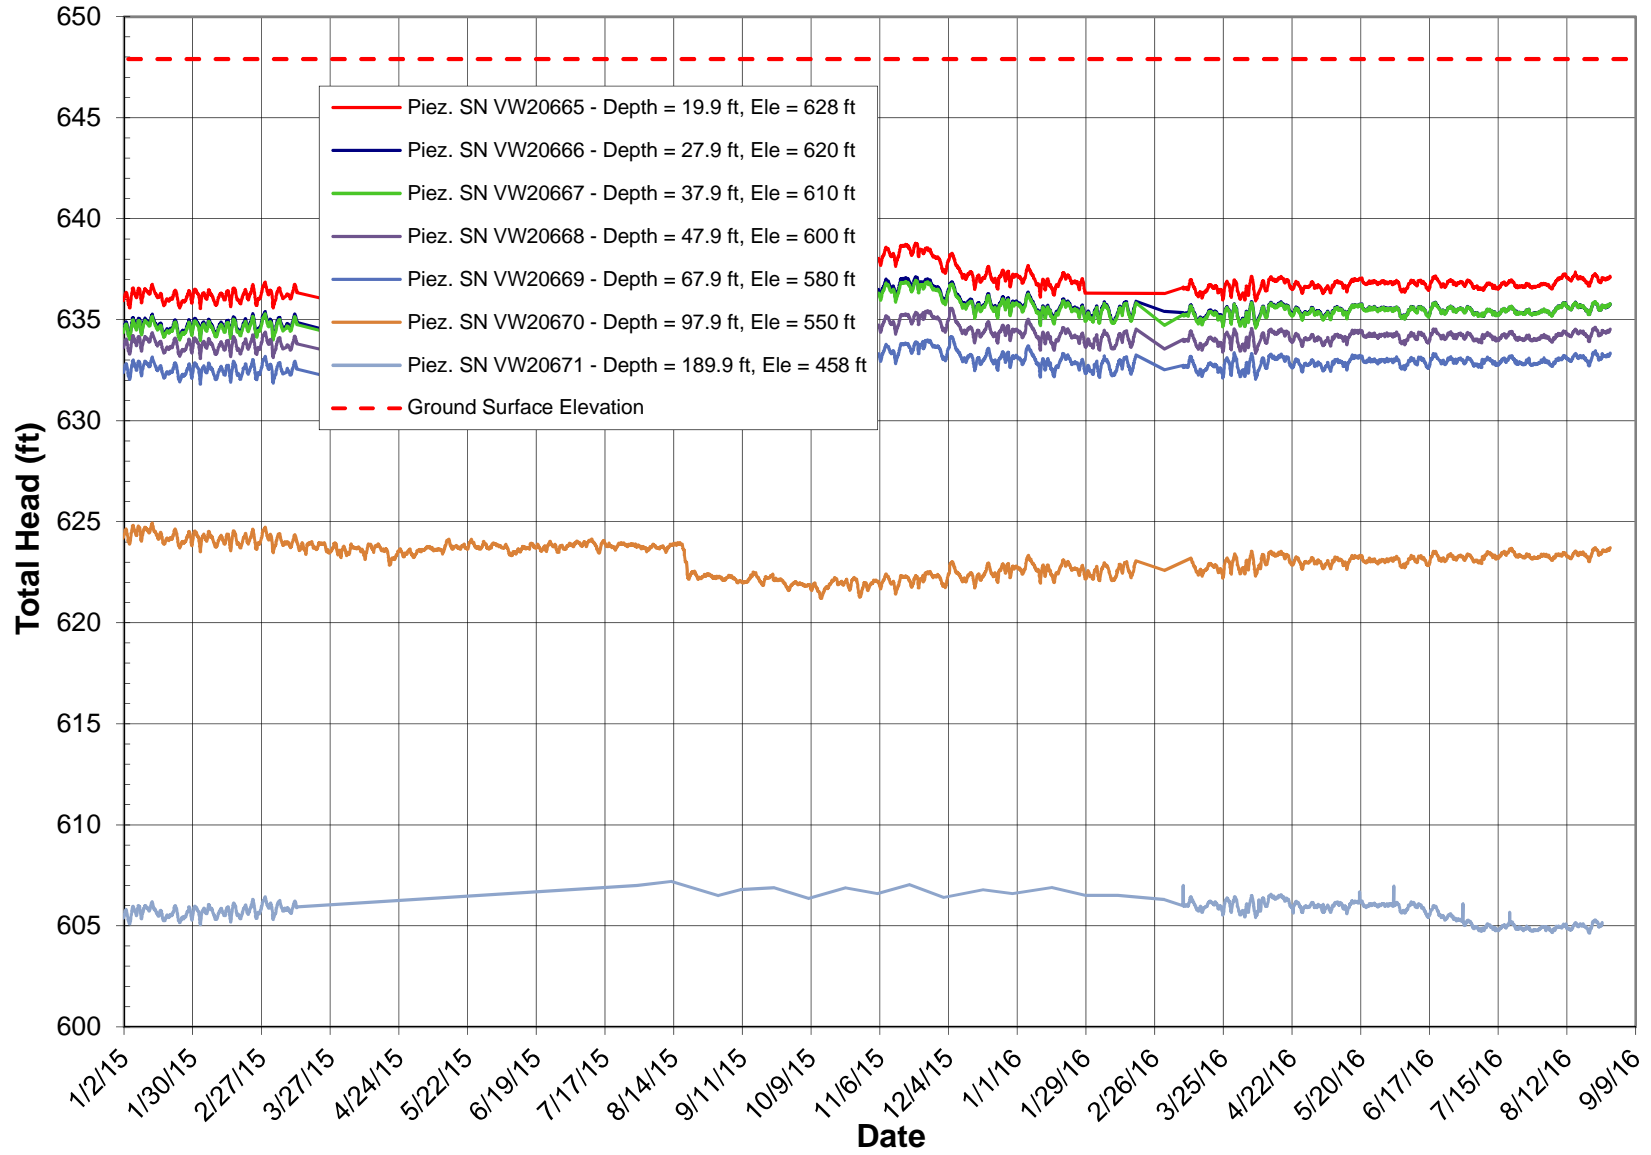
# P-003-10 VW Piezometer Readings

**P-003-10** – Total head in all but the deepest piezometer appear to have trended upward slightly this period. Total head in the piezometer at elevation 550 feet has been trending upward since October 2015.

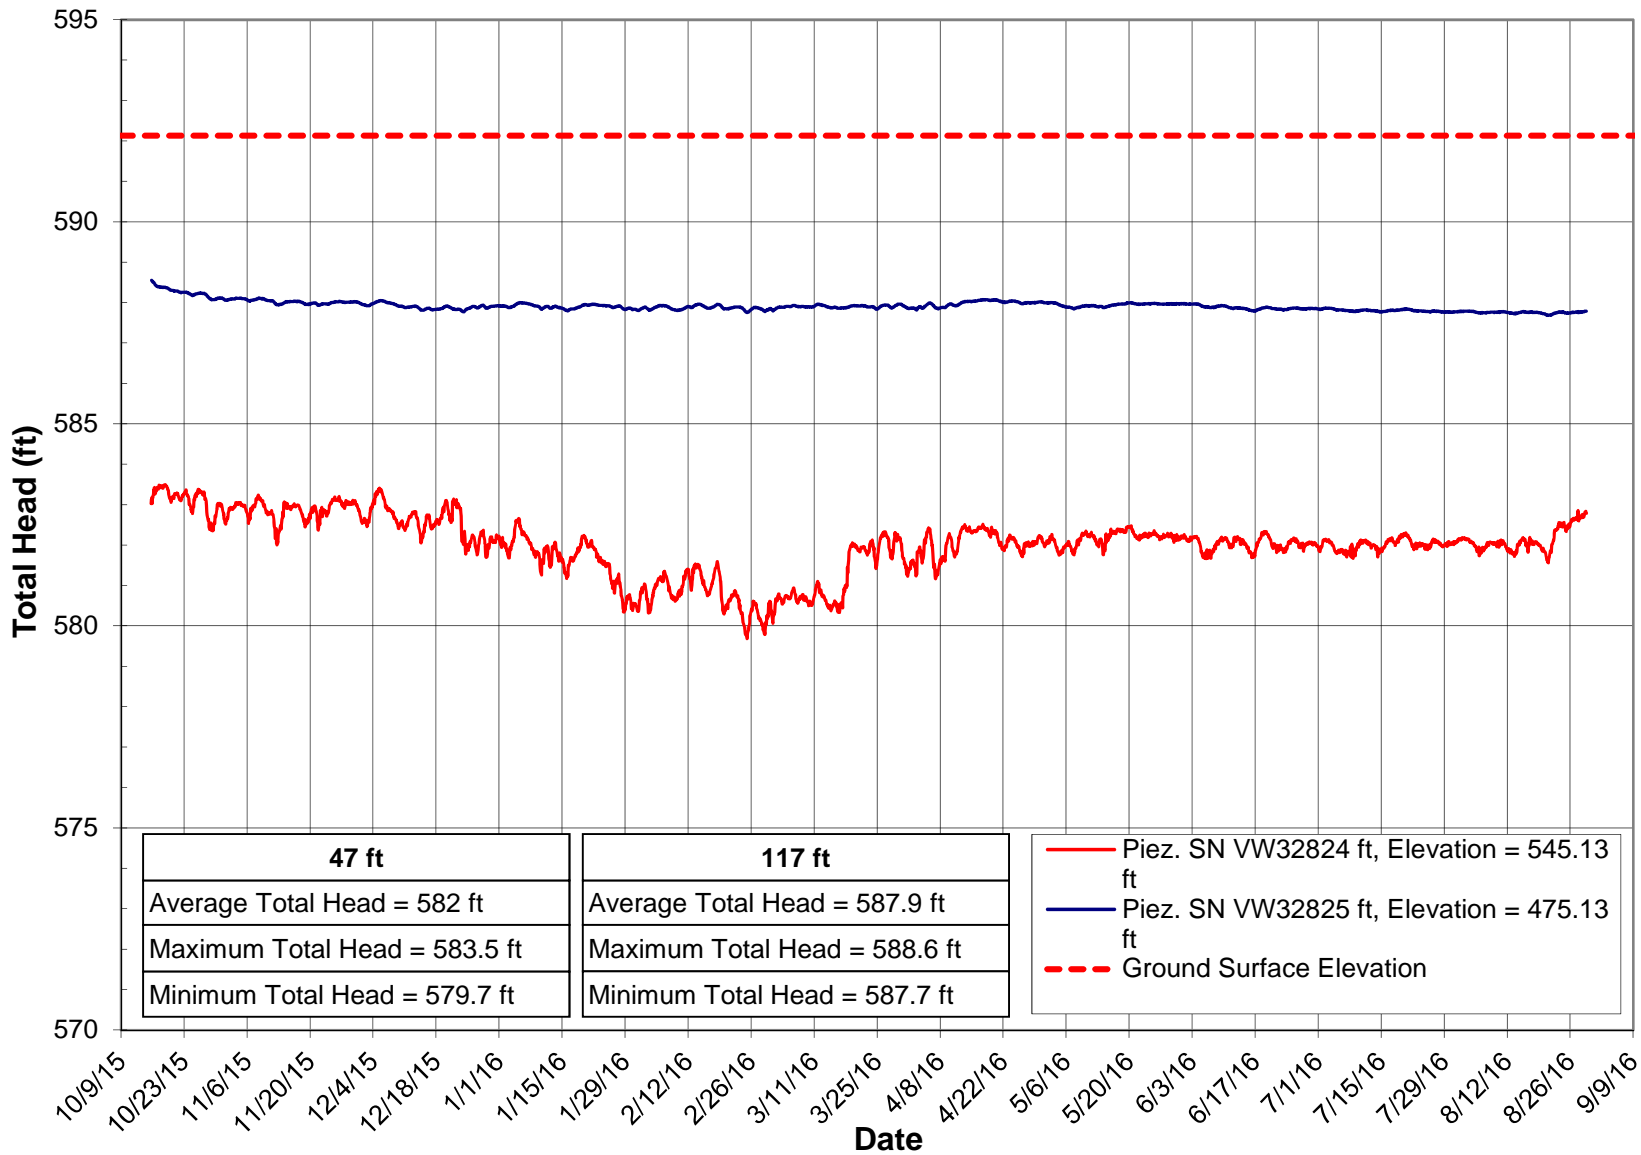
# P-004-13 VW Piezometer Readings

**P-004-13** – Pore pressure readings at this location indicate a 1 foot increase in total head in the piezometer at elevation 545 feet (shallow) that occurred between August 20 and 23. Pore pressures continued to increase slowly through the end of the two-week period with the total increase reaching 1.2 feet. The deep piezometer showed no change.

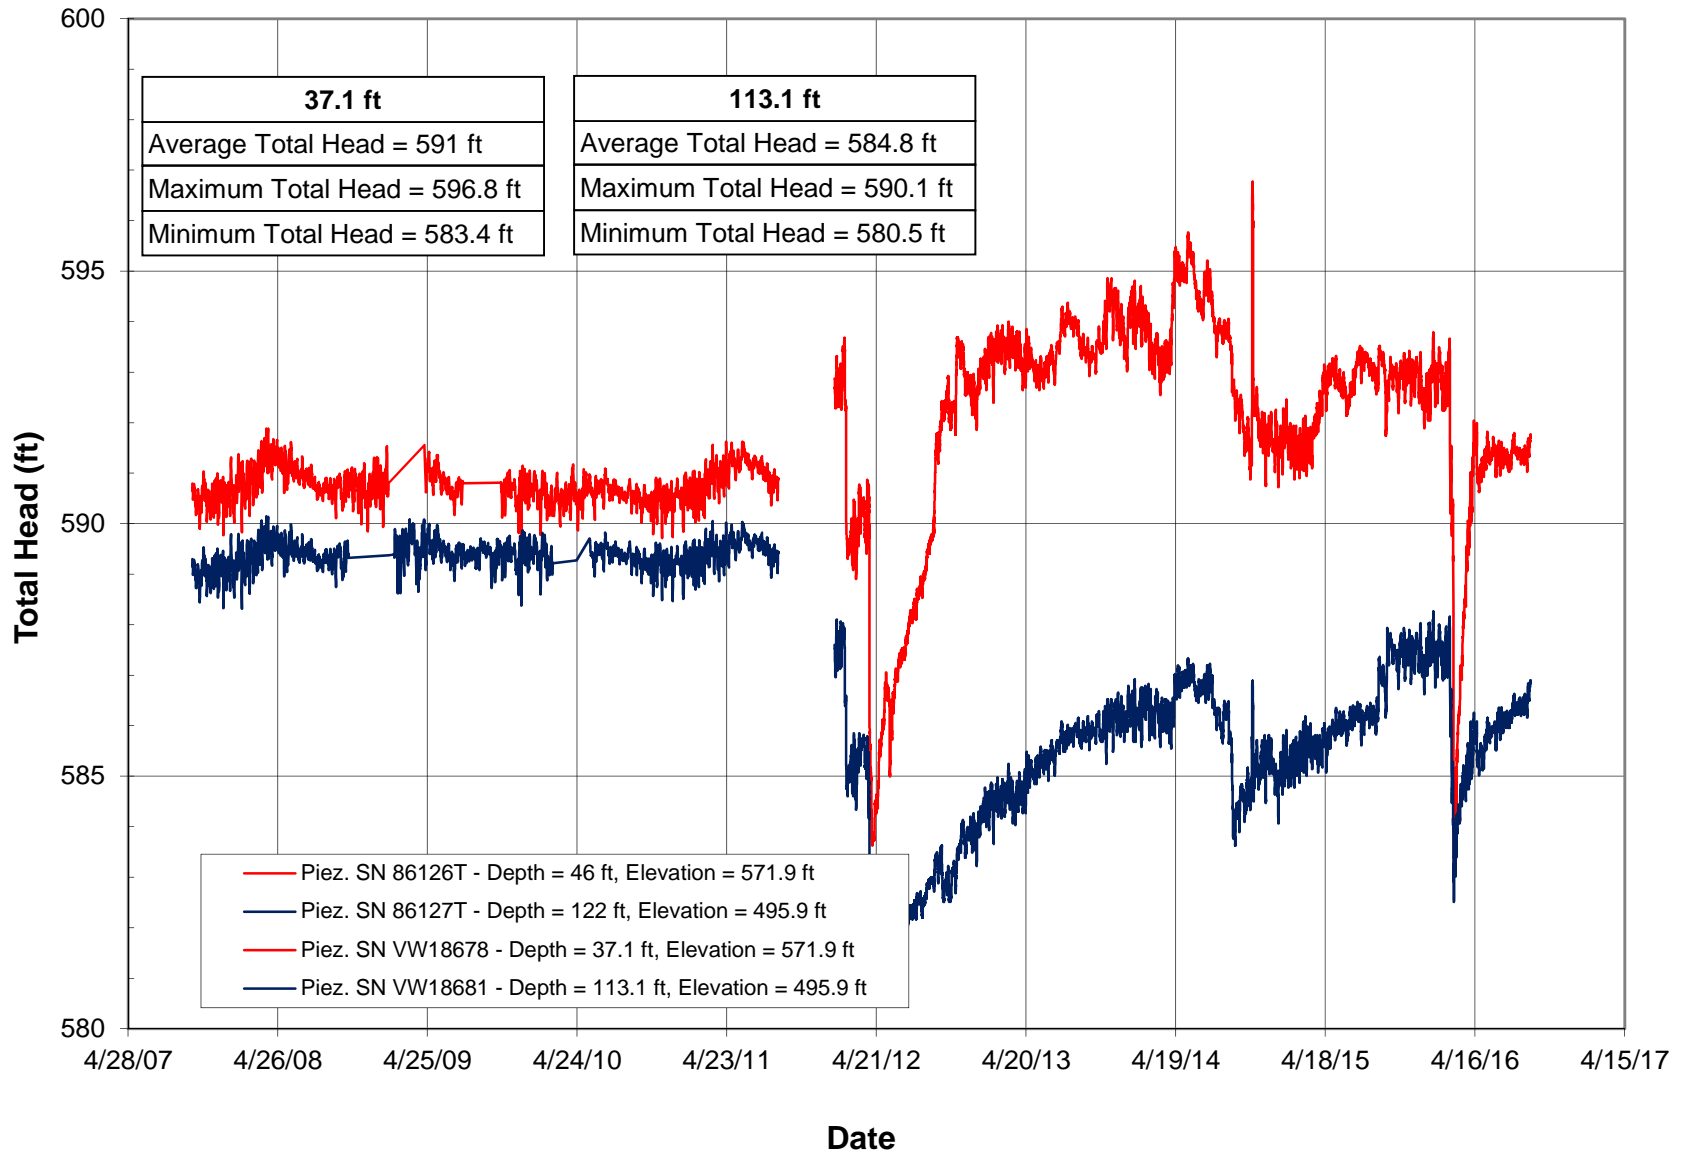
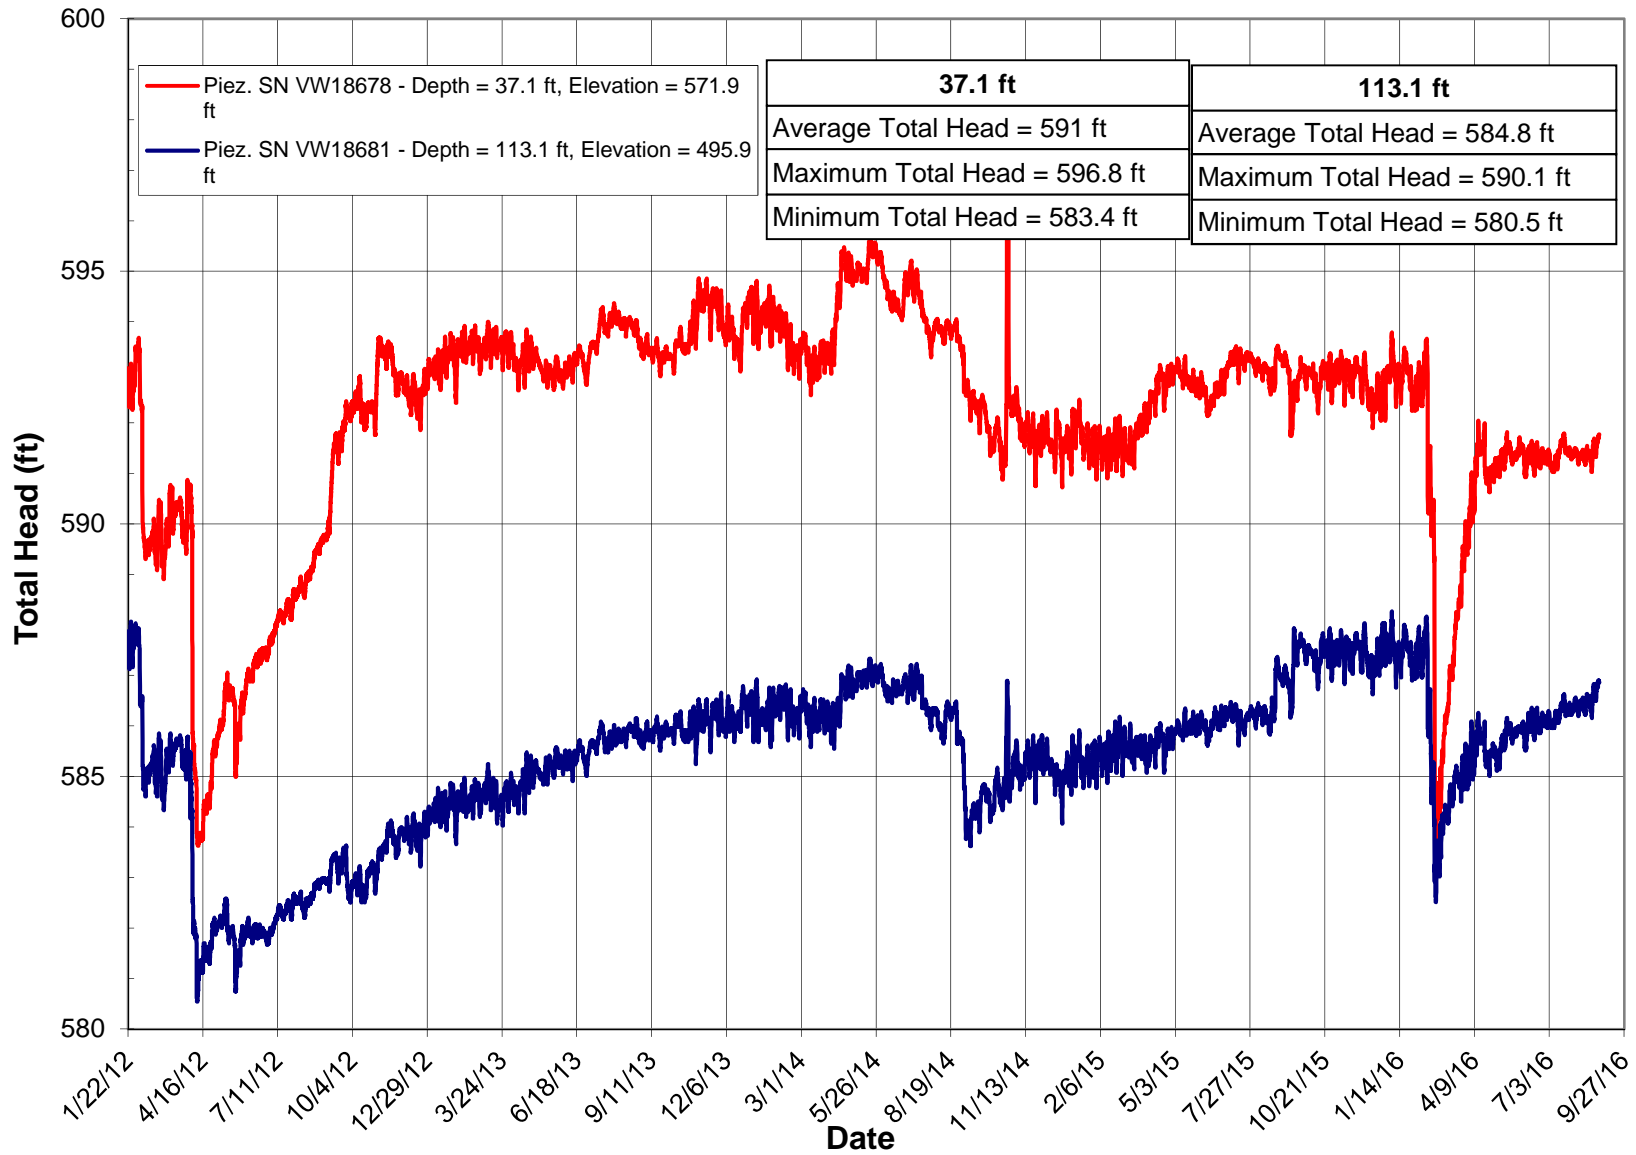
# B-05-02 VW Piezometer Readings

**B-05-02** – Total head in both piezometers at this location increased by about 0.5 feet.

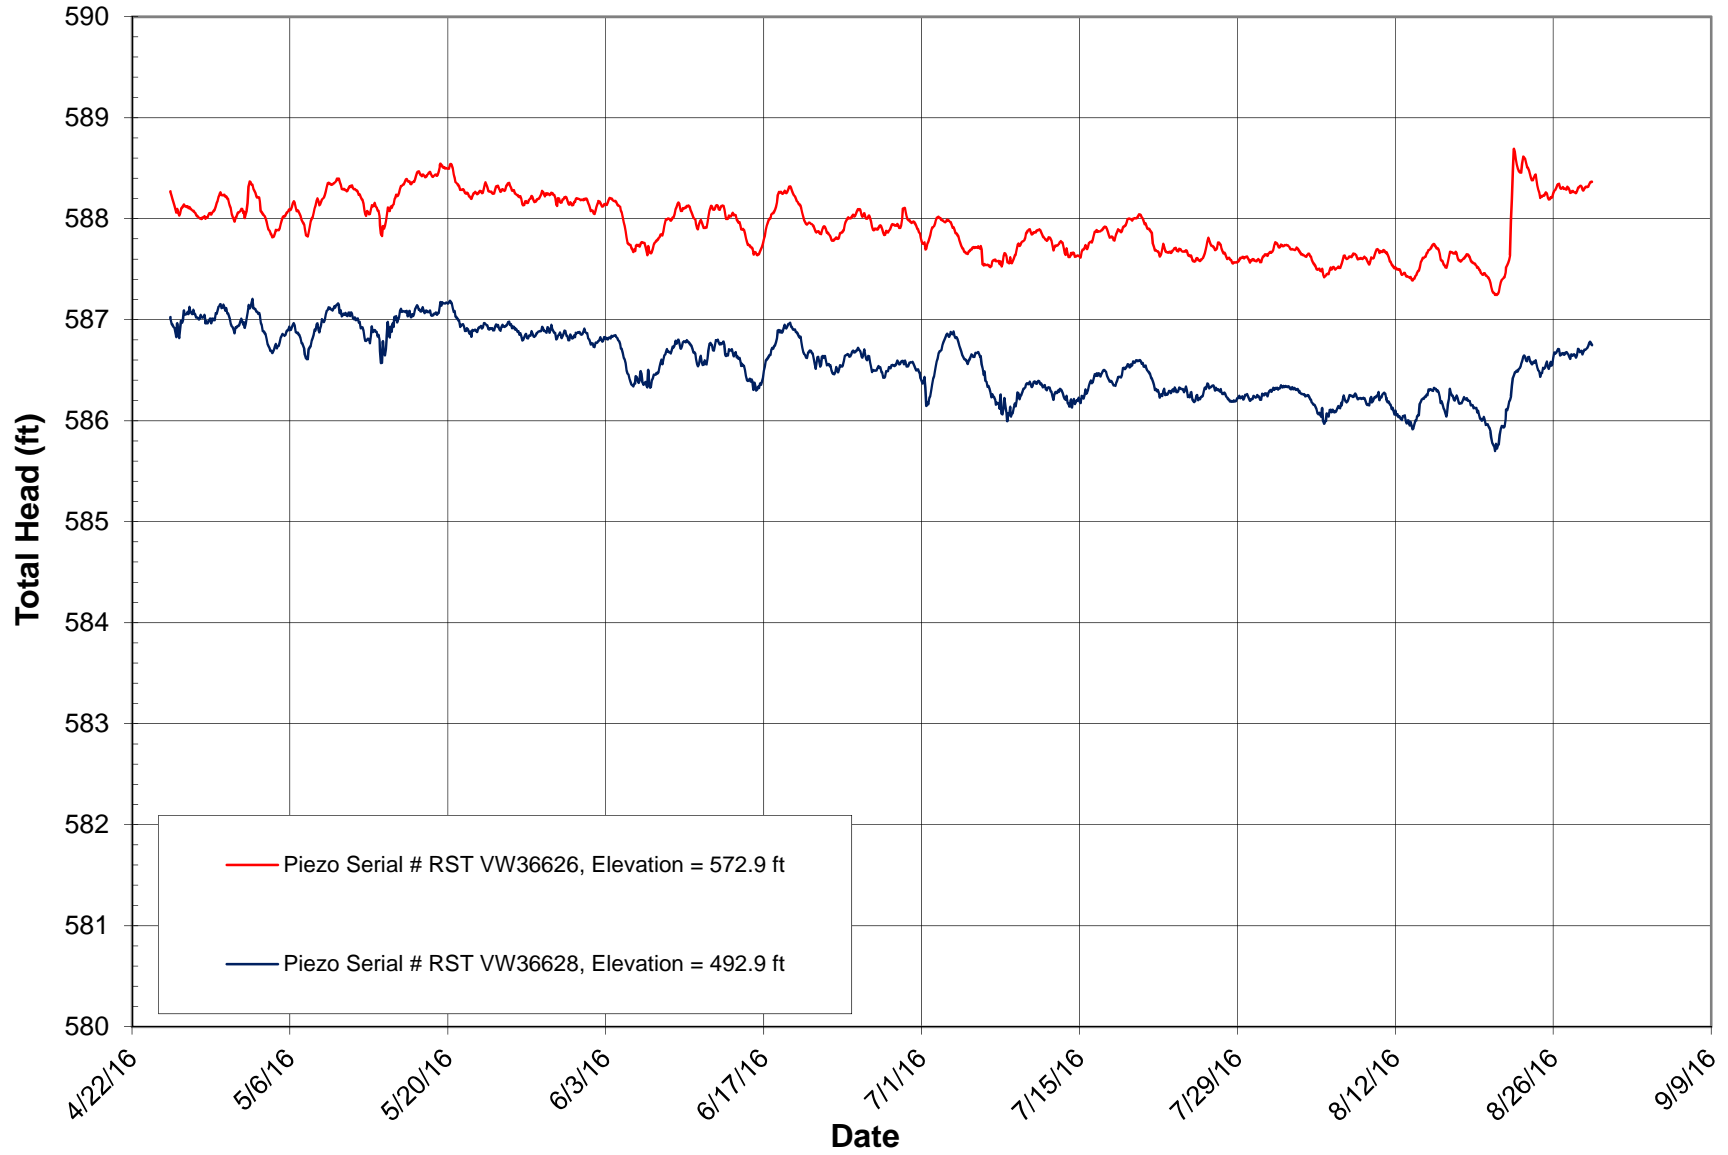
# B-05-A-03 VW Piezometer Readings

**B-05-A-03** – On about August 22, pore pressures in both piezometers at this location increased sharply. The total head increase was 1.4 feet in the shallow piezometer and 0.9 feet in the deep piezometer. Pore pressures recorded in the shallow piezometer then decreased slightly. Pore pressures in the deep piezometer continued to increase but at a much slower rate. Net increases were 0.9 feet and 0.7 feet in the shallow and deep piezometers, respectively.

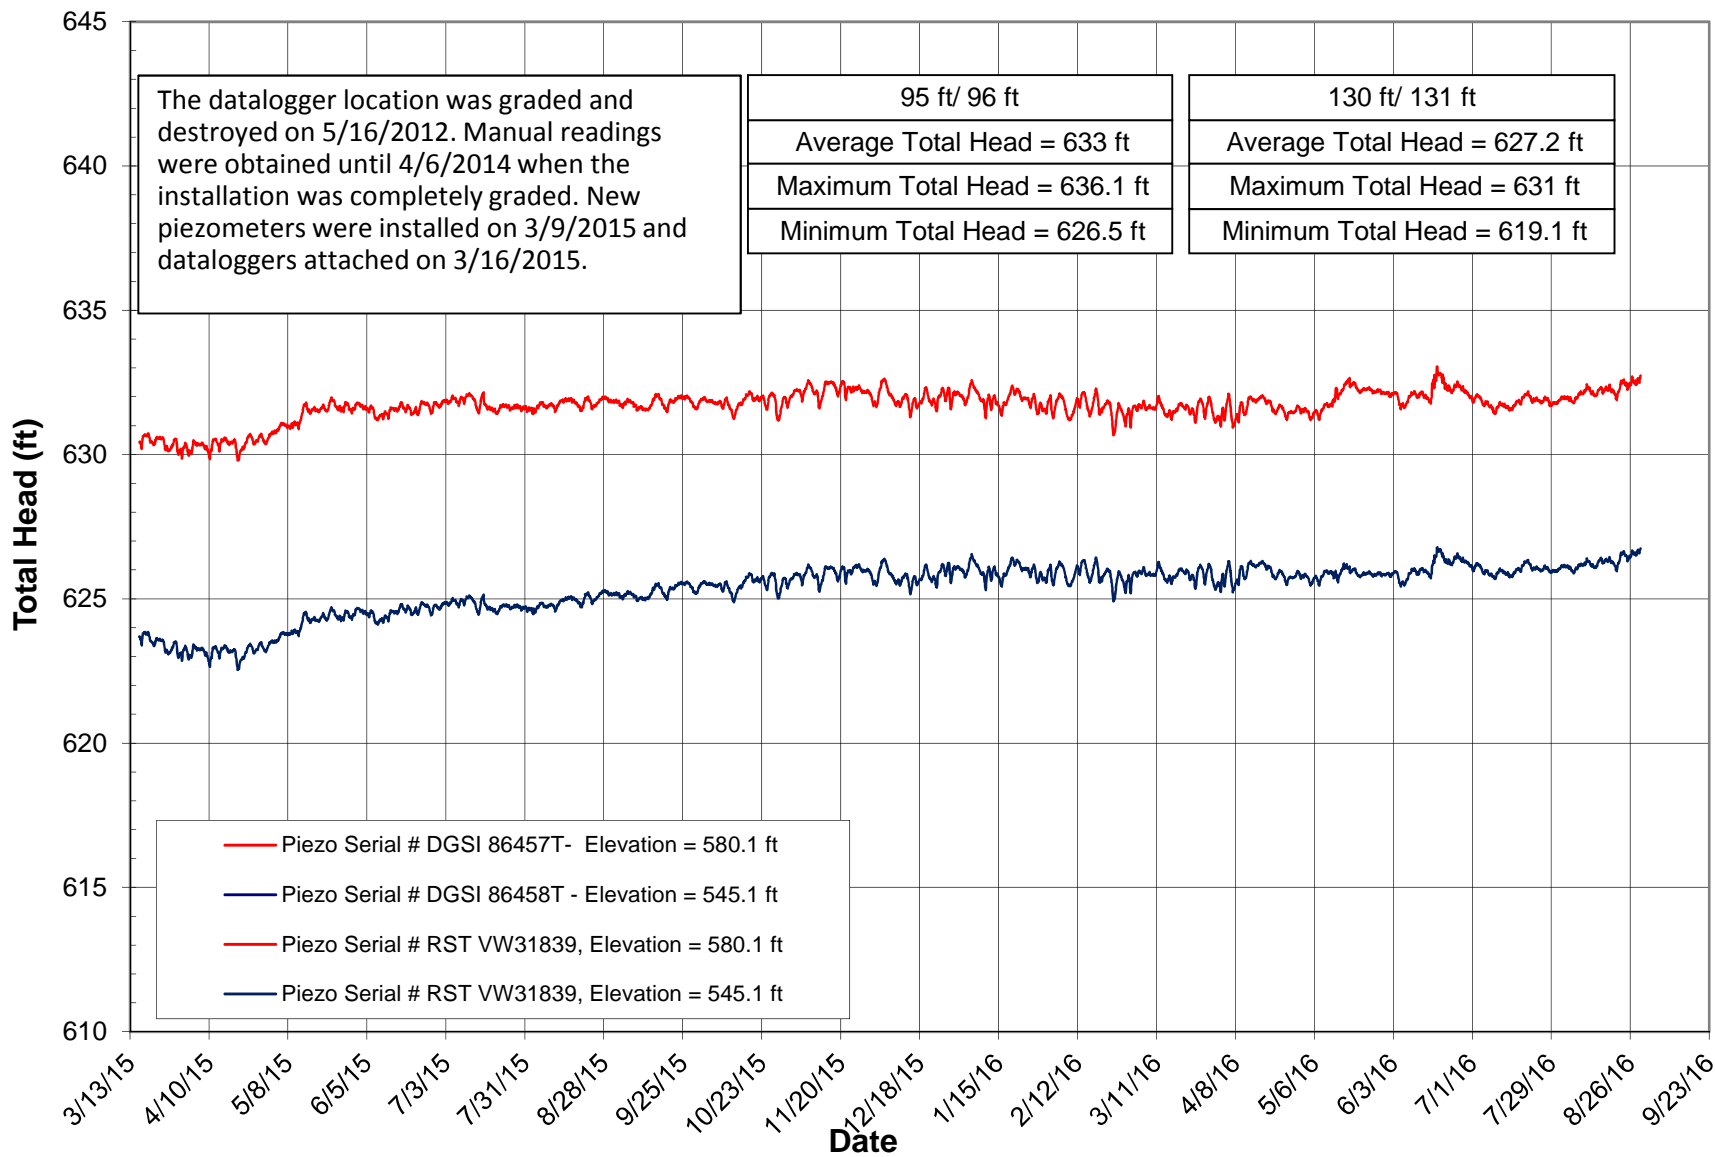
## B-05-11/B-05-A-11 VW Piezometer Readings

**B-05-A-11** – Pore pressure readings at this location indicate an increase in total head of about 0.6 feet in the shallow piezometer and about 0.7 feet in the deep piezometer. Total head in these piezometers has been increasing at a steady rate since the beginning of July 2016.

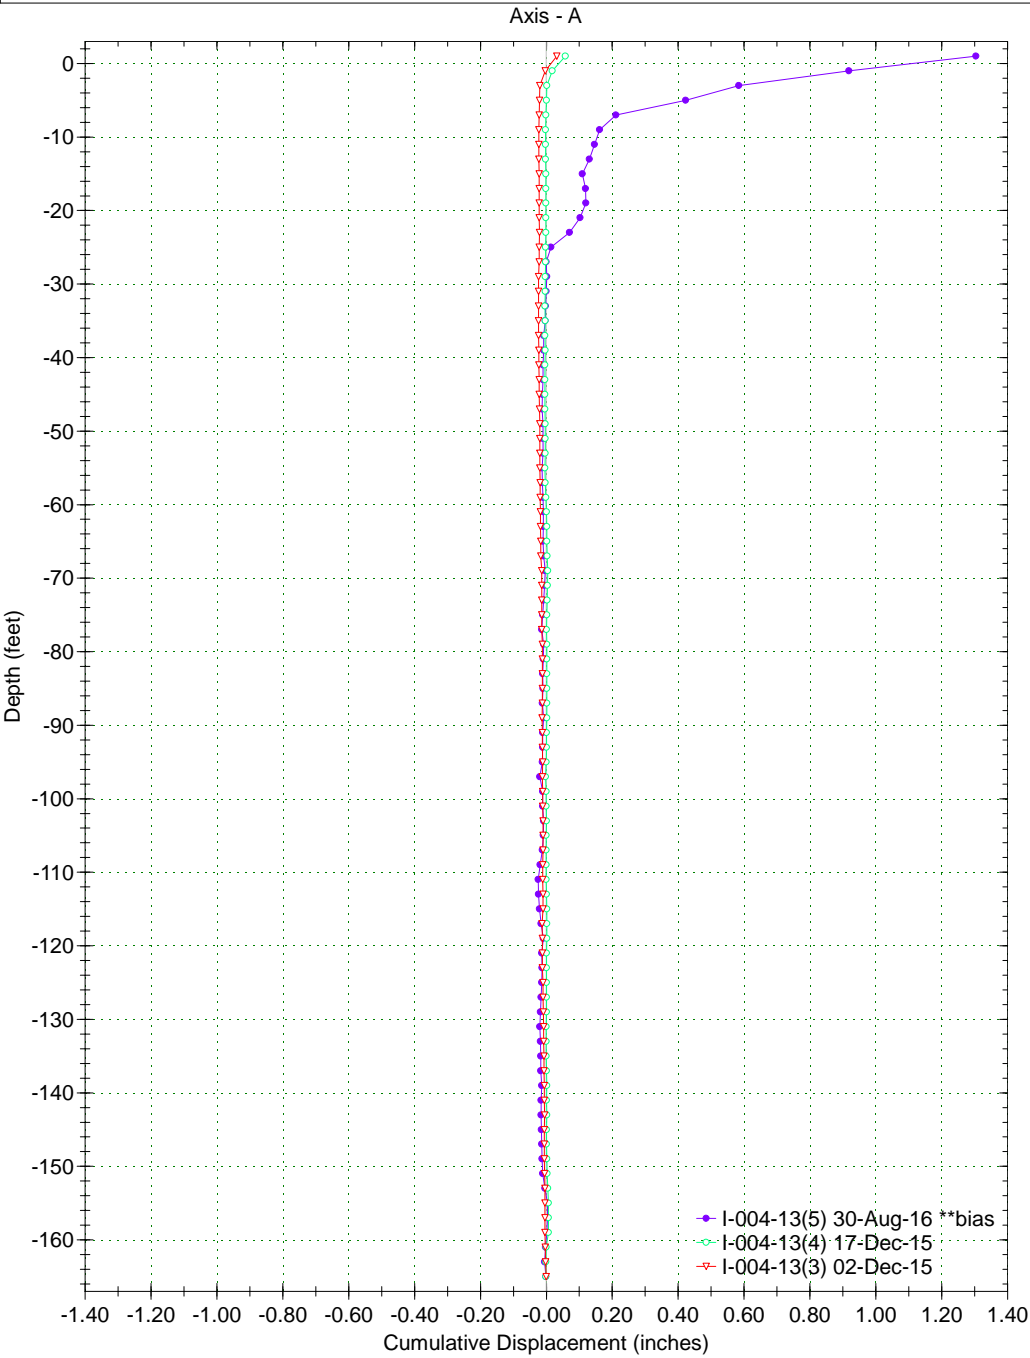
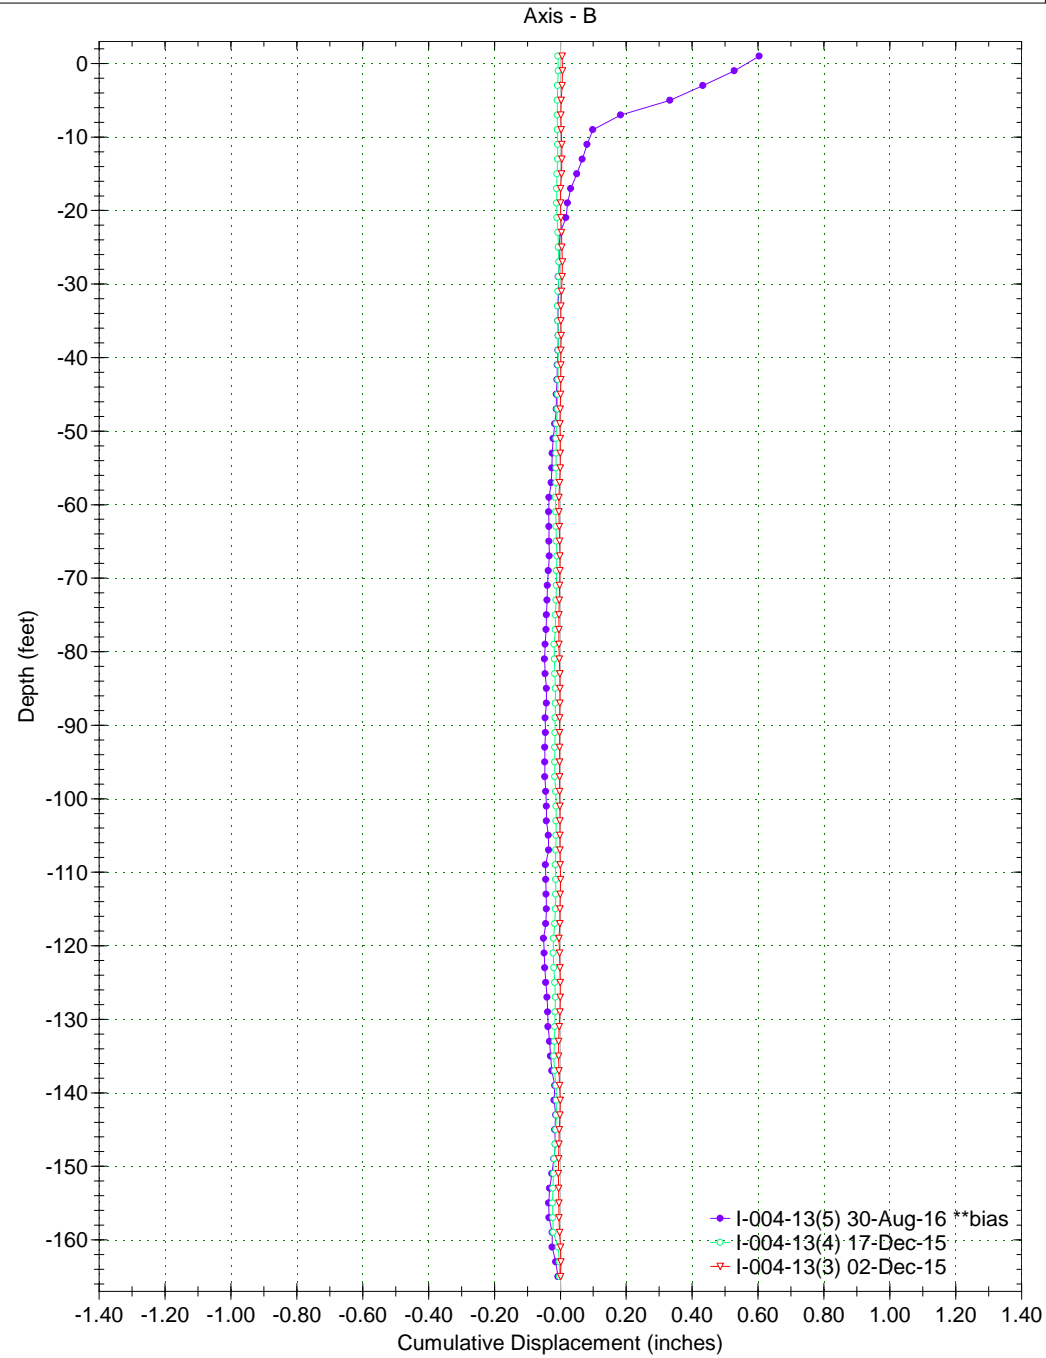
Borehole : I-004-13  
Project : CUY-90-15-24  
Location :  
Northing :  
Easting :  
Collar :

**I-004-13** – Inclinometer readings at this location indicate movement from the surface to about 24 feet. The maximum displacement, which occurs at the surface, is 1.3 inches in the positive A-axis direction and 0.6 inches in the positive B-axis direction.
