Re: December 1 and 2, 2016 Bi-Weekly Readings
CUY-90-15.24 Slope Monitoring
PID 96504
SME Project No. 069032.00

Bi-weekly instrument readings for the I-90 west slope taken on December 1 and 2, 2016, are presented in this report. Bi-weekly readings currently include instruments at I/P-001-13, I/P-002-13, I/P-003-10, I/P-004-13, I/P-009-13, B-101, B-102, B-105A, B-05-02, B-05-A-03, B-05-04, B-05-A-11, P-1, P-9N, and TGR I-4. Changes reported for the individual instruments are for the previous two-week period unless noted otherwise.

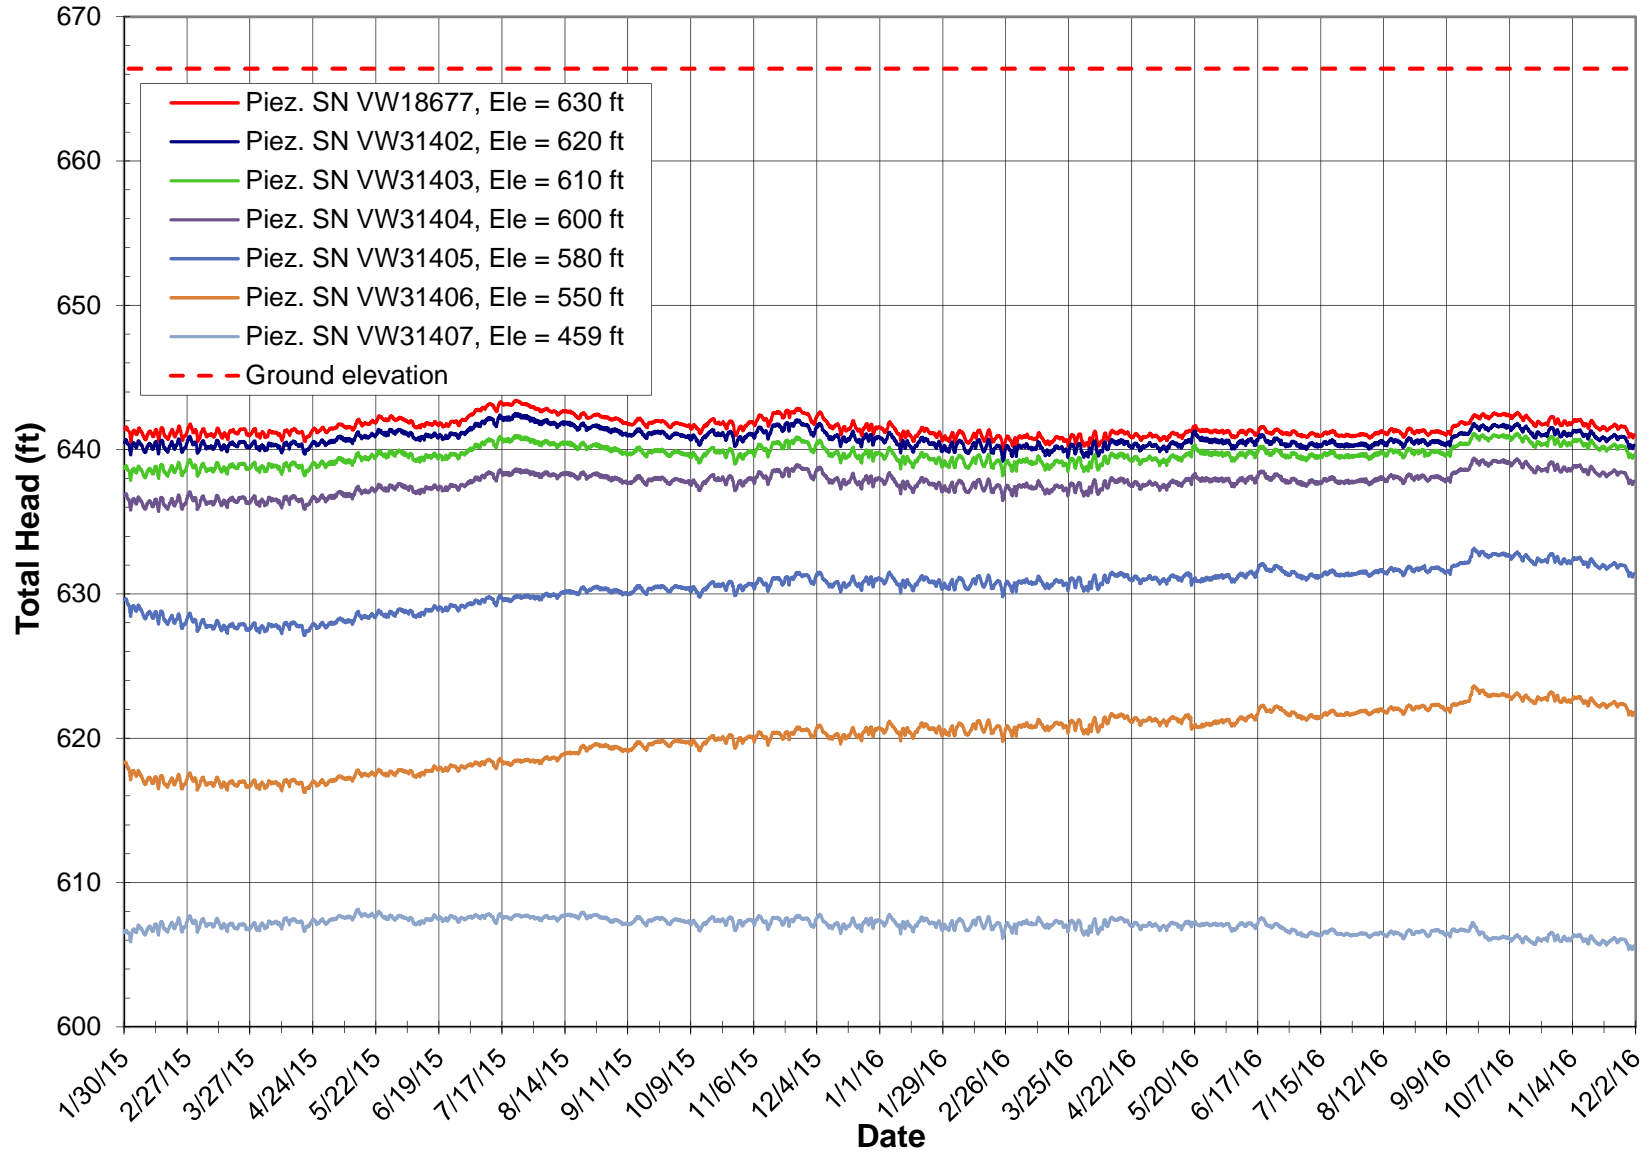
P-001-13 VW Piezometer Readings

P-001-13 – Pore pressures in all piezometers at this location decreased by about 0.7 feet during the last few days of this reading cycle.

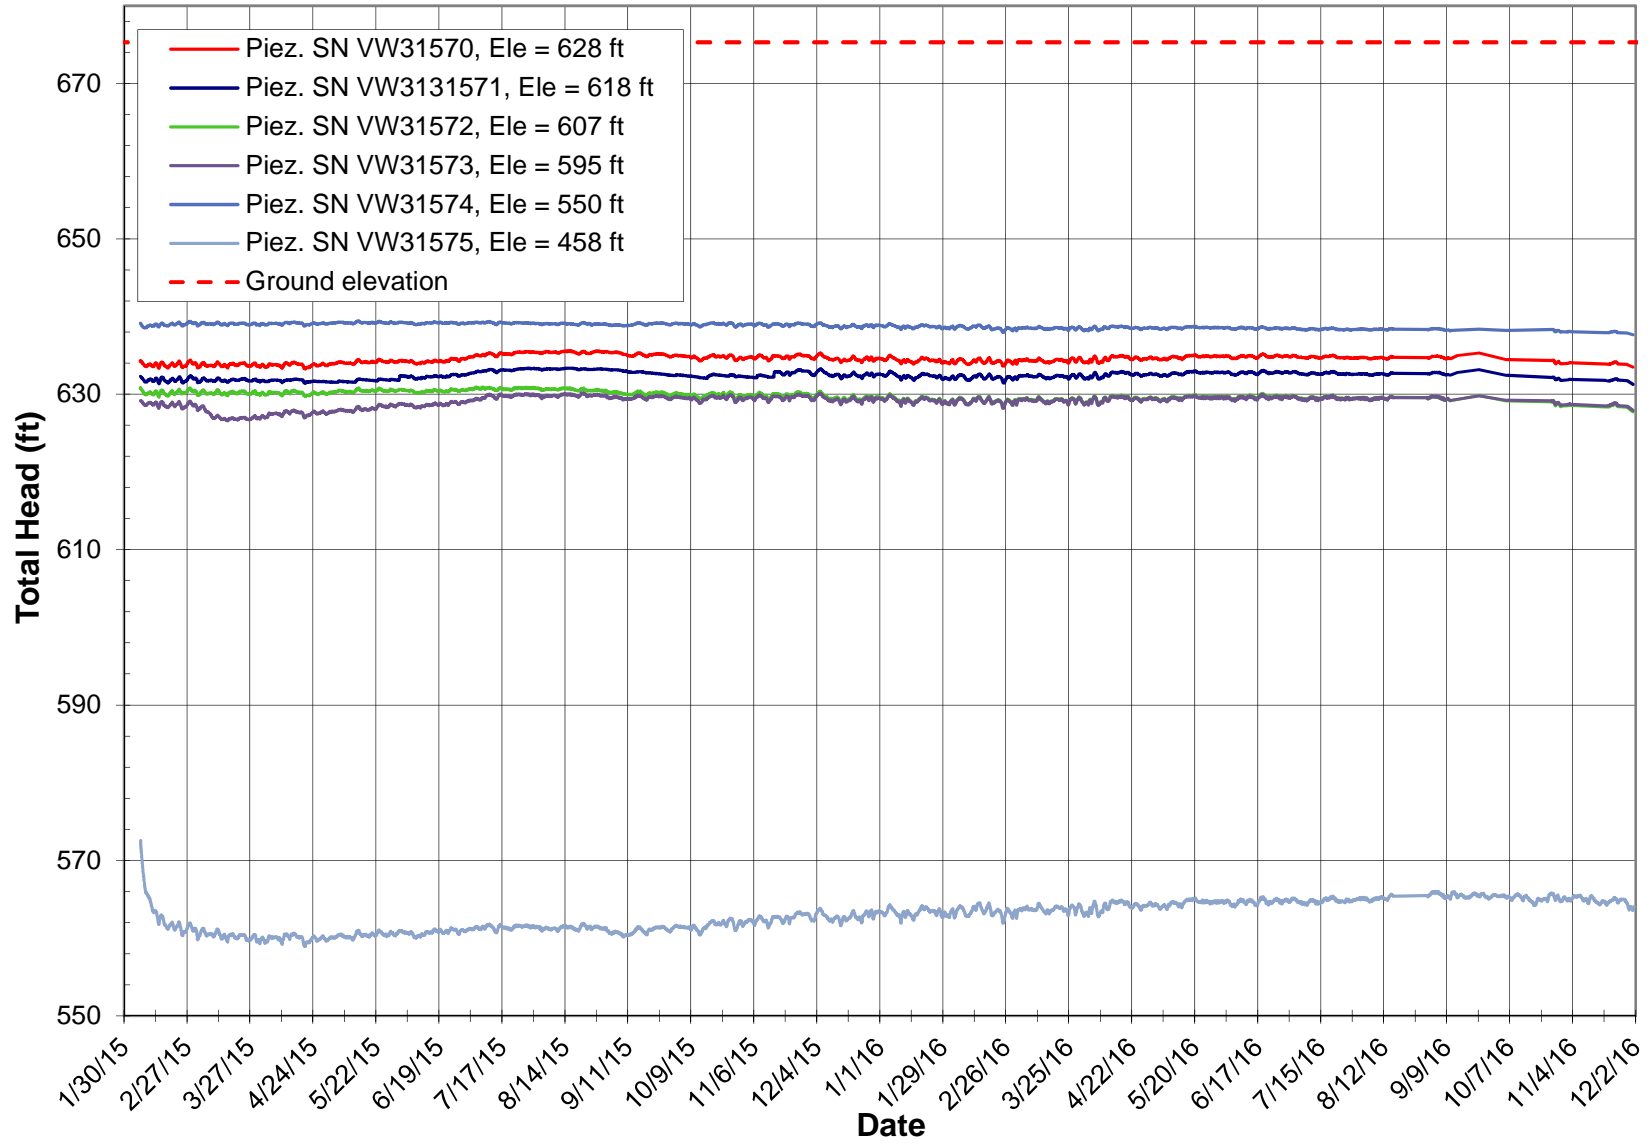
P-002-13 VW Piezometer Readings

P-002-13 – Pore pressures in all piezometers at this location decreased by 0.4 to 1.1 feet. The largest decrease occurred in the piezometer at elevation 458 feet.

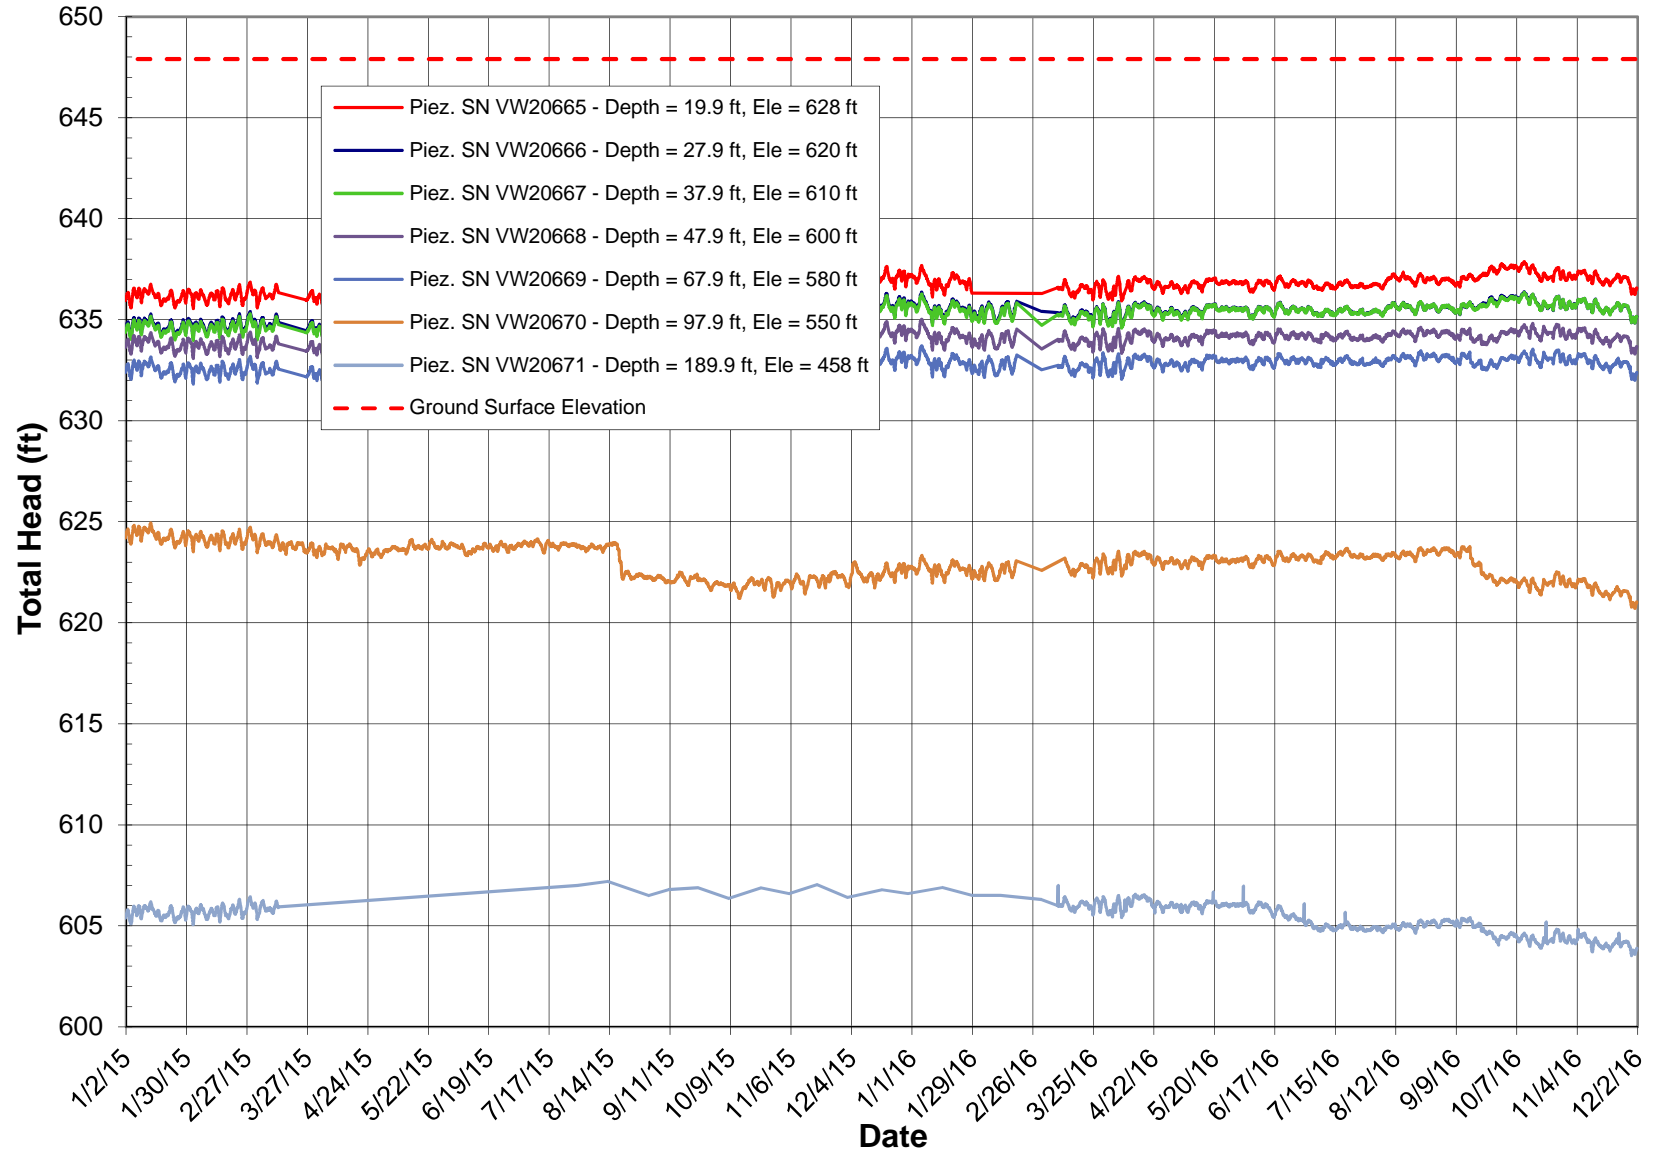
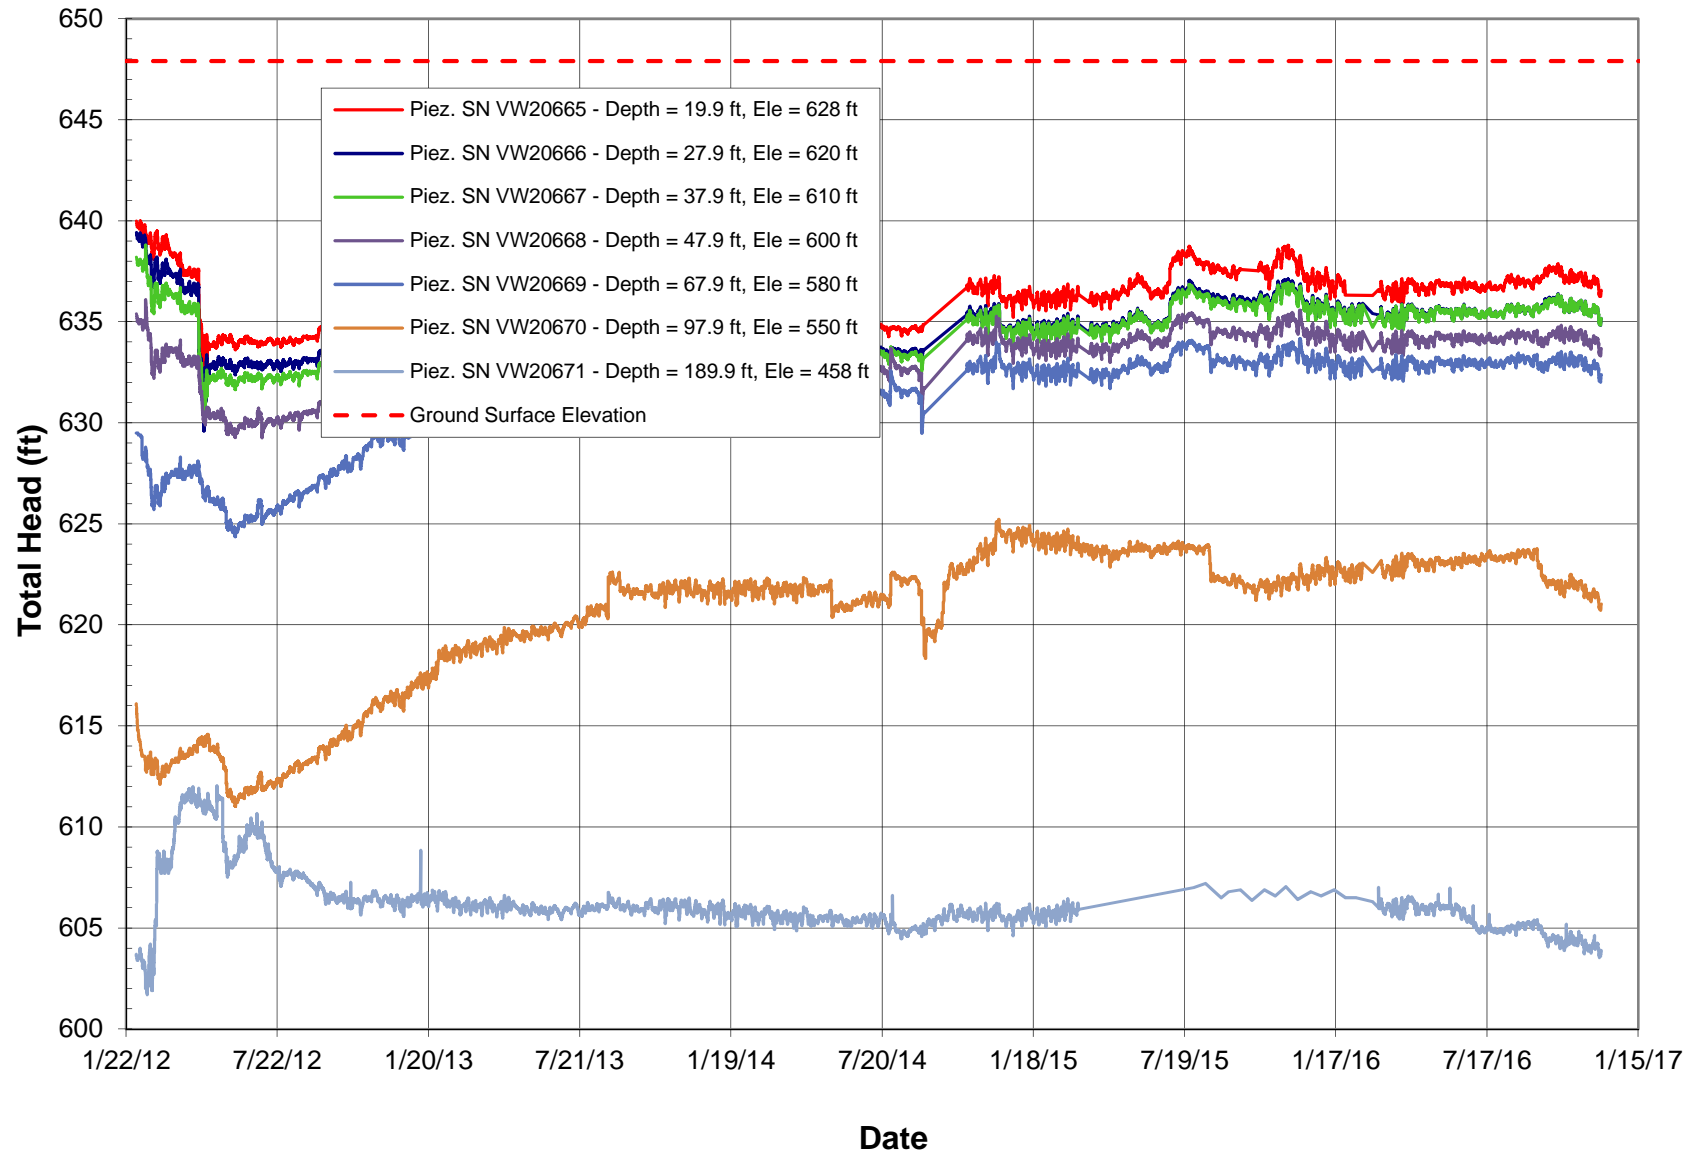
P-003-10 VW Piezometer Readings

P-003-10 – At this location, pore pressures in the 6 shallowest piezometers decreased by 0.6 feet. Pore pressure in the deepest piezometer decreased by 0.4 feet. Pore pressures have been decreasing since early October 2016 in the five shallowest piezometers and since early September 2016 in the two deepest piezometers.

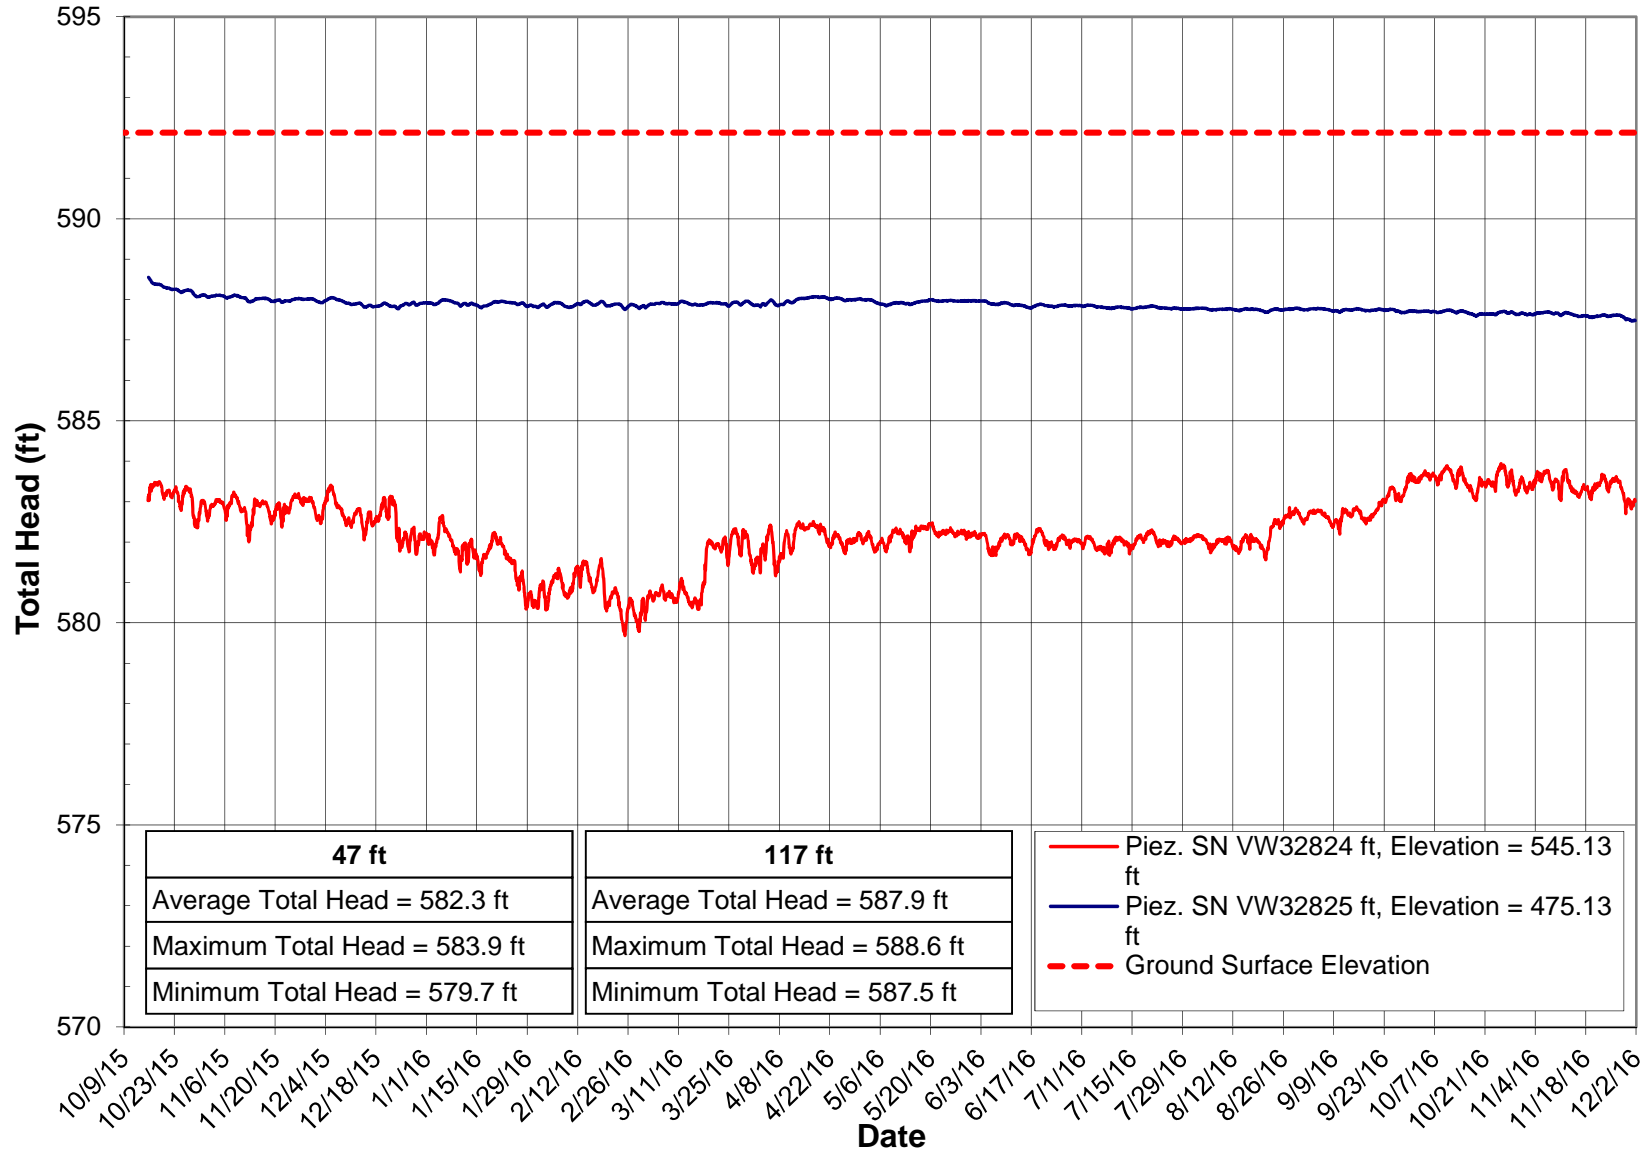
P-004-13 VW Piezometer Readings

P-004-13 – Pore pressure in the shallow piezometer at this location decreased by 0.6 feet during this reading cycle. Pore pressure in the deep piezometer show virtually no change.

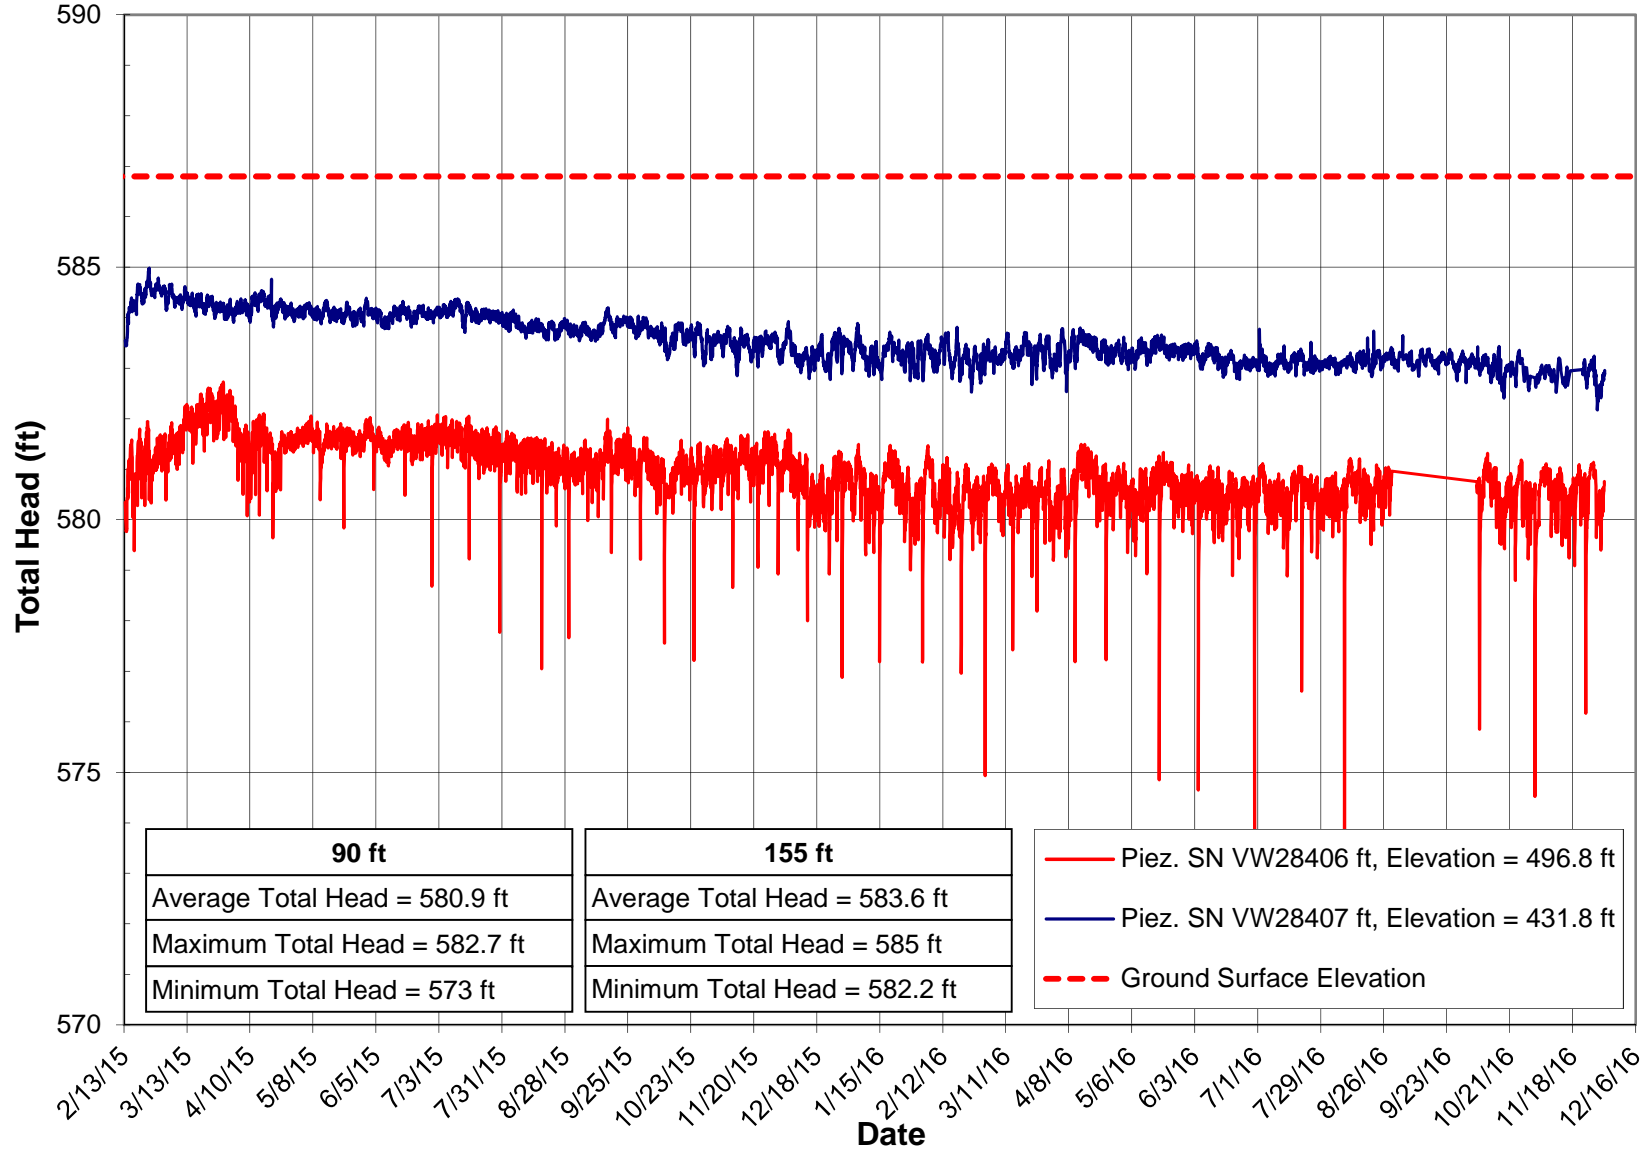
P-009-13 VW Piezometer Readings

P-009-13 – Pore pressure readings in both piezometers at this location show virtually no change.

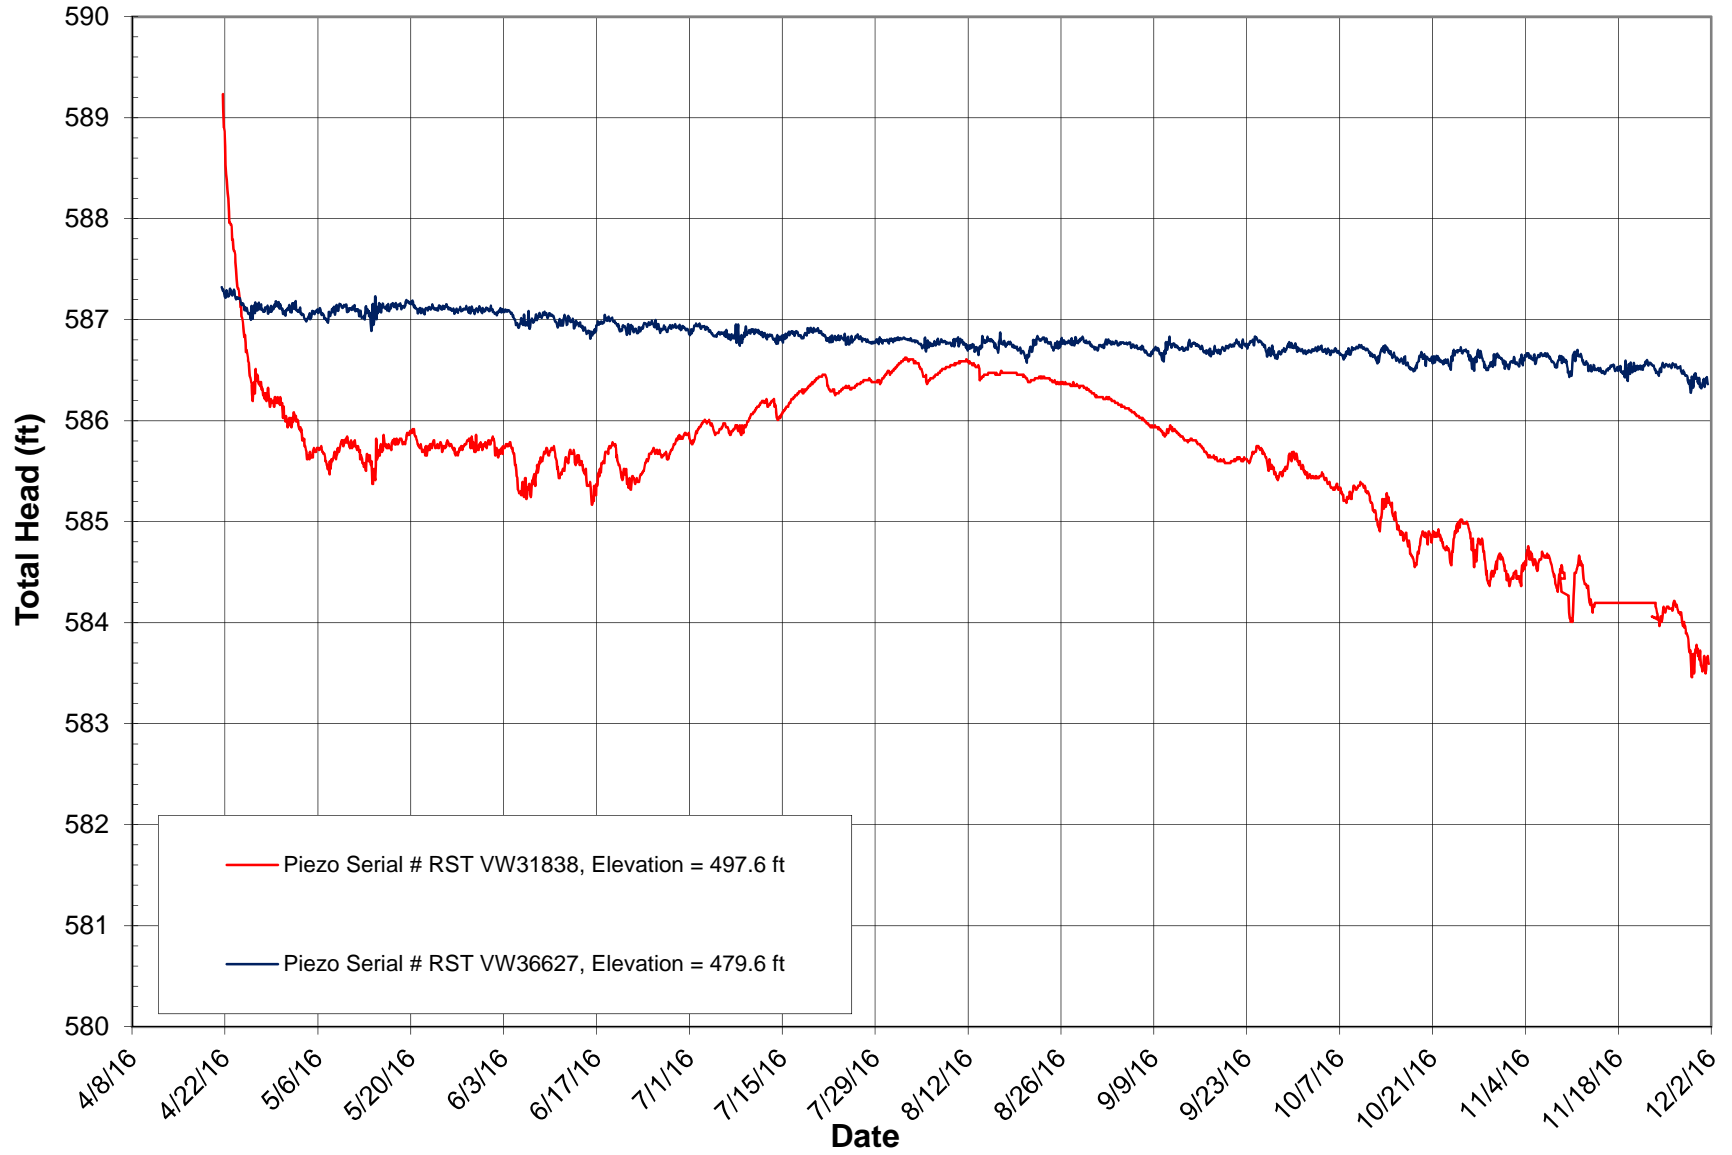
B-105A VW Piezometer Readings

B-105A – Total head in the shallow piezometer at this location continued to decrease during this recording cycle. From August 13 to December 1, 2016, the total head decreased by about 3 feet. Pore pressures in the deep piezometer continue to decrease at a very slow rate.

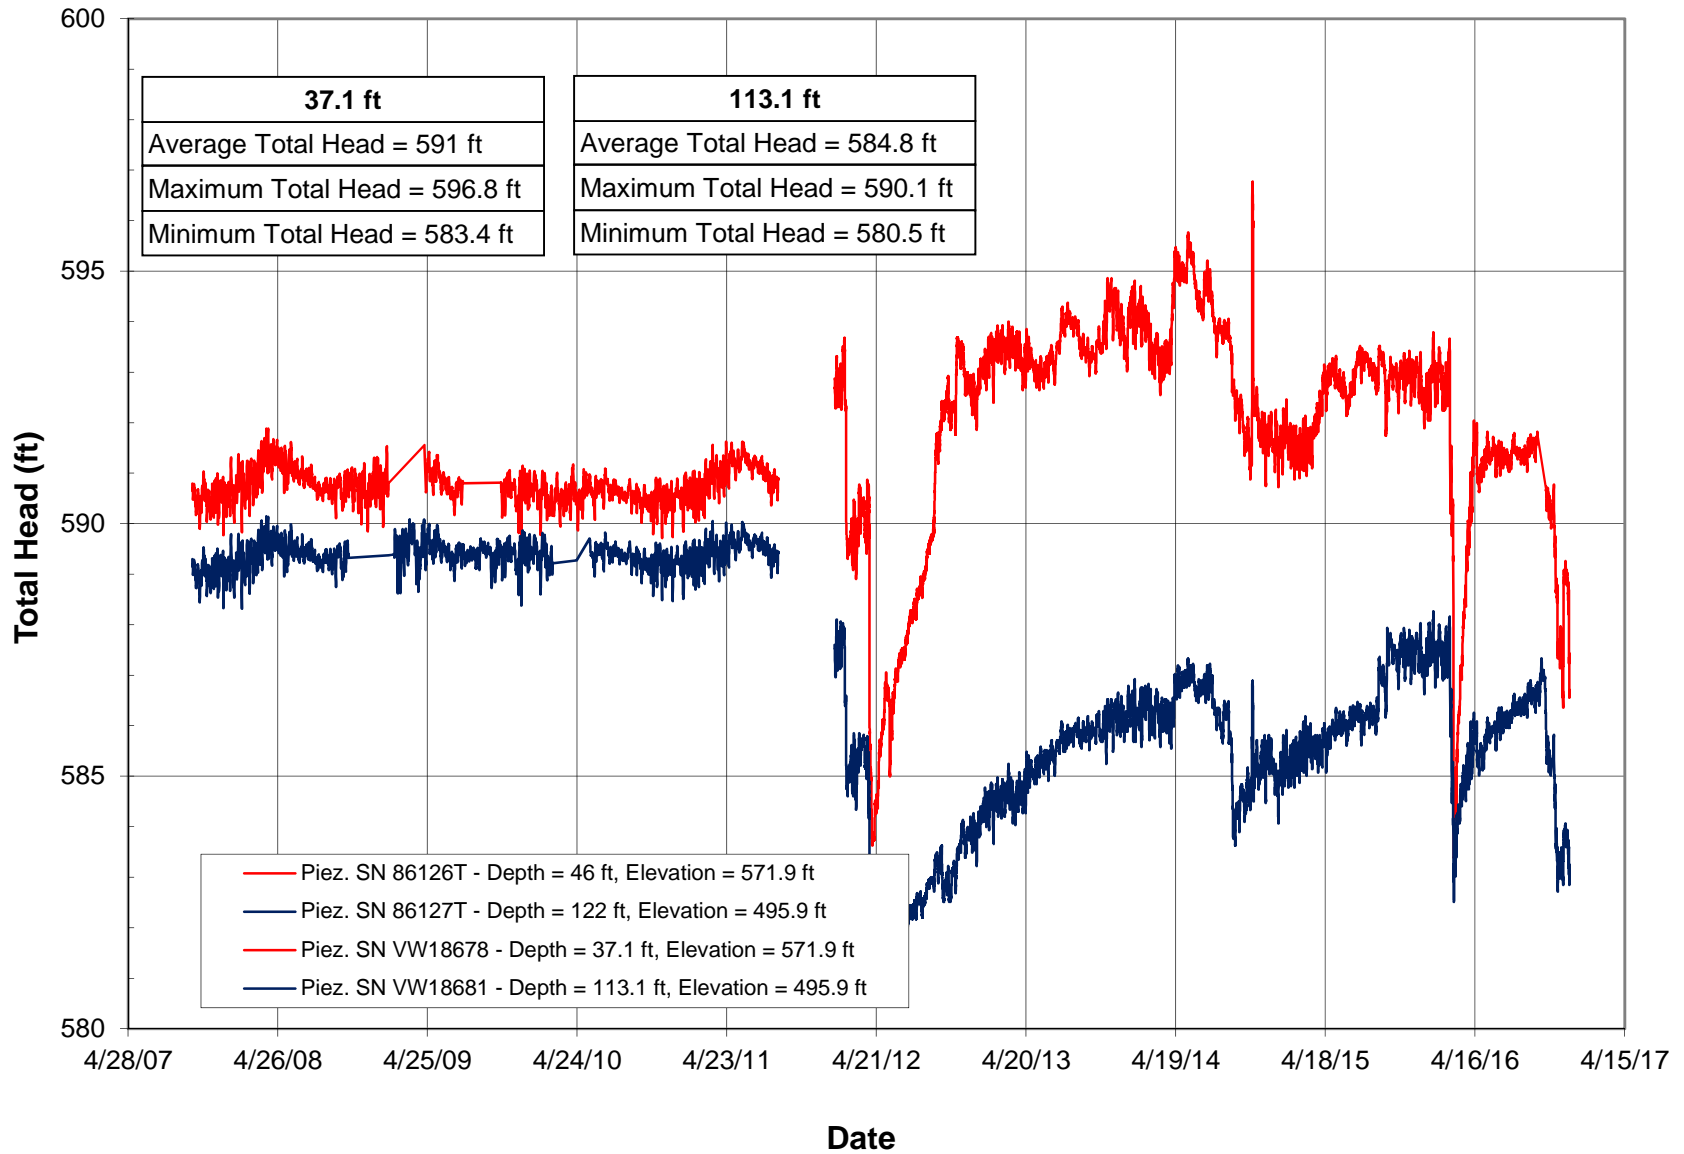
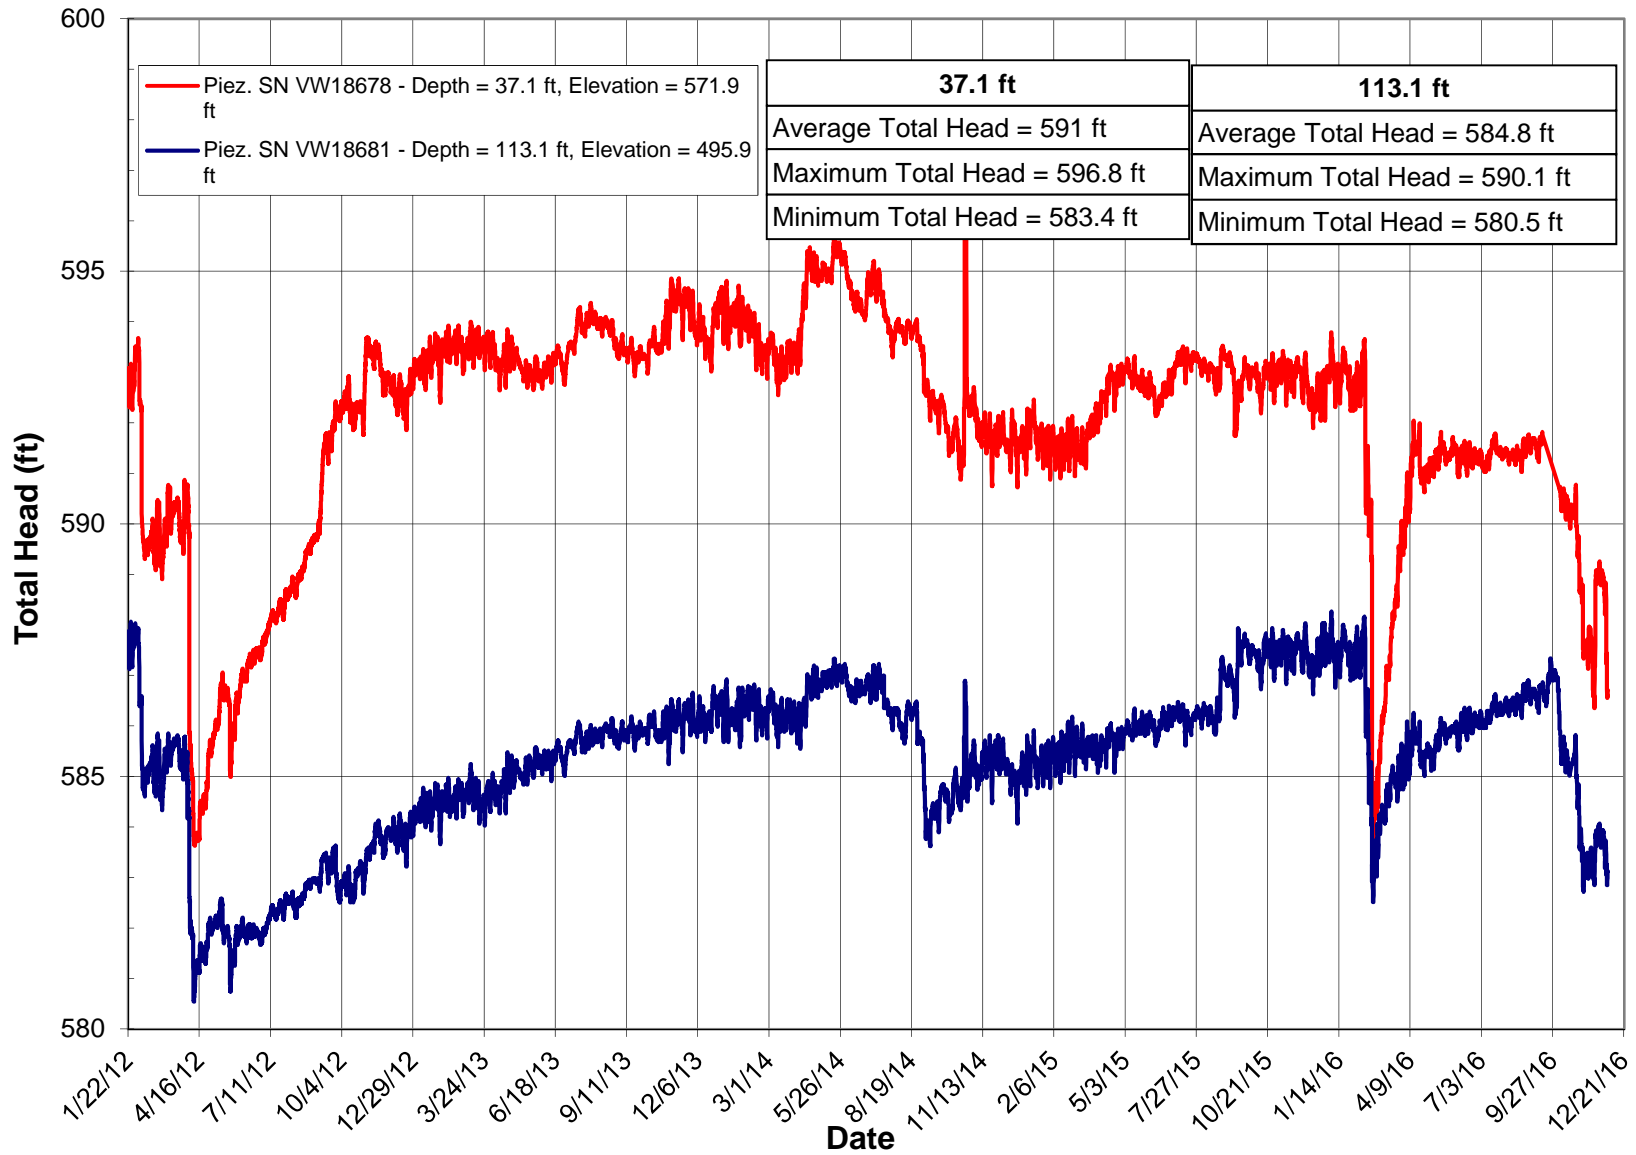
B-05-02 VW Piezometer Readings

B-05-02 – Pore pressures in both piezometers at this location decreased rapidly during this reading period by 2.4 feet in the shallow piezometer and by 0.9 feet in the deep piezometer. These changes are likely due to earthwork operations in the area of these instruments.

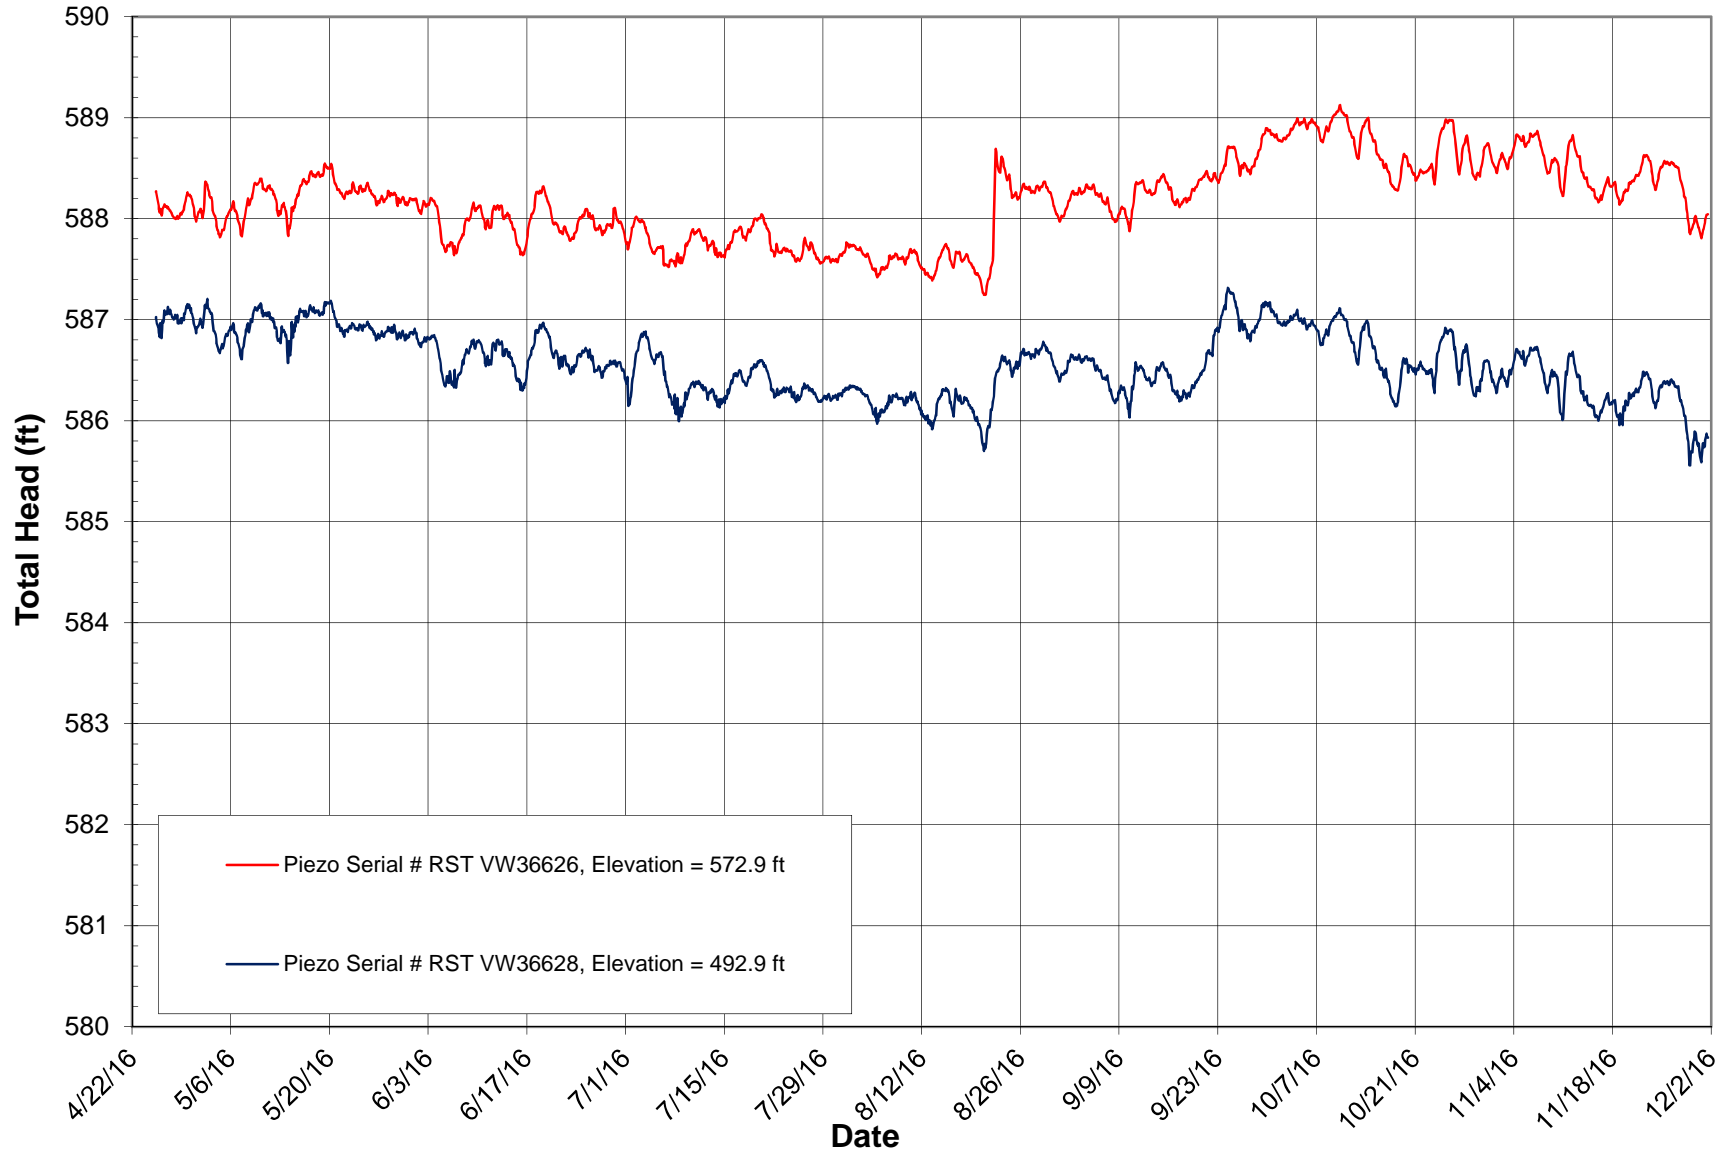
B-05-A-03 VW Piezometer Readings

B-05-A-03 – Pore pressure in both piezometers at this location decreased by 0.6 feet during this recording cycle.

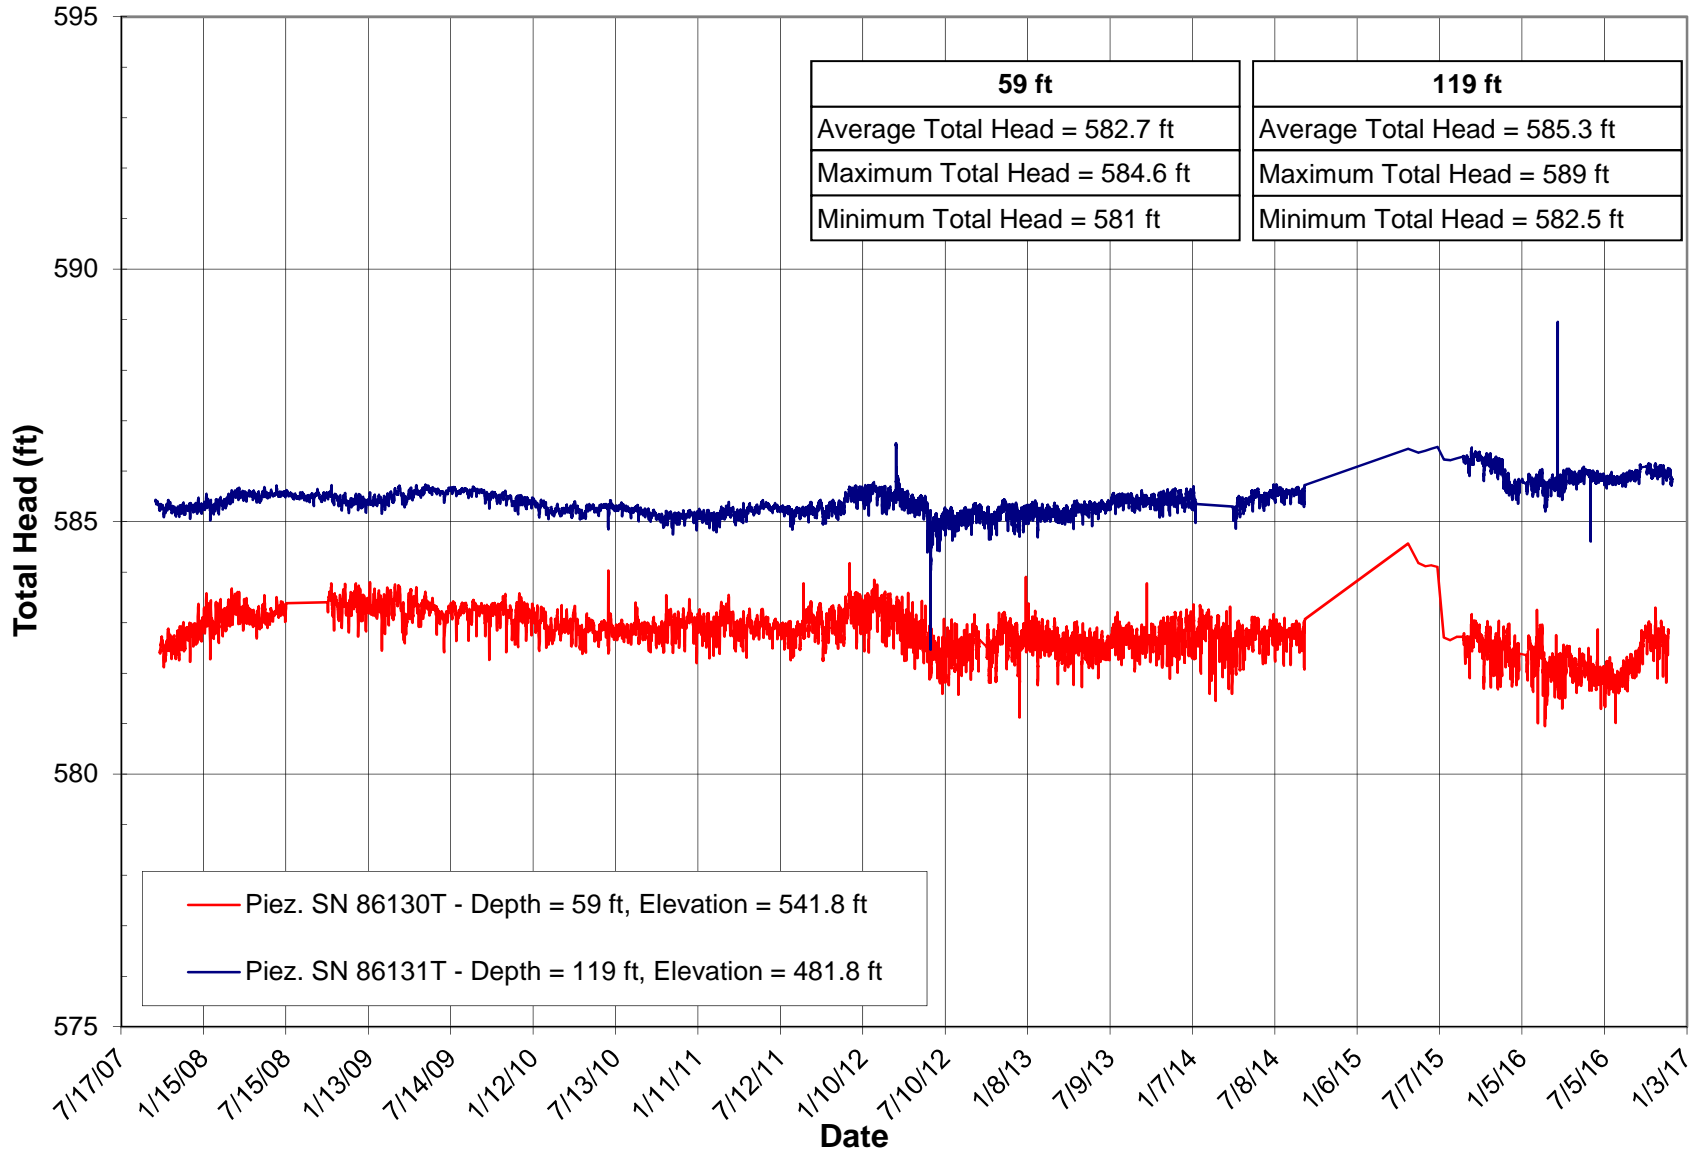
B-05-04 VW Piezometer Readings

B-05-04 – The most recent pore pressure readings for the shallow piezometer at this location are not shown on the attached plot because they flat-lined at an unrealistically high value. We think this is due to a connection issue within the data logger since the temperature readings for this piezometer look good. We repaired the connection and will check the status again prior to the next readings. Pore pressure readings in the deep piezometer show virtually no change.
