Re: December 1 and 2, 2016 Bi-Weekly Readings
CUY-90-15.24 Slope Monitoring
PID 96504
SME Project No. 069032.00

Bi-weekly instrument readings for the I-90 west slope taken on December 1 and 2, 2016, are presented in this report. Bi-weekly readings currently include instruments at I/P-001-13, I/P-002-13, I/P-003-10, I/P-004-13, I/P-009-13, B-101, B-102, B-105A, B-05-02, B-05-A-03, B-05-04, B-05-A-11, P-1, P-9N, and TGR I-4. Changes reported for the individual instruments are for the previous two-week period unless noted otherwise.

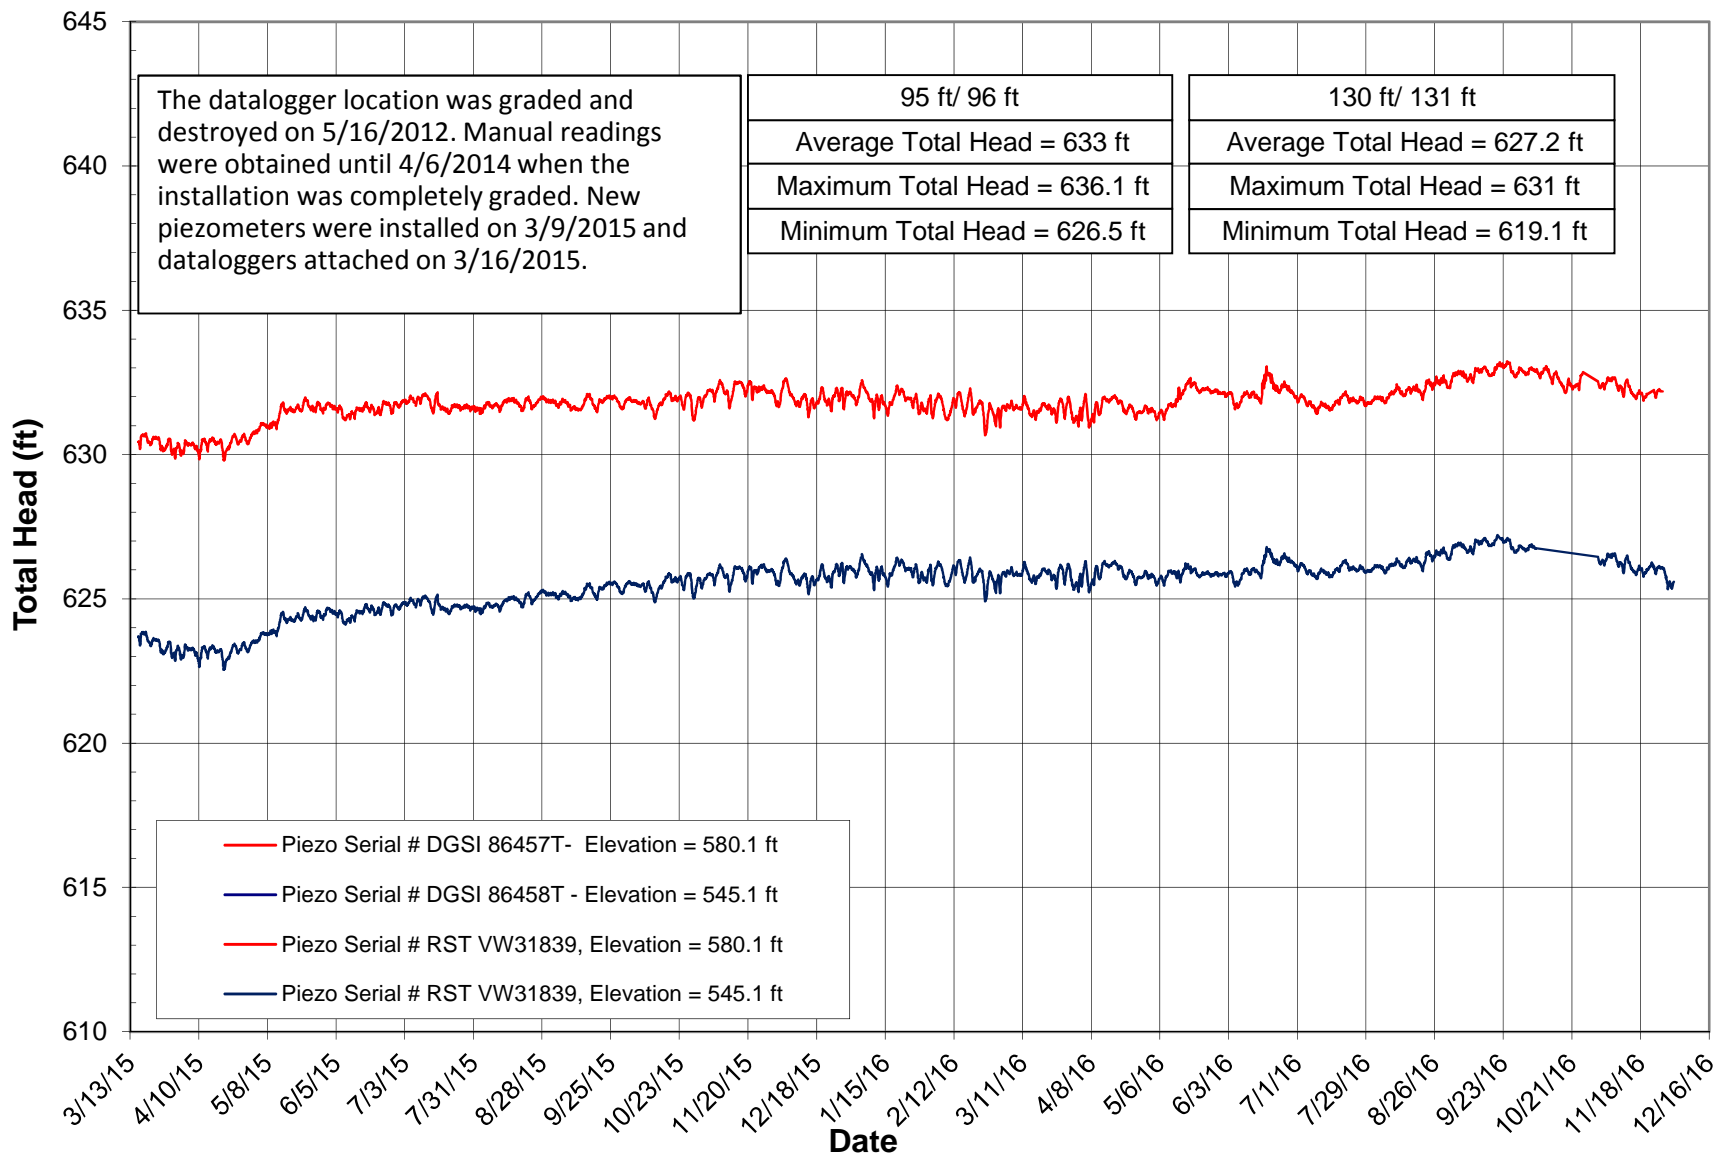
B-05-11/B-05-A-11 VW Piezometer Readings

B-05-A-11 – Pore pressure in the deep piezometer at this location continued to decrease. Since September 23, 2016, the pore pressure has decreased by 1.5 feet. The data logger for the shallow piezometer stopped working about halfway through this reading cycle. Prior to that, the pore pressure readings showed virtually no change. We are working with the manufacturer to determine why this and other data loggers are failing.

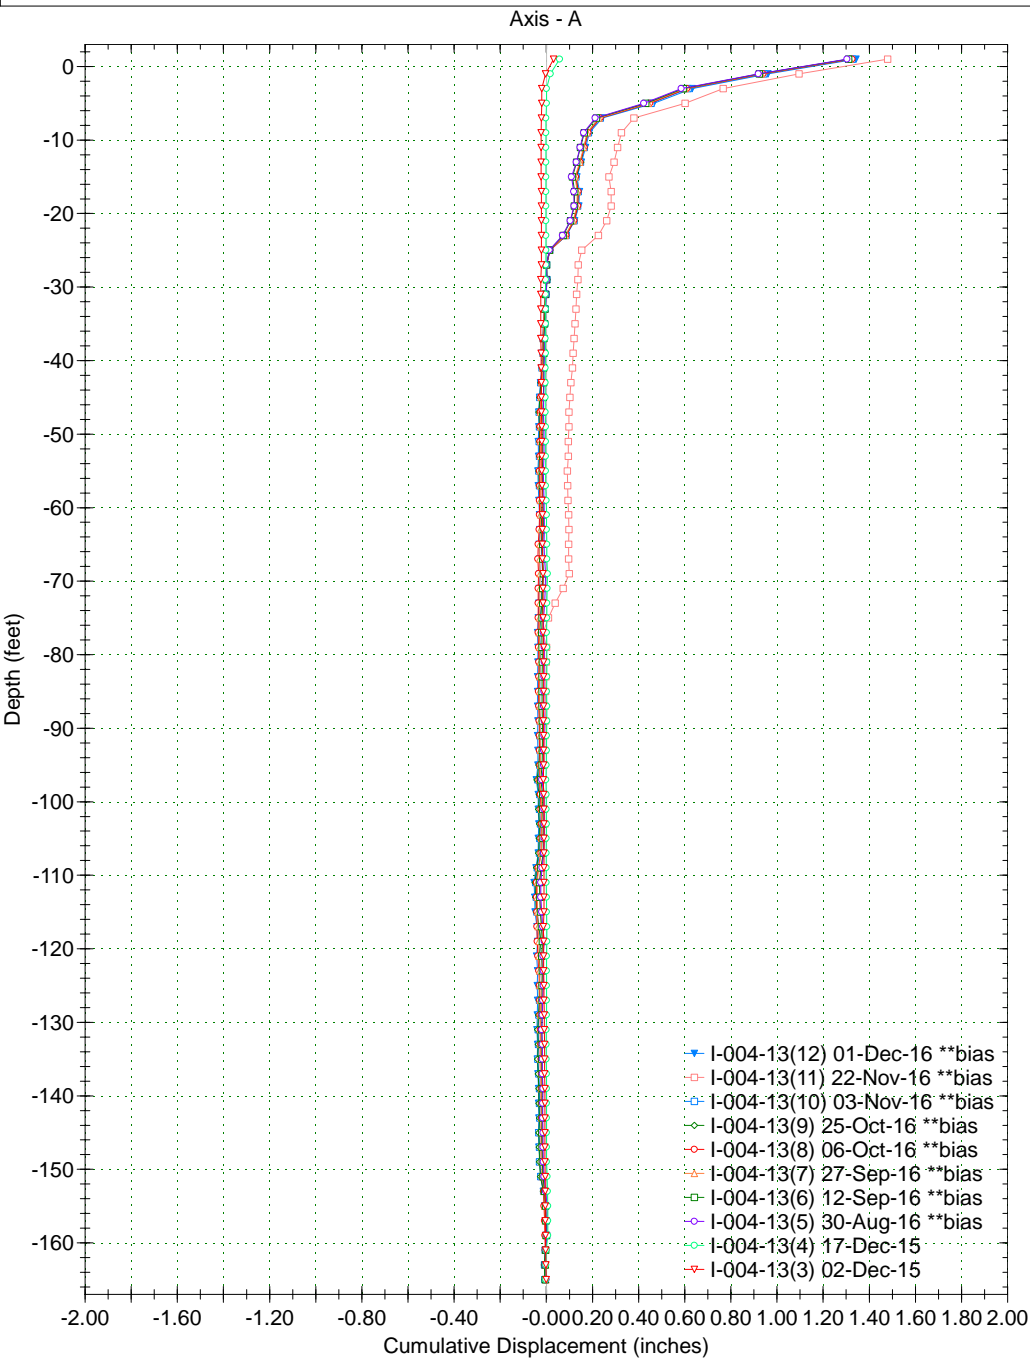
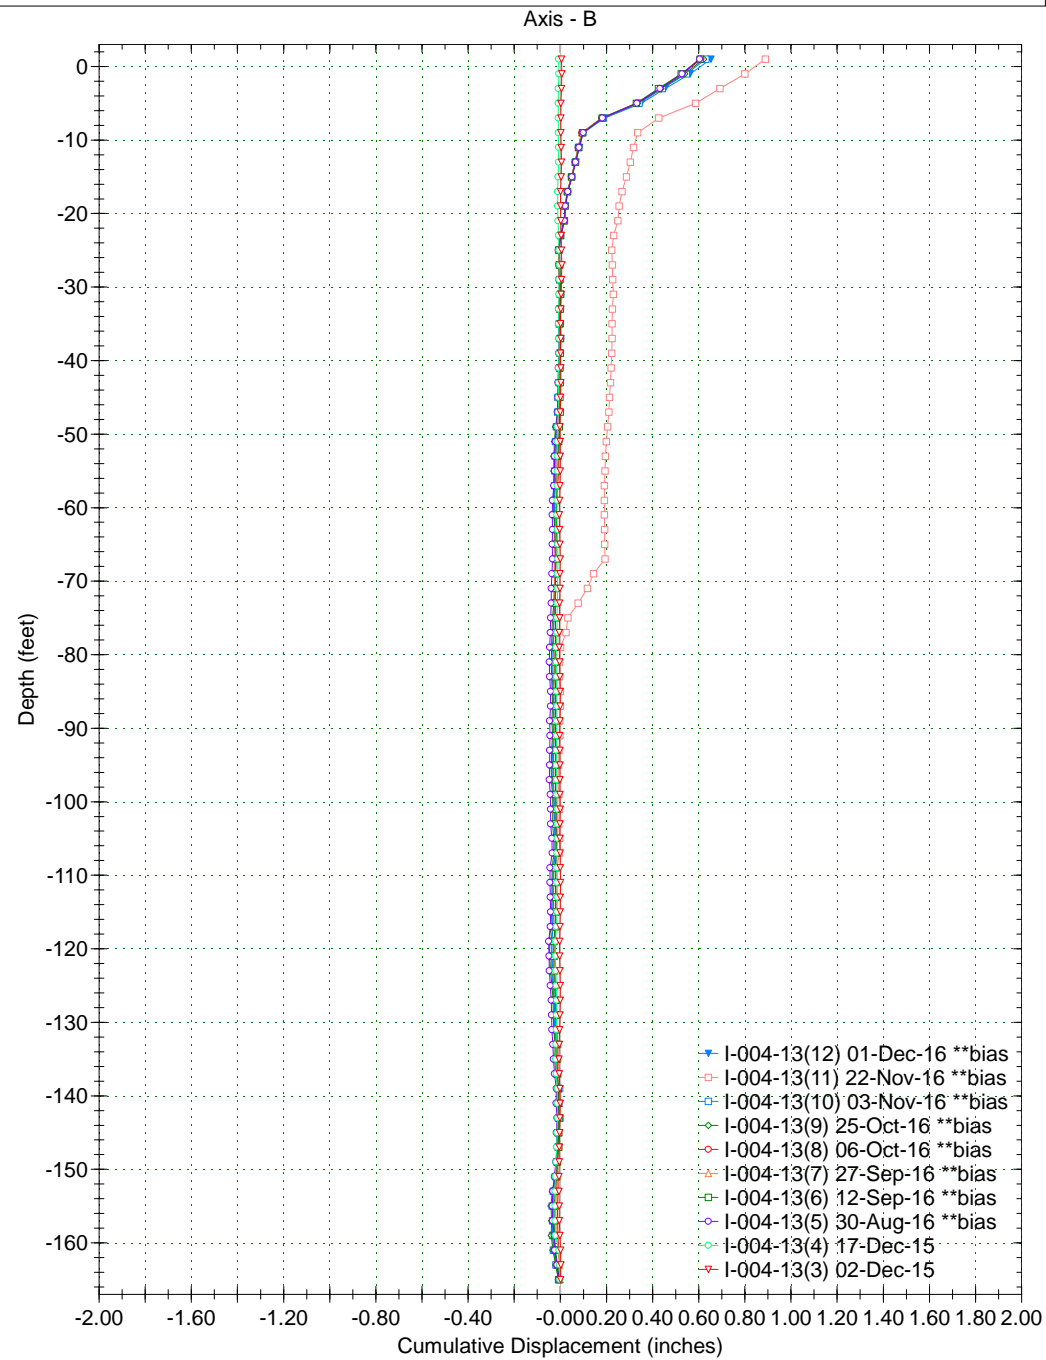
Borehole : I-004-13
Project : CUY-90-15-24
Location :
Northing :
Easting :
Collar :

I-004-13 – Inclinometer readings on November 22, 2016 at this location showed up to 0.2 inches of displacement in the positive A-axis and positive B-axis directions from about 67 to 75 feet. The December 1, 2016 readings, align with readings prior to November 22 and do not show any movement at this depth. It appears that the November 22 reading was erroneous.

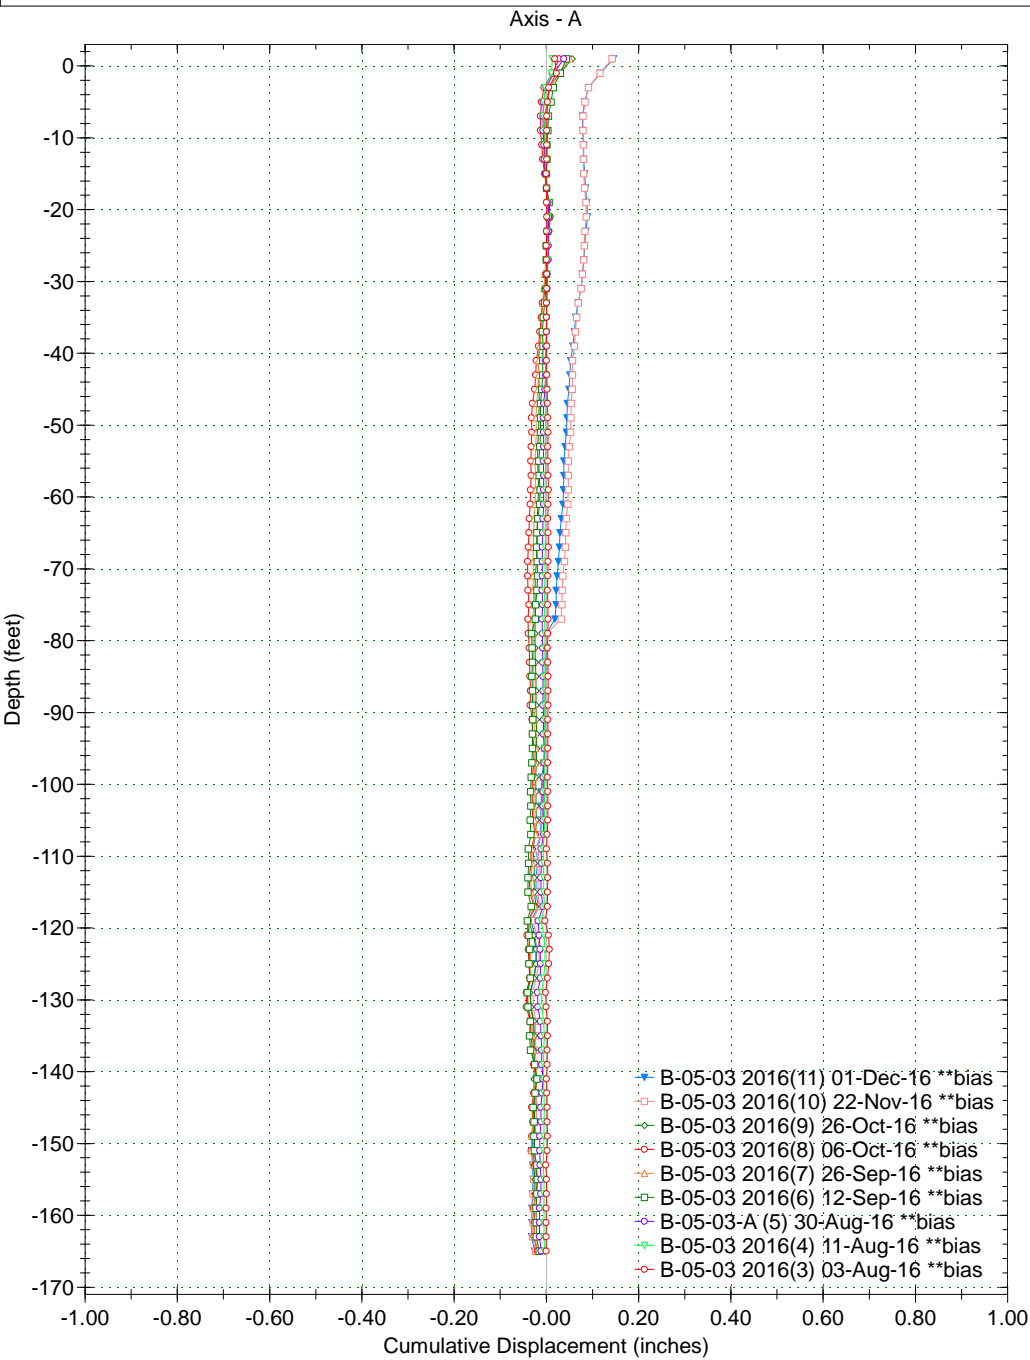
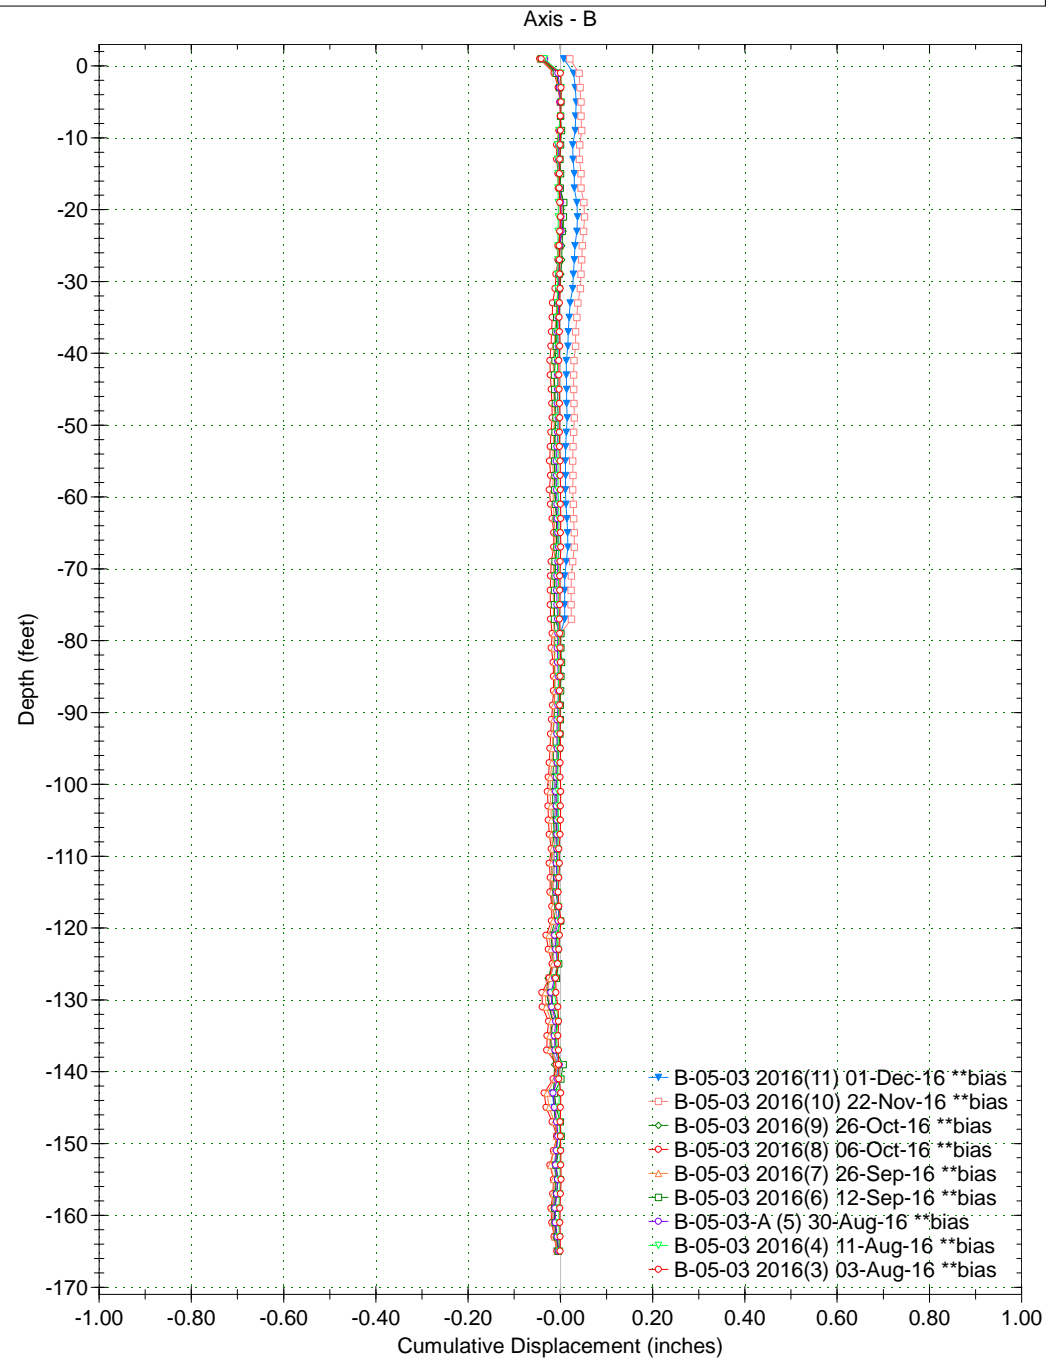
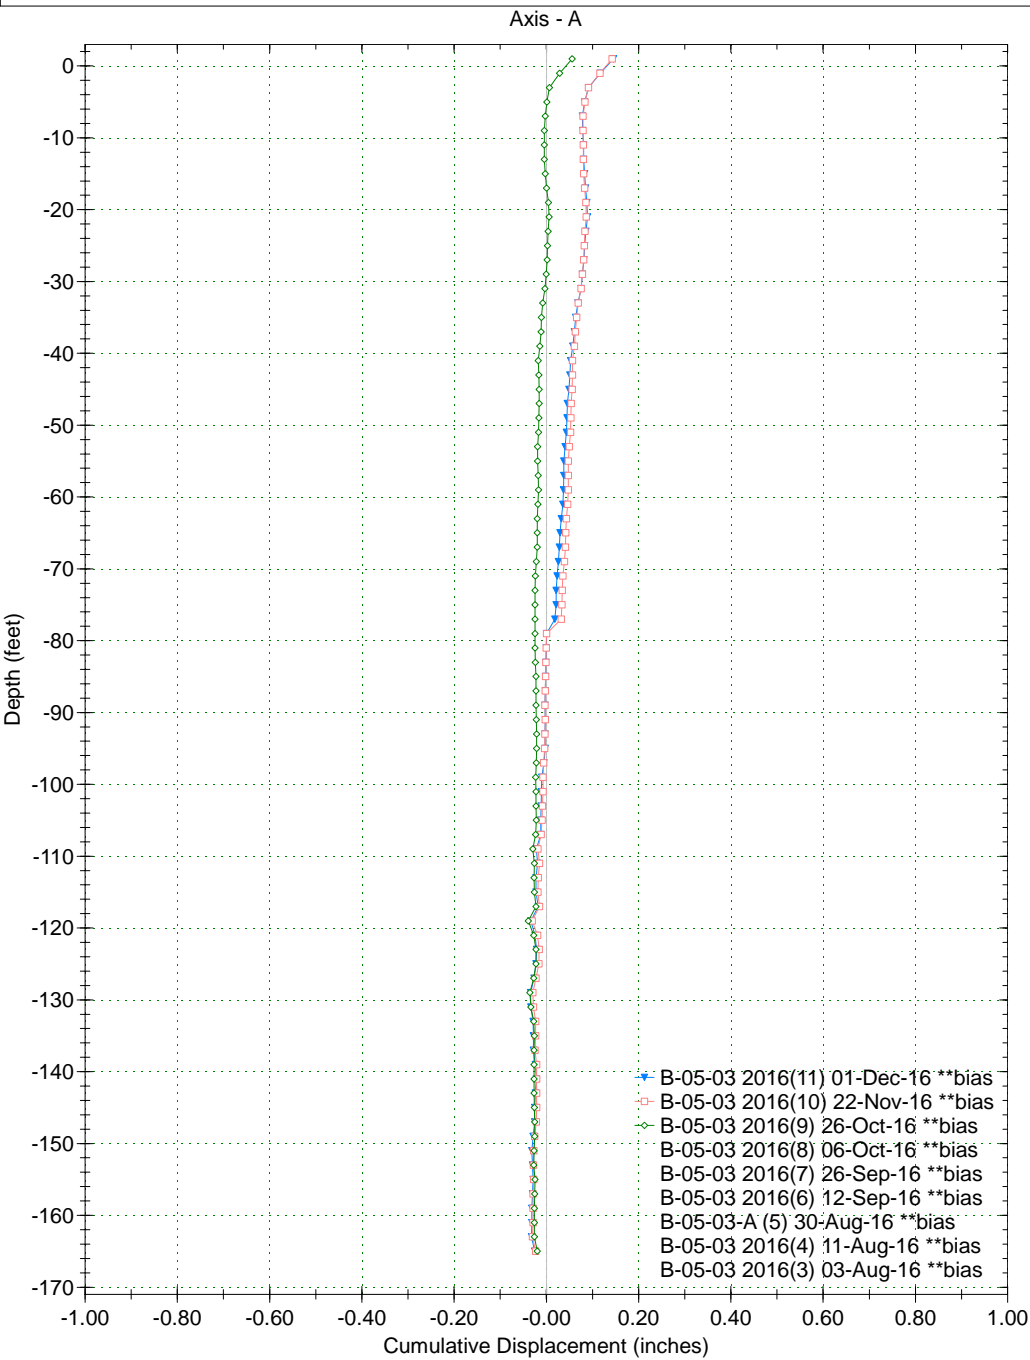
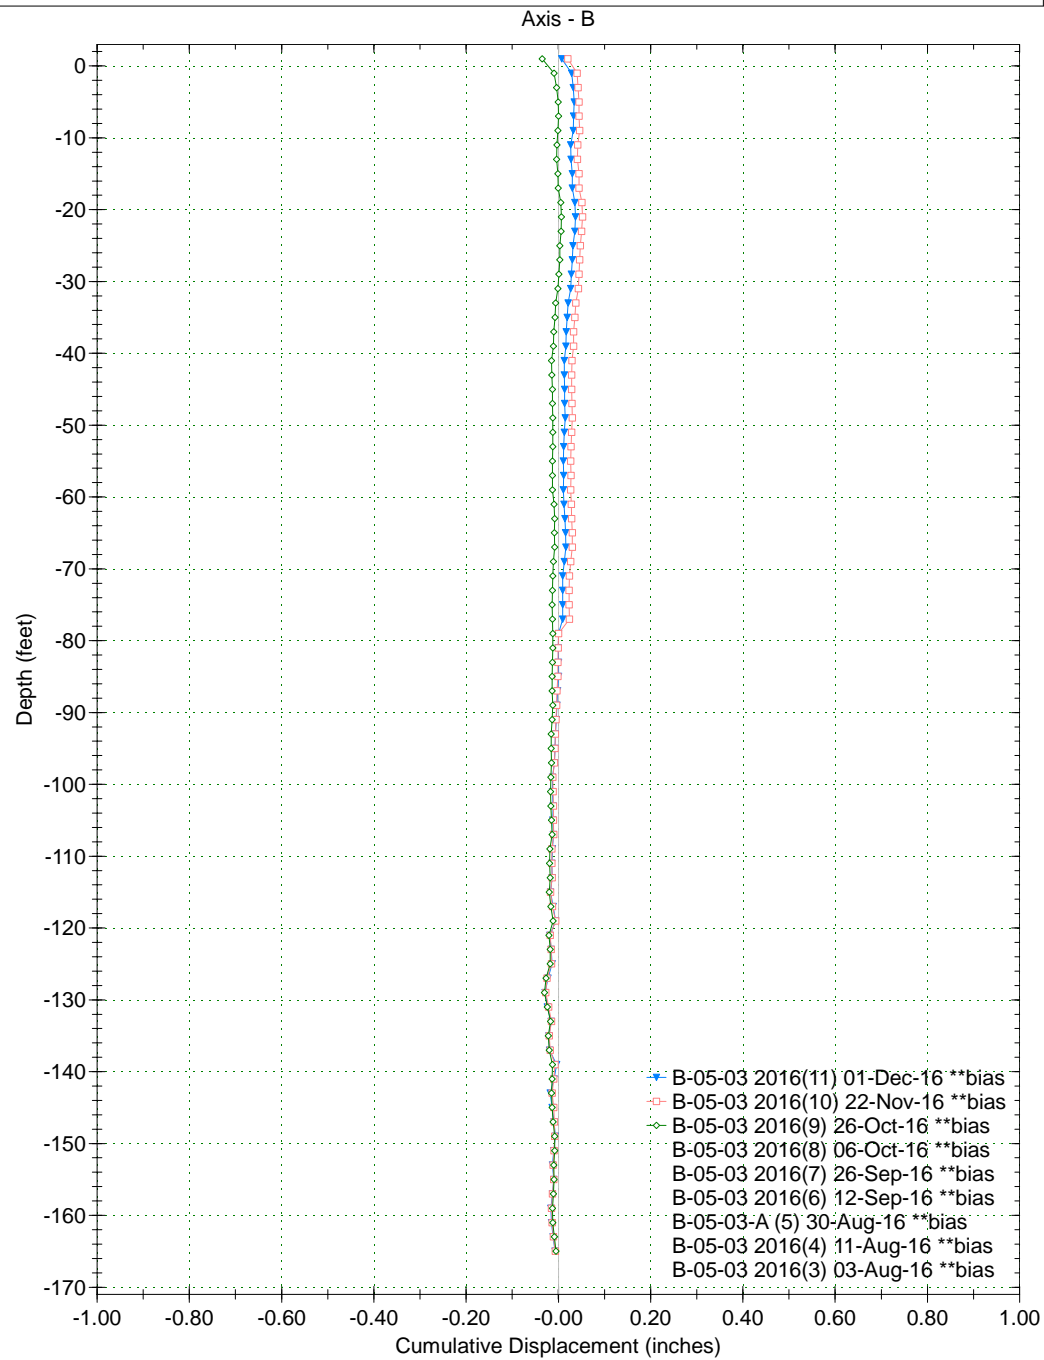
Borehole : B-05-03-A
Project : CUY-90-15-24
Location :
Northing :
Easting :
Collar :

B-05-A-03 – Inclinometer readings at this location are nearly the same as the last set of readings, and show no additional movement.
