January 12, 2017

Re: December 19, 20, and 21, 2016 Bi-Weekly Readings
CUY-90-15.24 Slope Monitoring
PID 96504
SME Project No. 069032.00

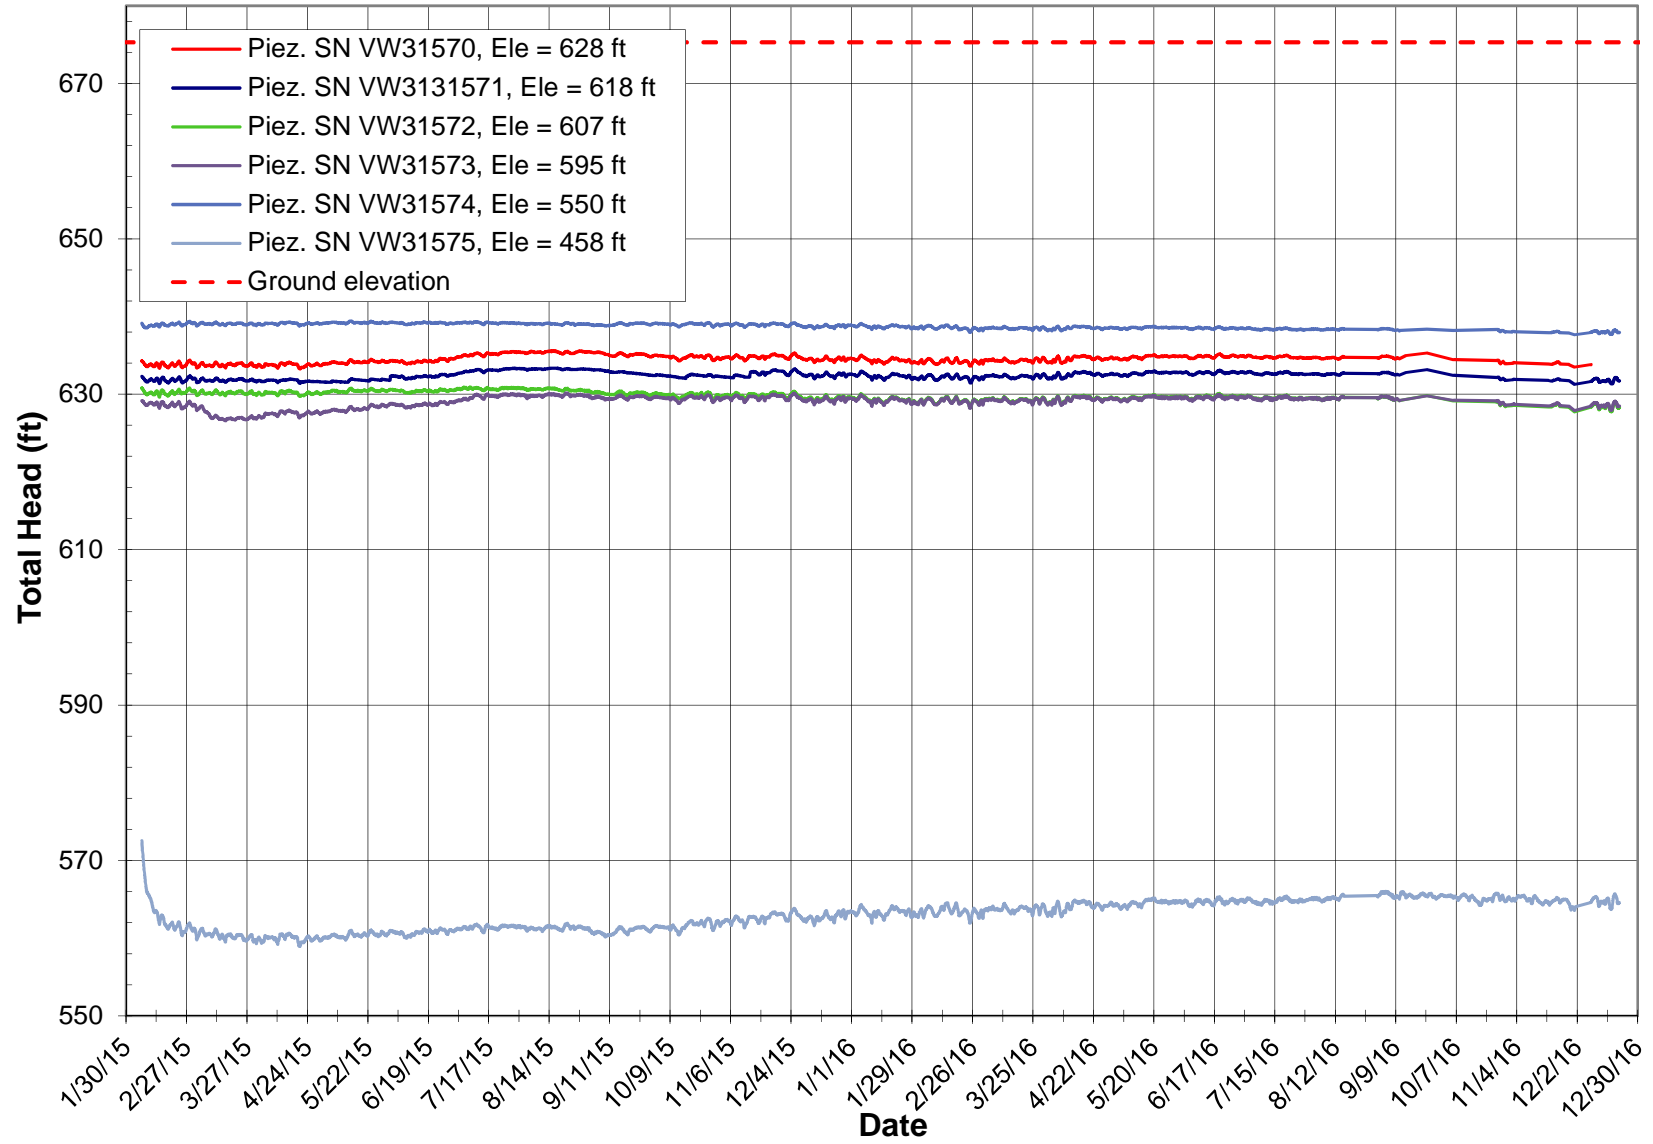
P-002-13 VW Piezometer Readings

P-002-13 – The multichannel data logger failed to record pore pressures for the piezometer at elevation 628 feet during this reading cycle. We think this is due to a connection issue within the data logger since the temperature readings for this piezometer appear to be good. We repaired the connection and will check the status again prior to the next readings. Pore pressure readings in the other piezometers at this location show virtually no change.

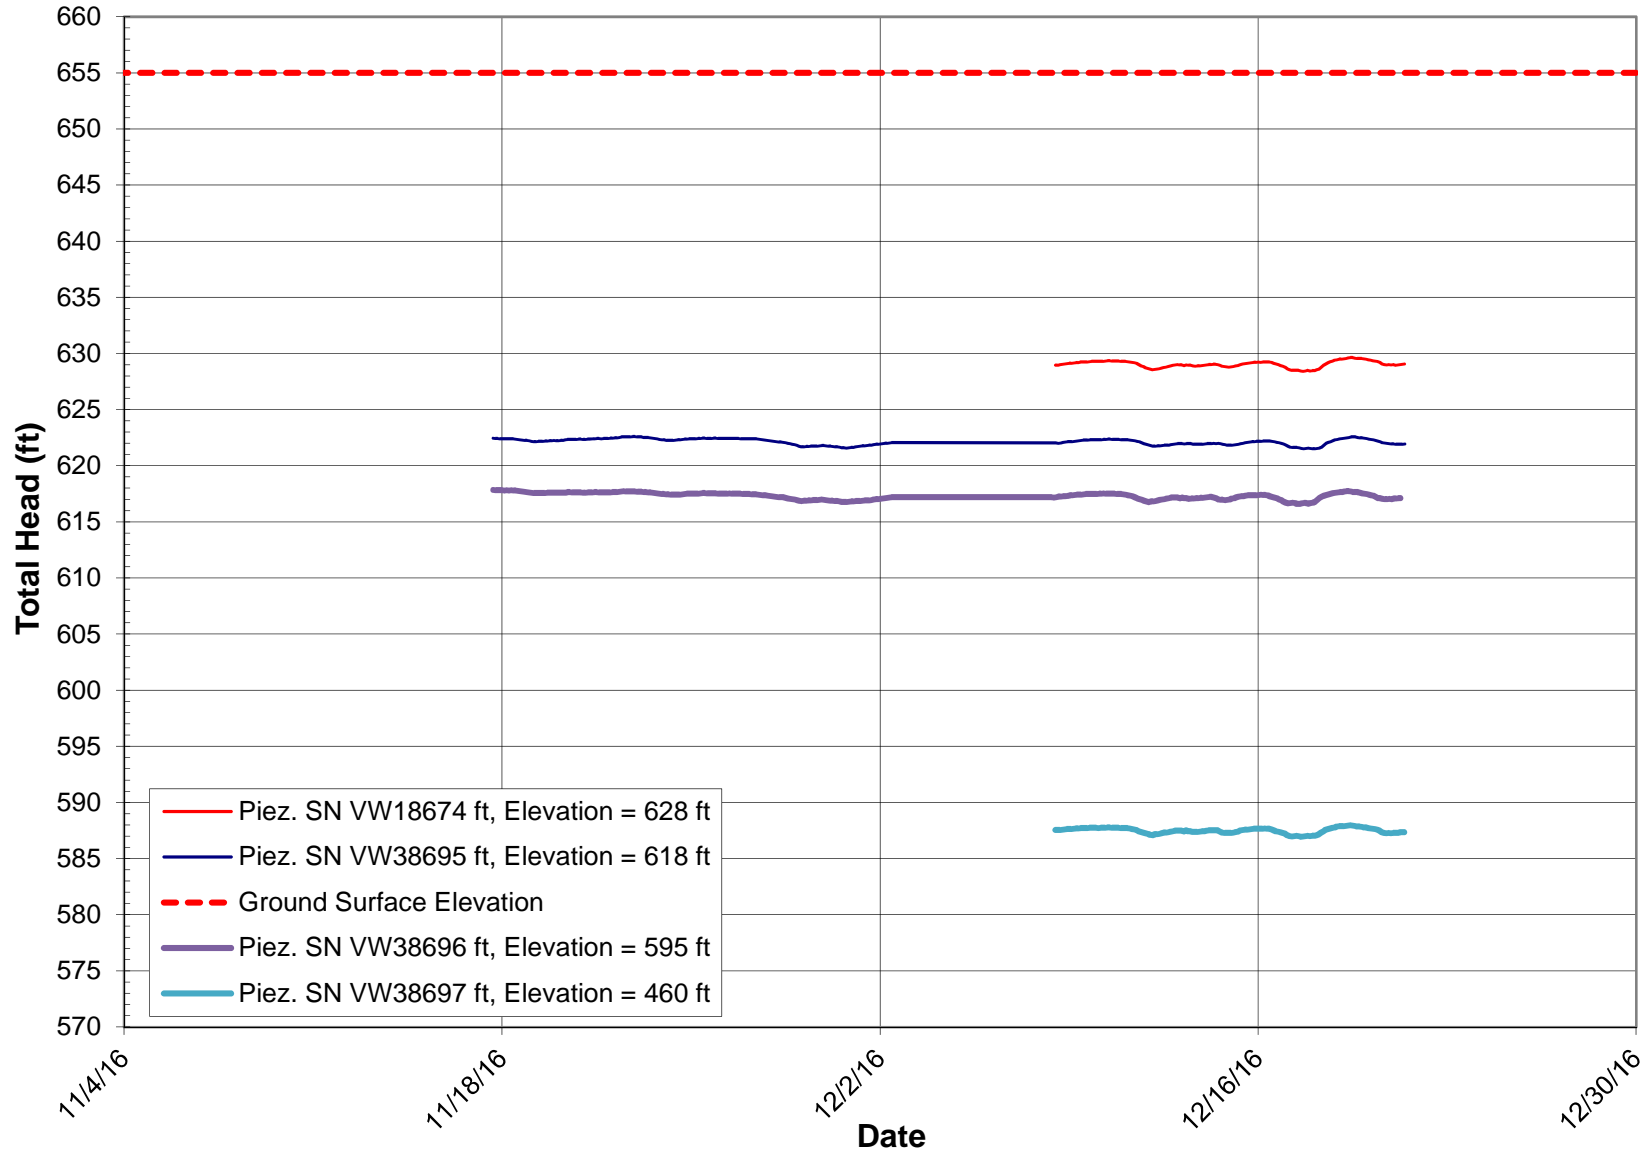
P-003-13 VW Piezometer Readings

P-003-13 – A plot showing the pore pressure readings for this location is now included in the bi-weekly reports. The delayed start for the piezometers at elevation 460 and 628 feet is due to the data loggers being used temporarily at other locations where the original data loggers had failed and were being repaired. Readings in all piezometers show virtually no change since data recording began.

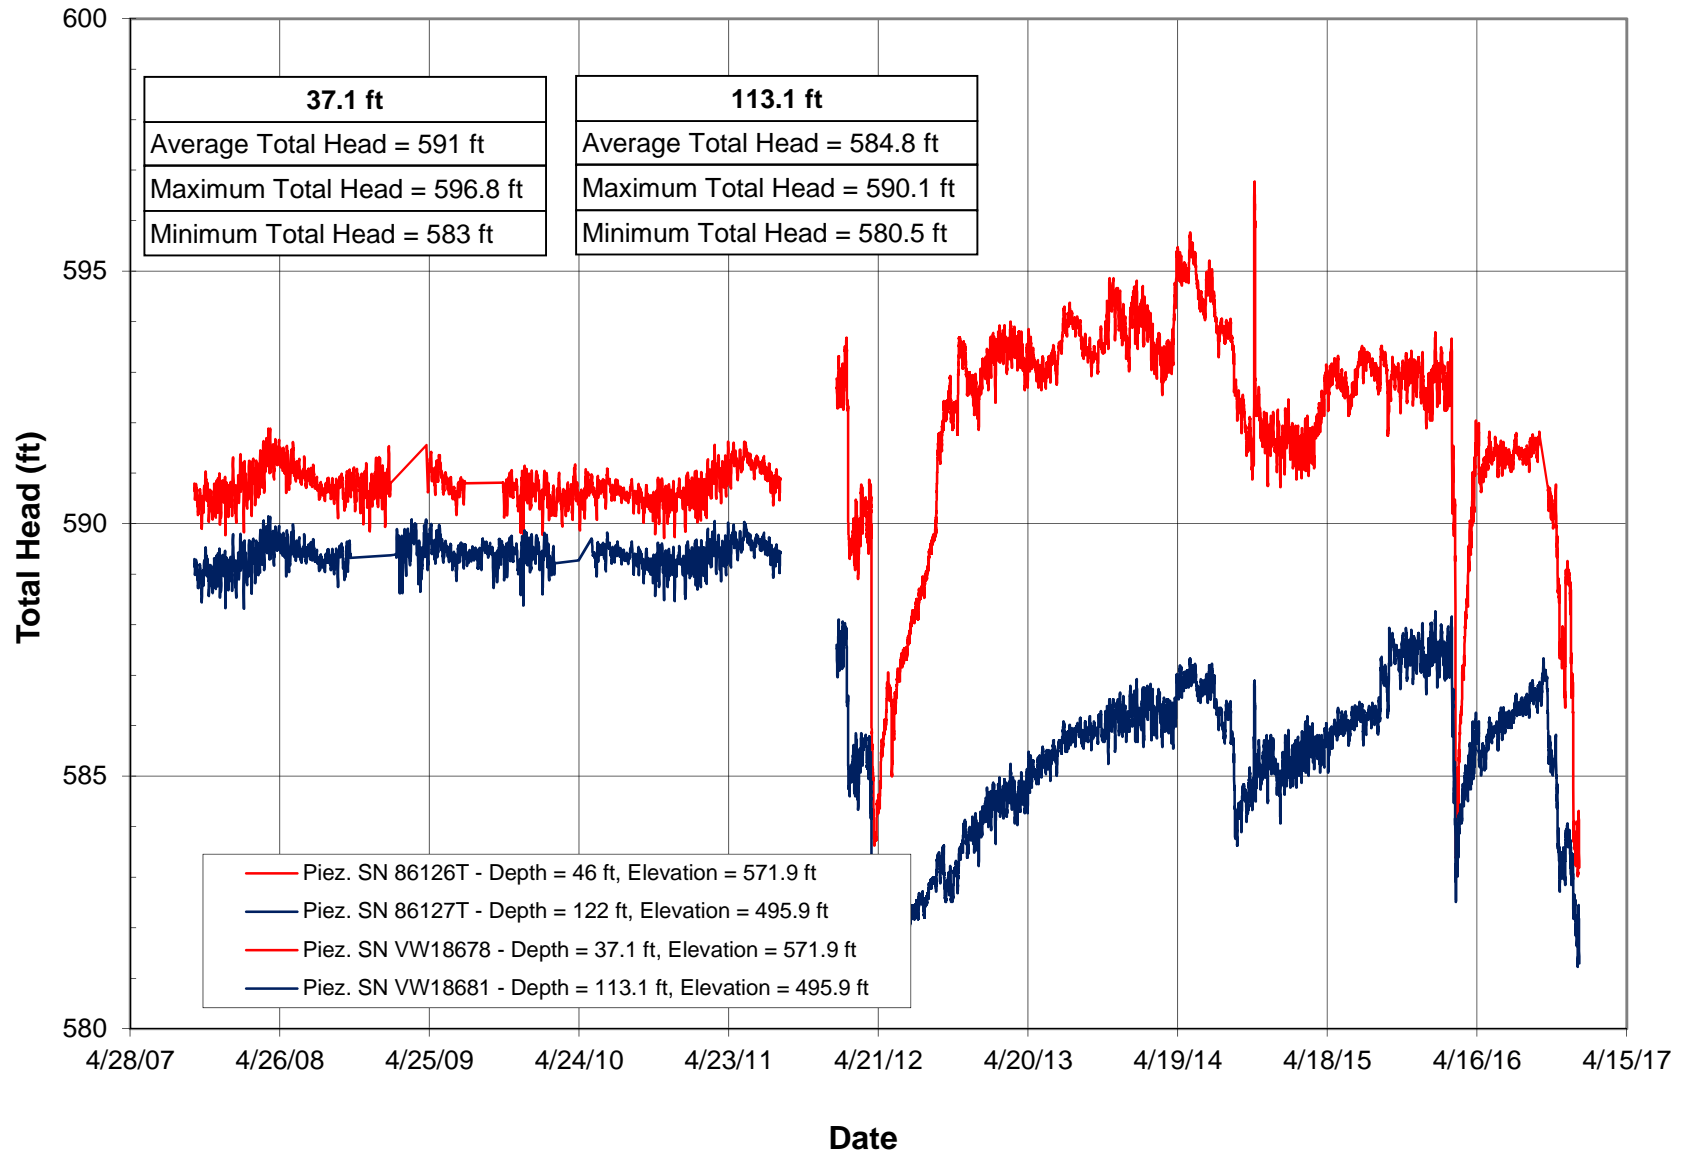
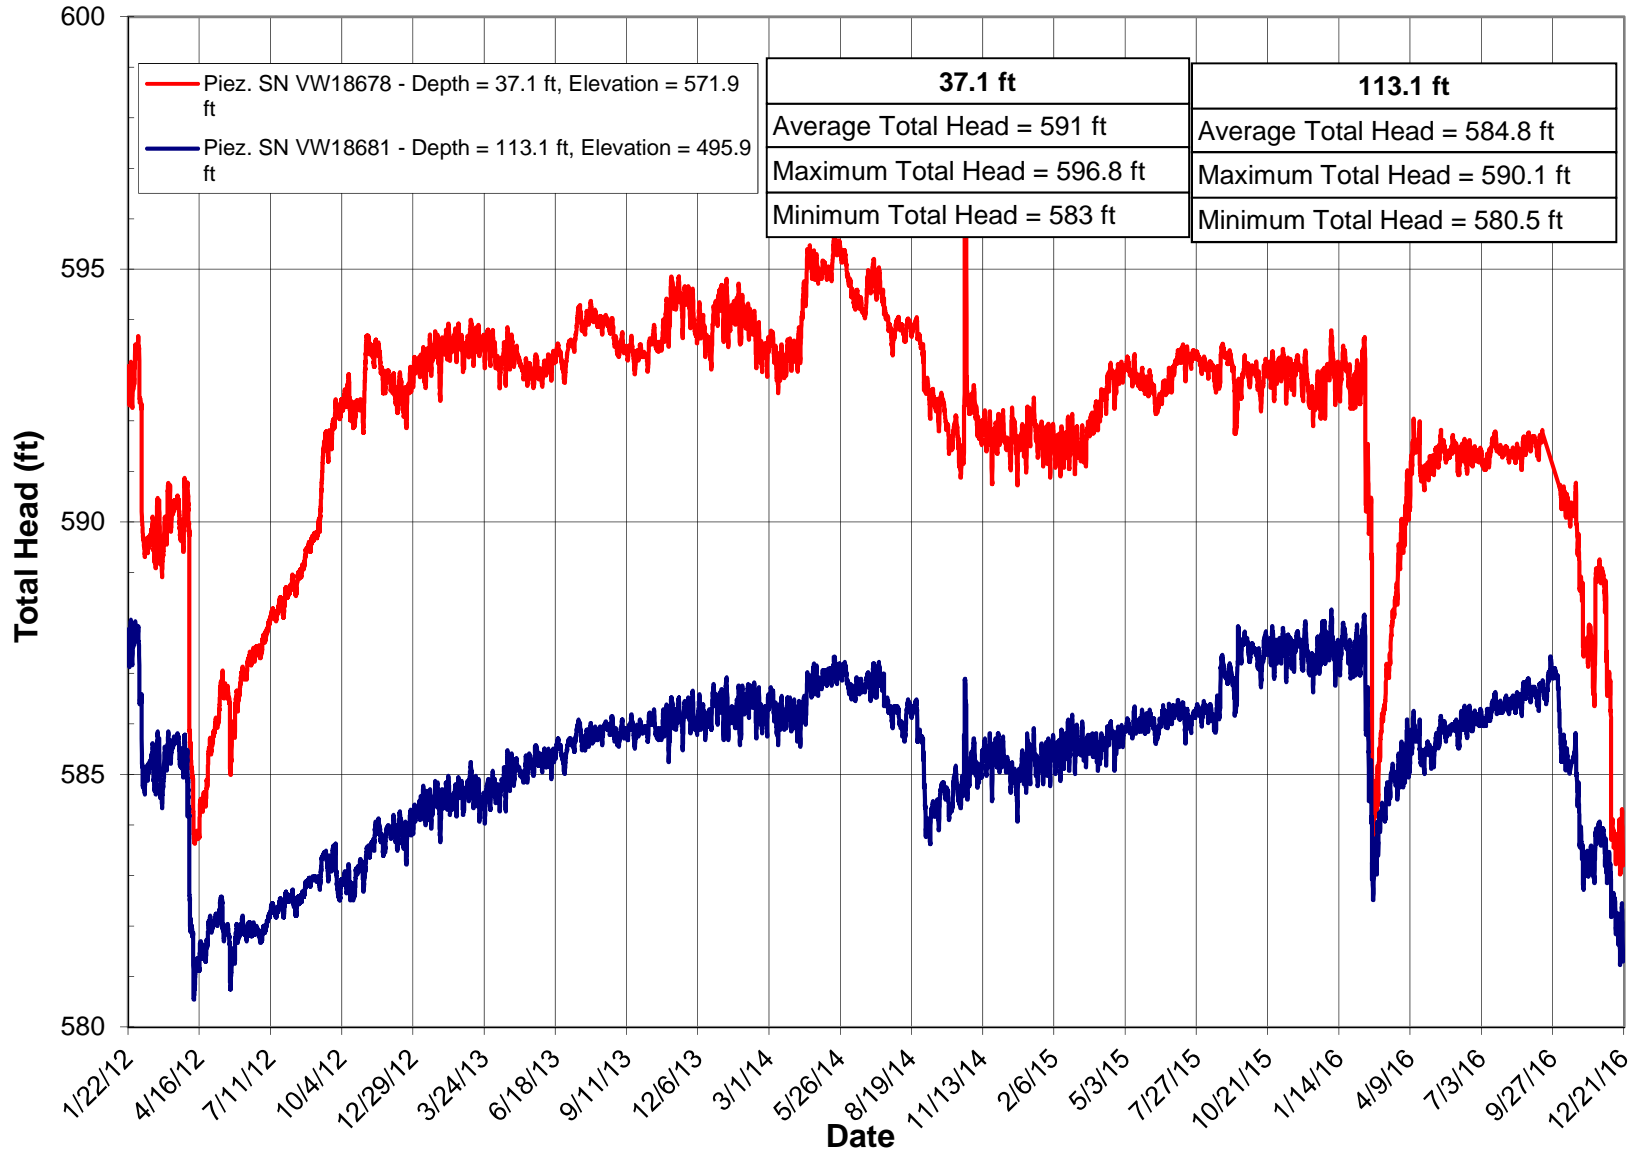
B-05-02 VW Piezometer Readings

B-05-02 – Pore pressures in both piezometers at this location continued to decrease rapidly during this reading period by 3.6 feet in the shallow piezometer and by 1.8 feet in the deep piezometer. These changes are likely due to earthwork operations in the area of these instruments.

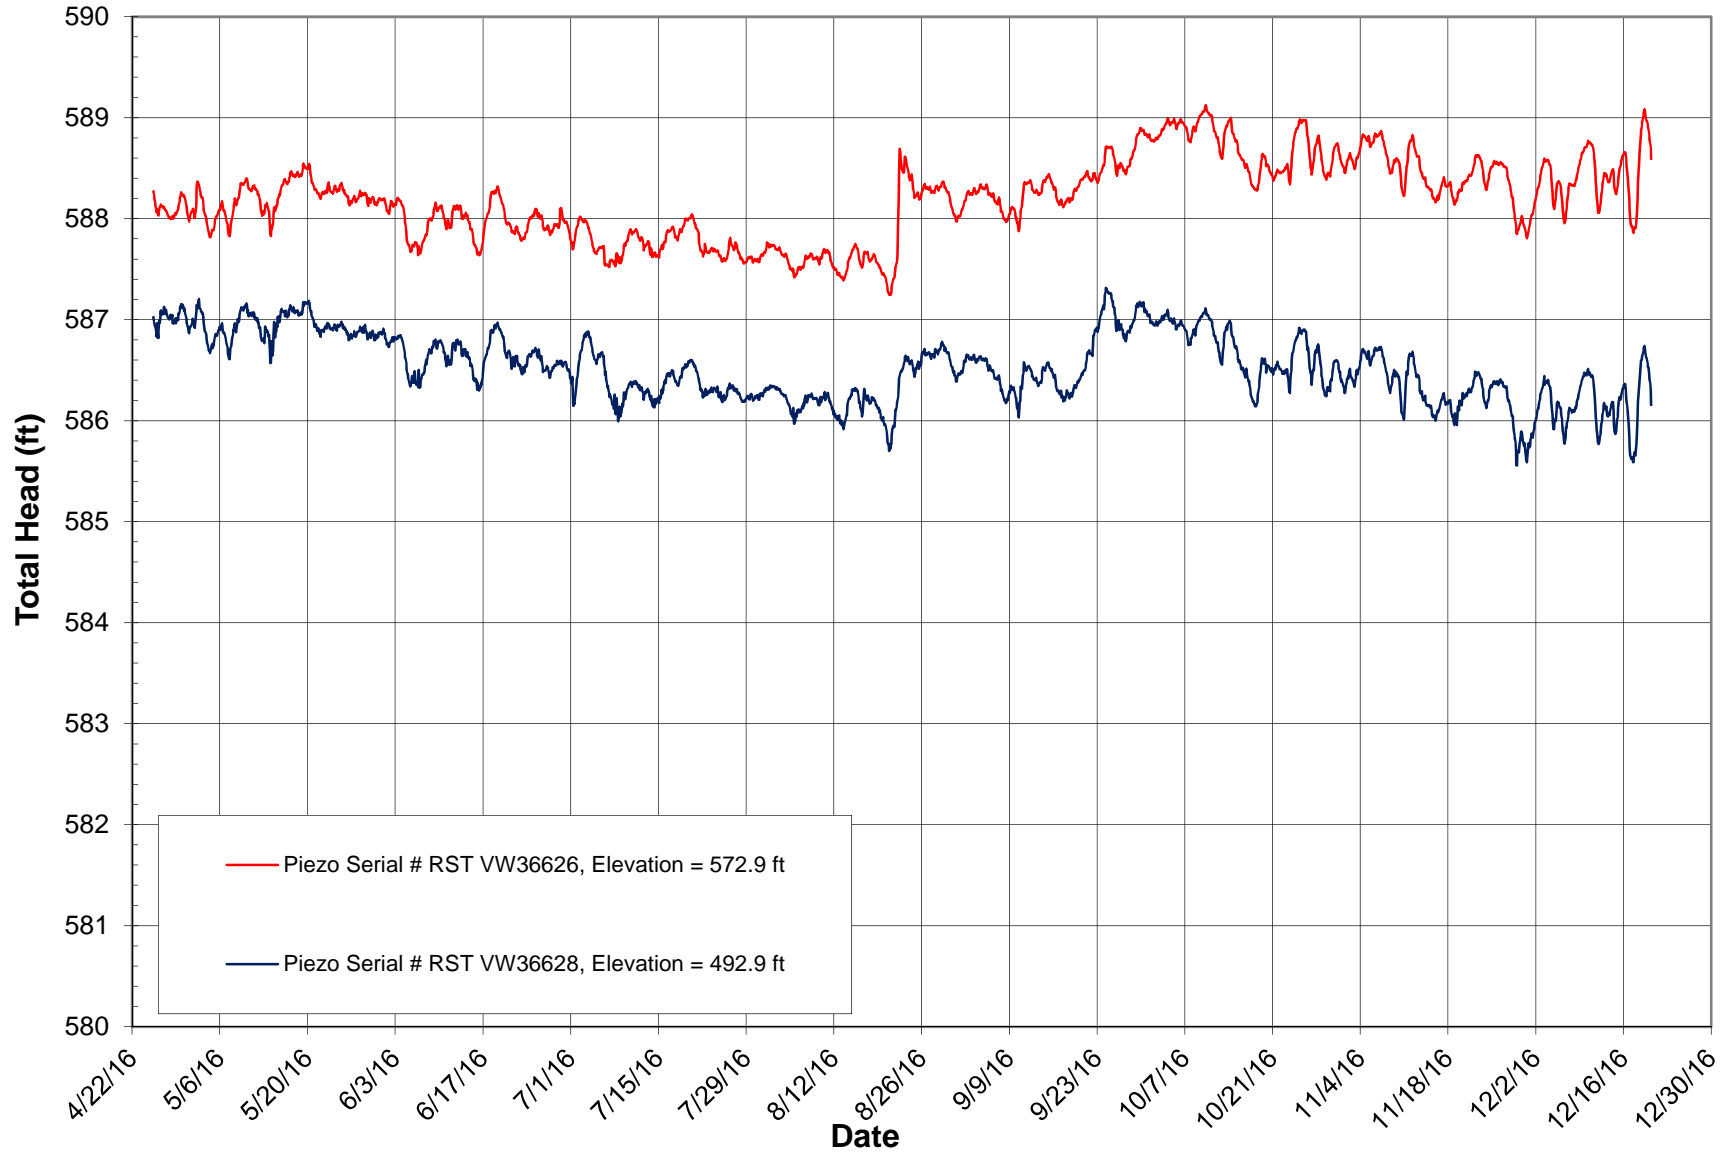
B-05-A-03 VW Piezometer Readings

B-05-A-03 – Pore pressures in both piezometers varied by slightly more than a foot during the last few days of this two-week period. Compared to the last two-week period, pore pressures remained higher but were decreasing at the end of the period.

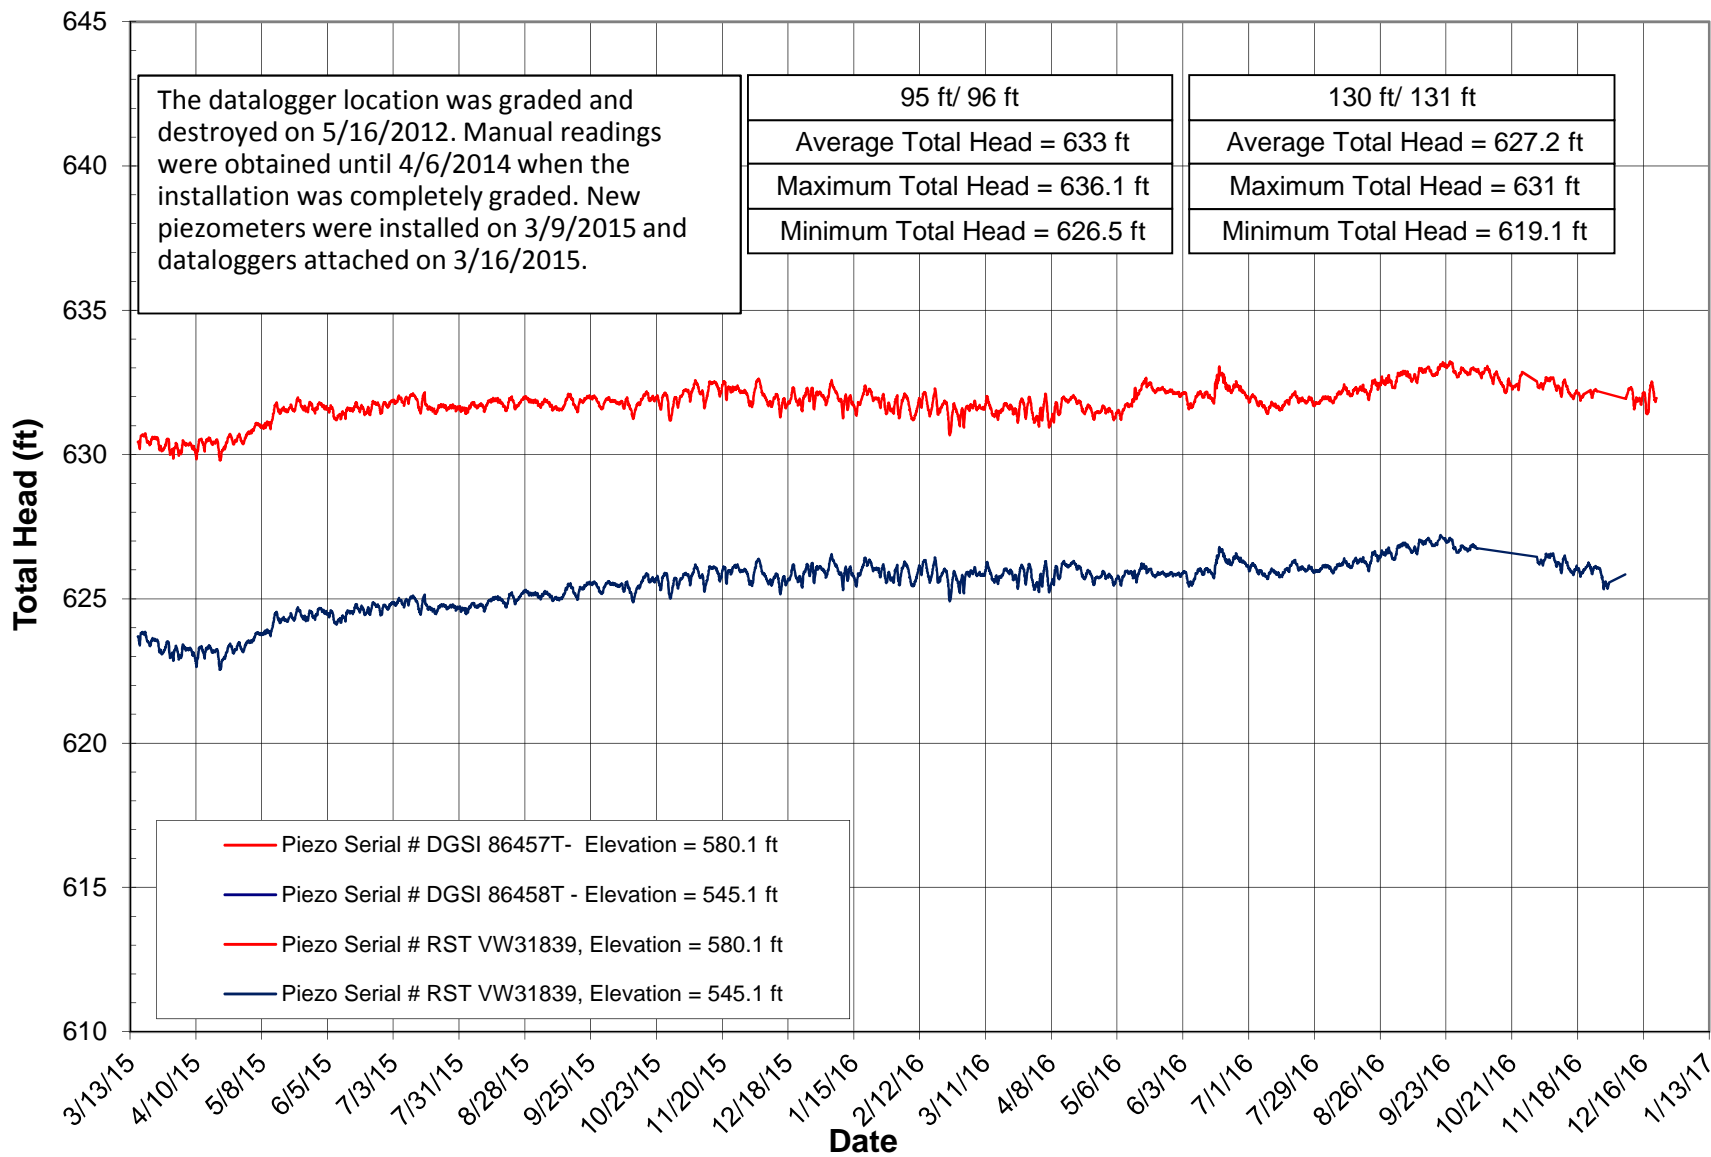
B-05-11/B-05-A-11 VW Piezometer Readings

B-05-A-11 – The data logger for the deep piezometer stopped working about halfway through this reading cycle. Prior to that, the pore pressure readings showed a slight increase. We believe the issue with the datalogger was caused by a faulty battery, which we have now replaced. Pore pressure readings in the shallow piezometer show virtually no change.

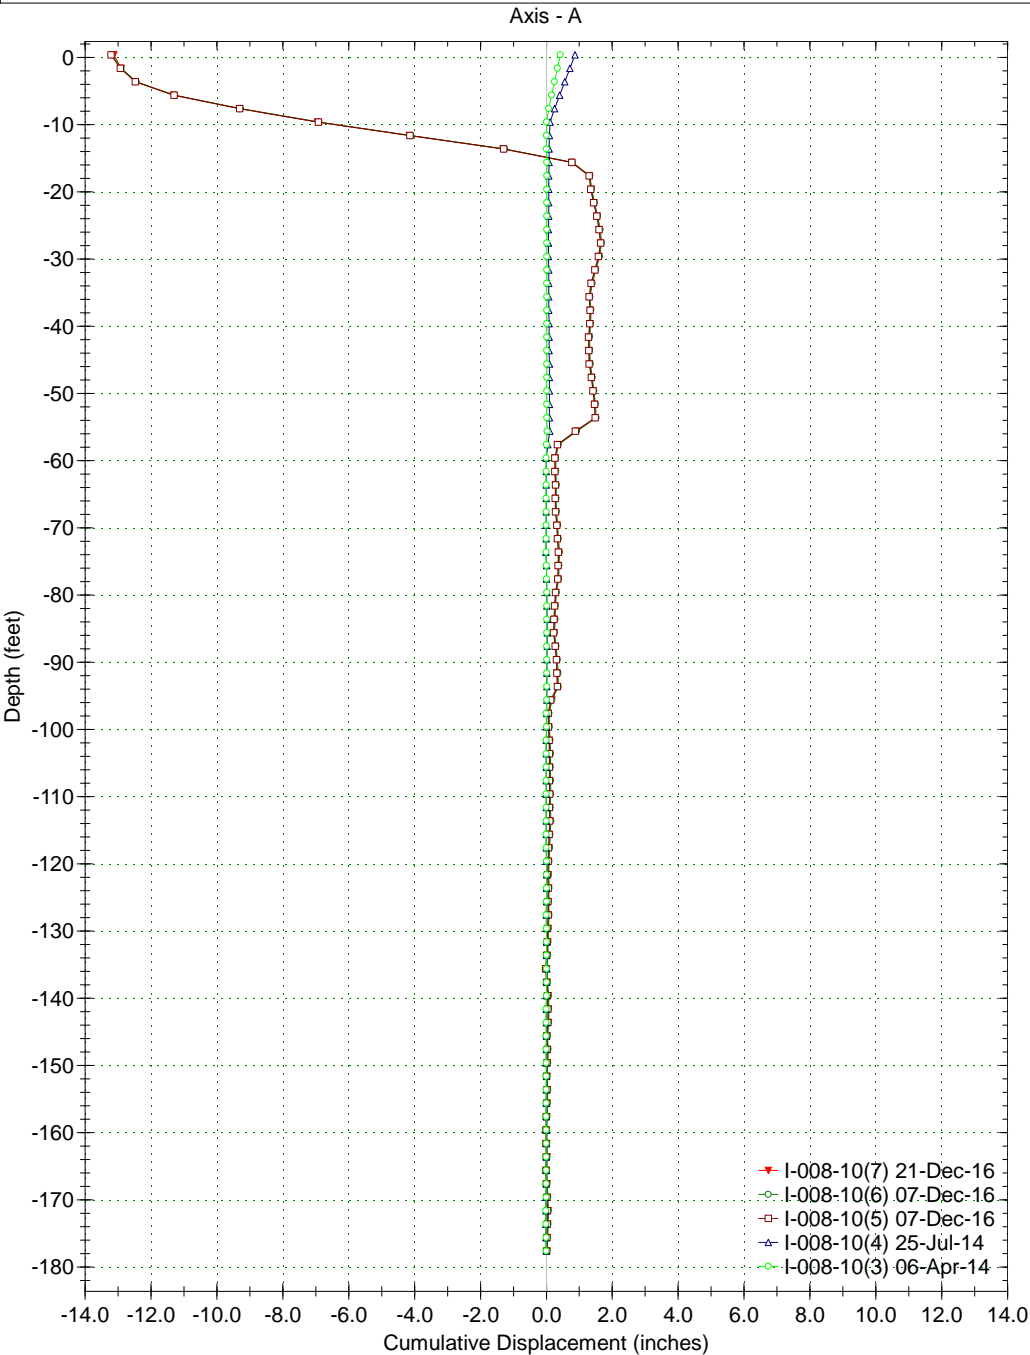
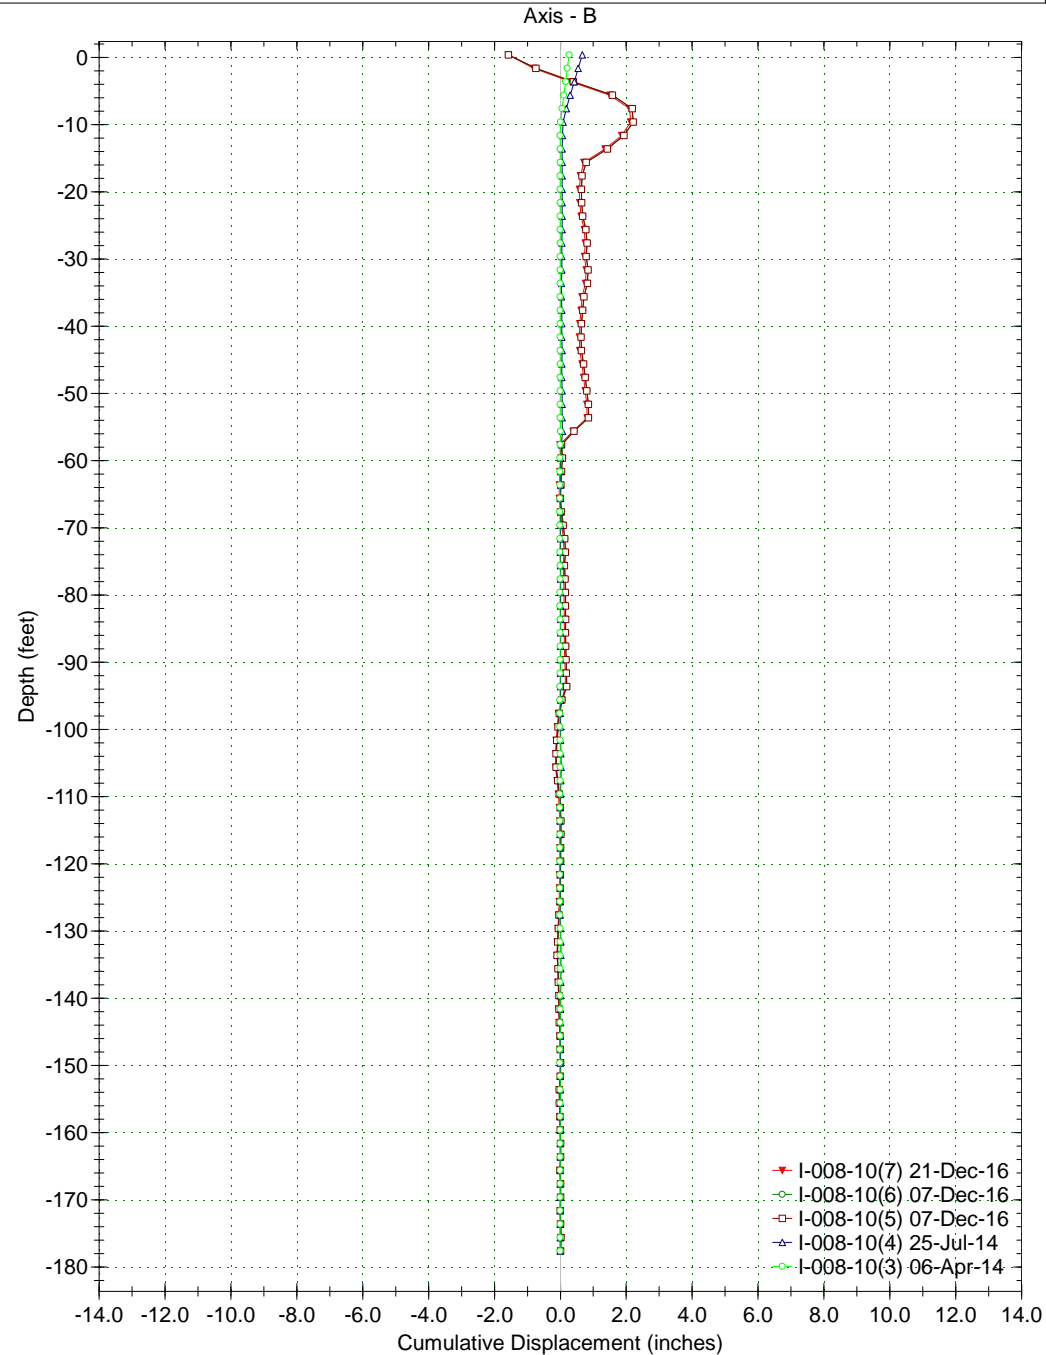
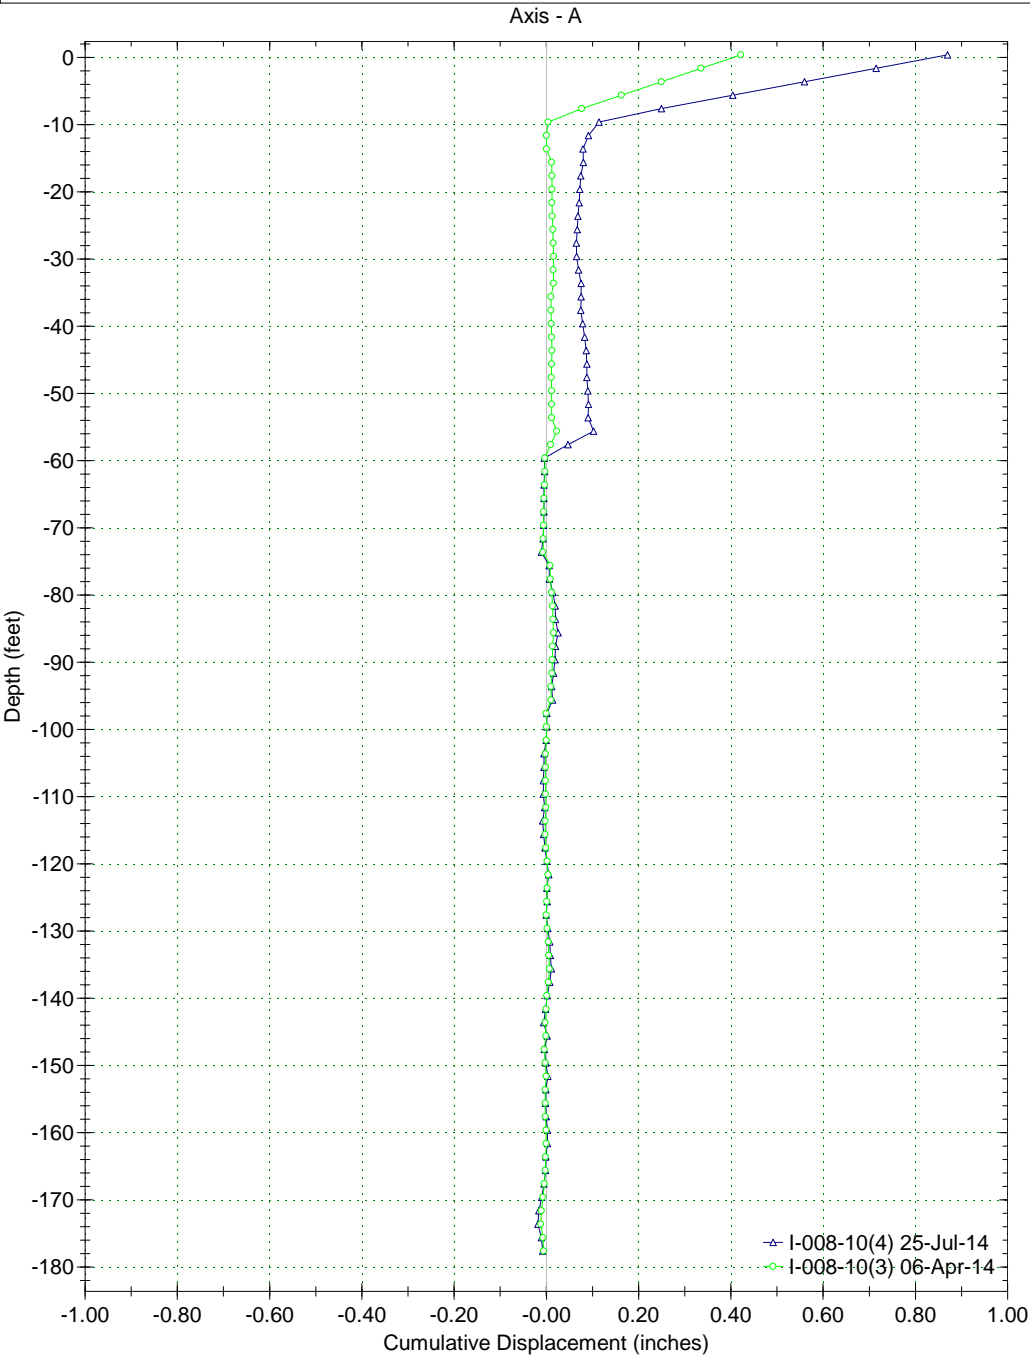
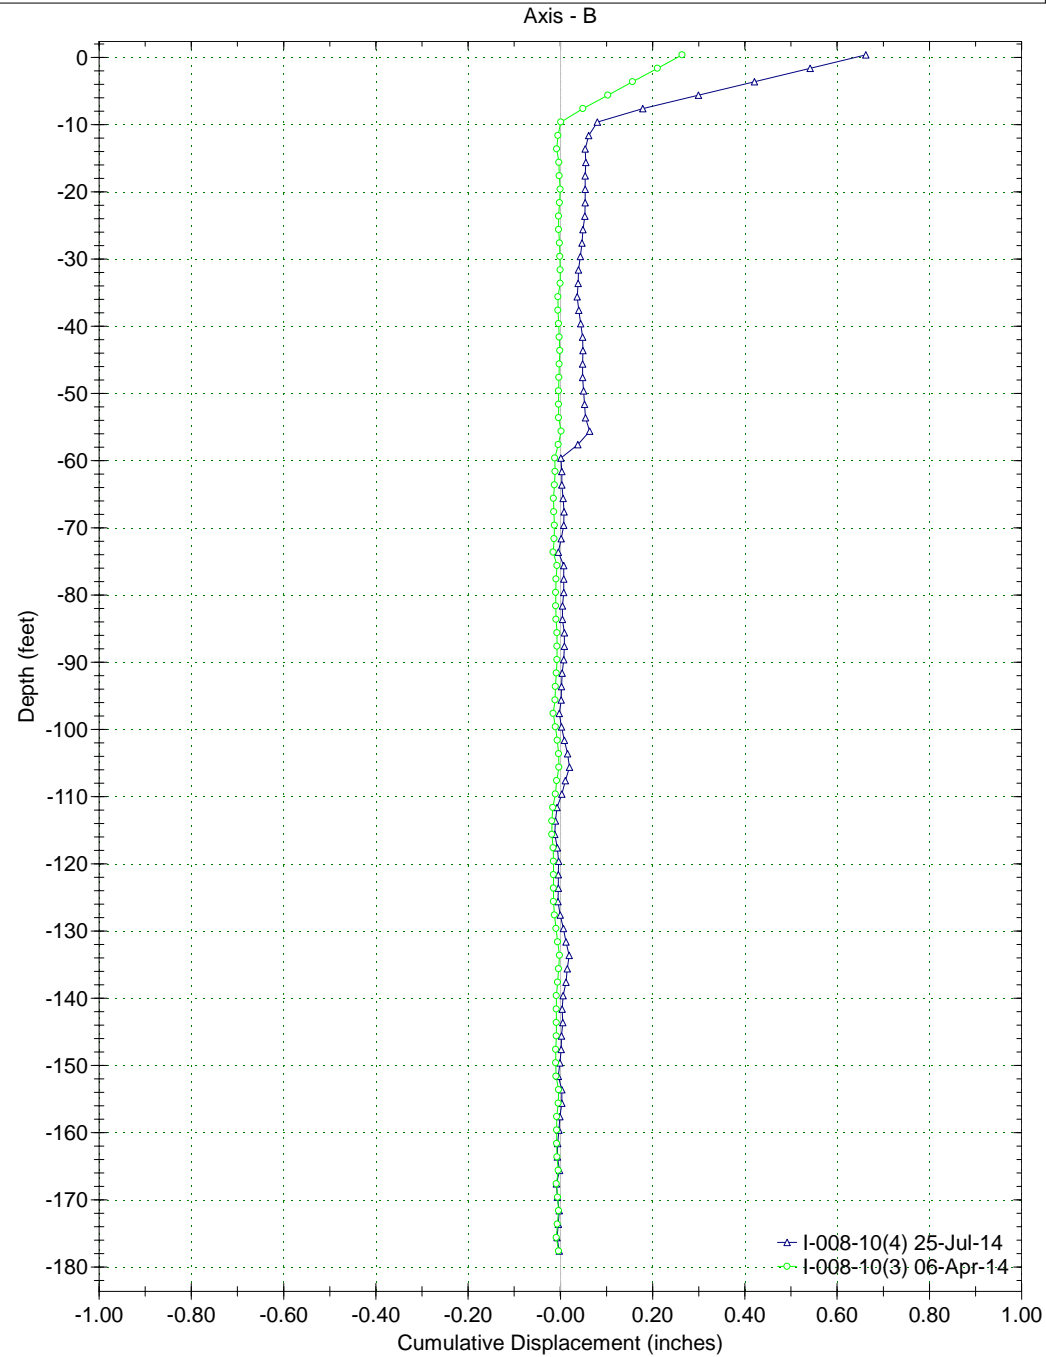
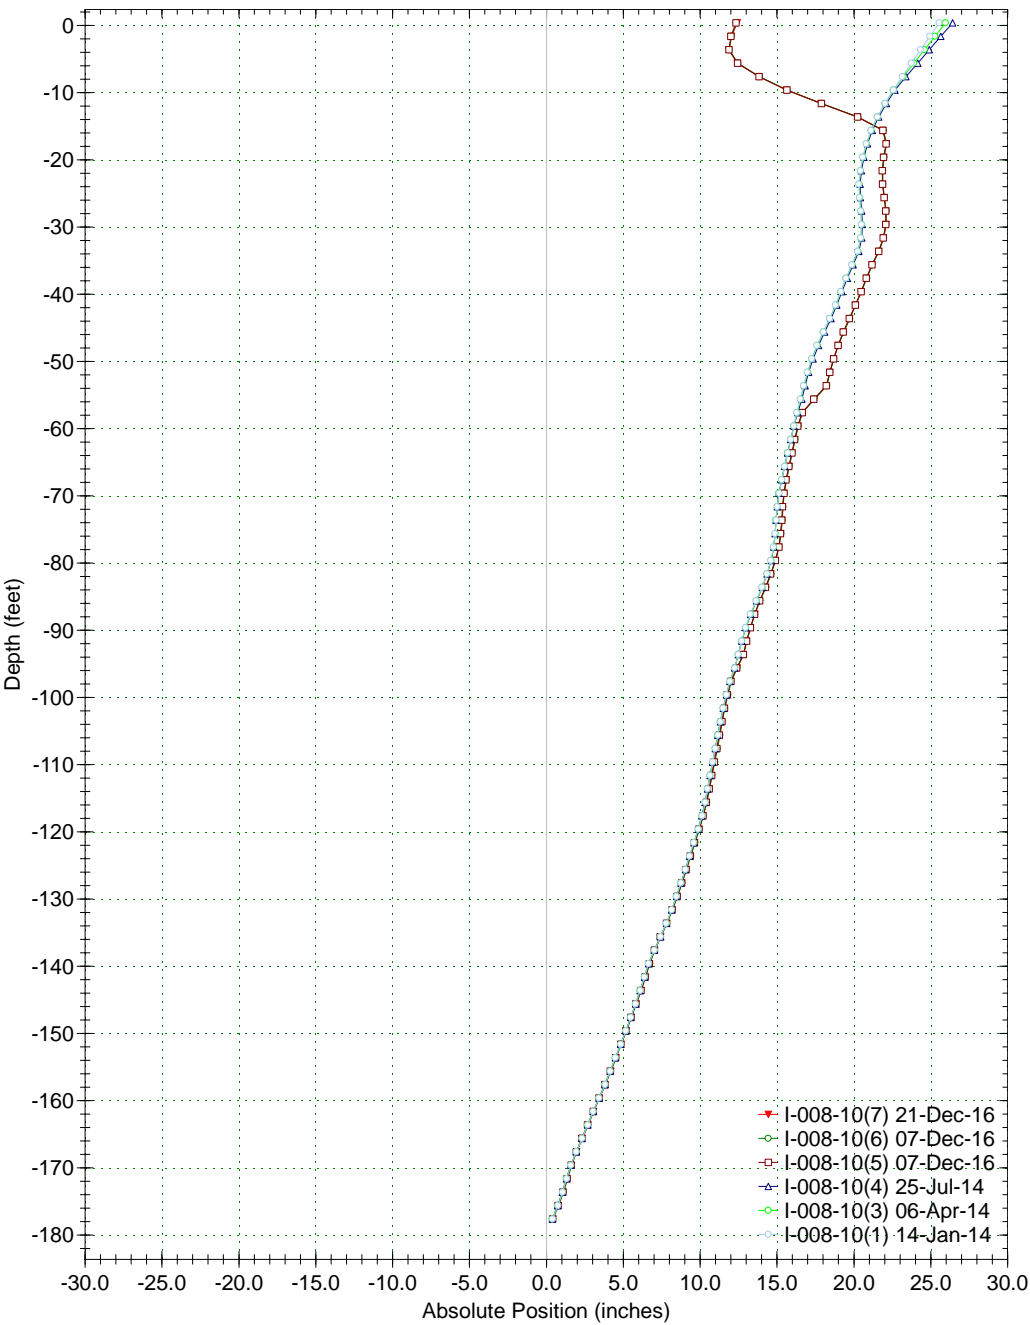
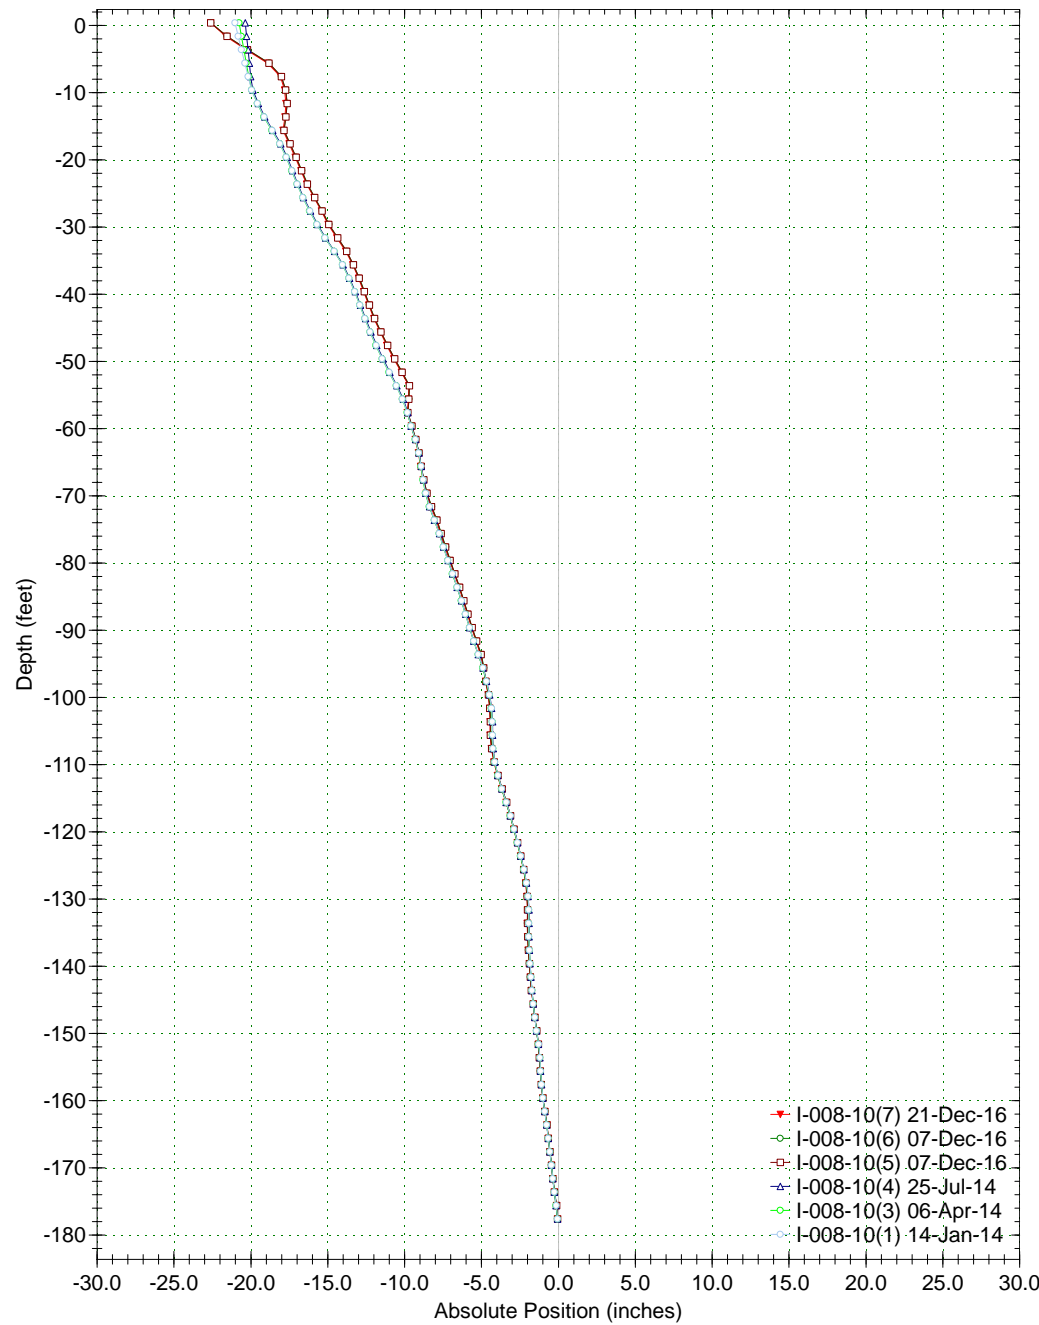
Borehole : I-008-10
Project : CUY-90-15-24
Location : Cleveland, Ohio
Northing :
Easting :
Collar :

I-008-10 – The inclinometer casing at I-008-10 was recently uncovered. During excavation or grading operations, the casing was bent and ripped off just below the surface. With the top of the casing open and unprotected, grading and/or surface runoff caused the casing to fill with soil. We repaired the casing first by flushing soil from the casing with a high pressure water stream, and then splicing on a new 20-foot section of casing to extend above grade. We were unable to clear the bottom 6 feet of the casing, which is likely filled with gravel too large to flush out. In order to plot new and old readings together, we are not plotting the bottom 6 feet of the old readings and we have added artificial data points to the top 6 feet. We have included the absolute plot with this report, which shows alignment of the old and new readings below 58 feet. The cumulative plot of the old readings shows about 0.1 inches of displacement in the positive A-axis and positive B-axis direction near 58 feet, which occurred between April and July 2014. The cumulative plot of all readings at this location shows additional displacement at this depth of about 1.5 inches in the A-axis direction and about 1 inch in the B-axis direction, which occurred between July 2014 and December 2016.
