January 12, 2017

Re: December 19, 20, and 21, 2016 Bi-Weekly Readings
CUY-90-15.24 Slope Monitoring
PID 96504
SME Project No. 069032.00

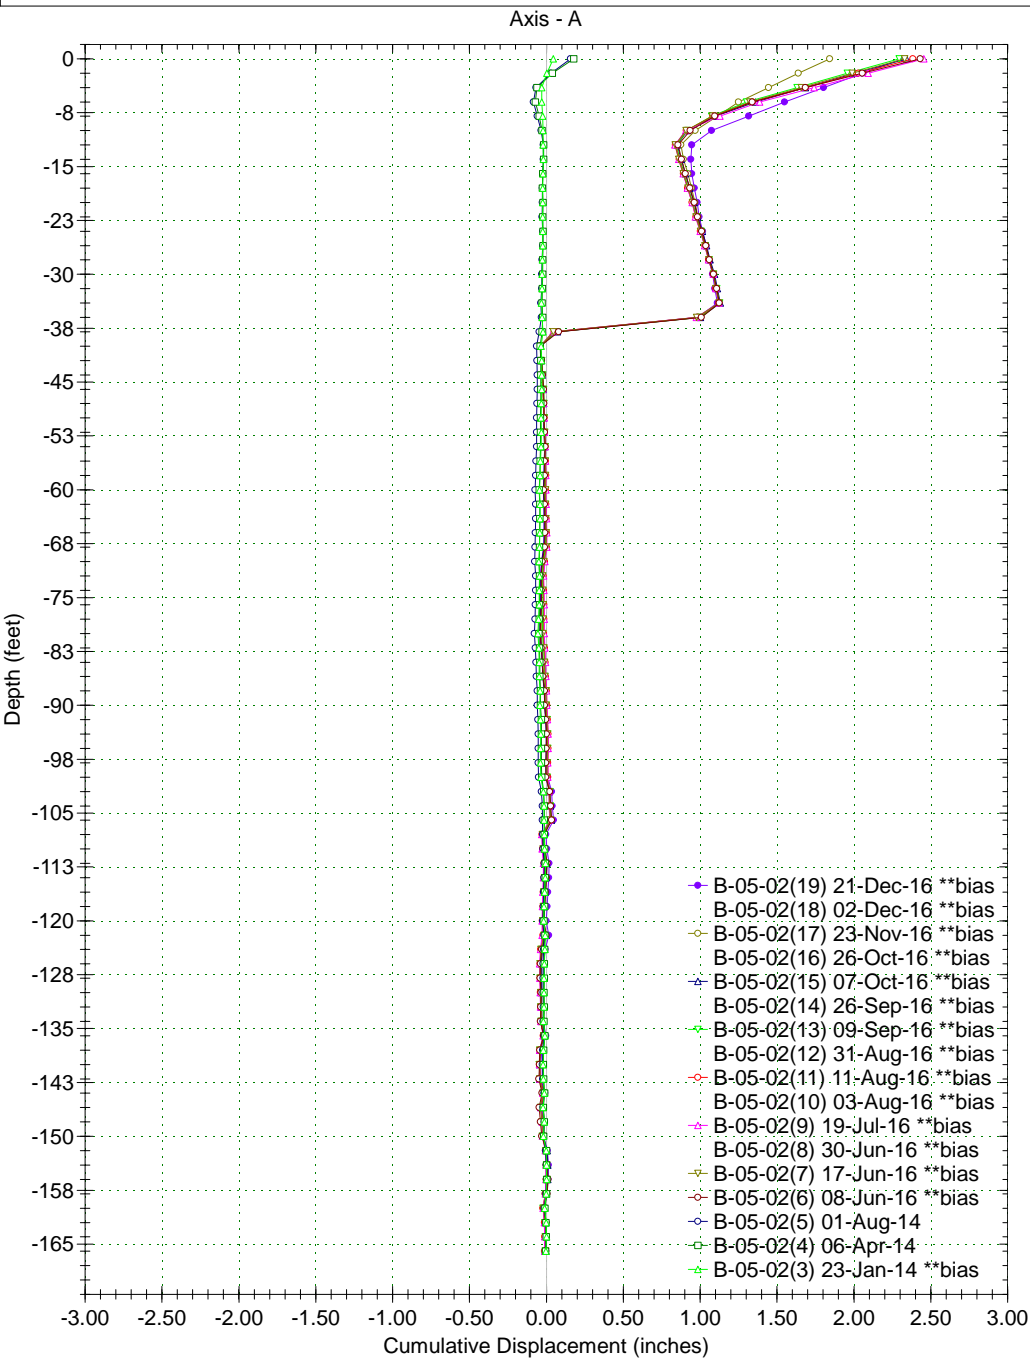
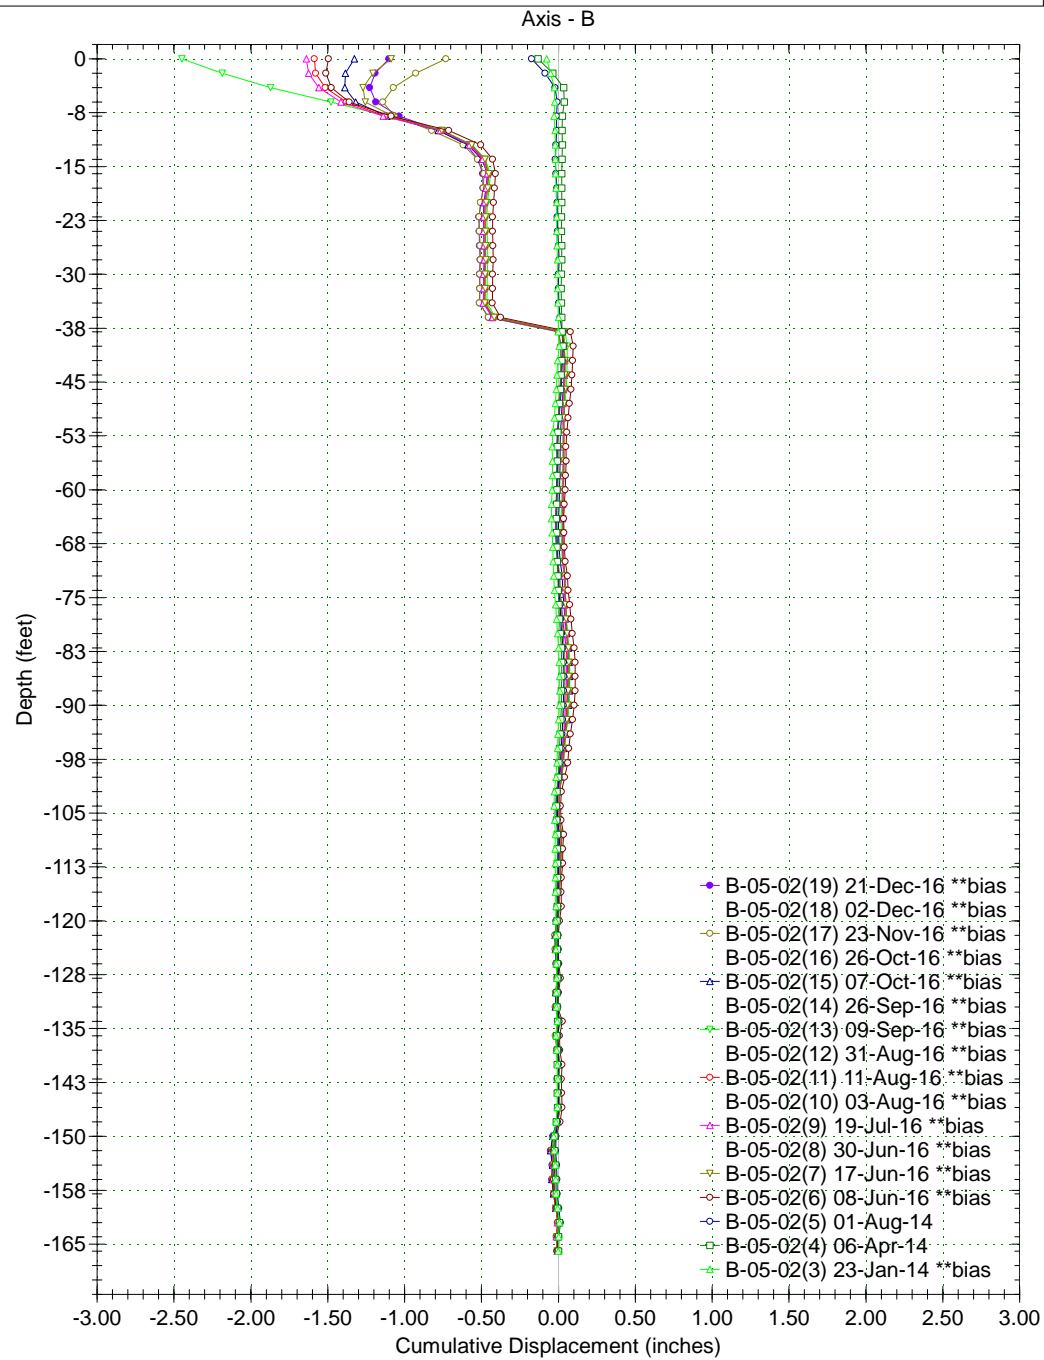
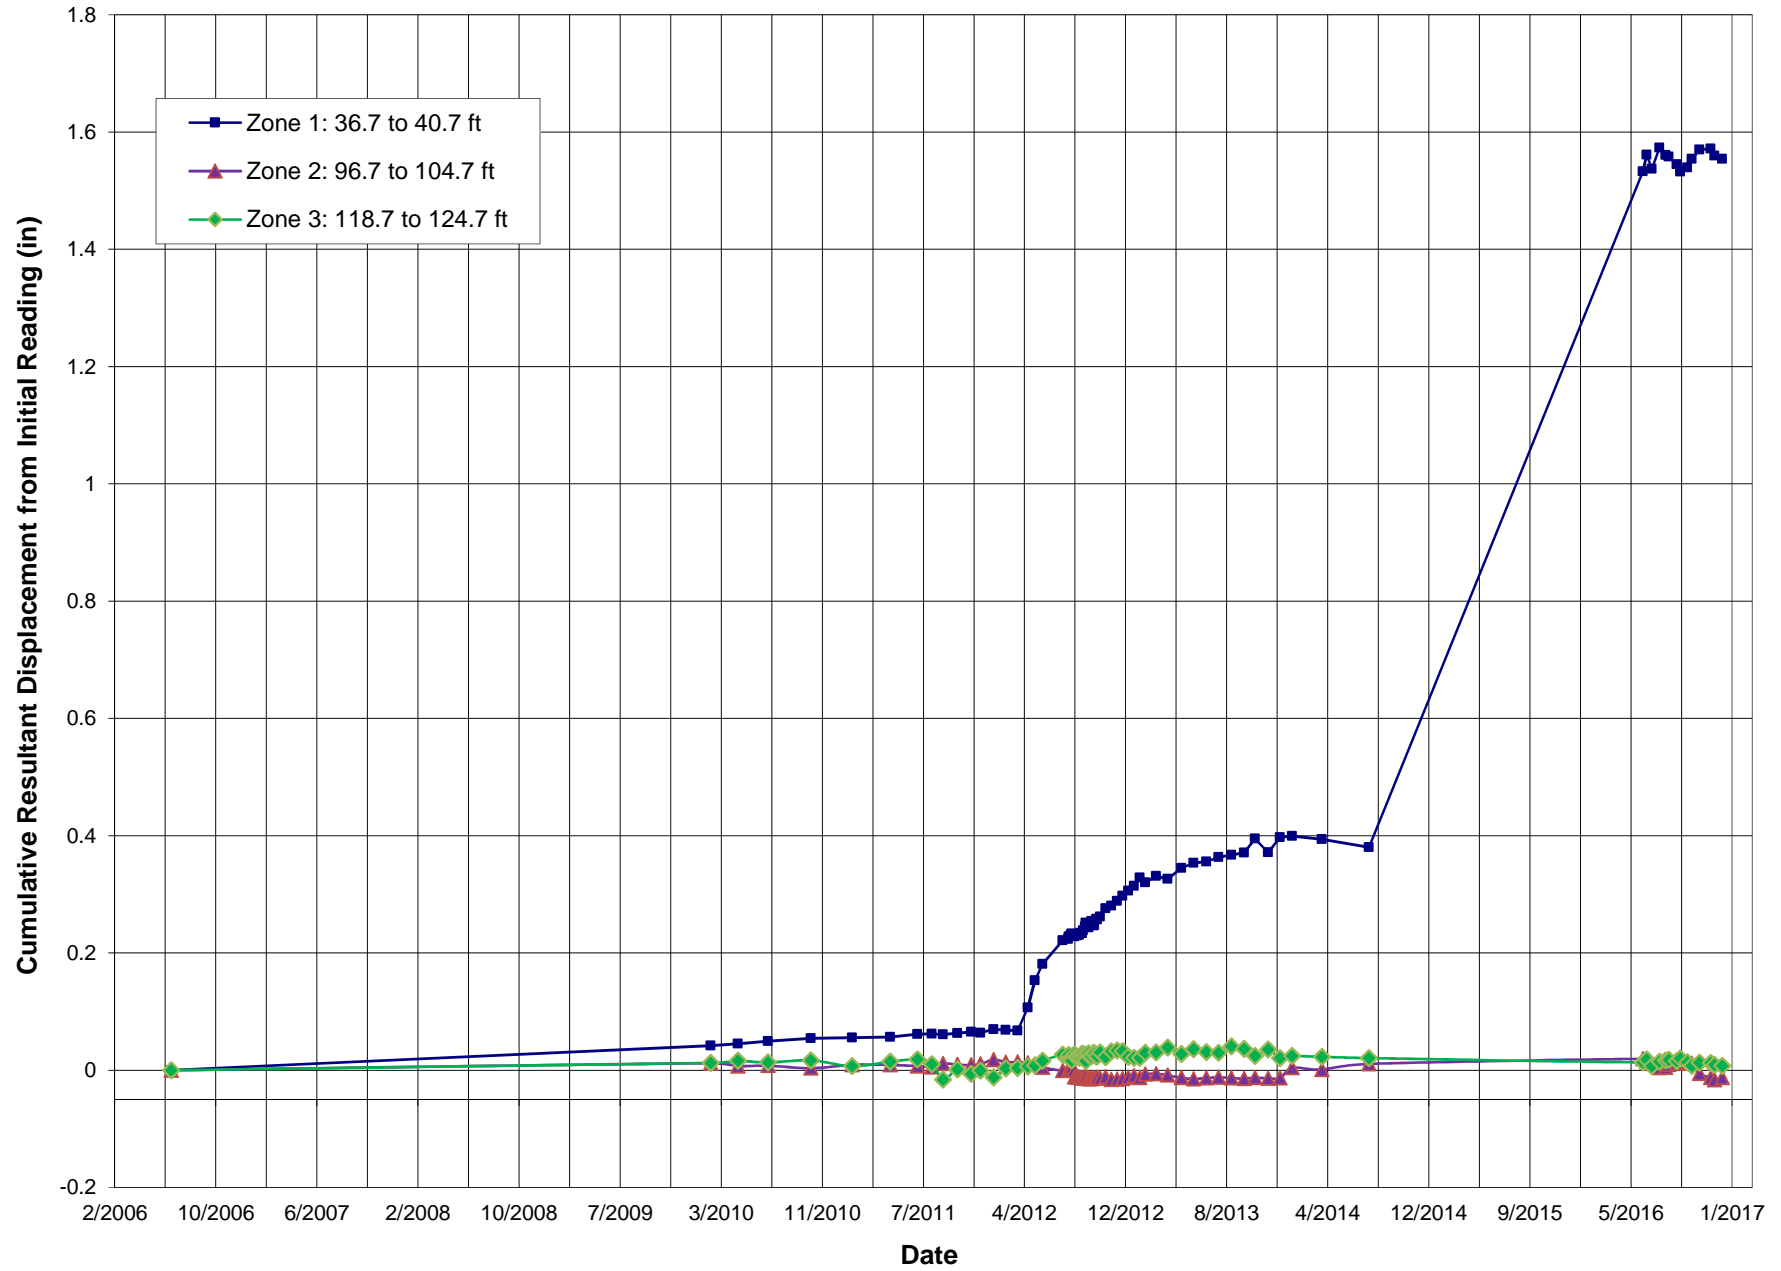
Borehole : B-05-02
Project :
Location : Cleveland, Ohio
Northing : 663737.939
Easting : 2190289.081
Collar :

B-05-02 – The soil near this instrument was recently cut to final grade. Close excavation of the soil immediately surrounding the instrument has yet to be completed. We cut off the top 4 feet of the inclinometer casing, so that the top is at a reachable height for readings. Additional casing may need to be removed once all surrounding soil is cut to final grade. Currently the top 8 feet of the plot are artificial so the new data can be plotted with historical data. Readings show slight movement in the positive A-axis direction from the surface to about 10 feet (20 feet on the plot) probably due to the cuts made around the instrument.
