Re: October 2016 Quarterly Report
CUY-90-15.24 Slope Monitoring
PID 96504
EDP Project No. 069032.00

OCTOBER 2016 ANNUAL REPORT

CUY-90-15.24 SLOPE MONITORING
PID 96504
CLEVELAND, OHIO
SME PROJECT NO. 069032.00

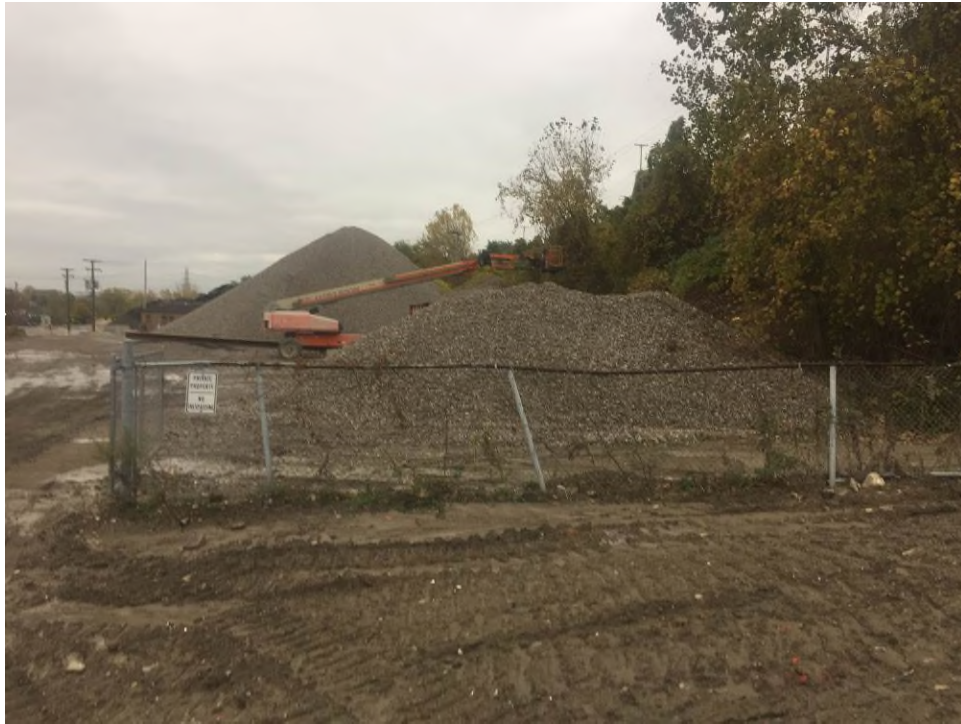
We observed and photographed the aggregate stockpiles on October 29, 2016. The photos are included in Appendix A as Figures 4 and 5. Only a small pile of aggregate remains closest to the right-of-way fence. This pile has not changed since January 2014. The pile is about 8 feet high and covers only a small area of the property.

Figure 4. Aggregate stockpile east of the ODOT right-of-way (October 29, 2016).

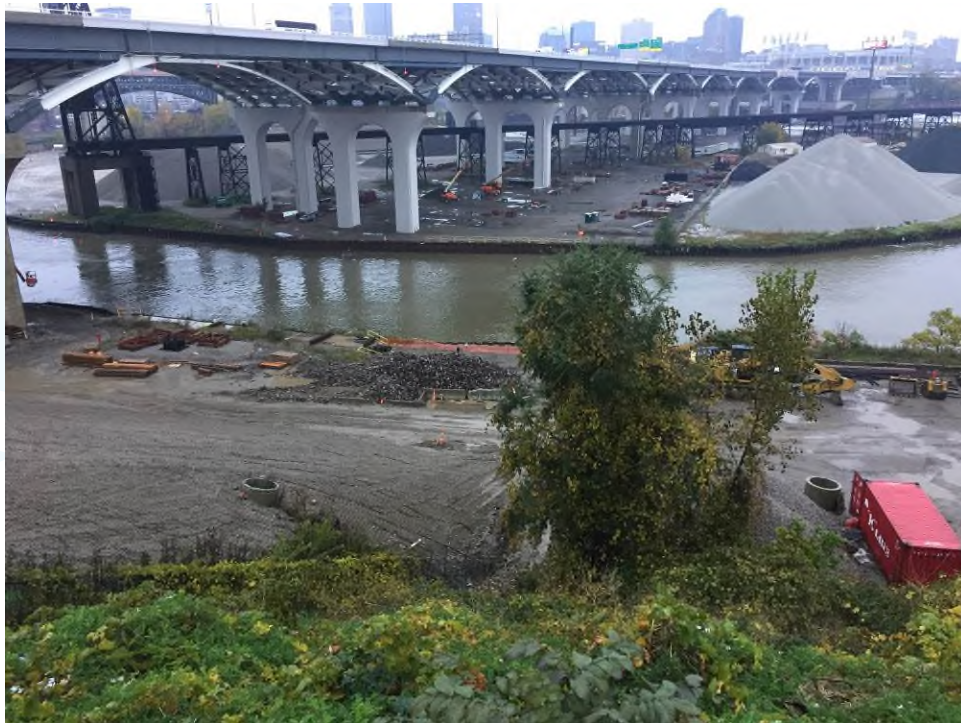
Figure 5. Aggregate stockpile near ODOT's east right-of-way fence (October 29, 2016).

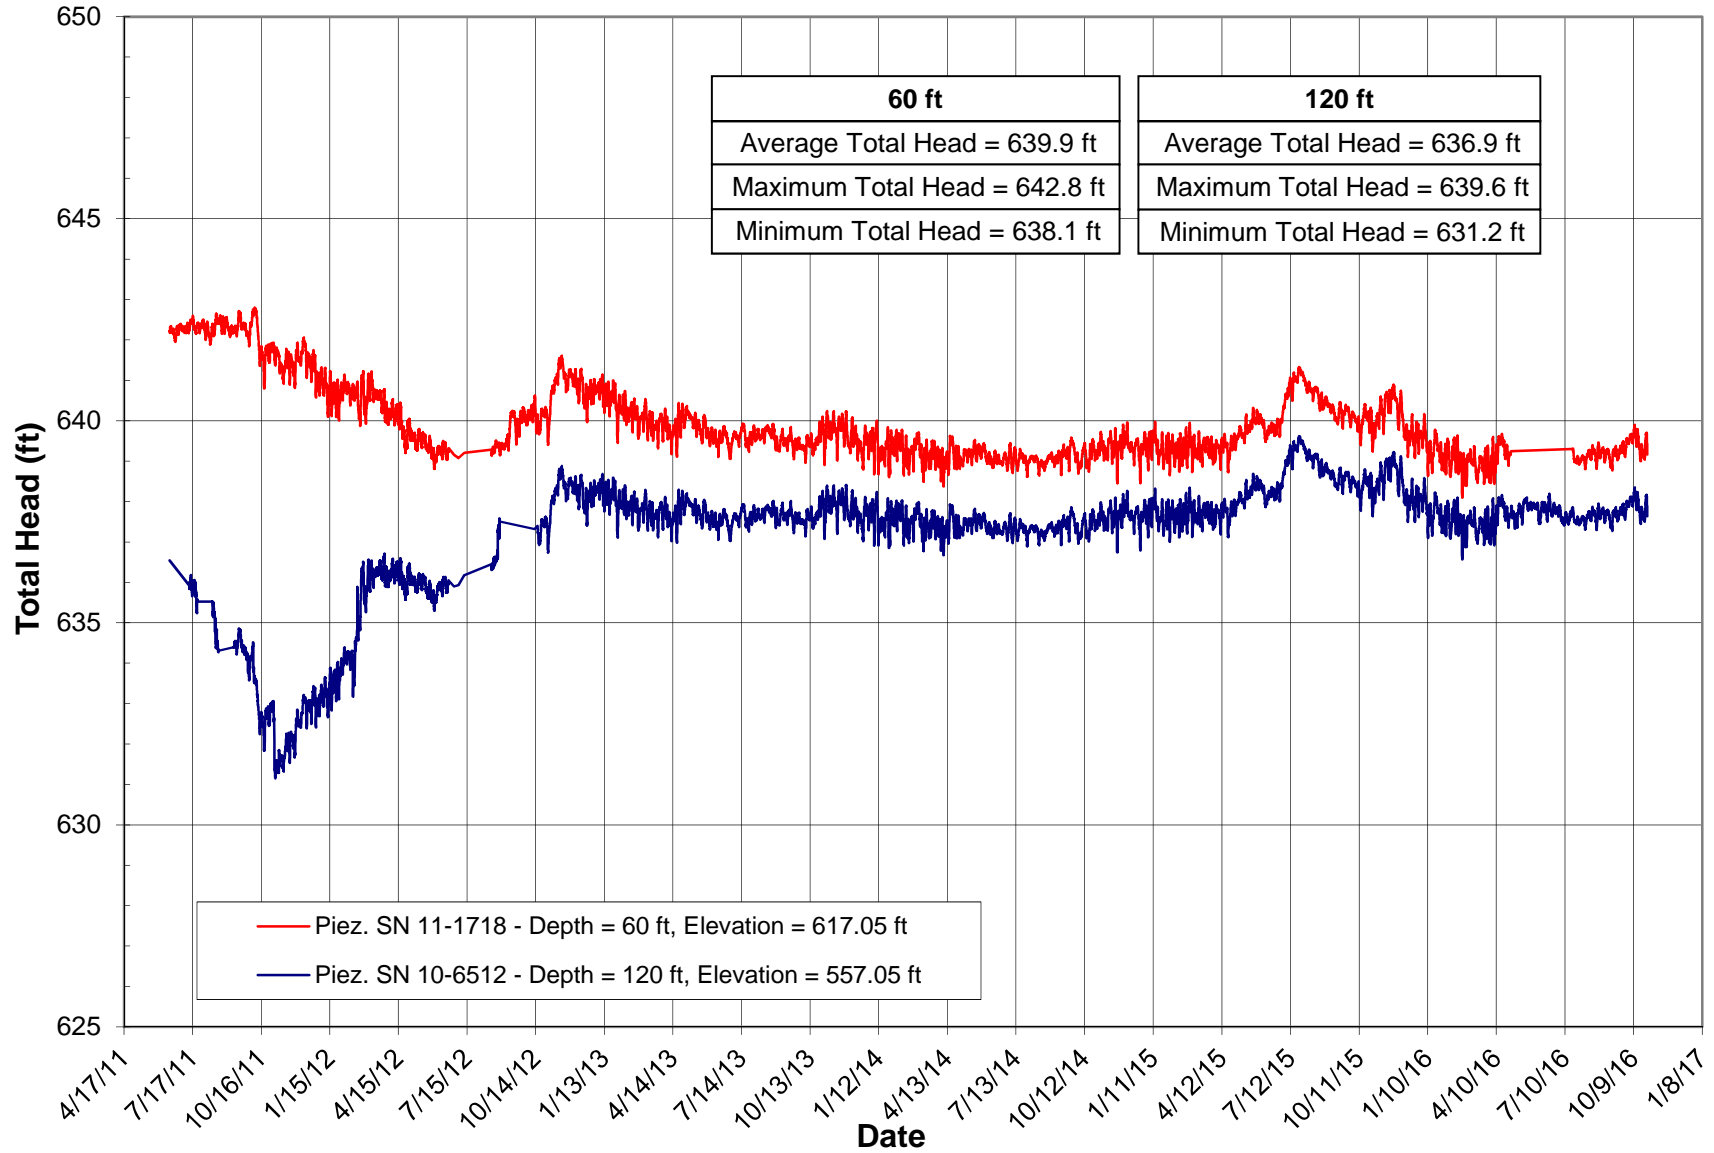
P-001-10 VW Piezometer Readings

P-001-10. Total head in both piezometers at P-001-10 decreased by about 2 feet between July 2015 and April 2016. A temporary rise of about 1 foot of total head occurred in November 2015. Since April 2016, variations in total head have stayed within a range of about 1 foot and are similar to the total heads recorded from April 2013 through April 2015. The datalogger for the shallow piezometer failed to record between April 29 and July 20, 2016, but pore pressure readings on either side of this gap in data indicated no net change in total head.

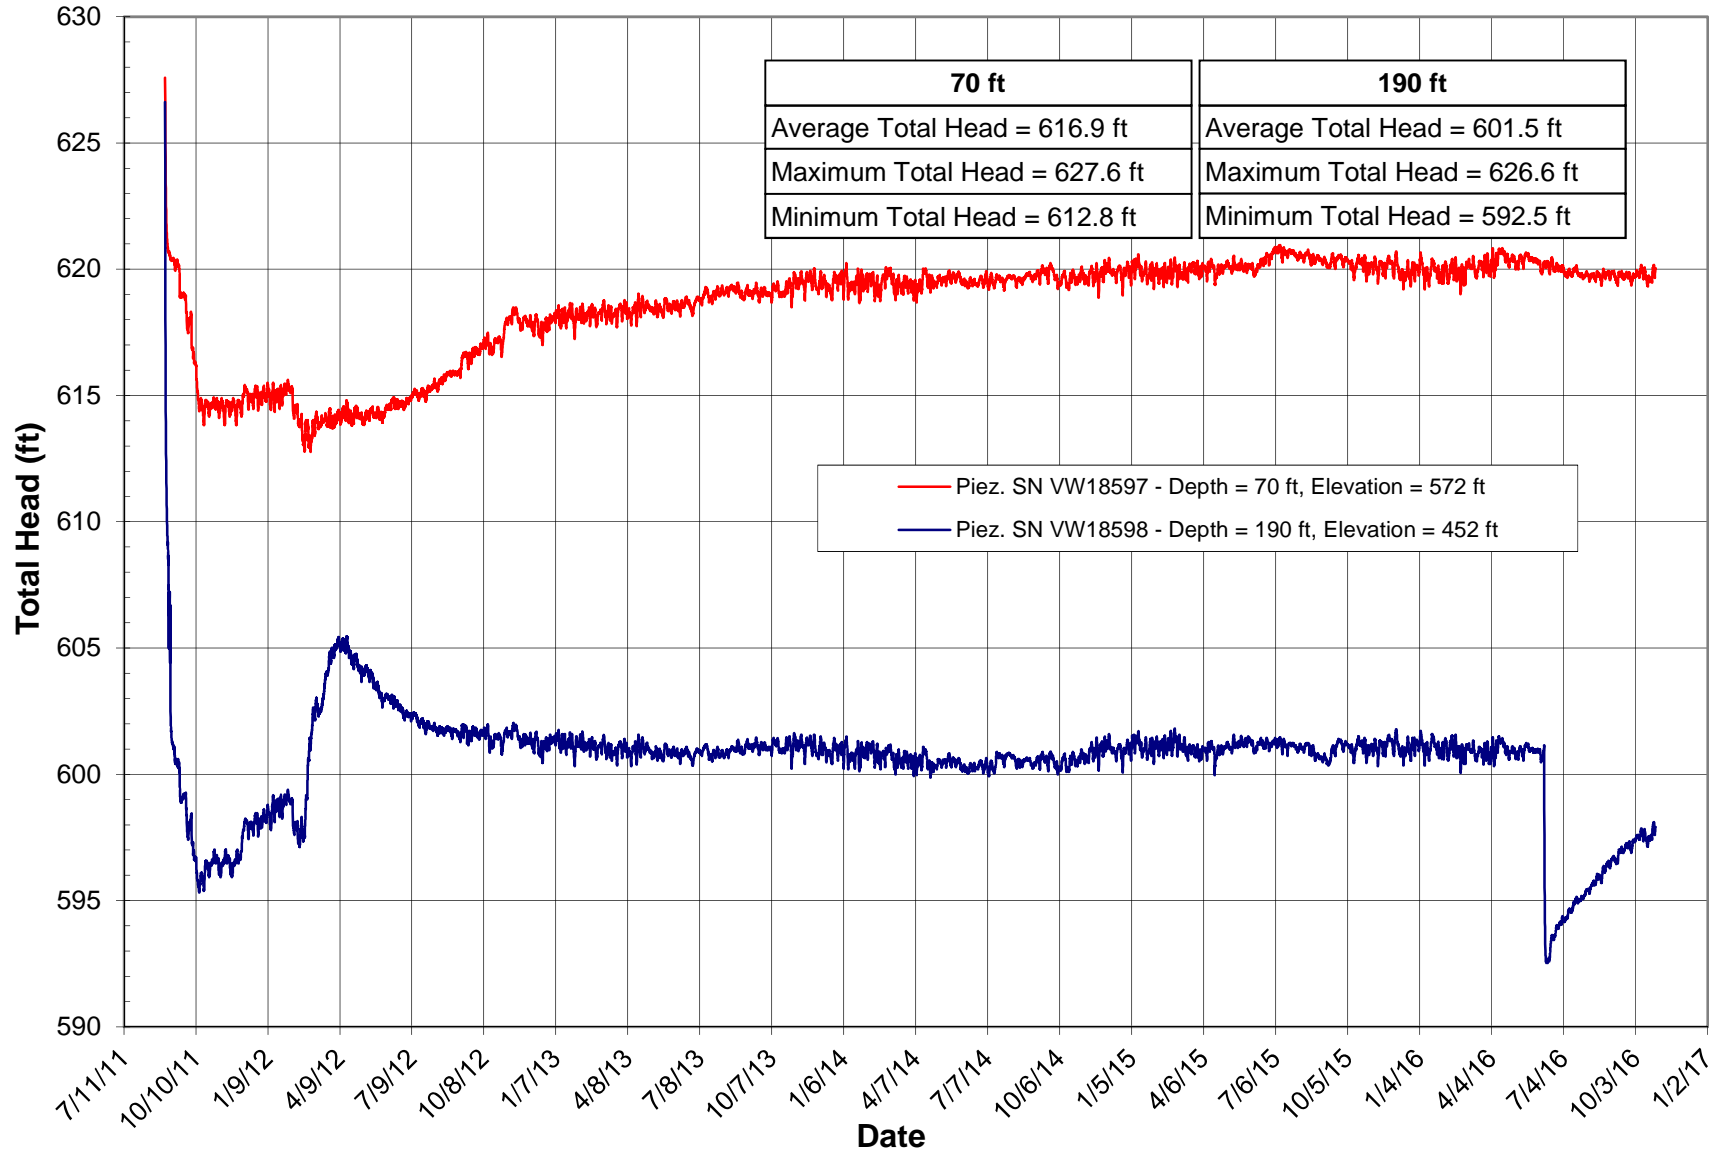
P-002-10 VW Piezometer Readings

P-002-10. Total head in the deep piezometer at P-002-10 decreased by 8.5 feet between June 9 and June 12, 2016, and then began to gradually increase. At the time of these quarterly readings, the increase had reached about 5.6 feet. Total head in the shallow piezometer at this location has fluctuated by about 1 foot throughout this past year, but has shown no significant change since January 2014.

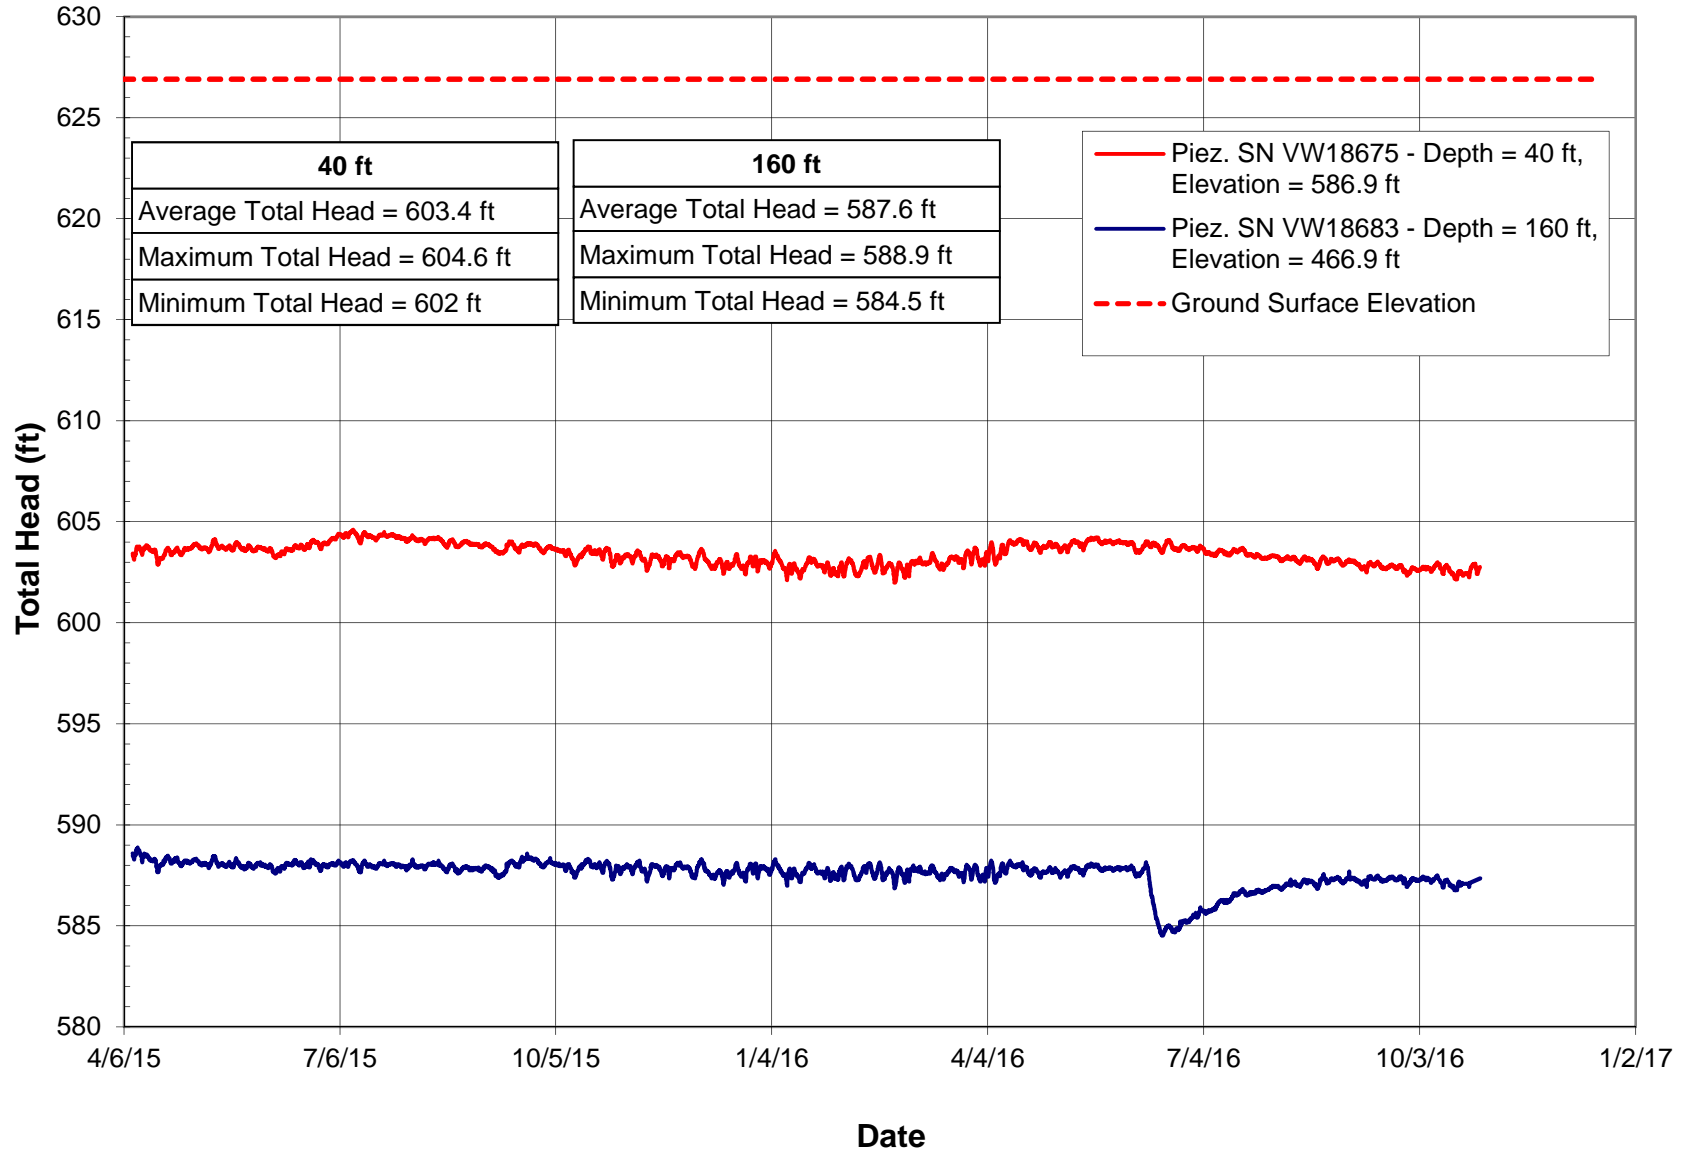
P-007-13 VW Piezometer Readings

P-007-13. Total head in the deep piezometer at P-007-13 decreased by 3.7 feet between June 9 and June 16, 2016, then gradually increased through the third week of August 2016, and has remained nearly constant since that time. The total increase was about 2.8 feet leaving a net decrease of about 0.9 feet since the first week of June 2016. Total head in the shallow piezometer at this location has been trending downward since July 2015. The total decrease during this time has been about 1.8 feet.

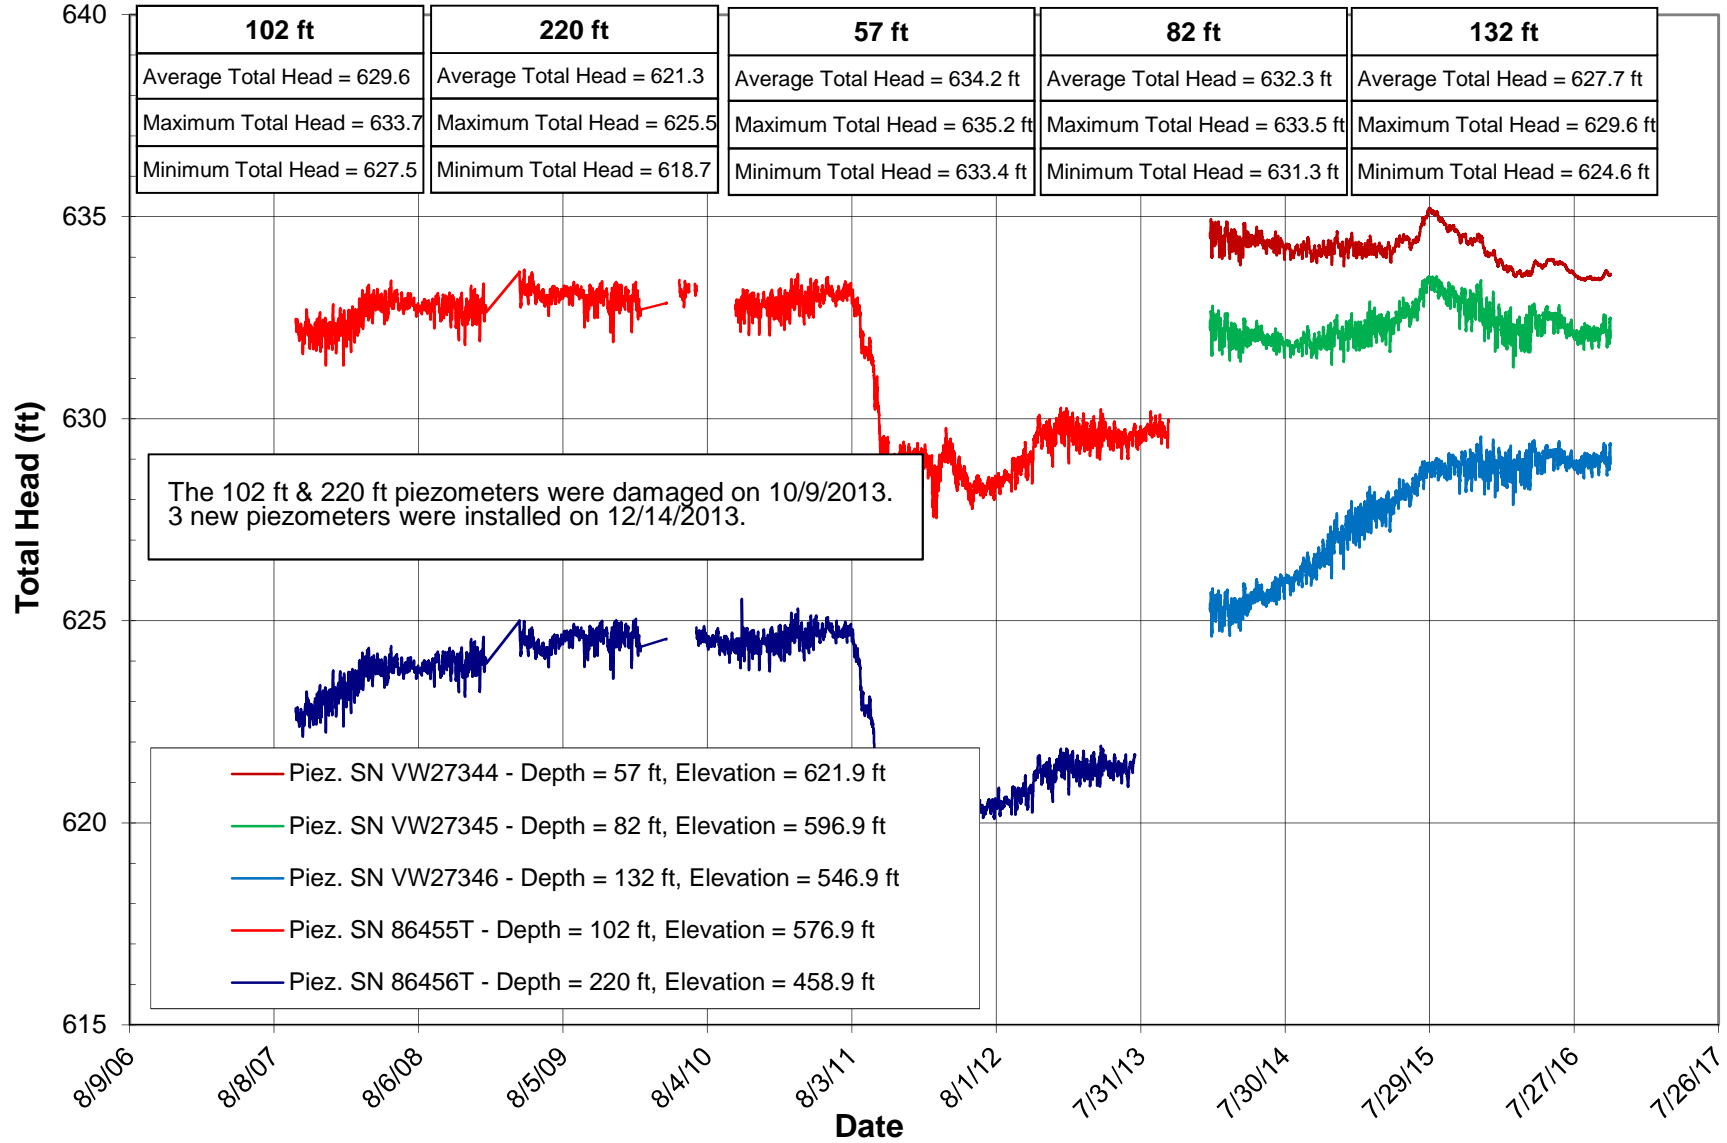
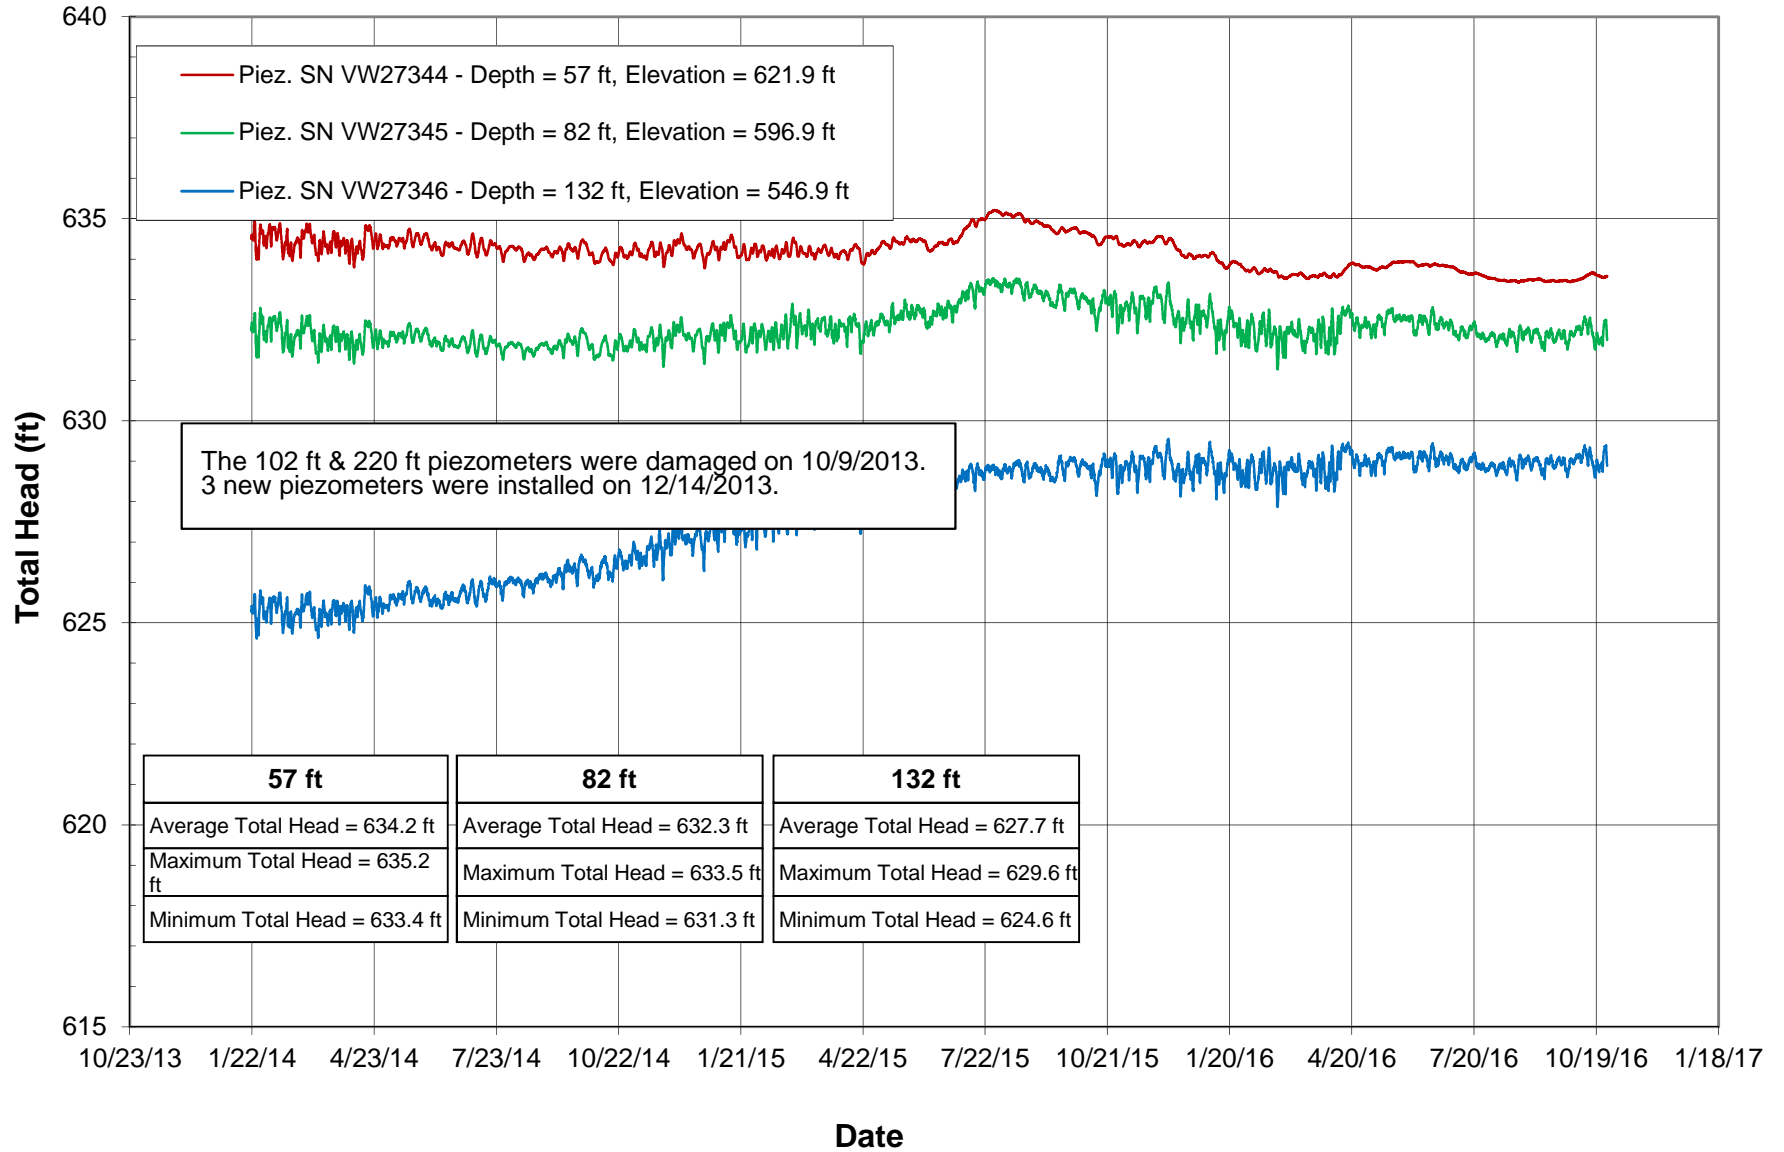
B-05-07 VW Piezometer Readings

B-05-07. Three piezometers are installed at this location. Pore pressures in the shallow and middle piezometers have been trending downward since July 2015. The majority of the decrease, about 1 to 1.5 feet of total head, occurred between July 2015 and the third week of April 2016. Since then, the change has been more gradual with only a slight decrease for the 6 months through October 2016. Total head in the deep piezometer at this location has trended upward very slightly this past year with a net change of less than four inches of total head.

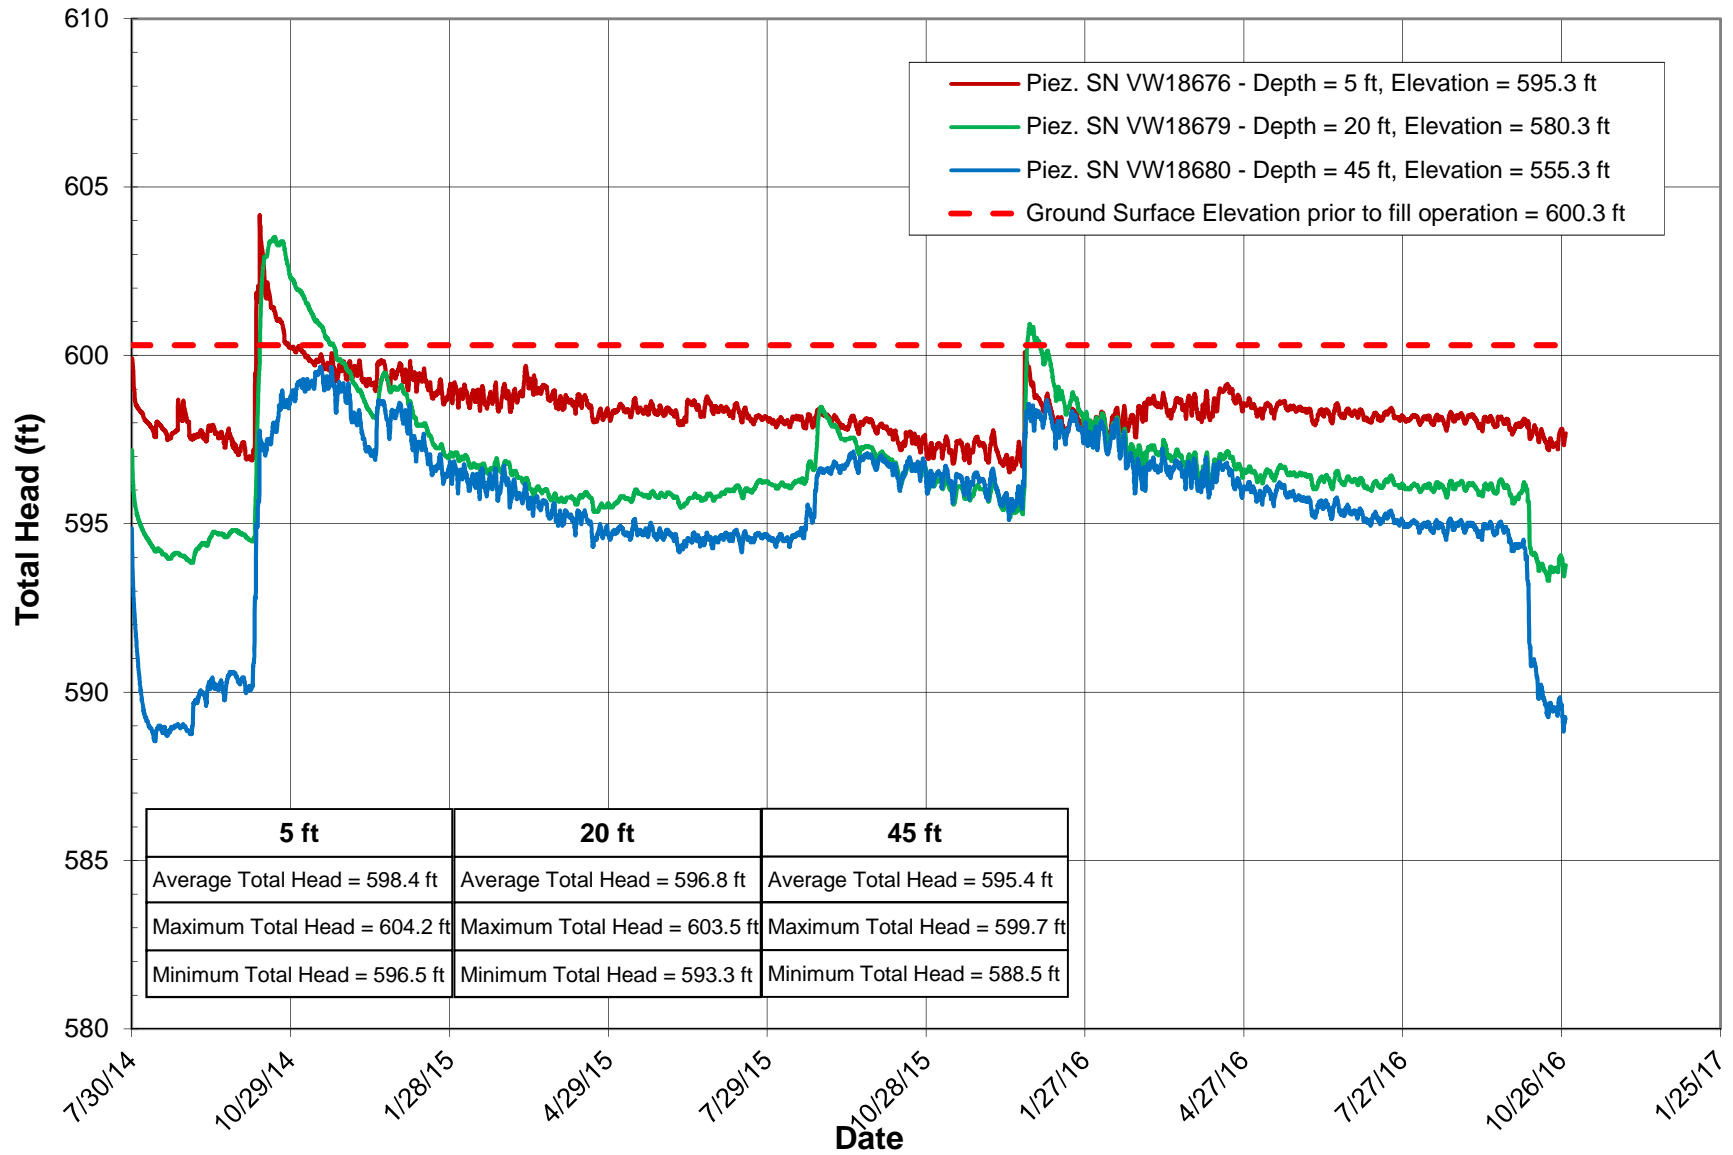
TGR P-3 VW Piezometer Readings

TGR P-3. Three piezometers are installed at this location. Total head in all three piezometers have generally trended downward between short periods where large changes occurred. On December 23, 2015, total head increases of 2.5 to 5 feet occurred in all three piezometers. This increase was caused by the placement of fill in the area immediately adjacent to the instruments. Pore pressures decreased rapidly in the shallow and middle piezometers over the next 3 to 5 weeks. Pore pressures then stabilized in the shallow piezometer remaining about one foot higher than they had been prior to the sudden increase. Pore pressures in the middle piezometer continued to decrease at a gradual rate. Pore pressures decreased gradually in the deep piezometer after the sudden December increase. Then, between September 25 and October 17, 2016, total head decreased by 6.2 feet in the deep piezometer, 2.7 feet in the middle piezometer, and 0.7 feet in the shallow piezometer. This was likely due to the final grading operations in the area of these instruments.

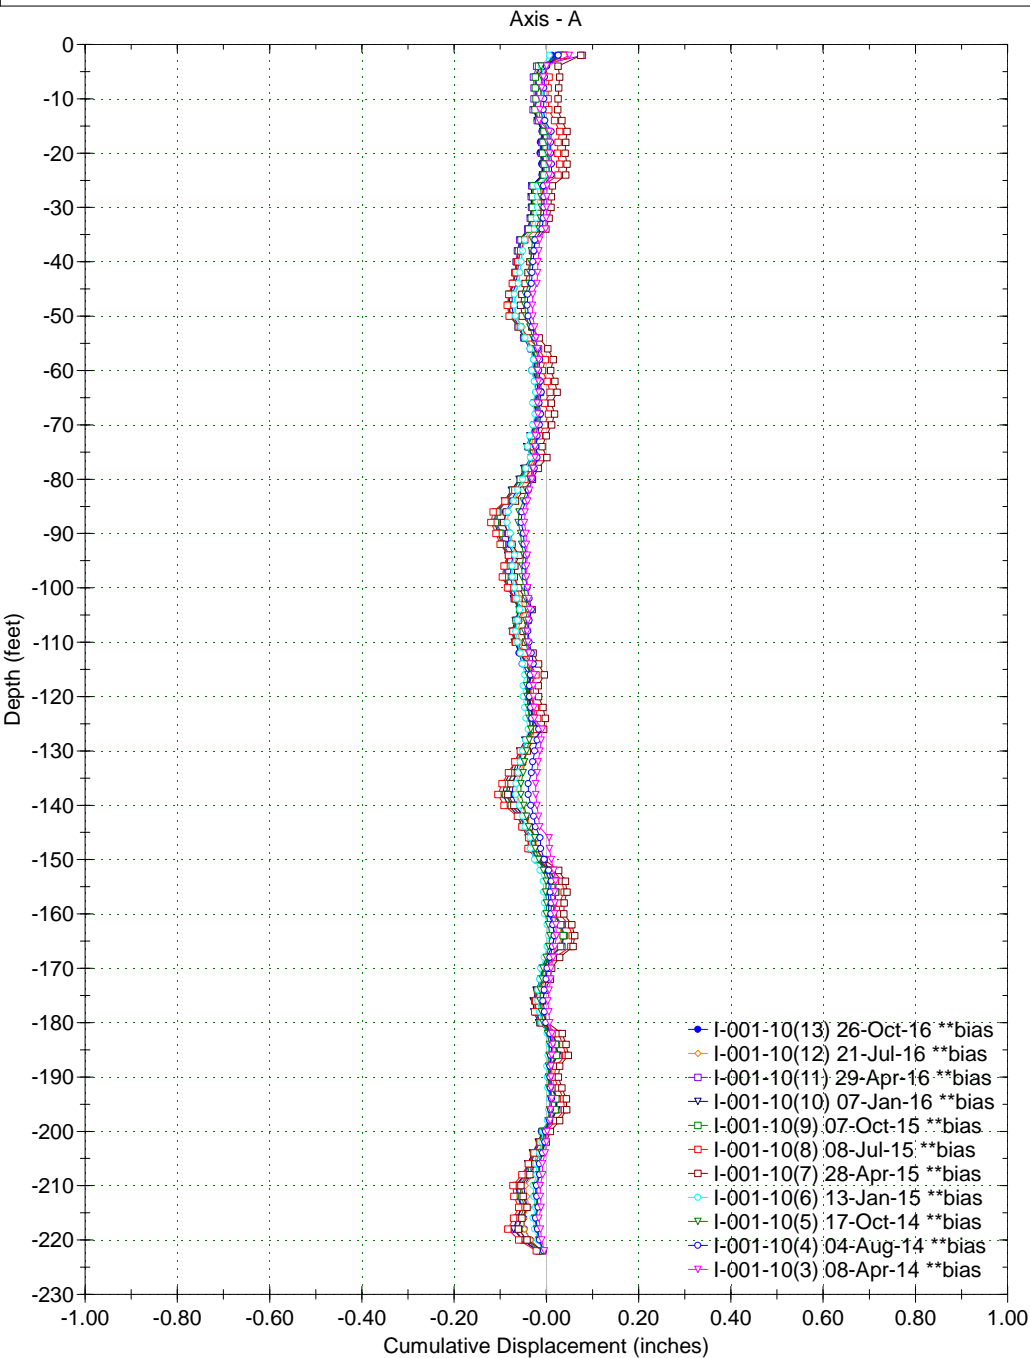
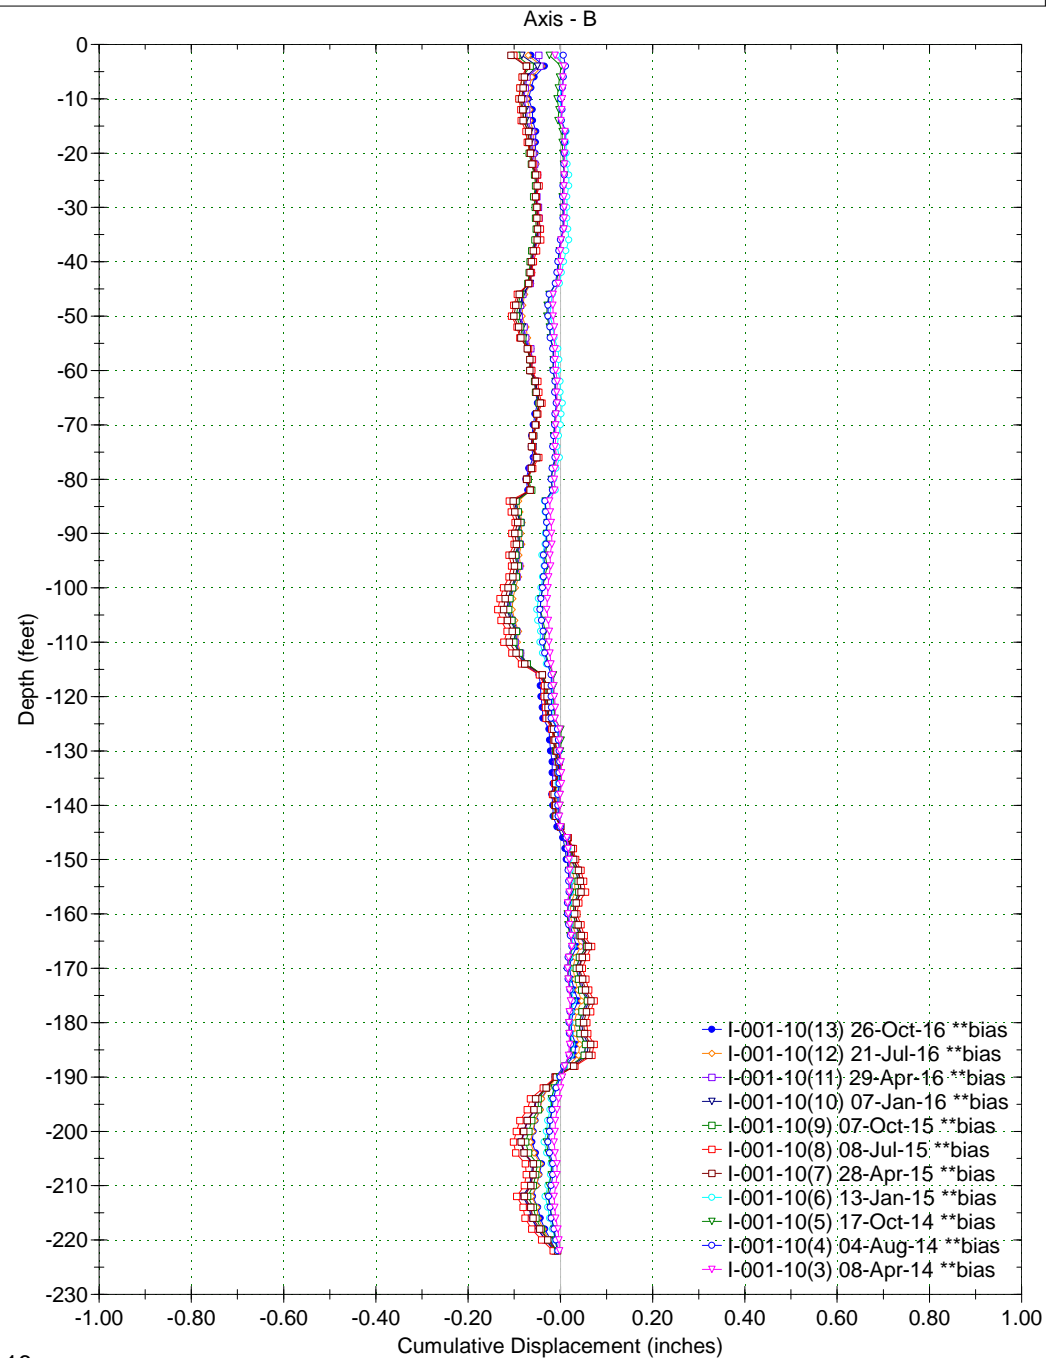
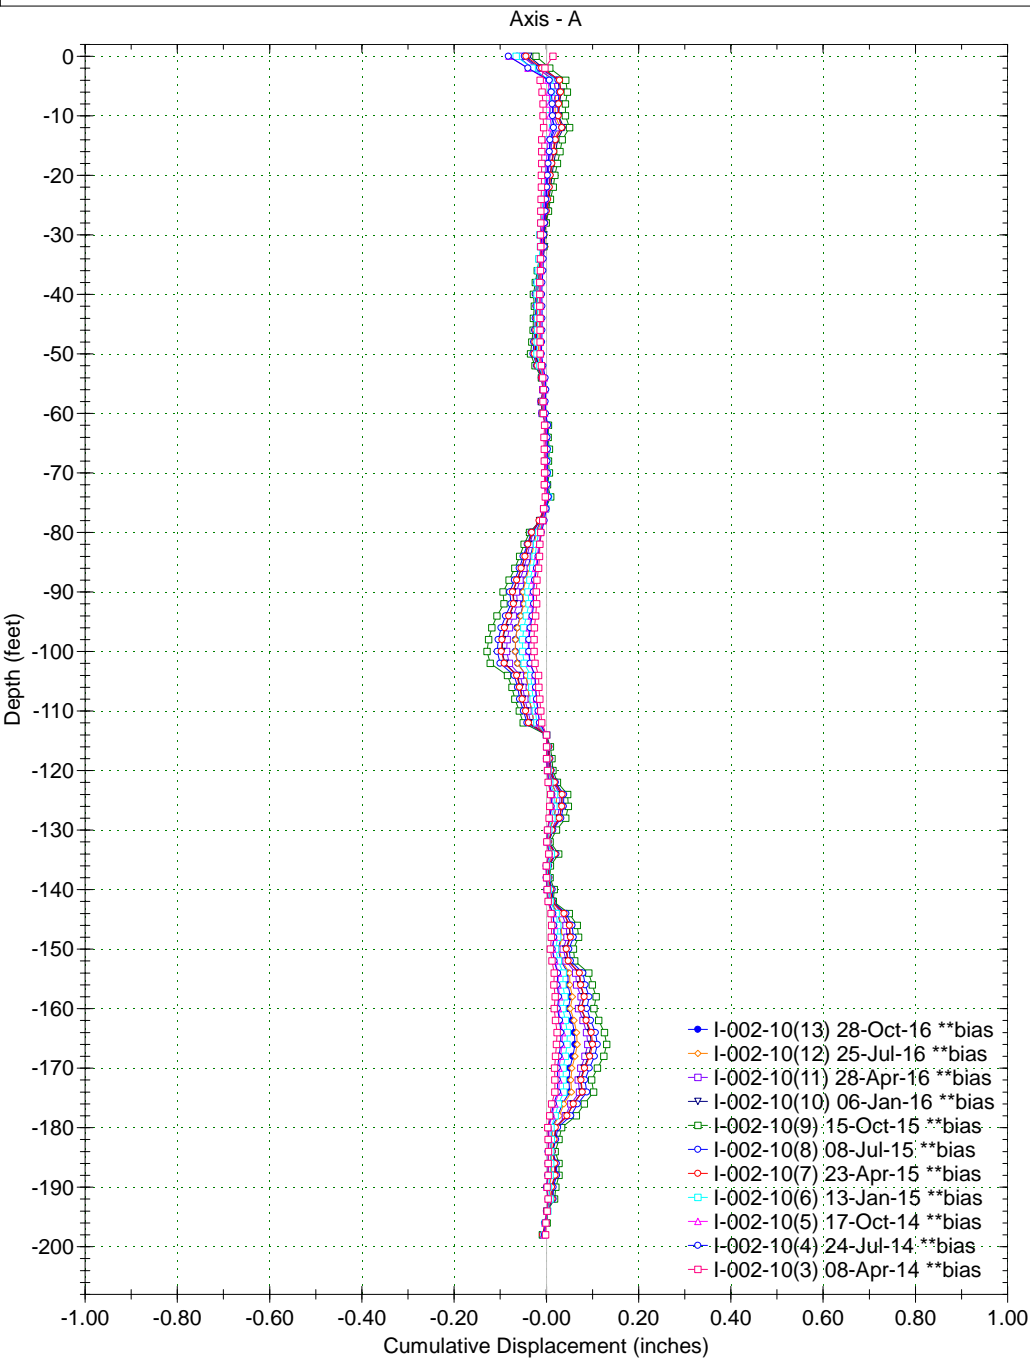
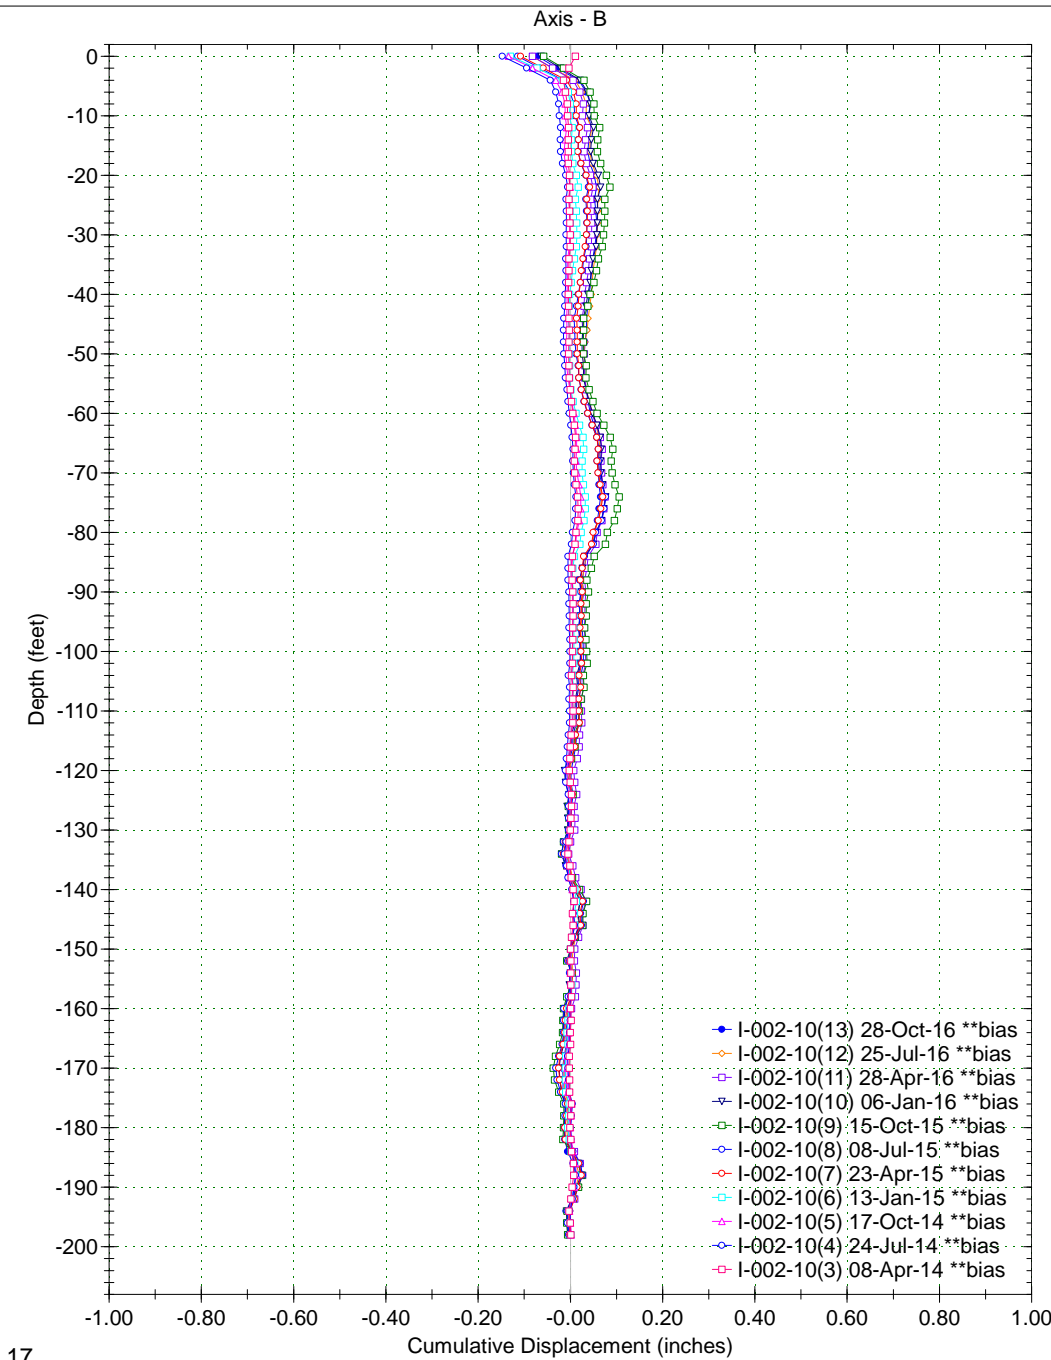
I-001-10, I-002-10. Inclinometer readings at these locations indicate no movement since April 2015.

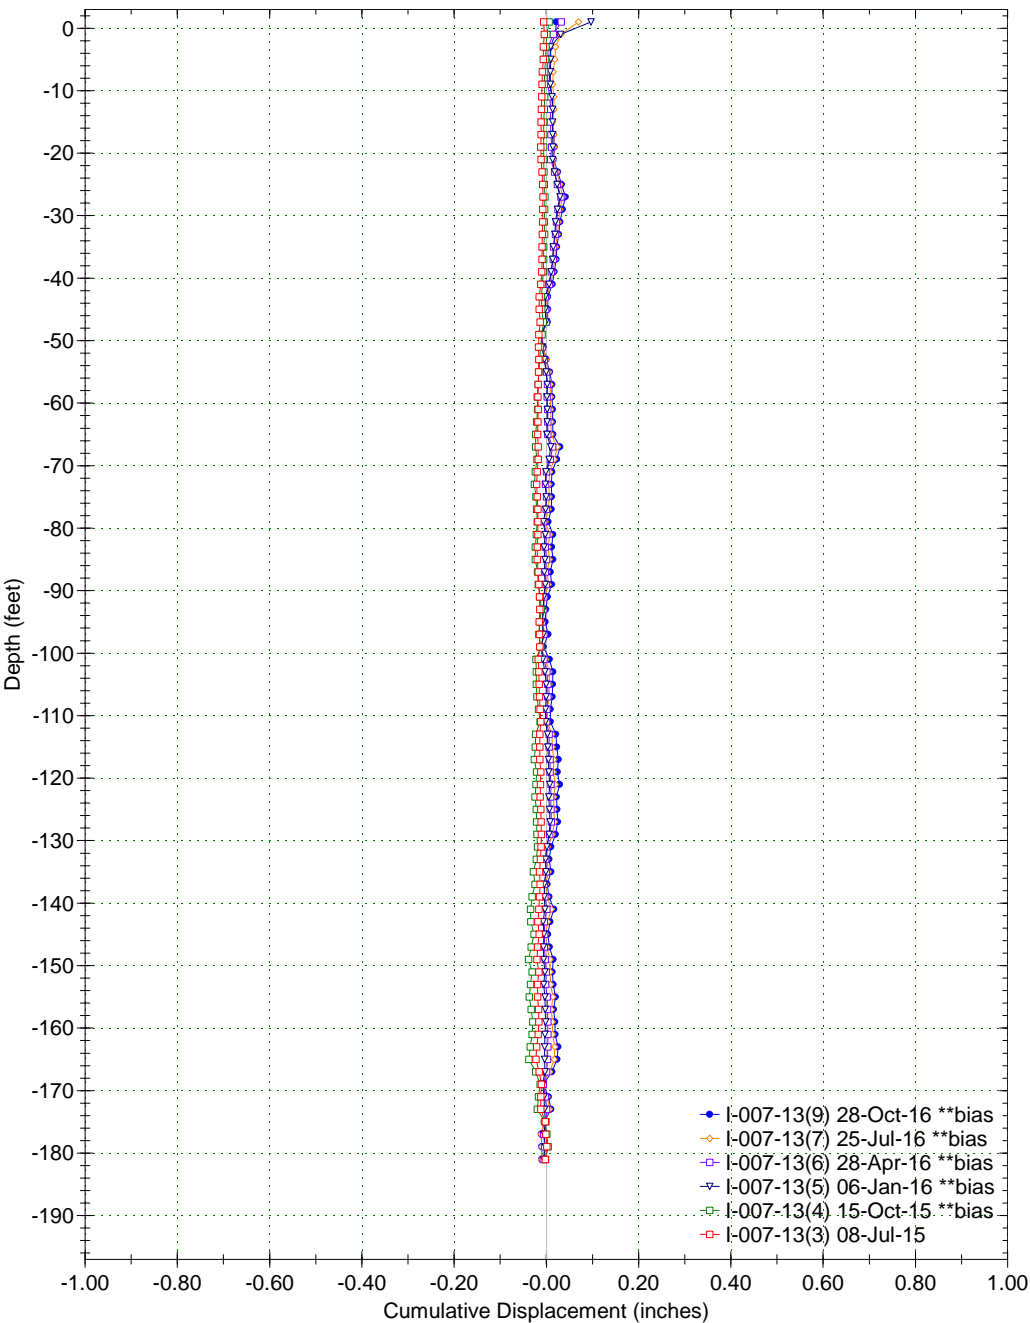
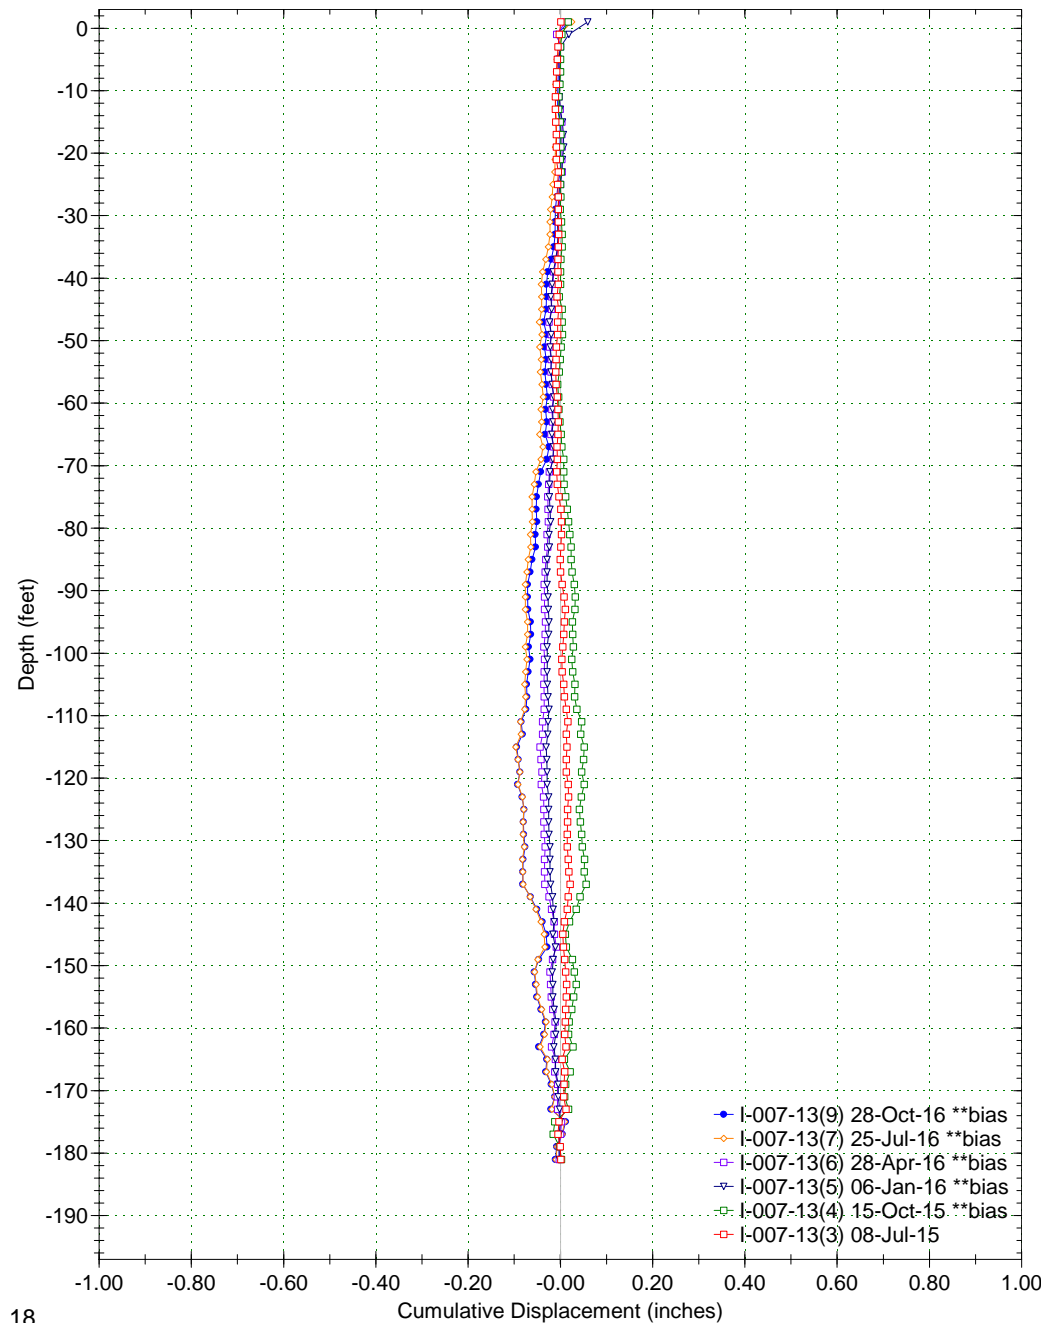
Borehole : I-007-13
 Project : CUY-90-15-24
 Location :
 Northing :
 Easting :
 Collar :

I-007-13. Inclinometer readings at this location indicate no movement since July 2016. The July and October 2016 readings appear as a mirror image of the October 2015 reading. We think this may be an issue with the data reduction program. We have discussed this with the manufacturer but have not been able to find the cause or correct the issue.
