Re: October 2016 Quarterly Report
CUY-90-15.24 Slope Monitoring
PID 96504
EDP Project No. 069032.00

OCTOBER 2016 ANNUAL REPORT

CUY-90-15.24 SLOPE MONITORING
PID 96504
CLEVELAND, OHIO
SME PROJECT NO. 069032.00

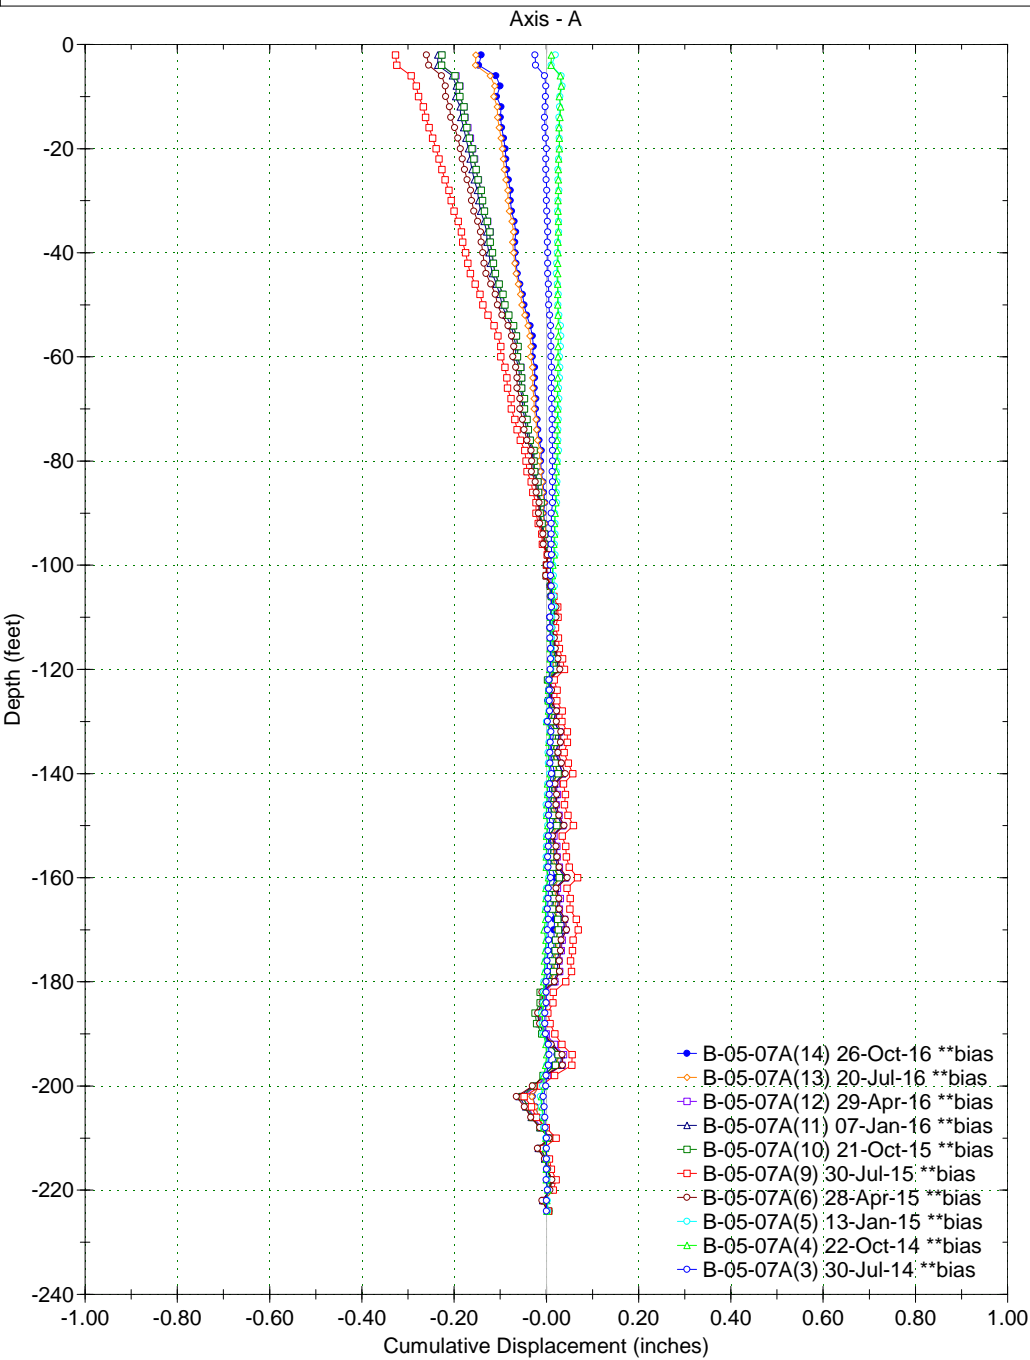
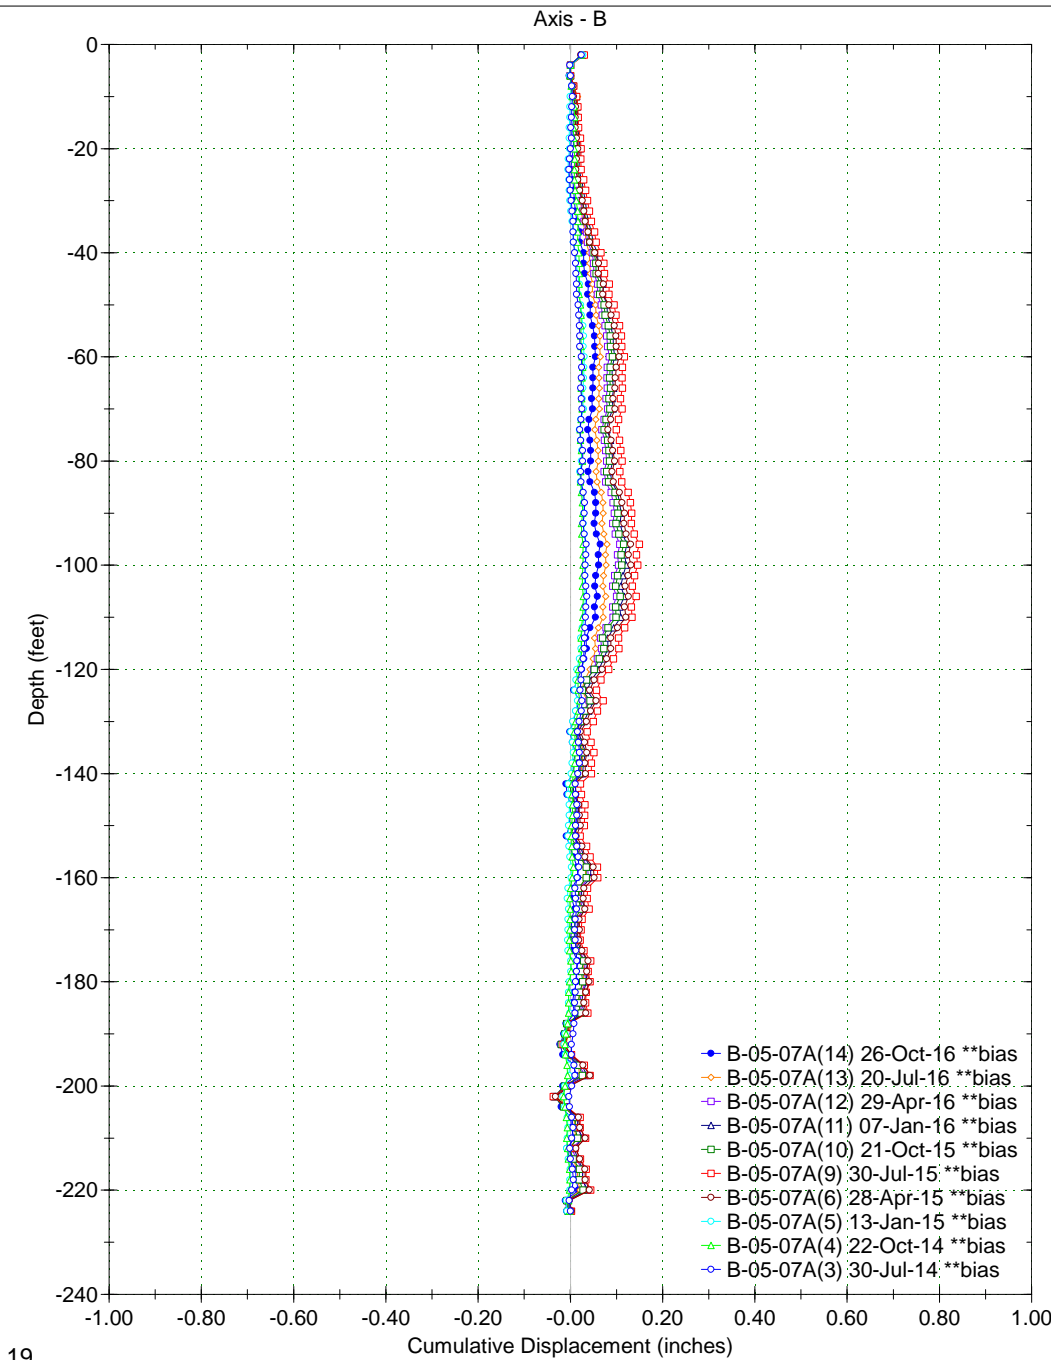
Borehole : B-05-07A
Project : CUY-90-15-24
Location : Cleveland, Ohio
Northing : 663369.991
Easting : 2189805.799
Collar :

B-05-07. Inclinometer readings at this location indicate slight movement in the positive A-axis direction from the surface to about 100 feet between April and July 2016. Throughout this year, slight movement is indicated in the negative B-axis direction from 40 to 120 feet. These changes are likely due to slight changes in the readings and are not considered to be significant.

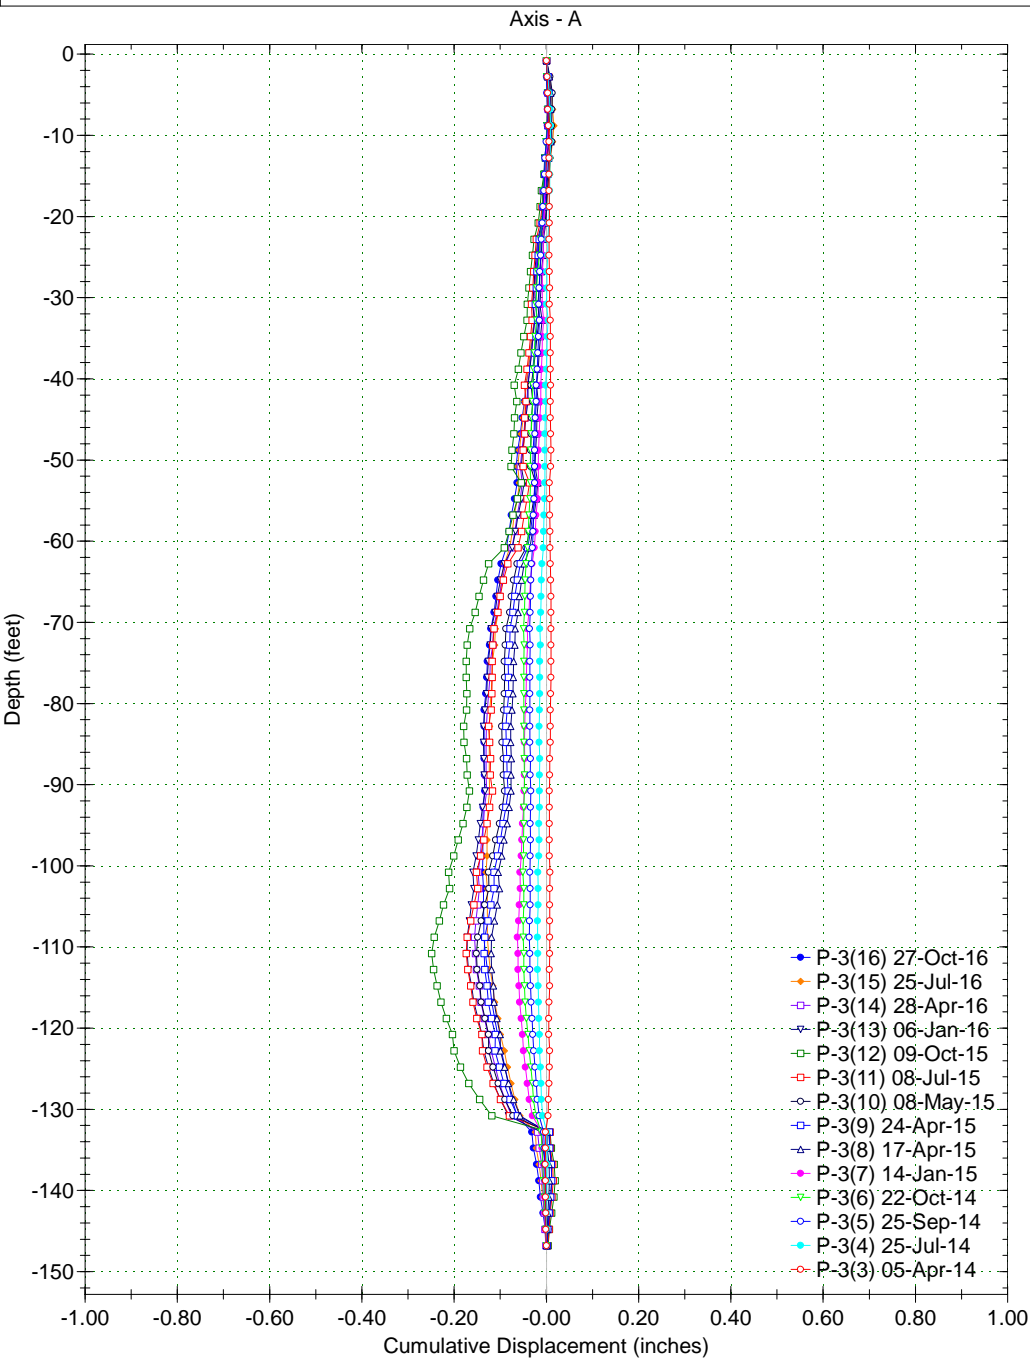
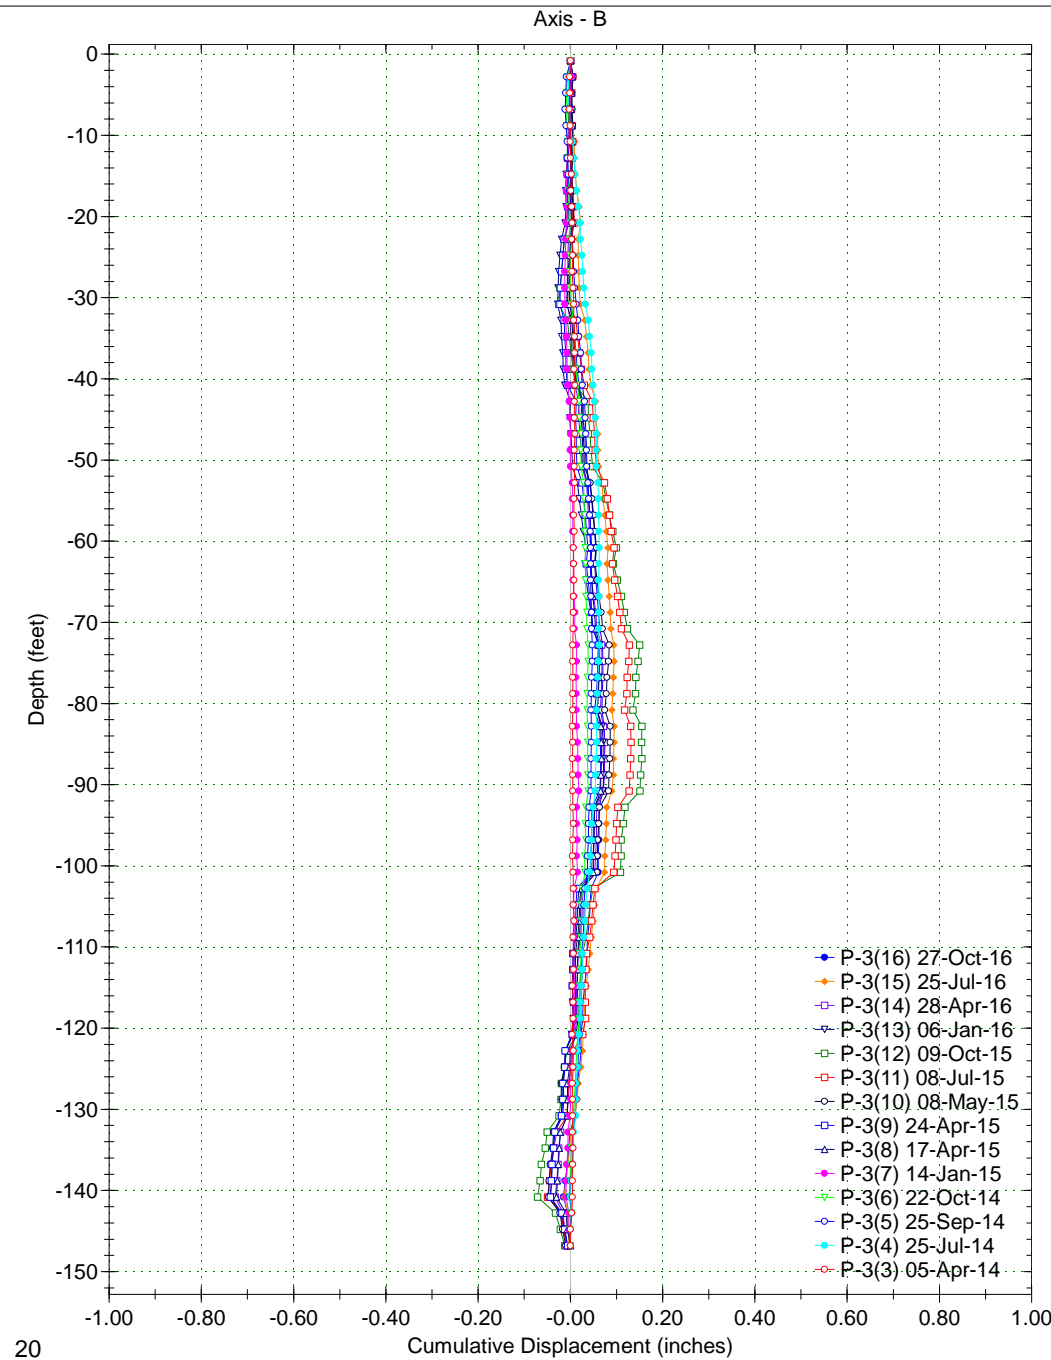
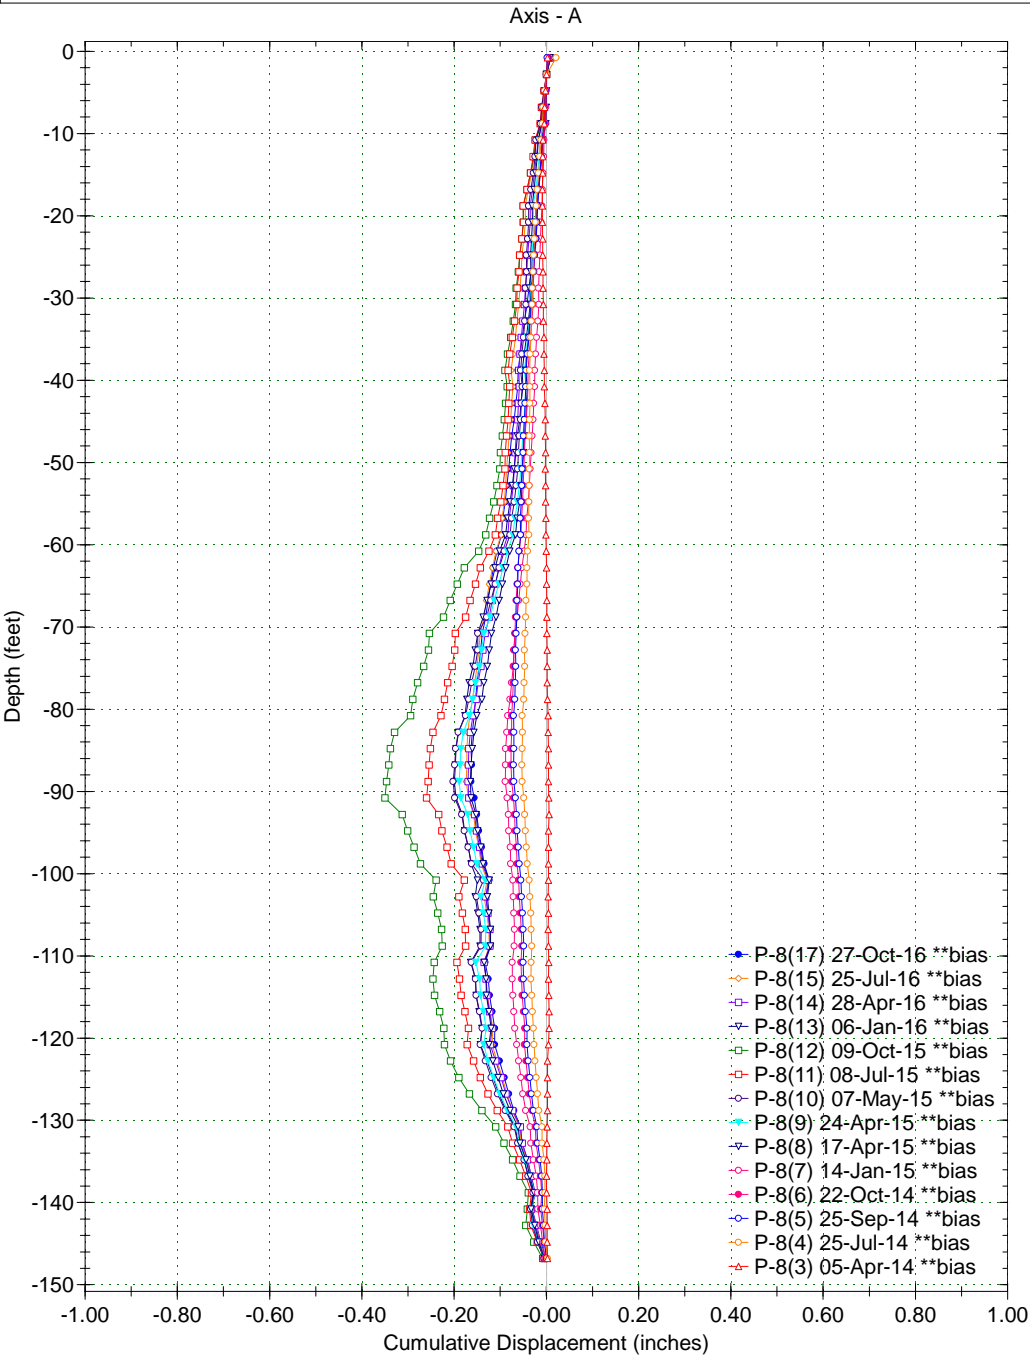
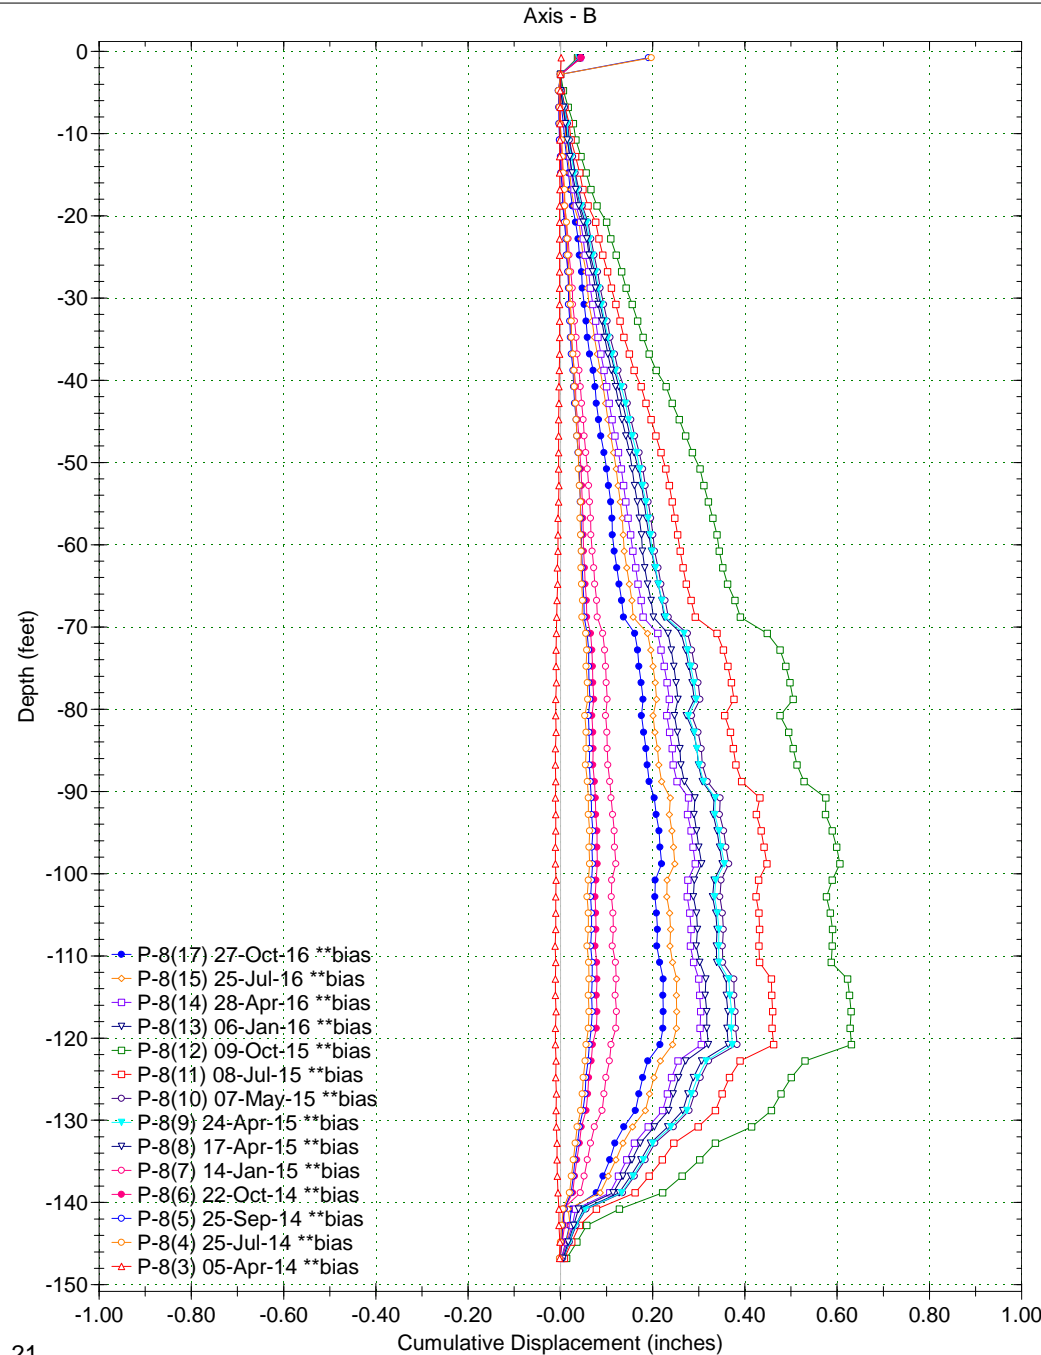
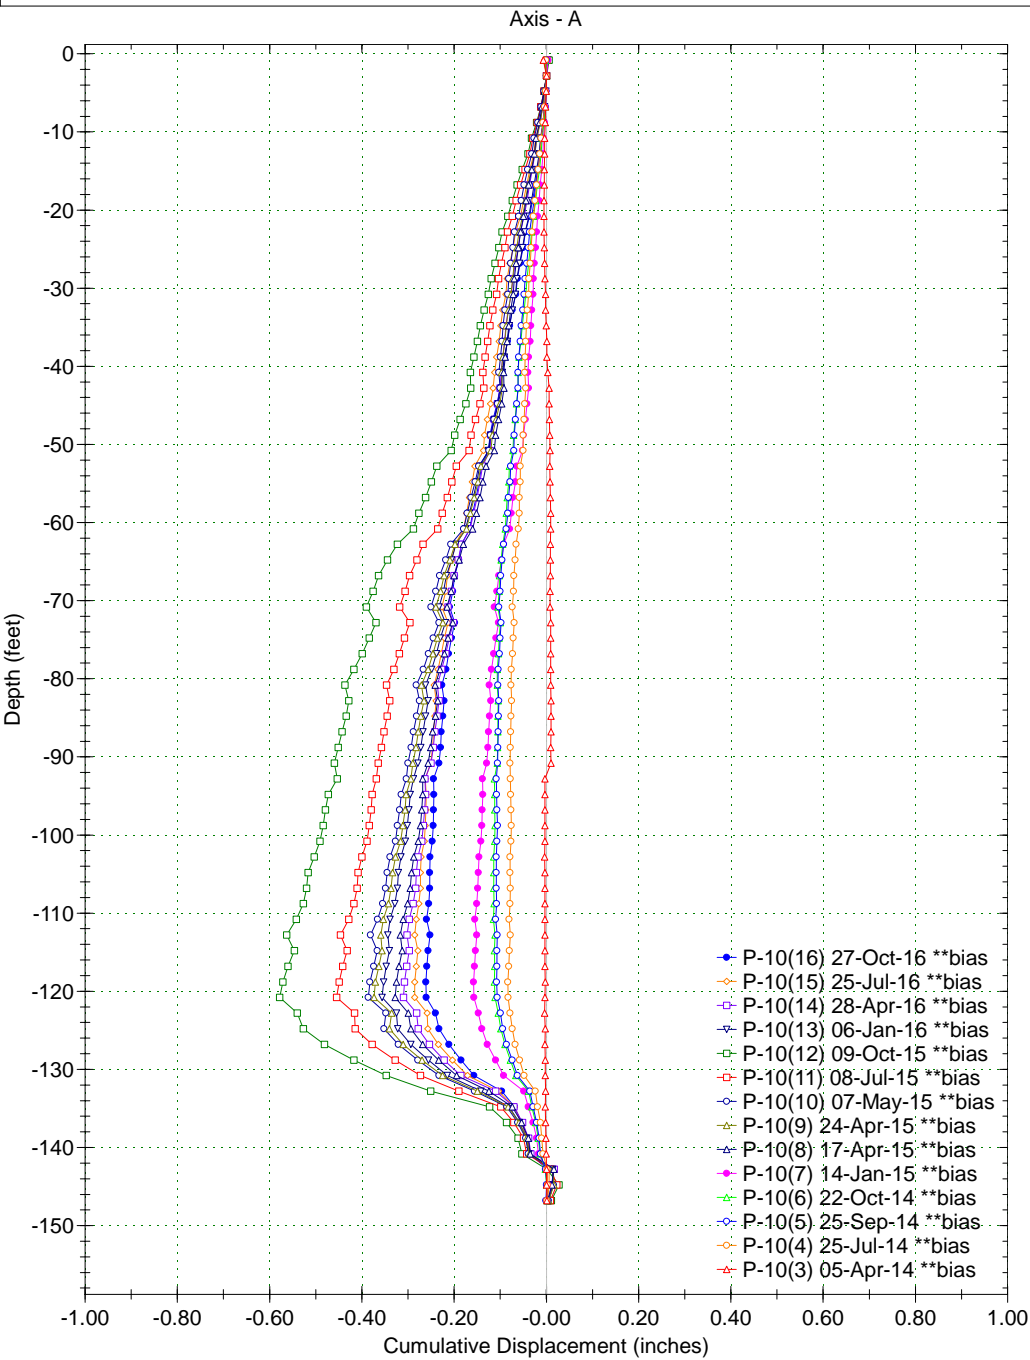
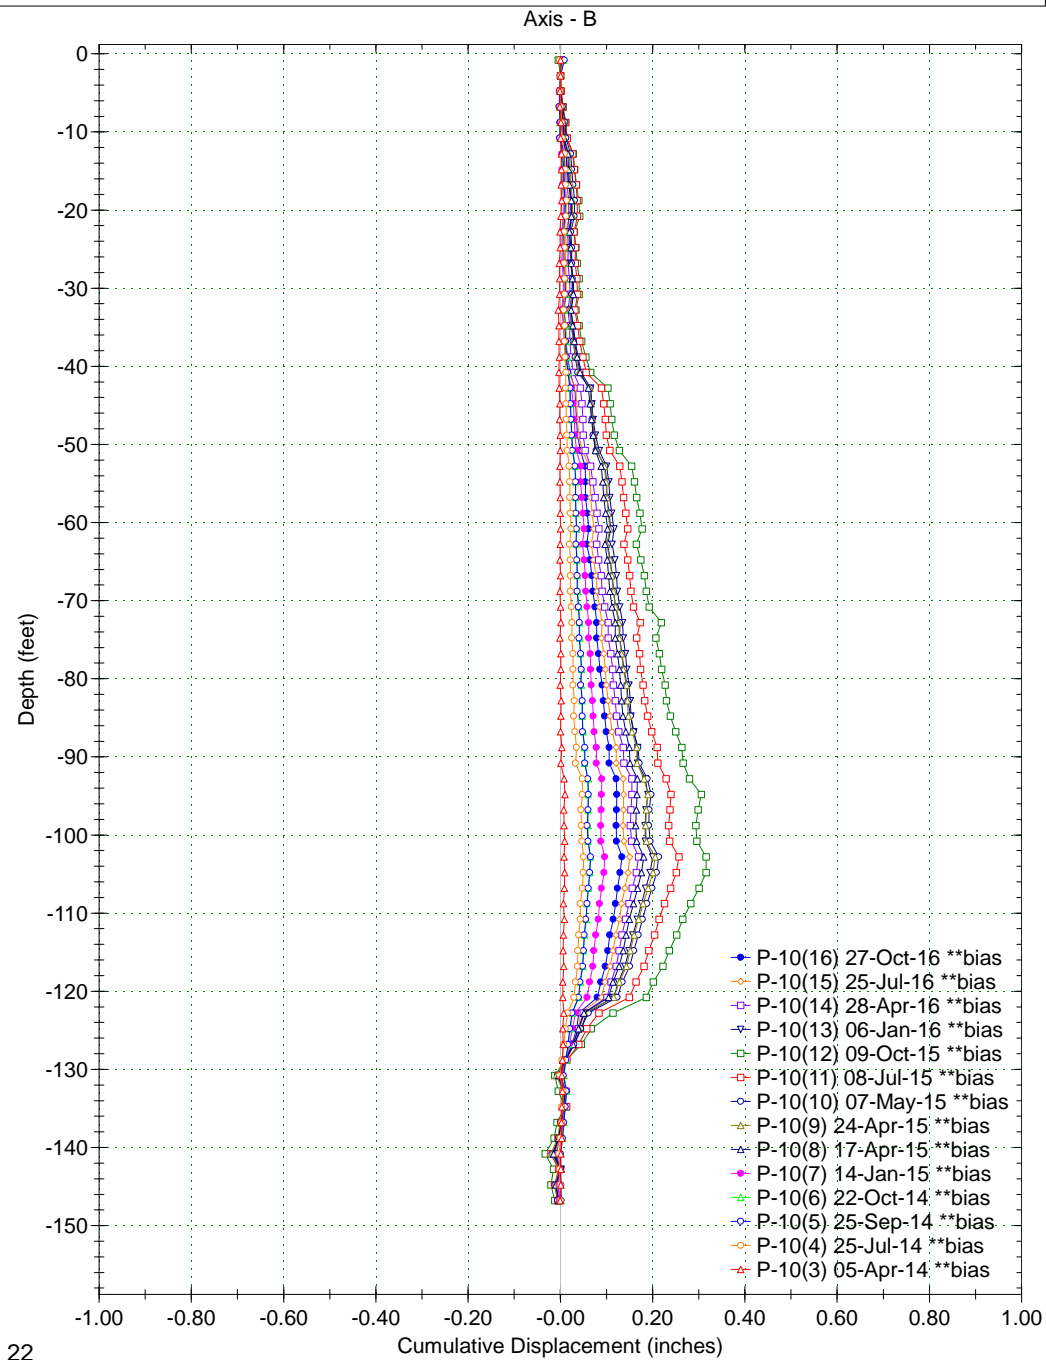
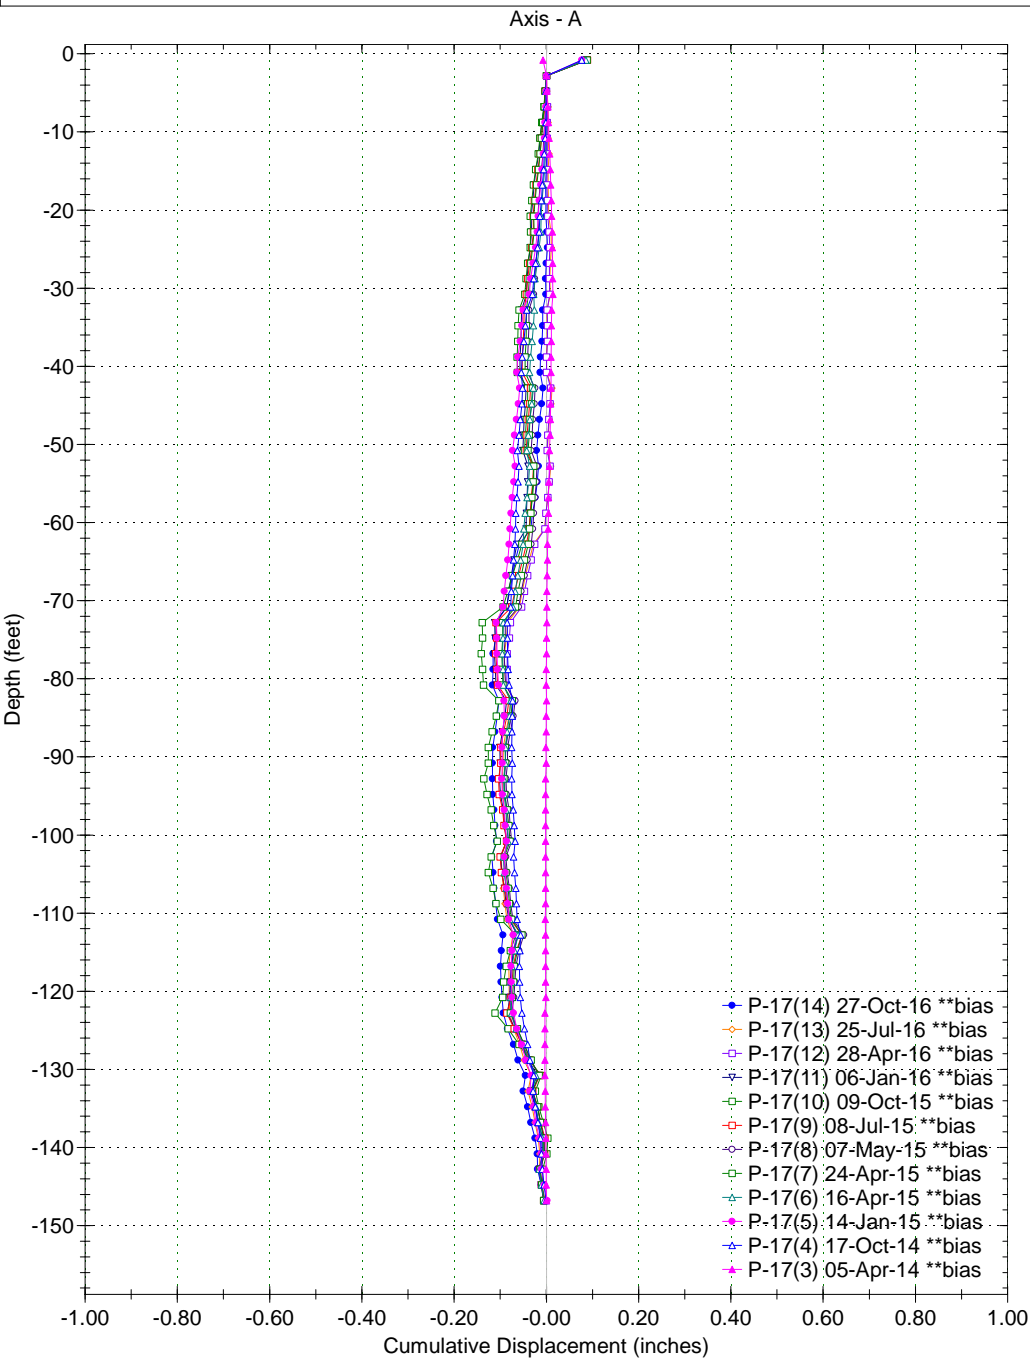
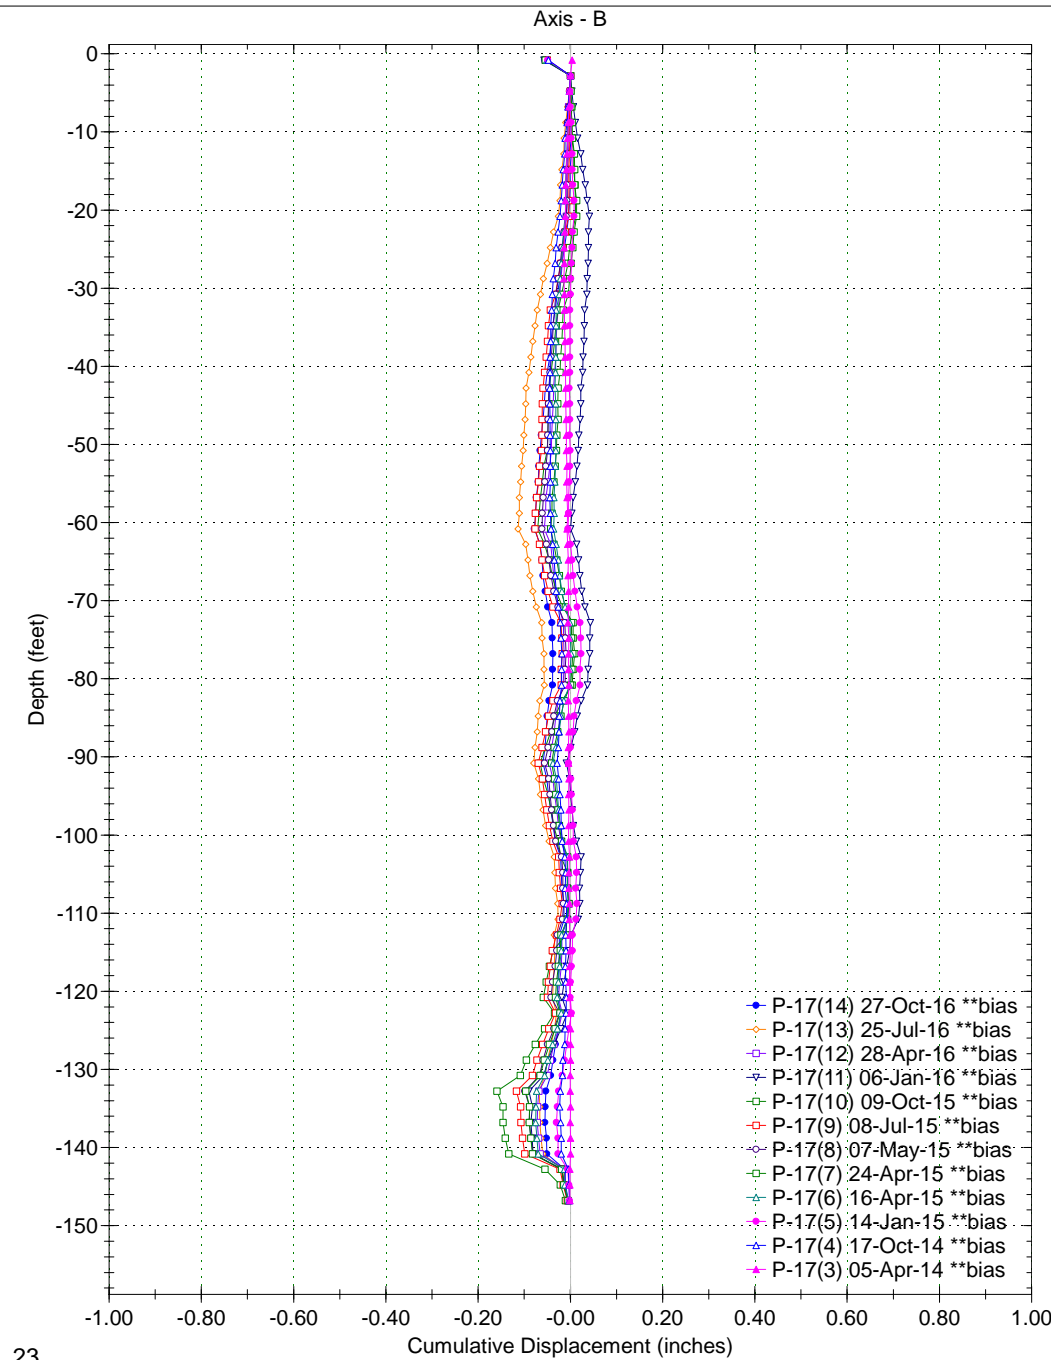
P-3, P-8, P-10, P-17. Inclinometer readings at these locations indicate movement between October 2015 and January 2016, which are a reversal in the direction of past displacements, i.e., displacement toward the baseline. The maximum displacement was about 0.2 inches at any point. At P-3, P-8, and P-10, this movement occurred in the positive A-axis and negative B-axis directions. At P-17, this movement occurred in the positive A-axis and positive B-axis directions. Since January 2016, the readings have indicated some slight but negligible displacement in both the positive and negative directions at various points along the slope tubes. This movement has generally been back toward the baseline.

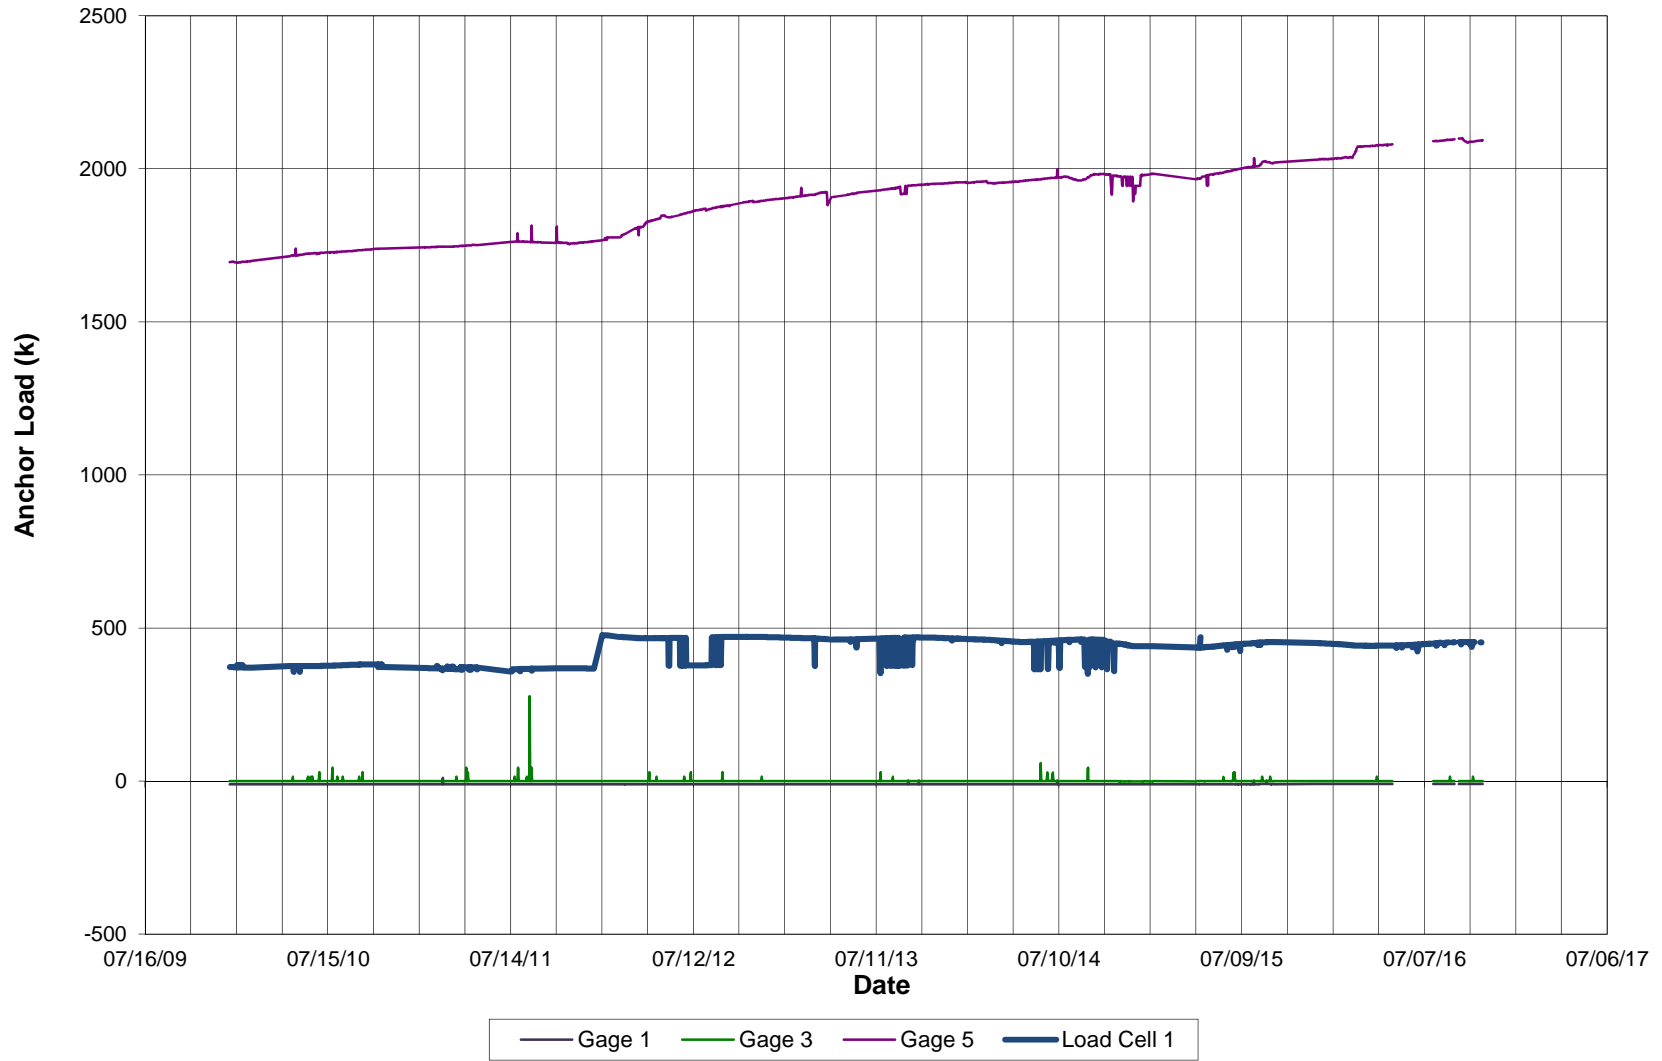
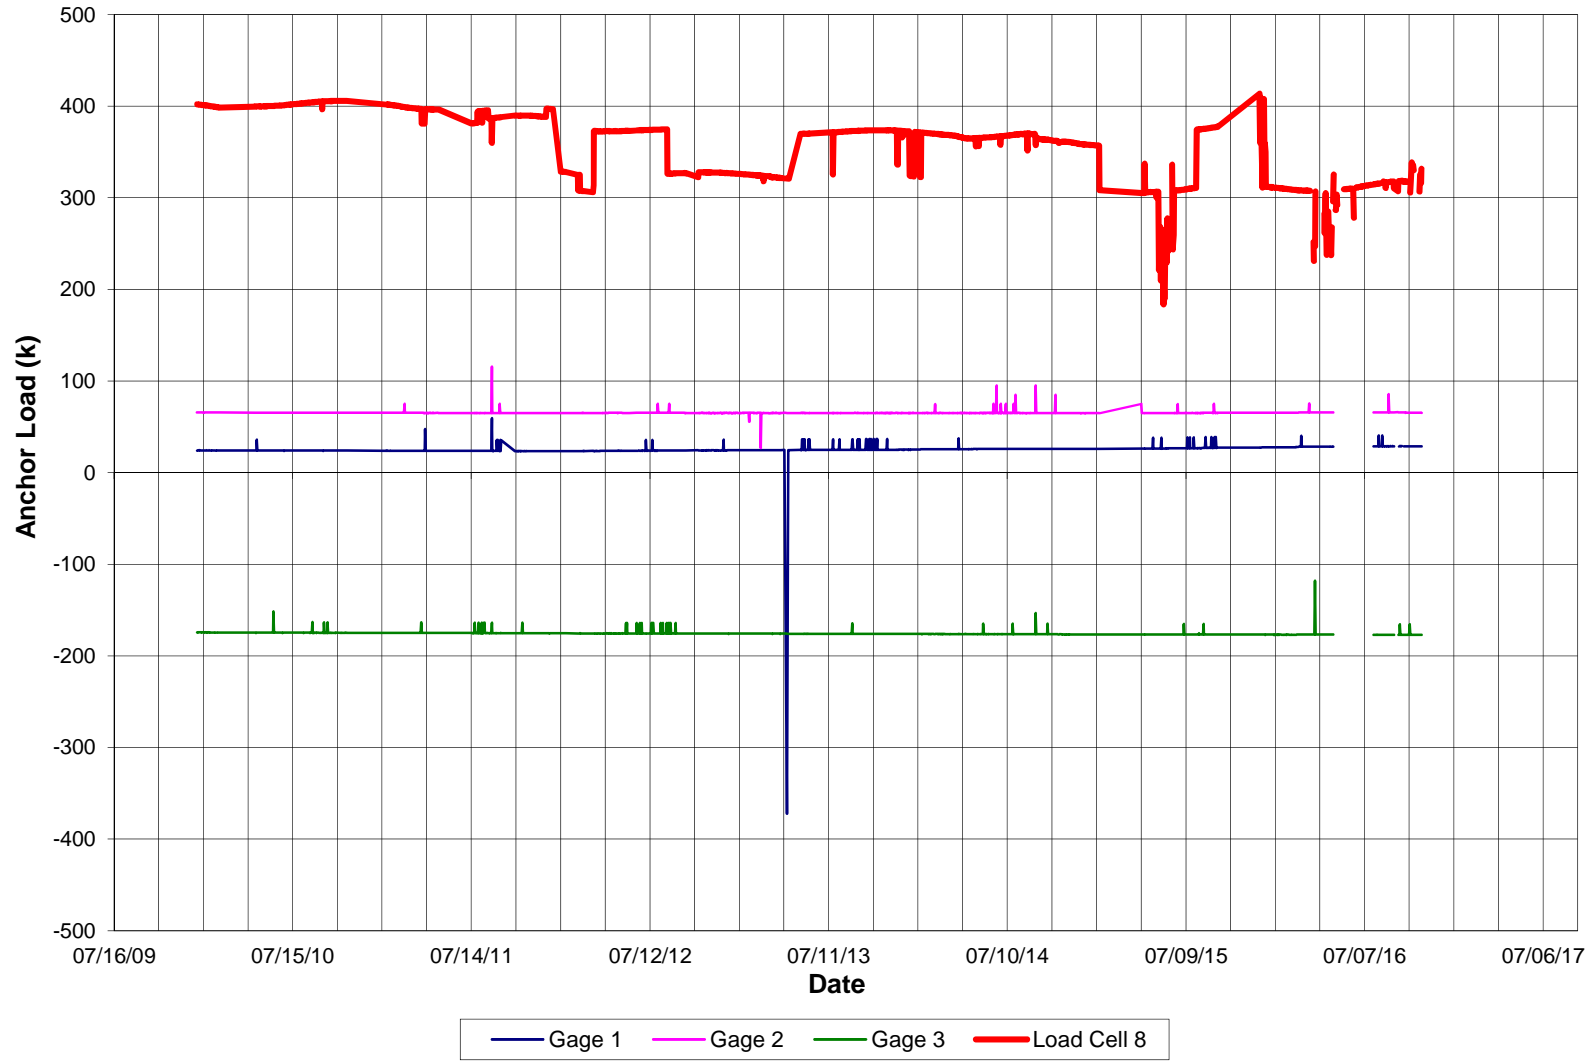
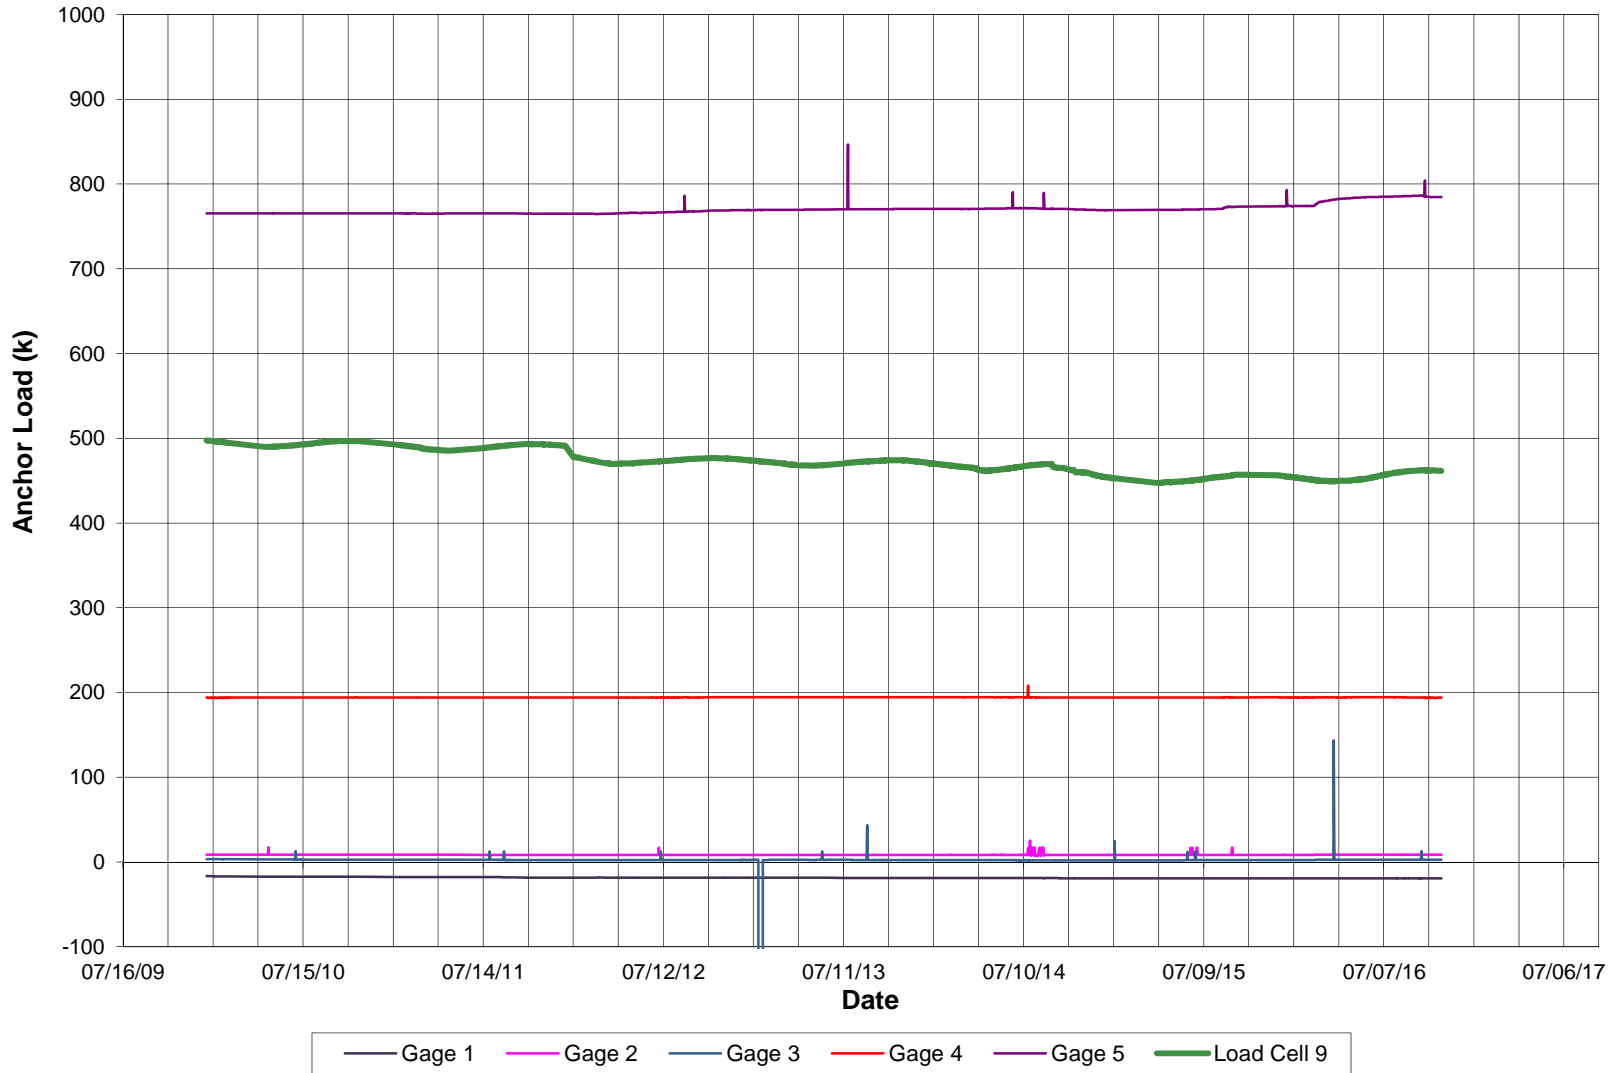
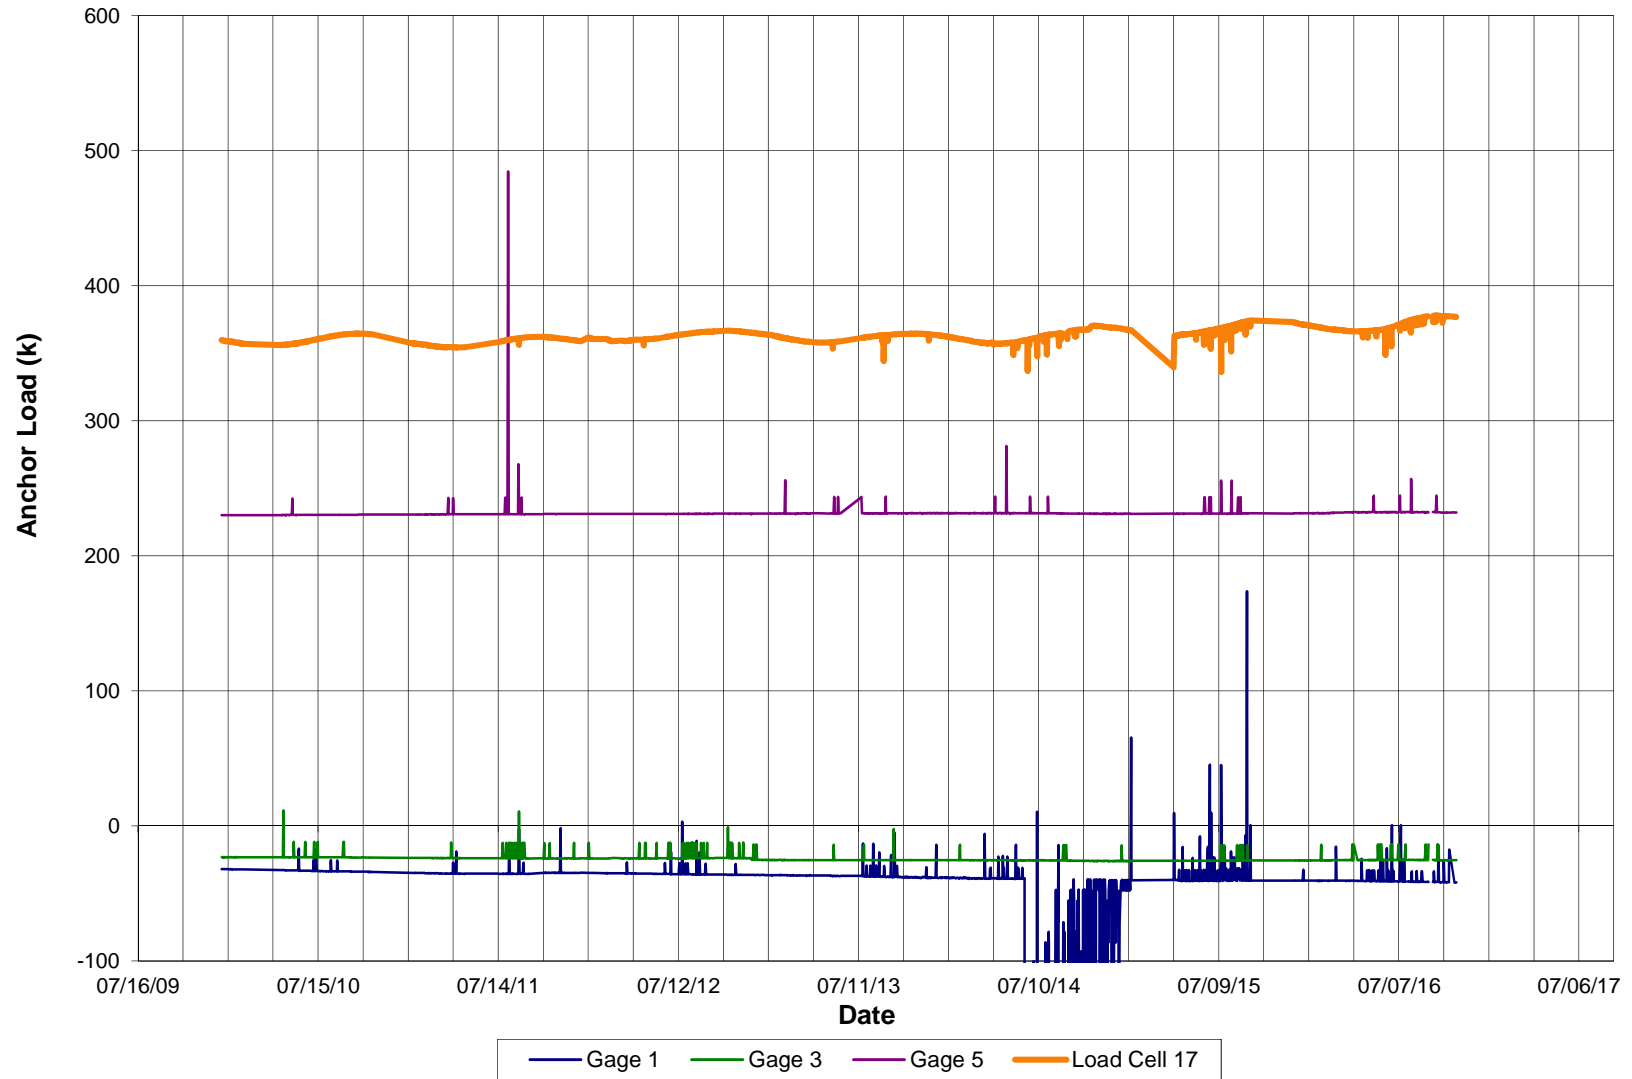
Seasonal variations are apparent in the plots for all the load cells with the usual increase in load during the summer months. The plots for all load cells indicate a slight upward trend this year. This is the first such increase we have seen since October 2009. The many spikes shown in the plot for Load Cell 8 occur when one or more of the gages in the load cell fail to record. These spikes are occurring in all load cells with the exception of Load Cell 9. Table 2 shows which gages were active in each of the load cells this quarter. A plot of the load cell data is included in Appendix B.
