Re: October 2016 Quarterly Report
CUY-90-15.24 Slope Monitoring
PID 96504
EDP Project No. 069032.00

OCTOBER 2016 ANNUAL REPORT

CUY-90-15.24 SLOPE MONITORING
PID 96504
CLEVELAND, OHIO
SME PROJECT NO. 069032.00

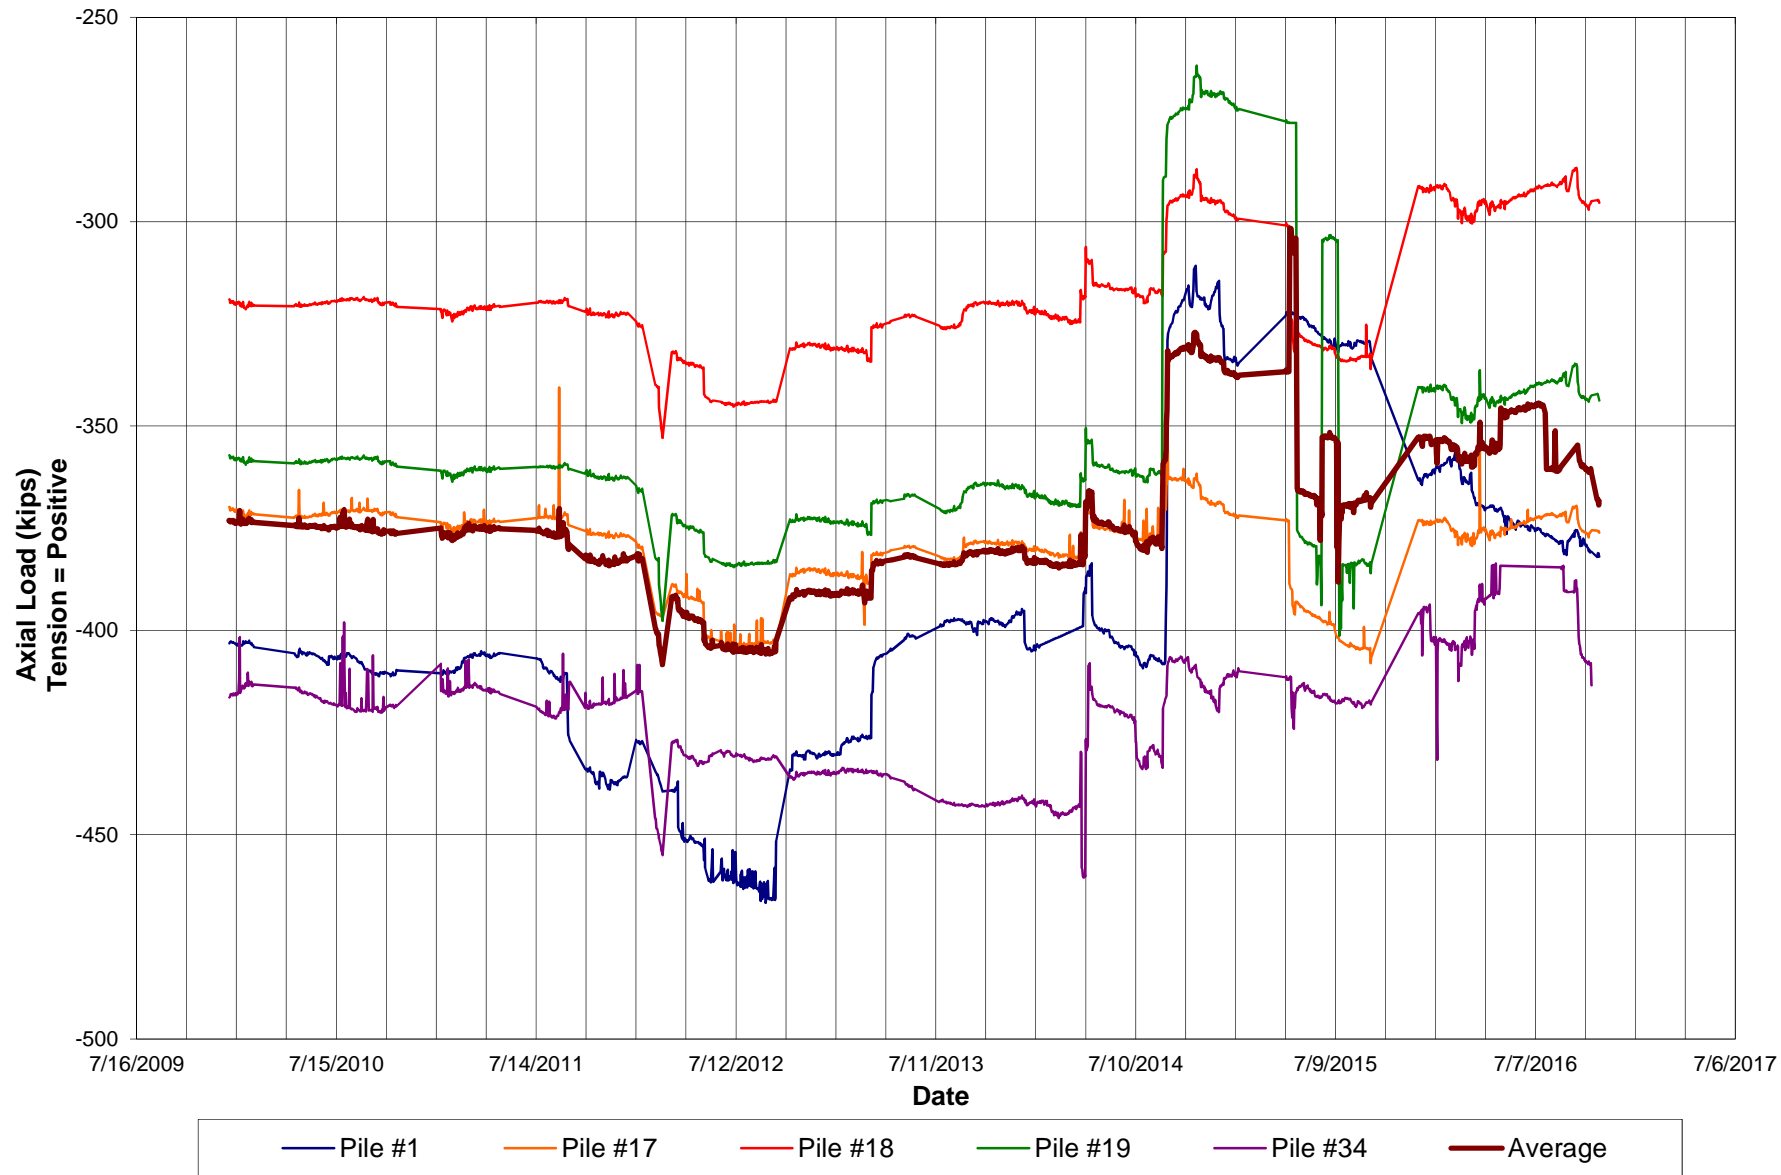
Axial loads in all driven piles except Pile 1 increased by 3 to 9 kips between January and February 2016 then gradually decreased between March and September 2016 by 10 to 15 kips. All of the gages in Pile 34 failed to record between May 5 and July 21, 2016, after which only gages 2, 3, and 4 started working again. Thus, it is difficult to interpret the changes that may have been occurring in this pile. Prior to this gap in the data, the axial load followed trends similar to the other gages except Pile 1. The axial load in Pile 1 decreased by about 6 kips between December 2015 and February 2016, then gradually increased through August 2016 when the total increase was about 20 kips. Between September 18 and October 31, 2016, the axial load in all driven piles increased by 5 to 20 kips. The largest, and apparently anomalous, increase was in Pile 34.

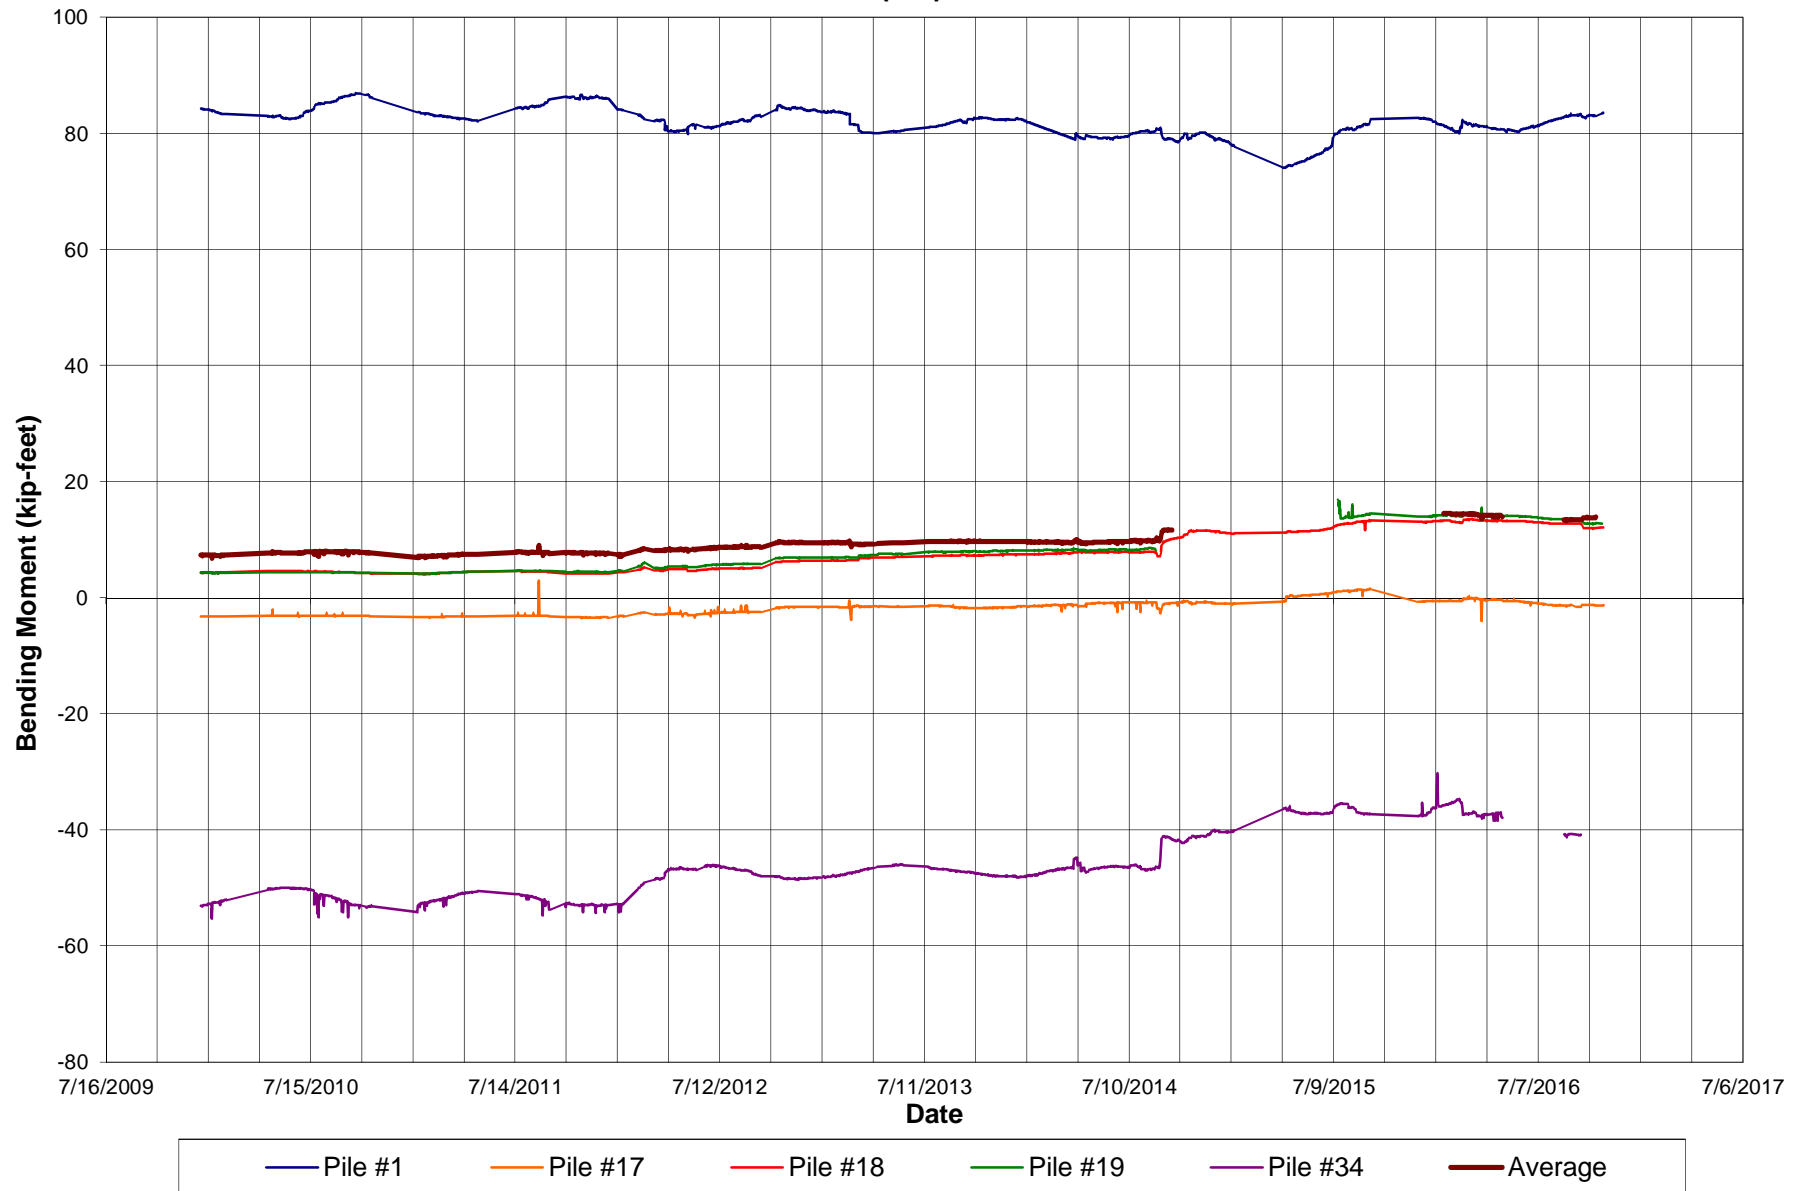
Average weak axis bending moments in Piles 1 and 34, which are at the ends of the stabilization structure, appear to have been relatively constant this past year. From 2010 through 2015 the weak axis bending moments in these piles had been trending downward. Changes in weak axis bending moments in the remaining piles were negligible. Gaps in a large part of the Pile 34 bending moment plot are due to the gage failures.

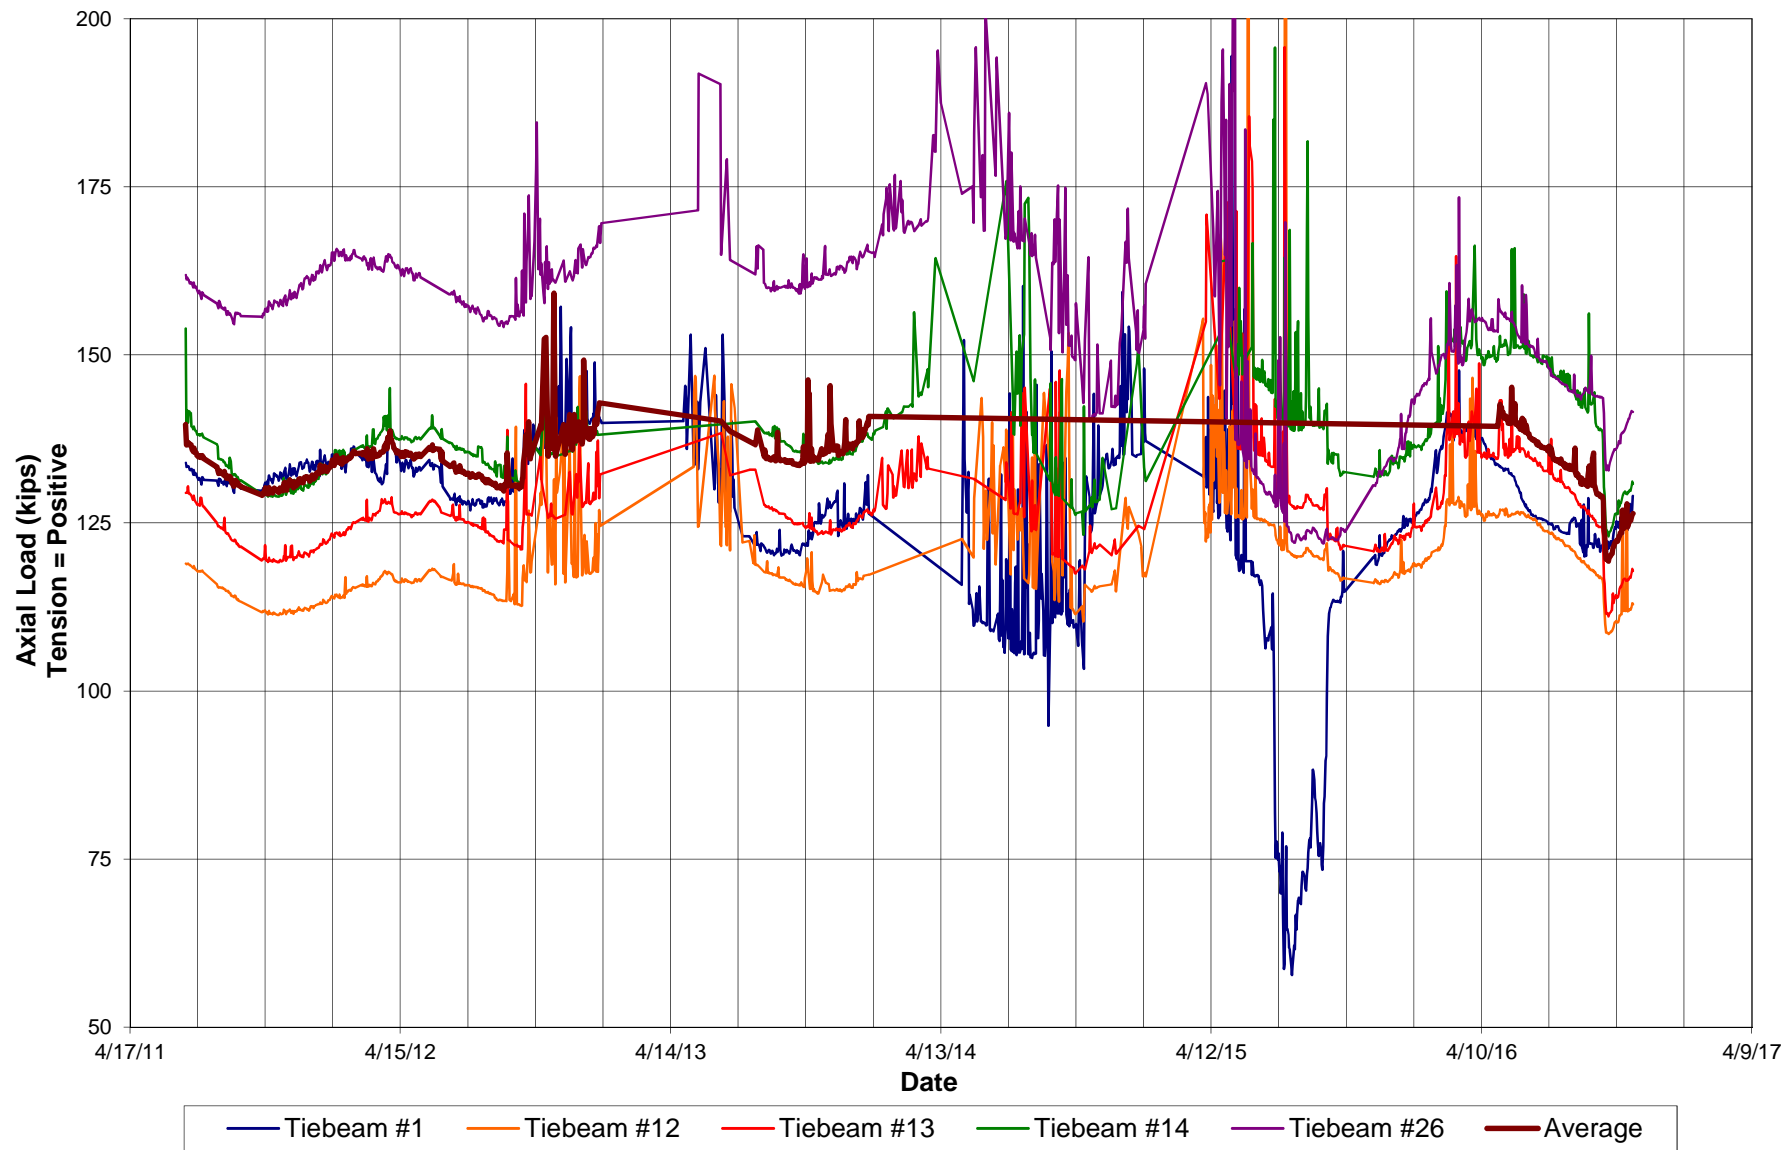
Seasonal changes are apparent in the data for the axial loads at the anchor end of the tiebeams. A seasonal peak was reached in early May 2016. Between September 20 and 25, the axial load in all of the tiebeams, except Tiebeam 1, decreased by 9 to 15 kips. Then, including Tiebeam 1, the axial load in all of the tiebeams began to increase. Axial loads are trending downward in the end tiebeams, and trending upward interior tiebeams. The spread in the axial loads between tiebeams is also narrowing. It is difficult to interpret the data for 2014-15, but it appears the difference between the maximum and minimum seasonal loads is greater this year than in past years.

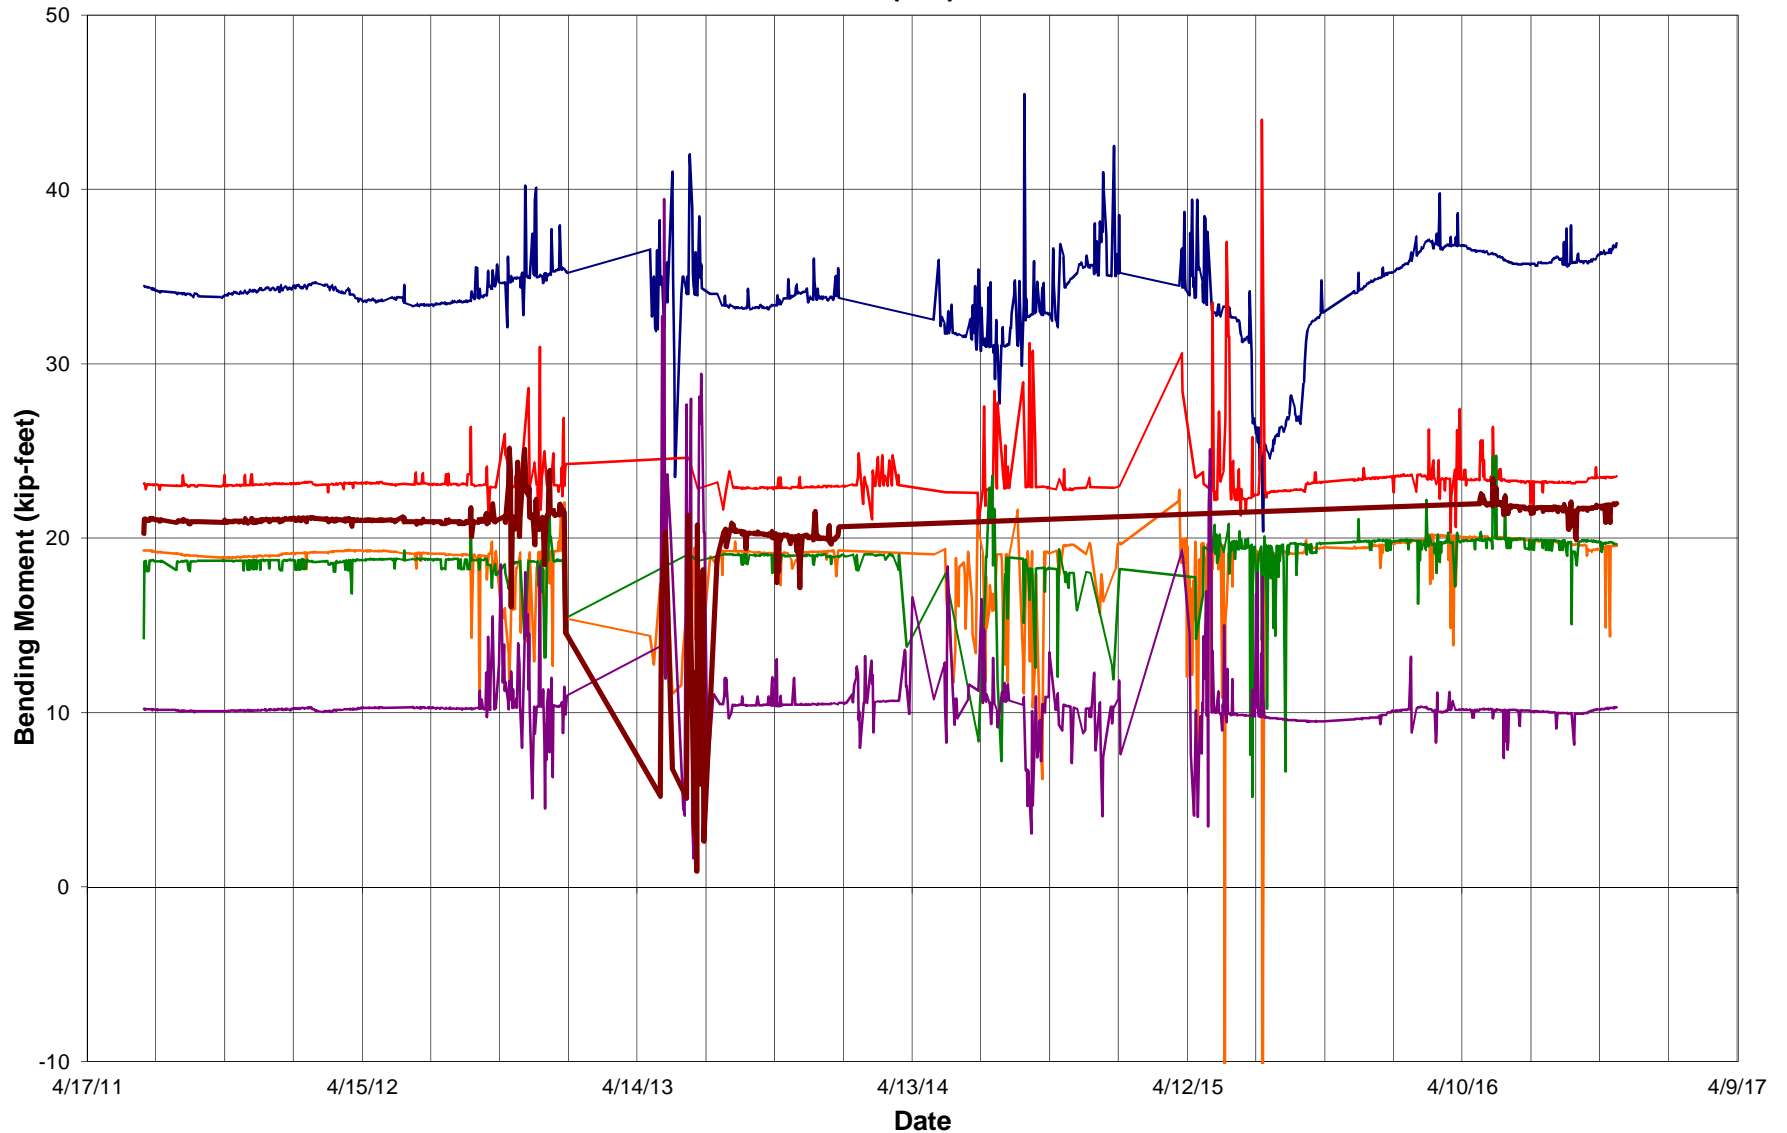
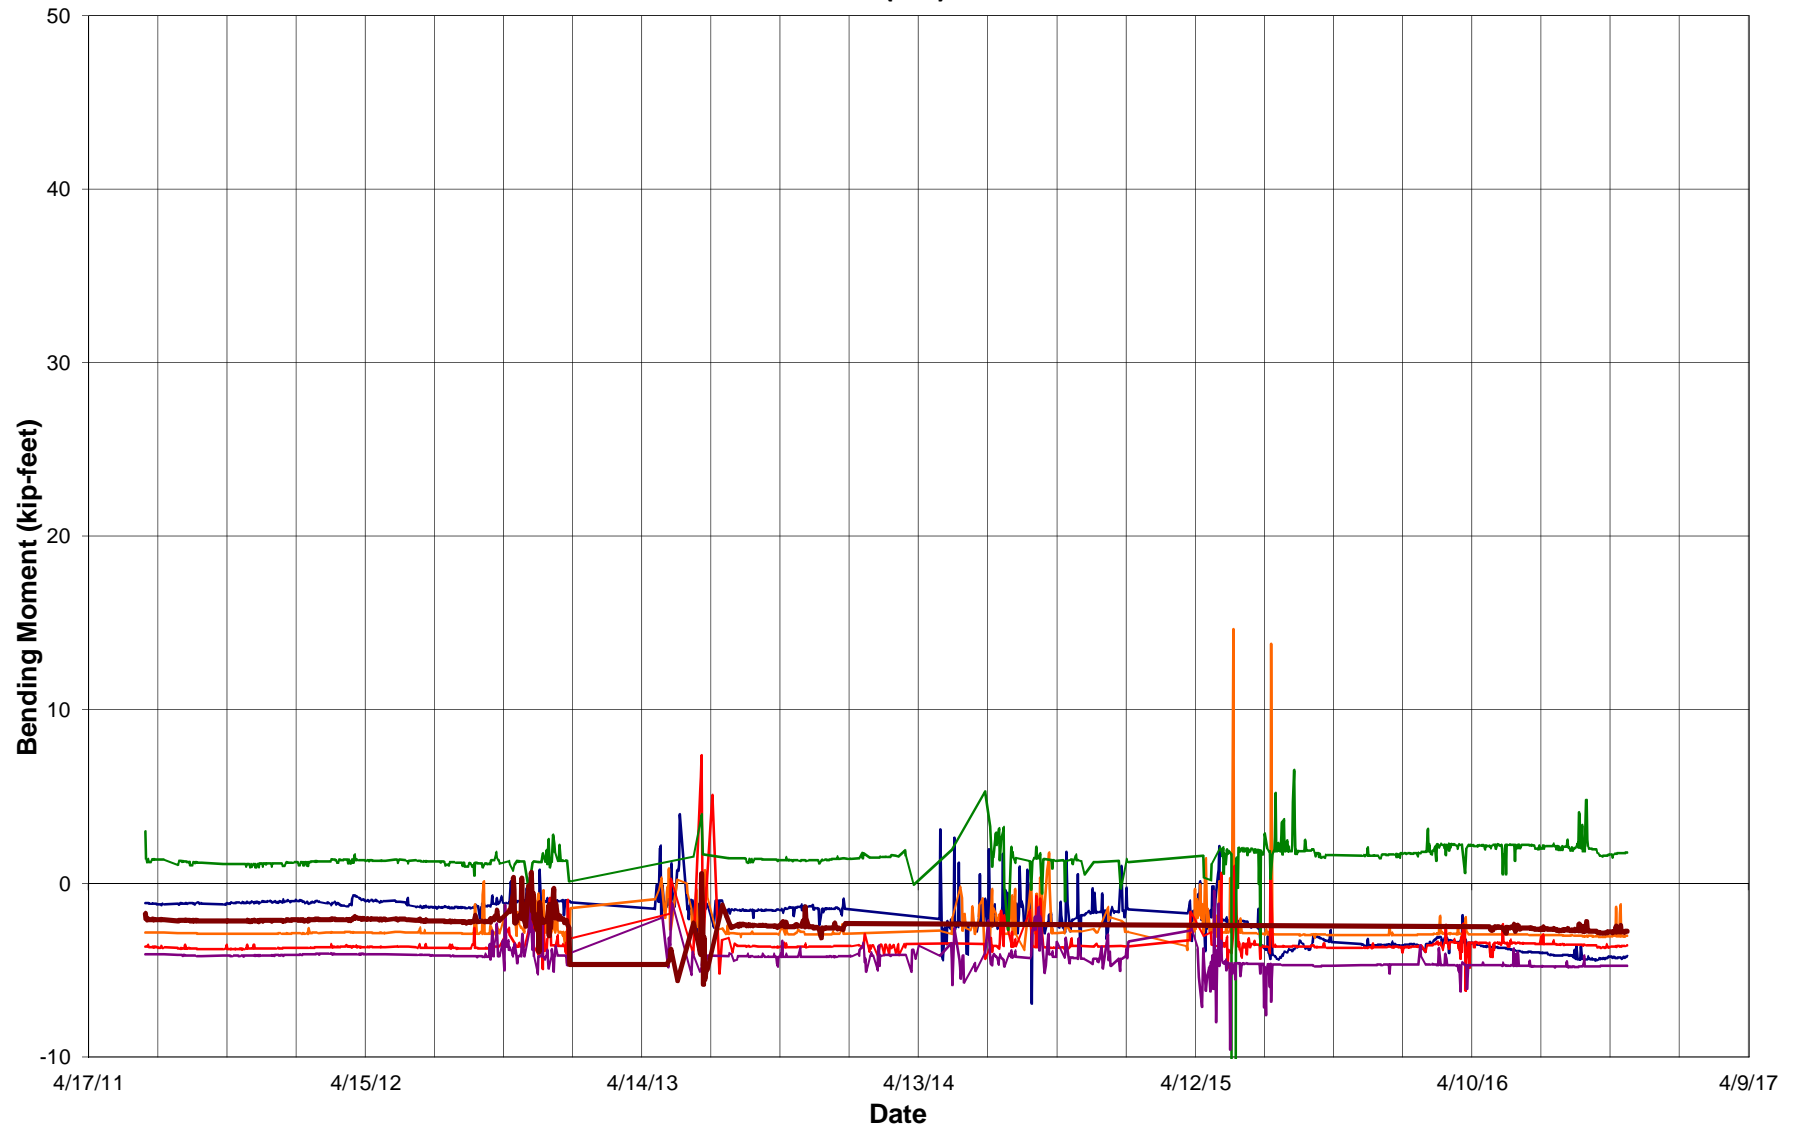
With the exception of Tiebeam 1, strong axis bending moments were constant this year. The strong axis bending moment in Tiebeam 1 increased by about 10 kip-feet between July and December 2015, decreased by about 1 kip-foot between April and July 2016, then increased by about 1 kip-foot between July and October 2016. Changes in weak axis bending moments were negligible for all tiebeams.

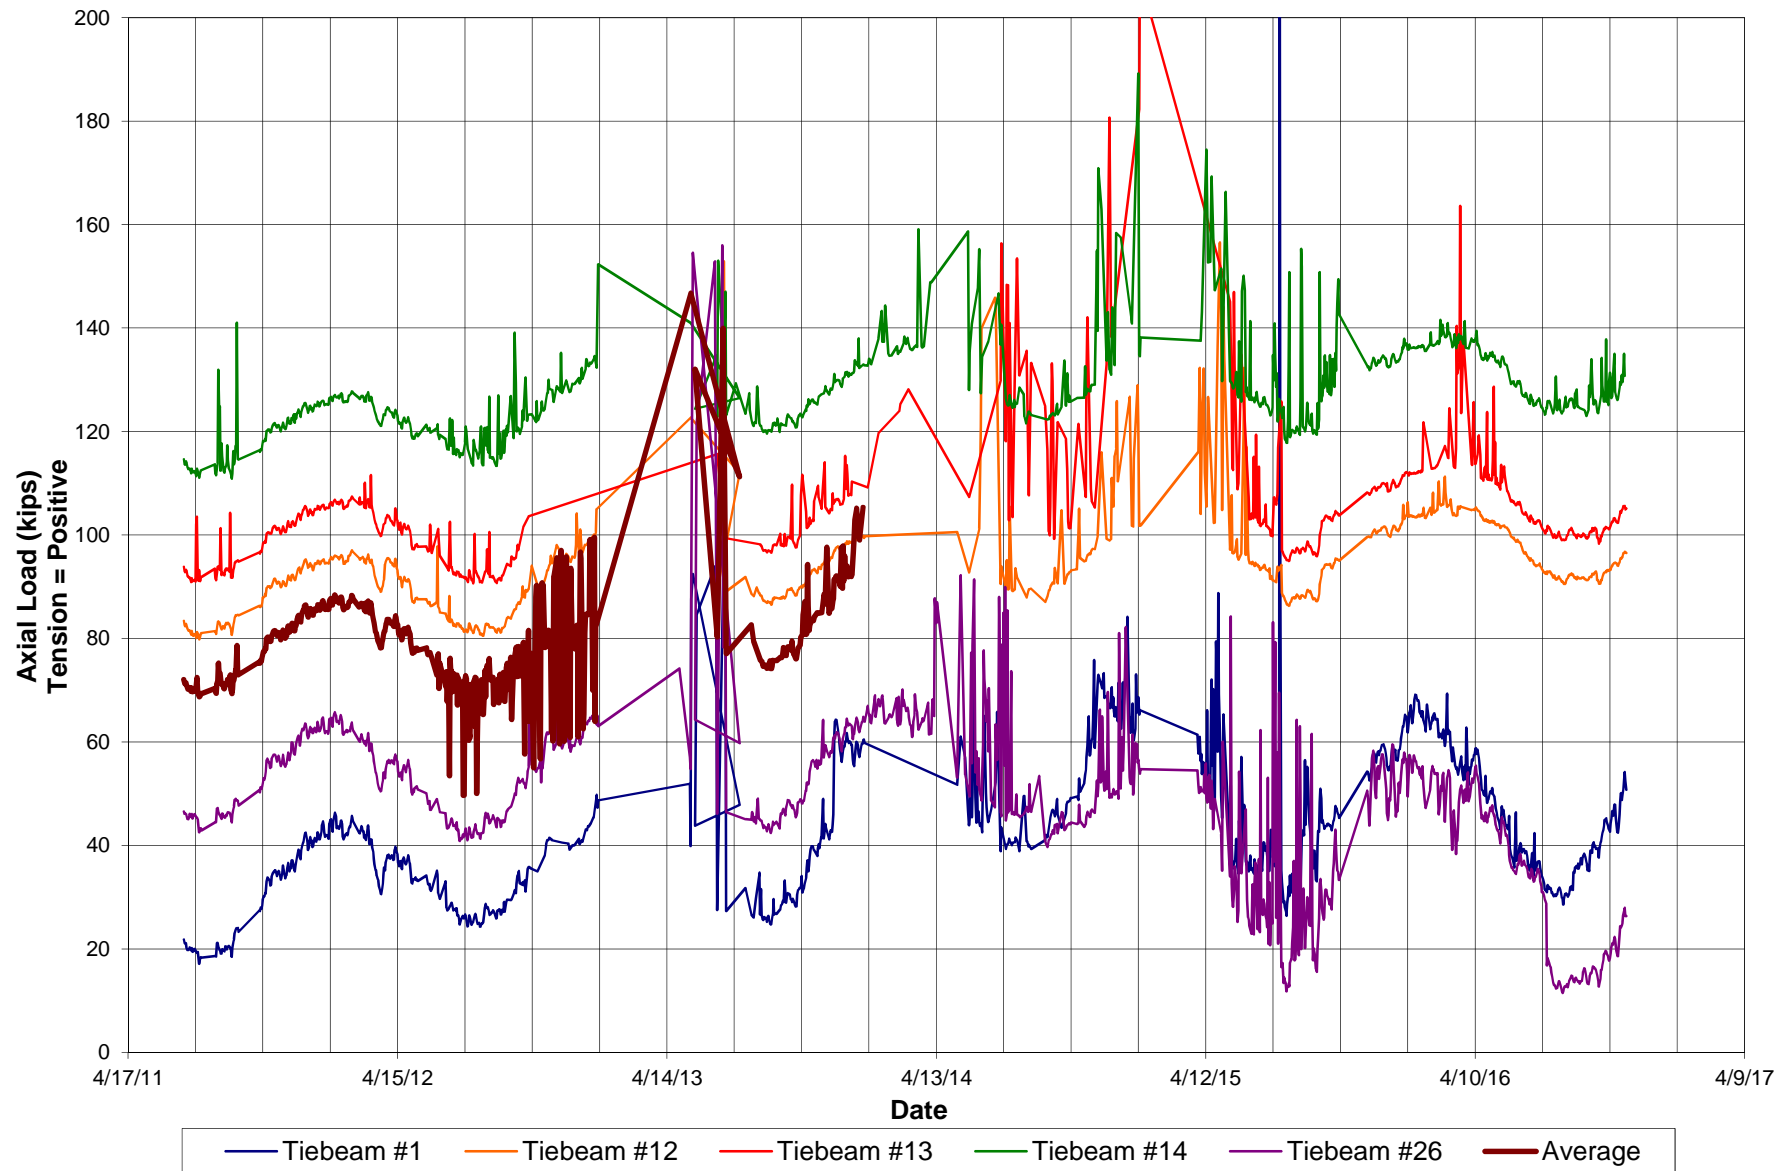
Seasonal changes are also seen in the axial loads in the tiebeams on the drilled pier side, reaching peak loads between February and March, and seasonal lows in August. Axial loads in Tiebeams 1 and 26 show larger changes than we have seen in previous years, decreasing by 39 kips and 44 kips, and increasing by 25 kips and 15 kips, respectively. Axial loads in the other tiebeams show seasonal changes similar to past years.

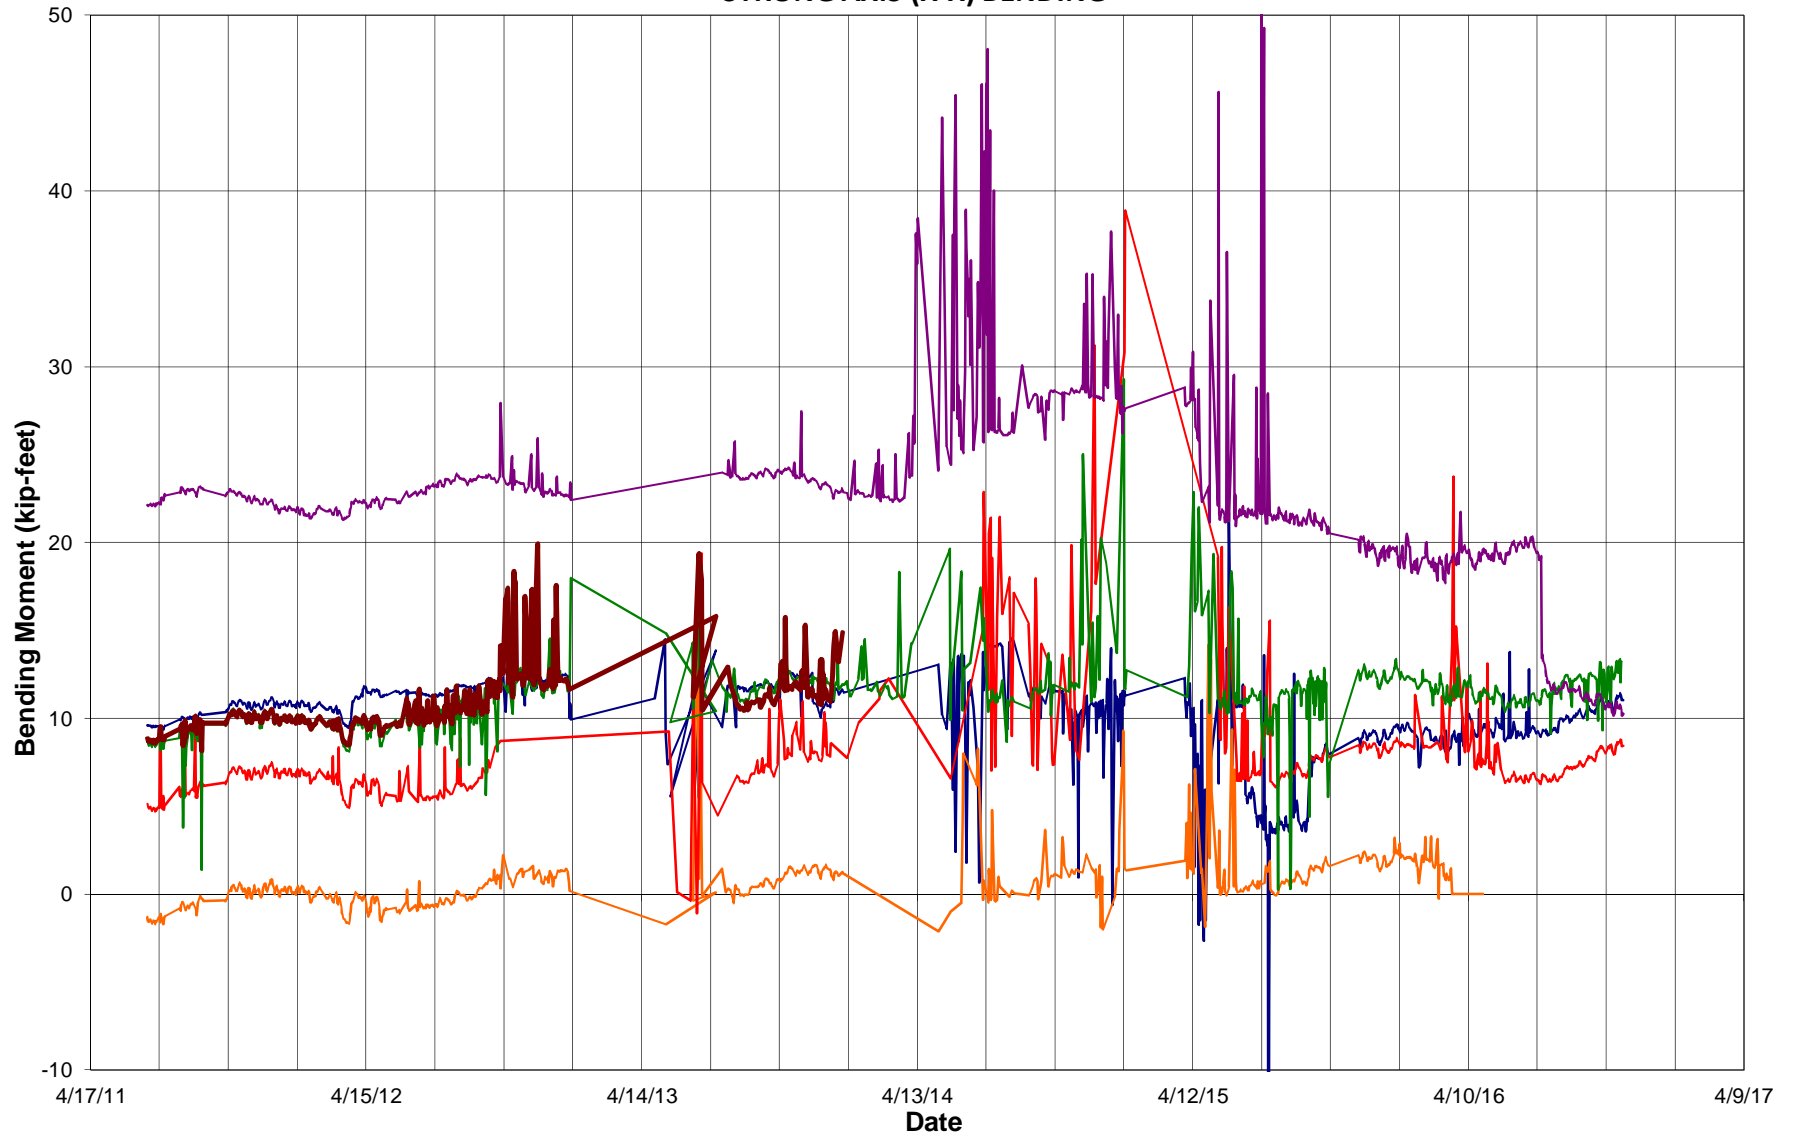
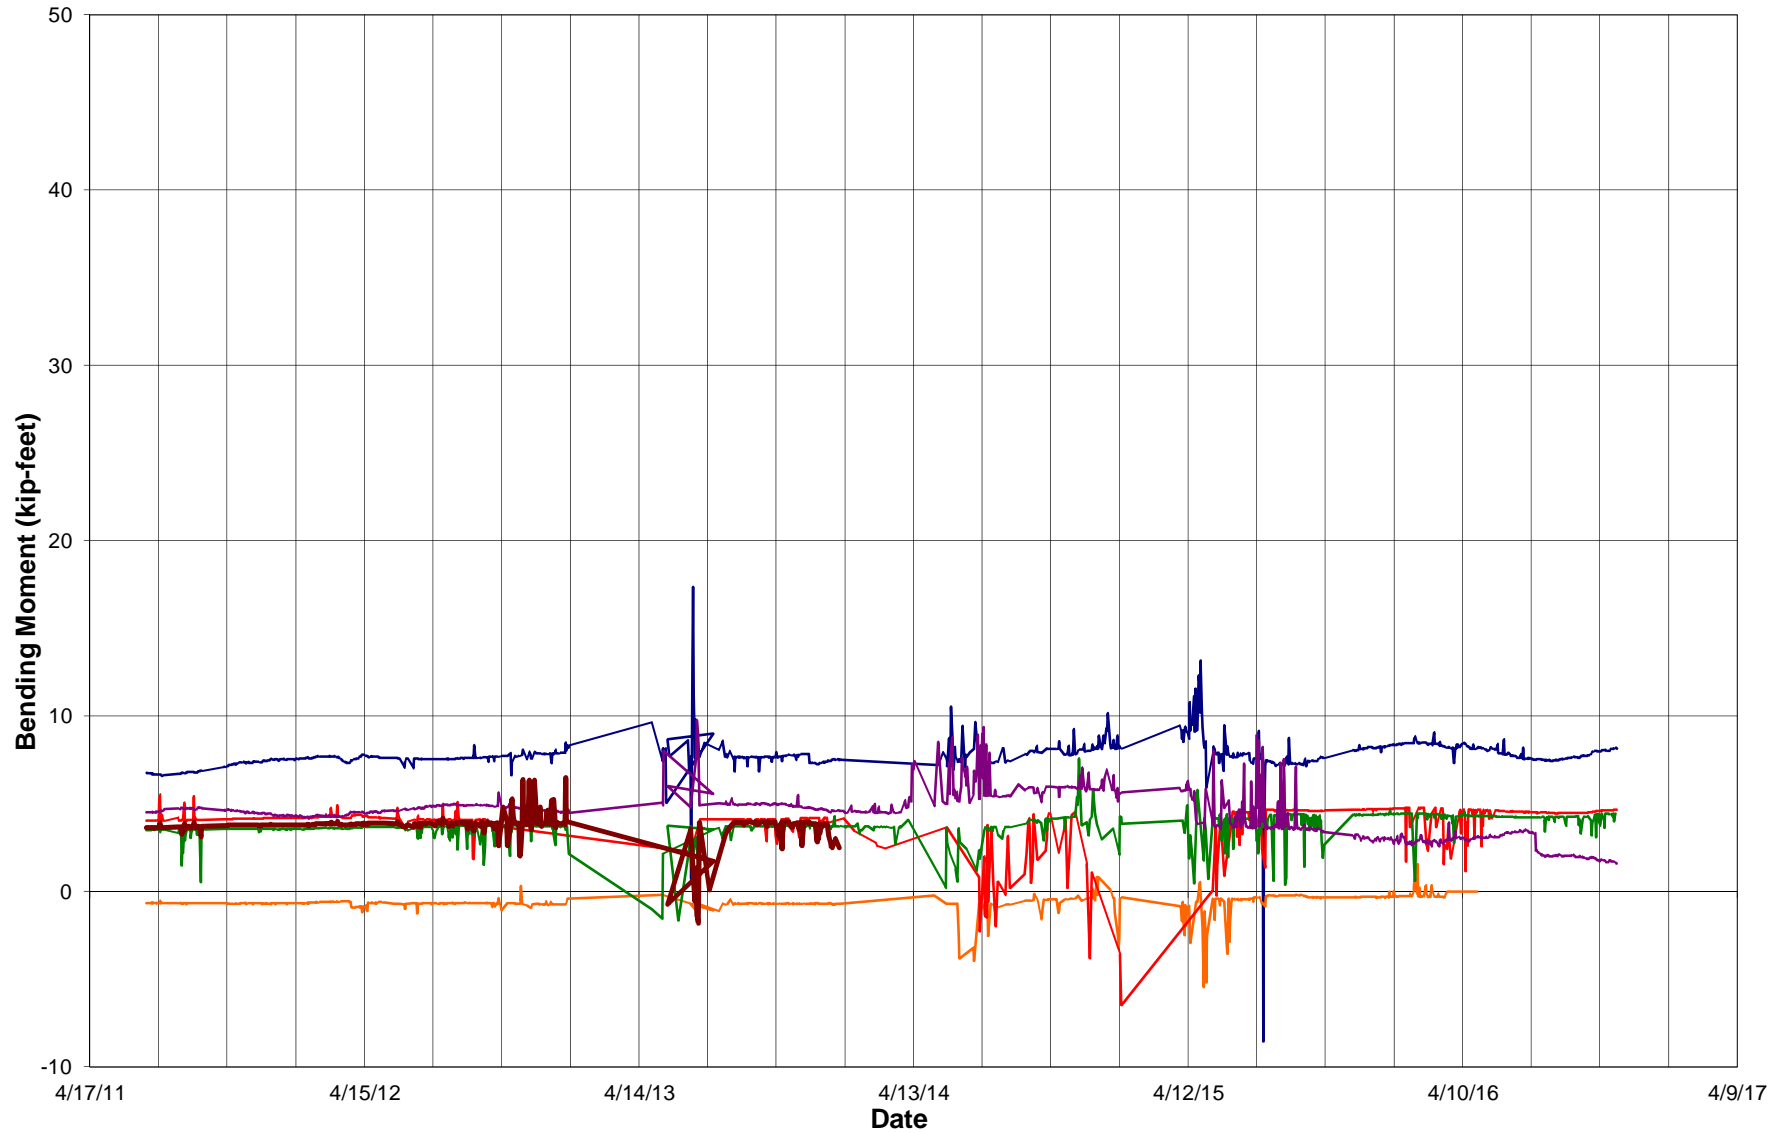
Strong axis bending moments exhibited seasonal changes, decreasing between October and April and then increasing. In July 2016, the strong axis bending moment in Tiebeam 26 decreased suddenly by about 8 kip-feet, then continued to decrease gradually. This corresponds to a similar

decrease in the axial load in this tiebeam. No bending moment data is presented for Tiebeam 12 due to gage failures. Changes in weak axis bending moments were negligible except for Tiebeam 26, which decreased by about 1 kip-foot in July 2016.
