Re: October 2016 Quarterly Report
CUY-90-15.24 Slope Monitoring
PID 96504
EDP Project No. 069032.00

OCTOBER 2016 ANNUAL REPORT

CUY-90-15.24 SLOPE MONITORING
PID 96504
CLEVELAND, OHIO
SME PROJECT NO. 069032.00

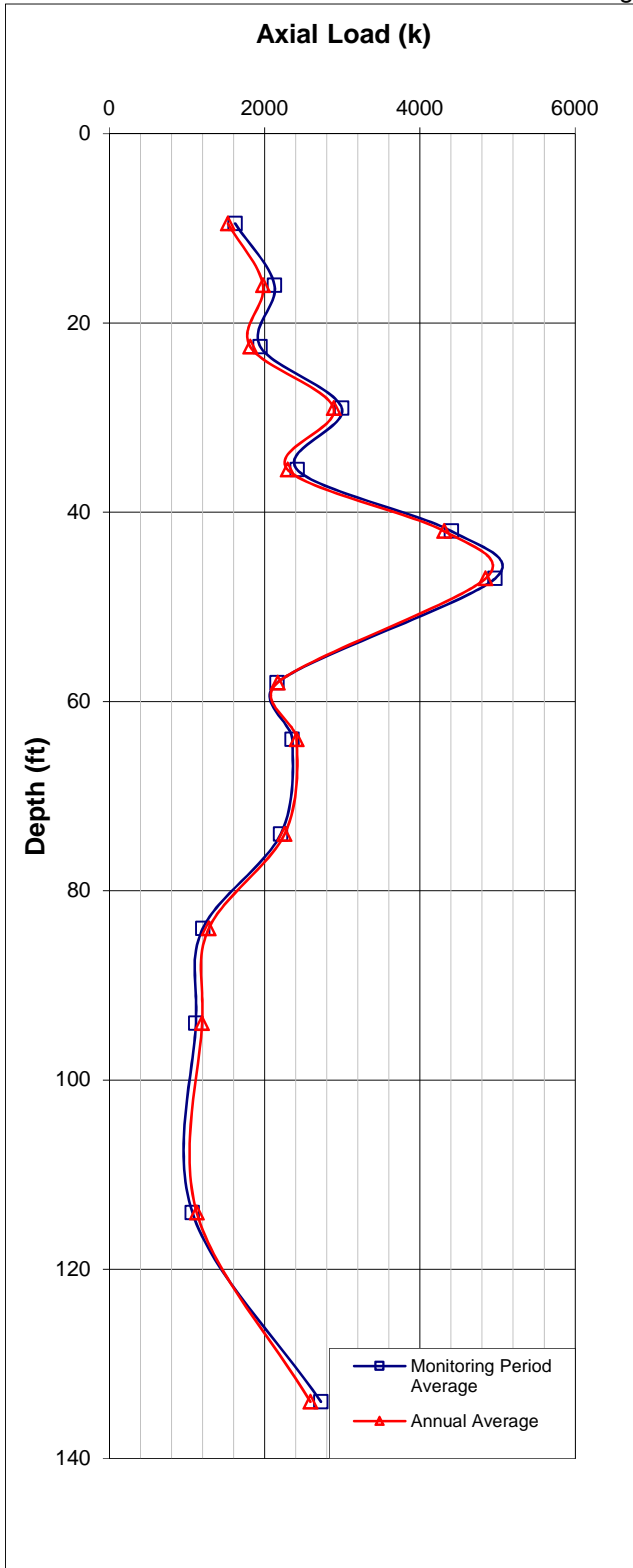
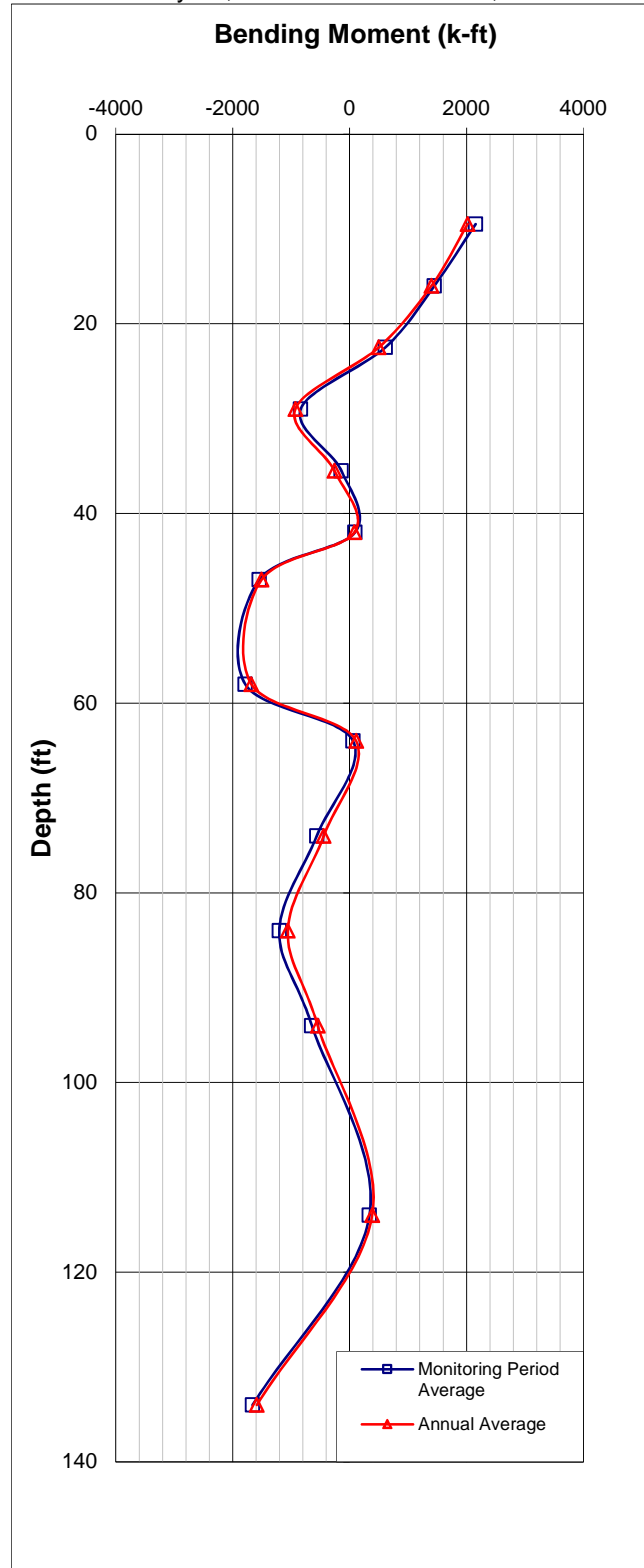
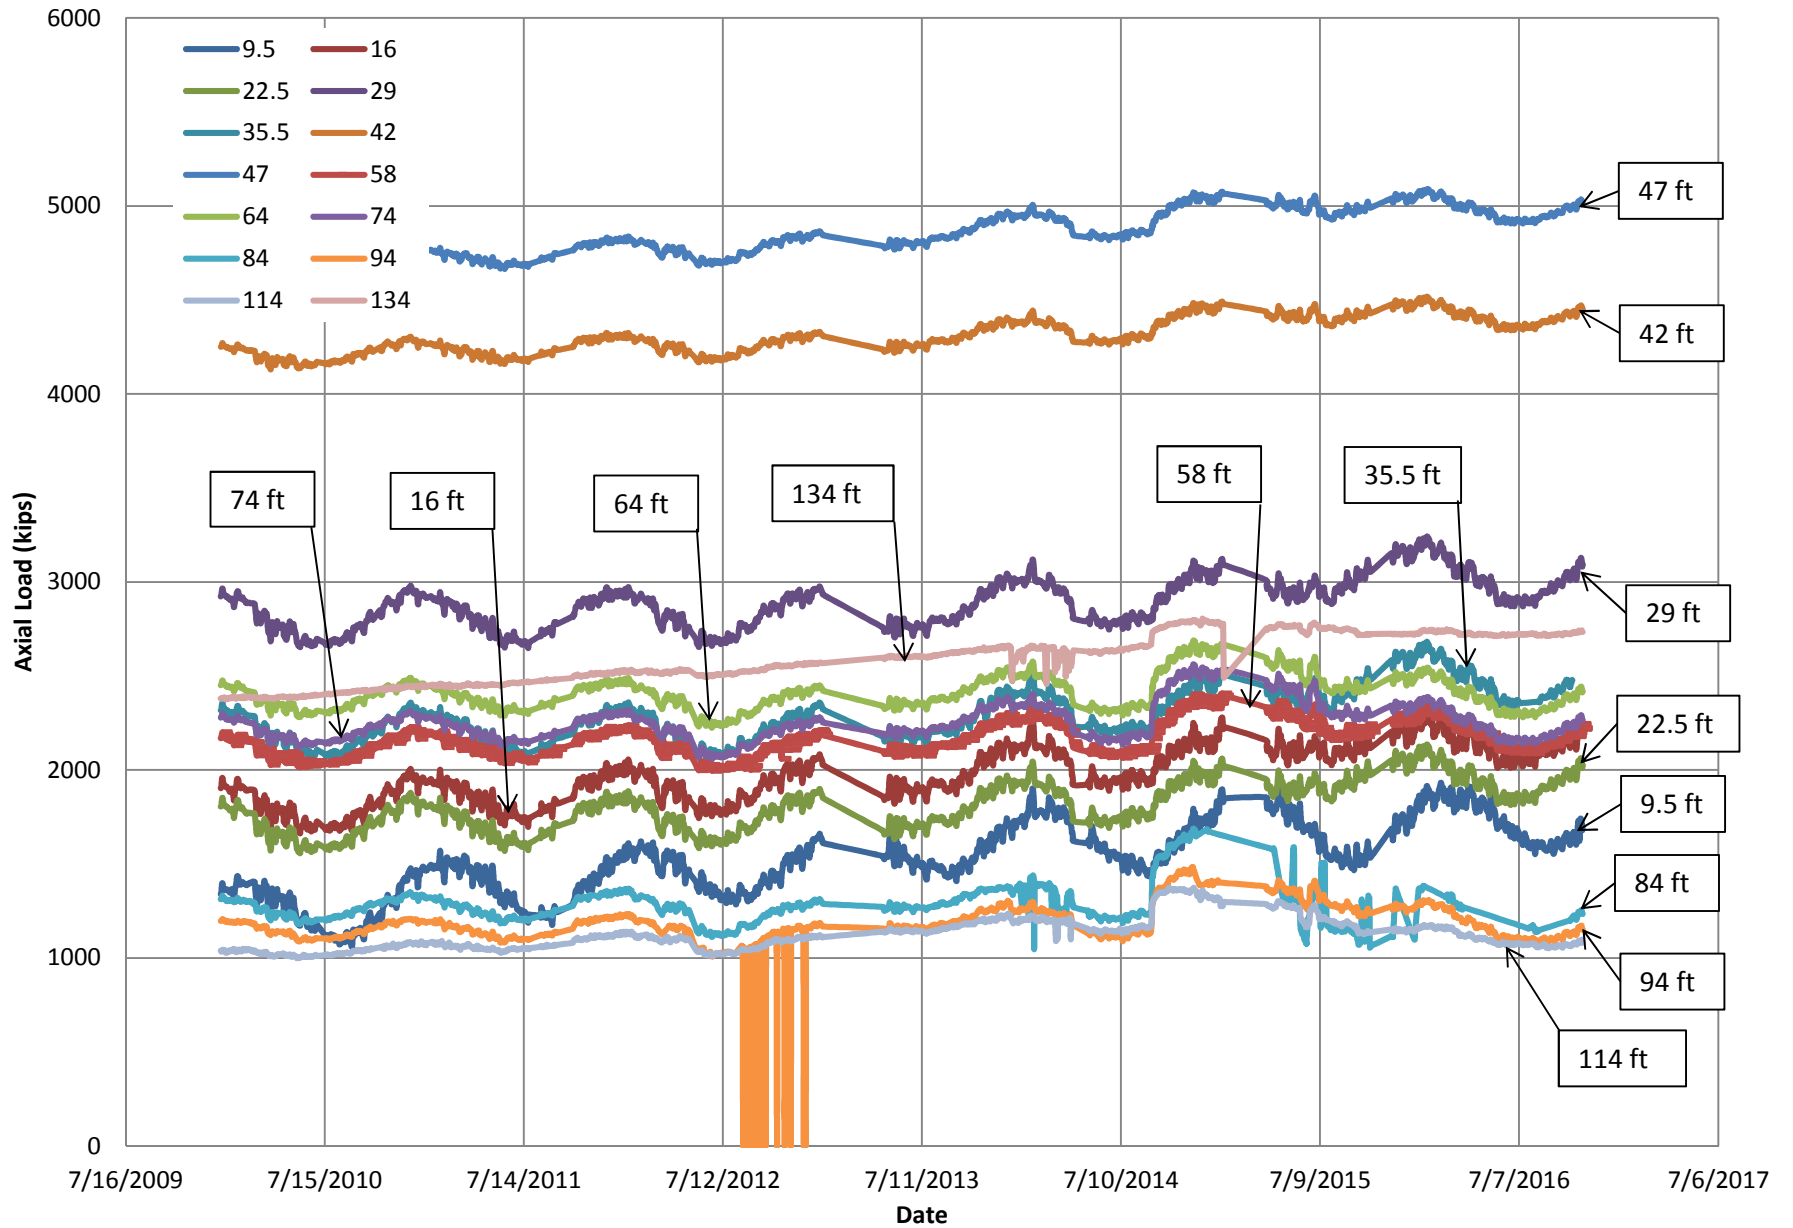
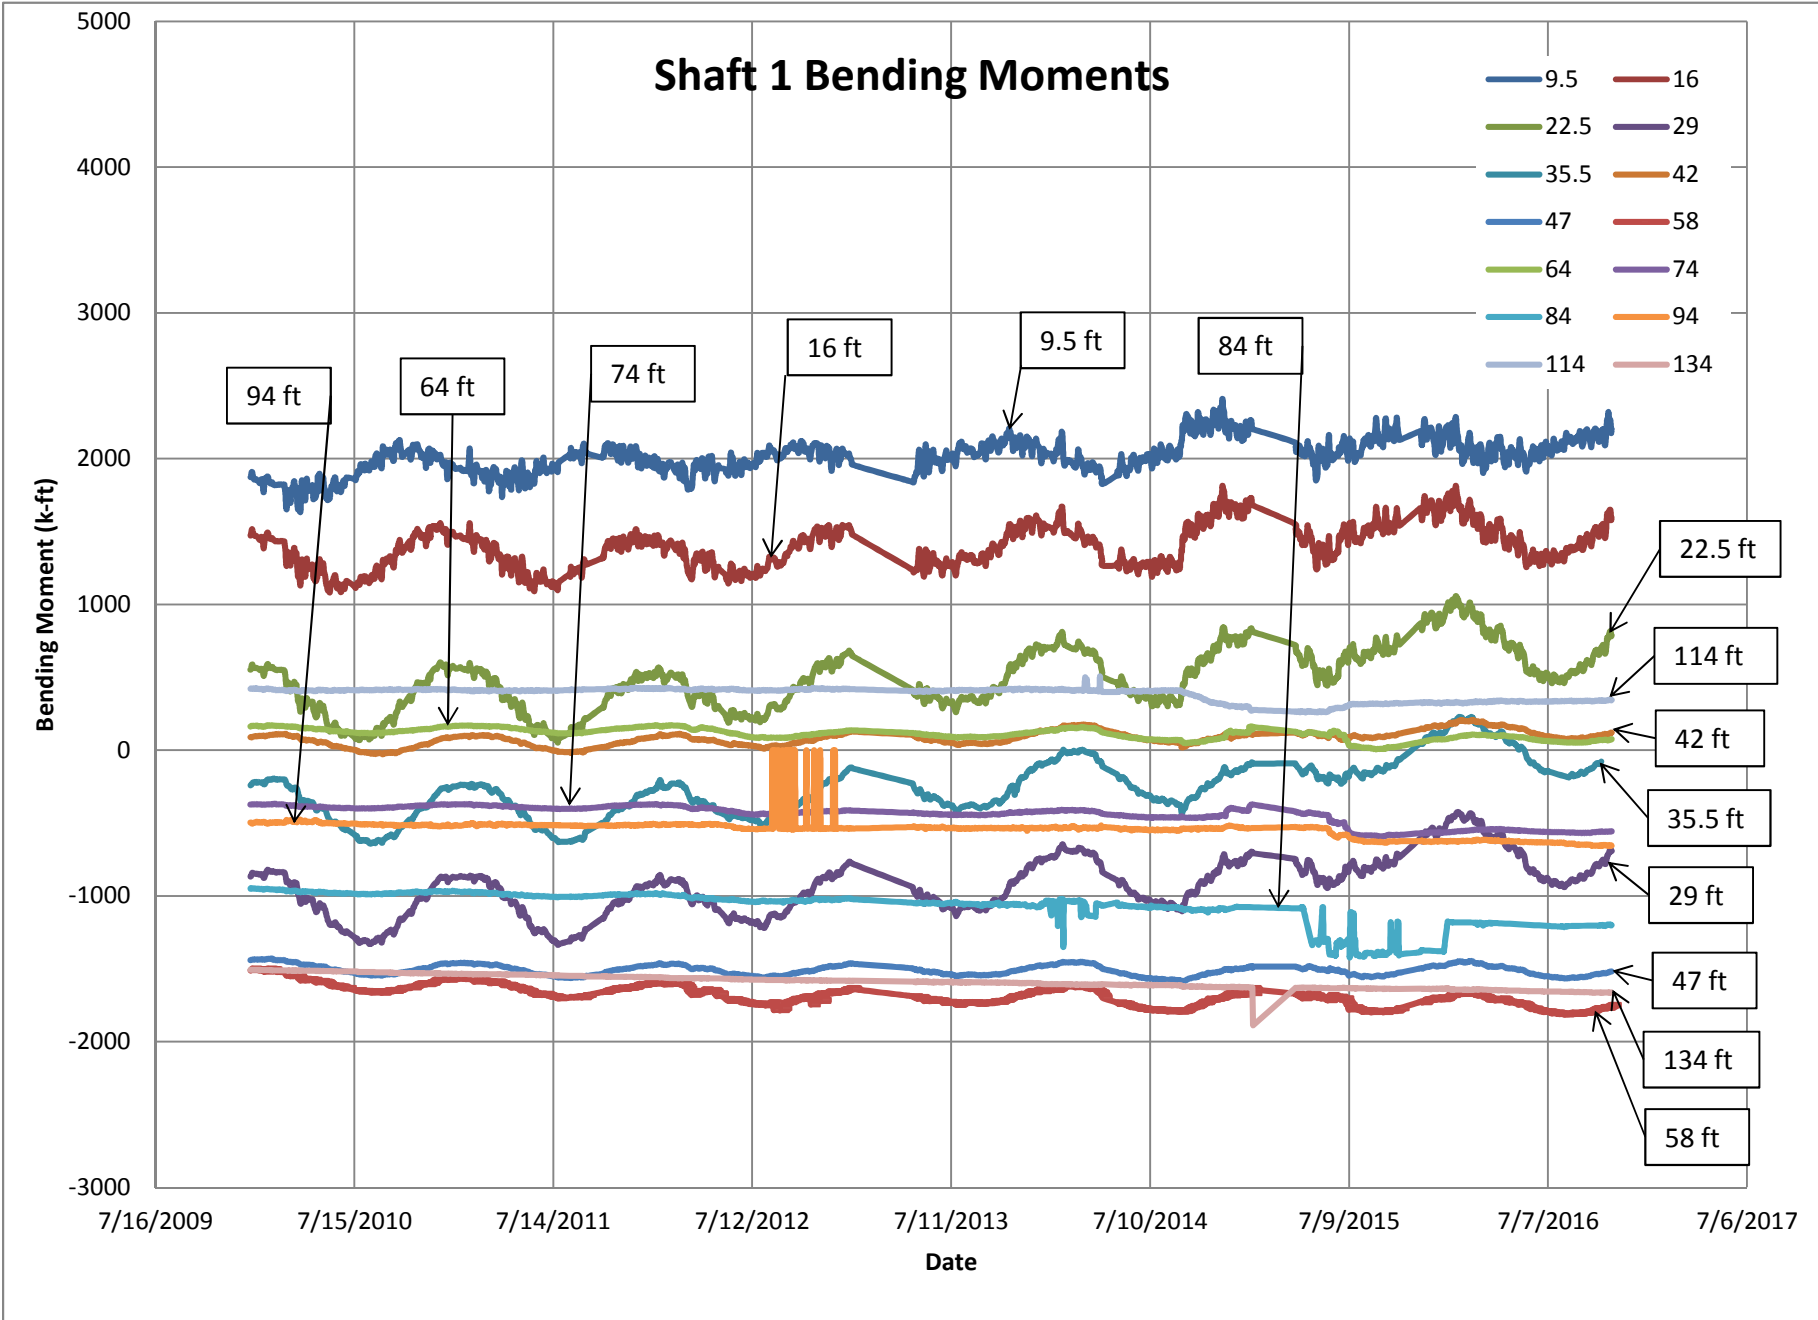
Drilled Shaft #1

Plots of axial load vs. time show the usual seasonal changes in both Piers. The load vs. time plots continue to show a gradual increase in axial load over time in both shafts at all depths except 84 to 114 feet in Shaft 1 where the axial load has remained relatively constant except for seasonal changes.

Bending moments in Pier 1 show the largest seasonal changes at the top end of the pier. Moments are decreasing from 29 and 35.5 feet, and are increasing above 22.5 feet and below 58 feet. A similar trend occurs in Pier 9 where the seasonal changes in bending moments show the greatest variation at 50 feet and above.
