Re: January 3, 4, 5, and 6, 2017 Bi-Weekly Readings  
CUY-90-15.24 Slope Monitoring  
PID 96504  
SME Project No. 069032.00

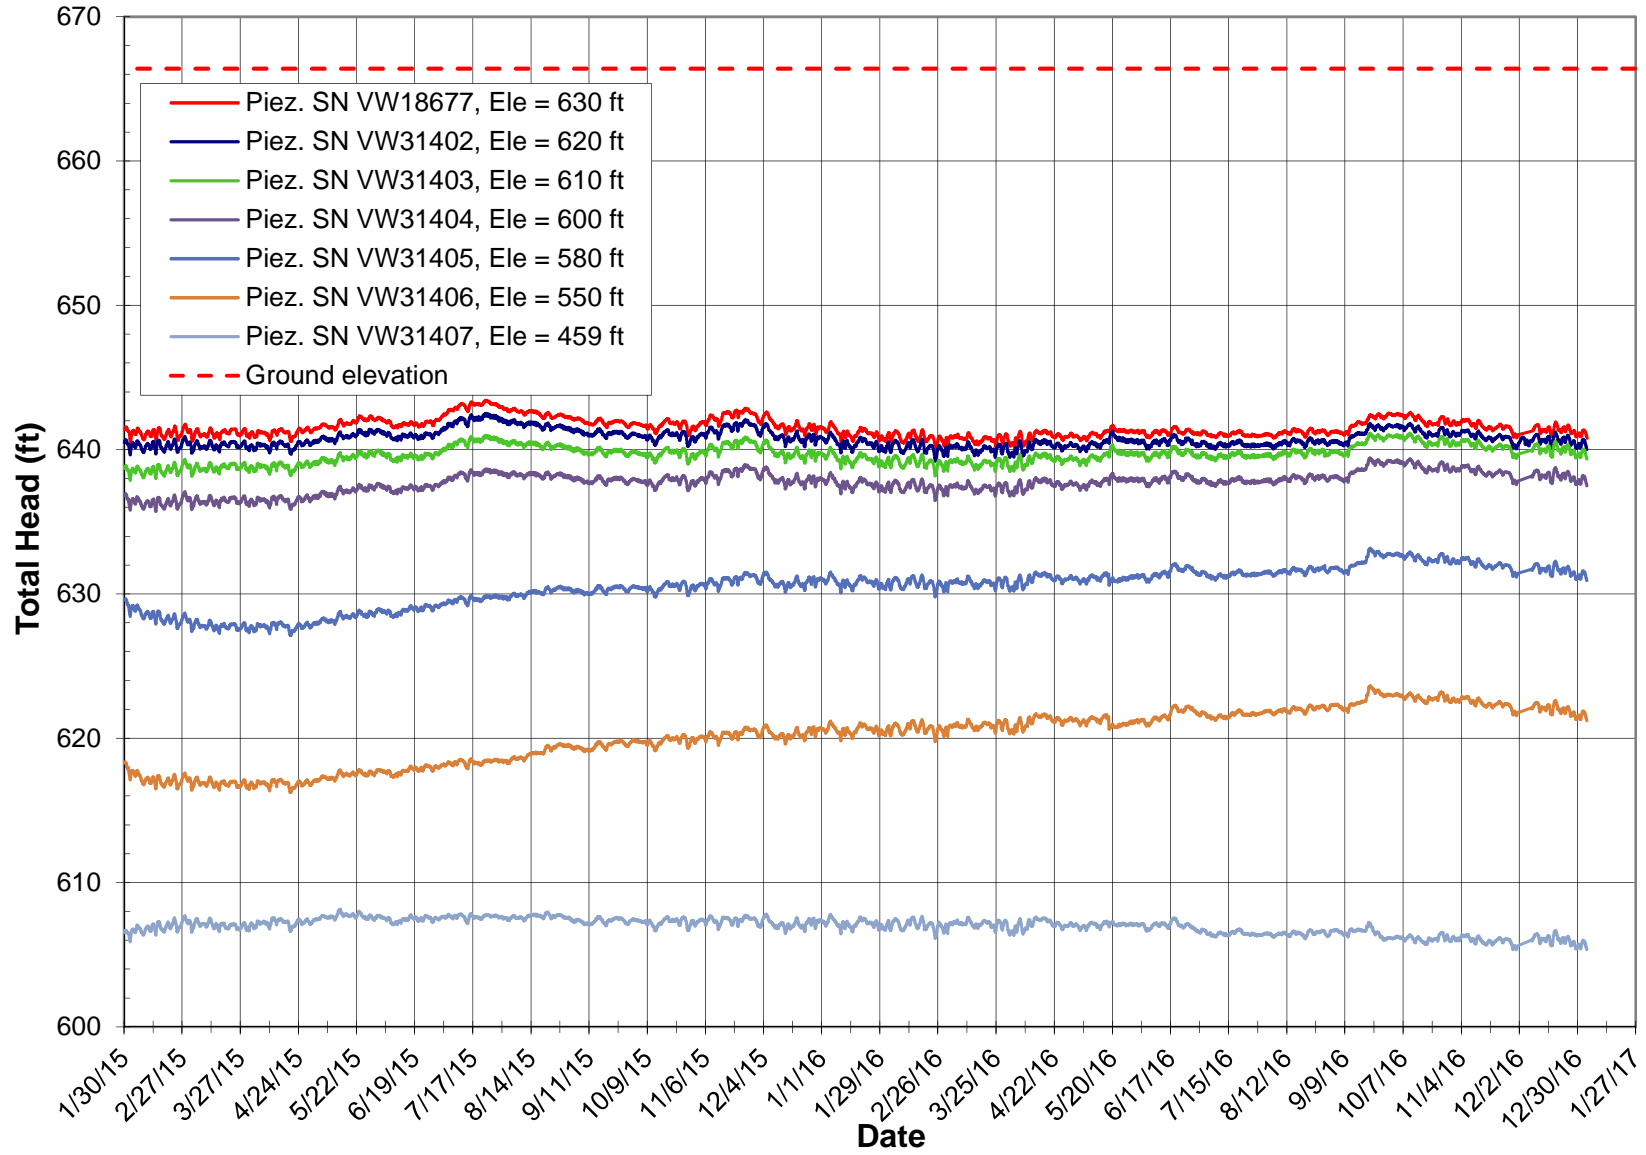
# P-001-13 VW Piezometer Readings

**P-001-13** – Pore pressure readings in all piezometers at this location indicate a decrease of about 1 foot in total head.

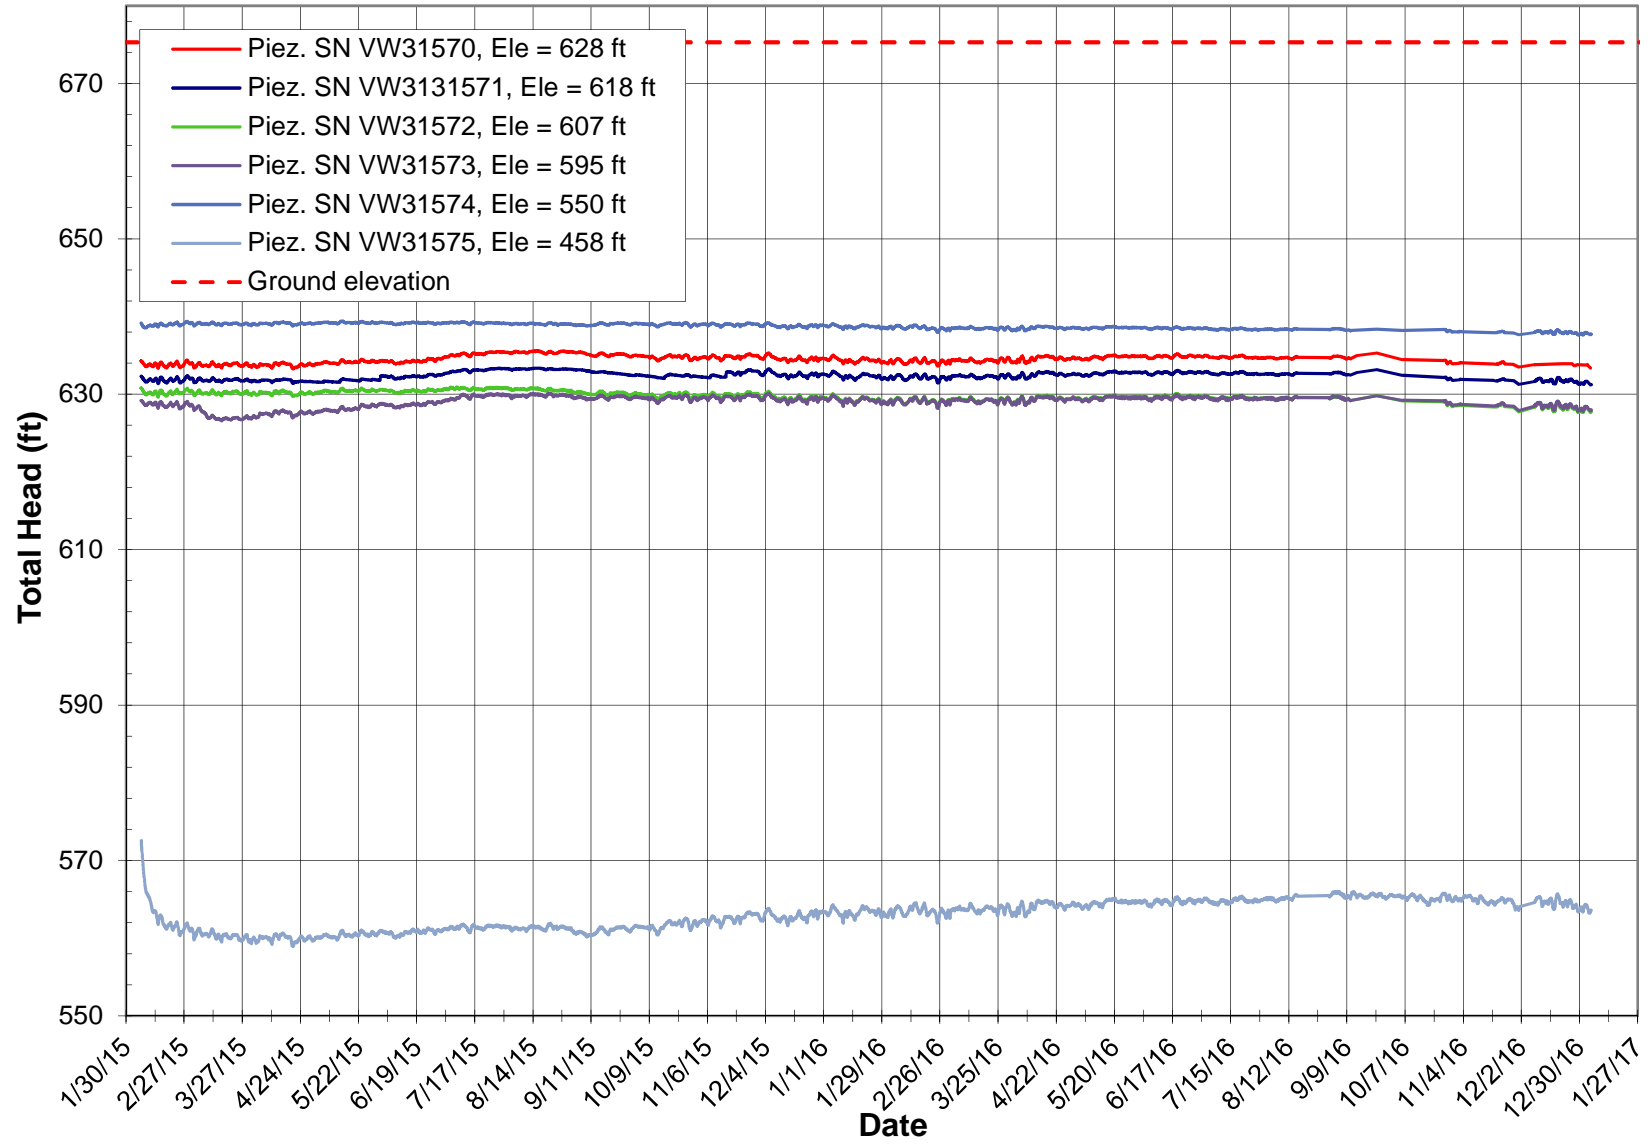
# P-002-13 VW Piezometer Readings

**P-002-13** – Pore pressure readings in the piezometers at this location show decreases in total head ranging from 0.5 feet to 1.7 feet, with the greatest decrease occurring at elevation 458 feet.

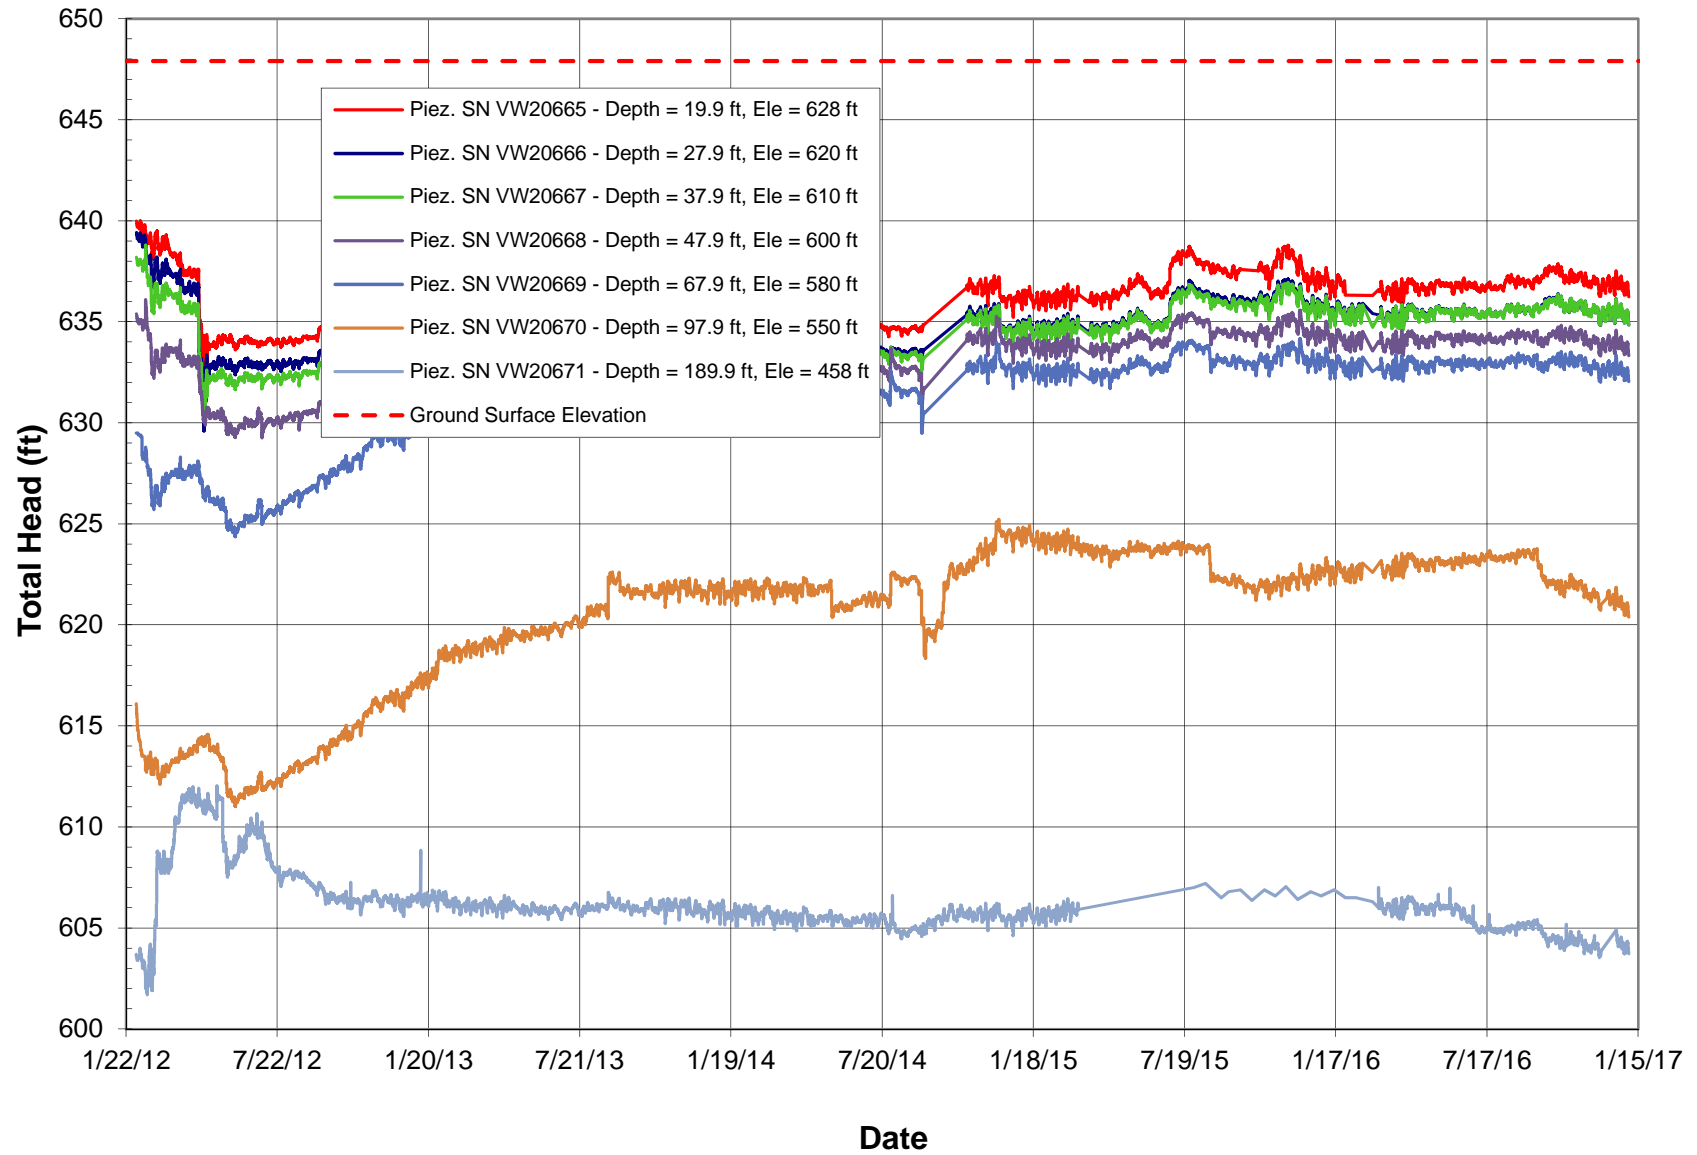
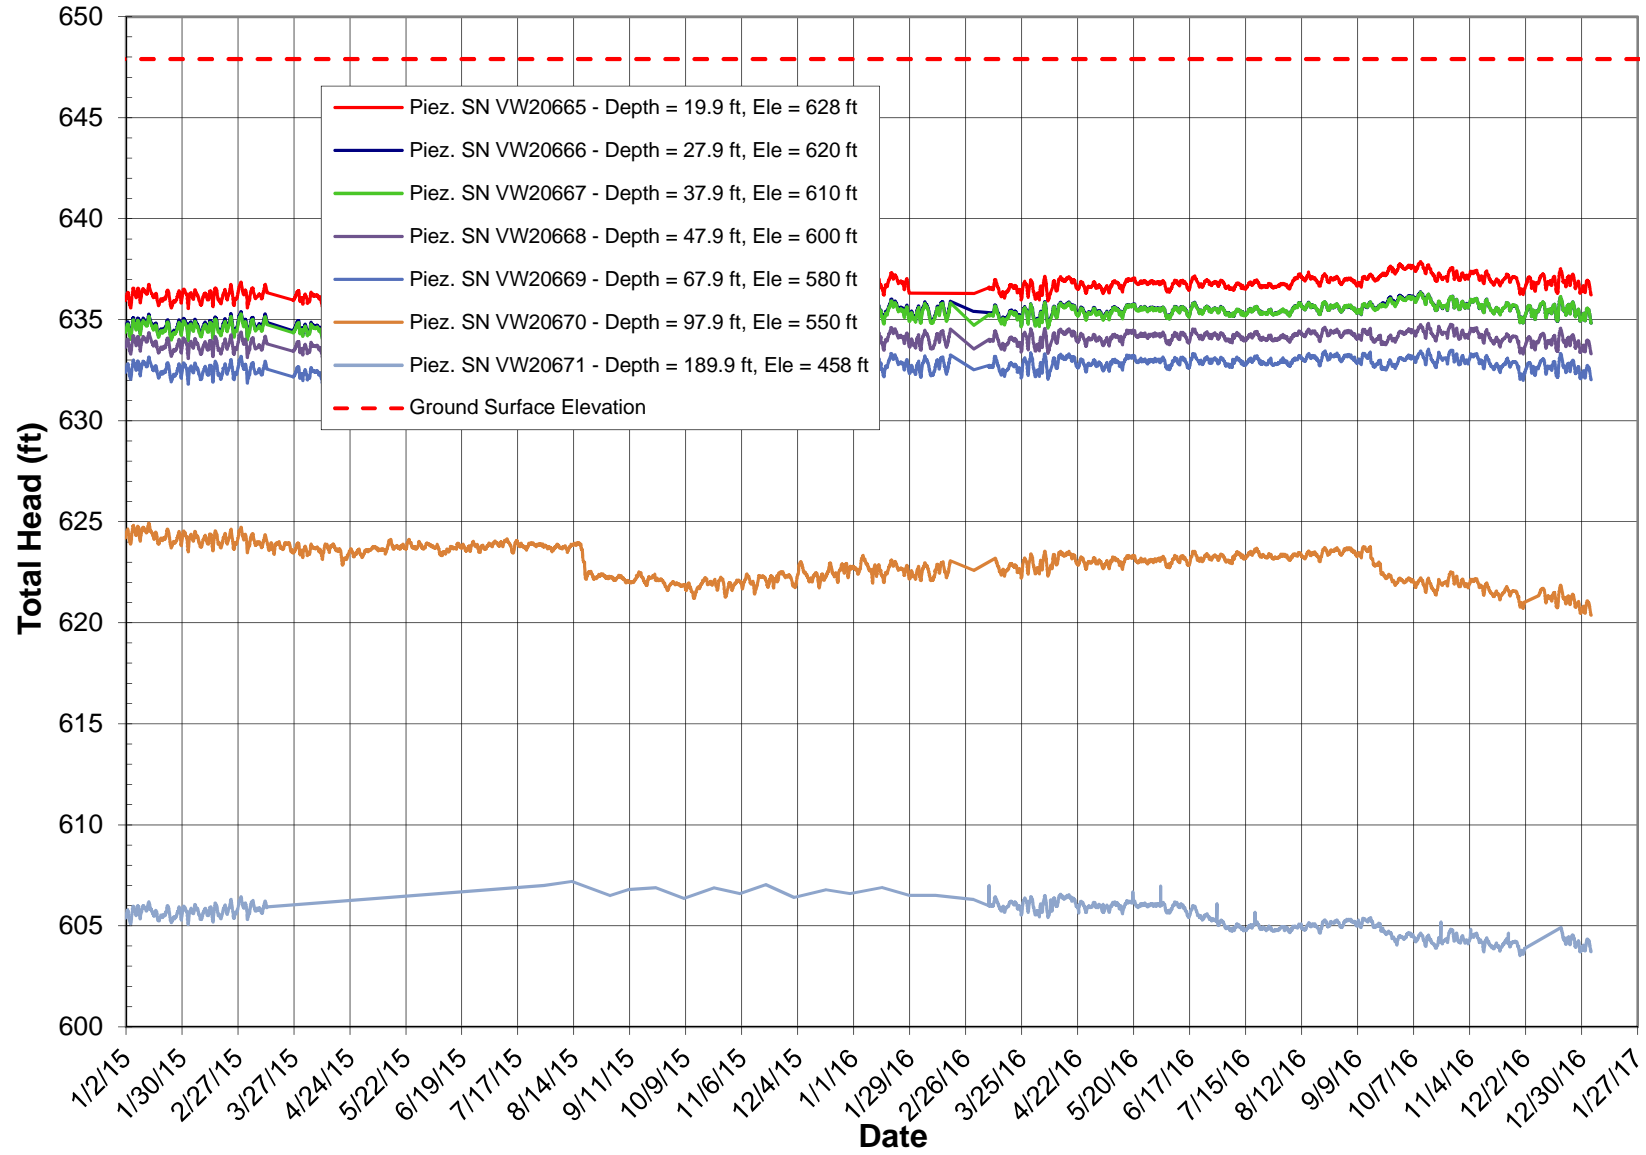
# P-003-10 VW Piezometer Readings

**P-003-10** – Pore pressure readings in the piezometers at this location show decreases in total head ranging from 1.0 feet to 1.3 feet, with the greatest decrease occurring at elevation 550 feet.

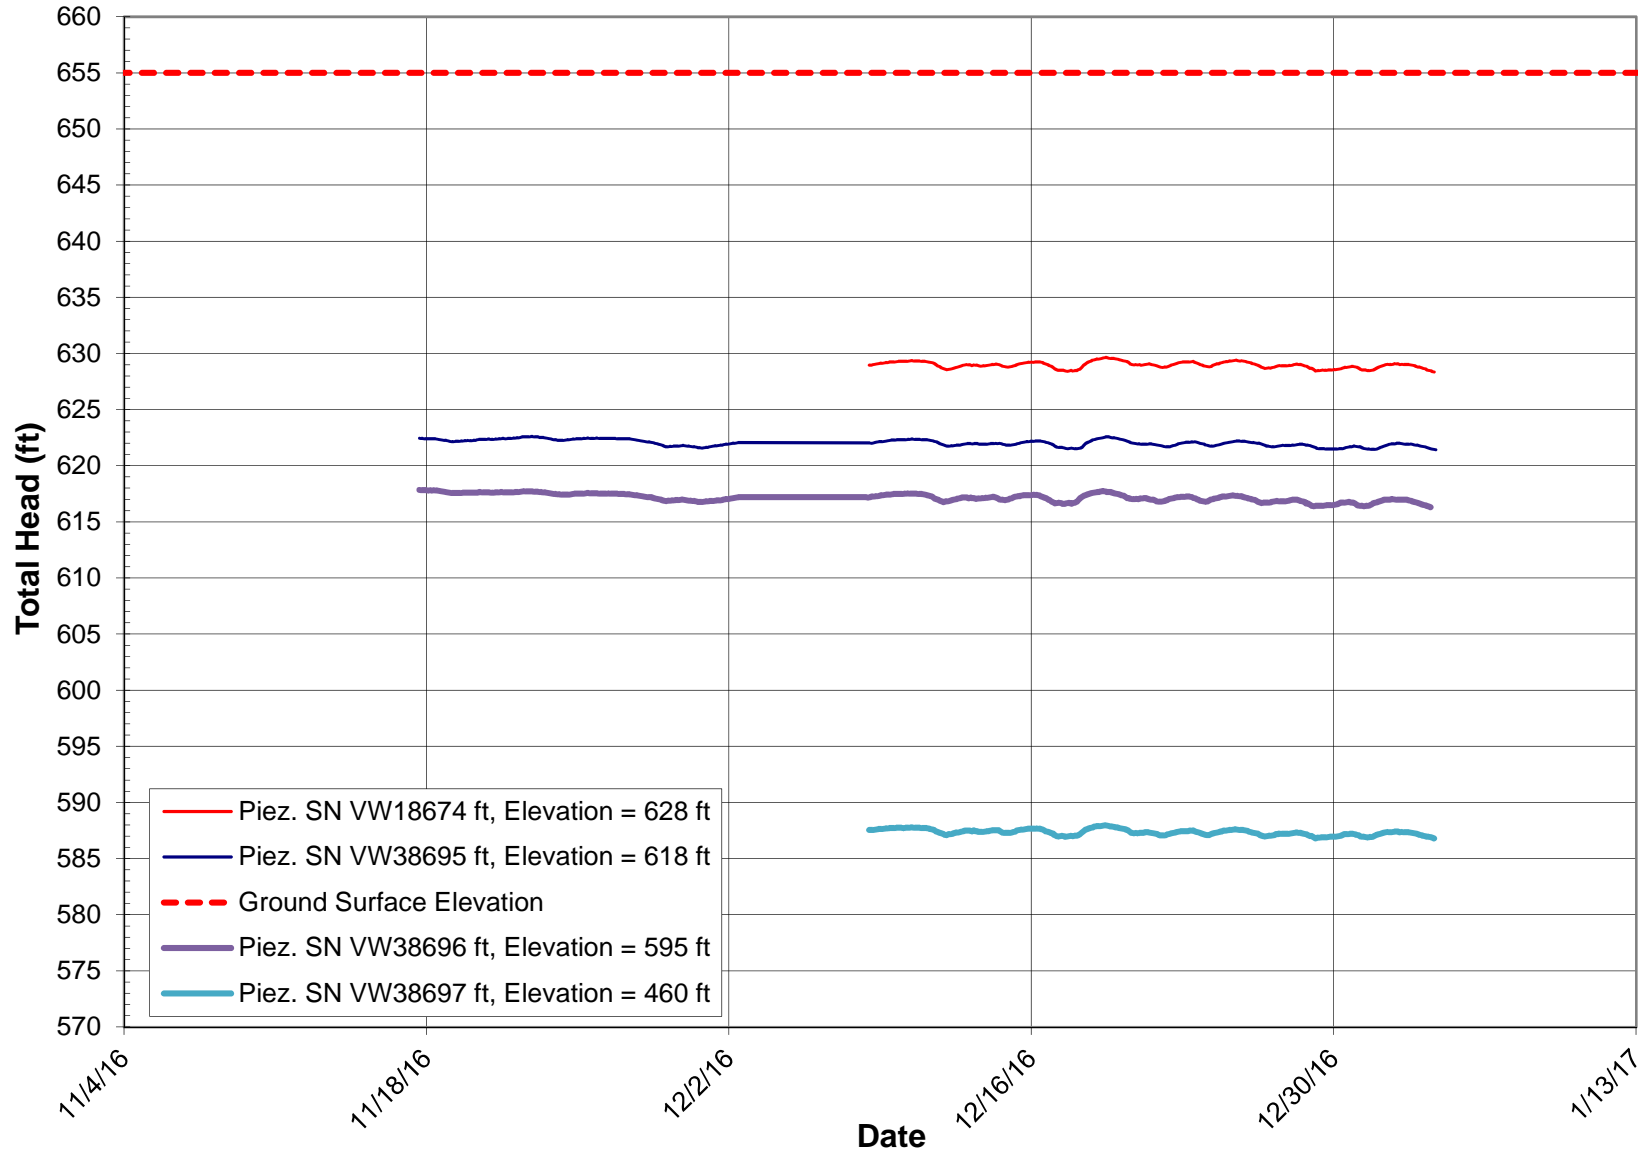
# P-003-13 VW Piezometer Readings

**P-003-13** – Pore pressure readings in all piezometers at this location indicate a decrease of about 1 foot in total head.

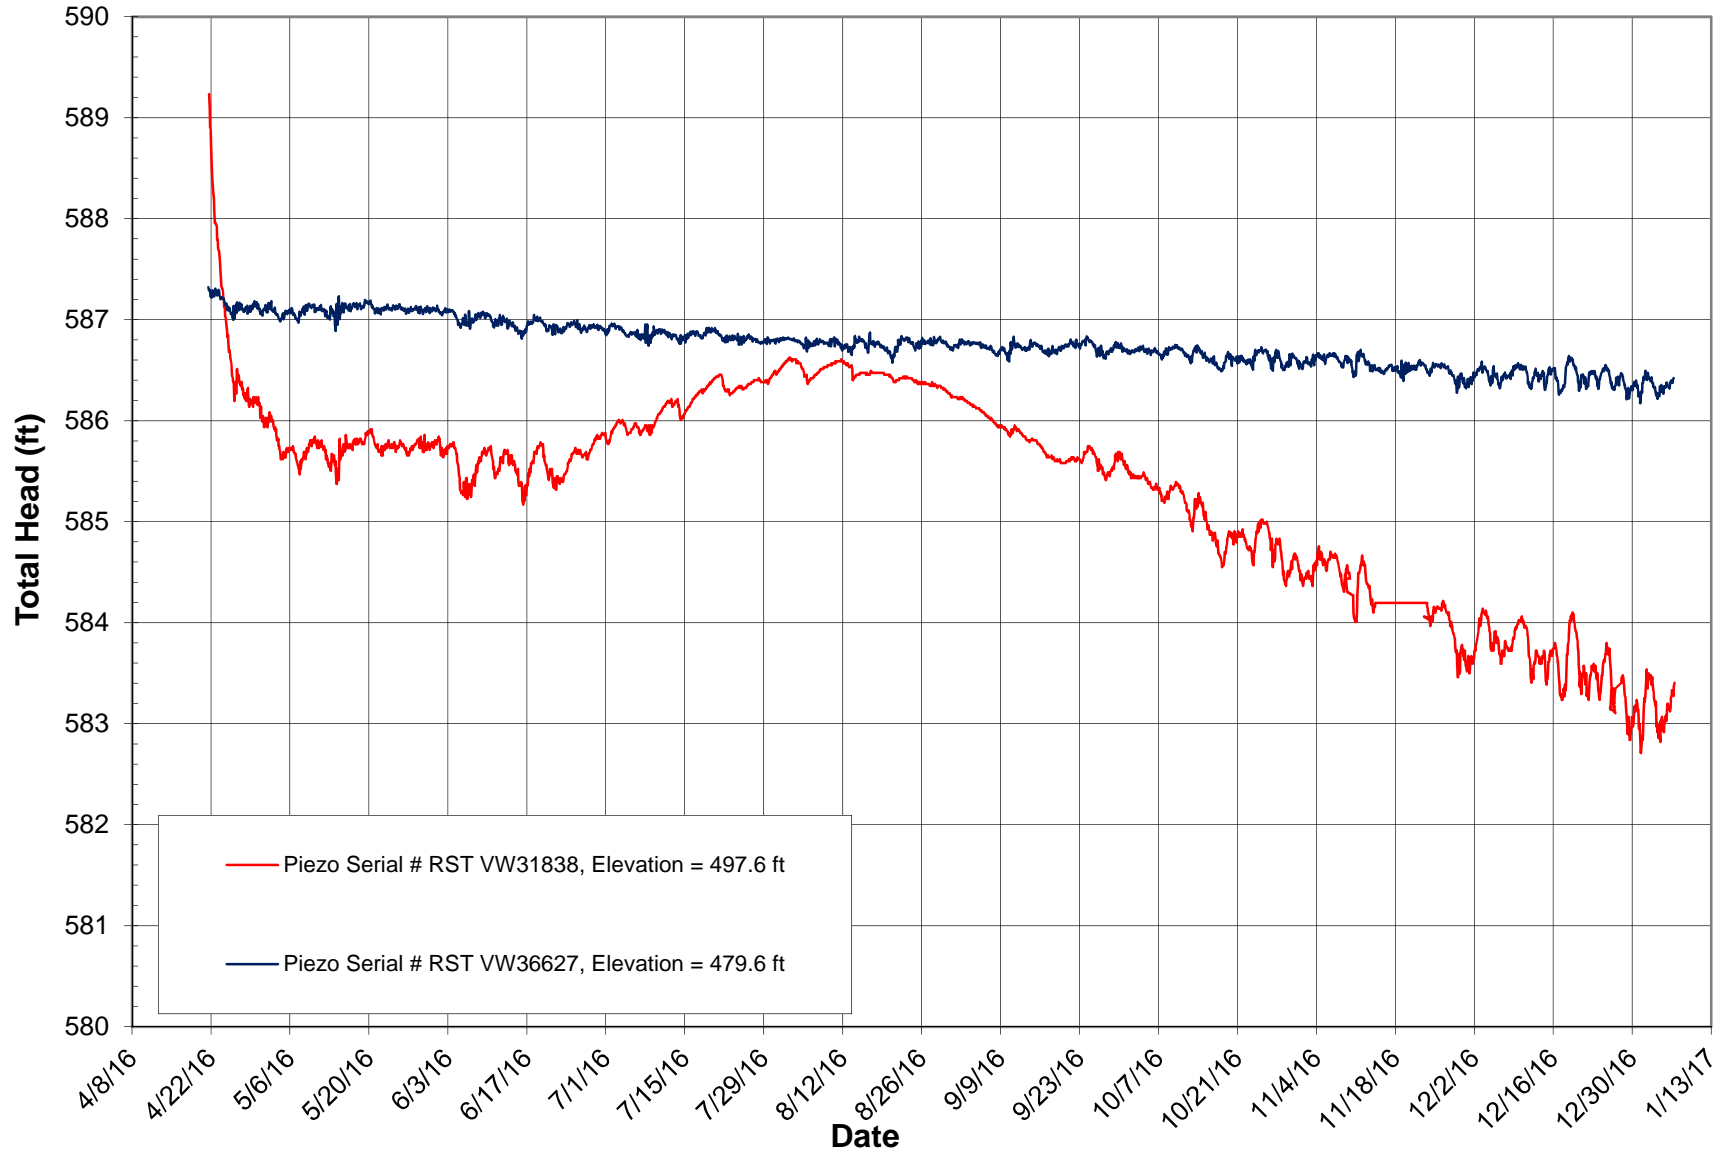
# B-105A VW Piezometer Readings

B-105A – Pore pressures varied by more than 0.5 feet in the shallow piezometer during the period but the net change for the period was less than 0.5 feet.

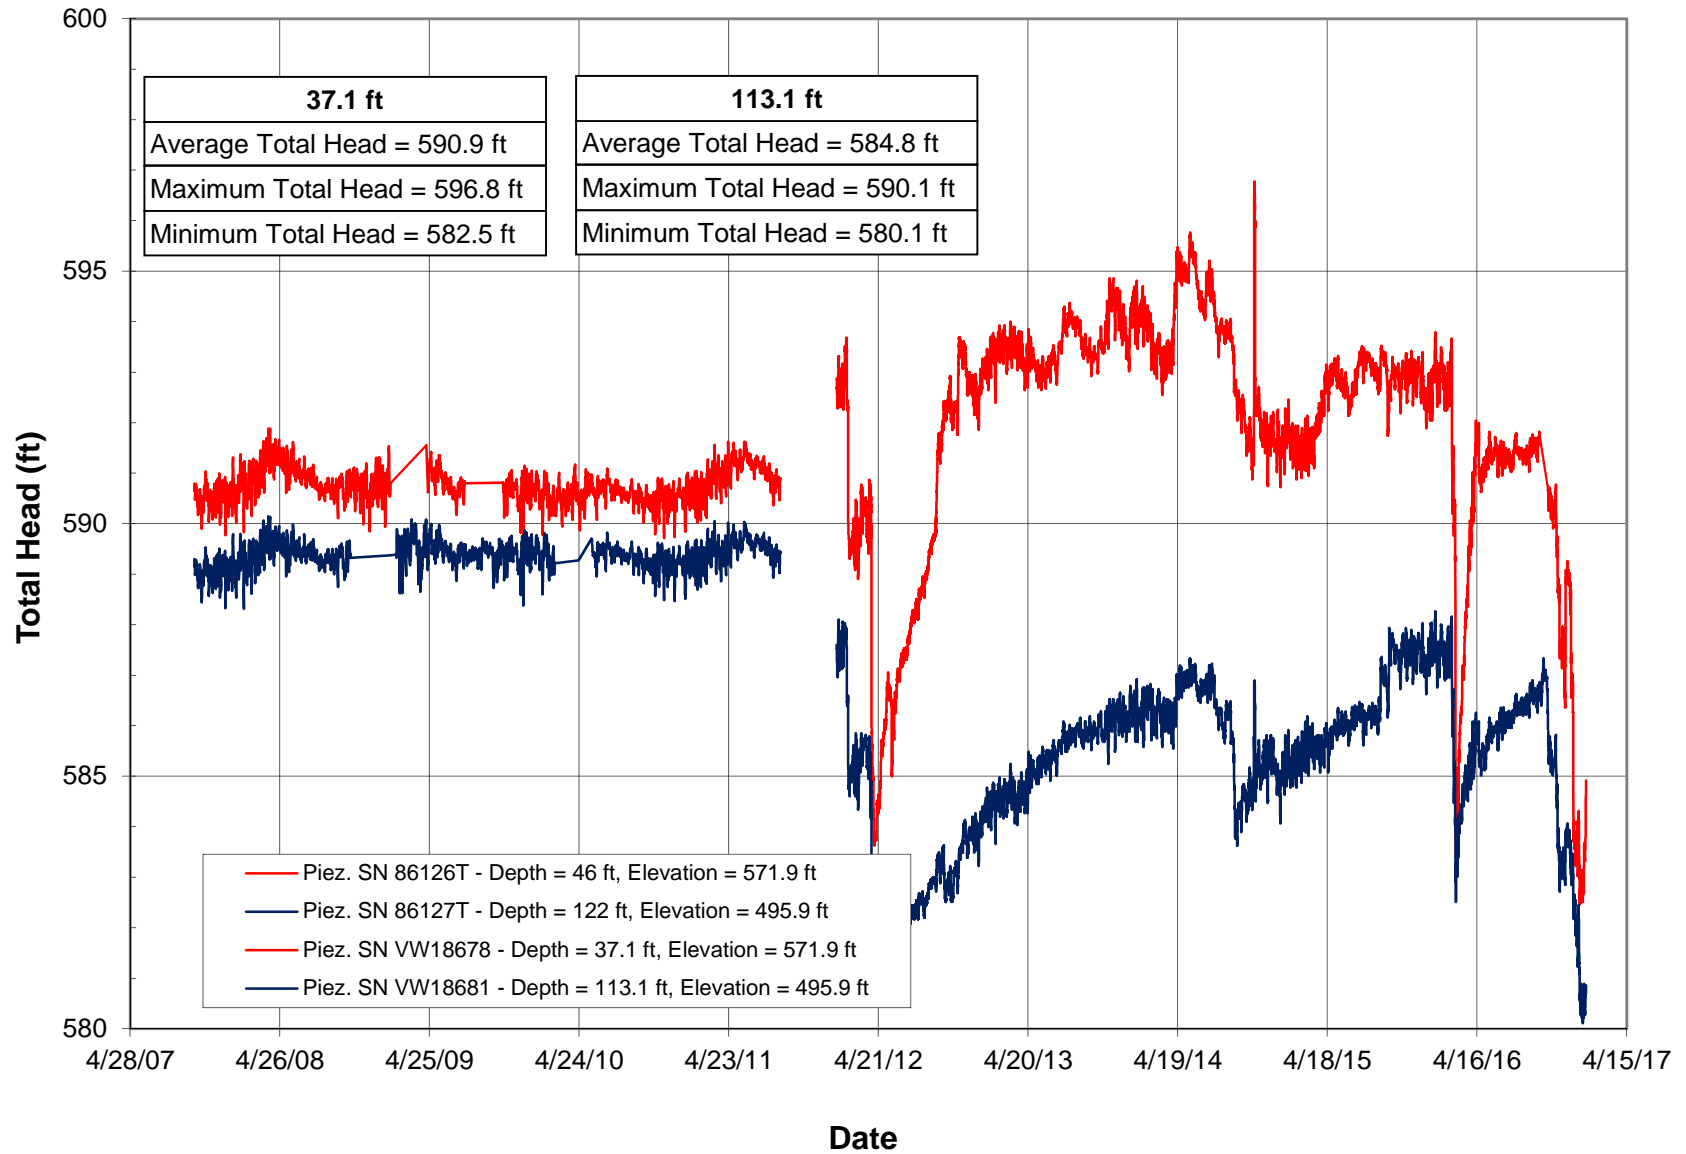
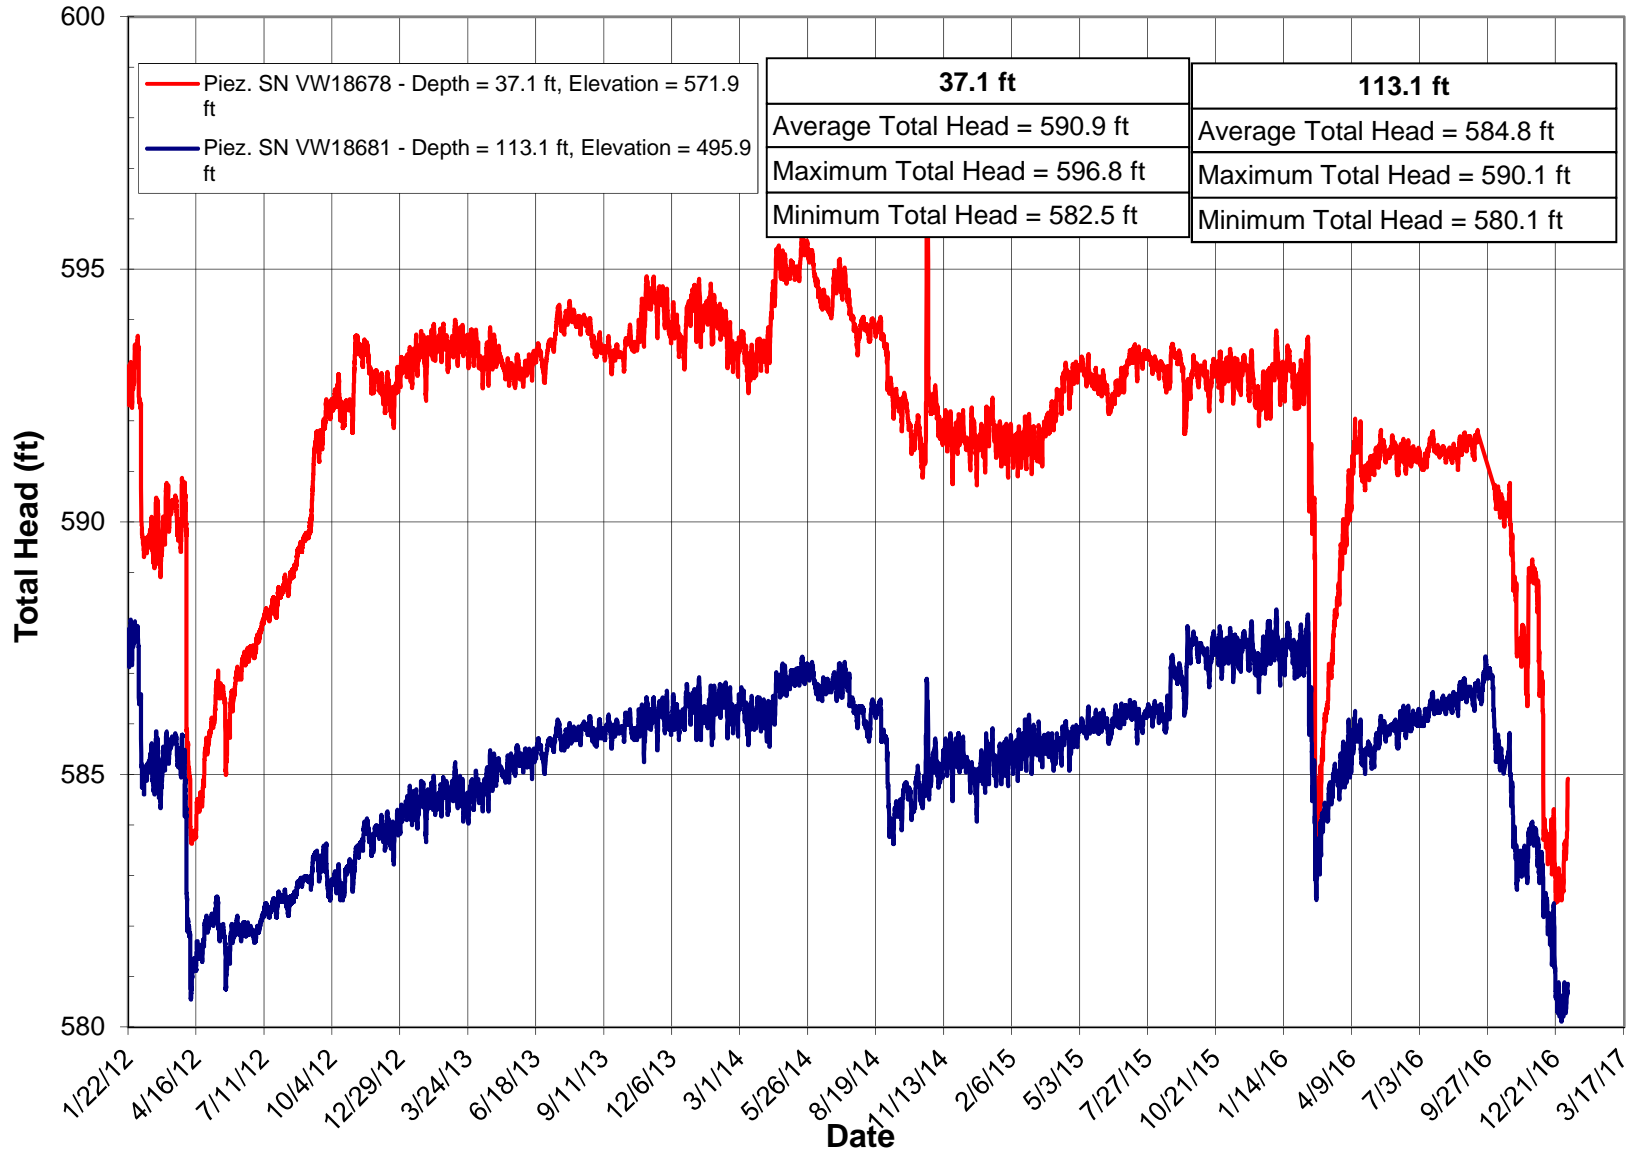
# B-05-02 VW Piezometer Readings

**B-05-02** – Pore pressures in both piezometers decreased after the last report and then increased during the second half of this period. The net change for this period is a pore pressure increase of 0.9 feet in the shallow piezometer and a decrease of 1.2 feet in the deep piezometer.

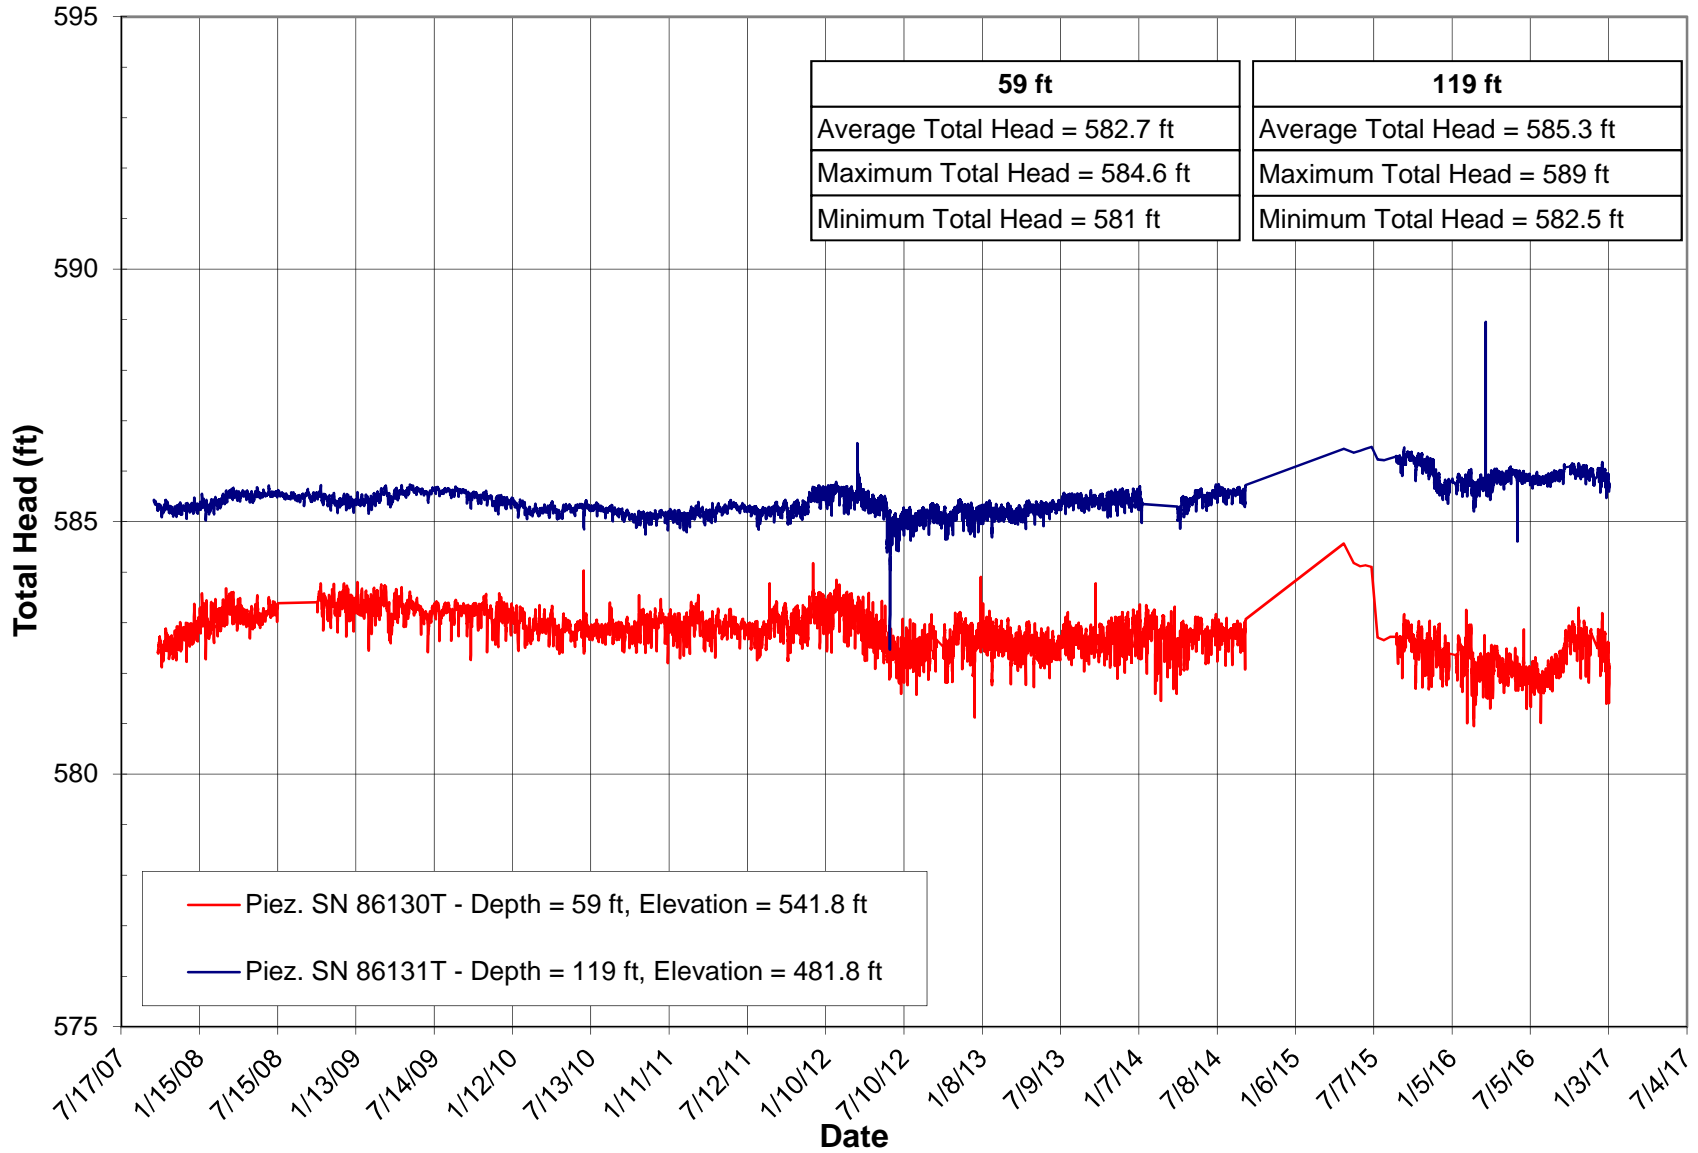
# B-05-04 VW Piezometer Readings

**B-05-04** – At this location, pore pressure readings indicate a decrease of about 0.8 feet in the shallow piezometer and virtually no change in the deep piezometer.

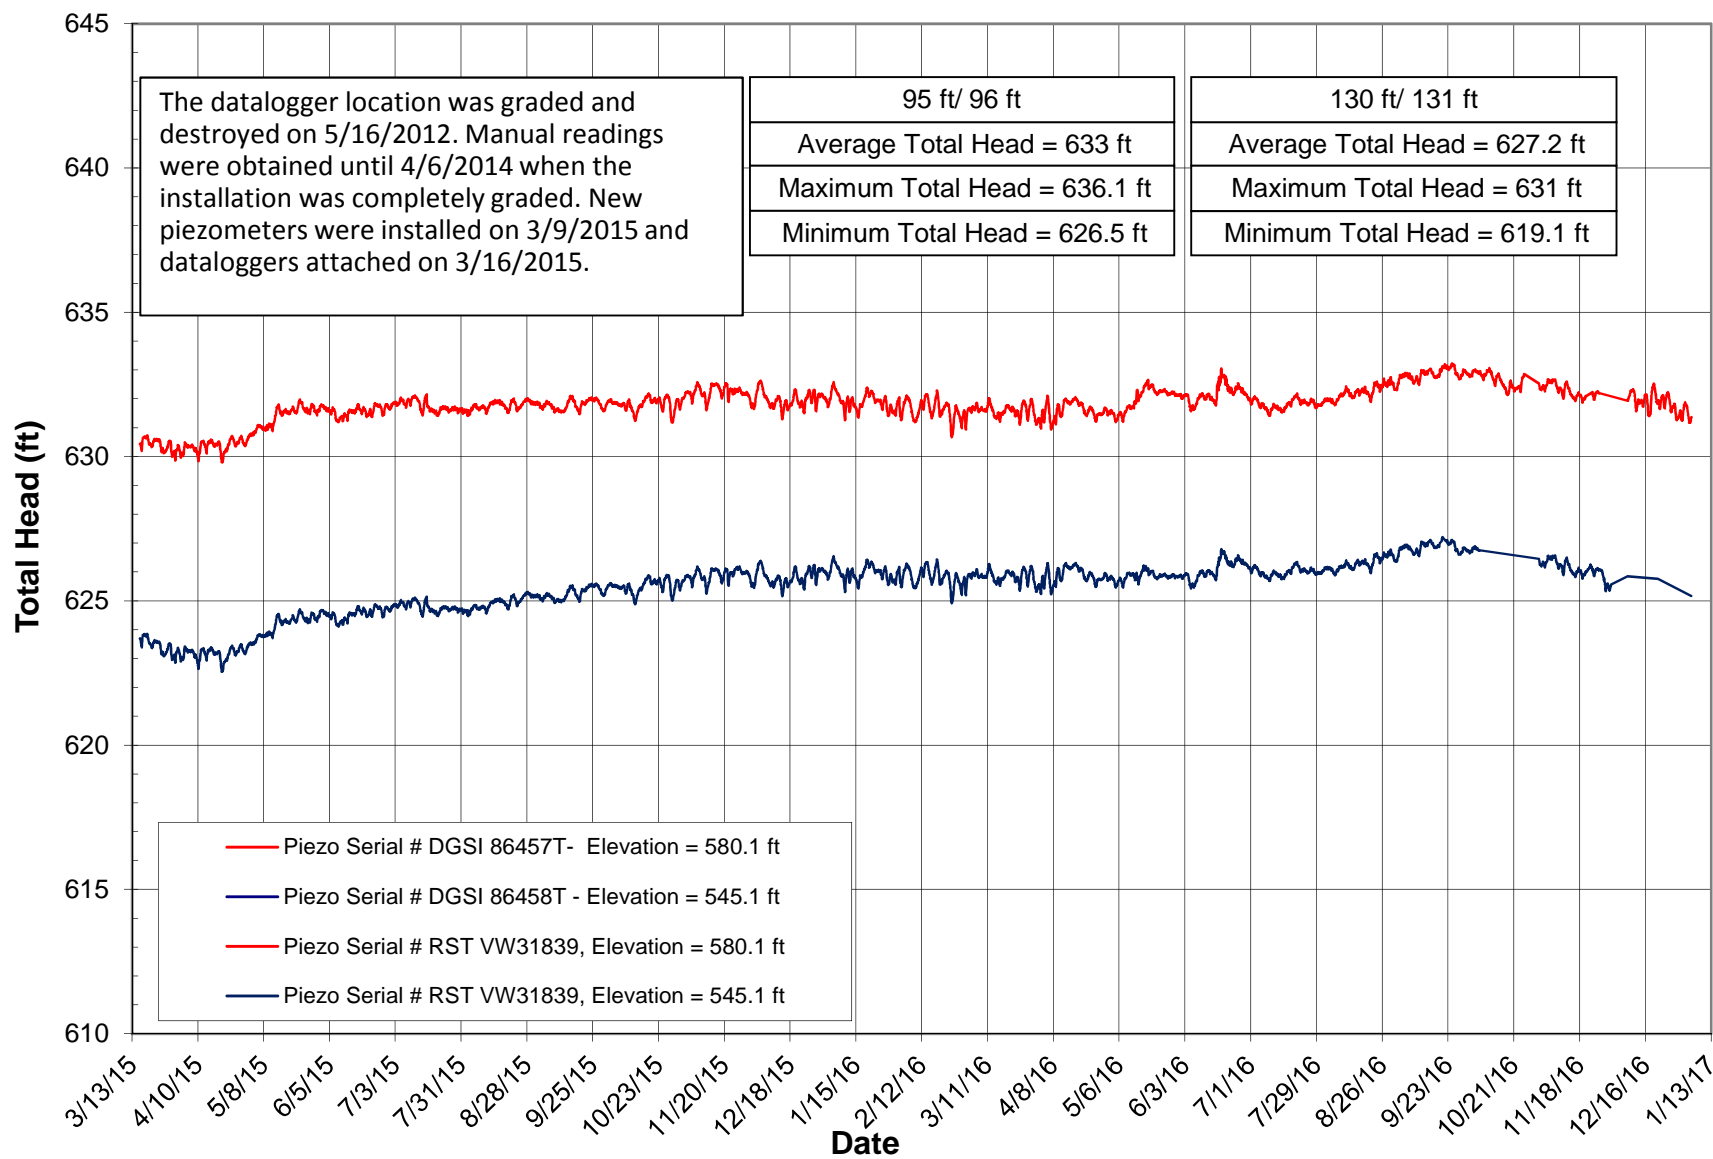
## B-05-11/B-05-A-11 VW Piezometer Readings

**B-05-A-11** – Pore pressure readings show decreases of about 1 foot and 0.6 feet in the shallow and deep piezometers, respectively. Pore pressures have been trending downward since late September 2016.

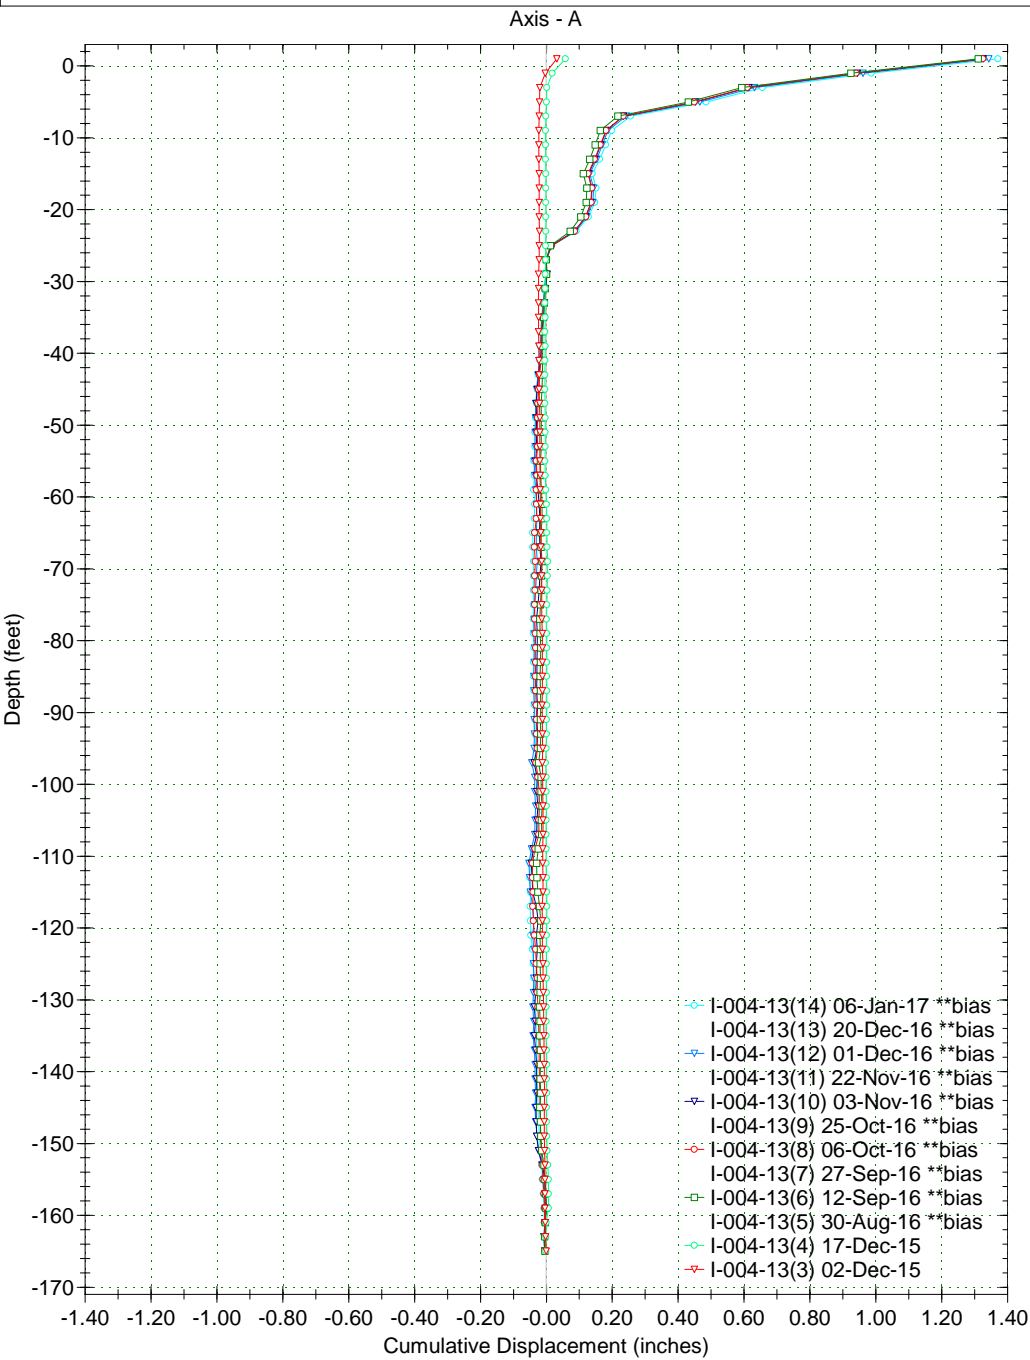
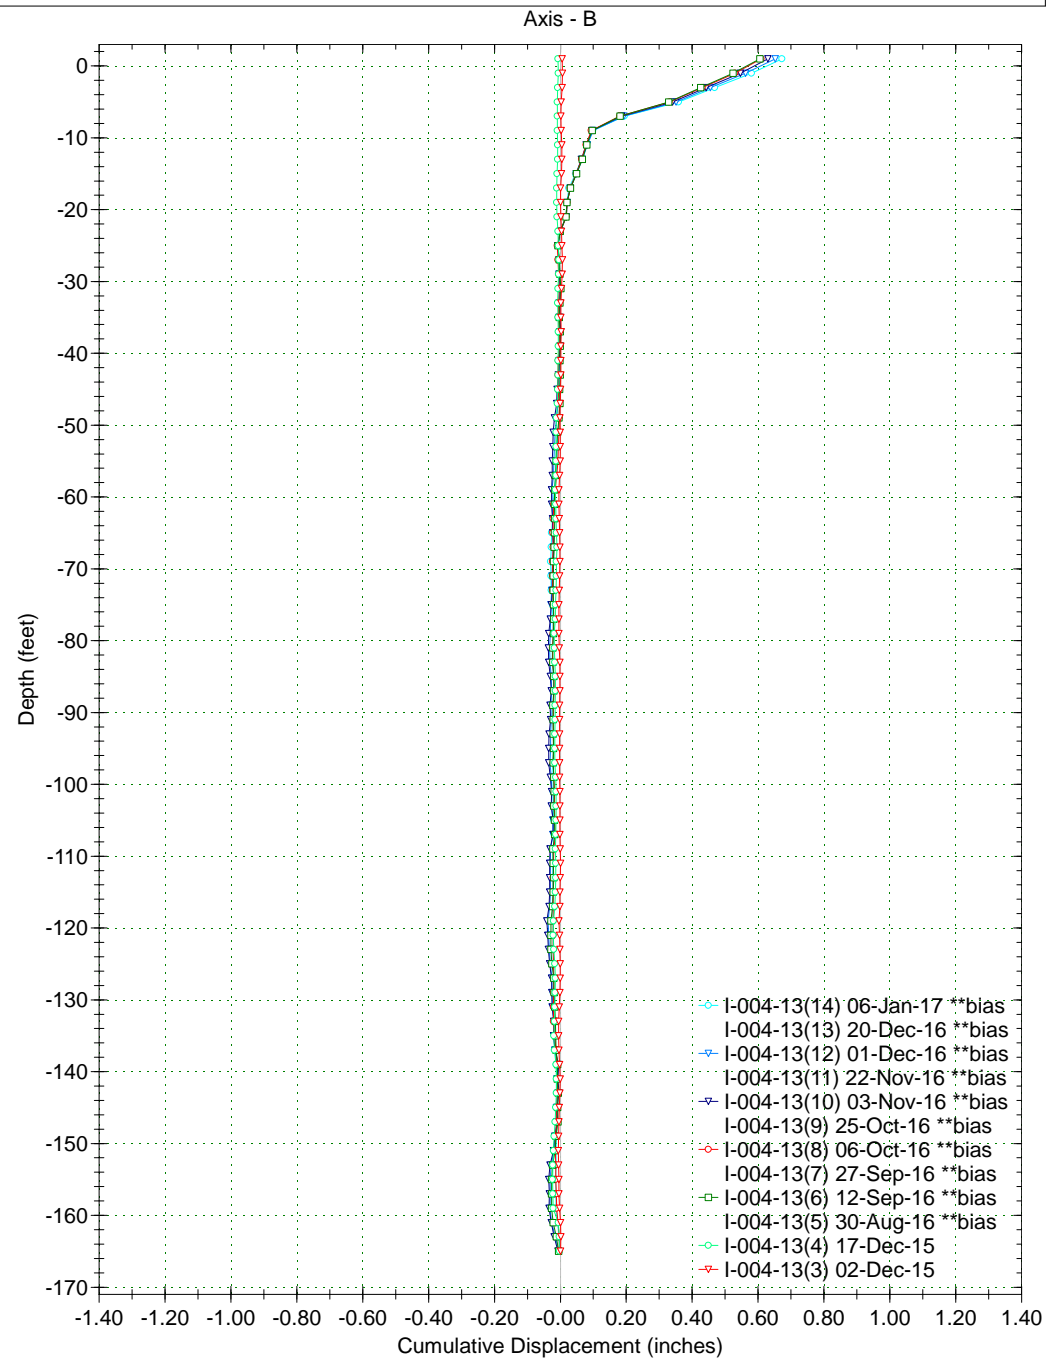
Borehole : I-004-13  
Project : CUY-90-15-24  
Location :  
Northing :  
Easting :  
Collar :

I-004-13 – The plot for this location suggest a slight increase in positive A and B-axis displacement from about 10 to 20 feet.
