Re: January 3, 4, 5, and 6, 2017 Bi-Weekly Readings  
CUY-90-15.24 Slope Monitoring  
PID 96504  
SME Project No. 069032.00

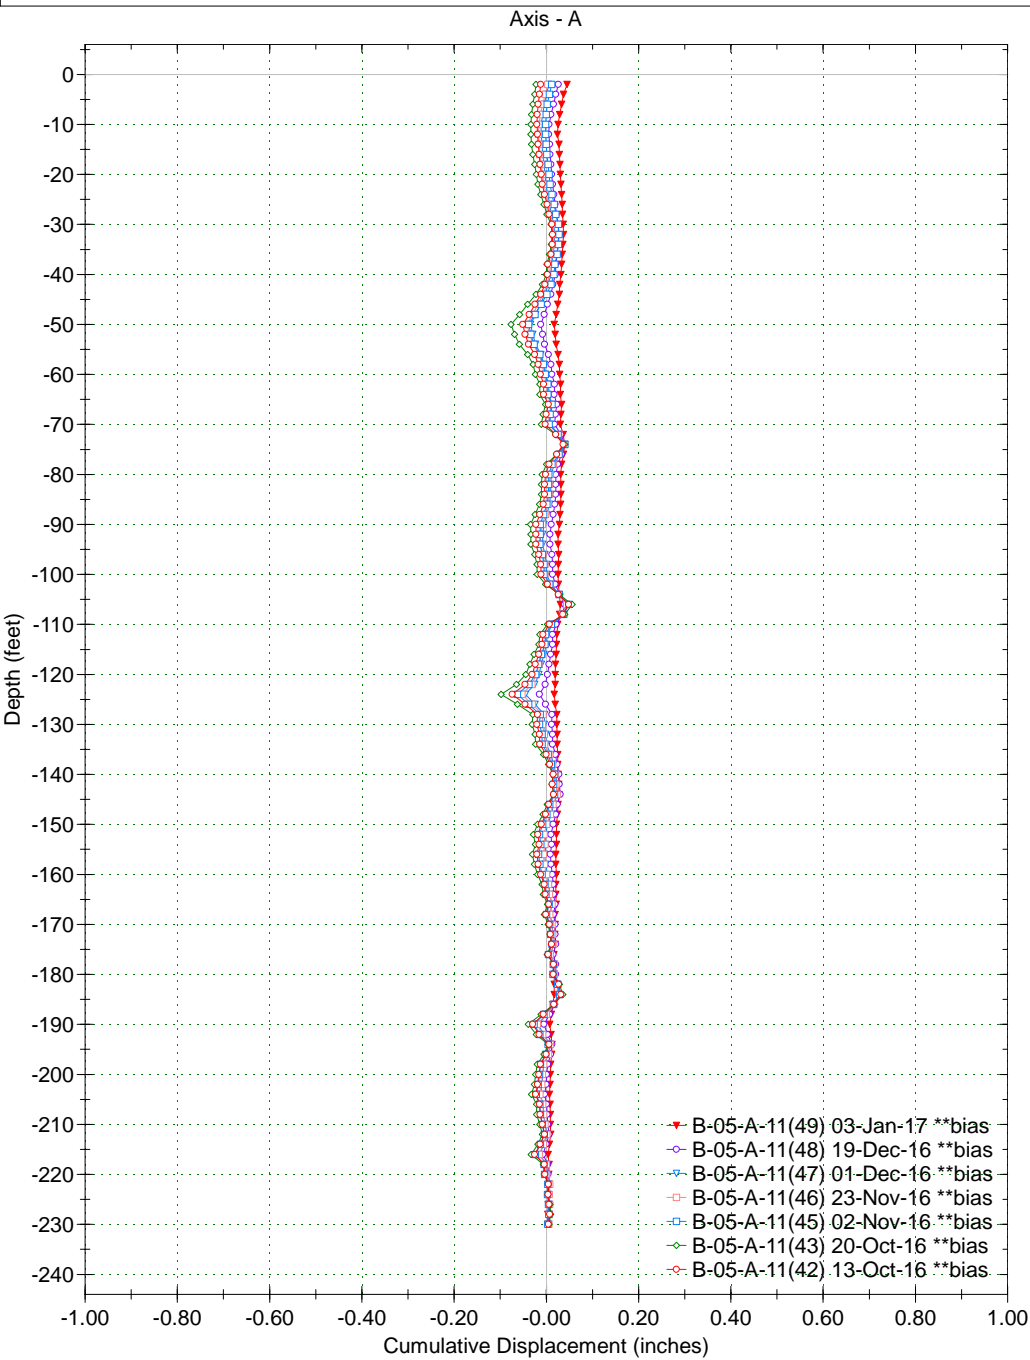
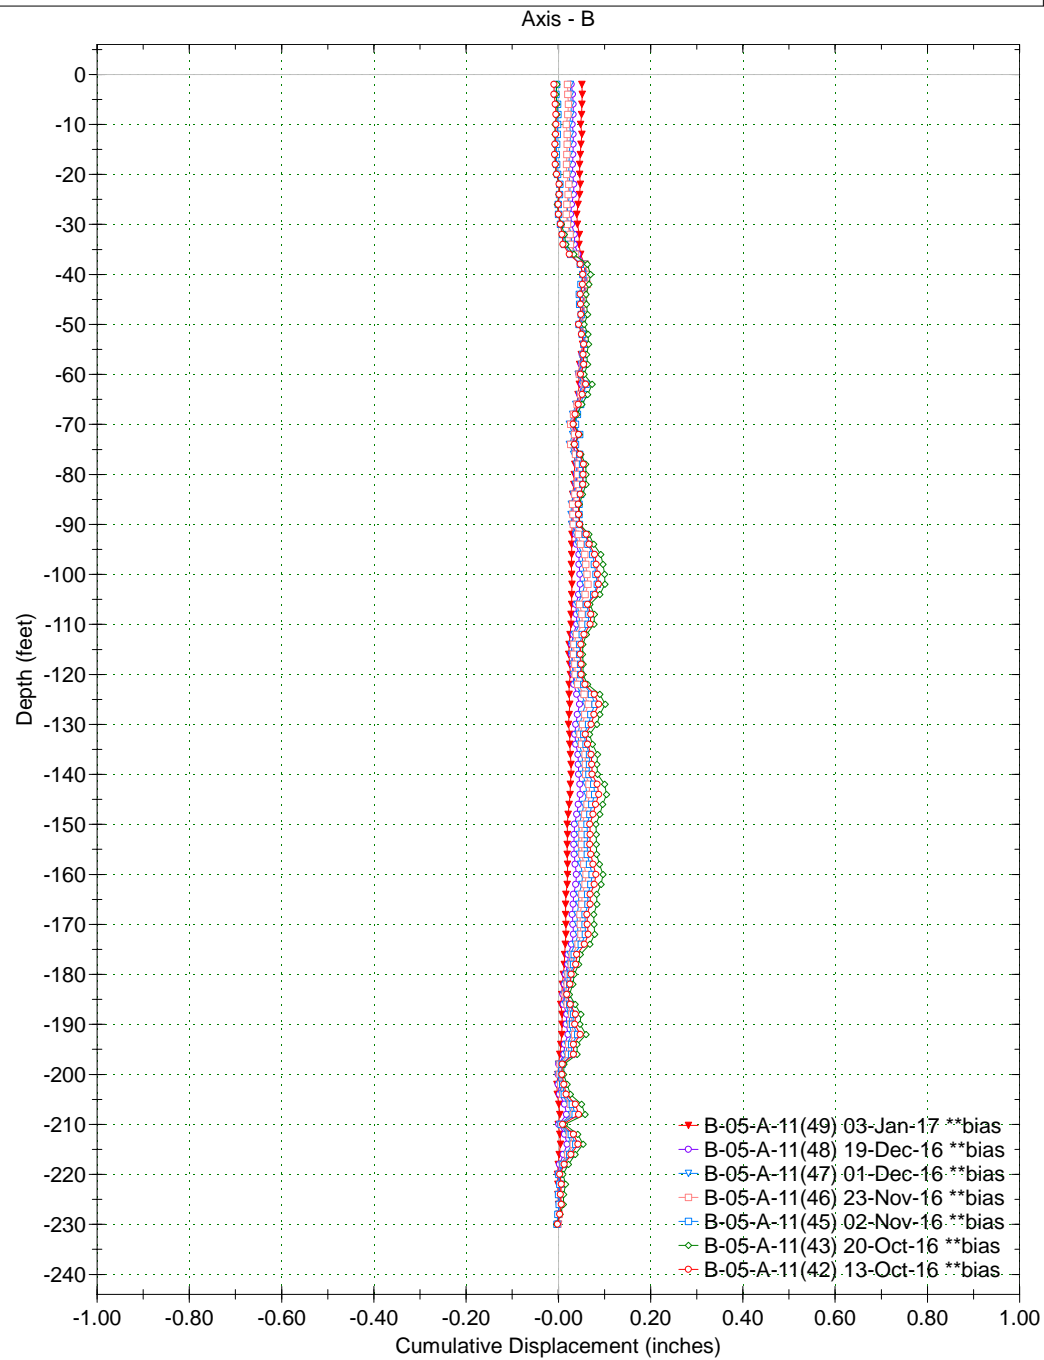
Borehole : B-05-A-11 230 ft  
Project : CUY-90-15-24  
Location :  
Northing :  
Easting :  
Collar :

B-05-A-11 – We recently had the wheels replaced and calibration checked on our slope inclinometer. This may be why most of the variations no longer appear in this plot.
