February 17, 2017

Re: January 18, 19, and 20, 2017 Bi-Weekly Readings
CUY-90-15.24 Slope Monitoring
PID 96504
SME Project No. 069032.00

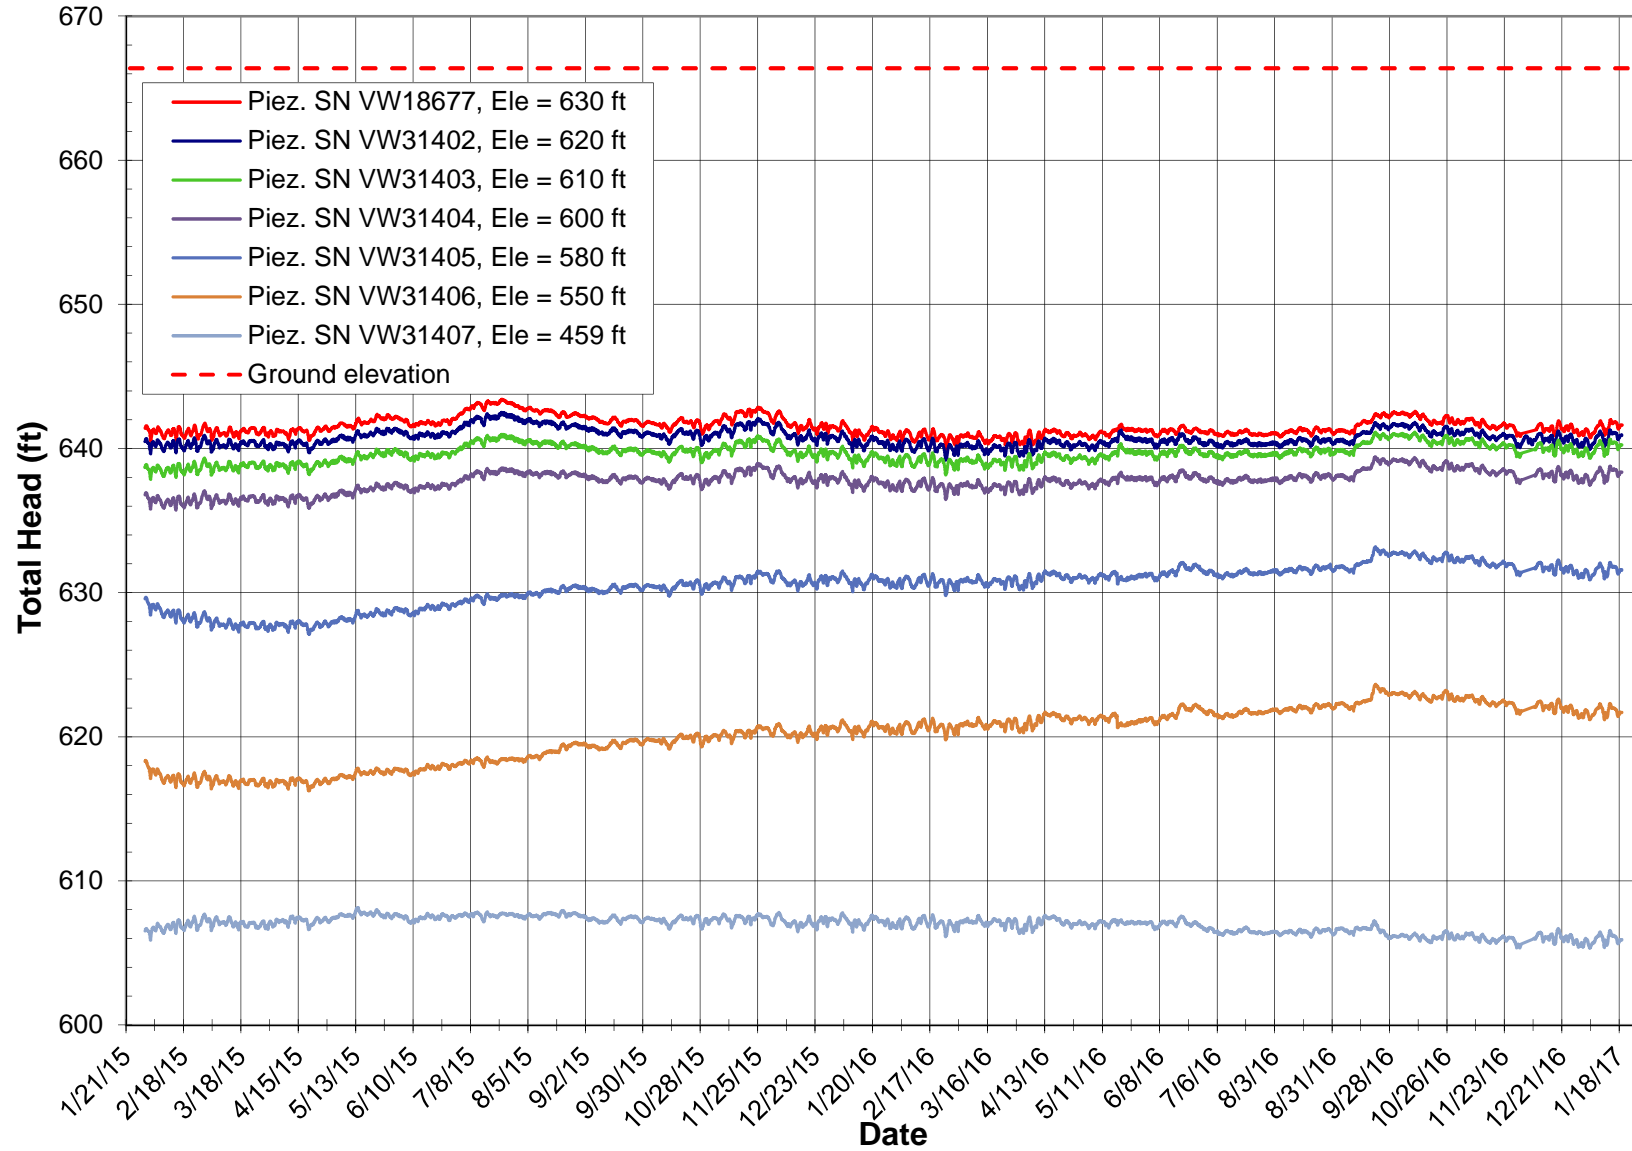
P-001-13 VW Piezometer Readings

P-001-13 – Pore pressure readings in the piezometers at this location show increases in total head ranging from 0.5 feet to 1.0 foot, with the greatest increase occurring at elevation 610 feet. Total head in the four shallow piezometers has remained nearly the same for at least a year varying by no more than about 1 foot. Total head in the piezometers at 550 and 580 feet has increased by about 2 feet, and total head in the piezometer at 459 feet and decreased by about 2 feet during this same period.

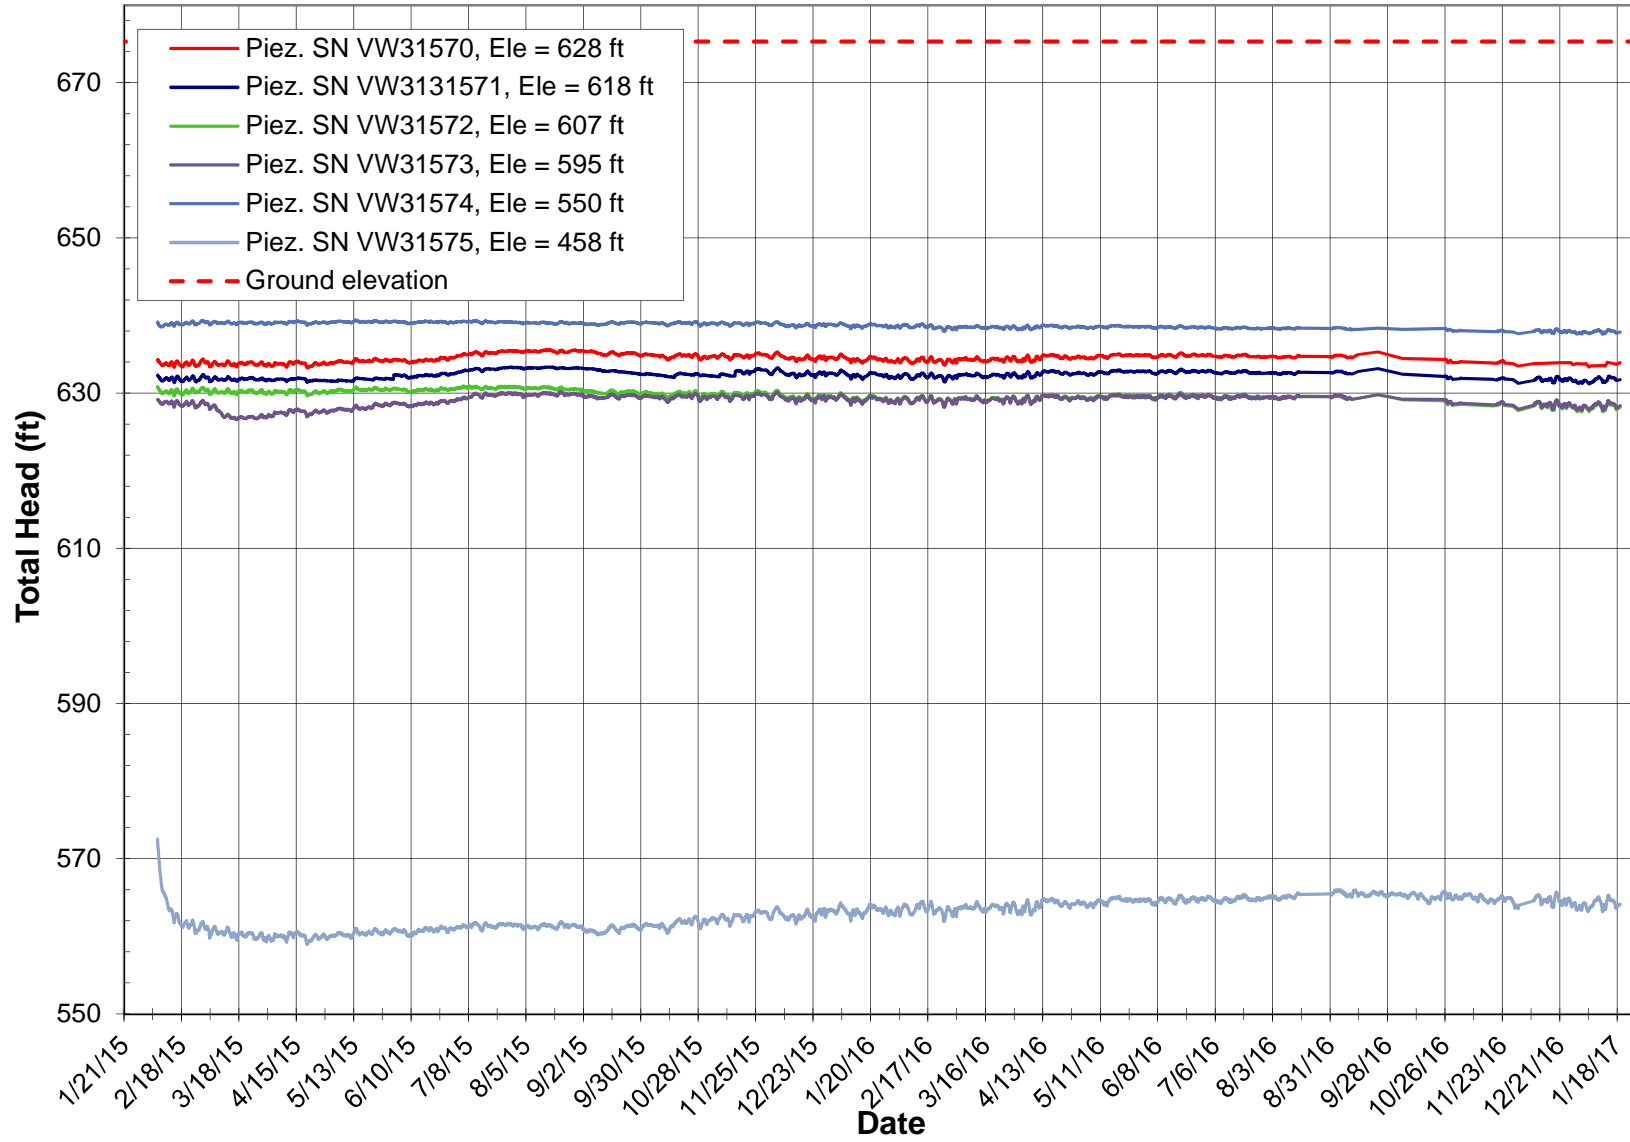
P-002-13 VW Piezometer Readings

P-002-13 – Pore pressure readings in the piezometers at this location show increases in total head ranging from 0.2 feet to 0.6 feet, with the greatest increase occurring at elevation 458 feet.

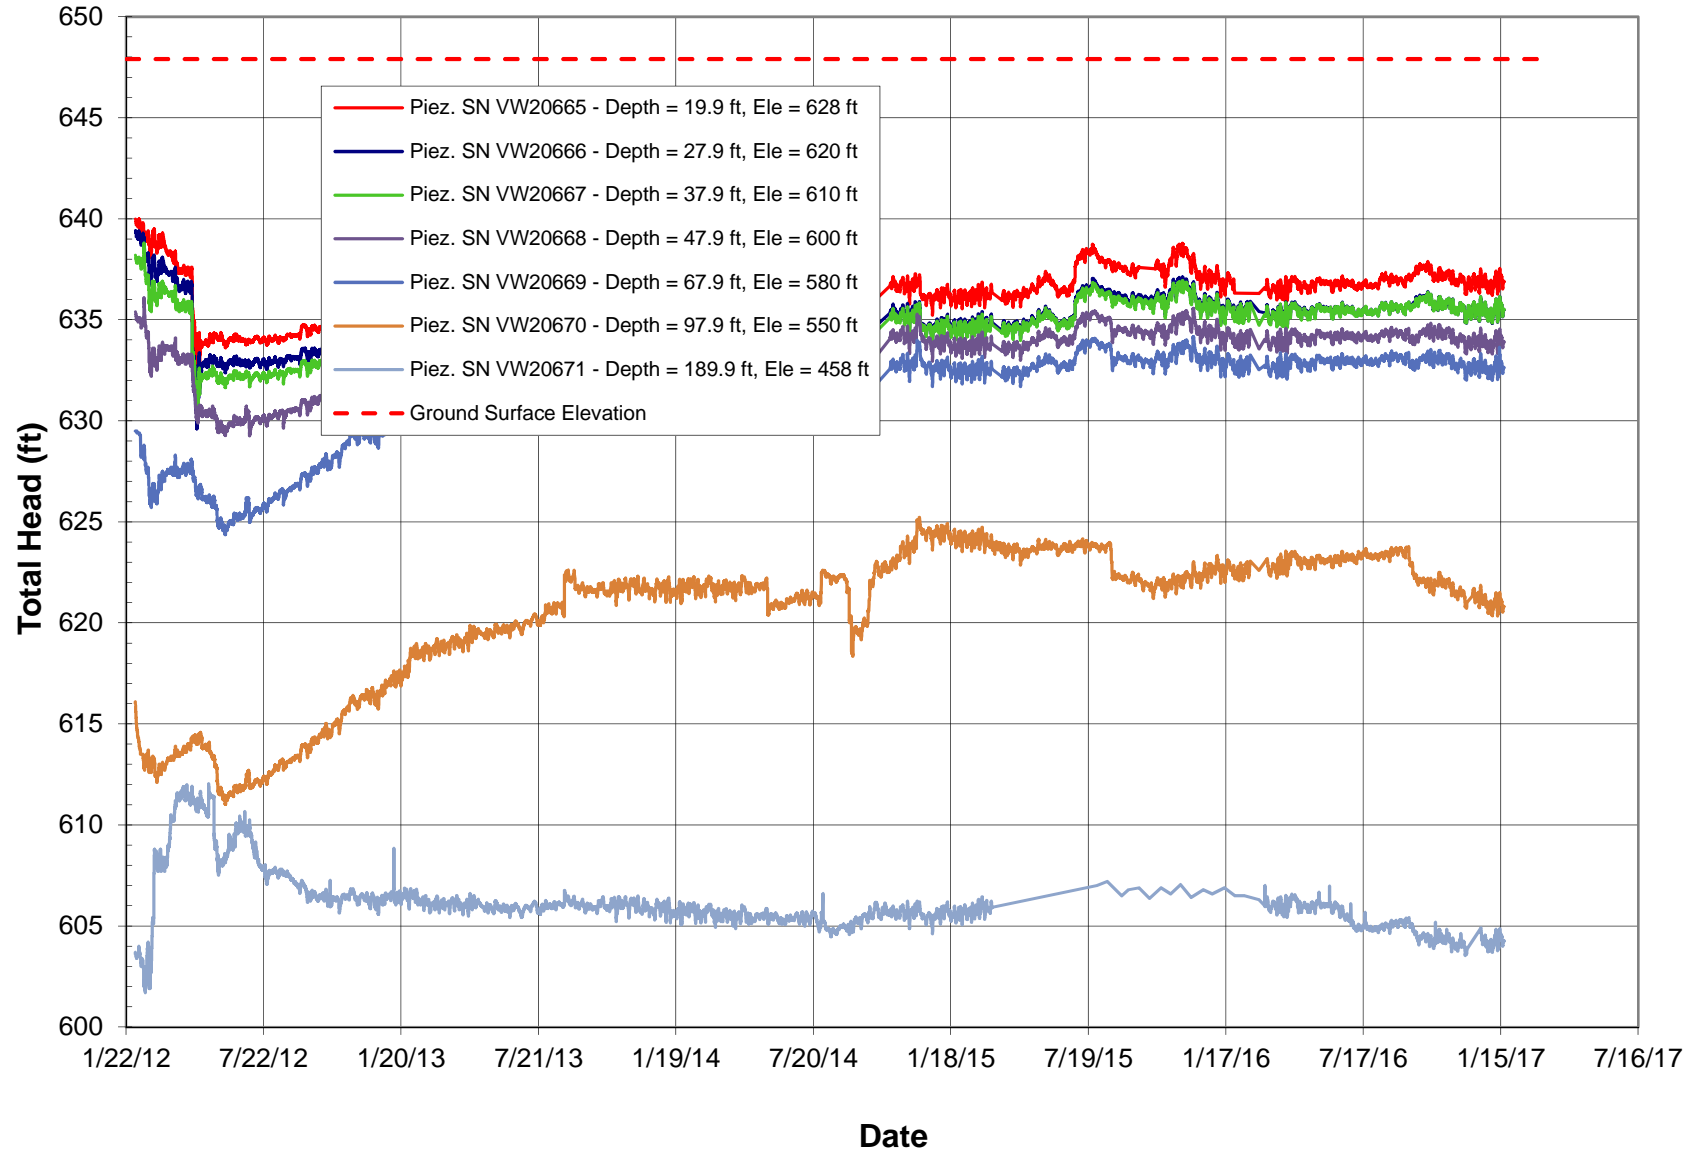
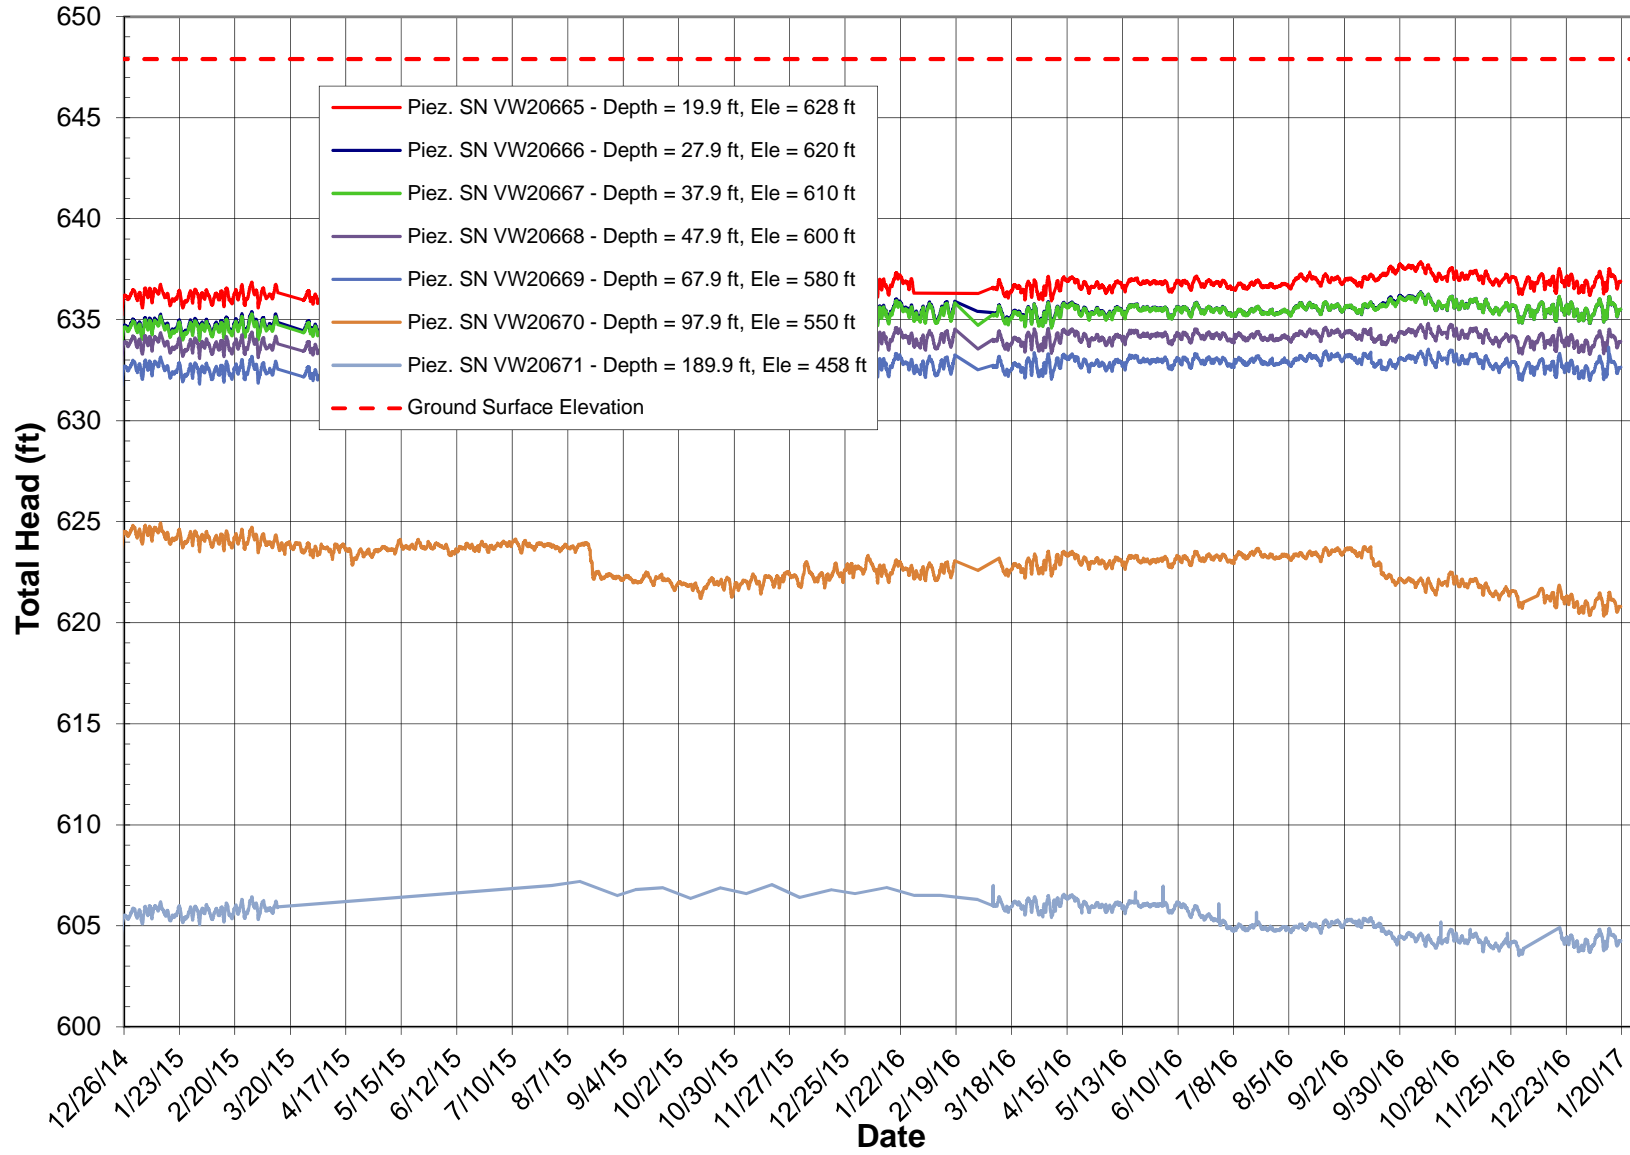
P-003-10 VW Piezometer Readings

P-003-10 – At this location, pore pressures in all piezometers increased by about 0.7 feet, except for the piezometer at elevation 550 feet, which only increased by 0.4 feet. Pore pressure variations have increased during the last 2 months compared to the prior 8 months, but total head has not changed appreciably in the five shallow piezometers. Pore pressures have decreased by about 2 feet in the two deep piezometers during this same period.

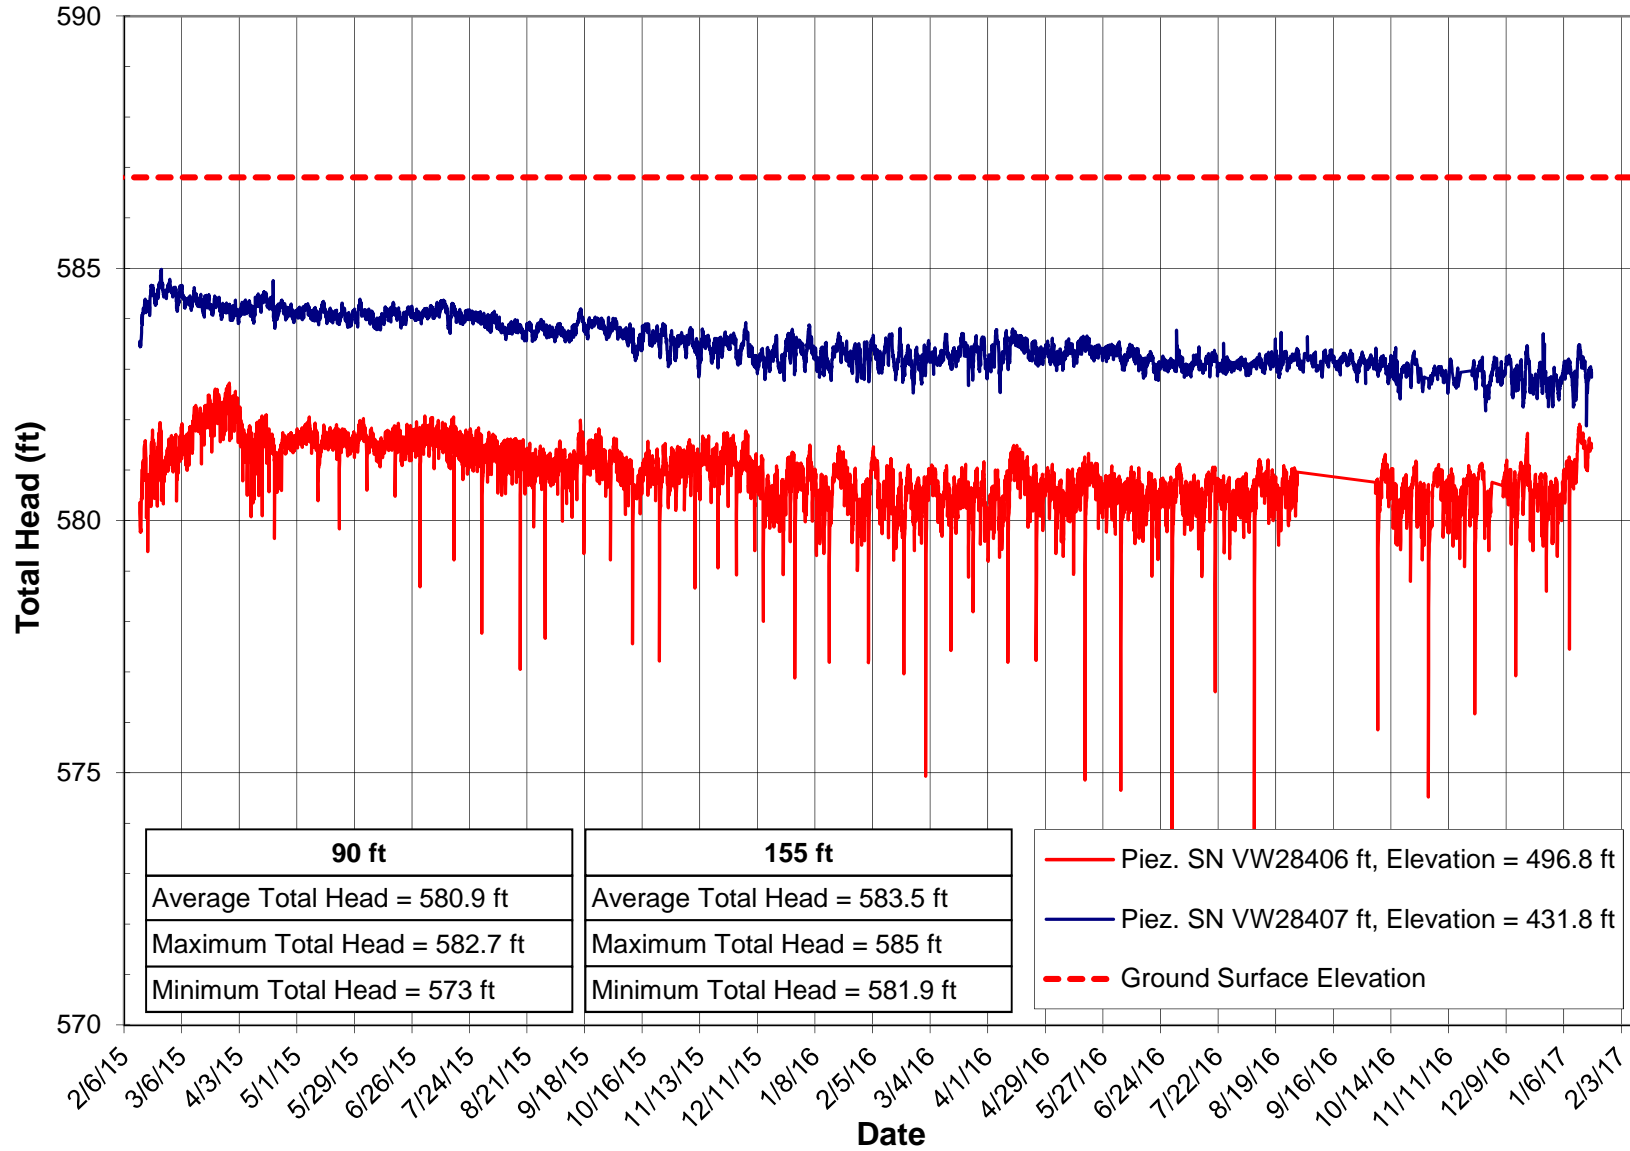
P-009-13 VW Piezometer Readings

P-009-13 – Pore pressure readings in the shallow piezometer show an increase of 0.9 feet, while pore pressure readings in the deep piezometer show a decrease of 0.4 feet.

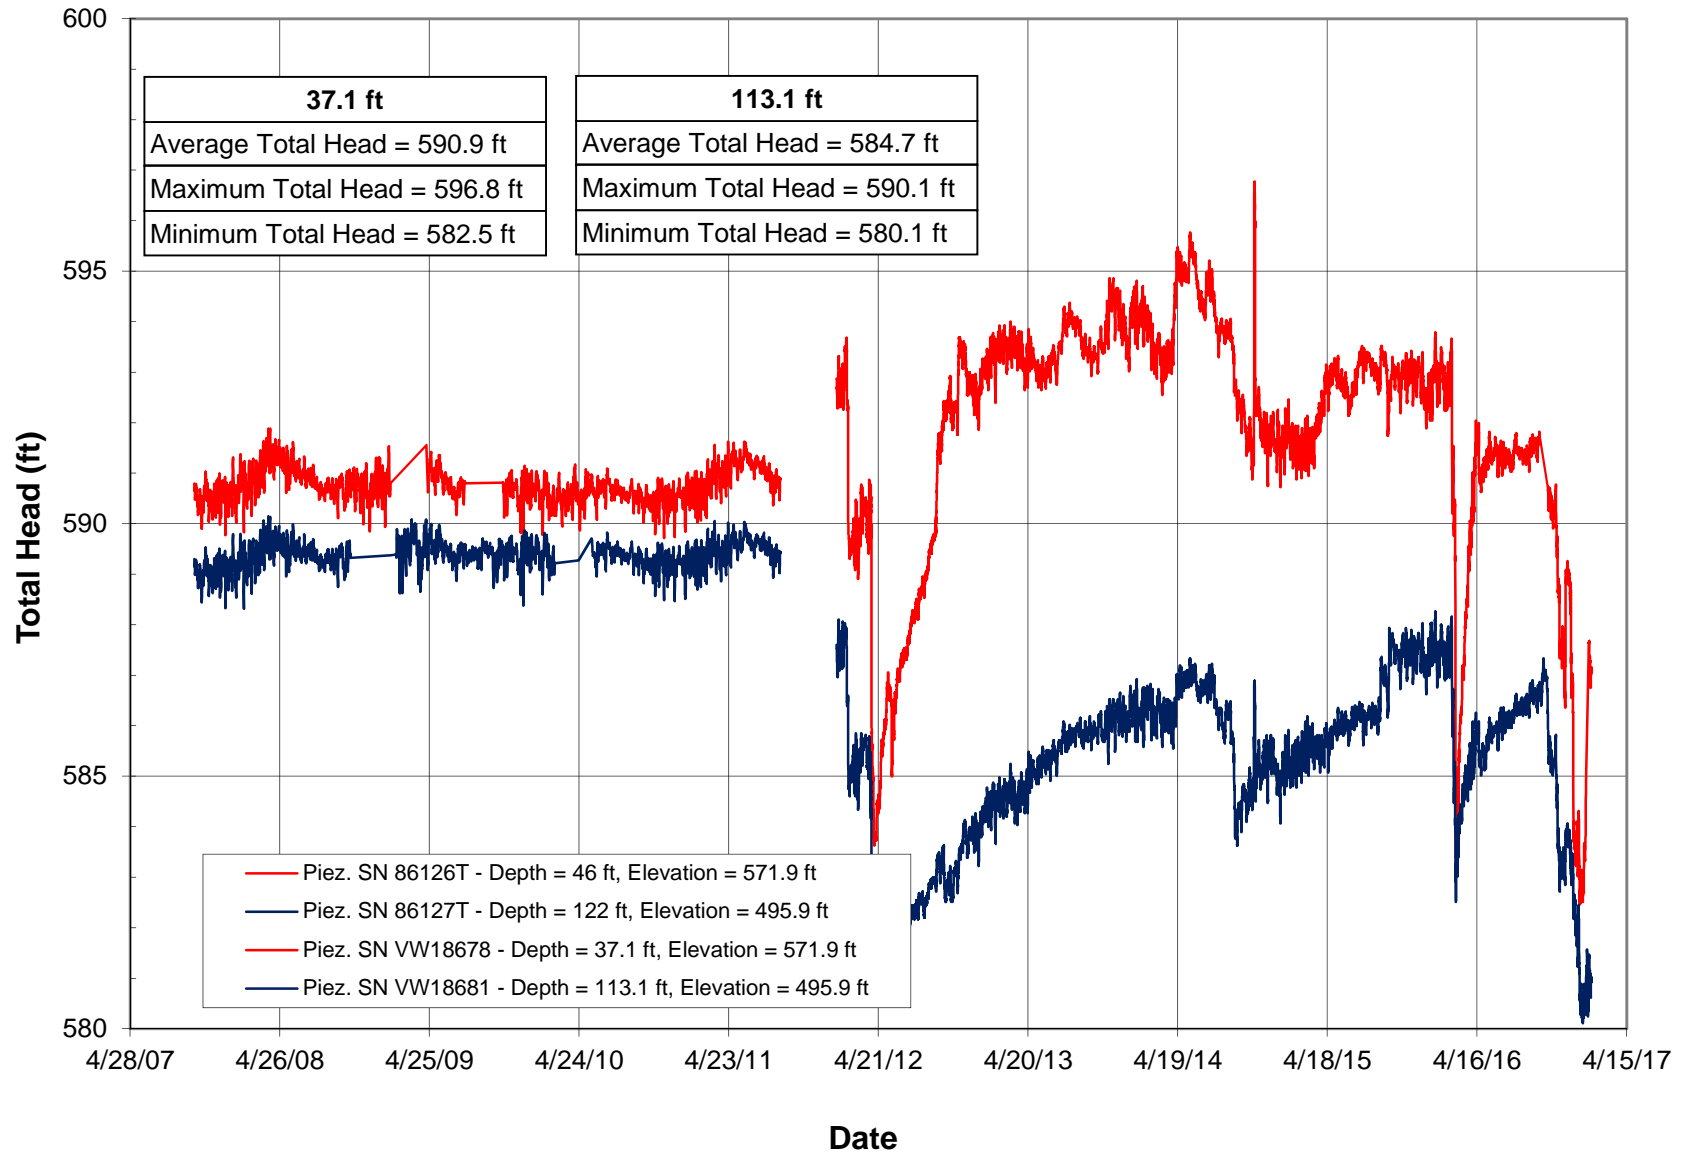
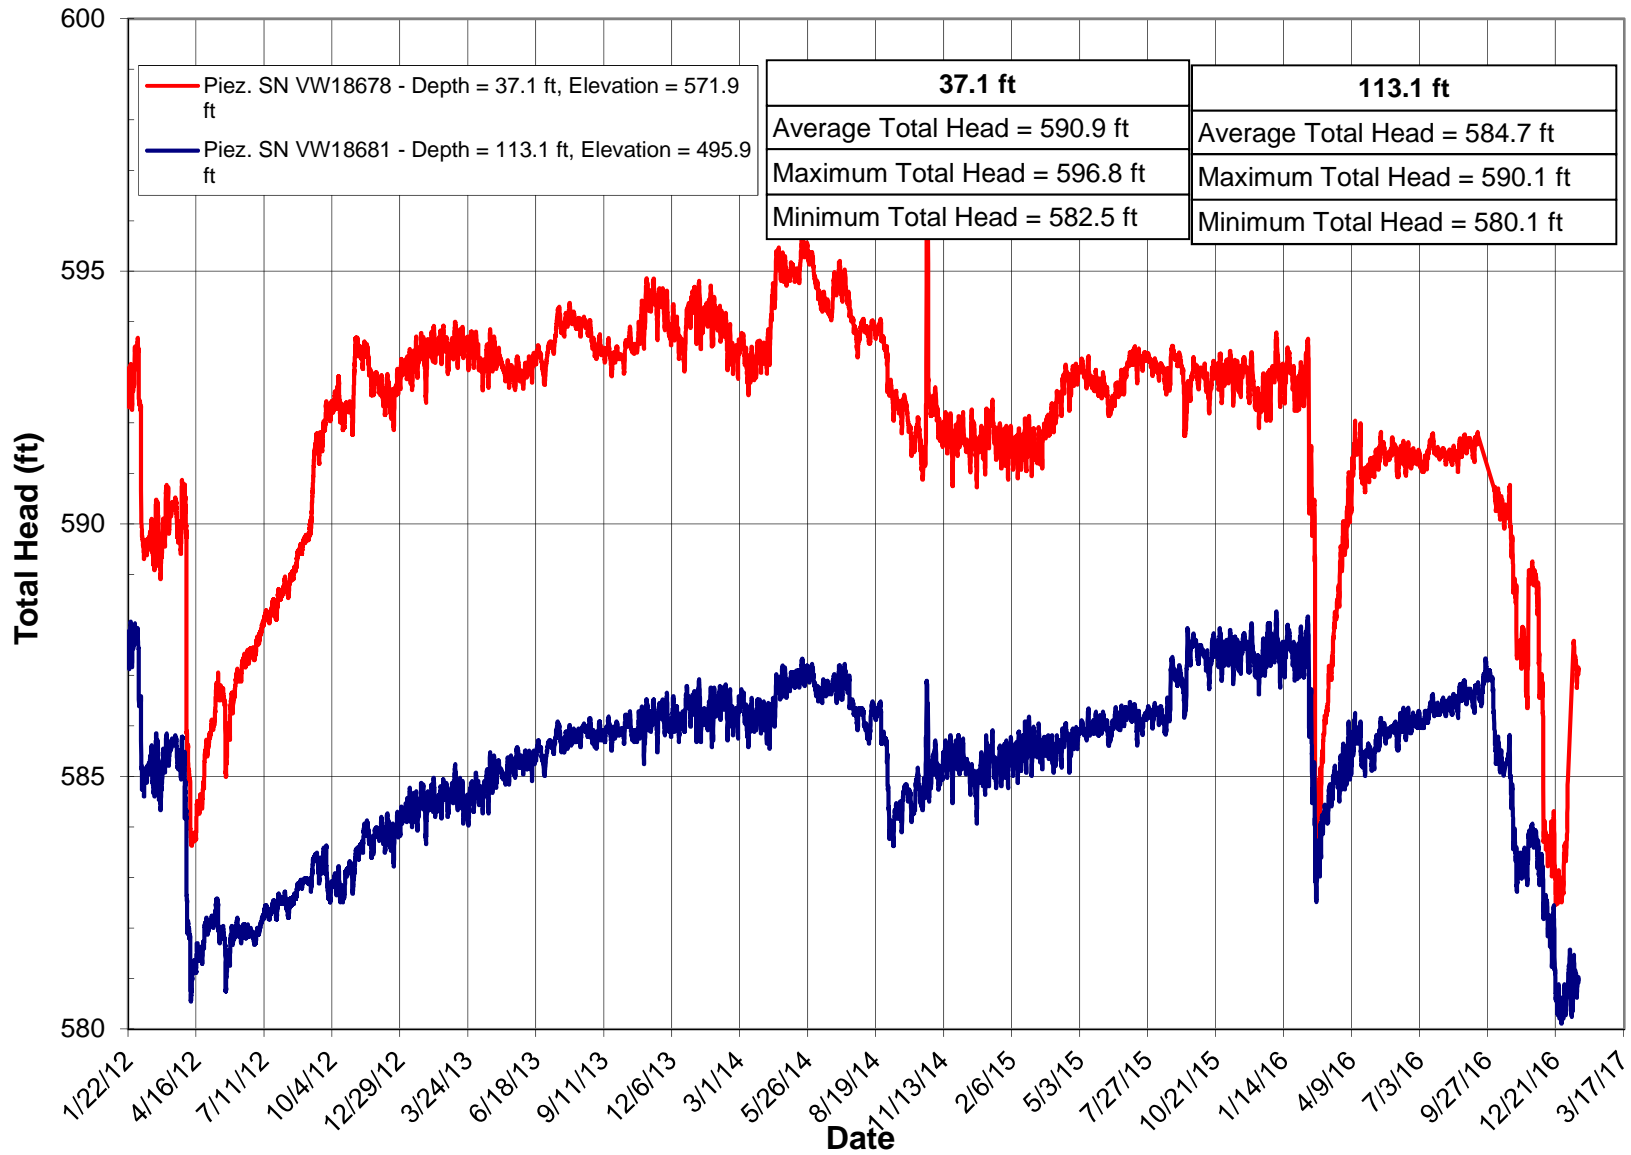
B-05-02 VW Piezometer Readings

B-05-02 – Pore pressures in the shallow piezometer continued to increase during this reading period and have now increased by about 4.5 feet since December 29, 2016. Pore pressure readings in the deep piezometer show virtually no change.

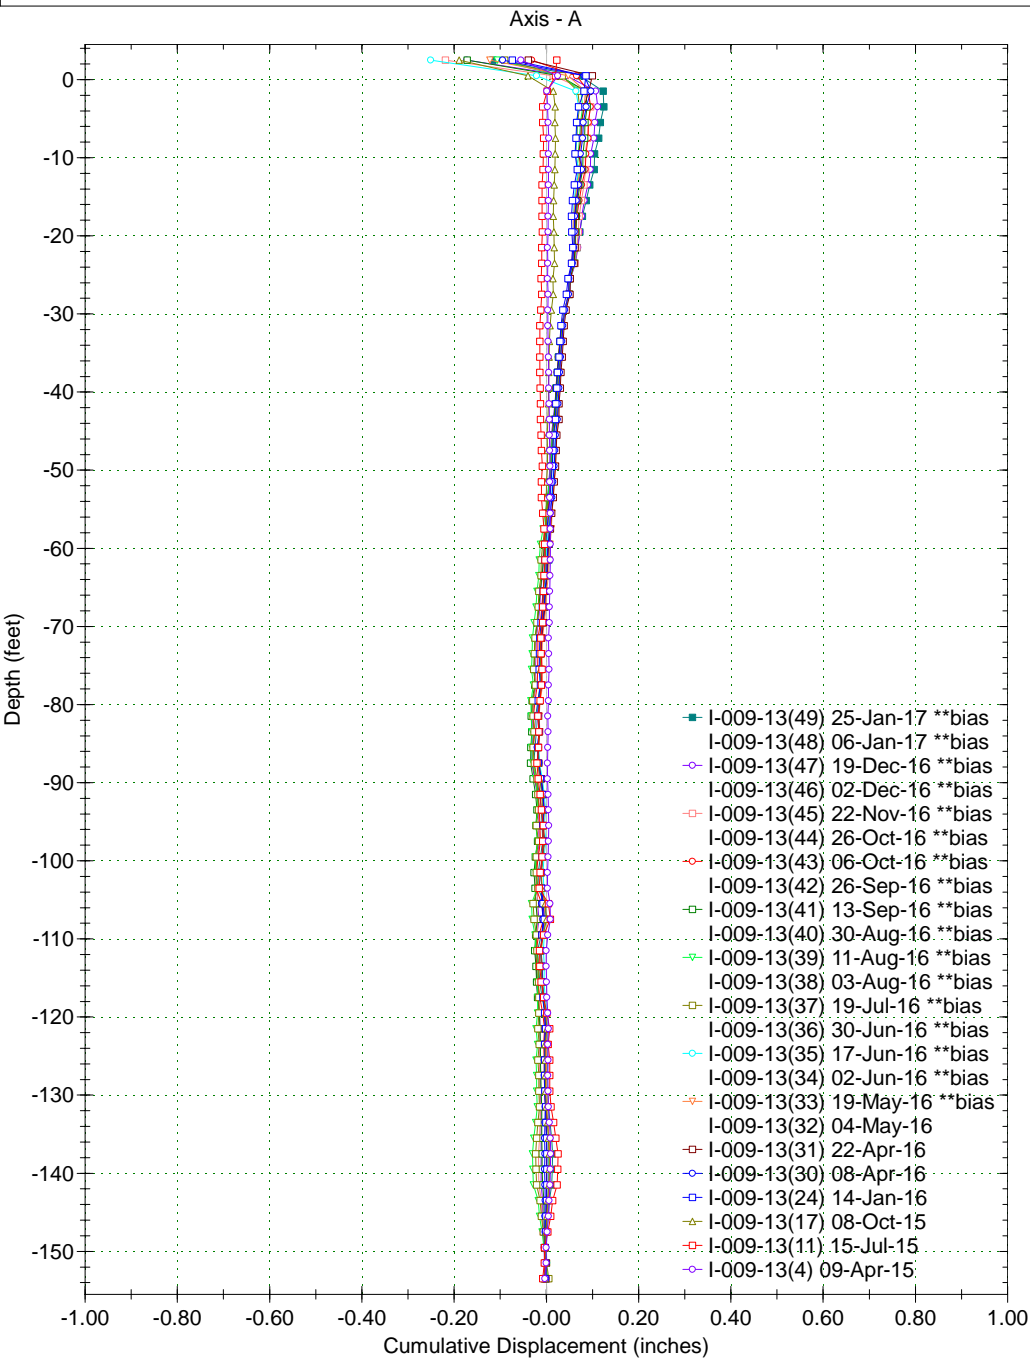
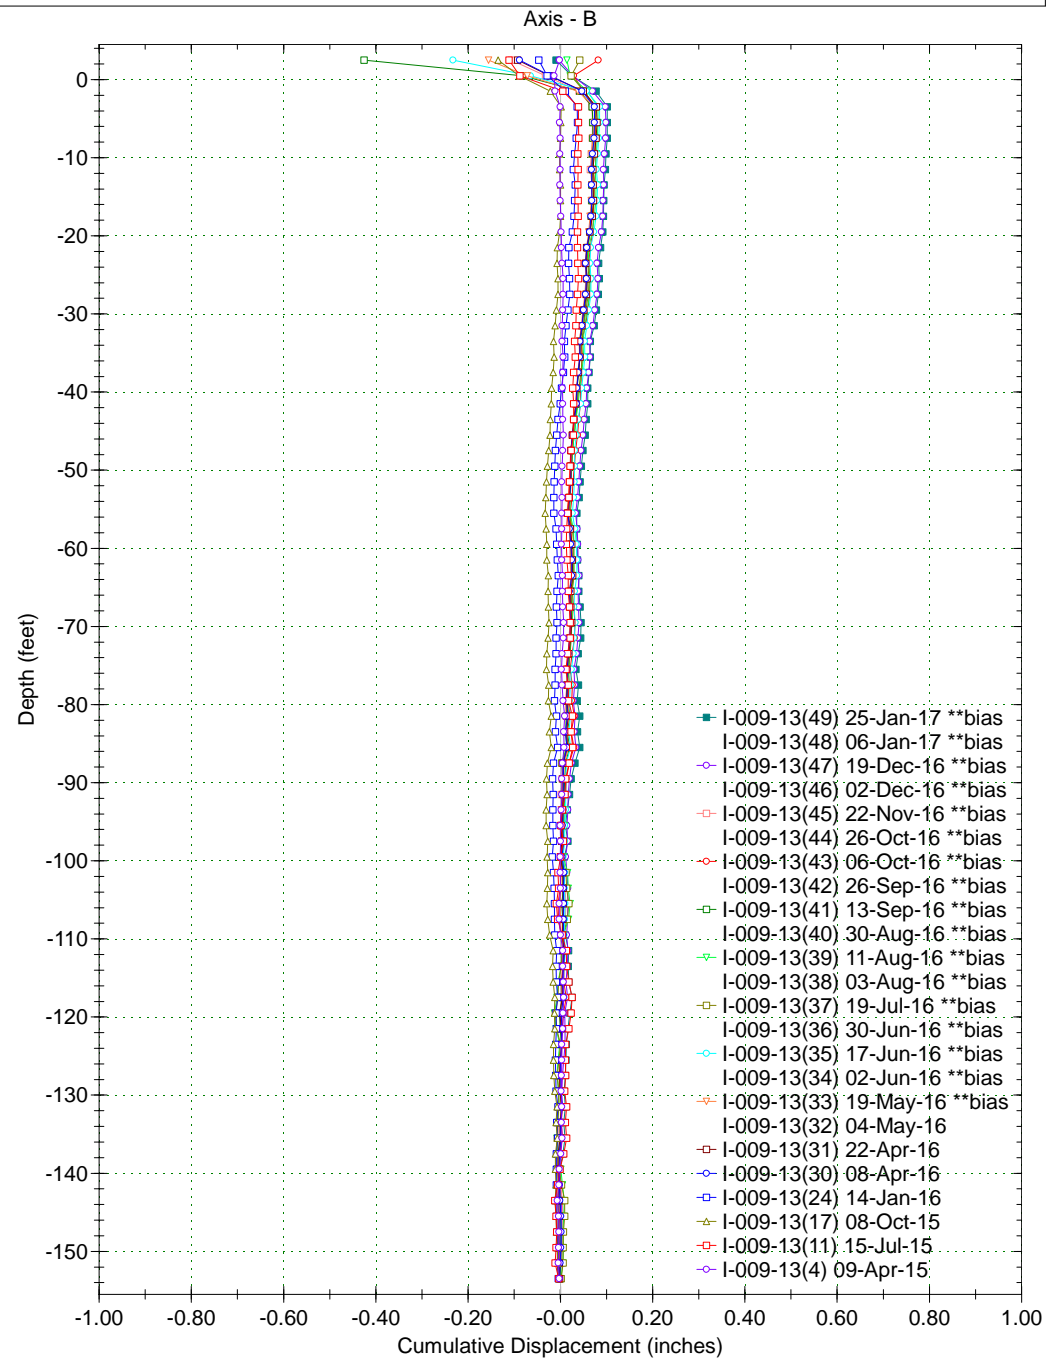
Borehole : I-009-13
Project : CUY-90-15-24
Location : Cleveland, Ohio
Northing :
Easting :
Collar :

I-009-13 – Inclinometer readings at this location indicate slight movement in the positive A-axis direction from the surface to about 20 feet. No movement is shown in the B-axis direction.

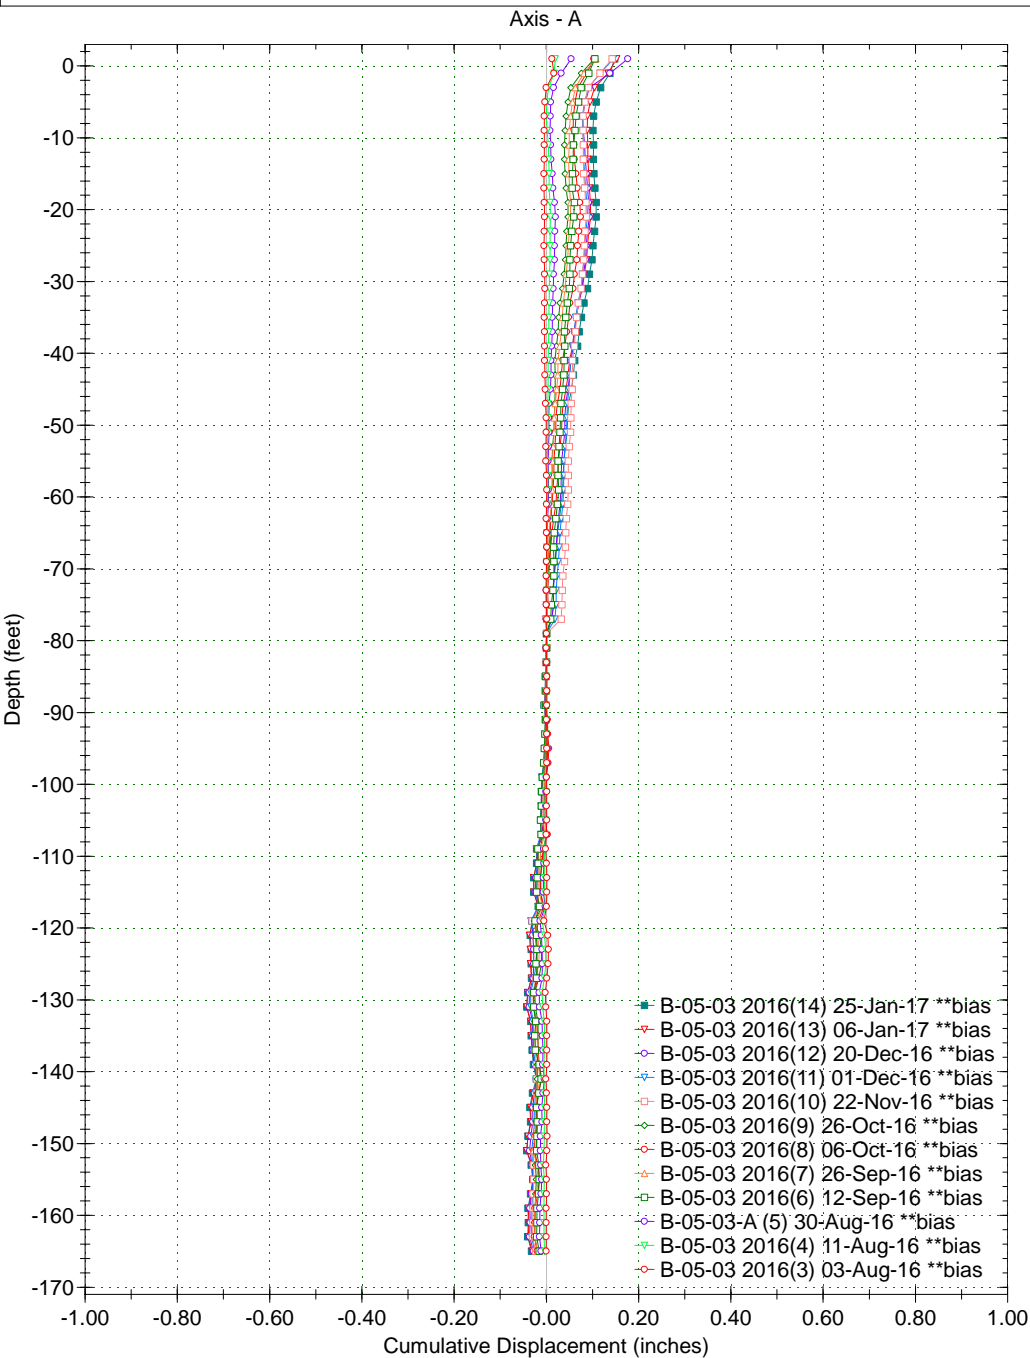
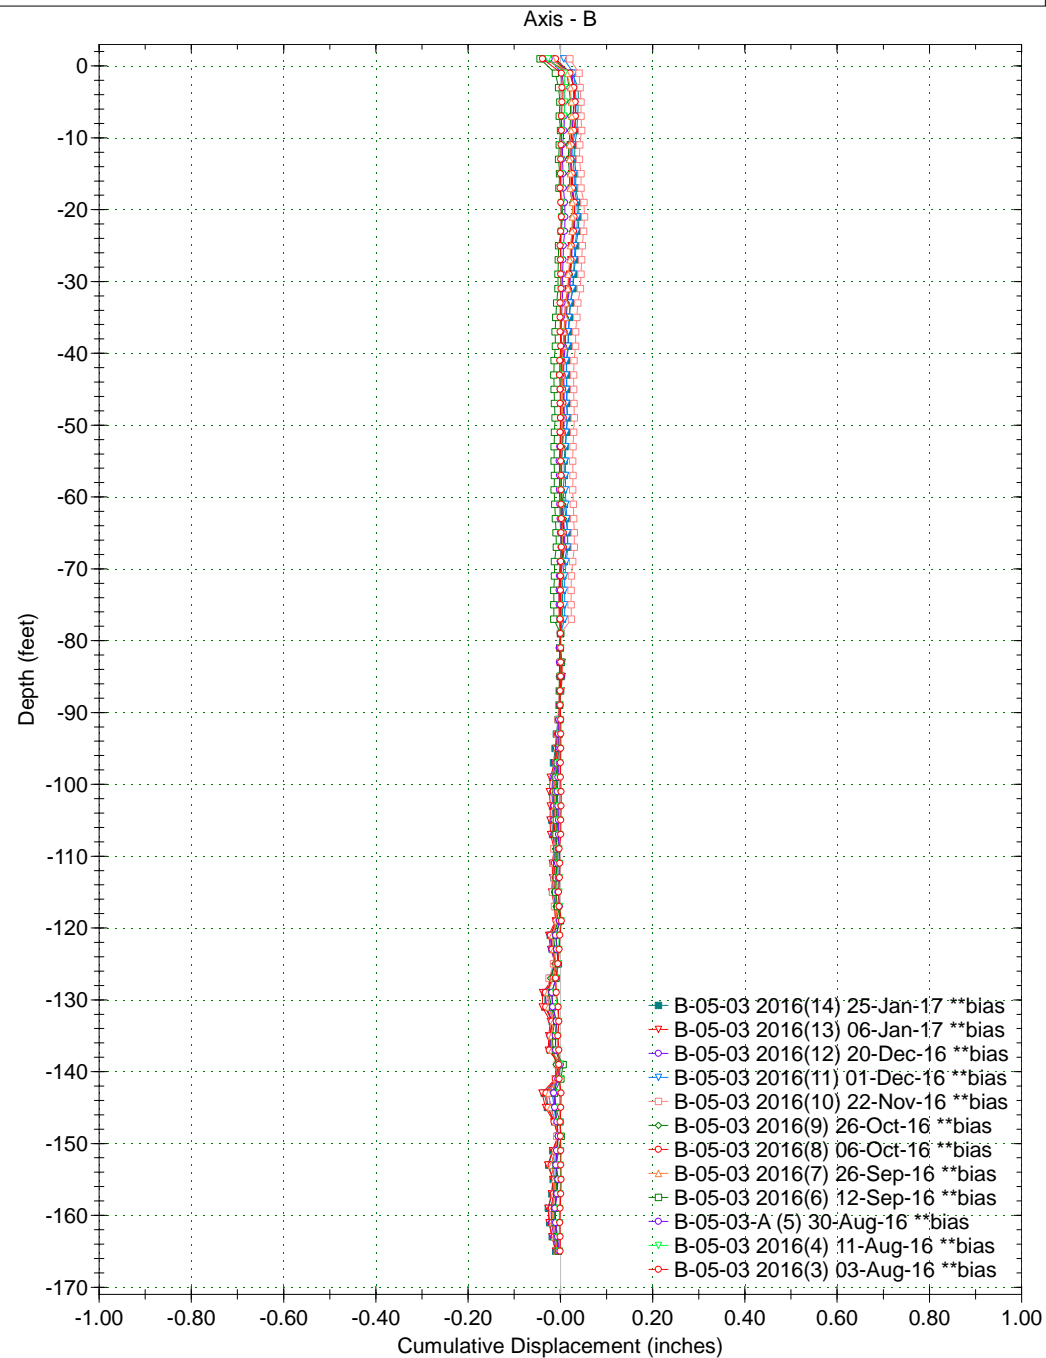
Borehole : B-05-03-A
 Project : CUY-90-15-24
 Location :
 Northing :
 Easting :
 Collar :

B-05-A-03 – Inclinometer readings at this location indicate slight movement in the positive A-axis direction above 40 feet. No movement is shown in the B-axis direction.
