Re: January 2017 Quarterly Report  
CUY-90-15.24 Slope Monitoring  
PID 96504  
EDP Project No. 069032.00

# JANUARY 2017 QUARTERLY REPORT

CUY-90-15.24 SLOPE MONITORING  
PID 96504  
CLEVELAND, OHIO  
SME PROJECT NO. 069032.00

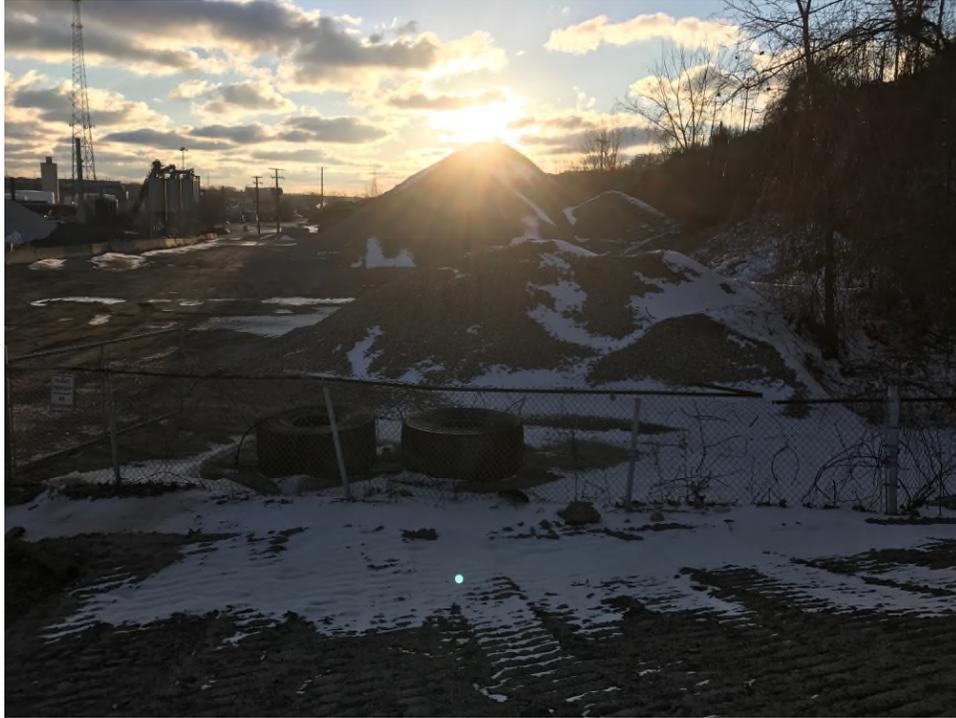
We observed and photographed the aggregate stockpiles on January 12, 2017. The photos are included in Appendix A as Figures 4 and 5. Only a small pile of aggregate remains closest to the right-of-way fence. This pile has not changed since January 2014. The pile is about 8 feet high and covers only a small area of the property.

Figure 4. Aggregate stockpile east of the ODOT right-of-way (January 12, 2017).

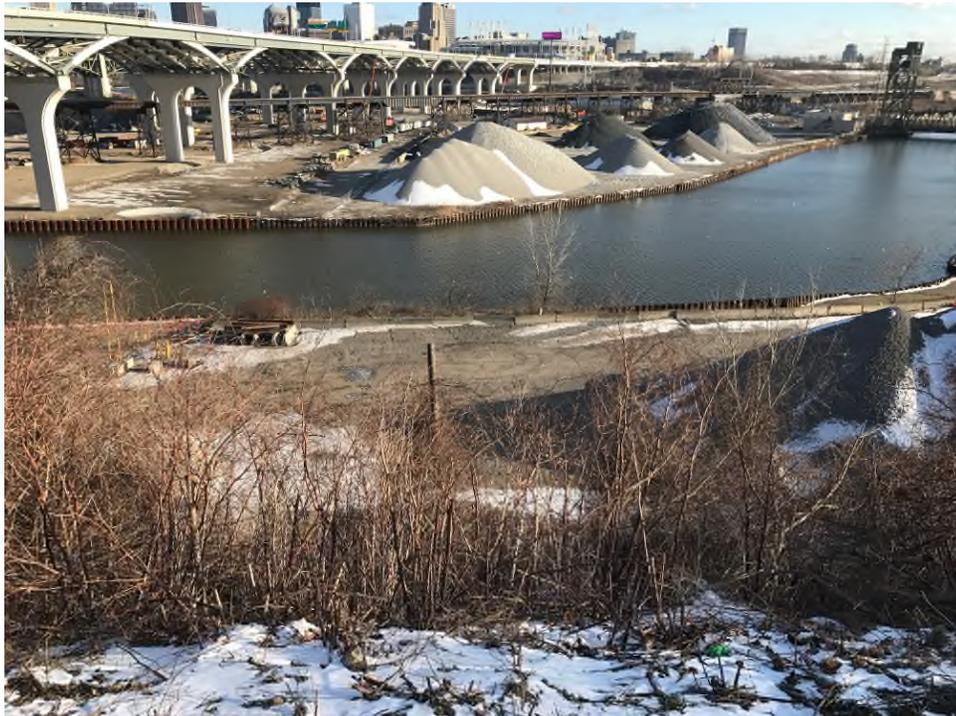
Figure 5. Aggregate stockpile near ODOT's east right-of-way fence (January 12, 2017).

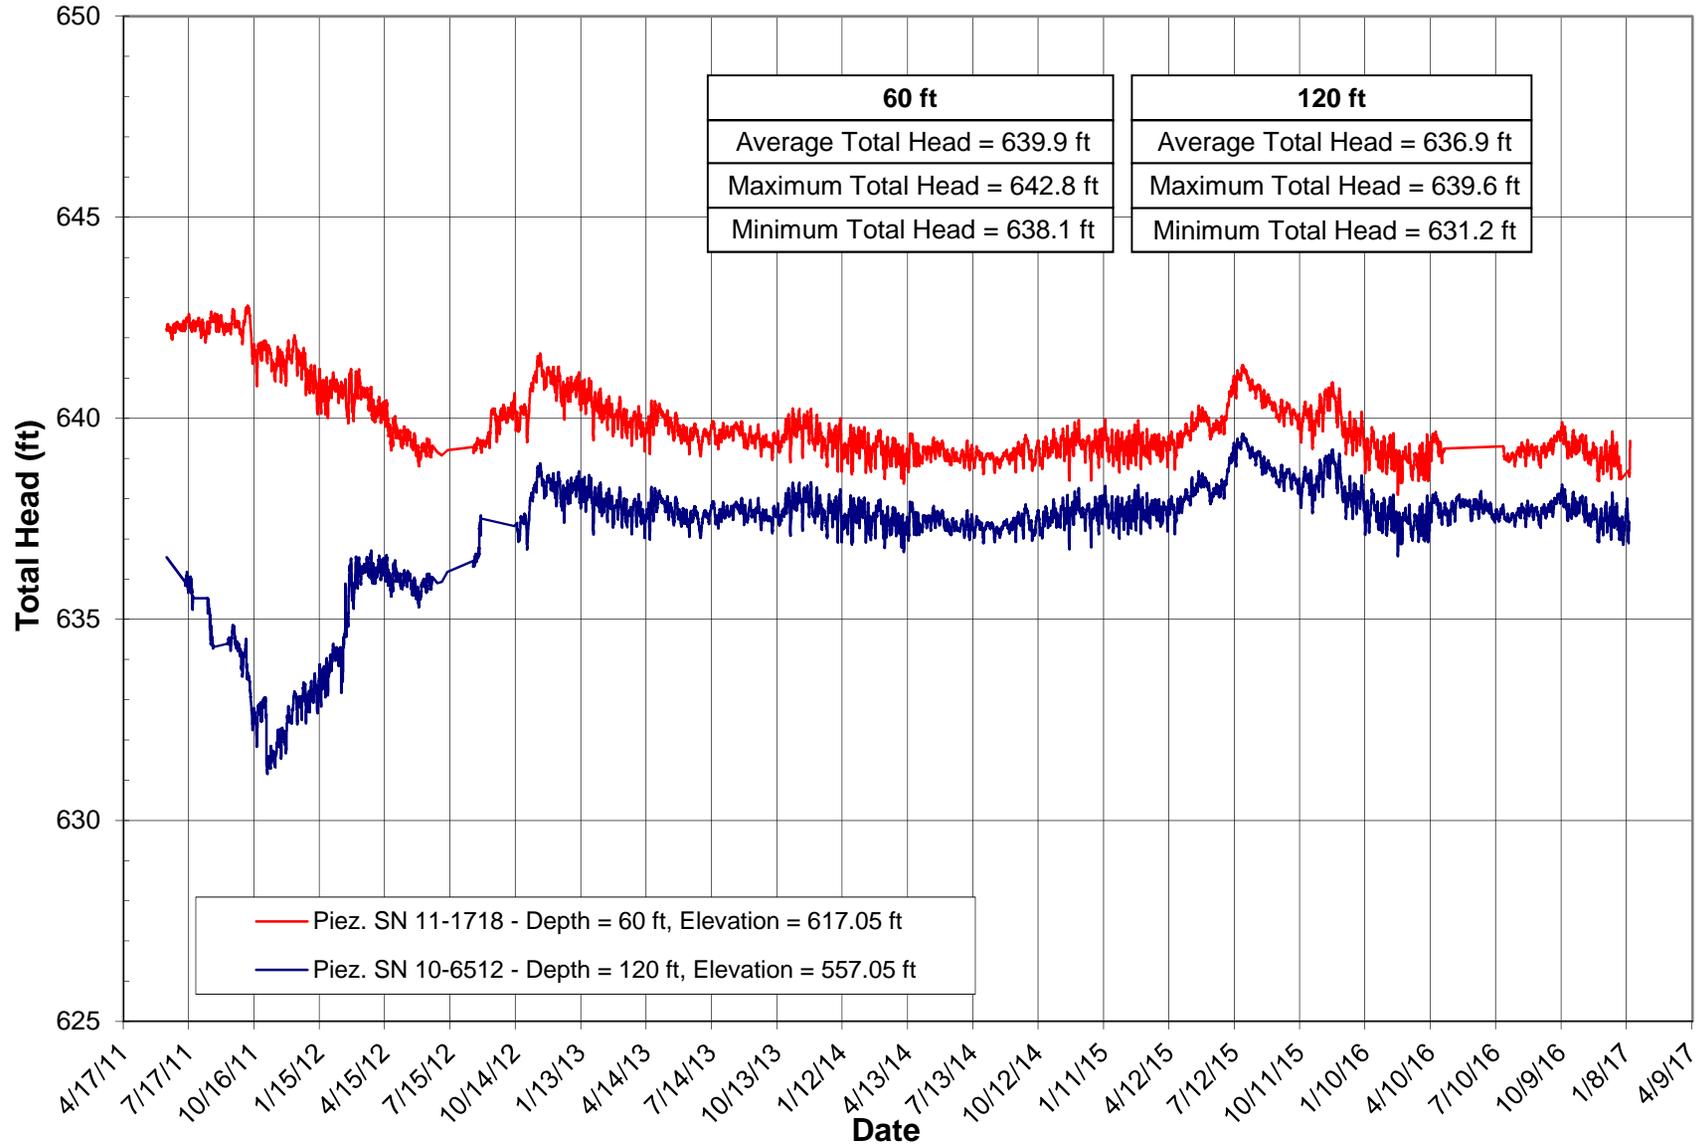
# P-001-10 VW Piezometer Readings

**P-001-10.** Total head in both piezometers at P-001-10 decreased by almost 1 foot since October 2016. The net decrease indicated by the pore pressure readings is less than 0.5 feet in both piezometers.

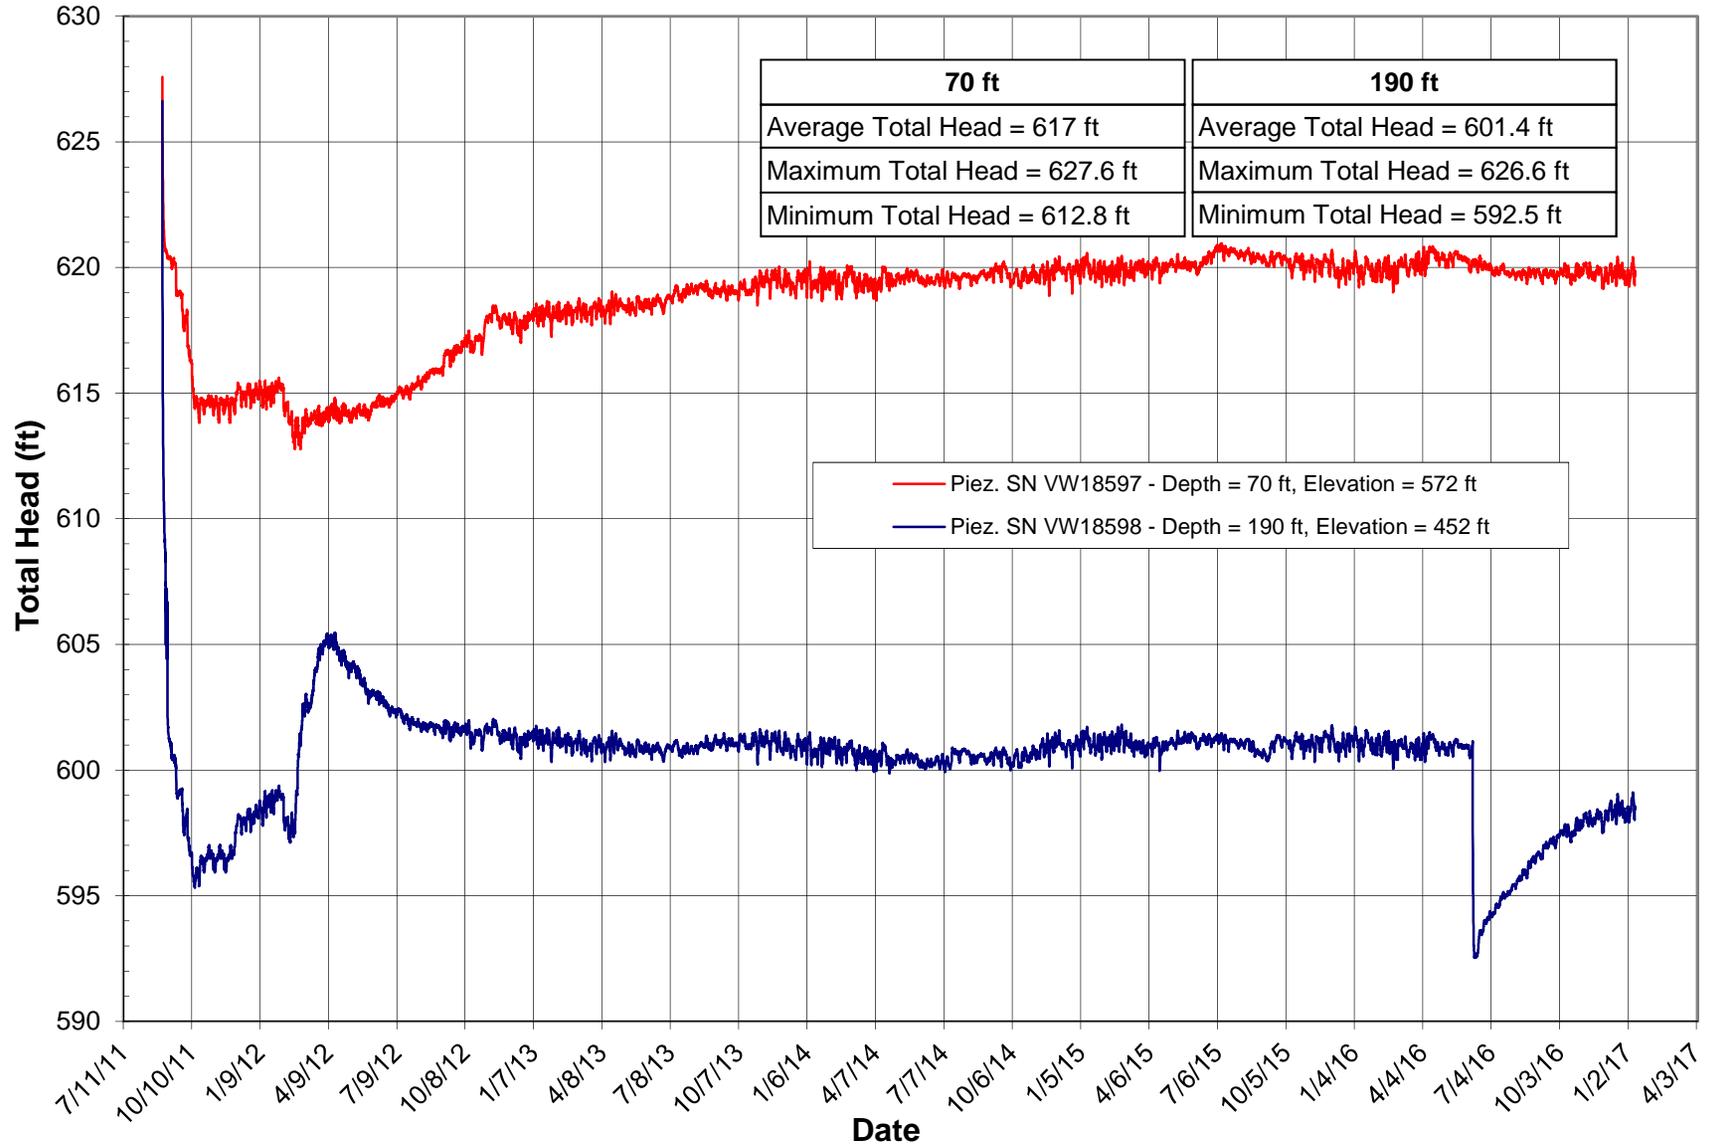
# P-002-10 VW Piezometer Readings

**P-002-10.** Total head in the deep piezometer at P-002-10 continued to increase this quarter with about 1 foot of change this quarter. The total head in this piezometer has increased by about 6.5 feet since June 12, 2016. Total head in the shallow piezometer at this location has fluctuated by about 1 foot this quarter with virtually no net change.

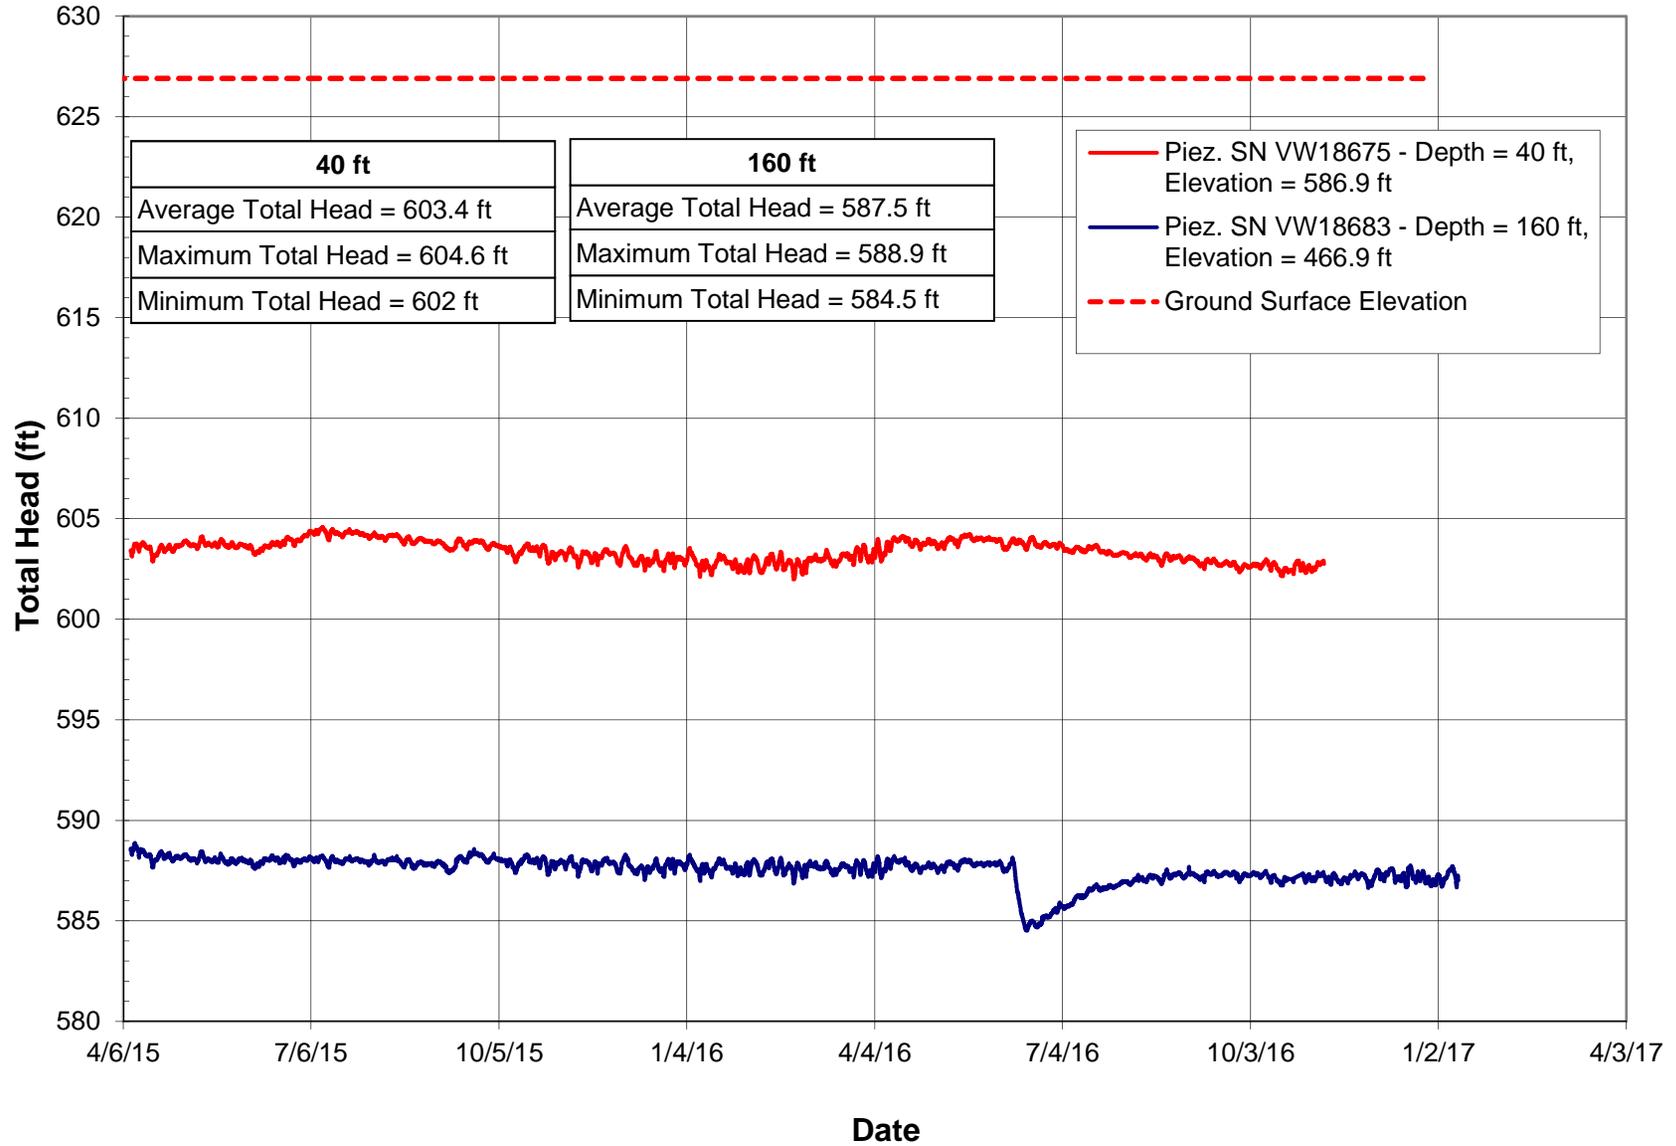
# P-007-13 VW Piezometer Readings

**P-007-13.** Total head in both piezometers at P-007-13 fluctuated by about 1 foot but show virtually no net change. The datalogger for the shallow piezometer failed to record during the second half of the quarter. It appears this was caused by a faulty battery. We replaced the battery and the data logger appears to be working properly.

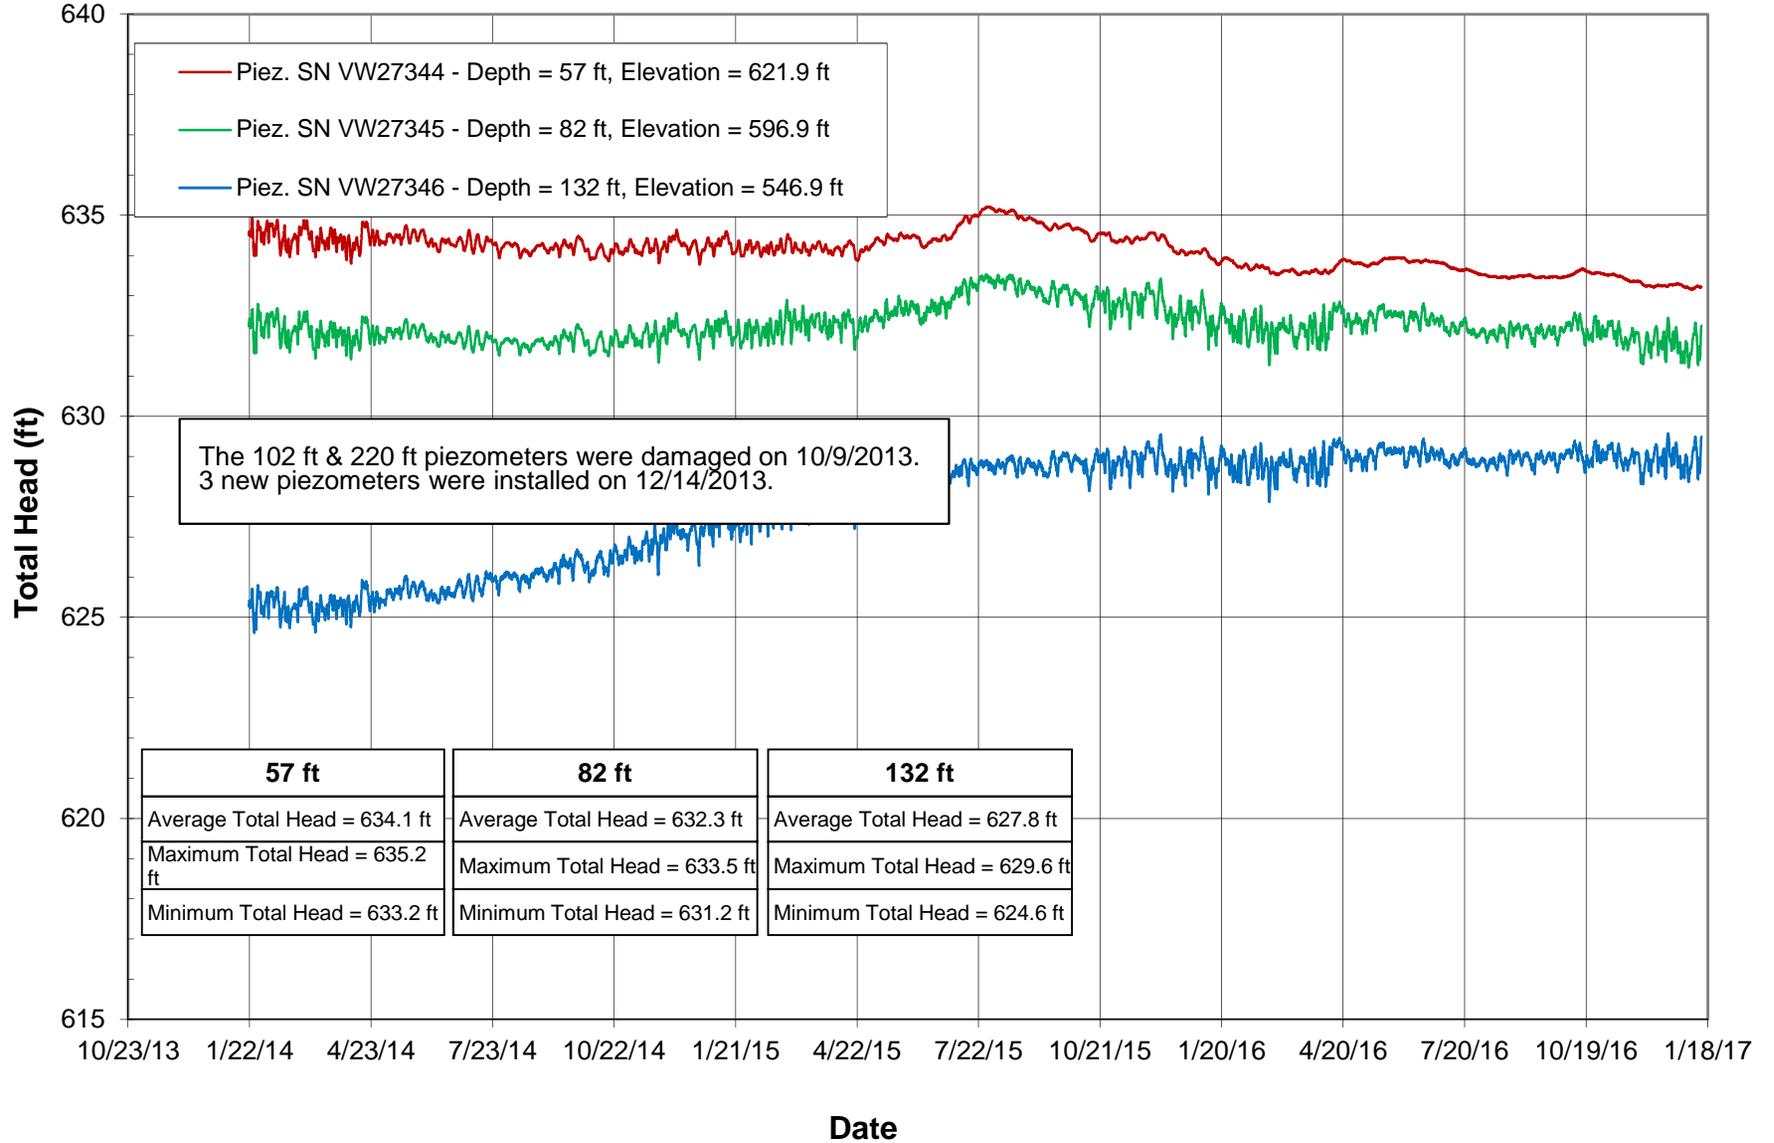
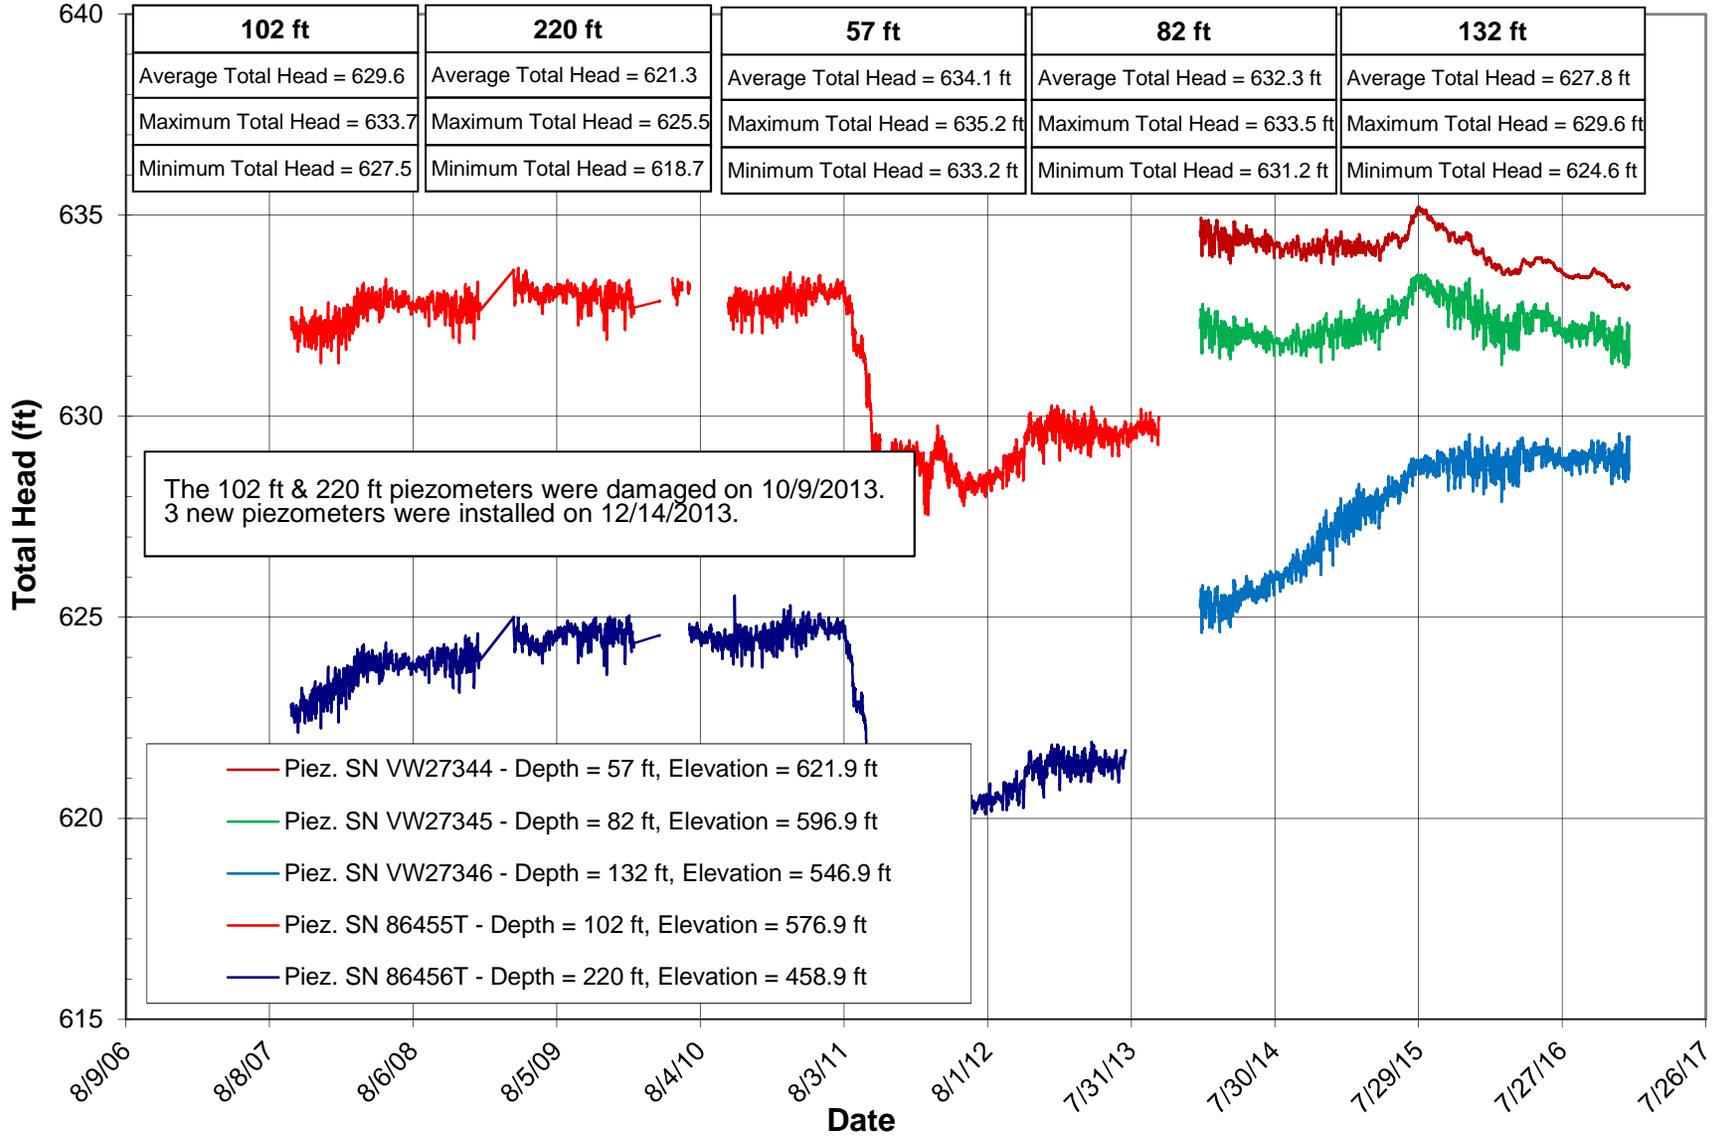
## B-05-07 VW Piezometer Readings

**B-05-07.** Three piezometers were reinstalled at this location after the original piezometers were lost to the construction. Pore pressures in the shallow and middle piezometers continued the downward trend that began in July 2015. Total head in the deep piezometer shows virtually no change in total head during this quarter.

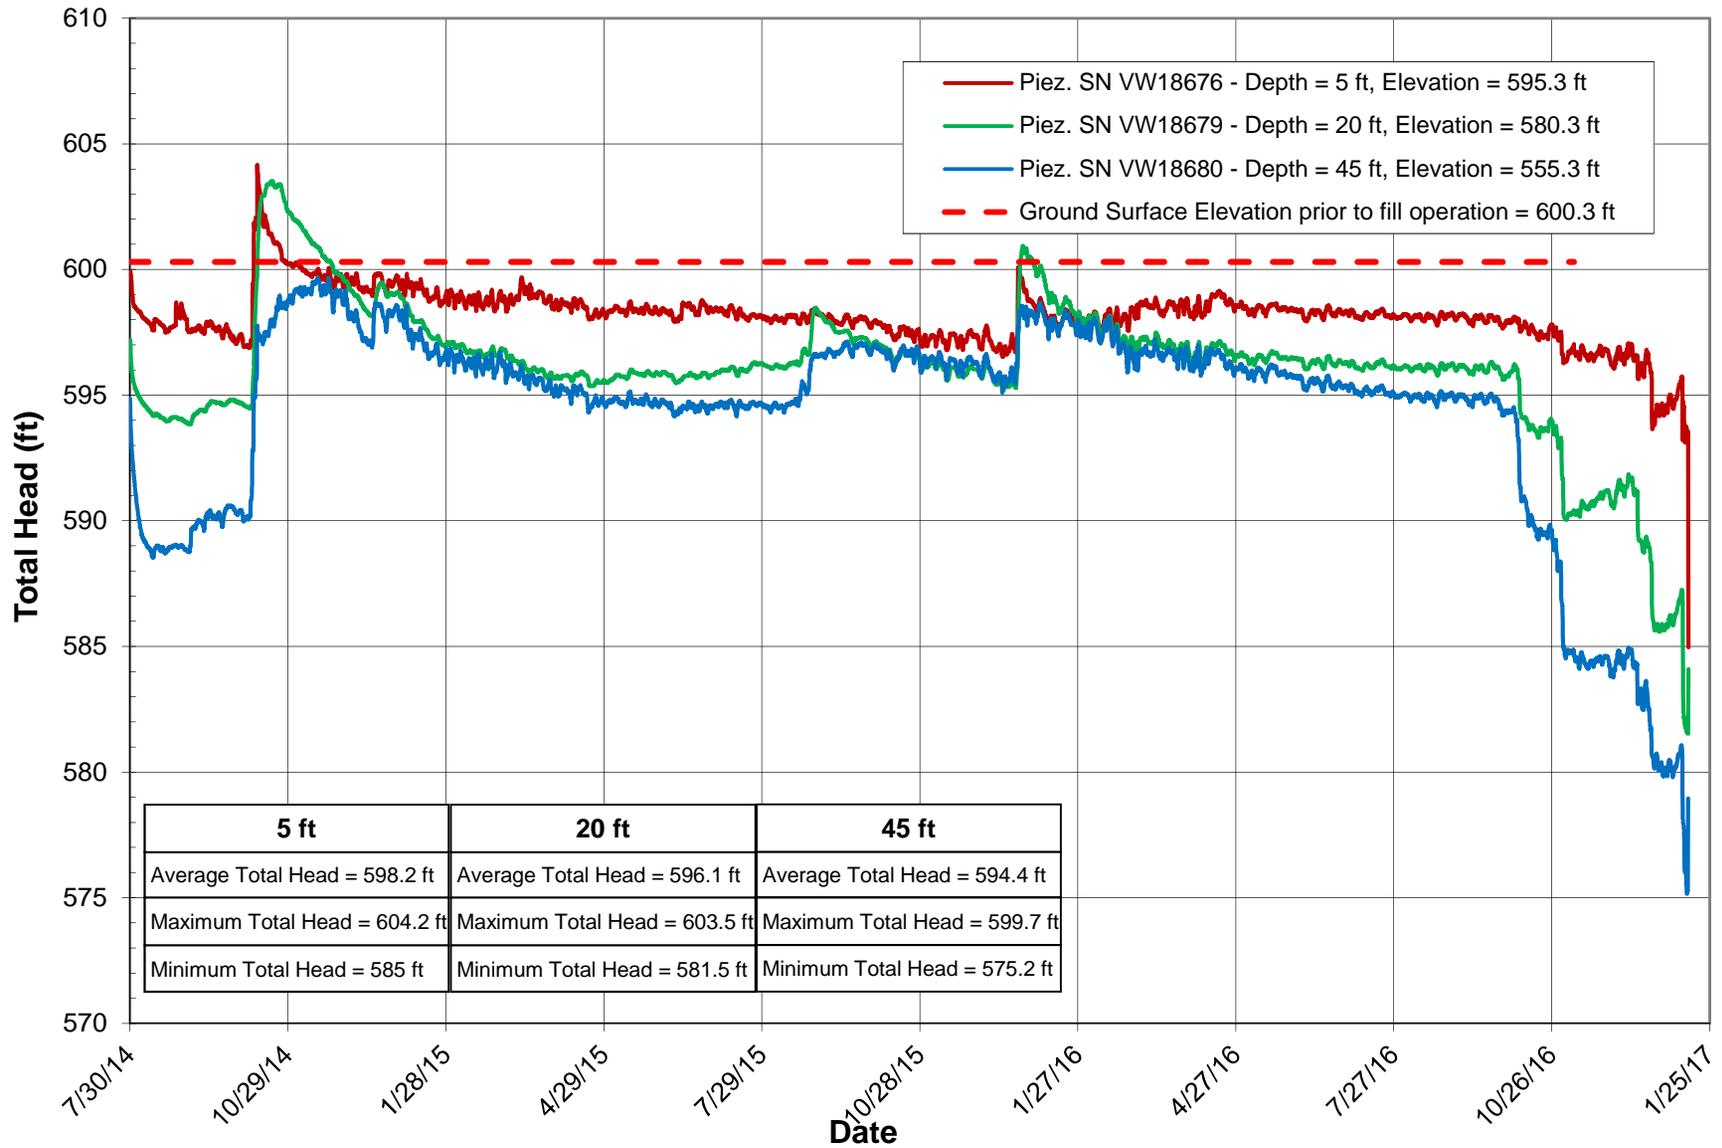
### TGR P-3 VW Piezometer Readings

**TGR P-3.** Three piezometers are installed at this location. Due to final grading operations in the area of these instruments, total head in all three piezometers has decreased in stages since October 2016. Total head has decreased by about 20 feet in the deep piezometer, 14.4 feet in the middle piezometer, and 12.6 feet in the shallow piezometer.

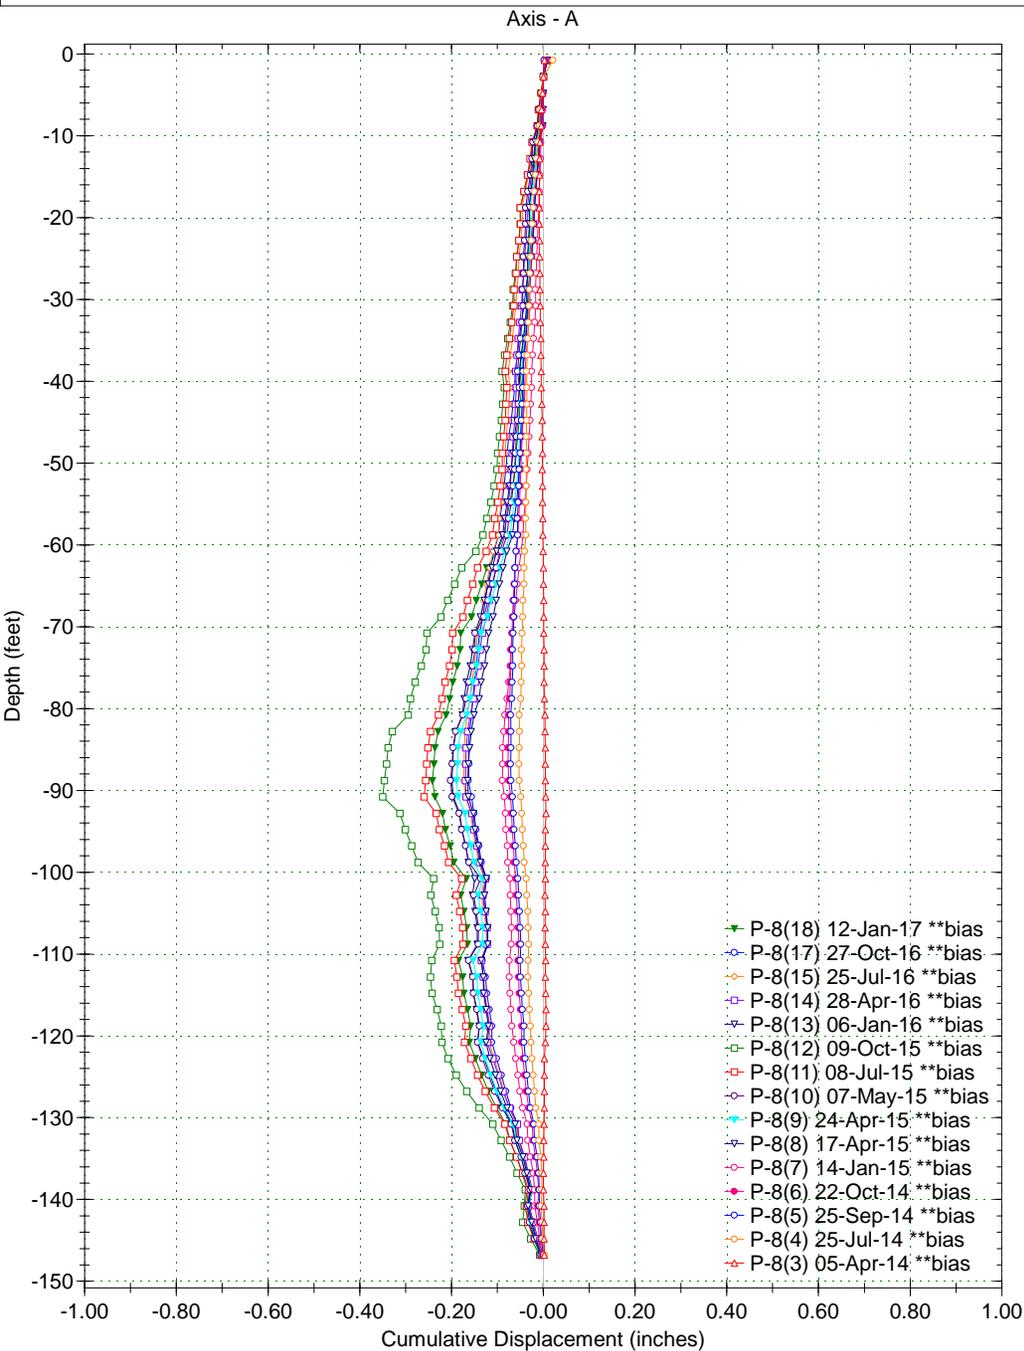
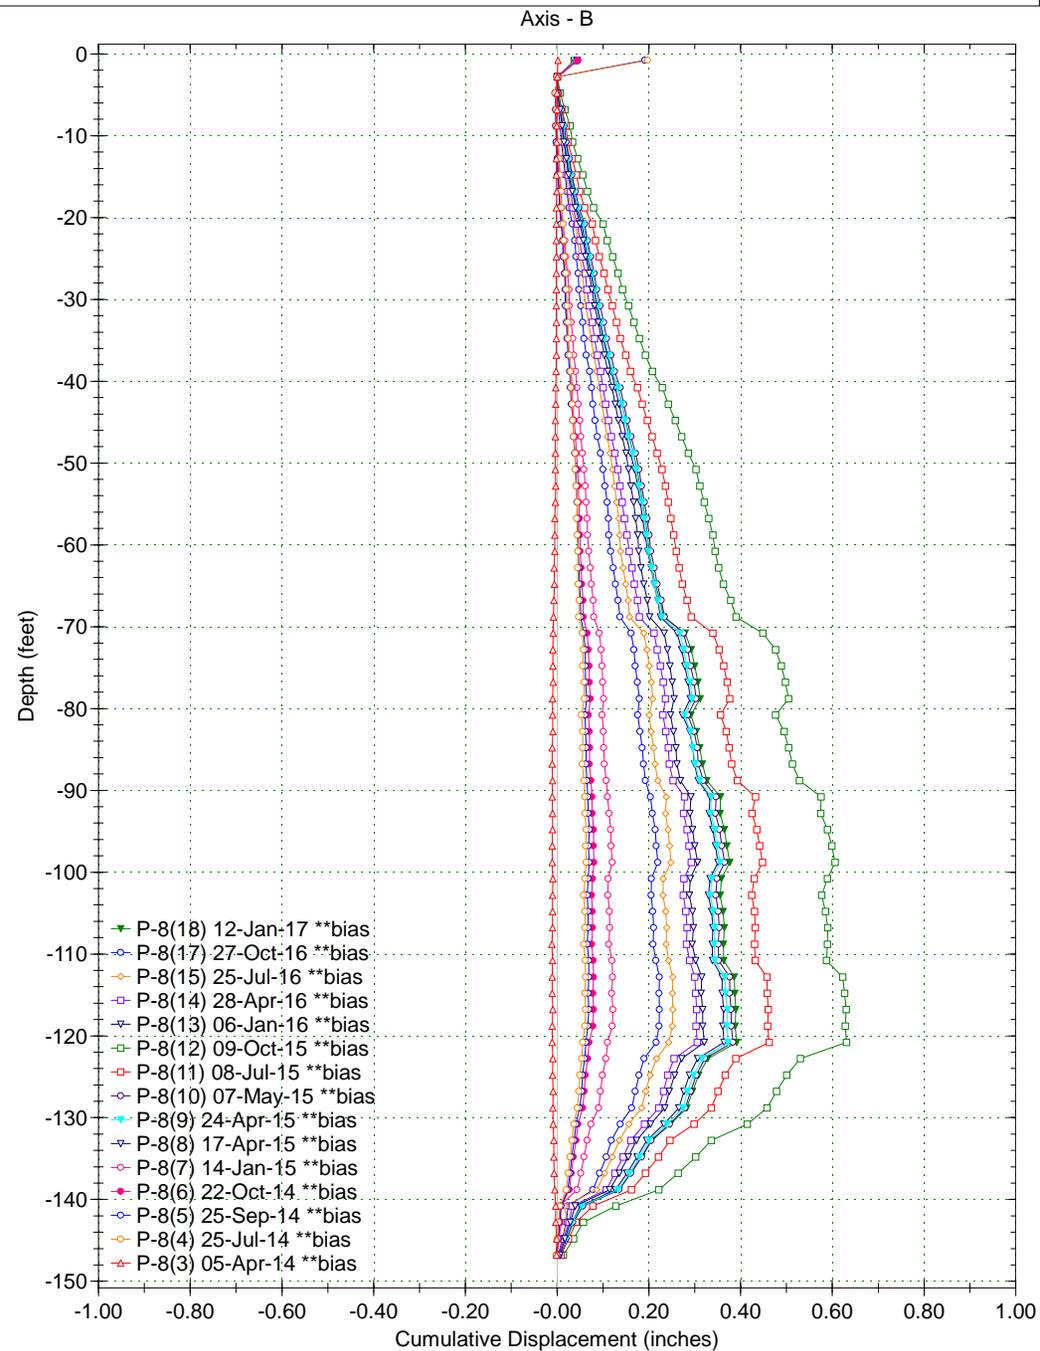
Borehole : P-8  
Project : CUY-90-15-24  
Location : Cleveland, Ohio  
Northing :  
Easting :  
Collar :

**P-8.** The displacement plot for this quarter falls between the October 2015 and October 2016 plots. The October 2015 plot shows the maximum displacement for the group of readings selected for plotting which covers the period since April 2014.

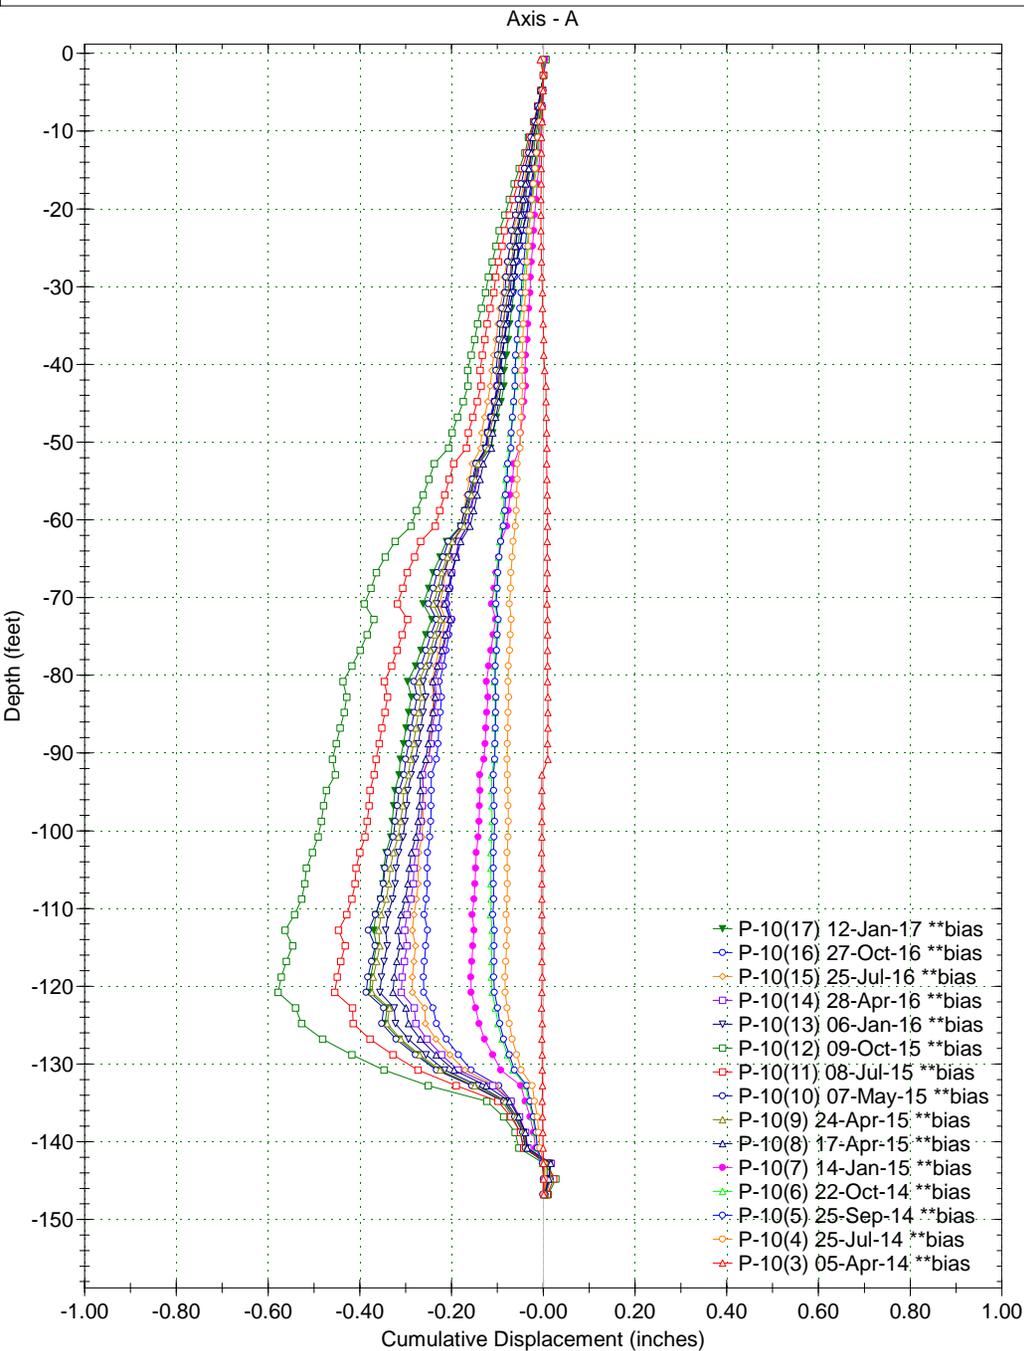
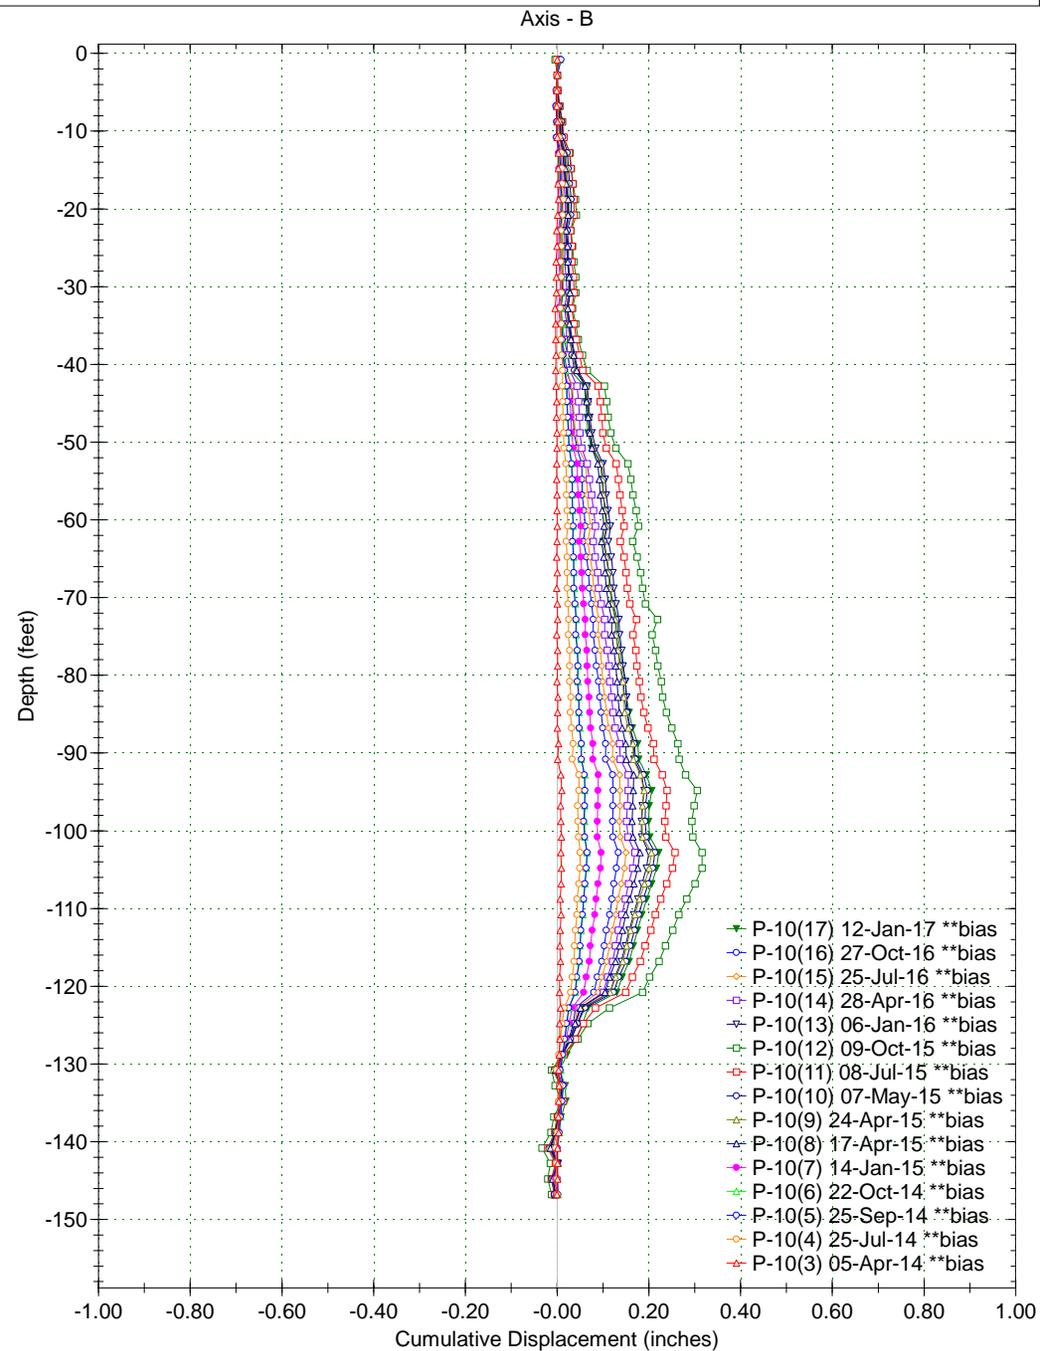
Borehole : P-10  
Project : CUY-90-15-24  
Location : Cleveland, Ohio  
Northing :  
Easting :  
Collar :

**P-10.** Like the plot for P-8, the displacement plot for this pier falls between the October 2015 and October 2016 plots. The October 2015 plot also shows the maximum displacement since April 2014.

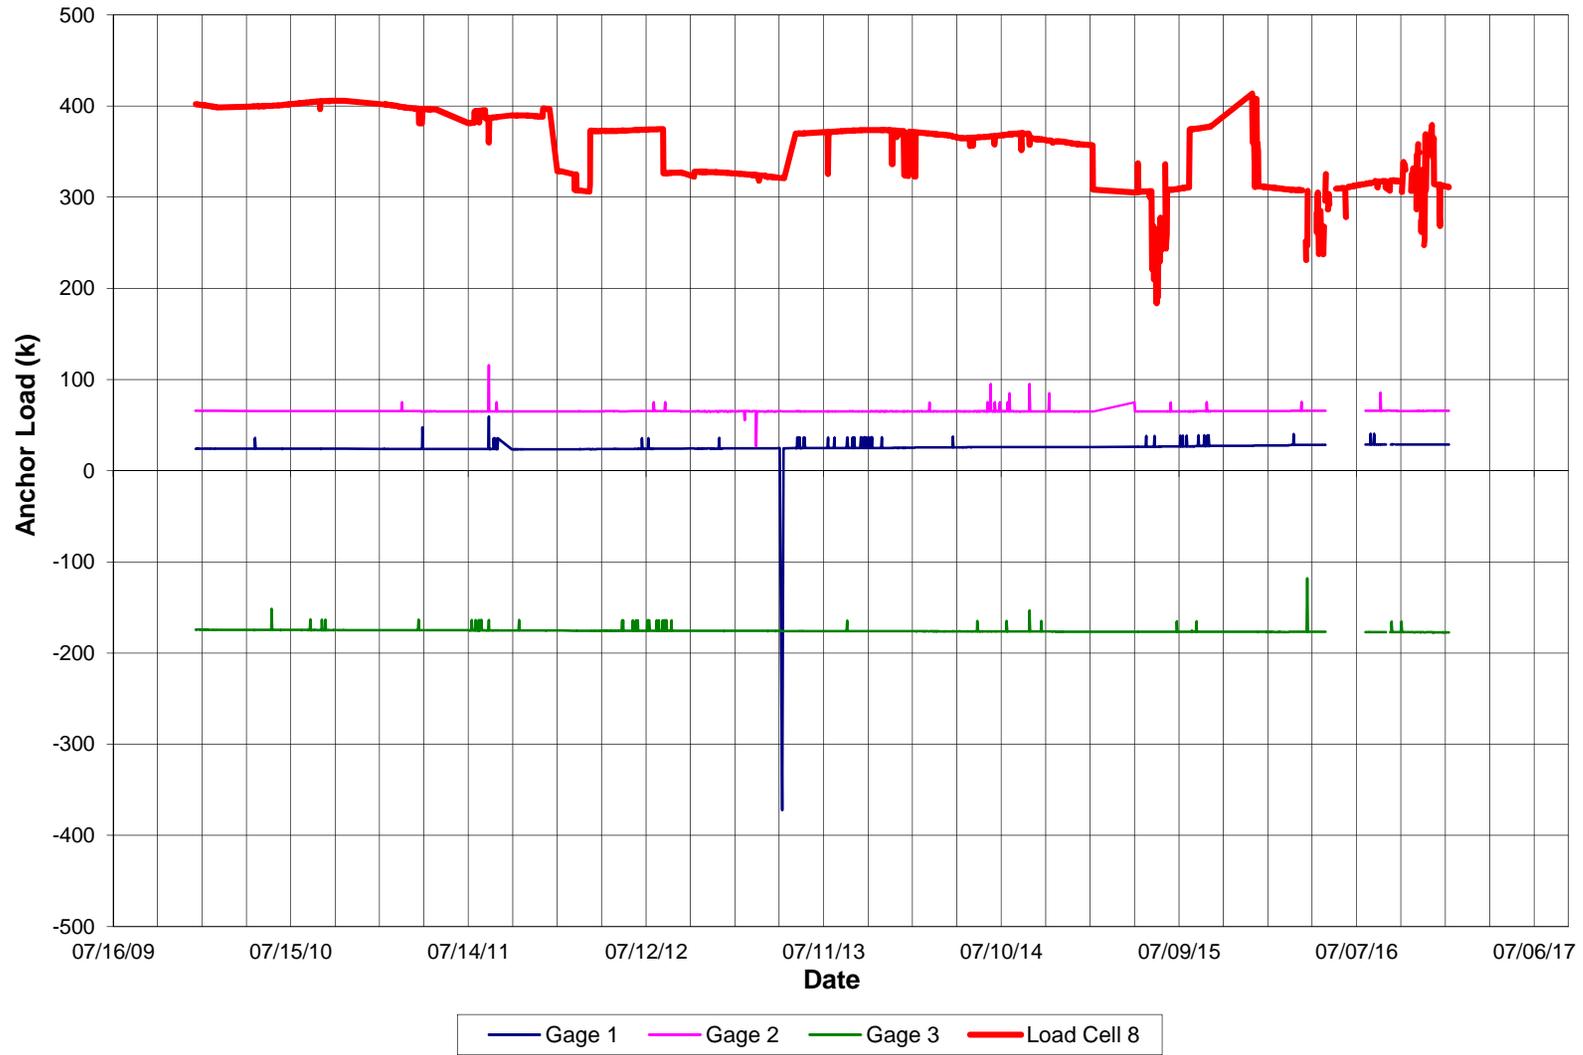
### Anchor #8 - Load Cell #8

Seasonal variations are apparent in the plots for all the load cells with the usual decrease in load occurring during the winter months. The plots for all load cells indicate a slight upward trend throughout 2016. The many spikes shown in the plot for Load Cell 8 occur when one or more of the gages in the load cell fail to record. These spikes are occurring in all load cells with the exception of Load Cell 9. Table 2 shows which gages were active in each of the load cells this quarter. A plot of the load cell data is included in Appendix B.
