Re: January 2017 Quarterly Report  
CUY-90-15.24 Slope Monitoring  
PID 96504  
EDP Project No. 069032.00

# JANUARY 2017 QUARTERLY REPORT

CUY-90-15.24 SLOPE MONITORING  
PID 96504  
CLEVELAND, OHIO  
SME PROJECT NO. 069032.00

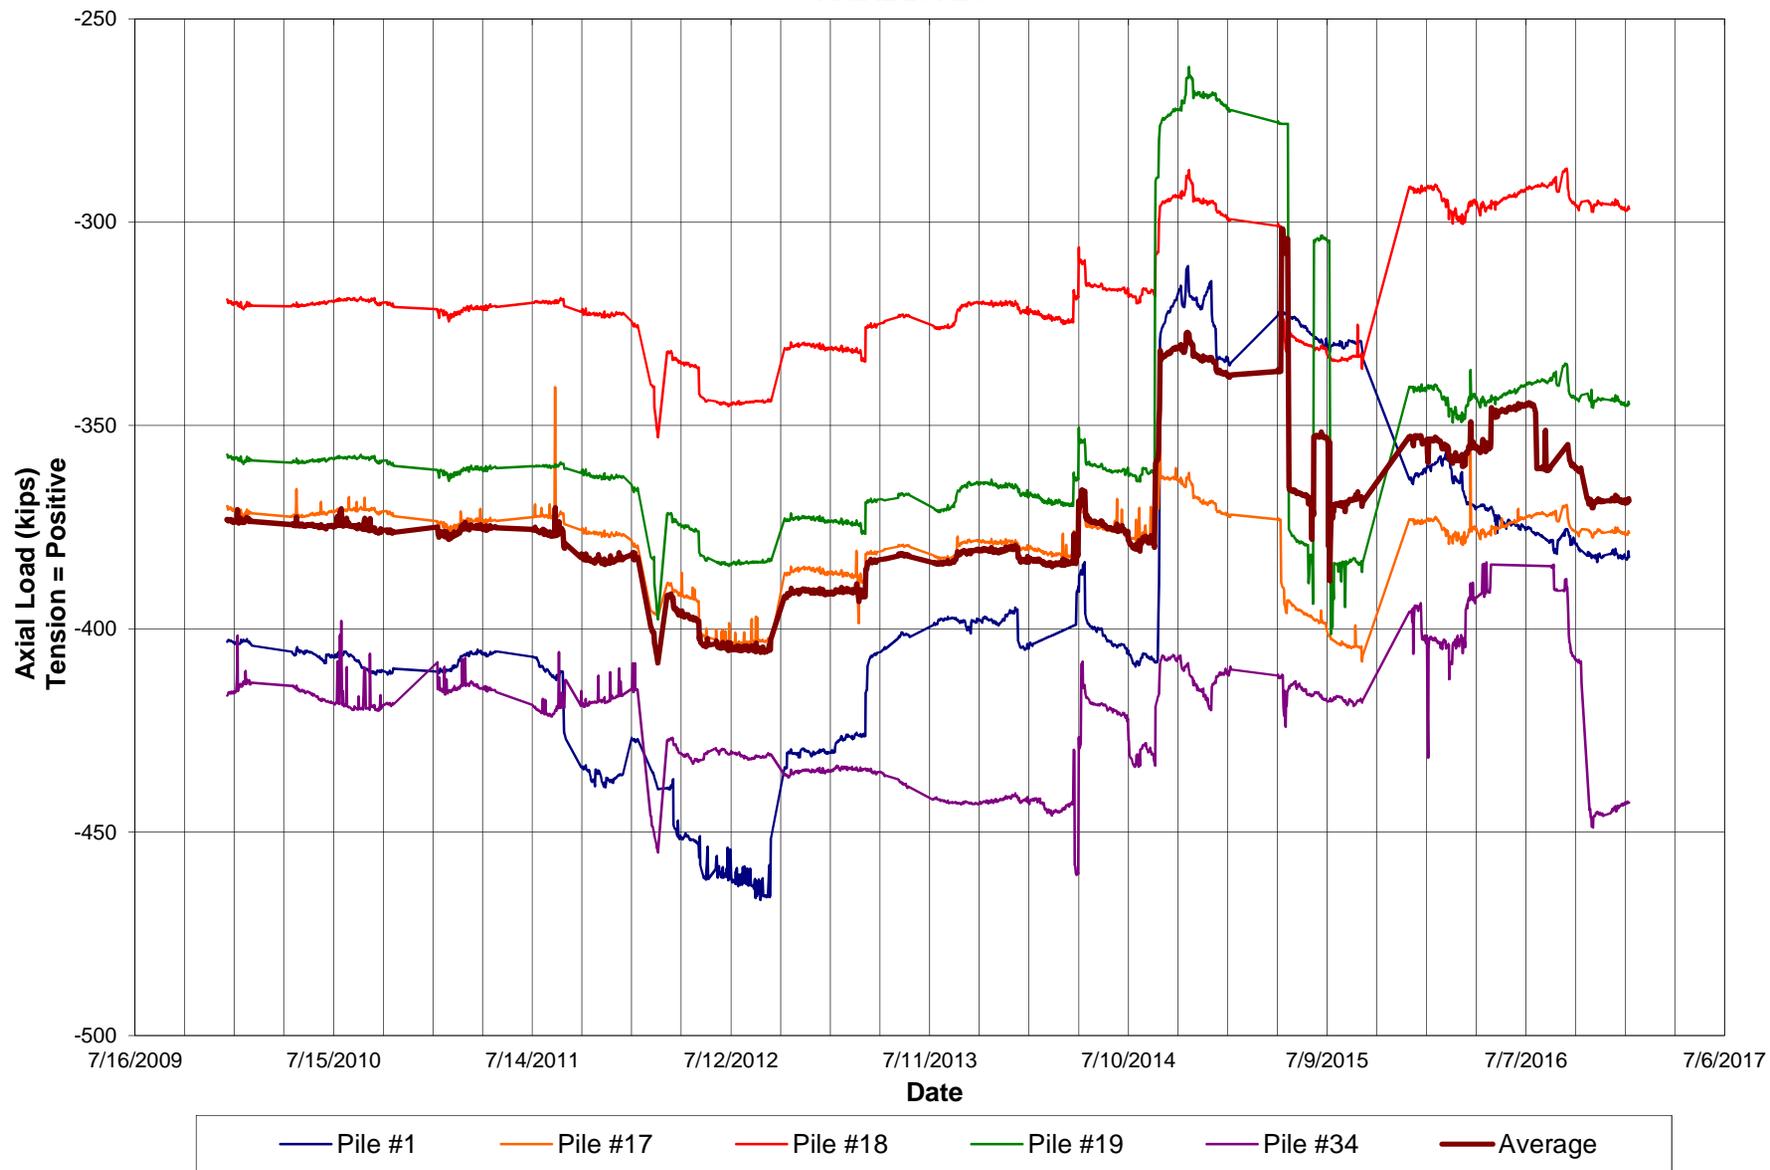
### AXIAL LOADS

Axial loads in all driven piles except Pile 34 increased by 1 kip or less this quarter. The axial load plot for Pile 34 shows a large increase, about 30 kips, during the last week of October 2016. This was likely caused by gage failures. From the end of October 2016 to the end of the quarter, gages 2, 3, and 4 appear to have worked properly. Based on data from these three gages, axial loads in Pile 34 decreased by 2 kips this quarter.

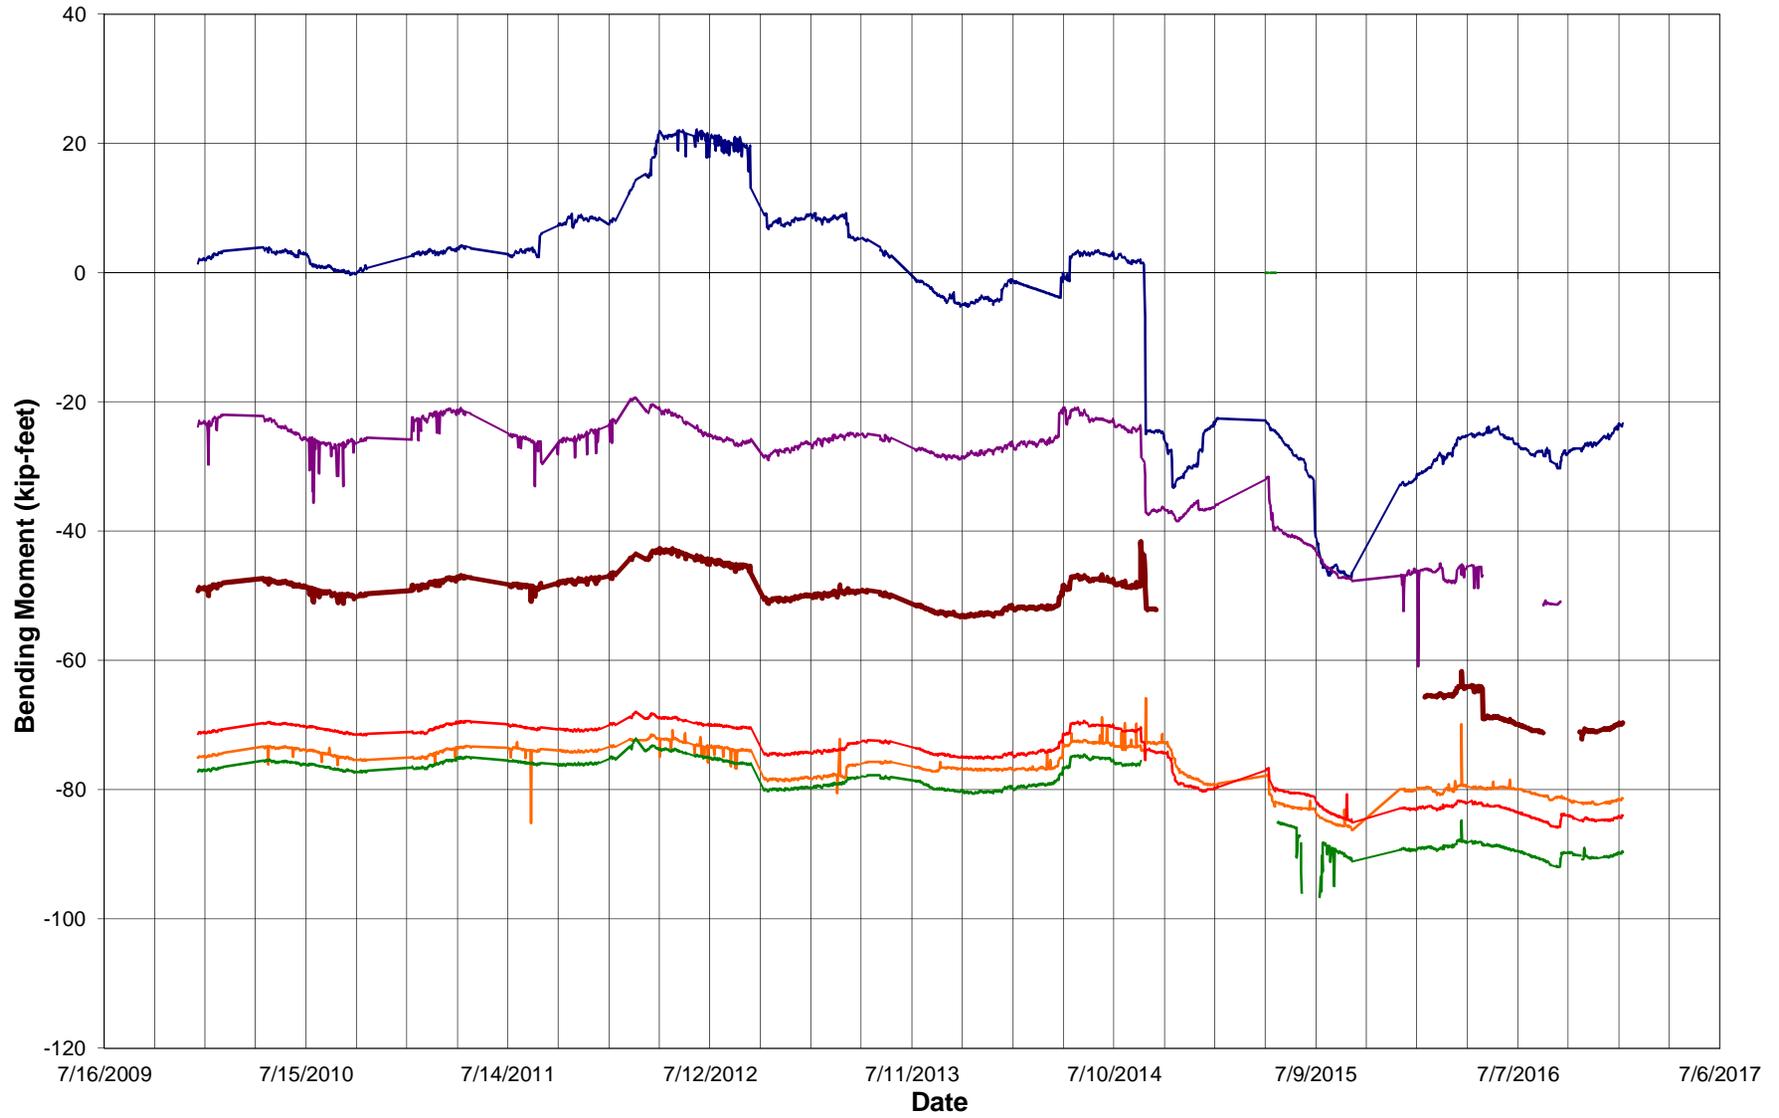
### STRONG AXIS (X-X) BENDING

Strong axis bending moments in all of the driven piles decreased slightly this quarter. The greatest decrease, 3.7 kip-feet, occurred in Pile 1. Strong axis bending moments for Pile 34 could not be calculated due to the failure of Gage 1. Seasonal variations are apparent in the data.

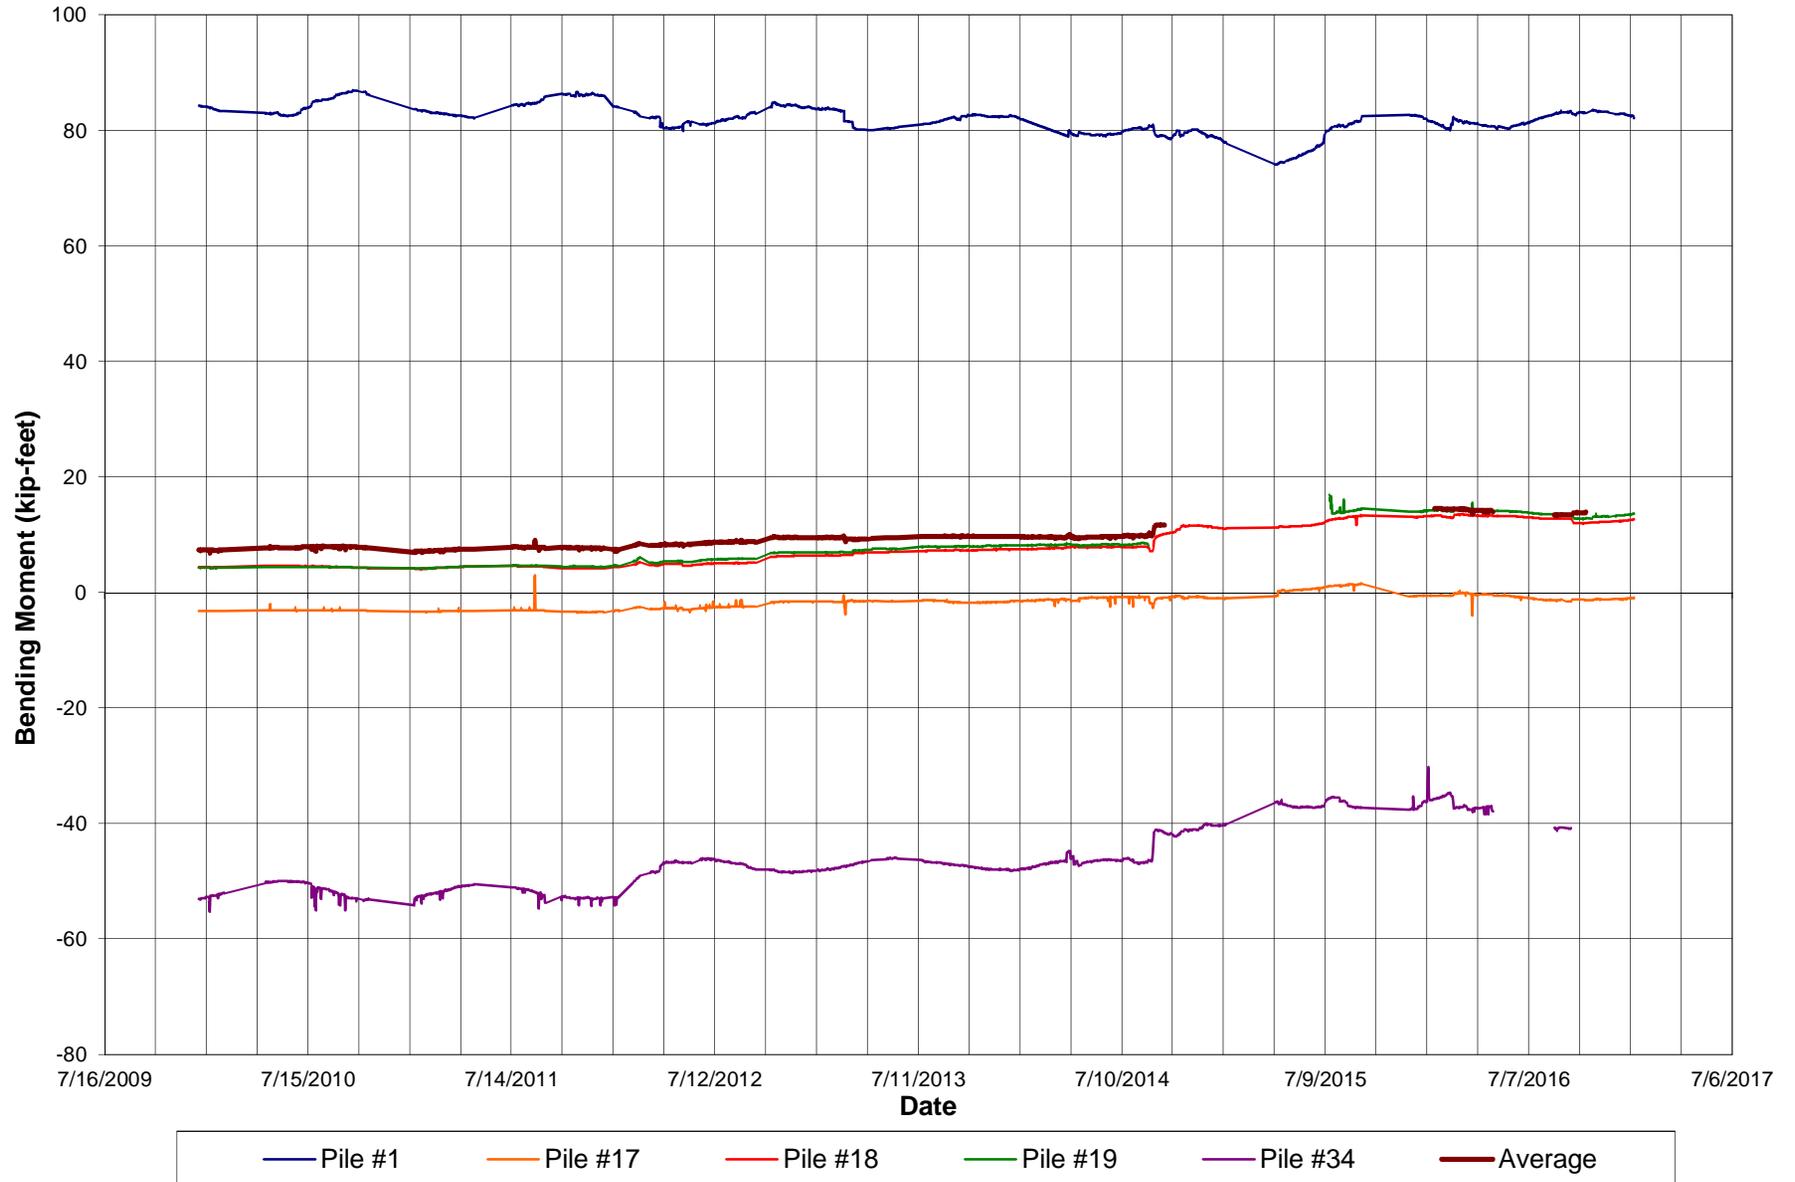
### WEAK AXIS (Y-Y) BENDING

Average weak axis bending moments in Piles 17, 18, and 19 increased by less than 1 kip-foot this quarter. The weak axis bending moment in Pile 1 decreased by about 1.5 kip-feet. Weak axis bending moments for Pile 34 could not be calculated due to the failure of Gage 1.

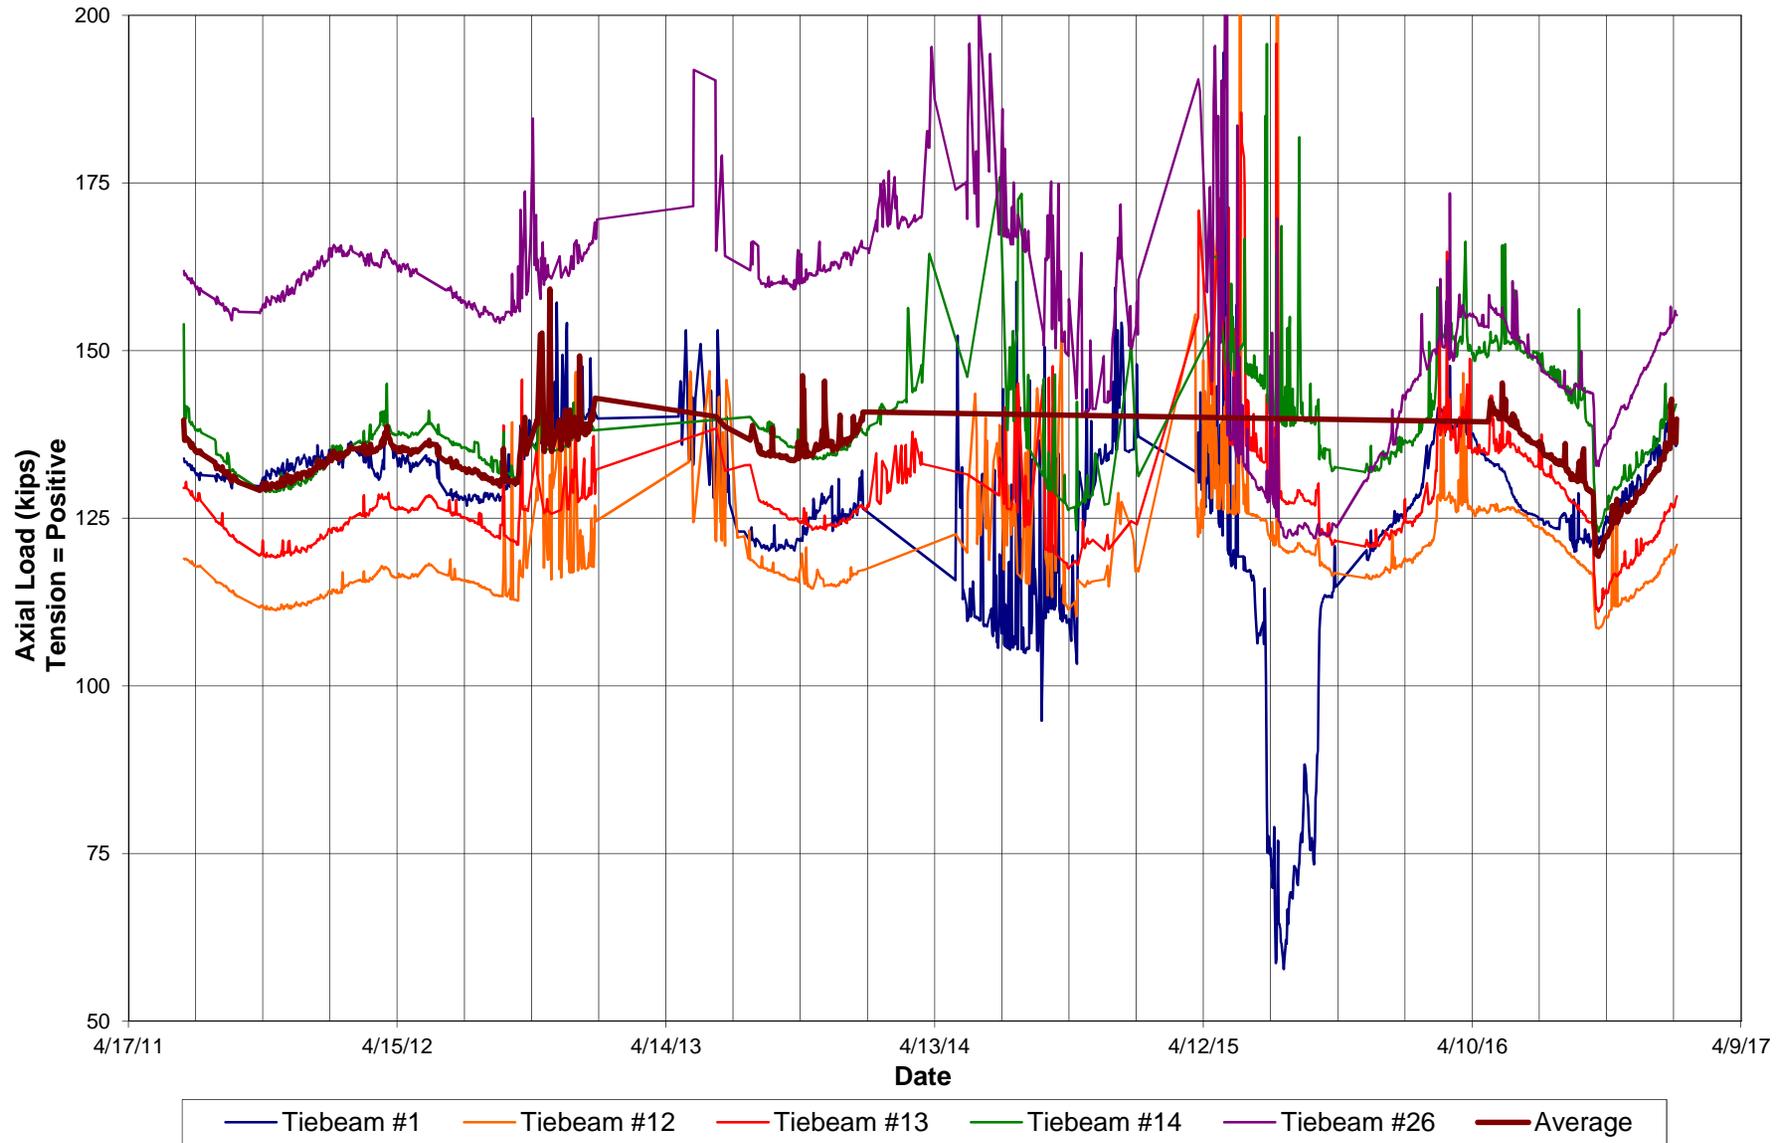
### AXIAL LOADS

Axial loads at the anchor end of the tiebeams typically increase during the November-January quarter and we see that increase again this year. However, the magnitude of the increases were greater this year than in previous years. Since the beginning of October 2016, the axial loads increased by 12 to 21 kips, with the largest increase occurring in Tiebeam 26.

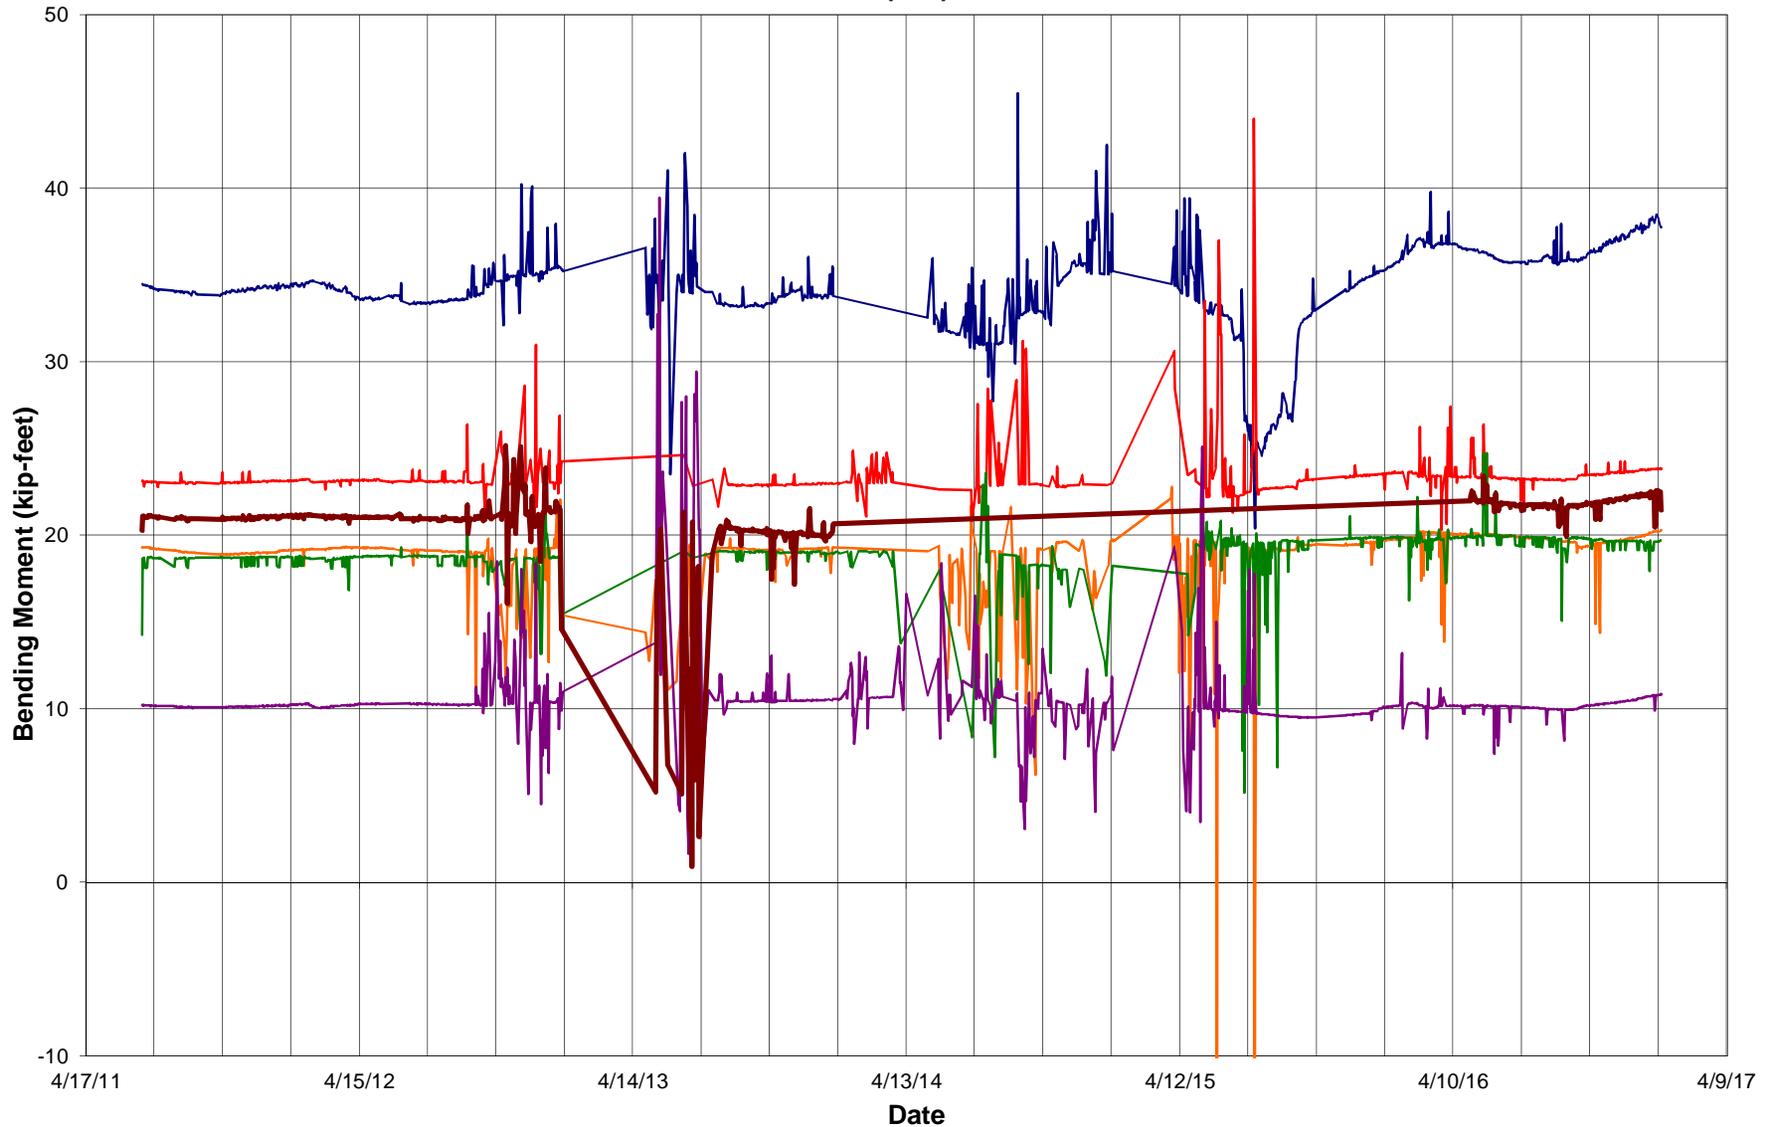
### STRONG AXIS (X-X) BENDING

Strong axis bending moments also increased this quarter. The seasonal change in Tiebeams 13, 14, and 26 were barely noticeable in prior years. This year we see a small but noticeable increase in Tiebeams 13 and 26. The seasonal variation has been more apparent in Tiebeam 1. The largest increase in strong axis bending moment occurred in Tiebeam 1. Changes in weak axis bending moments were negligible for all tiebeams.

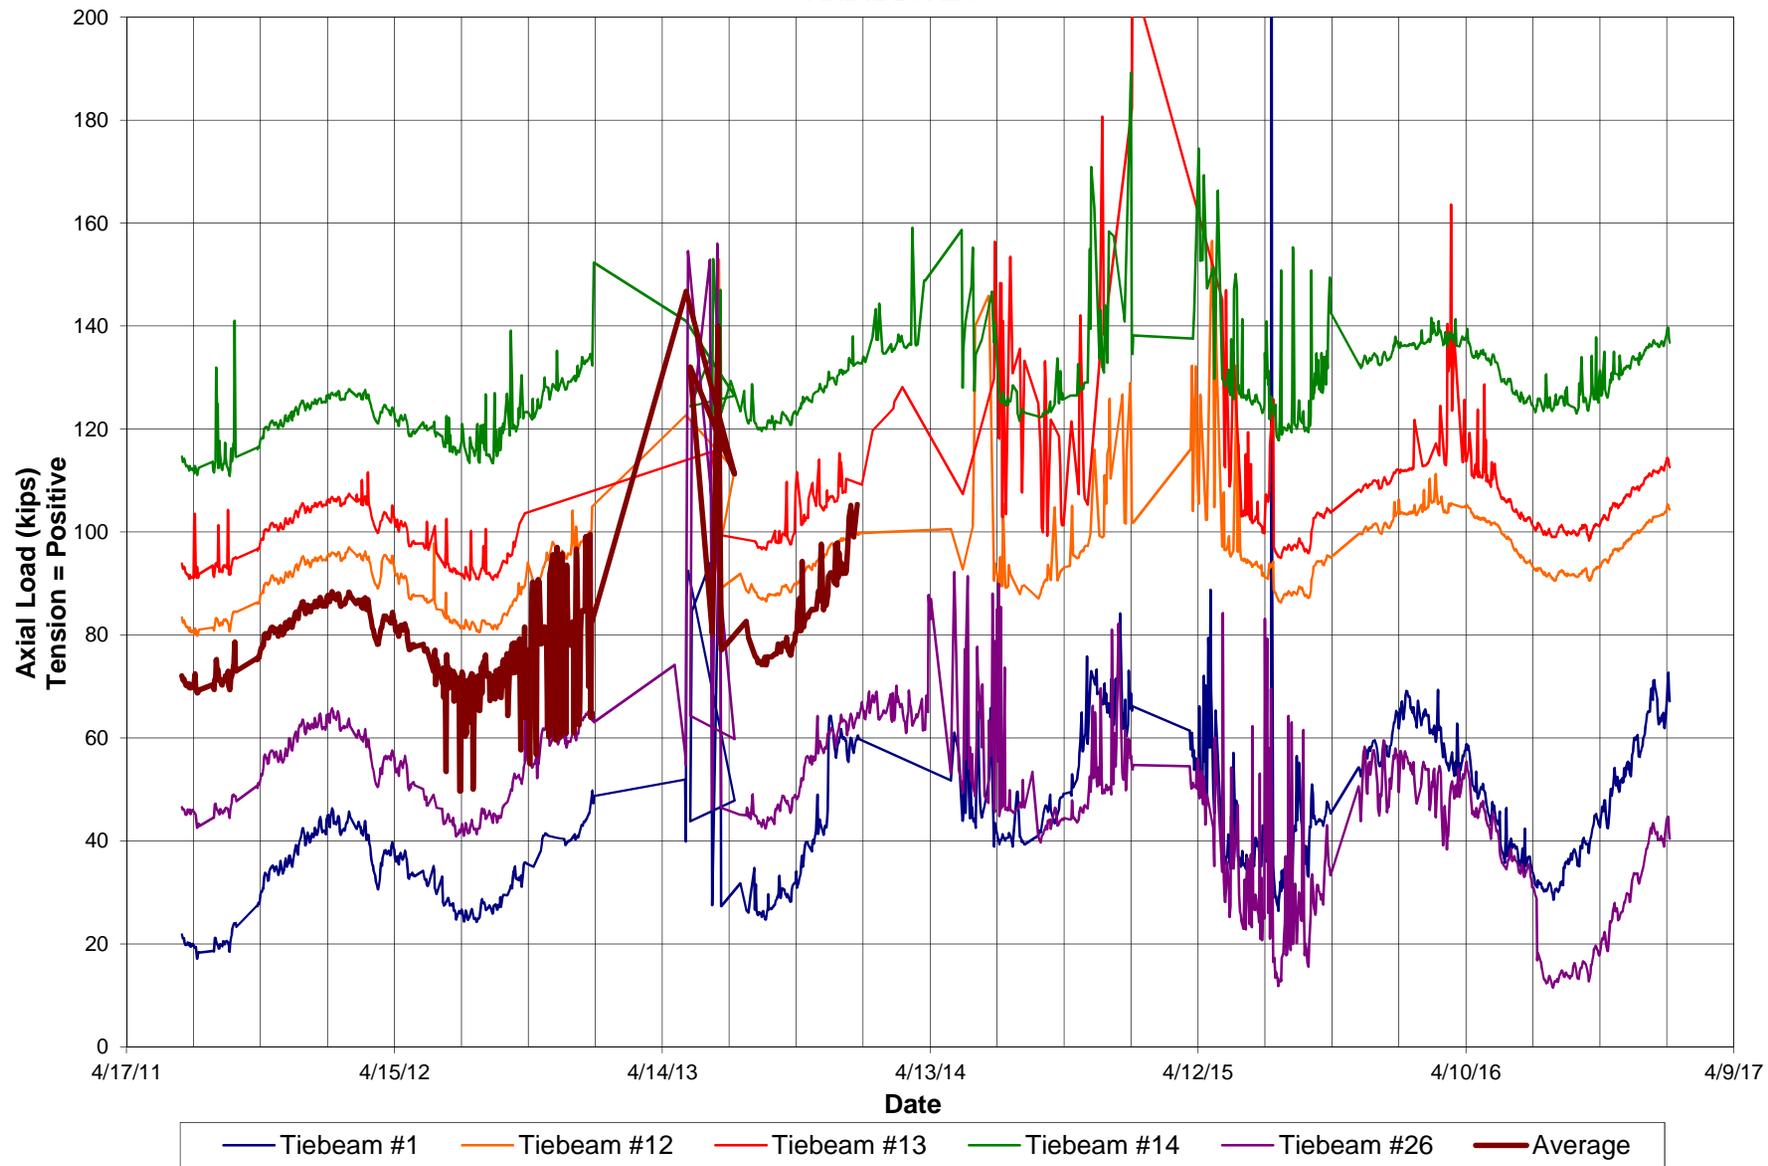
### AXIAL LOADS

Seasonal changes are also seen in the axial loads in the tiebeams on the drilled pier side, which increased throughout this quarter. Axial loads in Tiebeams 1 and 26 show the largest increases

from September 2016 to January 2017 of 32 kips and 27 kips, respectively. Axial loads in the other tiebeams show seasonal changes similar to past years, with increases ranging from 8 to 13 kips this quarter.

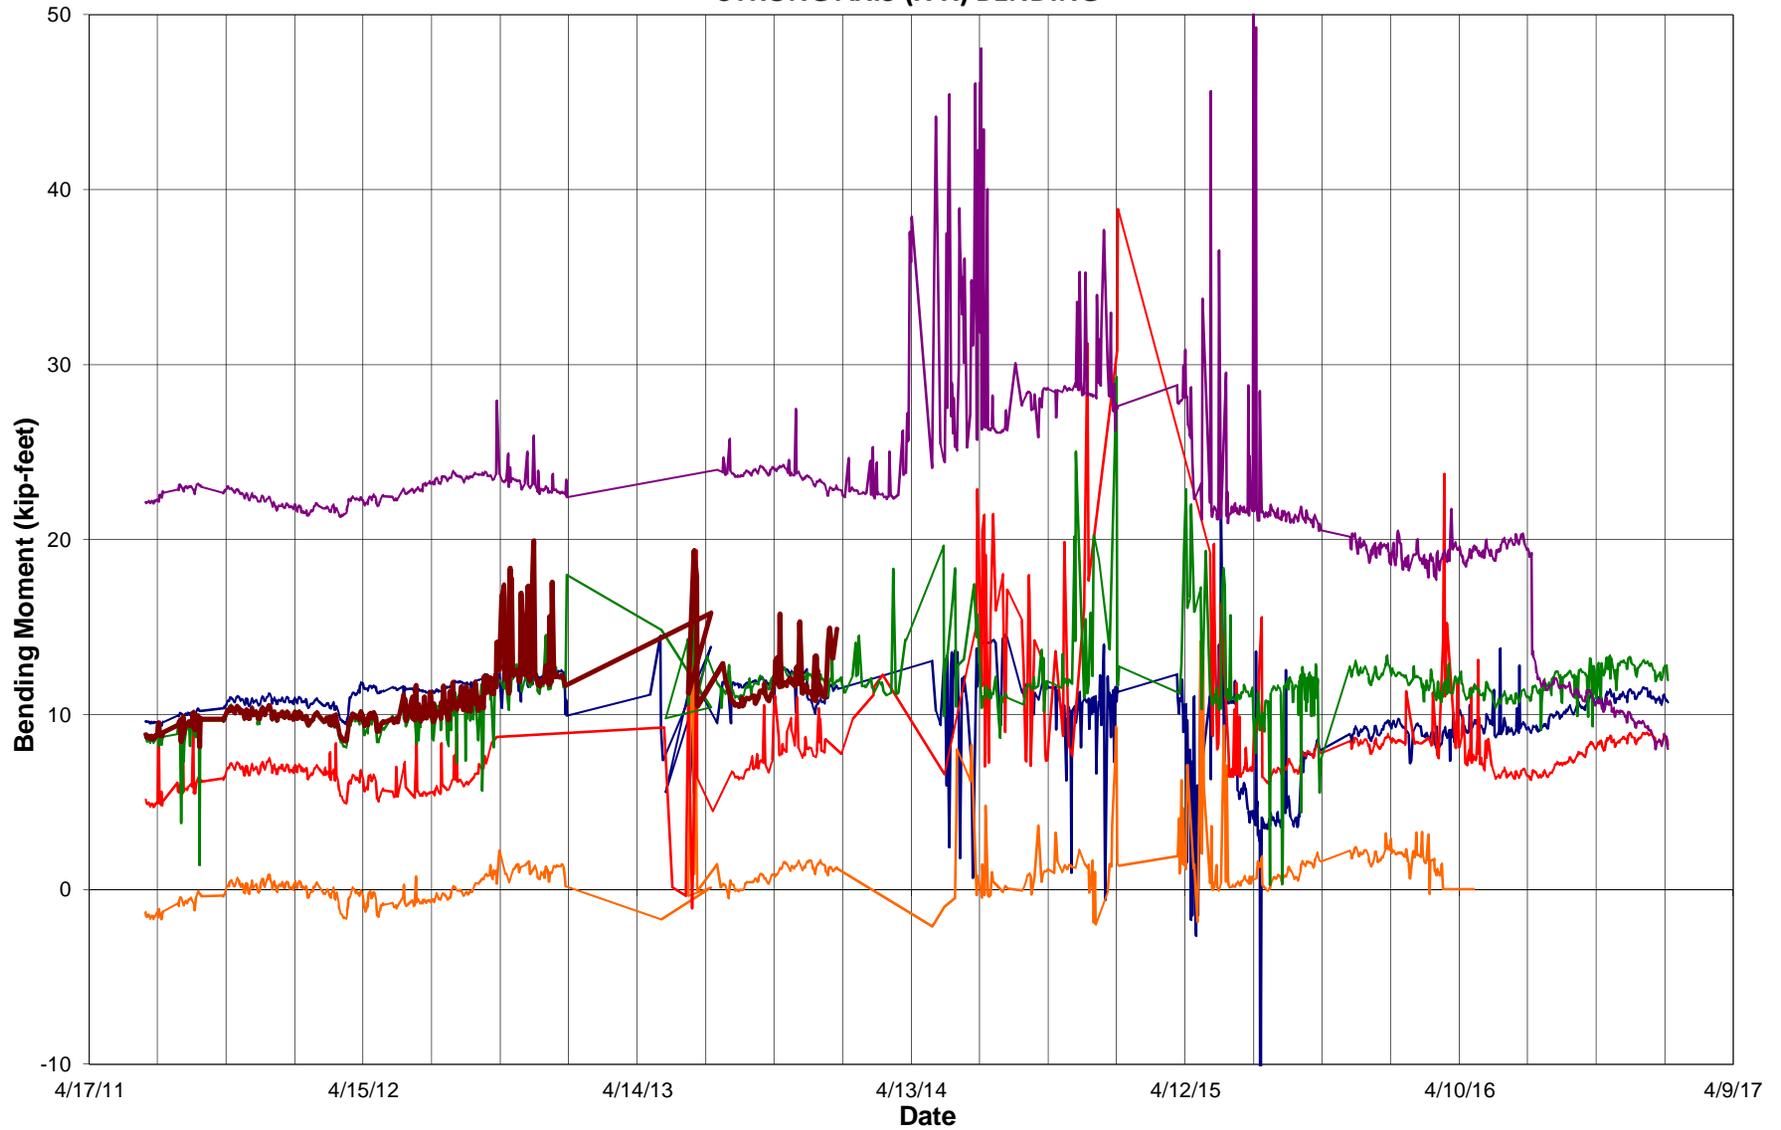
### STRONG AXIS (X-X) BENDING

Strong axis bending moments on the drilled pier side of Tiebeams 1, 13, and 14 exhibited the usual seasonal changes with increases of less than 1 kip-foot this quarter. The plot for Tiebeam 26, indicates that the strong axis bending moment decreased by about 12 kip-feet since July 2016. The majority of this decrease, about 8 kip feet, which occurred in July, was due to a gauge failure. We adjusted the calculations by using values for the companion gauge on the opposite end of the flange to compensate for the loss of this gauge. This allows us to calculate bending moments. However, this introduces some error into the calculated moments which depends on the relative magnitude of the strong and weak axis moments.

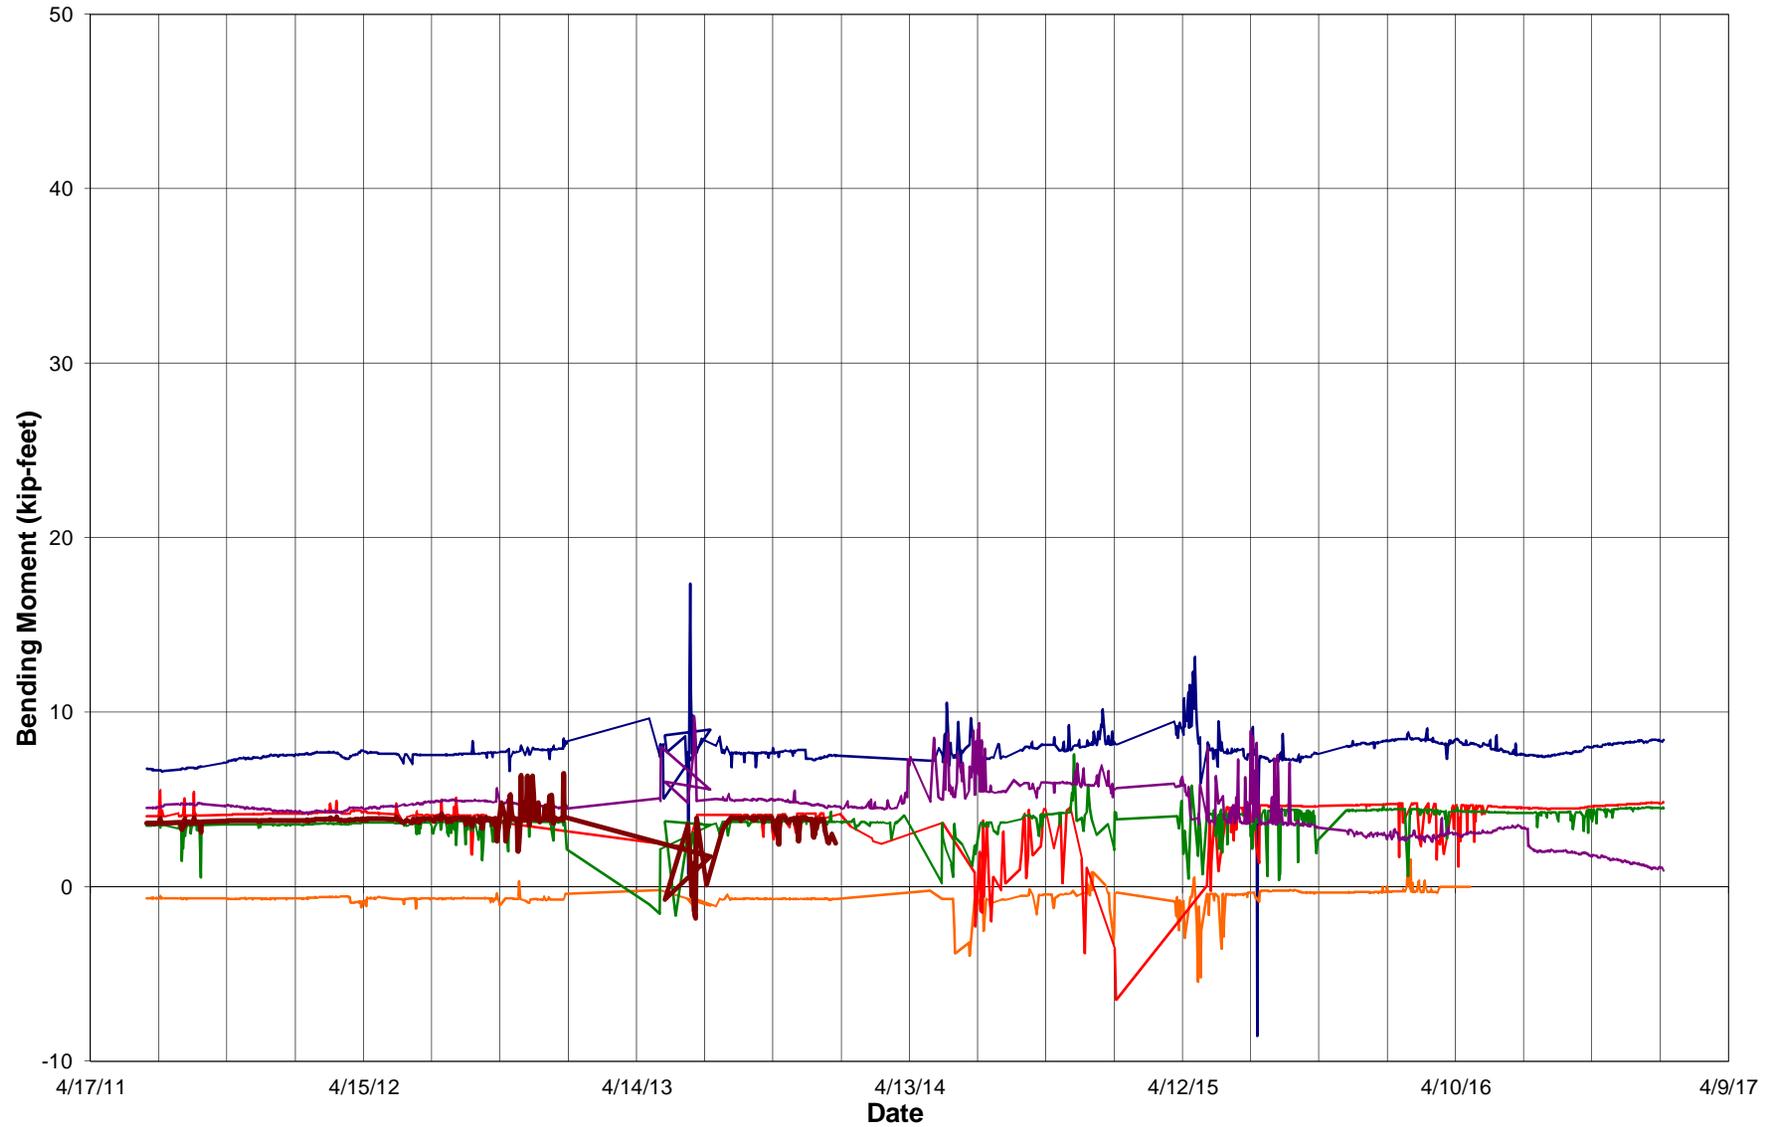
### WEAK AXIS (Y-Y) BENDING

Weak axis bending moments on the drilled pier side increased by about 1 kip-foot in Tiebeam 1 with a corresponding decrease of about 1 kip-foot in Tiebeam 26. Weak axis bending moments for the other tiebeams remained virtually constant. Bending moments were not calculated for Tiebeam 12 due to a gage failure. An adjustment similar to what was done for Tiebeam 26 will be made in the future.
