April 11, 2017

Re: March 30, 31, and April 4, 2017 Monthly Readings
CUY-90-15.24 Slope Monitoring
PID 96504
SME Project No. 069032.00

Monthly instrument readings at the I-90 west slope taken on March 30, 31 and April 4, 2017 are presented in this report. Monthly readings currently include instruments at I/P-001-13, I/P-002-13, I/P-003-10, P-003-13, I/P-004-13, I-008-10, I/P-009-13, B-101, B-102, B-105A, B-05-02, B-05-04, B-05-A-11, P-1, P-9N. Changes reported for the individual instruments are for the previous four-week period unless noted otherwise.

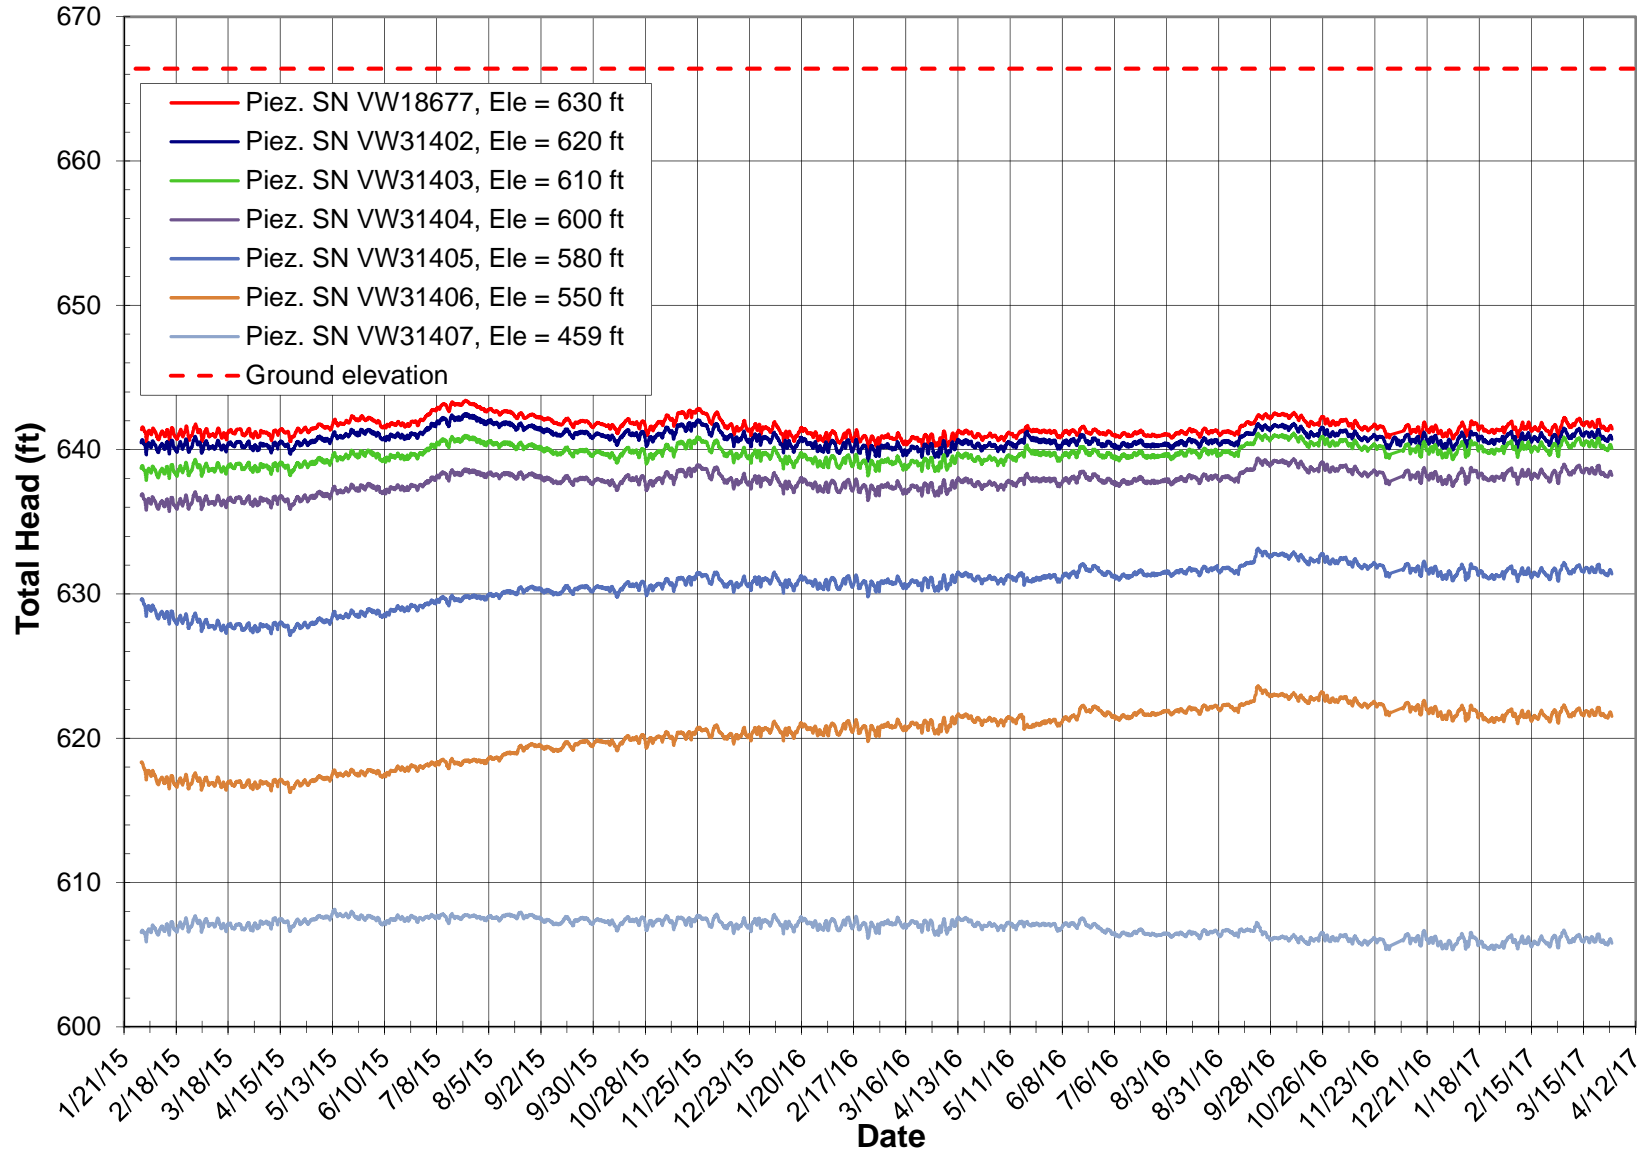
P-001-13 VW Piezometer Readings

Pore pressure readings at P-001-13, P-002-13, P-003-10, P-003-13, and B-05-A-11 show variations in total head of less than 0.5 feet for the period.

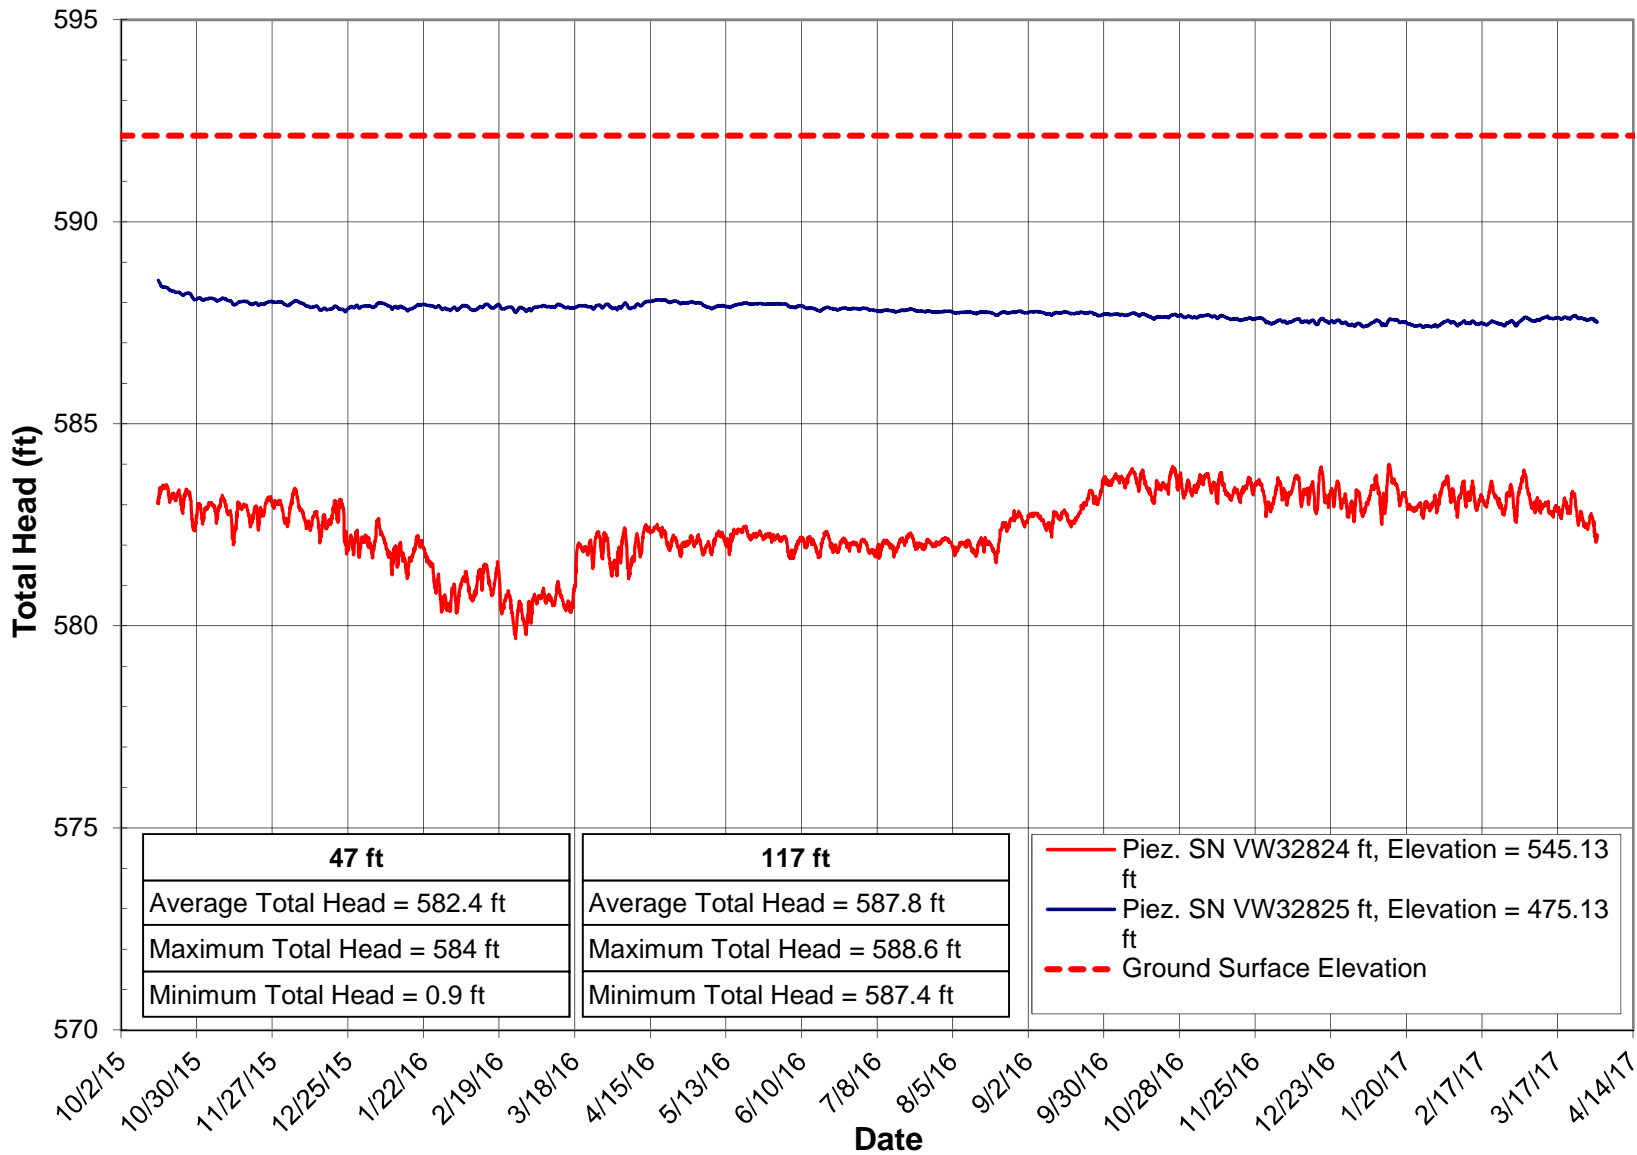
P-004-13 VW Piezometer Readings

P-004-13 – Pore pressure readings in the shallow piezometer at this location show a decrease of about 0.9 feet. Pore pressure readings in the deep piezometer show virtually no change.

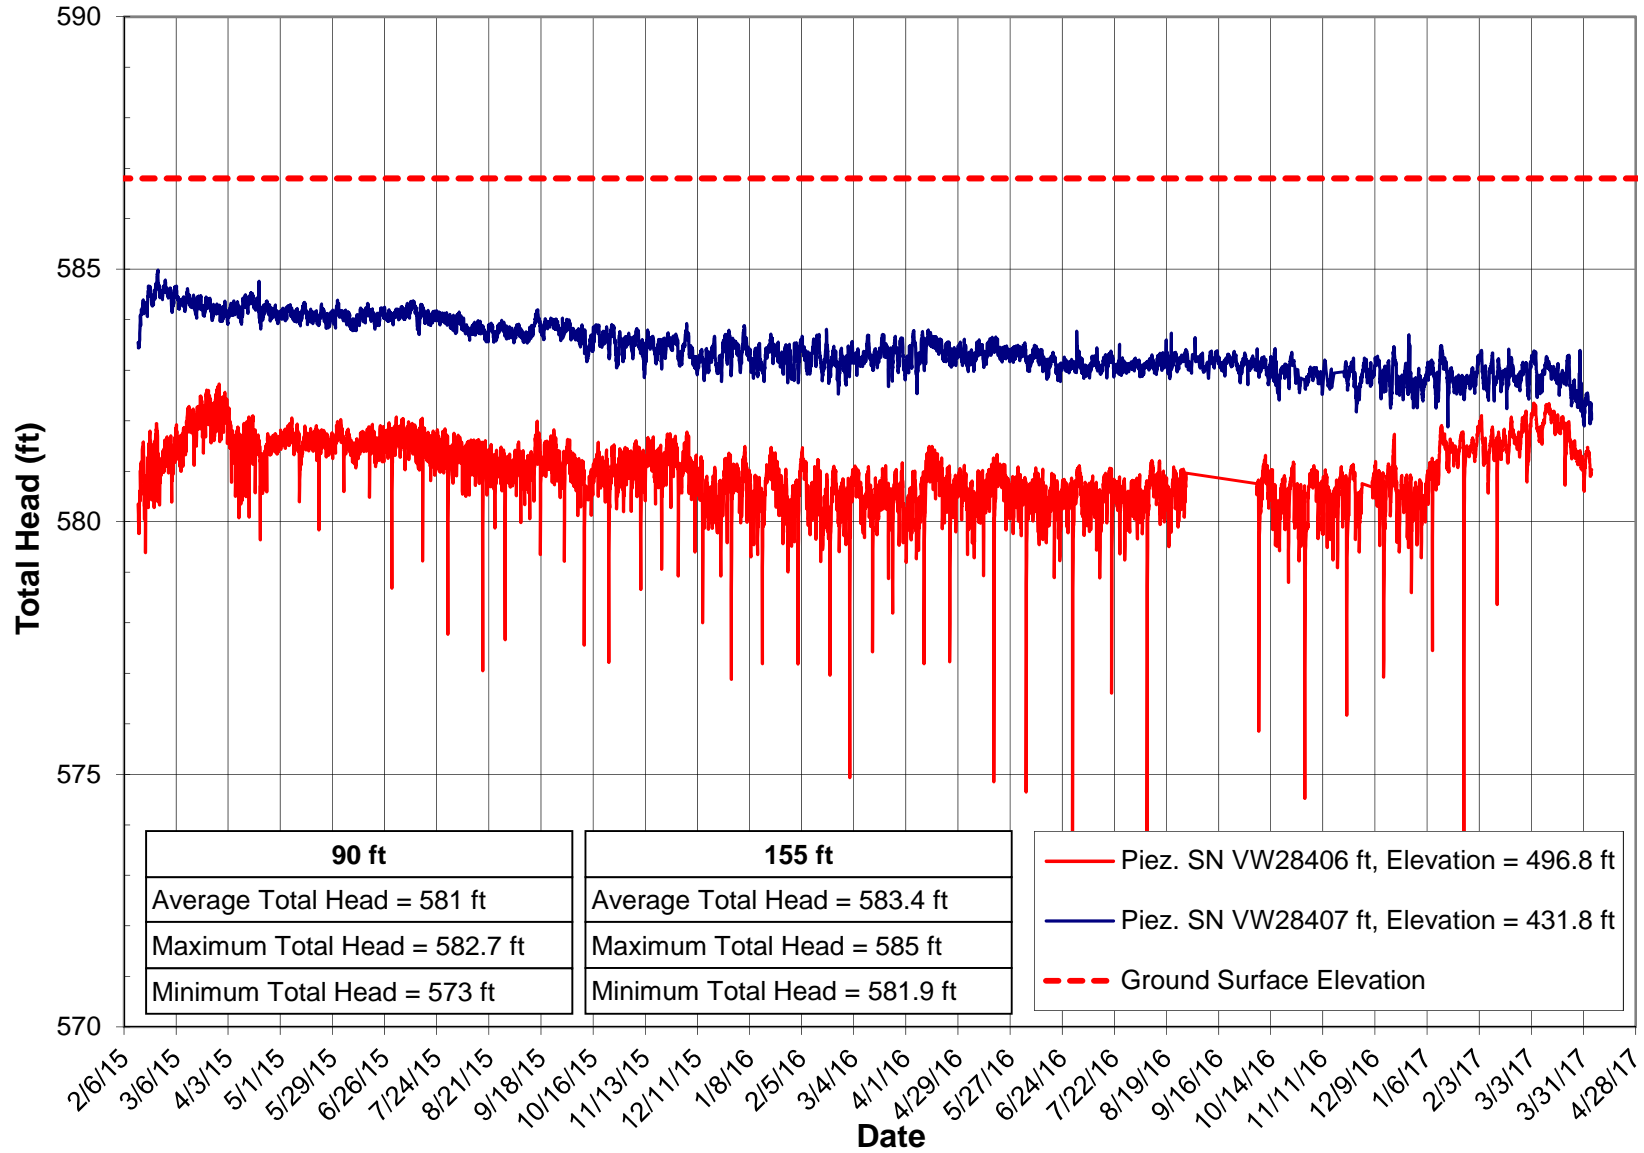
P-009-13 VW Piezometer Readings

P-009-13 – Pore pressure readings in both piezometers at this location show a decrease in total head of about 1.5 feet.

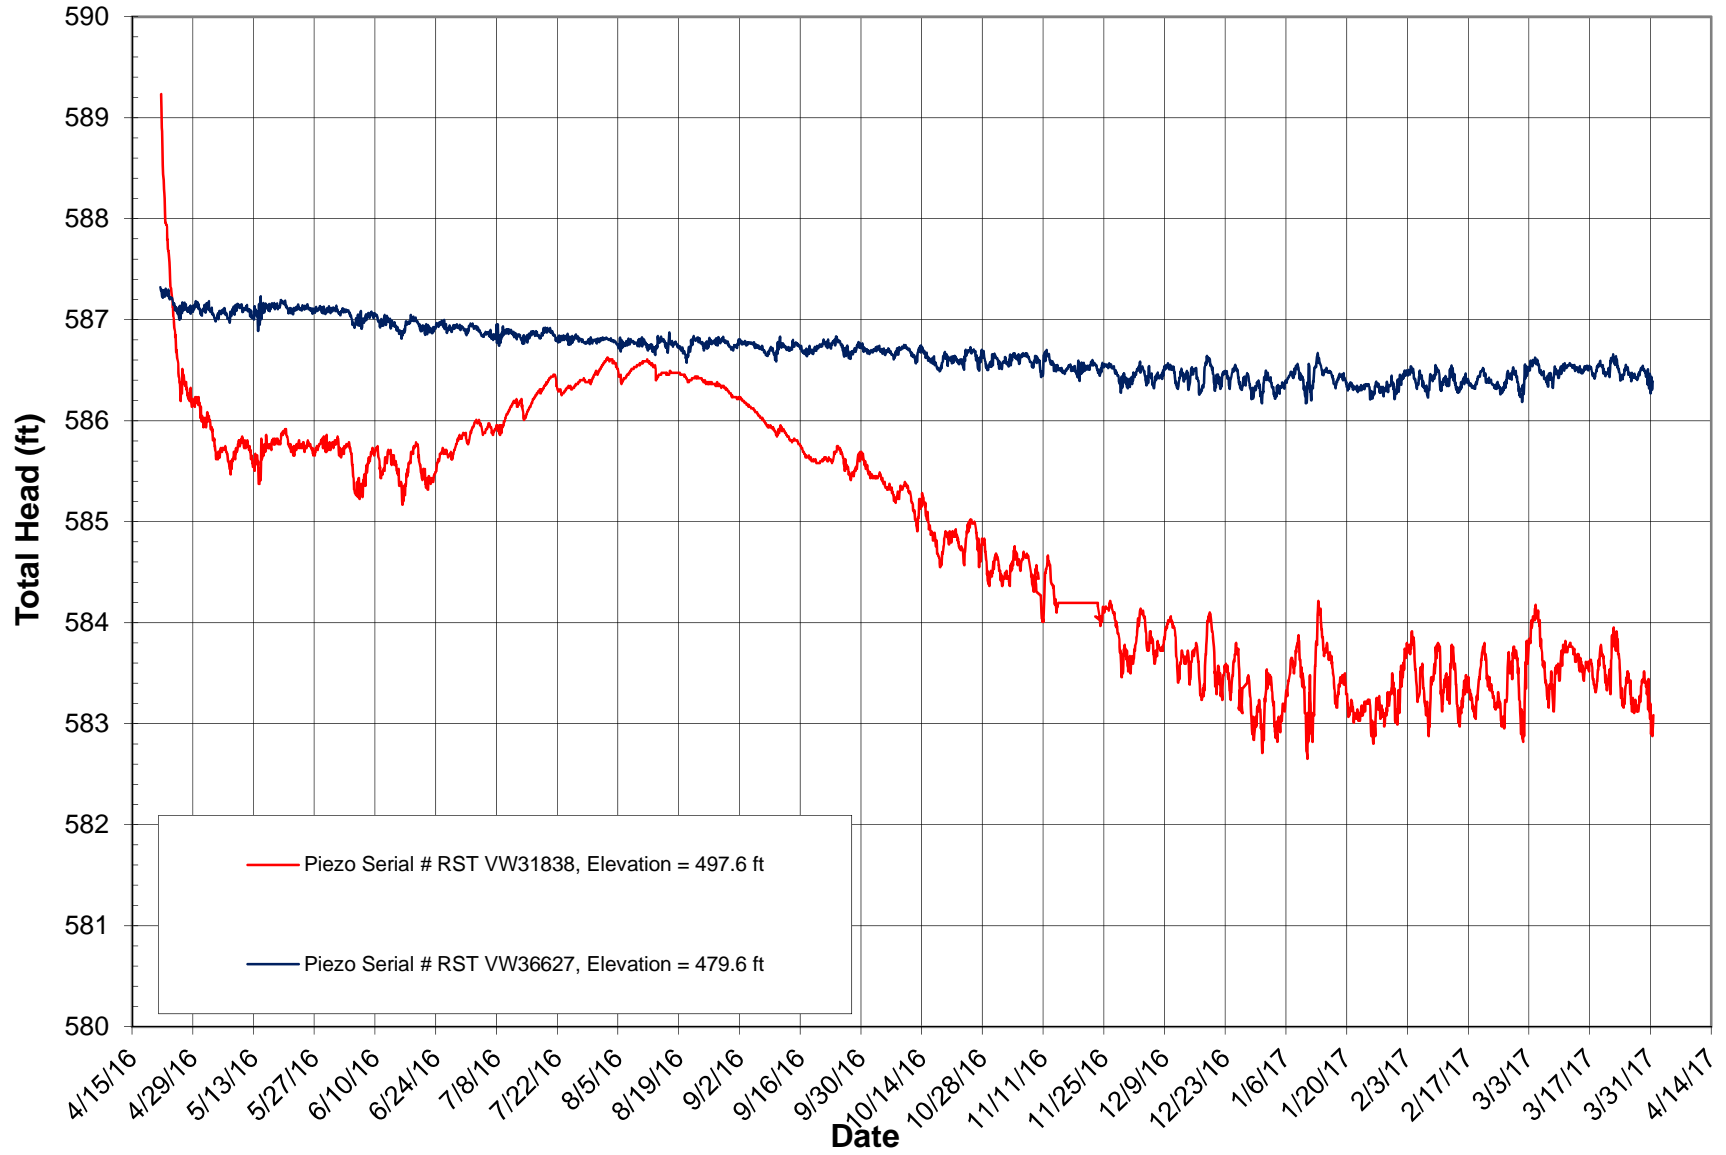
B-105A VW Piezometer Readings

B-105A – The shallow piezometer pore pressure readings at this location show a decrease of about 1.3 feet this month. The deep piezometer shows fluctuations in pore pressure, but no net change.

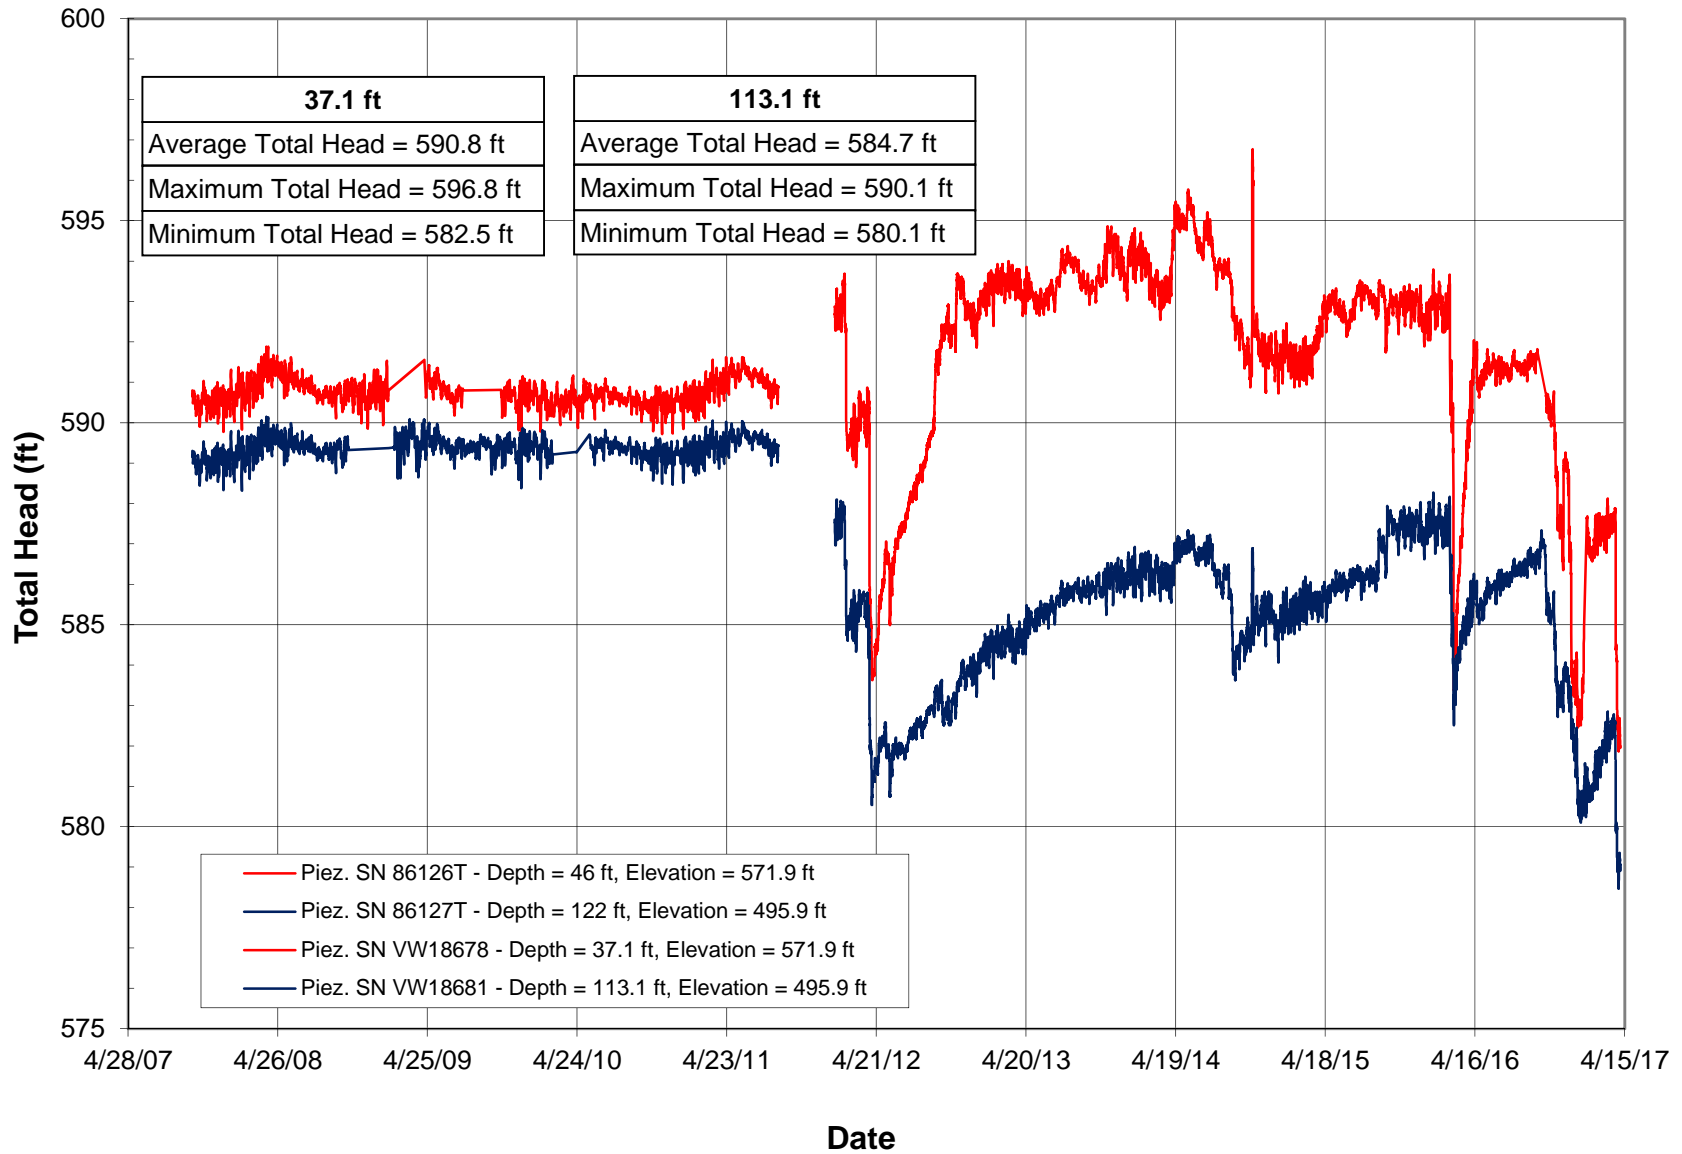
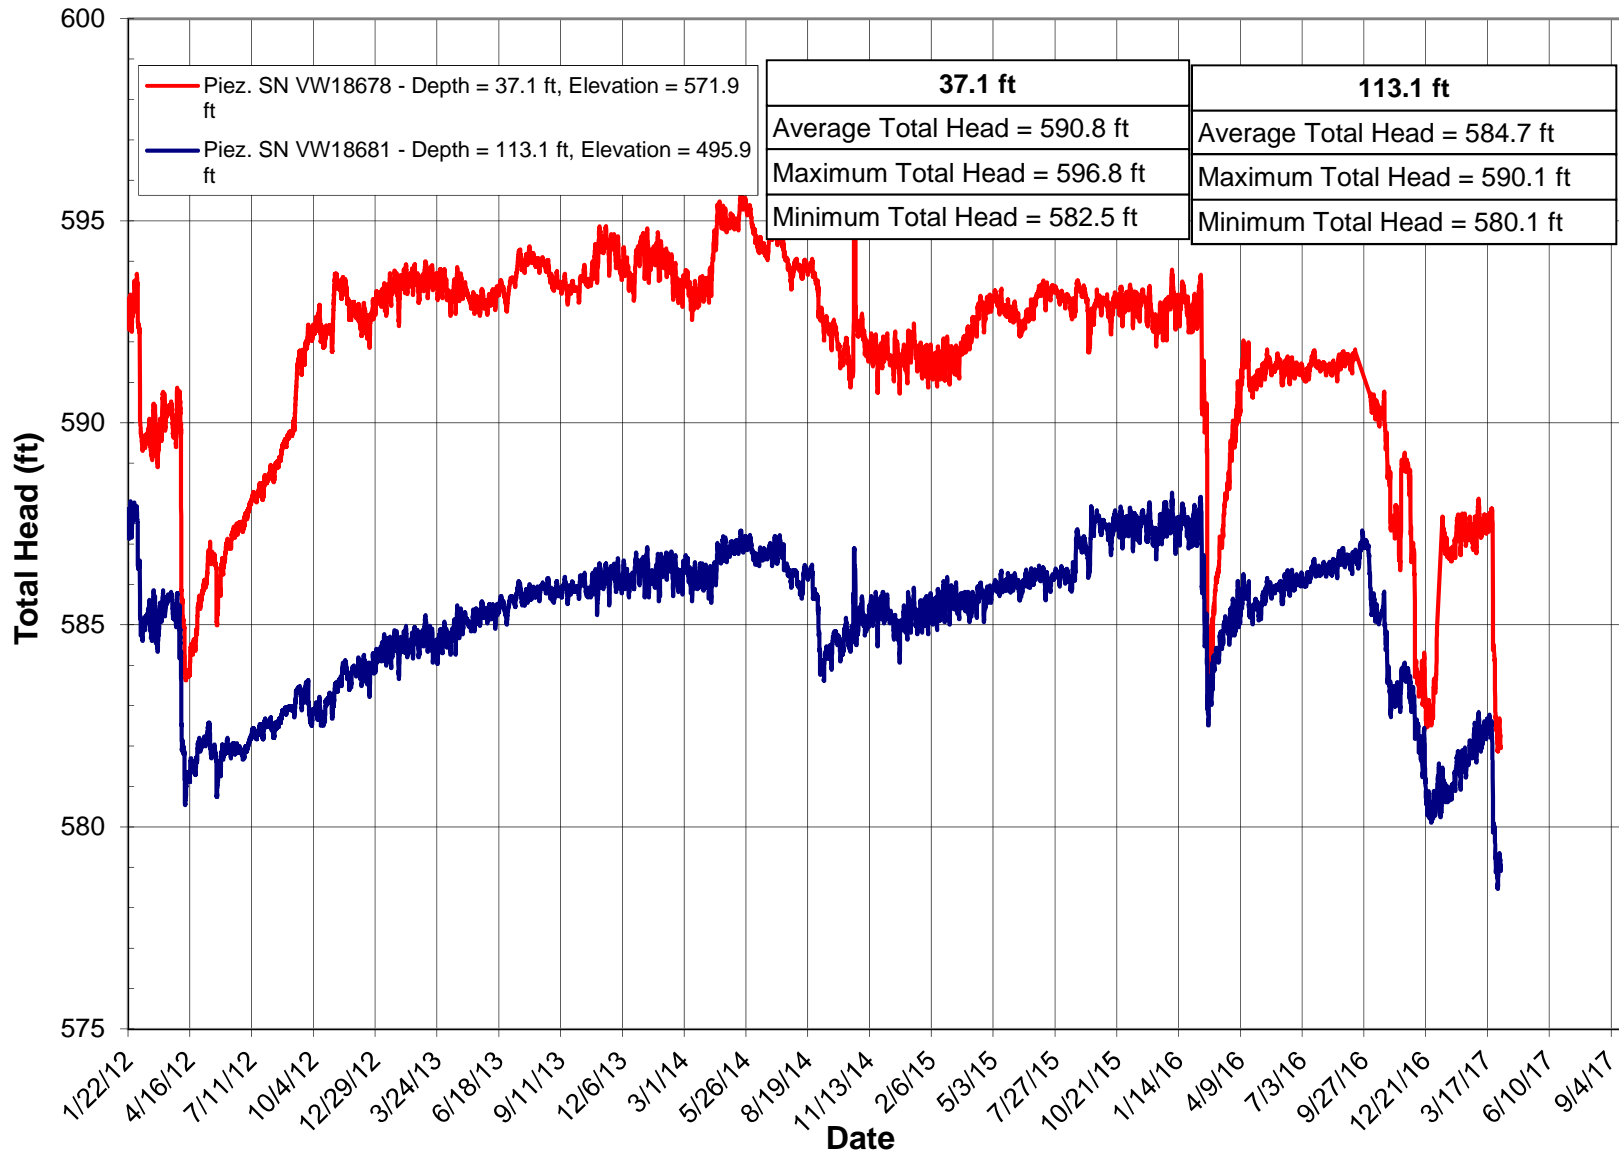
B-05-02 VW Piezometer Readings

B-05-02 – Beginning on March 23, 2017, pore pressure readings indicate a rapid decrease of about 6 feet in the shallow piezometer and about 3.6 feet in the deep piezometer. This is likely due to the final grading operations around this location.

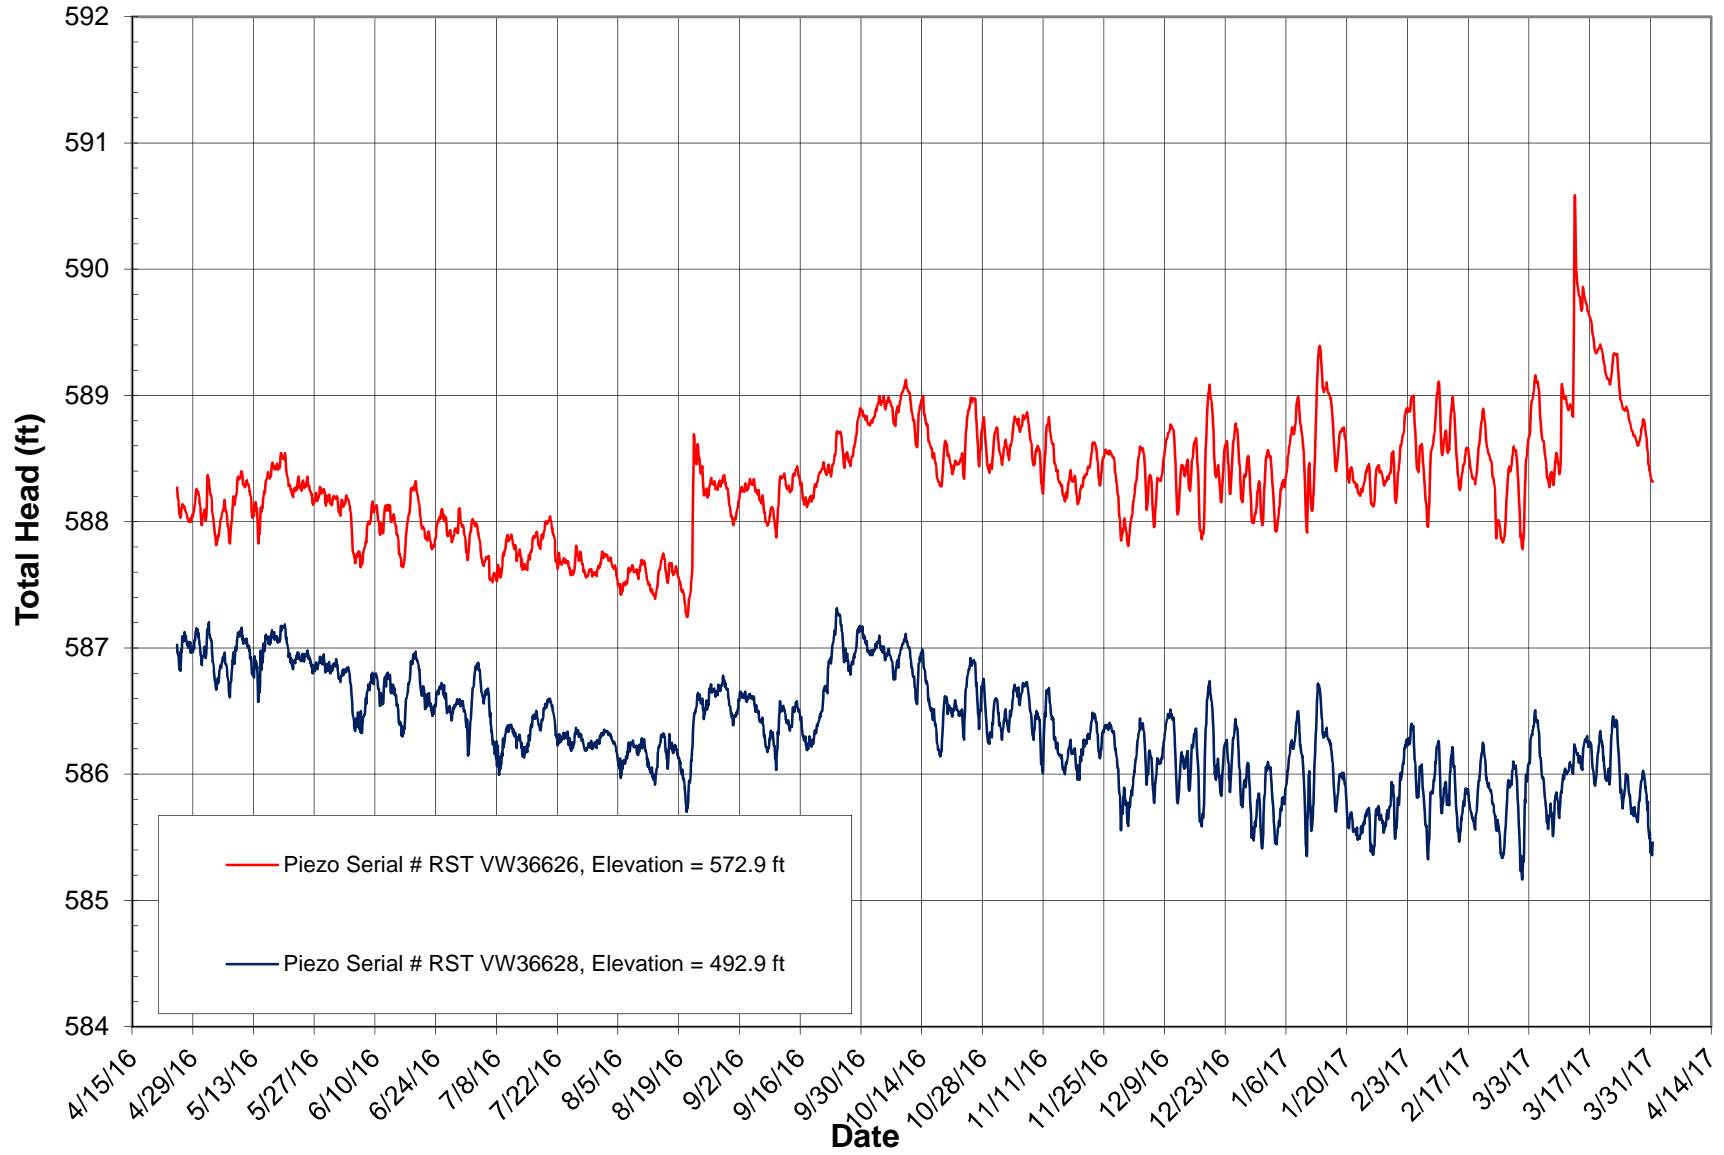
B-05-A-03 VW Piezometer Readings

B-05-A-03 – Pore pressure readings in the shallow piezometer at this location show an increase in total head of about 2 feet during the middle of March 2017. This was followed by a gradual decrease of 2 feet for the remainder of this reading period. The deep piezometer pore pressure readings indicate a similar pattern, but at a smaller magnitude increase of about 1 foot. These changes are likely due to the final grading operations in this area.

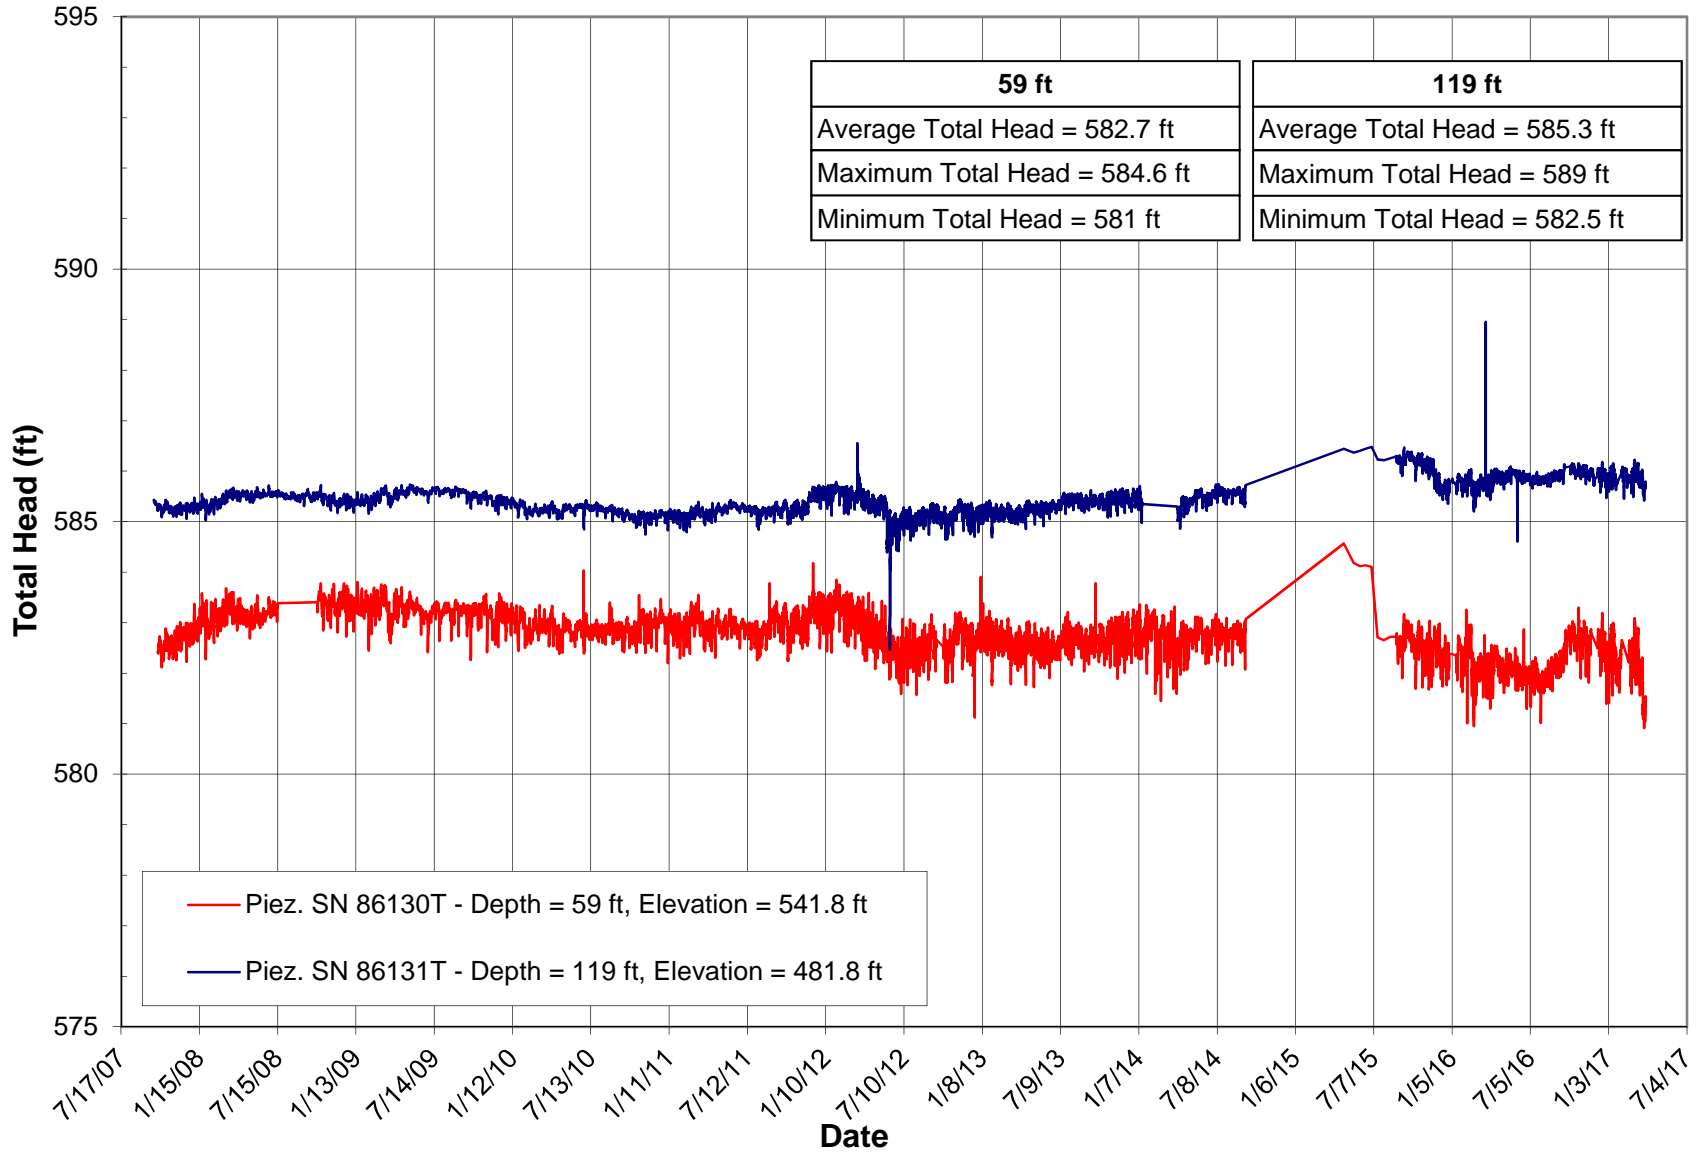
B-05-04 VW Piezometer Readings

B-05-04 – Pore pressure readings at this location show decreases in total head of about 1.4 feet in the shallow piezometer and almost no change in the deep piezometer. This is also likely due to the final grading operations. We have temporarily removed the data loggers from this location to avoid damage or loss during final grading operations.

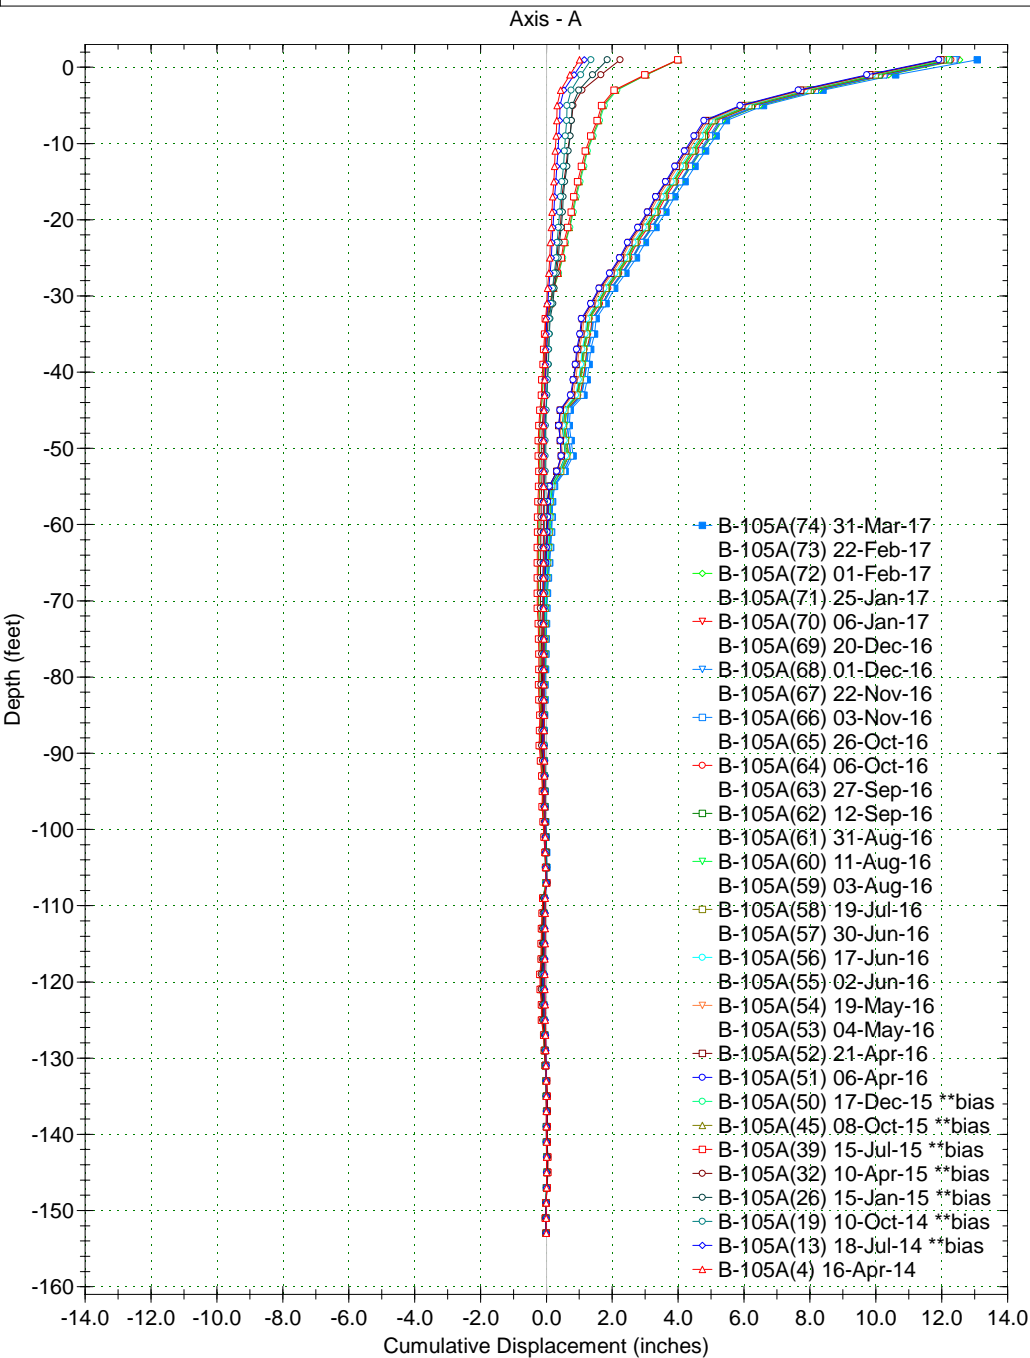
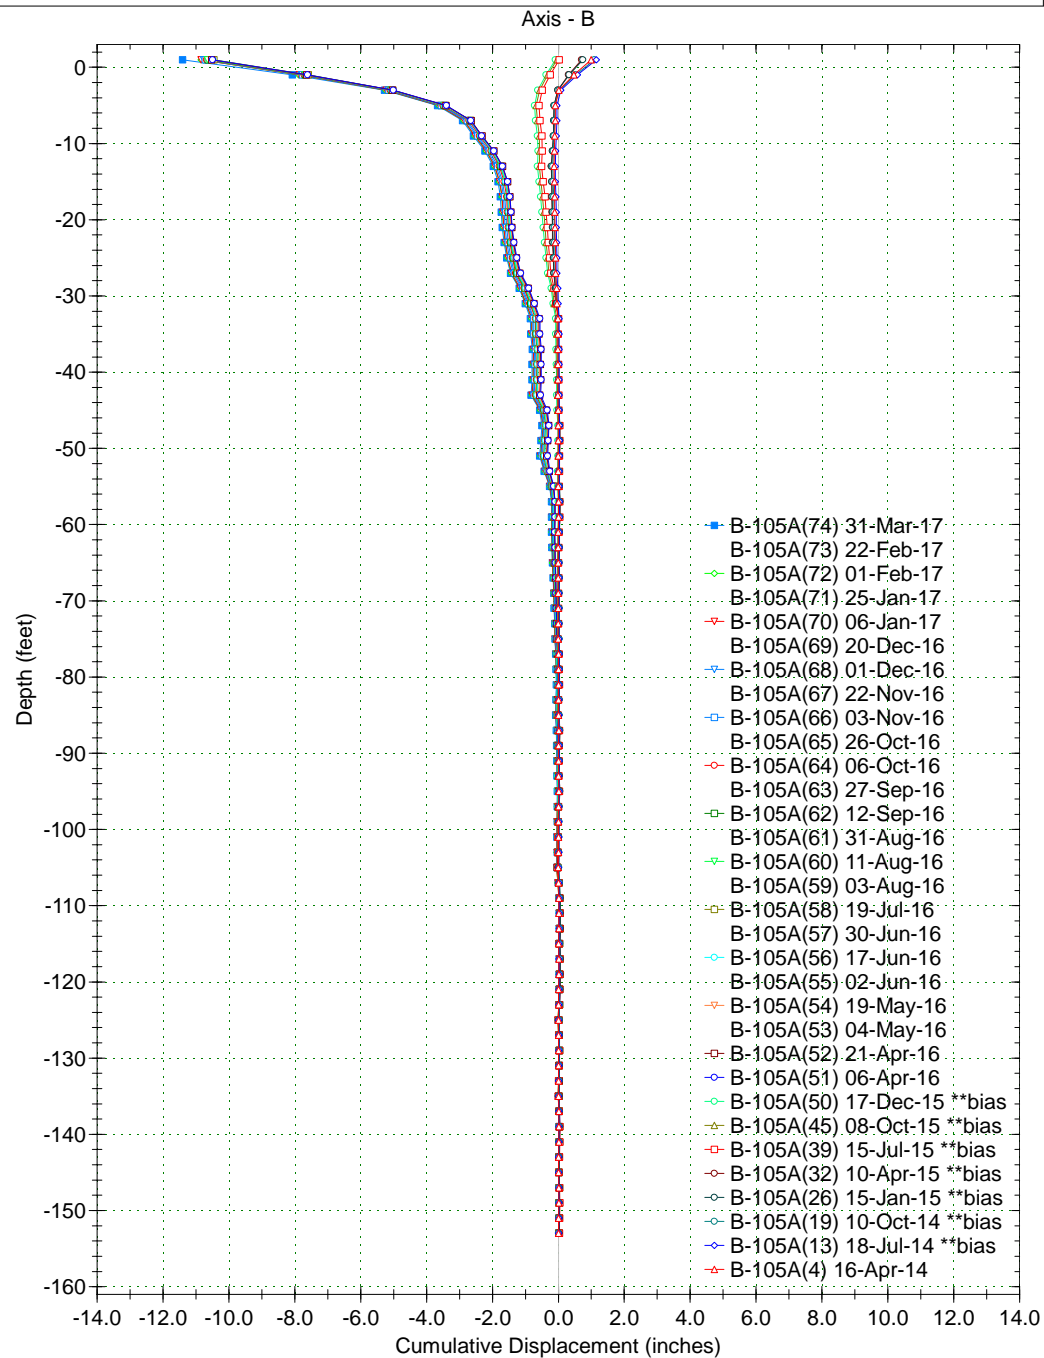
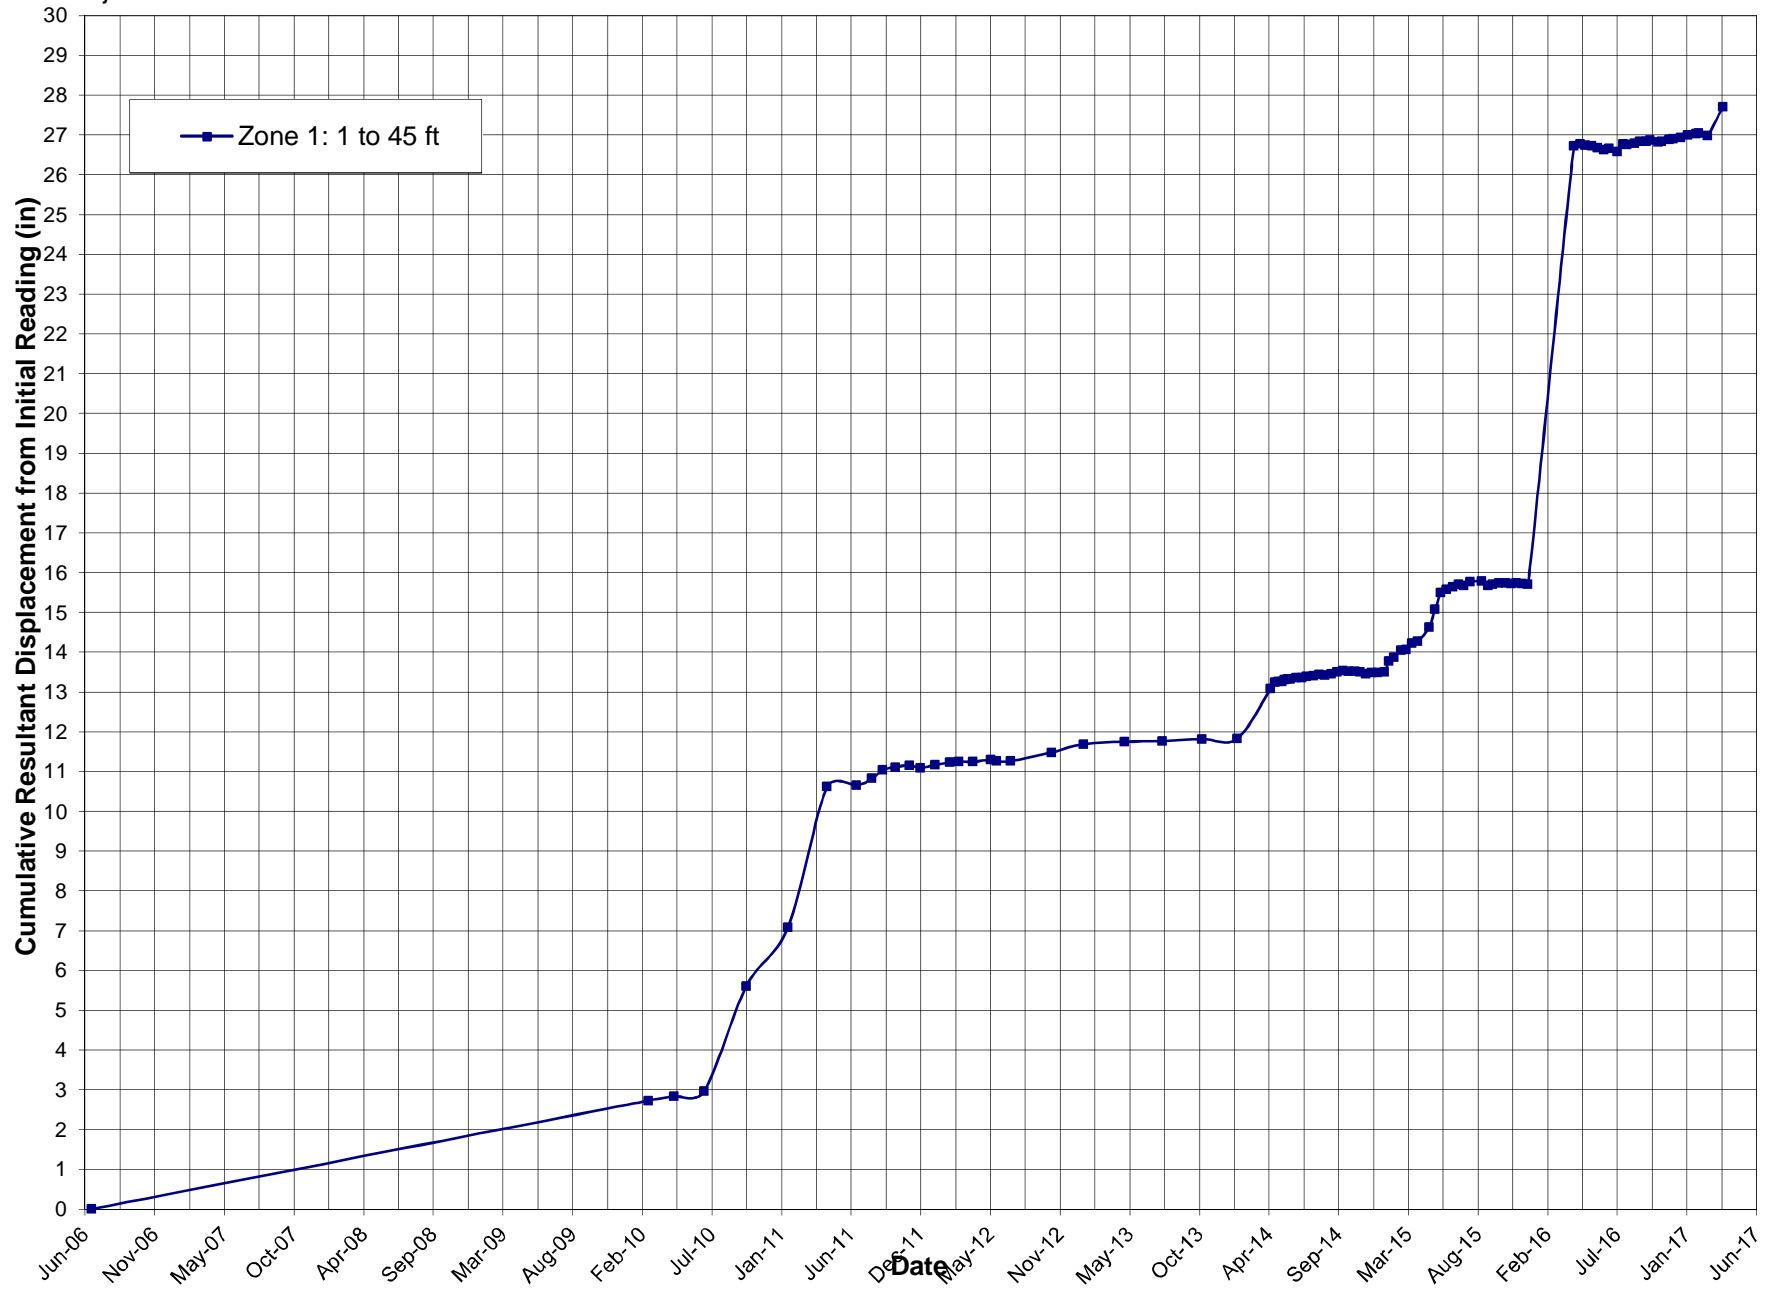
Borehole : B-105A
Project : CUY-90-15-24
Location : Cleveland, Ohio
Northing : Sta. 19+11.38
Easting : 90.9' Rt of CL
Collar :

B-105A – Inclinometer readings at this location indicate slight rotational movement for the upper 50 feet of the slope tube in the positive A-axis and the negative B-axis direction. The zone plot shows a resultant displacement of about 0.8 inches.
