April 11, 2017

Re: March 30, 31, and April 4, 2017 Monthly Readings
CUY-90-15.24 Slope Monitoring
PID 96504
SME Project No. 069032.00

Monthly instrument readings at the I-90 west slope taken on March 30, 31 and April 4, 2017 are presented in this report. Monthly readings currently include instruments at I/P-001-13, I/P-002-13, I/P-003-10, P-003-13, I/P-004-13, I-008-10, I/P-009-13, B-101, B-102, B-105A, B-05-02, B-05-04, B-05-A-11, P-1, P-9N. Changes reported for the individual instruments are for the previous four-week period unless noted otherwise.

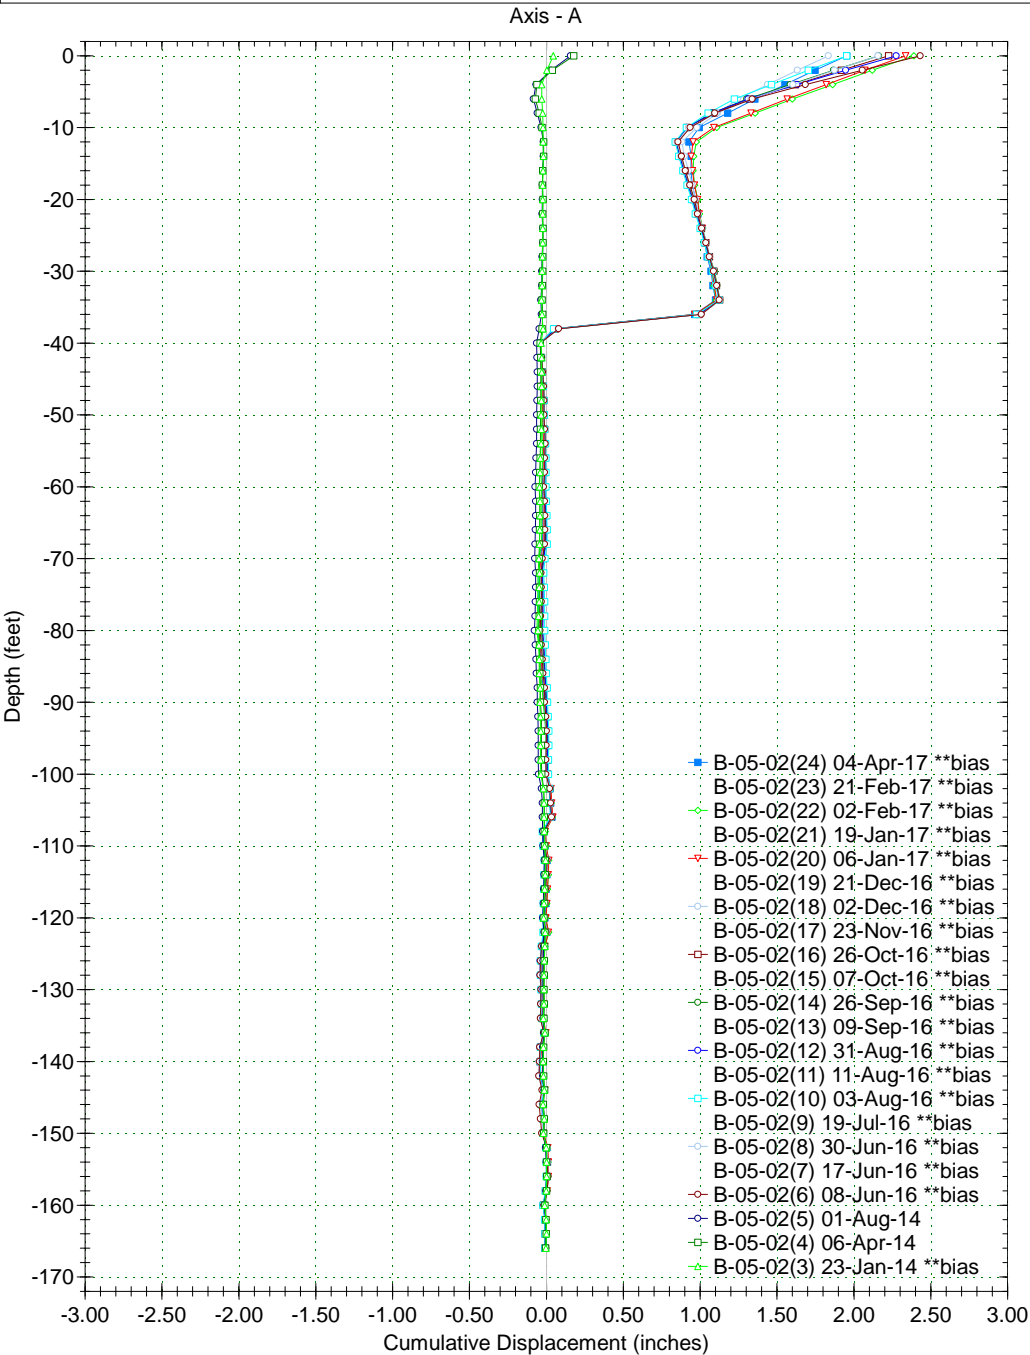
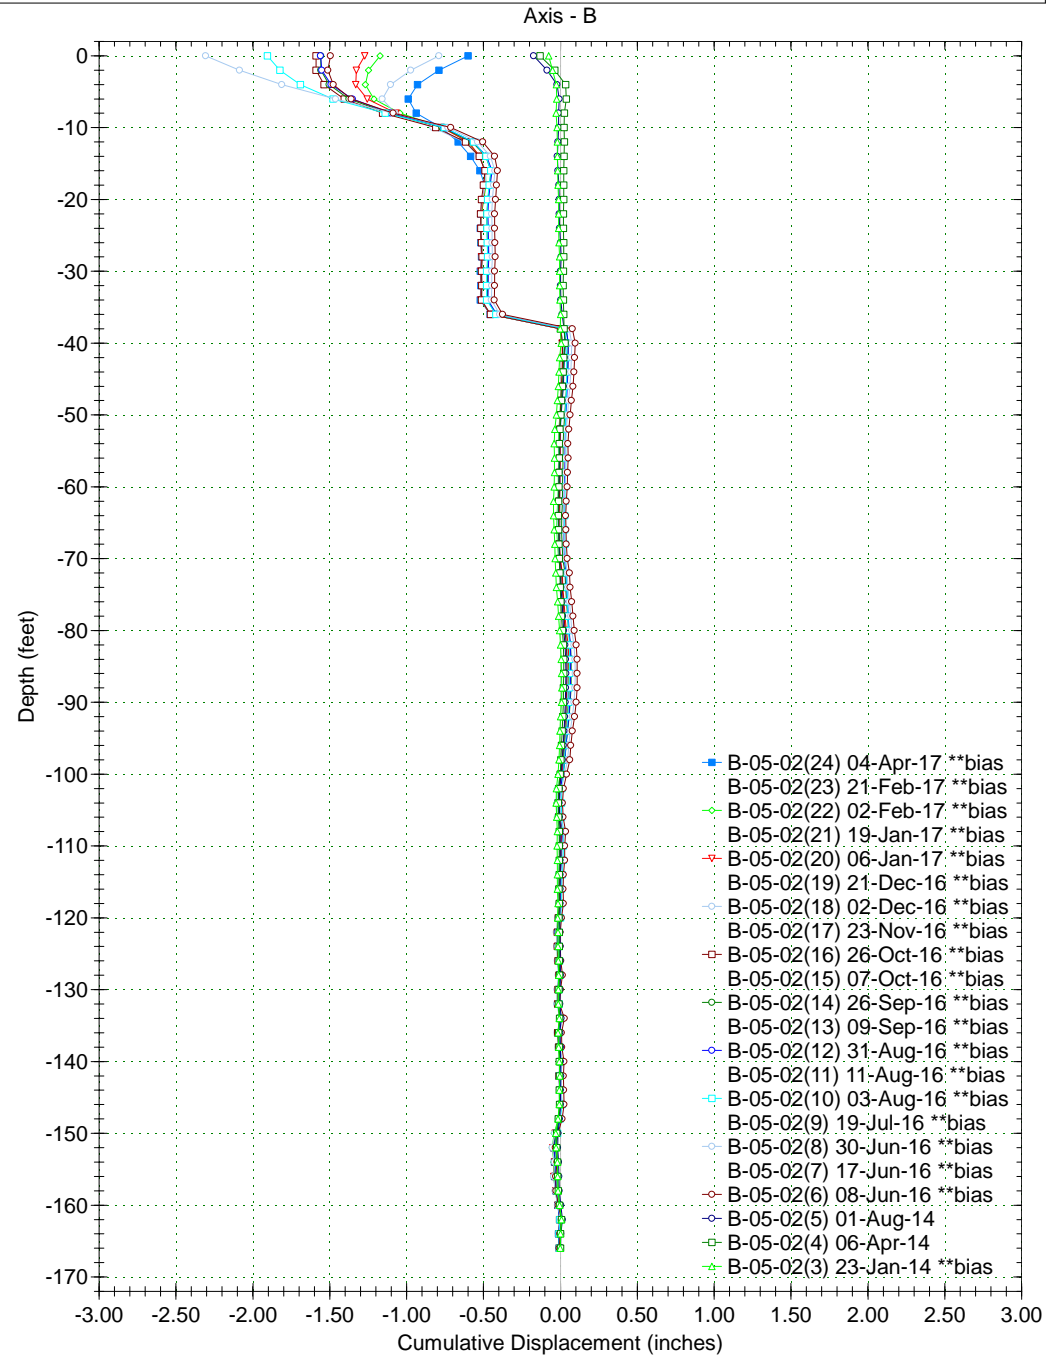
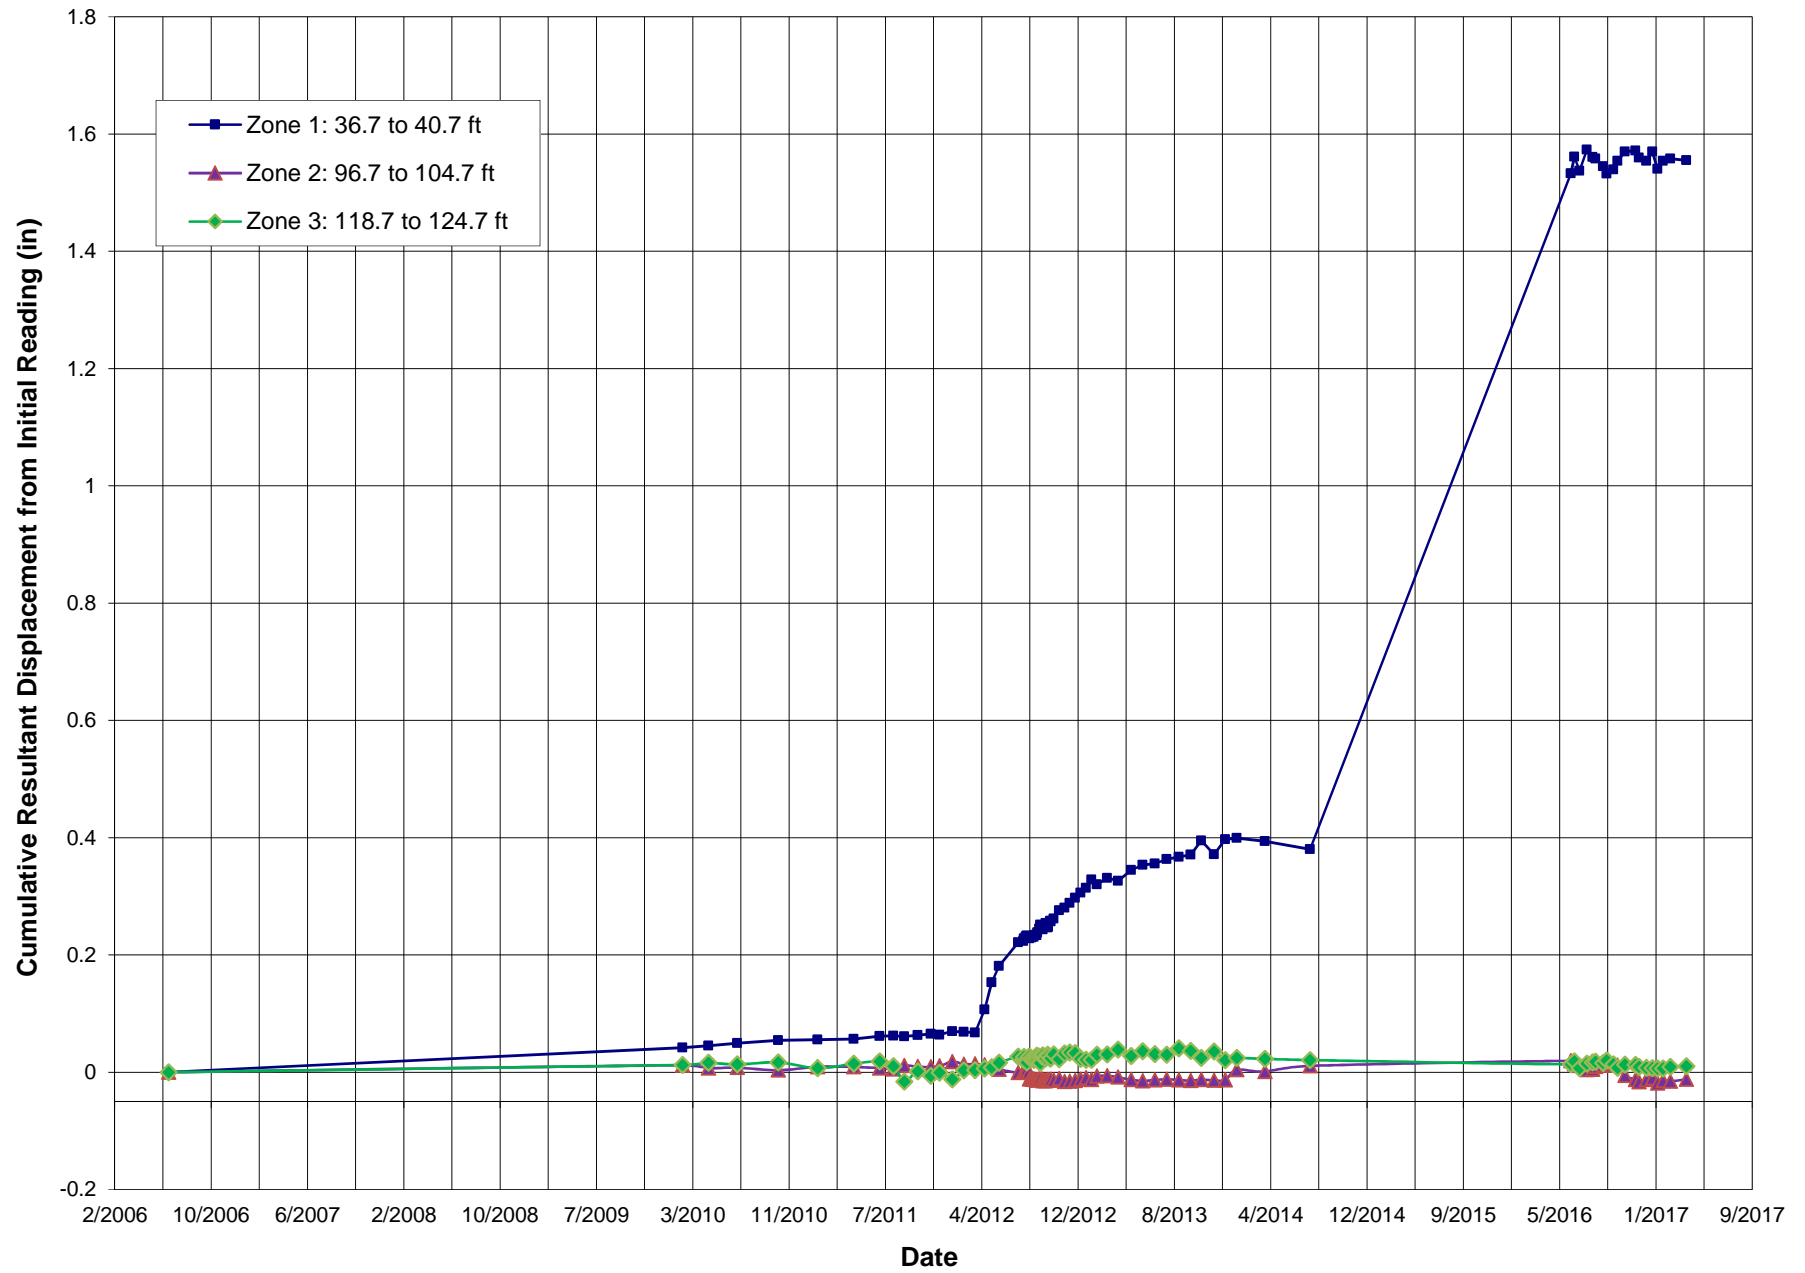
Borehole : B-05-02
Project : CUY-90-15-24
Location : Cleveland, Ohio
Northing : 663737.939
Easting : 2190289.081
Collar :

B-05-02 – The inclinometer casing at this location will need to be adjusted now that the surrounding soil is close to final grade. The casing currently has about 6 feet of stick up and is loose at the surface. The top 8 feet on the plot are artificial readings that were added to allow us to plot the current readings with the older readings. This will be adjusted when the site is at final grade and we can cut the casing down. The various zone plots show no displacement.
