Re: April 25, 26, 27, and 28, 2017 Monthly Readings  
CUY-90-15.24 Slope Monitoring  
PID 96504  
SME Project No. 069032.00

Monthly instrument readings at the I-90 west slope taken on April 25, 26, 27, and 28, 2017 are presented in this report. Monthly readings currently include instruments at I/P-001-13, I/P-002-13, I/P-003-10, P-003-13, I/P-004-13, I-008-10, I/P-009-13, B-101, B-102, B-105A, B-05-02, B-05-04, B-05-A-11, P-1, P-9N. Changes reported for the individual instruments are for the previous four-week period unless noted otherwise.

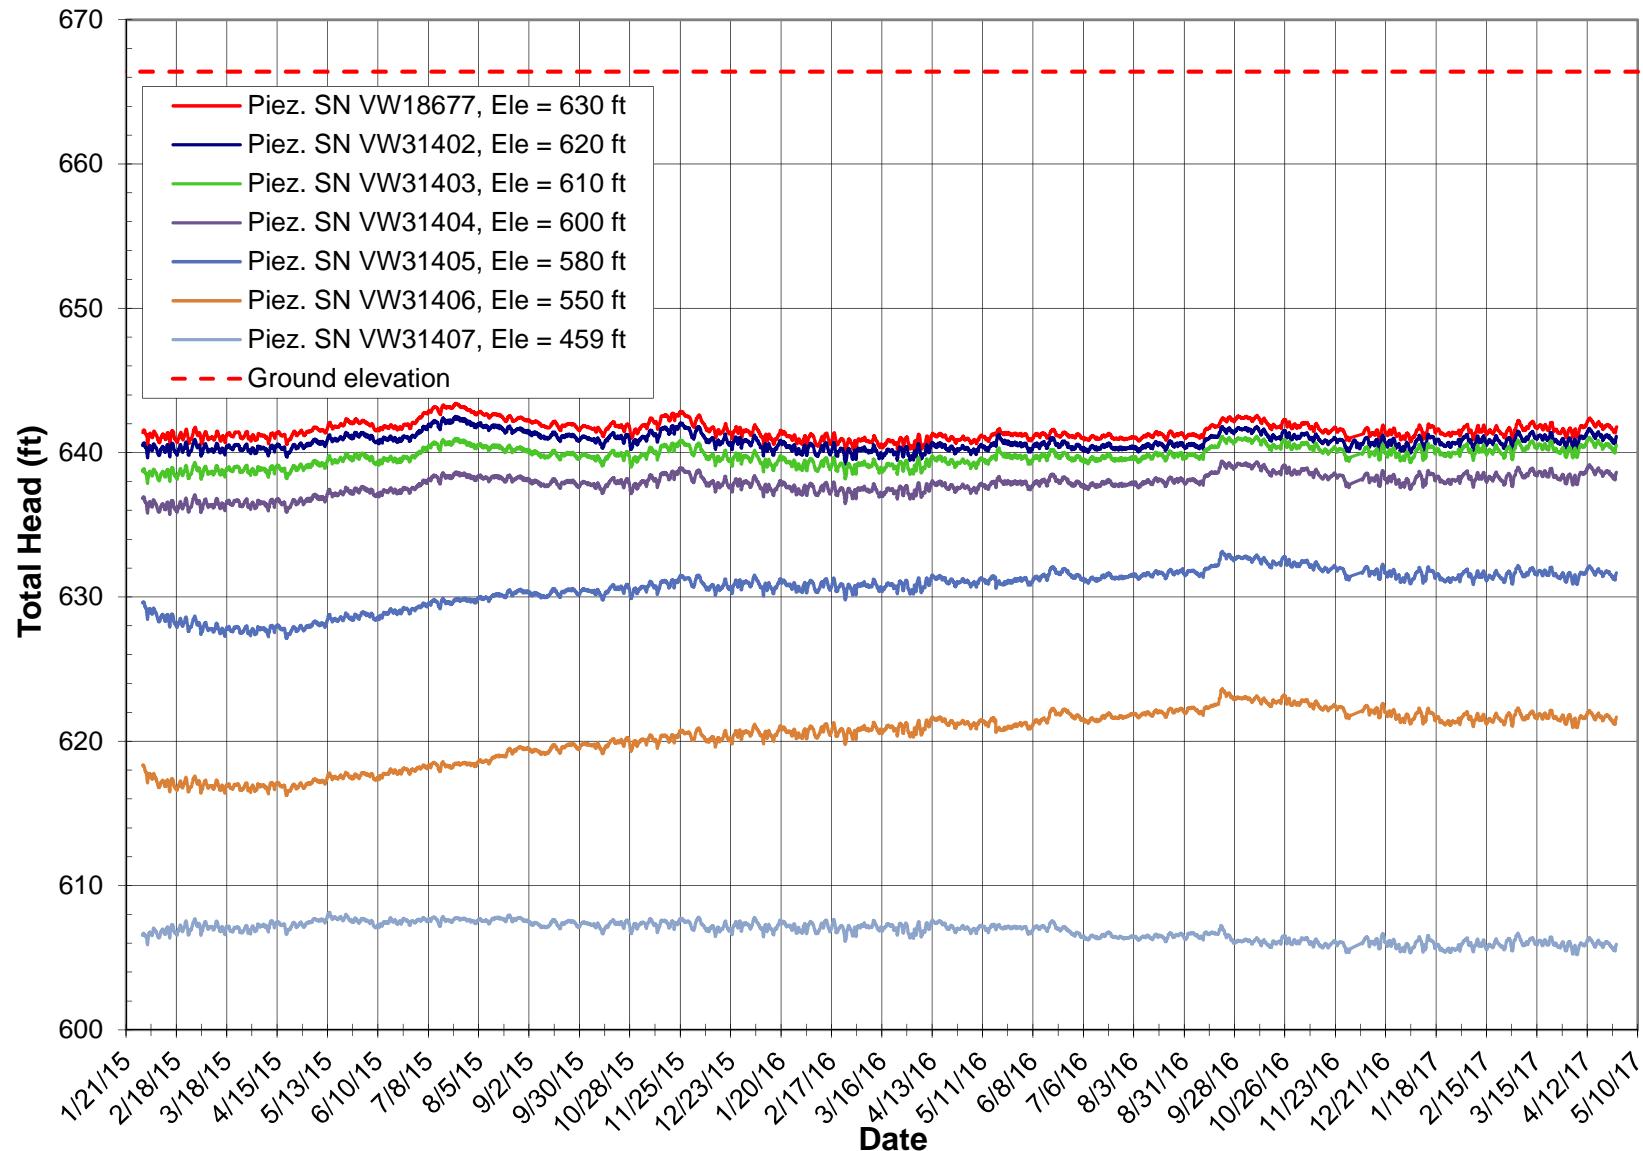
## P-001-13 VW Piezometer Readings

**P-001-13** – Pore pressure readings in all piezometers at this location had a net increase in total head ranging from 0.4 to 0.8 feet, with the largest increases occurring in the top five piezometers.

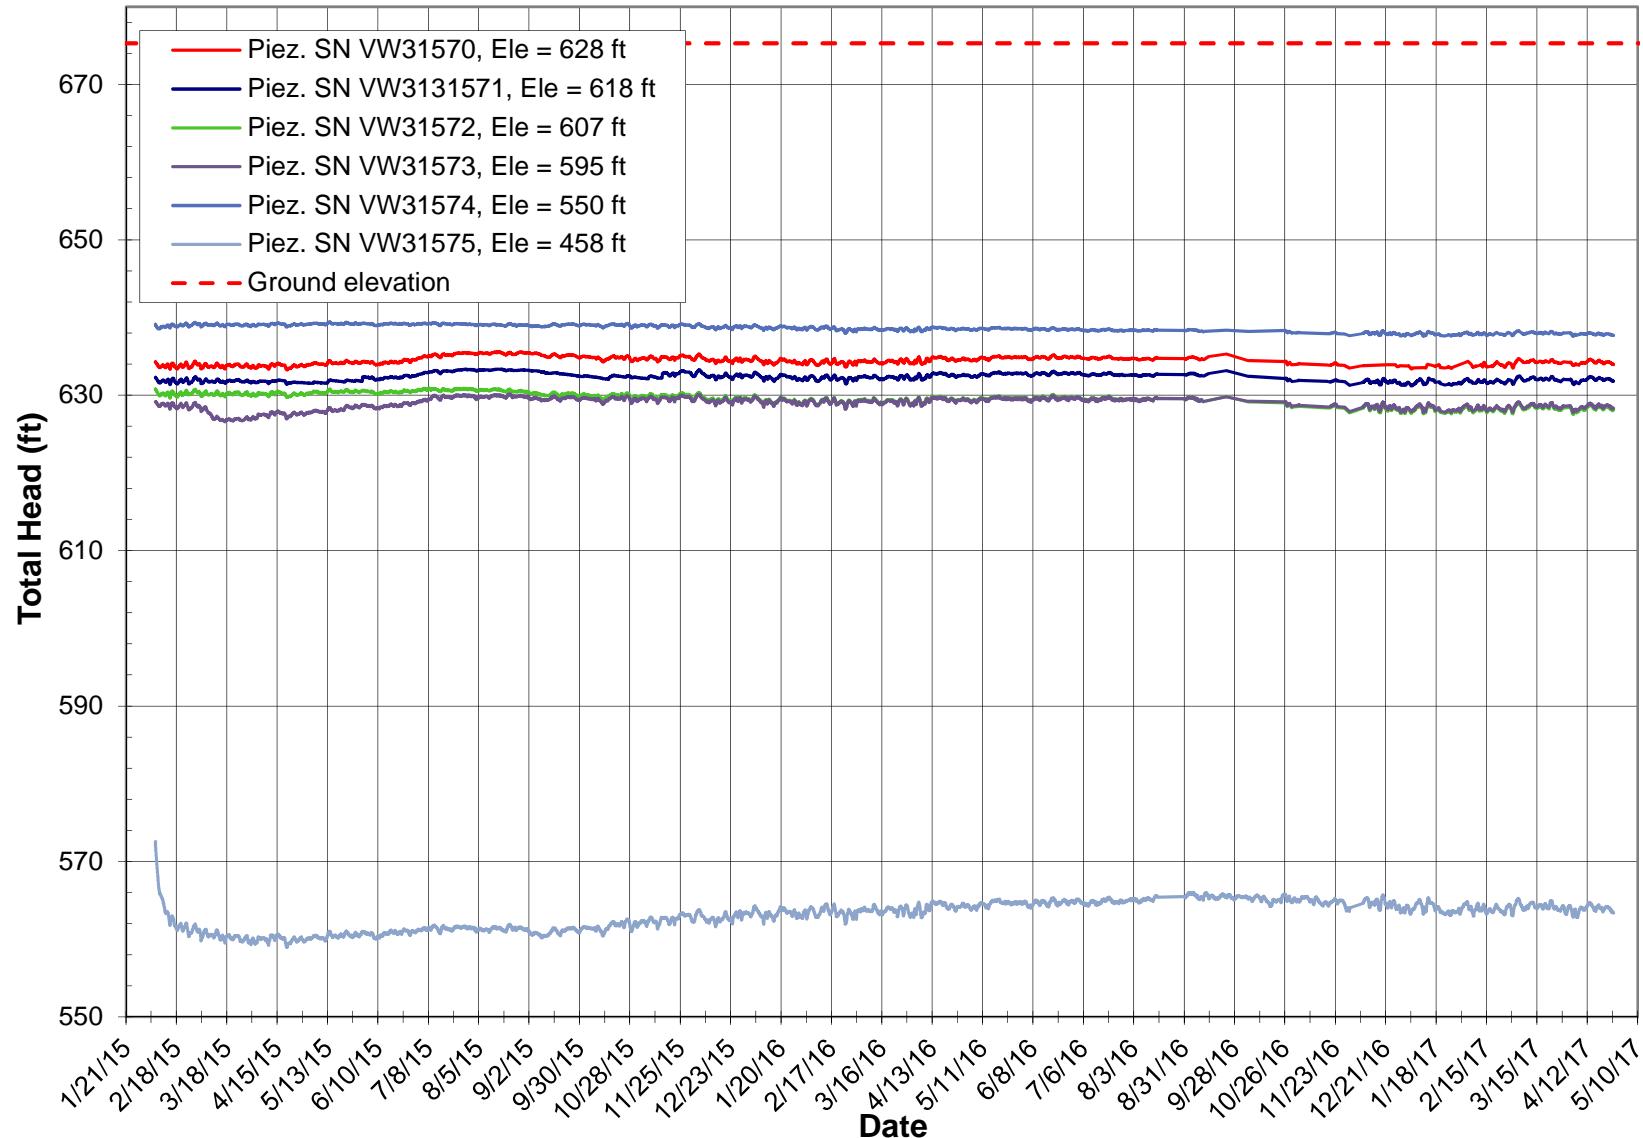
## P-002-13 VW Piezometer Readings

Pore pressure readings at P-002-13, P-003-13 and B-05-A-11 show variations in total head of less than 0.5 feet for the period.

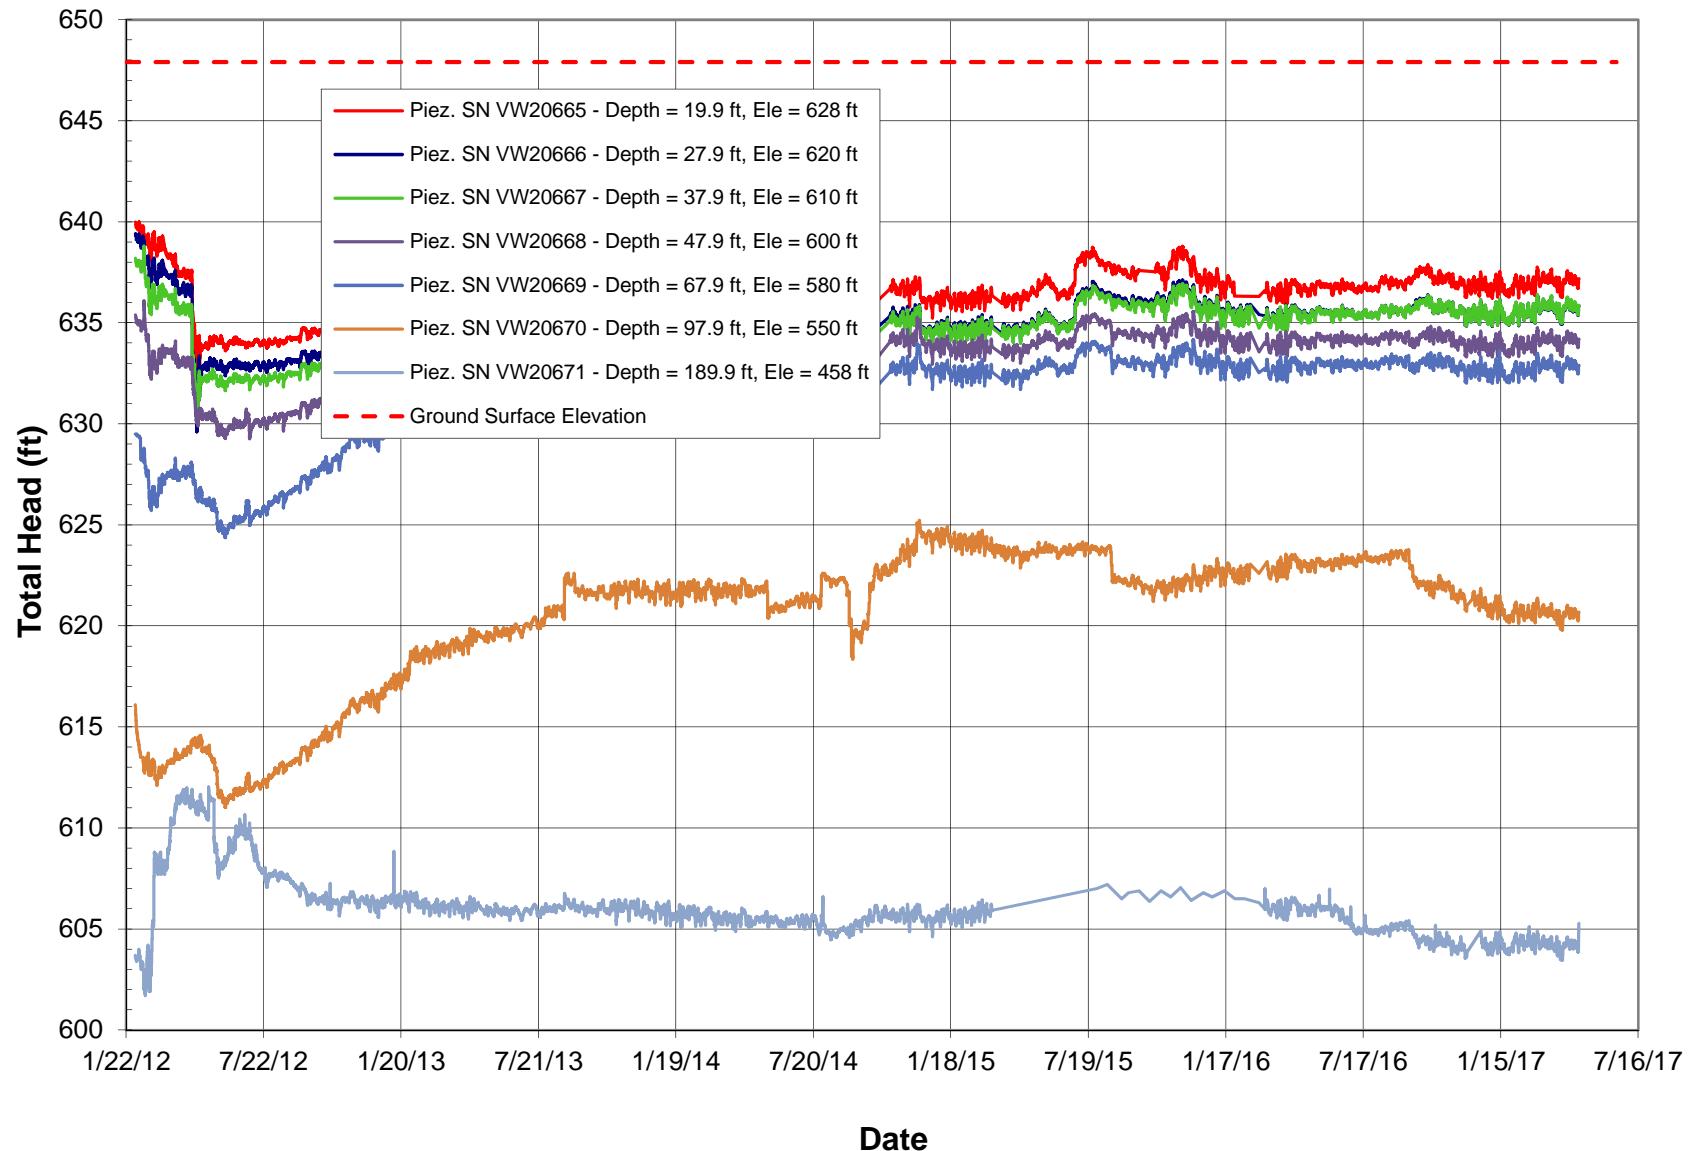
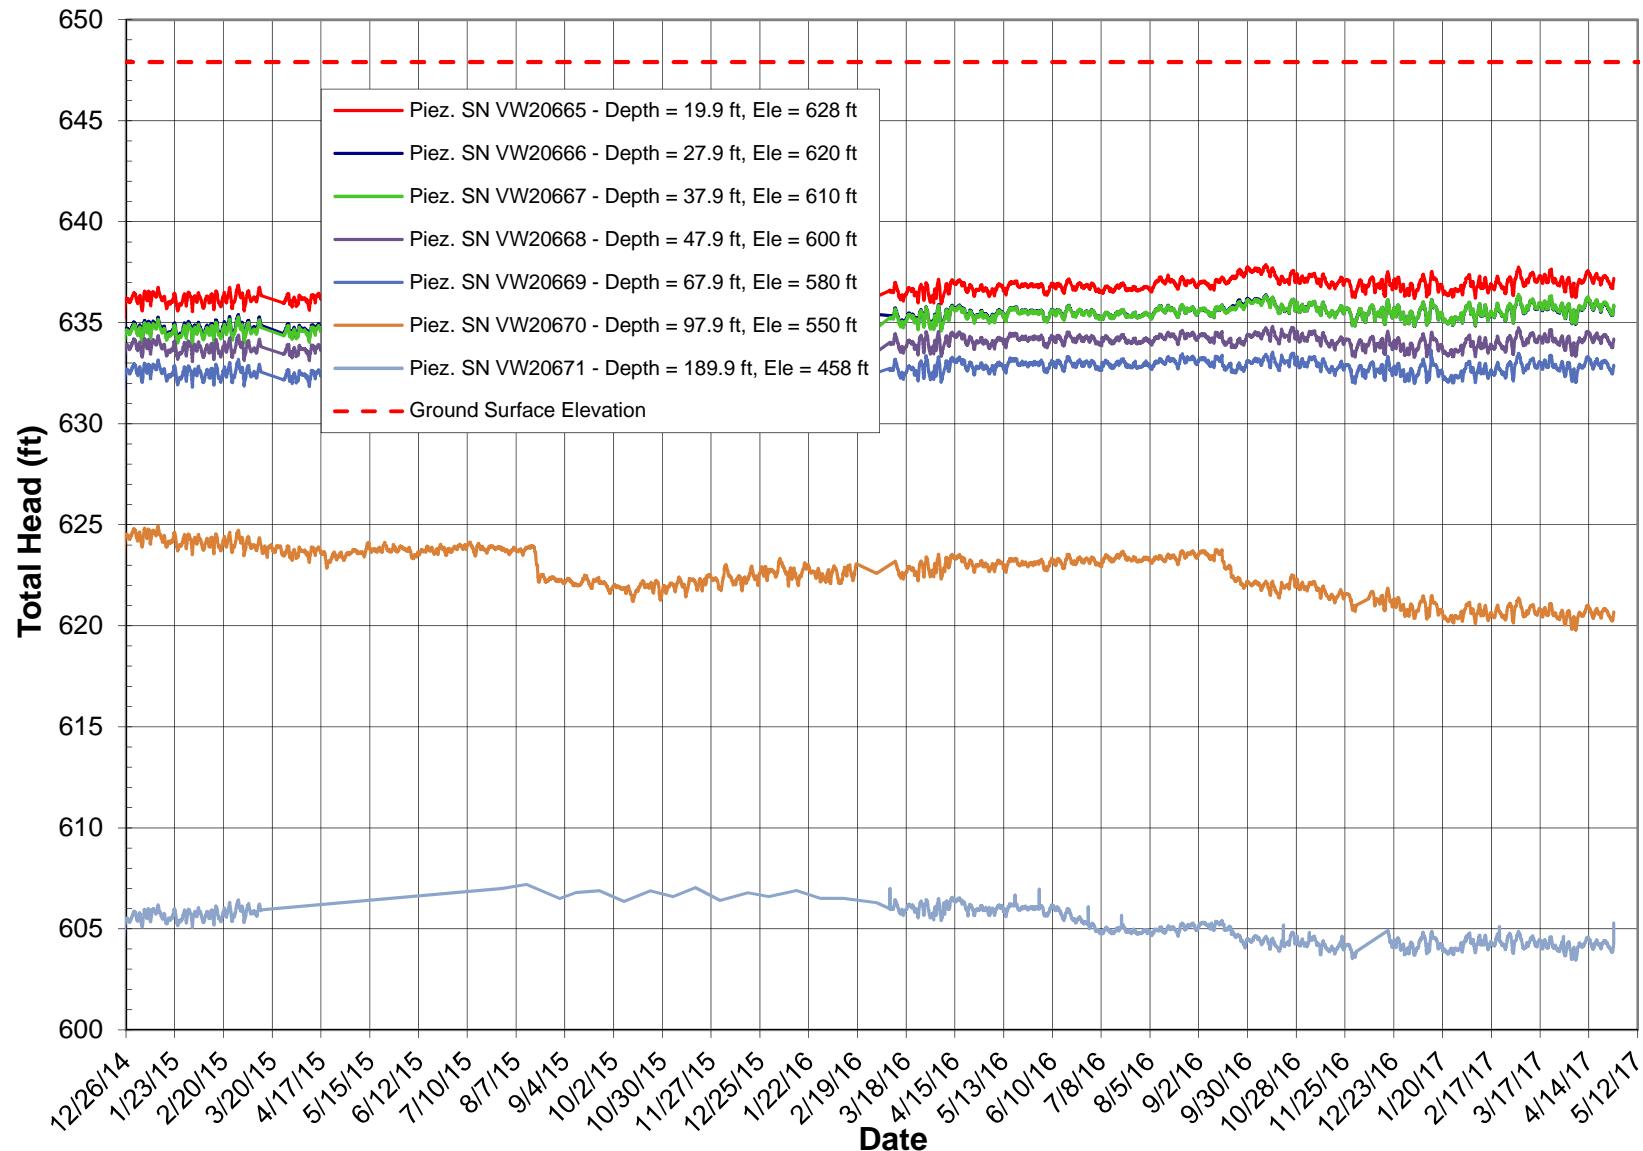
## P-003-10 VW Piezometer Readings

**P-003-10** – Total head in the piezometers at this location varied over a range of about 1 foot during this period. Variation in the deepest piezometer was greater than 1 foot. Net changes for the period were less than 0.5 feet.

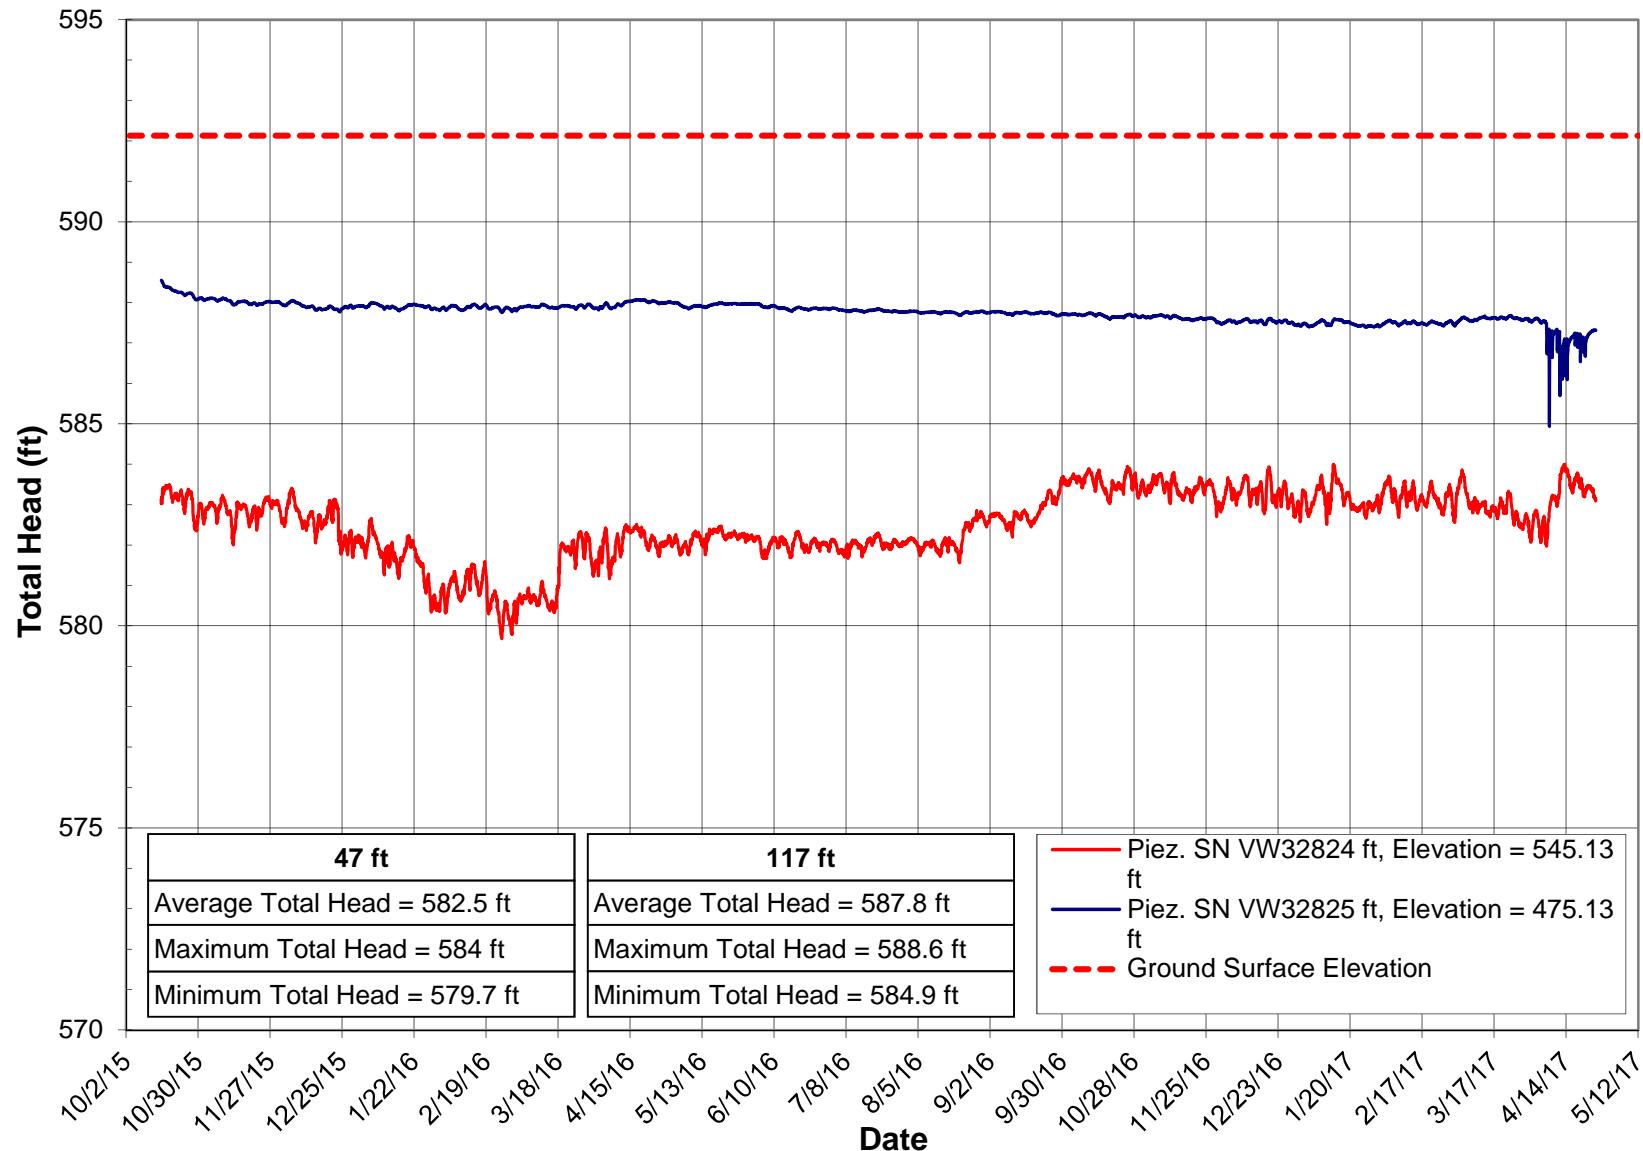
## P-004-13 VW Piezometer Readings

**P-004-13** – Pore pressures in the piezometers at this location varied over a range of 2 to 2.5 feet this period. Pore pressures in the shallow piezometer had been decreasing the prior month. Then in early to mid-April there was an increase of about 2 feet followed by a gradual decrease resulting in a net increase of about 0.8 feet. Pore pressures in the deep piezometer experienced a series of downward spikes throughout this period. The greatest decrease, about 2.5 feet, occurred in early April. Each successive decrease was smaller resulting in a net decrease of about 0.2 feet.

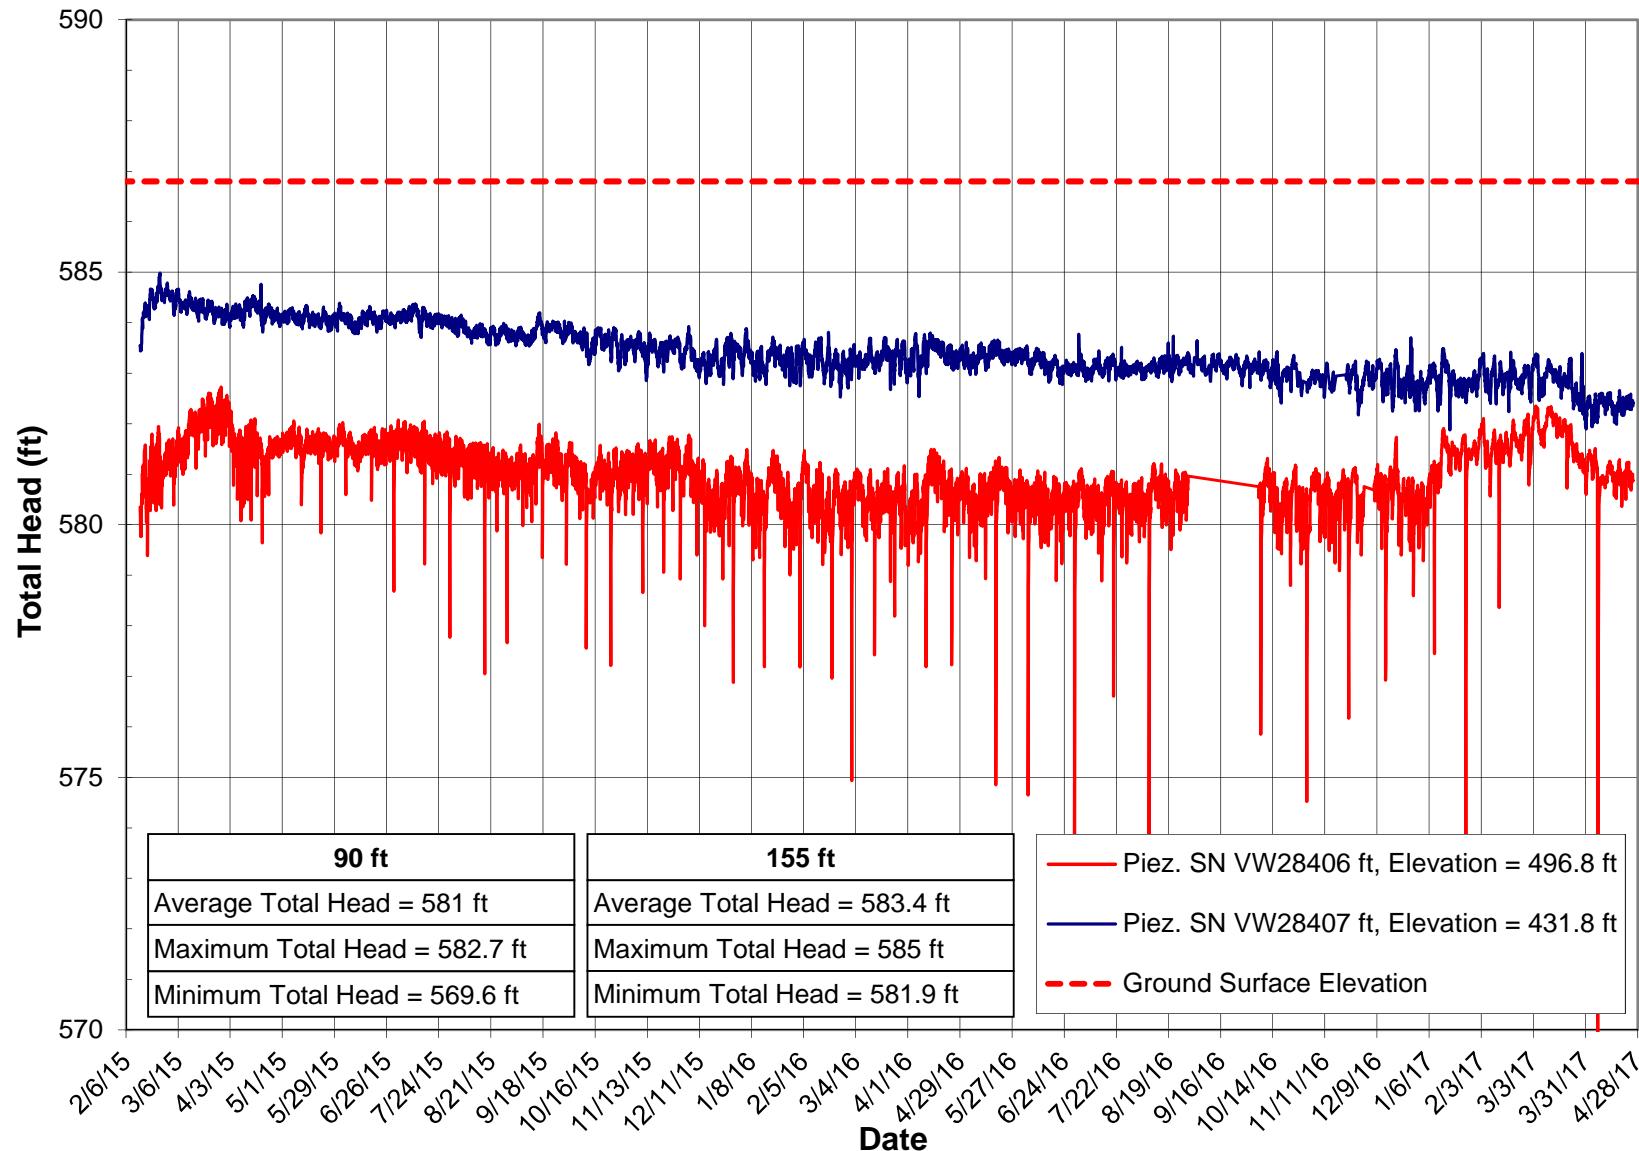
## P-009-13 VW Piezometer Readings

**P-009-13** – Pore pressure readings in the shallow piezometer show a decrease in total head of about 0.6 feet. Total head in the deep piezometer increased by about 0.3 feet.

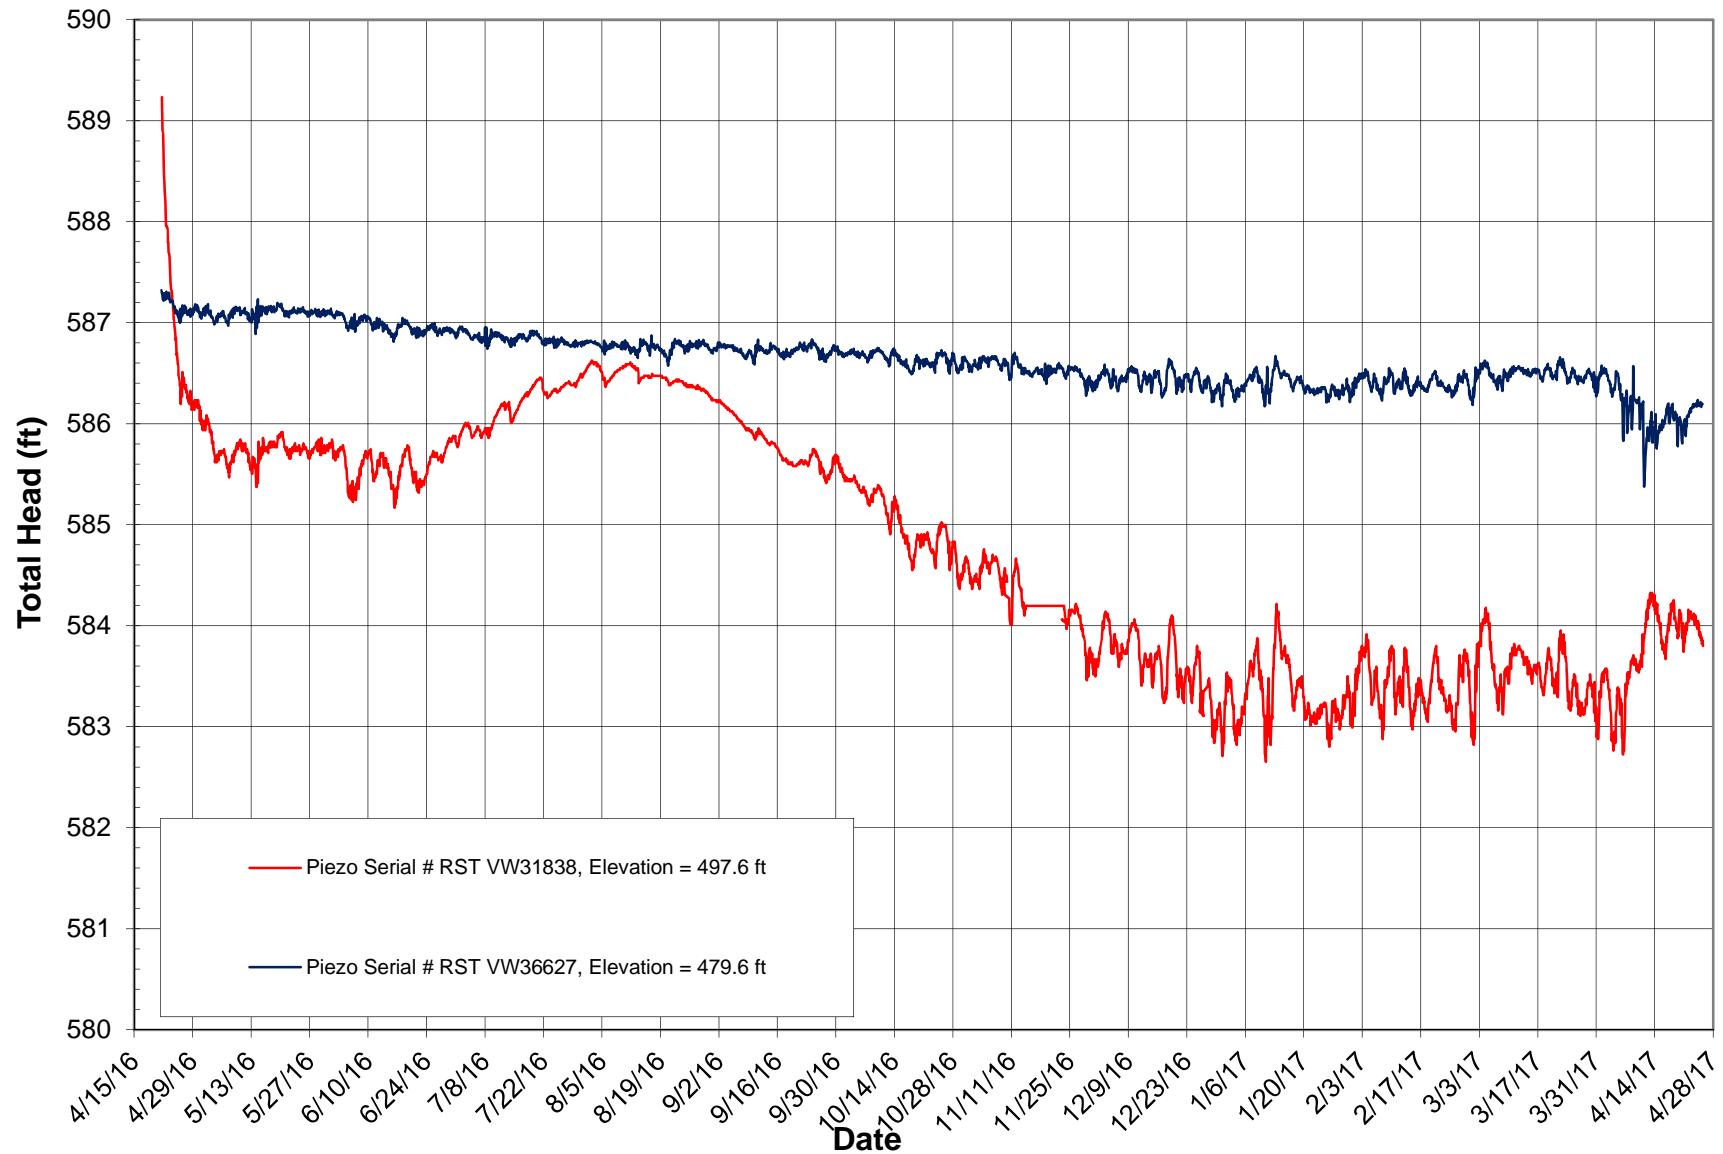
## B-105A VW Piezometer Readings

**B-105A** – Pore pressures in the piezometers at this location varied over a range of 1 to 1.5 feet. Net changes were about 0.9 feet in the shallow piezometer and about 0.2 feet in the deep piezometer.

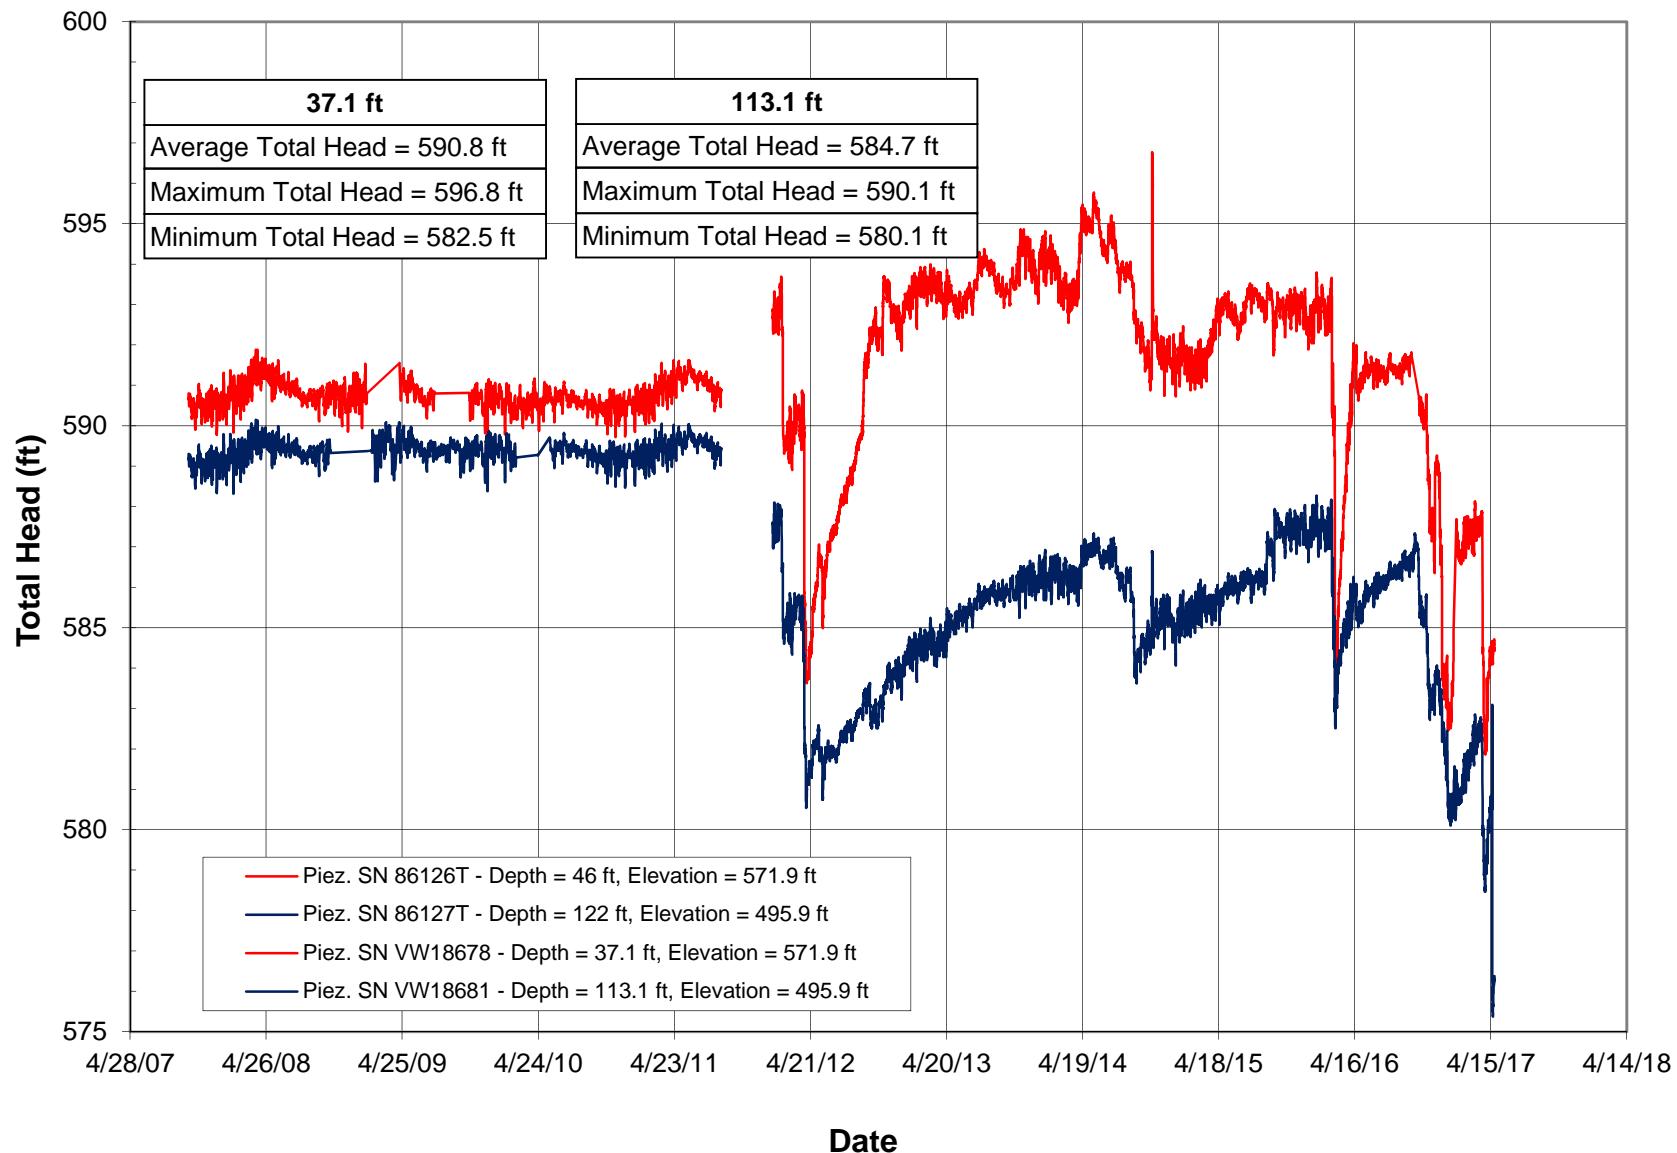
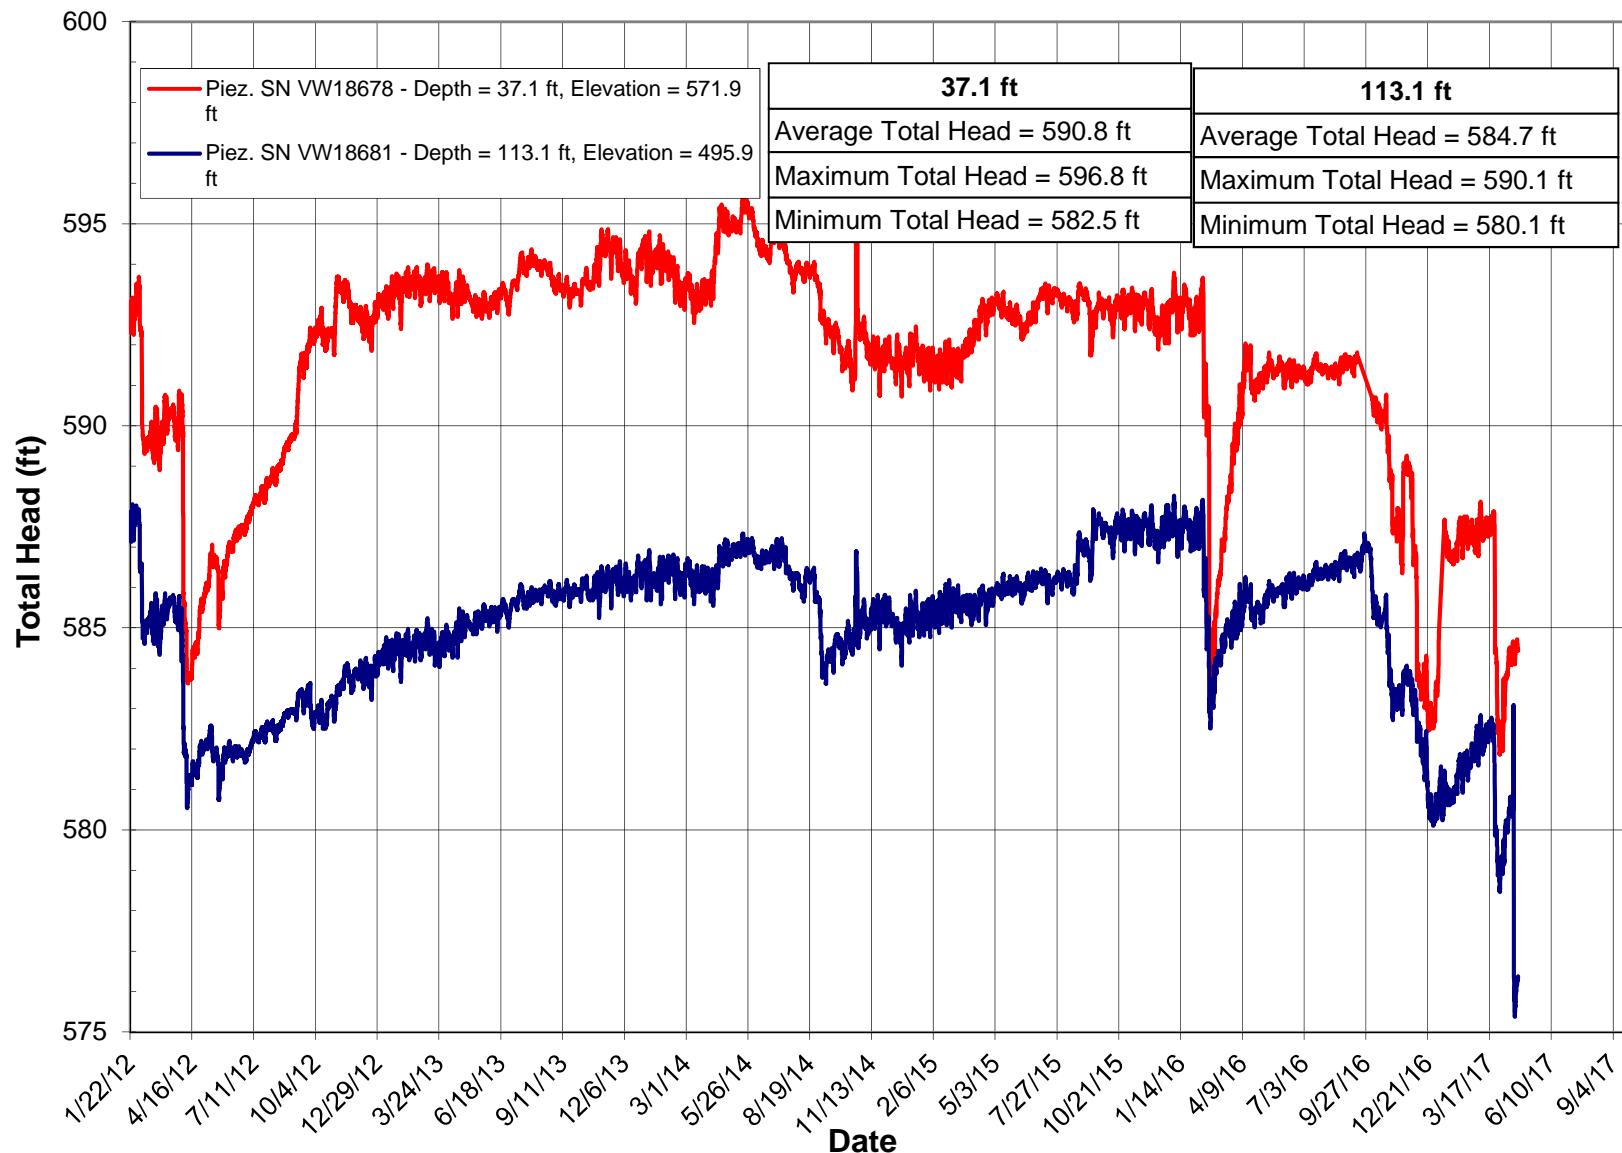
## B-05-02 VW Piezometer Readings

**B-05-02** – Between March 20 and March 30, 2017, pore pressure readings indicate rapid decreases of about 5.4 feet in the shallow piezometer and about 4.2 feet in the deep piezometer. From March 30 to April 25, total head in the shallow piezometer increased by 2.6 feet. Between March 30 and April 19, total head in the deep piezometer increased by 4.6 feet, followed by a decrease of 7.7 feet between April 19 and April 21. These large changes are due to the final grading operations around this location.

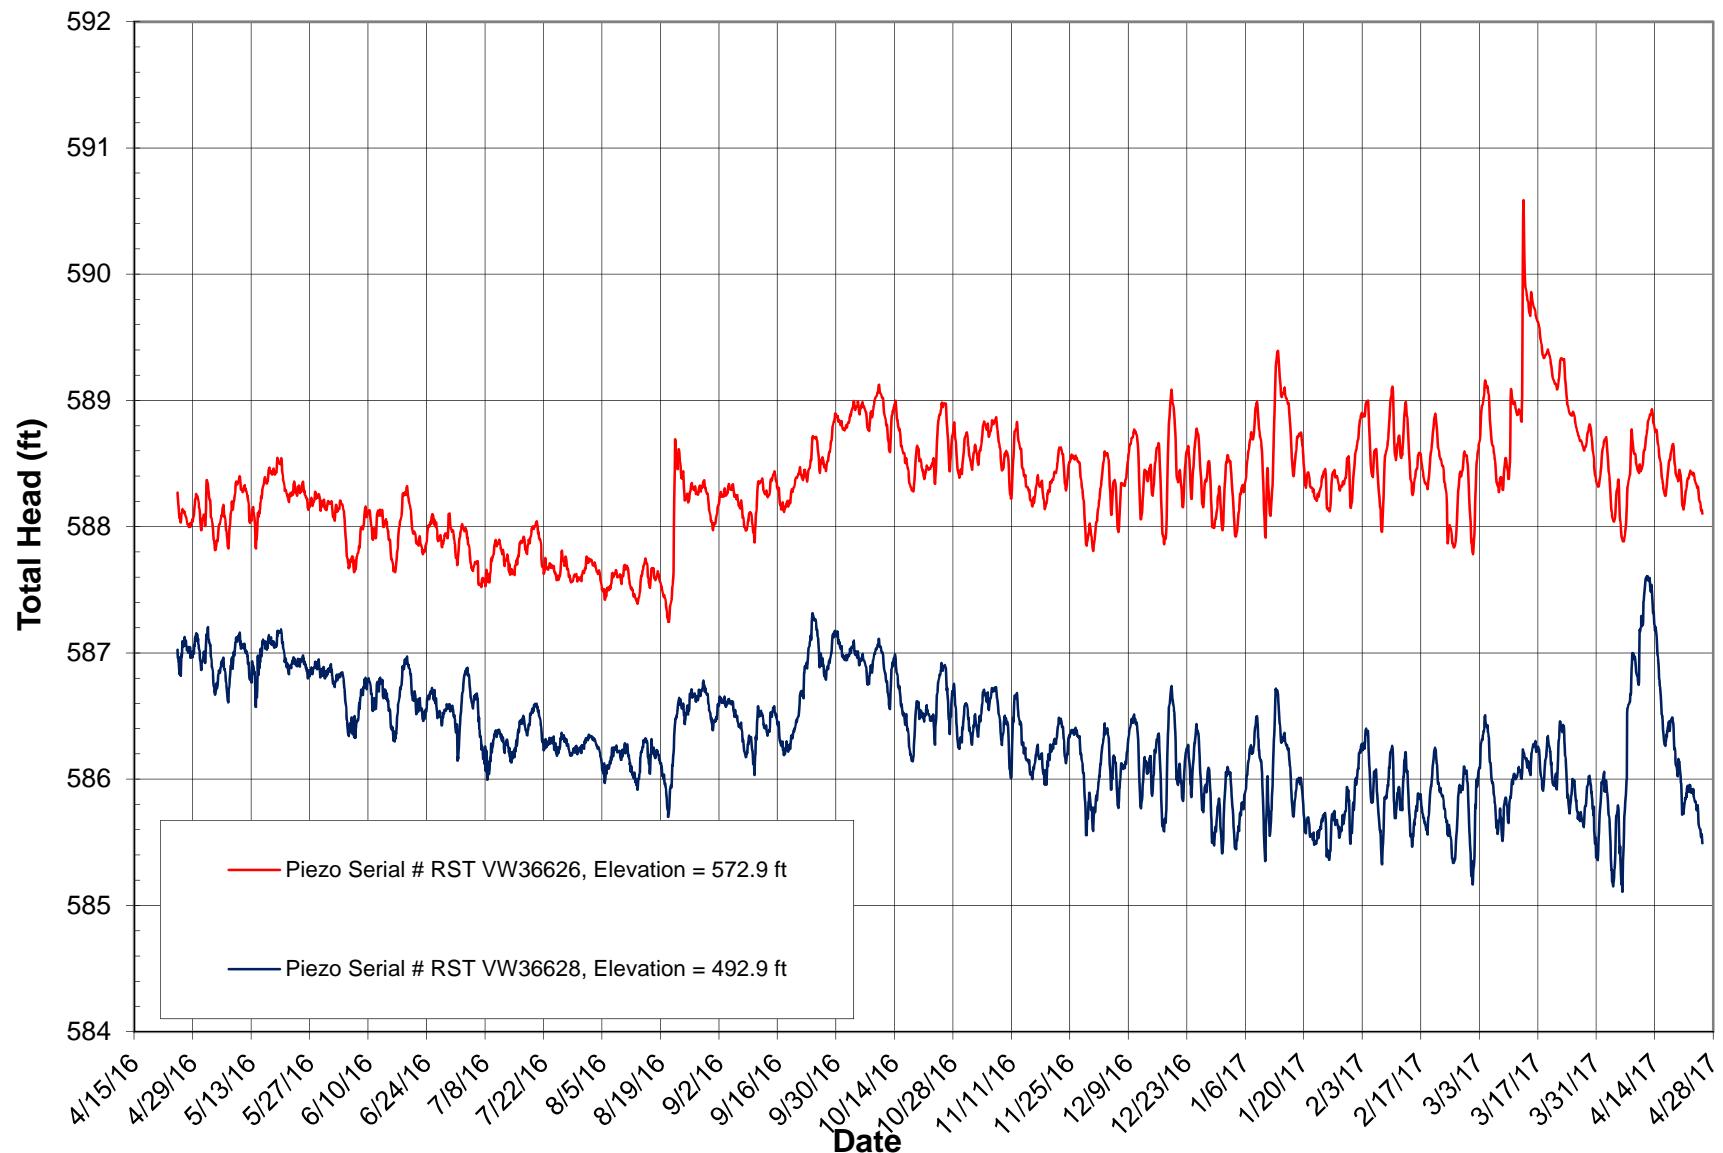
## B-05-A-03 VW Piezometer Readings

**B-05-A-03** – Pore pressures in the shallow piezometer at this location decreased by 2.4 feet from March 13 to April 6, 2017, followed by fluctuations of about 1 foot throughout the remainder of this period. Pore pressures in the deep piezometer increased by 2.5 feet from April 6 to April 11, followed by a decrease of 2.1 feet through the end of this period. These changes are due to the final grading operations in this area.

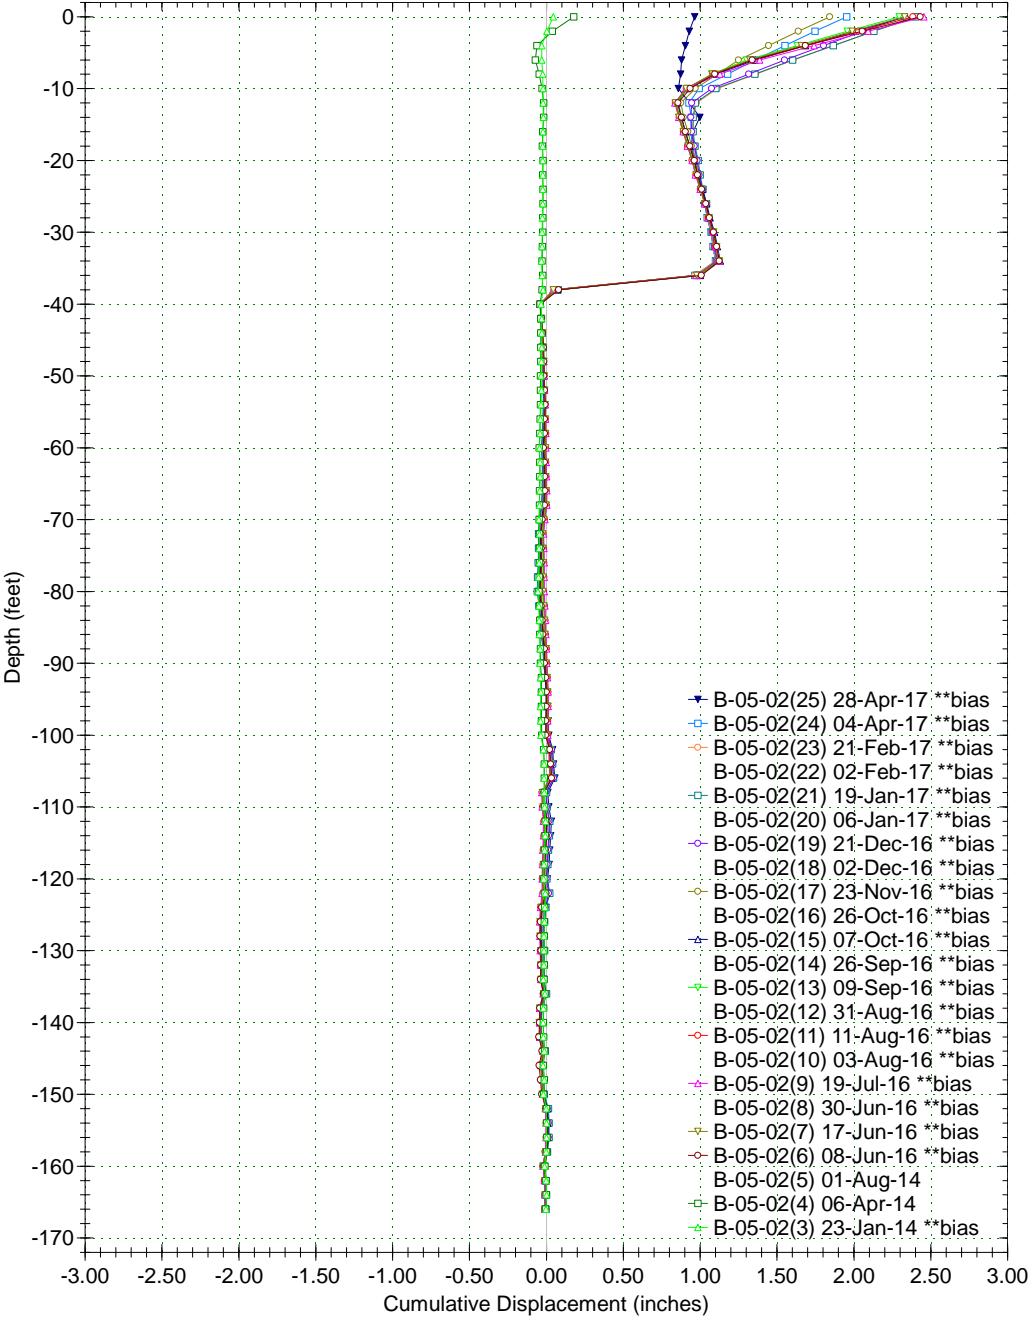
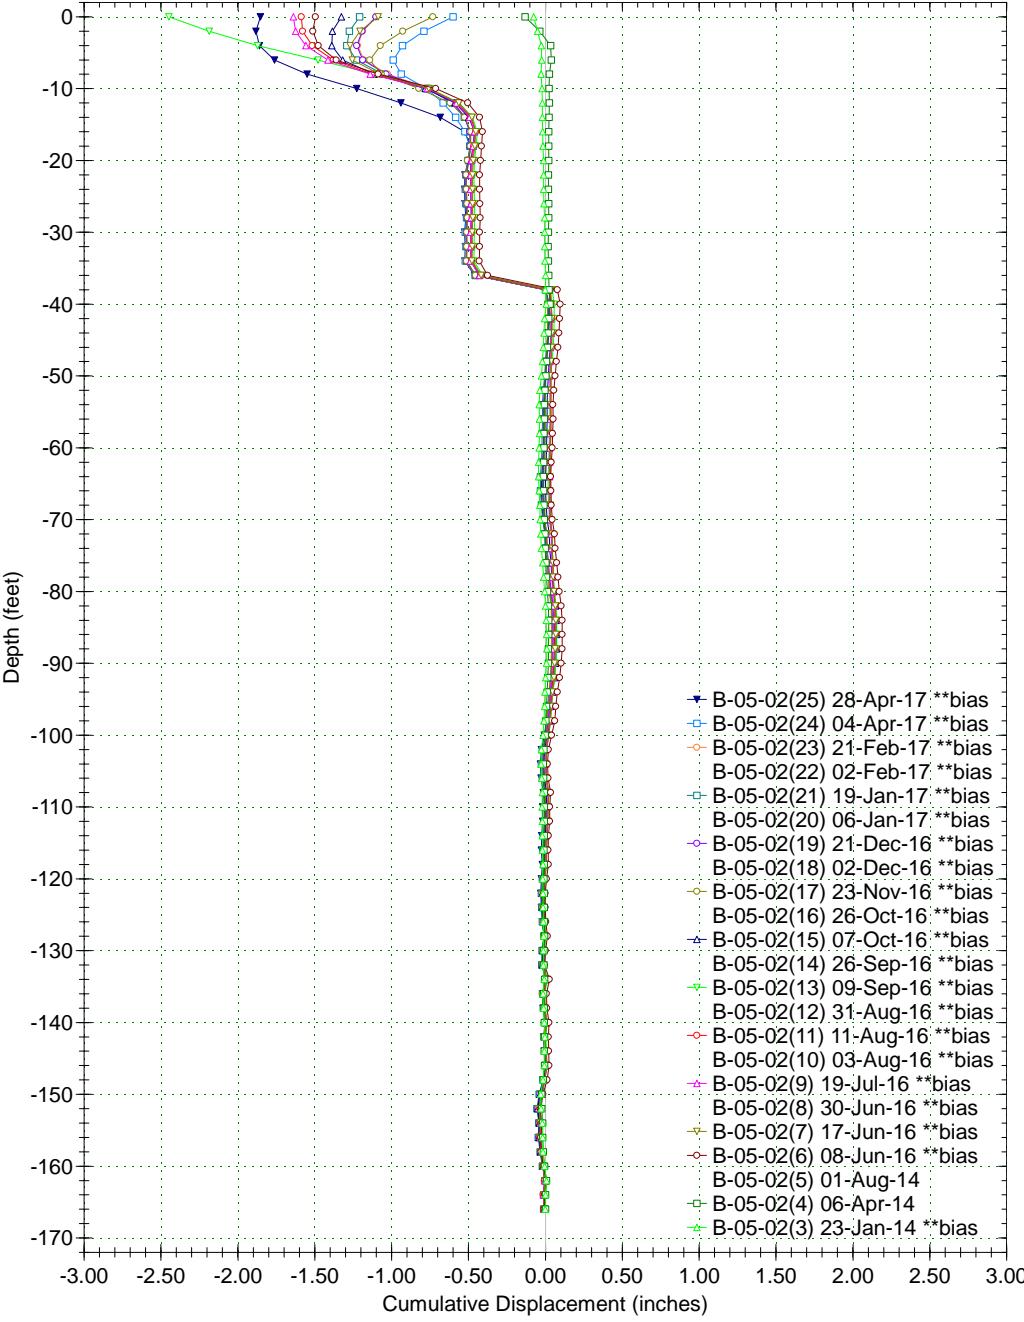
Borehole : B-05-02  
 Project : CUY-90-15-24  
 Location : Cleveland, Ohio  
 Northing : 663737.939  
 Easting : 2190289.081  
 Collar :

**B-05-02** – The top four readings at this location are fictitious. This is being done to preserve the ability to track current movement with the historic data. The ground surface at this location is actually at -8 feet relative to the top of casing in the plots. The current plot indicates movement of the top 8 feet of casing below the ground surface (16 feet below the 0 point in the plots). Rip rap was placed around this instrument which may be the cause of this movement.
