Re: April 25, 26, 27, and 28, 2017 Monthly Readings  
CUY-90-15.24 Slope Monitoring  
PID 96504  
SME Project No. 069032.00

Monthly instrument readings at the I-90 west slope taken on April 25, 26, 27, and 28, 2017 are presented in this report. Monthly readings currently include instruments at I/P-001-13, I/P-002-13, I/P-003-10, P-003-13, I/P-004-13, I-008-10, I/P-009-13, B-101, B-102, B-105A, B-05-02, B-05-04, B-05-A-11, P-1, P-9N. Changes reported for the individual instruments are for the previous four-week period unless noted otherwise.

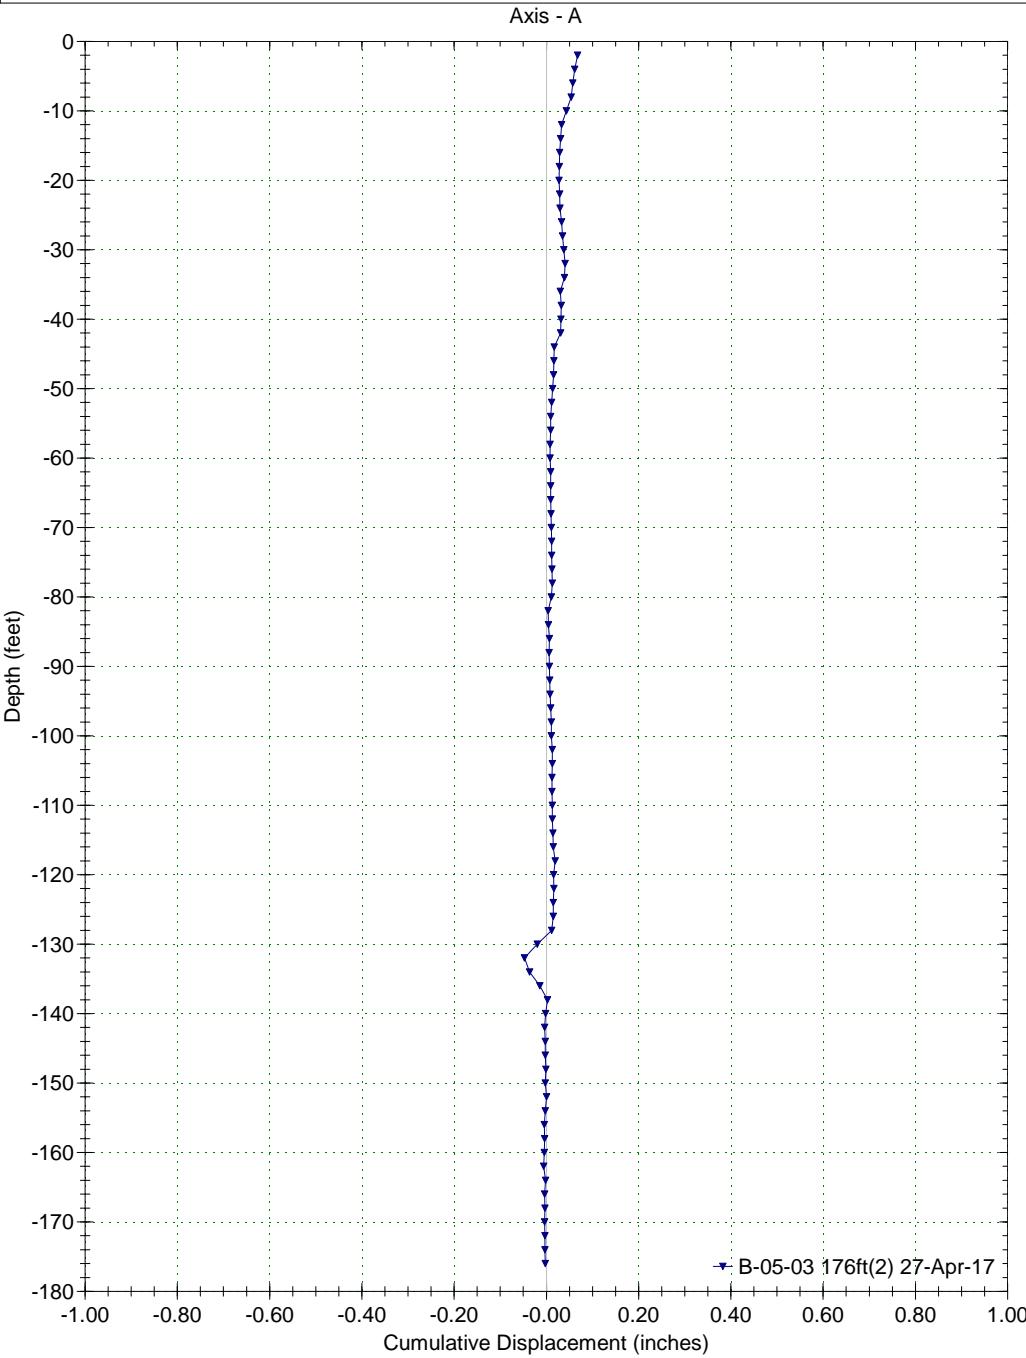
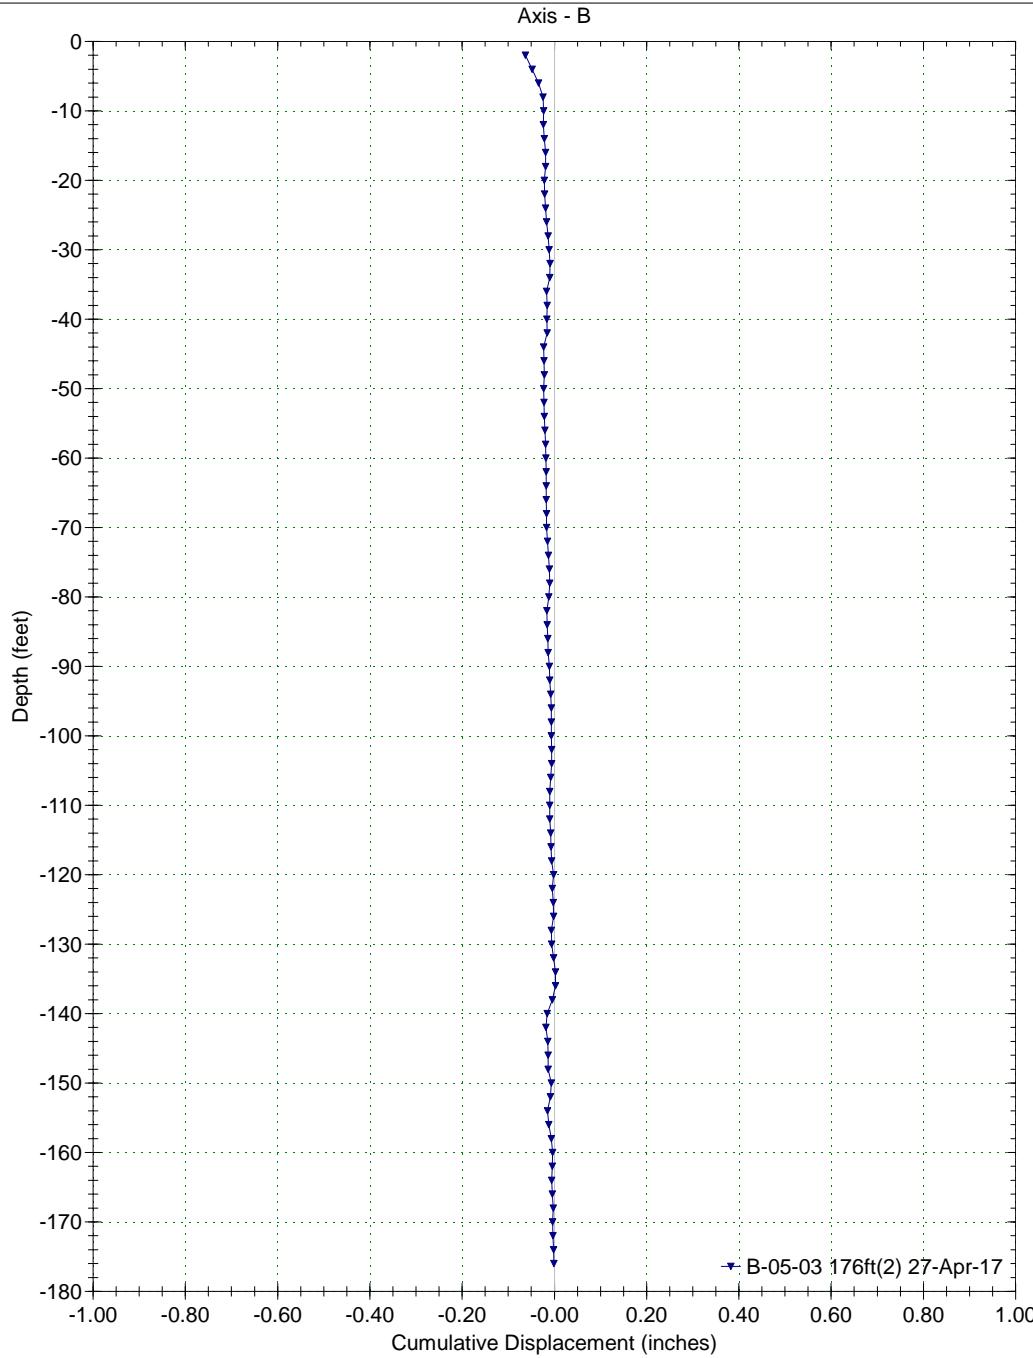
Borehole : B-05-03  
Project : CUY-90-15-24  
Location : Cleveland, Ohio  
Northing :  
Easting :  
Collar :

**B-05-A-03** – We have added 8 feet to the inclinometer casing at this location to account for the grade being raised in this area. The attached plot shows the first reading since the new baseline was taken. Small negative A-axis displacement is shown from 128 to 138 feet. This is likely an erroneous data point. Slight displacement is also shown in the positive A and B-axis directions at 42 to 44 feet.
