Ohio Department of Transportation 2016 Physical Condition Report

Detroit-Superior Bridge over Cuyahoga River
Bridge No. CUY-6-1456

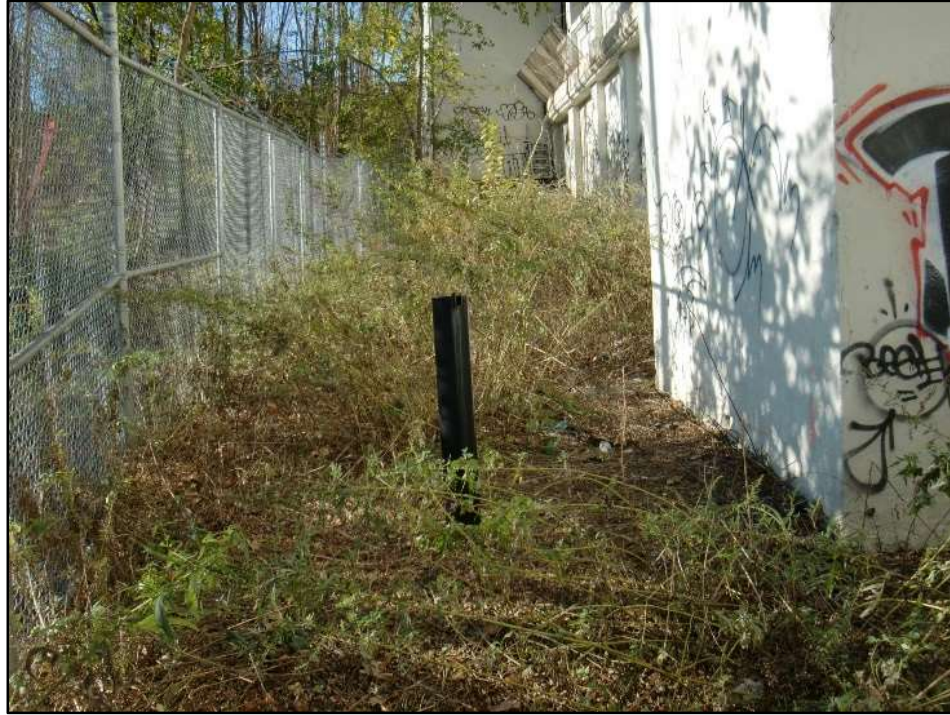
Photo 3– Slope Inclinometer, Tower B South.

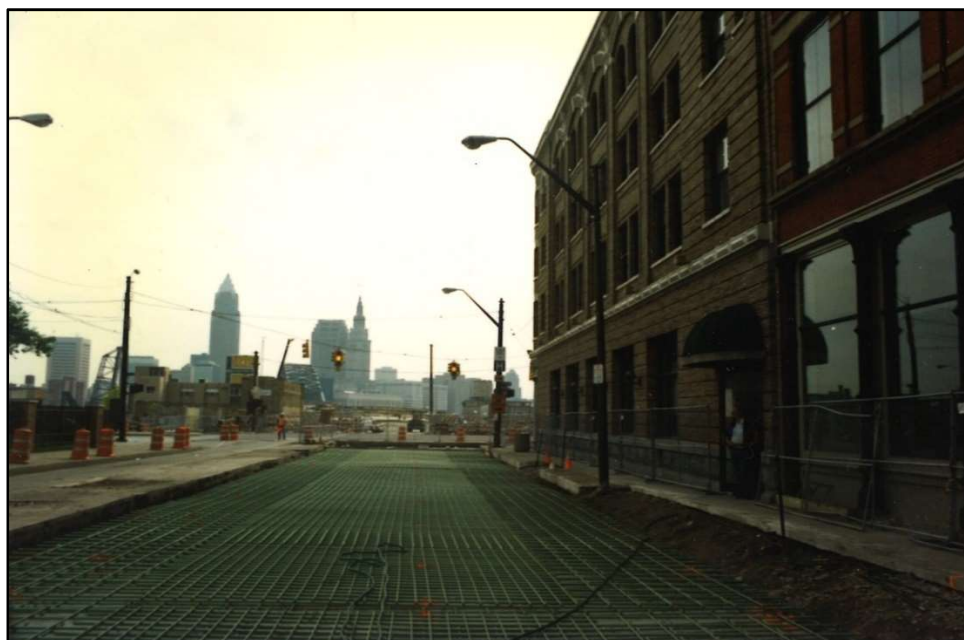
Photo 4 - Construction of Detroit Avenue Tunnel Supplemental Roof Slab, Looking East, 1996.

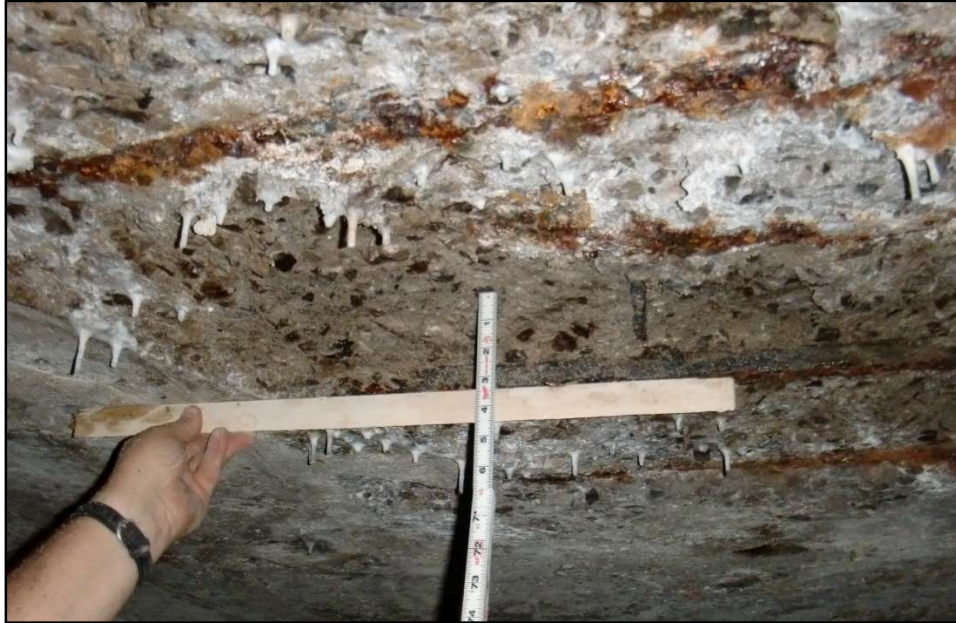
Photo 5 – Floor Spall with Infiltration, Bay C25, West Station.

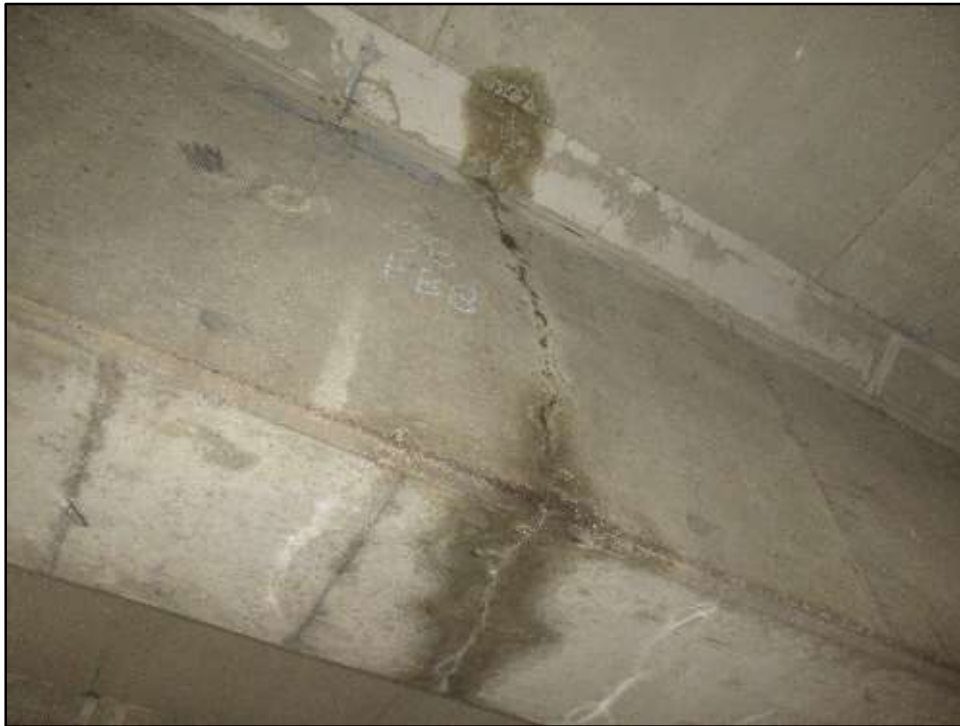
Photo 6 – Active Infiltration Through Upper Deck Floor, Floor Beam 8, Center Bay, Span 8.

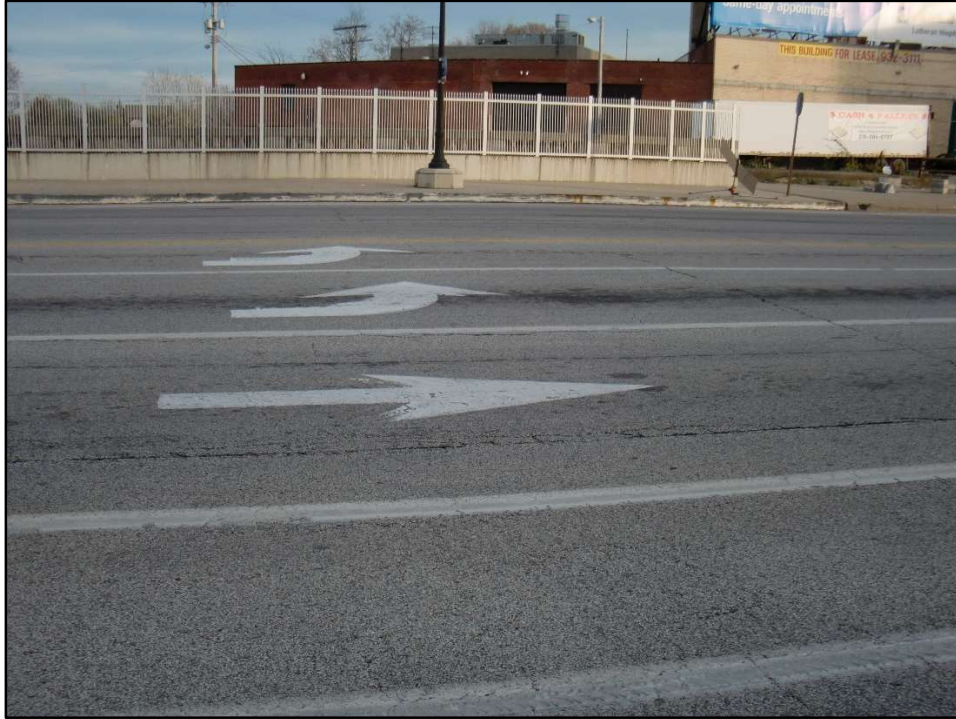
Photo 7 - Cracked Asphalt Wearing Surface, West Station.

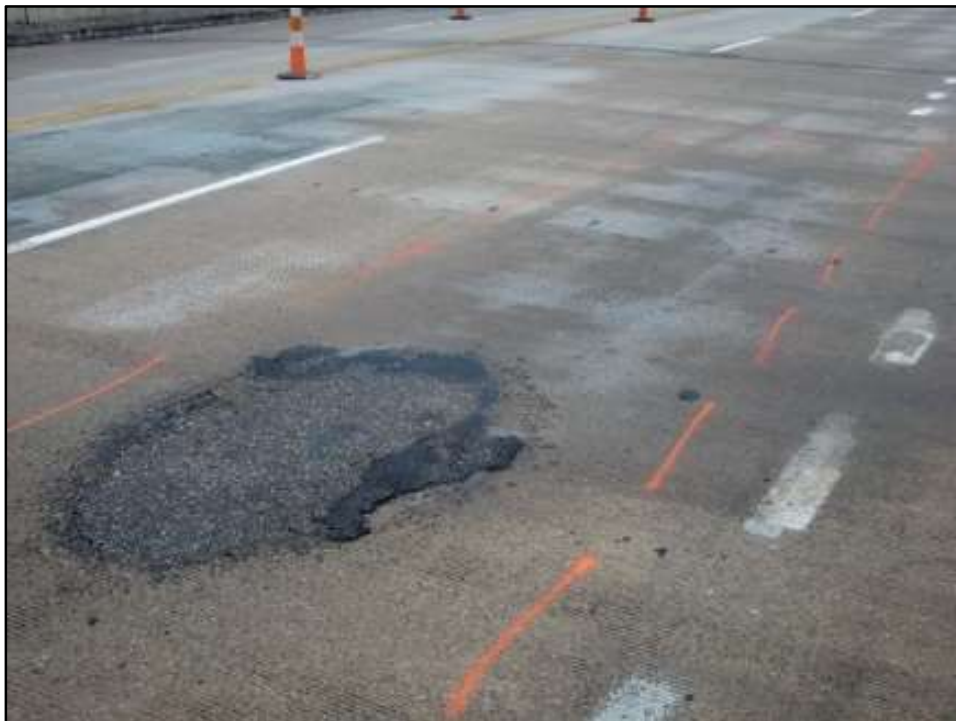
Photo 8 – Recent Wearing Surface Patching, Span 9.

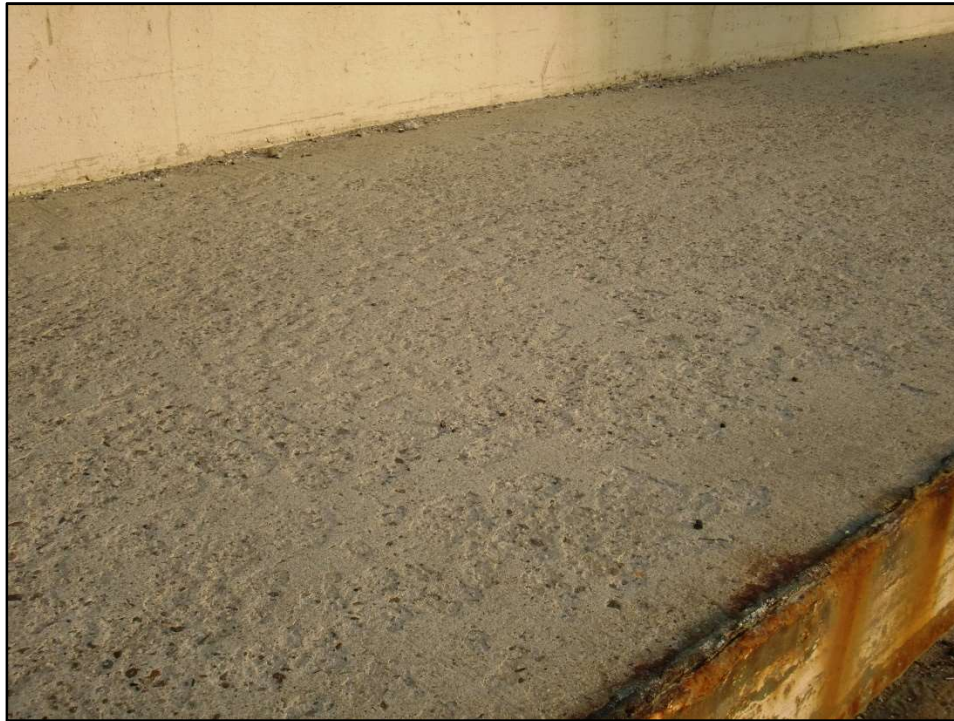
Photo 9 – Scaling of Lightweight Sidewalk Concrete, Span 4 South Sidewalk.

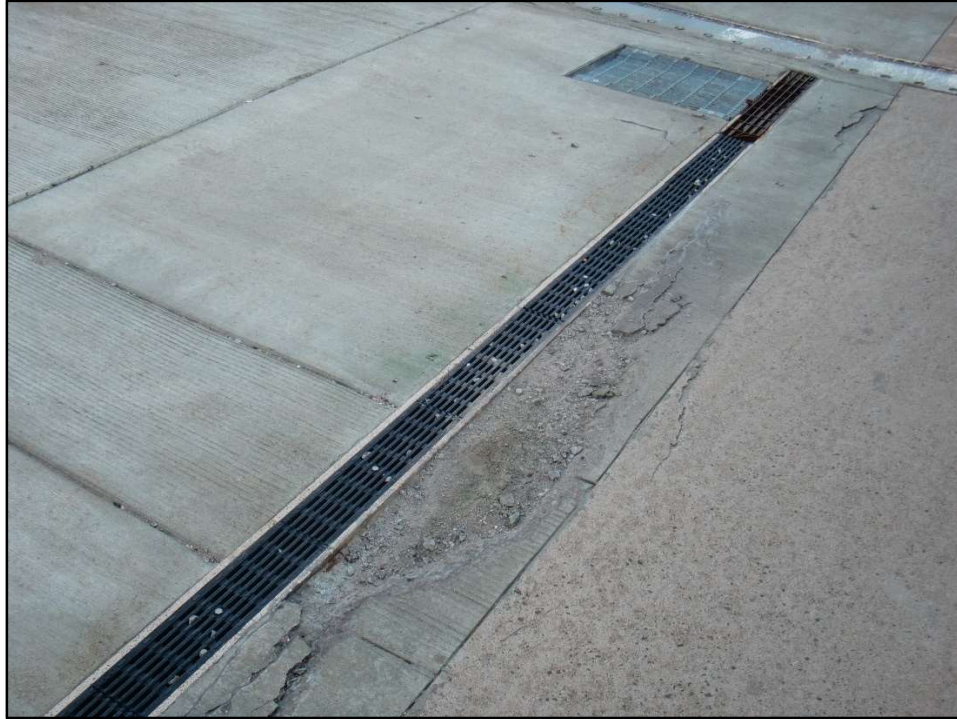
Photo 10 – Spalls Along Longitudinal Drain, 2003 Linear Park Sidewalk, Span 4.

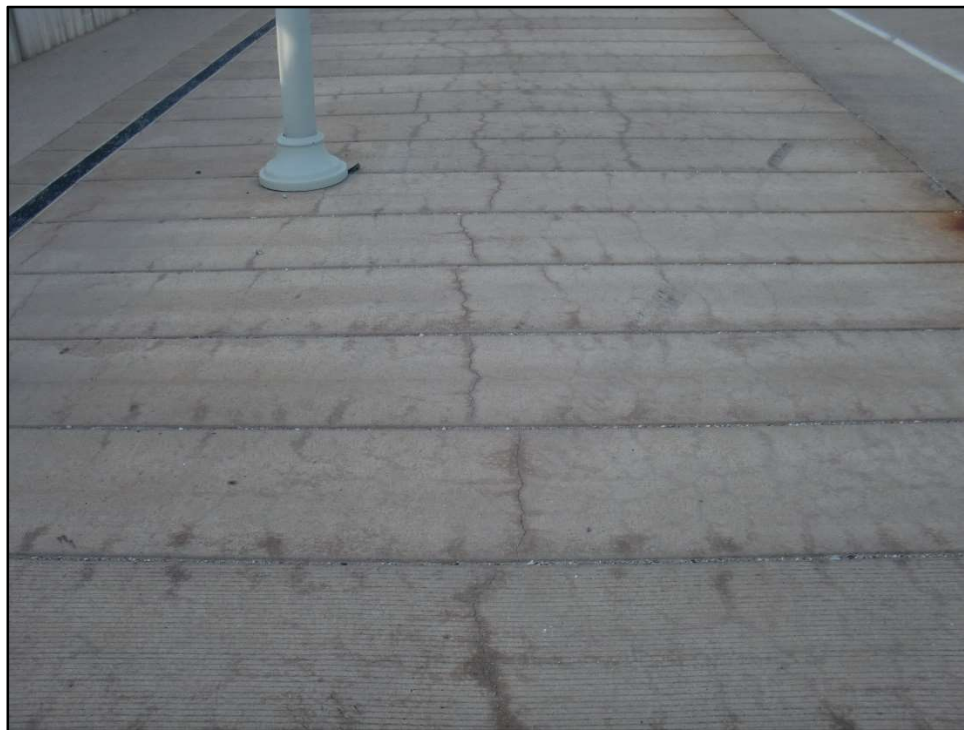
Photo 11 – Typical Longitudinal Cracks, 2003 Linear Park Sidewalk.

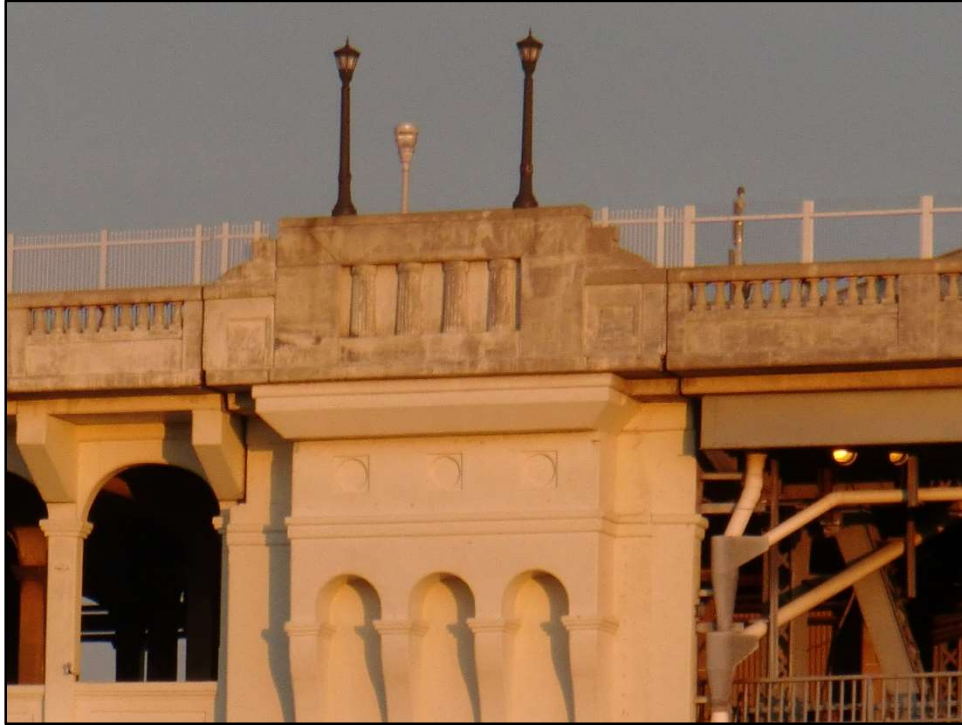
Photo 12 – Worn Non-Epoxy Railing Sealer (Pier 4 North shown).

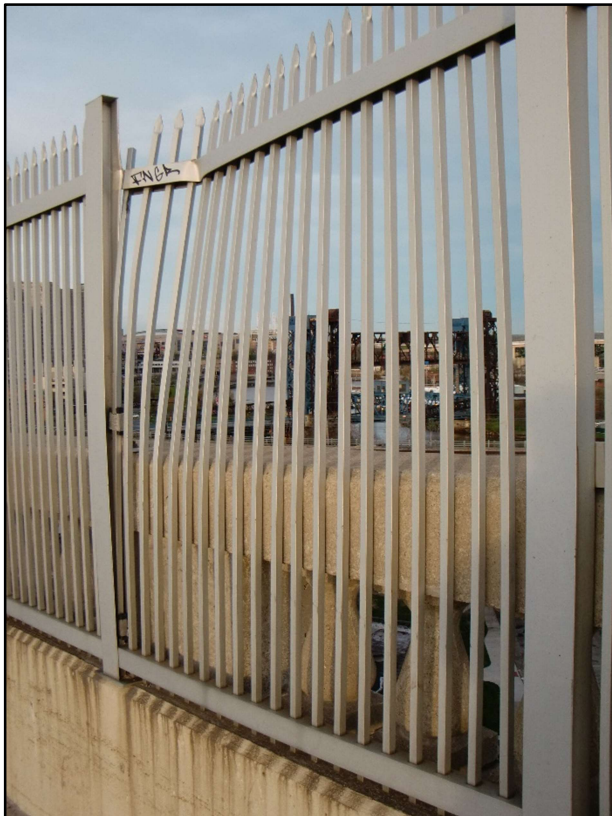
Photo 13 – Repeated Vandalism & Attempted Theft of Aluminum Fence, Span 6 South Rail.

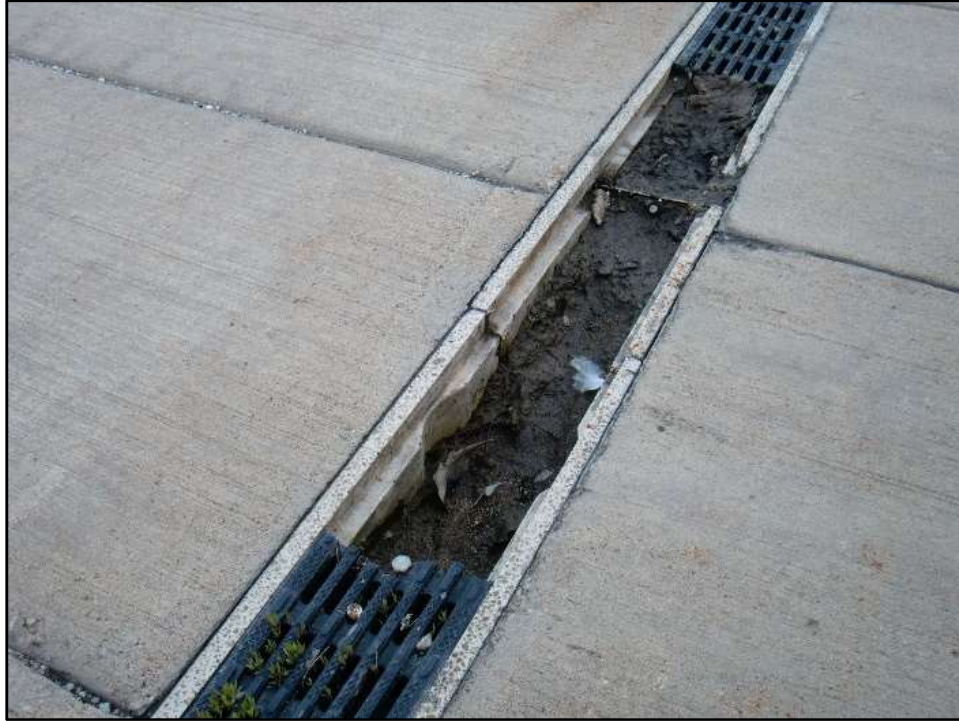
Photo 14 – Missing Sidewalk Drain Trough Cover with Debris Build-Up, North Sidewalk.

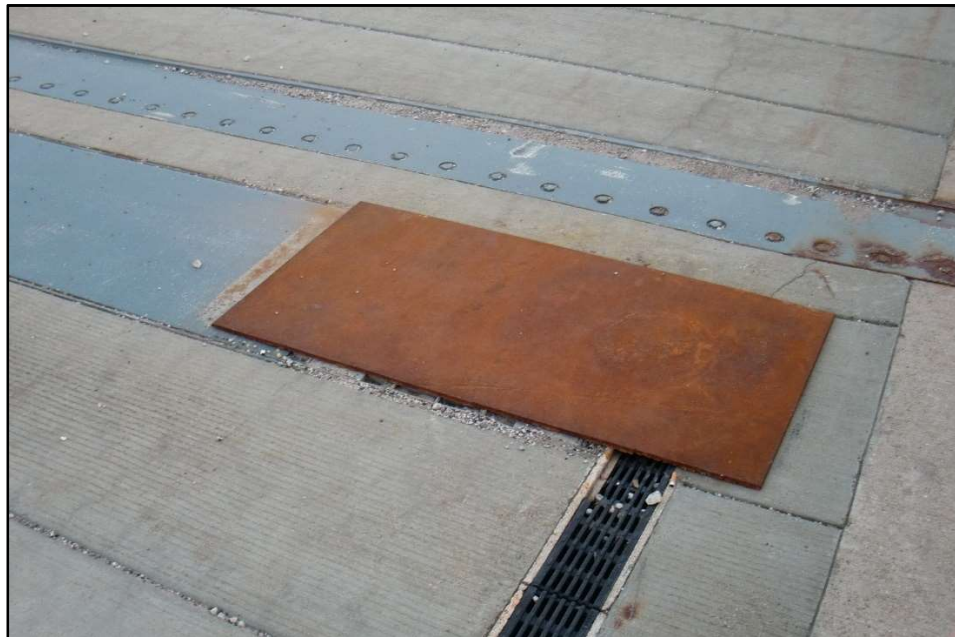
Photo 15 – Steel Cover Plate over Missing Sidewalk Drain Grate, Span 3.

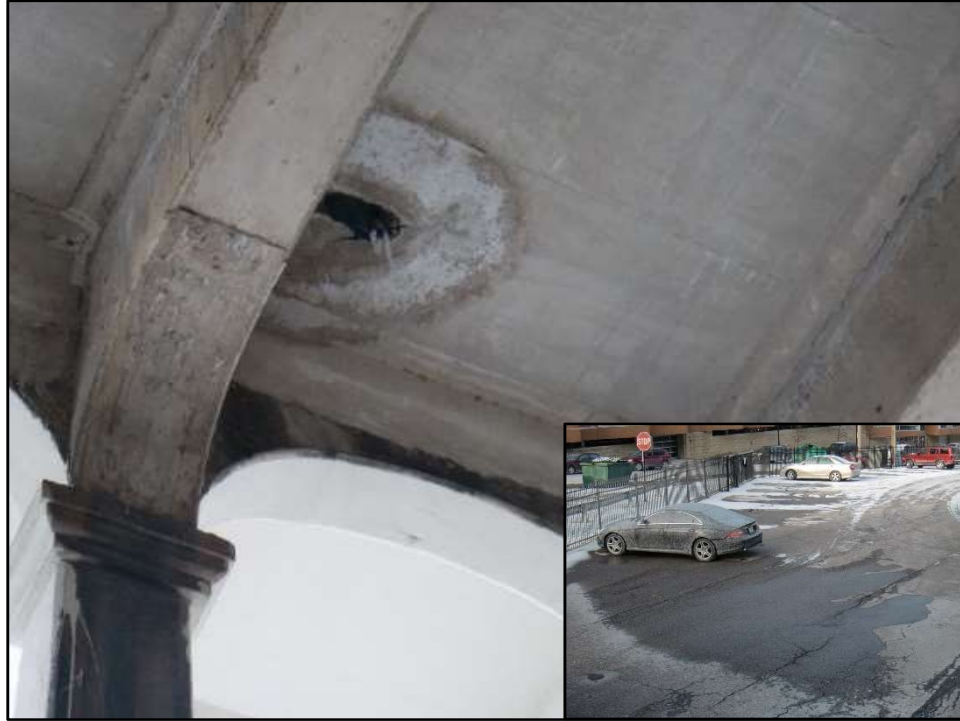
**Photo 16 – Leaking Sidewalk Subdrain, Span 3 North Exterior Column Line.
(Inset: Salt spray on car in private parking lot below.)**

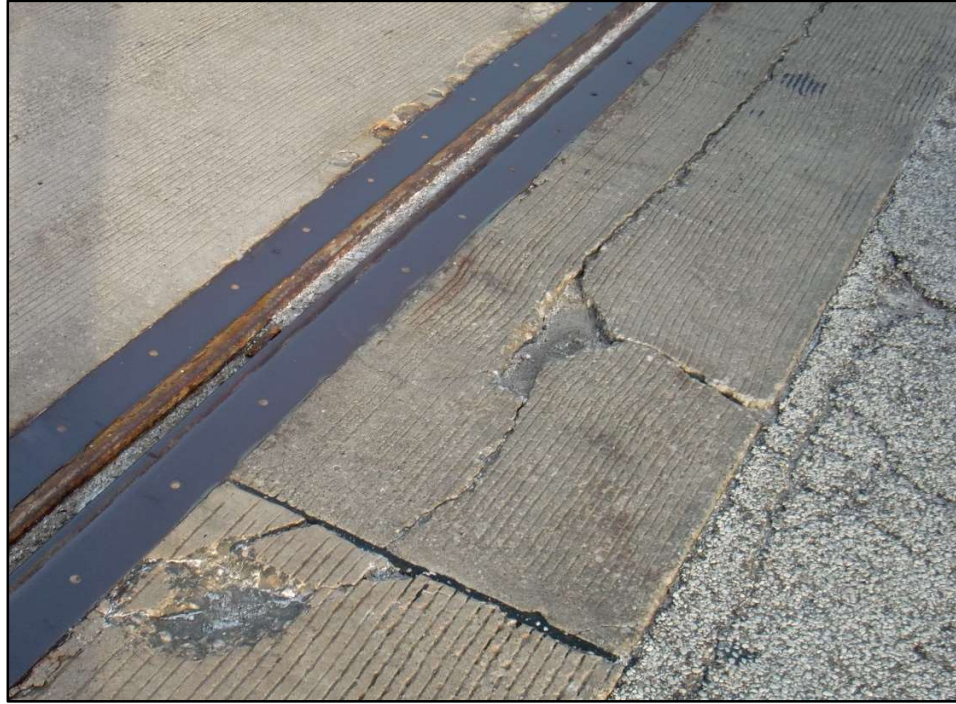
Photo 17 – Cracked Concrete Anchorage, Tower A Expansion Joint.

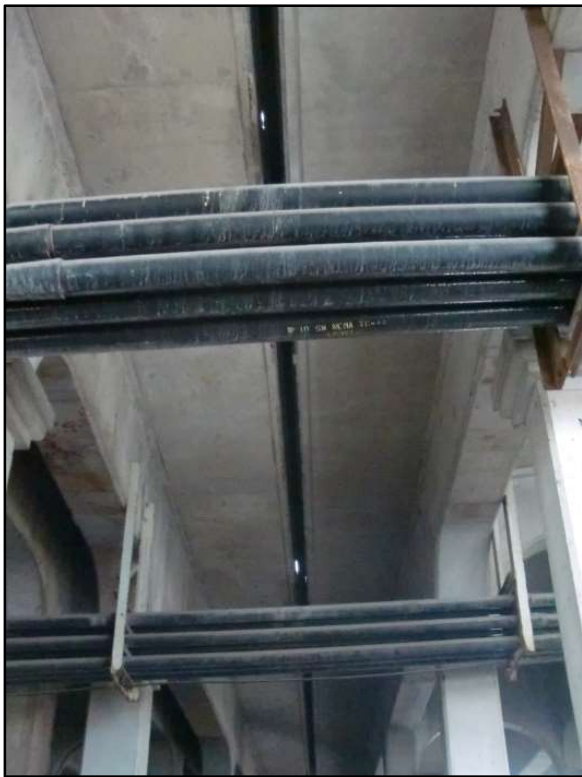
Photo 18 – Daylight Highlighting Two Broken Extrusion Welds, Tower B Expansion Joint.

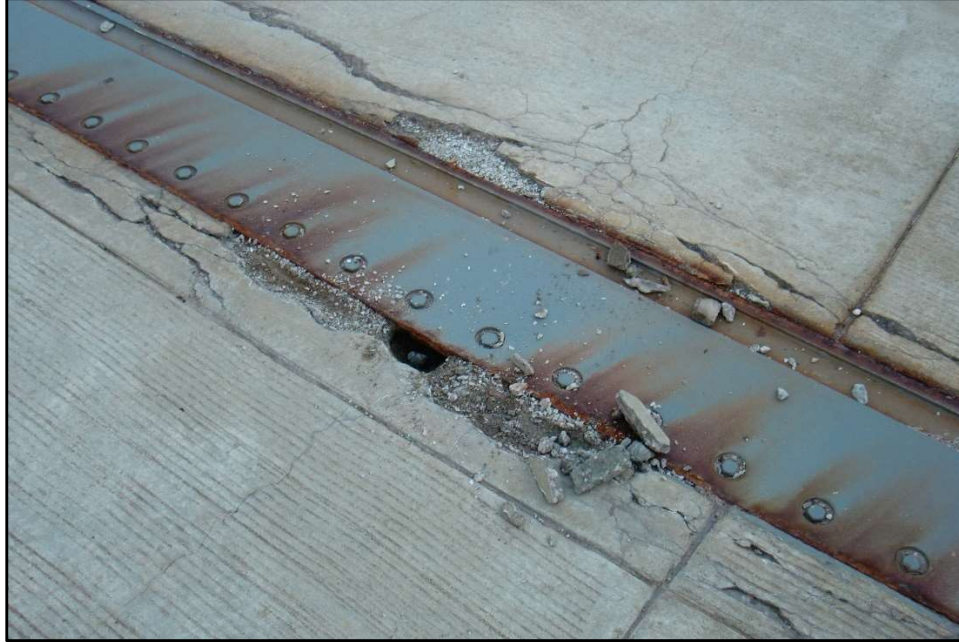
Photo 19 – Spalled Concrete Beneath Joint Armor, Pier 4, North Sidewalk.

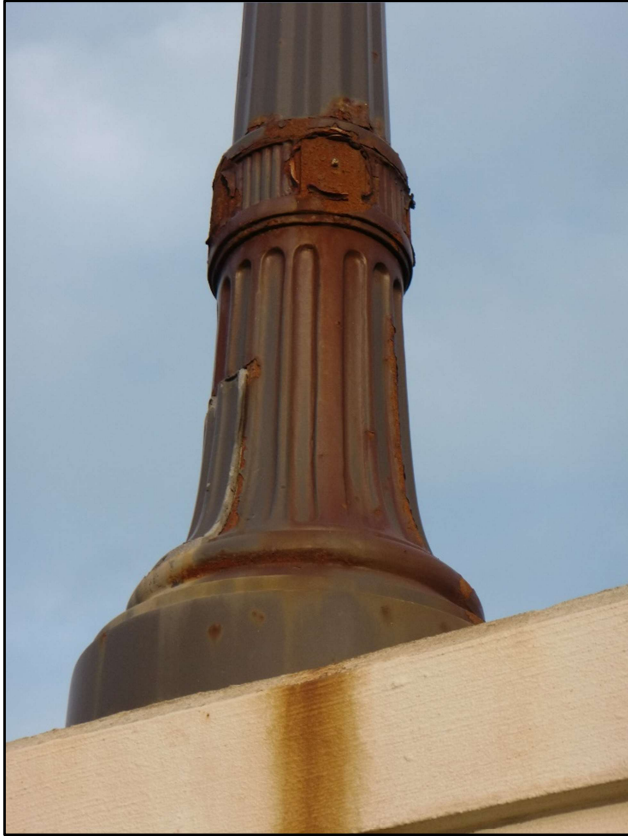
Photo 20 – Typical Failed Protective Coating & Corrosion on Architectural Light Standard (Pier 4 South shown).

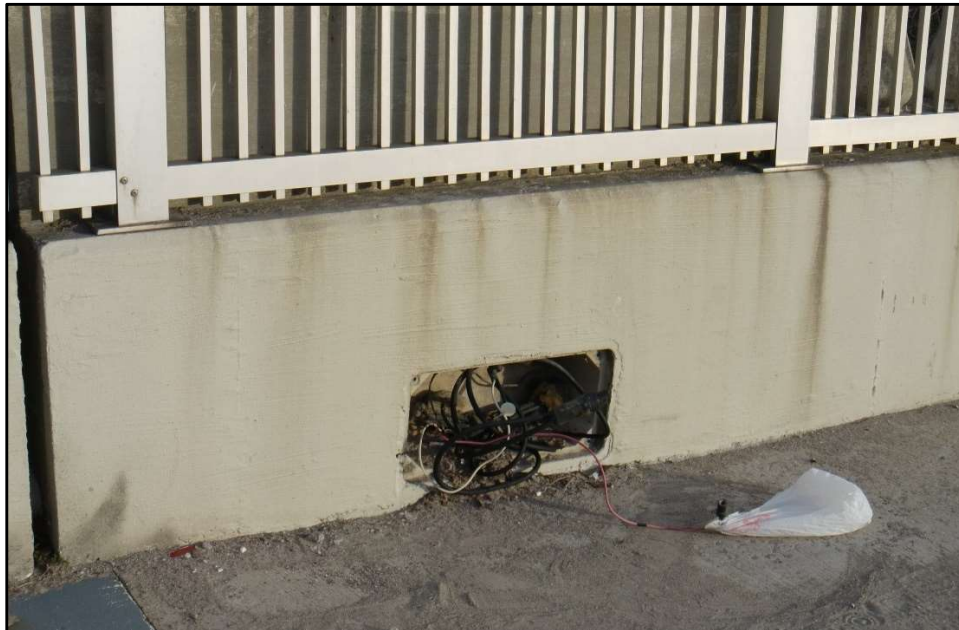
Photo 21 – Missing Junction Box Cover, Span 1 South Rail.

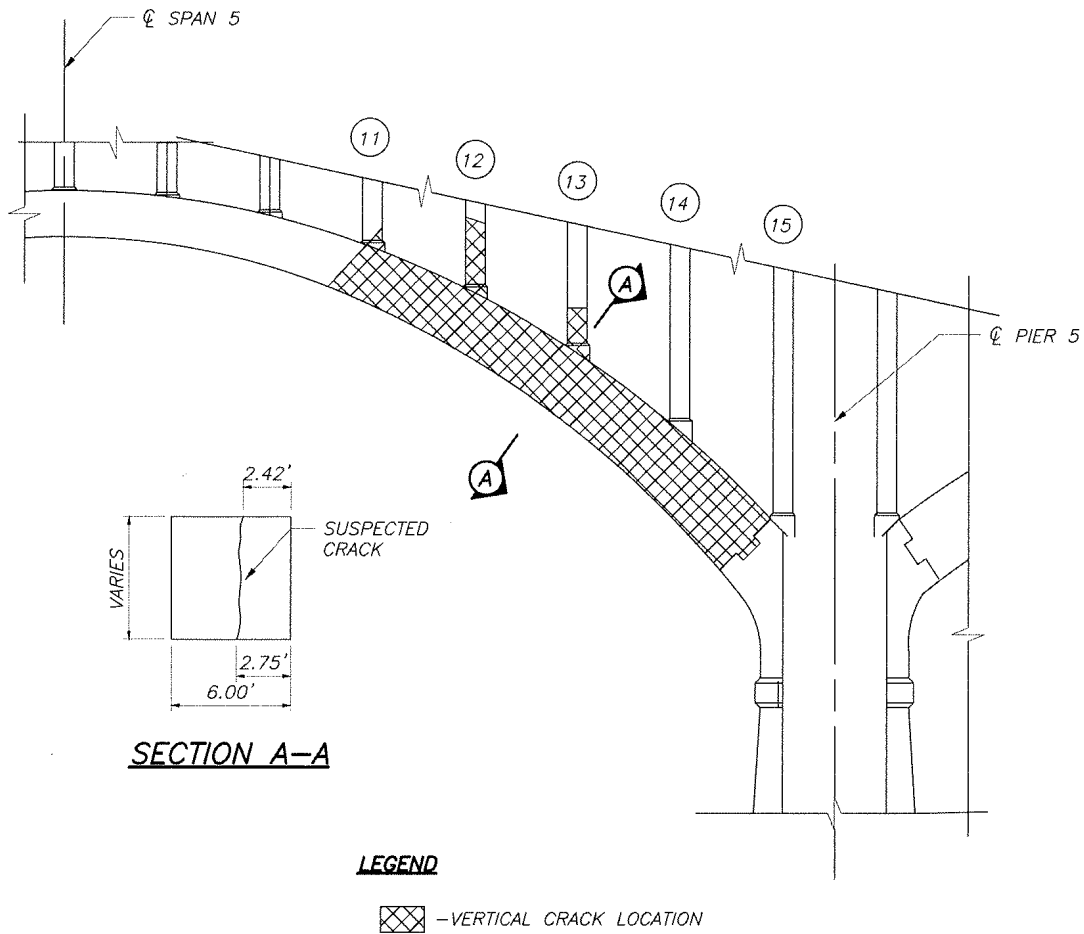
**Figure 5 – Estimated Alignment of Vertical Crack,
 Span 5 NE Arch & Spandrel Columns.**

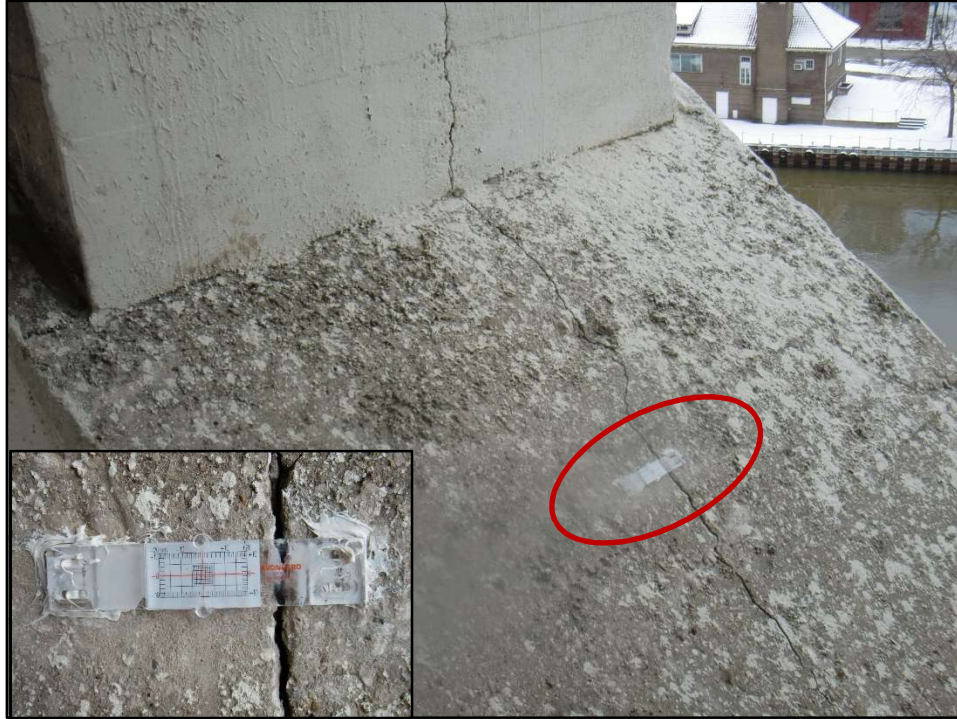
**Photo 22 – Crack Monitor Set Across Vertical Arch Rib Crack, NE Arch, Span 5.
(Inset: Close-up of Crack Monitor installed December 23, 2016.)**

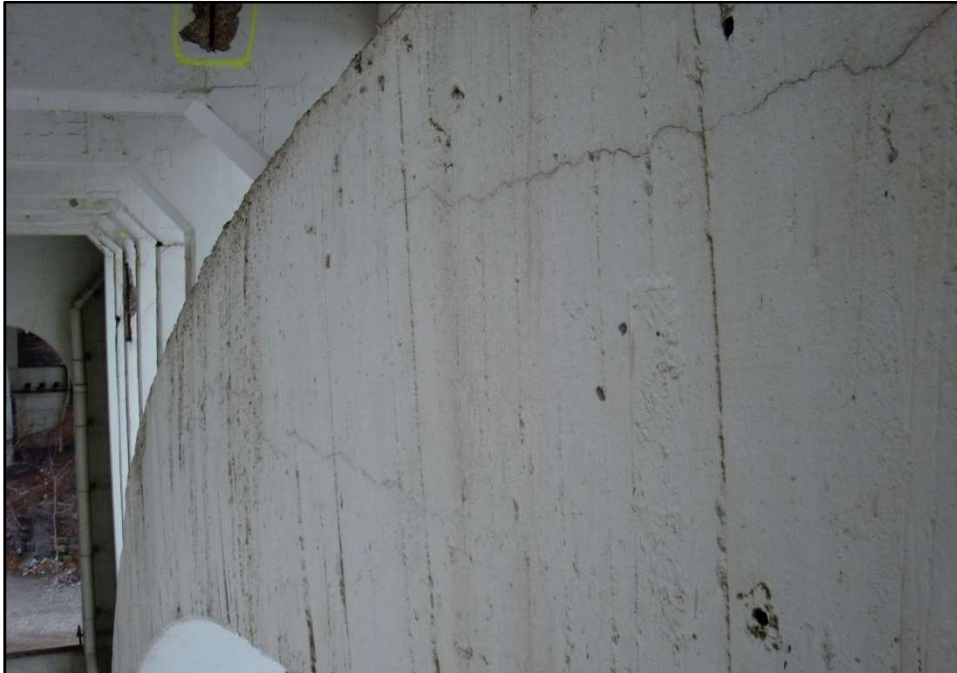
Photo 23 – Typical Horizontal Crack, Span 3 NE Arch Rib Shown.

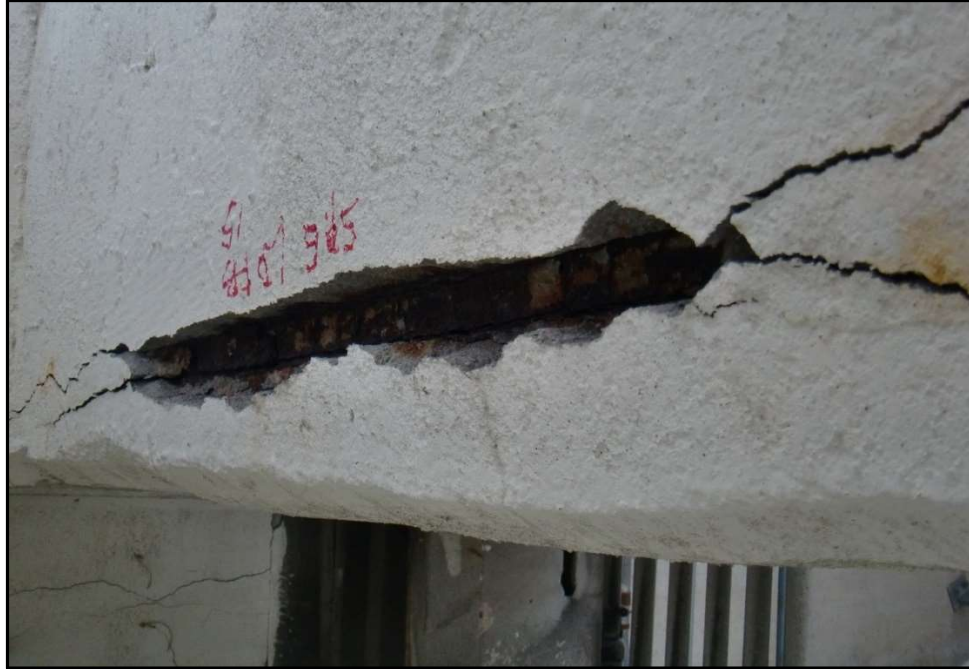
**Photo 24 – Outline of Delaminated Arch Rib Corner, SI Arch Rib, Span 7.
(Inset: Active rebar corrosion present.)**

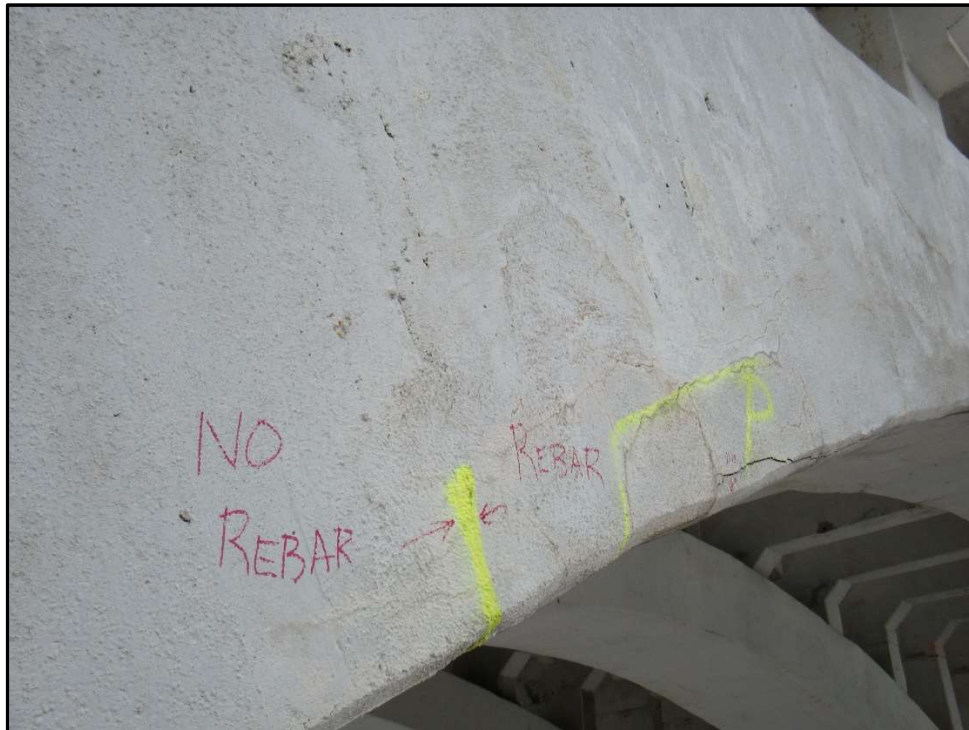
**Photo 25 – Sound 1996 Shotcrete Patch (Left of Paint Line) & Cracked
and Unsound Patch, Span 6 NE Arch Rib.**

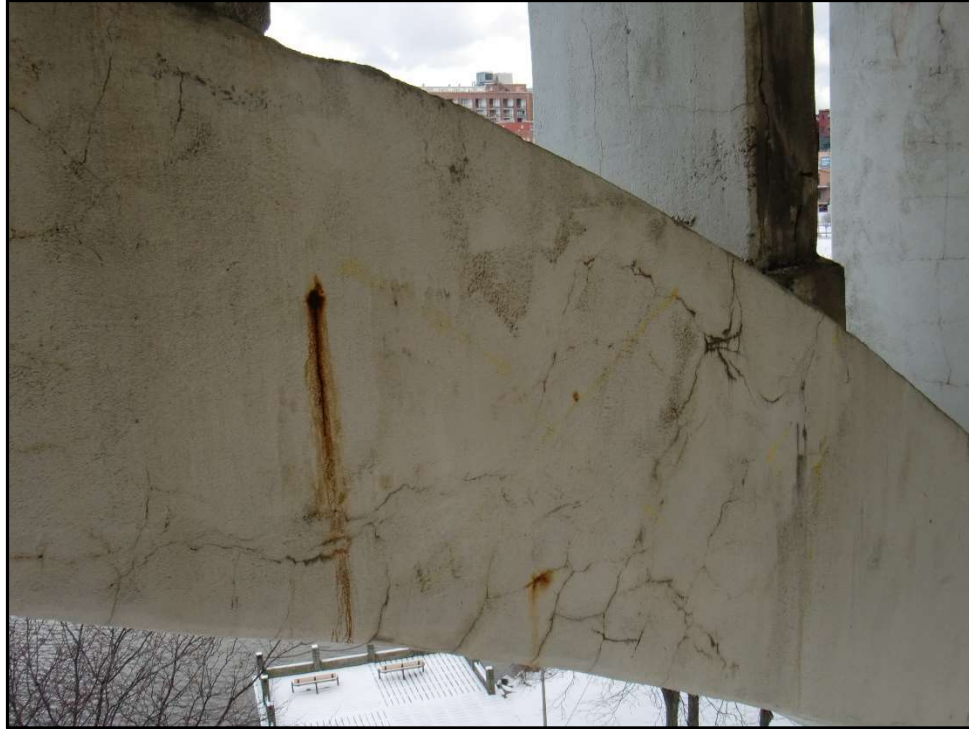
Photo 26 – Cracked Concrete at Location of 1915 Arch Repair, NE Arch Rib, Span 6.
 (Note: Rust staining likely from steel form connectors or discarded nails.)

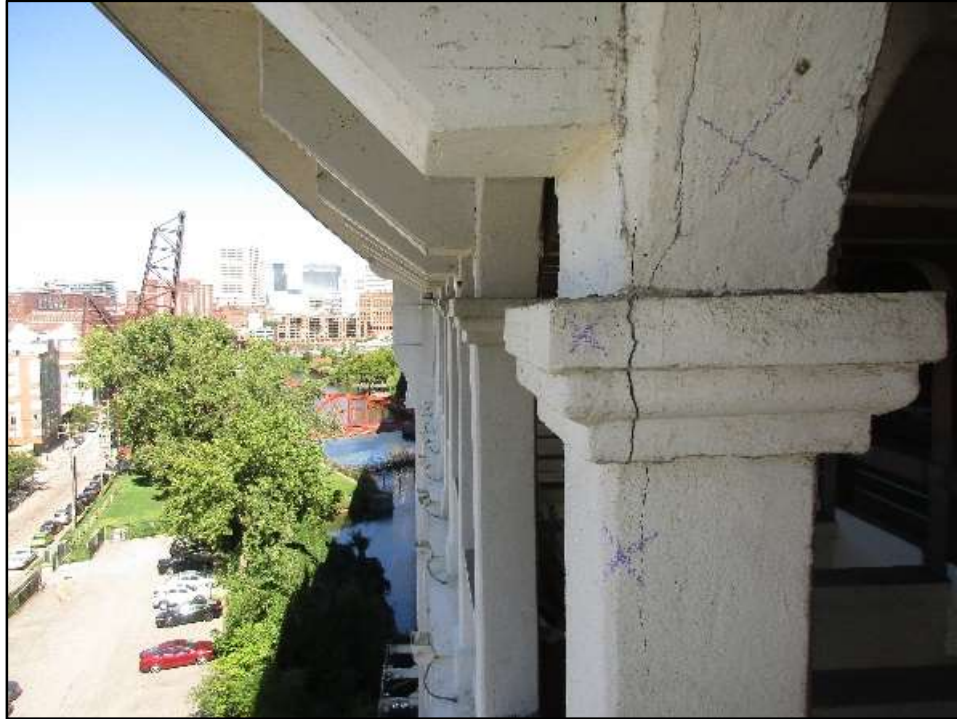
Photo 27 – Cracked Capital & Column Corner, NE Column 10, Span 3.

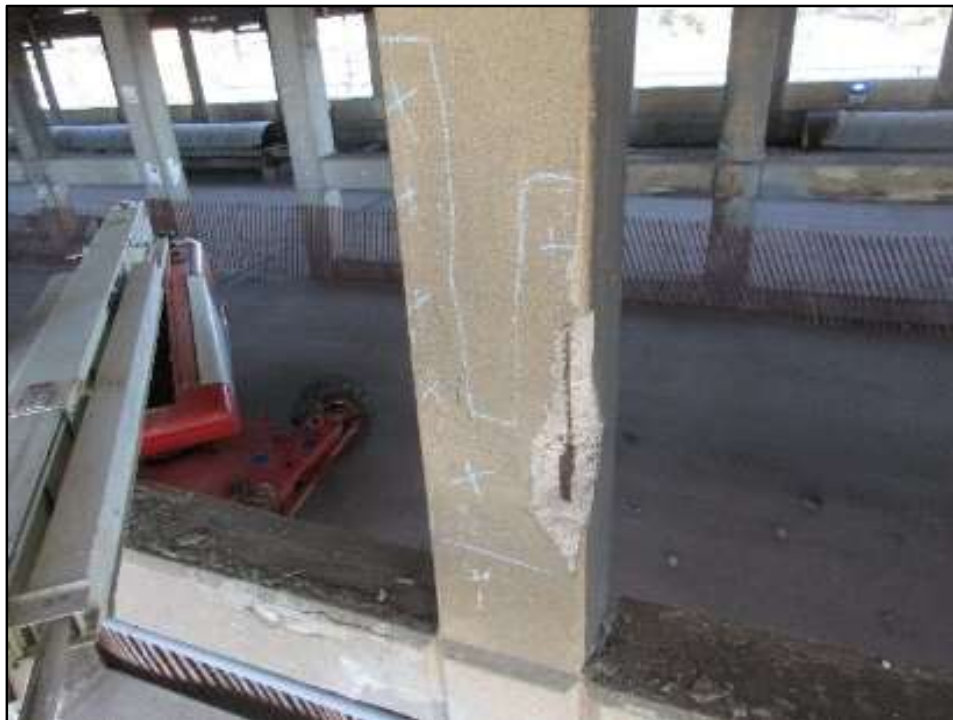
Photo 28 – Occasional Delamination & Spall of Original Upper Deck Columns.

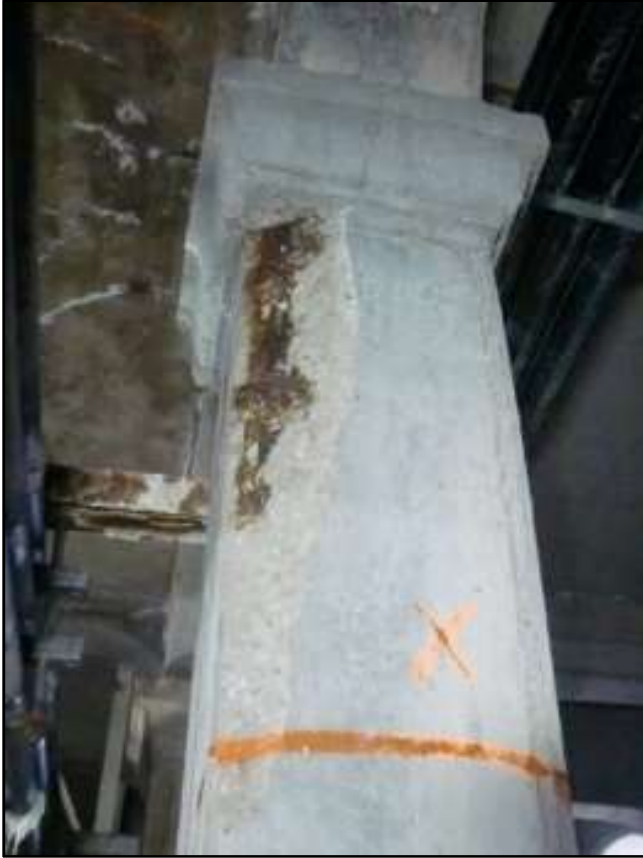
Photo 29 – Corner Spall with Corrosion to Epoxy Coated Reinforcement, Column D3, West Station.

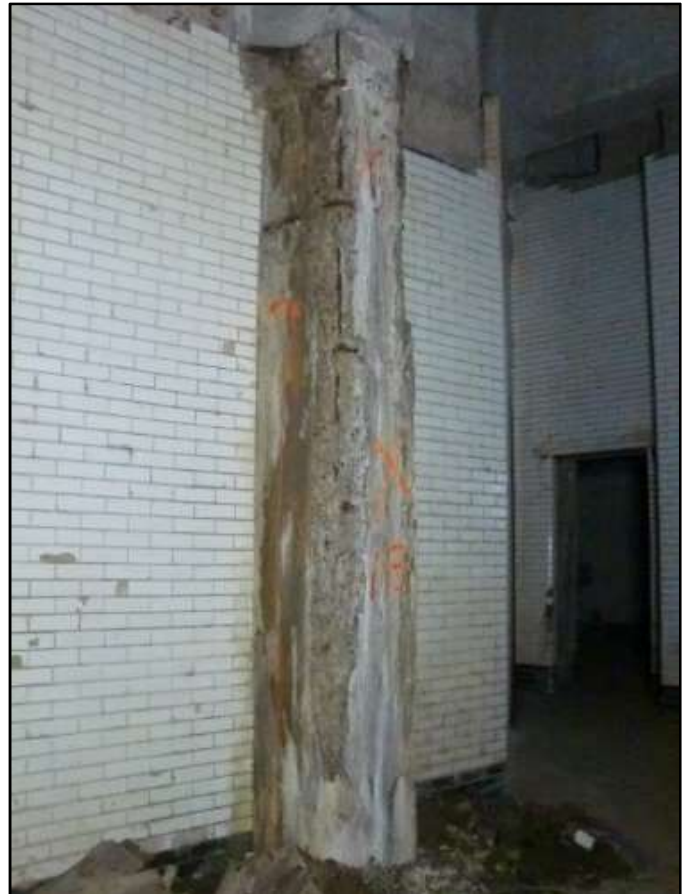
Photo 30 – Advanced Deterioration to Column G18, East Station.

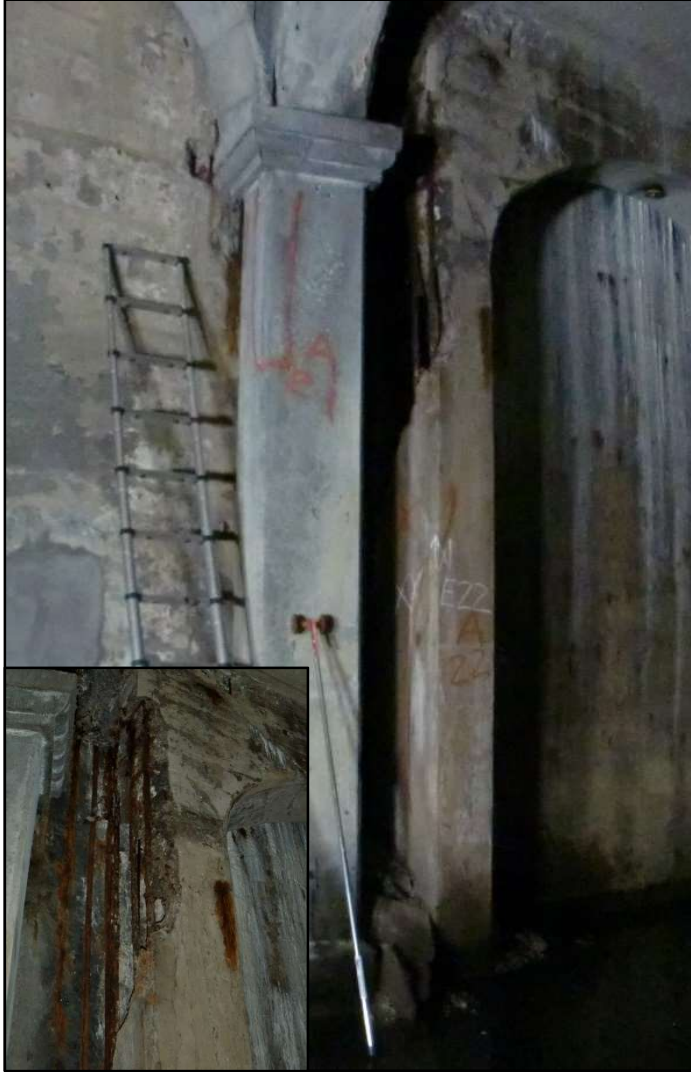
Photo 31 – Advanced Deterioration of Column M22, East Subway. (Inset: Exposed Reinforcement at top of column with 60% section loss.)

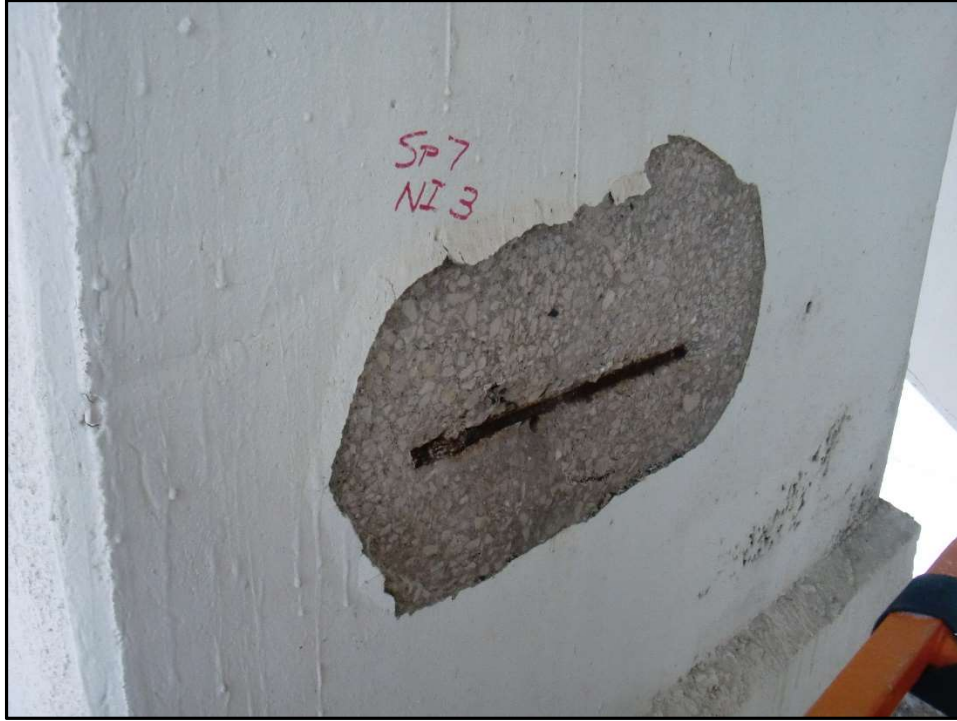
Photo 32 – Common Lower Deck Column Spall at Stirrup Reinforcement.

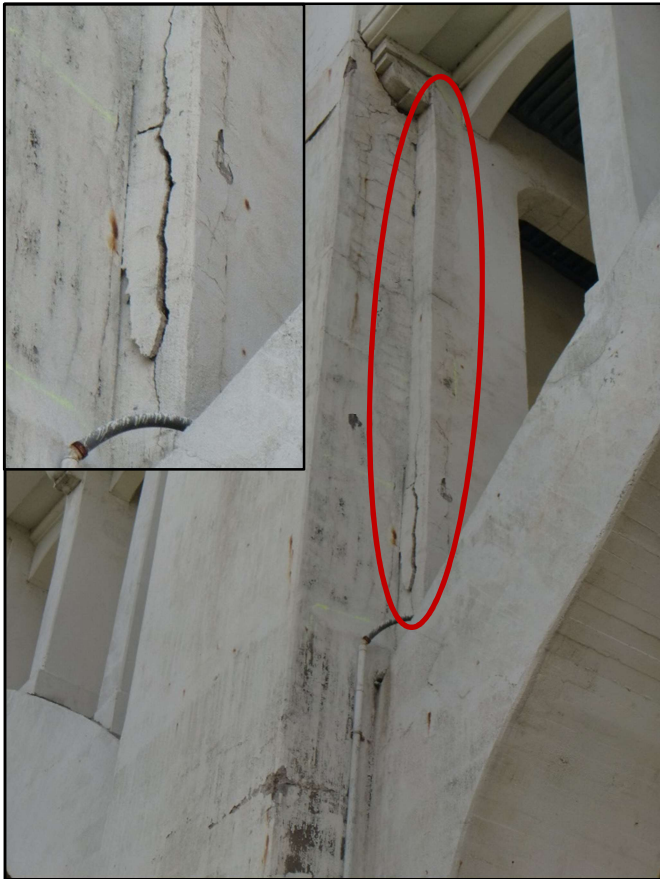
Photo 33 – Cracked & Spalled Surfaces (Circled) on Lower Deck Column SE 1, Span 9. (Inset: Loose concrete near column base, south face.)

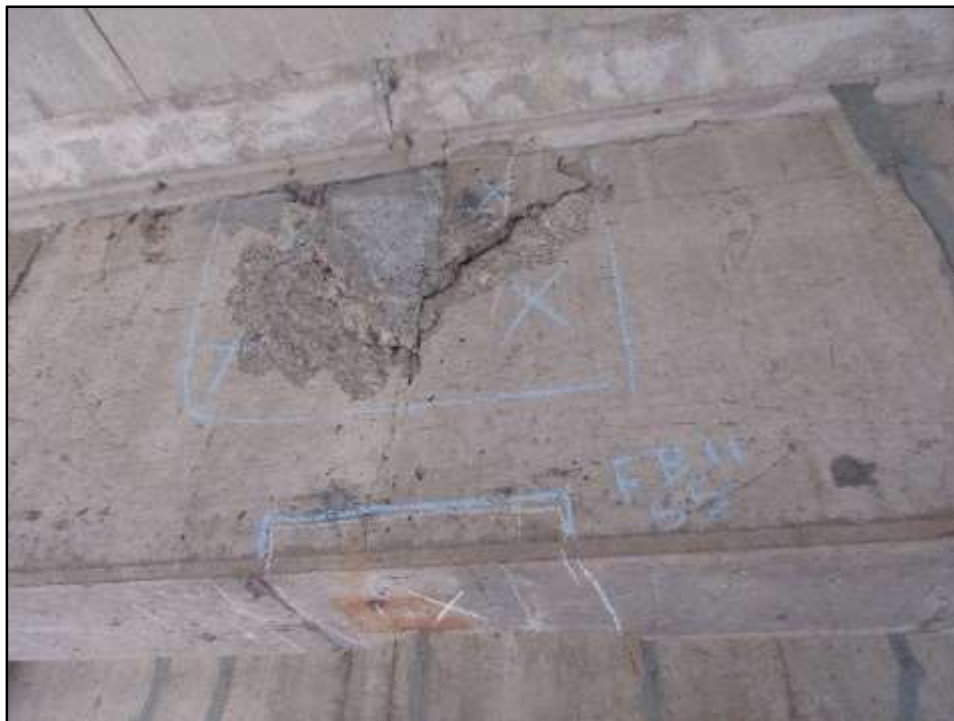
Photo 34 – Deterioration of Newer Upper Deck Floorbeam 11, Span 5.

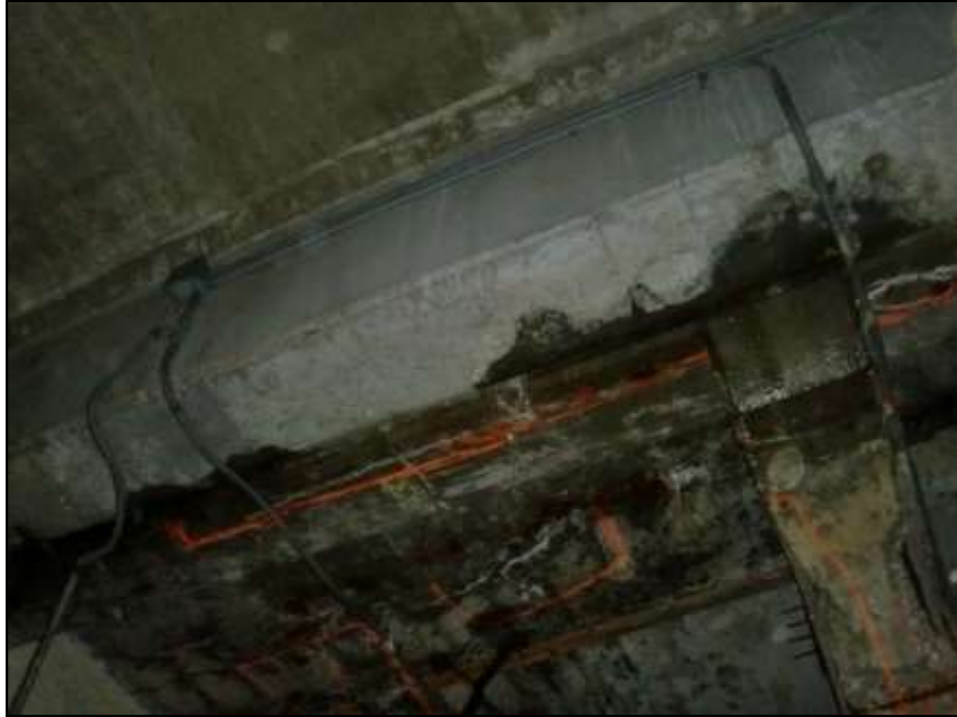
Photo 35 – Delaminated & Spalled Surfaces of Upper Deck Floorbeam 31, between Lines B & C and below Tower A Expansion Joint. (Note: This floor beam was cast during the 1995 rehabilitation.)
