Ohio Department of Transportation 2016 Physical Condition Report

Detroit-Superior Bridge over Cuyahoga River
Bridge No. CUY-6-1456

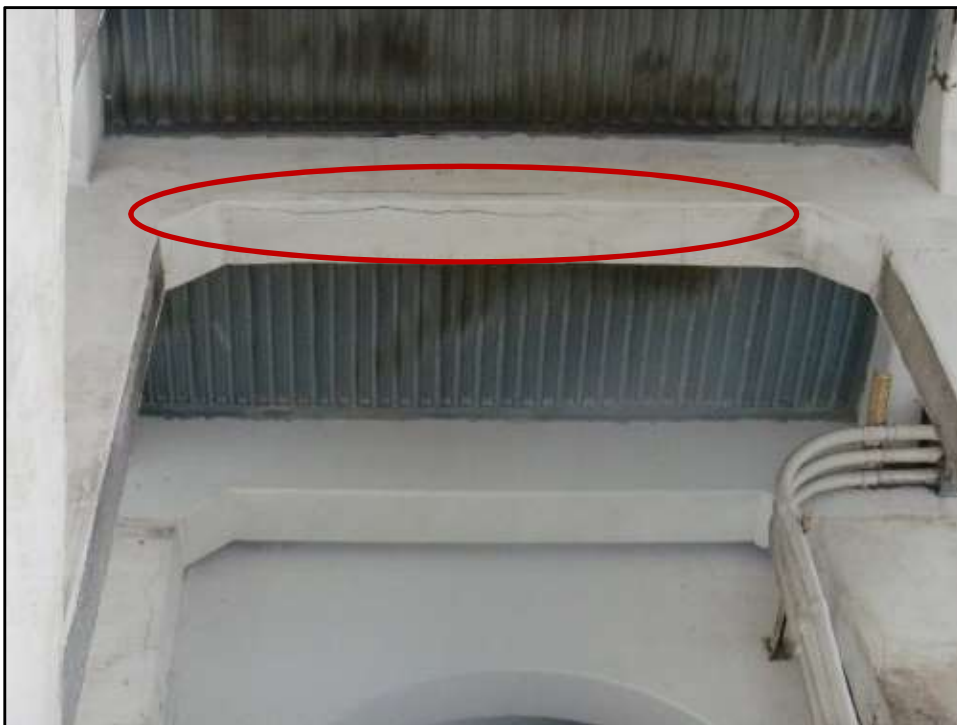
Photo 36 – Common Cracked & Delaminated Lower Deck Floorbeam Surface (Circled).

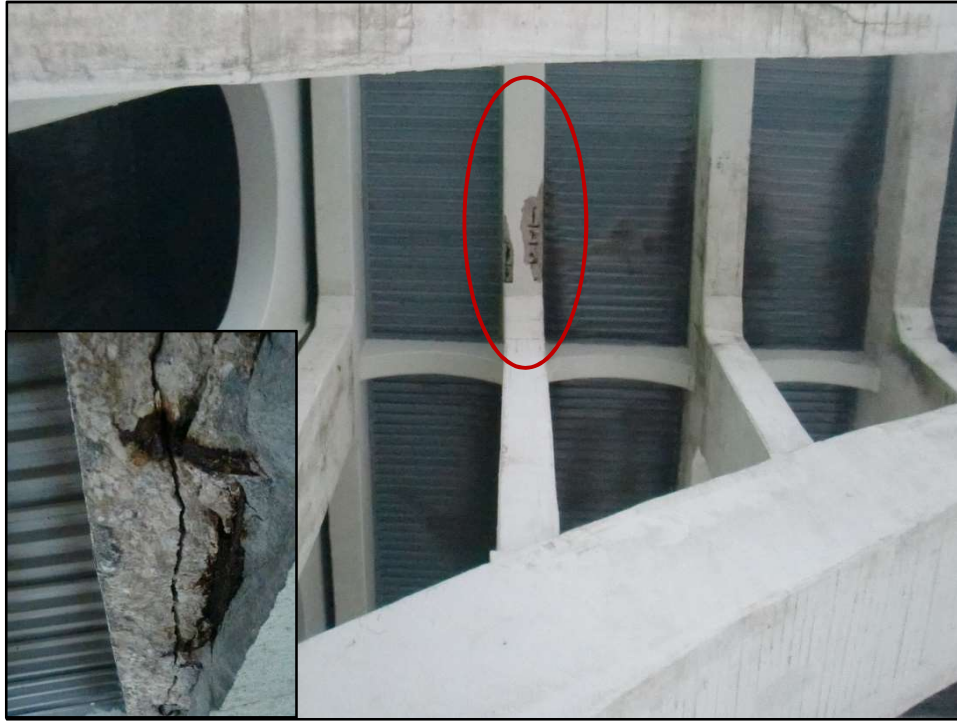
Photo 37 – Loose Concrete (Circled) over Parking Lot Removed, Lower Deck Floorbeam 2, Center Bay, Span 5. (Inset: Active corrosion of reinforcement steel present.)

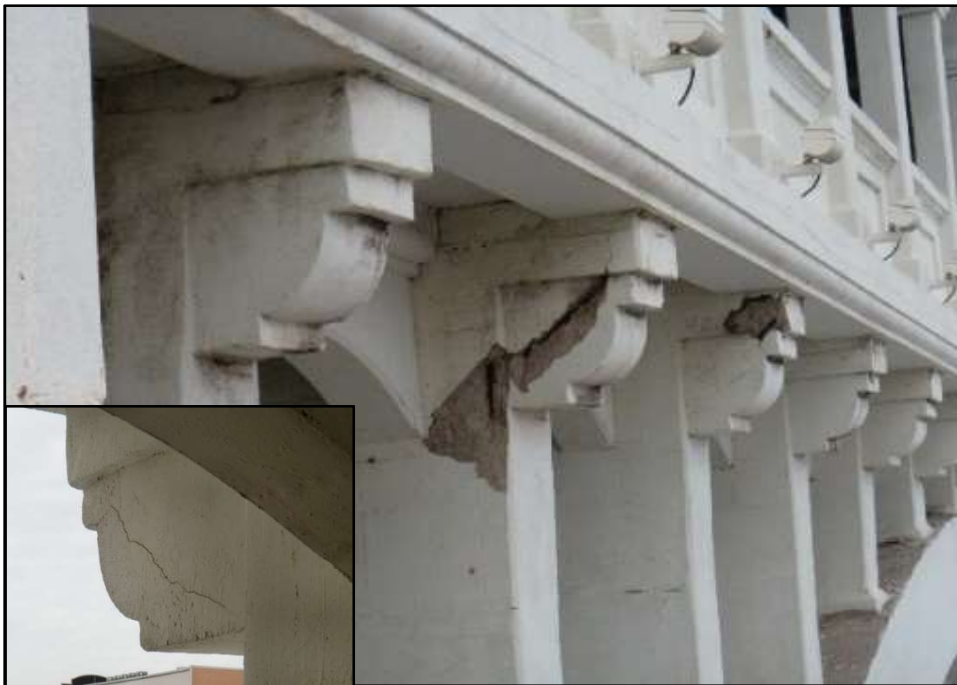
Photo 38 – Common Spalls on Lower Deck Corbels. (Inset: Diagonal crack indicating concrete corrosion present.)

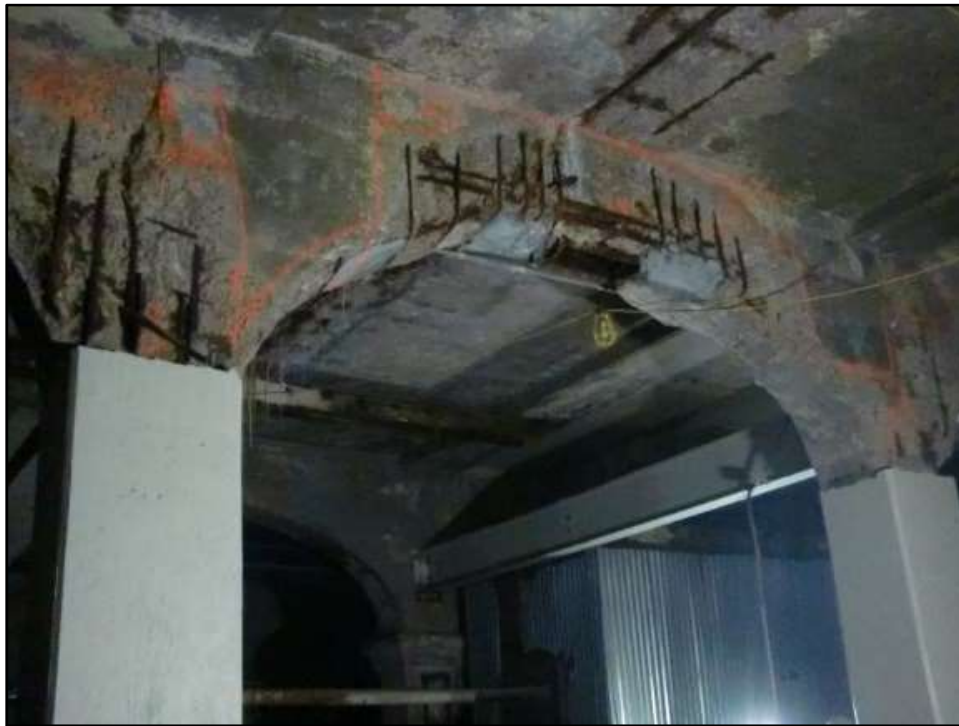
Photo 39 – Spalled Beam D21-D22, West Station.

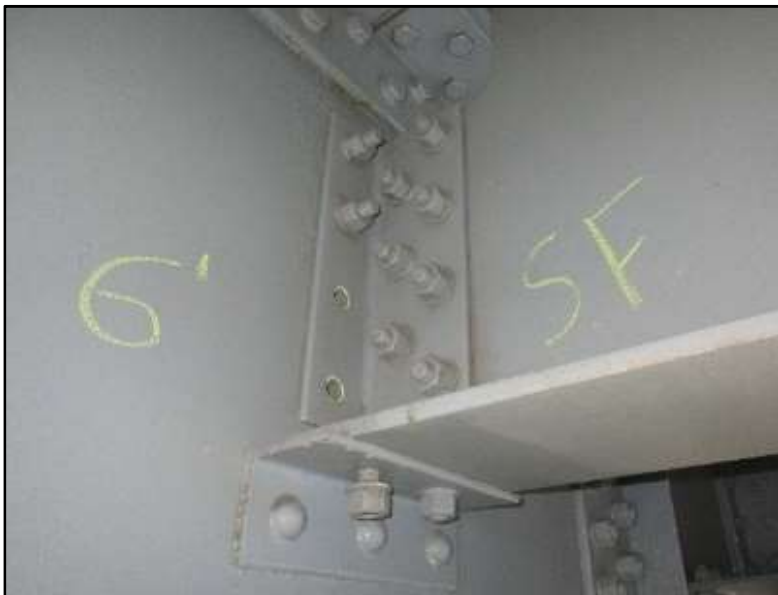
Photo 40 – Missing Bolts at Lug Connection, Stringer F, Panel 6'.

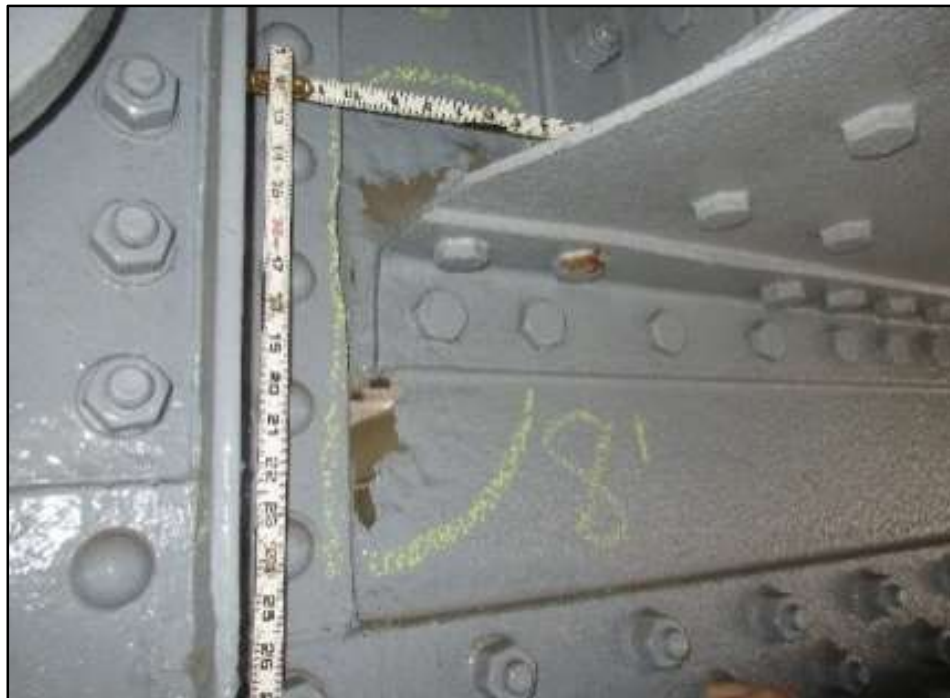
Photo 41 – Web Perforation on Upper Deck Floorbeam 8', Span 4.

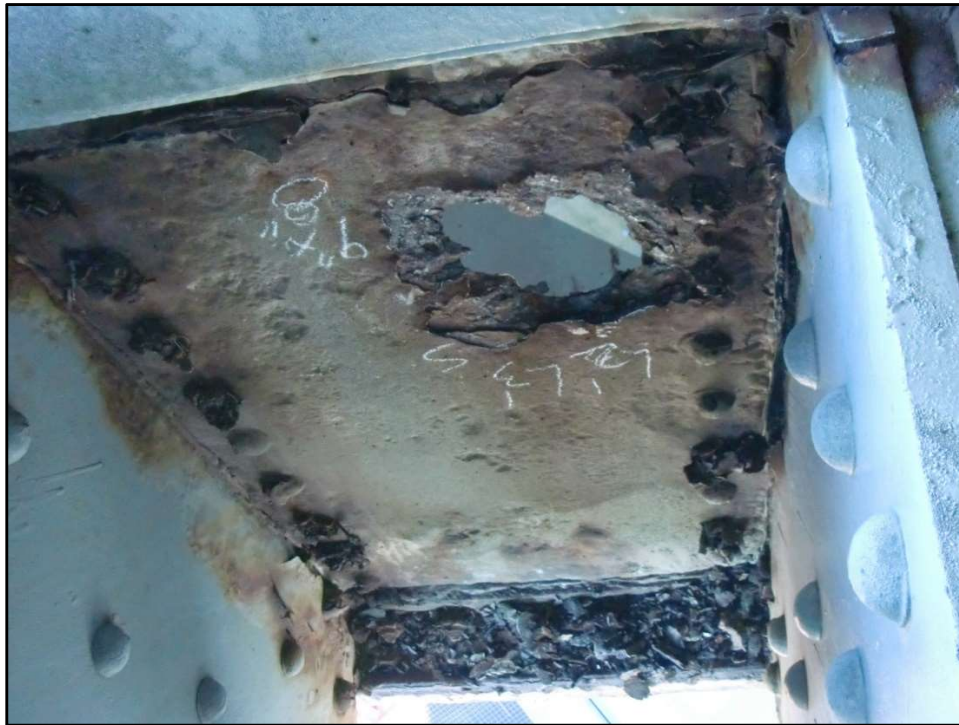
**Photo 42 – Common Perforations of Lower Chord Diaphragm
& Debris on Lower Transverse Angle.**

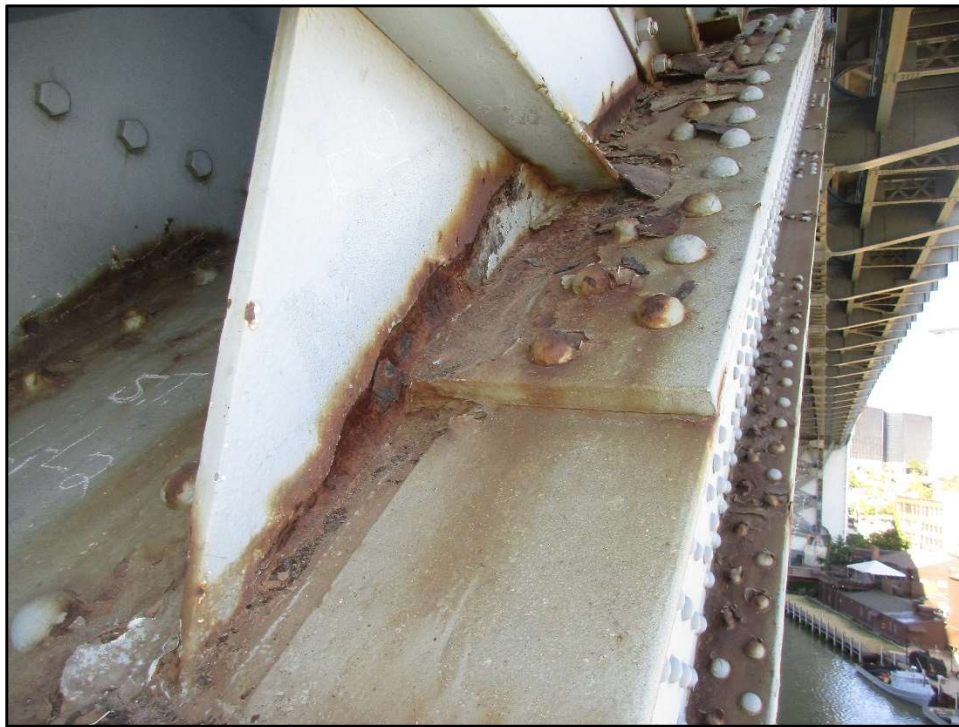
Photo 43 – Active Corrosion of Main Truss Gusset Plate above Lower Chord, Panel Point L2, South Truss.

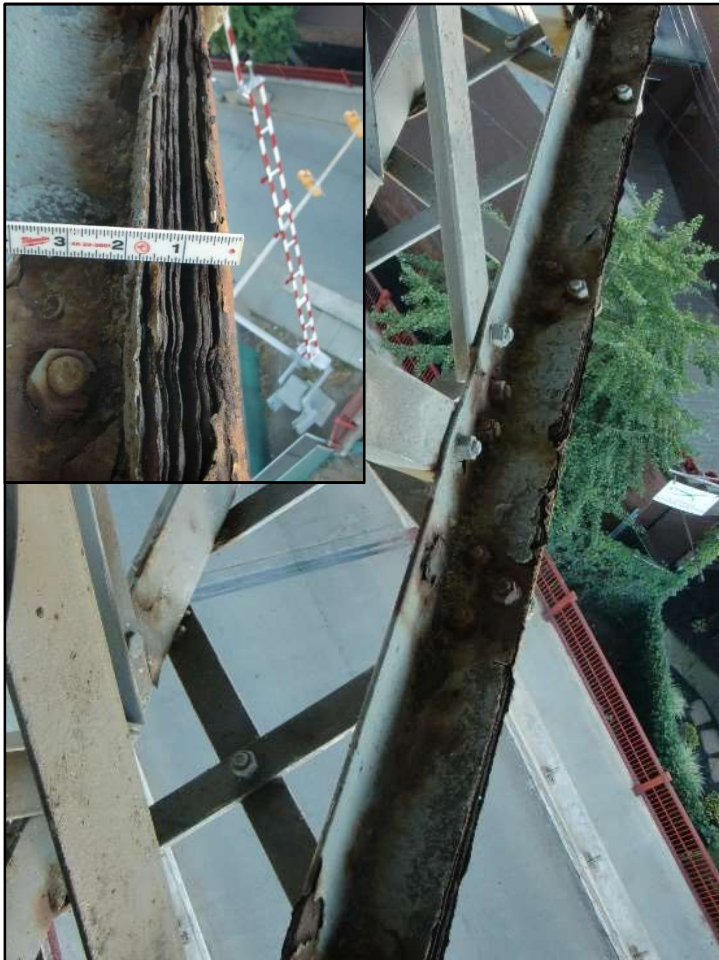
Photo 44 – Active Corrosion & Section Loss of Lower Lateral Bracing, Panel 3'.

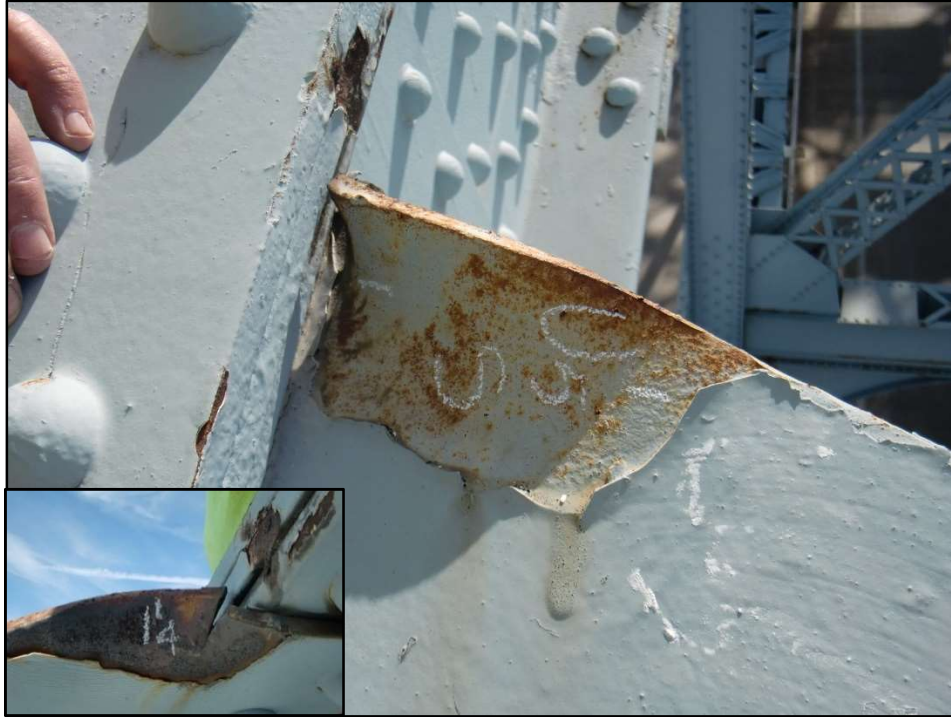
Photo 45 – Upper Lateral Gusset Plate Tear at Panel Point U₅'.
(Inset: View of tear looking up.)

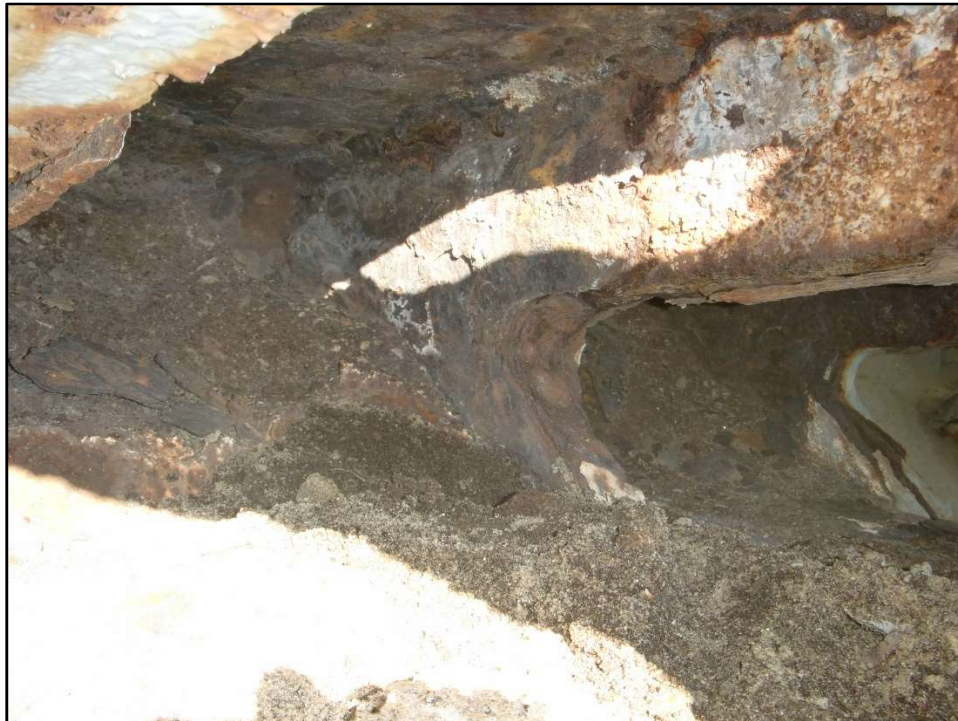
Photo 46 – Typical Steel Shot Blast Material & Corrosion within Truss Bearing.

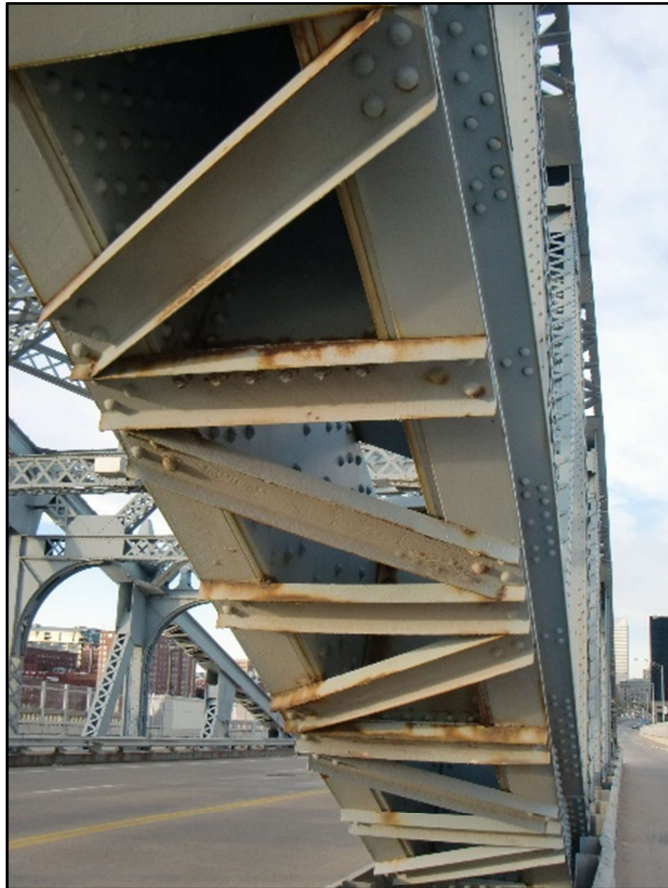
Photo 47 – Local Paint Failure within Lower Chord Immediately Above Upper Deck.

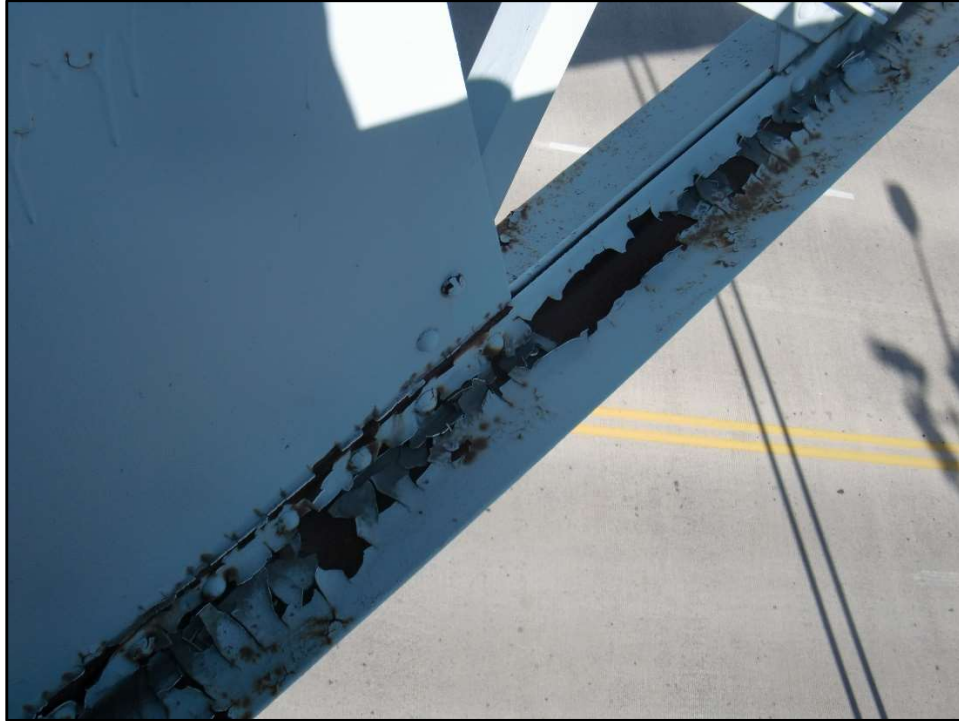
Photo 48 – Oxidized Top Coat & Peeling Paint Above Upper Deck.

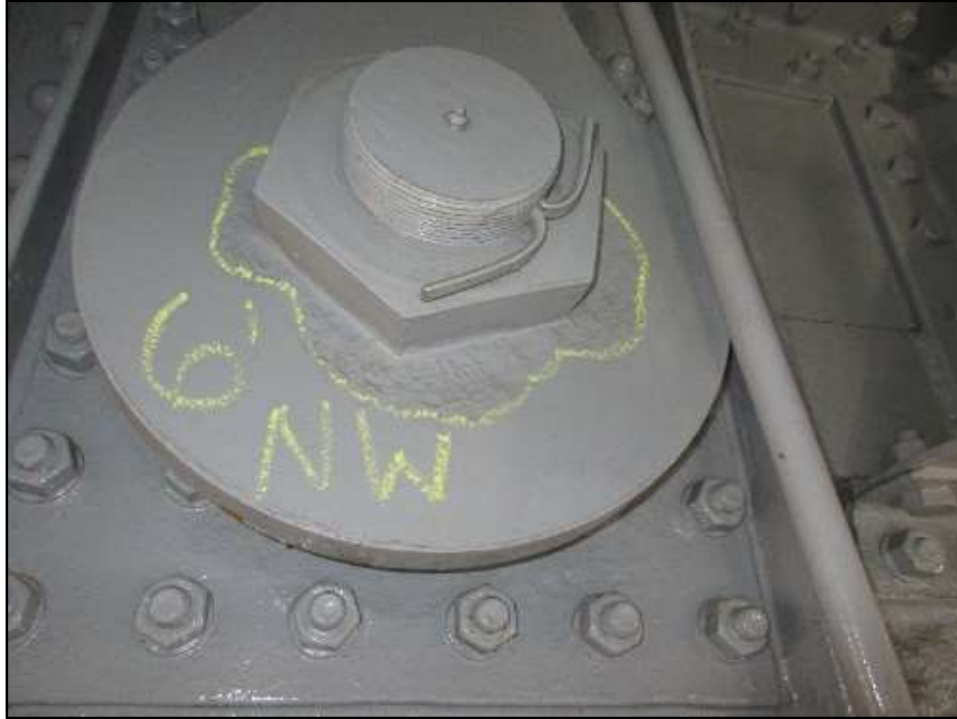
Photo 49 – Common Minor Pitting on Hangers Below Upper Deck Pin.

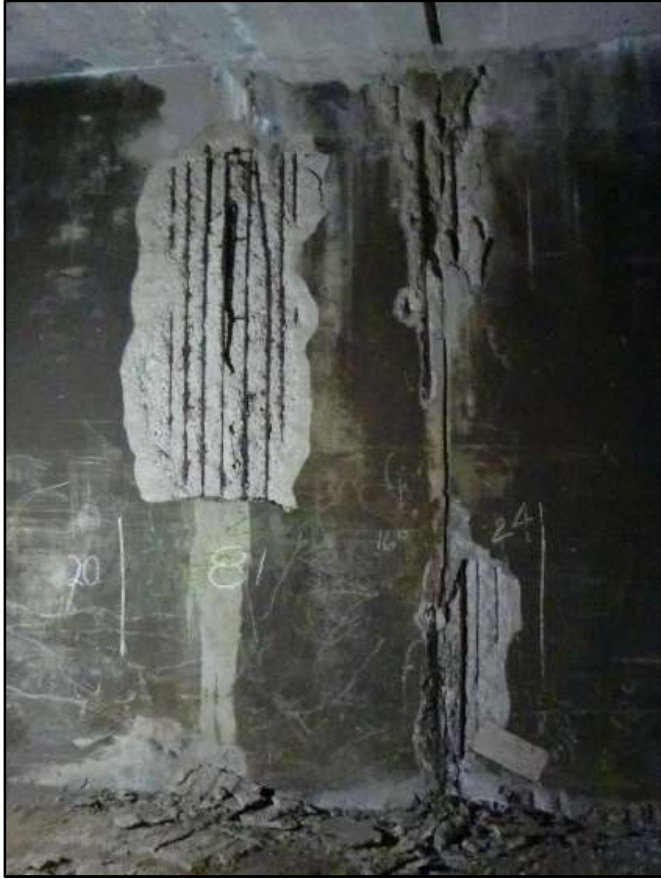
Photo 50 – Deep & Slow-Growing Spalls on Wall Joint, West 25th Street Tunnel.

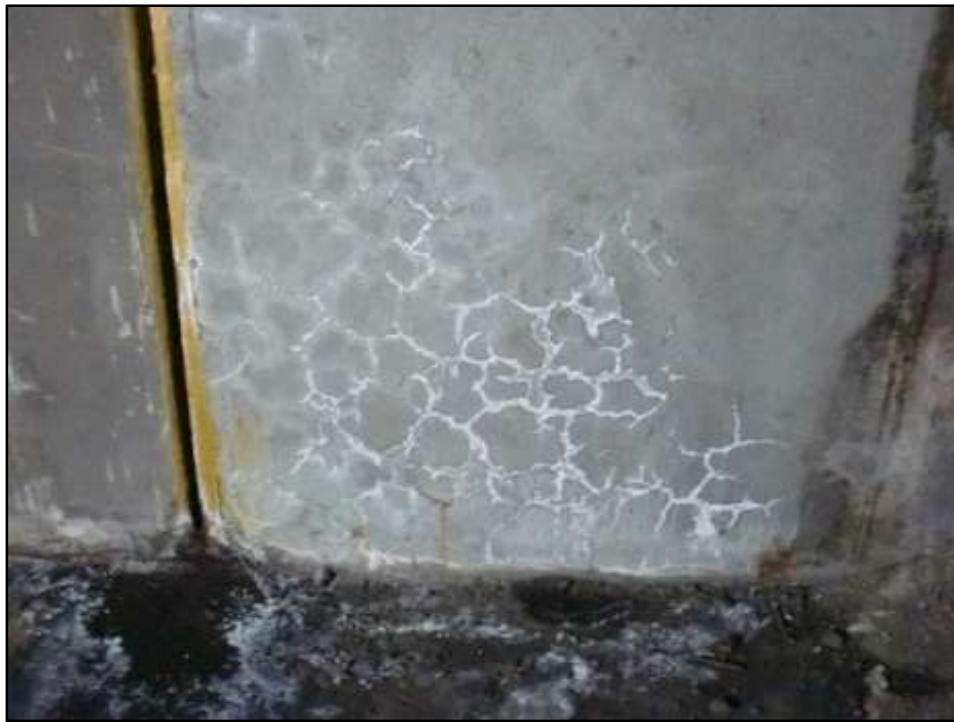
Photo 51 – Hairline Cracks on New Wall Patch, Detroit Avenue Tunnel.

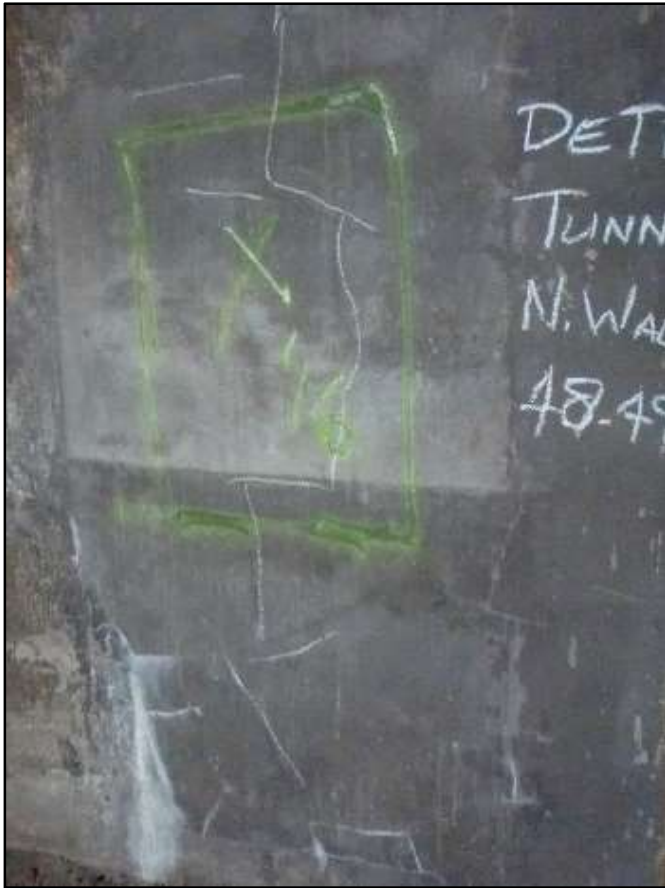
Photo 52 – Delaminated Area (Highlighted in Paint) on New Wall Patch, Detroit Avenue Tunnel.

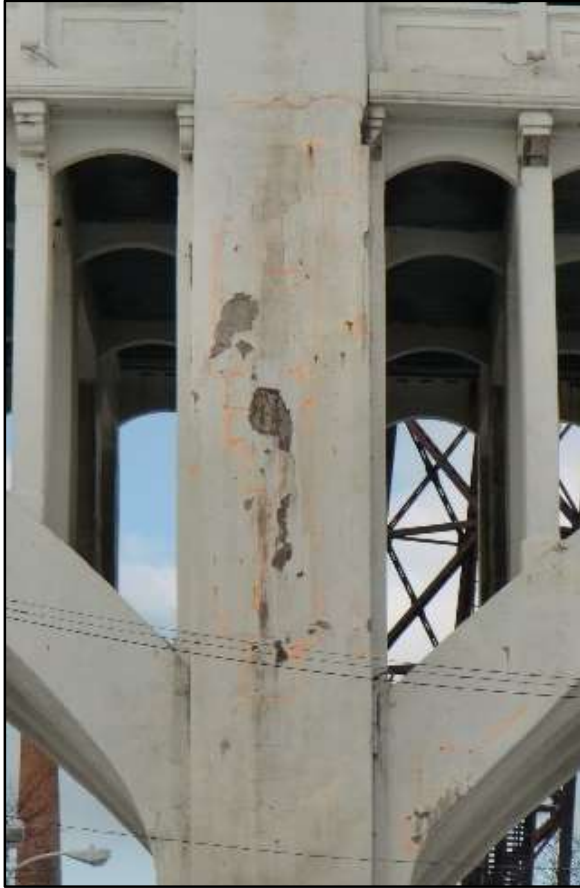
**Photo 53 – Deeply Scaled & Delaminated Area
(Highlighted in Paint), SE Lower Deck Pier
Shaft, Pier 6.**

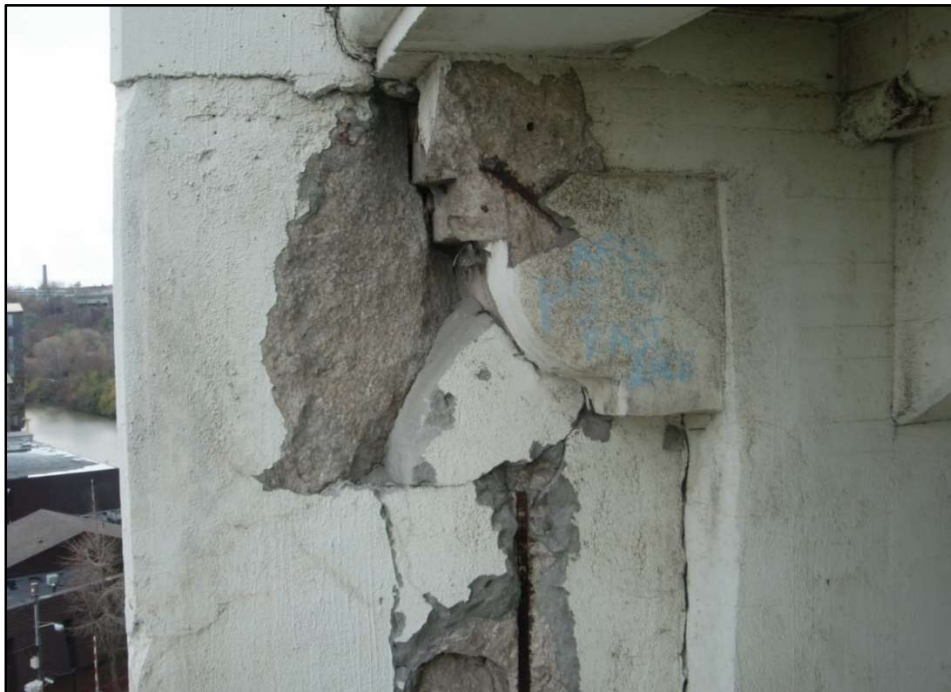
**Photo 54 – Spalled & Loose Concrete Due to Ineffective Bond Breaker,
Pier 5 Lower Deck Pier Shaft & South Lower Deck Corbel 1, Span 6.**

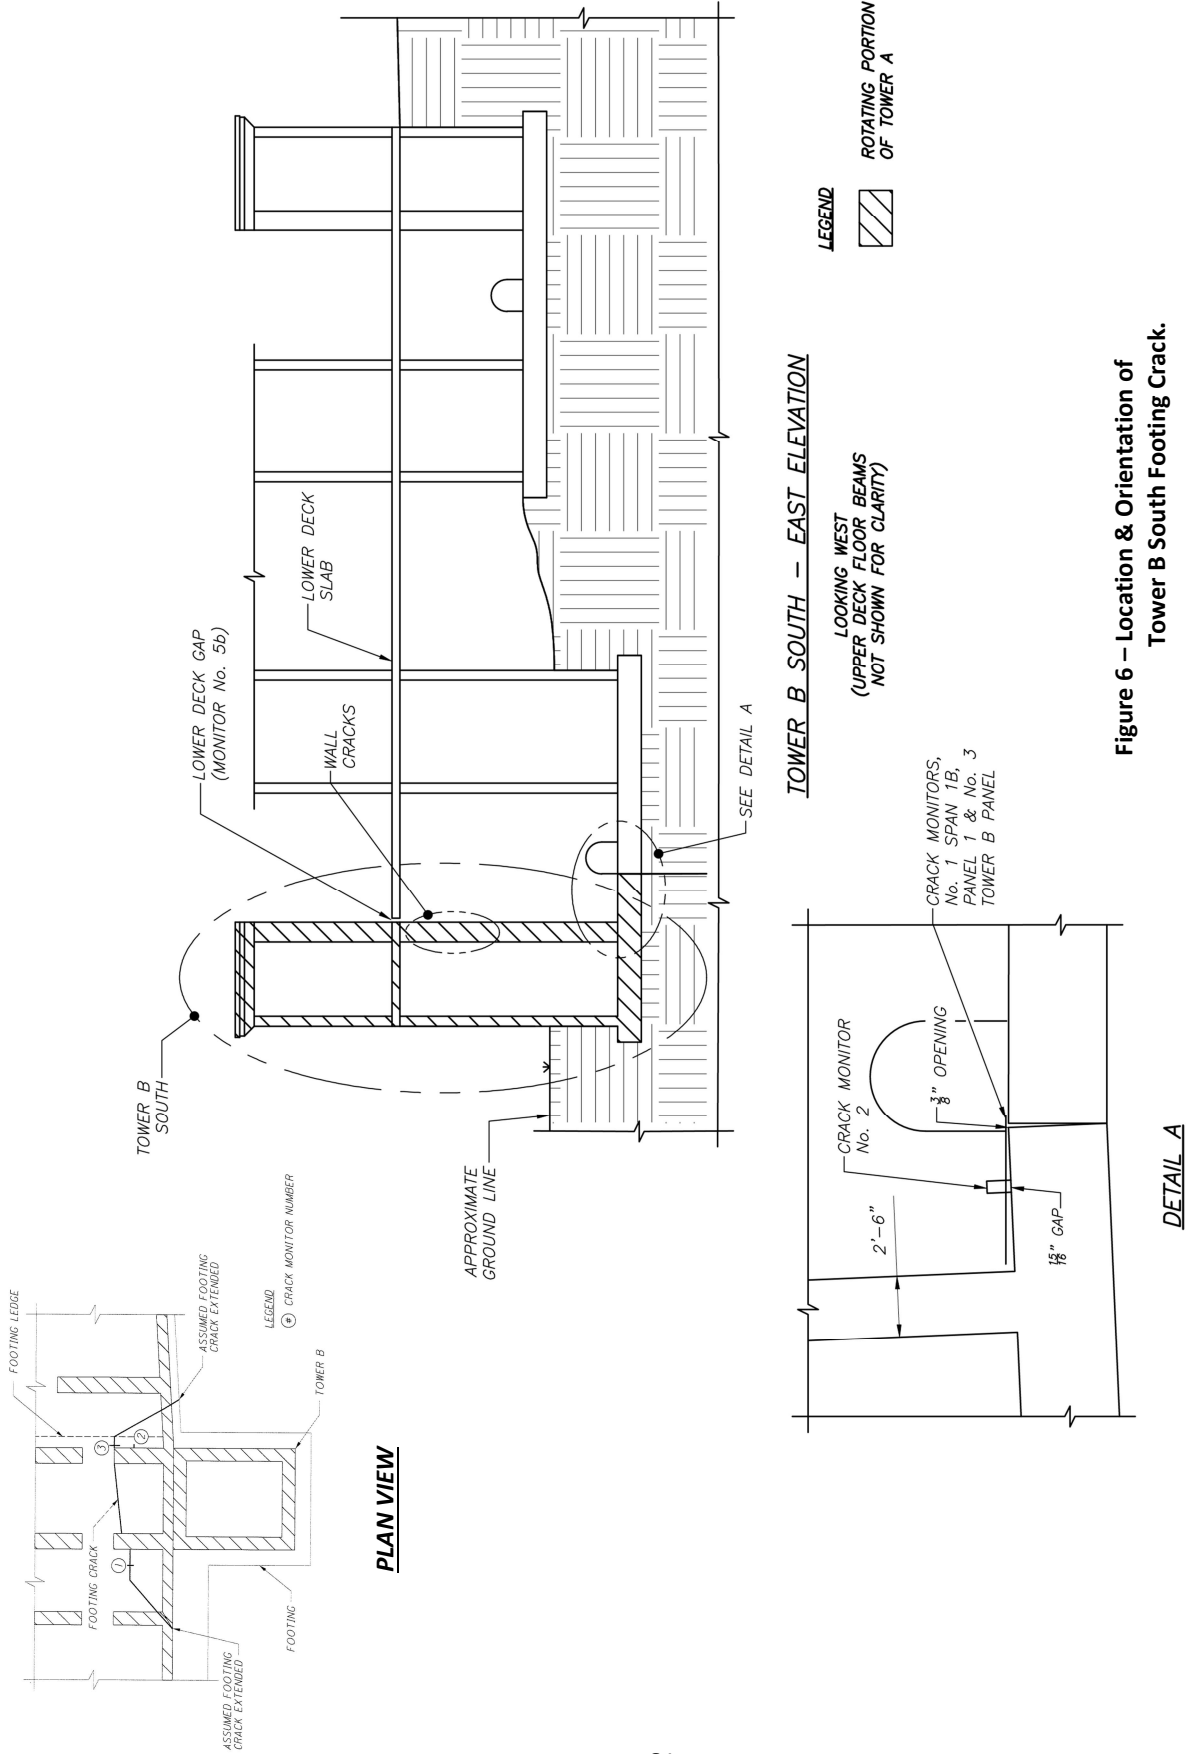
Figure 6 – Location & Orientation of Tower B South Footing Crack.

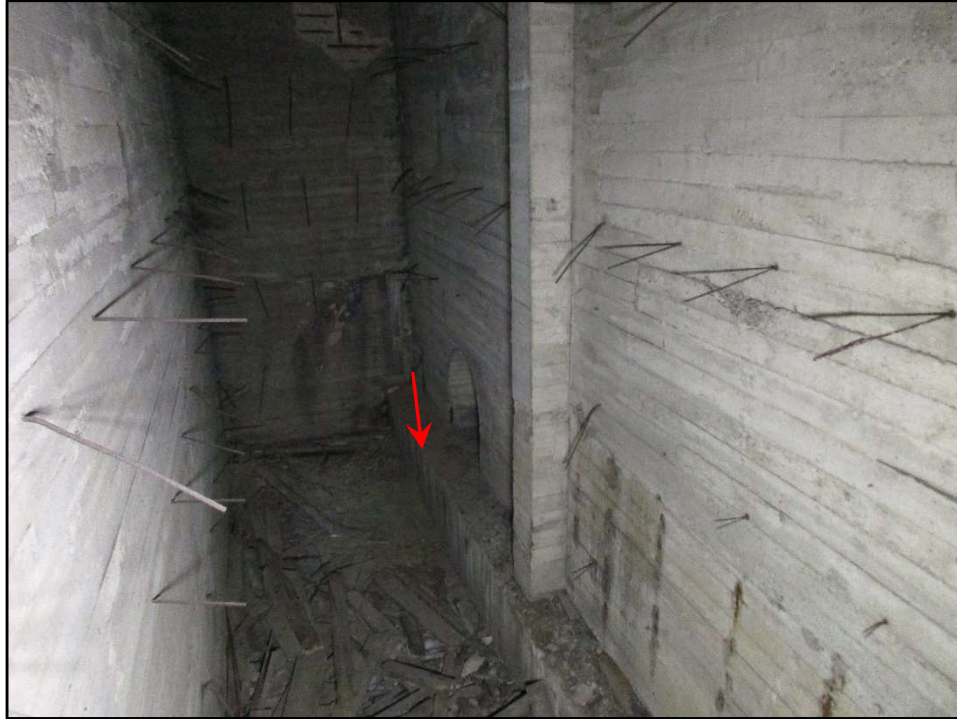
Photo 55 – Location of Tower B Footing Crack (at Arrow), Looking South in Cellular Construction, Panel 2, Span 1B.

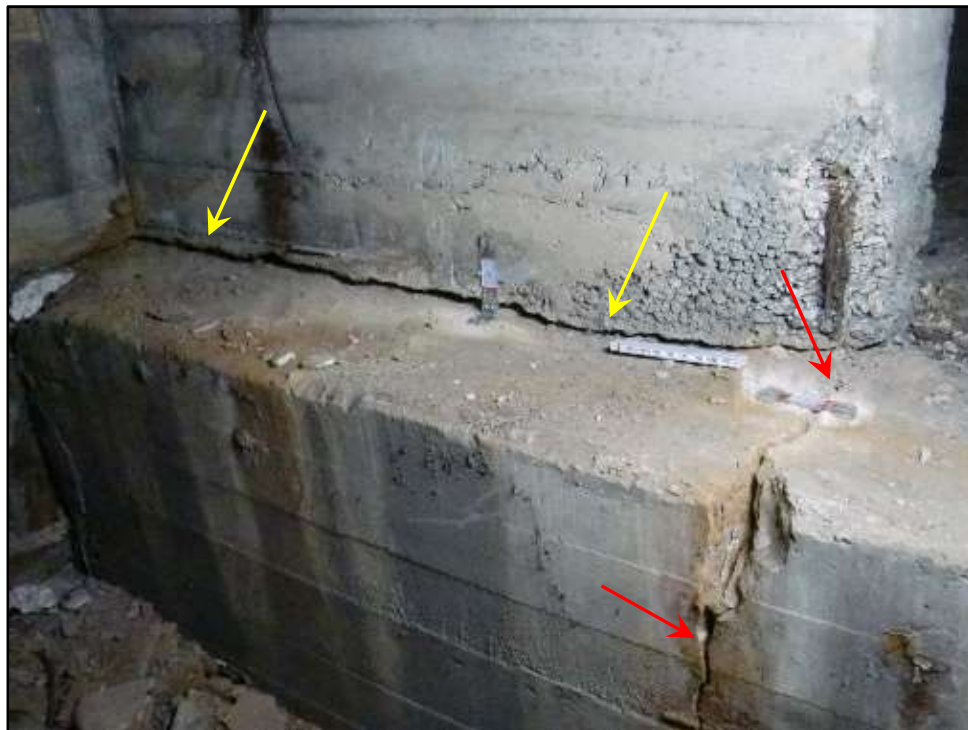
Photo 56 – Tower B Footing Crack (Highlighted with Red Arrows), and Footing Rotation & Drop with Respect to Transverse Wall (at Yellow Arrows), Looking South.

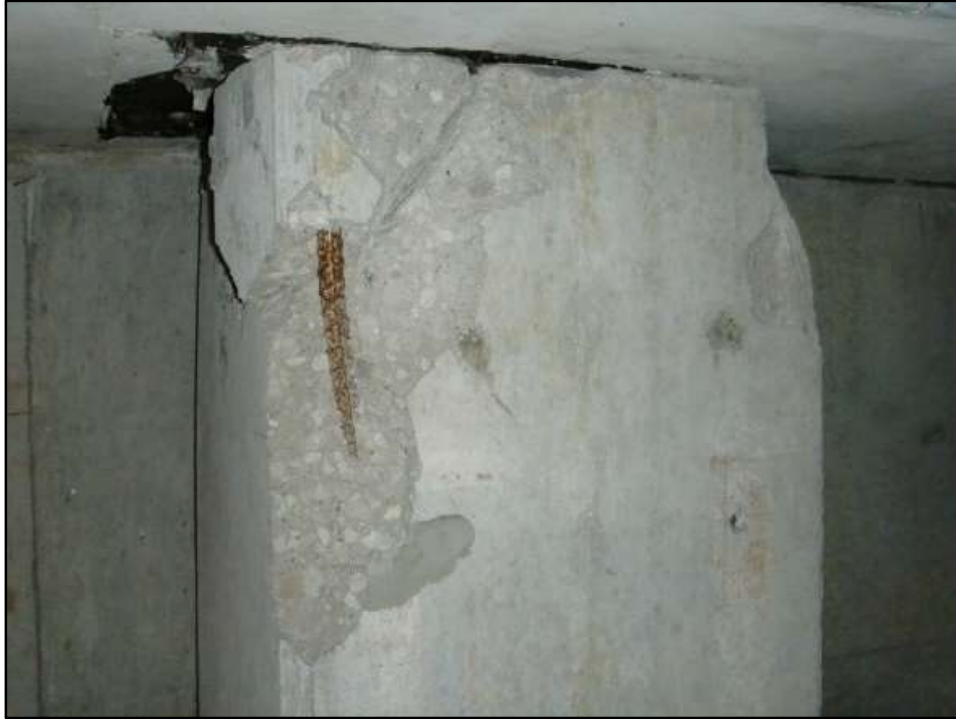
Photo 57 – Tower B Wall Shaft Wedged & Fracturing Against Sidewalk Cantilever.

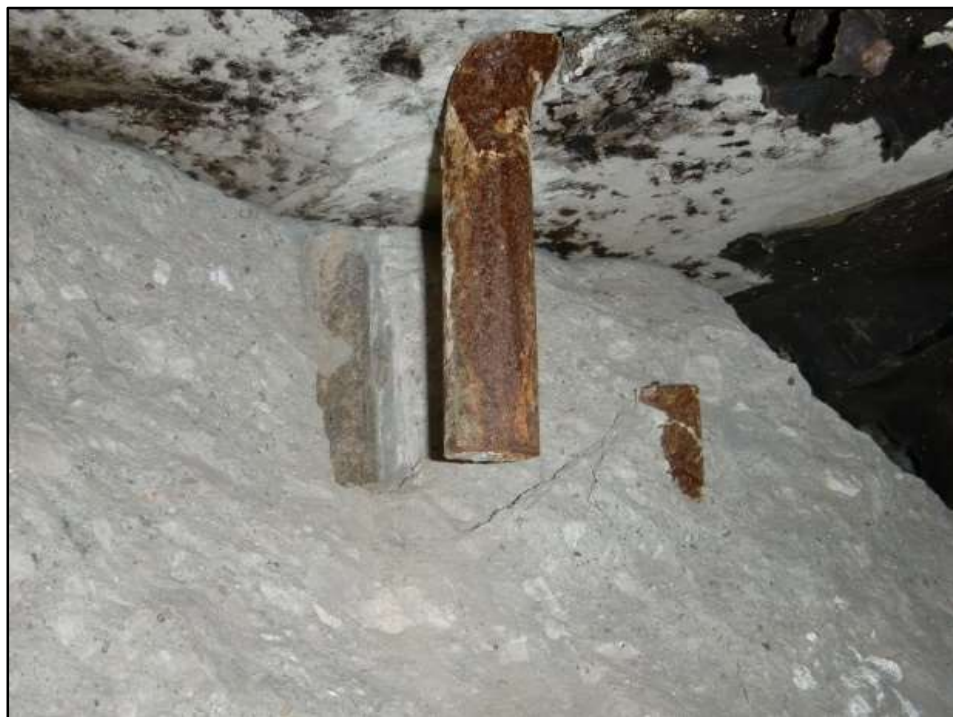
Photo 58 – Four-Inch Movement of Embedded Pipe Between Tower B Wall Shaft & Sidewalk Cantilever Above.

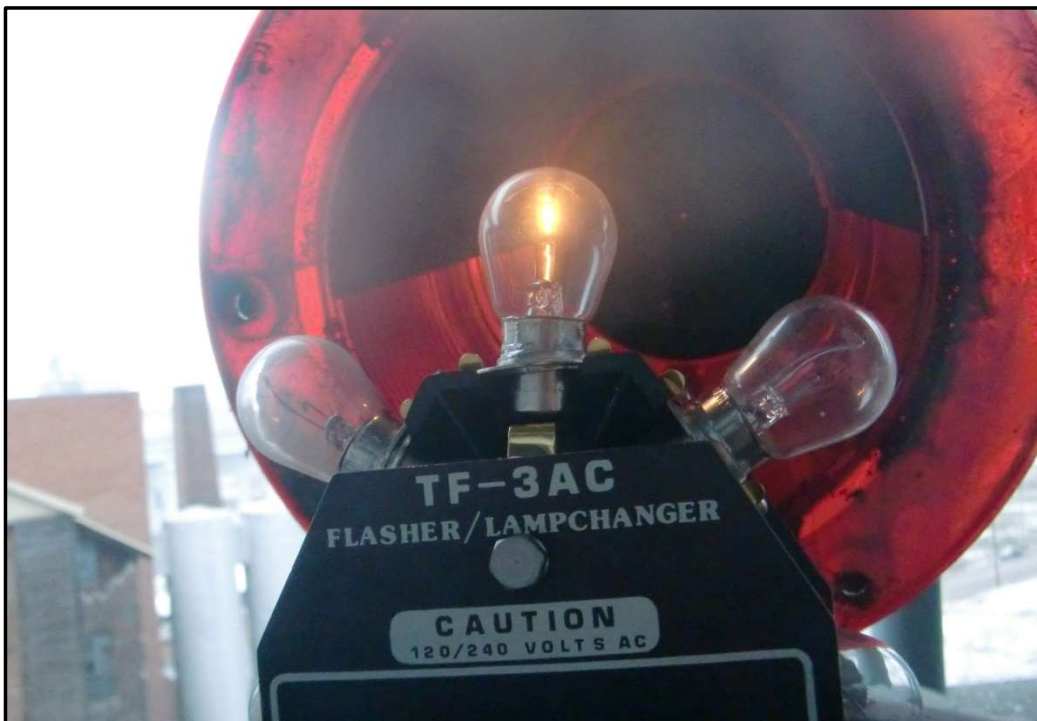
Photo 59 - Power Verification of Navigation Light (West Edge of Channel, South Face shown).

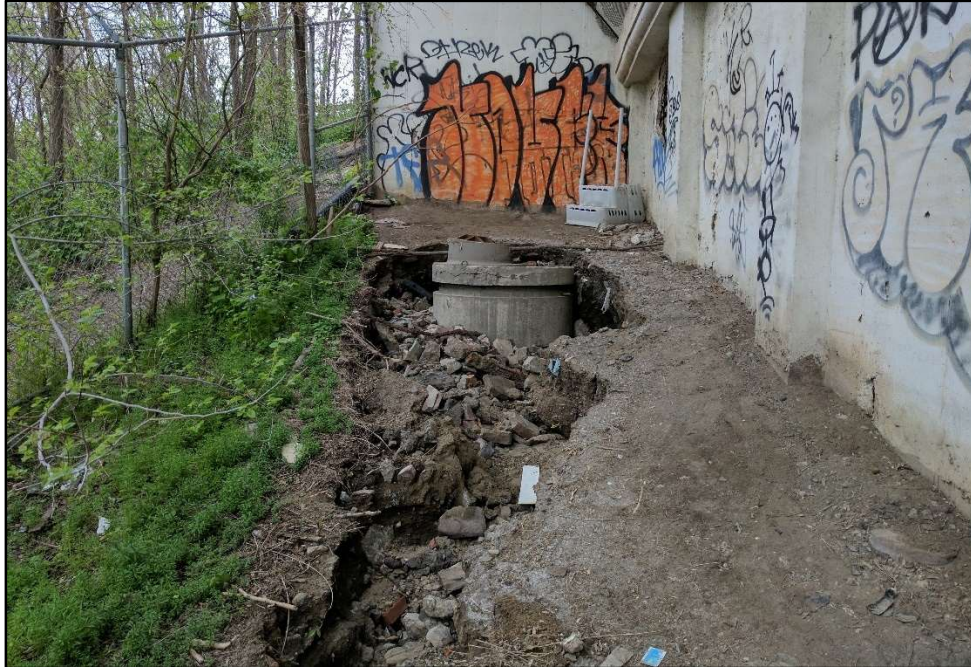
Photo 60 – Embankment Erosion at Span 1A Manhole, North of Tower A South.

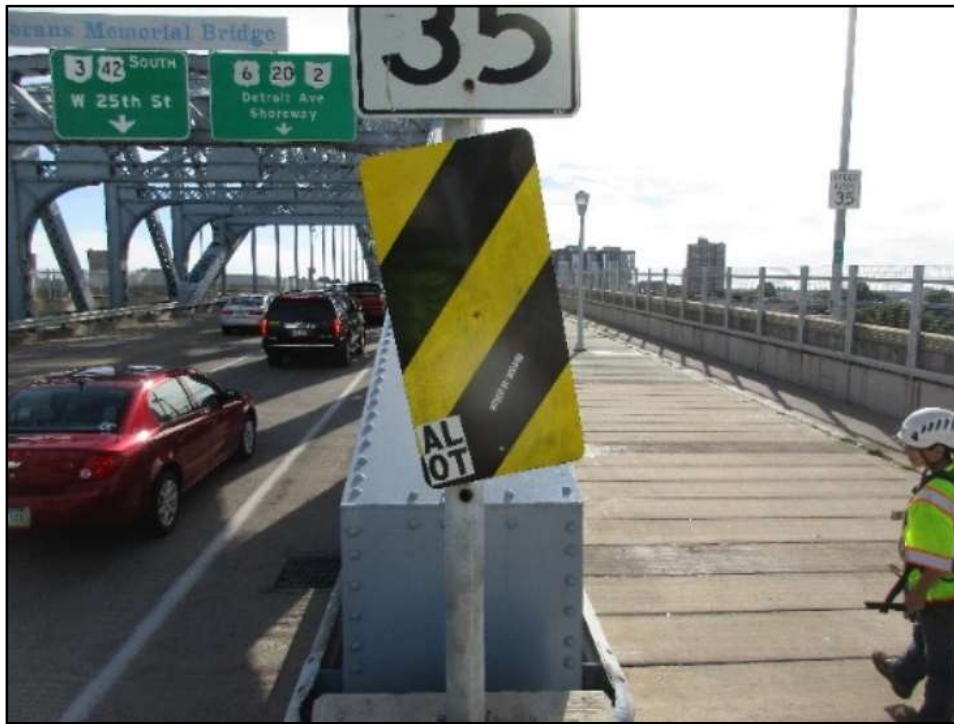
Photo 61 – Misaligned Chevron Sign, East End of Span 4 North Truss.

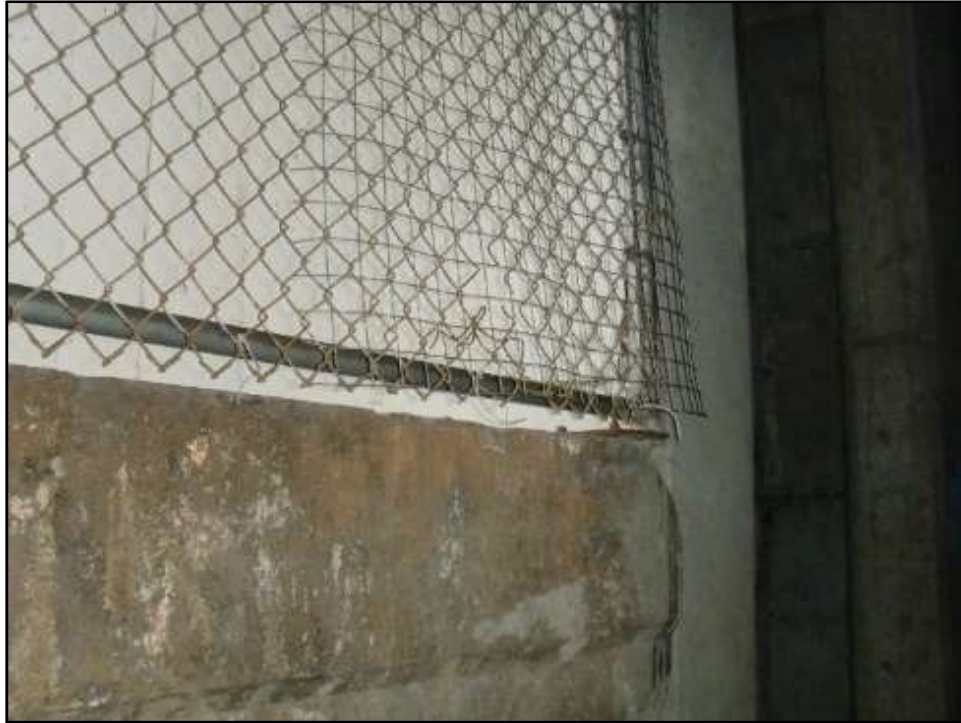
Photo 62 – Broken Ties to Fencing, Span 1A at Tower A.

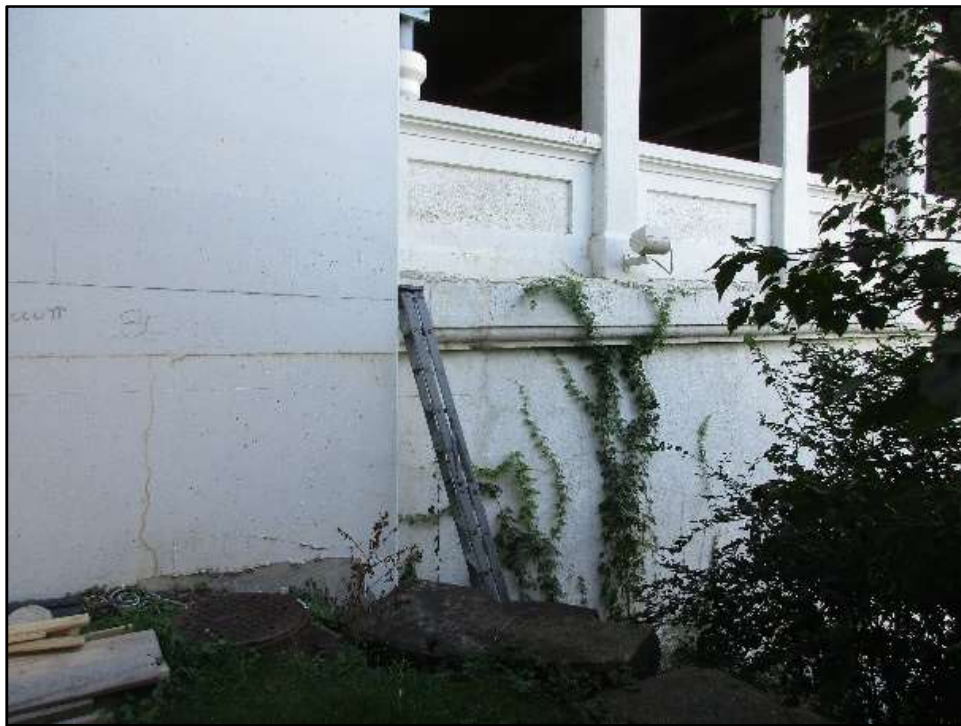
Photo 63 – Step Ladder Used for Vandal Access to Lower Deck, Span 13, North Face.

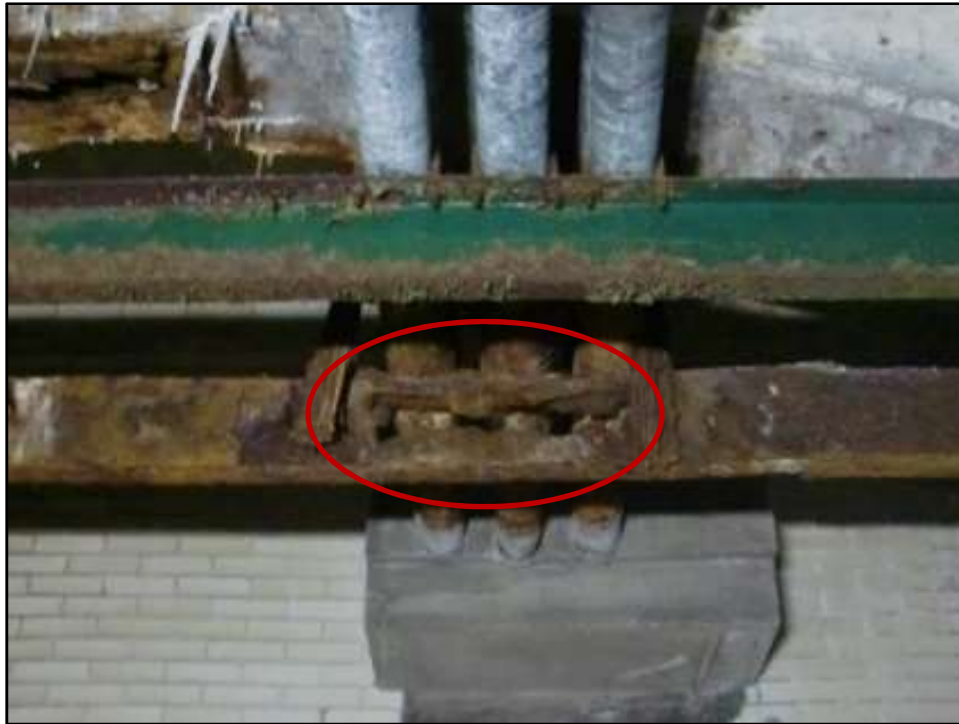
**Photo 65 – Failing Utility Bracket (Channel Web Hole Circled),
Panel A3-A4, West Station.**

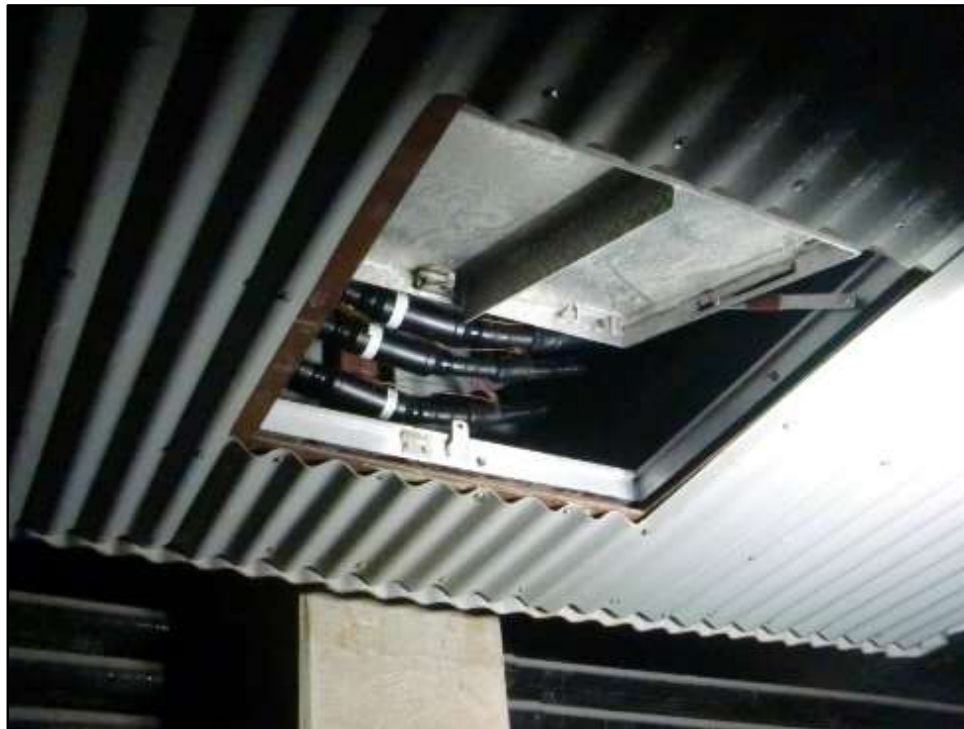
**Photo 66 – Unsecure Telephone Junction Chamber, Near Column D12,
West Station.**
