Ohio Department of Transportation 2016 Physical Condition Report

Detroit-Superior Bridge over Cuyahoga River
Bridge No. CUY-6-1456

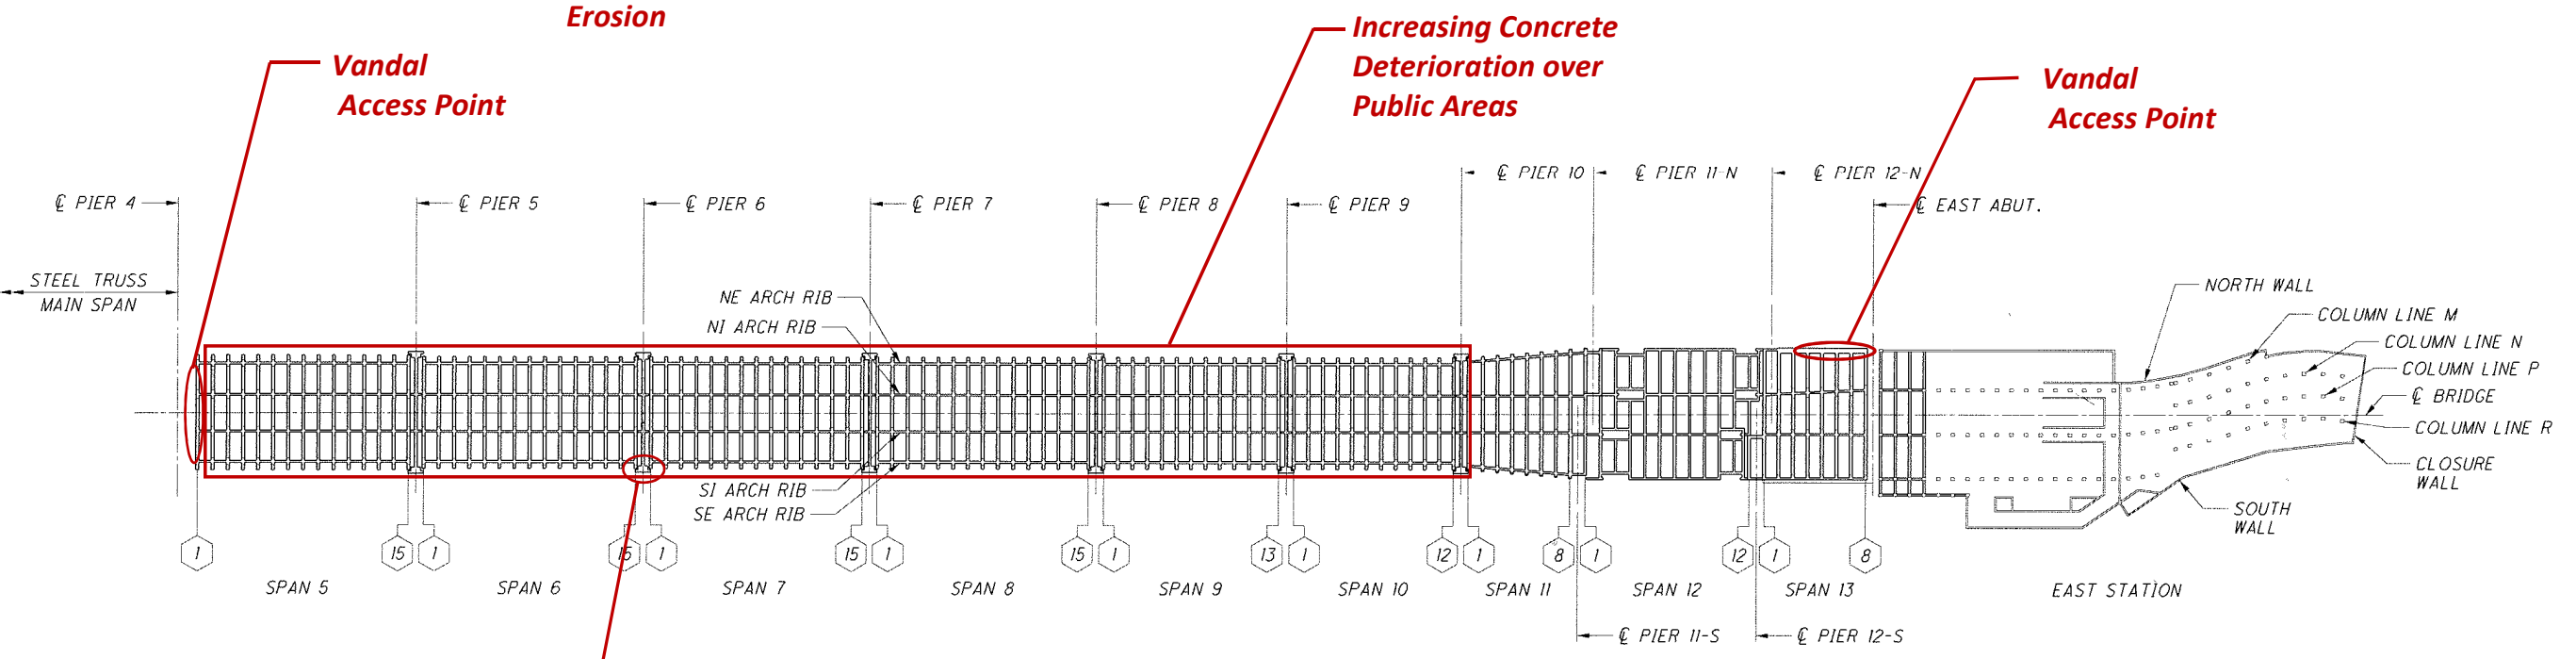
WEST LOWER DECK SUPERSTRUCTURE

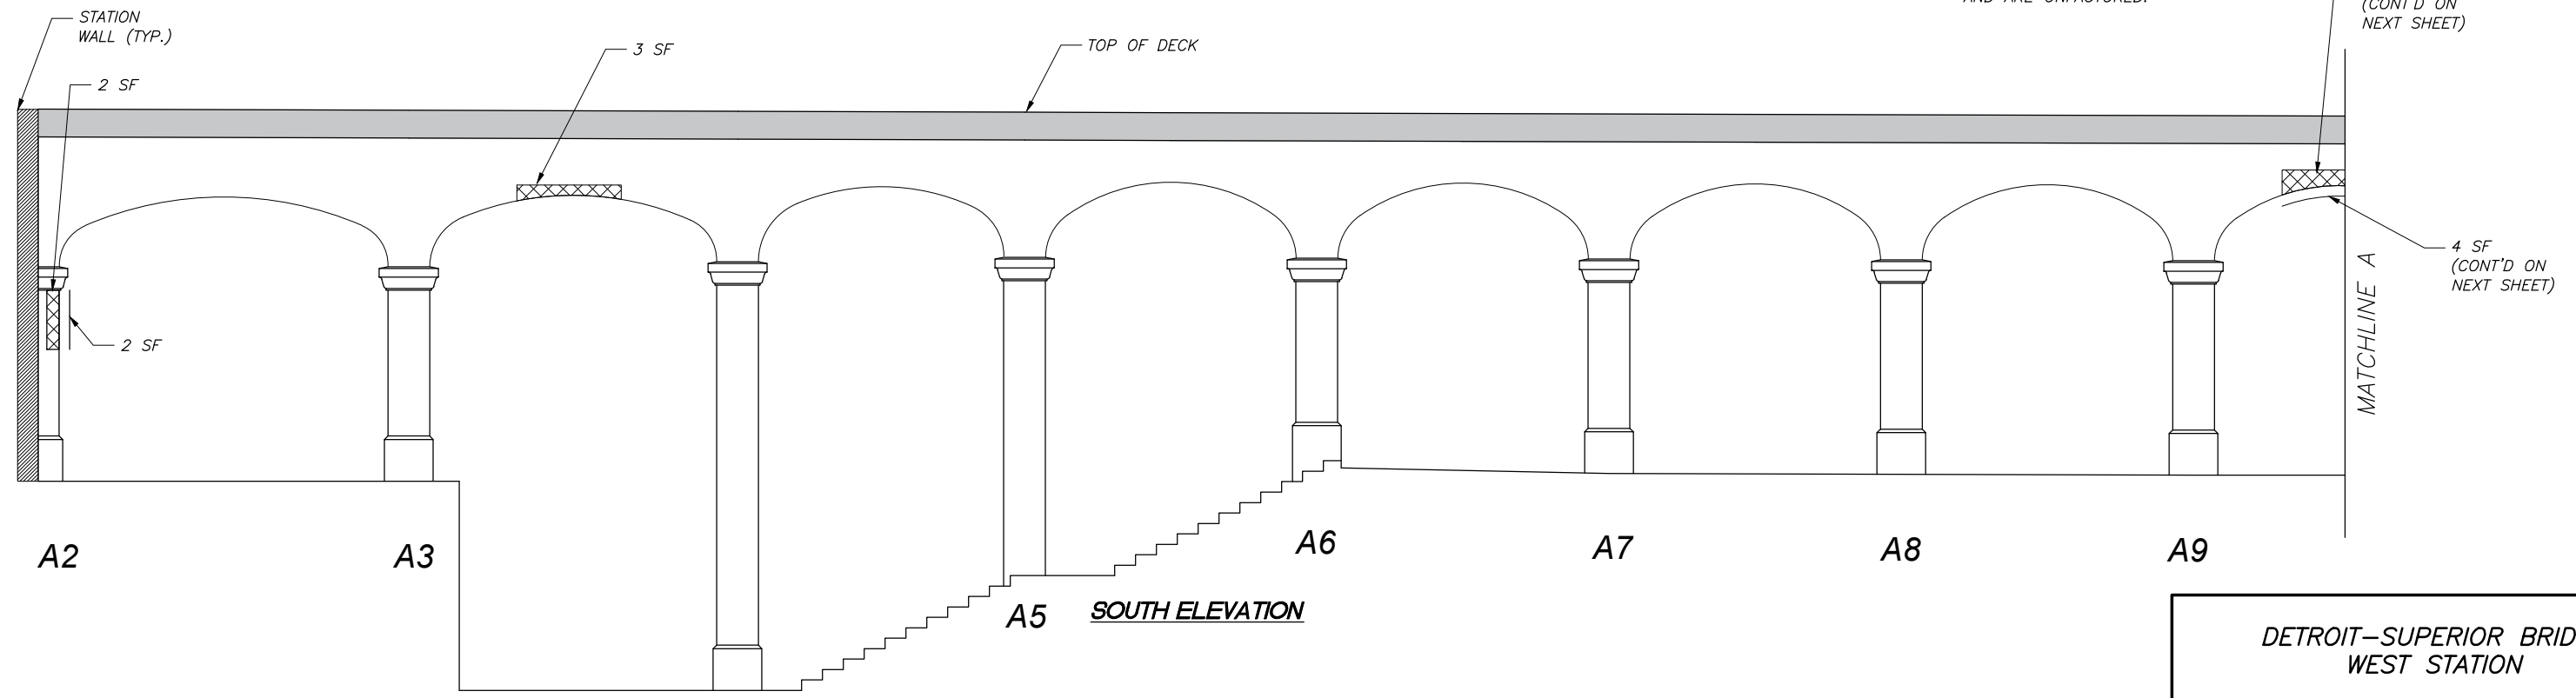
DETROIT-SUPERIOR BRIDGE
WEST STATION

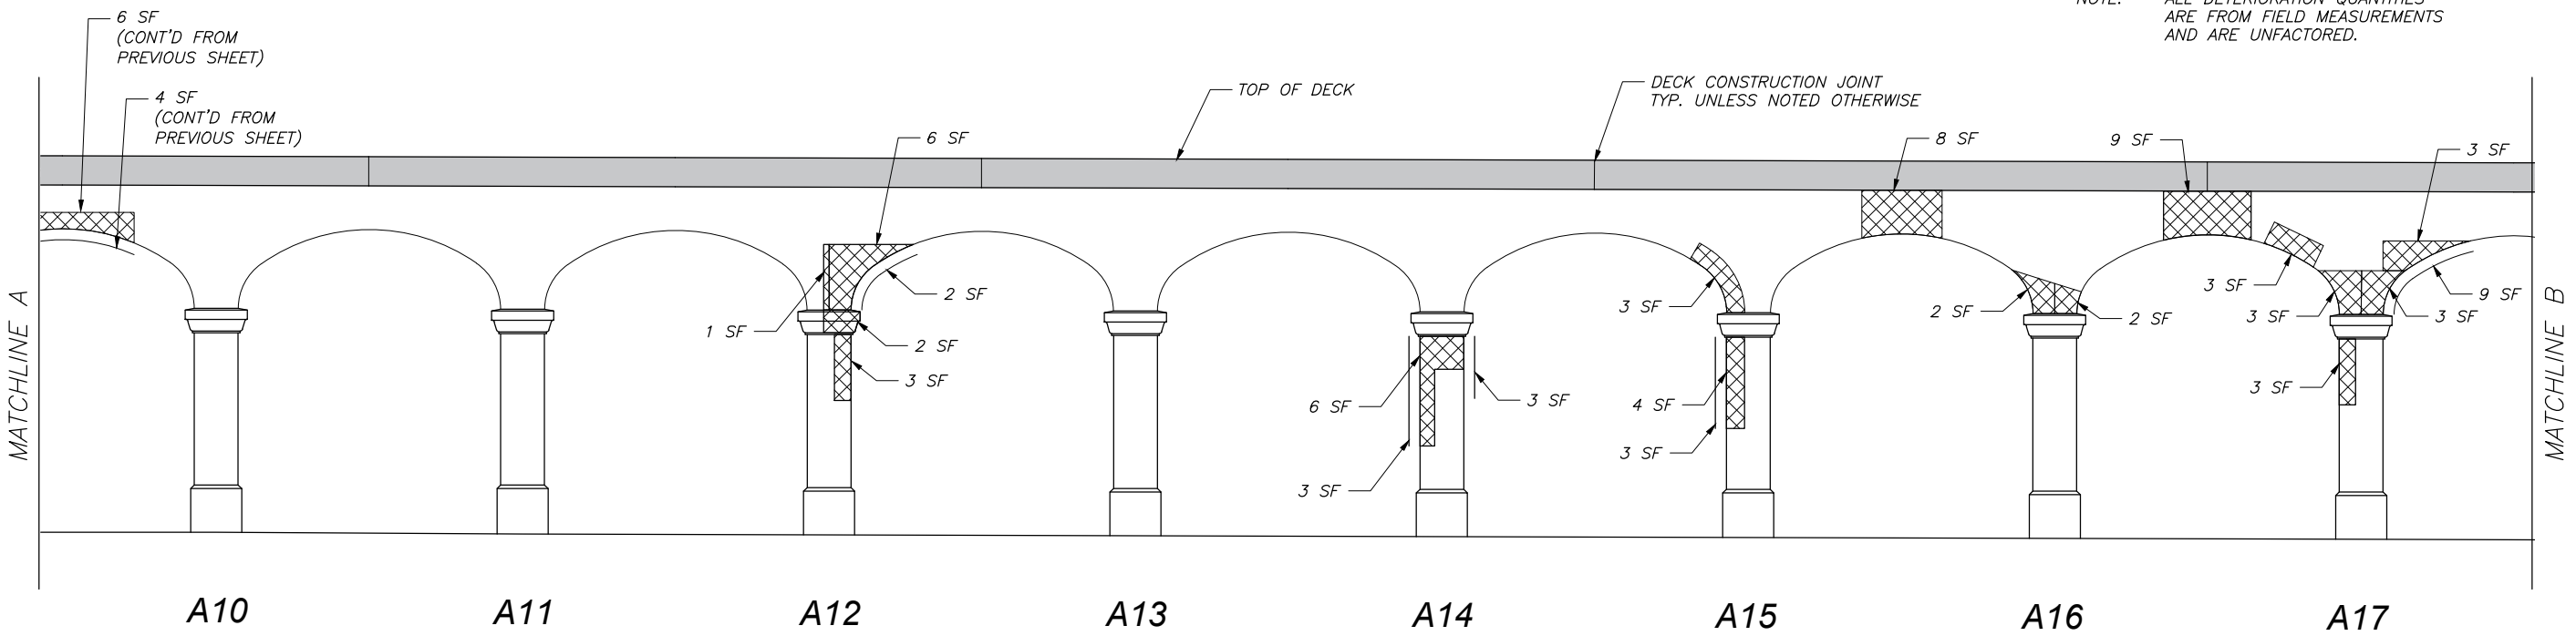
NOTE: ALL DETERIORATION QUANTITIES ARE FROM FIELD MEASUREMENTS AND ARE UNFACTORED.

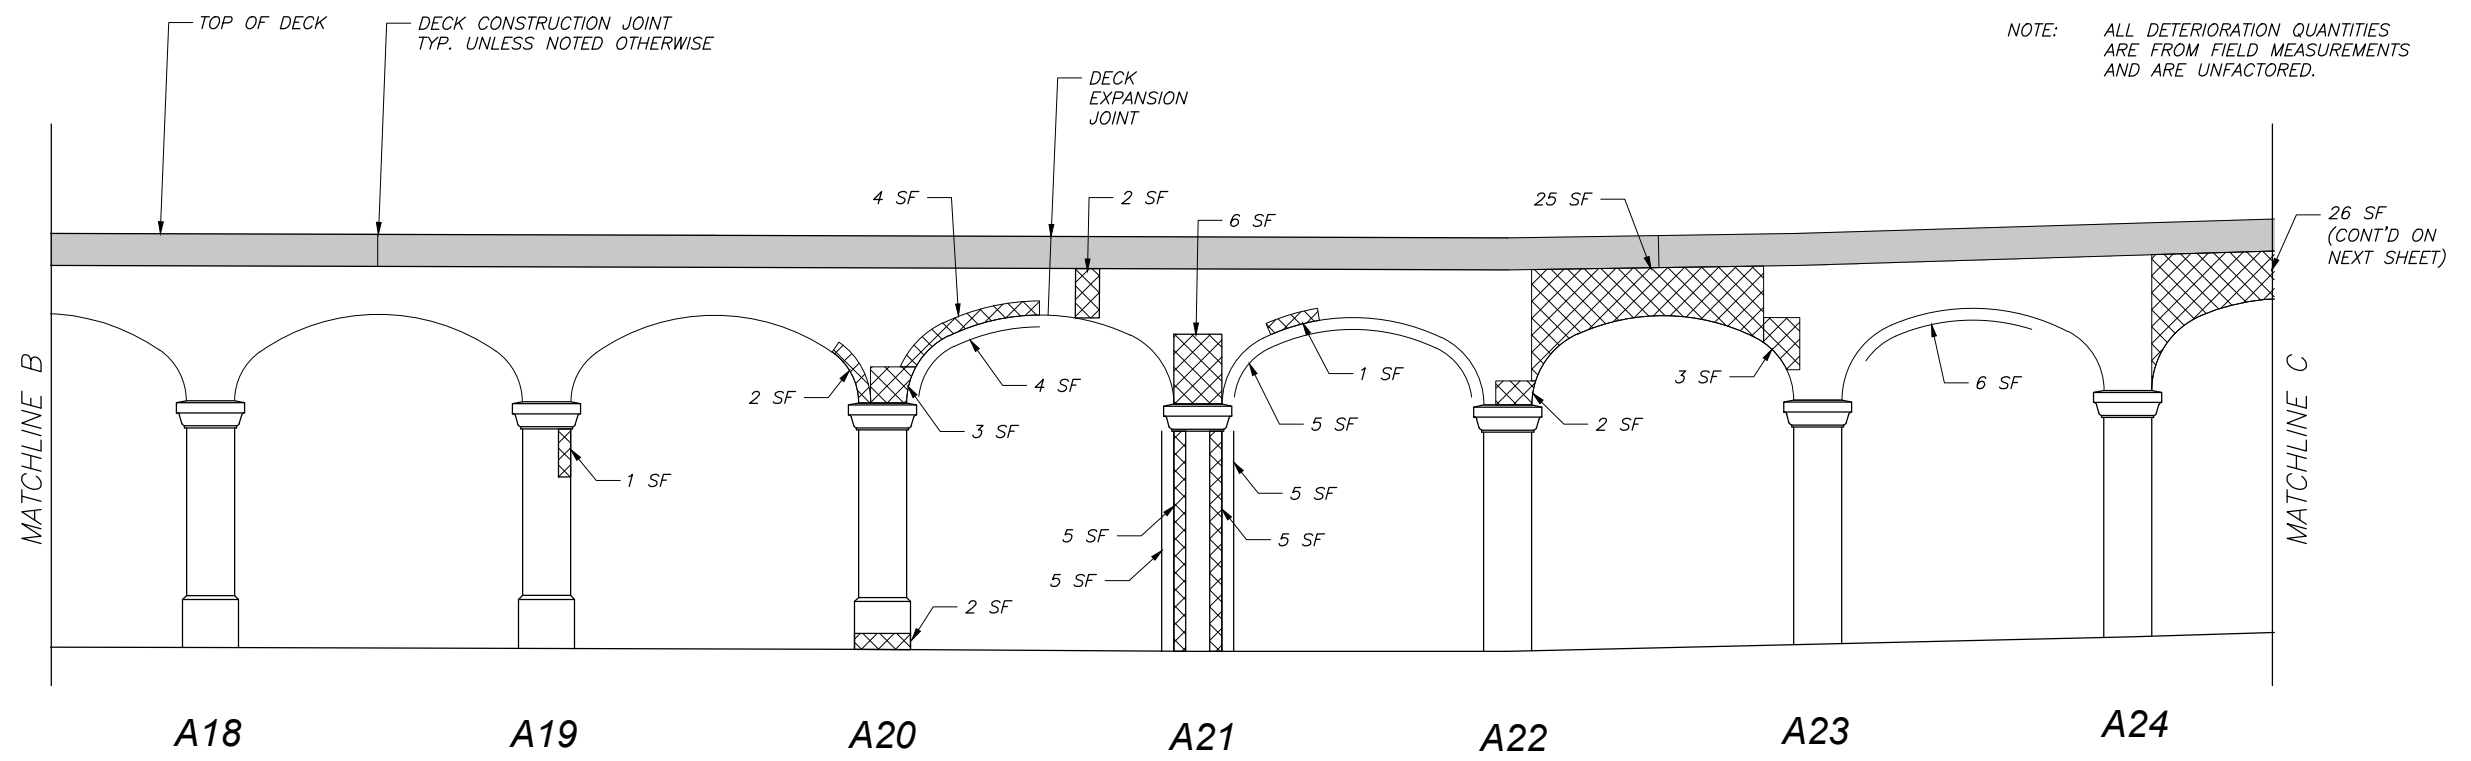
NOTE: ALL DETERIORATION QUANTITIES ARE FROM FIELD MEASUREMENTS AND ARE UNFACTORED.

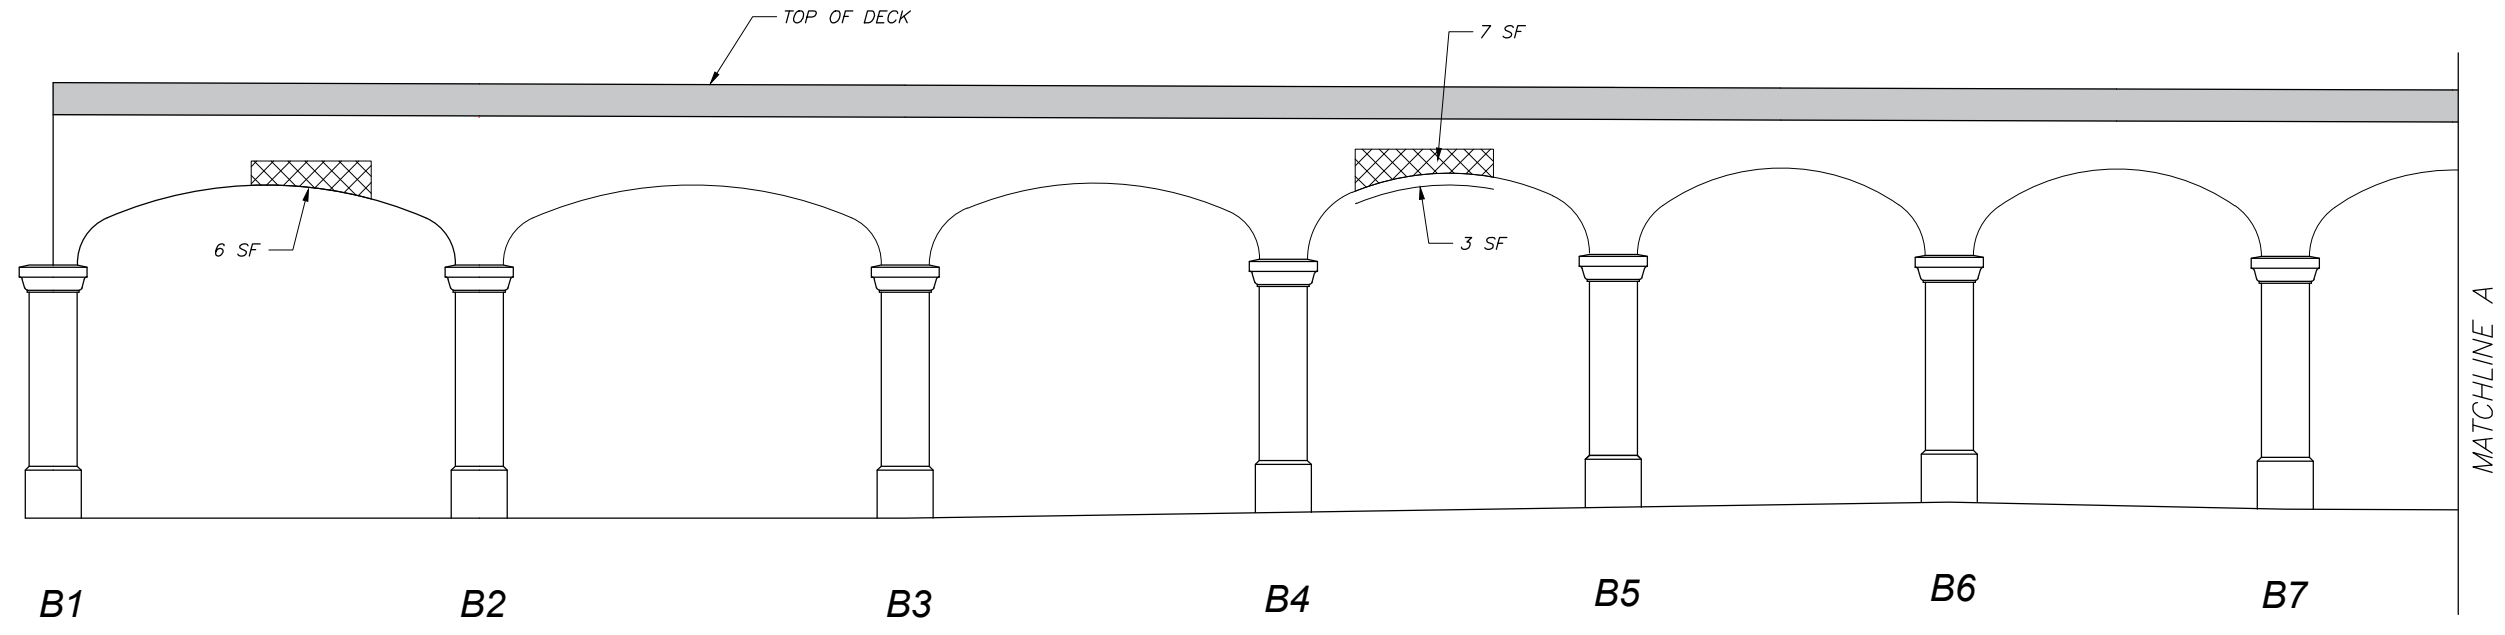
B1 B2 B3 B4 B5 B6 B7

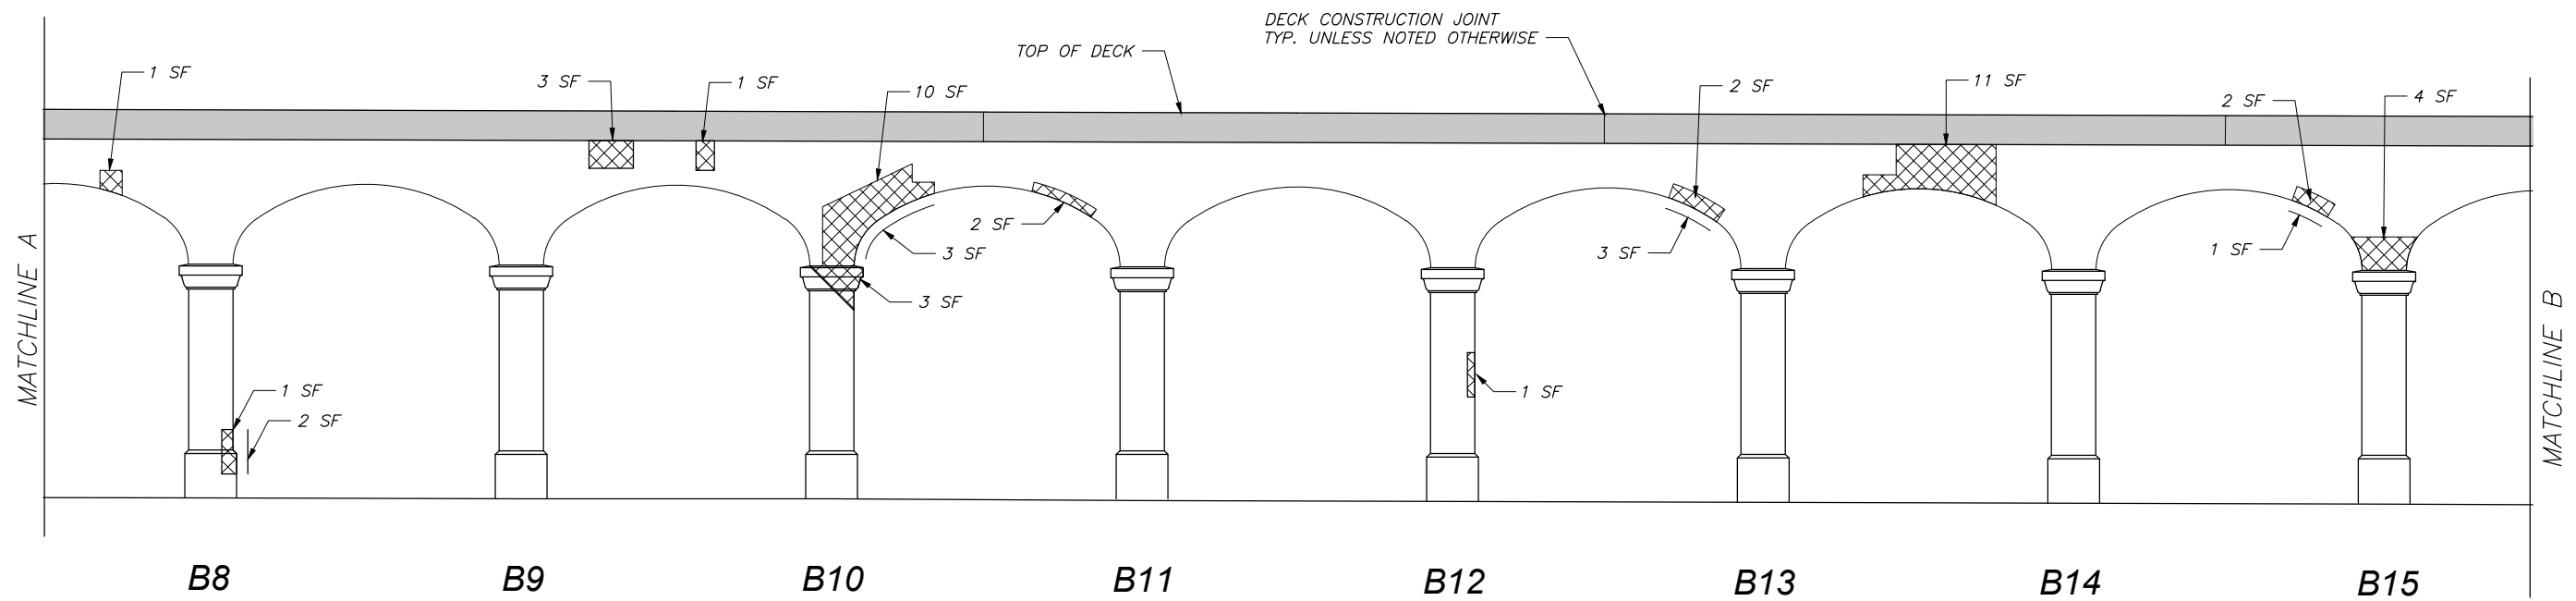
NOTE: ALL DETERIORATION QUANTITIES ARE FROM FIELD MEASUREMENTS AND ARE UNFACTORED.

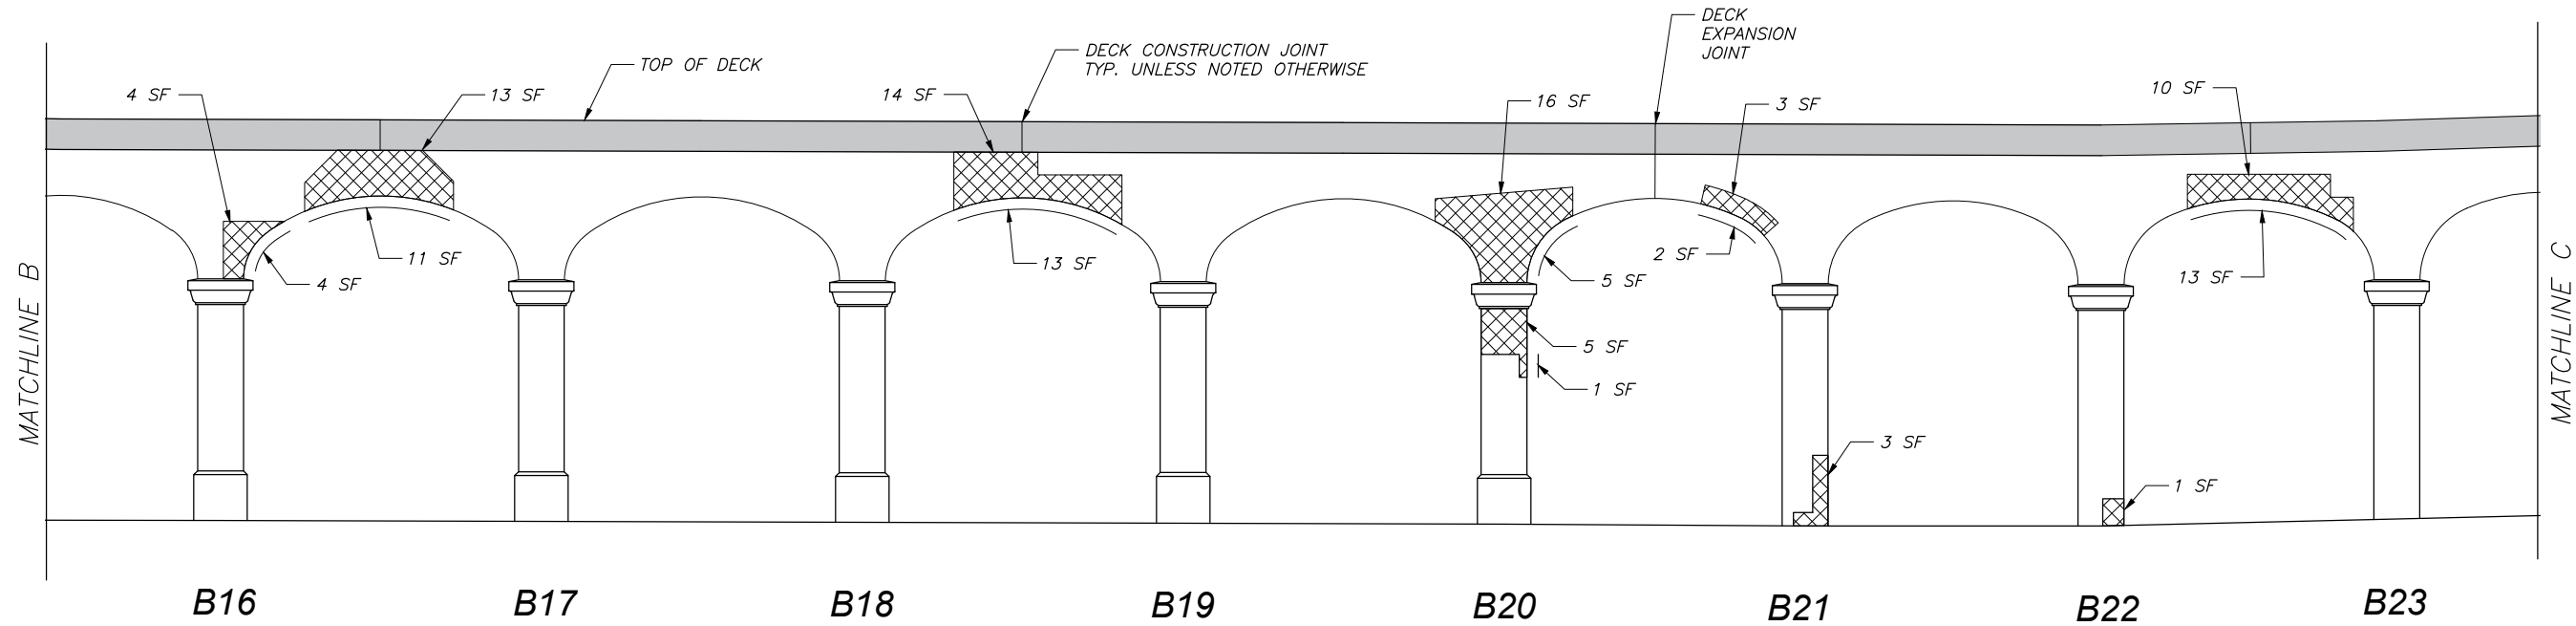
NOTE: ALL DETERIORATION QUANTITIES ARE FROM FIELD MEASUREMENTS AND ARE UNFACTORED.

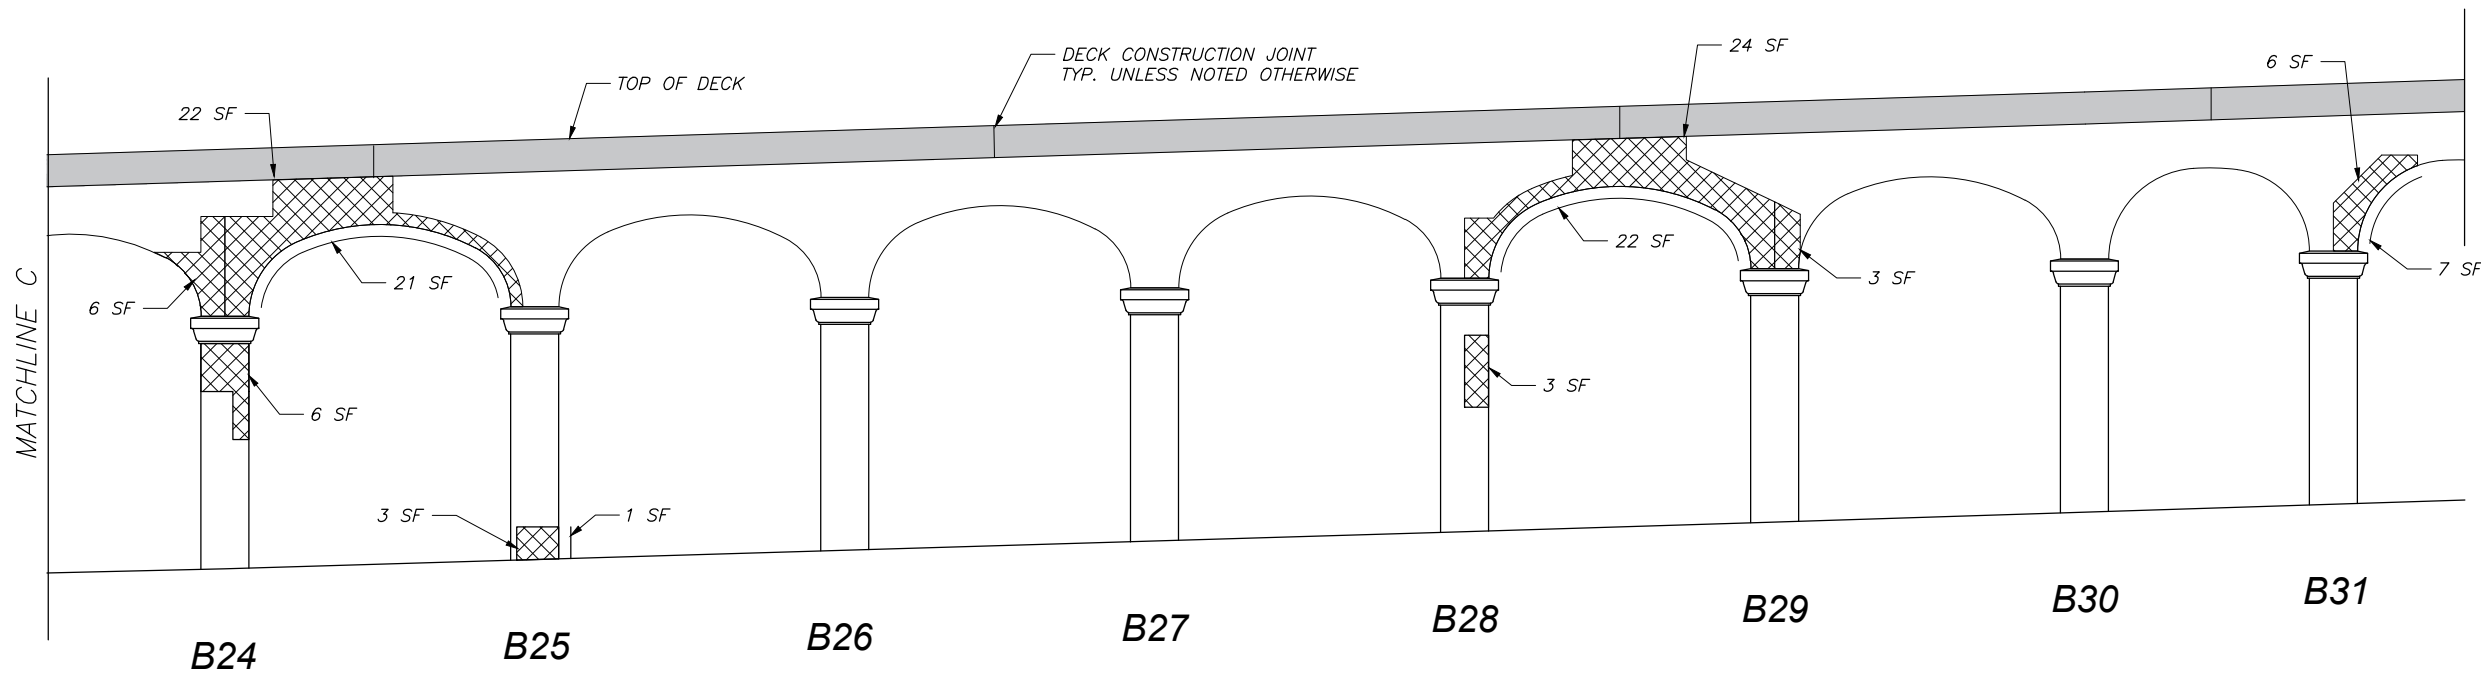
NOTE: ALL DETERIORATION QUANTITIES ARE FROM FIELD MEASUREMENTS AND ARE UNFACTORED.

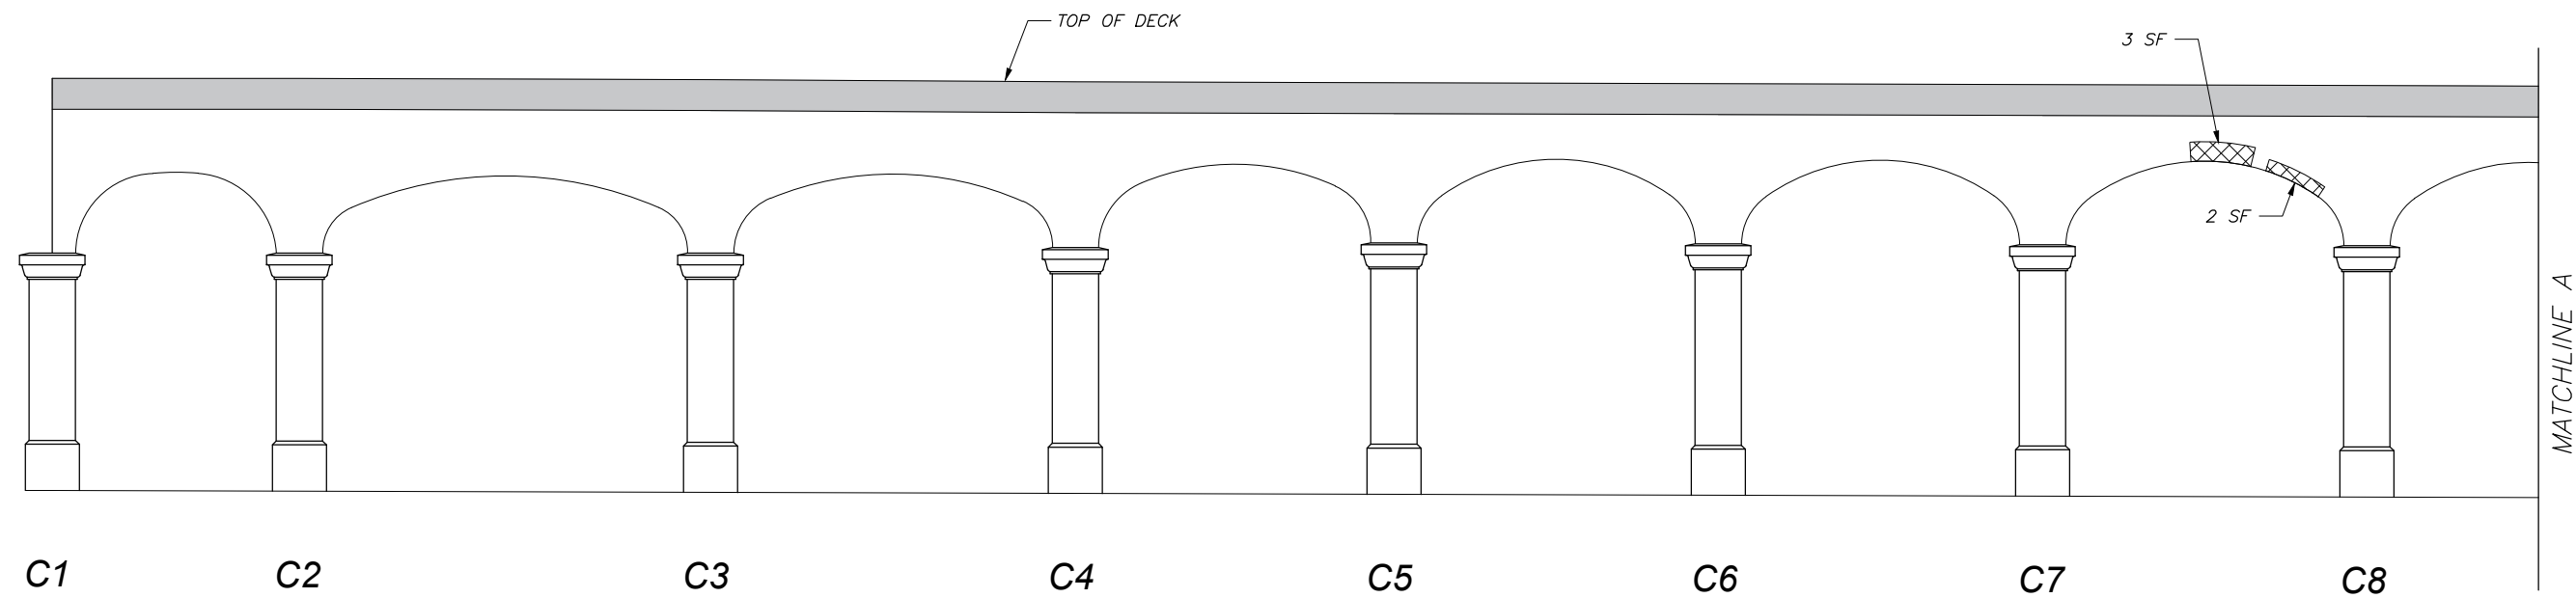
NOTE: ALL DETERIORATION QUANTITIES ARE FROM FIELD MEASUREMENTS AND ARE UNFACTORED.

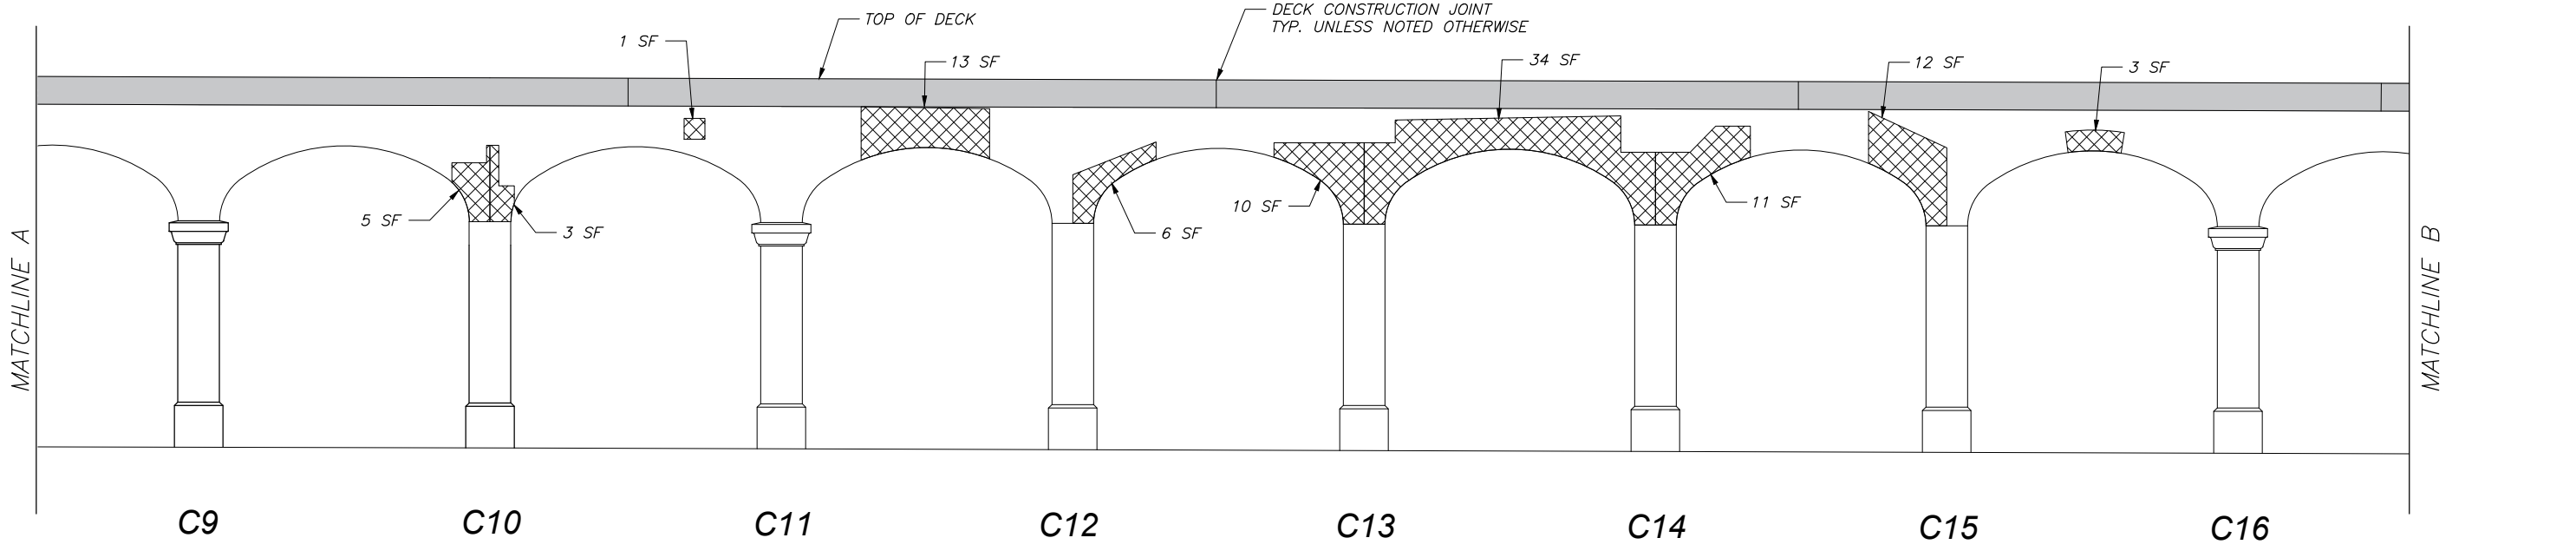
NOTE: ALL DETERIORATION QUANTITIES ARE FROM FIELD MEASUREMENTS AND ARE UNFACTORED.

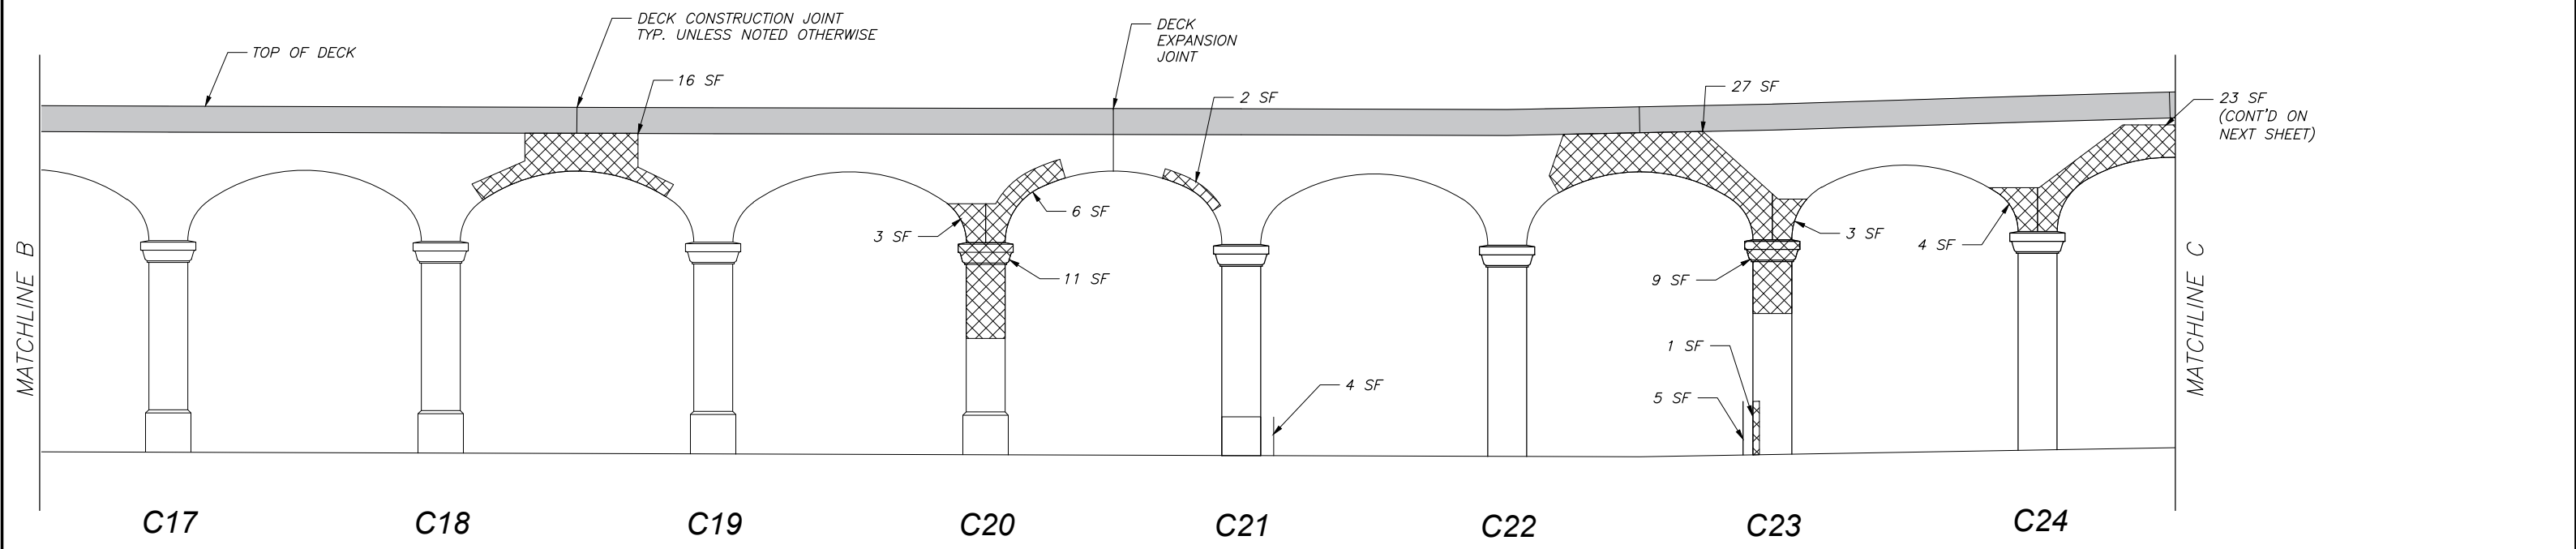
C17 C18 C19 C20 C21 C22 C23 C24

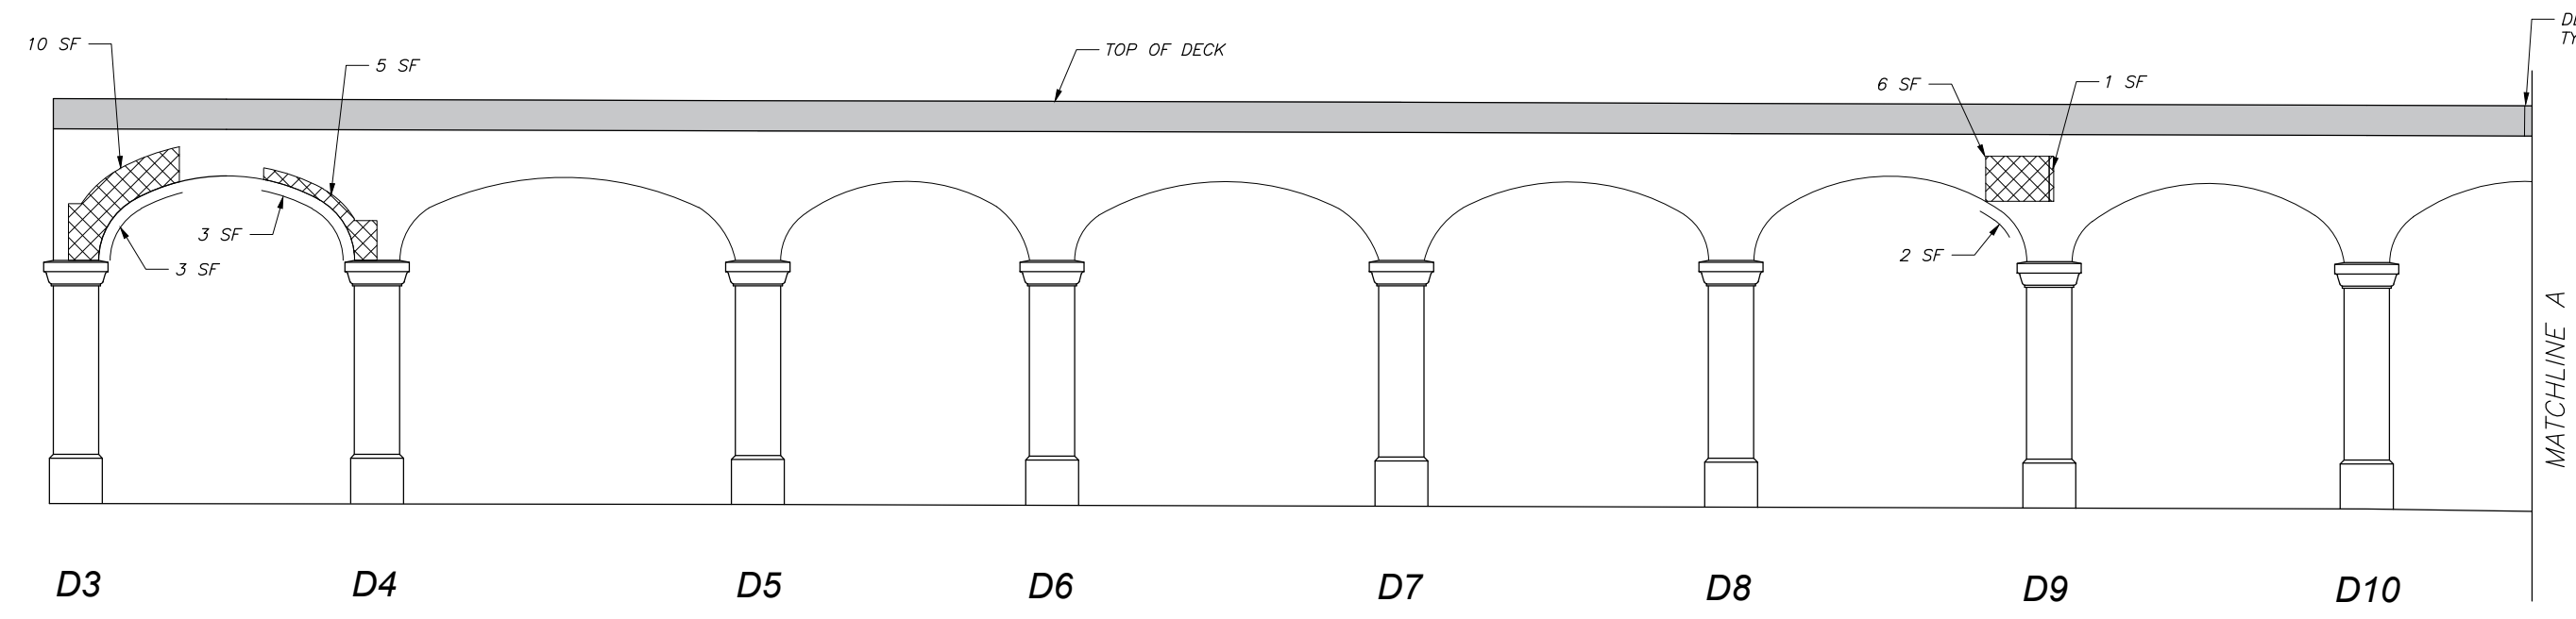
D3 D4 D5 D6 D7 D8 D9 D10

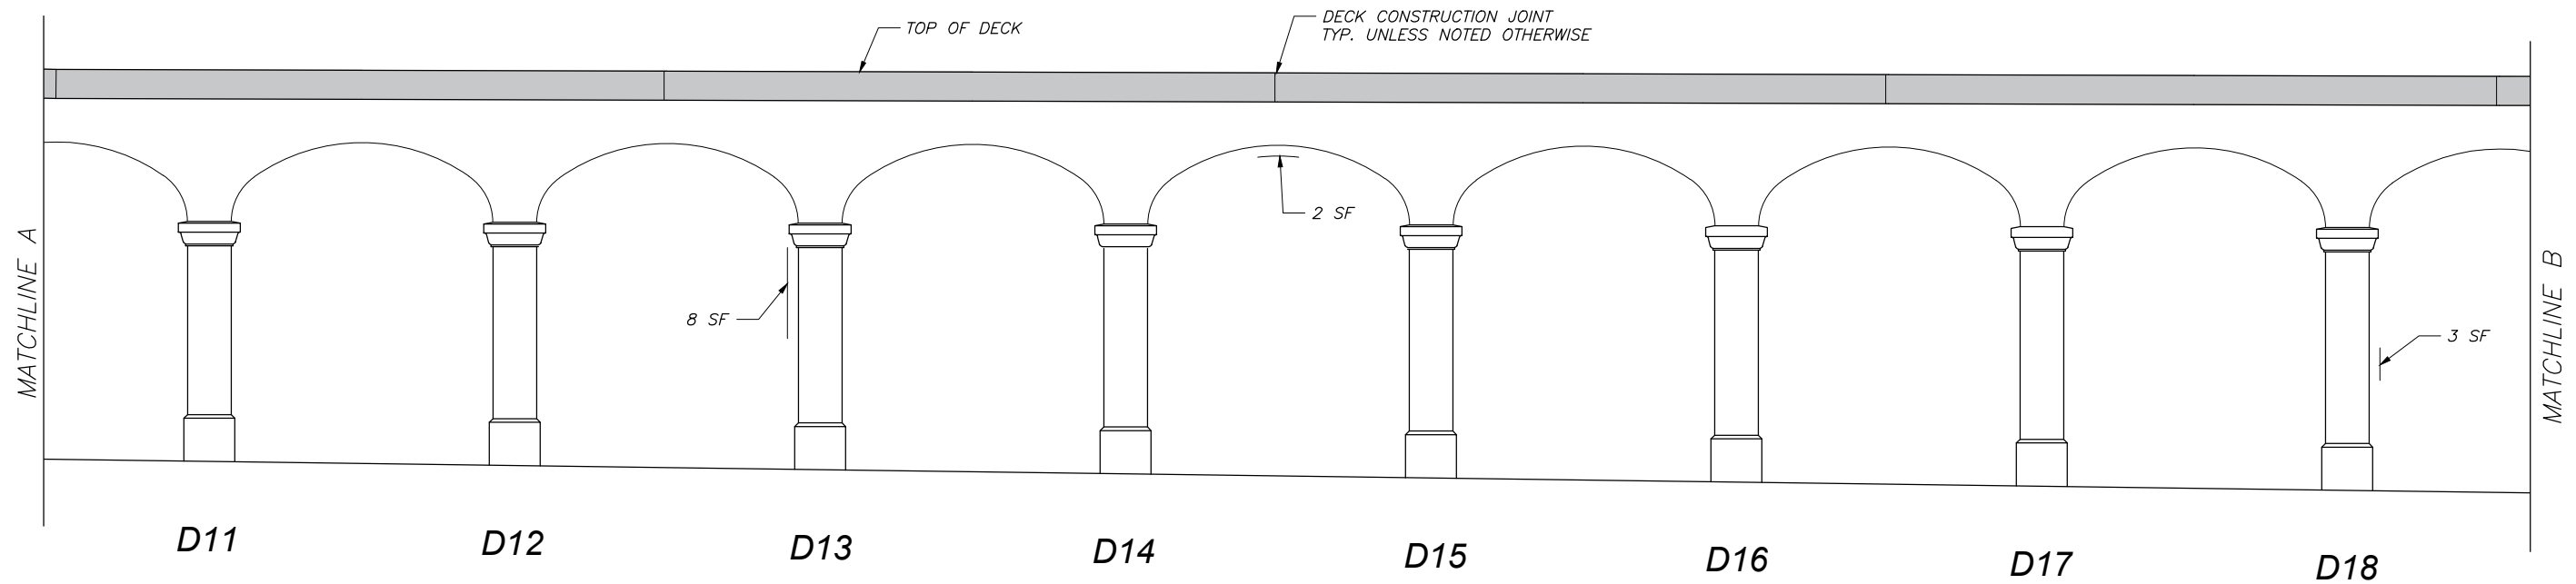
NOTE: ALL DETERIORATION QUANTITIES ARE FROM FIELD MEASUREMENTS AND ARE UNFACTORED.

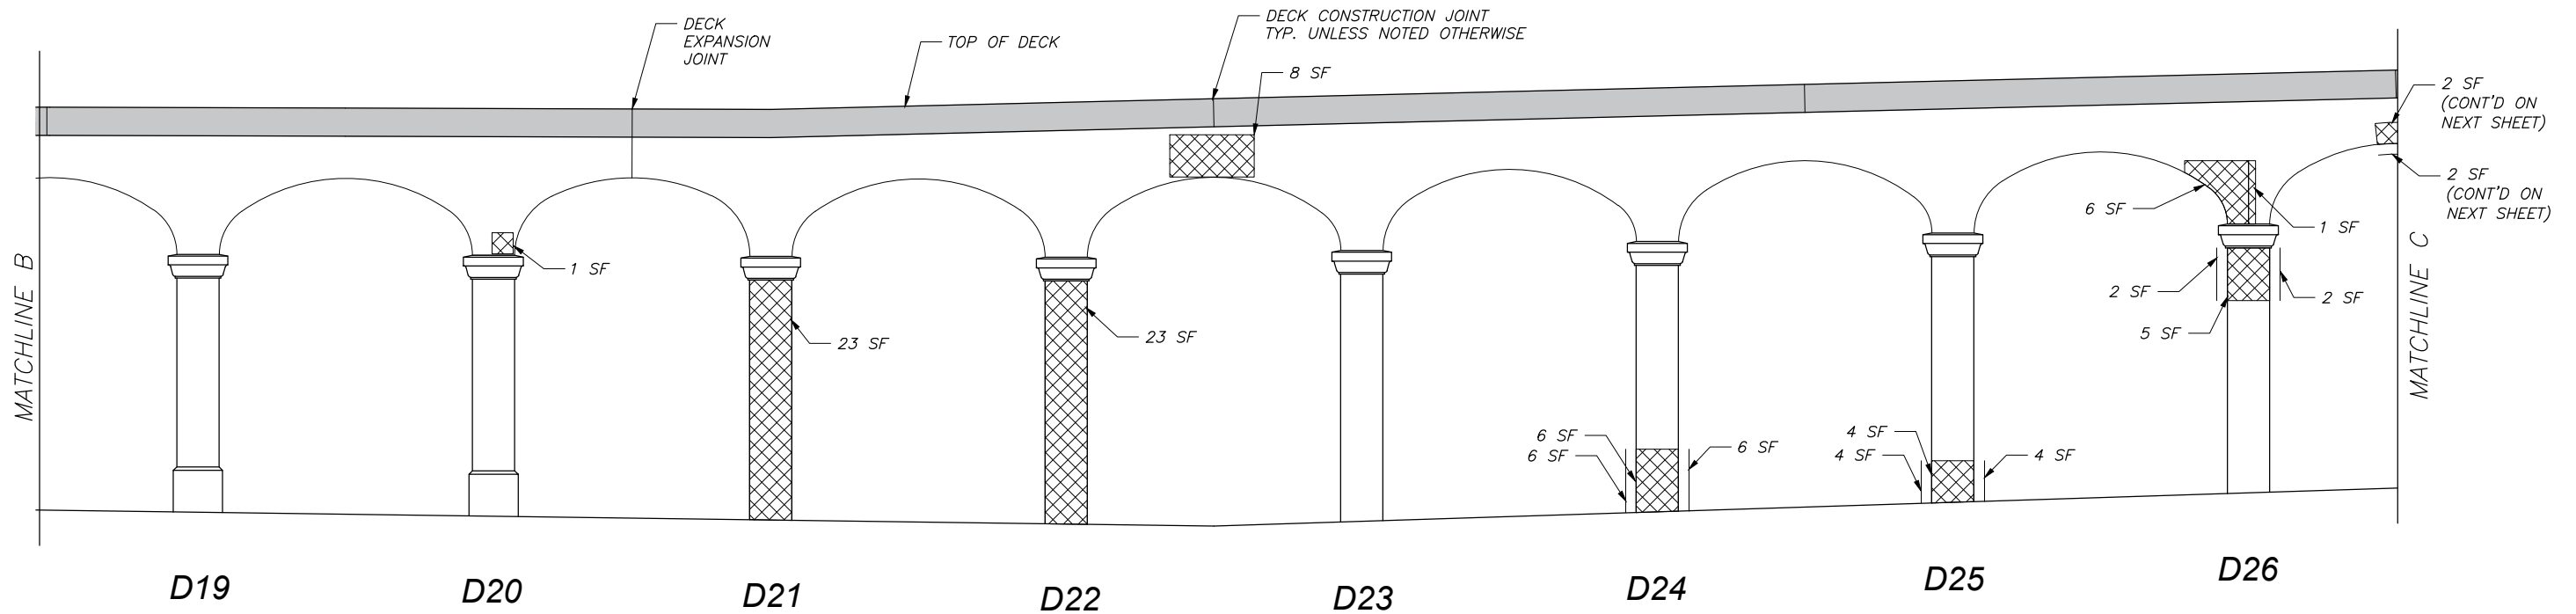
D19 D20 D21 D22 D23 D24 D25 D26
