Ohio Department of Transportation 2016 Physical Condition Report

Detroit-Superior Bridge over Cuyahoga River
Bridge No. CUY-6-1456

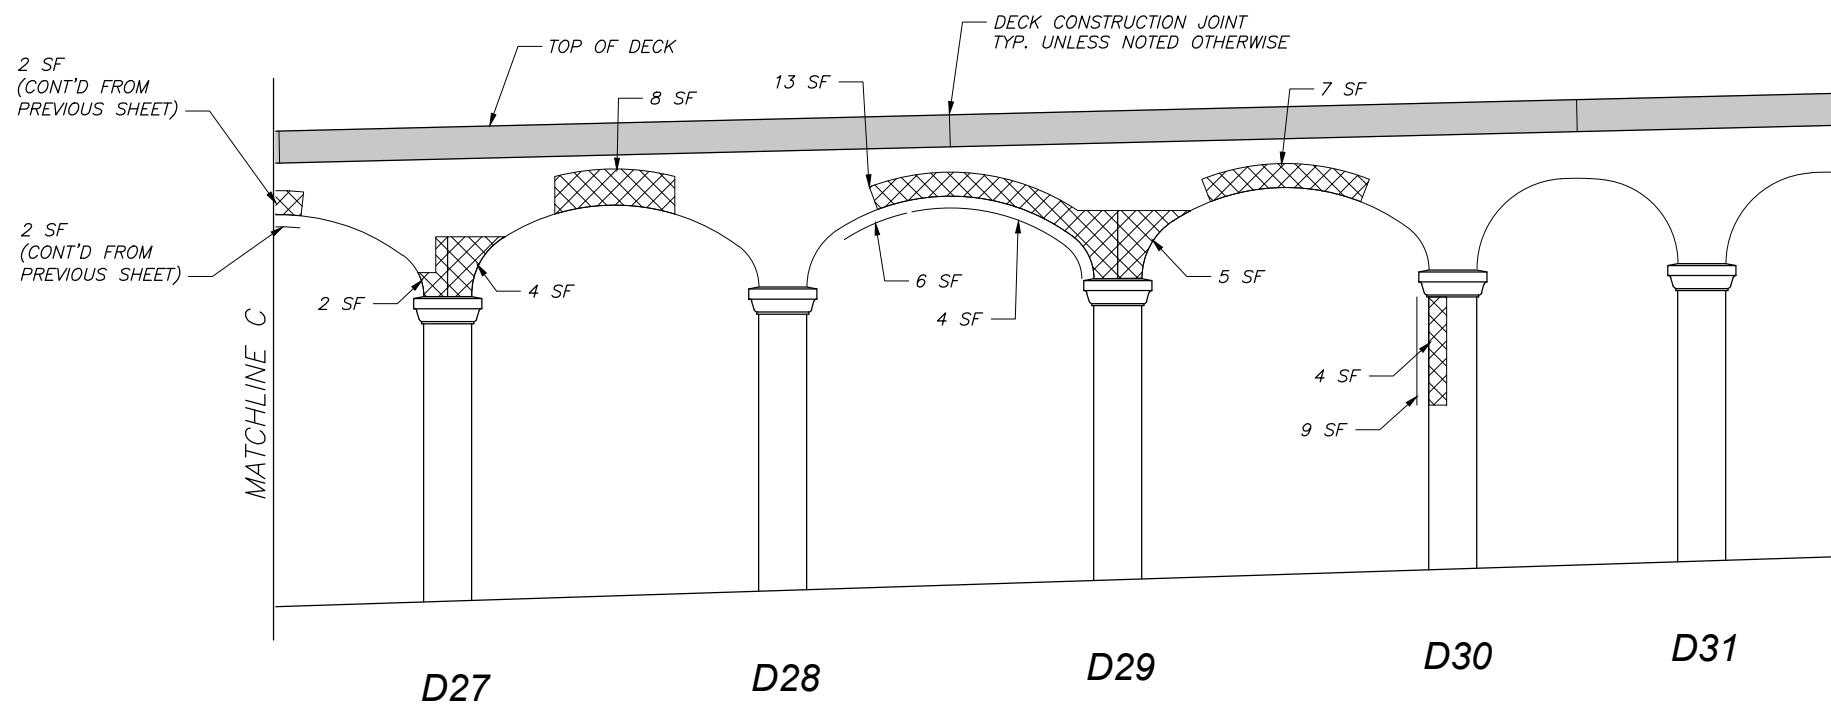
NOTE: ALL DETERIORATION QUANTITIES ARE FROM FIELD MEASUREMENTS AND ARE UNFACTORED.
