2019 PHYSICAL CONDITION FRACTURE CRITICAL INSPECTION REPORT

Bridge CUY-10-0869

SFN 1801325

S.R. 10 (Lorain Road) Bridge over the Rocky River Valley
Dates of Inspection September 9 to September 12, 2019

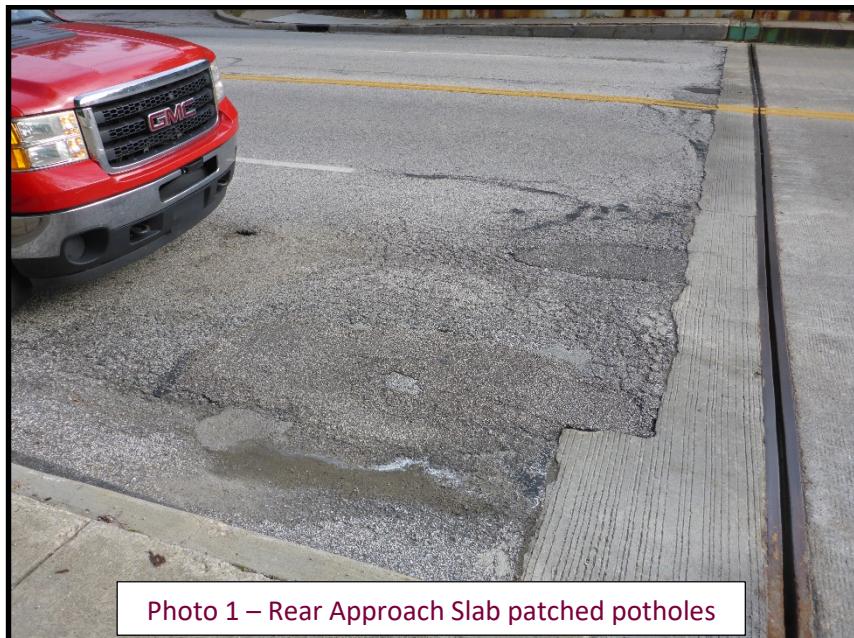
The approach slabs are in **fair** condition. The rear approach slab has an asphalt wearing surface with partially sealed longitudinal and alligator cracks and raveling. In the eastbound lanes, there are both previously asphalt patched and open potholes in the asphalt wearing surface. The south curb of the rear approach slab has three full-depth spalled cracks. The forward approach slab has a latex modified concrete wearing surface with transverse and diagonal cracking, a deteriorated asphalt patch in the westbound lanes, and deteriorated asphalt patches along the forward end of the slab in the eastbound lanes, which continue into the approach pavement.

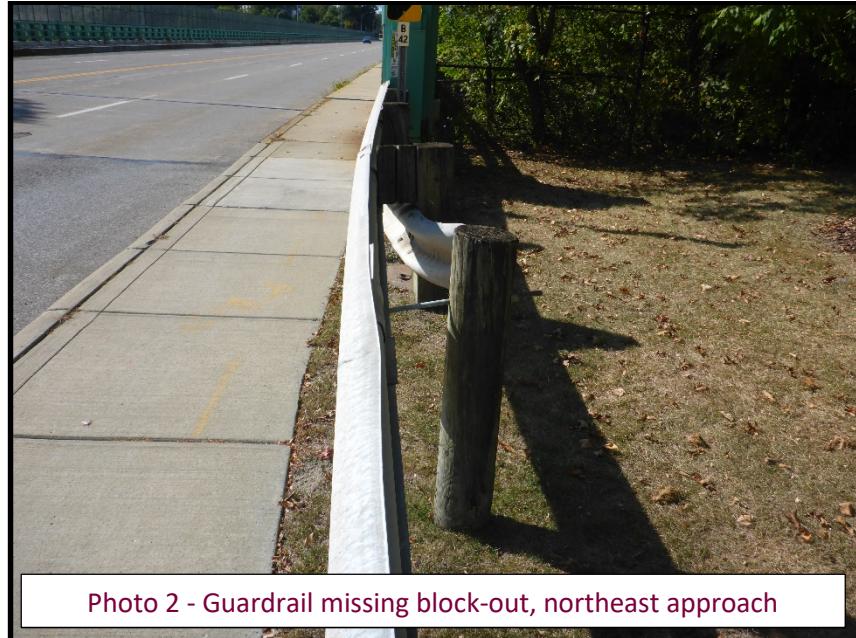
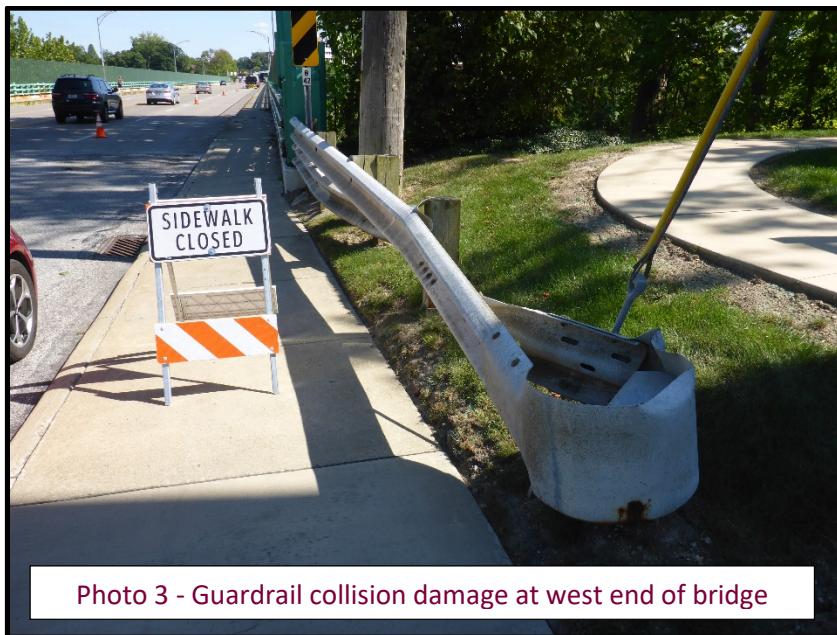
The guardrail is rated **fair**. Two posts on north guardrail, east approach, are missing block-outs. The south guardrail on west approach has collision damage and a broken end post at the end anchor assembly. The guardrail does not meet current standards at all four corners.

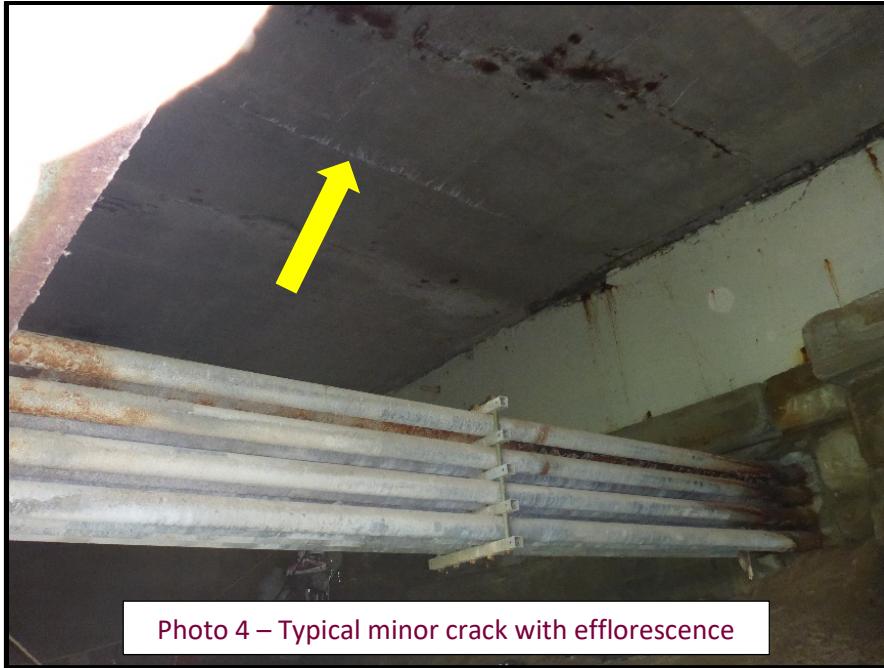
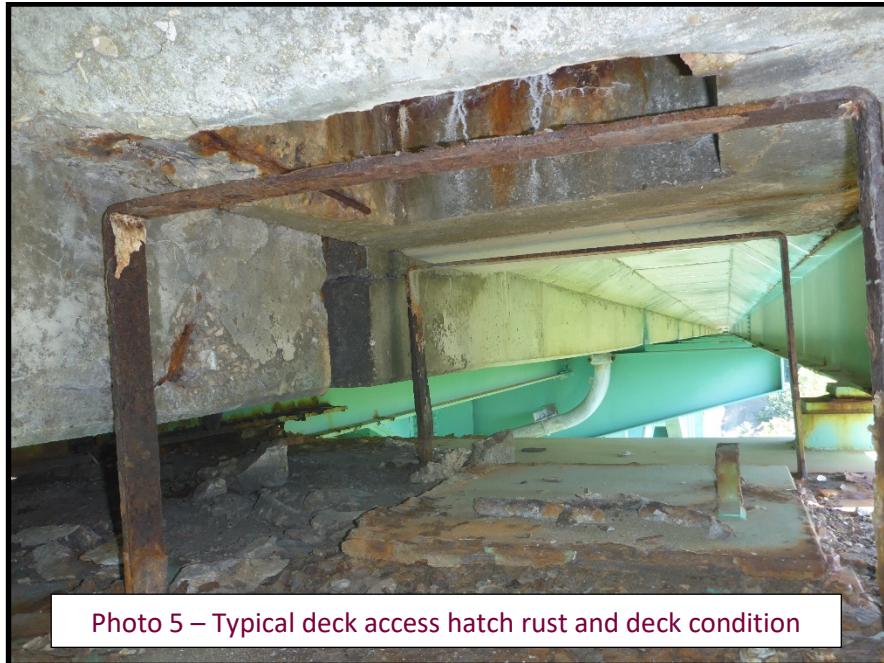
The access hatches in the deck over the pier towers in the arch spans are severely rusting and delaminating the surrounding deck concrete. The hatches leak and have dropped flaking rust onto the pier caps.

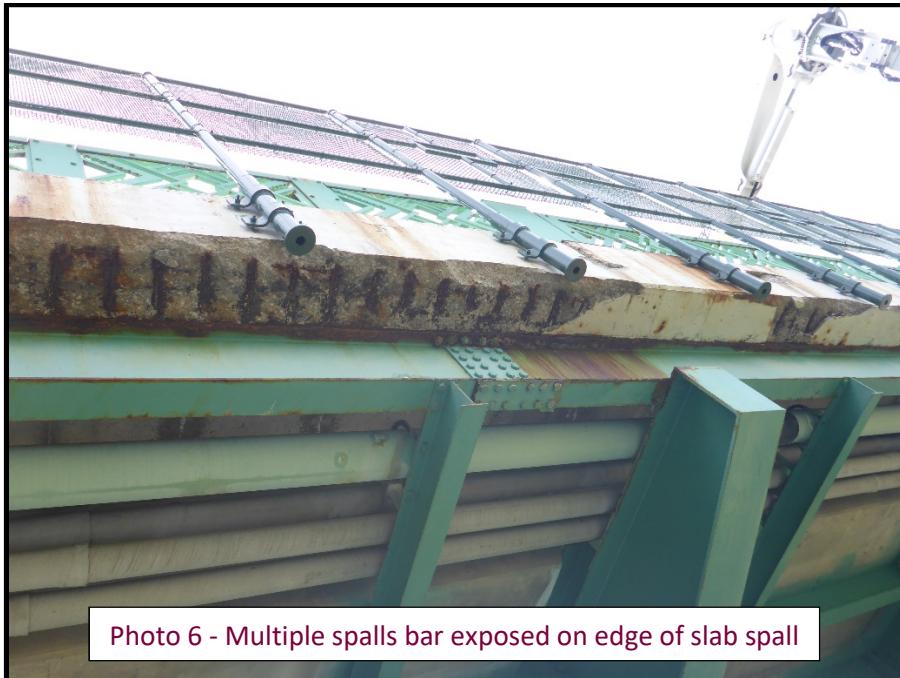
The Edge of Floor/Slab is in **poor** condition. Throughout the bridge fascia there are minor transverse cracks that continue to the interior of the deck. There are areas of patching where the new fence posts have been anchored to the edge of deck. The undersides of the deck exhibit spalls with multiple transverse bars exposed.

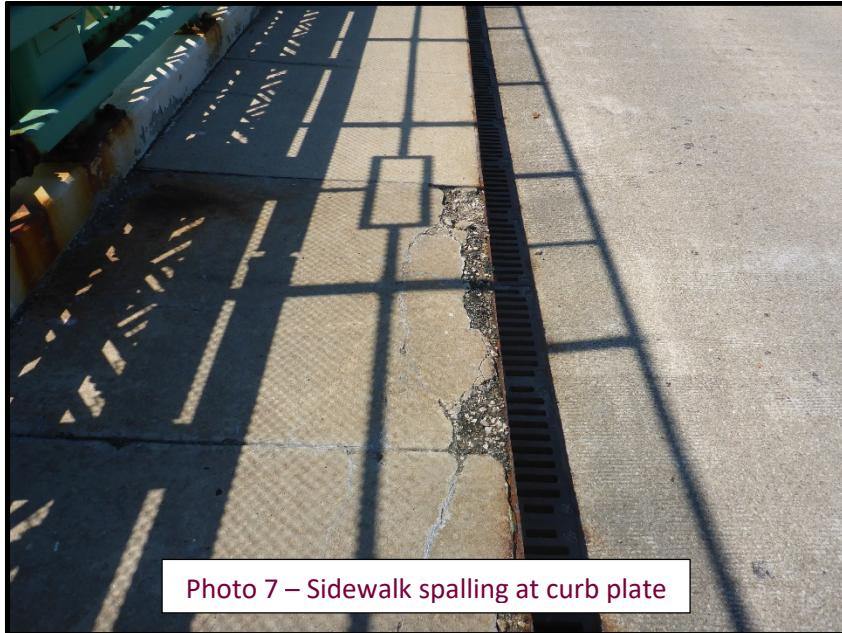
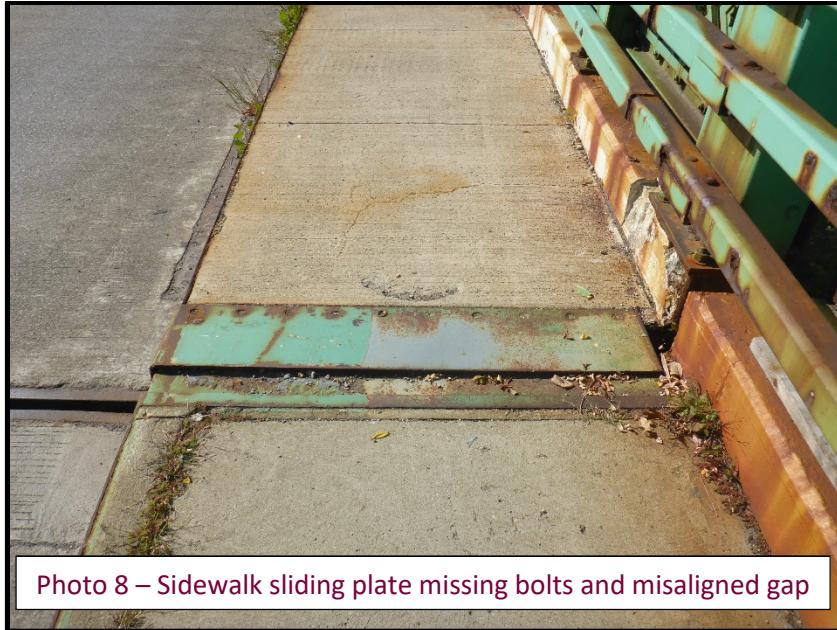
The reinforced concrete sidewalk slabs with steel curb plates are in **fair** condition with cracking and spalling in isolated areas stemming from the curb plate-to-sidewalk concrete interface. The sidewalks on the superstructure have a 3" thick concrete wearing surface. Various concrete repairs have been made to the sidewalk wearing surface, but there is typically additional deterioration around the repairs. Scaling was noted throughout the older portions of the sidewalk wearing surface in Spans 1 through 6. The northwest and southwest corners of the sidewalks along the approach slab are showing signs of heaving. An offset of up to 1½ inches exists at the northwest corner. The joint armor cover plates are missing connection bolts and are vertically misaligned at many of the expansion joints due to pack rust, and at several locations the curb portion of the joint armor cover plate is perforated due to corrosion. There is a 6" x 19" x 1" deep spall in the south sidewalk in Span 7.

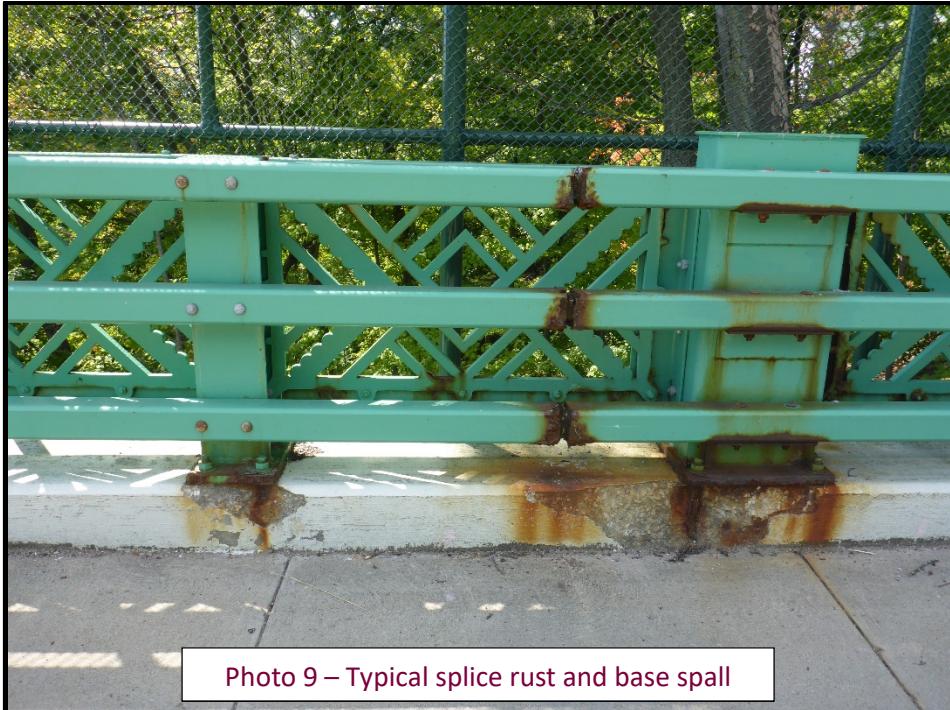
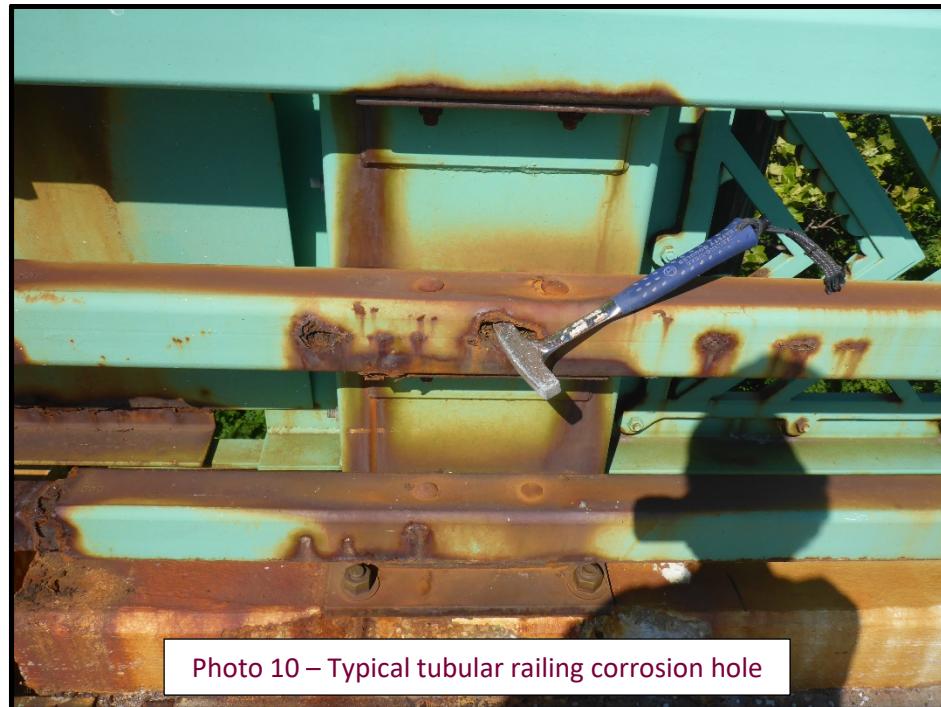
The steel tubular decorative railings on top of 11"-high concrete bases are in **poor** condition. The element level ratings are measured per linear foot and include deterioration to the steel post and tubes as well as the concrete base and the new vandal protection fence. The tubular horizontal rails are retaining water and corroding from the inside out. There are many locations where the rails have corrosion holes, particularly on the north side of the bridge. The expansion joints in the railing are heavily corroded throughout, with the north railing at Joint 5 having up to 100% section loss around the perimeter of the sliding angles. There is a broken connection bolt in the south railing connection in Span 8. The concrete bases of the railing posts are spalling in many locations, exposing the railing post anchor bolts. There is one location in Span 6 on the south railing where a two-foot long section of a 2x4 timber is embedded in the face of the concrete base. The decorative steel panels behind the tubular members are in generally good condition, though nearly all have corrosion along the top edge.

The newly installed vandal protection fence is in good condition.

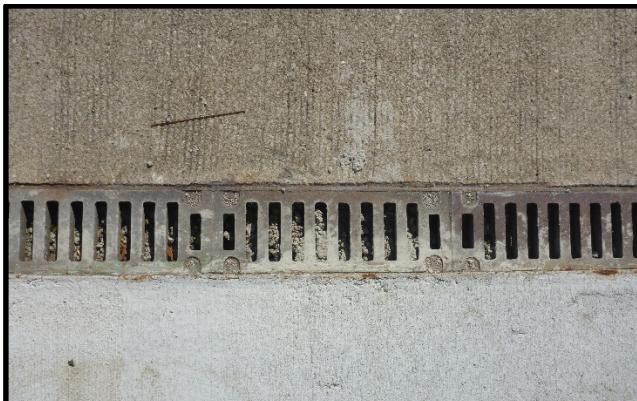
Photo 11 – Gutter drain with concrete inside

1. Clean and repaint the interior of the pier 7 north tower.
2. Clean all drainage troughs and downspouts to promote positive drainage on the bridge deck and to prevent water from the leaking downspouts from damaging the structural steel super- and substructure below.

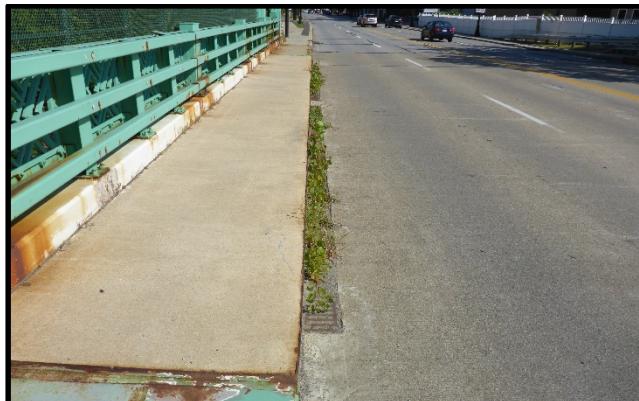
Photo 12 – Gutter drain with vegetation

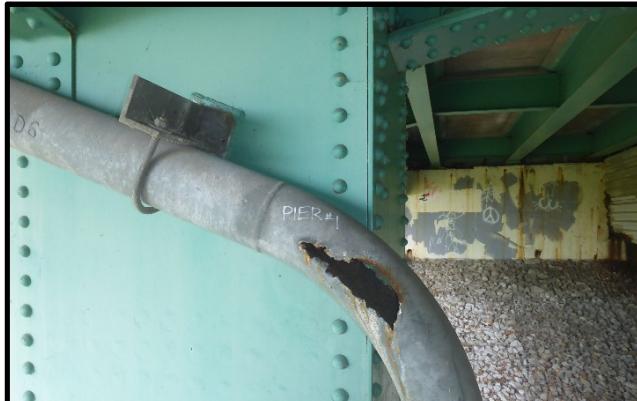
Photo 13 – Typical downspout corrosion hole

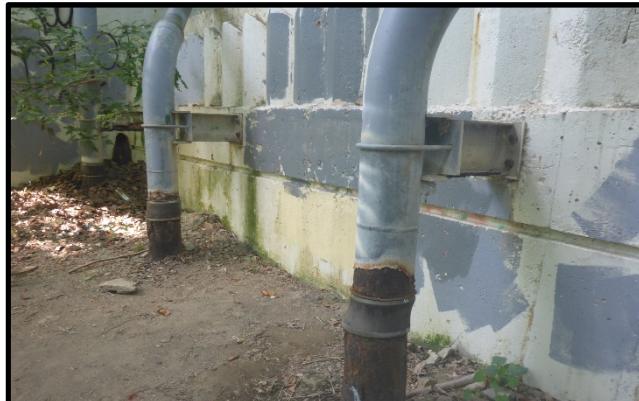
Photo 14 – Typical downspout base corrosion

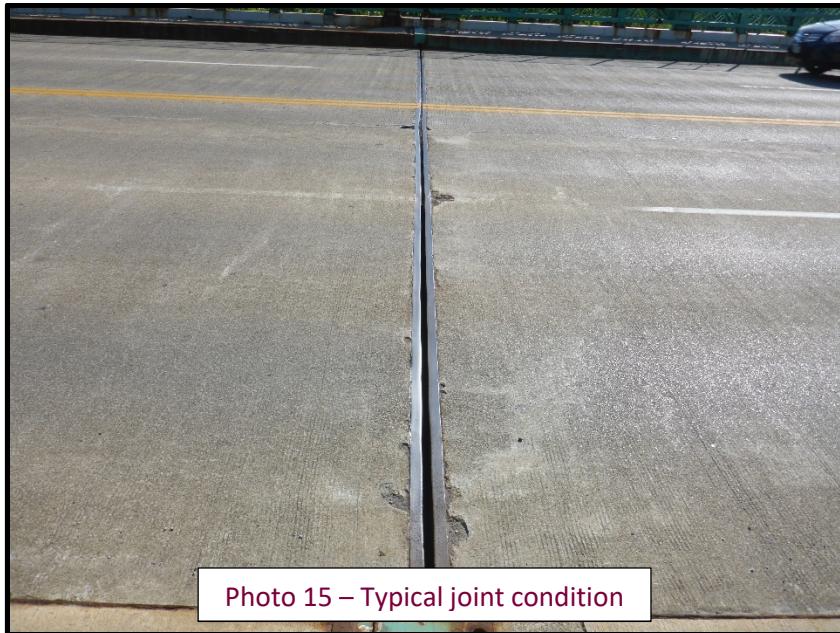
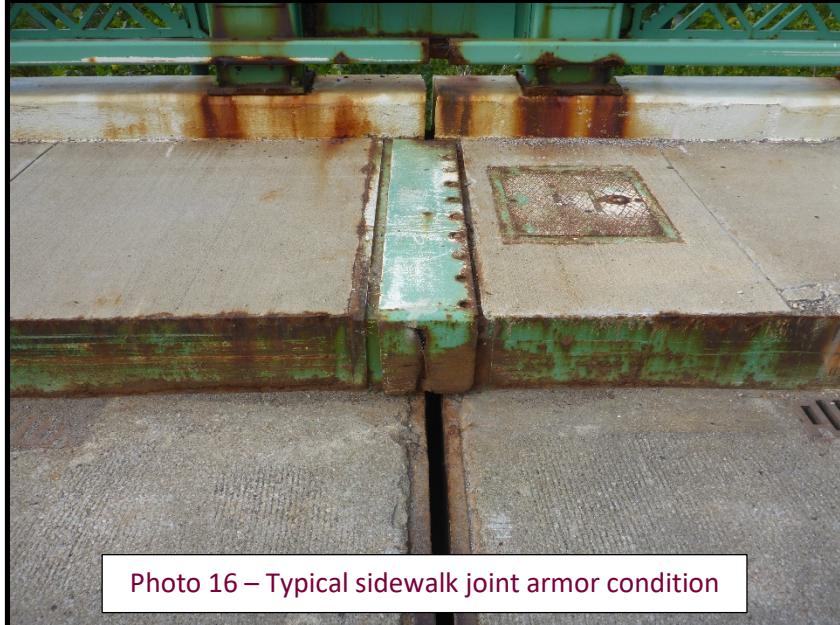
The expansion joints are in **poor** condition. The expansion joints consist of elastomeric strip seal joints at the abutments and above each pier tower. There is a 6" tear in the joint seal above Tower 8 just south of the centerline. The joints exhibit minor misalignment possibly from snow plow strikes. There is vertical misalignment in the north sidewalk joint above Towers 4 and 5, and in the south sidewalk in Spans 8 and 9. There are minor gouges in multiple locations of the joint armor. The elastomeric seal was missing in the curb lanes of the expansion joints during the inspection and the seals were impacted with debris in the remaining portions. The sidewalk portion of the expansion joints have cover plates that turn vertically down the face of the curb. The cover plates generally exhibit section loss and missing bolt heads on the top surface of the sidewalk portion and through-holes due to corrosion on the curb portion.

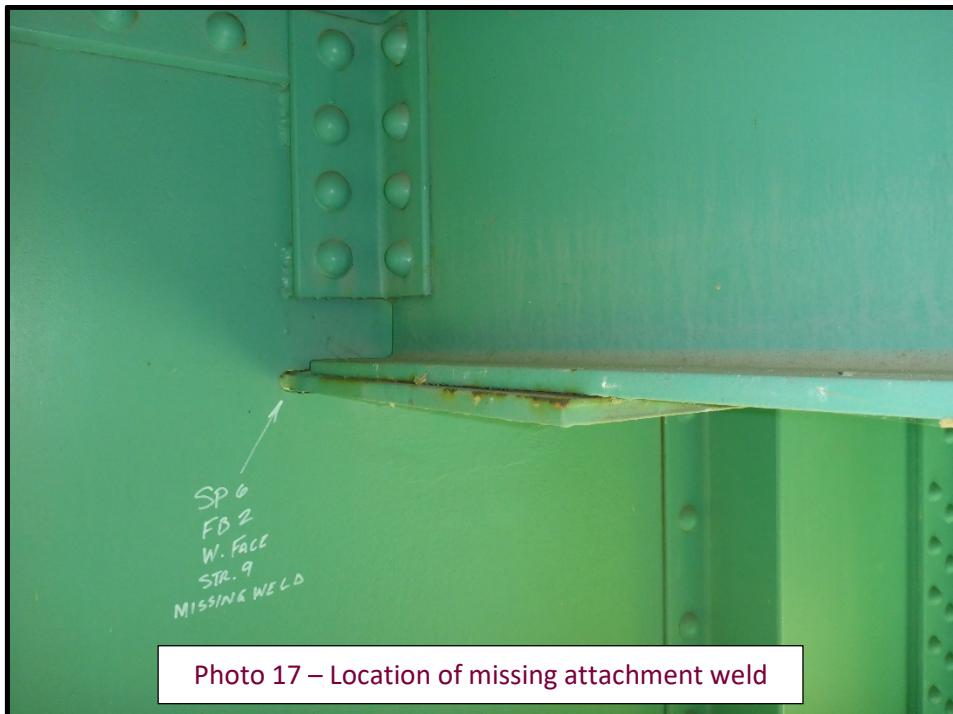
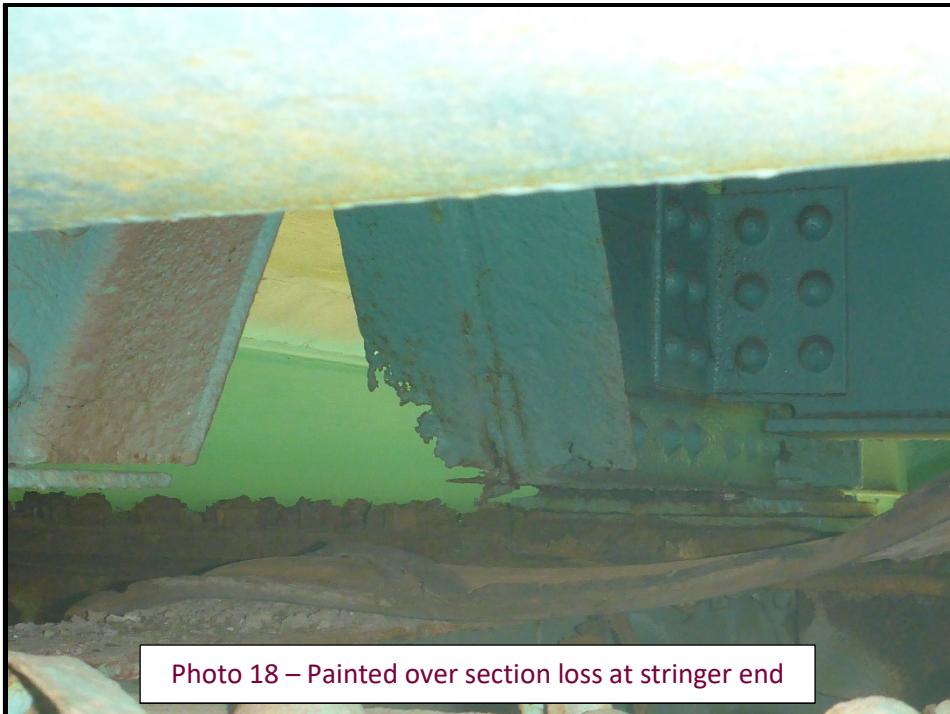
The Stringers are in **good** condition. The original stringers under the interior roadway were reused in the 1987 rehabilitation and exhibit old section loss near the expansion joints that has been painted over and are starting to show rust from beneath in some locations. There is one missing bolt on the bottom flange of Stringer 8 in Span 8 at Tower 7. There are missing welds from the stringer ends to the floorbeam seats at the ends of Stringer 9 at Floorbeam 11 in Span 5, and at Floorbeam 2 in Span 6.

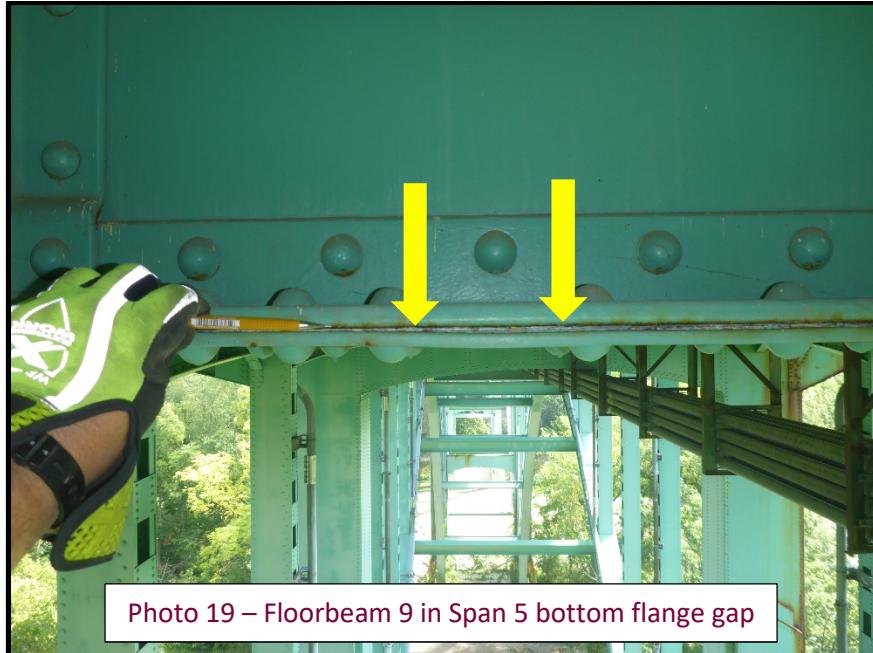
Photo 19 – Floorbeam 9 in Span 5 bottom flange gap

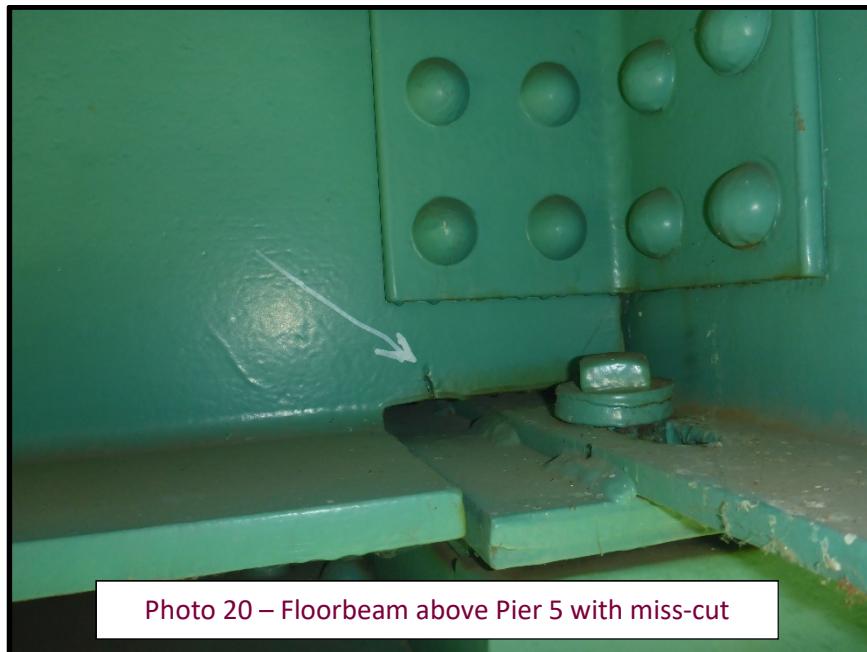
Photo 20 – Floorbeam above Pier 5 with miss-cut

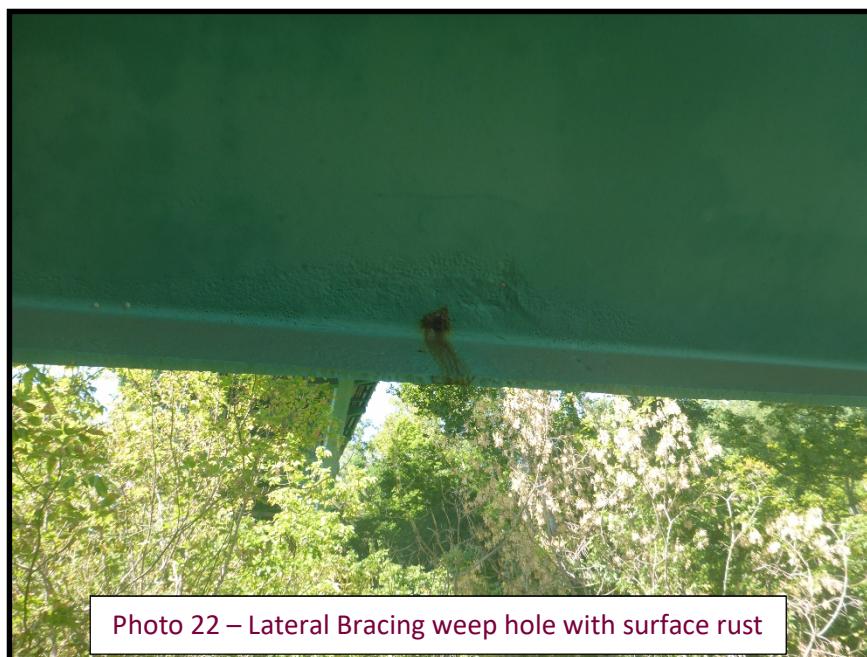
The strut lower lateral bracing is in **fair** condition. There is peeling paint with surface corrosion at several locations, but otherwise no significant deficiencies were noted.

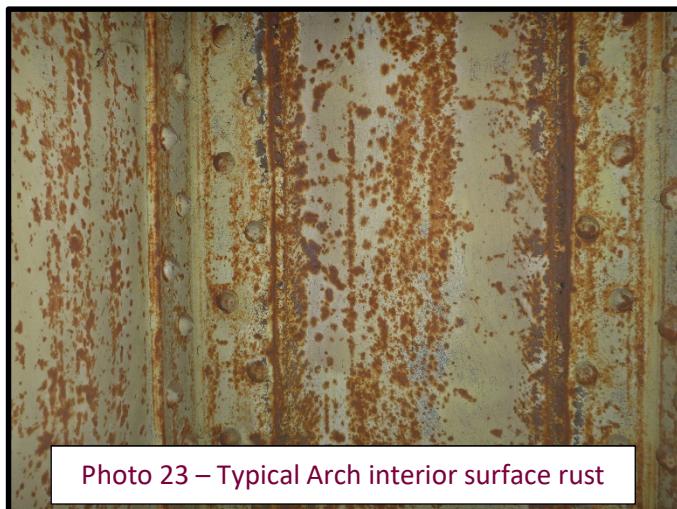
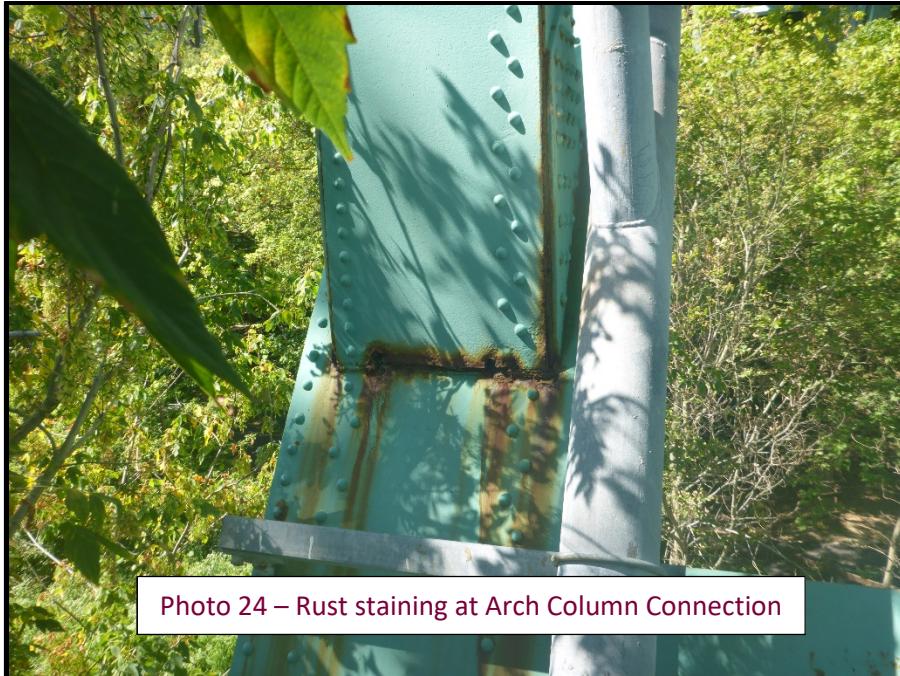
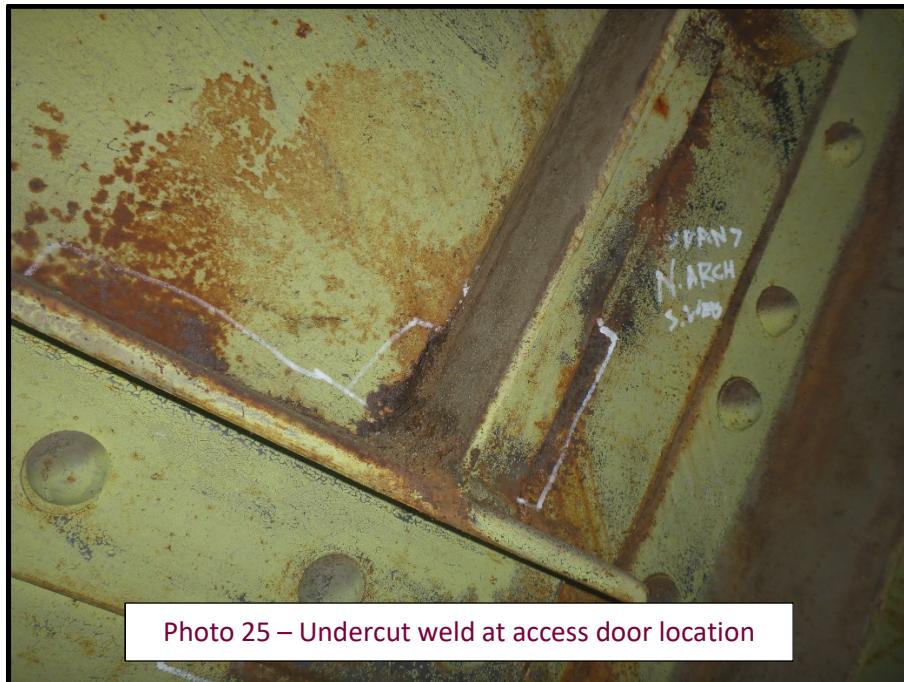
The Arches are in **good to fair** condition with random areas of peeling paint and section loss. Area around the access doors exhibit laminar corrosion with section loss up to $\frac{1}{4}$ ". Several access doors are missing, broken, or near breaking due to section loss of the hinges. Old section loss is painted over along the arch webs at the bottom flanges on the outside of the box. Rust staining at the base of Arch Columns is prevalent at the last columns near the piers and at the corresponding Lateral Bracing connections. An opossum was present in the Pier 5 base of the north arch.

There are 5 locations where there are issues with the arch access doors. In Span 5, the N access door is missing and is covered by a filter fabric. The metal ties holding it are rusting away. In Span 5, the S access door has a broken latch, so it cannot be locked. The door also does not sit flush, which is causing the hinge to bend and fatigue. It is currently being held closed by paracord. In Span 6, both the N & S access doors have broken hinges and are only held on by the lock and friction. In Span 8, the N access door has a broken hinge and is only held on by the lock and friction.

The arch interiors were inspected and are in good condition. All arches show evidence of raccoon nesting, and some arches exhibit rust staining from raccoon waste. Several locations appeared to have leaks, but all locations were dry at the time of inspection. Arch interiors were not repainted during the 1990 painting contract and have peeling paint and bare metal with a surface rust patina. Minor surface rust on the internal faces primarily located near the end Pins. The arch web base metal was undercut on the welds to the closed construction access door frames in the upper portions of the Arch (refer to photo 25).

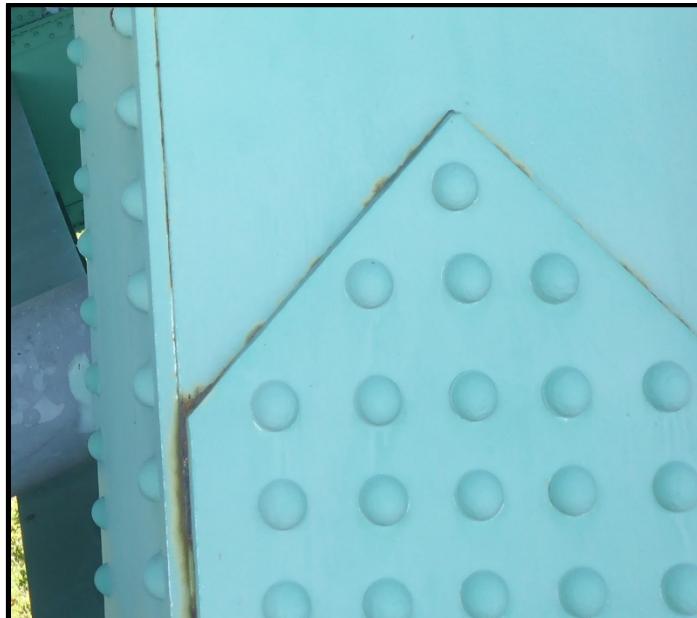
The arch columns are in **poor** condition. Minor pack rust was noted between the built-up section on both interior and exterior faces. Many of the columns are collecting debris through the open interior face. There is painted over section loss in isolated locations on the Arch Columns.

Photo 26 – Pack rust forming between plates of the Arch Column

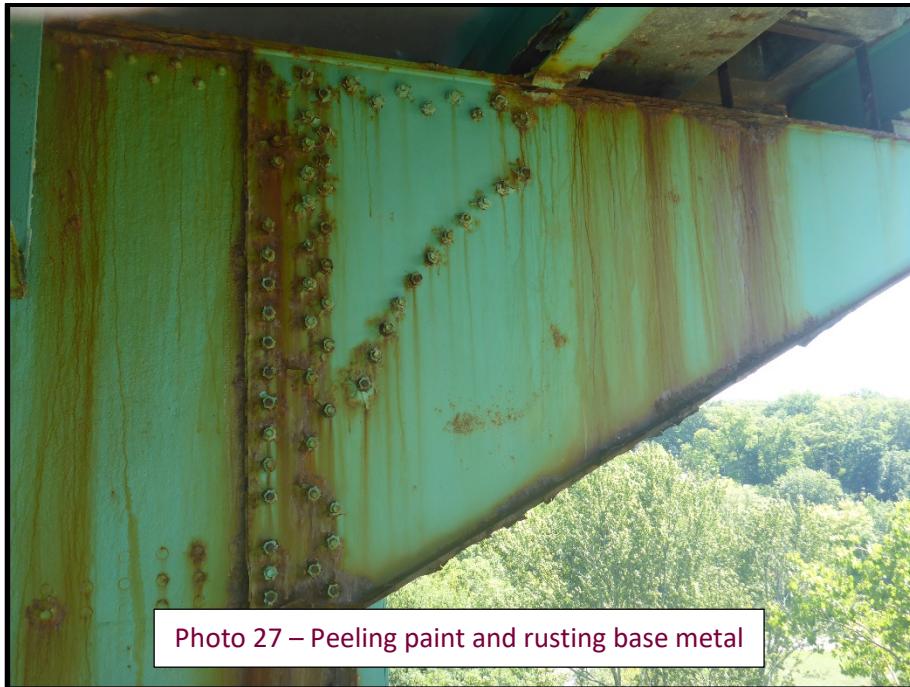
The Protective Coating System is in **poor** condition. There are localized areas where the paint is missing and the primer is exposed. Areas around the drainage system show the most deterioration to the PCS. In these areas, there is both surface corrosion and laminar corrosion to the girder, floorbeam, and bearings. The PCS on the arches and arch columns are in poor condition exhibiting a dull chalky appearance and rust staining.

The interior of the arches was not repainted during the 1990 painting contract. Since the interiors of the arches are generally dry and not exposed directly to weather, failure of the paint system is not a great concern. Even though the paint on the exterior of the arches was generally in good condition, the arch interior that was in poor condition governed the paint rating for the arches (see Photo 21).

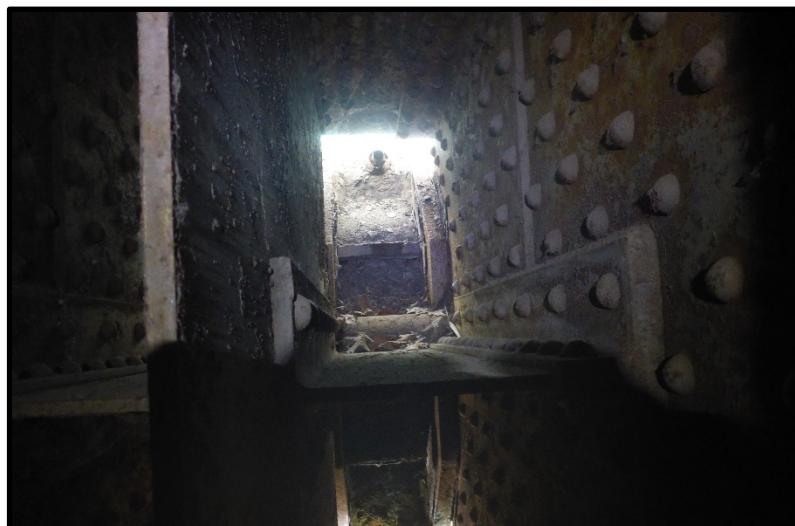
The pins for the arches are rated in **good** condition. The visual inspection noted minor section loss due to surface corrosion.

Photo 28 – Surface corrosion surrounding arch pin

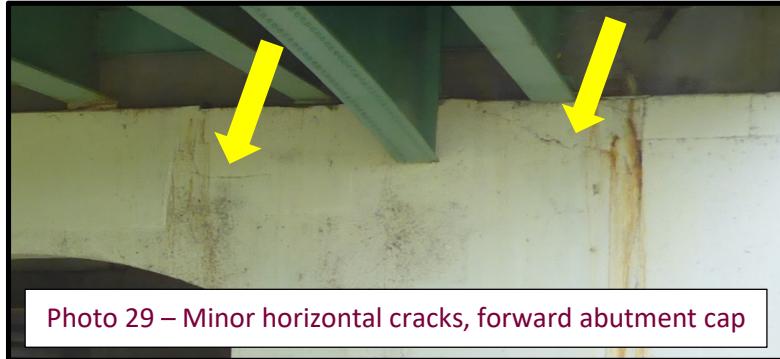
The abutment caps are in **good** condition. The forward abutment exhibits a horizontal crack and a vertical crack below Stringers 10 and 12.

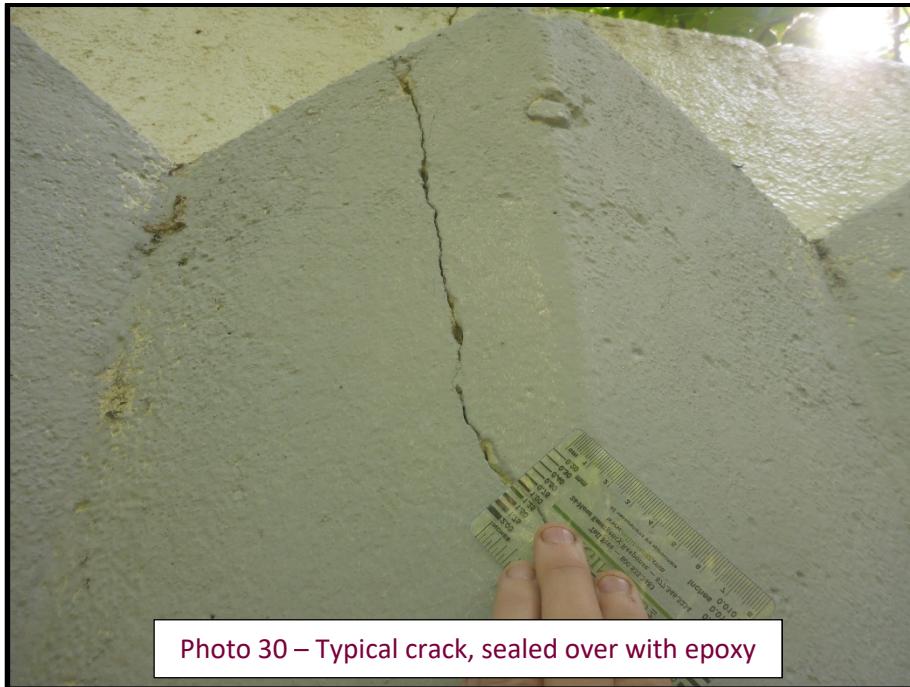
The pier walls are in **fair** condition. The pier walls and the pier caps were visually inspected. The pier walls exhibit areas of delaminations, cracks, and spalling with exposed reinforcing steel. The following deficiencies were also noted:

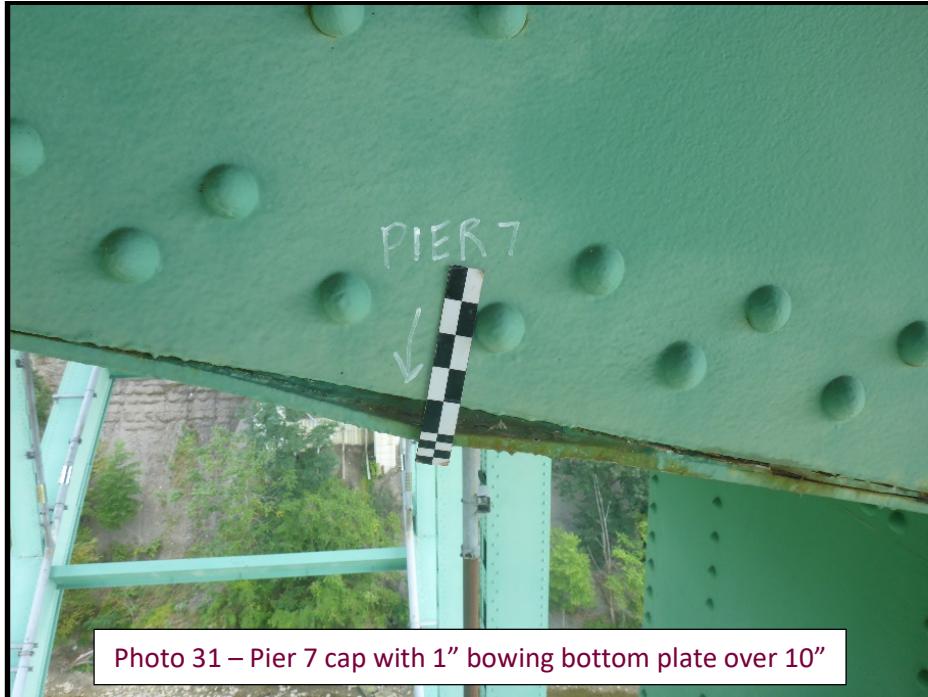
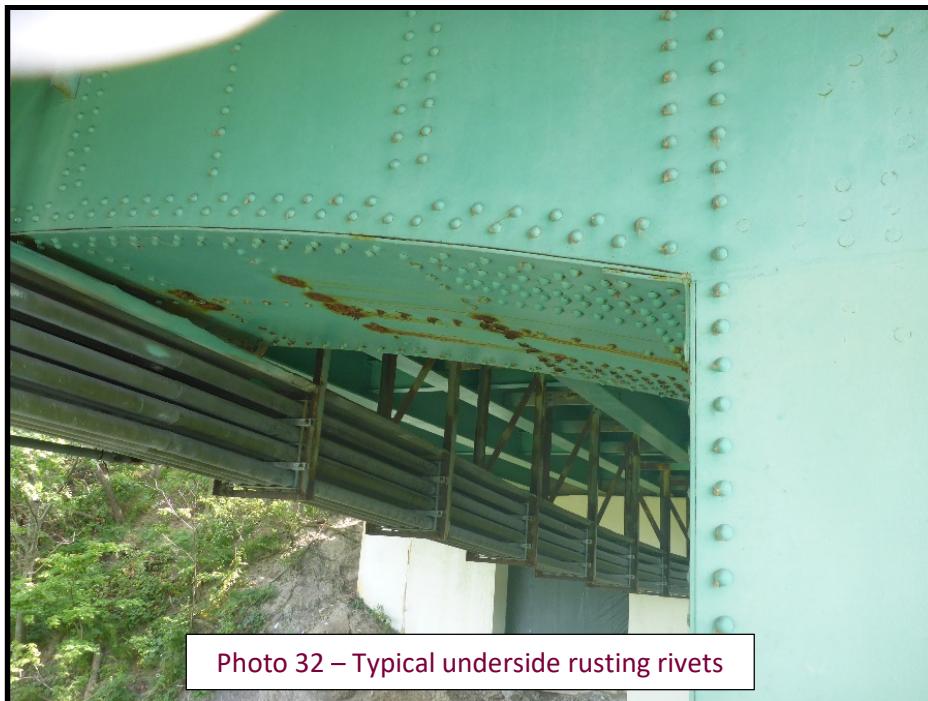
The steel pier caps are in **good to fair** condition. The arch-span Pier Caps exhibit minor corrosion and section loss due to leaking expansion joints. There is section loss on several stiffeners on the bottom of the cap interiors. The bottom plate of Pier 7 is bowed 1" over 10" on the West face of the Pier cap north of the South tower. Critter screen protection has failed, and the pier caps and columns are littered with raccoon fur and droppings.

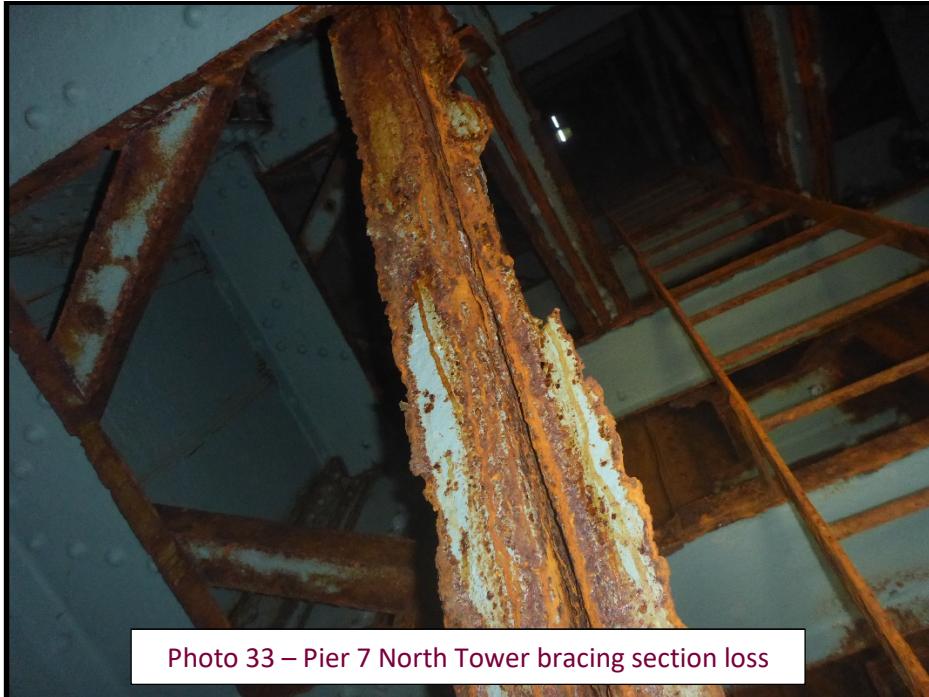
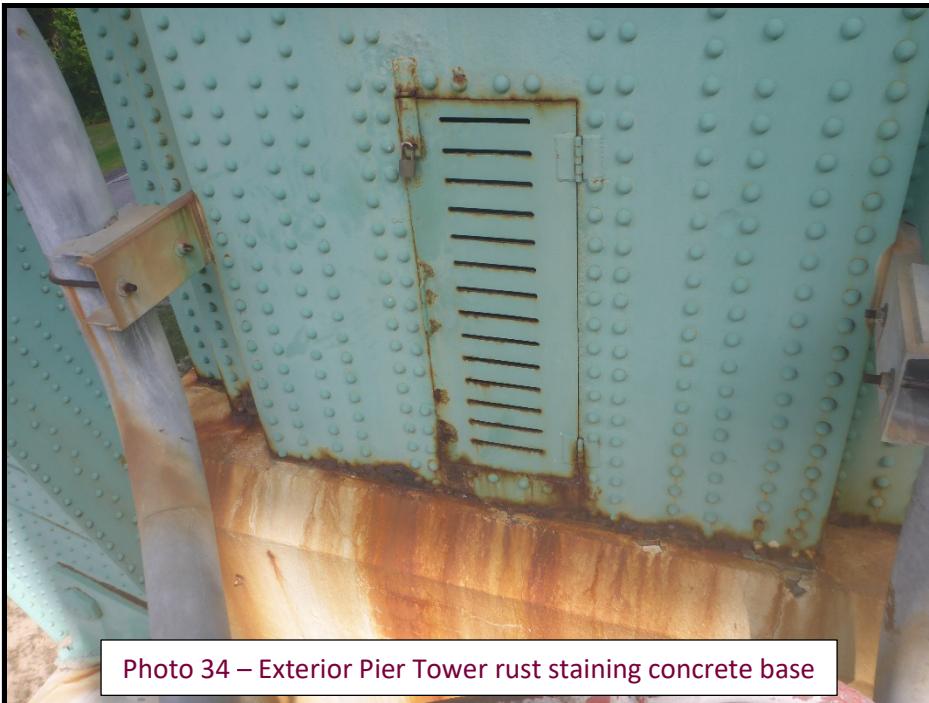
The steel built-up box pier columns are in **poor** condition. The Pier Columns rated as "each", which causes the presence of corrosion holes or bent plates due to pack rust to lower the entire column rating down to CS-3. The tower columns have minor surface corrosion on the exterior, localized to the connection between the art deco chevron relief. The approach span Pier Columns exhibited rust around the base of the Columns. Debris and fallen rust have accumulated along the horizontal stiffeners, flanges and in the corners of all towers.

The interiors of the towers have section loss in multiple locations up to complete flange loss of the dual-angle bracing members. Multiple stiffeners inside Towers 5, 6 and 7 have 50%-100% section loss. Corrosion holes in plates in several towers range from 1/8" up to 2-1/2" in diameter but are not concentrated in any one plate. Pack rust is distorting the bracing angles up to 1-1/4". Several access door hinges are broken making opening the steel doors for the access hatches dangerous for inspectors.

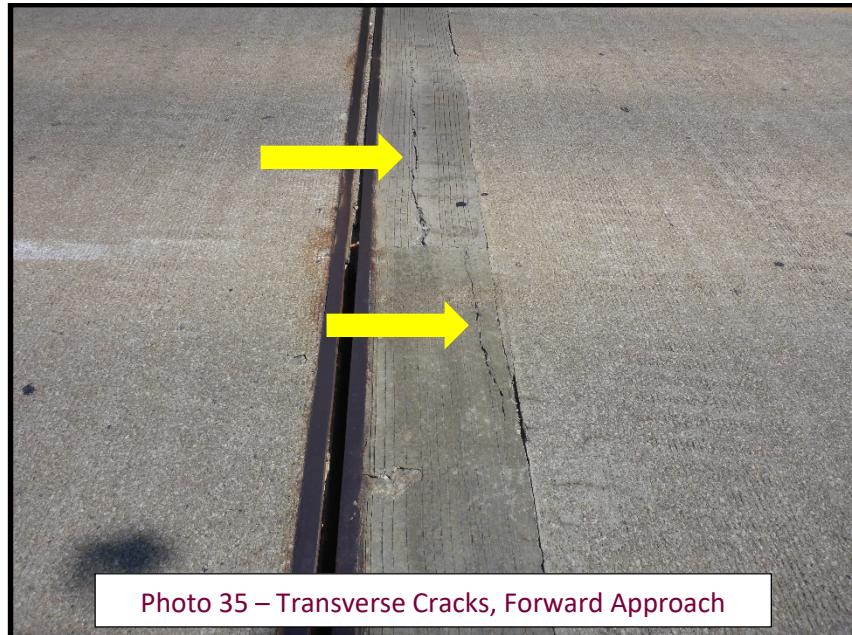
The backwalls are in **good** condition with few vertical cracks. The top of the forward abutment backwall at the joint anchor has transverse cracking.

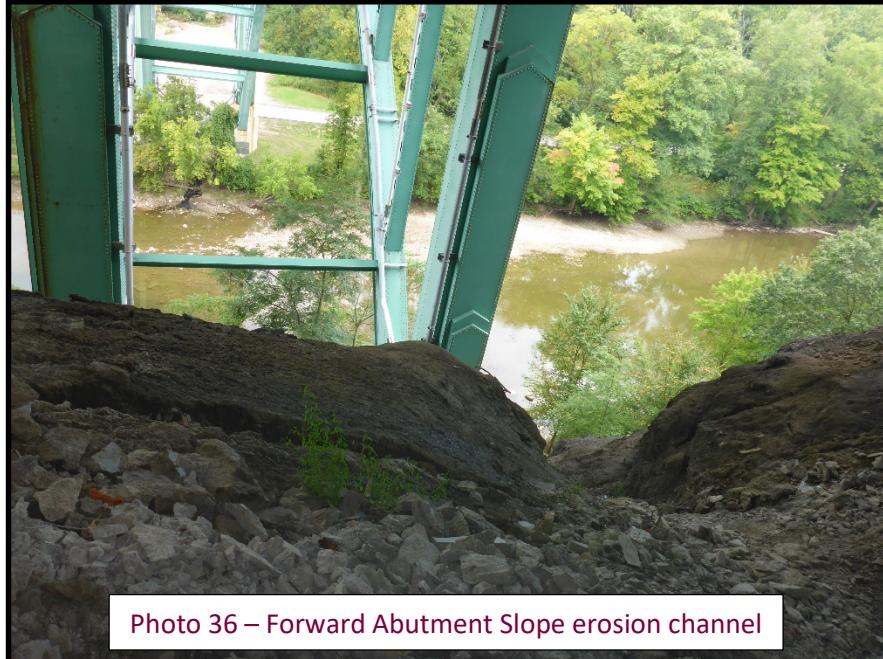
The slope protection is in **poor** condition. The Rear Abutment slopes down to a gabion basket wall at the multi-use path, which appear to be new and are in good condition. The west embankments below the path and Tower 4 are heavily vegetated with drainage erosion causing a channel down the center of the bridge. The east bank of the Rocky River at the Forward Abutment consists of easily erodible, heavily weathered shale and has

sloughed up against and overtopped the concrete base of Tower 8. The slope on the west side of Tower 8 is severely eroded with a swale forming on the northern side of the shale slope.
