2019 PHYSICAL CONDITION FRACTURE CRITICAL INSPECTION REPORT

Bridge CUY-10-0869

SFN 1801325

S.R. 10 (Lorain Road) Bridge over the Rocky River Valley
Dates of Inspection September 9 to September 12, 2019

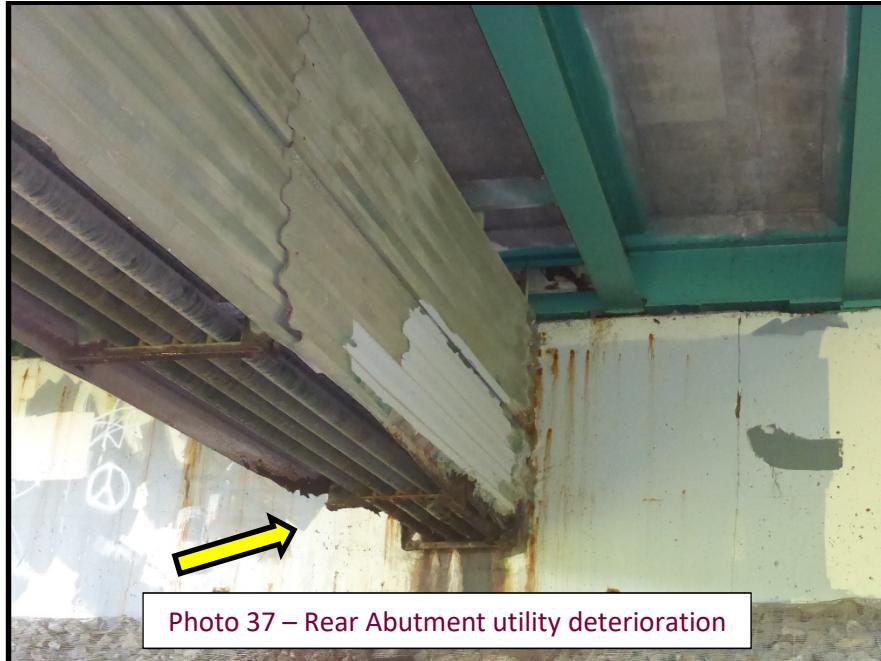
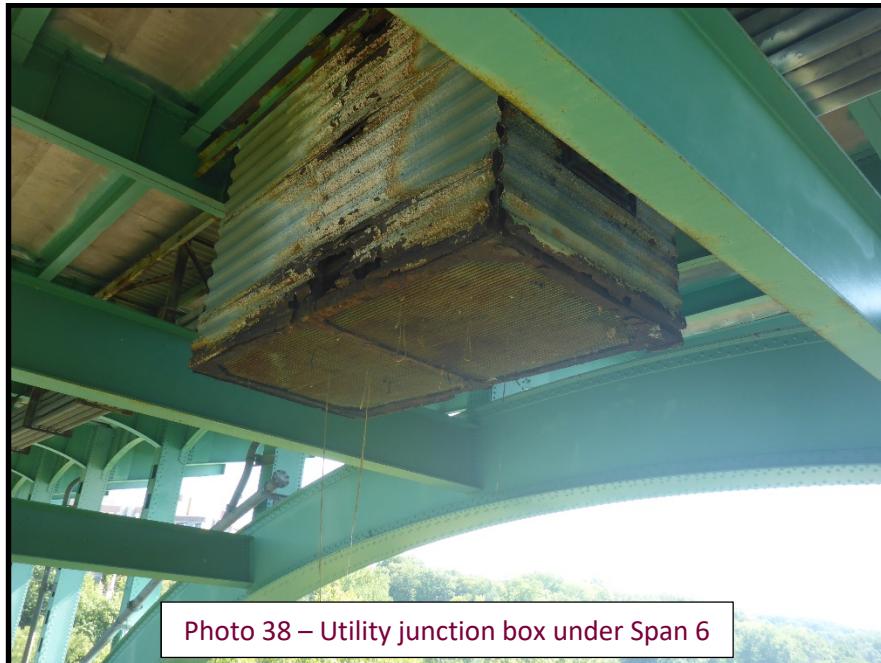
The utility supports under the deck are heavily corroded with the worst location in Span 6. Several conduits are open at the Rear Abutment. Raccoons use the utility conduits to travel from the abutments to the towers.
