2020 PHYSICAL CONDITION ELEMENT LEVEL INSPECTION REPORT

Bridge CUY-176-1334

SFN 1805436

S.R. 176 NB (Jennings Freeway) under I-71 NB

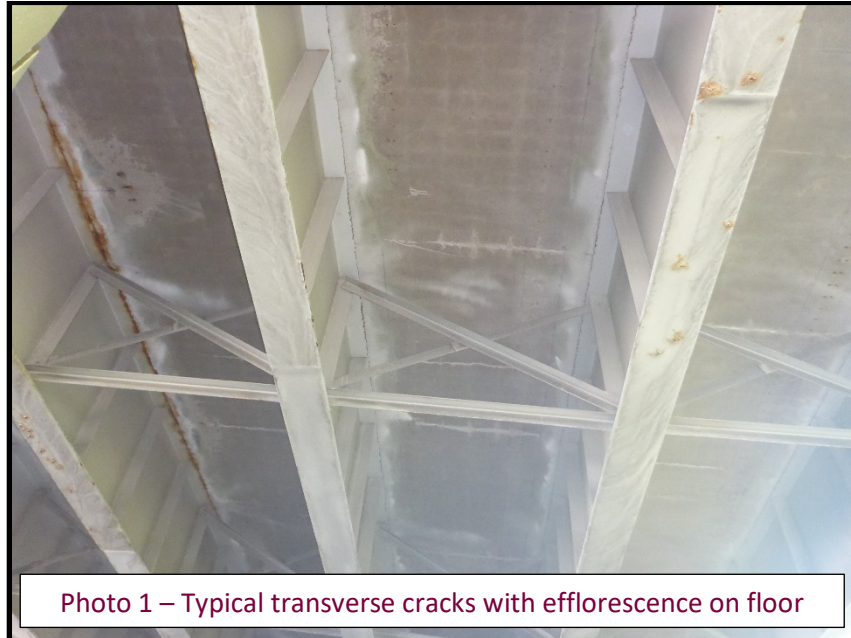
The floor is in **satisfactory** condition. The floor exhibits typical transverse cracks with efflorescence (Photo 1), spalls, closely spaced cracks, and map cracks. There are multiple locations of poorly consolidated concrete with cracks and efflorescence at locations like span 26BE.

Photo 1 – Typical transverse cracks with efflorescence on floor

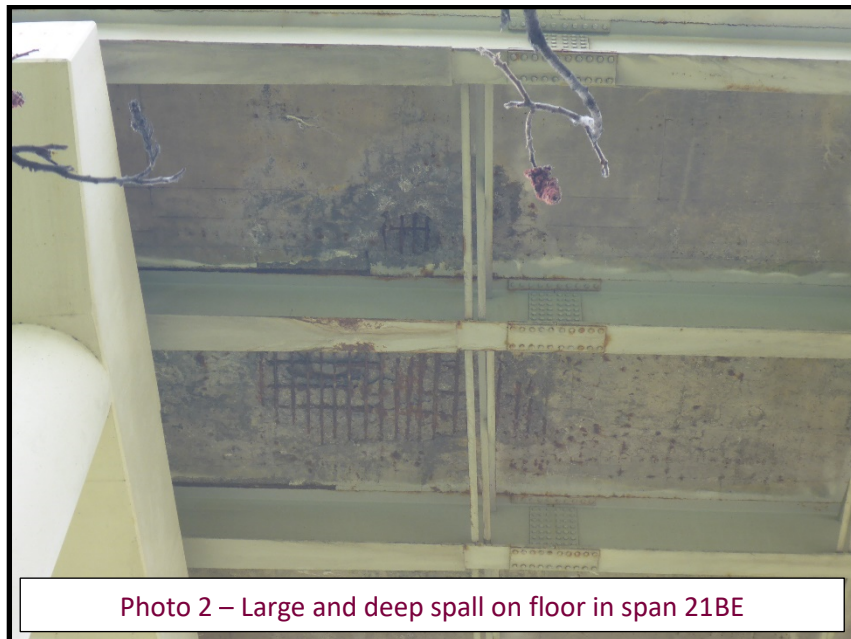
In span 21BE, the floor exhibits a deep, 16'x12' spall with 27 exposed and deteriorated rebar located south of Pier 21BE (Photo 2). There is concern that there is minimal remaining structural floor at this location. In span 27BE, the concrete floor exhibits a large 20'x8' damp area (Photo 3).

Photo 2 – Large and deep spall on floor in span 21BE

1. Perform full depth deck repair on the large and deep spall with many deteriorated rebar on the underside of the floor in span 21BE
2. Patch 4" deep pothole near the left edge line of north approach slab BE

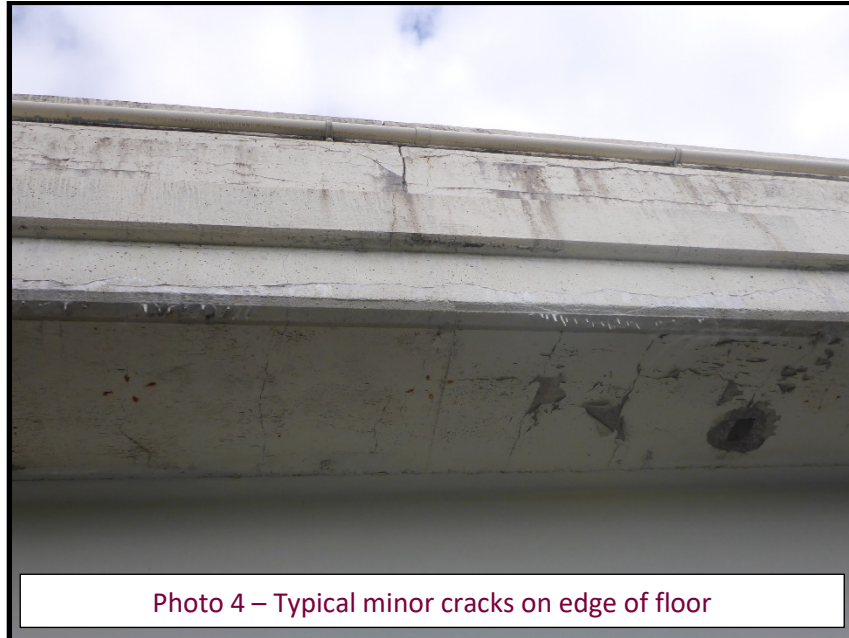
The edge of floor/slab is in **good** condition. The edge of deck exhibits some locations of minor cracks and spalls (Photo 4).

Photo 4 – Typical minor cracks on edge of floor

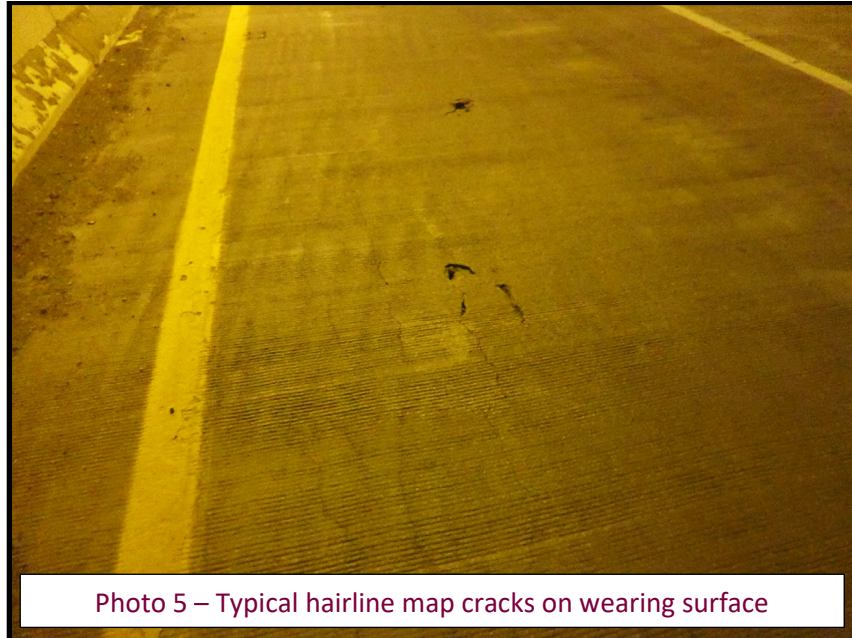
The bridge wearing surface is in **good** condition. The wearing surface exhibits many hairline map cracks along the bridge (Photo 5). Although there were multiple hairline map cracks, the rideability was good, and few map cracks were chipping or spalling. Otherwise, the wearing surface exhibits some small potholes, minor cracks, minor abrasion, missing reflectors, and patches. Multiple patches on the wearing surface are deteriorated.

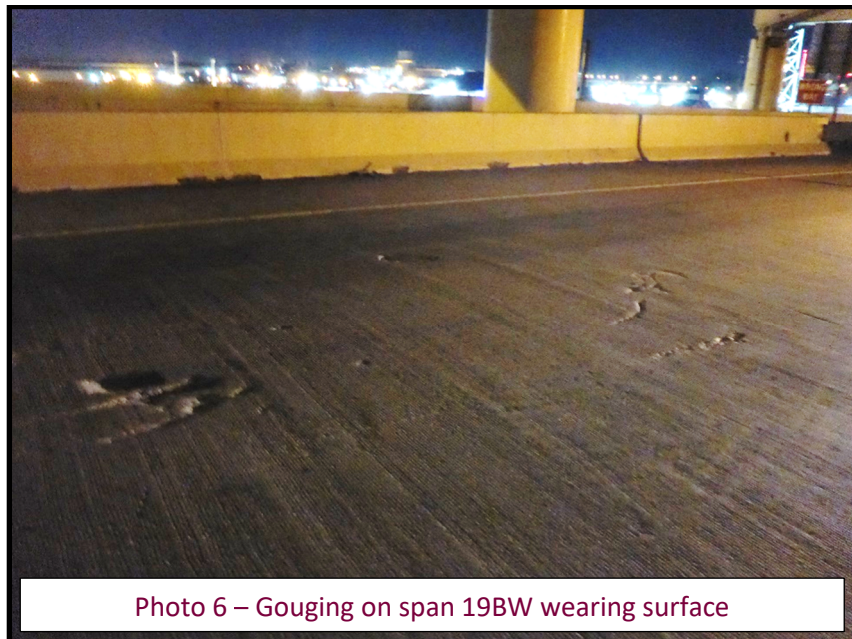
In span 19BW, there are multiple areas of gouging on the wearing surface (Photo 6). In span 24BE, there is a 3'x8' partial patch with map cracks and settlement (Photo 7). In span 29BE, there is a 3'x3'x2.5" deep pothole (Photo 8).

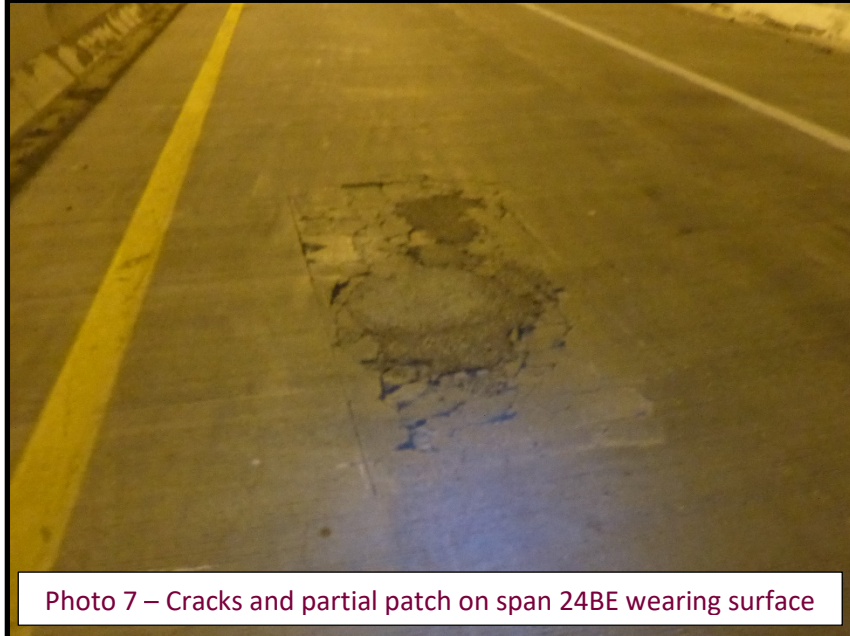
Photo 7 – Cracks and partial patch on span 24BE wearing surface

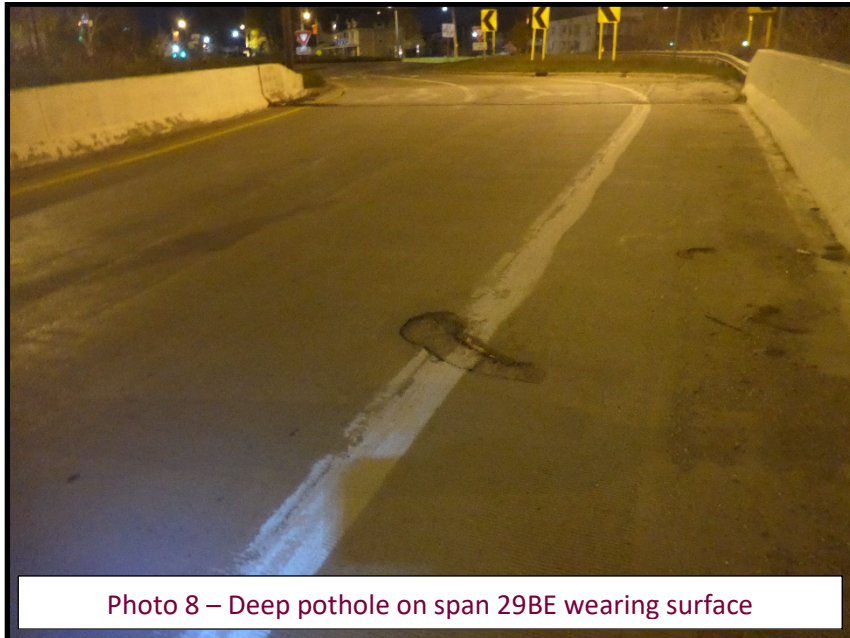
Photo 8 – Deep pothole on span 29BE wearing surface

1. Patch spalls or perform full depth deck repair on deteriorated areas of the floor
2. Patch potholes on the wearing surface
3. Patch and reseal concrete spalls on the railings

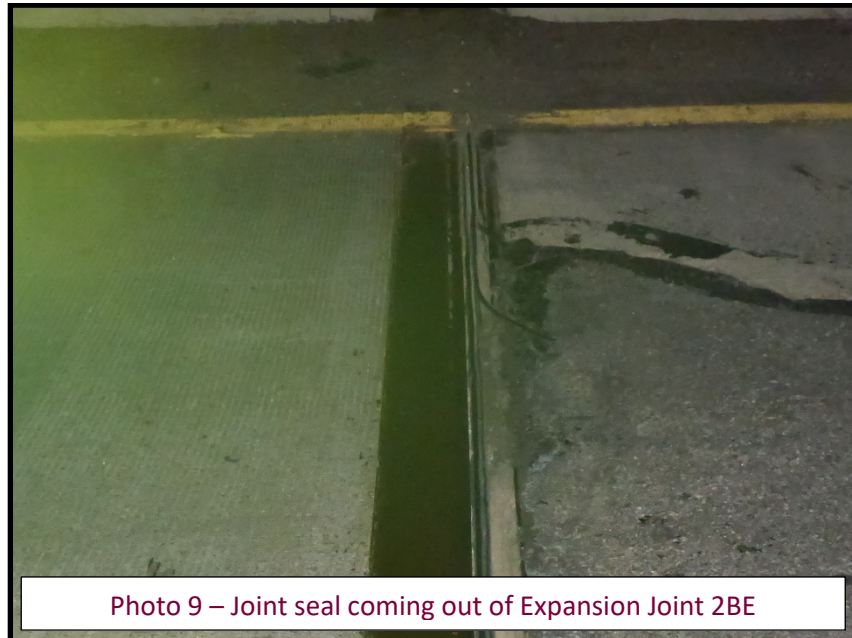
At Expansion Joint 1B, the joint seal is broken and coming out of the joint on the left shoulder. At Expansion Joint 2BW, the seal is coming out of the joint on both shoulders and **cars driving in the right lane make a sound when driving over the joint that seem to indicate a portion of the joint was loose**. At Expansion Joint 2BE, the joint seal is broken and coming out of the joint on the left side (Photo 9) and **the joint metal is sticking above the wearing surface on the left side**. At Expansion Joint 3BE, the entire joint seal is becoming detached and appears wavy (Photo 10).

Photo 9 – Joint seal coming out of Expansion Joint 2BE

4. Clean all scuppers and downspouts that are filled with dirt and debris
5. Replace missing scupper downspouts in spans 19BW and 25BE
6. Repair broken or wavy expansion joint seal at Expansion Joints 2BW, 2BE, and 3BE

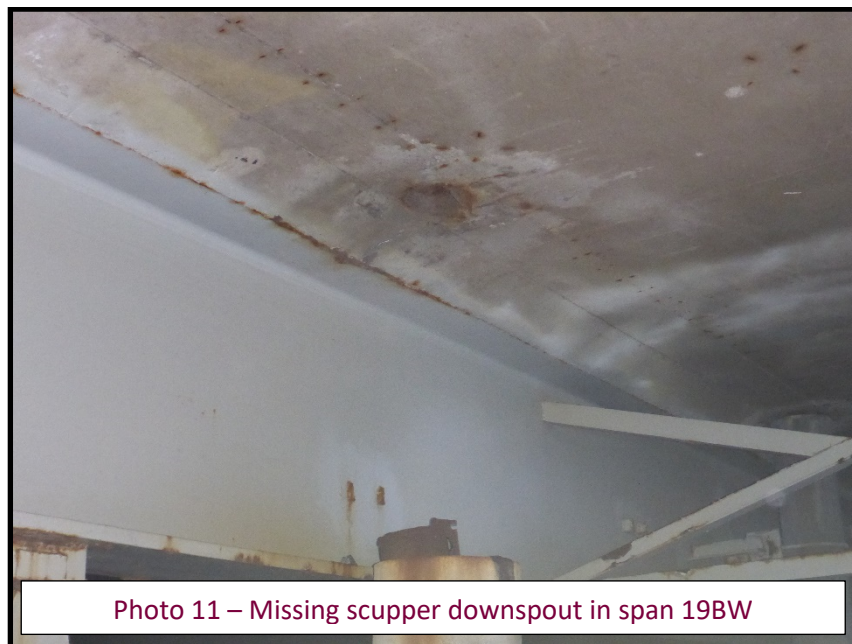
The drainage system is in **fair** condition. Most scupper grates on the bridge are 25-75% filled with dirt and debris, but the downspouts are visible and are not clogged. There are a total of 5 clogged scuppers with grates that are completely filled with dirt and debris and are located on the right side of spans 8, 14, and 16. Multiple scupper downspouts exhibit minor section loss and are located on the right side of spans 14 and 25BE and the left side of span 27BE. **There are scuppers with downspouts missing on the left side of span 19BW (Photo 11) and the right side of span 25BE.**

Photo 11 – Missing scupper downspout in span 19BW

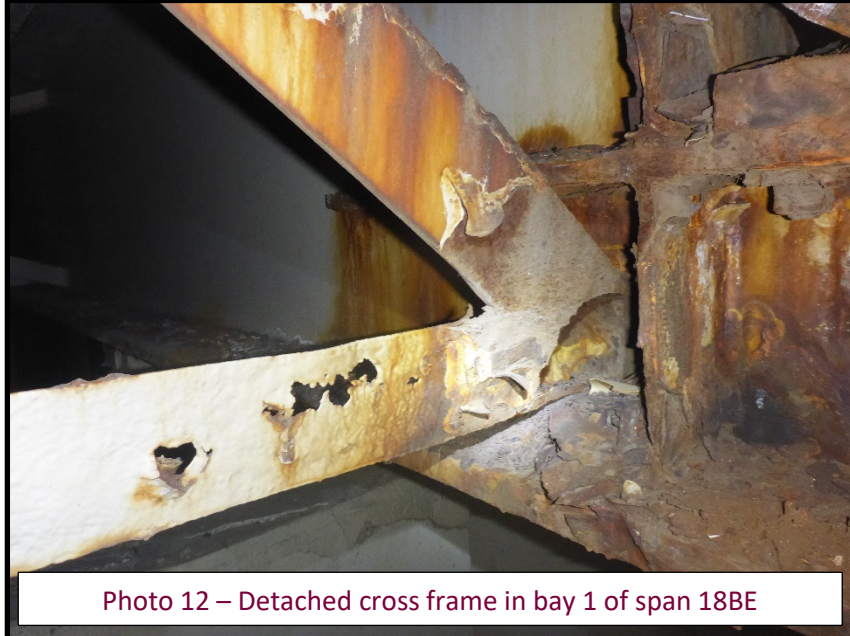
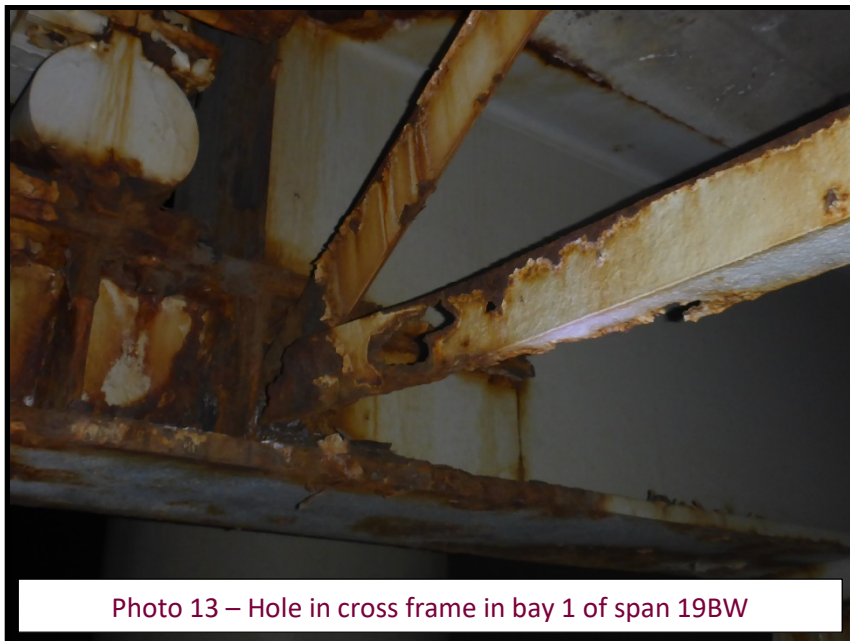
The cross frames are in **satisfactory** condition. Multiple cross frames exhibit minor rust. Cross frames near expansion joints exhibit more rust and section loss. The following cross frame locations have significant deterioration:

Span	Bay	Cross Frame Deterioration
13	6	Detached
18BW	2	Detached
18BE	1	Detached (Photo 12)
18BE	3	Hole
19BW	1	Hole (Photo 13)
24BE	2	Hole

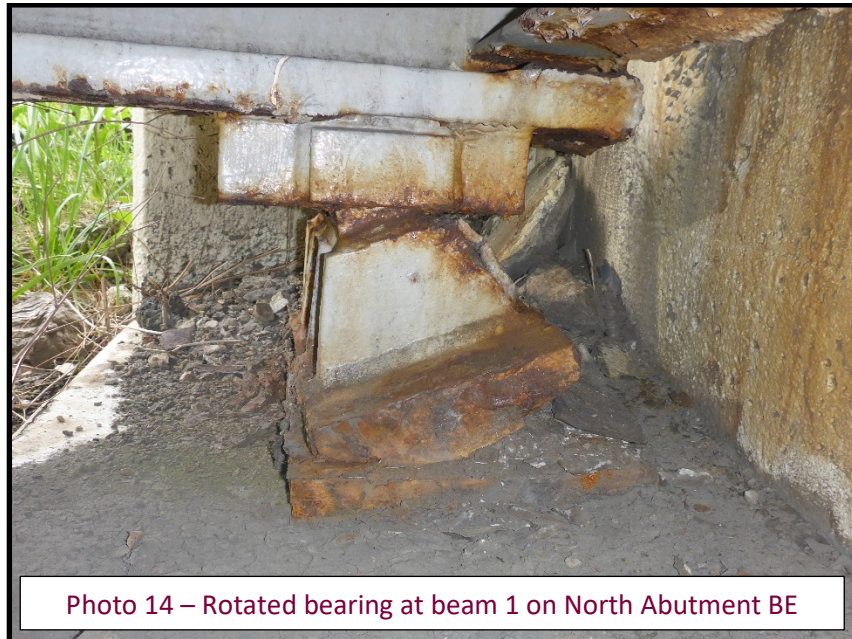
The bearings are in **fair** condition. Multiple bearings at the abutments and piers exhibit minor to moderate rust and multiple rocker bearings are at their maximum rotation (Photo 14). Pack rust at multiple bearings, including at the North Abutment BW, is limiting the movement of the bearings.

Photo 14 – Rotated bearing at beam 1 on North Abutment BE

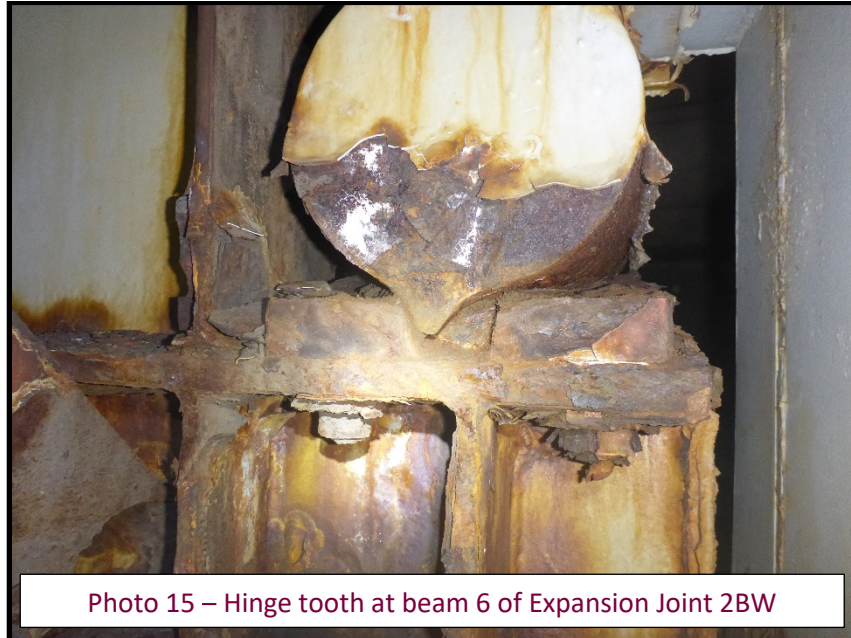
The hinges are in **fair** condition. Almost all of the hinges have rust and deterioration. **At Expansion Joint 2BW, the bottom hinge tooth is chipped**, pack rust has started, and there is significant debris at beam 6 (Photo 15). At Expansion Joint 3BE, there is section loss on the web of the support under the hinges.

Photo 15 – Hinge tooth at beam 6 of Expansion Joint 2BW

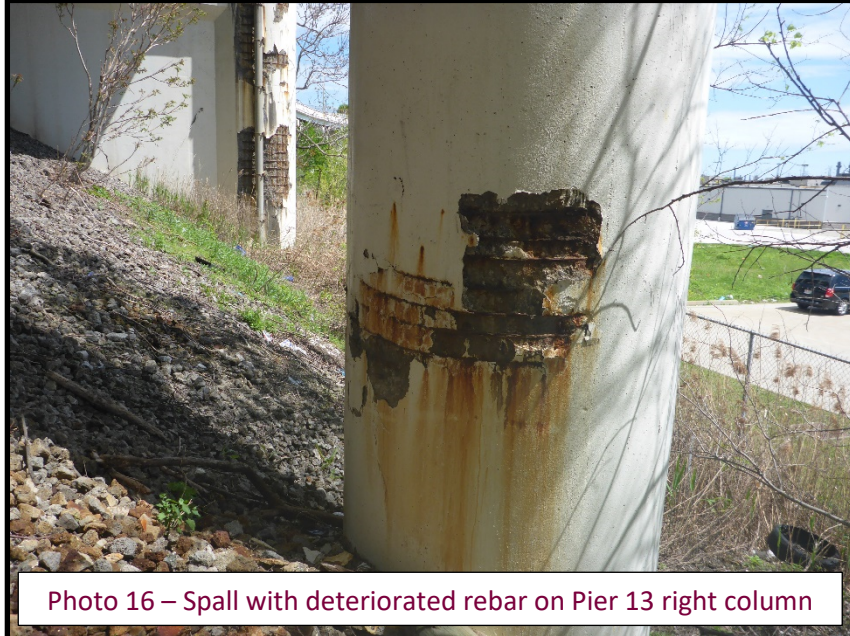
The pier columns are in **satisfactory** condition. The right columns of Piers 11 and 19BW have a minor delamination for half the column height and a minor spall, respectively. The right columns of Piers 13-16 have deep spalls with deteriorated spiral rebar (Photos 16, 17, & 18).

Photo 16 – Spall with deteriorated rebar on Pier 13 right column

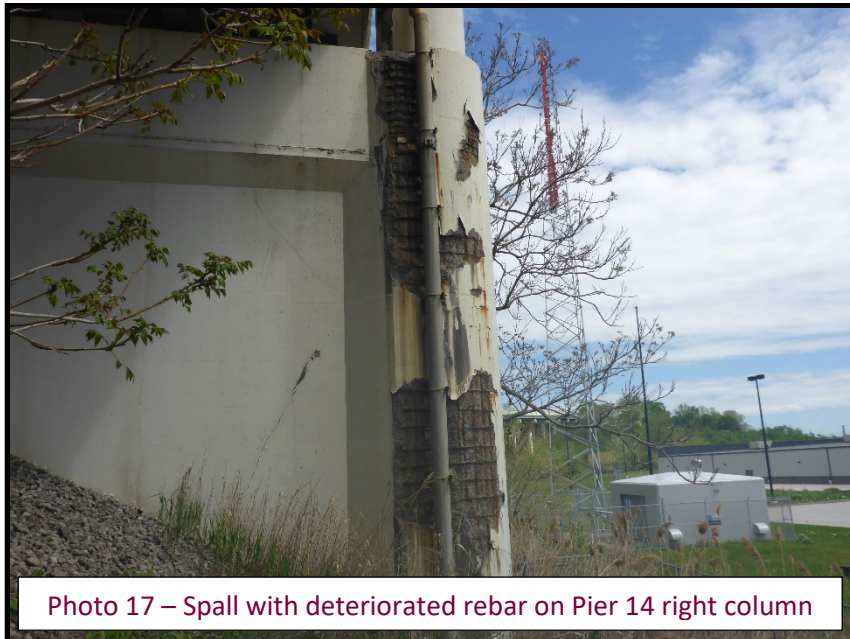
Photo 17 – Spall with deteriorated rebar on Pier 14 right column

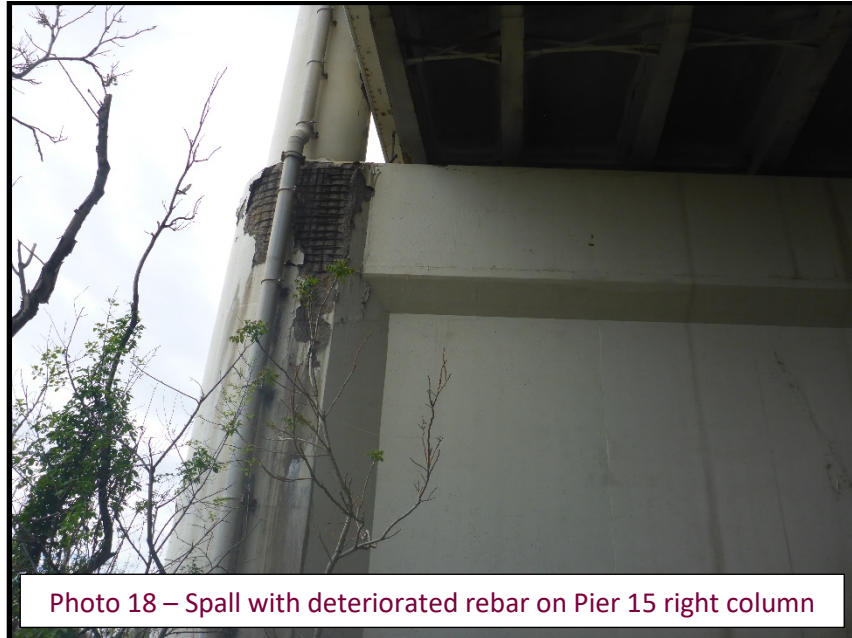
Photo 18 – Spall with deteriorated rebar on Pier 15 right column

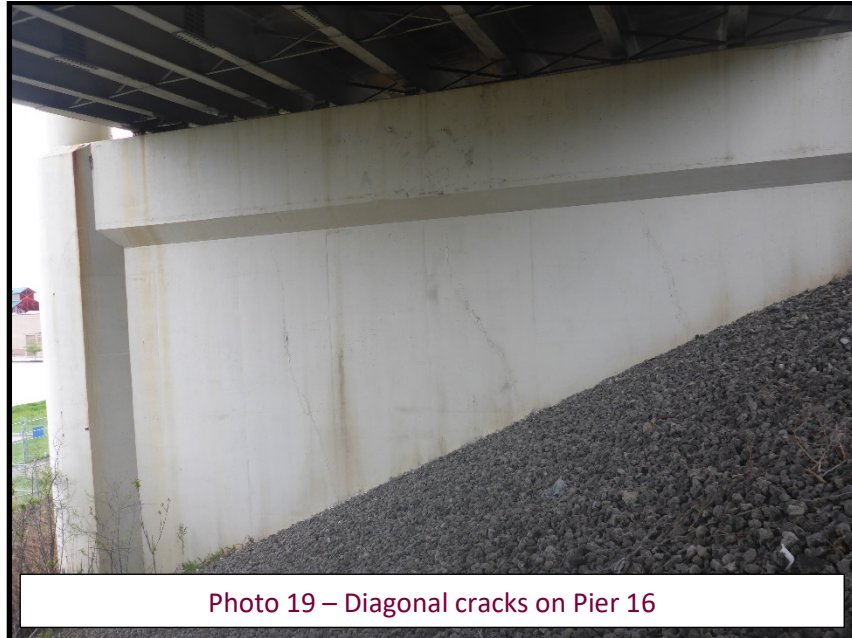
The pier walls are in **satisfactory** condition. Pier walls are located at Piers 14-16. All pier walls exhibit minor cracks and spalls. Piers 14 and 16 have minor diagonal cracks that are reflected on both sides of the pier (Photo 19).

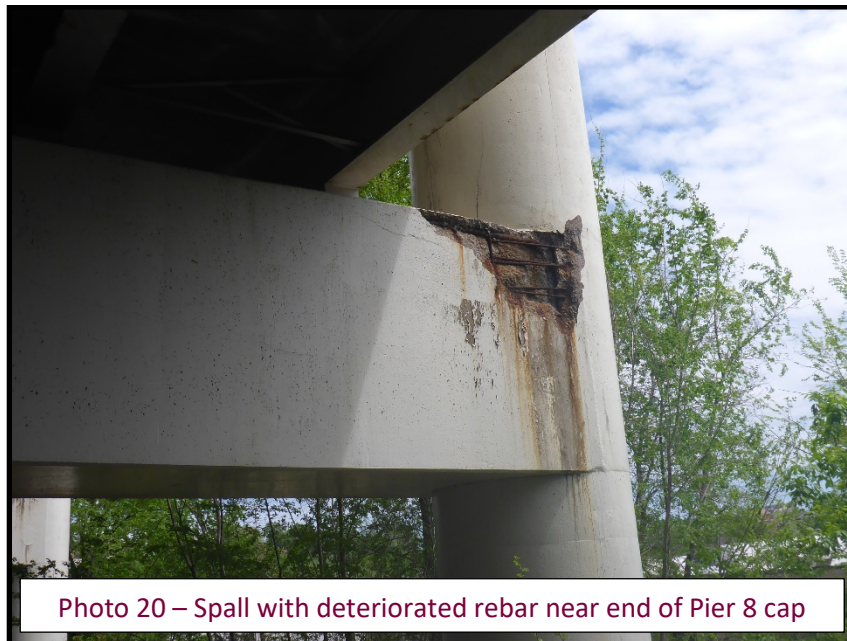
Pier	Cap End	Cap Side	Comments
8	Right	South	Deep spall with deteriorated rebar (Photo 20)
9	Left	South	Map cracks and deep spall
9	Right	South	Map cracks and deep spall
10	Right	South	Deep spall with deteriorated rebar
13	Right	North & South	Deep spalls with significantly deteriorated rebar and gaps below rebar on both sides of cap (Photos 21 & 22)
16	Right	South	Deep spall with deteriorated rebar (Photo 23)
18BW	Right	South	Map cracks and deep delamination

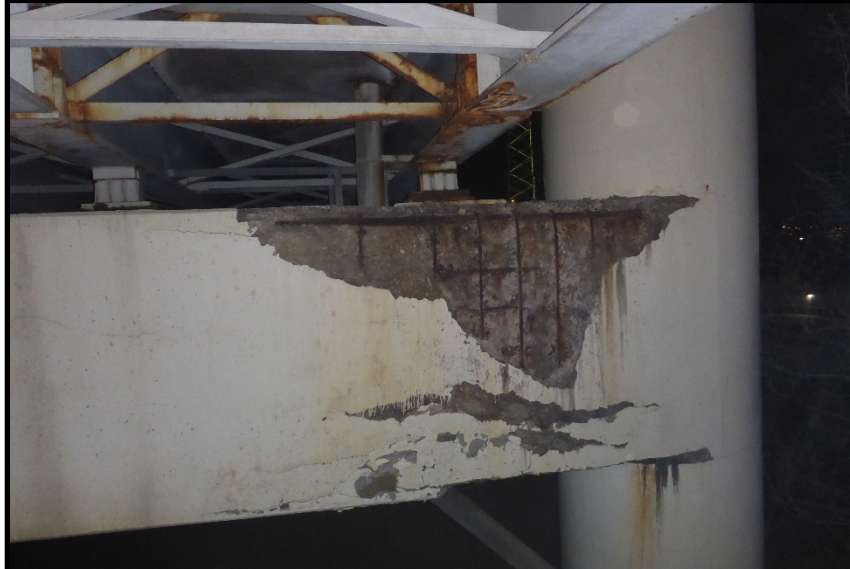
Photo 21 – Spalls with deteriorated rebar near end of Pier 13 cap

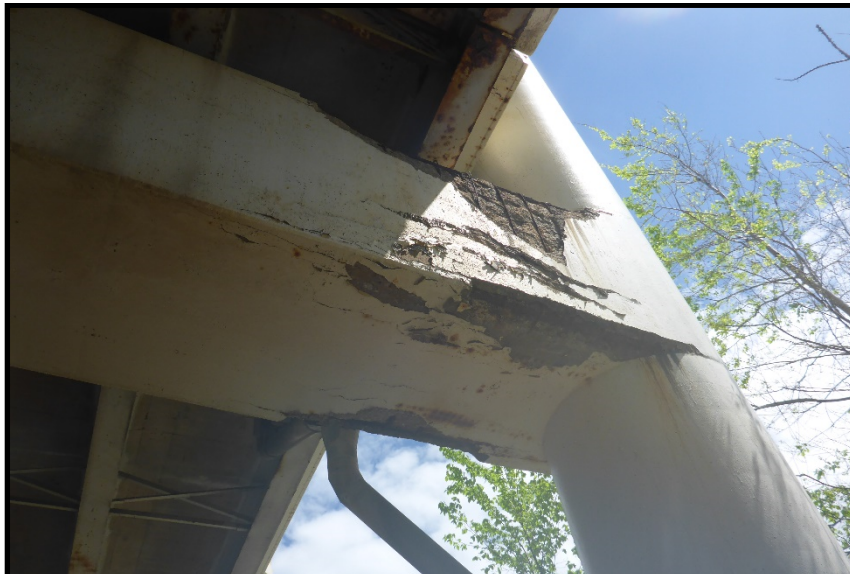
Photo 22 – Spalls with deteriorated rebar on bottom of Pier 13

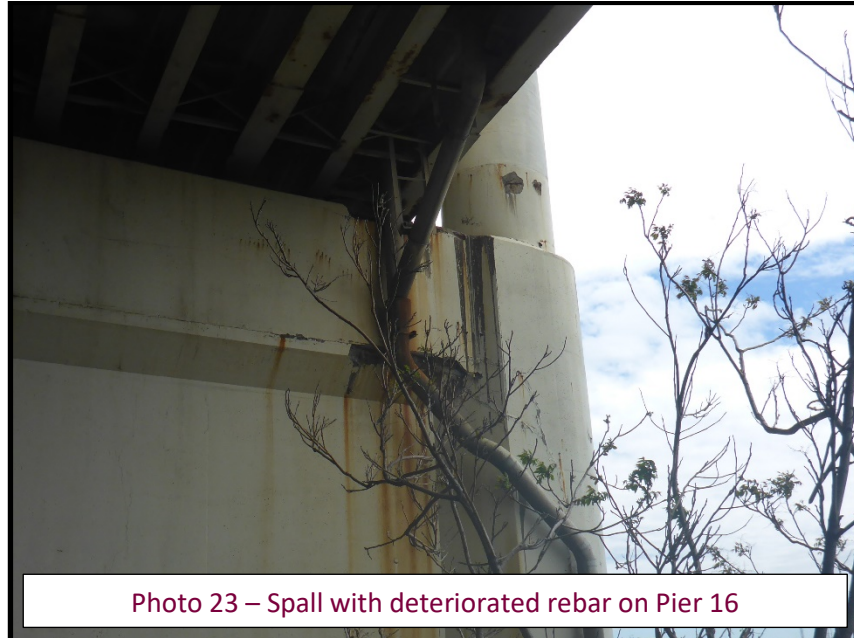
Photo 23 – Spall with deteriorated rebar on Pier 16

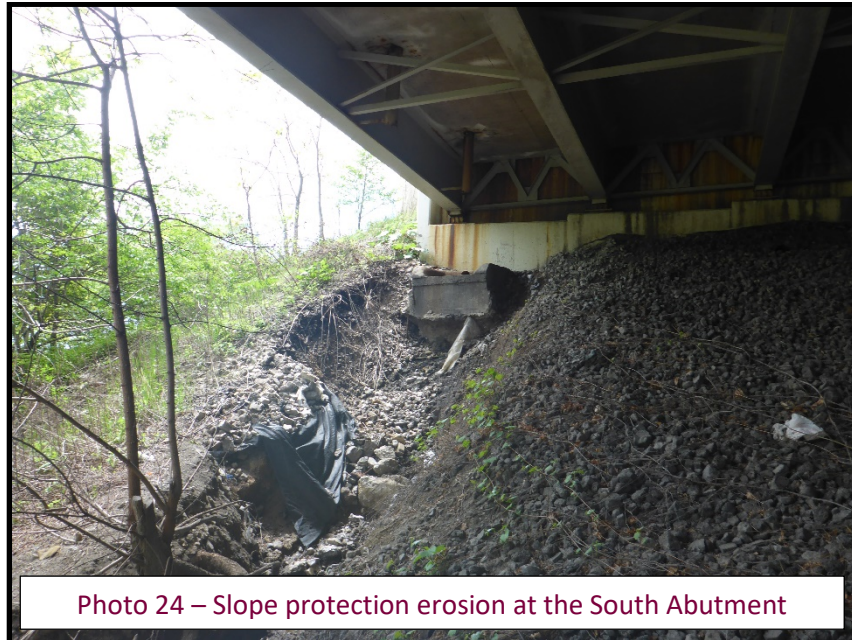
The slope protection is in **fair** condition. There is significant erosion in front of the right side of the South Abutment with an approximately 10' wide by 5' deep rut below the downspouts of the deck scuppers (Photo 24). Due to the significant erosion, the front of the concrete splash pad below the scuppers is visible.

Photo 24 – Slope protection erosion at the South Abutment

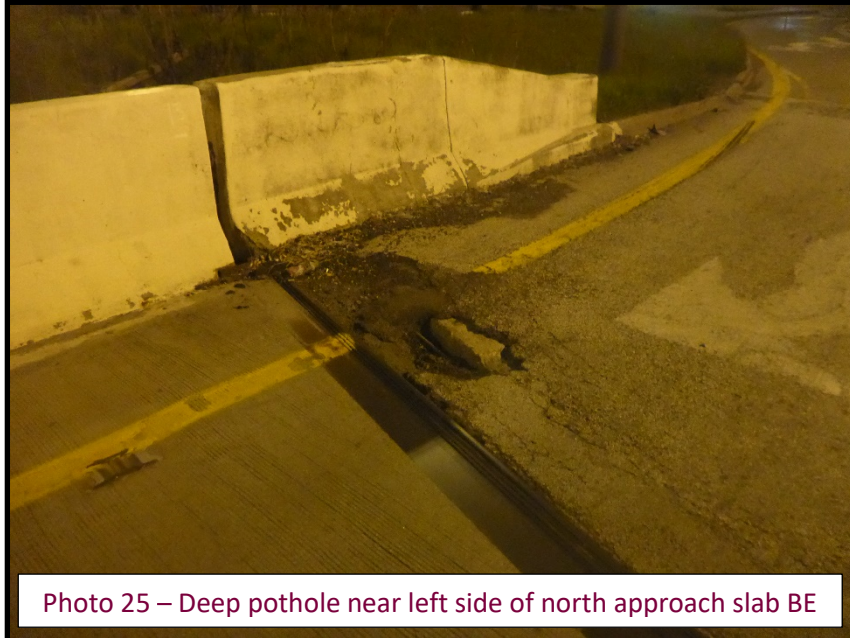
The approach slabs are in **good** condition. **The north approach slab BW has map cracks along the entire expansion joint, a large patch, and a wide crack on the left shoulder. The north approach slab BE has wide map cracks on the right shoulder and the middle lane line, minor map cracks in the right lane, and a 2'x6'x4" deep pothole near the left edge line (Photo 25).**

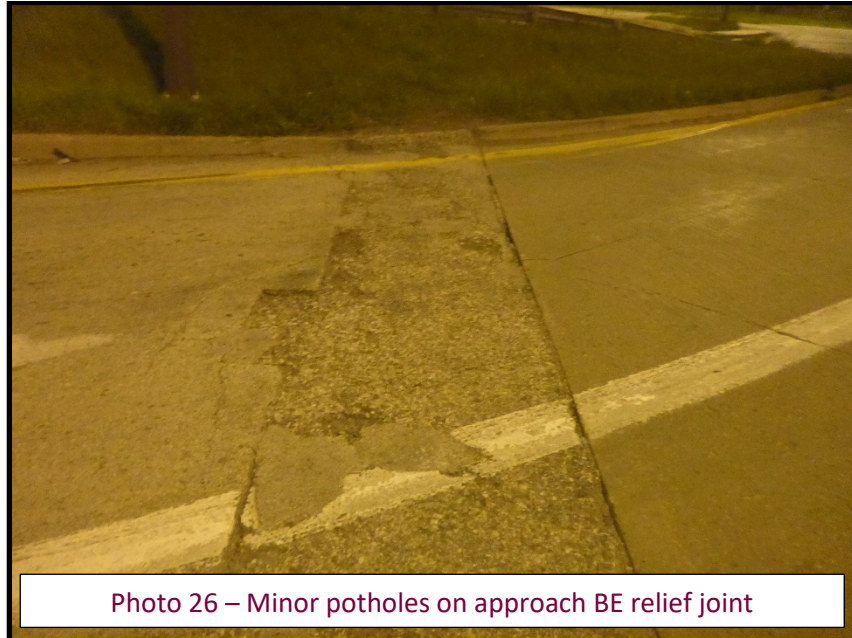
The approach relief joints are in **good** condition. **The north approach BE relief joint has minor potholes in the left lane (Photo 26).**

Photo 26 – Minor potholes on approach BE relief joint
