February 27, 2012

Re: District 12 GES Pavements and Structure Investigation and
Report of Pavement and Bridge Deck Coring
Lak-2-14.28 (Newell Street over SR-2)
PID No.: 88352
Task Order No.: 16687-1
Lake County, Ohio
PSI Project No.: 0142-576

Date: 2/9/2012	Core Photo Log
Drawn By: AC	Task Order No: 16687-1
Scale: NA	PSI Project No: 0142-576

Proposed Pavement Coring
LAK-2-14.28, PID No.: 88352
Newell Street over Lake-2
Lake County, Ohio

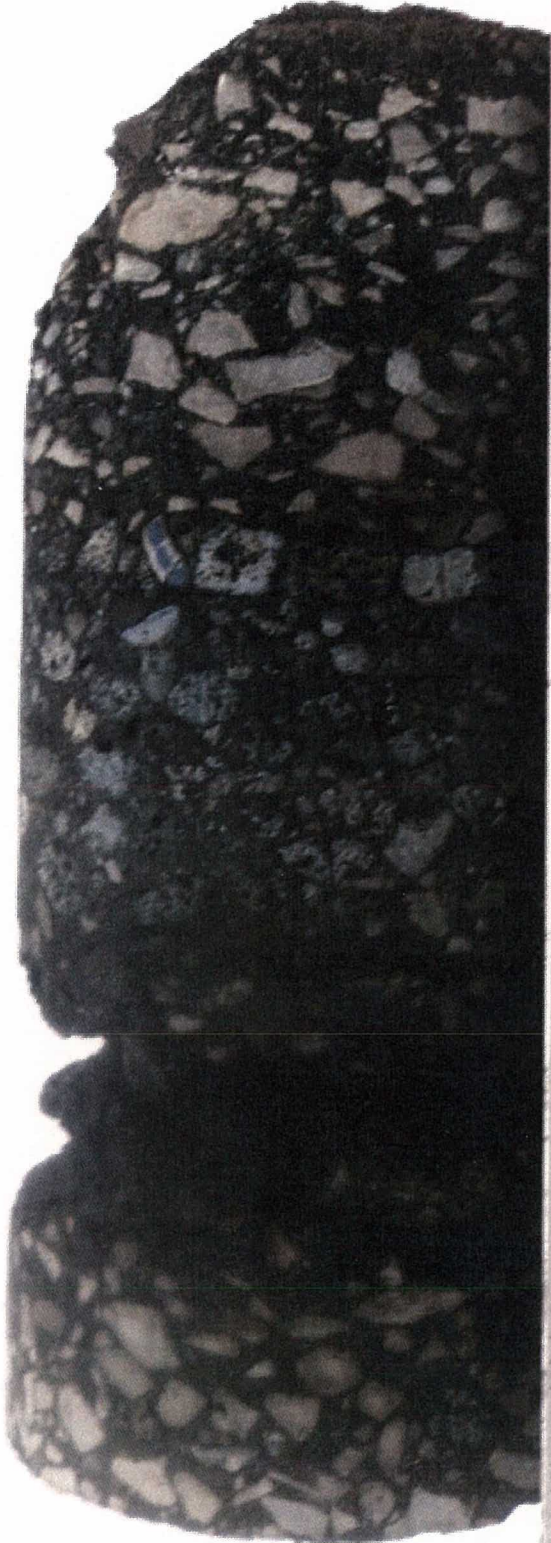
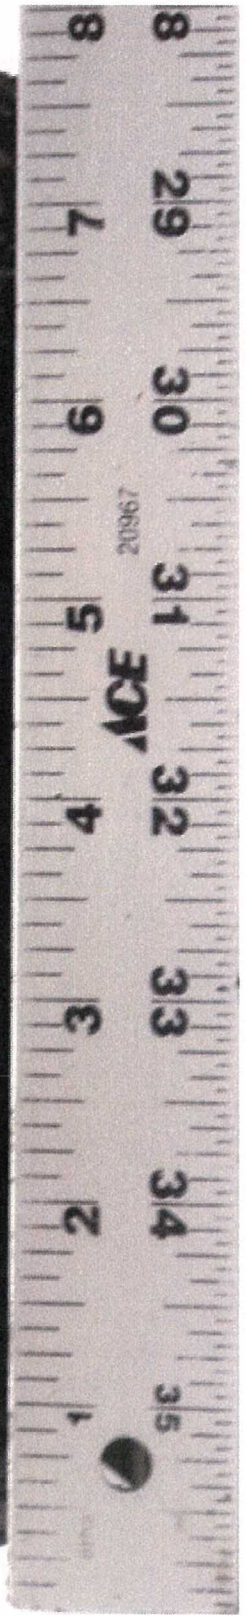
Core Number	Location	Layers	Core Composition		Remarks
			Asphalt Concrete	Concrete	
C-1	LAK-2 NB-RWT Latitude : 41° 43' 31.0" Longitude : -81° 16' 7.9"	A	404 402	--	Fair Condition, Broken at 1 1/2"
		C	--	5 1/4"	Good Condition
Information To Build On Engineering • Consulting • Testing			Pavement Coring LAK-2-14.28, PID No.: 88352 Lake County, Ohio		Date: 2/24/2012
					Task Order No: 16687-1
					Scale: NA
					Core Photo Log

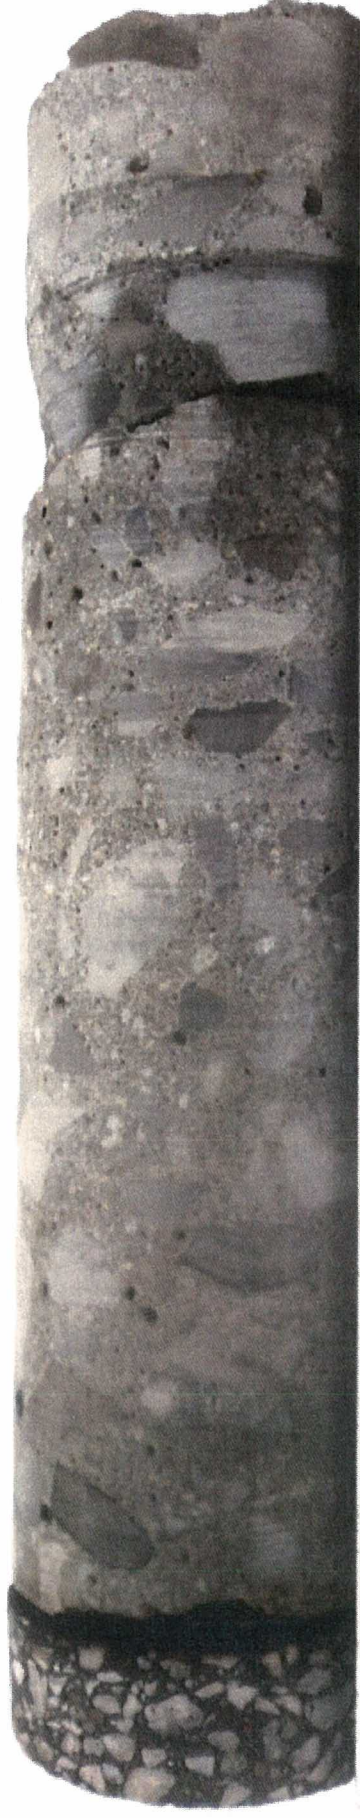
Core Number	Location	Layers	Core Composition		Remarks
			Asphalt Concrete	Concrete	
C-2	LAK-2 NB-RWT Latitude : 41° 43' 31.3" Longitude : -81° 16' 8.0"	A	404 1 1/2"	402 --	Good Condition
		B	--	--	Good Condition
Information To Build On Engineering • Consulting • Testing					Date: 2/24/2012
Pavement Coring LAK-2-14.28, PID No.: 88352 Lake County, Ohio					Task Order No: 16687-1
					Scale: NA
					PSI Project No.: 0142-576

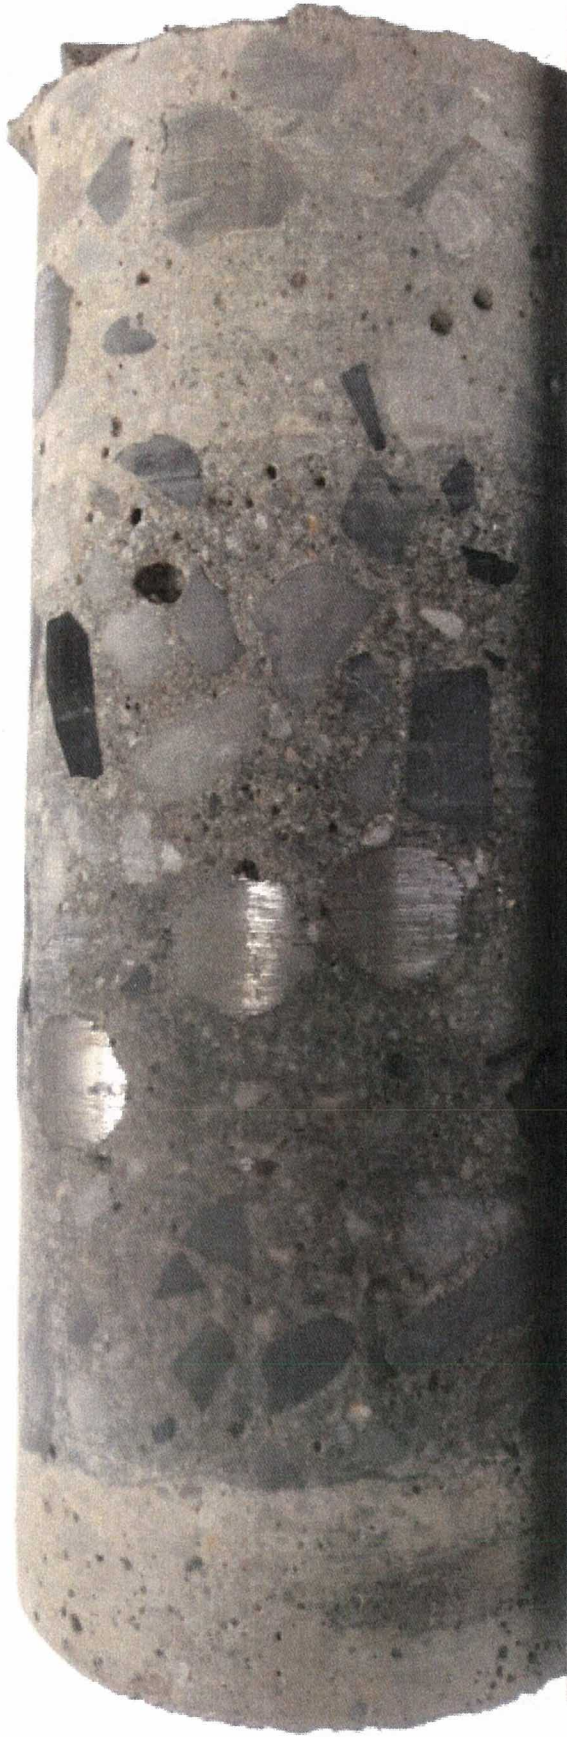
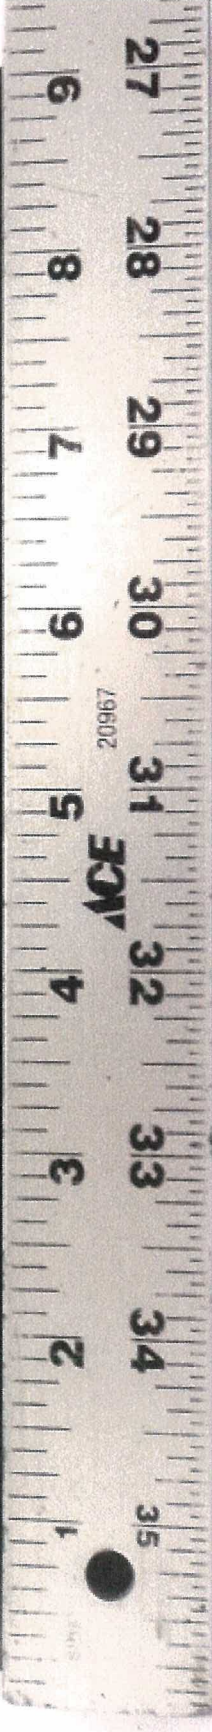
Core Number	Location	Layers	Core Composition		Remarks		
			Asphalt Concrete	Concrete			
C-3	LAK-2 NB-RWT Latitude : 41° 43' 31.9" Longitude : -81° 16' 8.2"	A	404	402	Good Condition

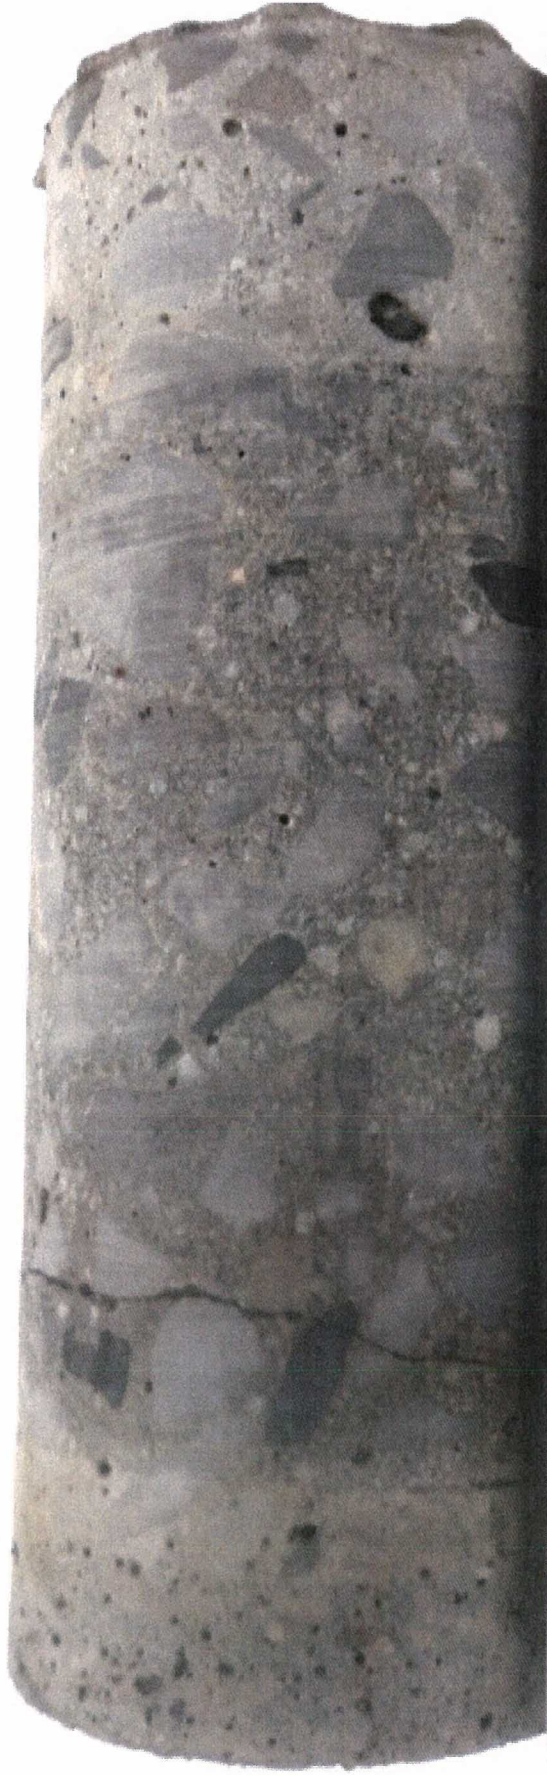
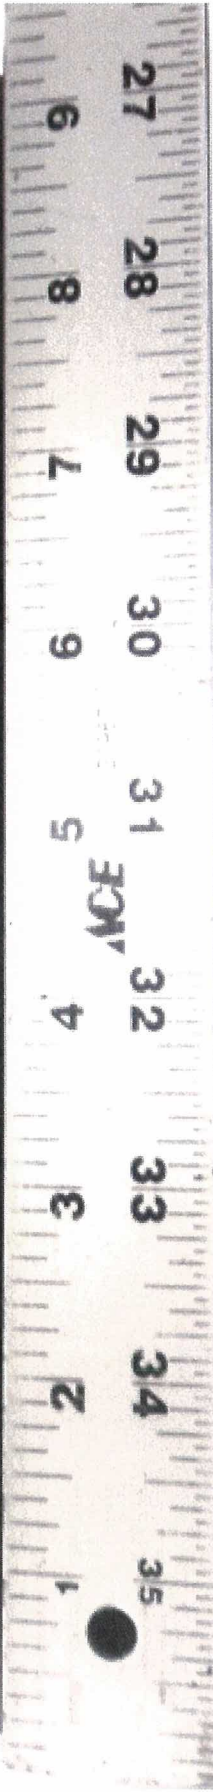
Core Number	Location	Layers	Core Composition		Remarks
			Asphalt Concrete	Concrete	
C-4	LAK-2 SB-LWT Latitude : 41° 43' 33.3" Longitude : -81° 16' 9.1"	A	404	402	Good Condition, Small Crack at 2 1/4"
Information To Build On Engineering • Consulting • Testing			Pavement Coring		
			LAK-2-14.28, PID No.: 88352 Lake County, Ohio		
			Date: 2/24/2012	Core Photo Log	
			Drawn By: AC	Task Order No: 16687-1	
			Scale: NA	PSI Project No.: 0142-576

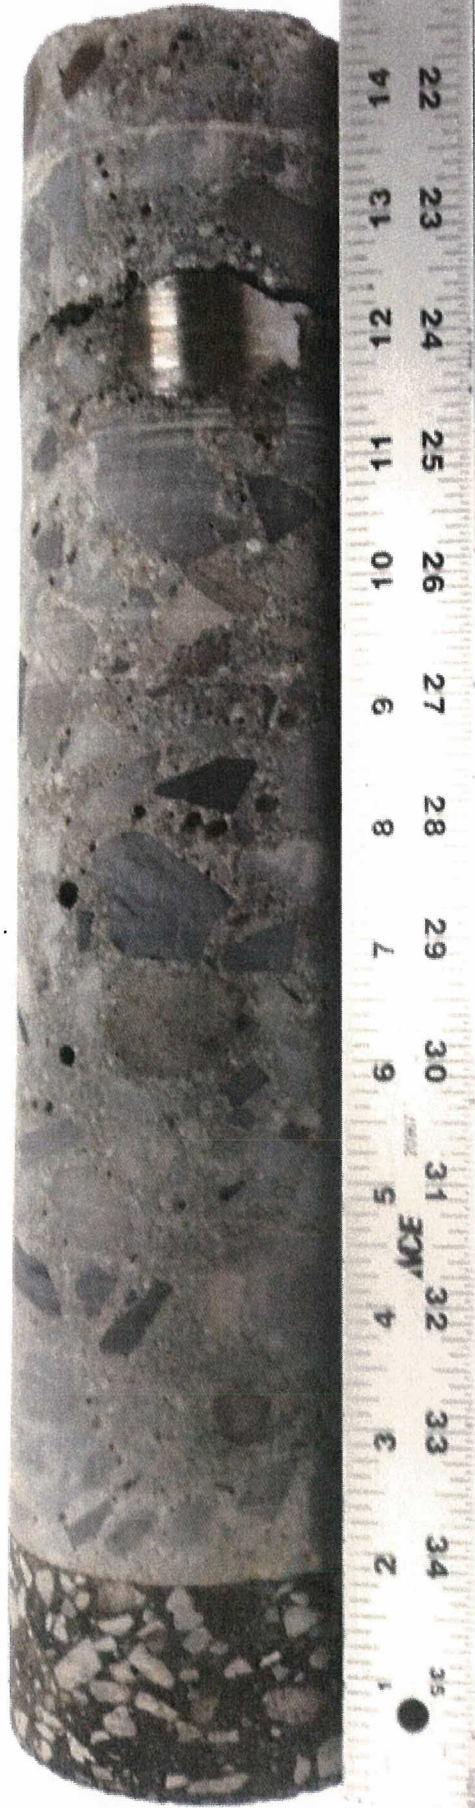
Core Number	Location	Layers	Core Composition		Remarks				
			Asphalt Concrete	Concrete					
C-5	LAK-2 SB-RWT Latitude : 41° 43' 33.7" Longitude : -81° 16' 9.3"	A	404 1 3/4"	402 --	Good Condition				
		B	--	--	Good Condition, Cracked at Rebar During Coring				
Information To Build On Engineering • Consulting • Testing			Pavement Coring LAK-2-14.28, PID No.: 88352 Lake County, Ohio			Date: 2/24/2012			
						Core Photo Log			Drawn By: AC
									Task Order No: 16687-1
			Scale: NA						
			PSI Project No.: 0142-576

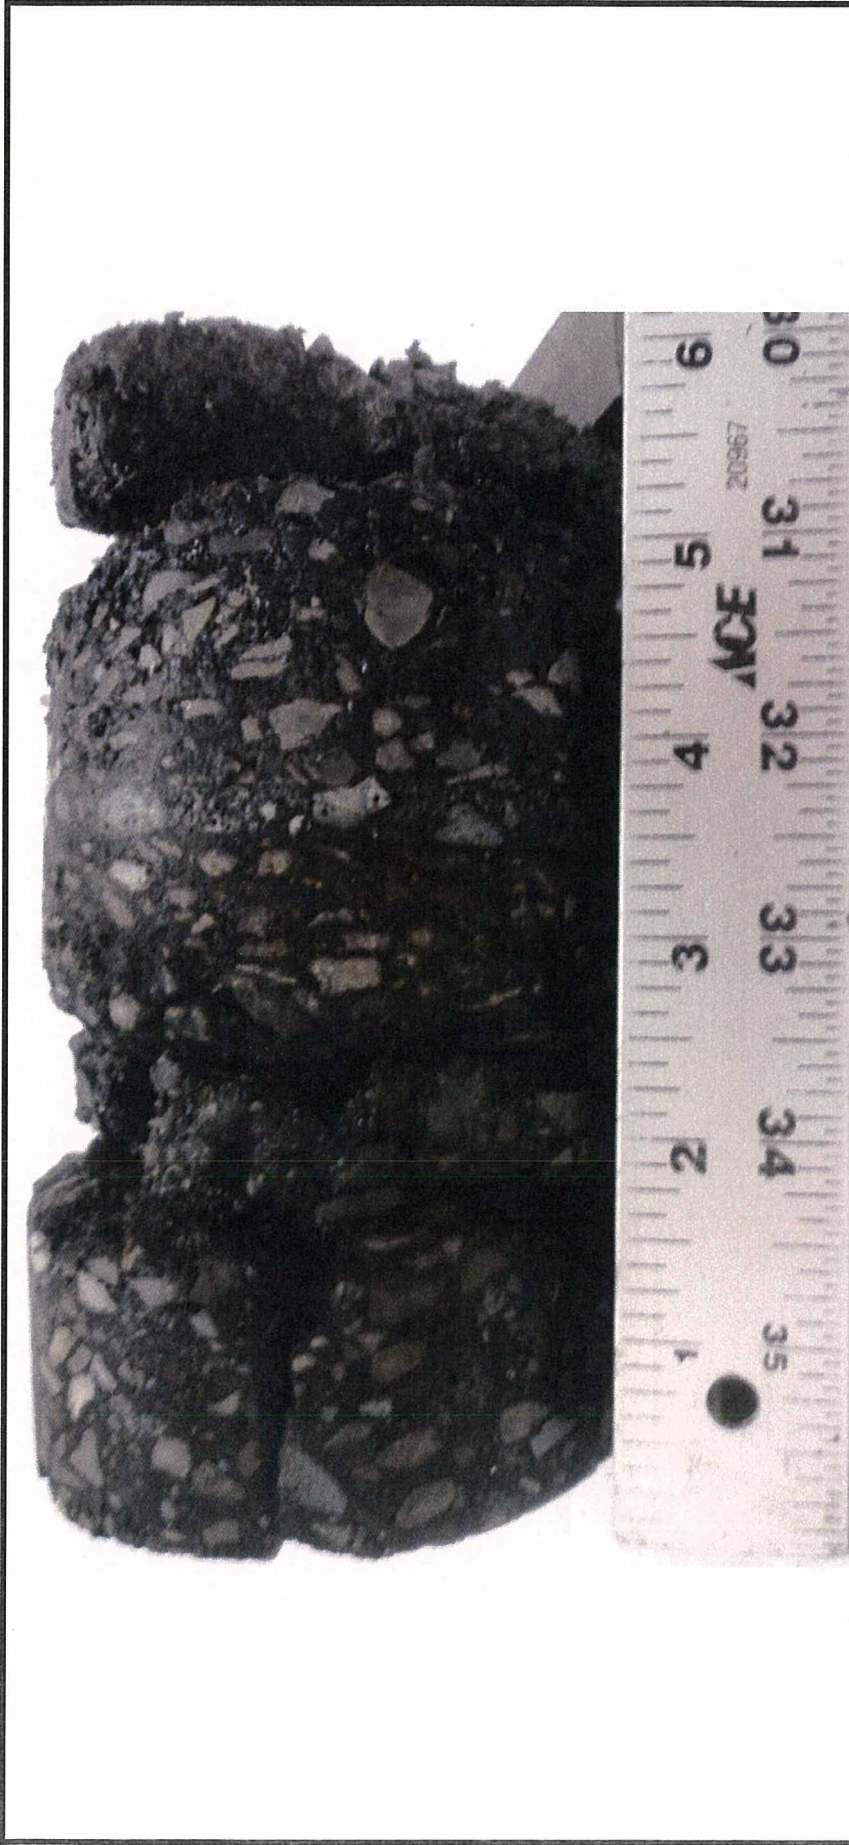
Core Number	Location	Layers	Core Composition		Remarks
			Asphalt Concrete	Concrete	
C-6	LAK-2 SB-RWT Latitude : 41° 43' 34.1" Longitude : -81° 16' 9.4"	A	404 402	--	Fair Condition
		B	--	2 3/4"	Good Condition
Information To Build On Engineering • Consulting • Testing					Core Photo Log
Pavement Coring LAK-2-14.28, PID No.: 88352 Lake County, Ohio					Date: 2/24/2012
					Drawn By: AC
					Scale: NA
					Task Order No: 16687-1
					PSI Project No.: 0142-576
