STATE OF OHIO DEPARTMENT OF TRANSPORTATION  
BRIDGE INSPECTION REPORT

Structure File Number: 1812831

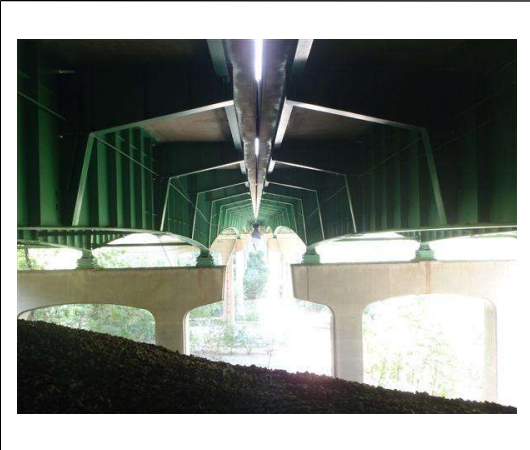
Photo 1 Typical good paint and steel condition.

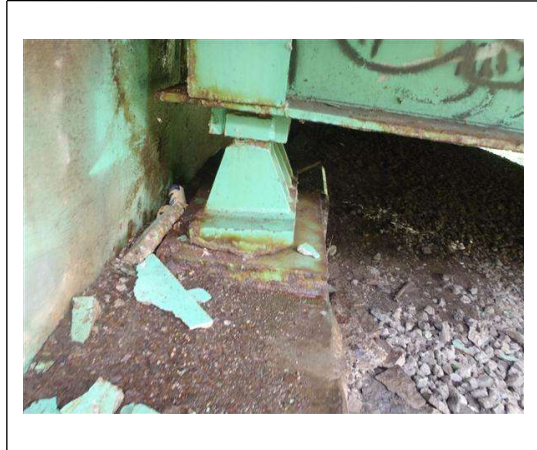
Photo 2 Evidence of edge spalls occurring in the tops of the backwalls.

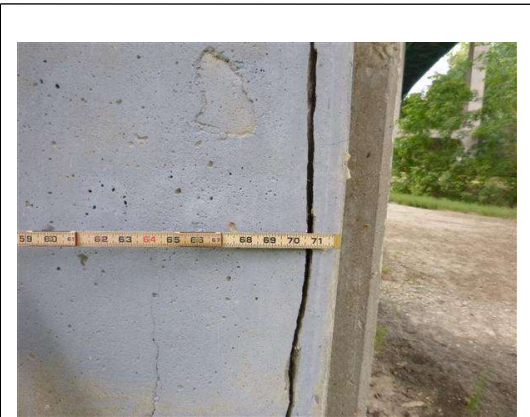
Photo 3 Corner crack on a pier column (wider than typical).

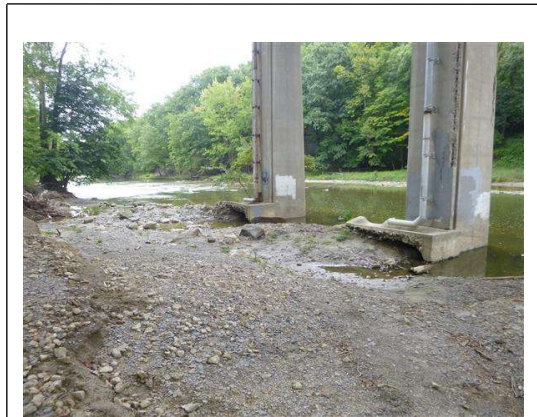
Photo 4 Drainage troughs at bases of Pier 6 columns. Localized scour that was occurring last inspection seems to have stabilized and is not progressing.
