2025 PHYSICAL CONDITION ROUTINE ELEMENT LEVEL INSPECTION REPORT

Bridge CUY-10-1613

SFN 1801503

Hope Memorial/Lorain Carnegie over Cuyahoga River

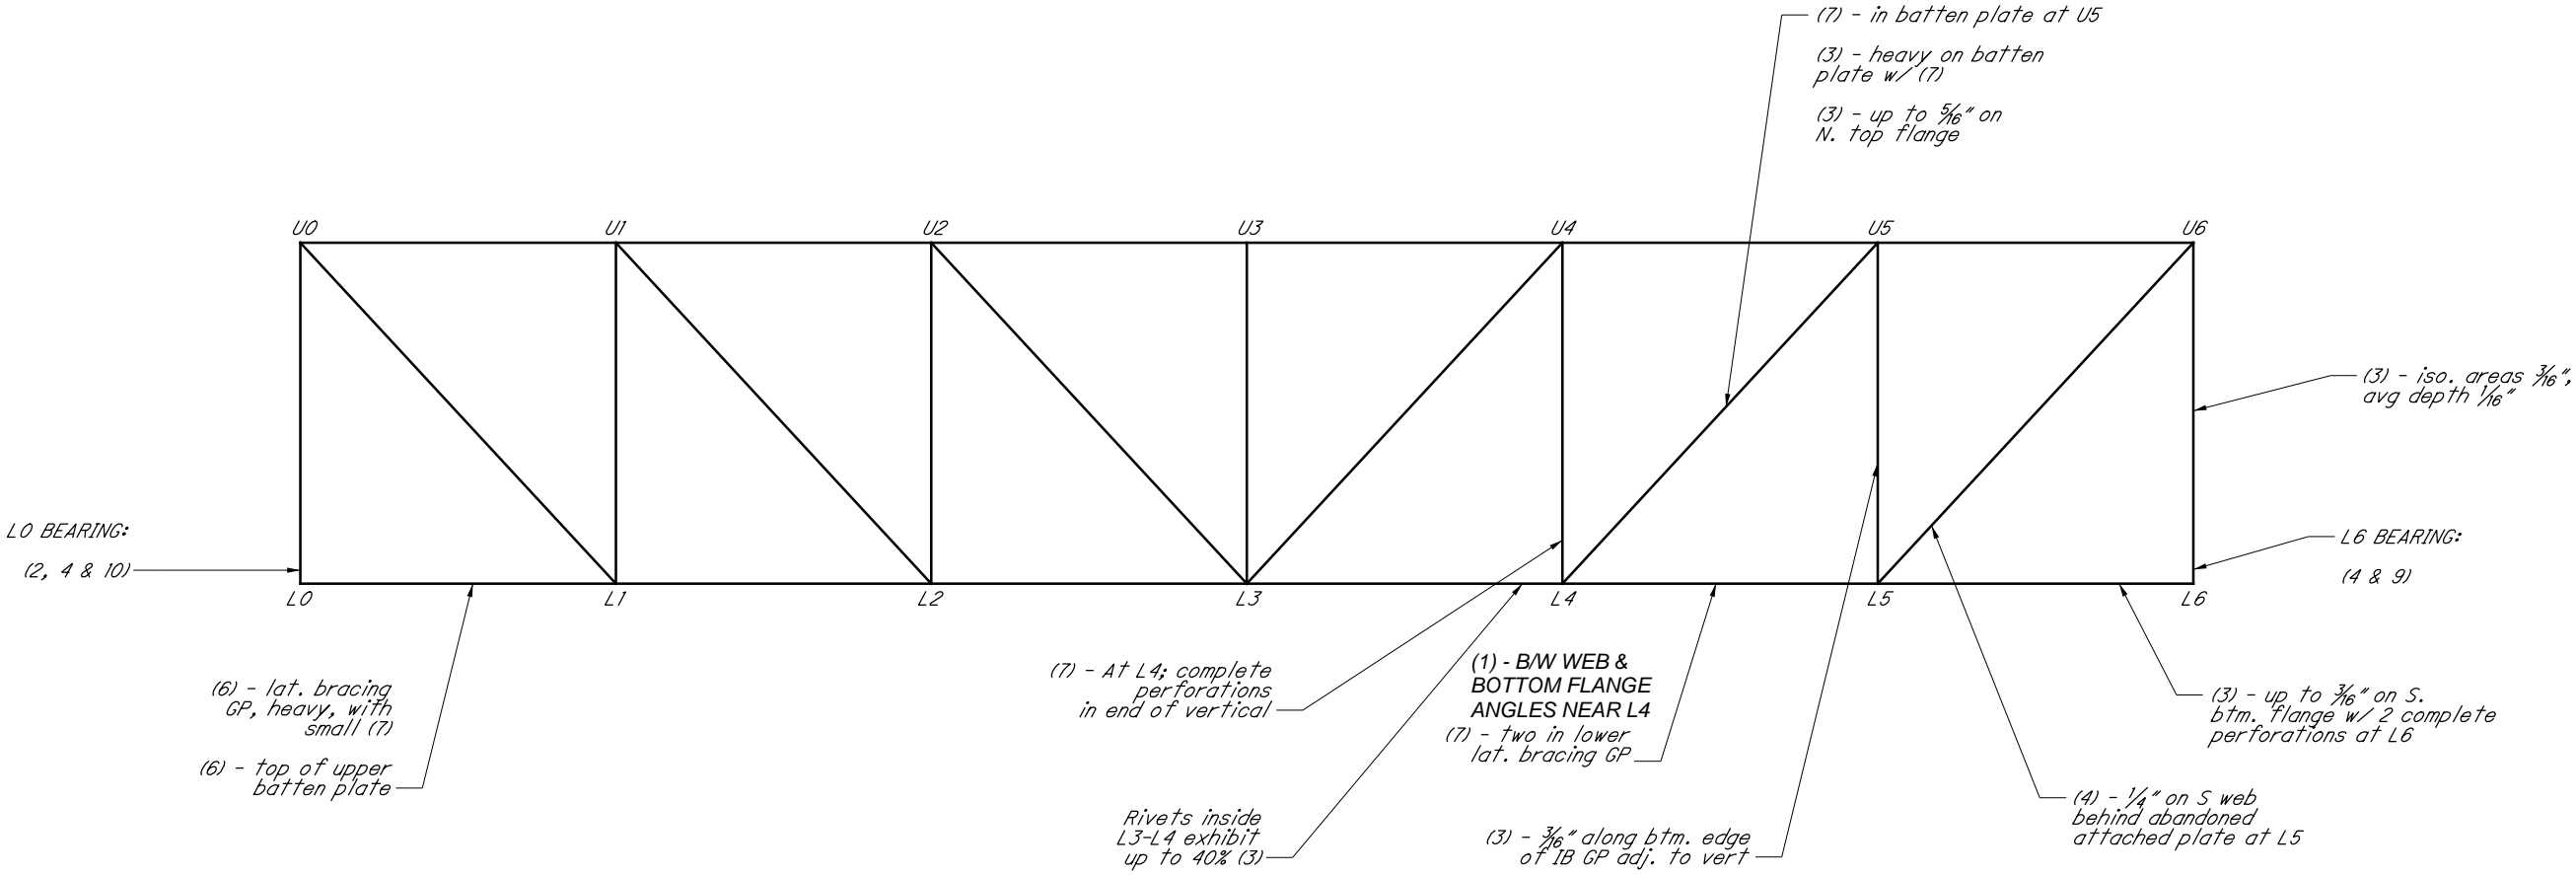
WHEELING & LAKE ERIE SPAN - NORTH EXTERIOR TRUSS ELEVATION

W&LE NORTH EXTERIOR GUSSET PLATE DEFICIENCIES

- L2, BOTH - (10)
- L3, IB GP - (2) - 1" T b/w top edge and diagonal, reactivating (6) - BELOW L3U4
- L4, IB GP - (6) - widespread 5/16"
(4) - up to 1/4" D
(3) - up to 3/16" D on OB face
- L4, OB GP - (5) - localized 1/4"
- L6, OB GP - (4) - widespread 1/4" & rivet head loss
- U6, IB GP - (9) - between FB and upper chord
U6, OB GP - (10)

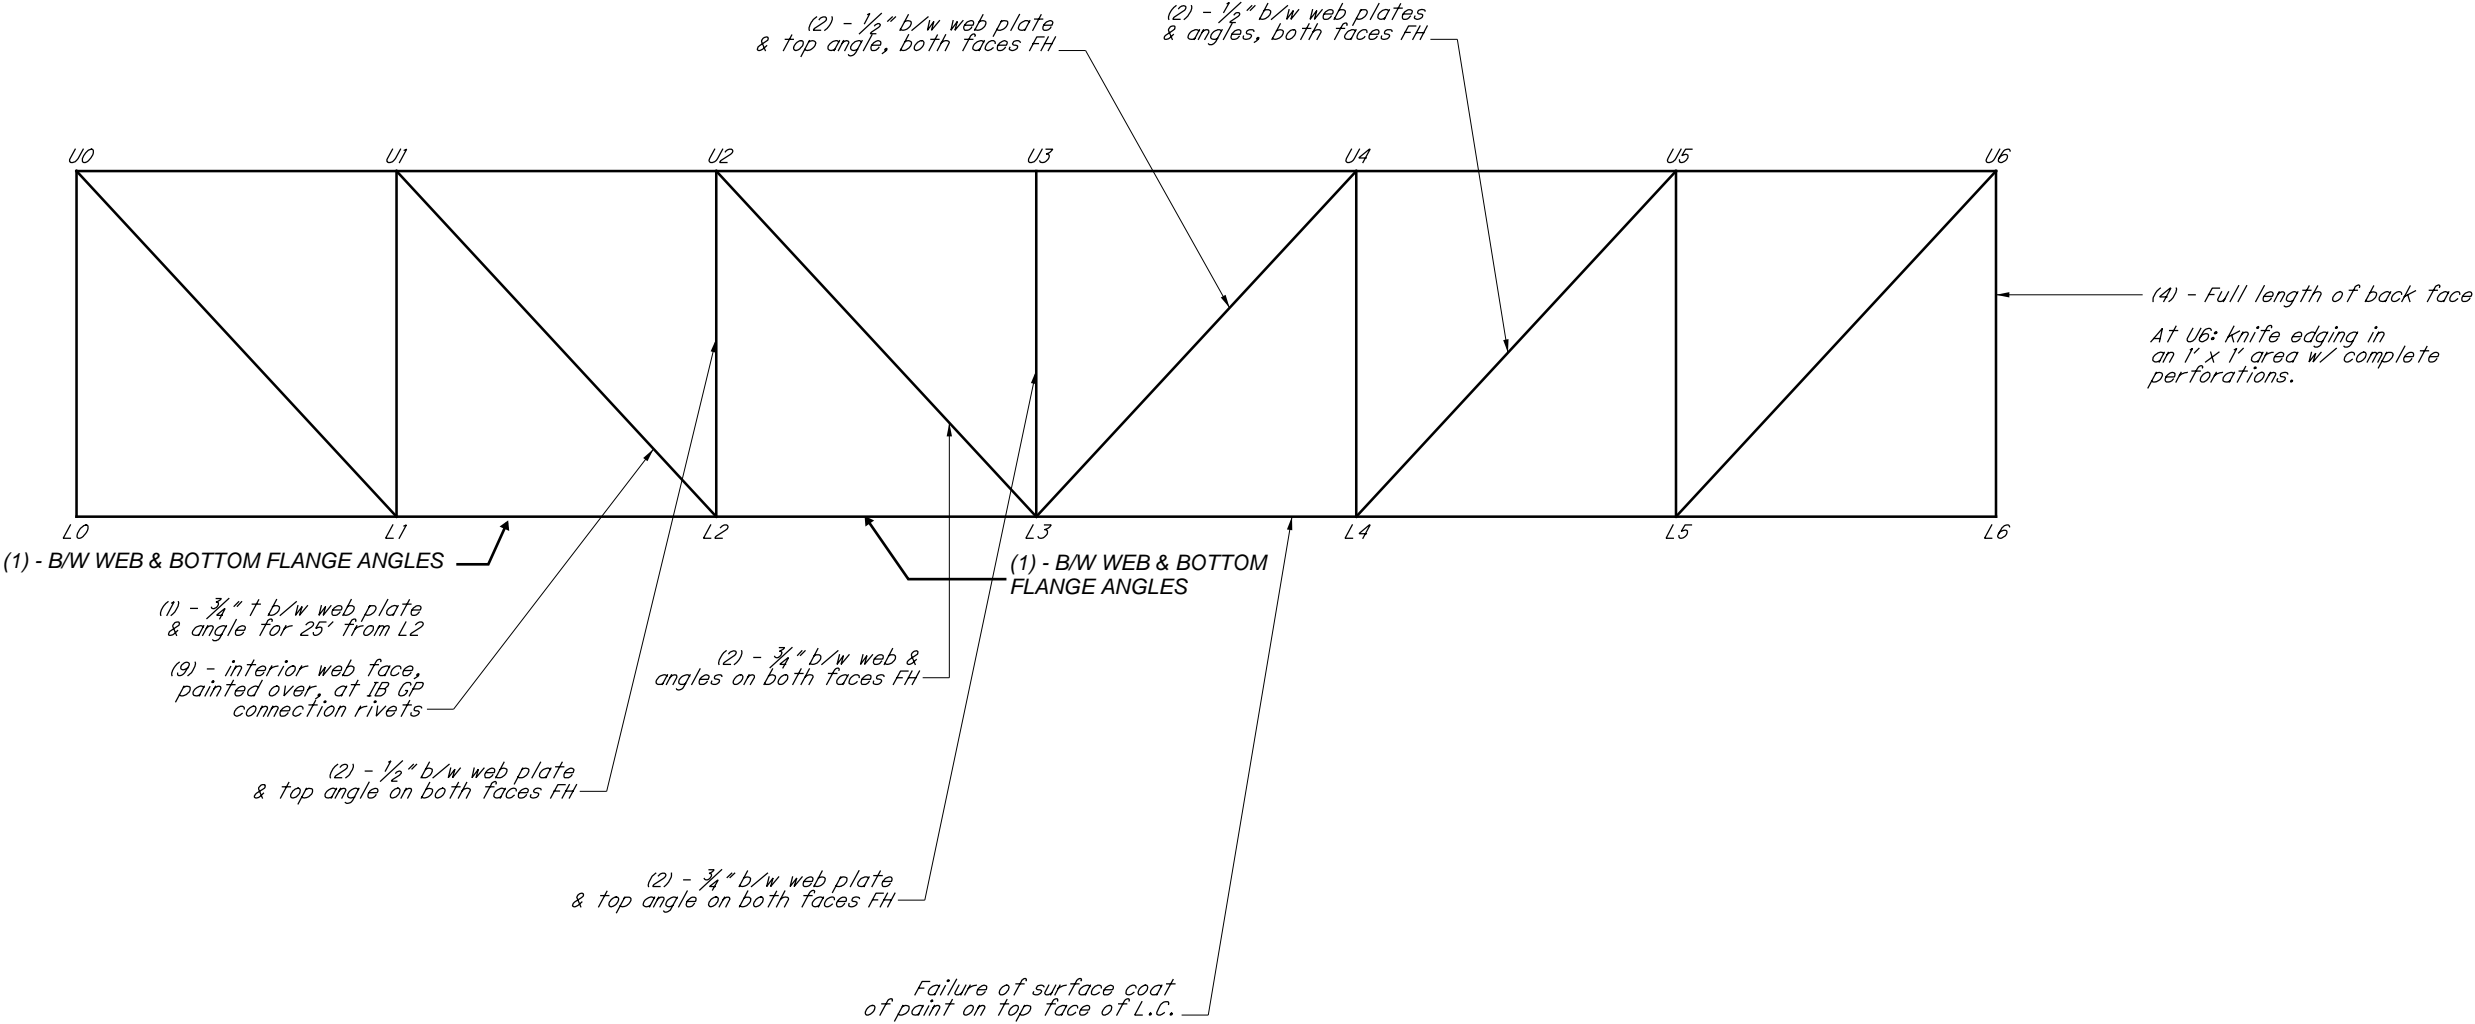
WHEELING & LAKE ERIE SPAN - NORTH INTERIOR TRUSS ELEVATION

W&LE NORTH INTERIOR GUSSET PLATE DEFICIENCIES

L3, BOTH - (4) - minor, up to $\frac{1}{8}$ "
L5, BOTH - (1) - between both GPs and vertical, up to $\frac{5}{8}$ " T for 20" L

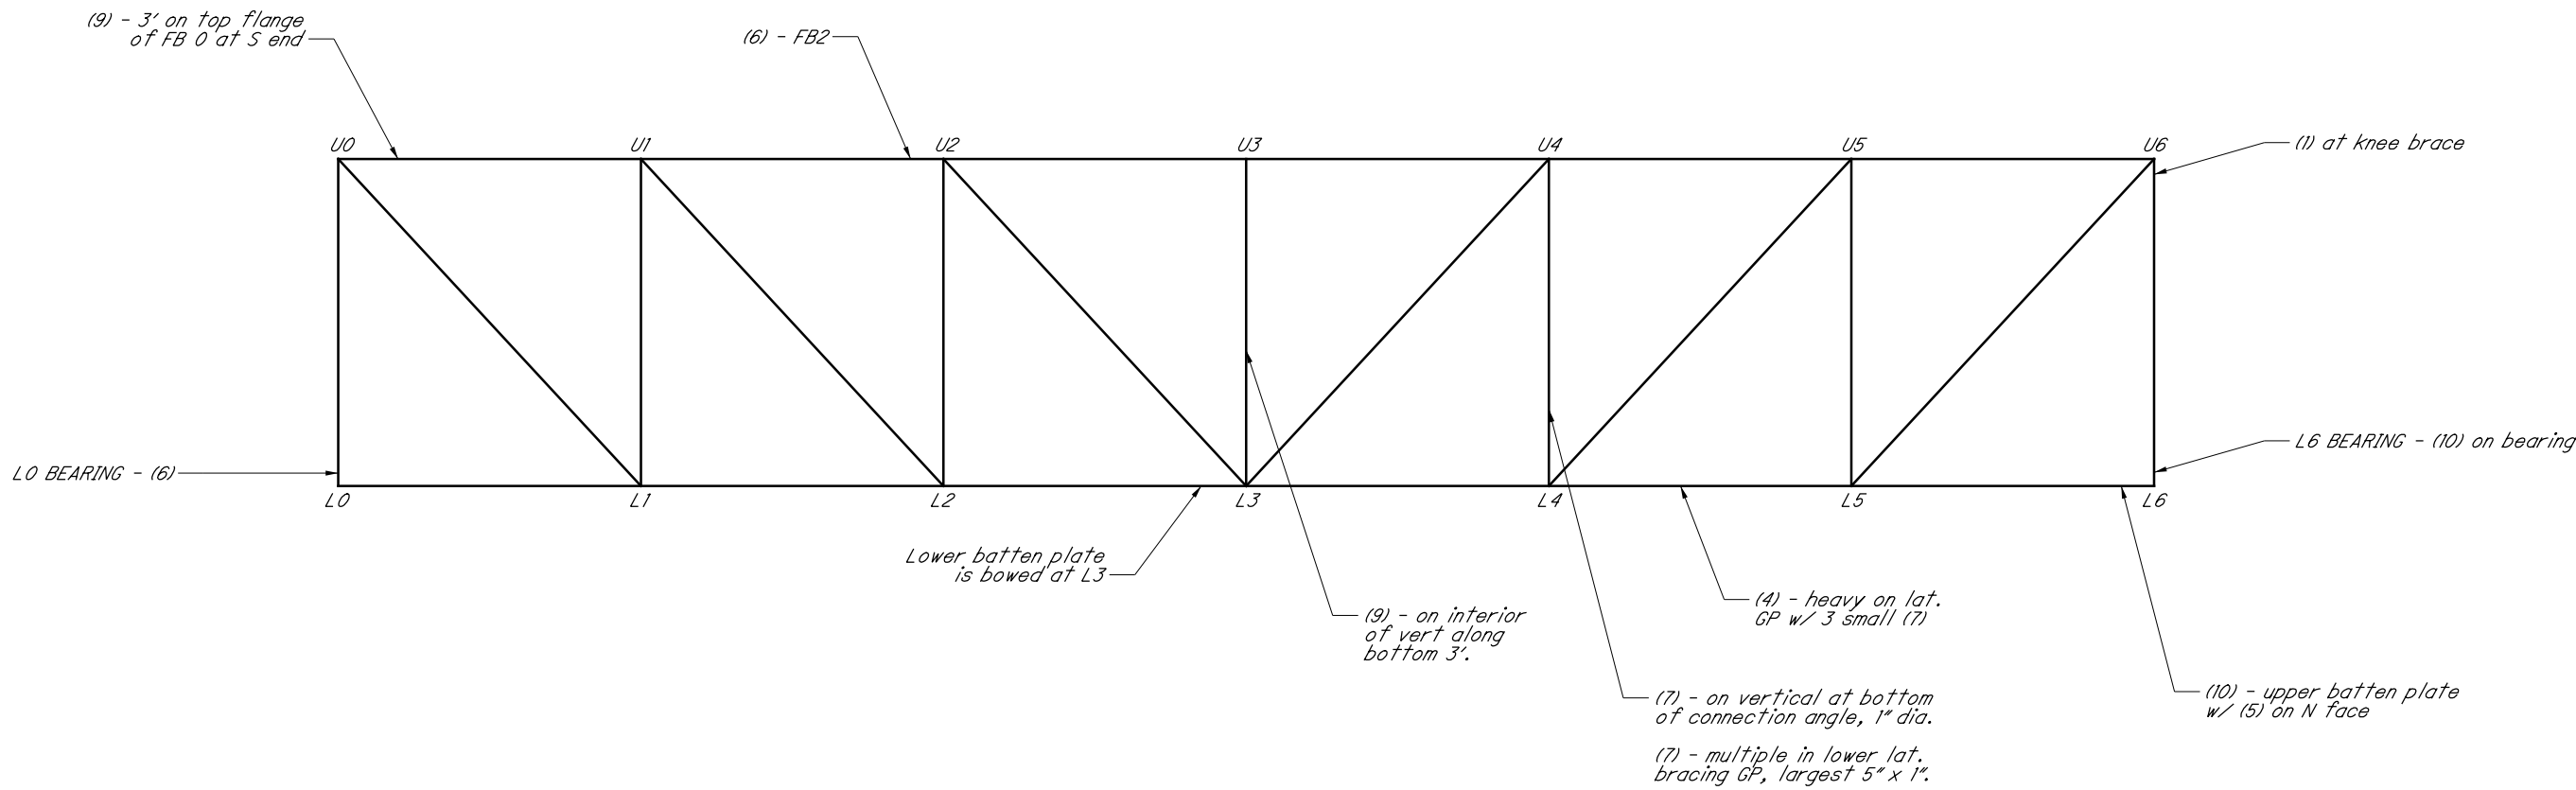
WHEELING & LAKE ERIE SPAN - SOUTH EXTERIOR TRUSS ELEVATION

W&LE SOUTH EXTERIOR GUSSET PLATE DEFICIENCIES

- L3, OB GP - (9) - active along top of the bottom flange.
- L4, IB GP - (3) - 1/4"
- L4, OB GP - (3) - 1/8" along bottom chord
- L5, OB GP - (10) - 1/8" with (5) on IB face and minimal (3)

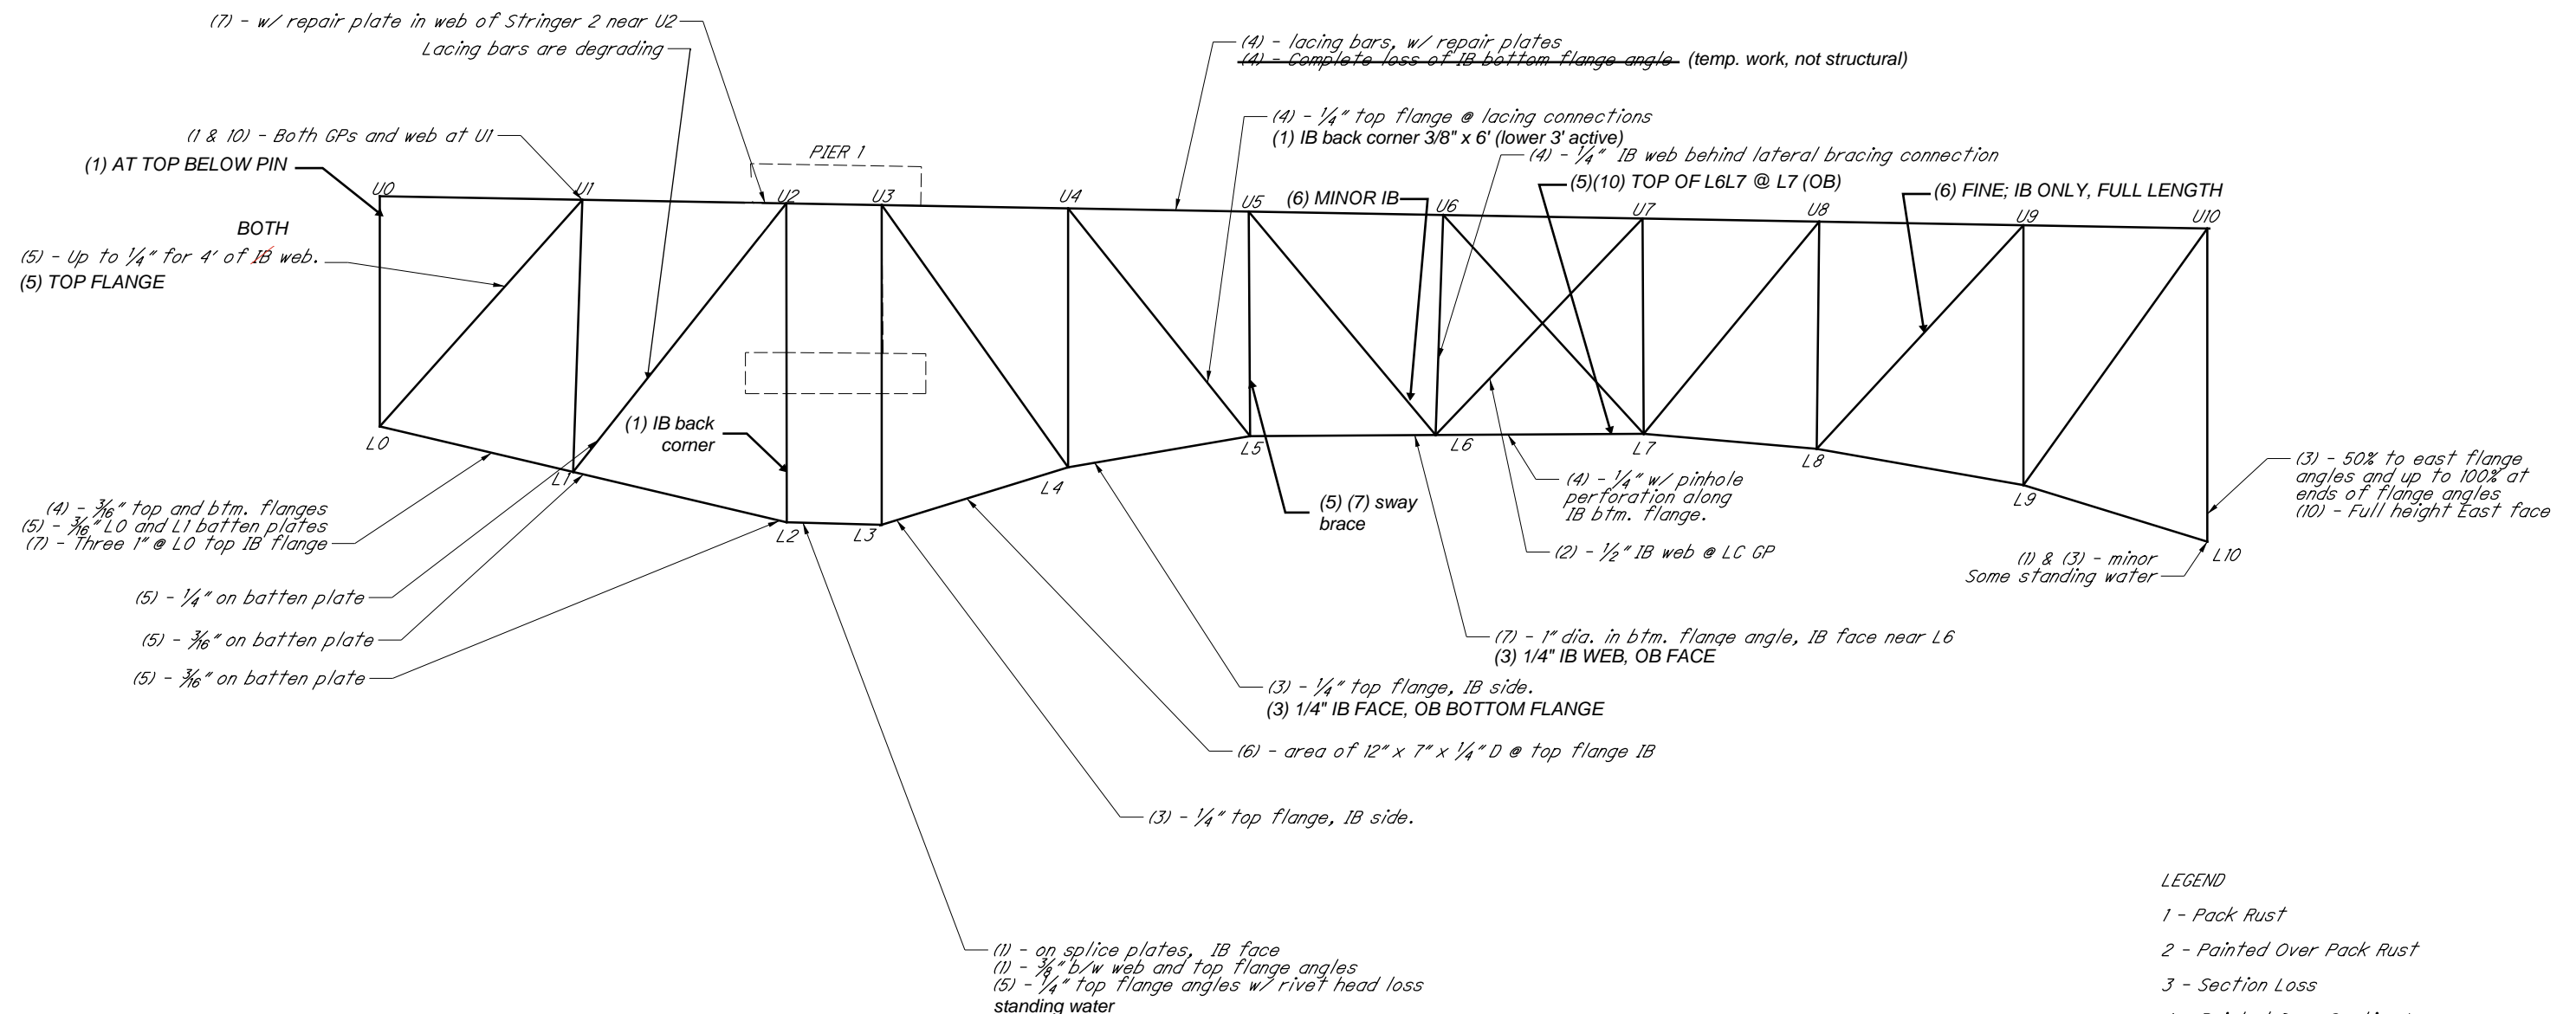
OPEN HOLE THROUGH DECK AT END
OF JOINT ADJACENT TO GUARDIAN;
DUMPS ON TO STEEL COLUMN U10L10

NORTH EXTERIOR GUSSET PLATE DEFICIENCIES

L0, BOTH - (6) 1/2" remaining

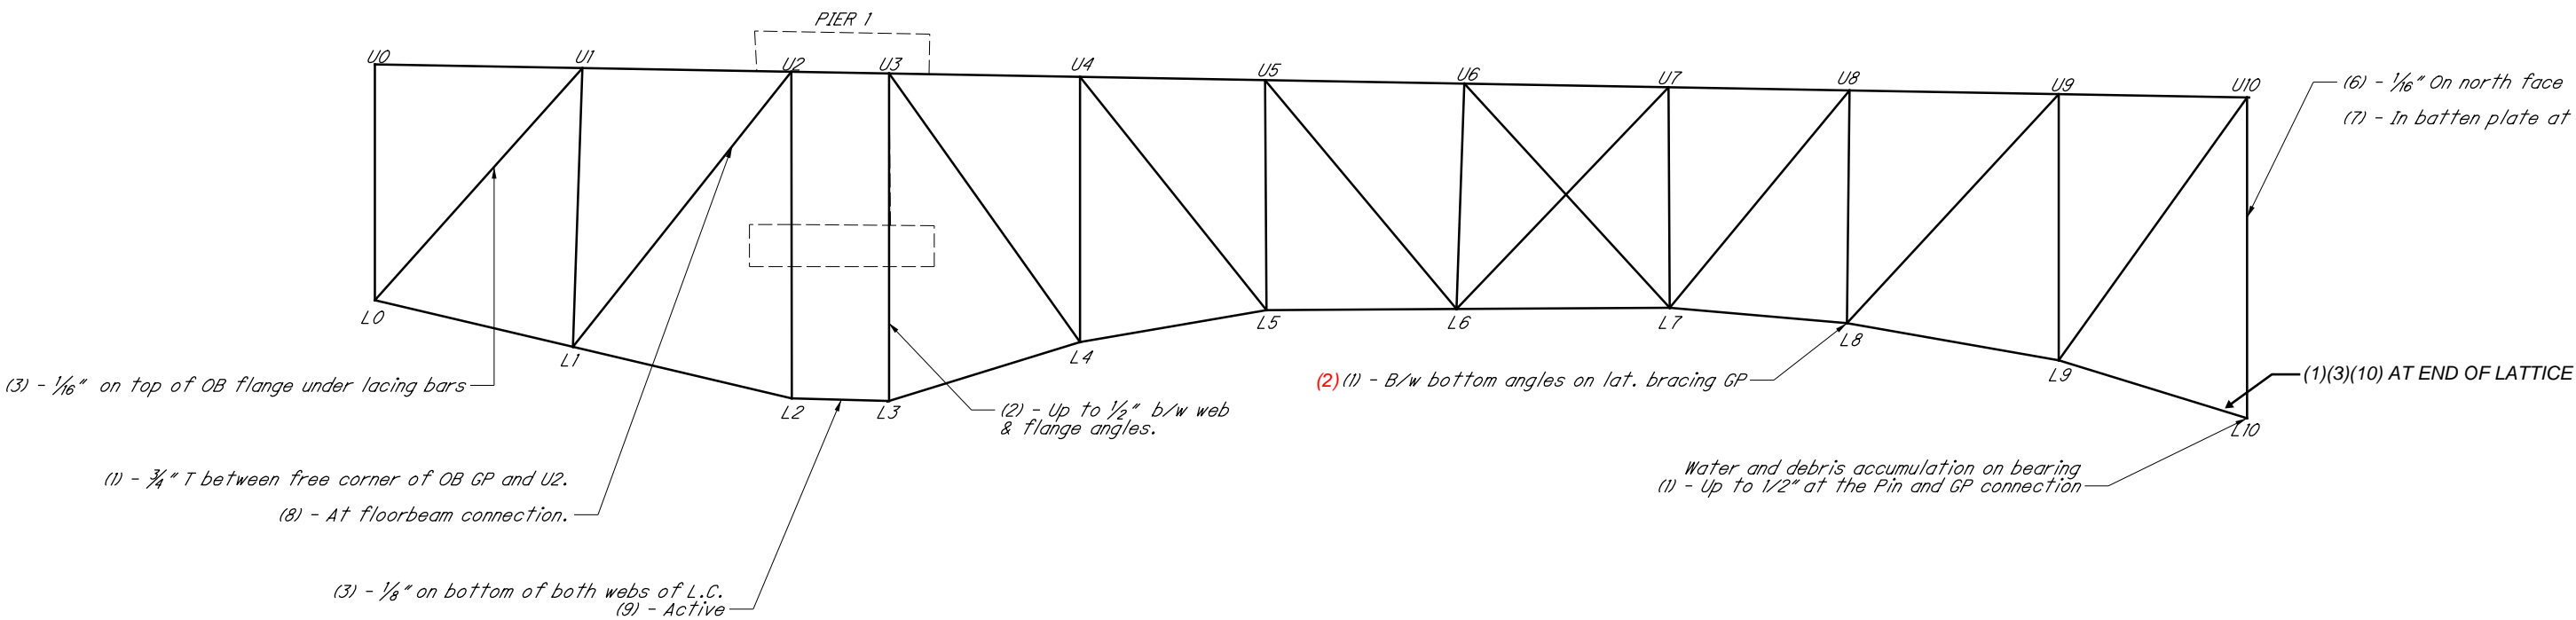
SPAN 1 - NORTH INTERIOR TRUSS ELEVATION

L0 - GP - (1)
L1 - GP - (10) (9) (3) at horizontal bracing angles near gusset connections
L5 - GP - (2) at top of lower chord and connection
L6 - GP - paint failure between gussets
L7 - GP - (2) at horz. diagonal gusset up to 1.5"
L8 - GP - reactivated corrosion at bottom

L0, IB GP - (1) AT DIAGONAL; PAINT FAILURE
L0, OB GP - (4) - 3/16\" around the pin nut.; (1) AT LATERAL BRACE CONNECTION
U0 - BOTH - (1) between GP & vertical
L1, IB GP - paint failure at bottom
L4, IB GP - (5) inside between diagonal & vertical
L4, OB GP - (10)
L6, IB GP - (3) - Up to 1/4\" between vertical and diagonal, (8)
L10, BOTH - (4) - 3/16\", inboard faces (6), (1) at lateral brace connection

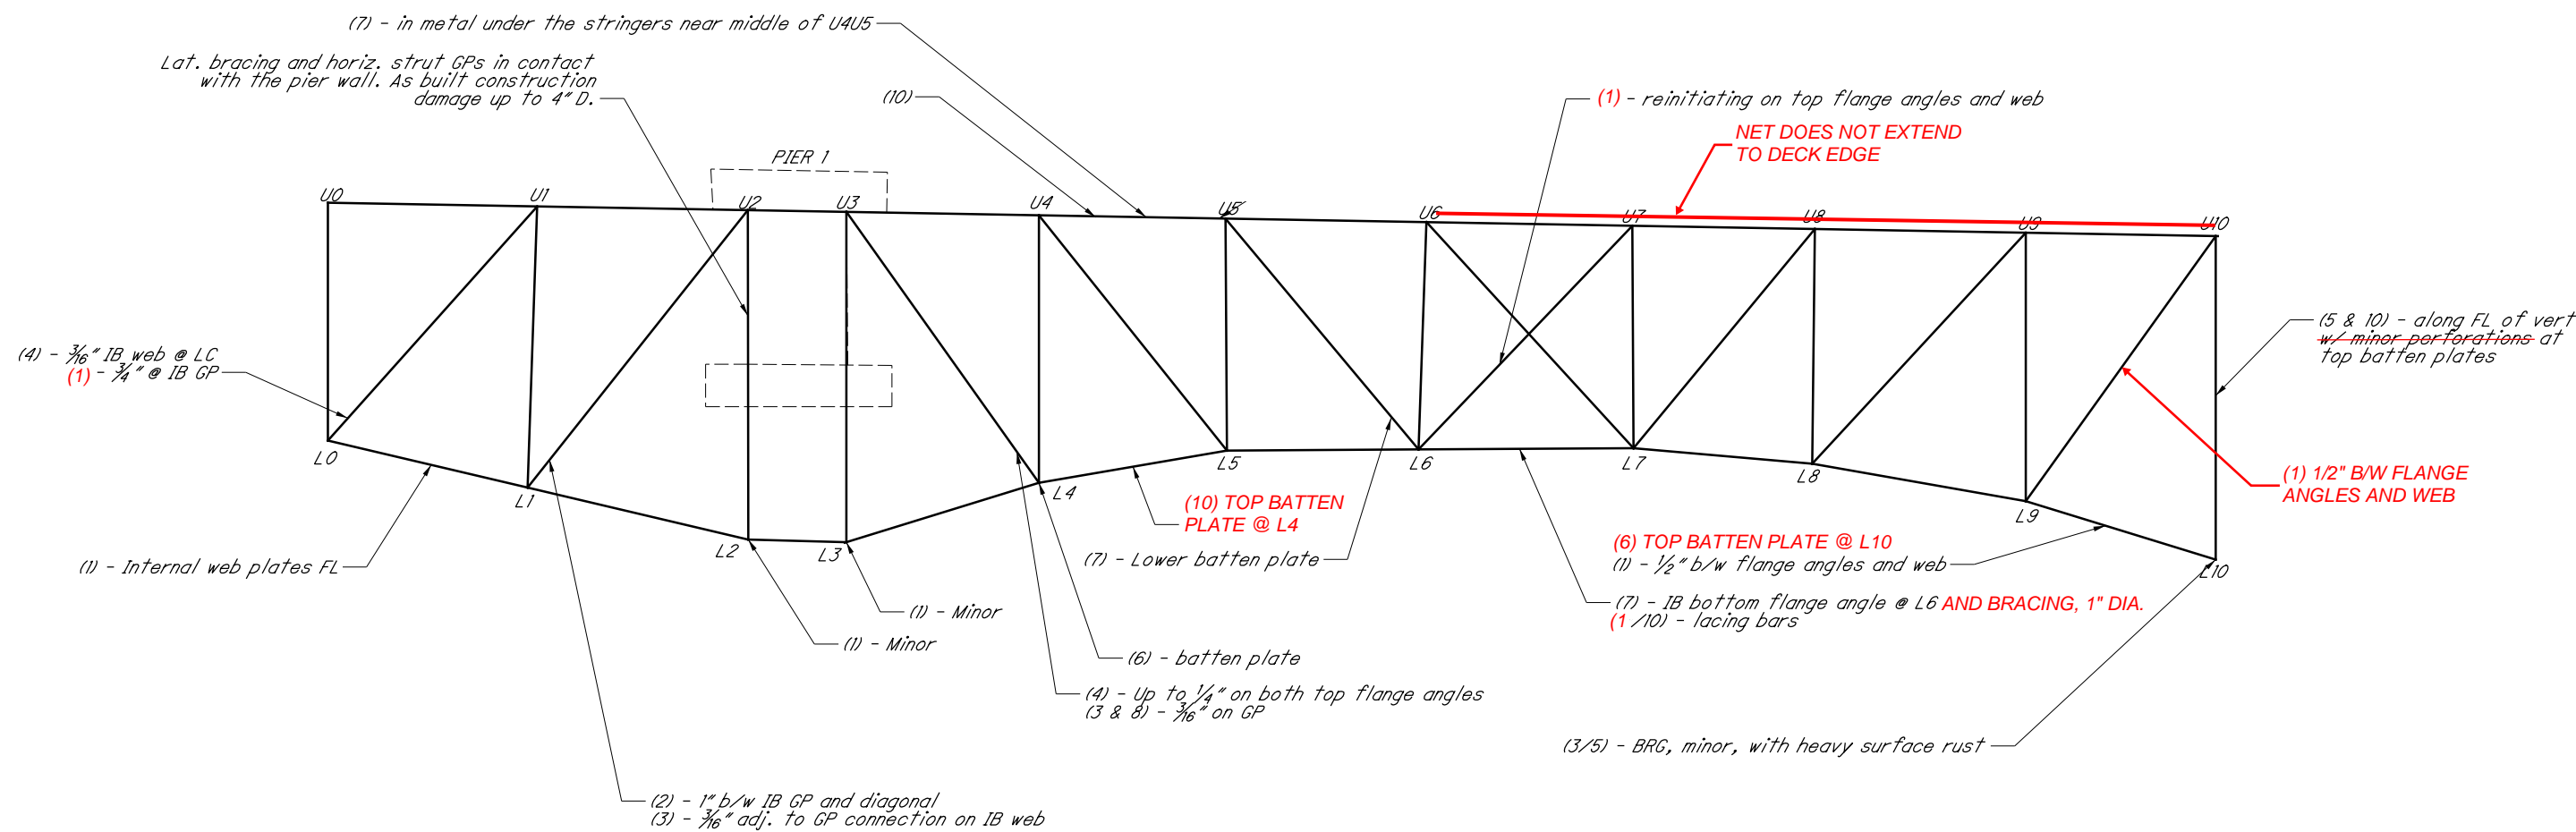
SPAN 1 - SOUTH EXTERIOR TRUSS ELEVATION

SOUTH EXTERIOR GUSSET PLATE DEFICIENCIES

- L0, BOTH- (5) 3/16"
- L2, IB GP - (4) 3/16" along top of lower chord
OB GP - (4) 1/4" behind OB web
- L4, IB GP - (6) 1/4", with widespread above the lateral bracing gusset plate for full width
(3) 3/16" for BOTH
(10)
- U5, IB GP - (10) on rivet heads
- L6, IB GP - (5) 1/4" D on IB face above LC
- L10, IB GP - (5) 1/2" above vertical
OB GP - (5) 1/2" between lower chord and vertical

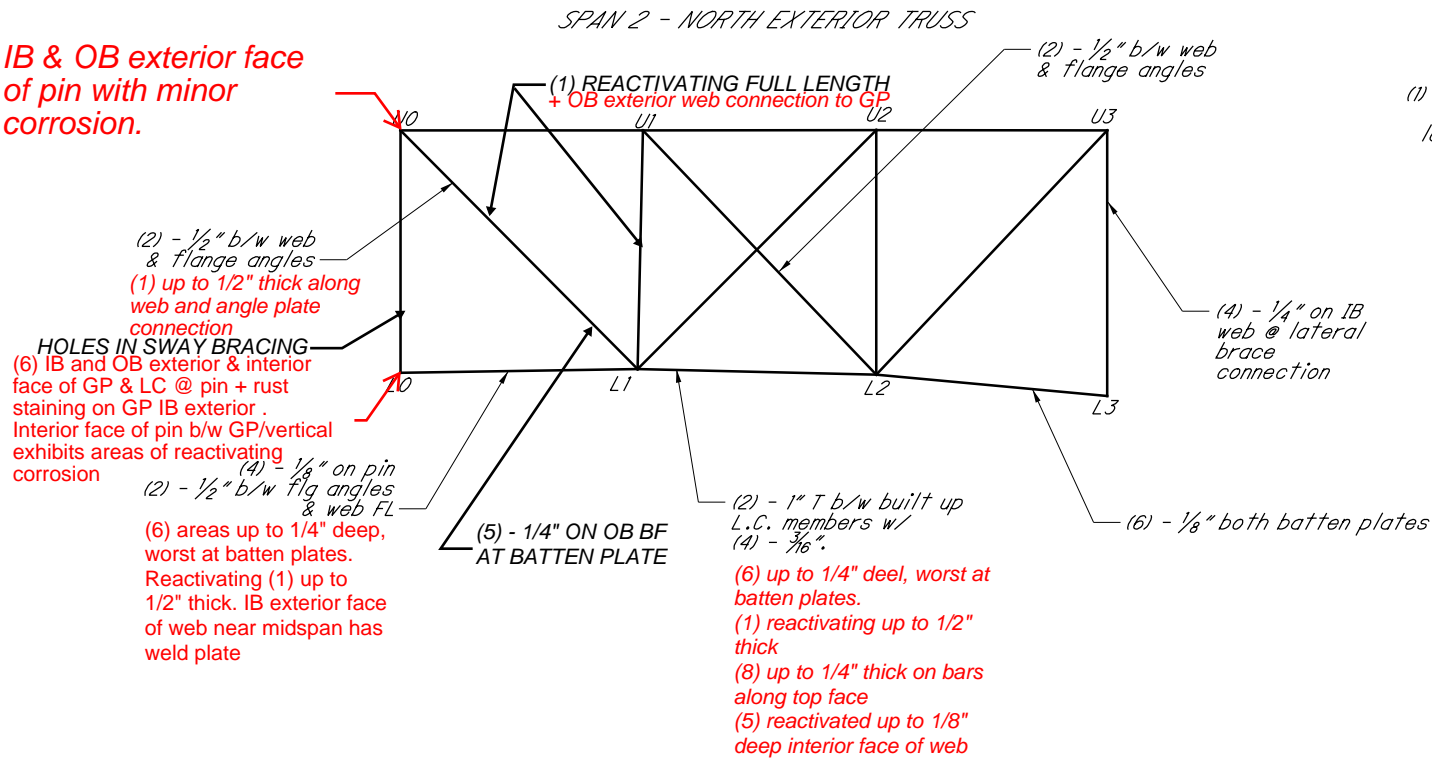
IB & OB exterior face of pin with minor corrosion.

(1) - b/w IB and OB L.C. plates up to 1-3/4", OB end of pin is no longer flush with cover plates.
(2) - 1/8" b/w web and flange angles causing scalloping.
(5) - 1/4" on the pin

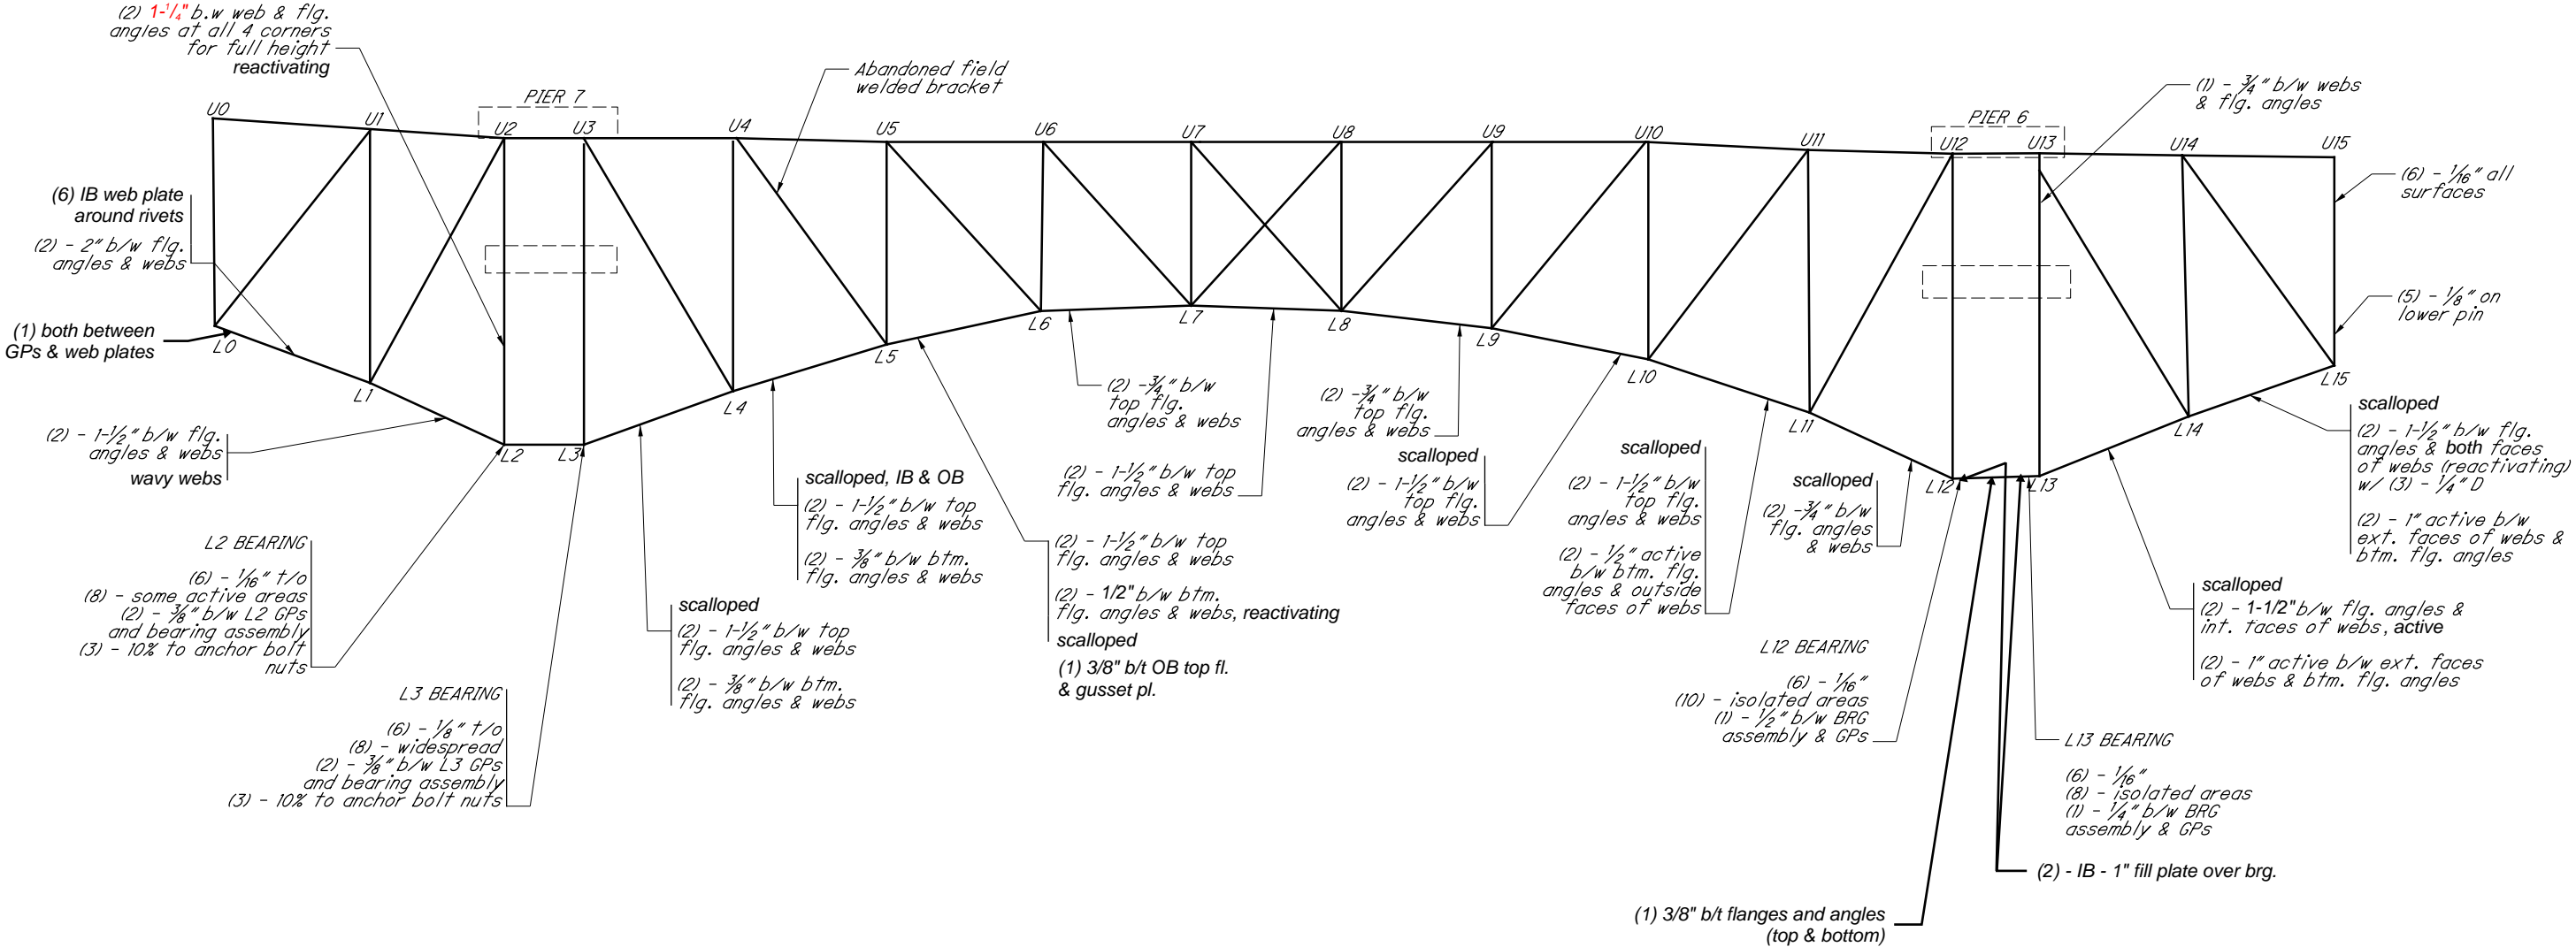
SPAN 7 - SOUTH INTERIOR TRUSS ELEVATION

SPAN 7 SOUTH INTERIOR - GUSSET PLATE DEFICIENCIES
L0, OB GP - (3) - 4 rivets at bottom @ 50%
L0, OB GP - (6) around pin
L1, IB GP - (8) - bottom of plate above lower chord connection
L2, IB GP - (5) - 1/8" x 2" H on IB face, with (8 & 10)
L2, OB GP - (4) - 1/8" along L.C. on OB face
(6) - 1/16" scattered @ IB face
L12, BOTH - (5) - 3/8" deep x 2.5" high x 3' long @ vert. above top flange of L.C.
L15 OB GP - (5)

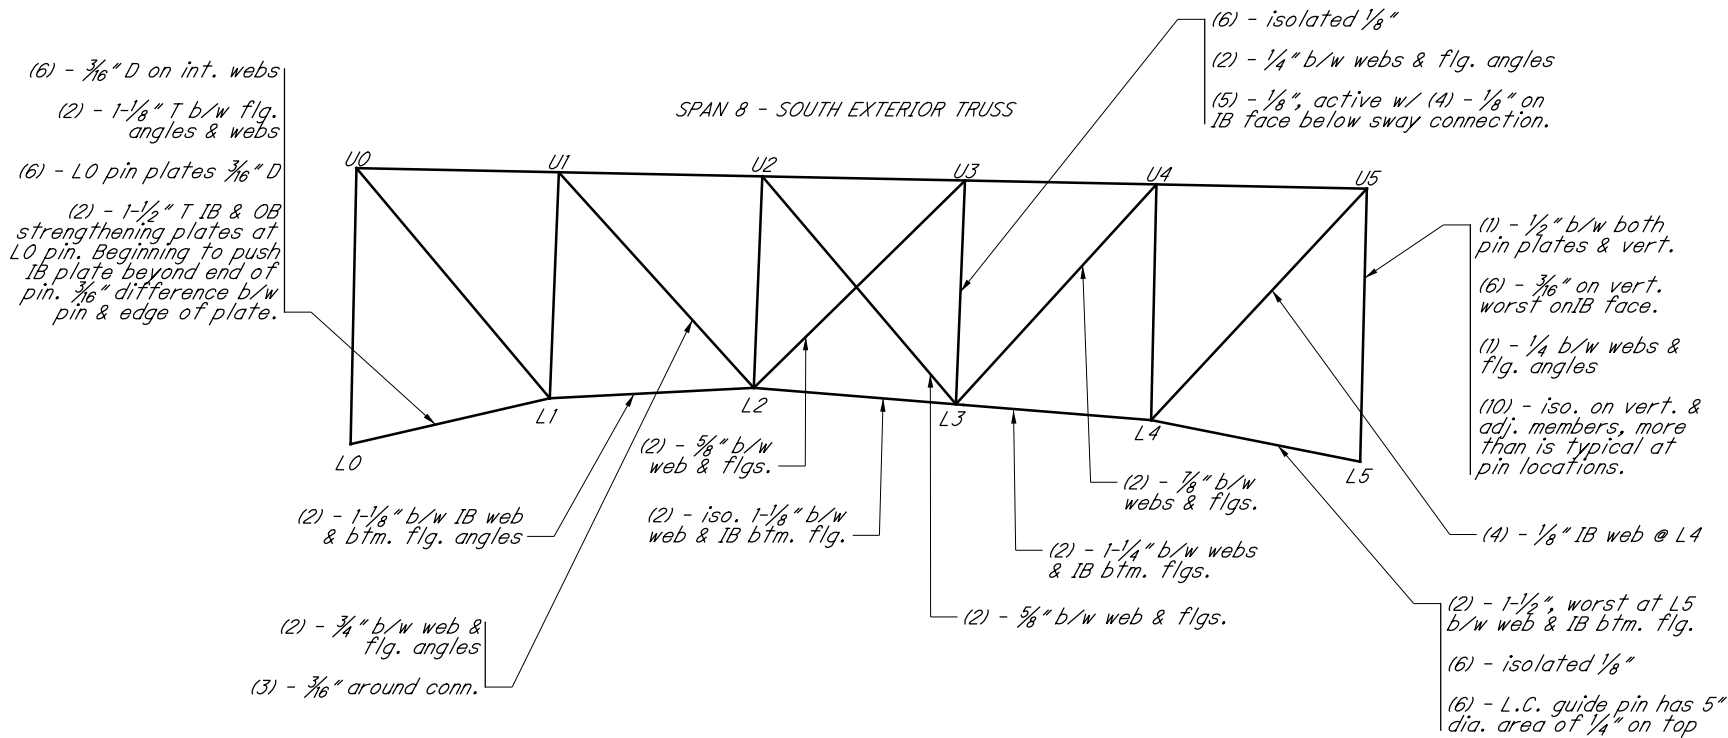
- (1) up to 1 $\frac{1}{2}$ " thick between GP and vertical pin at OB
(6) at OB side

SOUTH EXTERIOR GUSSET PLATE DEFICIENCIES

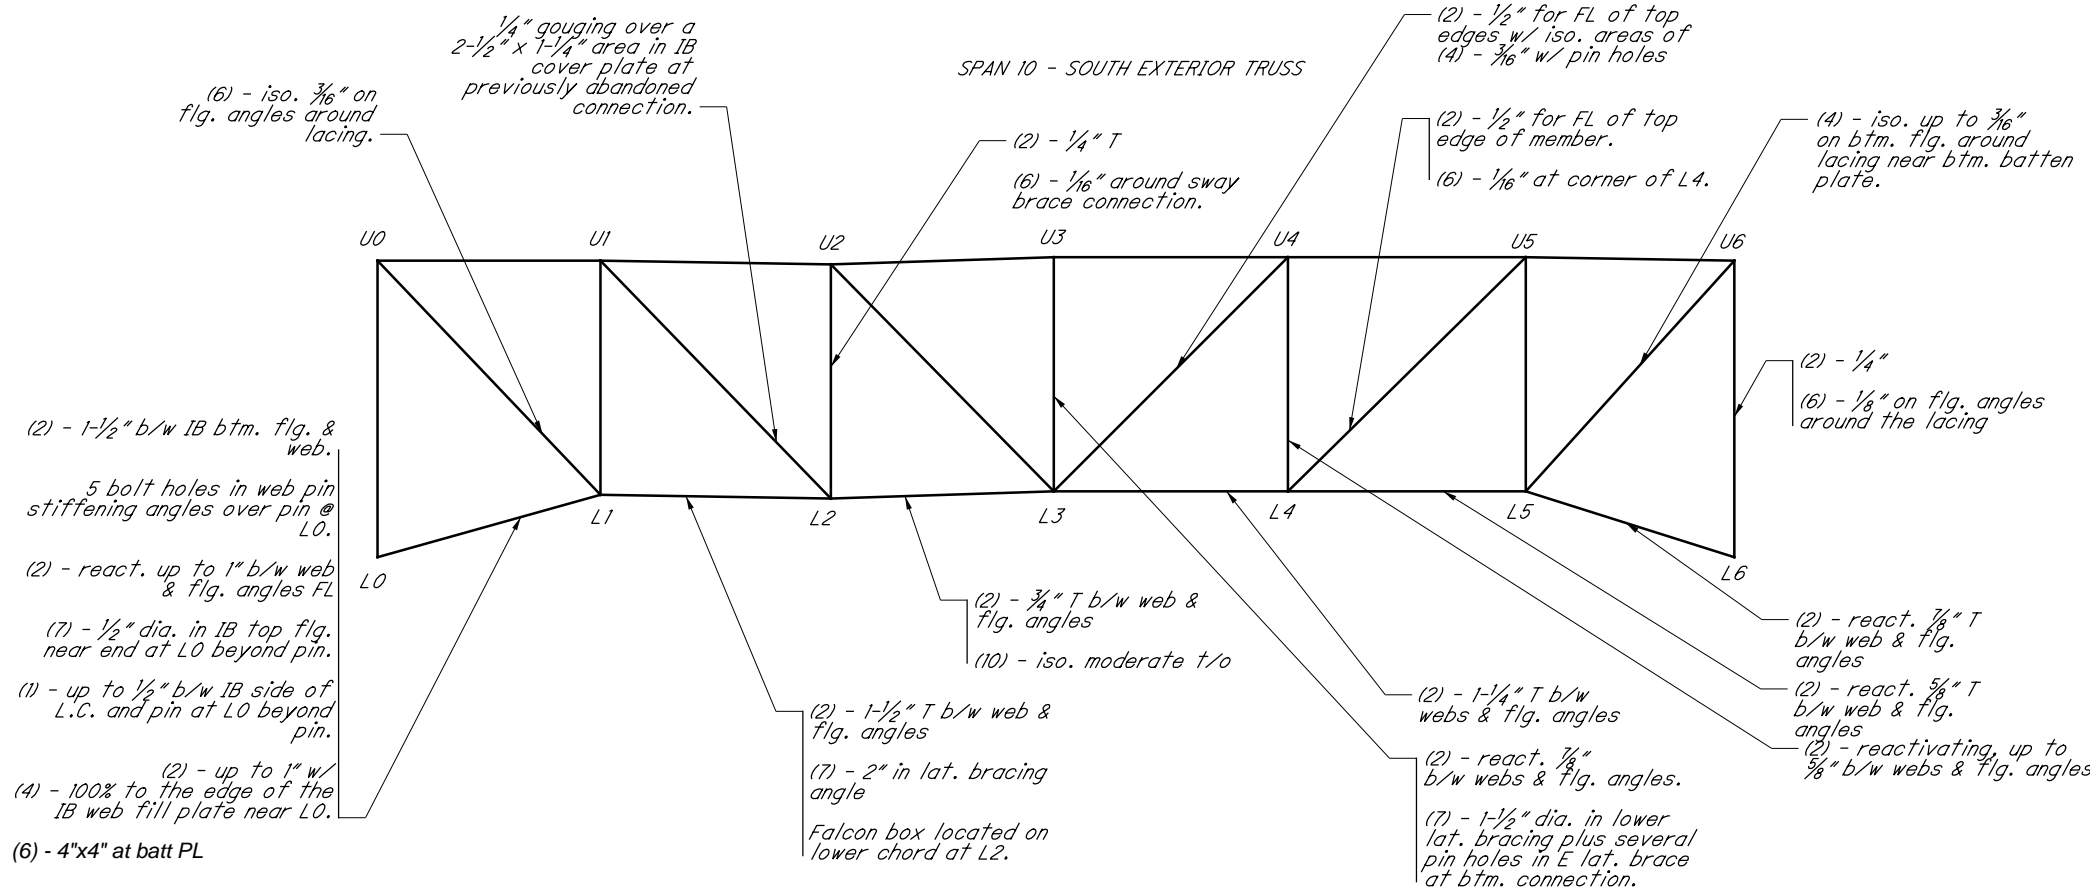
SPAN 10 - SOUTH TRUSS ELEVATIONS

SOUTH EXTERIOR GUSSET PLATE DEFICIENCIES

- L2, BOTH - (6) - isolated up to $\frac{1}{8}$ "
- L2, IB GP - (10)
- L3, IB GP - (1) - up to $\frac{1}{4}$ " at the corner
- L5, IB GP - (6) - up to $\frac{1}{8}$ " along IB corner due to 1- $\frac{1}{4}$ " (1).
- L6, BOTH - (3) - $\frac{3}{16}$ " t/o
- (2) - reactivated along all edges and isolated areas of reactivated surface corrosion.
- (2) - up to $\frac{3}{4}$ " between GPs and vertical at the pin.
- U6, BOTH - (1) - active, up to $\frac{1}{2}$ " between pin plates and top of vertical.
- (3) - up to $\frac{3}{16}$ " full perimeter of the upper pins.
