2025 PHYSICAL CONDITION ROUTINE ELEMENT LEVEL INSPECTION REPORT

Bridge CUY-10-1613

SFN 1801503

Hope Memorial/Lorain Carnegie over Cuyahoga River

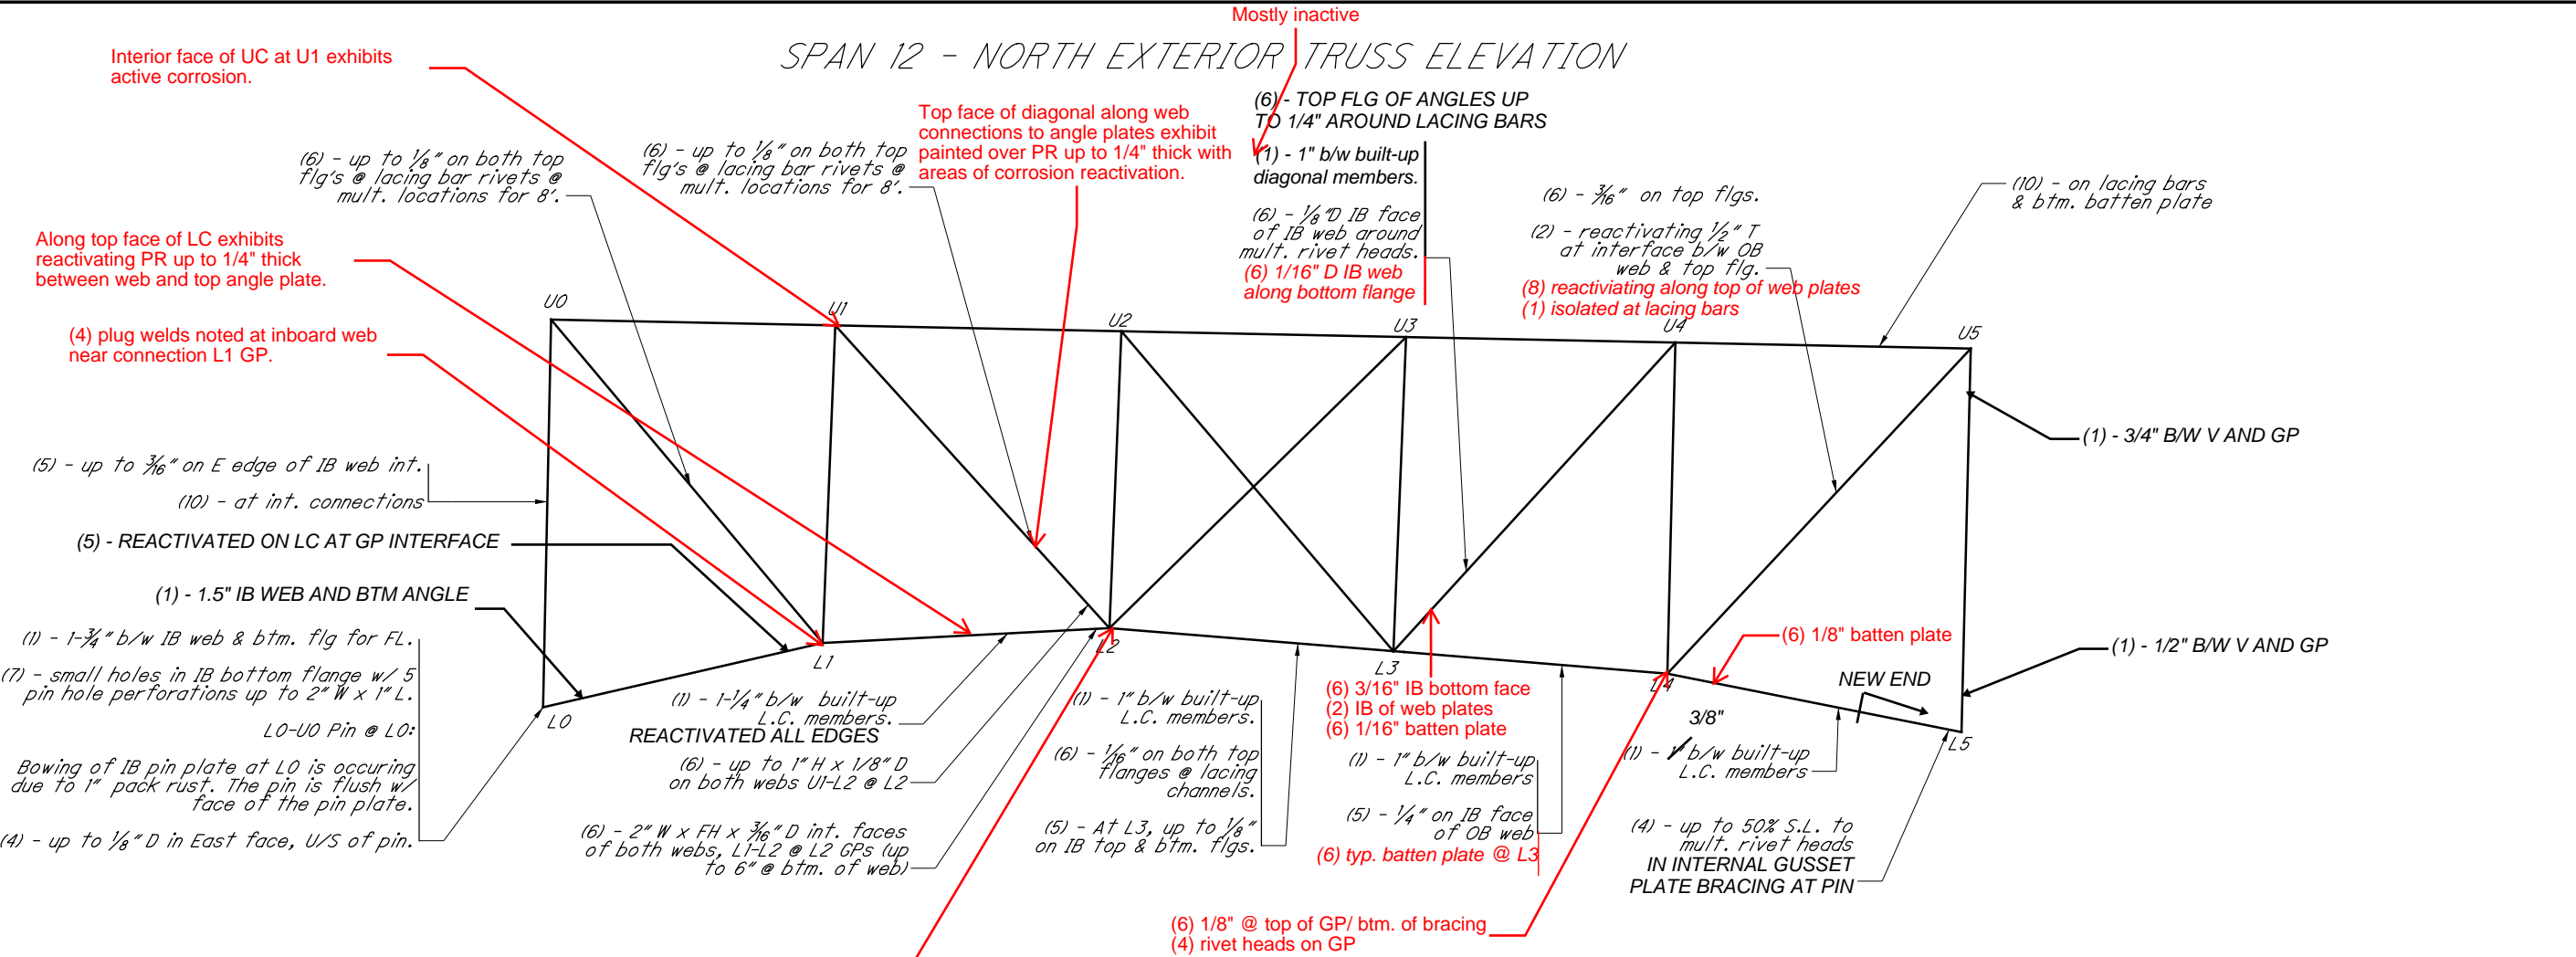
J:\ODOT\09534-VAR-D12 Inspections\Inspection\CUY-10-16.13_Lorain Carnegie Inspection_Notes_2022.dgn Span 12 - N Exterior 11/28/2022 12:31:21 PM adam-l

L0, OB GP – (6) up to 1/16" deep exterior face along connection to LC
L2, OB GP – (6) up to 1/8" D along IB face bottom
L2, IB GP – (6) up to 1/4" D along OB face, areas of reactivation

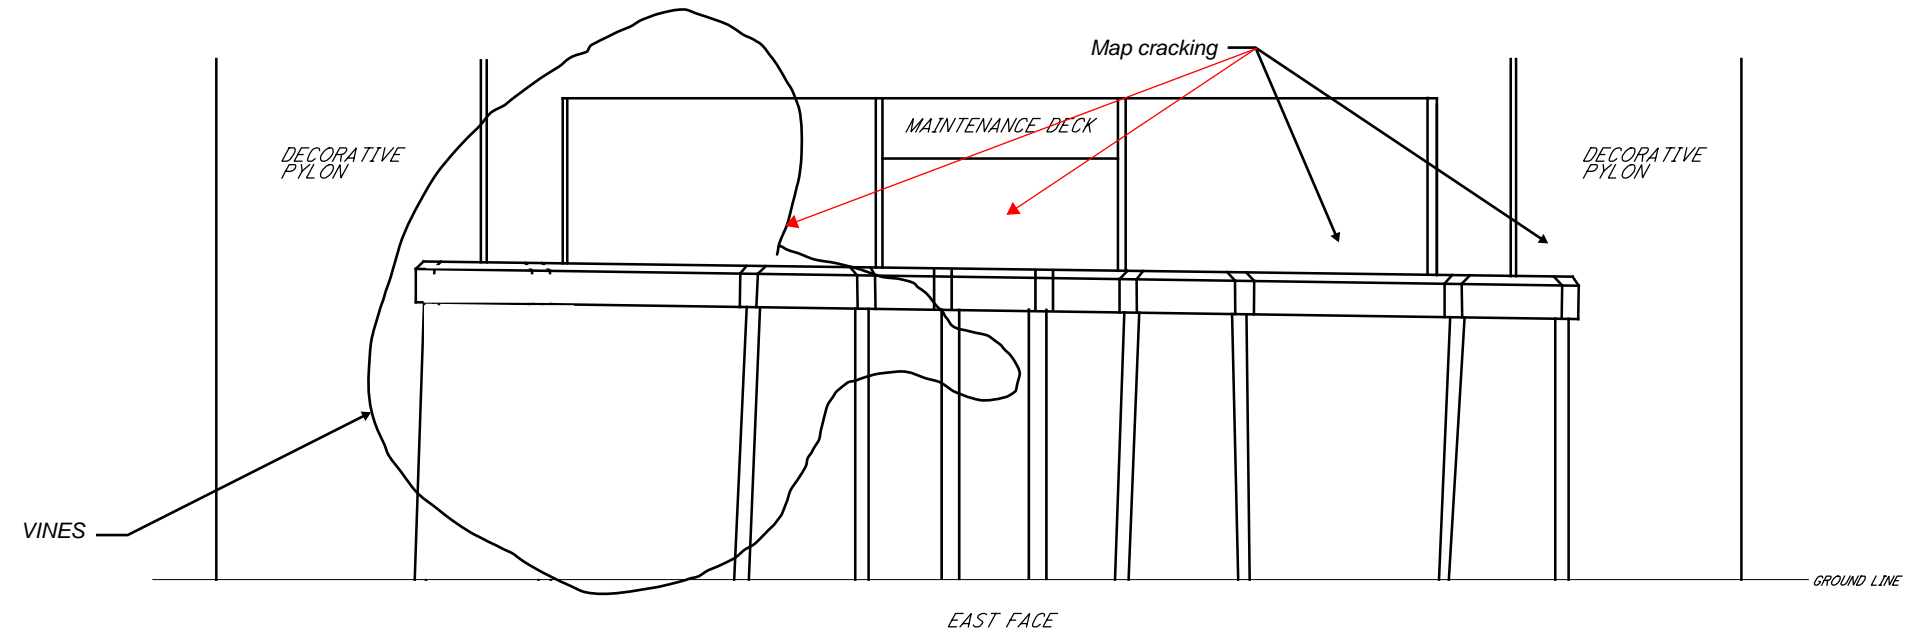
The access manholes in the pier caps are in poor condition with the lips heavily deteriorated.

Does not look like this.
There are only 3 bearings
at East Face.

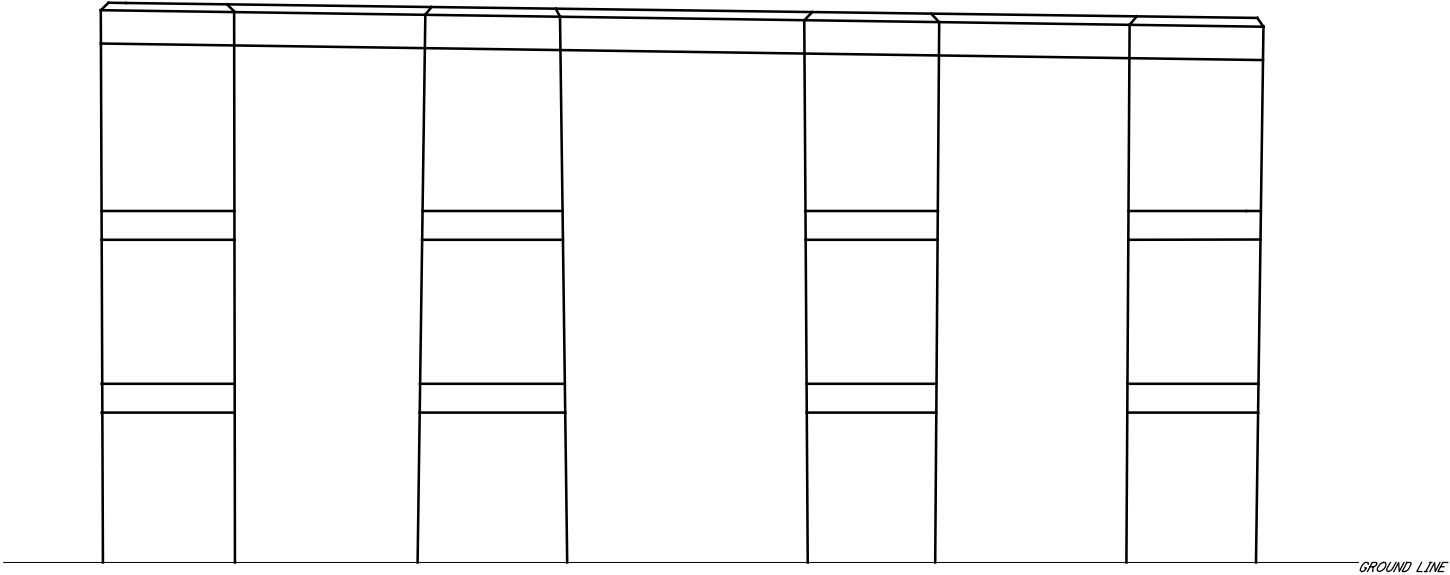
EAST FACE

- Pier columns have some areas of cracking, staining, delamination or spalling concentrated around previously patched areas.
- The underside of the pier towers are deteriorated with cracks, spalls, delaminations and spalls. The majority of the spalling has exposed reinforcing.
- The access manholes in the pier caps are in poor condition with the lips heavily deteriorated.
- Spalls with exposed rebar at corbels on pier legs.
