June 15, 2026

**Re: CLAIM NO. 06-233008-01  
FAY-SR 435-1.52, PID 117955  
RAMP D CRACKED CONCRETE STEP 3**

### **EXECUTIVE SUMMARY**

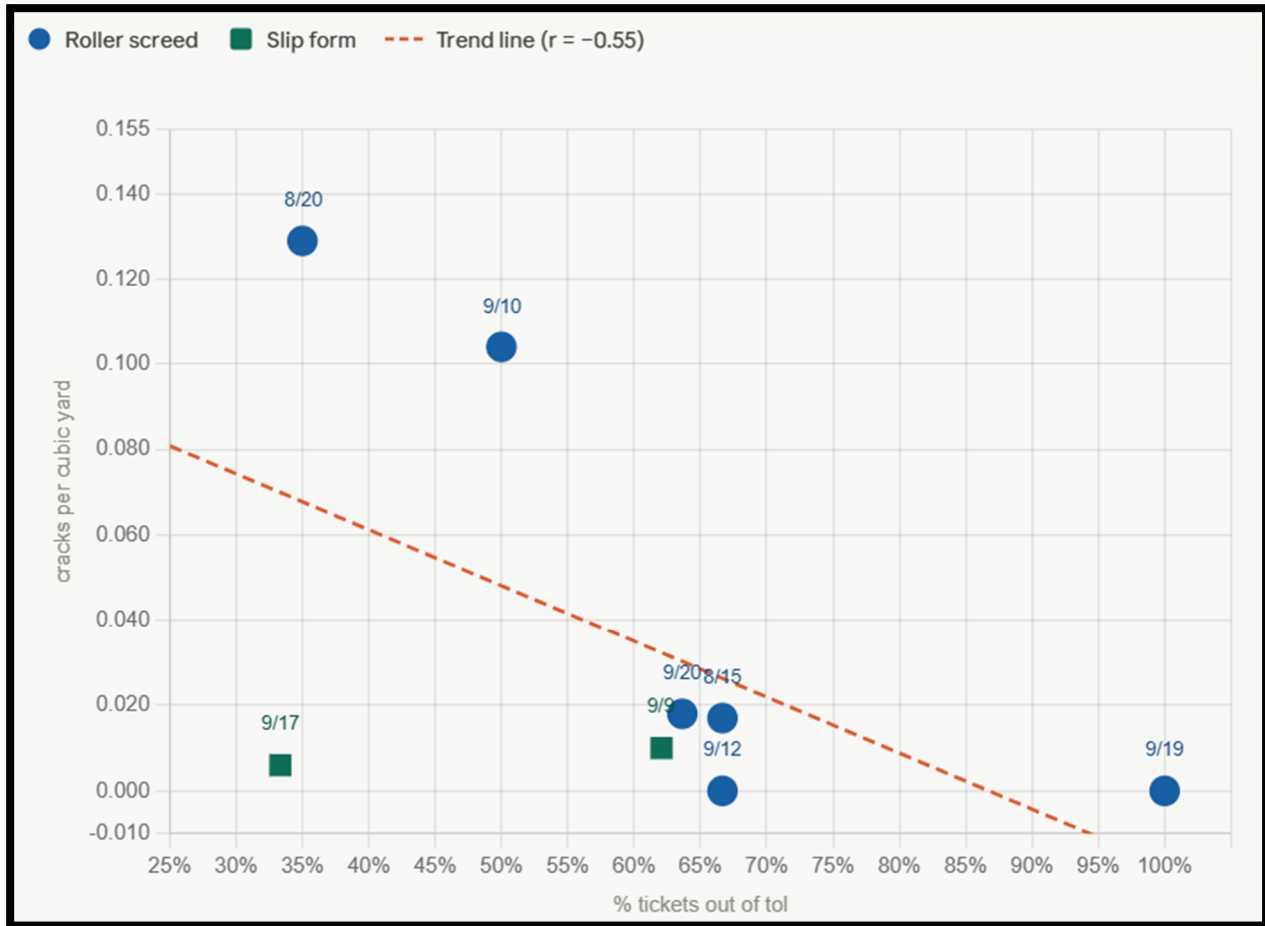
In its decision, ODOT District 6 included the out of tolerance concrete as a potential contributing factor (along with roller screed placement and MOT phasing). When reviewing the data that ODOT presented at the Step 2 Conference, ODOT's crack data actually shows a negative correlation between out of tolerance concrete and subsequent cracking – i.e. concrete with higher % of out of tolerance loads had the least amount of cracking per cubic yard and concrete with the lower % of out of tolerance loads had the most amount of cracking per cubic yard<sup>6</sup>.

As shown, the two placements that ODOT is focusing on for cracking (the August 20, 2024, and September 10, 2024 placements) had the least percentage of out of tolerance loads (50% or less). In contrast, the roller screed placements of August 15, 2024, September 20, 2024, September 12, 2024, and September 19, 2024, had a higher percentage of out of tolerance loads (60% or above) but had less cracking per cubic yard. This data demonstrates that **there is no correlation** between the out of tolerance loads and presence of cracking. In fact, the data suggest that if there is a

correlation, it is a negative correlation – i.e. the higher % of out of tolerance loads for a placement resulted in lower cracking per yard.

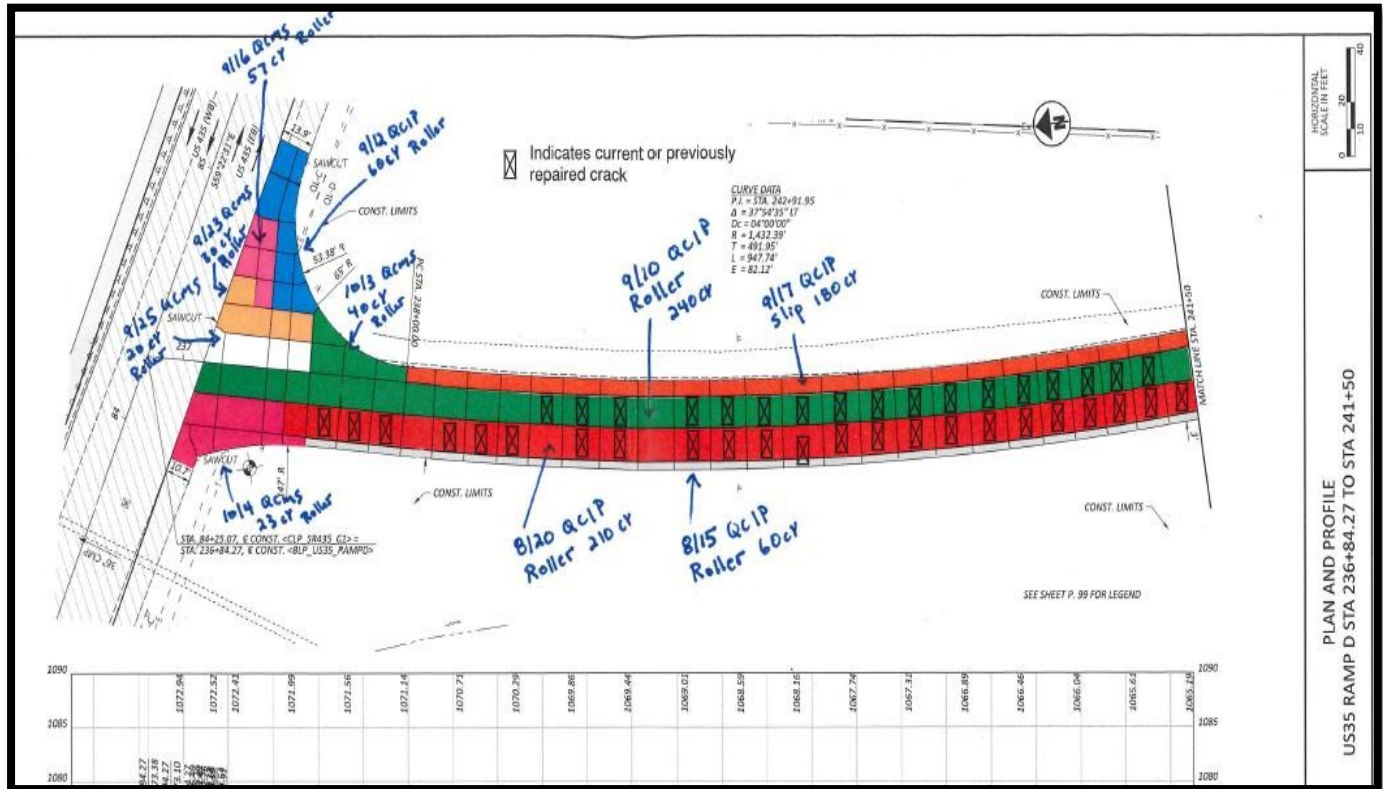
The September 10, 2024 pour also involved the QC1P mix placed by roller screed which showed a high level of correlation of the same mid-panel cracking from the August 20, 2024 pour, essentially mirroring the same mid-panel crack. See the ODOT Crack Map below showing August 20 pour (red) and September 10 pour (dark green).

The mirror cracking, or sympathy cracking, on the September 10, 2024 pour is likely the result of the stresses created by the heavy truck traffic on the August 20 pour. These two pours are tied together with #5 tie bars 24" in length spaced at 30" intervals. During the September 10, 2024 placement, heavy truck traffic was using the adjacent 8/20 pavement to maintain the single lane of traffic required by the Project. As the August 20 pavement flexed with the heavy truck traffic at the control joints and the mid-panel cracks (which were seen as early as September 3), similar stresses and movement were created in the freshly placed September 10 concrete pavement which resulted in the mirrored cracking.
