| PROJECT: BEL-147-24.65 | | DRILLING FIRM / OPERATOR: TERRACON / FAY | | DRILL RIG: MOBILE B-57 | | STATION / OFFSET: 1368+32, 6' LT. | | EXPLORATION ID | | | | | | | | | | | | | |
| TYPE: LANDSLIDE | | SAMPLING FIRM / LOGGER: TERRACON / SWYCK | | HAMMER: CME AUTOMATIC | | ALIGNMENT: BEL - 147 | | B-001-0-23 | | | | | | | | | | | | | |

N4225522 BEL-147-24.65 PID 118147 – Slide Repair

| Checked by: BH | File Name: Rockcore Photos | | Geotechnical Investigation |

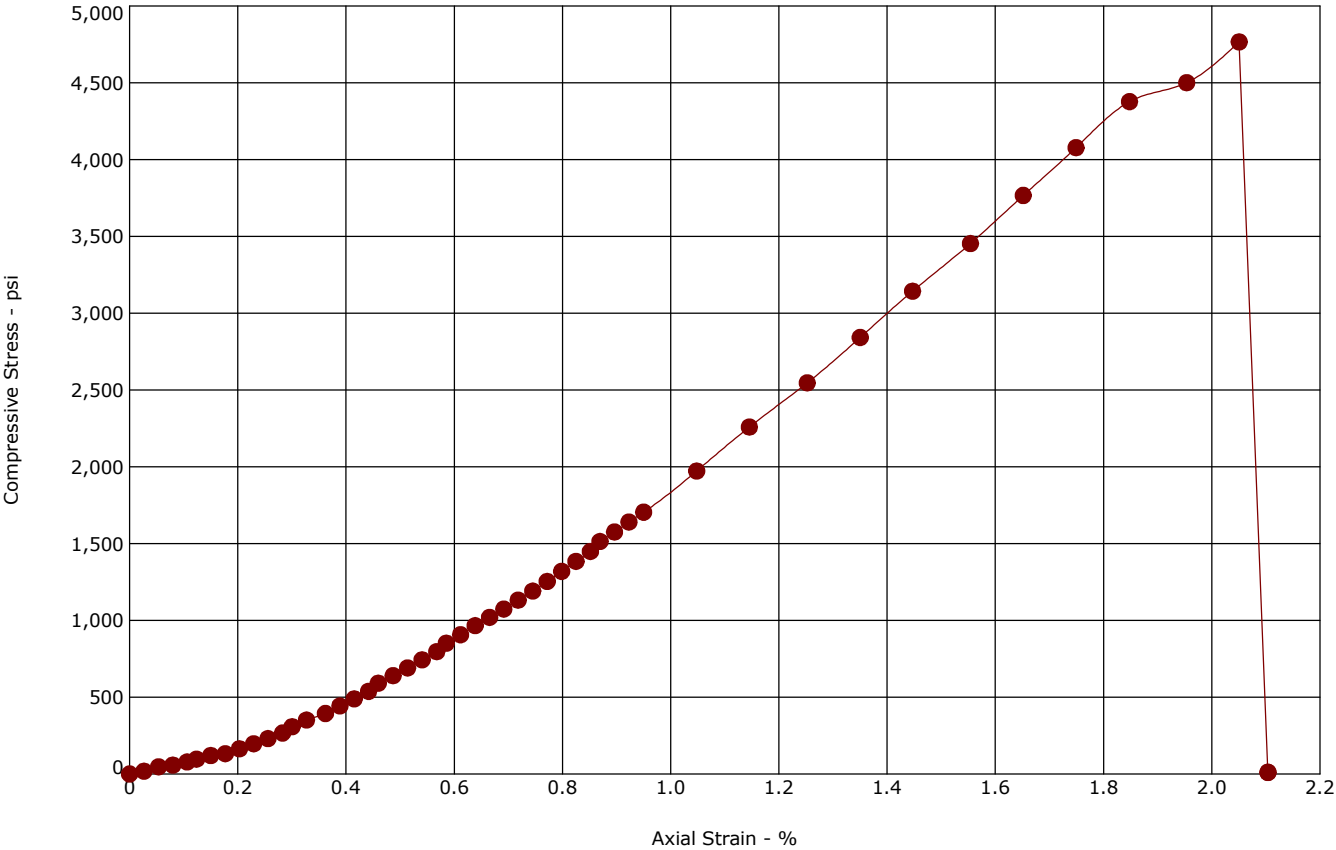
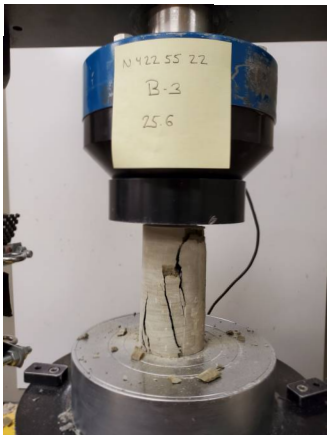
Unconfined Compression Test

| Boring ID | Depth (Ft) | Sample type | LL | PL | PI | Fines (%) | Description |
|---|---|---|---|---|---|---|---|
| B-003-0-23 | 25.6 - 26 | NQ2 | | | | | SANDSTONE |

| Specimen Failure Mode | Specimen Test Data |
|---|---|
| | Unconfined Compressive Strength (psi): 4766 |

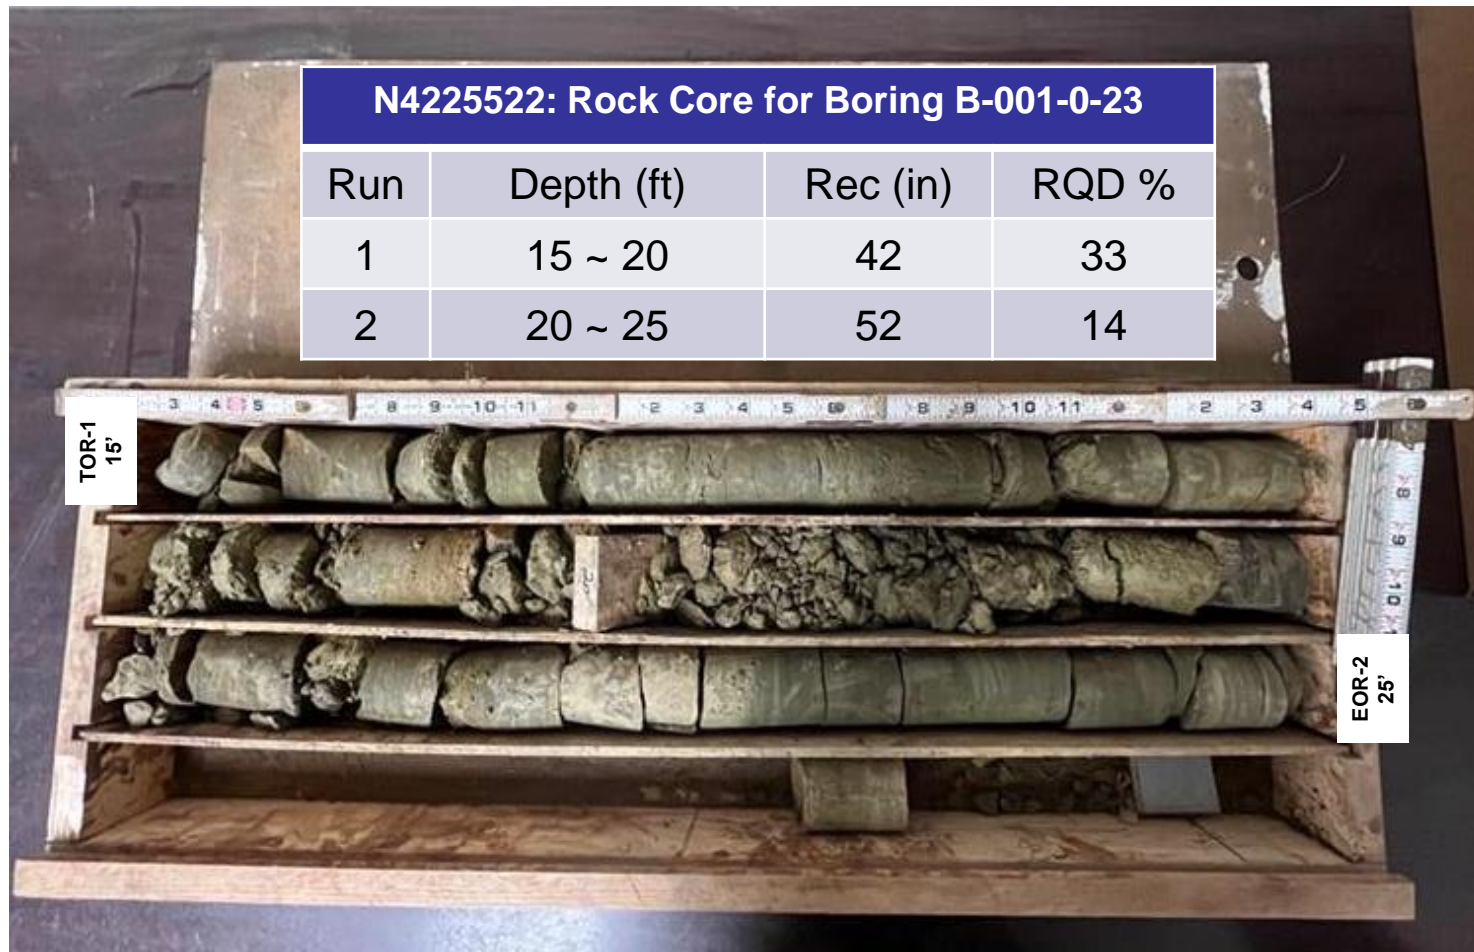
PHOTO 1: ROCK CORE OF BORING B-001-0-23, BOX 1 of 1

| SHALE, GRAY AND BROWN, MODERATELY TO HIGHLY WEATHERED, WEAK TO MODERATELY STRONG, FINE GRAINED, THIN TO MEDIUM BEDDED, ARGILLACEOUS; RQD 33%, REC 70%. | | | | 16 | | | | | | | | | | | | | | | | | |
| @24'- 24.3'; Sc = 322 psi | | 1268.4 | EOB | | | | | | | | | | | | | | | | | | |

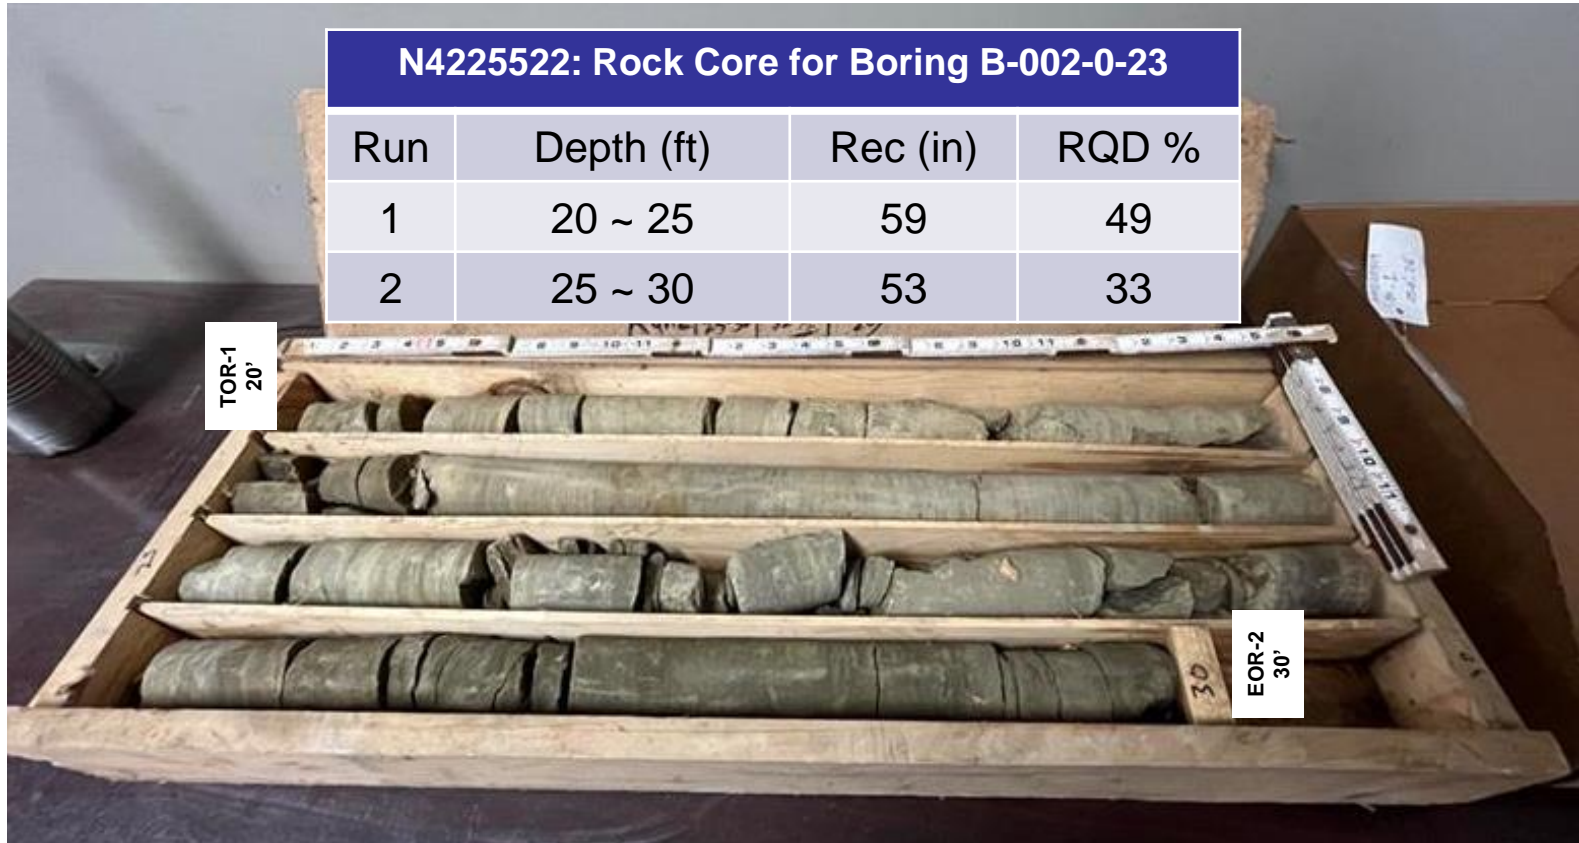
PHOTO 2: ROCK CORE OF BORING B-002-0-23, BOX 1 of 1

| INTERBEDDED SANDSTONE (90%) AND SHALE (10%), RQD 49%, REC. 98%; SANDSTONE, GRAYISH BROWN, SLIGHTLY TO MODERATELY WEATHERED, MODERATELY STRONG TO STRONG, COARSE GRAINED, VERY THIN TO THIN BEDDED, ARGILLACEOUS; SHALE, GRAY, SLIGHTLY WEATHERED, MODERATELY STRONG, FINE GRAINED, VERY THIN BEDDED. | | | 1270.7 | 20 | | | | | | | | | | | | | | | | | |
