Subject: CUY-BH-FY2023 (B) Misc - PID 105909, Asbestos Survey

CUY-90-10.620, West 117<sup>th</sup> Street bridge over I-90, SFN 1808249

Report of Findings of an Asbestos Survey Conducted of the West 117<sup>th</sup> Street Bridge over Interstate 90 Located in Cleveland, Cuyahoga County, Ohio

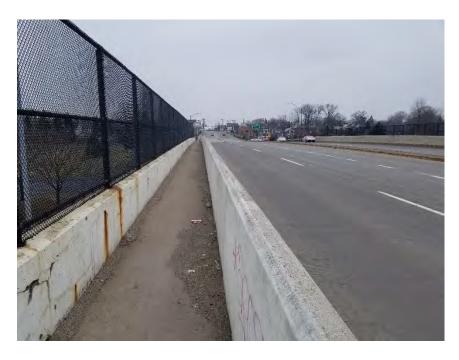
Photograph 01

View Looking South at the Top of the West 117<sup>th</sup> Street Bridge over Interstate 90, Cleveland, Cuyahoga County, Ohio

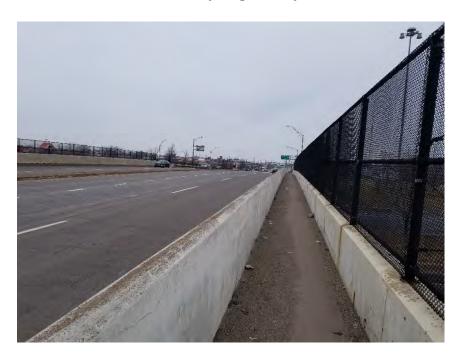
Photograph 02

View Looking North at the Top of the West 117<sup>th</sup> Street Bridge over Interstate 90, Cleveland, Cuyahoga County, Ohio

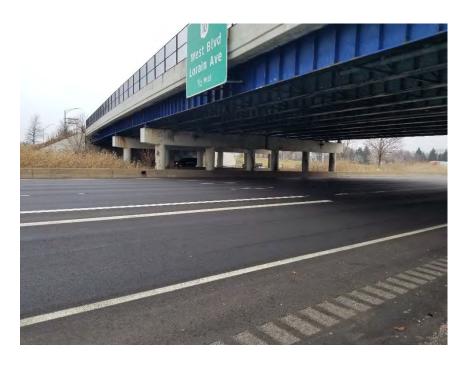
Photograph 03

View Looking Northeast at the Underside of the West 117<sup>th</sup> Street Bridge over Interstate 90, Cleveland, Cuyahoga County, Ohio

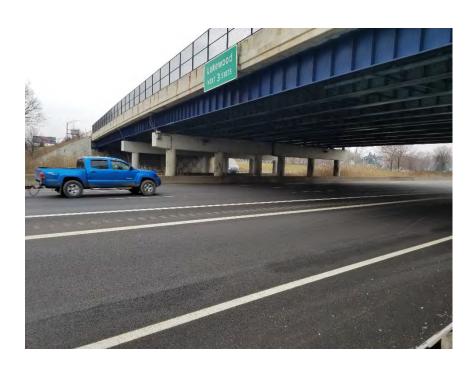
Photograph 04

View Looking Southwest at the Underside of the West 117<sup>th</sup> Street Bridge over Interstate 90, Cleveland, Cuyahoga County, Ohio

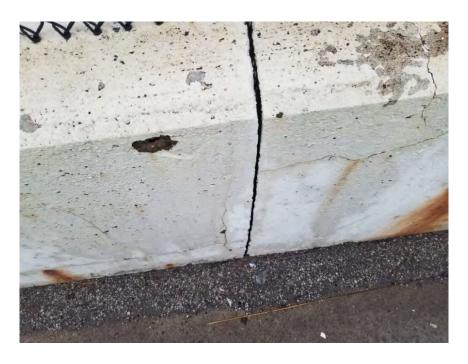
Photograph 05

View Looking at Parapet Wall Gasket Located at the West 117<sup>th</sup> Street Bridge over Interstate 90, Cleveland, Cuyahoga County, Ohio

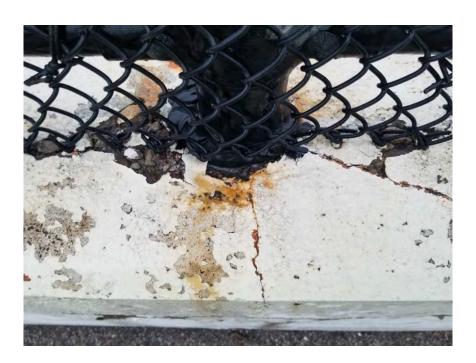
Photograph 06

View Looking at Fence Caulk Located at the West 117<sup>th</sup> Street Bridge over Interstate 90, Cleveland, Cuyahoga County, Ohio

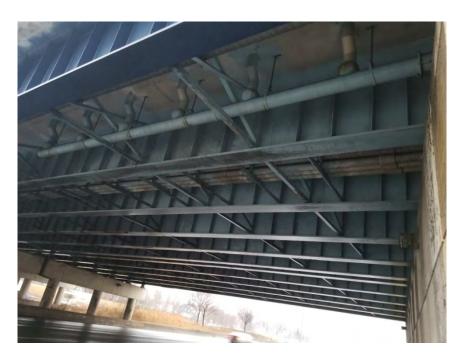
Photograph 07

View Looking at One Metal Drain Pipe and Six Cementitious 8-inch Pipes Located on the East Side of the Underside of the West 117<sup>th</sup> Street Bridge over Interstate 90, Cleveland, Cuyahoga County, Ohio

- Notify any outside contractor(s), prior to them working on the subject bridge, of the presence of
  the assumed asbestos-containing pipe insulation and assumed cementitious pipe identified on
  the bridge. In addition, the suspect building materials identified during the construction plan
  review and not identified during the physical inspection may still be present on the structure;
  hence outside contractor(s) should be notified that these suspect building materials may be
  present on the bridge structure.

- 2. If renovation activities have the potential to disturb the assumed asbestos-containing pipe insulation and assumed cementitious pipe located on the subject bridge, then a licensed asbestos abatement contractor should be retained to abate this material prior to it being disturbed.

4. If the assumed asbestos-containing pipe insulation and assumed cementitious pipe is to remain in place, implement an operations and maintenance (O&M) program whereby these materials are continually evaluated and maintained by trained personnel.

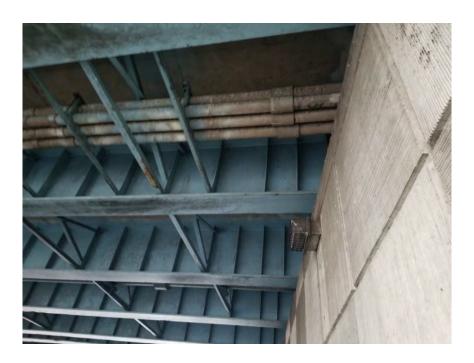
Photograph 08

View Looking at Six Cementitious 8-inch Pipes Located on the East Side of the Underside of the West 117<sup>th</sup> Street Bridge over Interstate 90, Cleveland, Cuyahoga County, Ohio

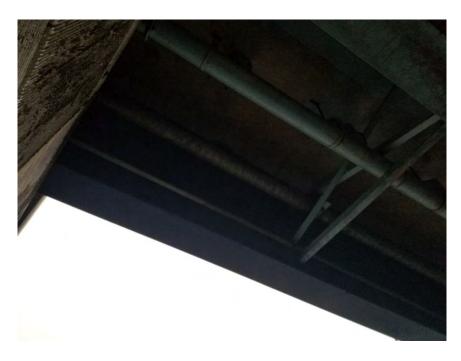
Photograph 09

View Looking at One 12-inch Pipe Located on the East Side of the Underside of the West 117<sup>th</sup> Street Bridge over Interstate 90, Cleveland, Cuyahoga County, Ohio

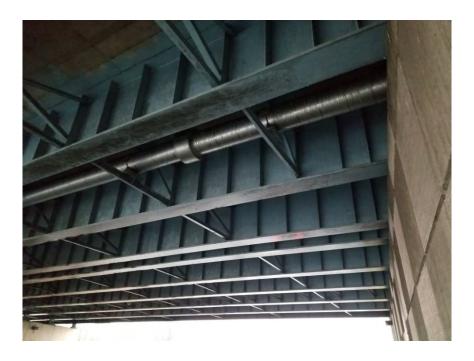
Photograph 10

View Looking at One 2-Foot Metal Jacketed Pipe Located on the Underside of the West 117<sup>th</sup> Street Bridge over Interstate 90, Cleveland, Cuyahoga County, Ohio

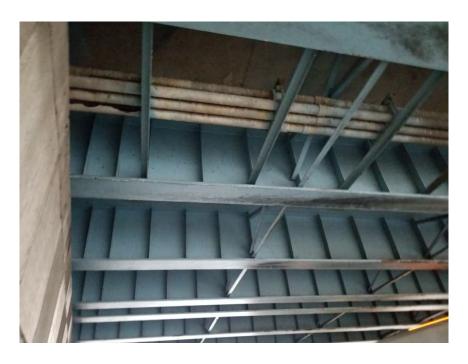
Photograph 11

View Looking at Six Cementitious 8-inch Pipes Located on the West Side of the Underside of the West 117<sup>th</sup> Street Bridge over Interstate 90, Cleveland, Cuyahoga County, Ohio
